US010967989B2

(54) **CESSNA TAIL-CONE REINFORCEMENT ANGLE SPLICE, INSTALLATION KIT, AND METHOD FOR INSTALLATION THEREOF**

(71) Applicant: **QMI, Inc.**, Joseph, OR (US)

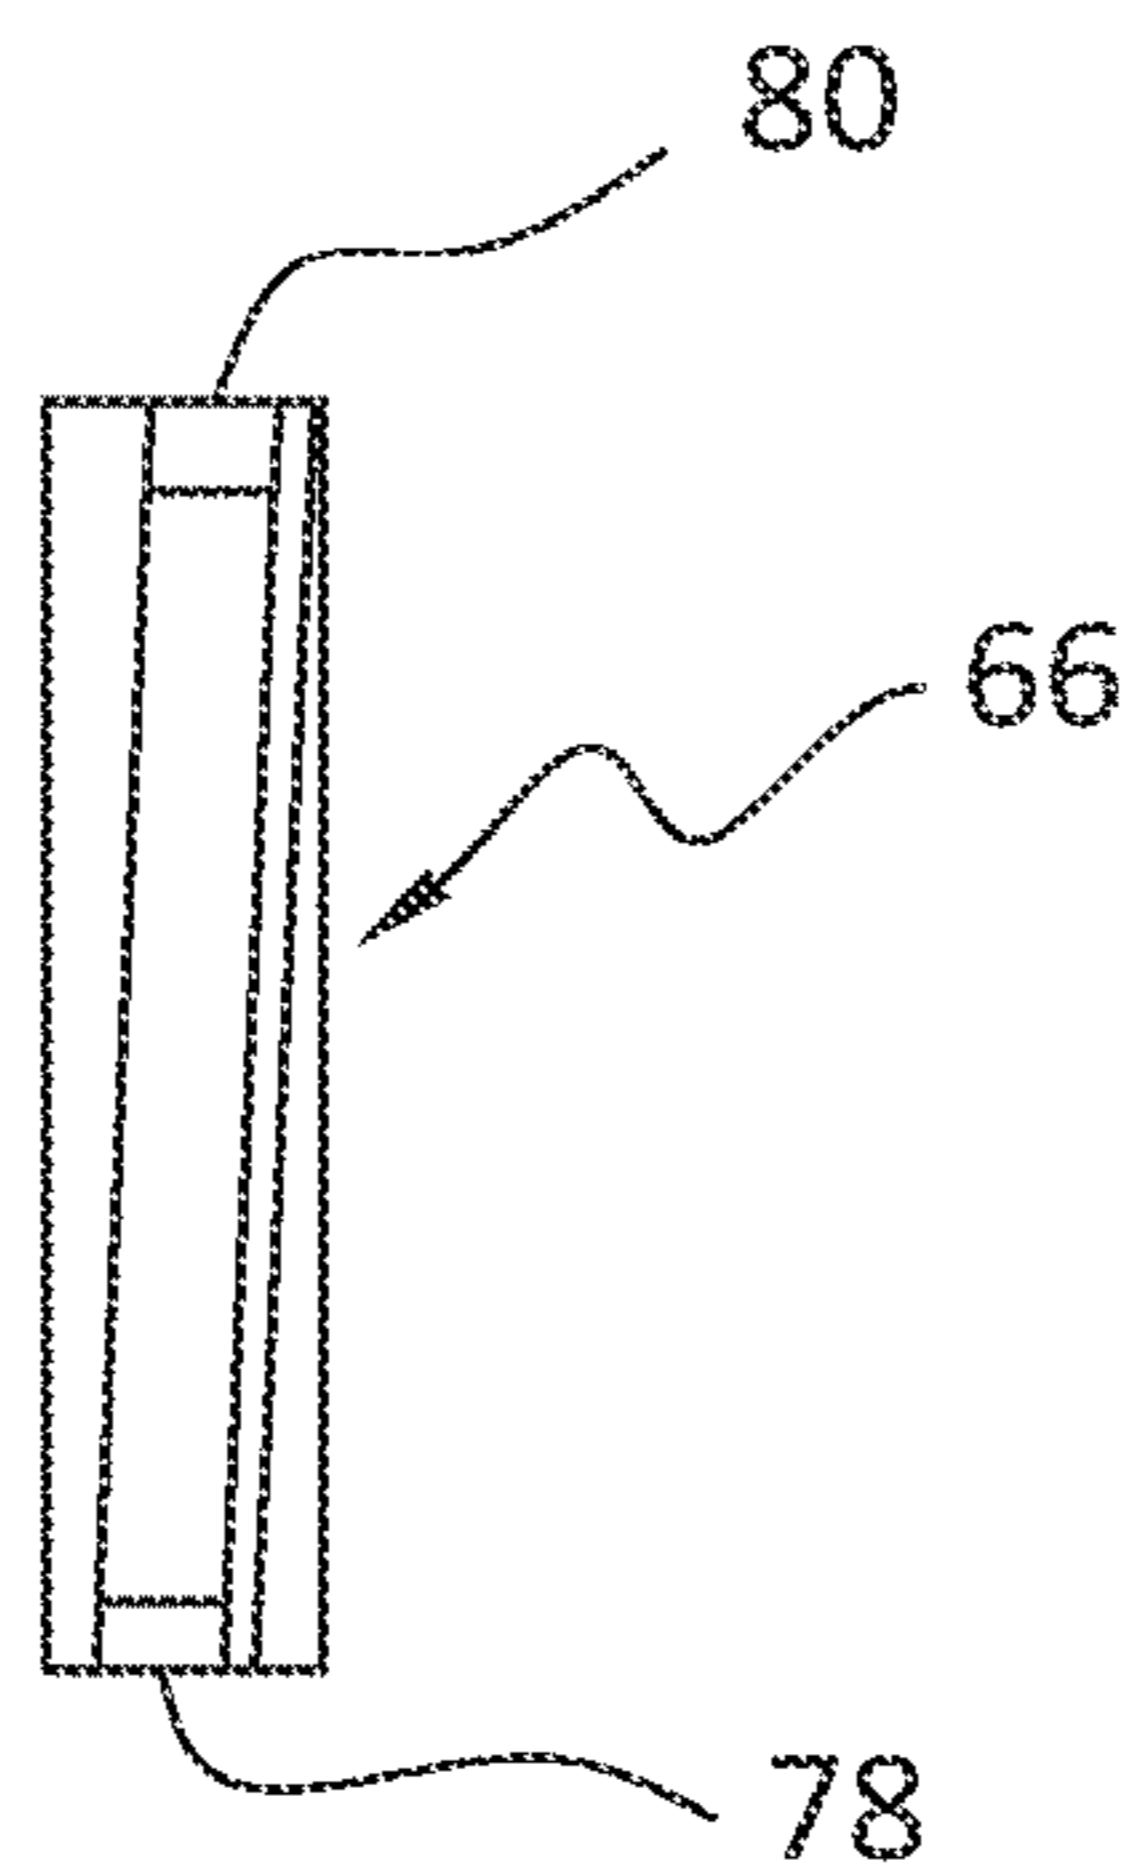
FIG. 8 is an aft end view of the reinforcement angle splice depicted in FIGS. 6 and 7 and taken from the right as seen in FIG. 6 and from the left as seen in FIG. 7;

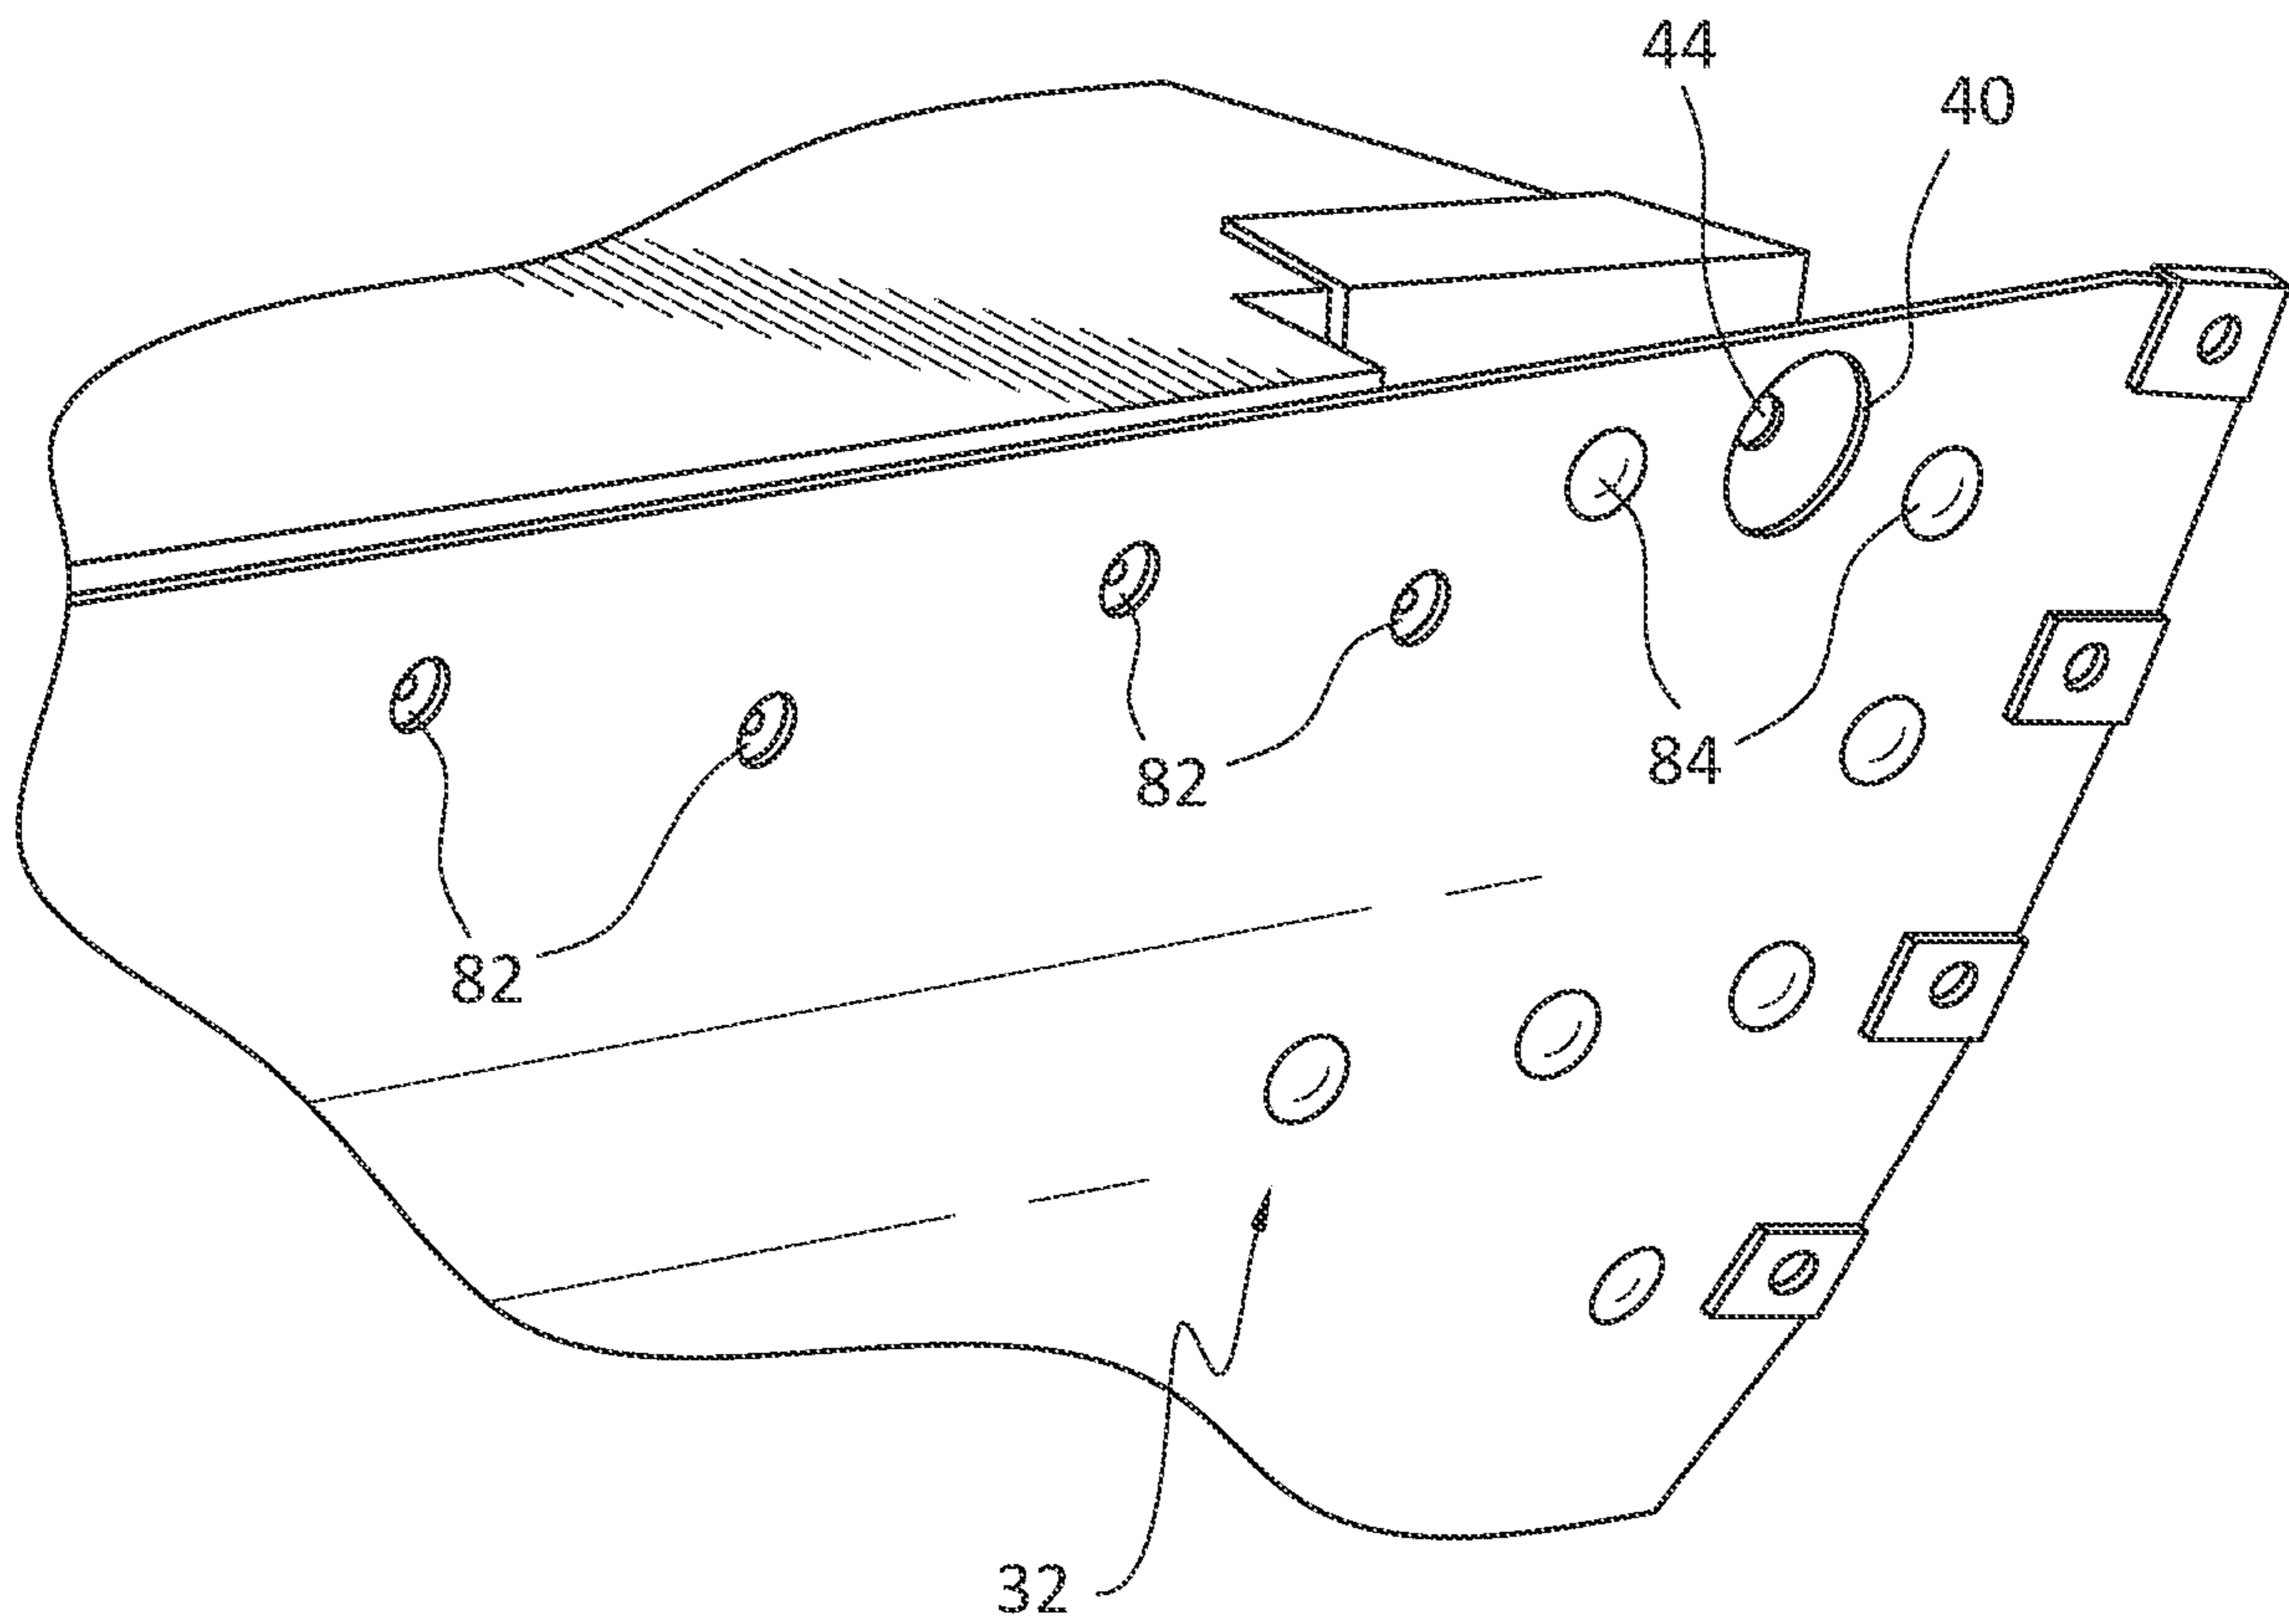
FIG. 9 is a view of an aft portion of the tail cone and showing the removal of four rivets;

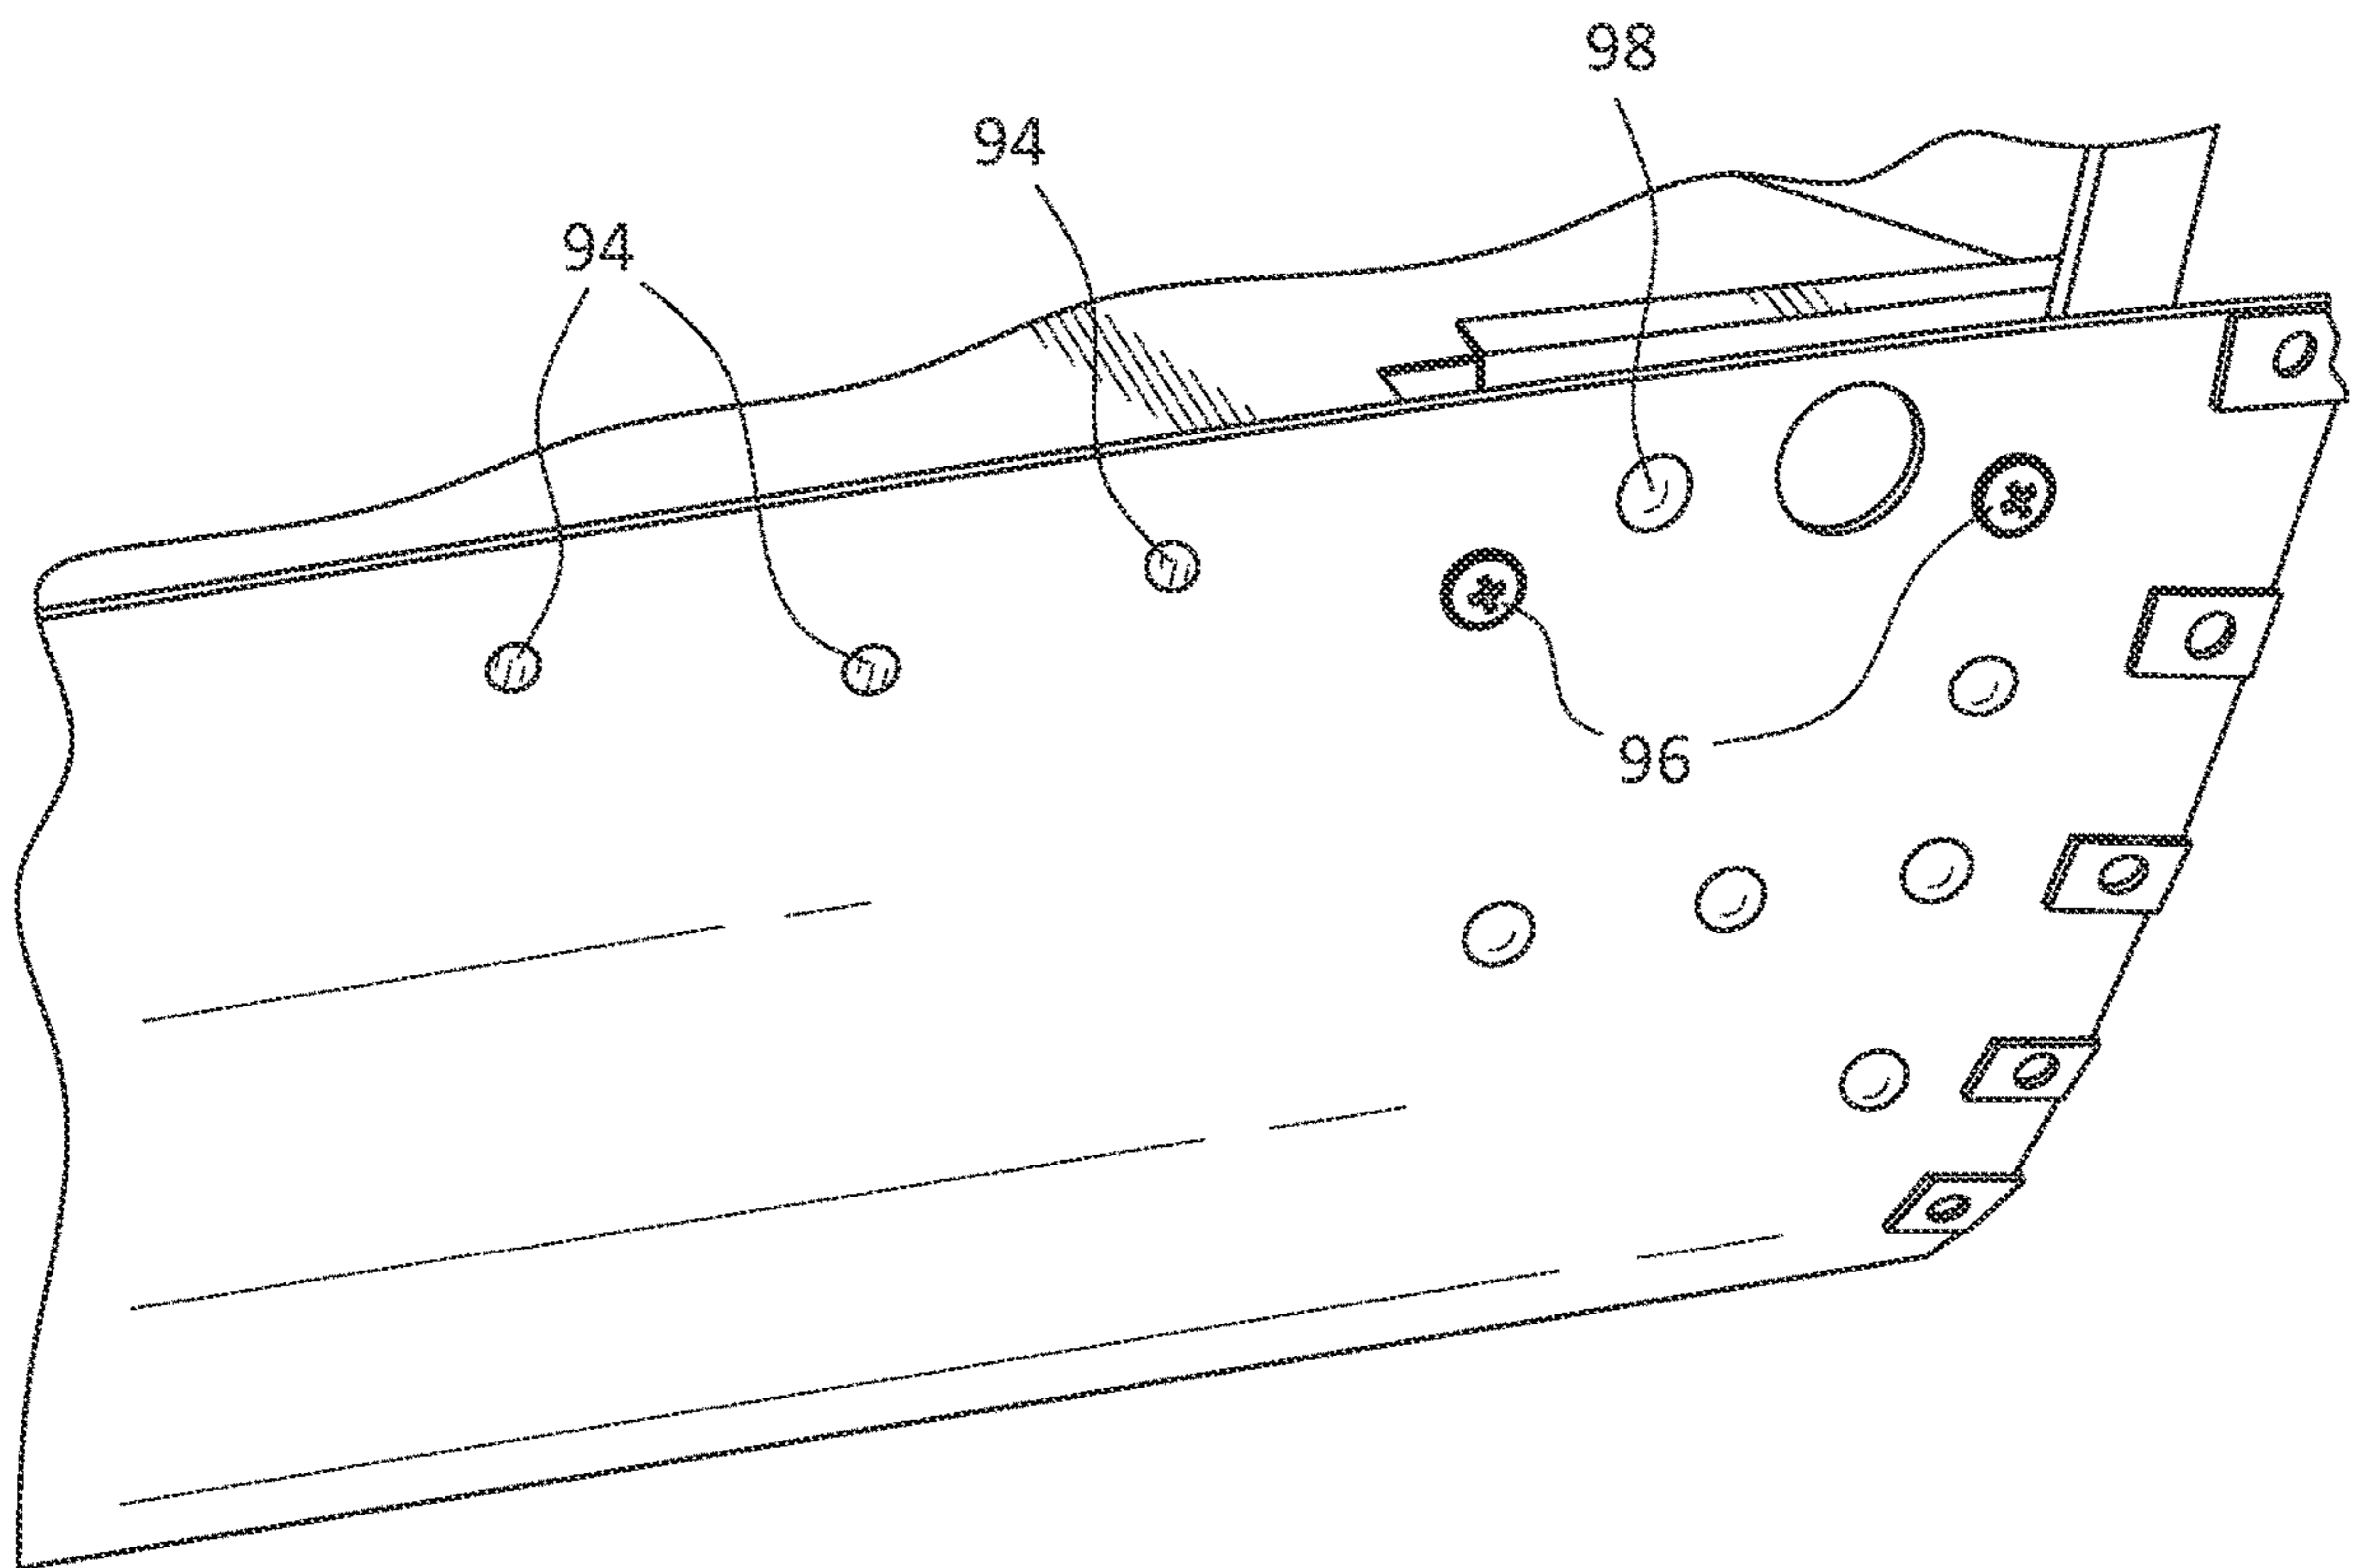
FIG. 10 is a view similar to FIG. 9 with the tail-cone reinforcement angle splice installed and secured in place;

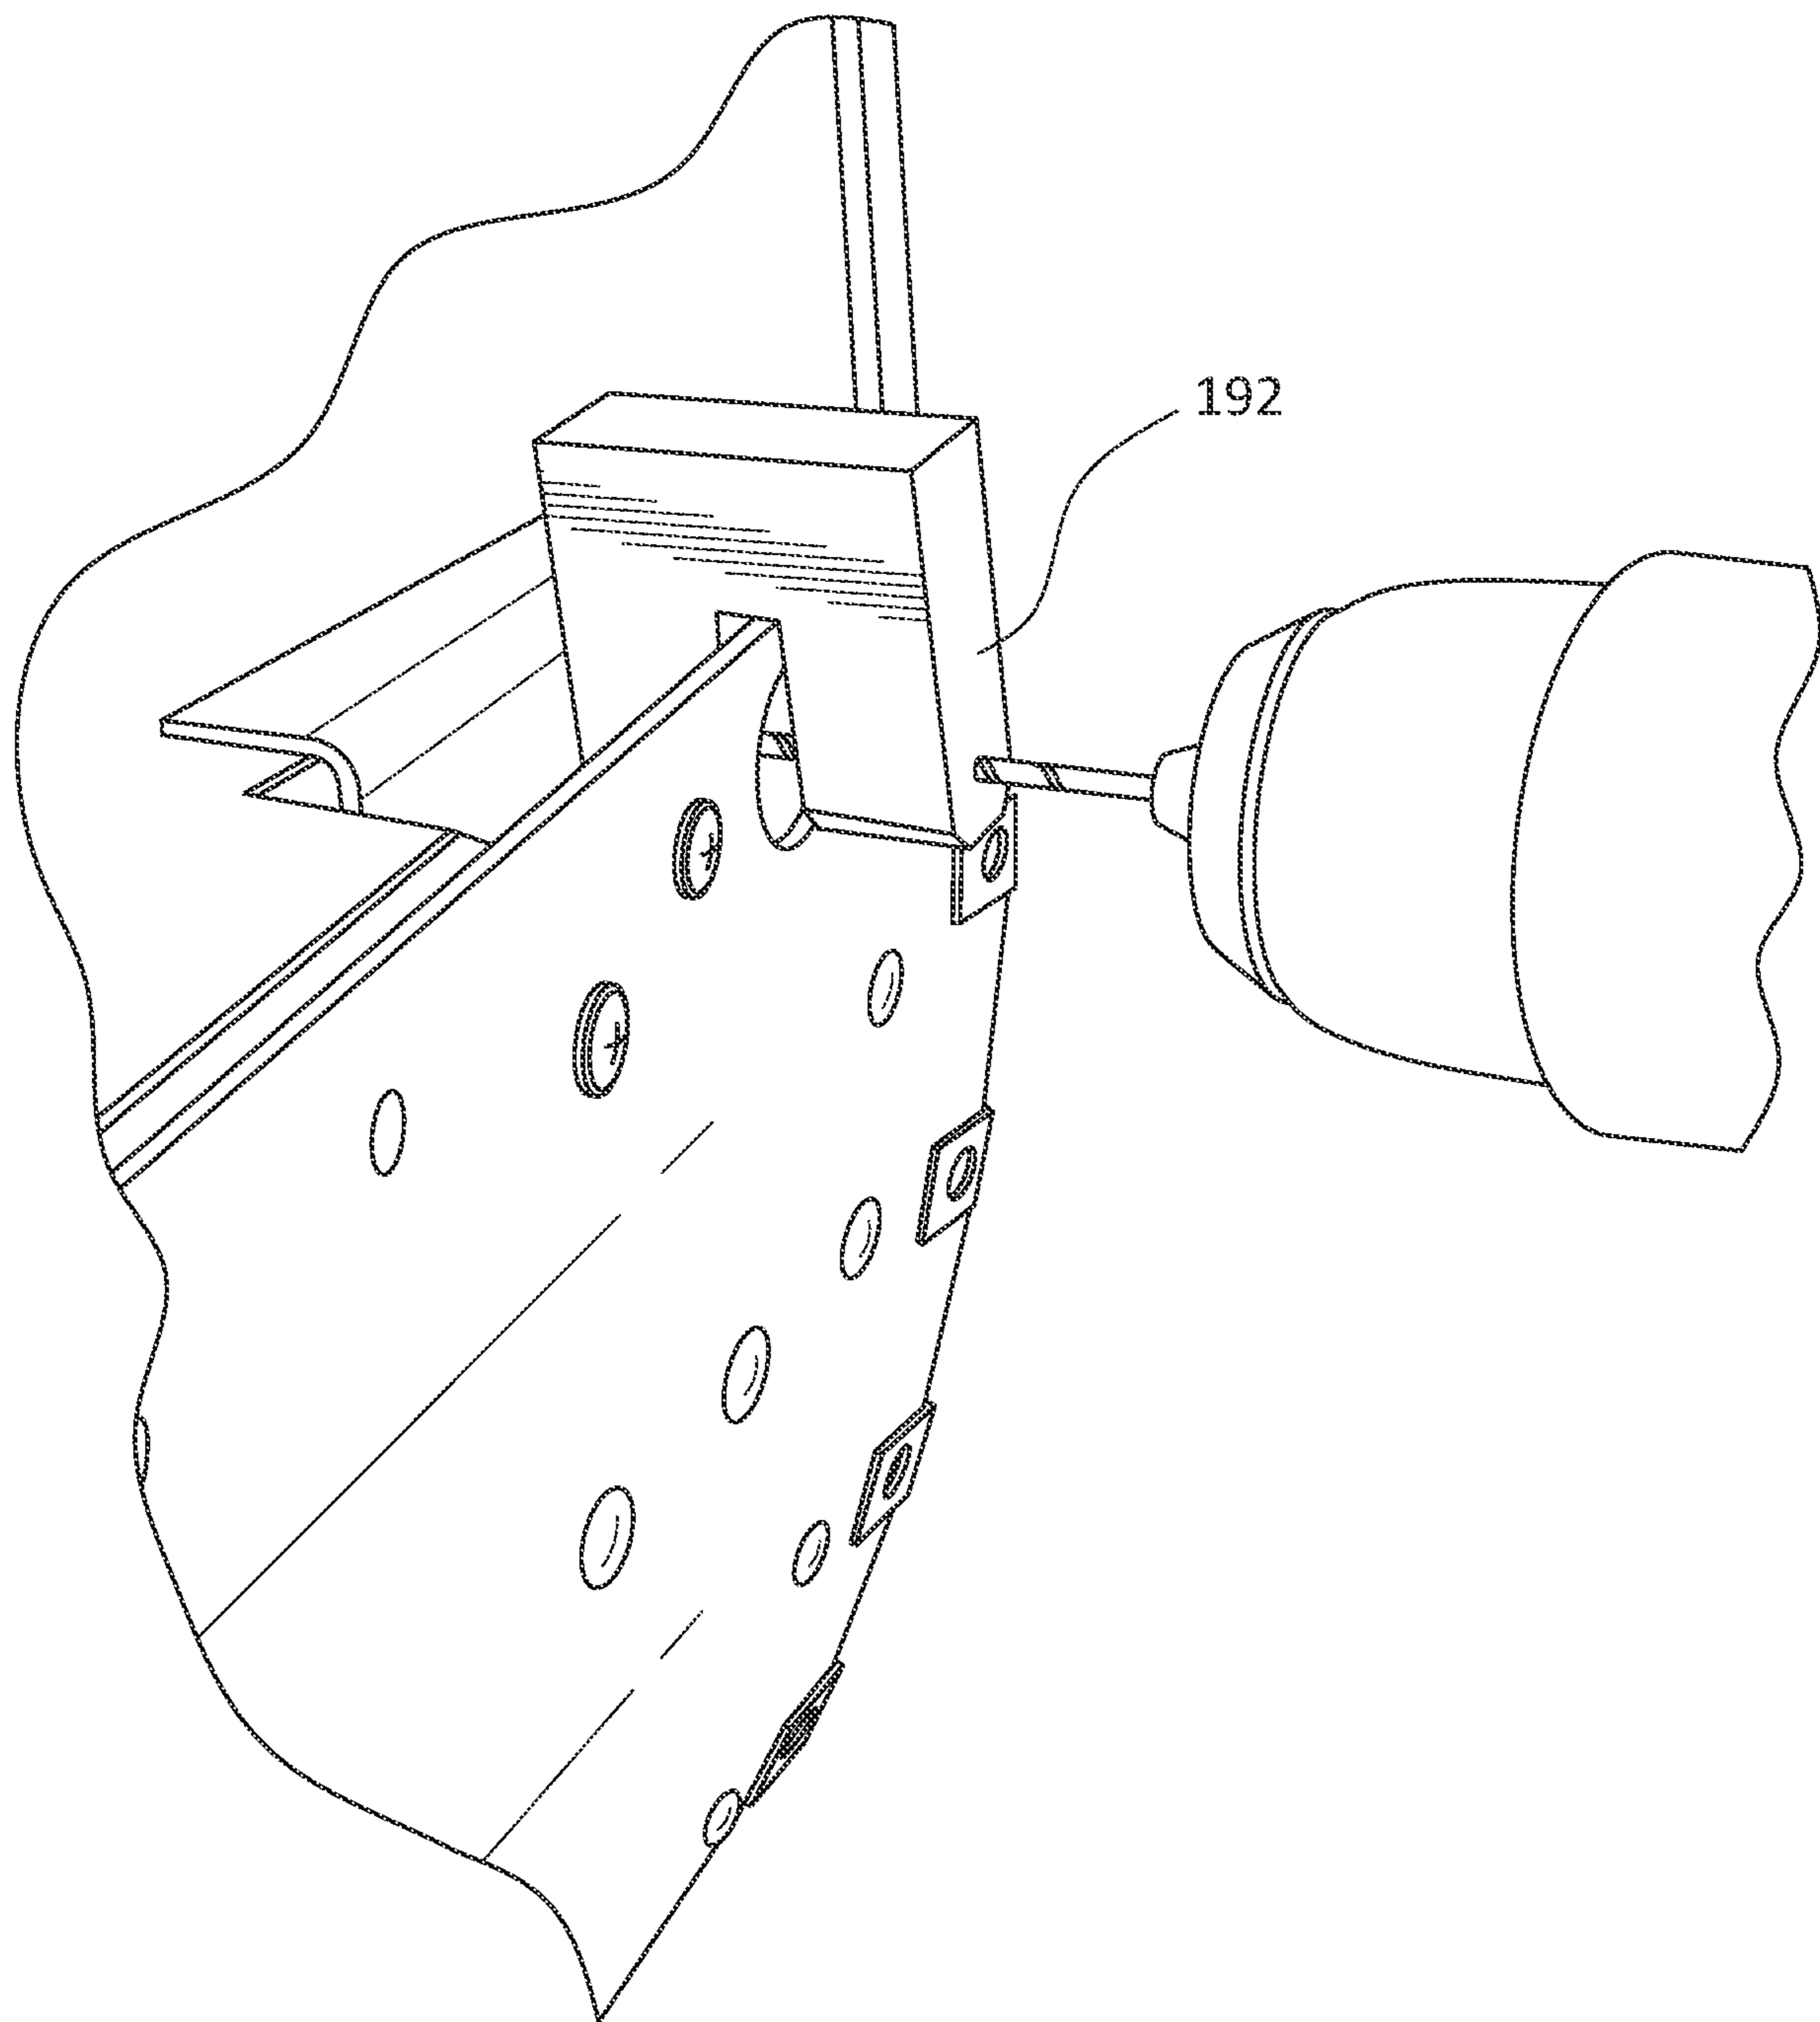
FIG. 11 is a view of the aft section of the tail cone and showing the forming of the horizontal stabilizer shaft receiving bore in the tail-cone reinforcement angle splice;

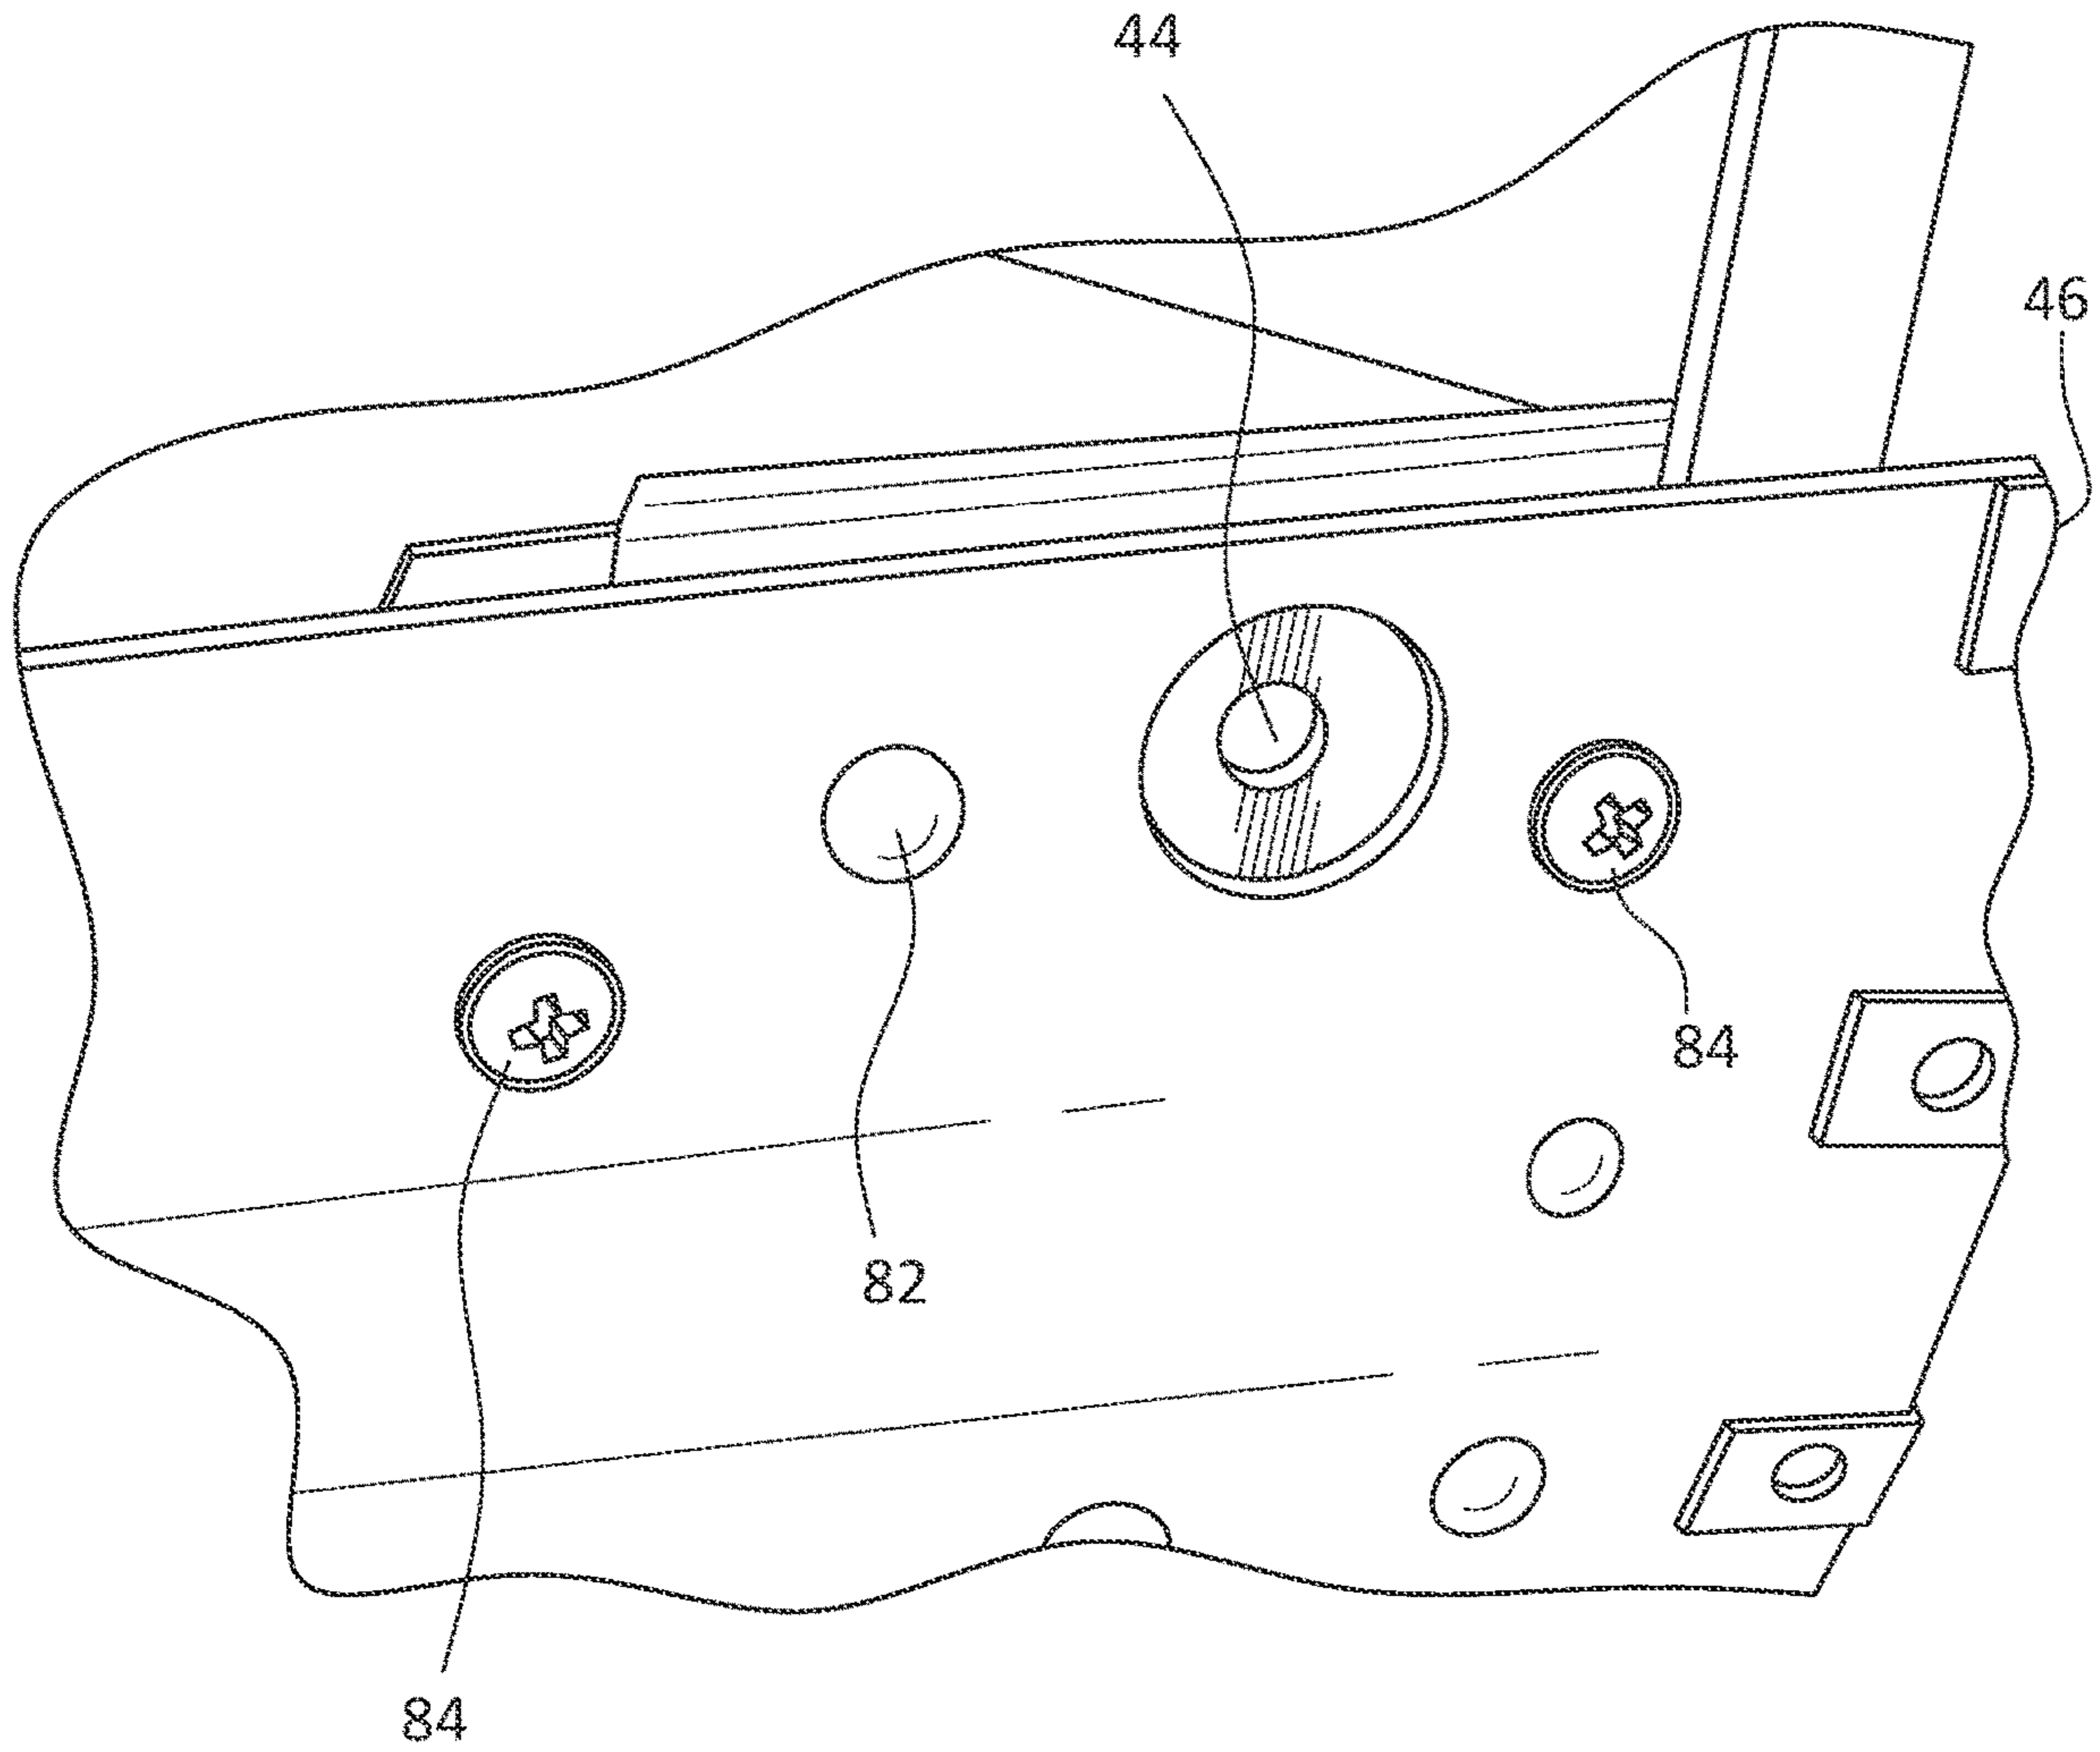
FIG. 12 is a view of the aft section of the tail cone and showing the completed horizontal stabilizer pivot shaft receiving bore formed in the tail-cone reinforcement angle splice; and
