(54) **CESSNA TAIL-CONE REINFORCEMENT ANGLE SPLICE, INSTALLATION KIT, AND METHOD FOR INSTALLATION THEREOF**

A tail-cone reinforcement angle of a Cessna 180-185 series aircraft is repaired by the removal of an aft most section of that tail-cone reinforcement angle and its replacement with an elongated splice body. The elongated splice body is attached to the remainder of the tail-cone reinforcement angle and to the tail-cone portion of the fuselage of the aircraft. The aft section of the original tail-cone reinforcement angle is subject to the development and propagation of cracks in the area of the rear pivot shaft receiving bore, which cracks render the aircraft unfit for use. The invention includes the provision of a suitable elongated splice body, a method for its installation, and a tool kit which is usable in accomplishing the removal and replacement of the aft section of the tail-cone reinforcement angle.

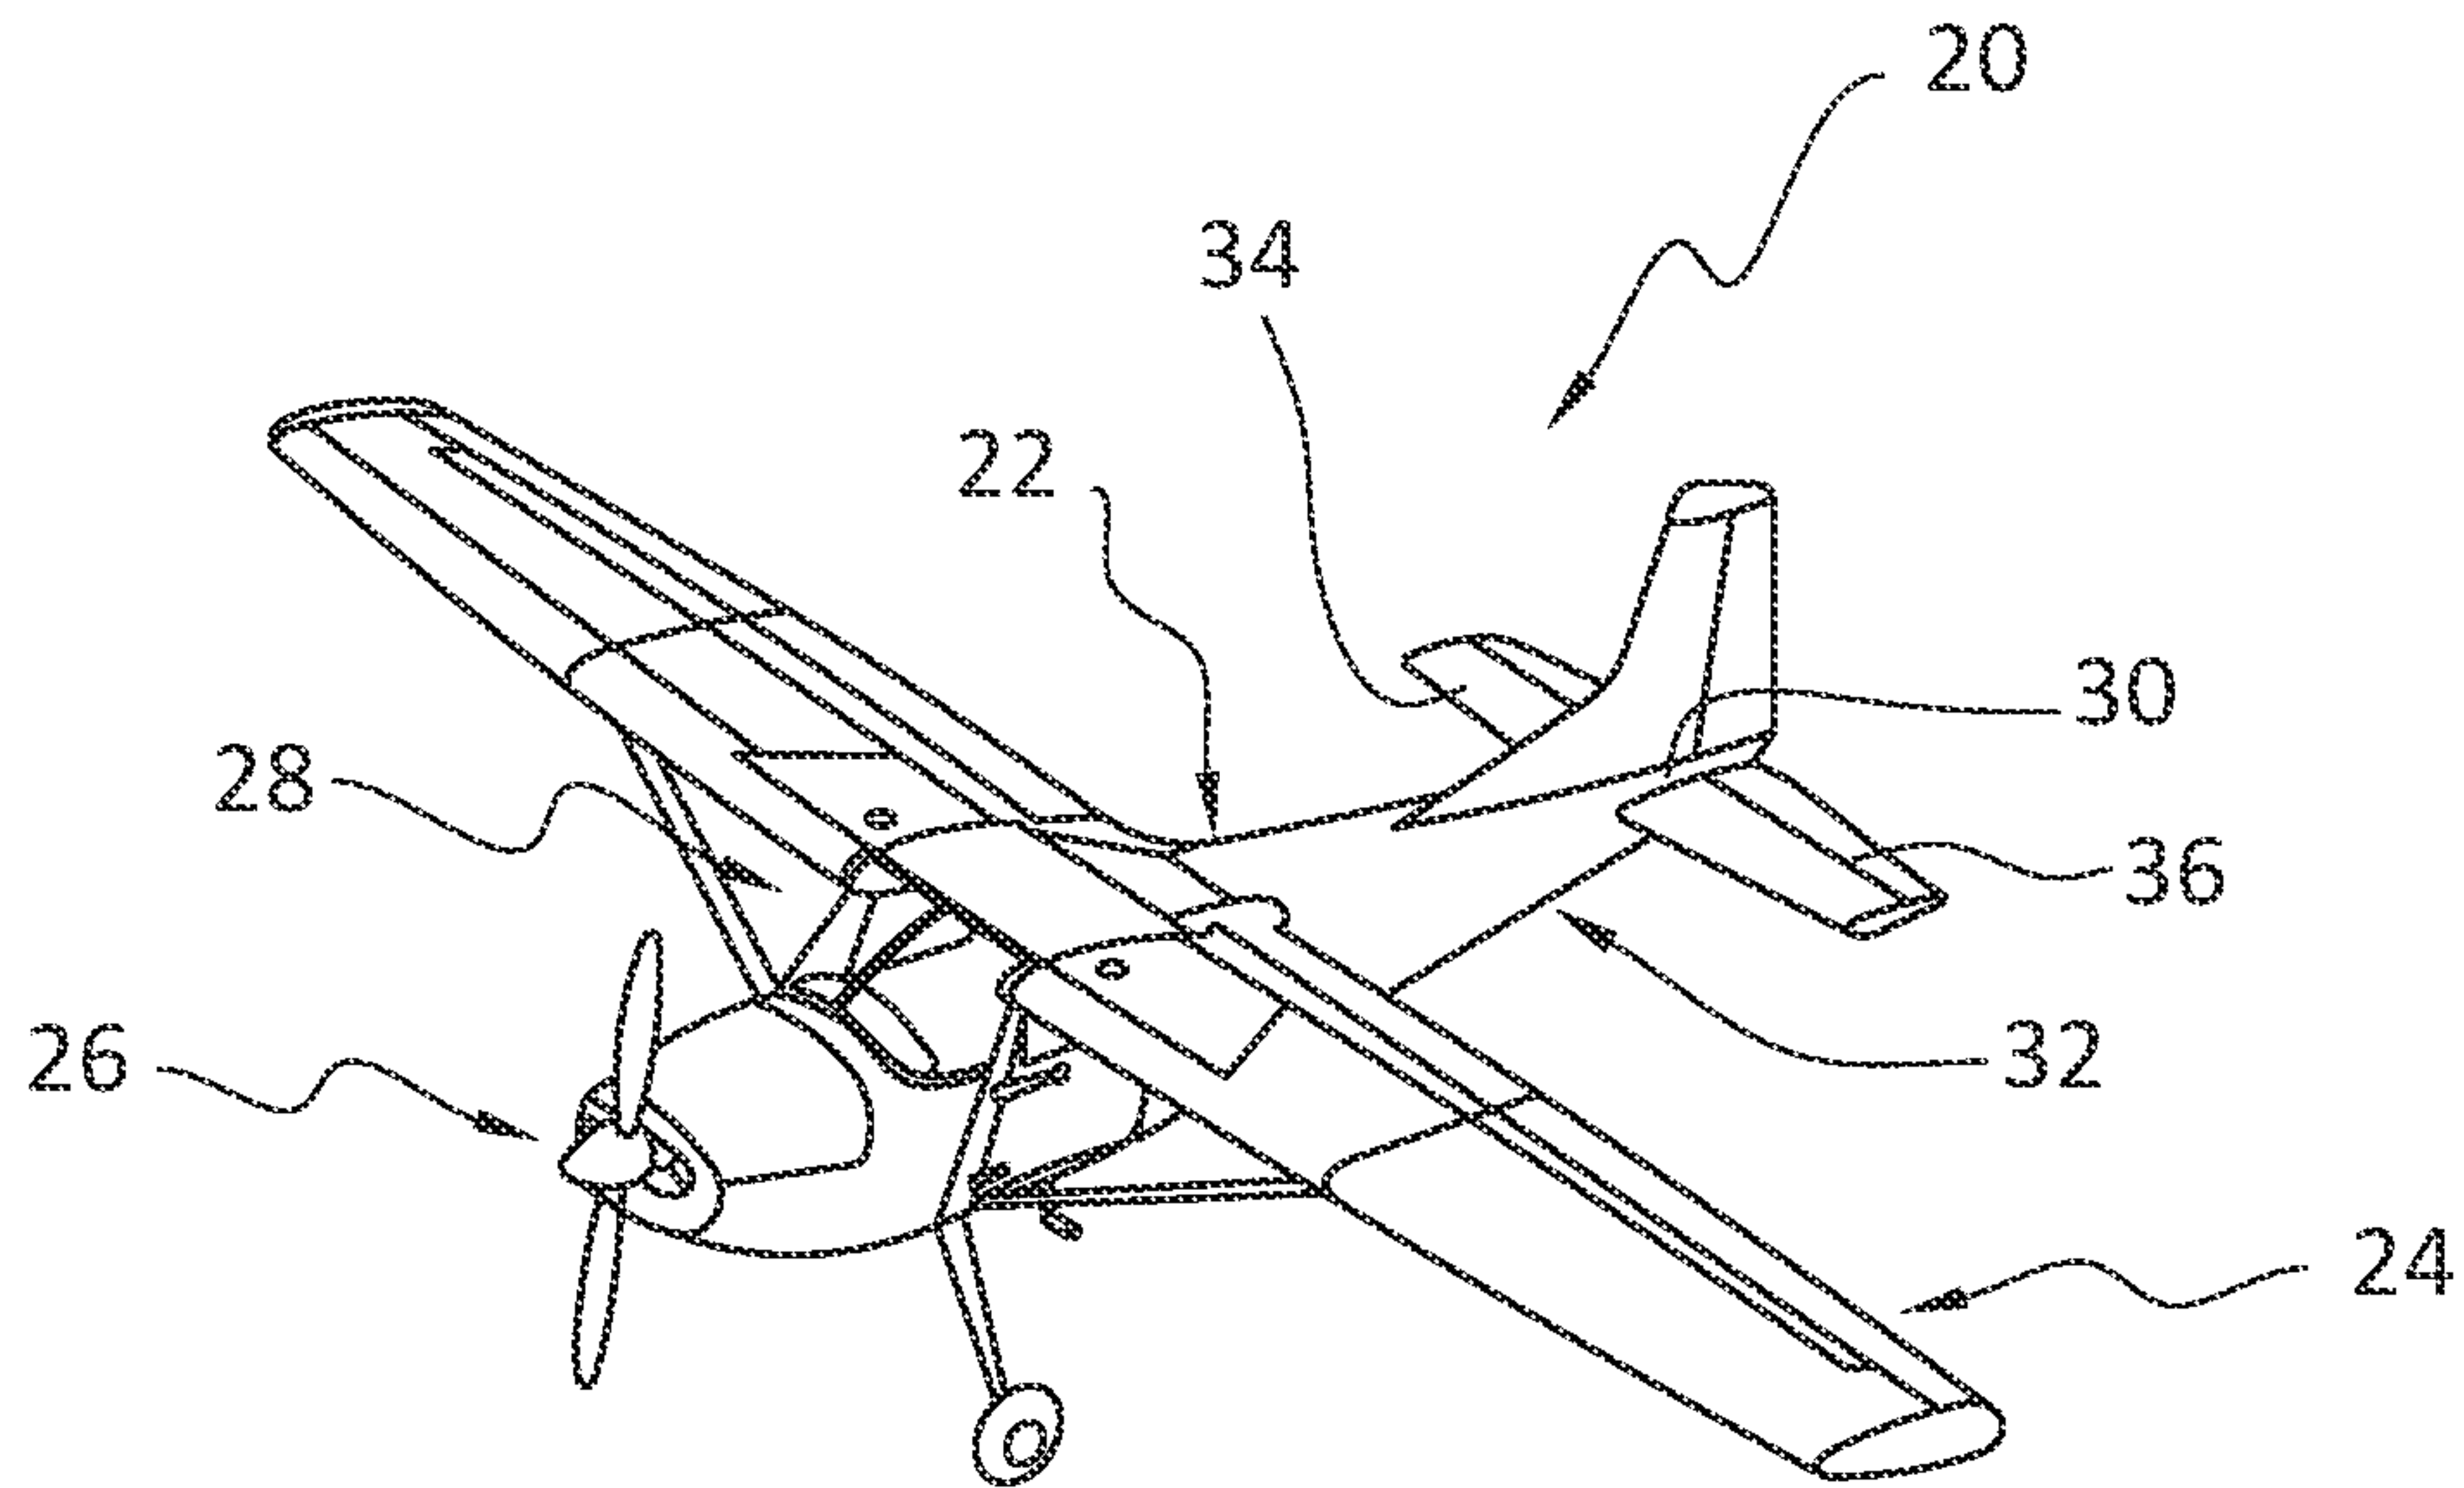
FIG. 1 is a schematic depiction of a Cessna series 180-185 series aircraft with which the pertinent invention is intended for use;

Referring initially to FIG. 1 of the patent drawings filed in the subject U.S. patent application, there may be seen, generally at 20, a typical Cessna 180-185 series aircraft with which the tail-cone reinforcement angle splice, in accordance with the present invention, finds particular usage. Aircraft 20, as is well known to one familiar with such aircraft, includes a fuselage, generally at 22, forward upper mounted wings 24, an engine and propeller assembly 26, a cockpit 28 and a rear elevator and stabilizer assembly generally at 30. The rear elevator and stabilizer assembly generally at 30, is attached to a rear portion of the fuselage 22, in an area that fuselage known as the tail-cone 32, which tail-cone area 32 is seen somewhat schematically in FIG. 2. The rear stabilizer and elevator assembly, generally at 30, includes a pivotally mounted horizontal stabilizer 34 and a pair of elevators 36. The horizontal stabilizer 34 is attached to the tail-cone, generally at 32, in an aft portion 38 of the tail cone 32. The attachment of the horizontal stabilizer 34 is accomplished by providing pivot shafts which are located in the trailing portion of the horizontal stabilizer 34, which pivot shafts are well known, are not illustrated, and which form no part of the present invention. The horizontal stabi-

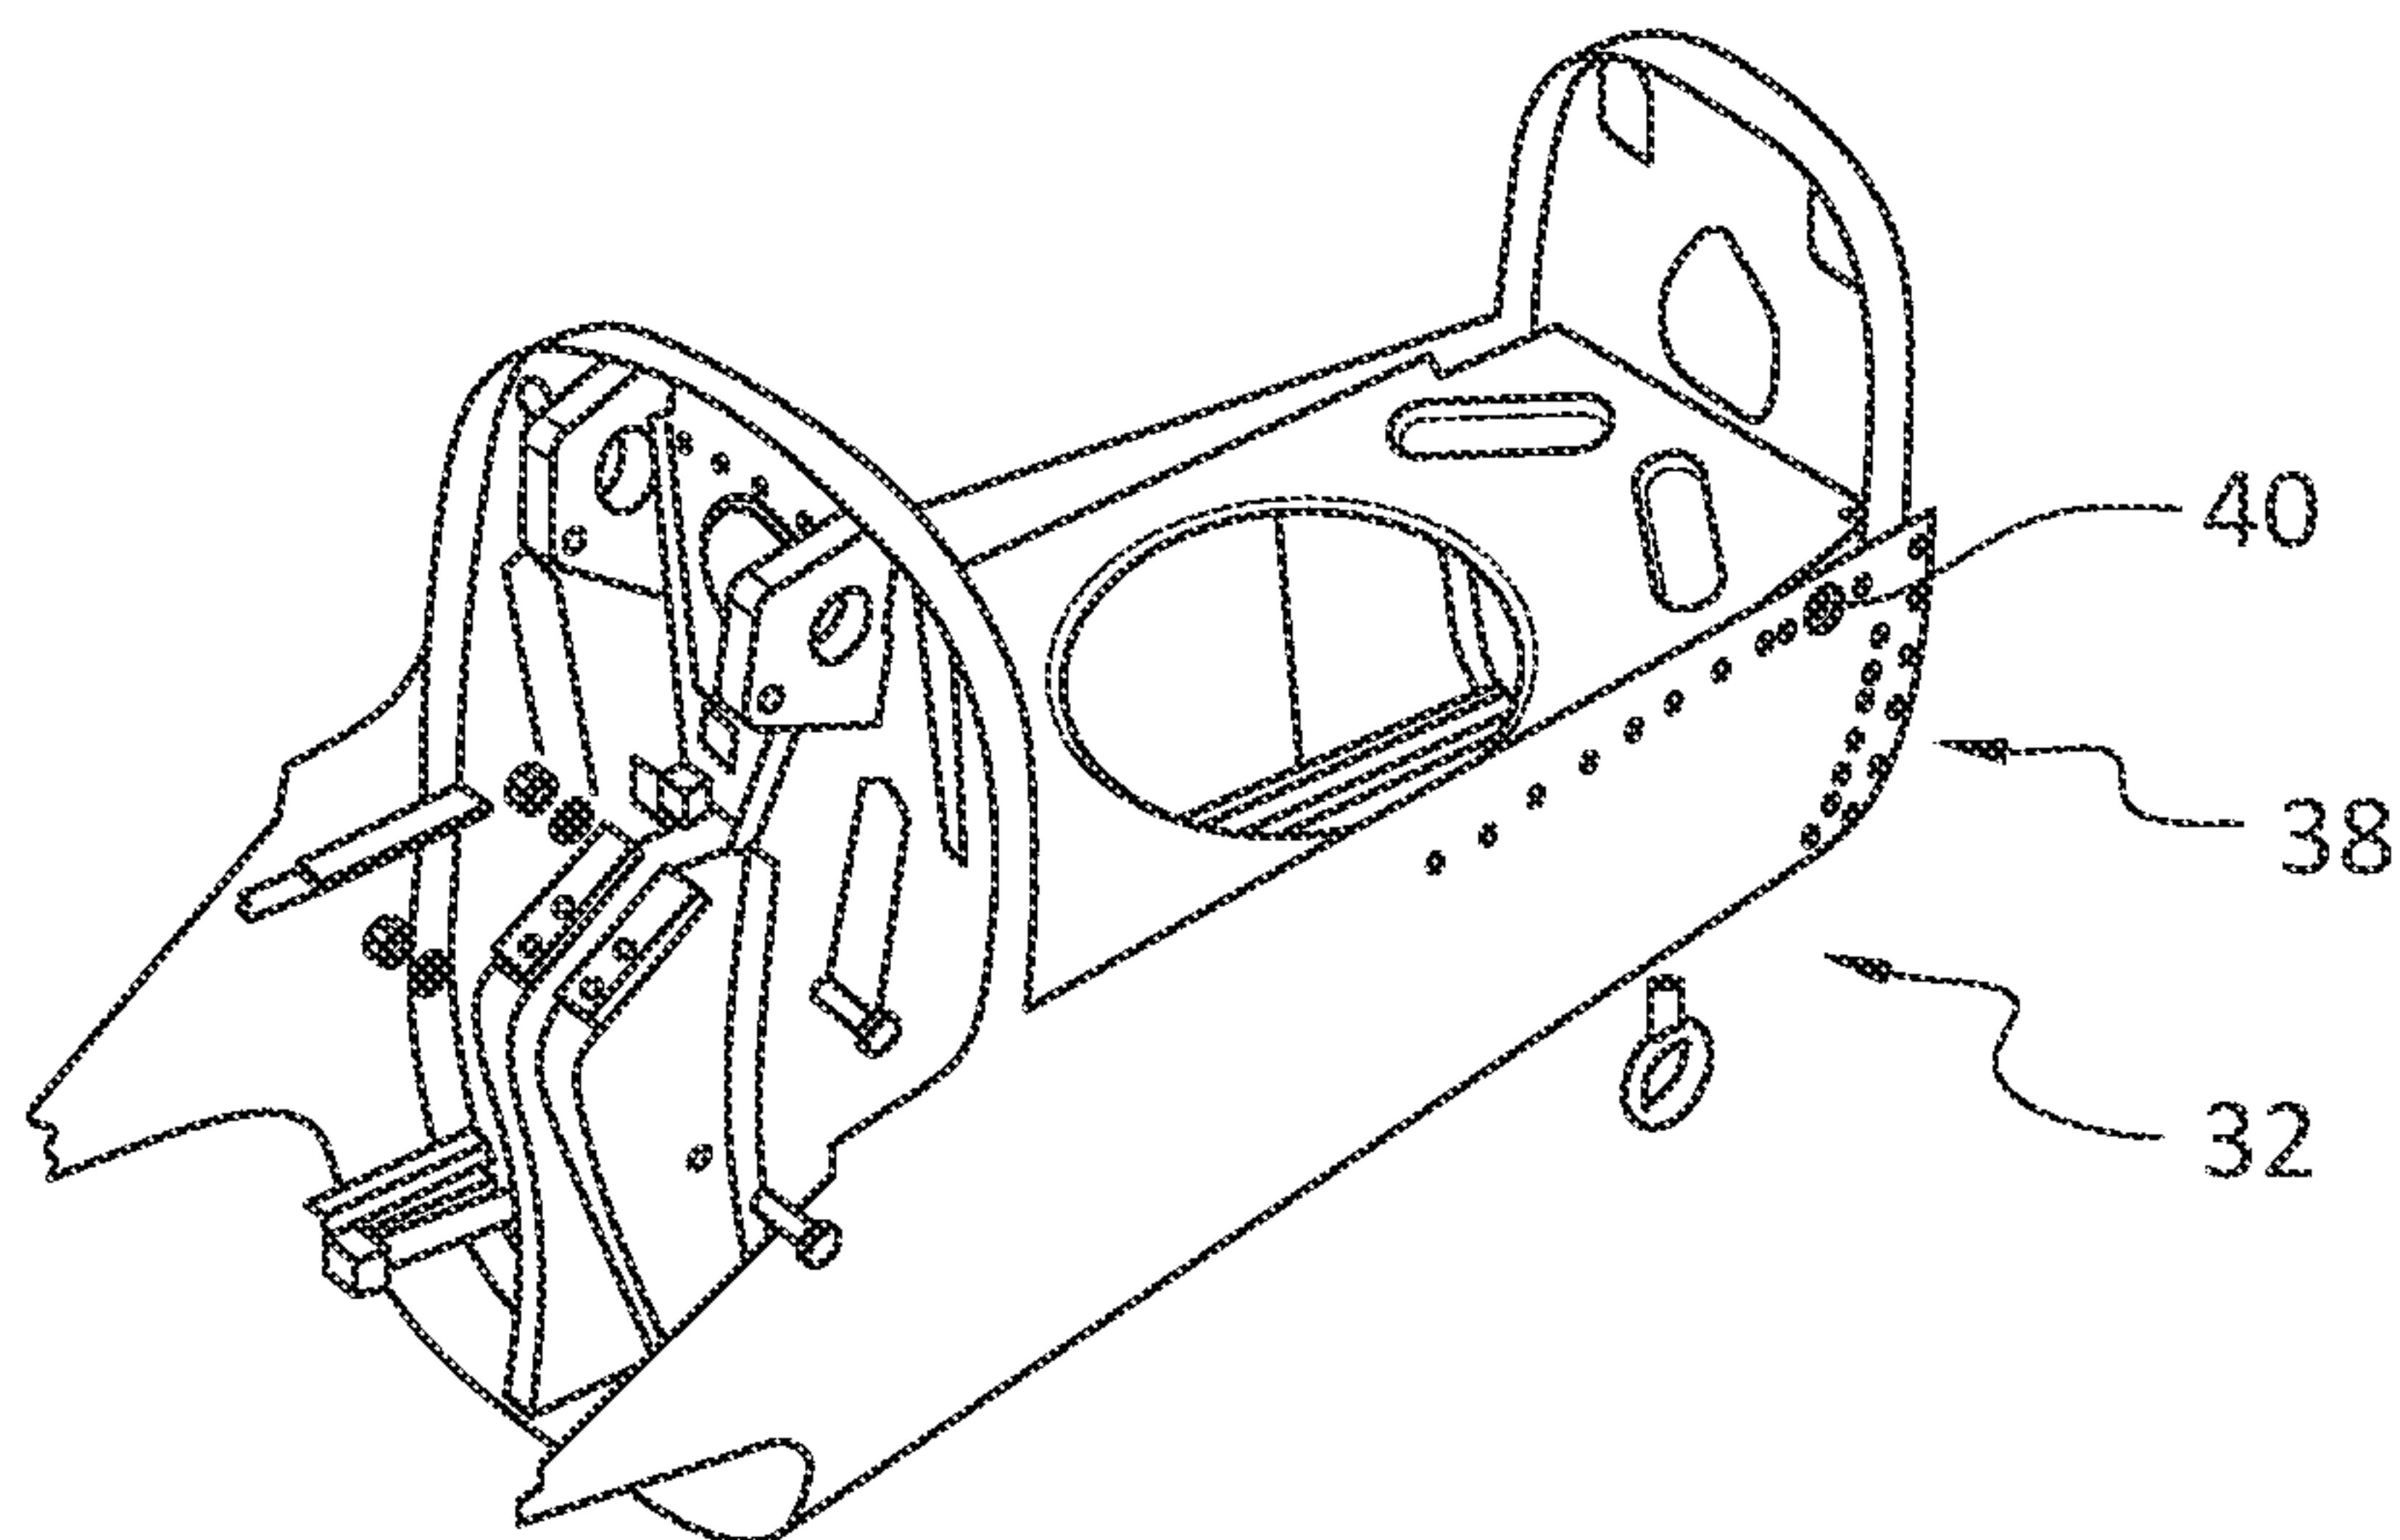
FIG. 2 is a schematic depiction of a tail-cone area of the Cessna 180-185 series aircraft depicted in FIG. 1, and with the horizontal stabilizer, elevator, tail, tail wheel and stinger removed;

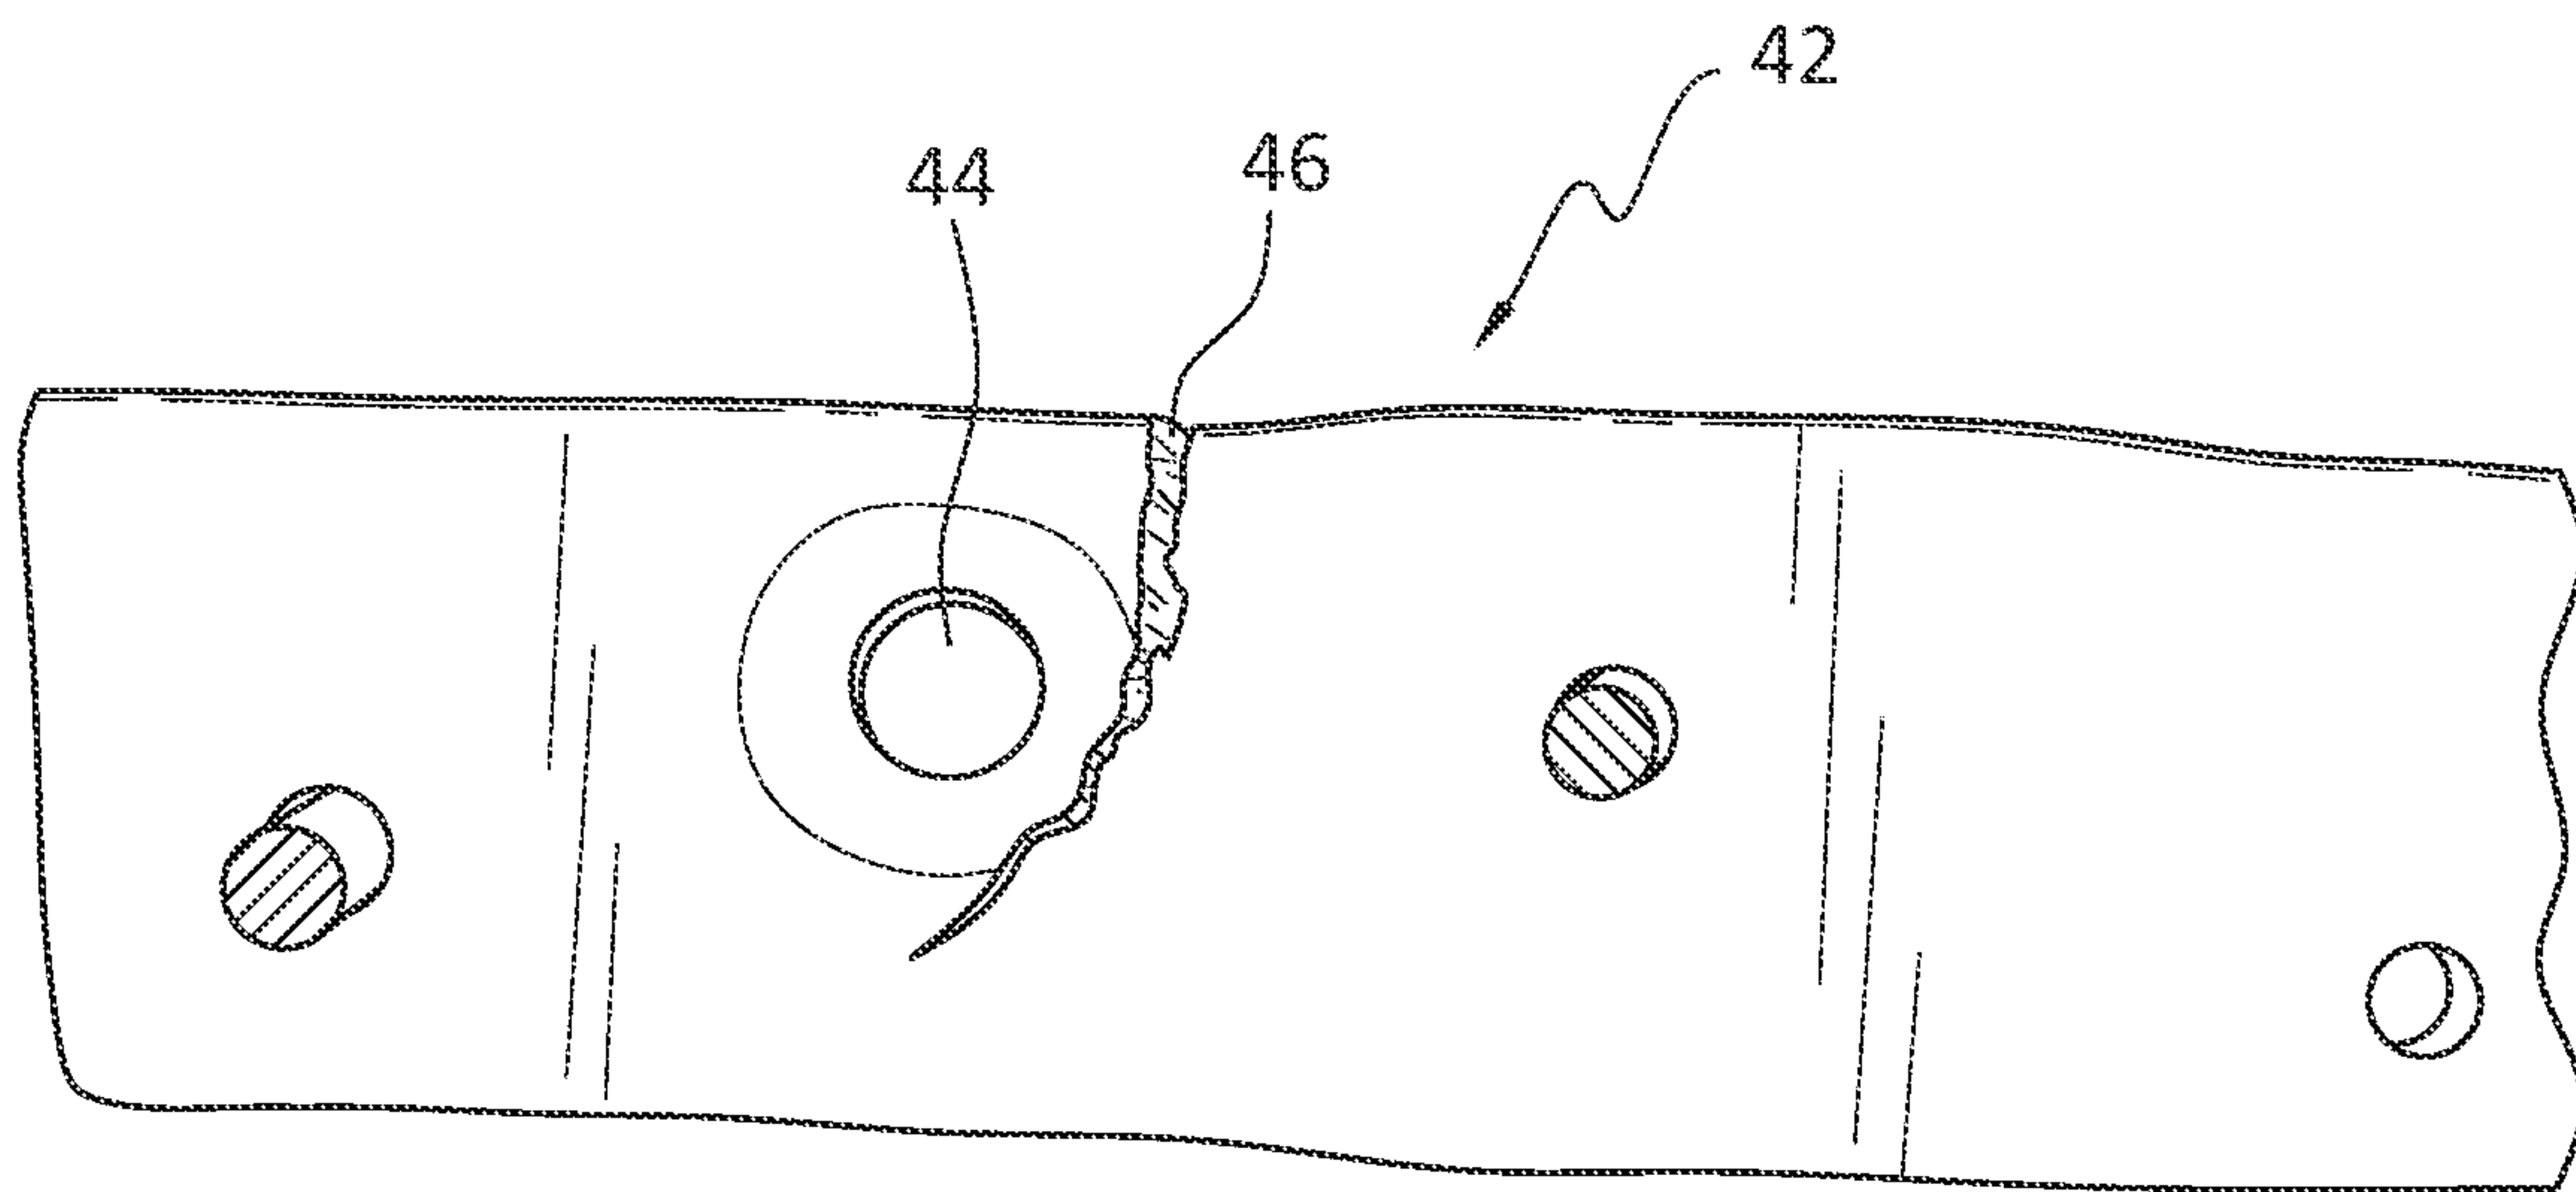
FIG. 3 is a photograph of an aft portion of a tail-cone reinforcement angle showing a typical failure in the horizontal stabilizer pivot shaft receiving bore of tail-cone reinforcement angle;

A rear "blade" portion 42 of each such tail-cone reinforcement angle 50, as seen at 42 in FIG. 3, is provided with a horizontal stabilizer pivot shaft receiving bore, indicated at 44, again in FIG. 3. Bore 44 is aligned with the horizontal stabilizer pivot shaft receiving apertures 40 in the aft portion 38 of the tail cone 32. These tail cone fuselage apertures 40 and their aligned tail-cone reinforcement angle blade bores 44 are aligned and form the mounting points for the horizontal stabilizer 34, as is known in the art.

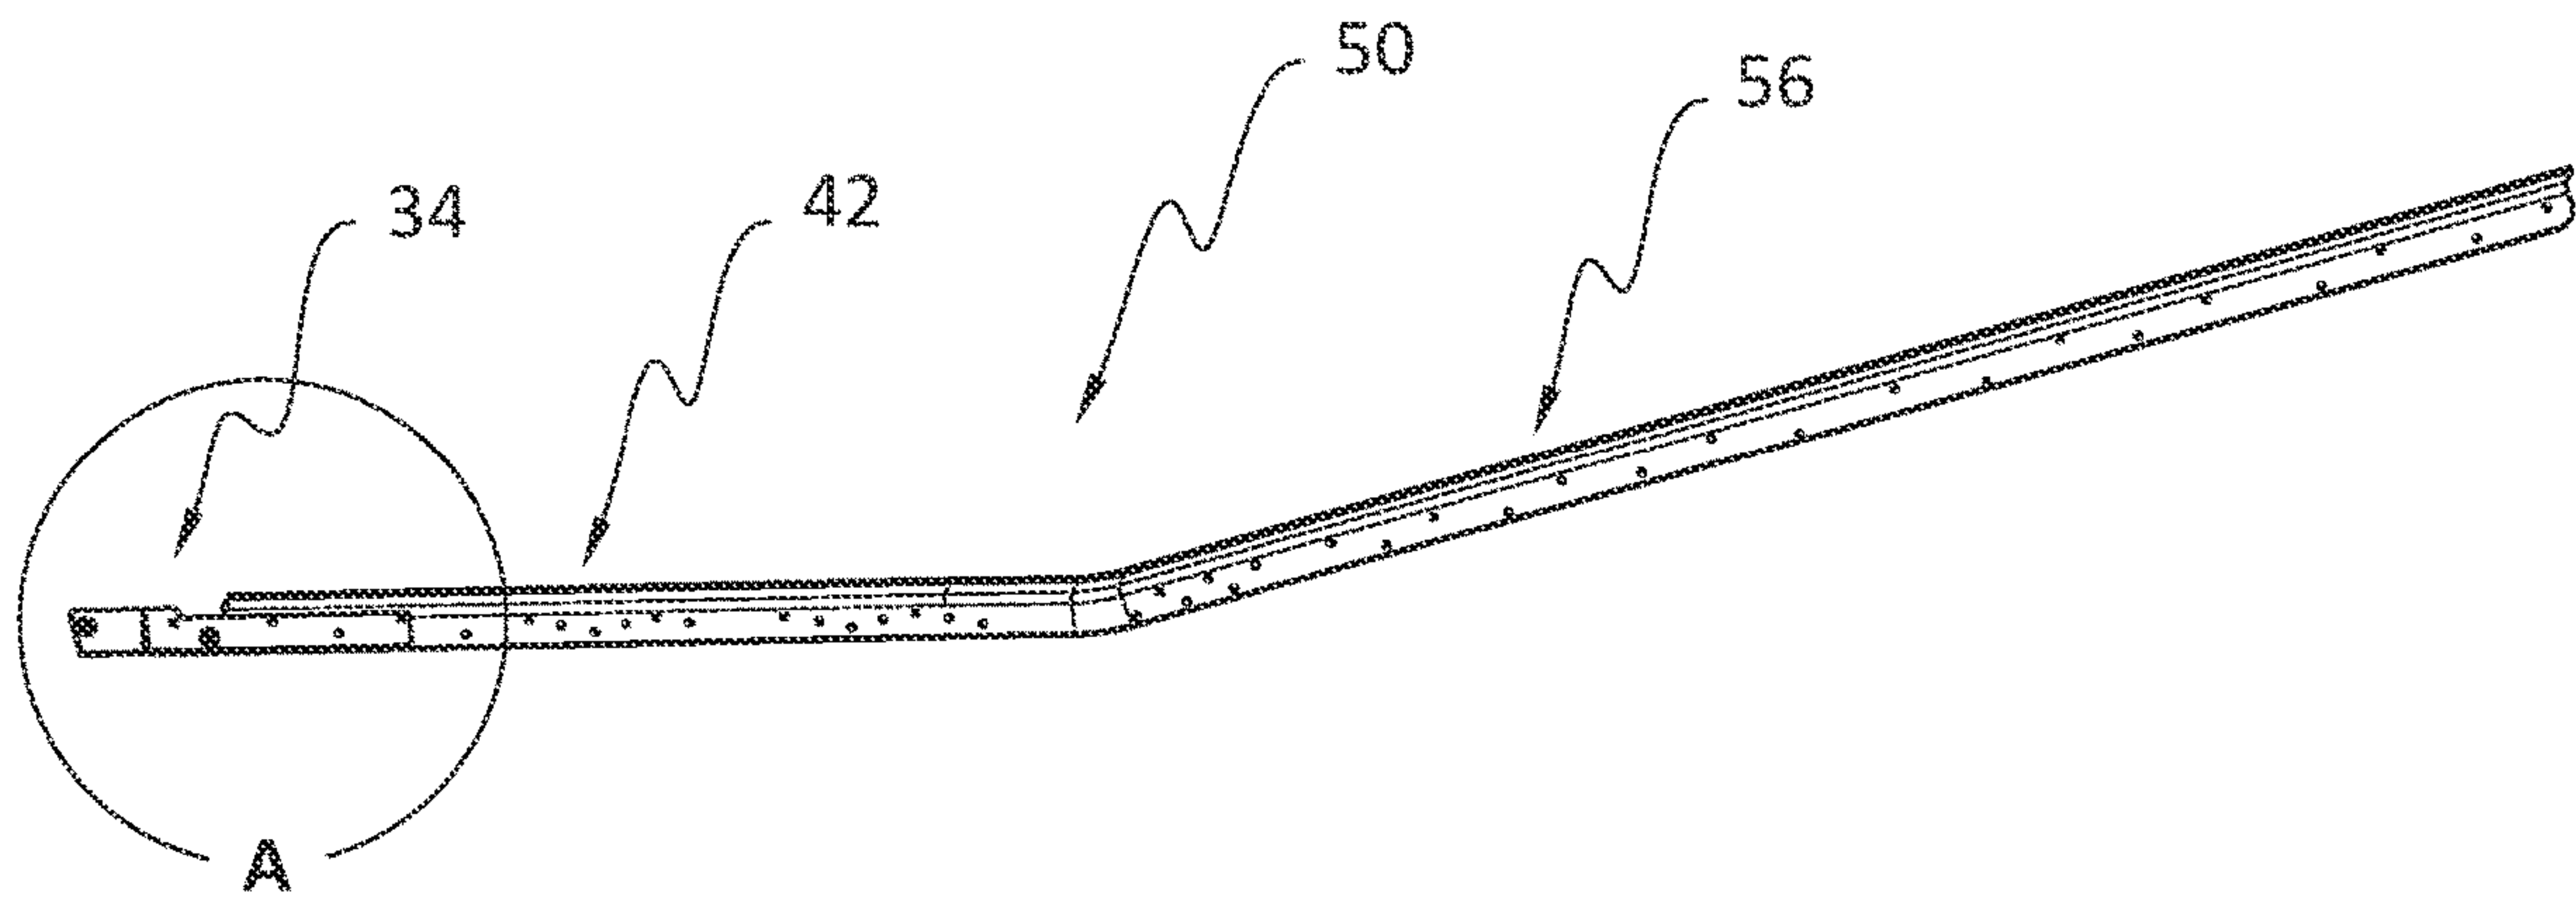
FIG. 4 is a perspective view of a left side tail-cone reinforcement angle including a left side tail-cone reinforcement angle splice, in accordance with the present invention;

As is also well known to those familiar with the Cessna 180-185 series aircraft, the rear fuselages of such aircraft are typically reinforced by tail-cone reinforcement angles, often referred to as "hockey sticks" because of their shape, which somewhat resemble a typical hockey stick. These tail-cone reinforcement angles are attached to interior right and left portions of the rear section of the aircraft's fuselage. These tail-cone reinforcement angles are intended to provide structural rigidity to the aircraft's fuselage 22 and are intended to prevent inward deflection of that portion of the fuselage if lateral exterior pressure were to be applied to the fuselage, typically as a result of physical pressure being applied to the fuselage while the plane is being handling on the ground. A typical tail-cone reinforcement angle is depicted generally at 50 in FIGS. 4 and 5.

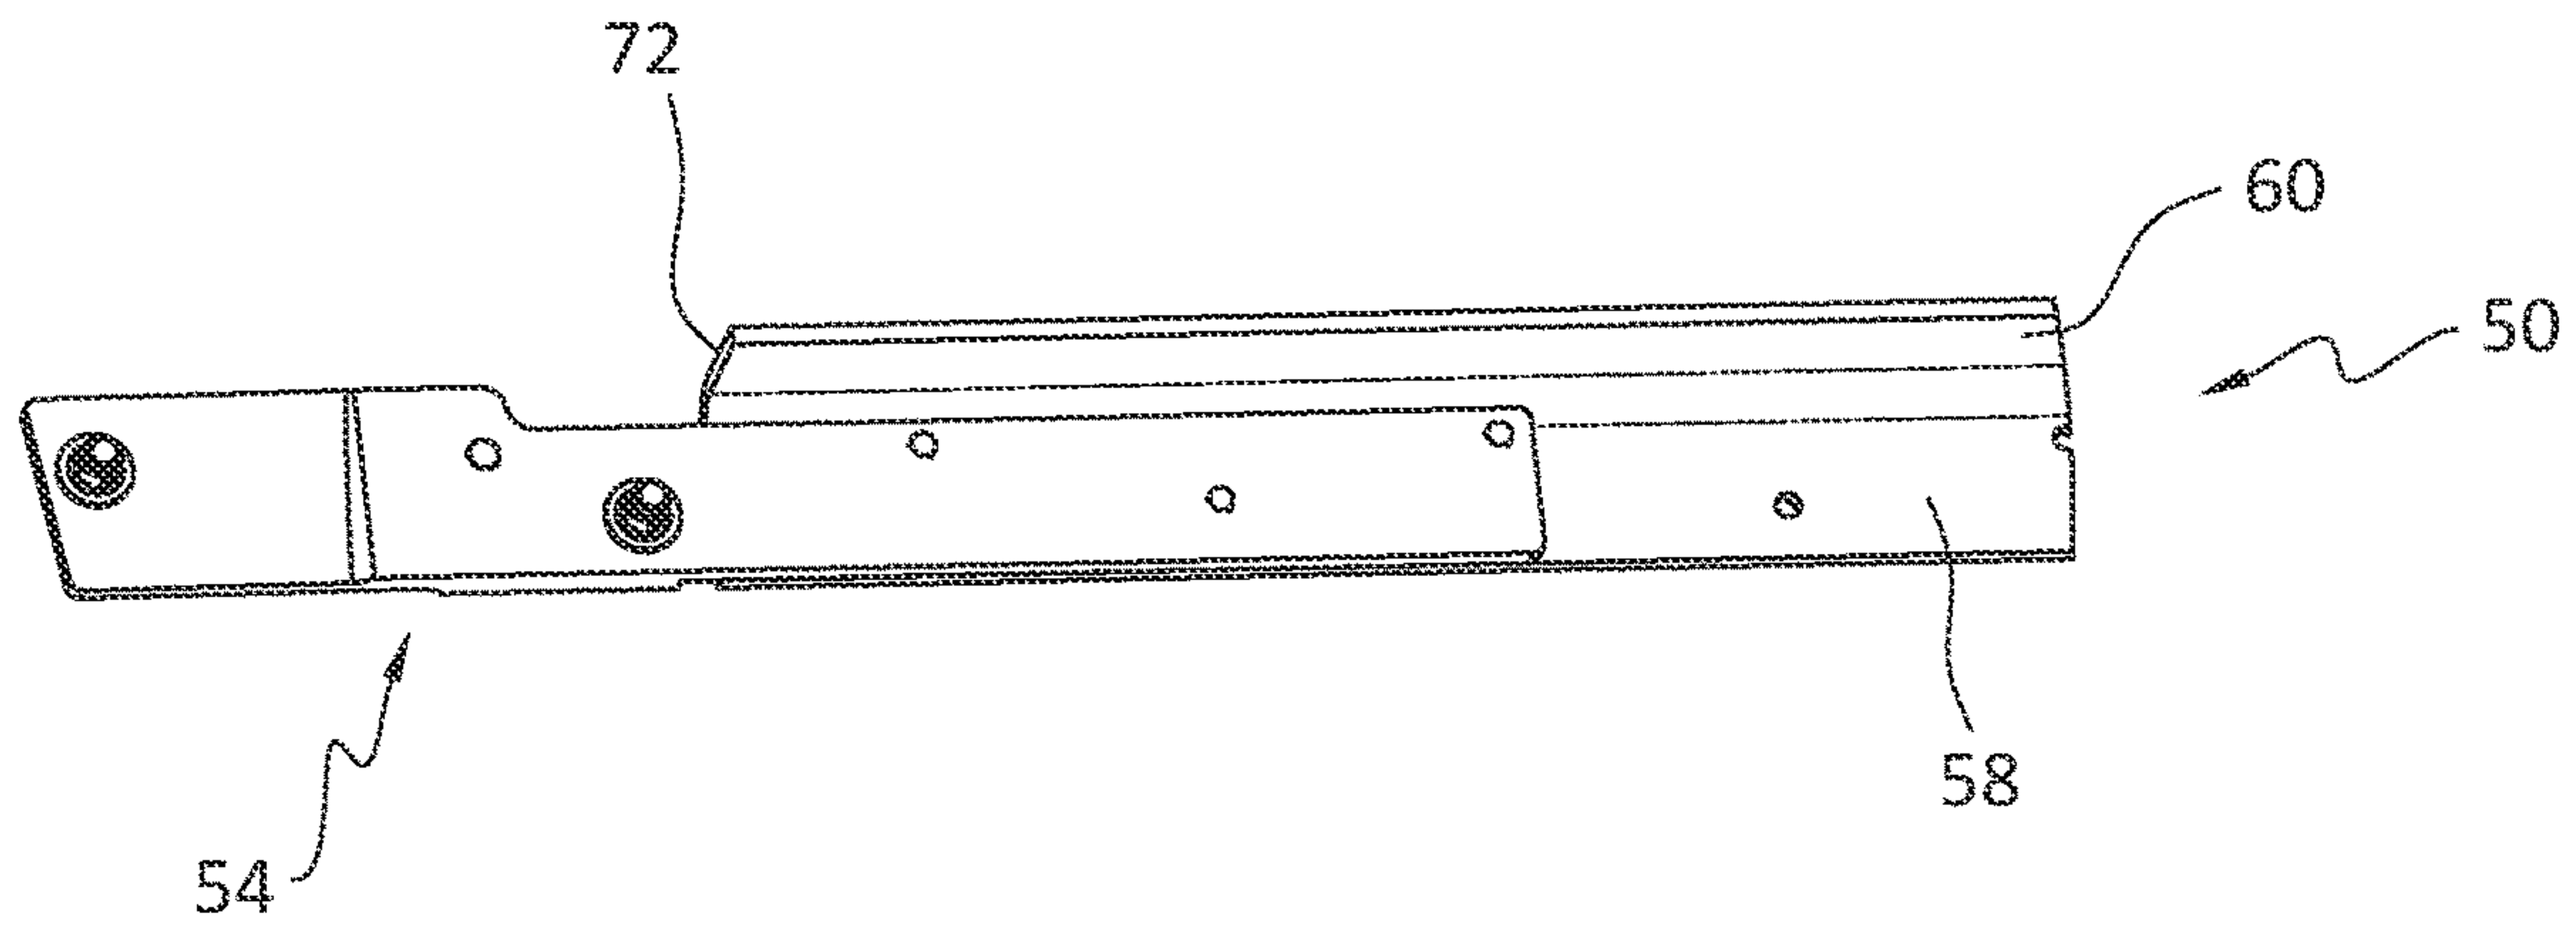
FIG. 5 is a side elevation view of an aft portion of the left side tail-cone reinforcement angle, encircled at A in FIG. 4, with the tail-cone reinforcement angle splice, in accordance with the present invention, in place;

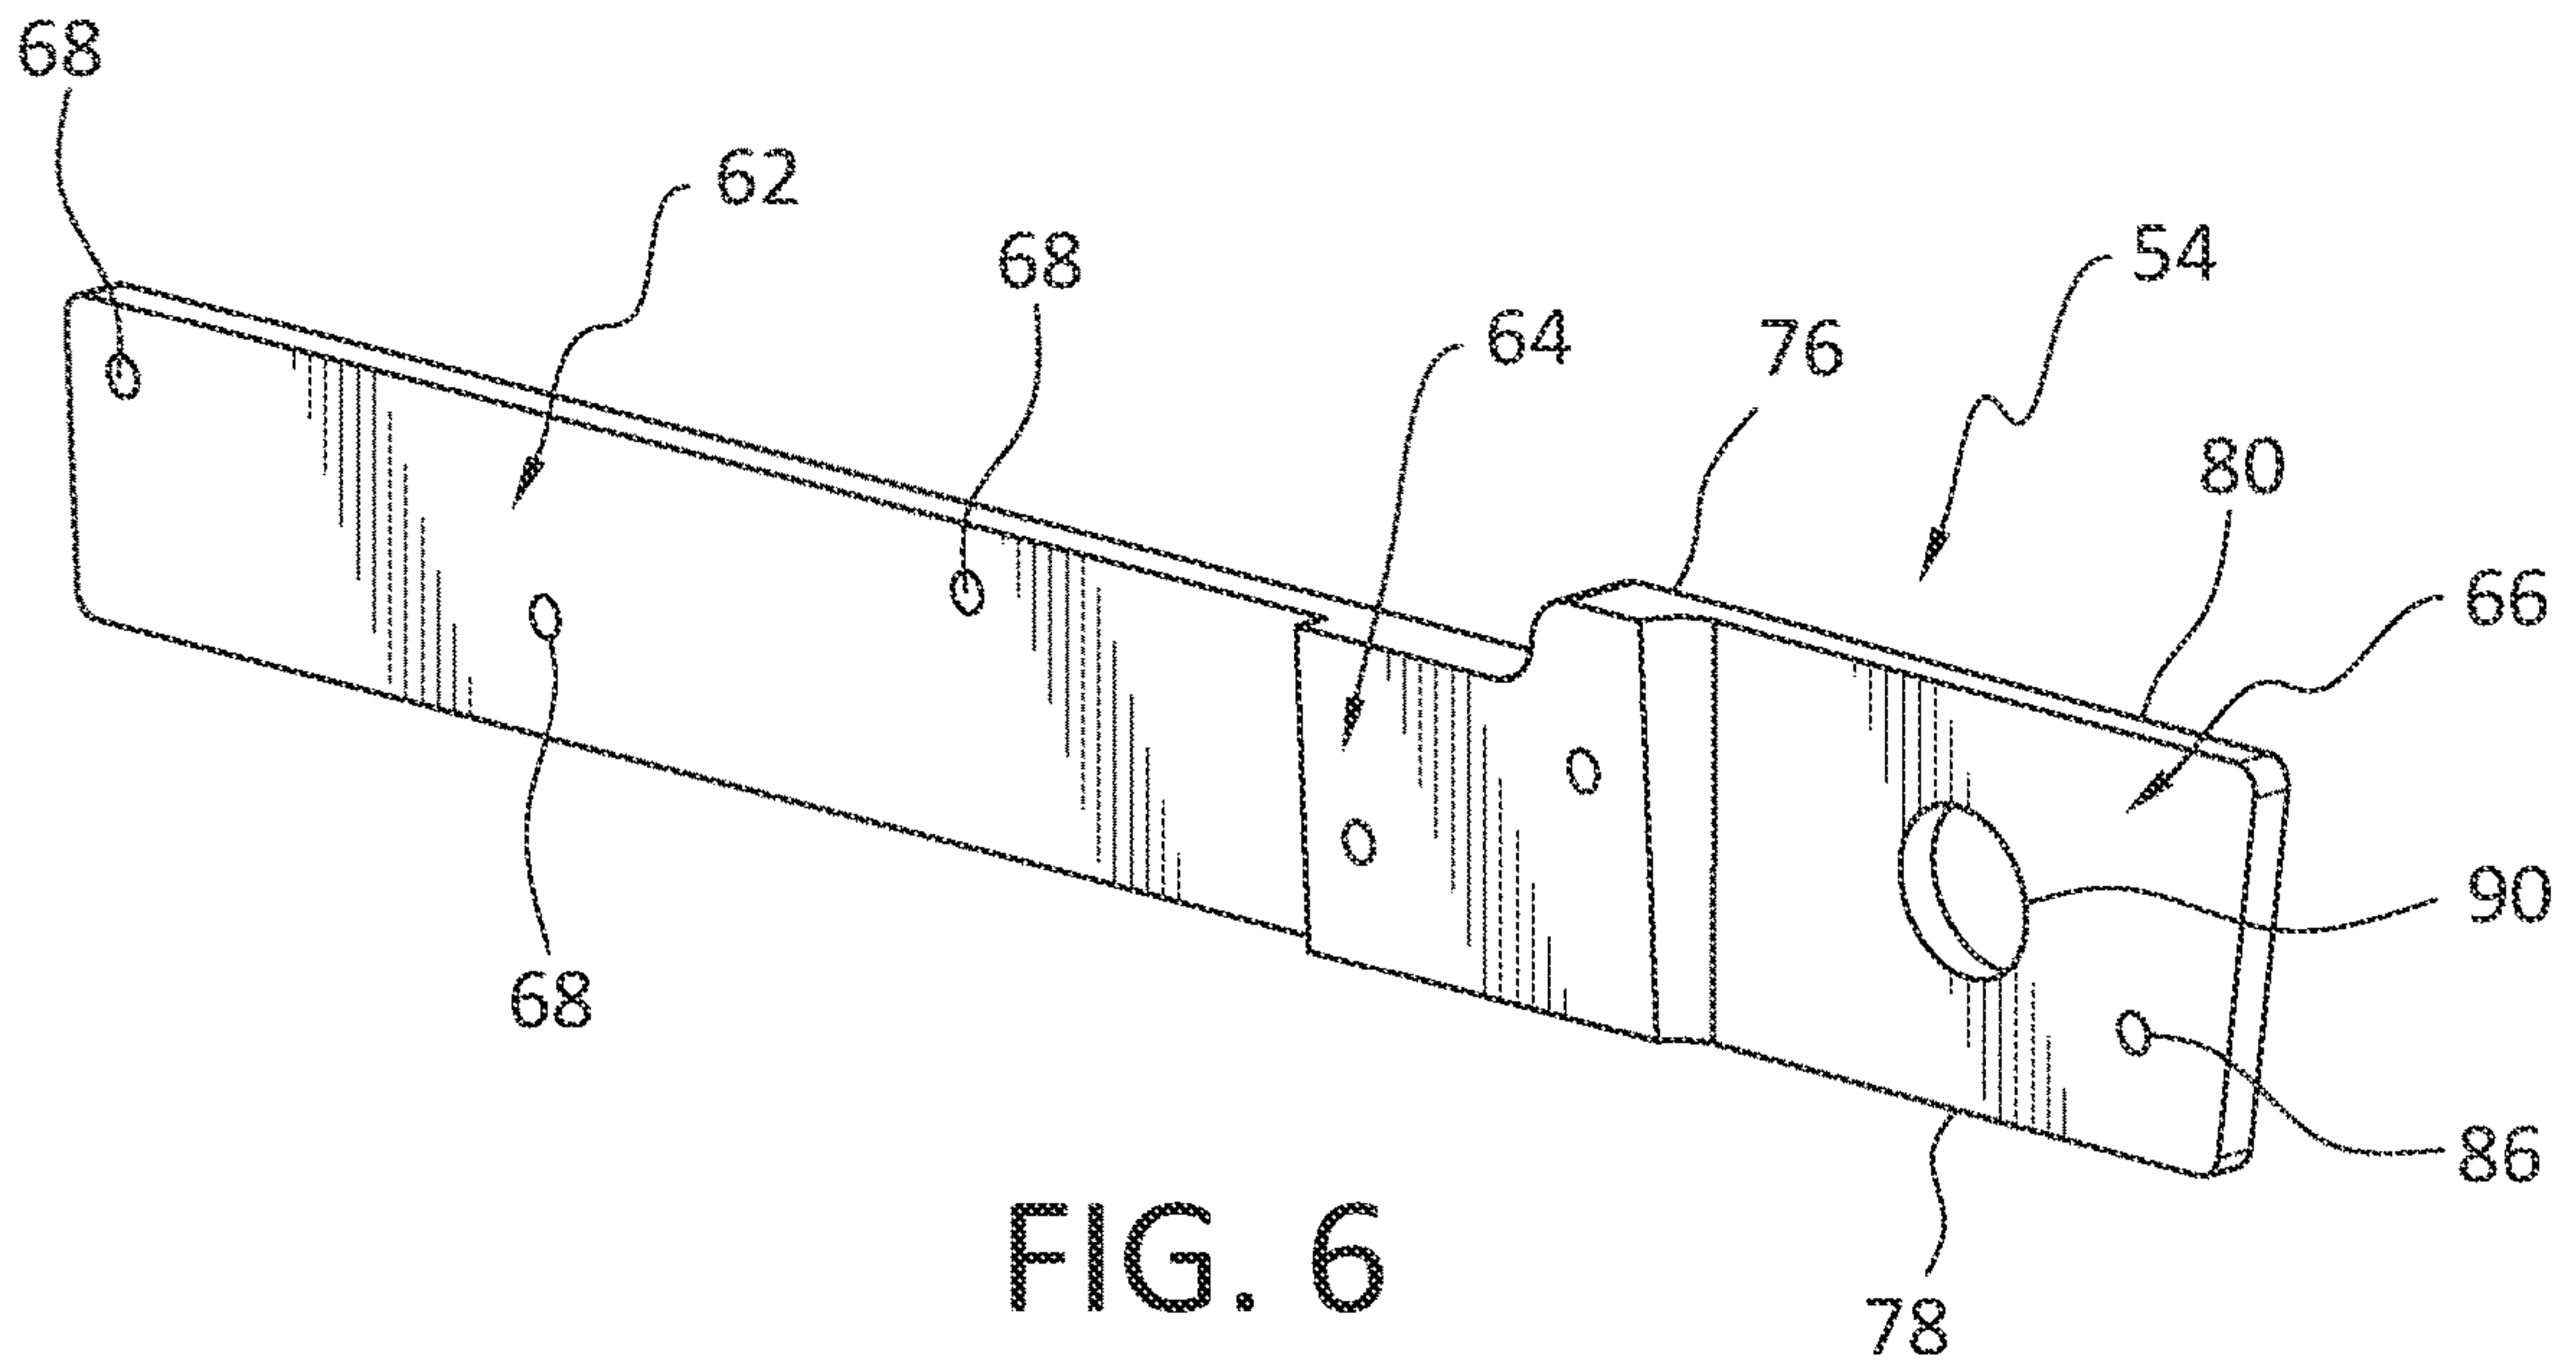
FIG. 6 is a perspective view of a left side tail-cone reinforcement angle splice prior to installation;

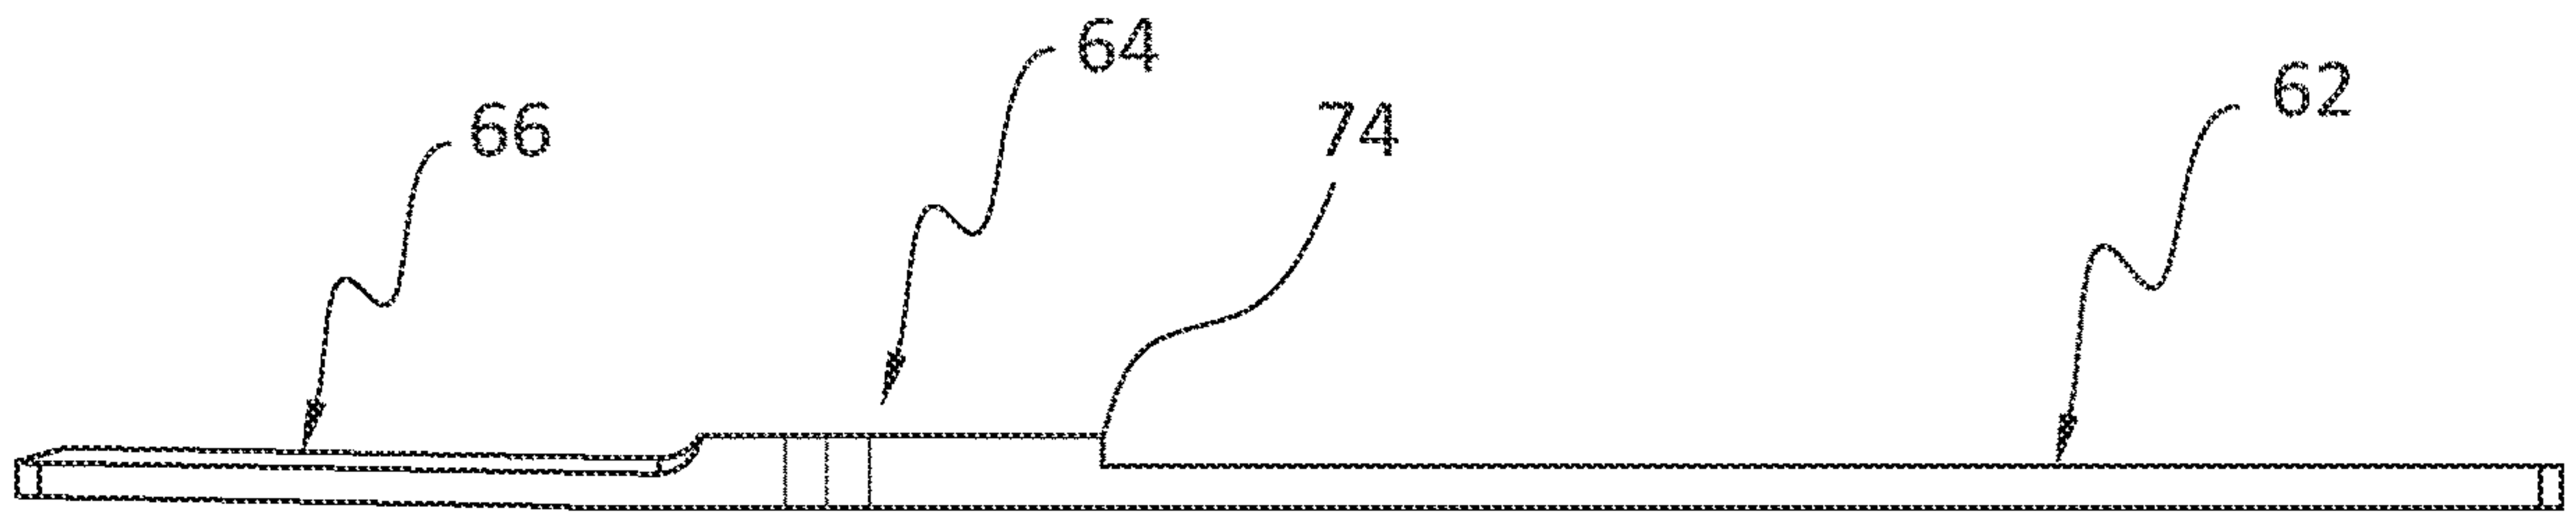
FIG. 7 is a top-plan view of the reinforcement angle splice depicted in FIG. 6;
