(54) **CESSNA TAIL-CONE REINFORCEMENT ANGLE SPLICE, INSTALLATION KIT, AND METHOD FOR INSTALLATION THEREOF**

A tail-cone reinforcement angle of a Cessna 180-185 series aircraft is repaired by the removal of an aft most section of that tail-cone reinforcement angle and its replacement with an elongated splice body. The elongated splice body is attached to the remainder of the tail-cone reinforcement angle and to the tail-cone portion of the fuselage of the aircraft. The aft section of the original tail-cone reinforcement angle is subject to the development and propagation of cracks in the area of the rear pivot shaft receiving bore, which cracks render the aircraft unfit for use. The invention includes the provision of a suitable elongated splice body, a method for its installation, and a tool kit which is usable in accomplishing the removal and replacement of the aft section of the tail-cone reinforcement angle.

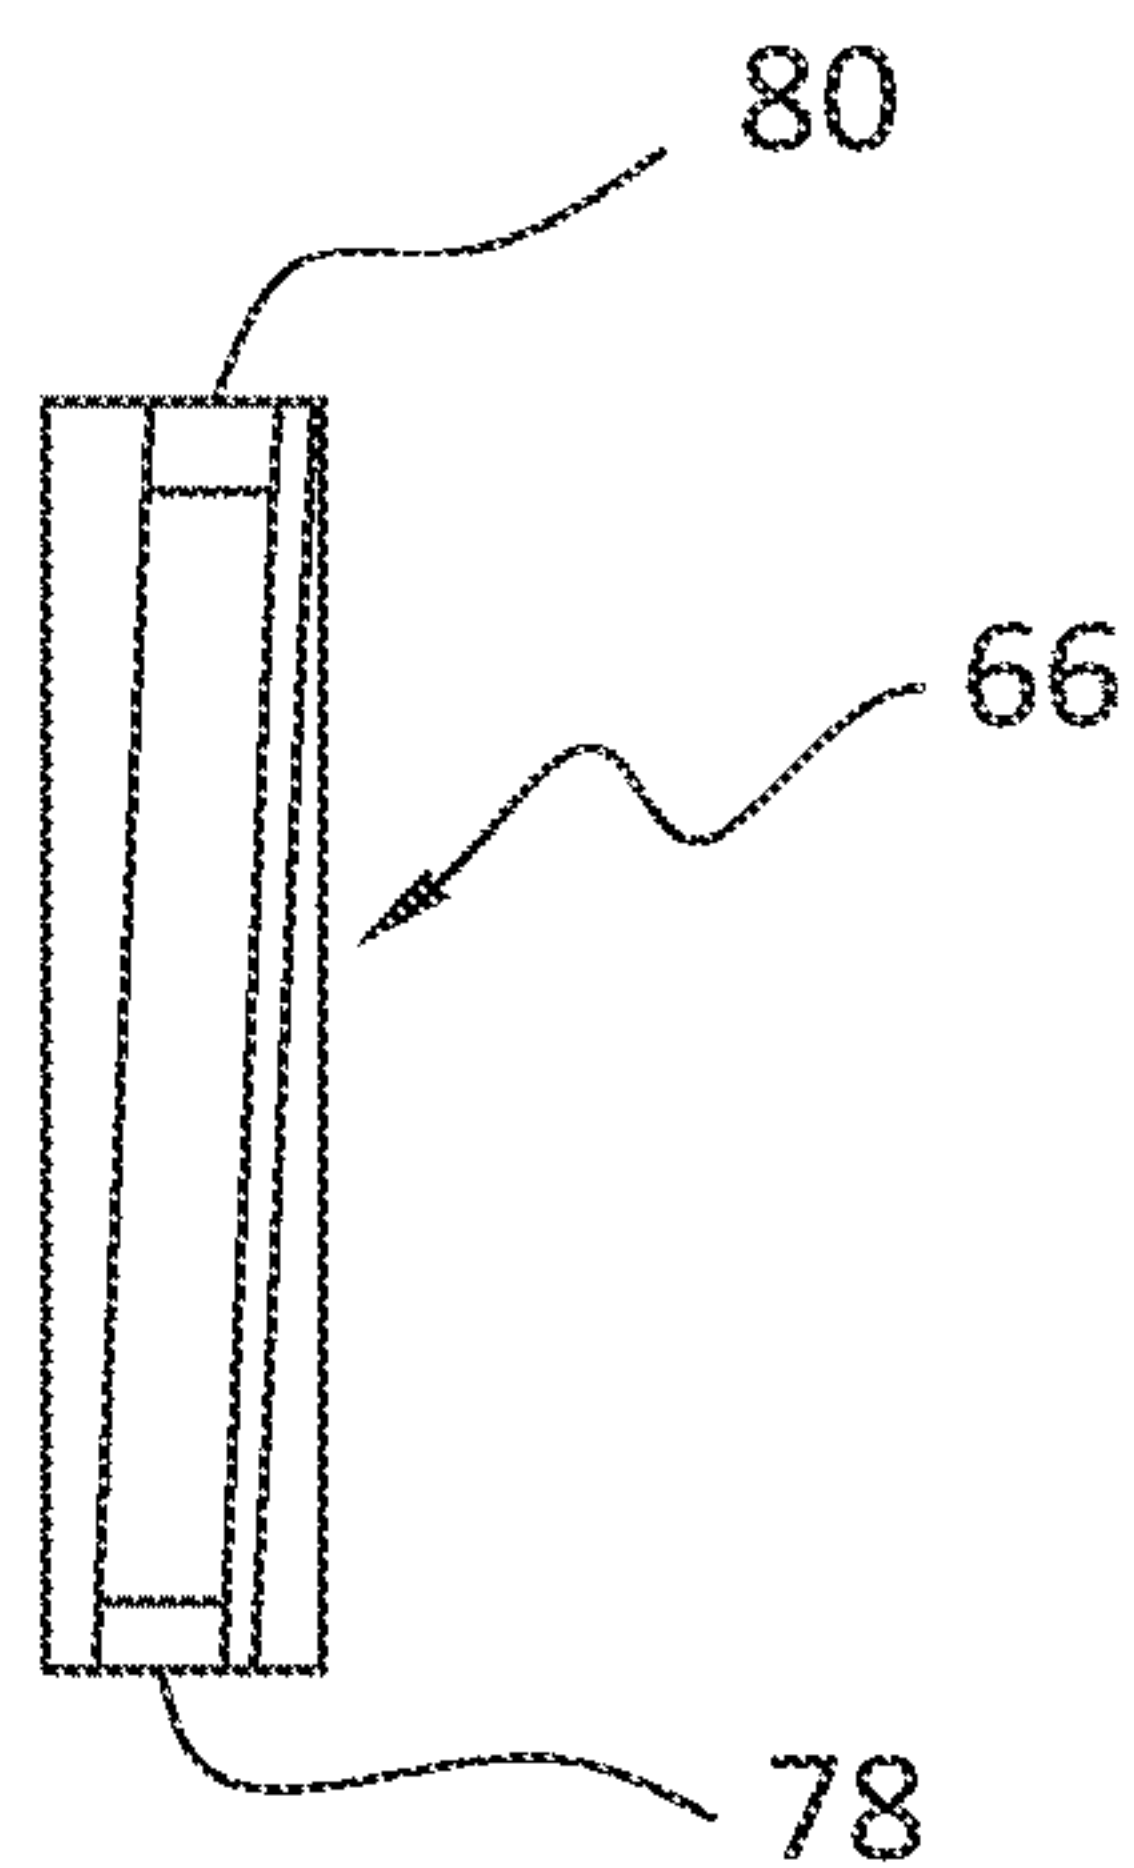
FIG. 8 is an aft end view of the reinforcement angle splice depicted in FIGS. 6 and 7 and taken from the right as seen in FIG. 6 and from the left as seen in FIG. 7;

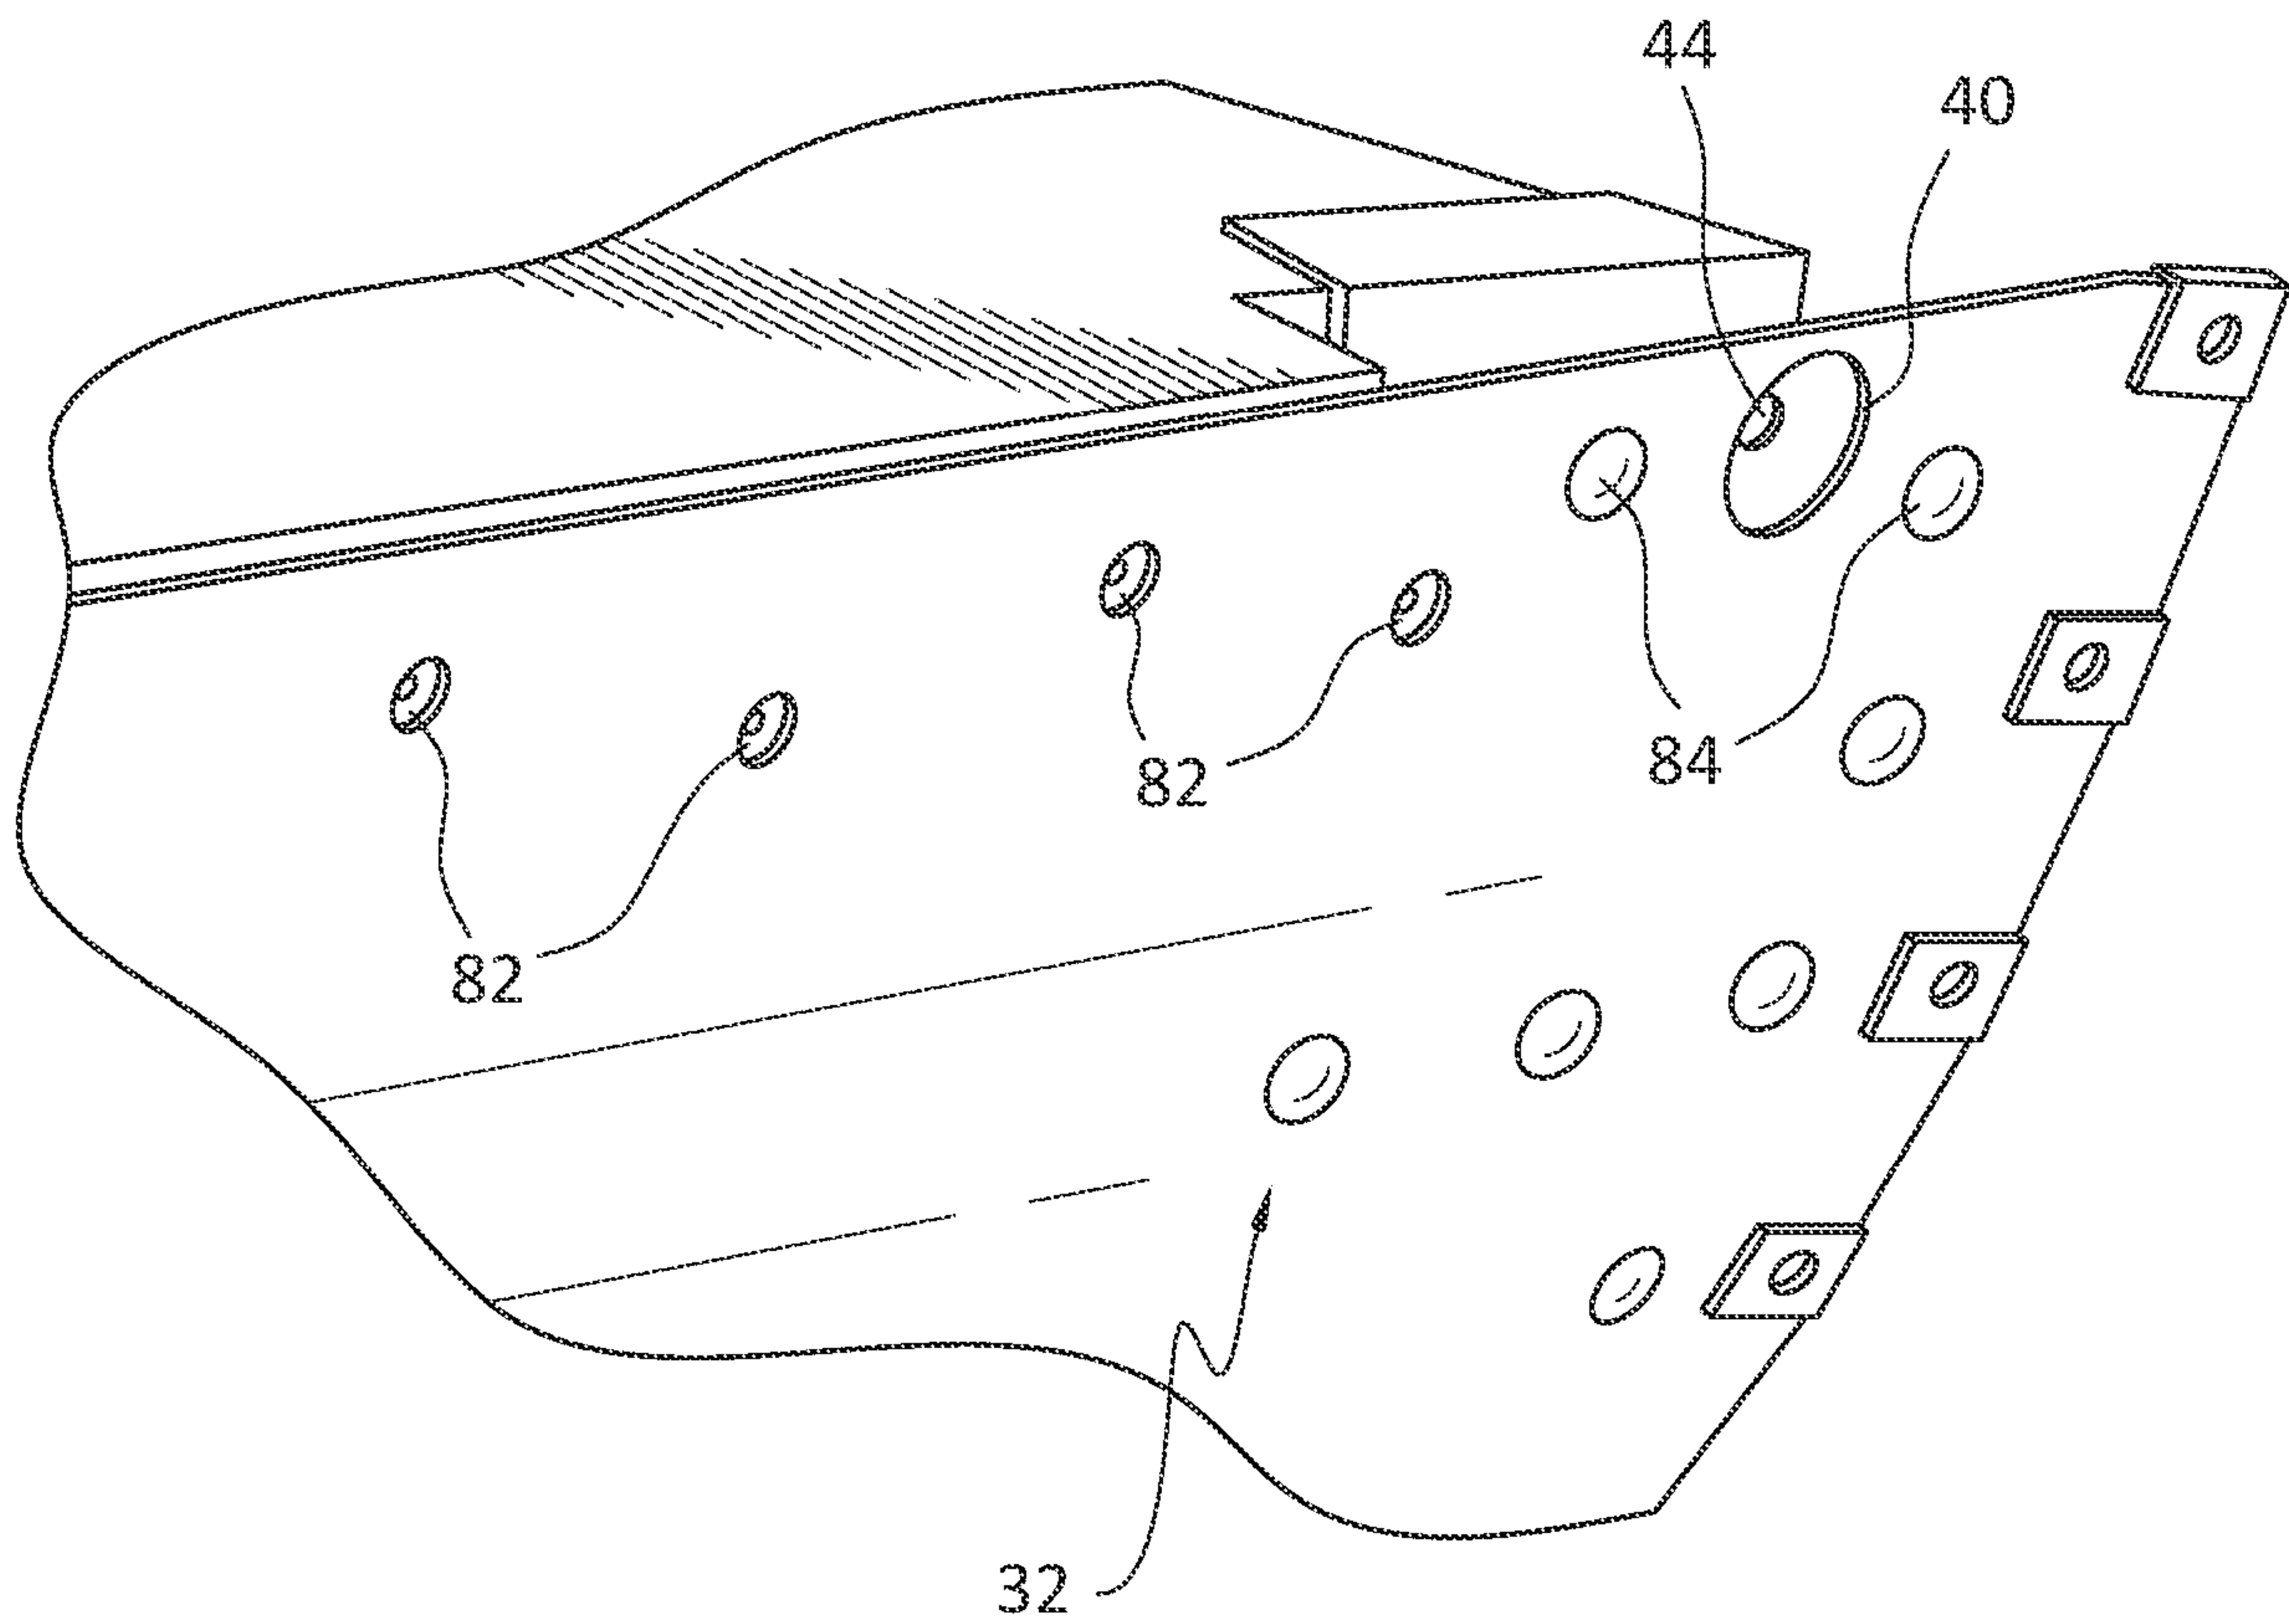
FIG. 9 is a view of an aft portion of the tail cone and showing the removal of four rivets;

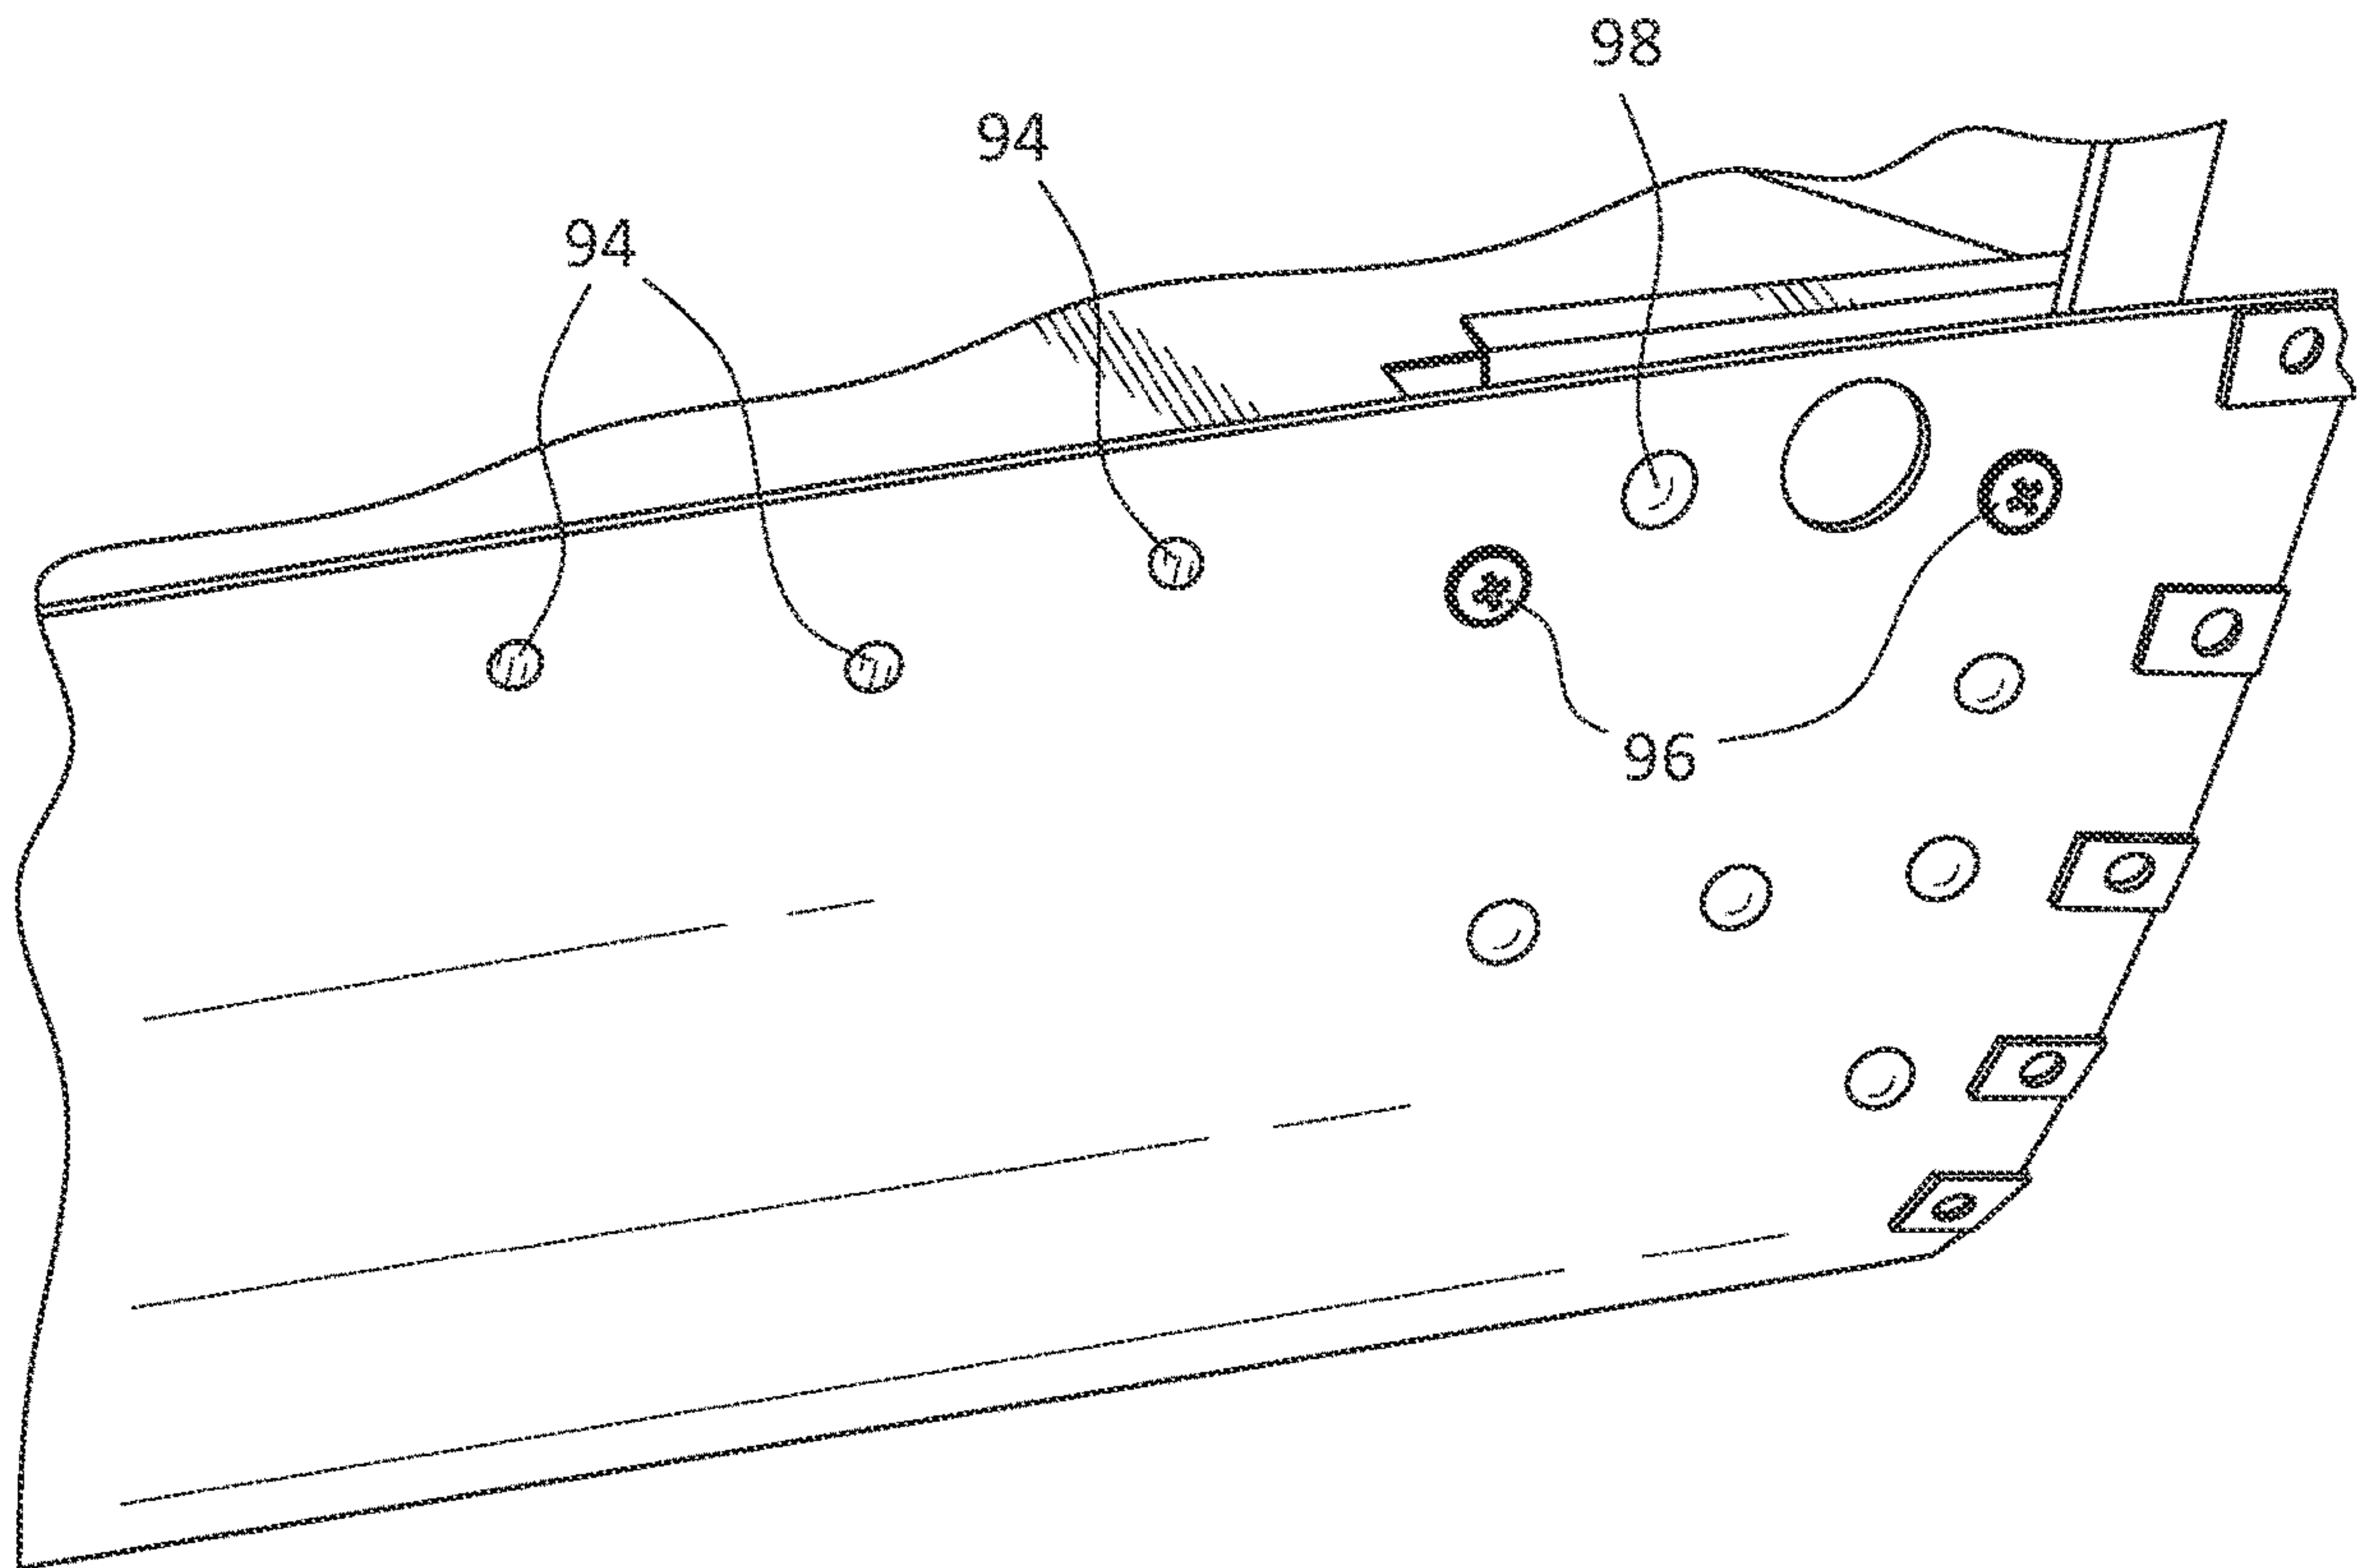
FIG. 10 is a view similar to FIG. 9 with the tail-cone reinforcement angle splice installed and secured in place;

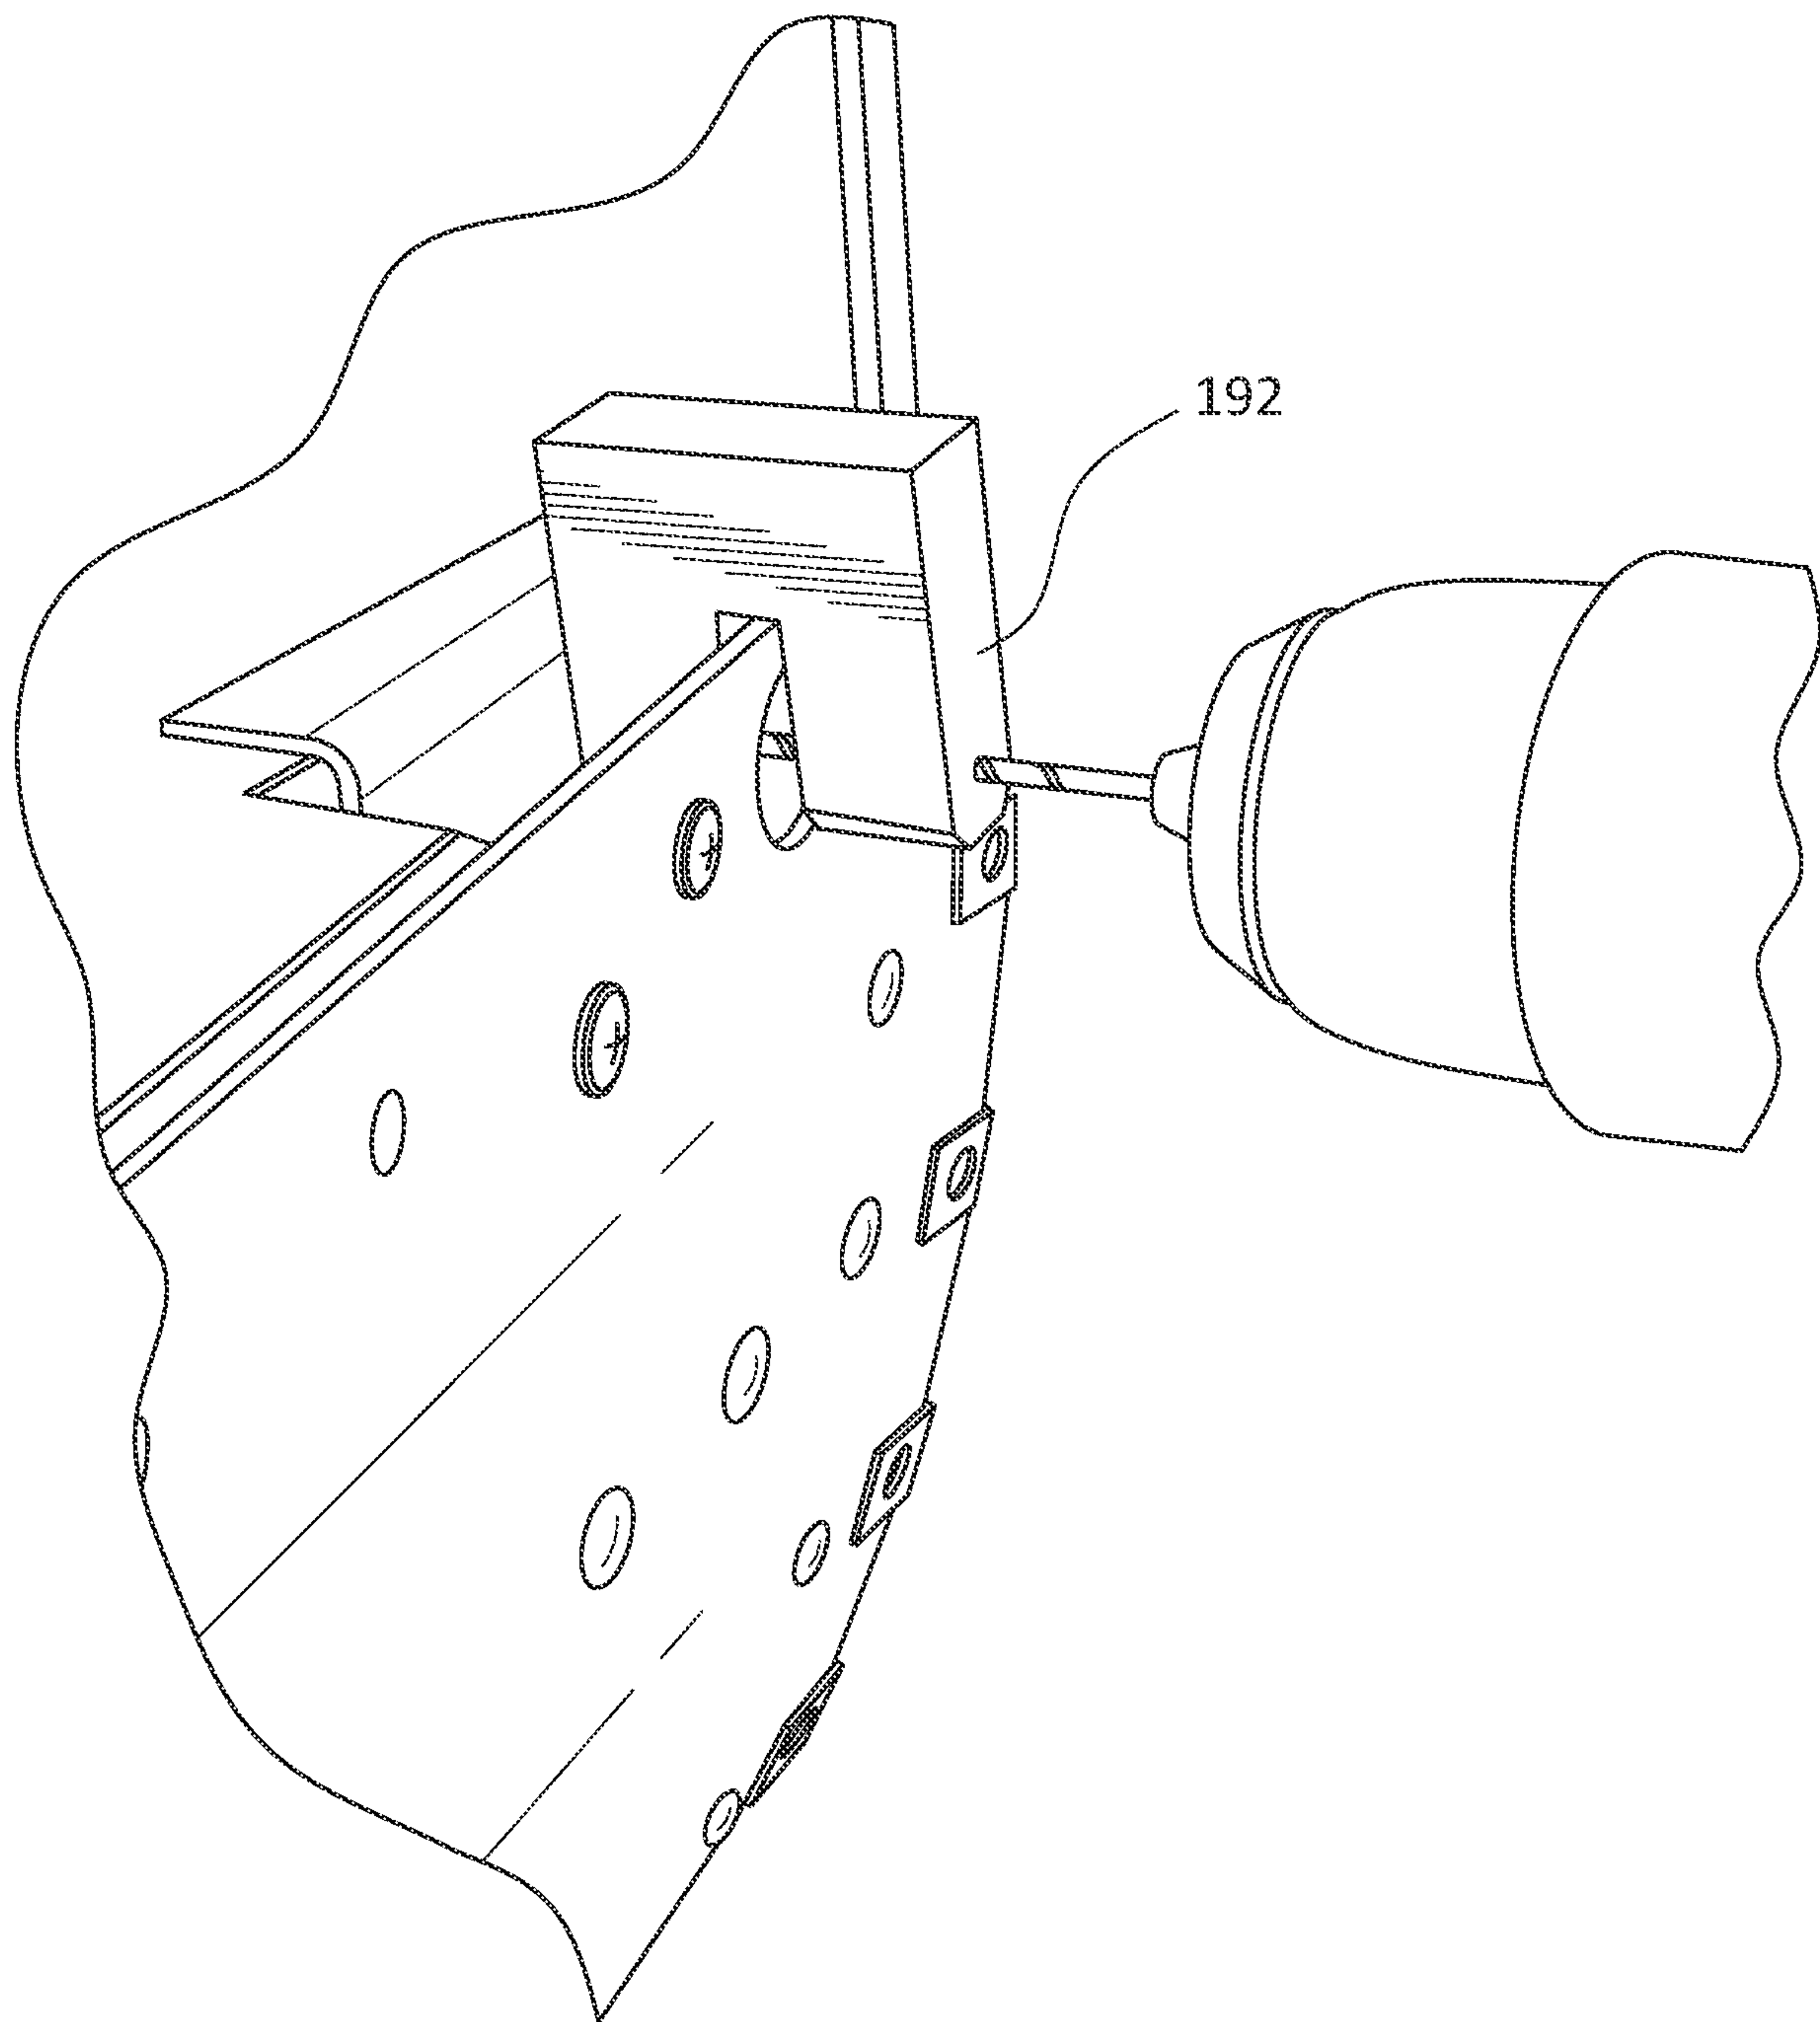
FIG. 11 is a view of the aft section of the tail cone and showing the forming of the horizontal stabilizer shaft receiving bore in the tail-cone reinforcement angle splice;

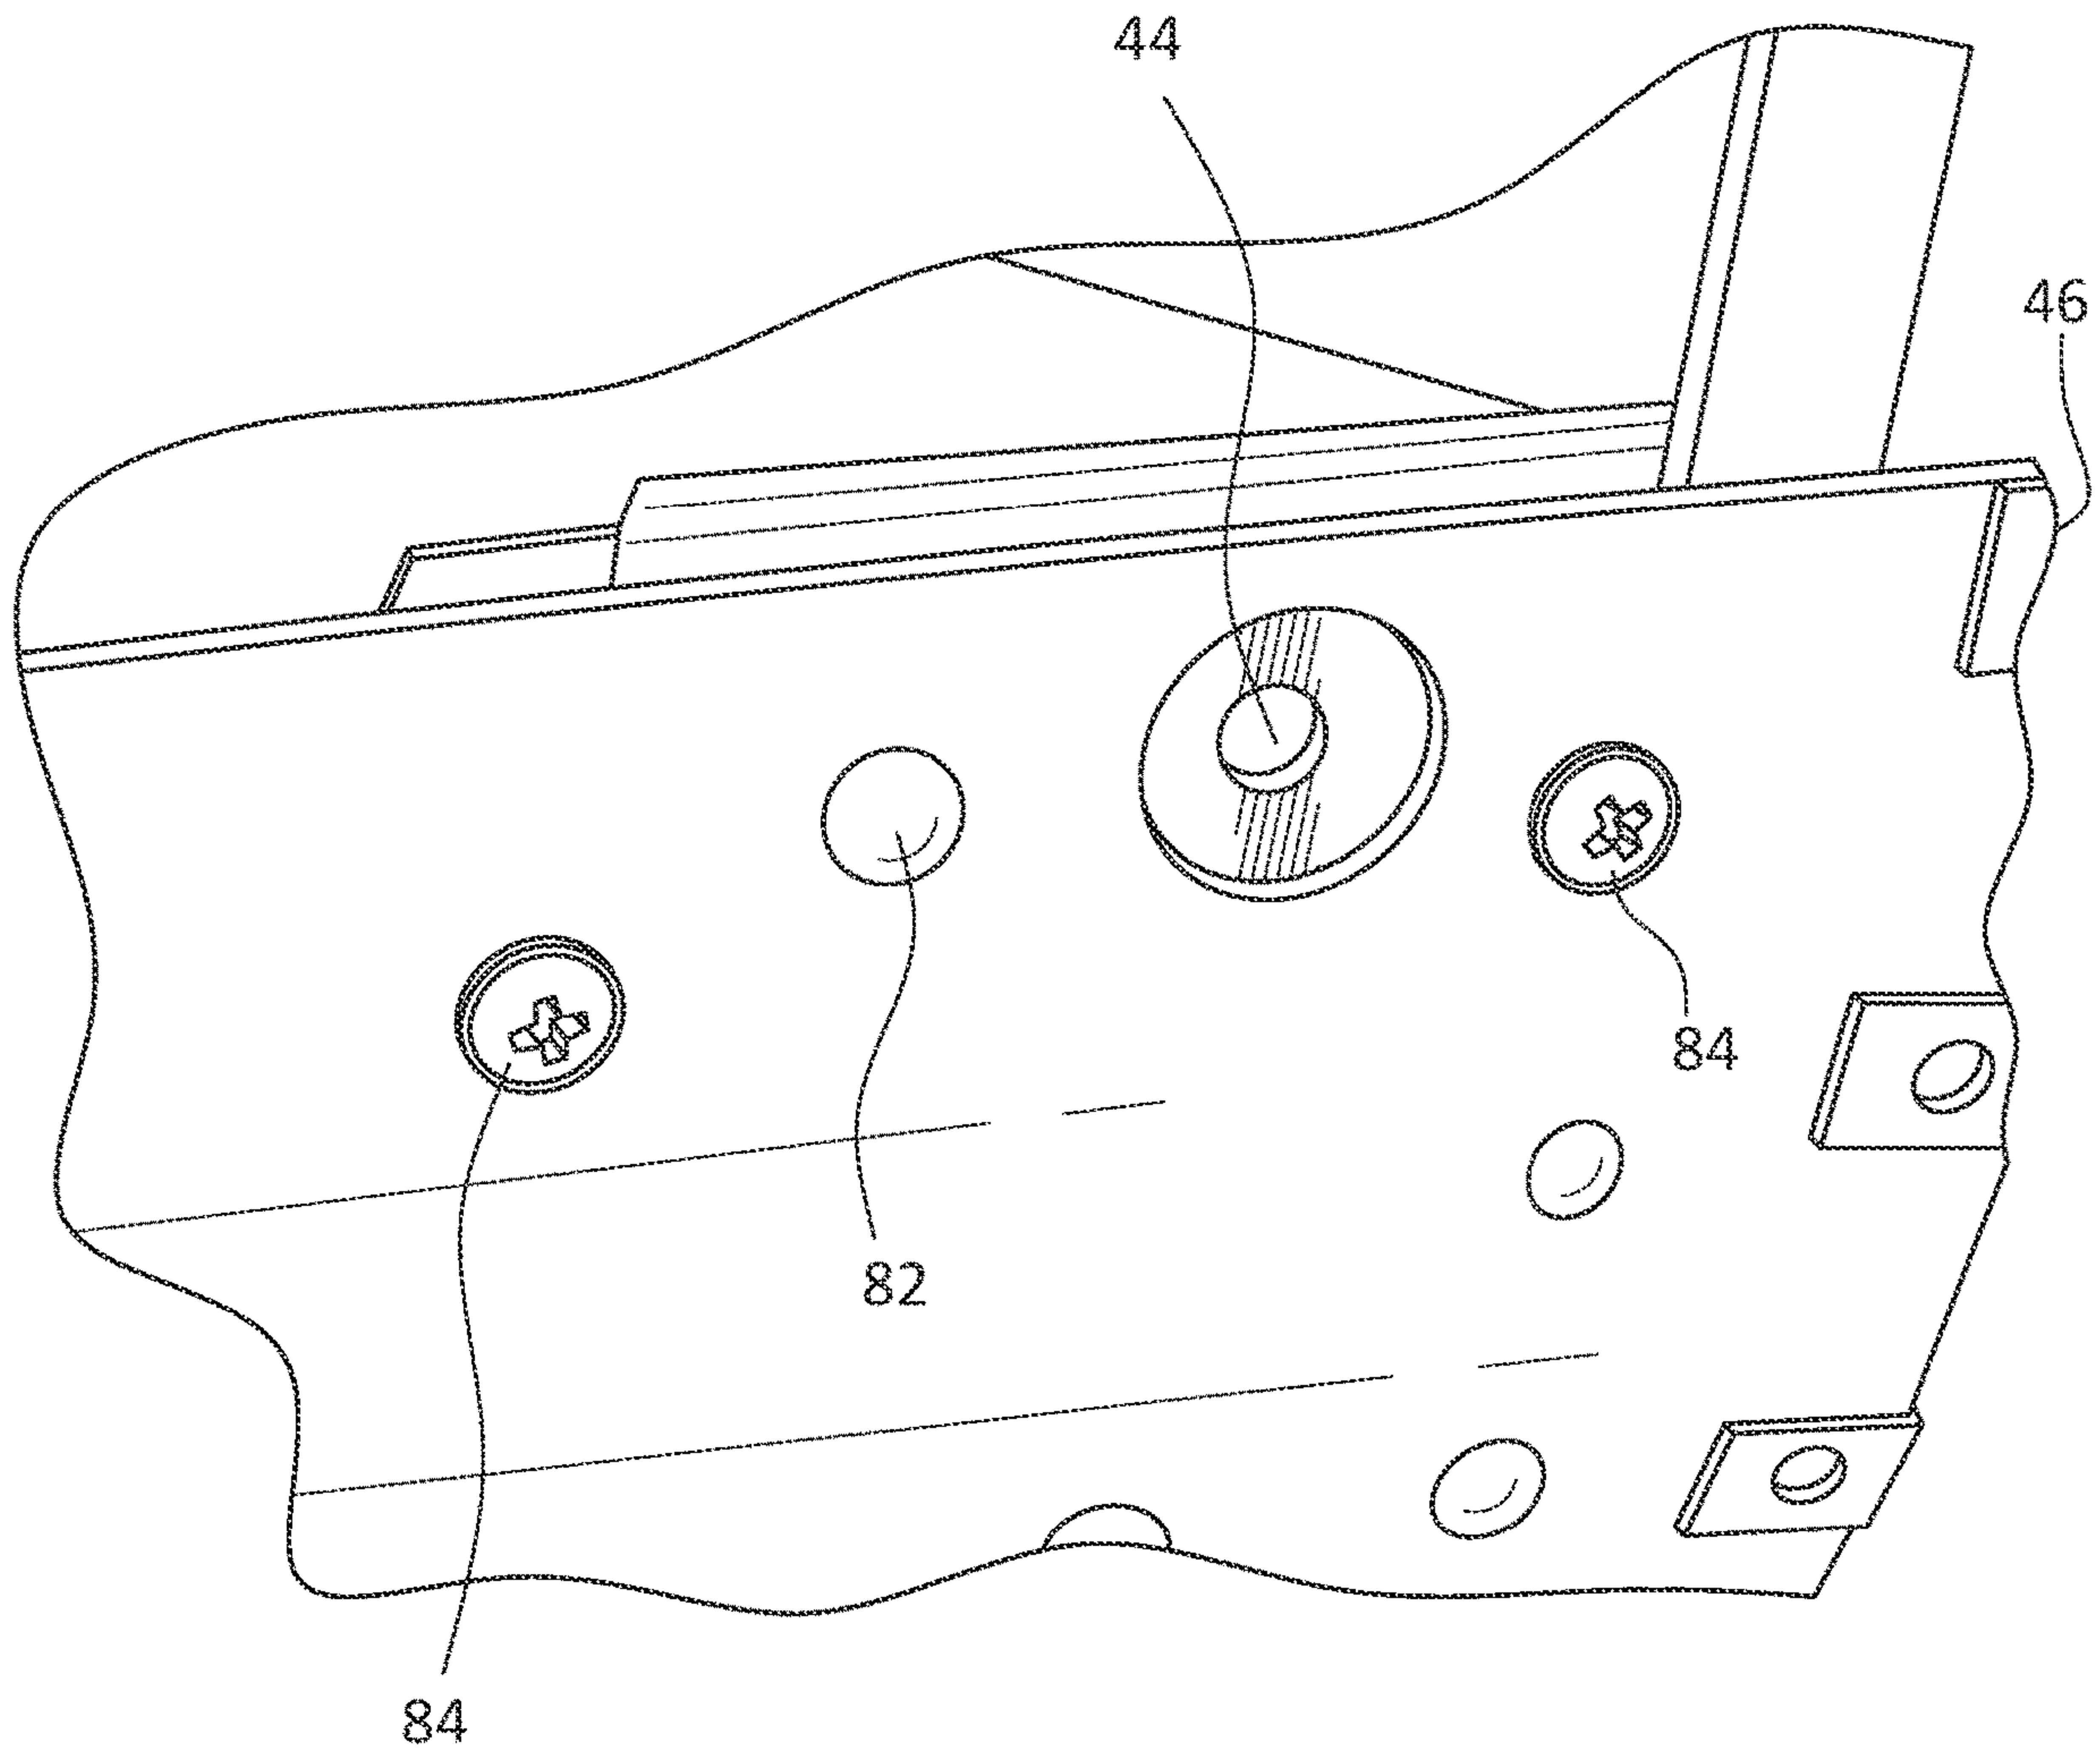
FIG. 12 is a view of the aft section of the tail cone and showing the completed horizontal stabilizer pivot shaft receiving bore formed in the tail-cone reinforcement angle splice; and
