US010967989B2

(12) **United States Patent**  
**Duncan**

(54) **CESSNA TAIL-CONE REINFORCEMENT ANGLE SPLICE, INSTALLATION KIT, AND METHOD FOR INSTALLATION THEREOF**

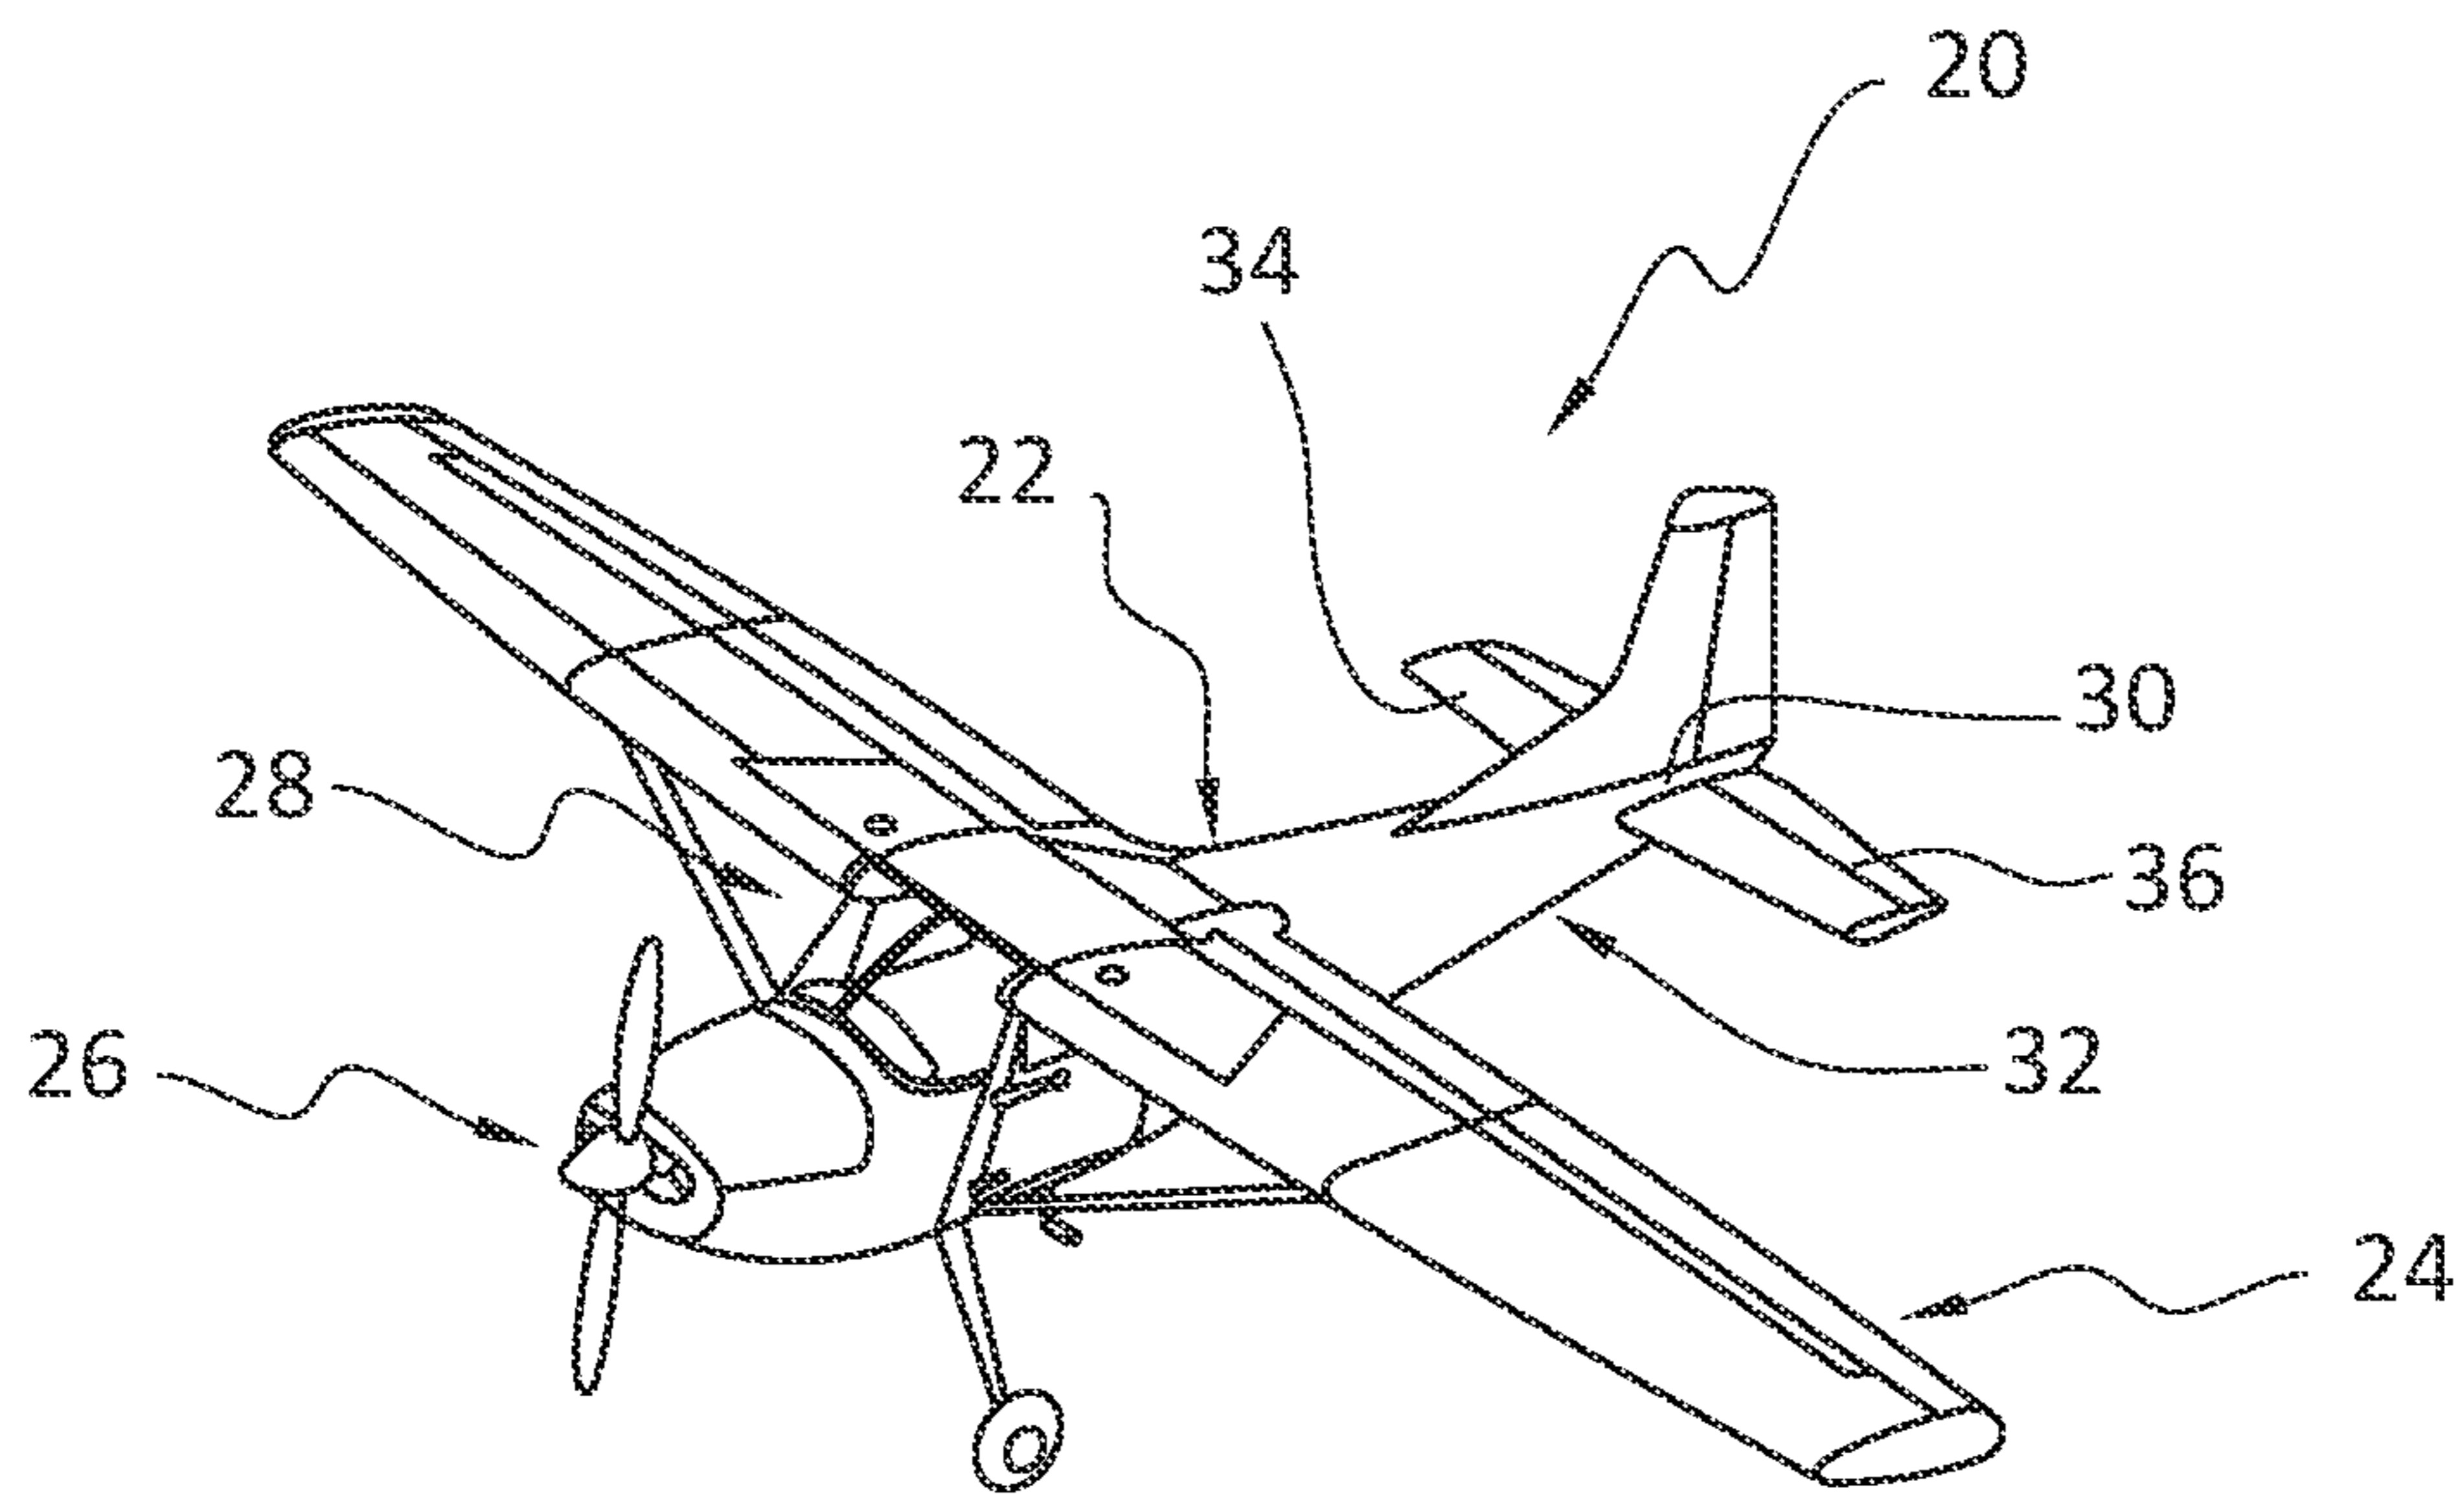
FIG. 1 is a schematic depiction of a Cessna series 180-185 series aircraft with which the pertinent invention is intended for use;

Referring initially to FIG. 1 of the patent drawings filed in the subject U.S. patent application, there may be seen, generally at 20, a typical Cessna 180-185 series aircraft with which the tail-cone reinforcement angle splice, in accordance with the present invention, finds particular usage. Aircraft 20, as is well known to one familiar with such aircraft, includes a fuselage, generally at 22, forward upper mounted wings 24, an engine and propeller assembly 26, a cockpit 28 and a rear elevator and stabilizer assembly generally at 30. The rear elevator and stabilizer assembly generally at 30, is attached to a rear portion of the fuselage 22, in an area that fuselage known as the tail-cone 32, which tail-cone area 32 is seen somewhat schematically in FIG. 2. The rear stabilizer and elevator assembly, generally at 30, includes a pivotally mounted horizontal stabilizer 34 and a pair of elevators 36. The horizontal stabilizer 34 is attached to the tail-cone, generally at 32, in an aft portion 38 of the tail cone 32. The attachment of the horizontal stabilizer 34 is accomplished by providing pivot shafts which are located in the trailing portion of the horizontal stabilizer 34, which pivot shafts are well known, are not illustrated, and which form no part of the present invention. The horizontal stabi-

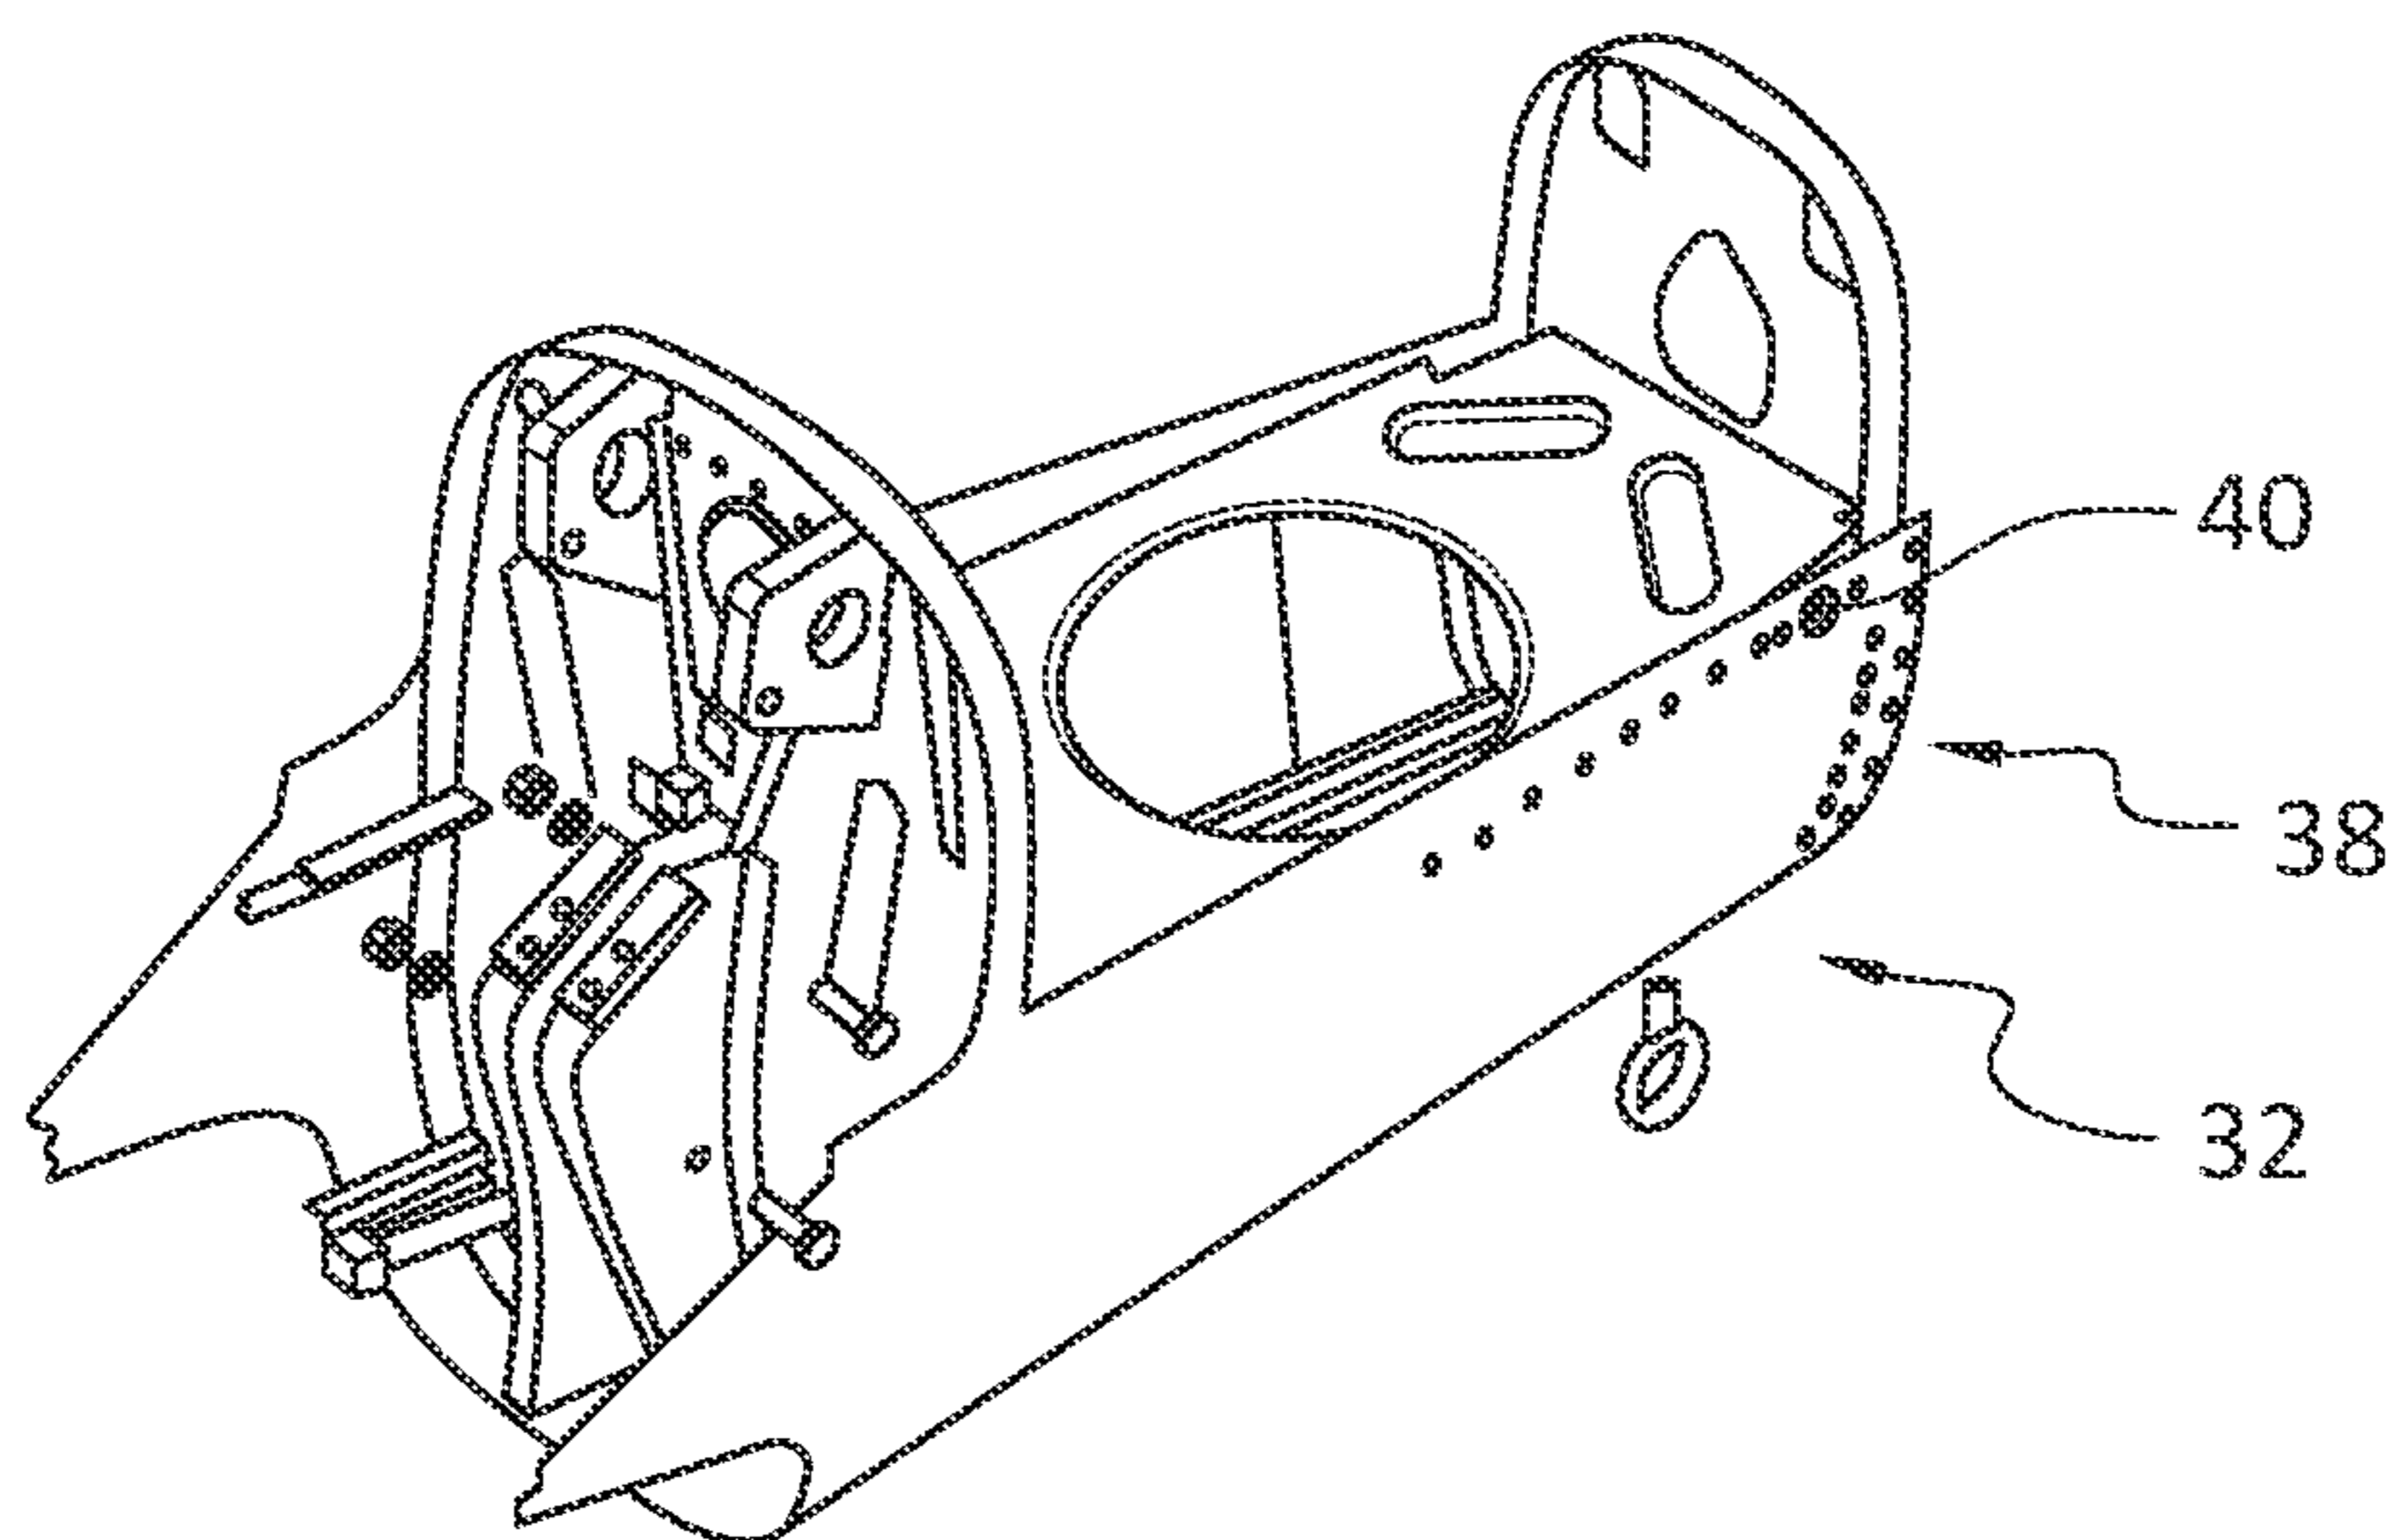
FIG. 2 is a schematic depiction of a tail-cone area of the Cessna 180-185 series aircraft depicted in FIG. 1, and with the horizontal stabilizer, elevator, tail, tail wheel and stinger removed;

Once the tail of the Cessna 180-185 series aircraft has been disassembled, to render the tail-cone assembly as it is depicted in FIG. 2, the installation process may commence. The initial step is to use a suitable reamer, which is supplied in a kit that is provided by the manufacturer of the subject invention, and which is supplied together with, and including the subject tail-cone reinforcement angle splice, as will be discussed subsequently, to ream out both the horizontal stabilizer rear pivot aperture **40** in the tail cone of the fuselage and the underlying bore **44** in the original far aft portion of the now defective tail-cone reinforcement angle. Once this has been accomplished, four aft flush rivets **82**, in the tail cone portion **32** of the fuselage **22** and in the underlying blade portion **42** of the tail-cone reinforcement angle, are drilled out. This is depicted in FIG. 9 of the drawings accompanying the application. The holes in the web of the blade portion of the tail-cone reinforcement angle, which result from the drilling out of these four flush rivets **82**, will align with the rivet receiving holes **68** in the forward or overlap section **62** of the splice **54**.

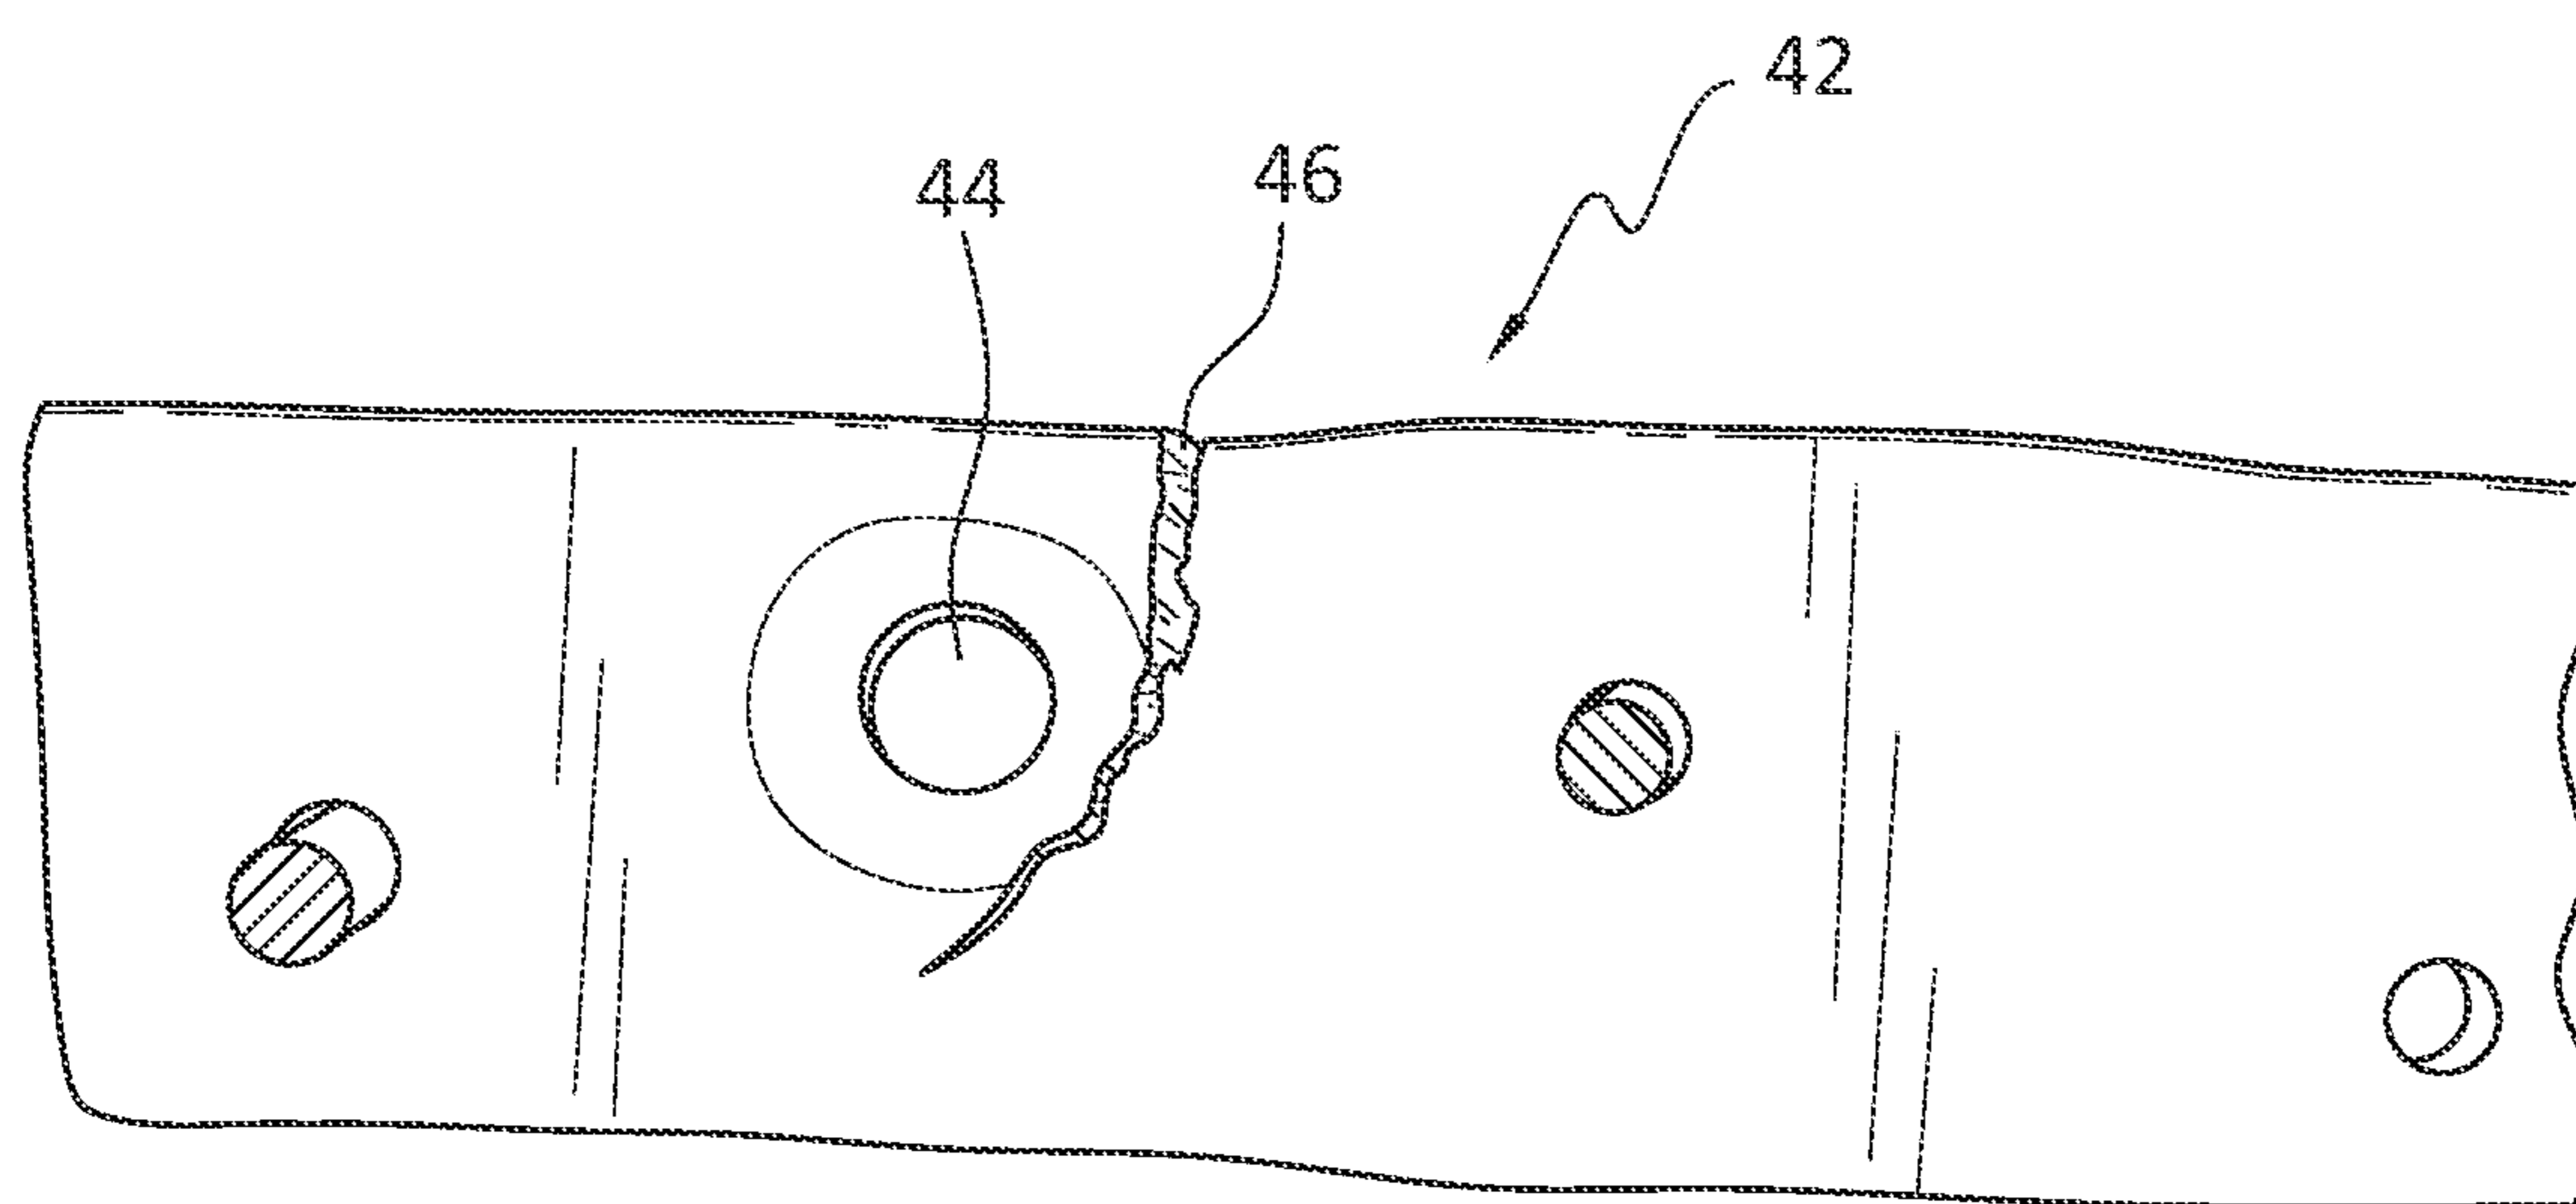
FIG. 3 is a photograph of an aft portion of a tail-cone reinforcement angle showing a typical failure in the horizontal stabilizer pivot shaft receiving bore of tail-cone reinforcement angle;

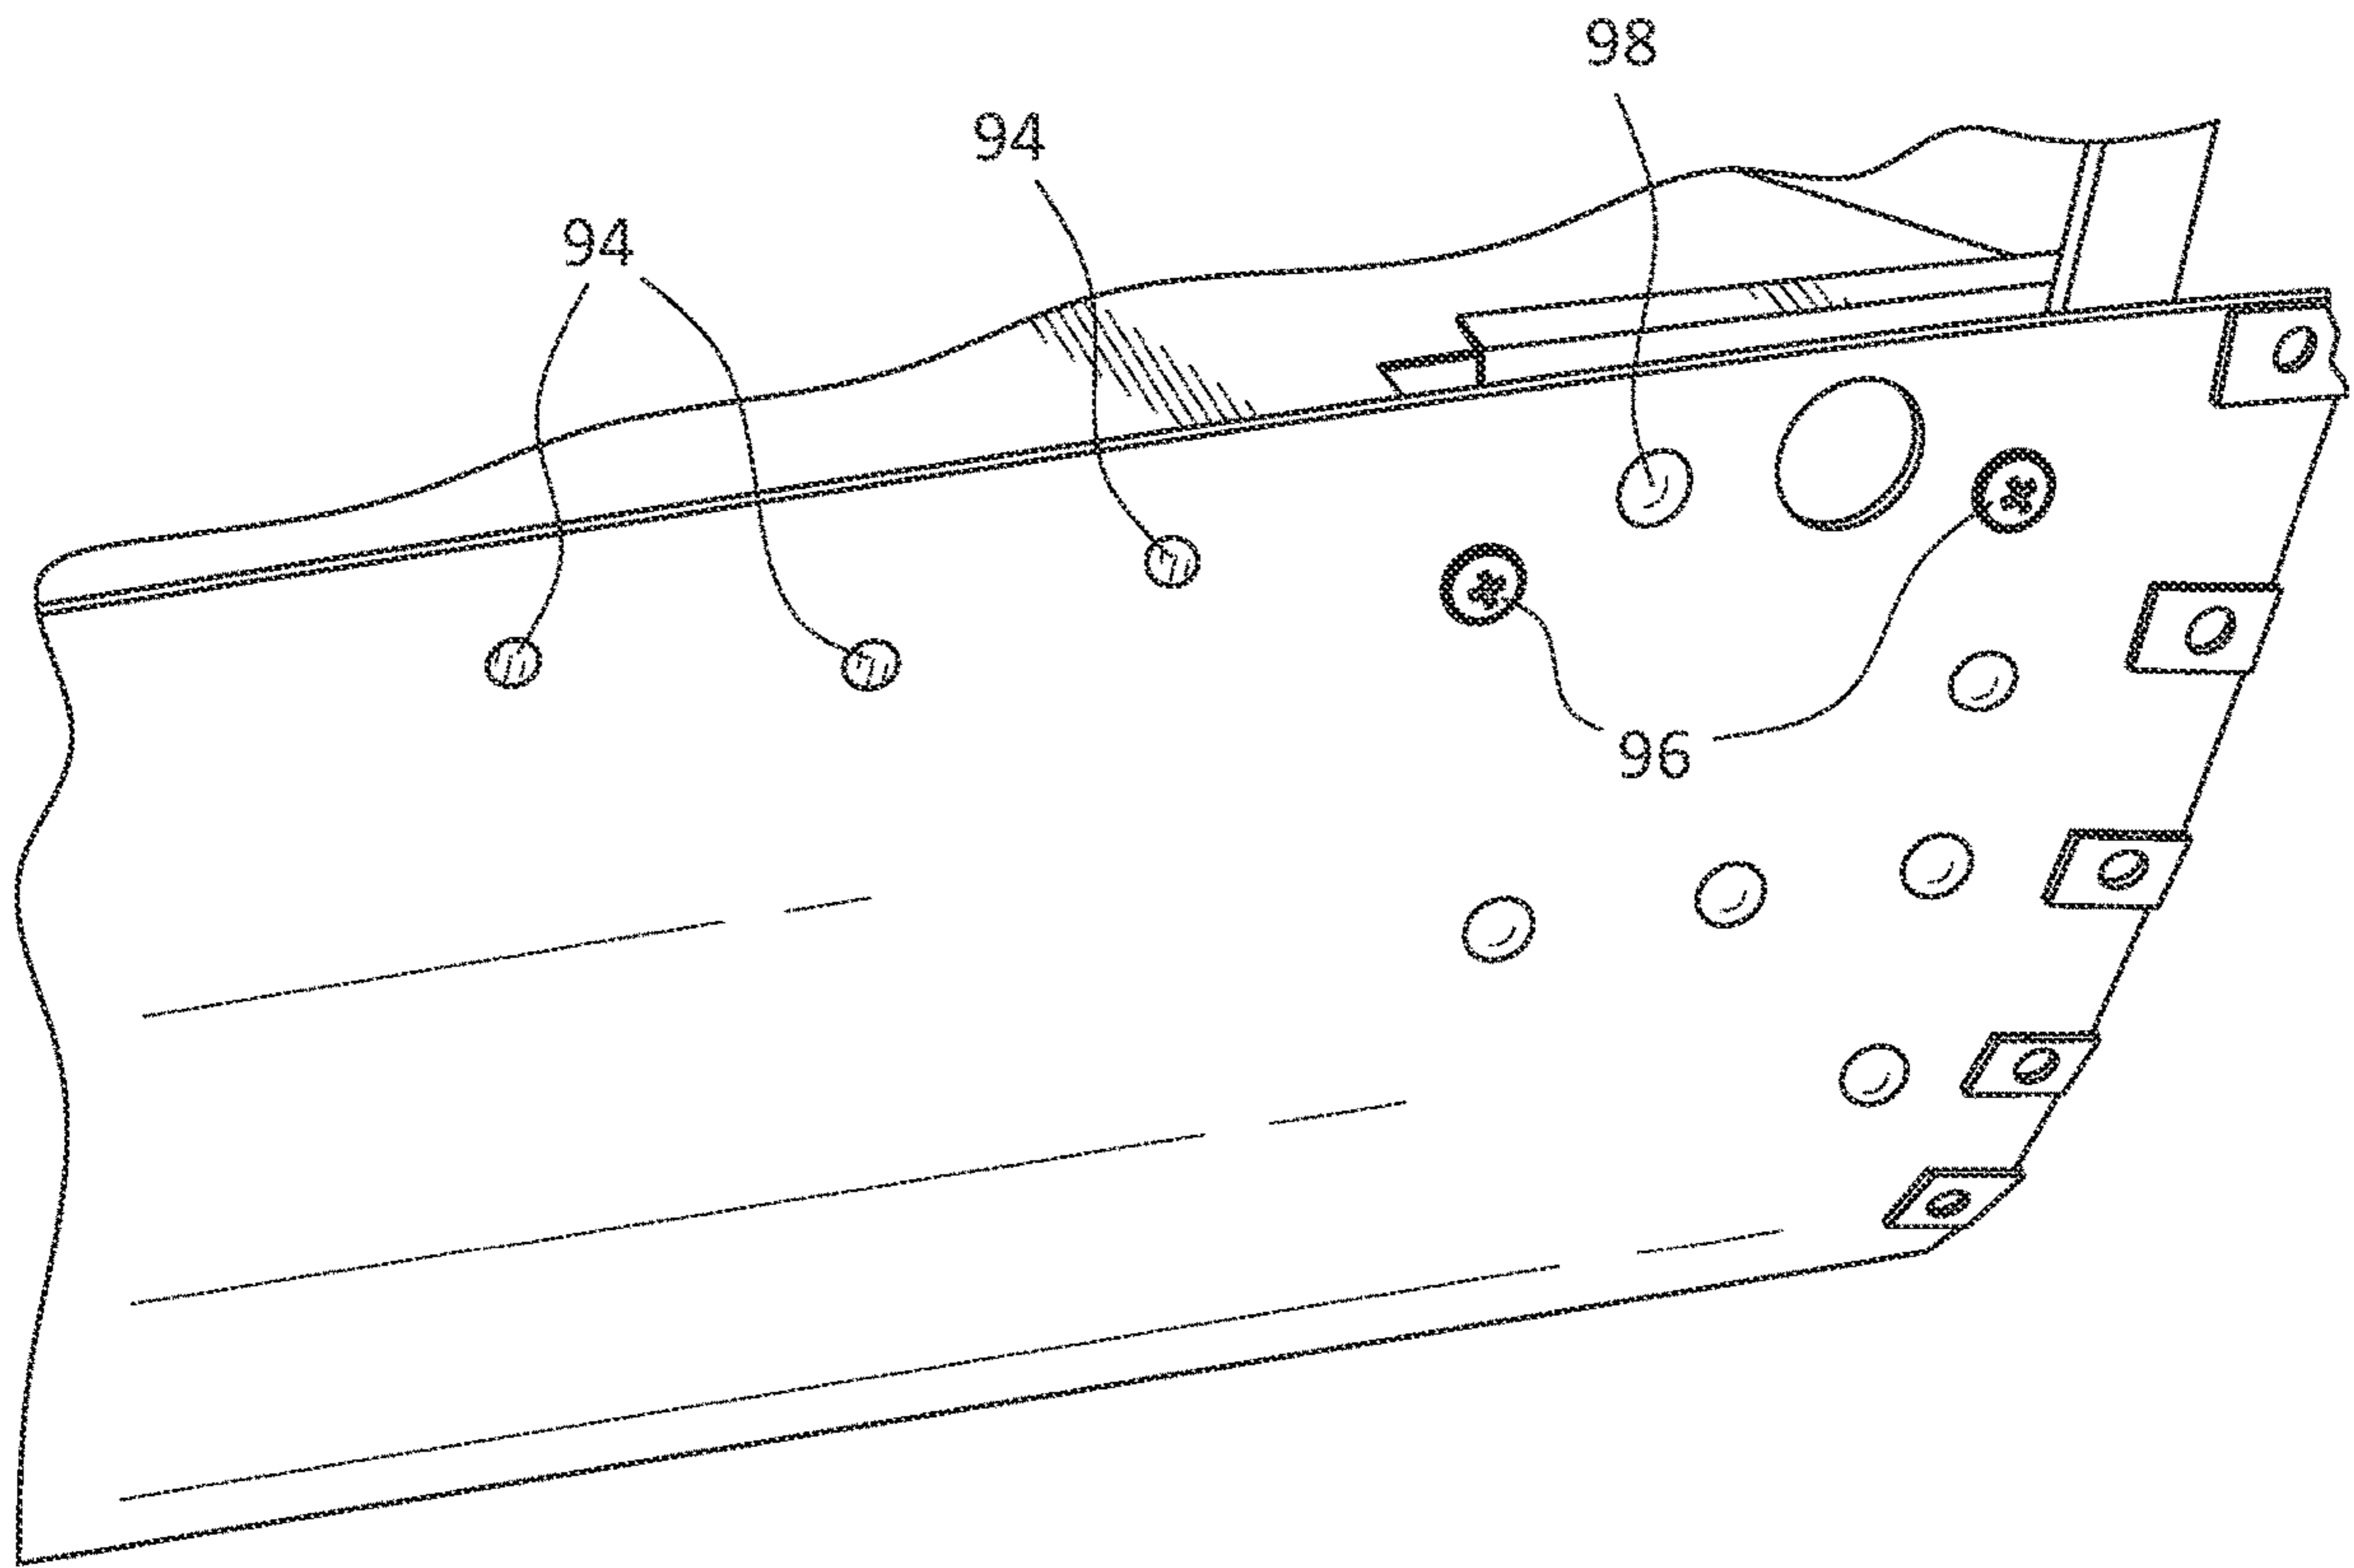
FIG. 10 is a view similar to FIG. 9 with the tail-cone reinforcement angle splice installed and secured in place;

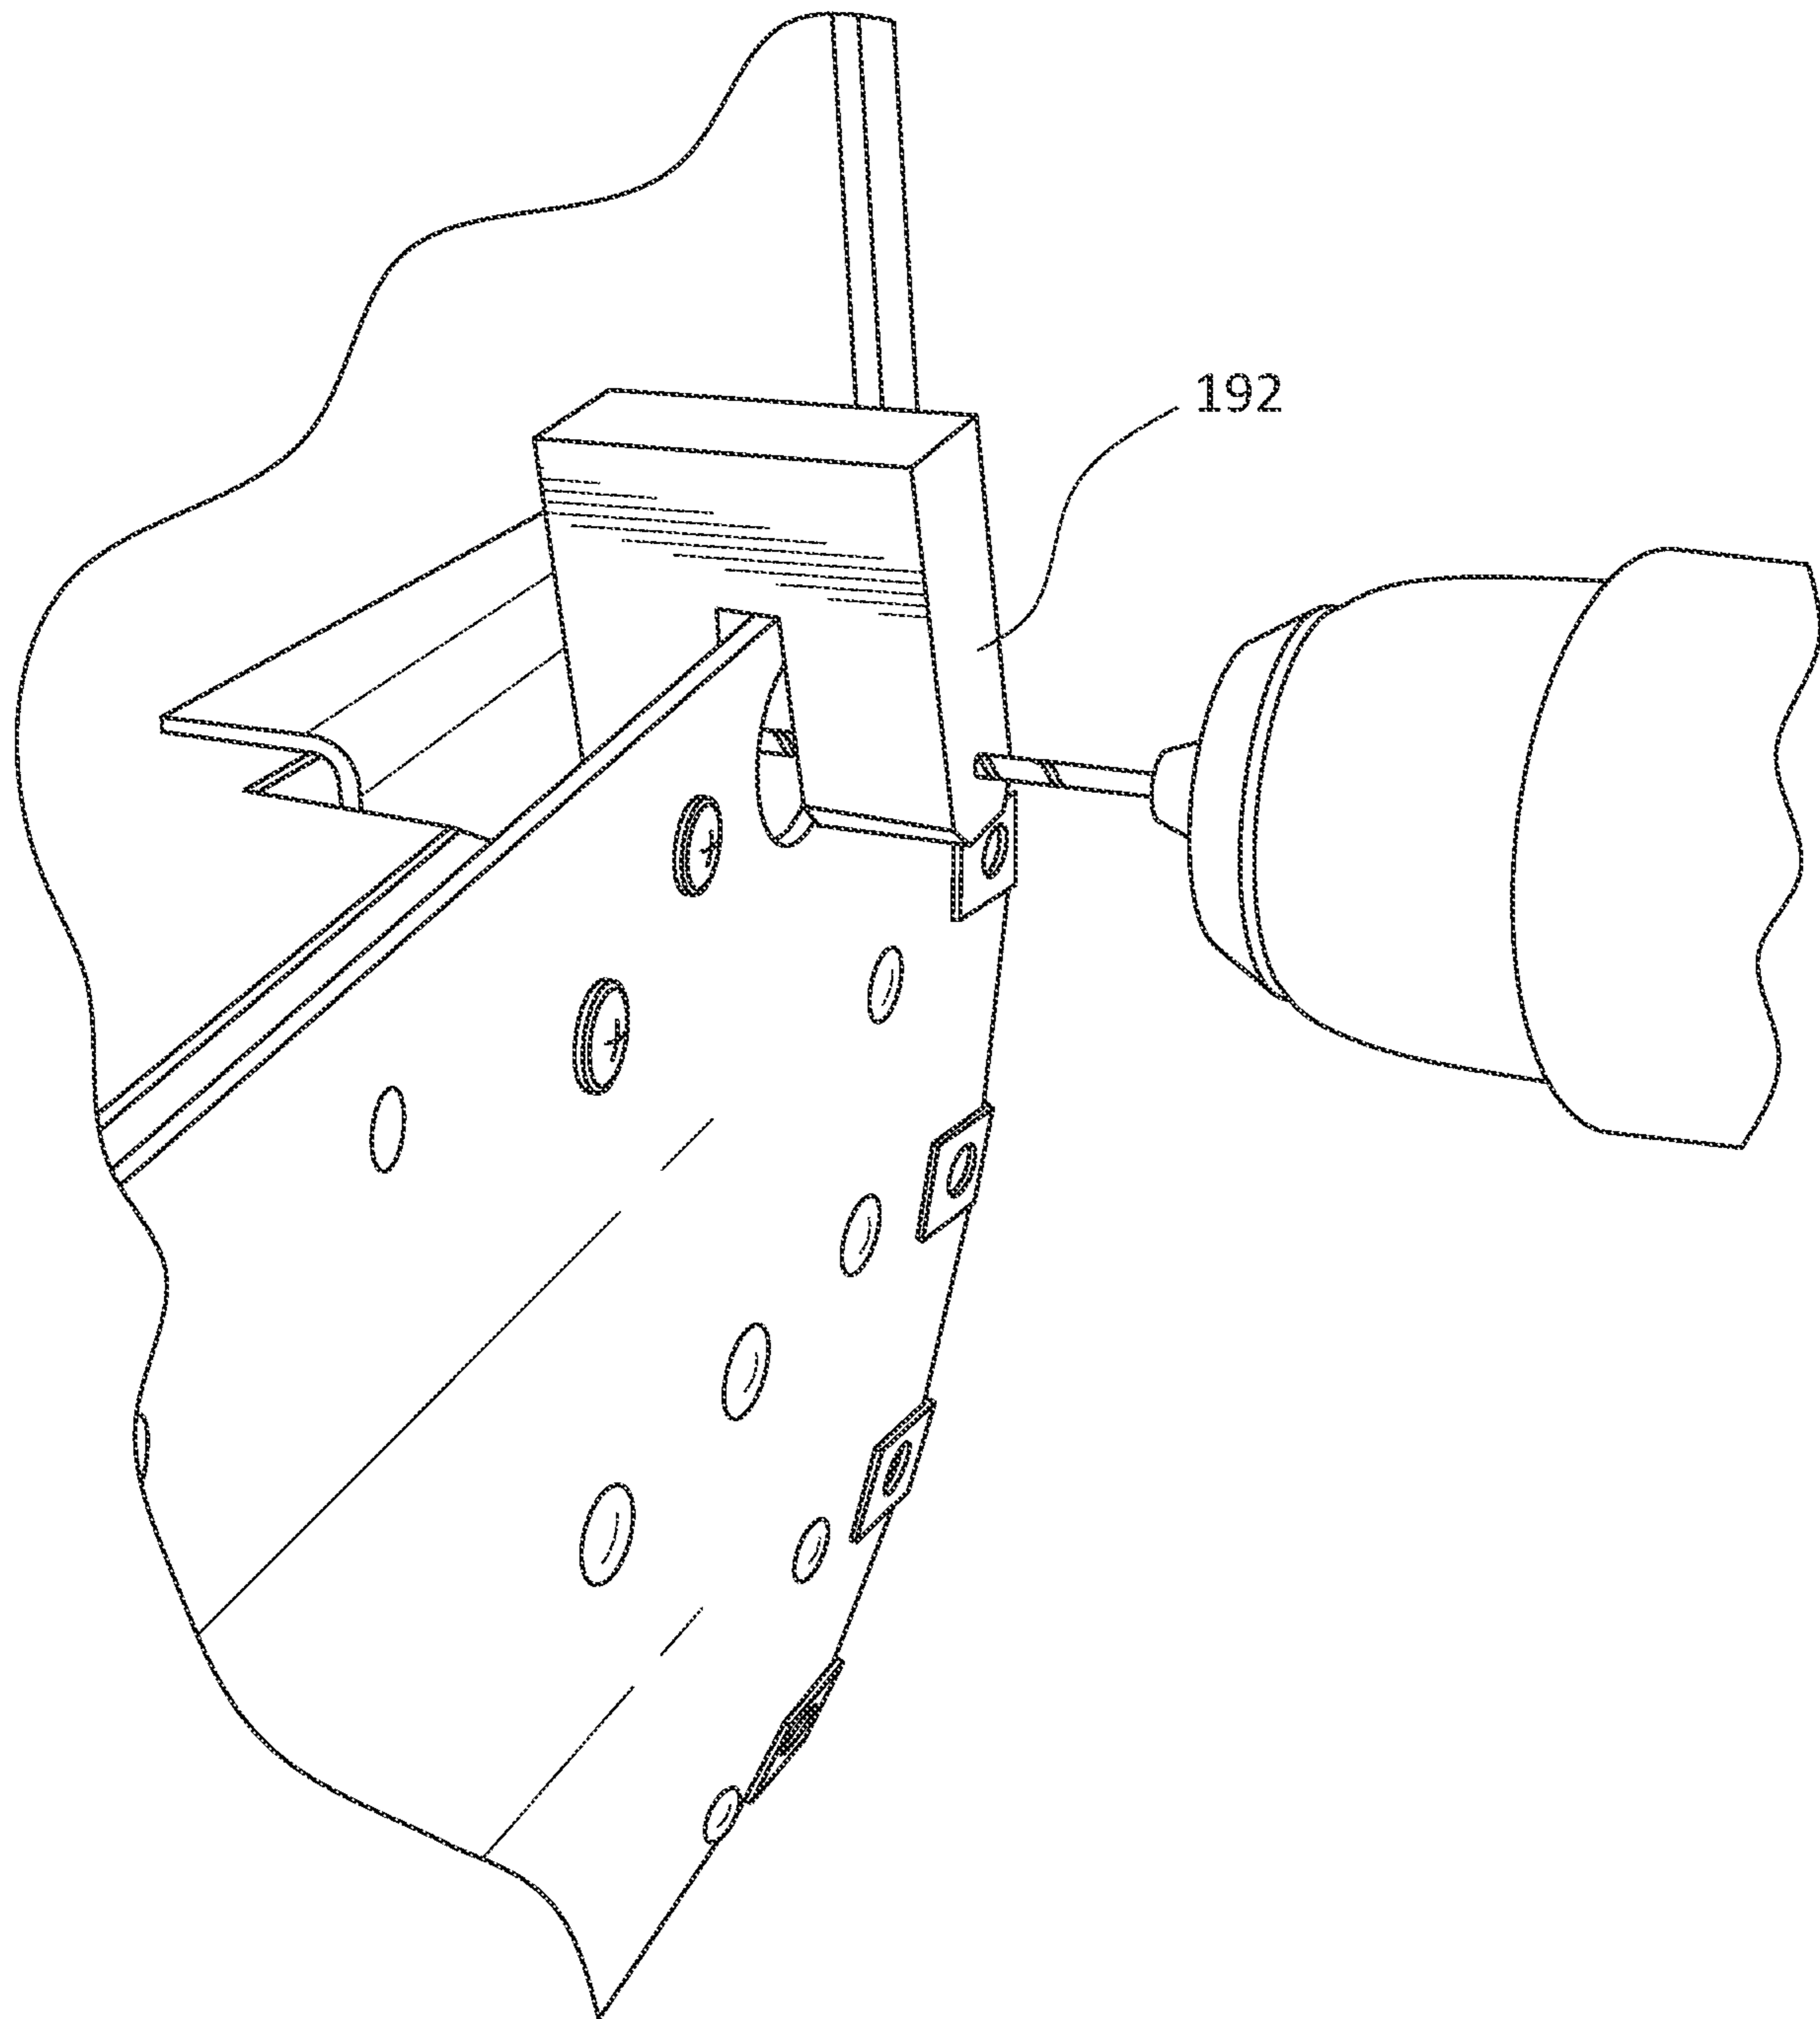
FIG. 11 is a view of the aft section of the tail cone and showing the forming of the horizontal stabilizer shaft receiving bore in the tail-cone reinforcement angle splice;

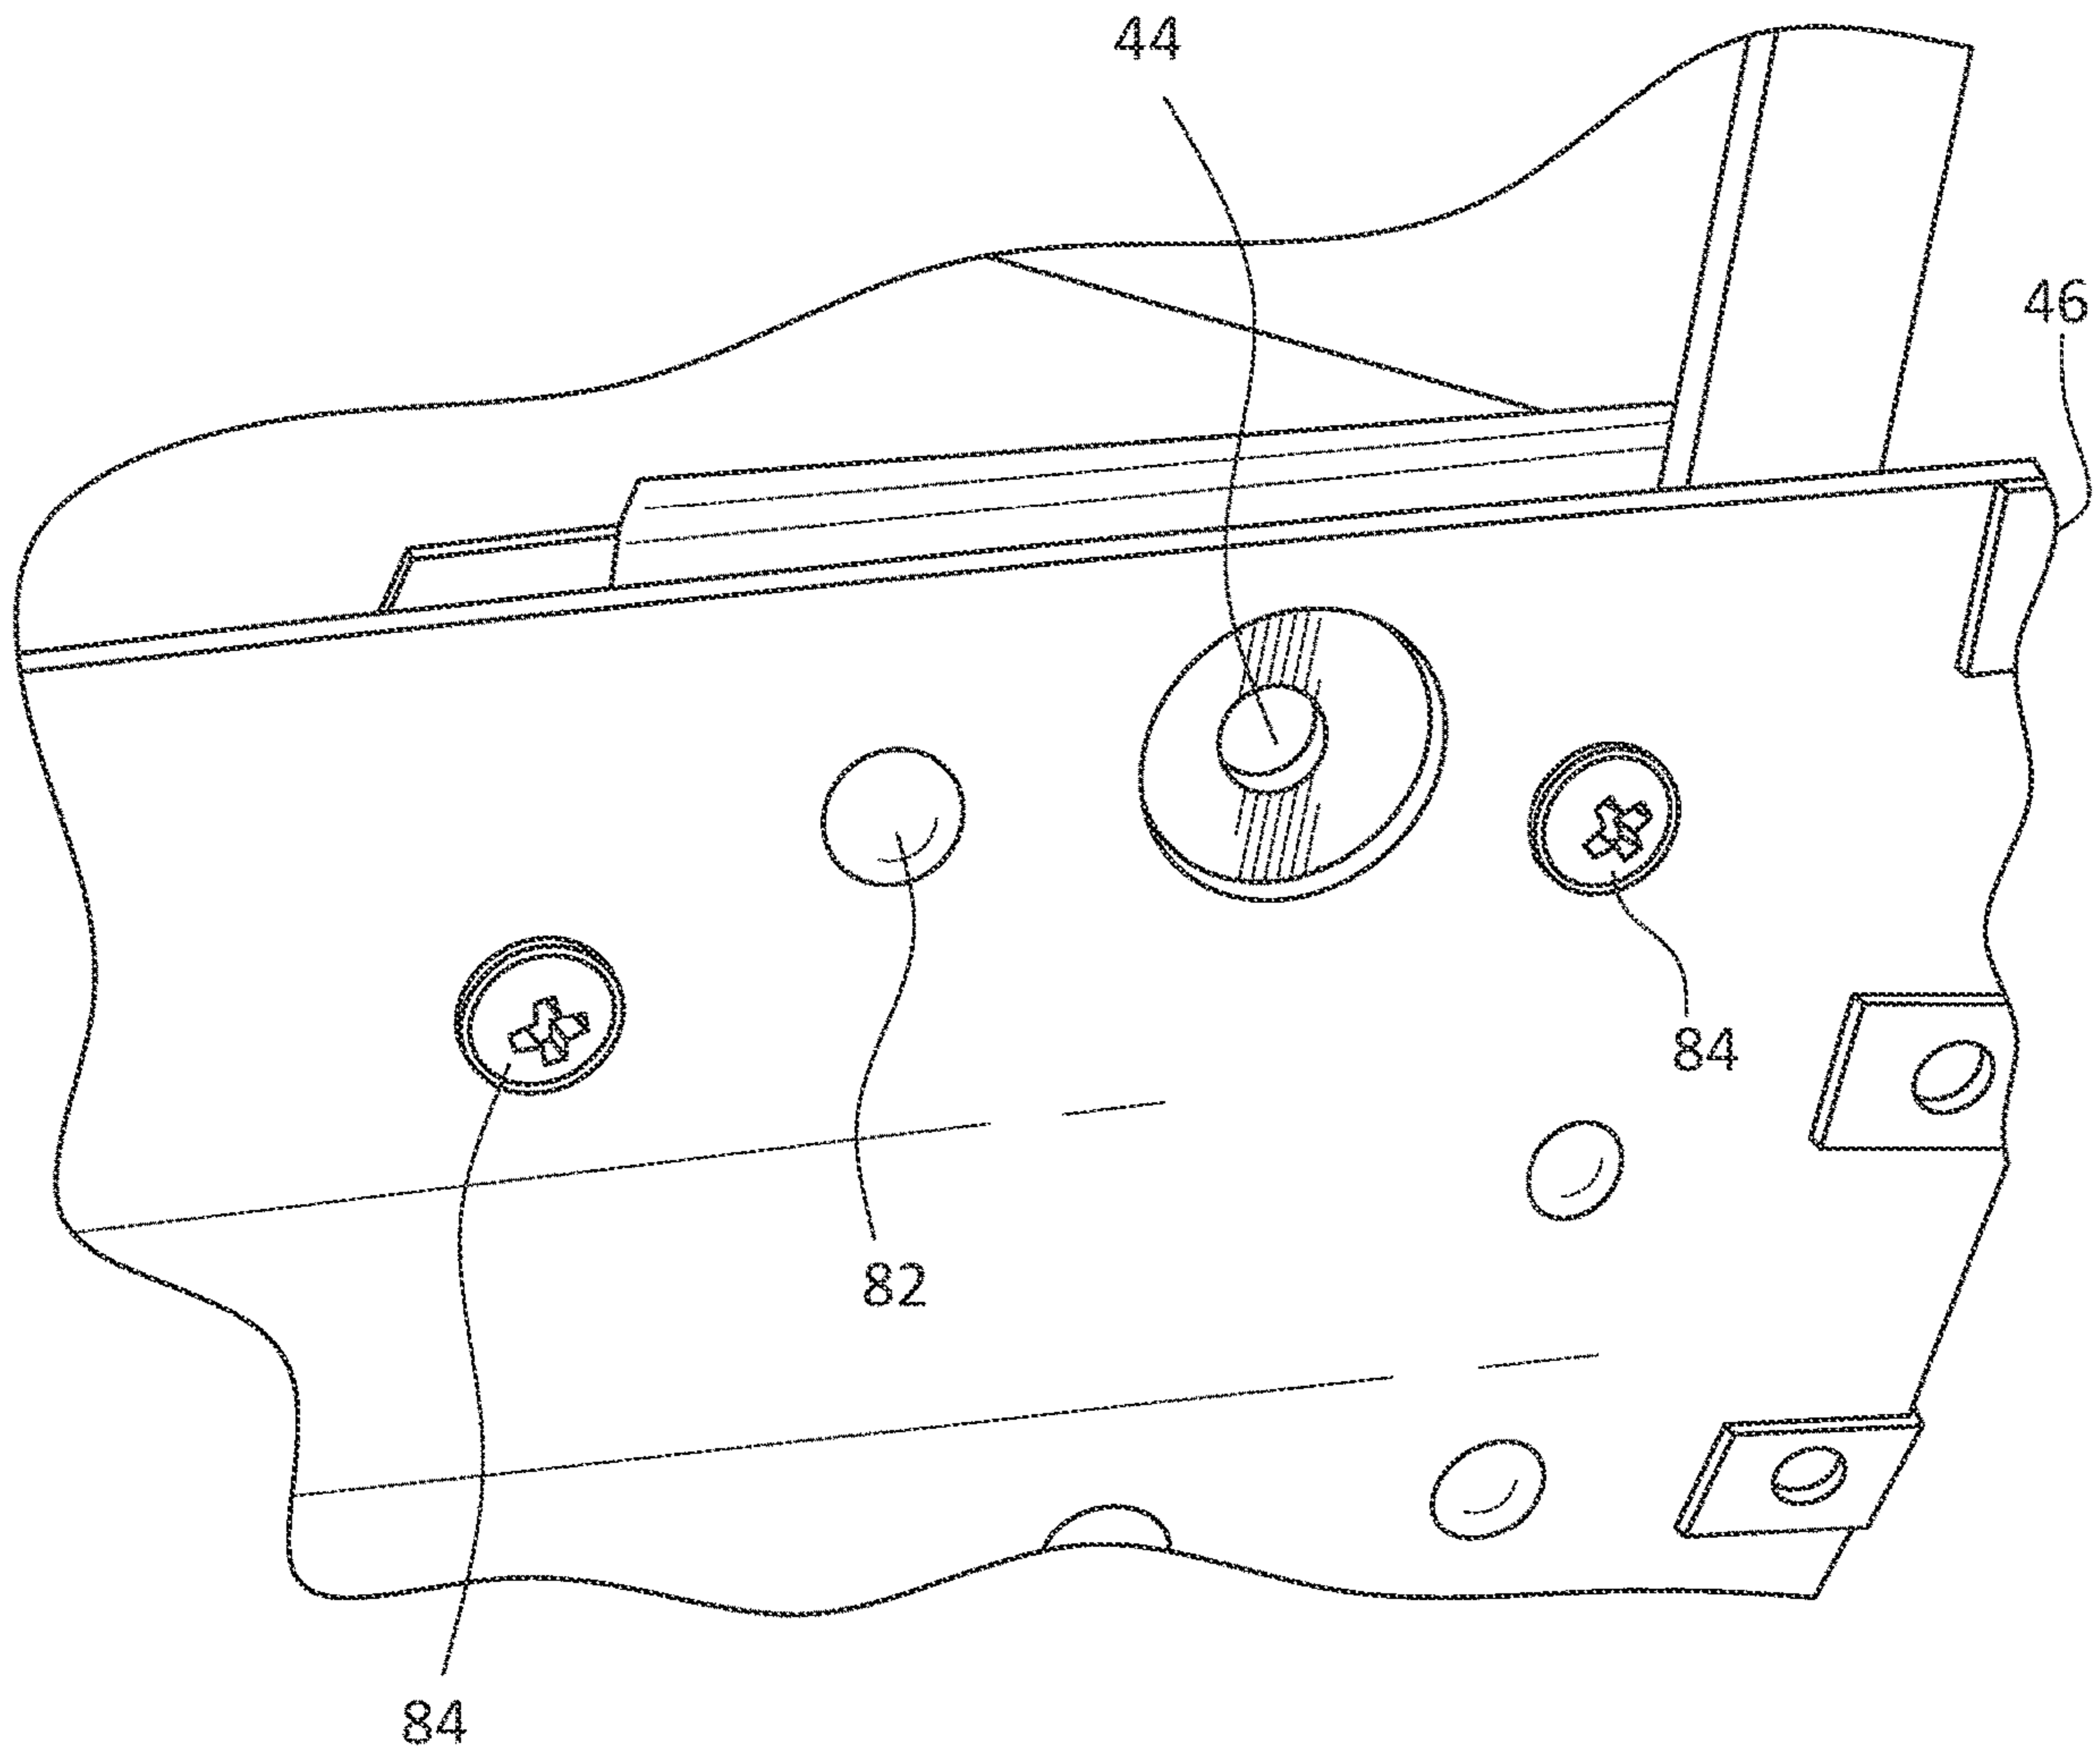
FIG. 12 is a view of the aft section of the tail cone and showing the completed horizontal stabilizer pivot shaft receiving bore formed in the tail-cone reinforcement angle splice; and
