(54) **CESSNA TAIL-CONE REINFORCEMENT ANGLE SPLICE, INSTALLATION KIT, AND METHOD FOR INSTALLATION THEREOF**

A tail-cone reinforcement angle of a Cessna 180-185 series aircraft is repaired by the removal of an aft most section of that tail-cone reinforcement angle and its replacement with an elongated splice body. The elongated splice body is attached to the remainder of the tail-cone reinforcement angle and to the tail-cone portion of the fuselage of the aircraft. The aft section of the original tail-cone reinforcement angle is subject to the development and propagation of cracks in the area of the rear pivot shaft receiving bore, which cracks render the aircraft unfit for use. The invention includes the provision of a suitable elongated splice body, a method for its installation, and a tool kit which is usable in accomplishing the removal and replacement of the aft section of the tail-cone reinforcement angle.

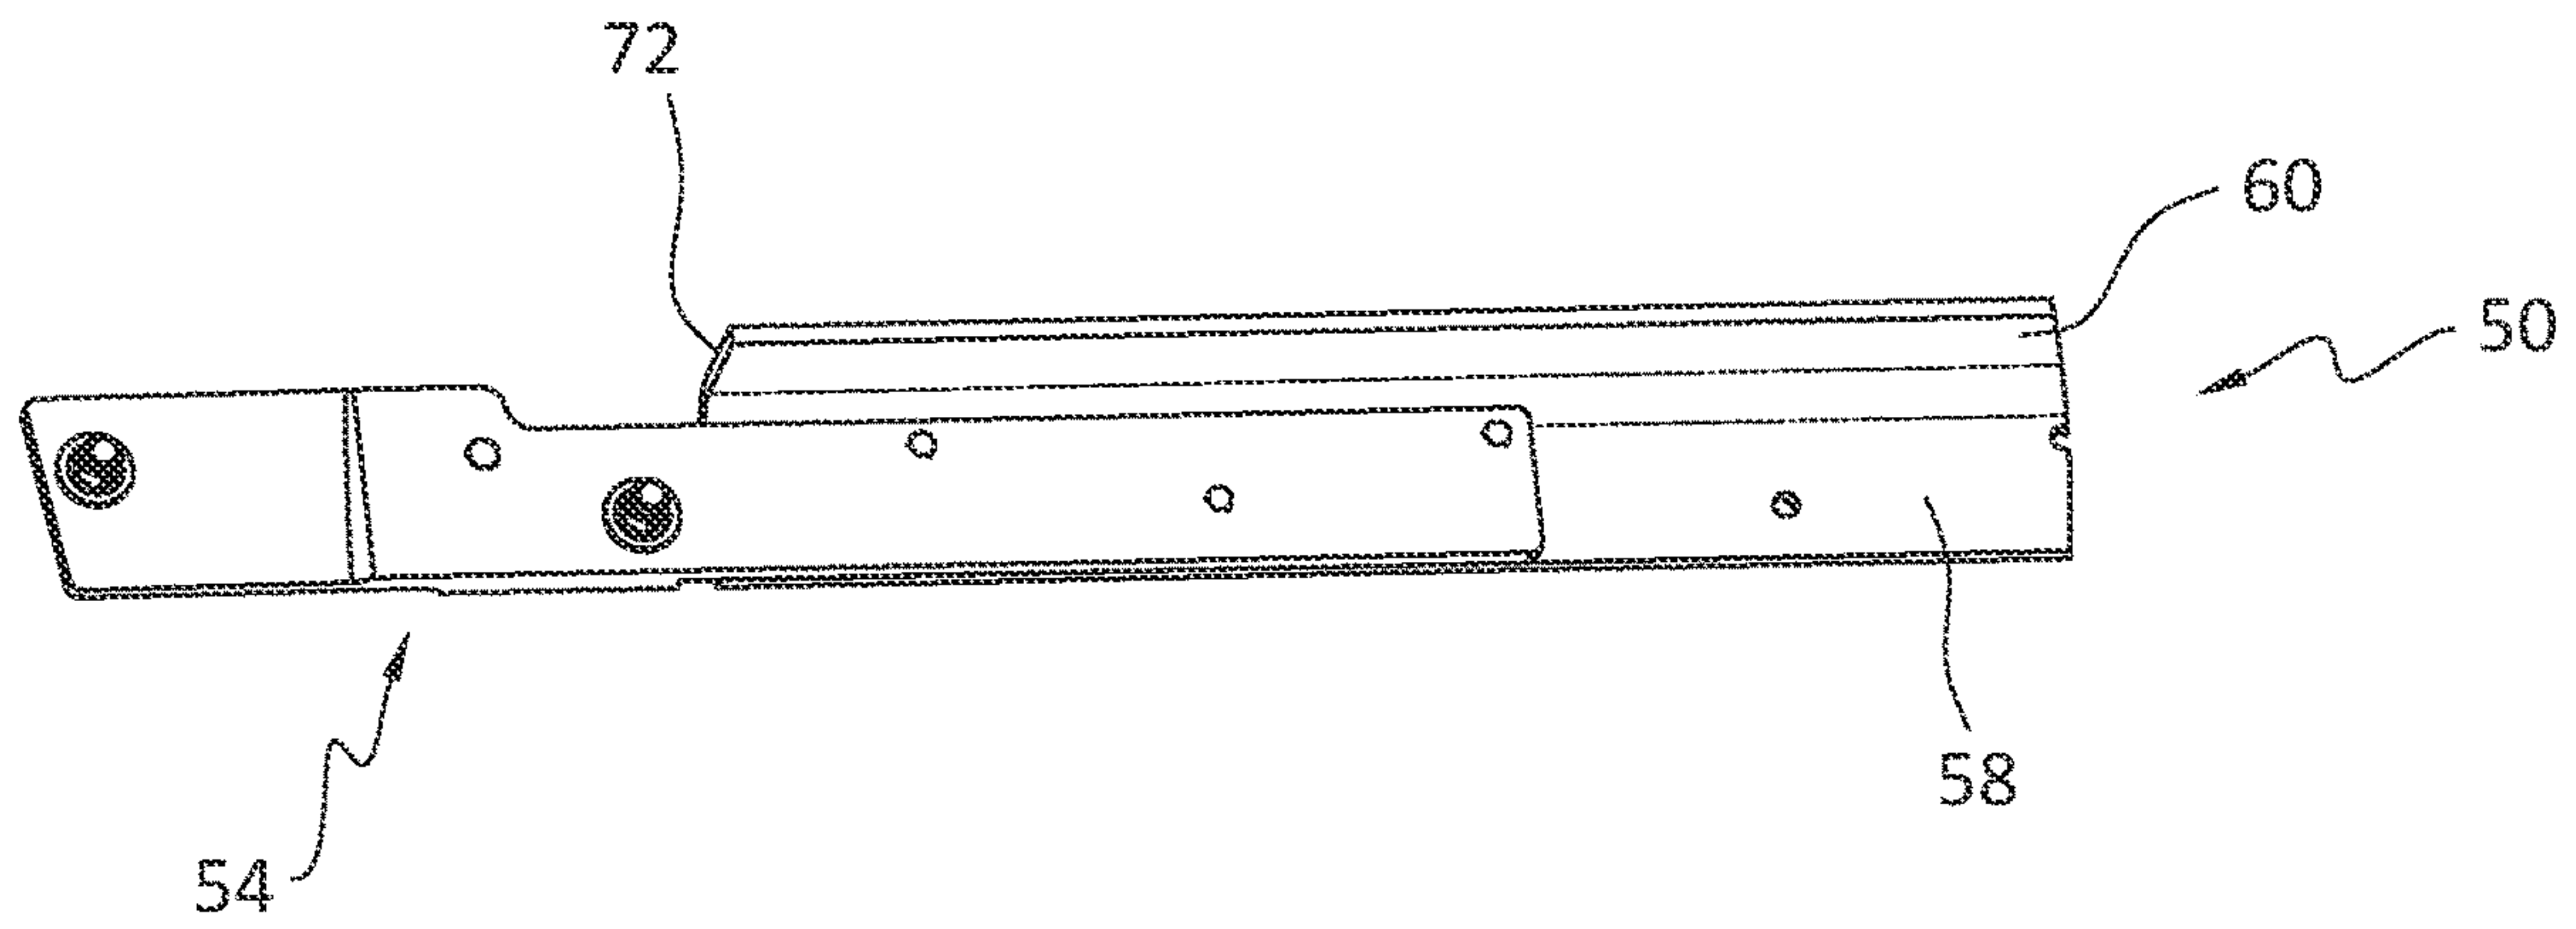
FIG. 5 is a side elevation view of an aft portion of the left side tail-cone reinforcement angle, encircled at A in FIG. 4, with the tail-cone reinforcement angle splice, in accordance with the present invention, in place;

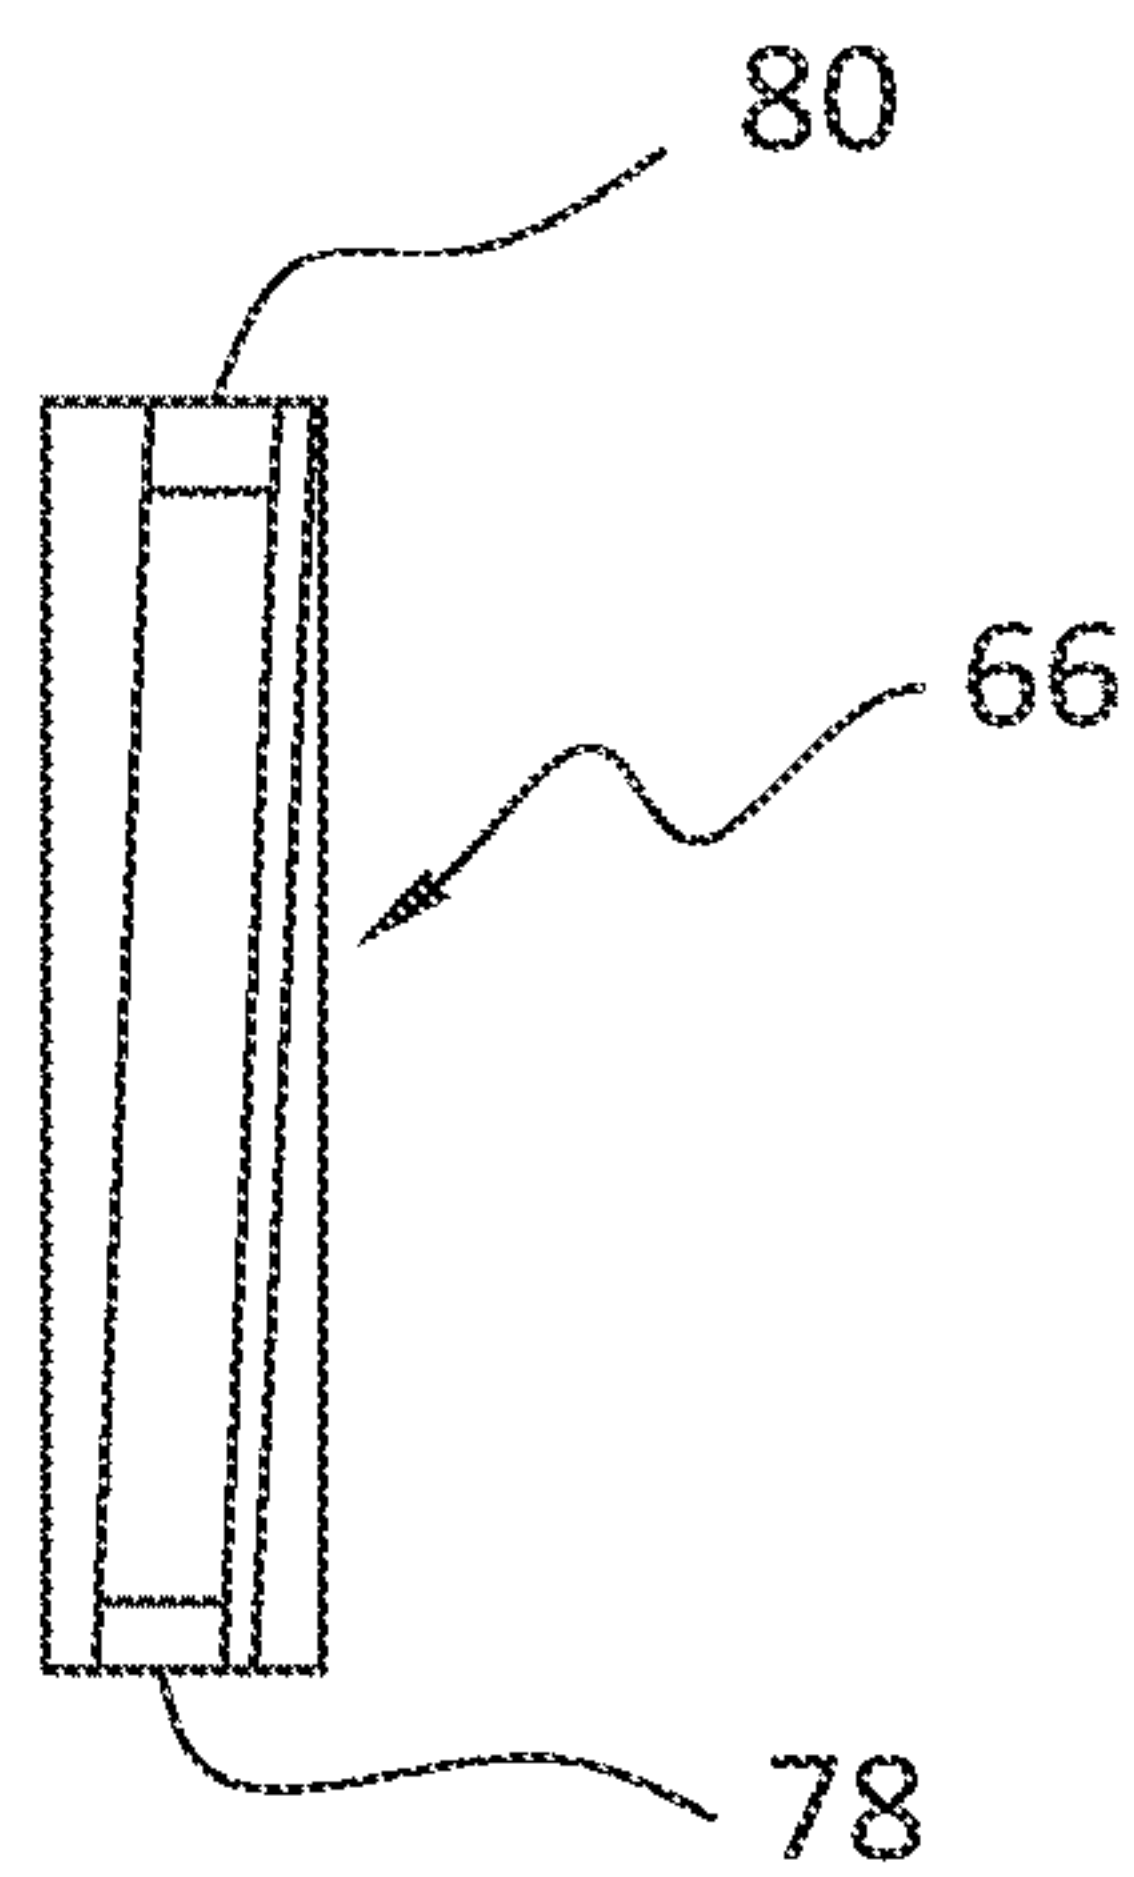
FIG. 8 is an aft end view of the reinforcement angle splice depicted in FIGS. 6 and 7 and taken from the right as seen in FIG. 6 and from the left as seen in FIG. 7;

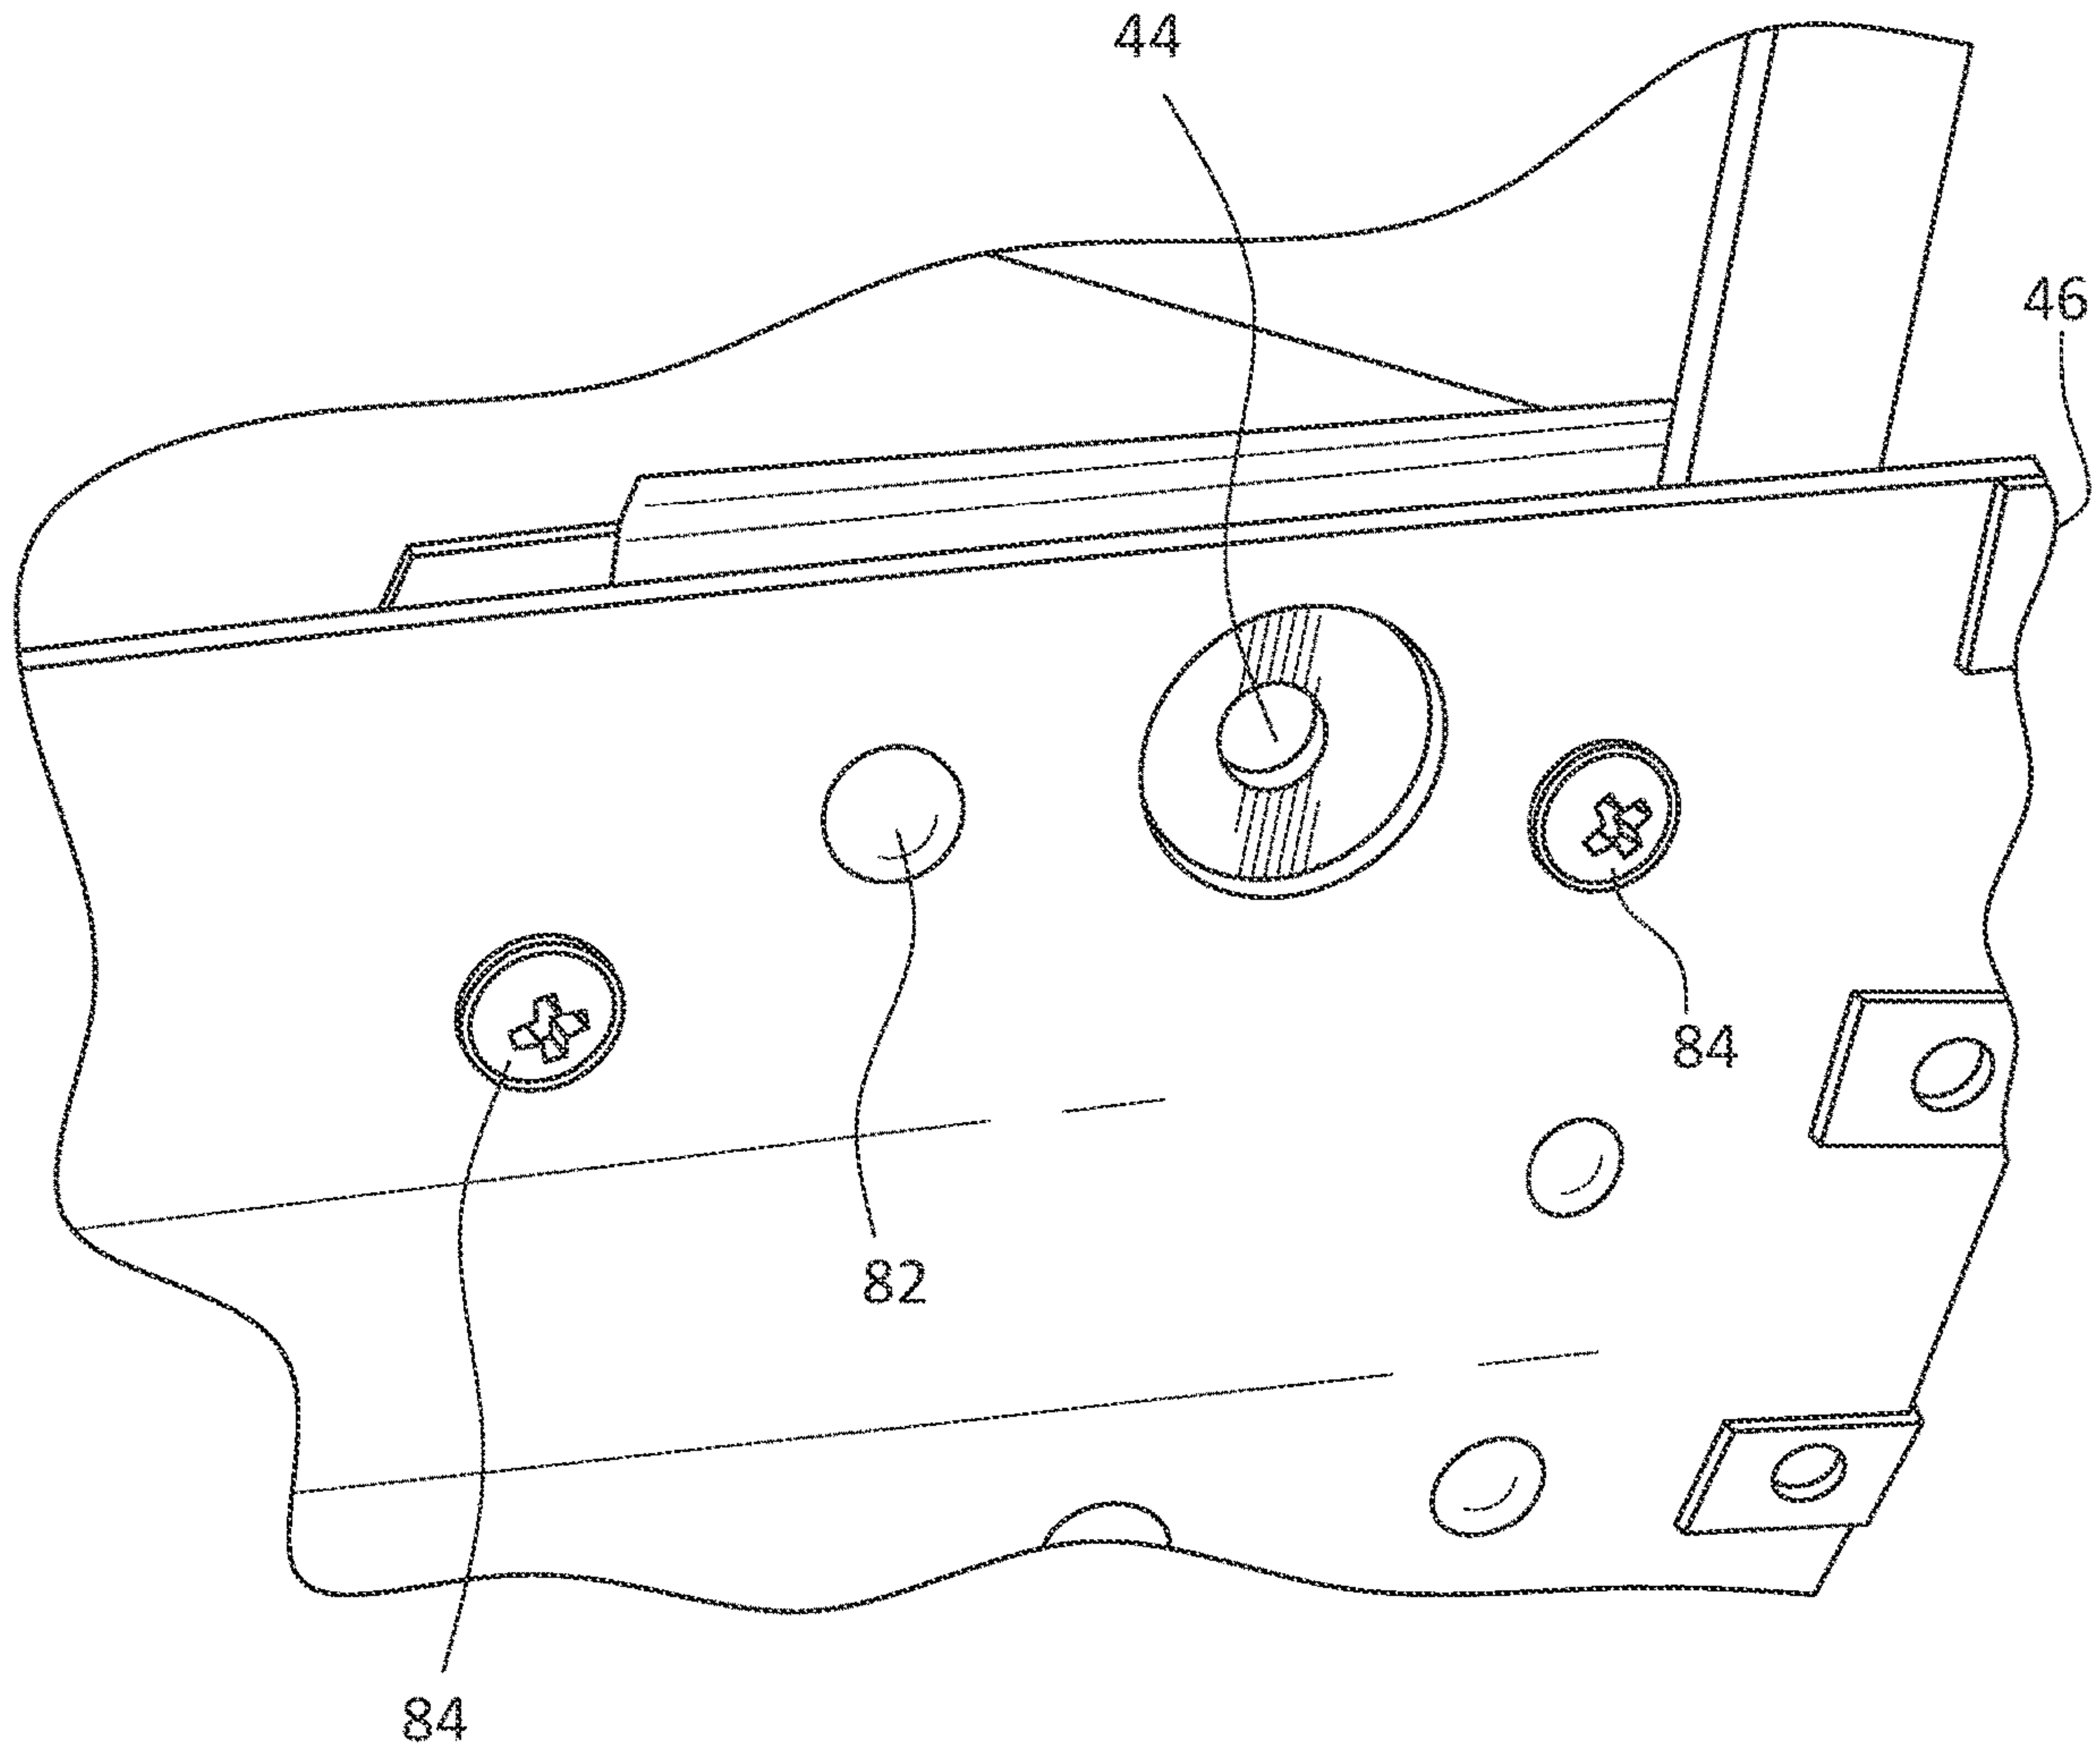
FIG. 12 is a view of the aft section of the tail cone and showing the completed horizontal stabilizer pivot shaft receiving bore formed in the tail-cone reinforcement angle splice; and
