#### US011112051B2

### (54) FLARED-END AUTOMOTIVE ENGINE COOLANT PIPE REPAIR STENT AND METHOD FOR REPAIRING AN ENGINE

# FLARED-END AUTOMOTIVE ENGINE COOLANT PIPE REPAIR STENT AND METHOD FOR REPAIRING AN ENGINE

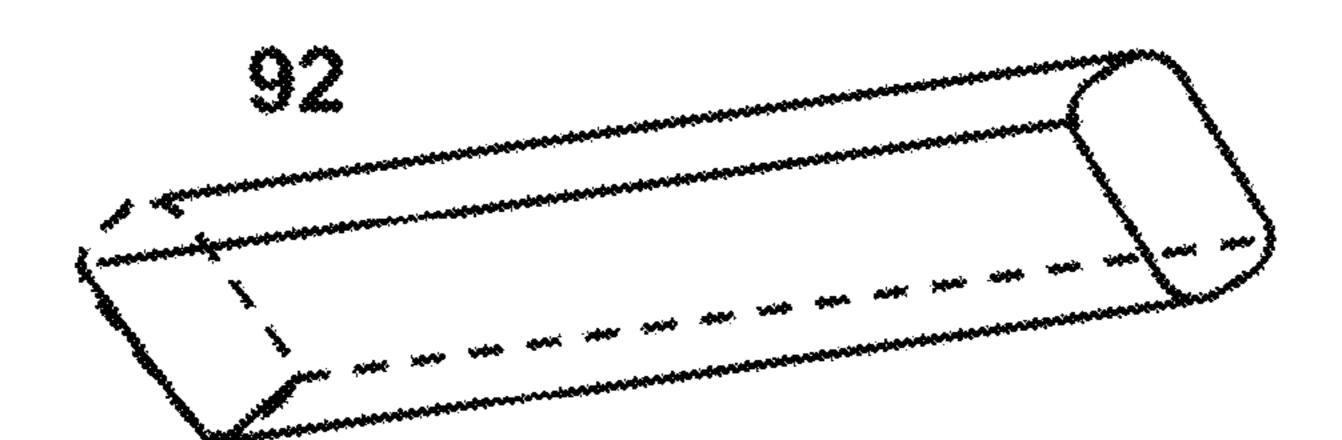
Repair Tube Insert (The Stent)

FIGS. 11A-11H and 11J illustrate various embodiments of repair tube inserts, in accordance with the present disclosure.
