(54) **FIBER COMPOSITE SYSTEM AND METHOD FOR PIPE REINFORCEMENT**

A reinforced pipe and a method of preparing the reinforced pipe are provided. The reinforced pipe has repair area where a wrinkle bend is present in a center section of the repair area. The reinforced pipe comprises a unidirectional fabric circumferentially wrapped around the repair area of the pipe so as to result in multiple layers of the unidirectional fabric around the repair area. The unidirectional fabric is composed of high-performance fibers with at least 90% of the high-performance fibers oriented in the 90° direction, and the unidirectional fabric is wrapped such that the high-performance fibers run in the axial direction. The reinforced pipe further comprises a bidirectional fabric wrapped of over the unidirectional fabric such the at least one layer of bidirectional fabric is wrapped over the unidirectional fabric.

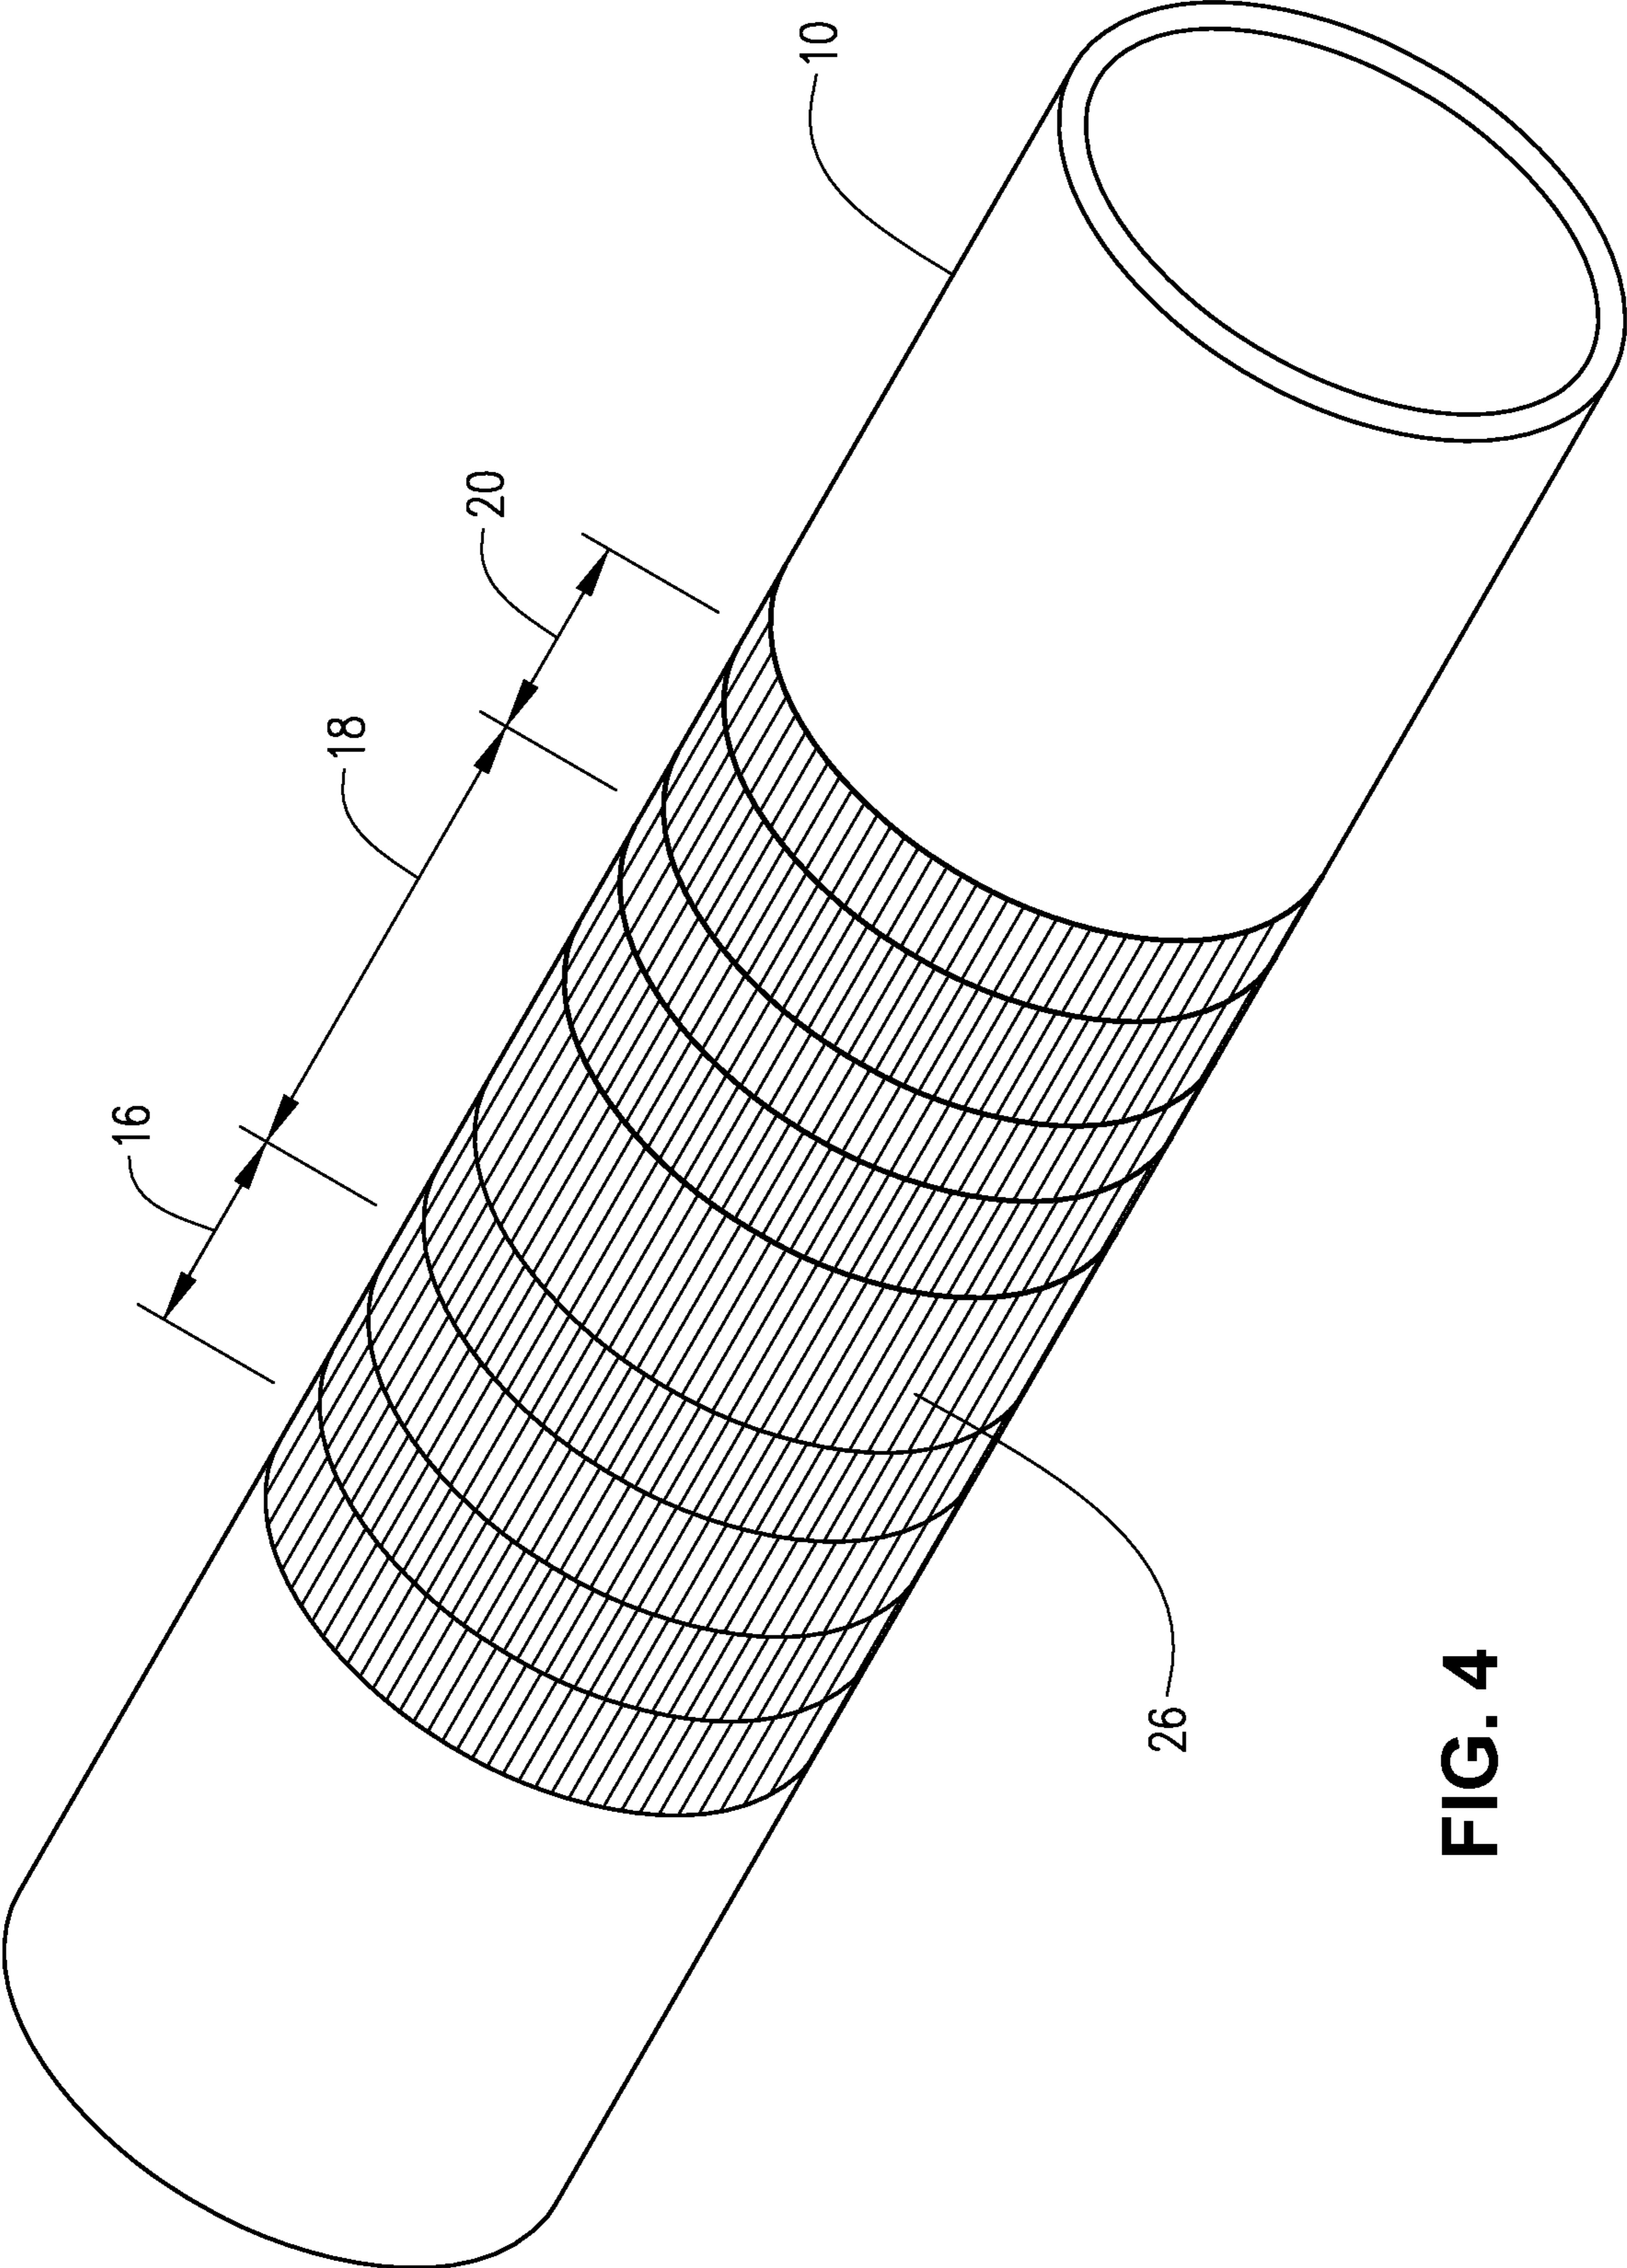
FIG. 4 is a perspective view of the pipe of FIG. 3 illustrating the completed application of the unidirectional fabric.

As illustrated in FIGS. 3 and 4, a unidirectional fabric 28 is placed on top of load transfer material 26 and resin, if applied. Unidirectional fabric 28 is circumferentially

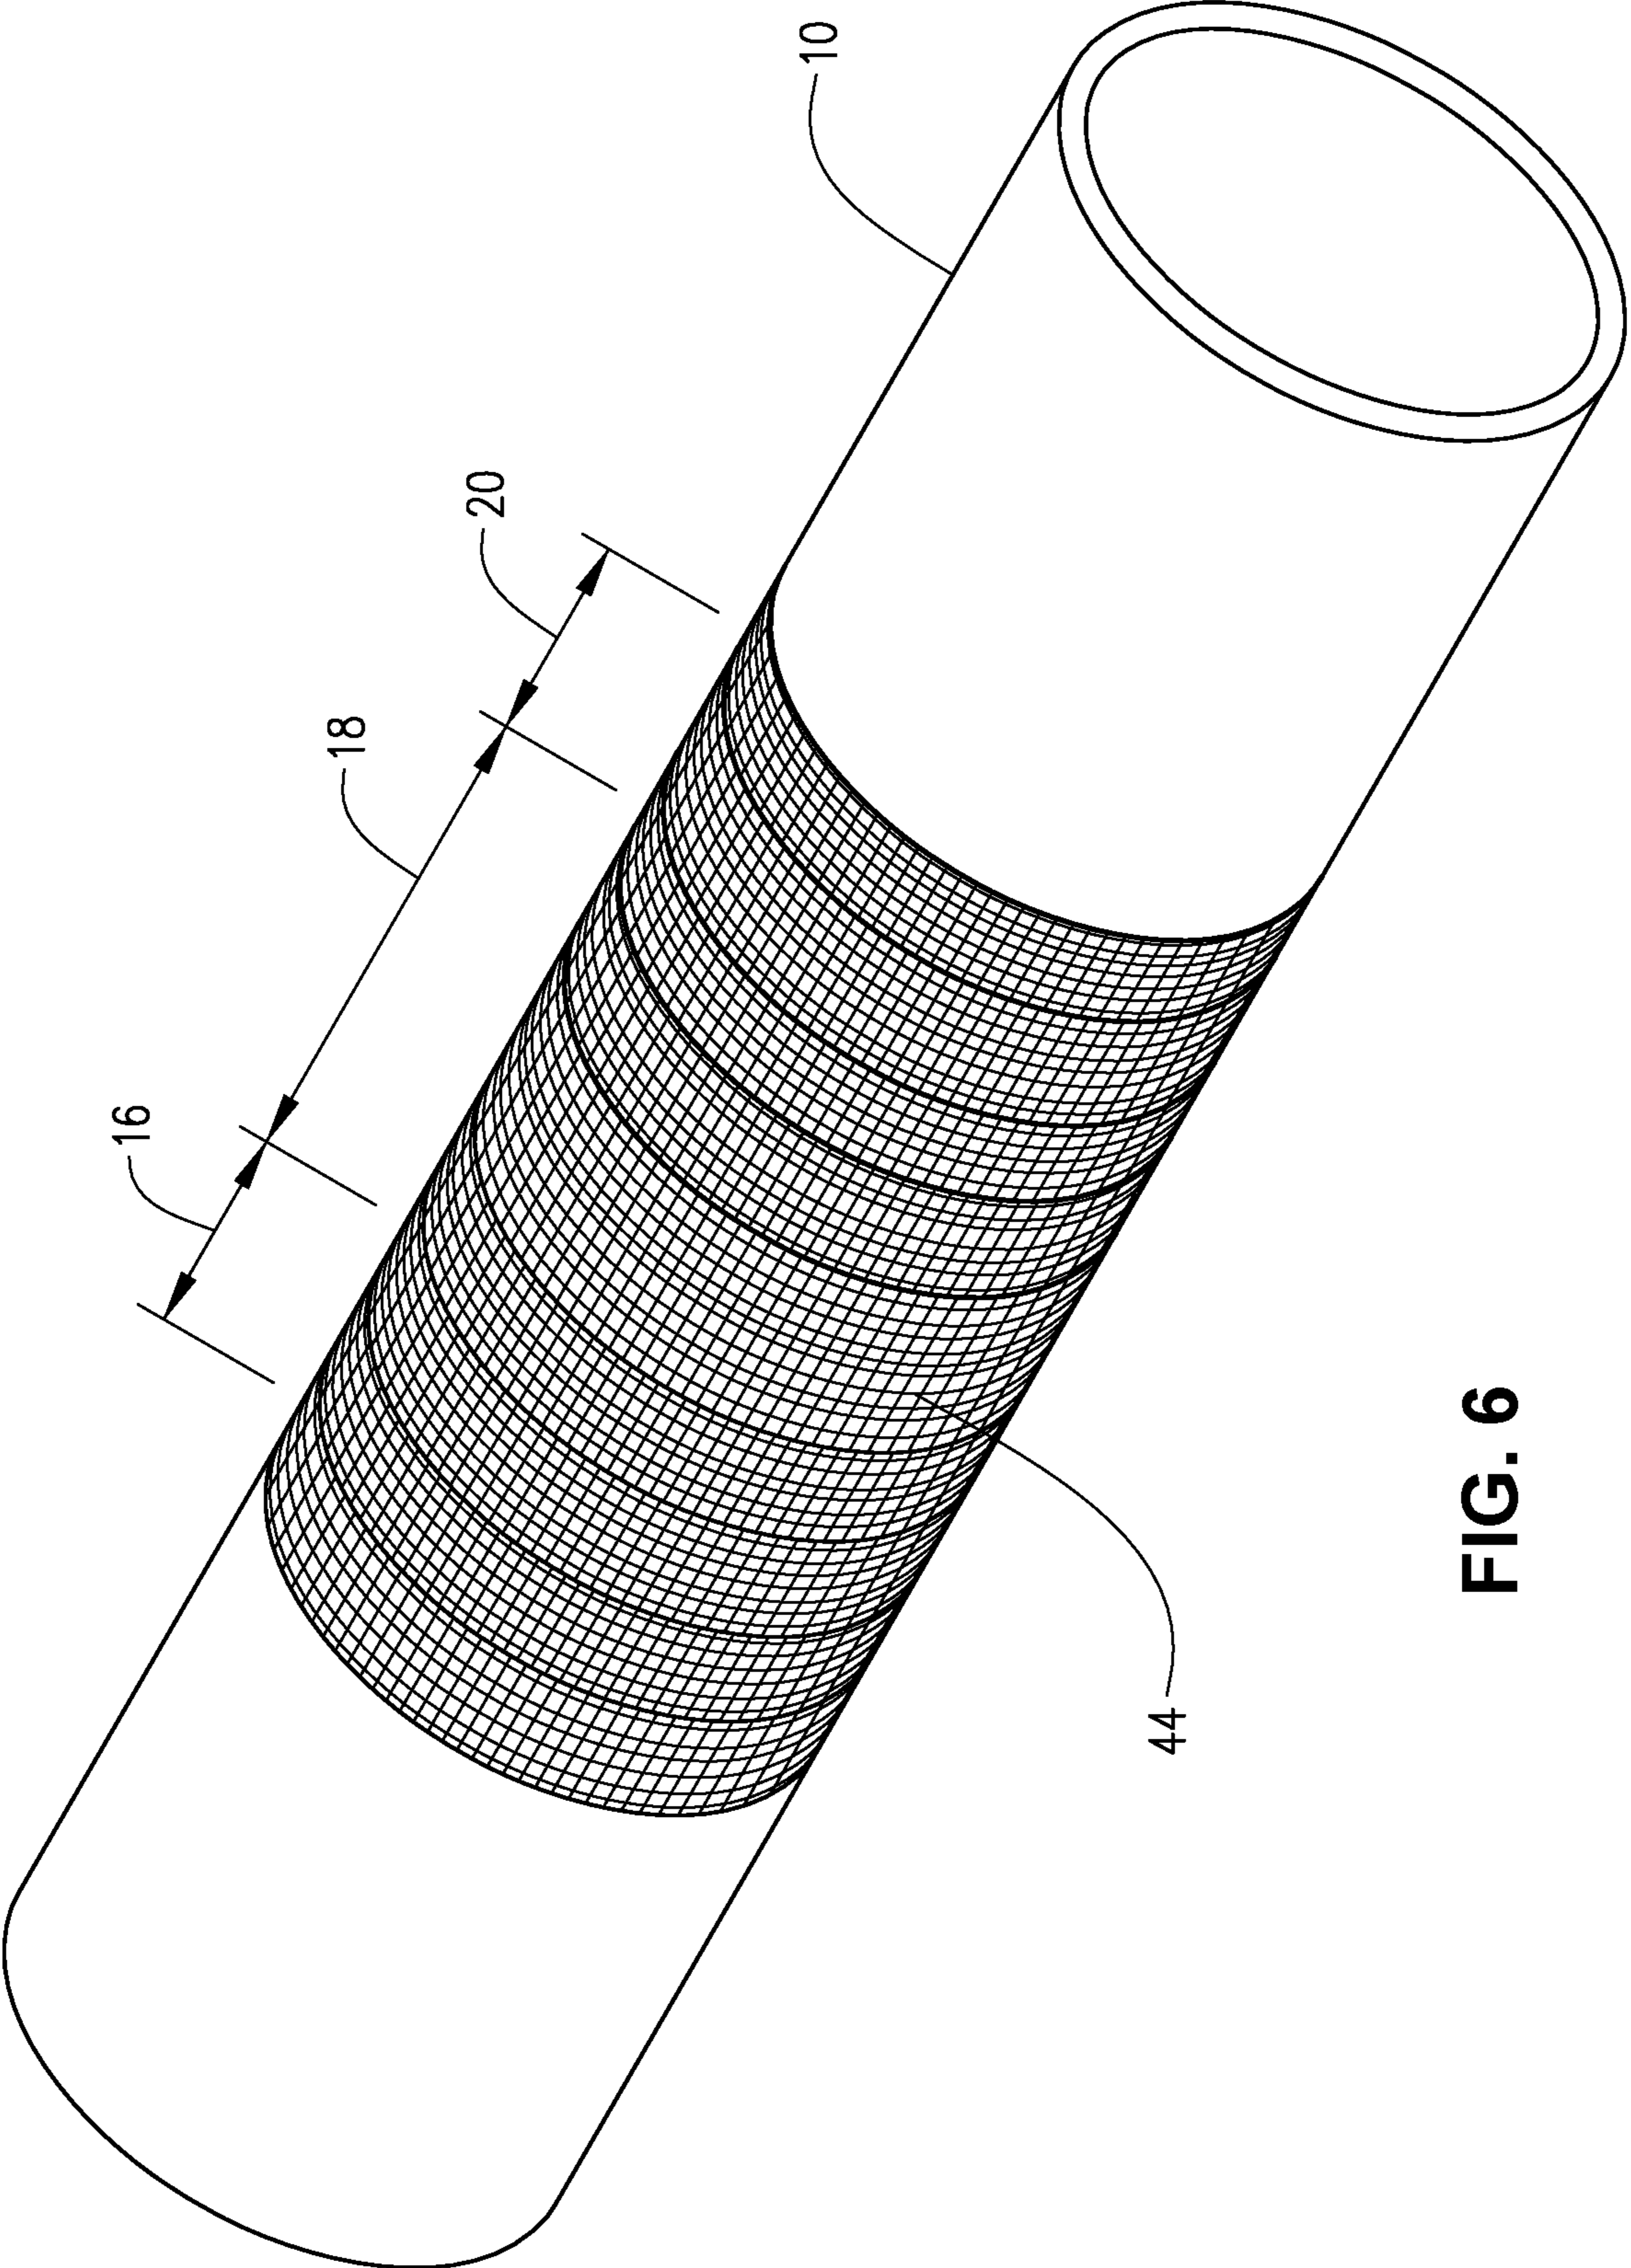
FIG. 6 is a perspective view of the pipe of FIG. 5 illustrating the completed application of the bidirectional fabric.

In accordance with this disclosure, there is provided a reinforced pipe wherein the pipe 10 has wrinkle bend 12, and repair area 14 around the wrinkle bend has been reinforced by several distinct layers. The reinforced pipe is described below in relation to FIGS. 2 to 6, which illustrate the distinct layers.
