(12) **United States Patent**  
**Walker et al.**

(54) **FIBER COMPOSITE SYSTEM AND METHOD FOR PIPE REINFORCEMENT**

A reinforced pipe and a method of preparing the reinforced pipe are provided. The reinforced pipe has repair area where a circumferential defect is present in a center section of the repair area. The reinforced pipe comprises a unidirectional fabric circumferentially wrapped around the repair area of the pipe so as to result in multiple layers of the unidirectional fabric around the repair area. The unidirectional fabric is composed of high-performance fibers with at least 90% of the high-performance fibers oriented in the 90° direction, and the unidirectional fabric is wrapped such that the high-performance fibers run in the axial direction. The reinforced pipe further comprises a bidirectional fabric wrapped over the unidirectional fabric such the at least one layer of bidirectional fabric is wrapped over the unidirectional fabric.

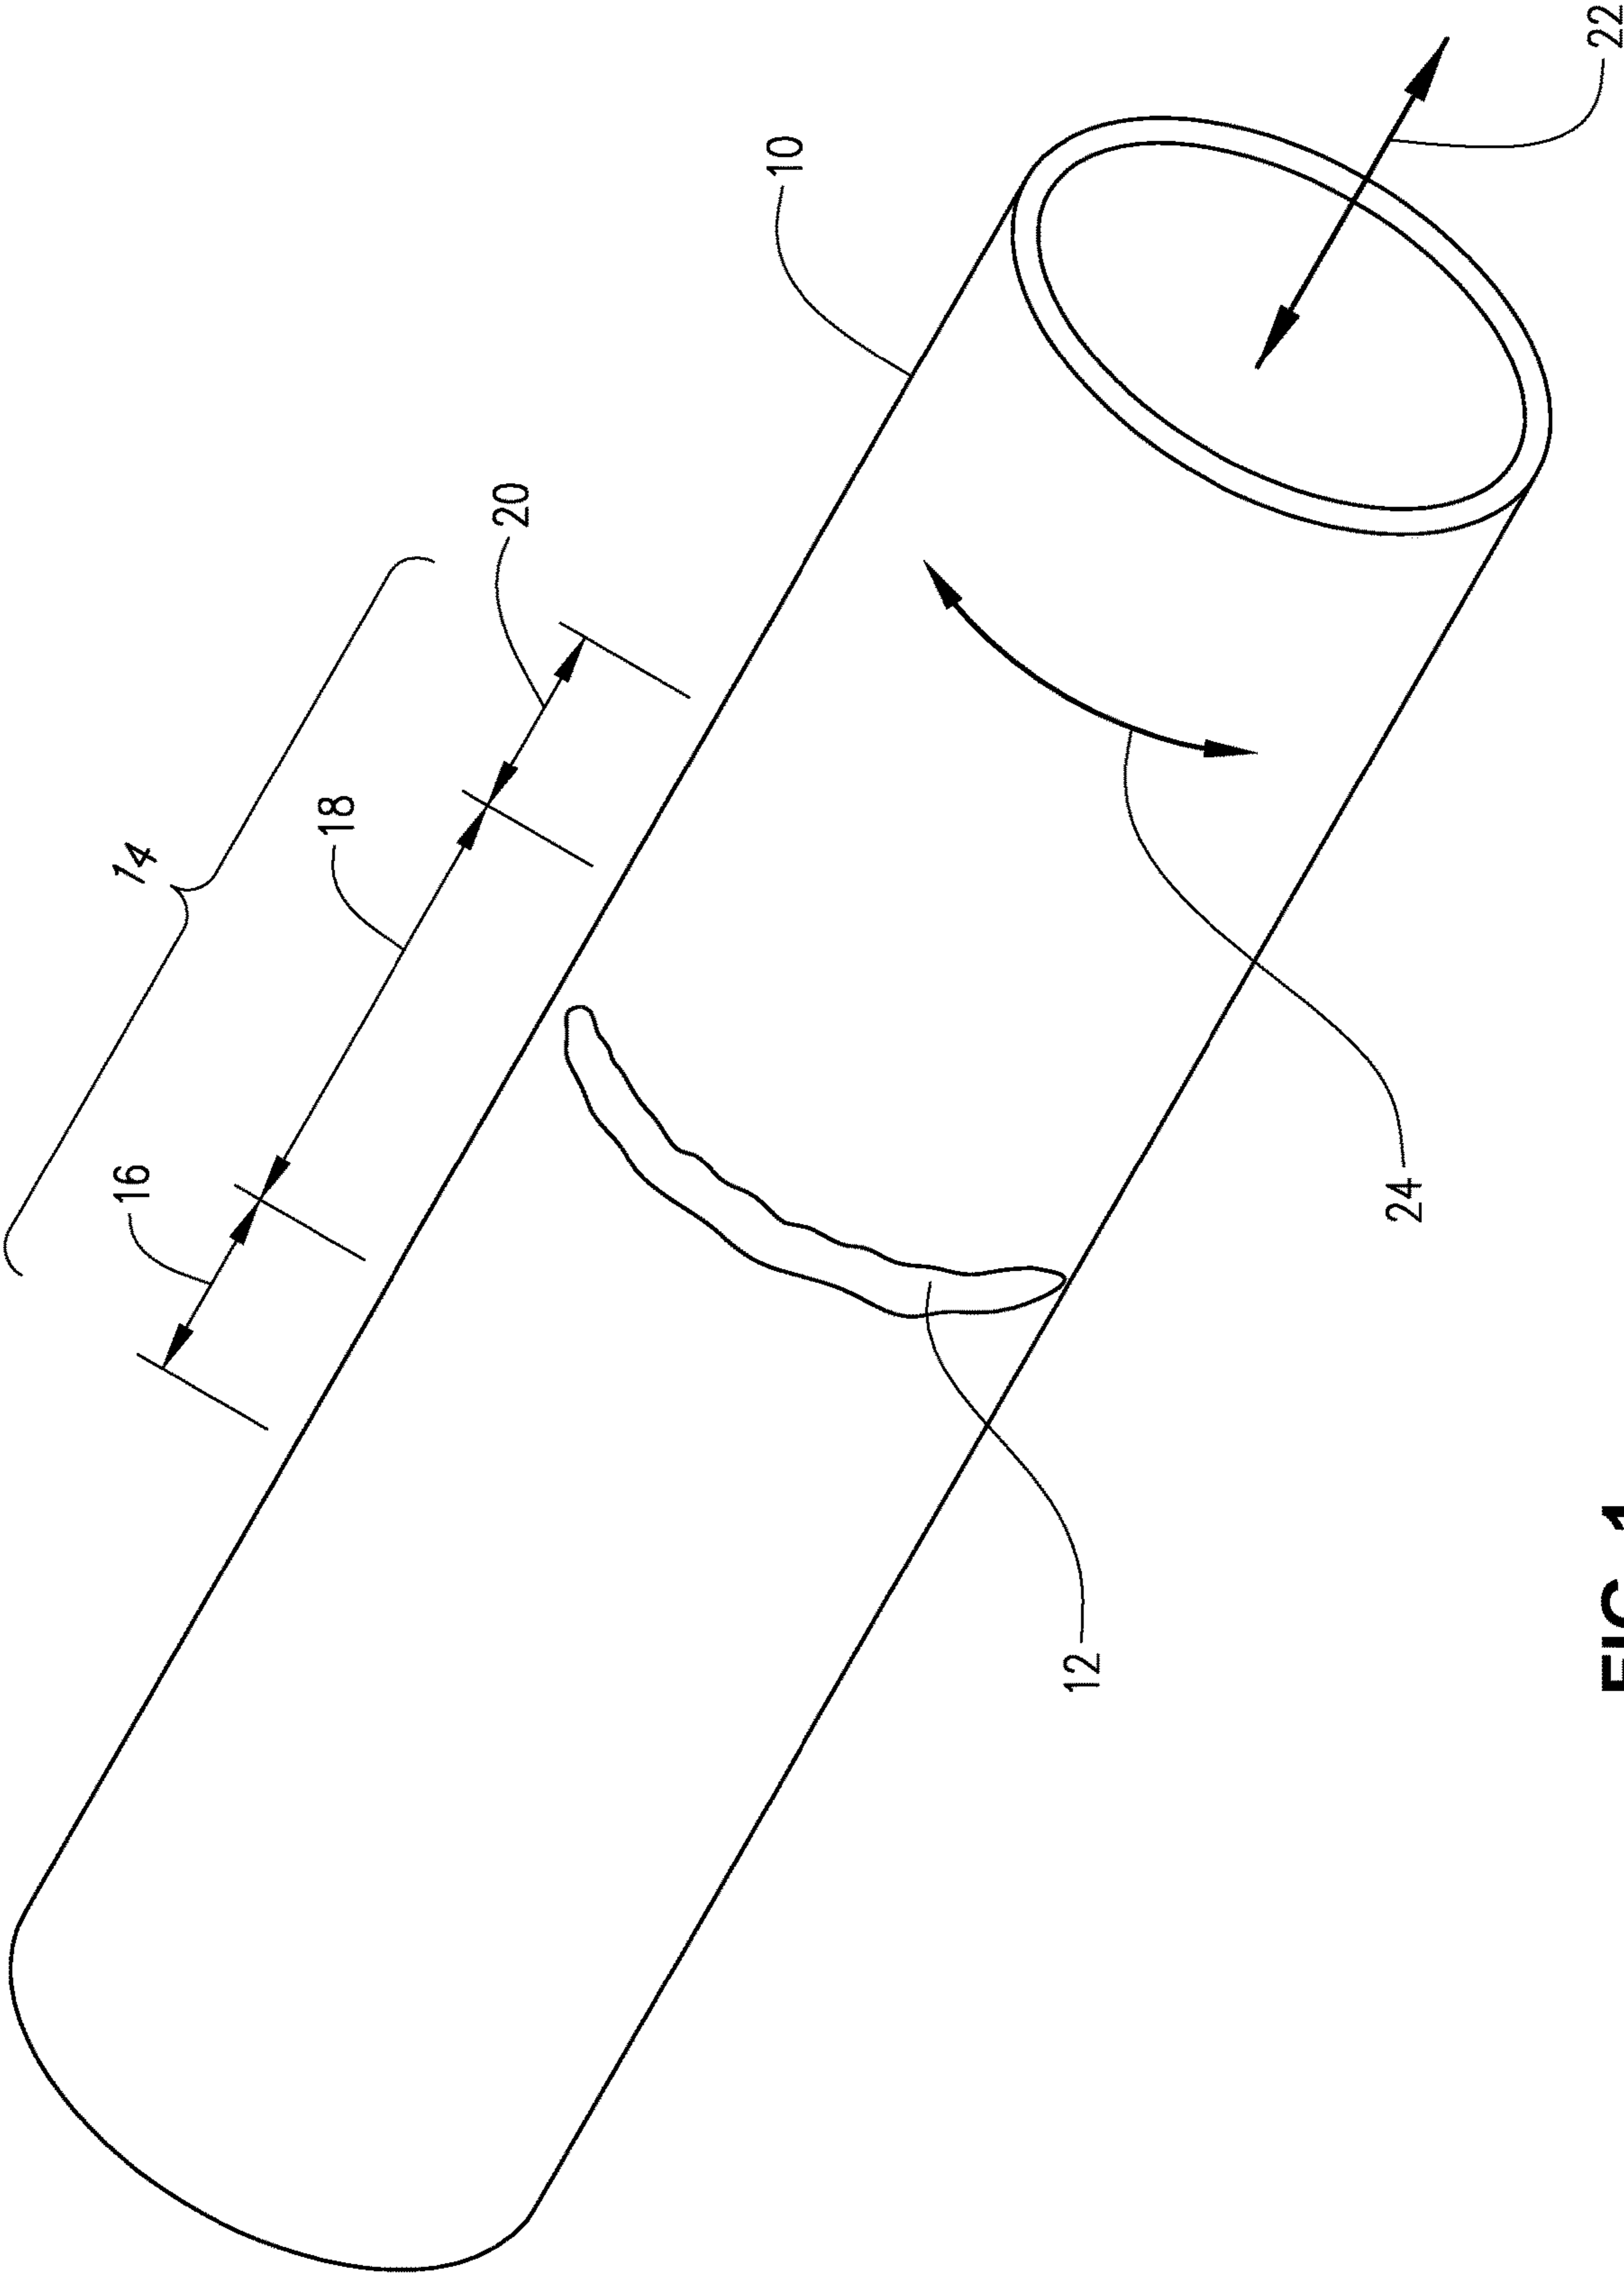
FIG. 1 is a perspective view illustrating a pipe having a circumferential defect.

Referring now to FIG. 1, a pipe 10 is illustrated. Pipe 10 is a pipe having at least one circumferential defect 12 such as a wrinkle bend. Typically, pipe 10 will be a metal pipe, such as steel, aluminum, etc. More typically, pipe 10 is a steel pipe. Circumferential defect 12 such as a wrinkle bend is the type that is introduced in a pipe during construction during alignment of the pipe by bending. Circumferential defect 12 runs circumferentially along pipe 10. A repair area 14 is defined around circumferential defect 12. The repair area has a left section 16, a center section 18 and a right section 20. Center section 18 is between left section 16 and right section 20, and center section 18 contains circumferential defect 12. Pipe 10 has an axial direction (or longitudinal direction) 22 and a circumferential direction 24. As previously indicated, circumferential defect 12 is oriented in the circumferential direction.

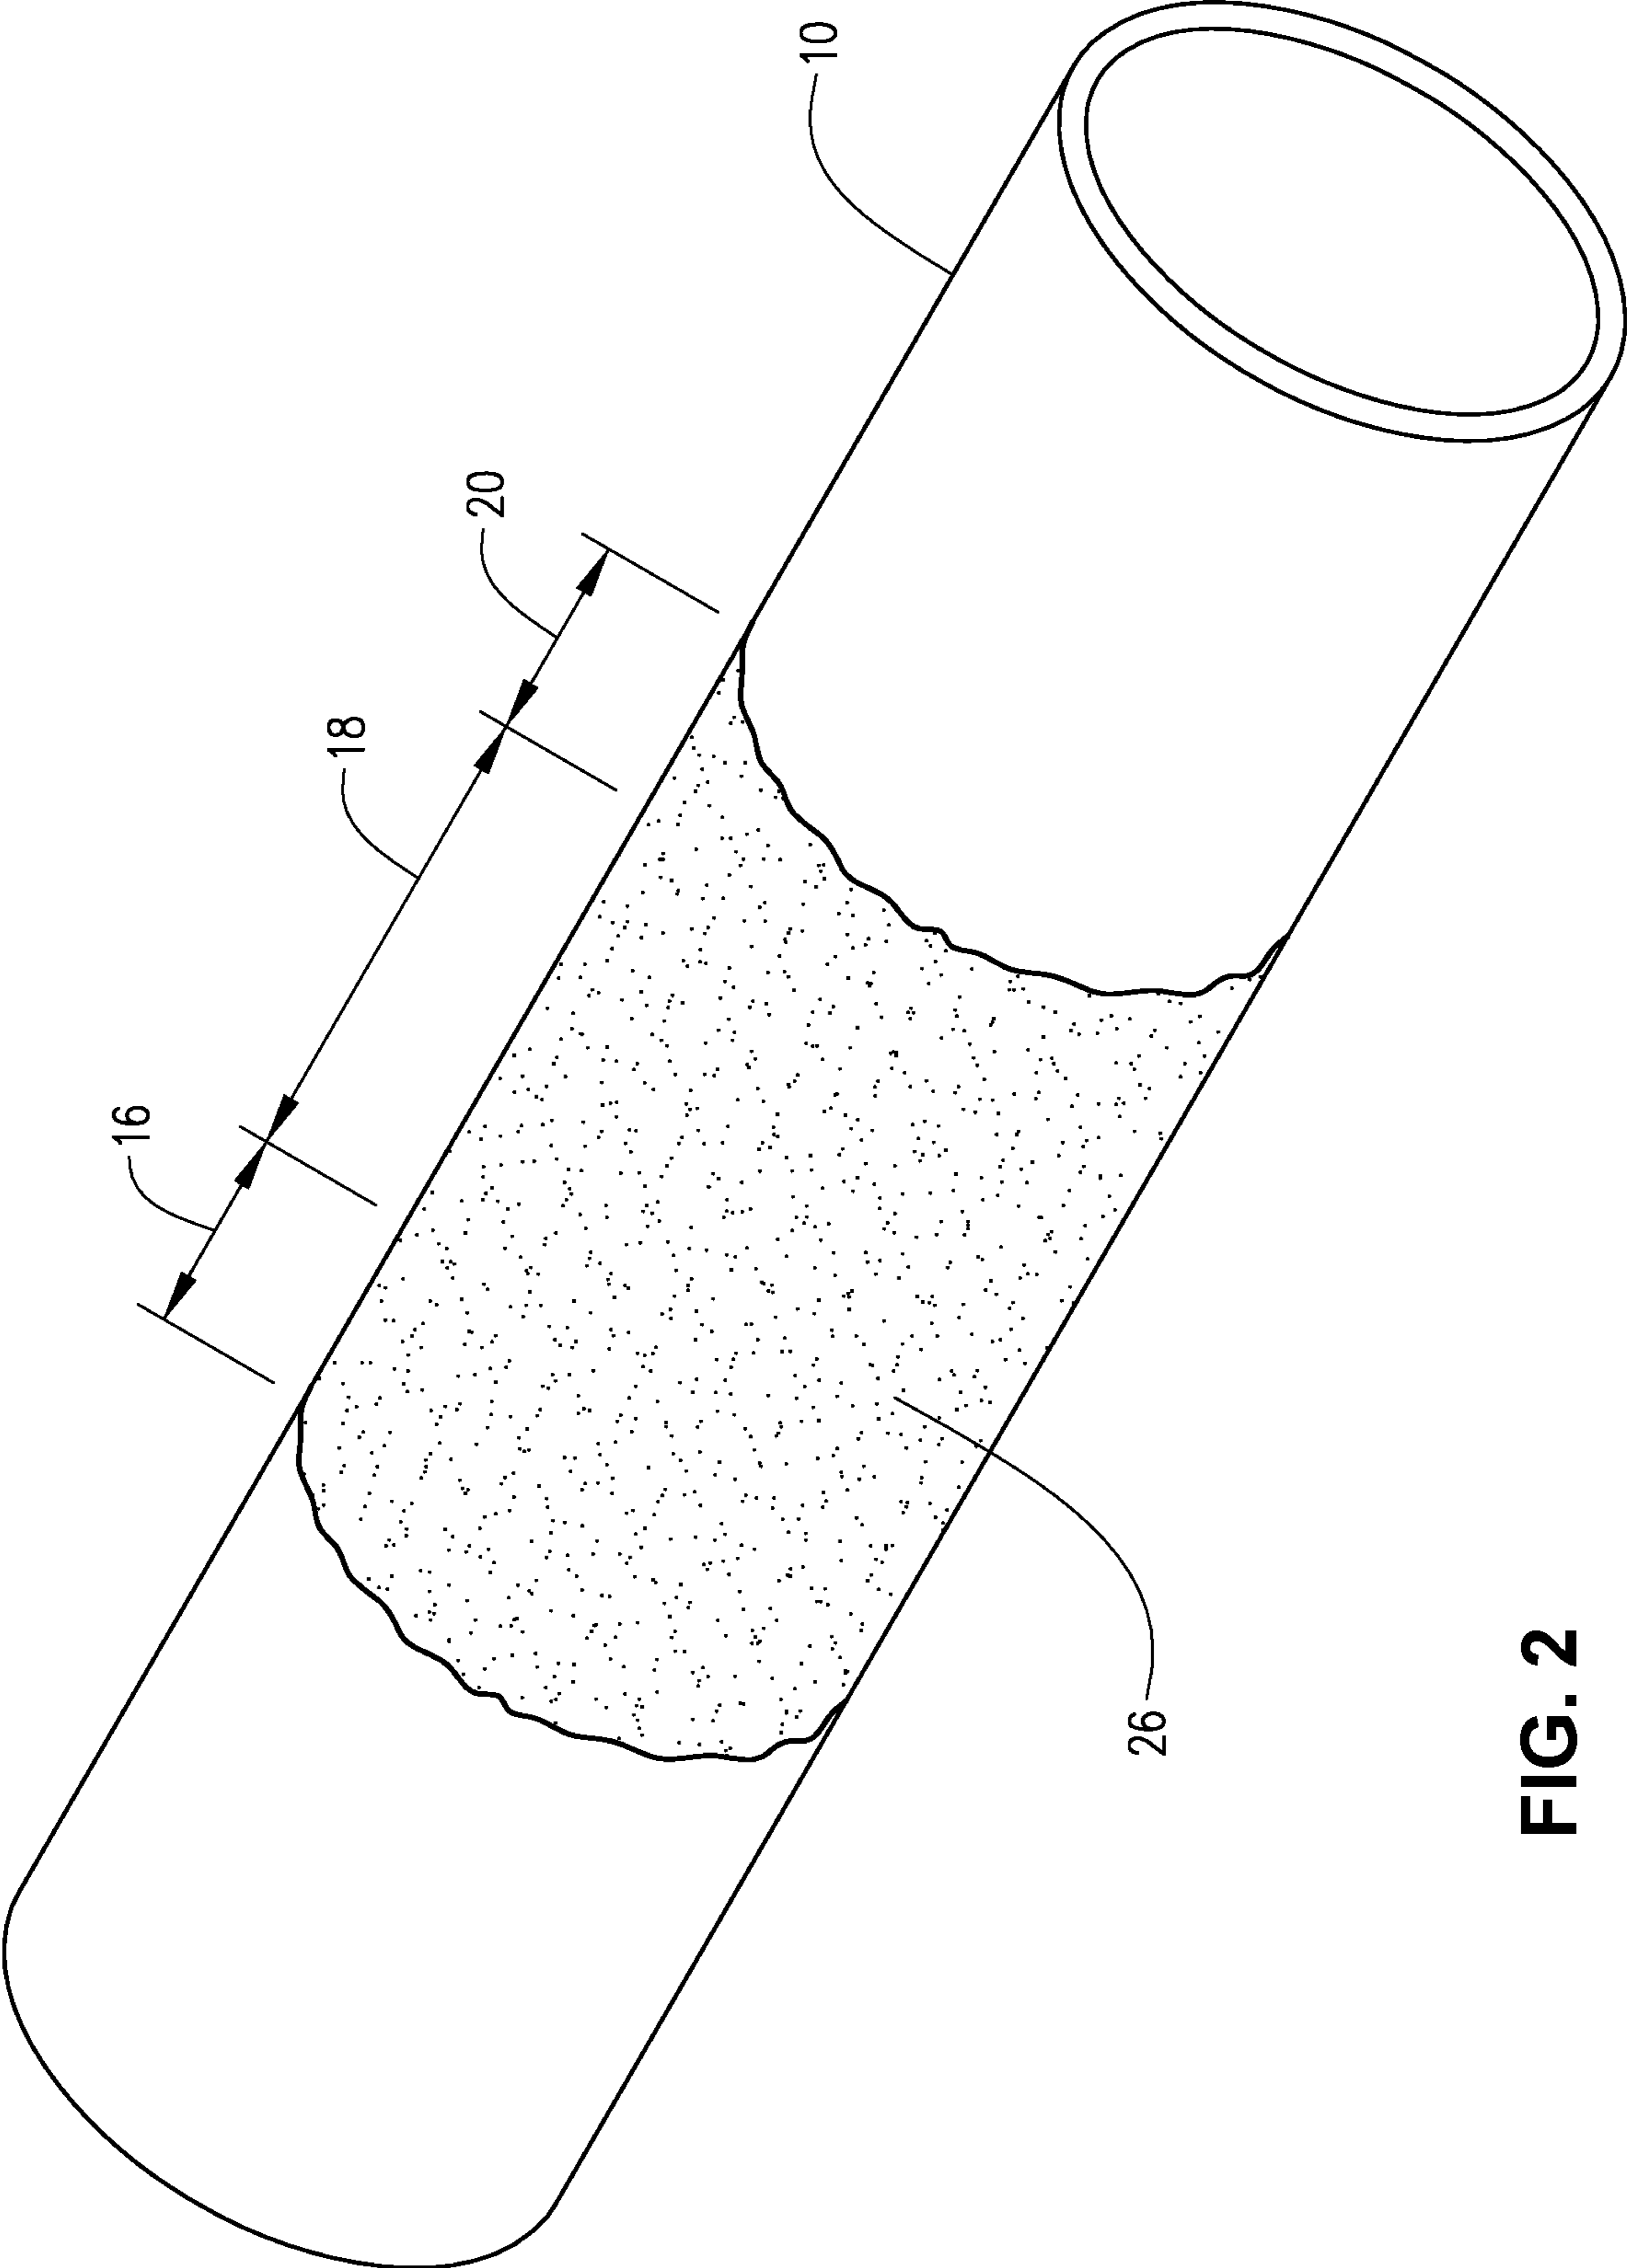
FIG. 2 is a perspective view of the pipe of FIG. 1 with a resin coating on the repair area.

Turning now to FIG. 2, the first layer to be deposited on pipe 10 typically will be a load transfer material 26 to even out the surface of the repair area and fill in any gaps or voids in the surface, such as dents, gouges and/or cracks. The load transfer material typically is tested for compressive strength and modulus, and additionally for compatibility with the composite system being applied to the pipe 10. While generic load transfer materials are often unsuitable for use in this application, the load transfer material generally can be any suitable putty such as epoxy putties designed for making fast and curable repairs to metals, or ceramic load transfer fillers. Load transfer material 26 is applied to center section 18, in the location of the wrinkle bend, and in localized areas within repair section 14 where any other defects may exist.

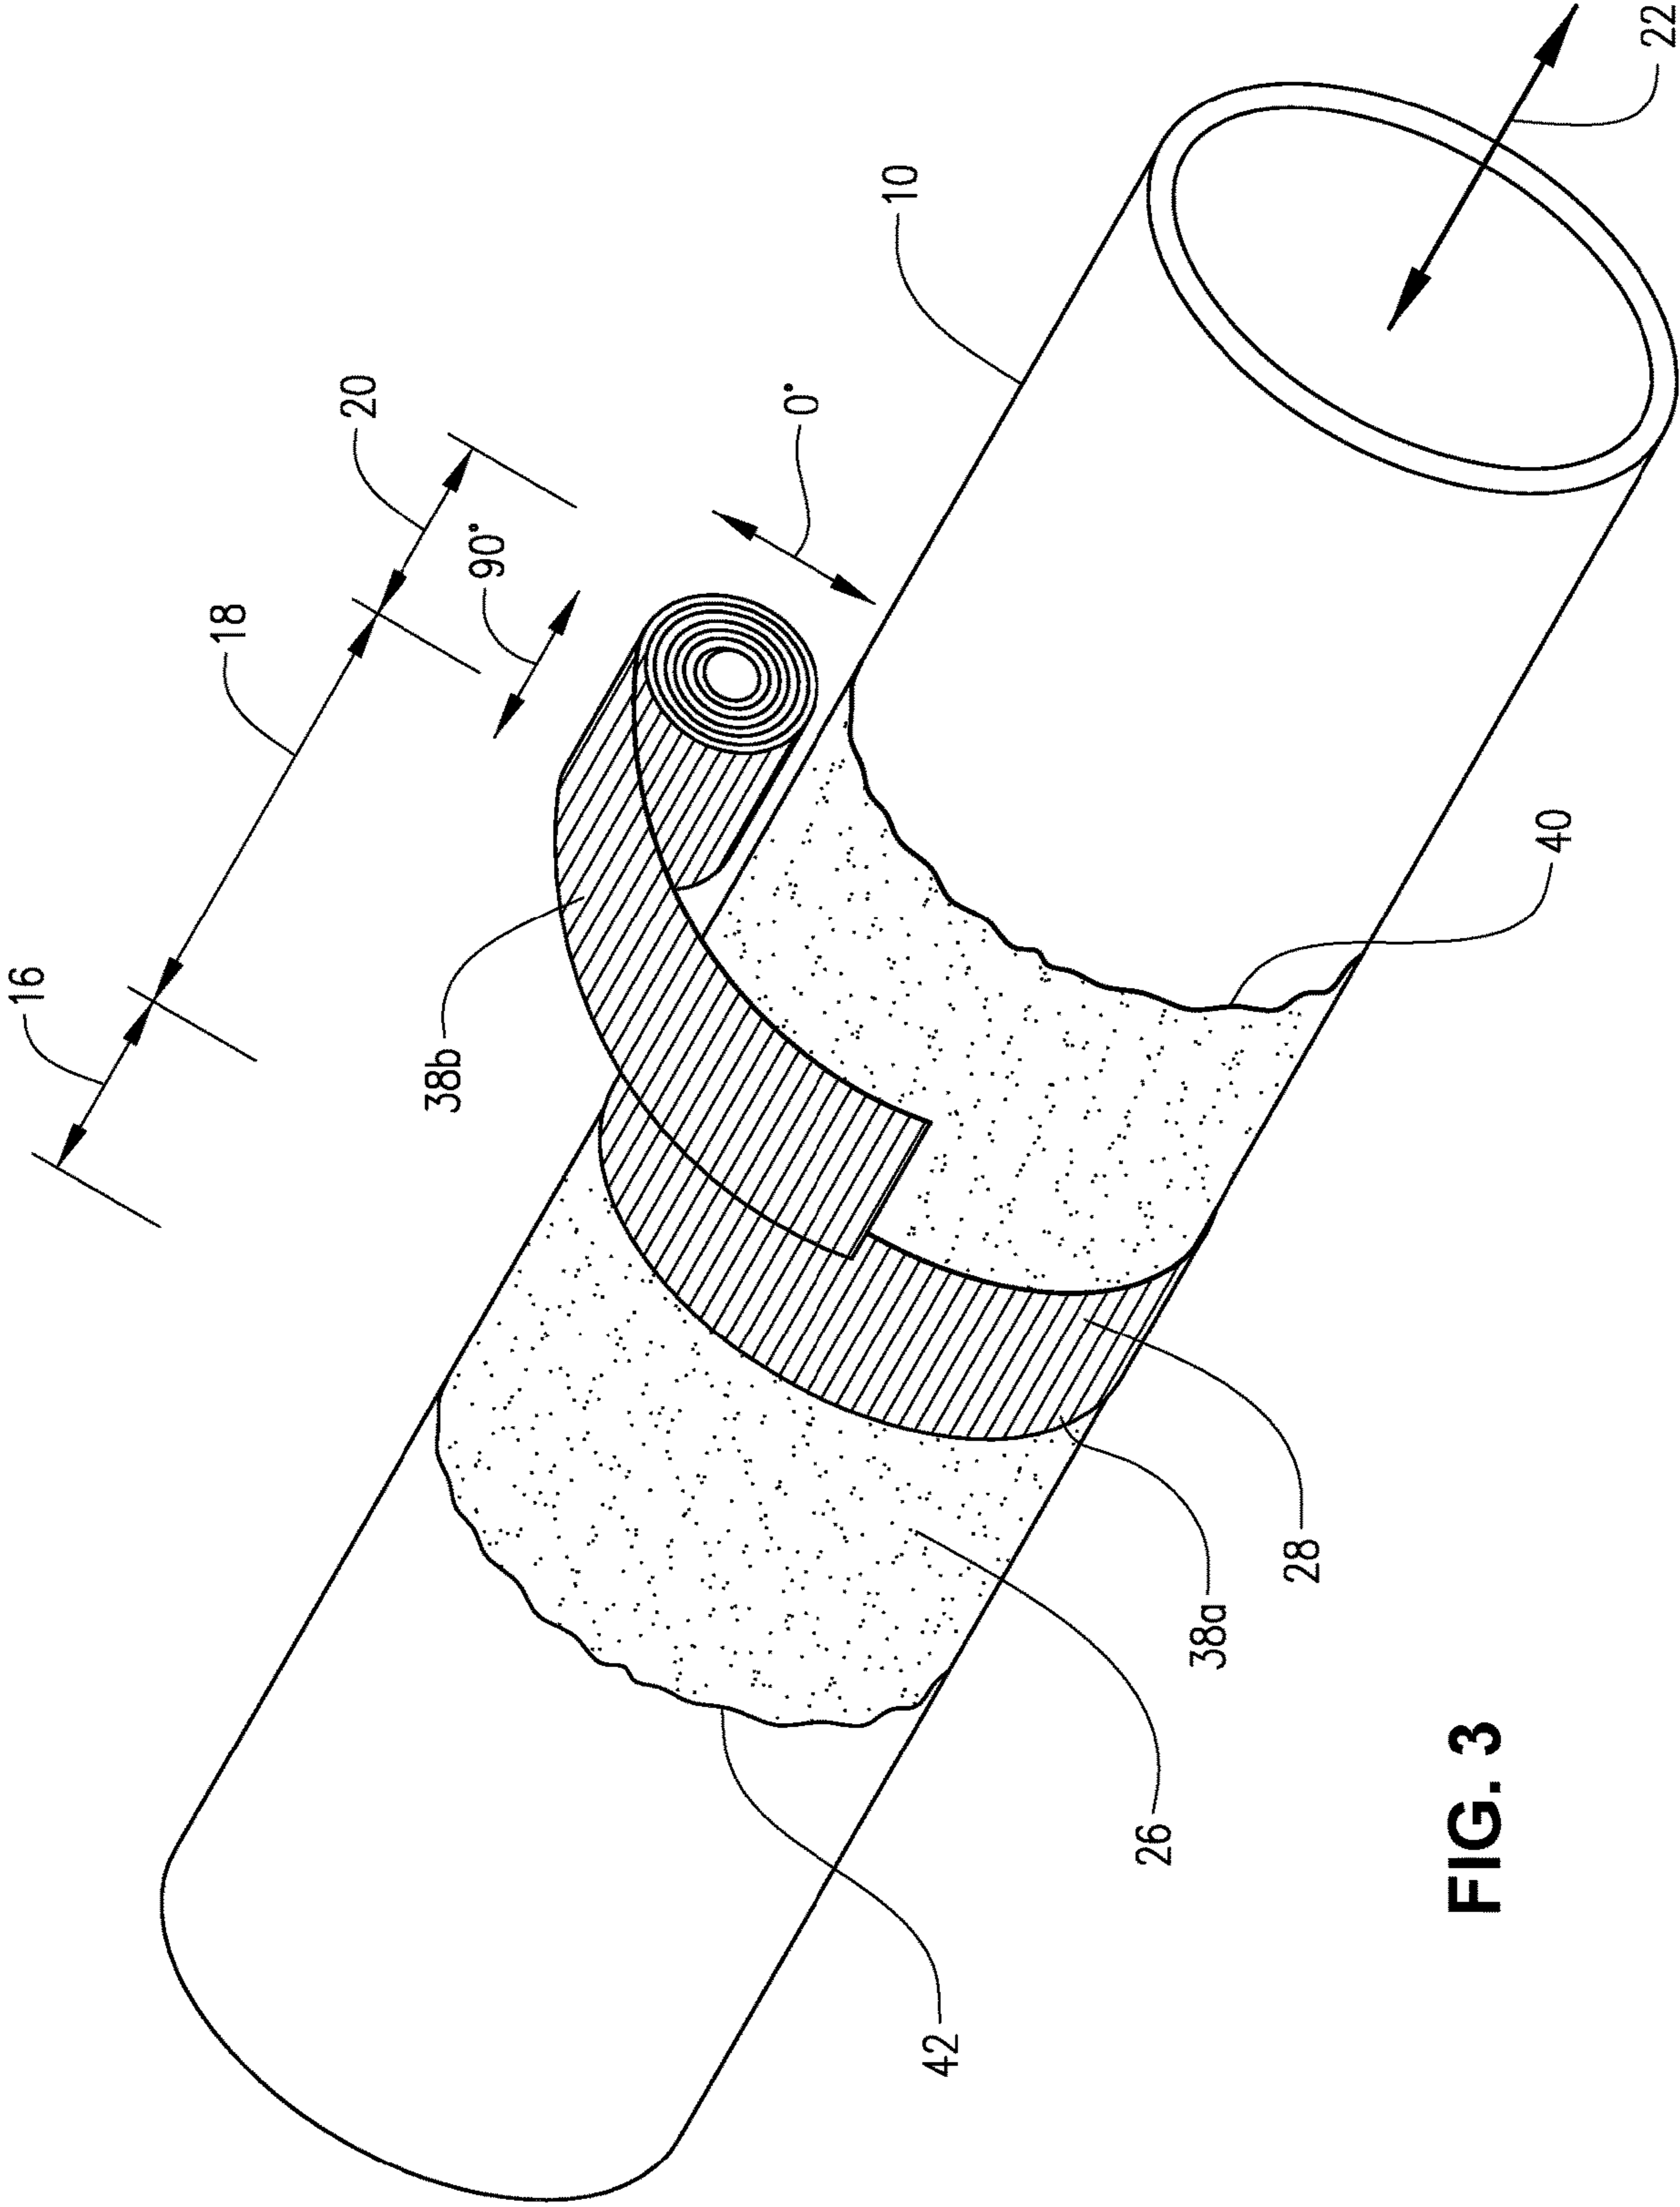
FIG. 3 is a perspective view of the pipe of FIG. 2 illustrating the application of a unidirectional fabric to the repair area.

As illustrated in FIGS. 3 and 4, a unidirectional fabric **28** is placed on top of load transfer material **26** and resin, if applied. Unidirectional fabric **28** is circumferentially wrapped around repair area **14** of the pipe so as to result in multiple layers of the unidirectional fabric around repair area **14**.

As illustrated in FIG. 3, the unidirectional fabric is wrapped around pipe **10** such that the 90° direction of the fabric runs parallel to axial direction **22** of pipe **10**. Accordingly, when the unidirectional fabric is applied to pipe **10**, the high-performance fibers run in the axial direction.

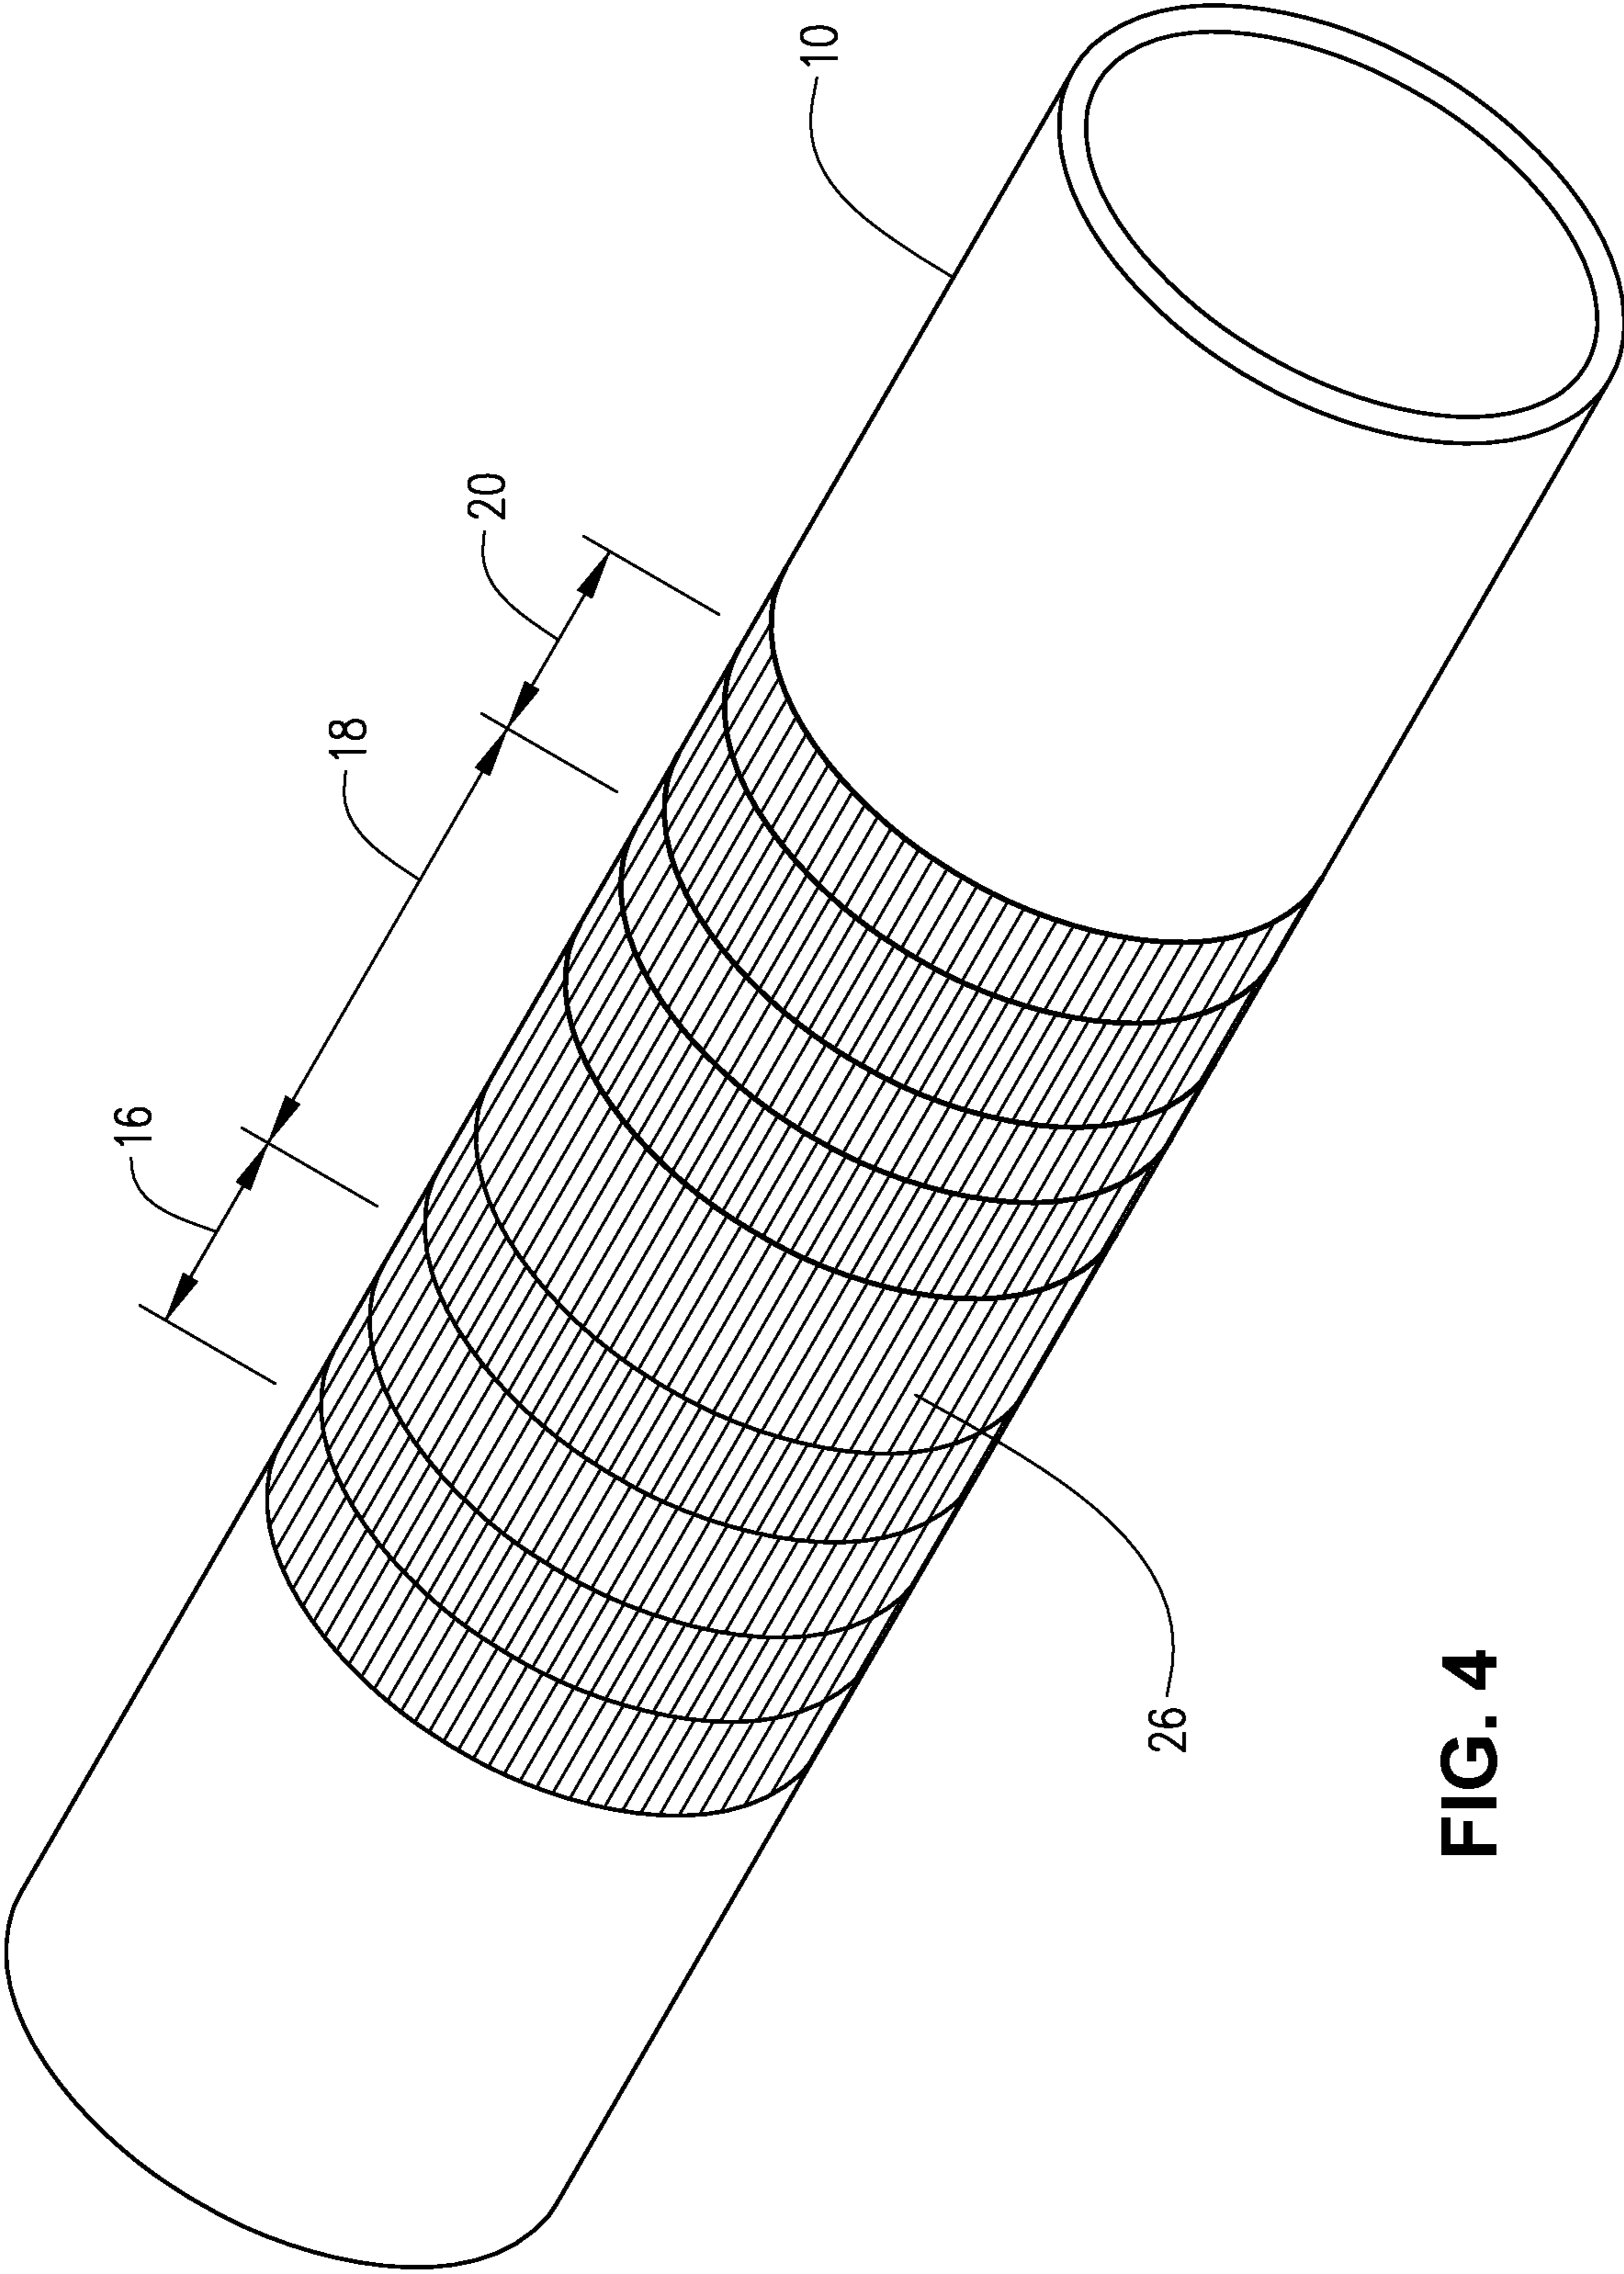
FIG. 4 is a perspective view of the pipe of FIG. 3 illustrating the completed application of the unidirectional fabric.

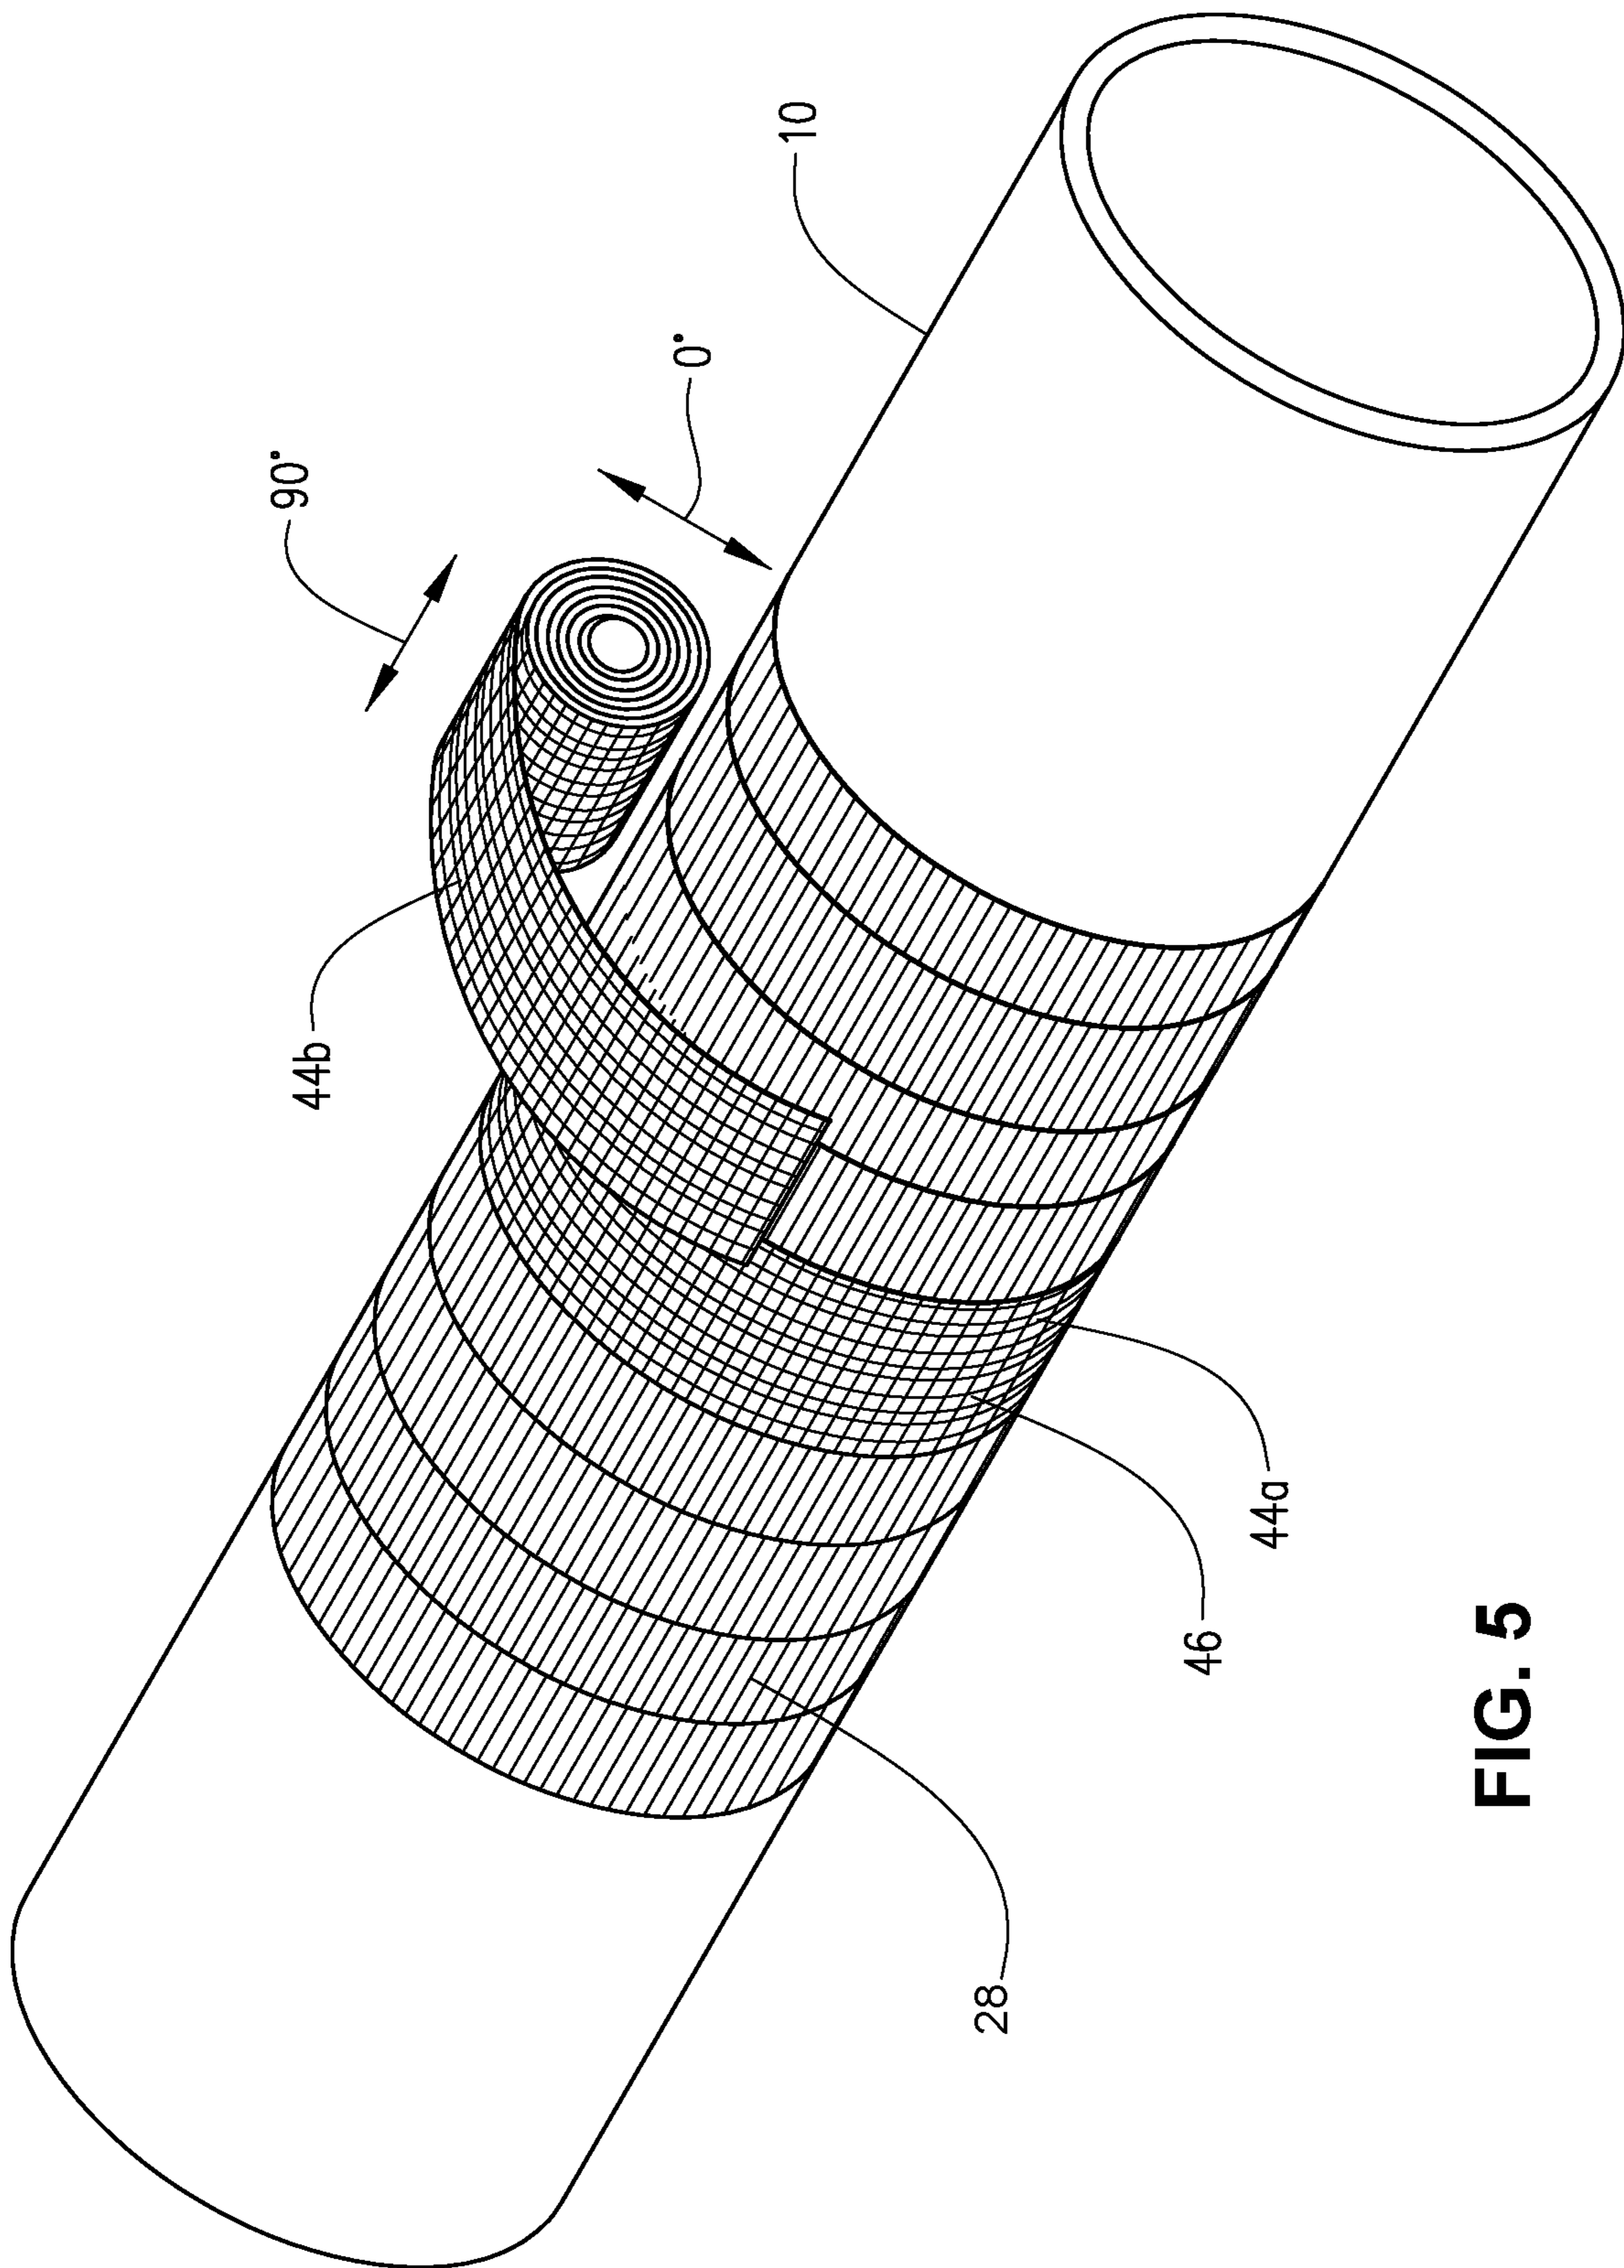
FIG. 5 is a perspective view of the pipe of FIG. 4 illustrating the application of a bidirectional fabric to the repair area.

In accordance with this disclosure, there is provided a reinforced pipe wherein the pipe 10 has circumferential defect 12, and repair area 14 around the circumferential defect 12 has been reinforced by several distinct layers. The reinforced pipe is described below in relation to FIGS. 2 to 6, which illustrate the distinct layers.
