(12) **United States Patent**  
**Walker et al.**

(54) **FIBER COMPOSITE SYSTEM AND METHOD FOR PIPE REINFORCEMENT**

A reinforced pipe and a method of preparing the reinforced pipe are provided. The reinforced pipe has repair area where a circumferential defect is present in a center section of the repair area. The reinforced pipe comprises a unidirectional fabric circumferentially wrapped around the repair area of the pipe so as to result in multiple layers of the unidirectional fabric around the repair area. The unidirectional fabric is composed of high-performance fibers with at least 90% of the high-performance fibers oriented in the 90° direction, and the unidirectional fabric is wrapped such that the high-performance fibers run in the axial direction. The reinforced pipe further comprises a bidirectional fabric wrapped over the unidirectional fabric such the at least one layer of bidirectional fabric is wrapped over the unidirectional fabric.

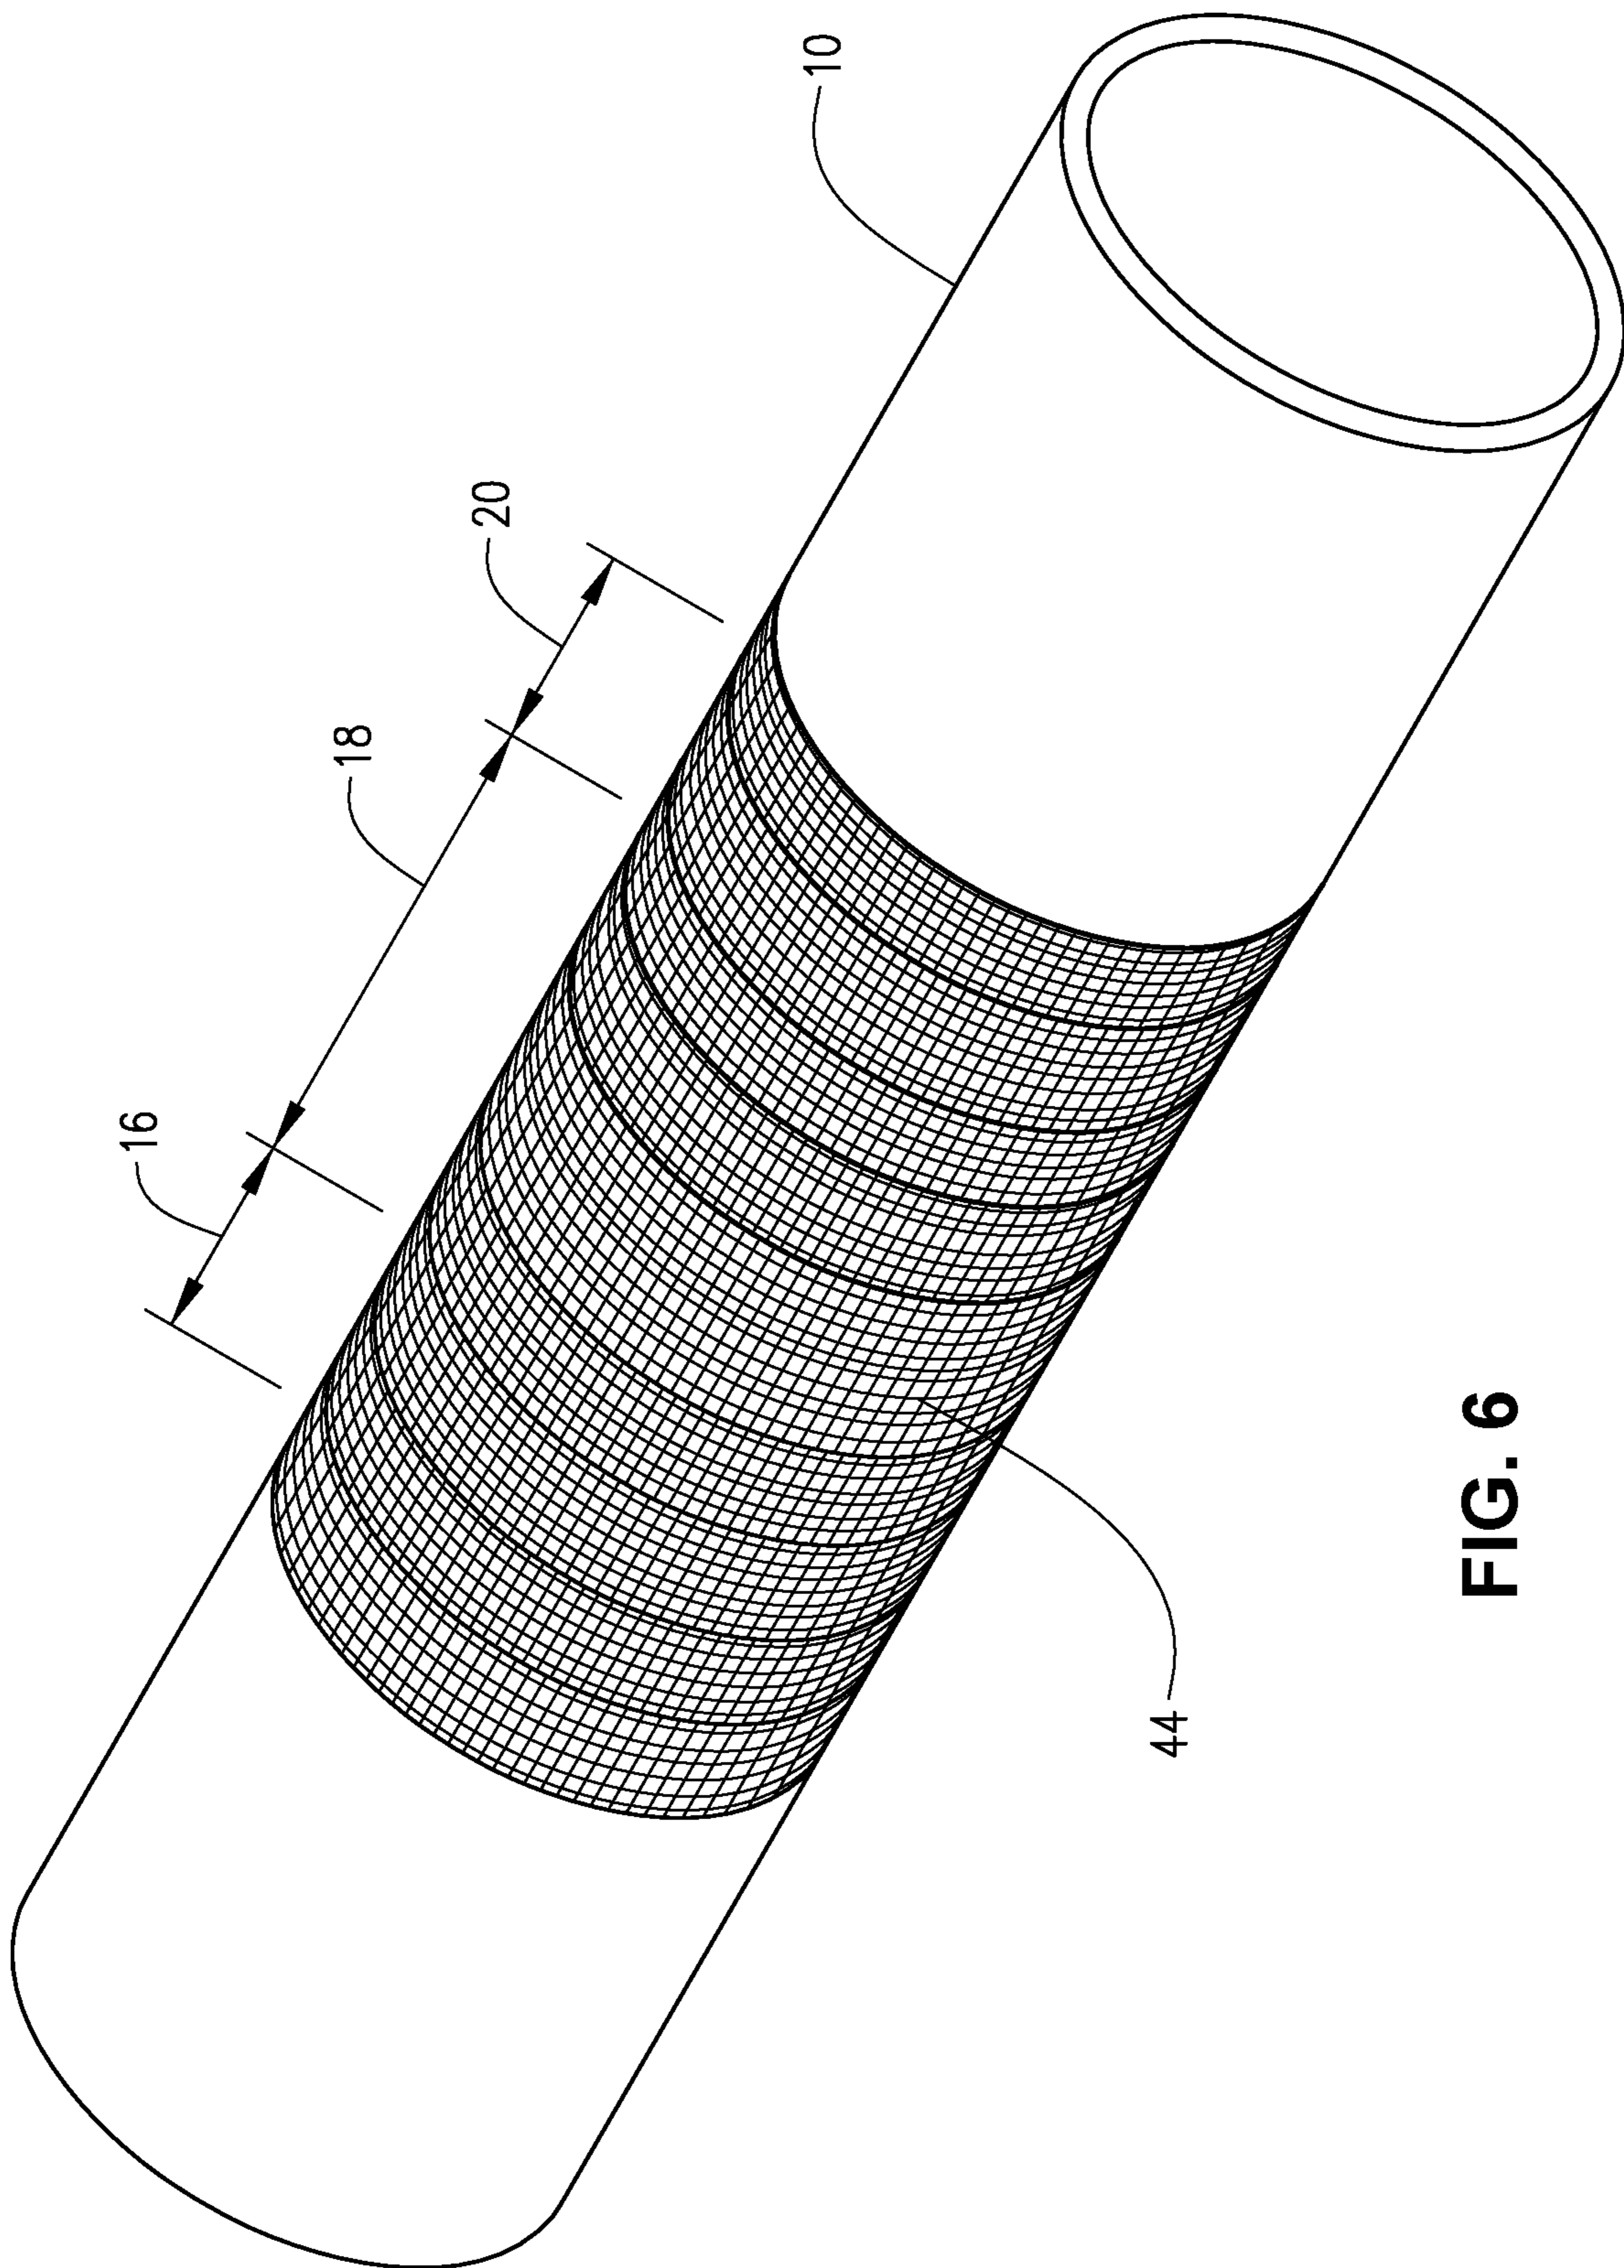
FIG. 6 is a perspective view of the pipe of FIG. 5 illustrating the completed application of the bidirectional fabric.

In accordance with this disclosure, there is provided a reinforced pipe wherein the pipe 10 has circumferential defect 12, and repair area 14 around the circumferential defect 12 has been reinforced by several distinct layers. The reinforced pipe is described below in relation to FIGS. 2 to 6, which illustrate the distinct layers.

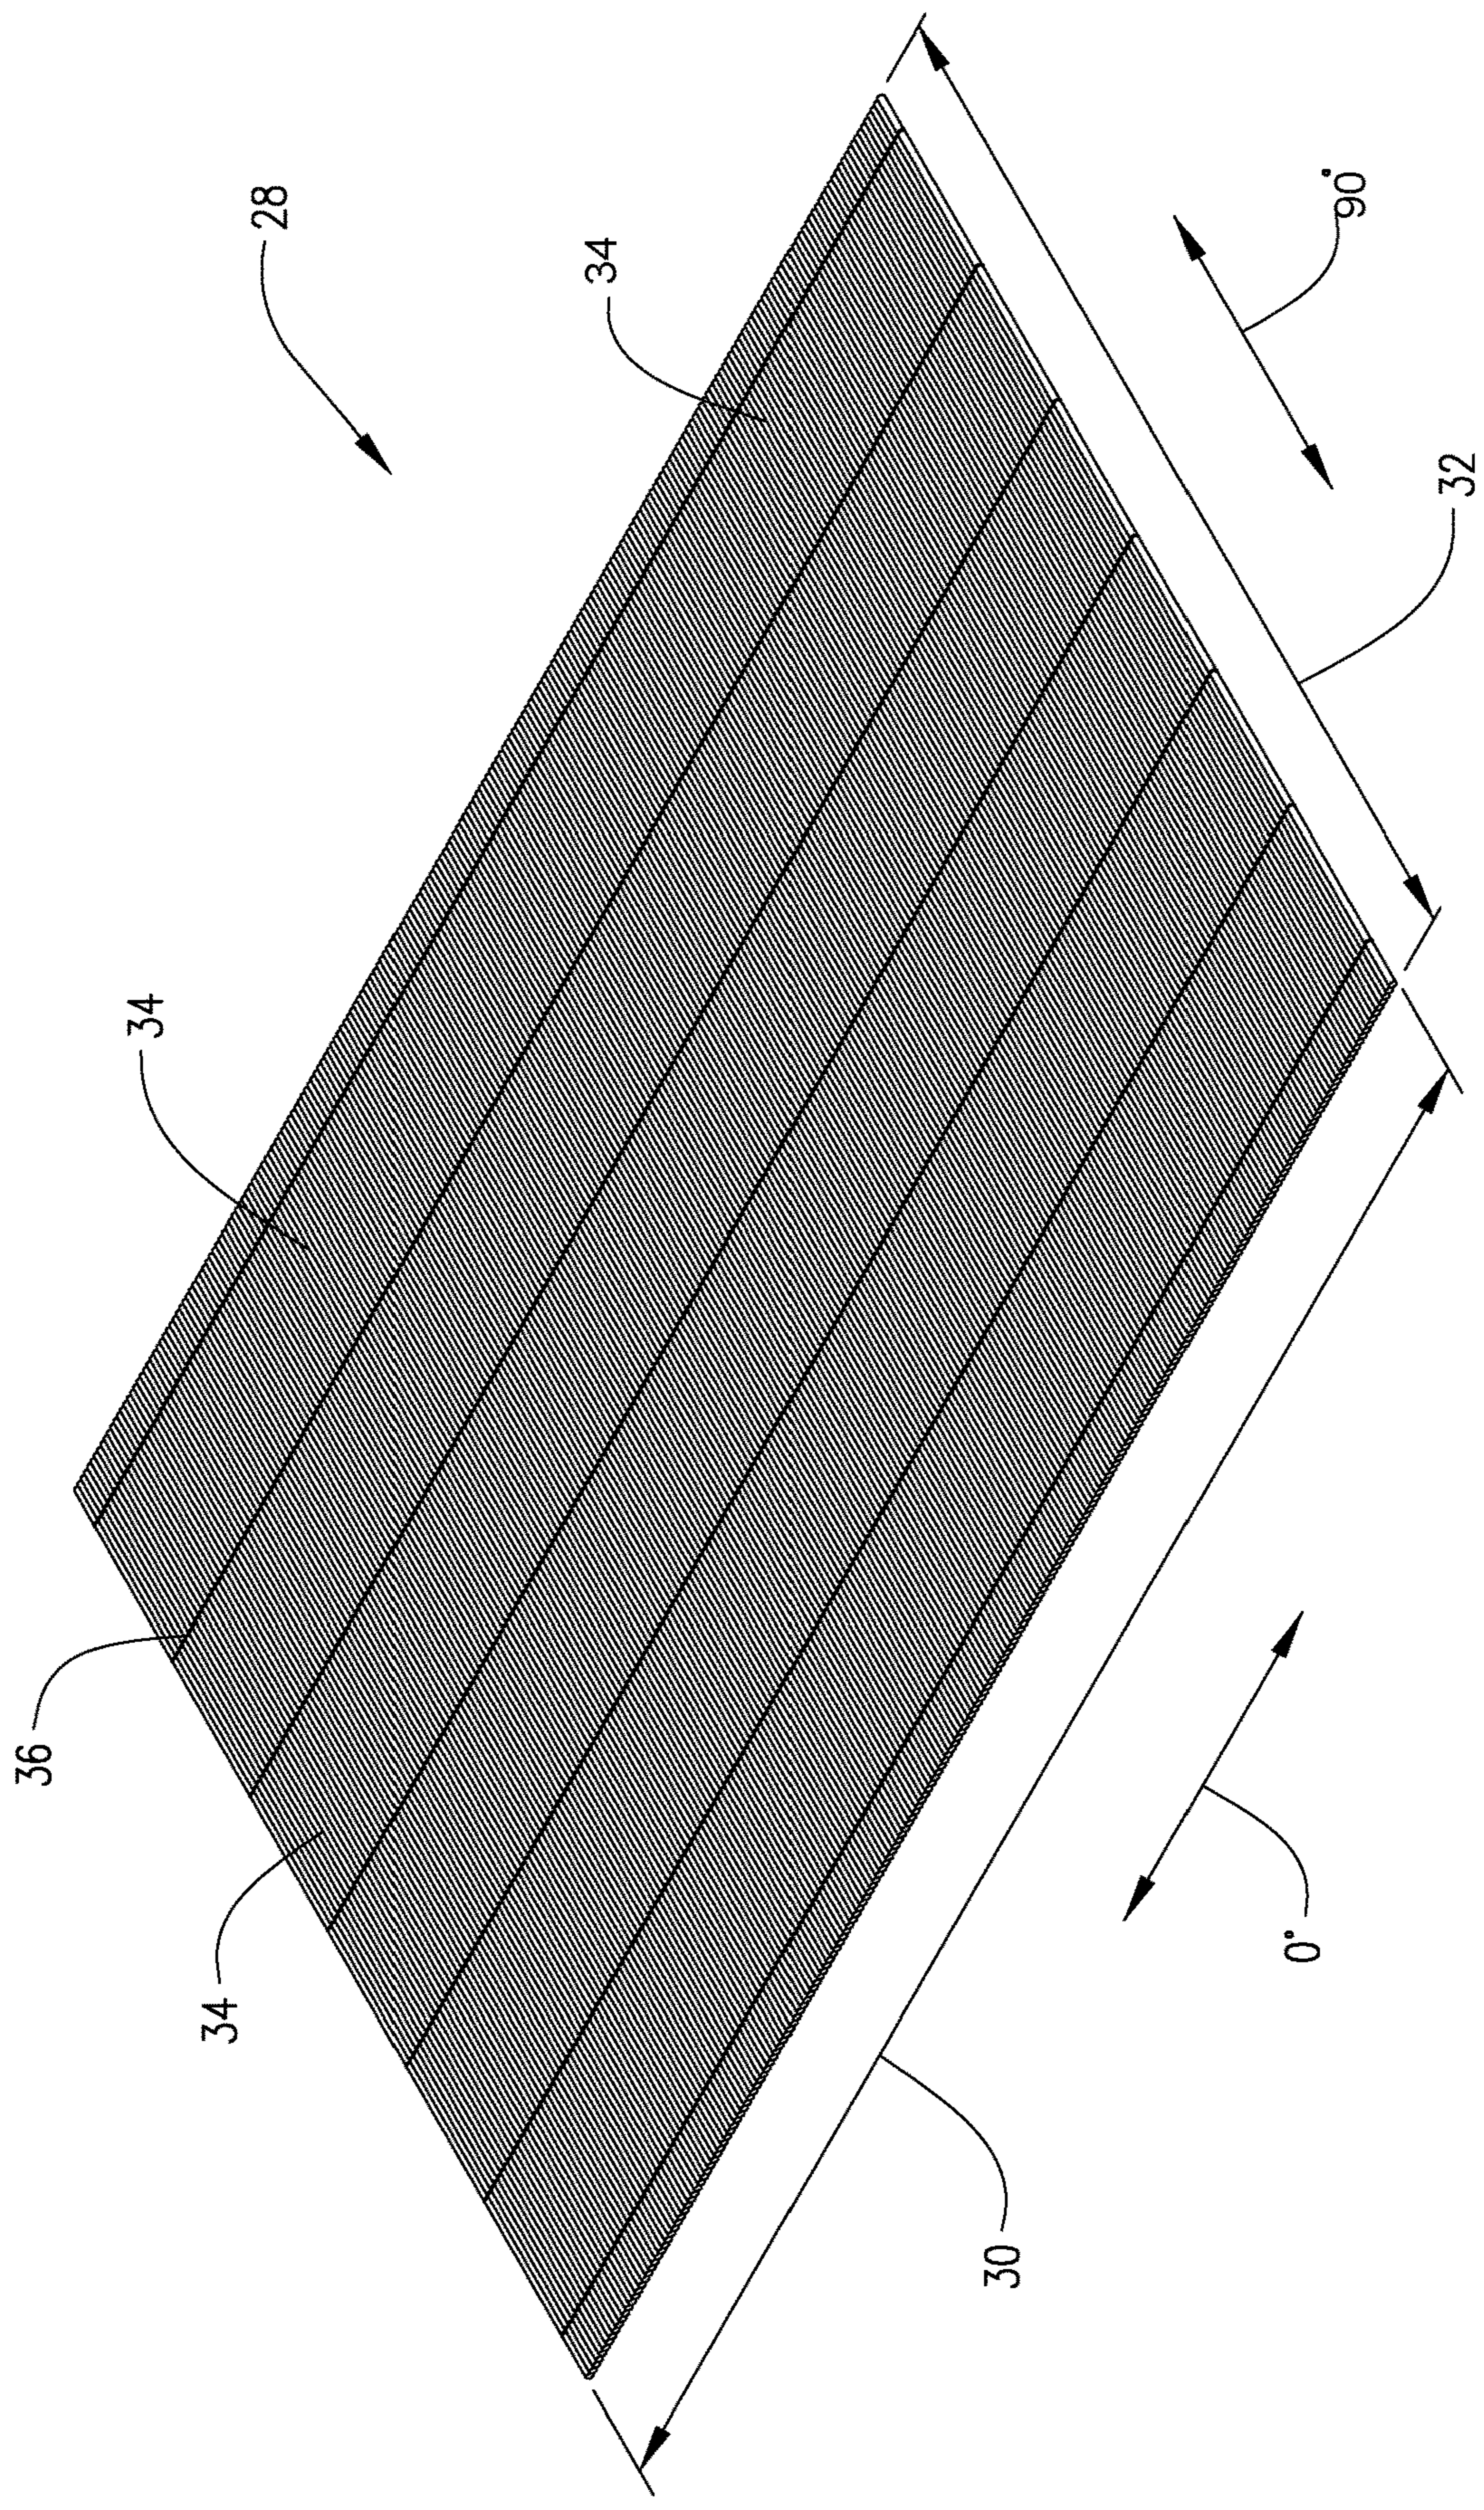
FIG. 7 is an illustration of a unidirectional fabric for use in the reinforcement of a pipe in accordance with this disclosure.

Referring to FIG. 7, unidirectional fabric **28** has a length **30** and width **32**, with length **30** typically being greater than width **32**. Often, width **32** will be less than the pipe circumference, and length **30** will be greater than the pipe circumference and even greater than two pipe circumferences. The length corresponds to the 0° direction for the fabric and the width corresponds to the 90° direction of the fabric. Unidirectional fabric **28** will have substantially all of its high-performance fibers **34** oriented in the 90° direction. Generally, this will mean that at least 90% of high-performance fibers **34** are oriented in the 90° direction. Typically, at least 95% or at least 98% of high-performance fibers **34** are oriented in the 90° direction. More typically, at least 99%, at least 99.5%, at least 99.9% or 100% of high-performance fibers **34** are oriented in the 90° direction.

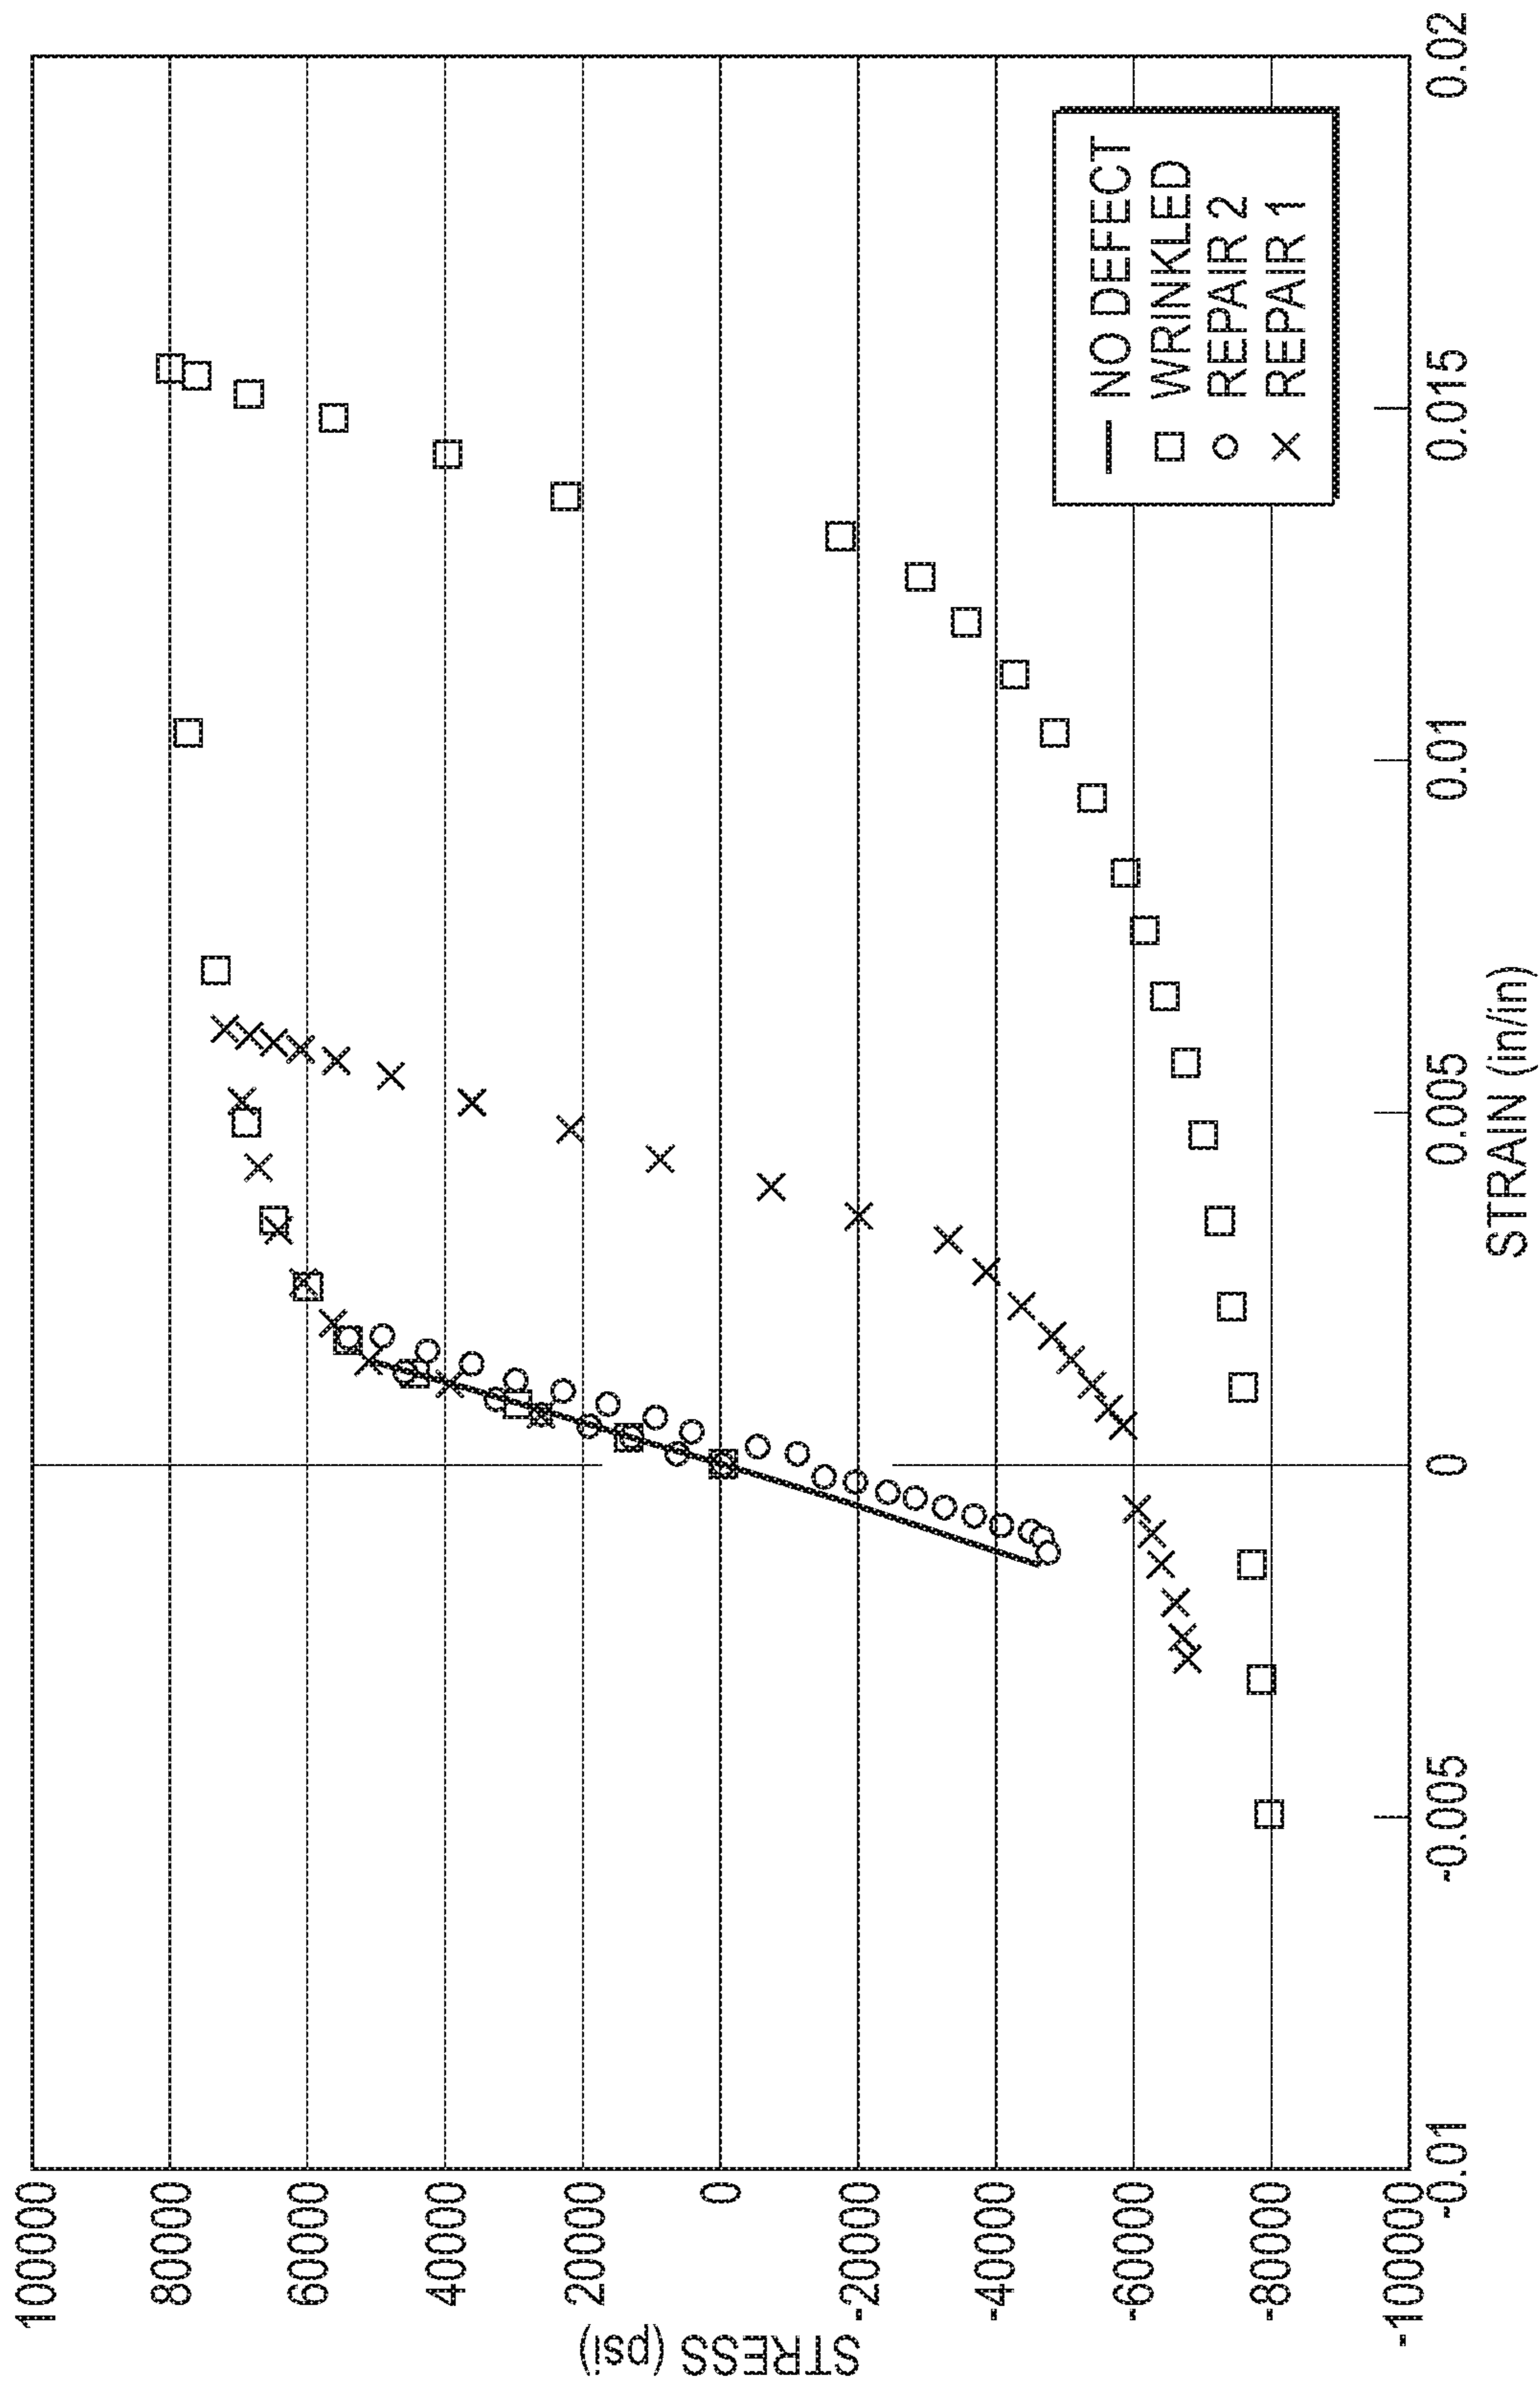
FIG. 8 is a graph of stress v. strain that illustrates the stress and strain ranges for a typical bending cycle for Control I, Control II, Control III and Example I.
