(54) **FIBER COMPOSITE SYSTEM AND METHOD FOR PIPE REINFORCEMENT**

A reinforced pipe and a method of preparing the reinforced pipe are provided. The reinforced pipe has repair area where a circumferential defect is present in a center section of the repair area. The reinforced pipe comprises a unidirectional fabric circumferentially wrapped around the repair area of the pipe so as to result in multiple layers of the unidirectional fabric around the repair area. The unidirectional fabric is composed of high-performance fibers with at least 90% of the high-performance fibers oriented in the 90° direction, and the unidirectional fabric is wrapped such that the high-performance fibers run in the axial direction. The reinforced pipe further comprises a bidirectional fabric wrapped over the unidirectional fabric such the at least one layer of bidirectional fabric is wrapped over the unidirectional fabric.

FIBER COMPOSITE SYSTEM AND METHOD FOR PIPE REINFORCEMENT

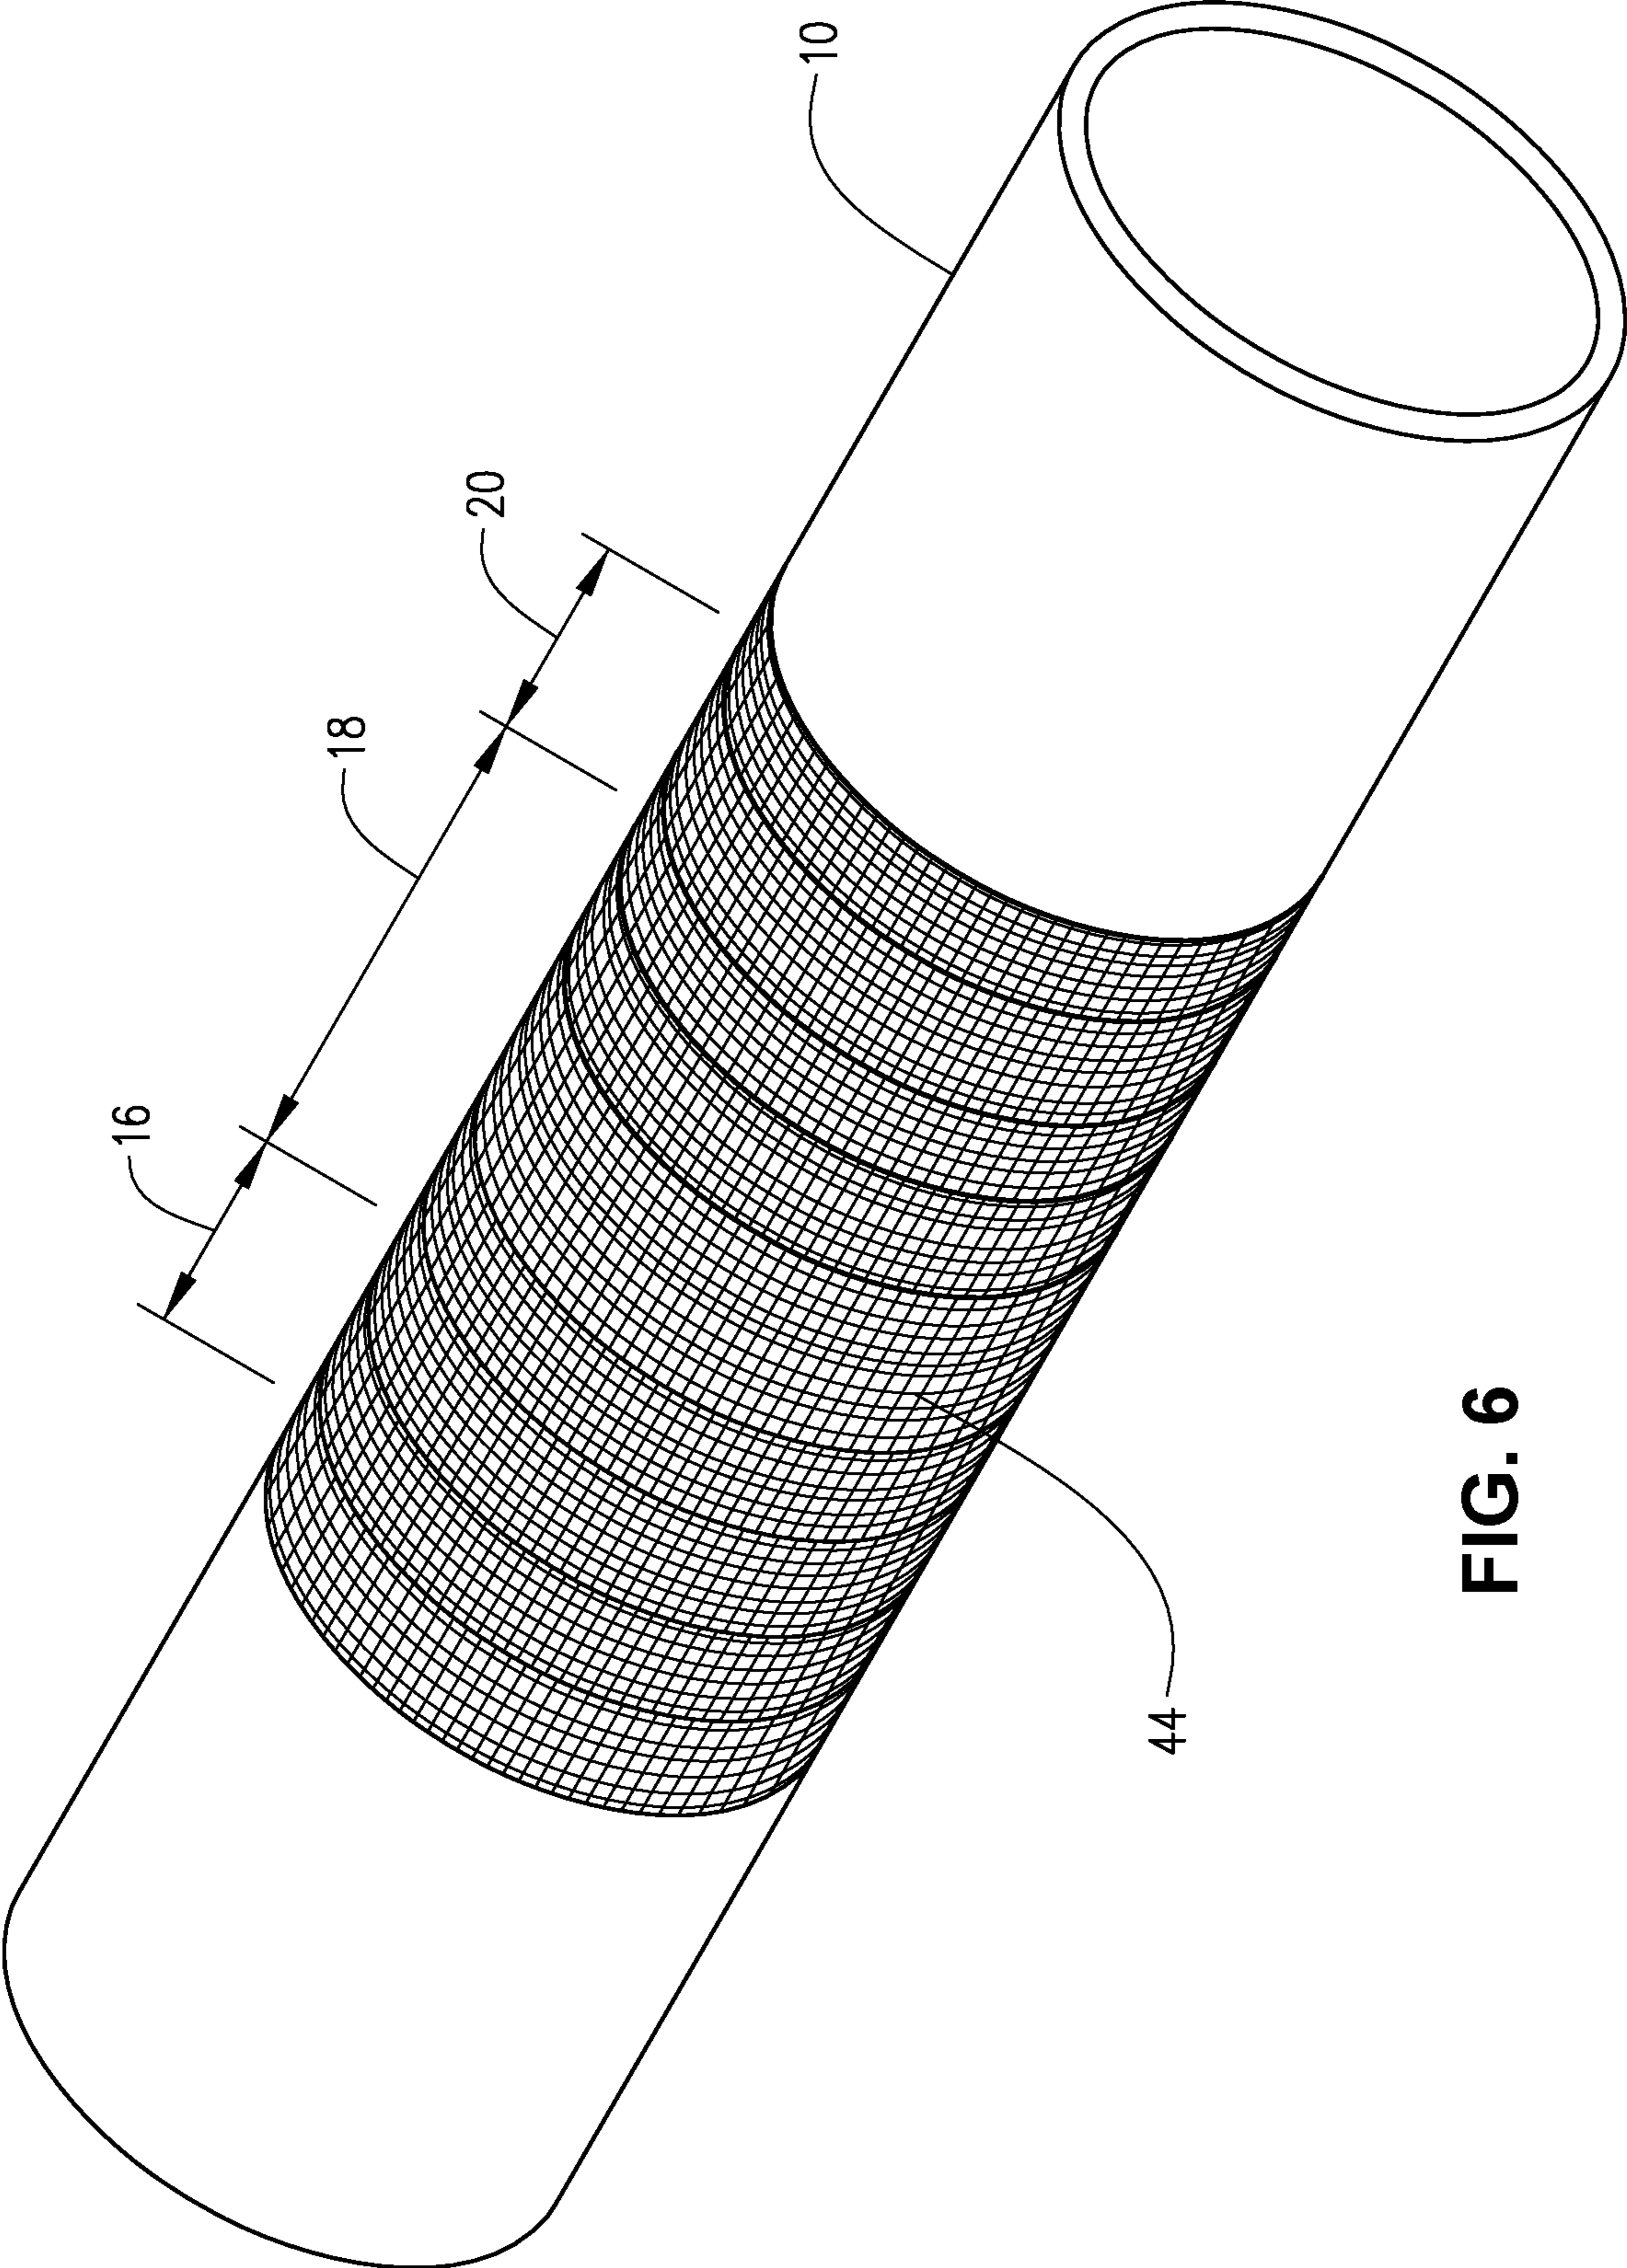
FIG. 6 is a perspective view of the pipe of FIG. 5 illustrating the completed application of the bidirectional fabric.

In accordance with this disclosure, there is provided a reinforced pipe wherein the pipe 10 has circumferential defect 12, and repair area 14 around the circumferential defect 12 has been reinforced by several distinct layers. The reinforced pipe is described below in relation to FIGS. 2 to 6, which illustrate the distinct layers.

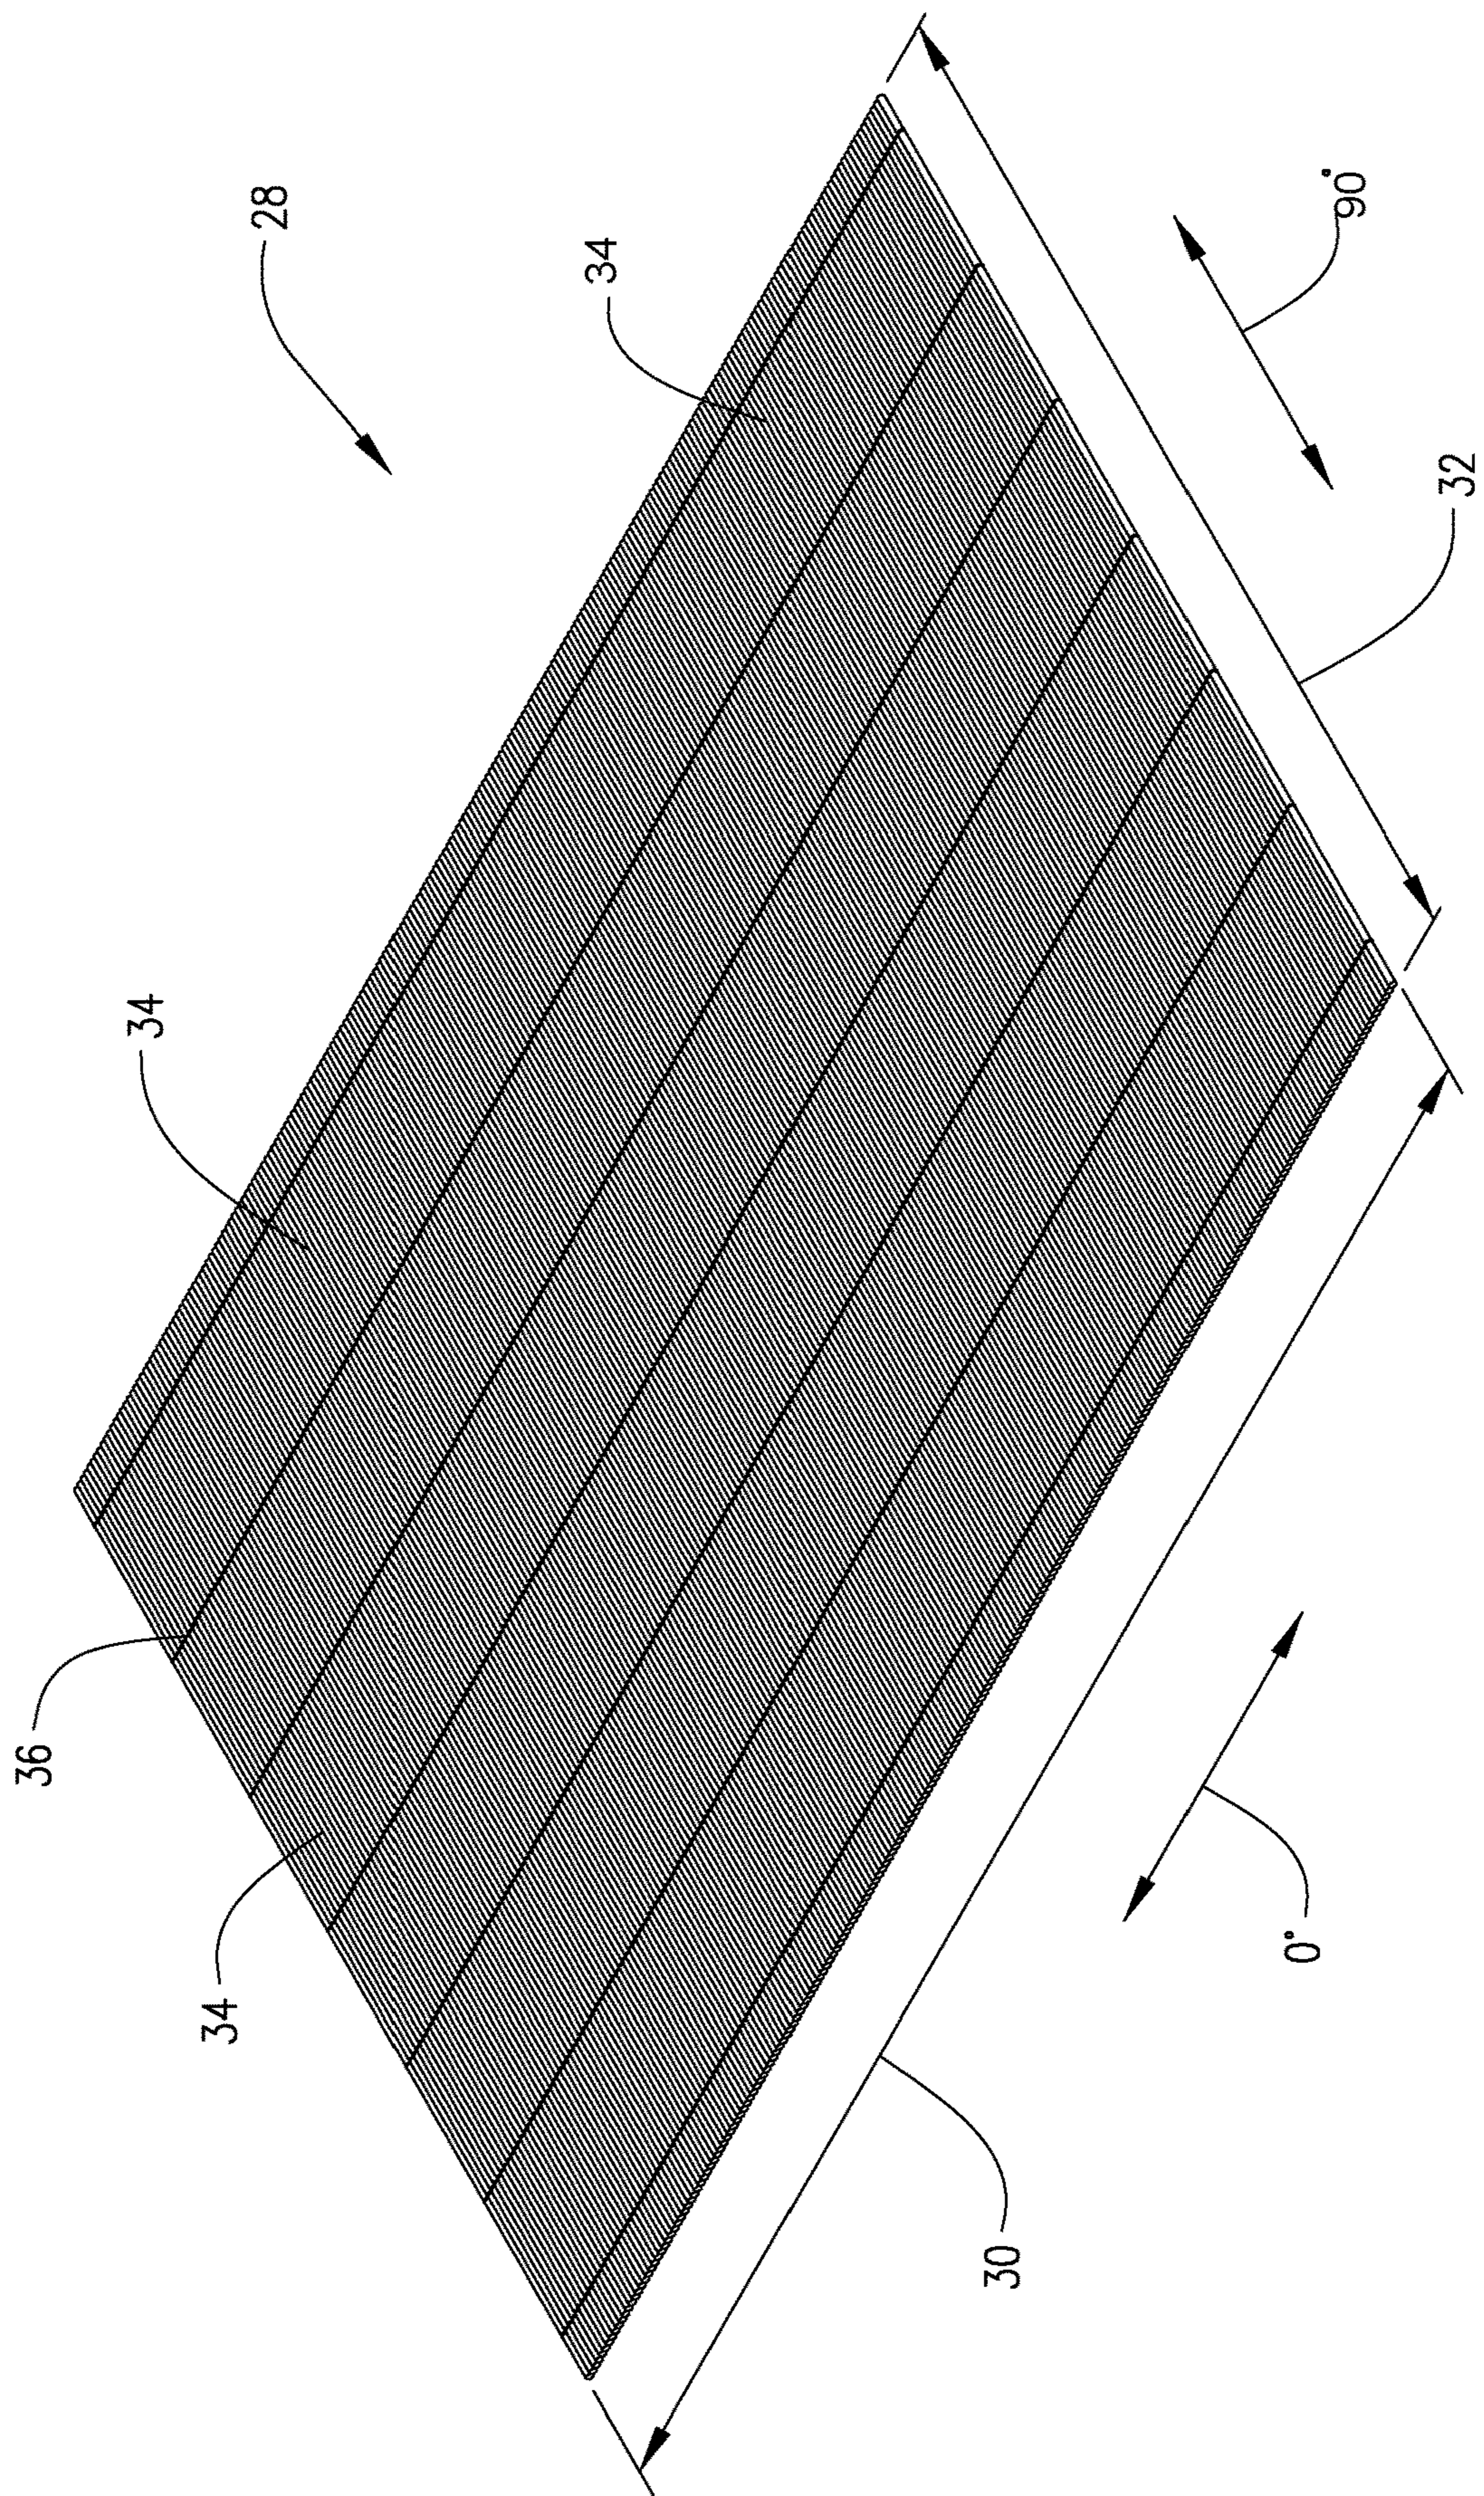
FIG. 7 is an illustration of a unidirectional fabric for use in the reinforcement of a pipe in accordance with this disclosure.

Referring to FIG. 7, unidirectional fabric **28** has a length **30** and width **32**, with length **30** typically being greater than width **32**. Often, width **32** will be less than the pipe circumference, and length **30** will be greater than the pipe circumference and even greater than two pipe circumferences. The length corresponds to the 0° direction for the fabric and the width corresponds to the 90° direction of the fabric. Unidirectional fabric **28** will have substantially all of its high-performance fibers **34** oriented in the 90° direction. Generally, this will mean that at least 90% of high-performance fibers **34** are oriented in the 90° direction. Typically, at least 95% or at least 98% of high-performance fibers **34** are oriented in the 90° direction. More typically, at least 99%, at least 99.5%, at least 99.9% or 100% of high-performance fibers **34** are oriented in the 90° direction.
