(10) **Patent No.:** **US 11,247,733 B2**
(45) **Date of Patent:** **Feb. 15, 2022**

(54) **DEFORMING WHEELHOUSE STRUCTURE FOR A VEHICLE**

(71) Applicant: **TOYOTA MOTOR ENGINEERING & MANUFACTURING NORTH AMERICA, INC.**, Plano, TX (US)

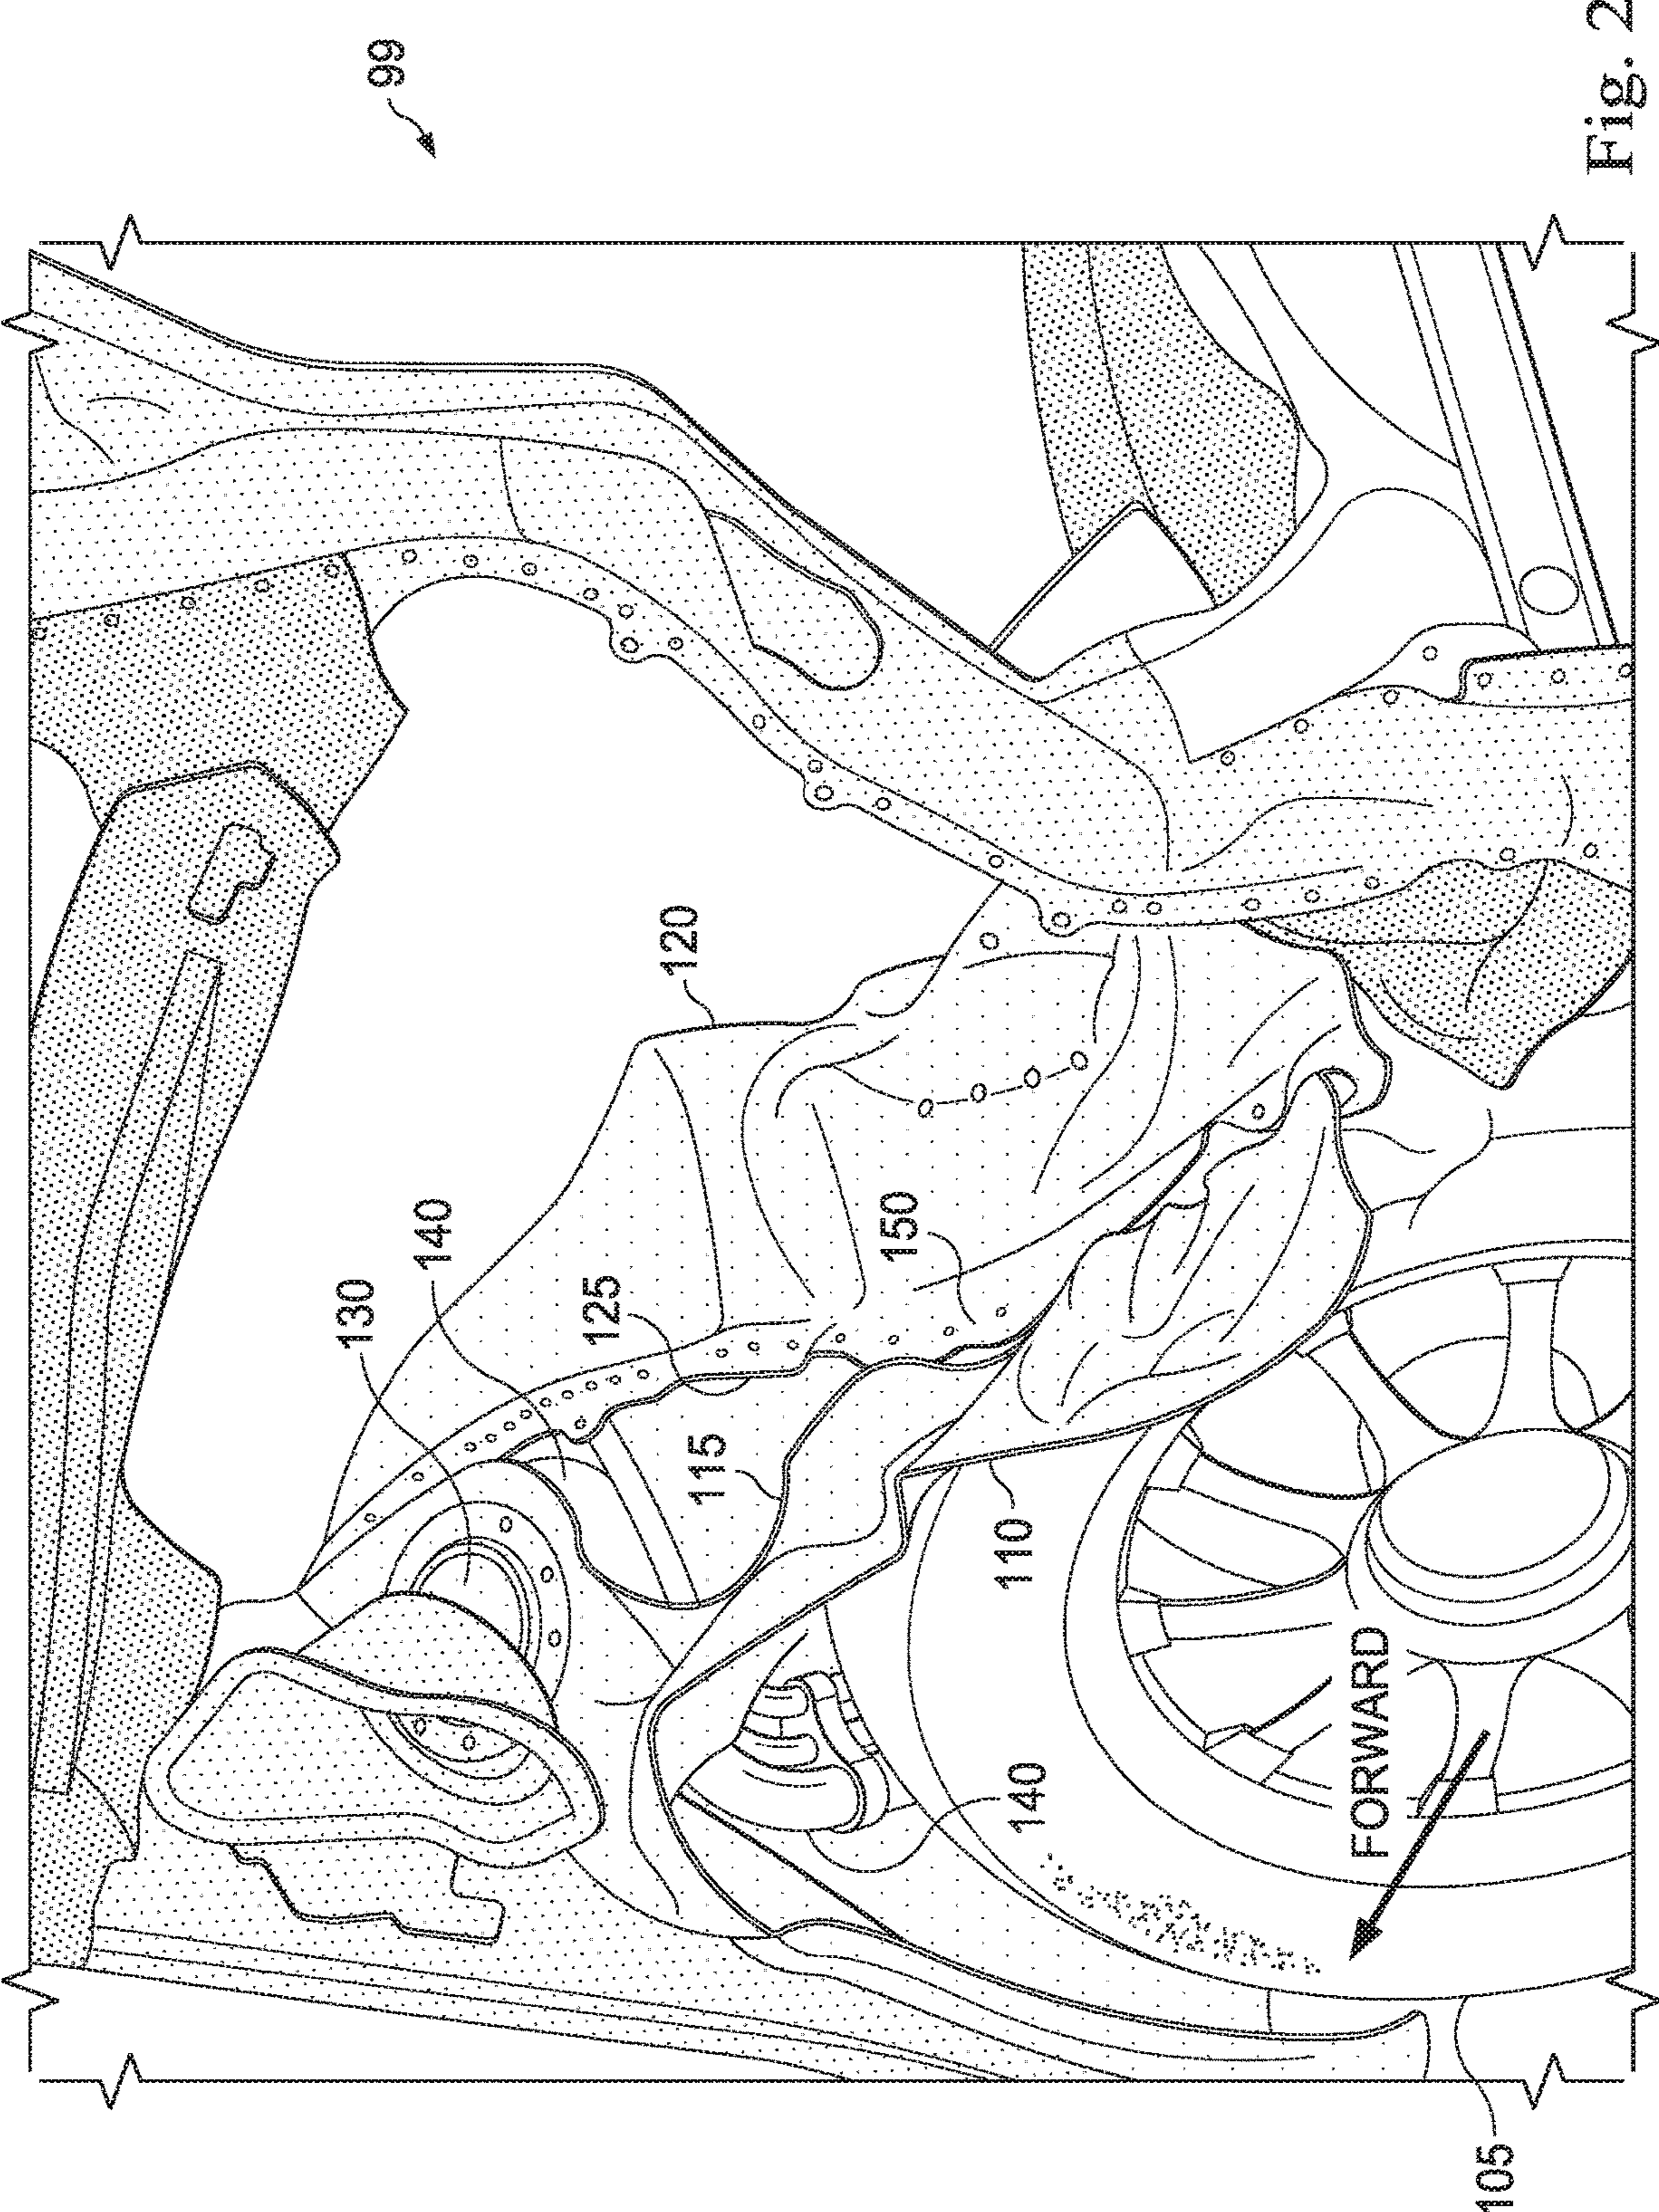
Fig. 2

FIG. 2 is a side rear perspective view of a baseline-case wheelhouse structure following a rear-impact collision, according to aspects of the present disclosure.

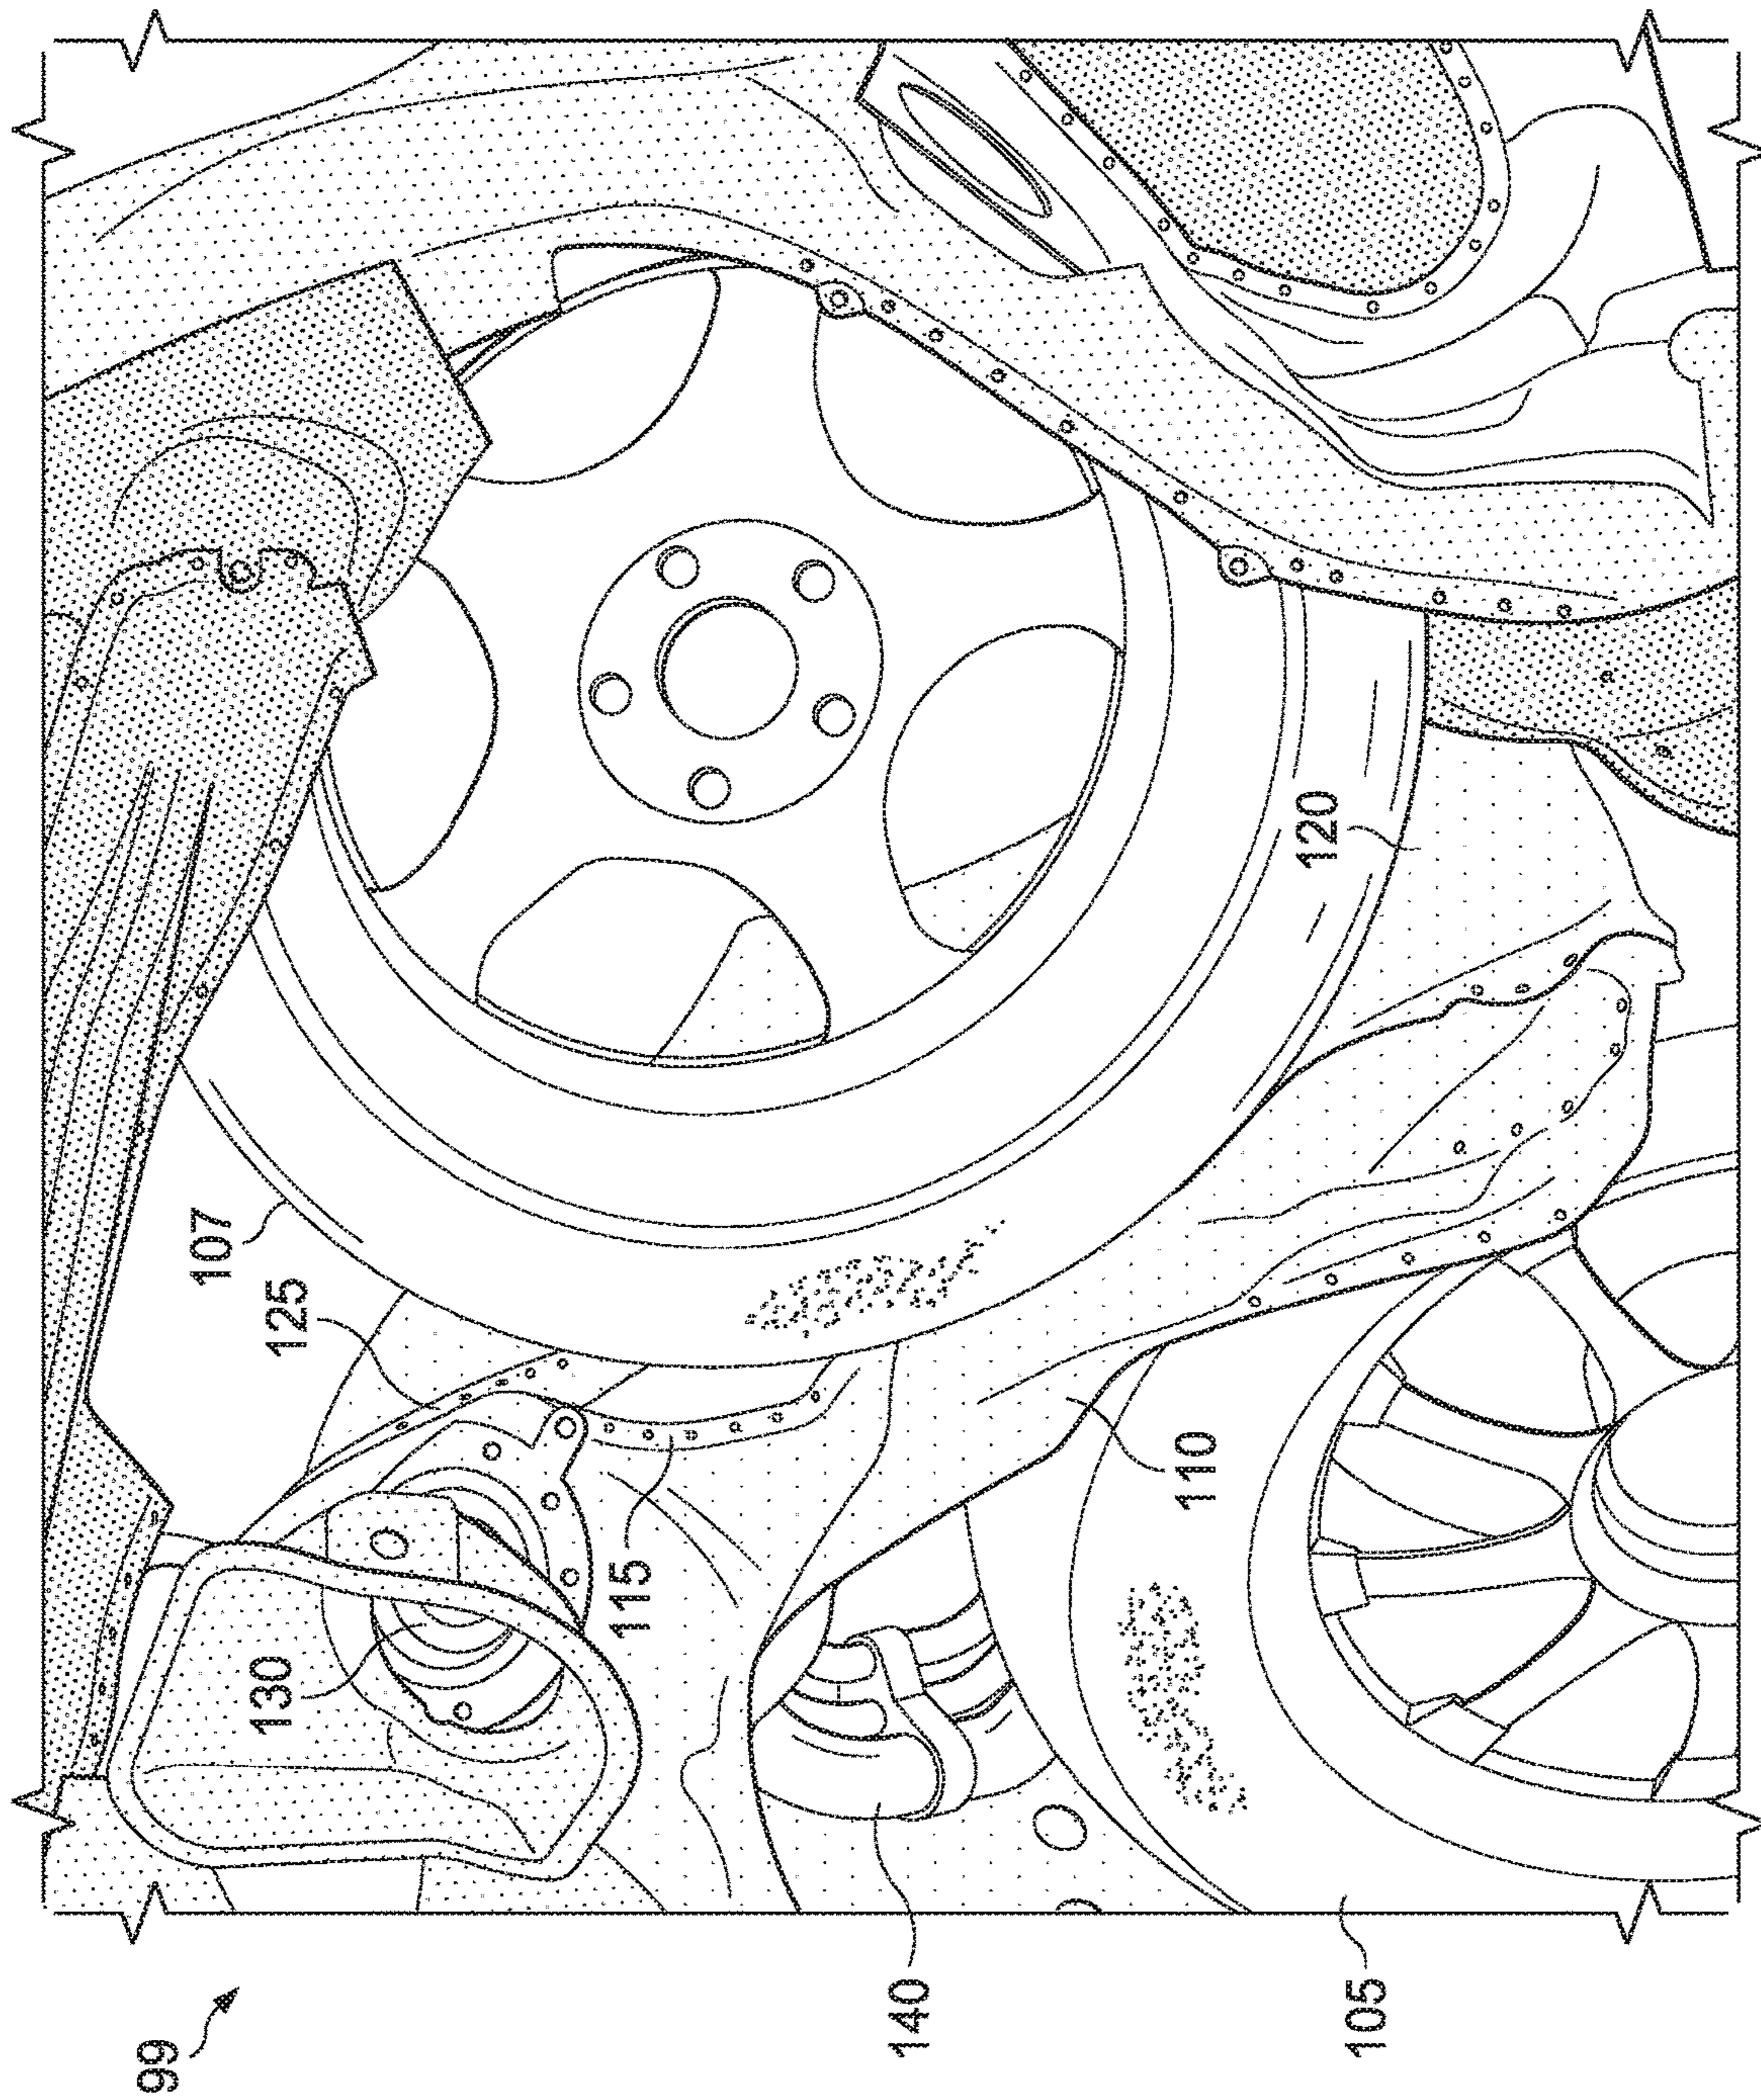
Fig. 3

FIG. 3 is a side rear perspective view of a baseline-case wheelhouse structure following a rear-impact collision, according to aspects of the present disclosure.

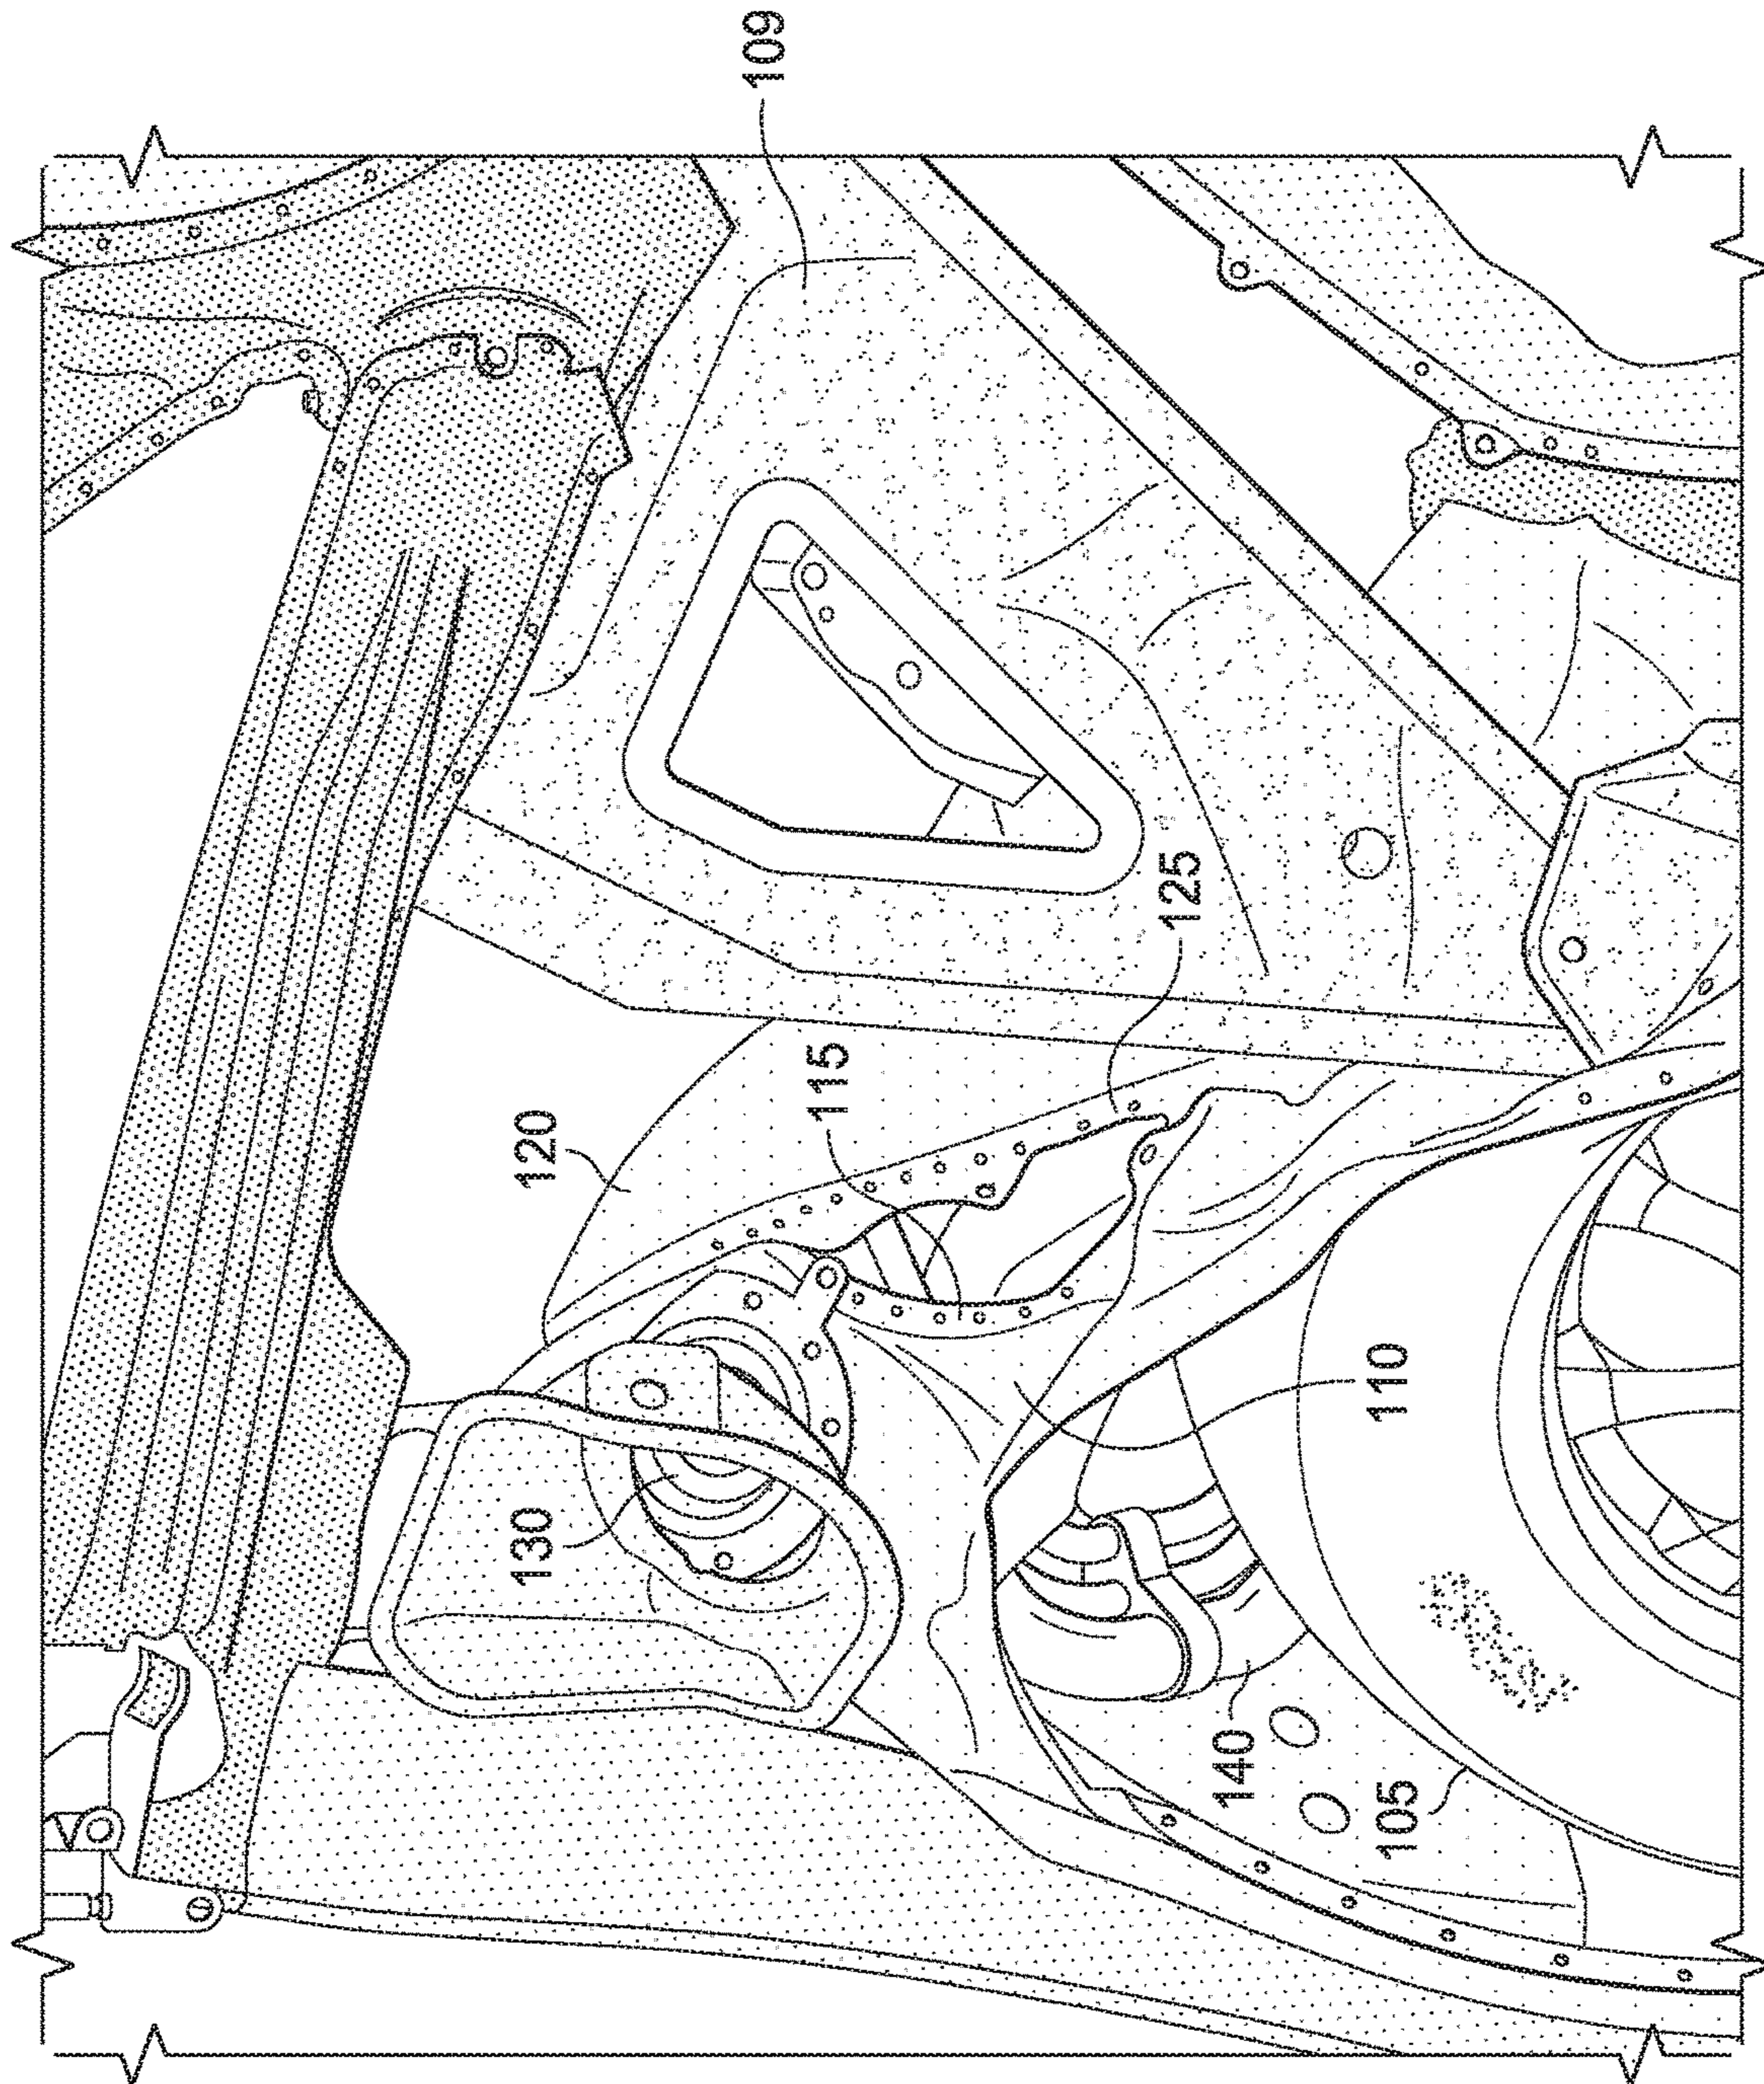
Fig. 4

FIG. 4 is a side rear perspective view of a baseline-case wheelhouse structure following a rear-impact collision, according to aspects of the present disclosure.

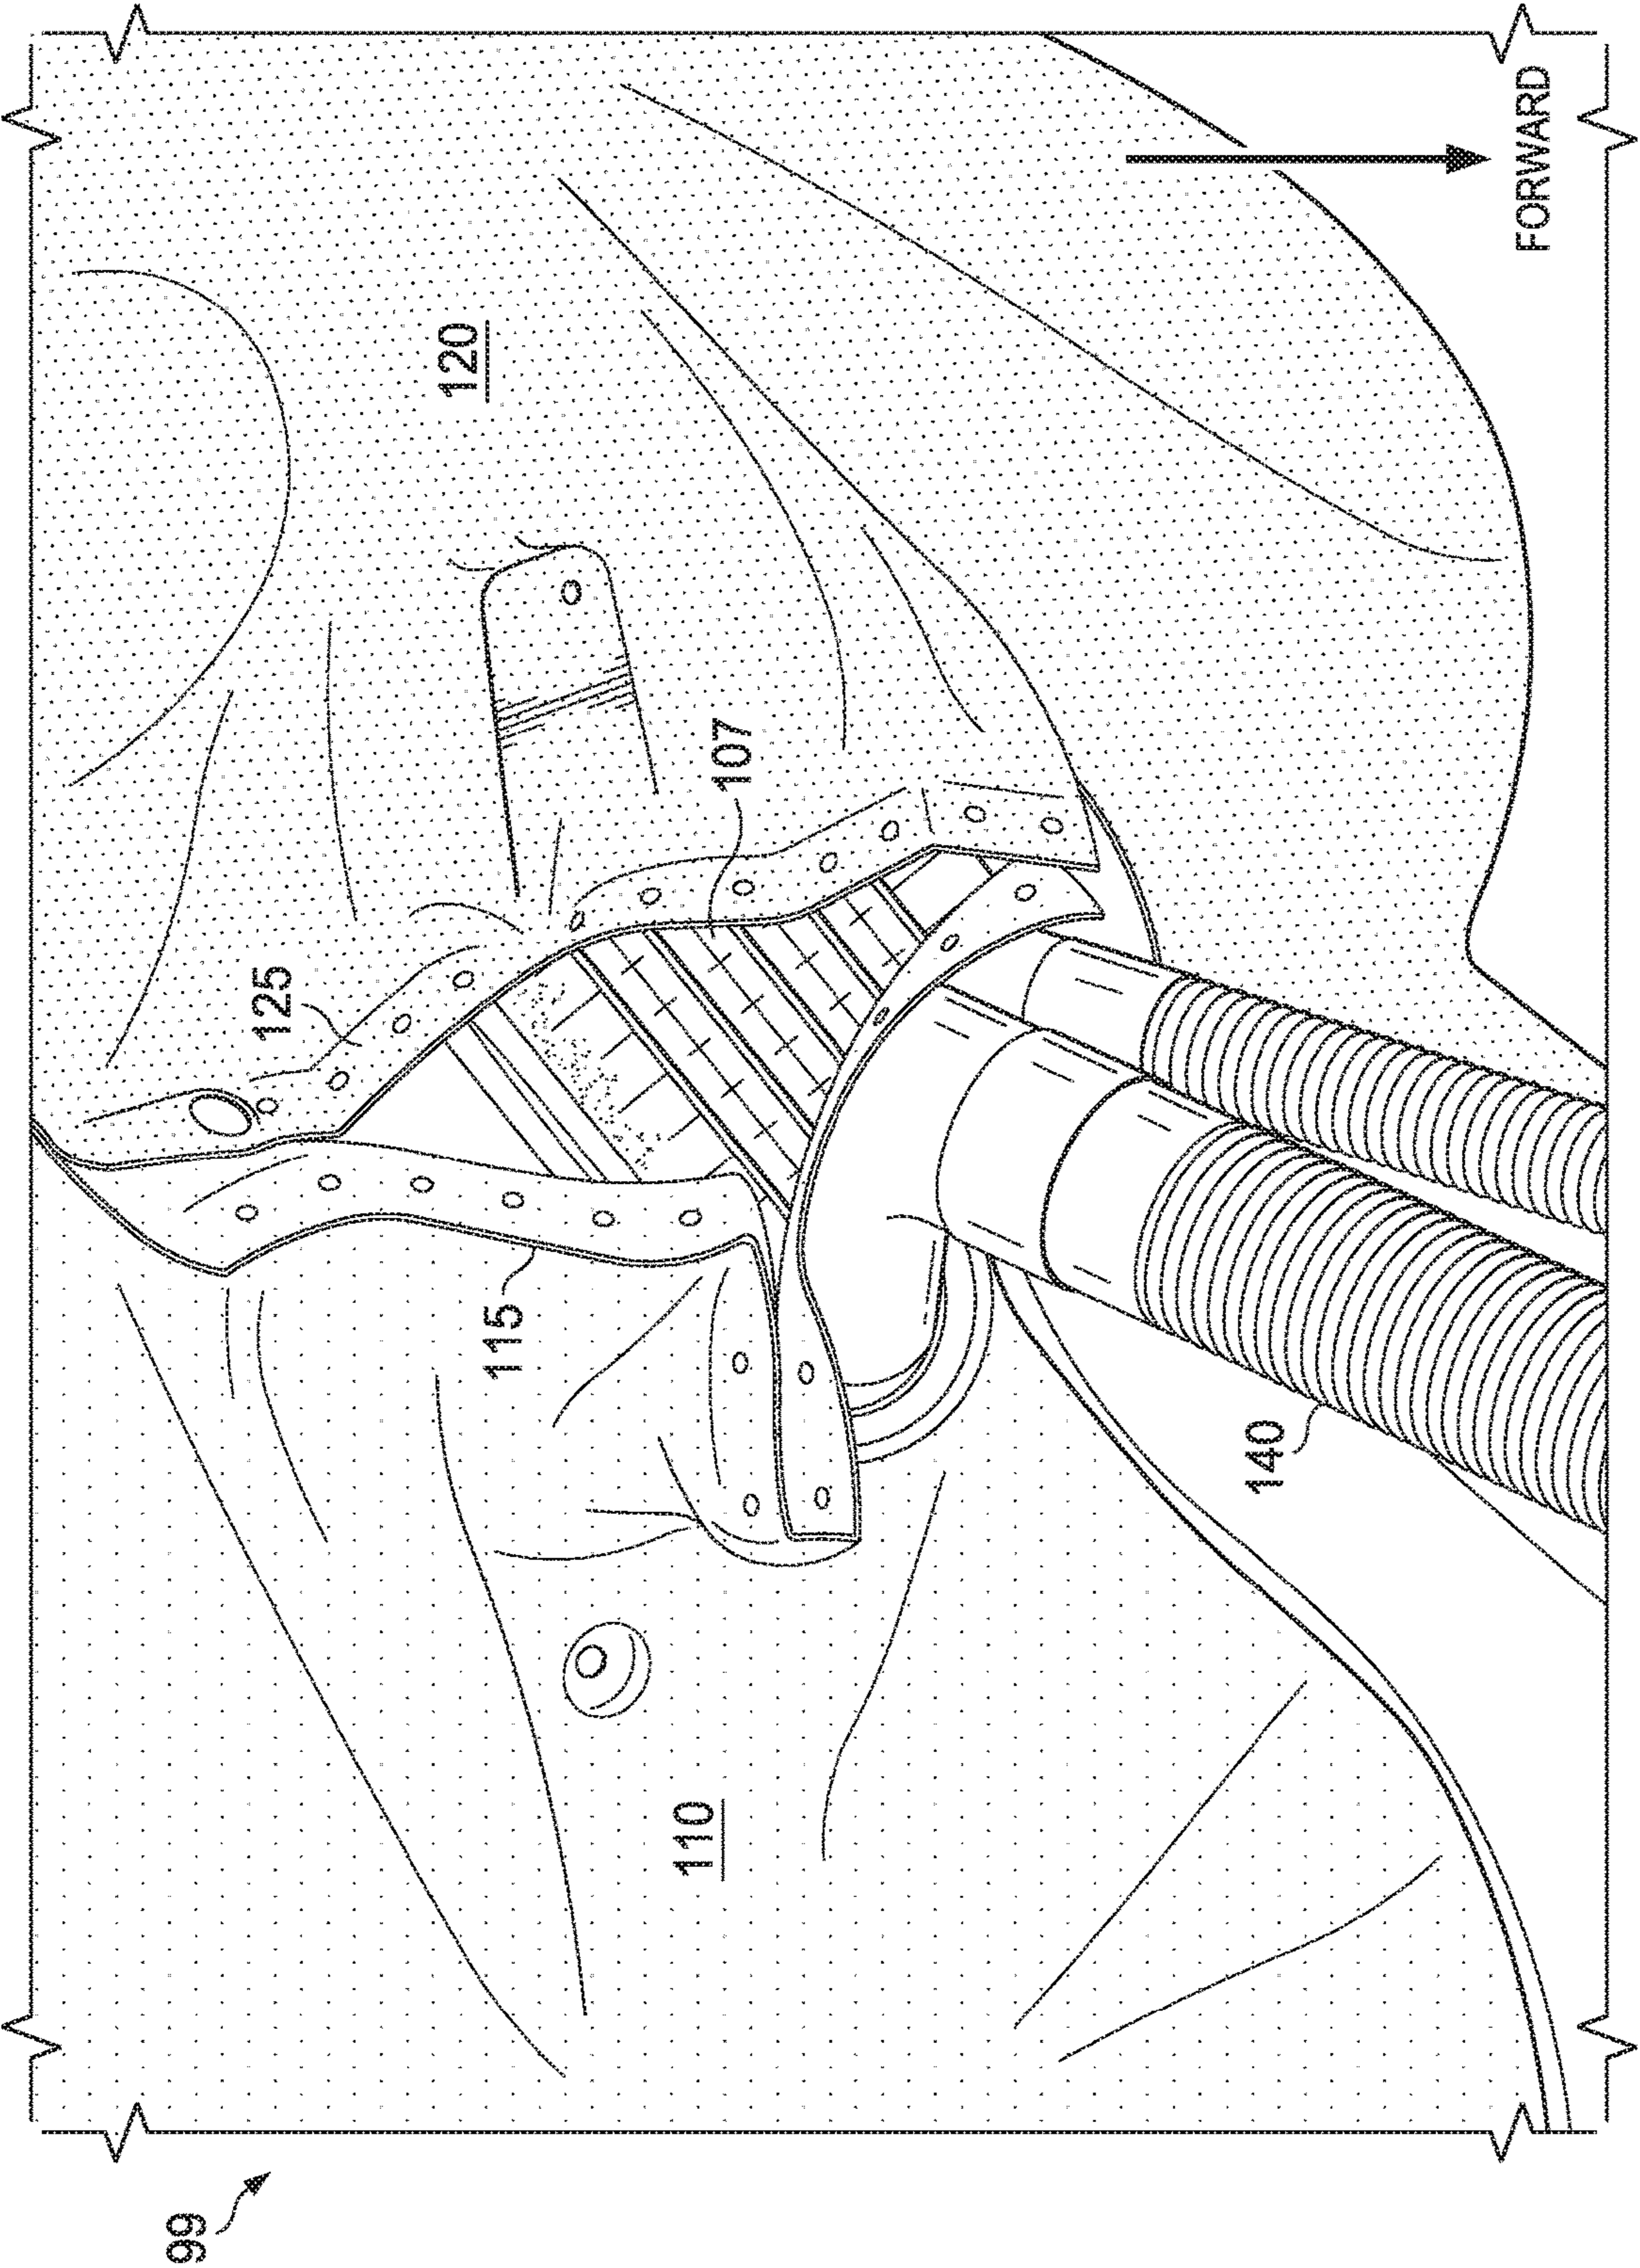
Fig. 5

FIG. 5 is an upward-facing inside view of a baseline-case wheelhouse structure following a rear-impact collision, according to aspects of the present disclosure.

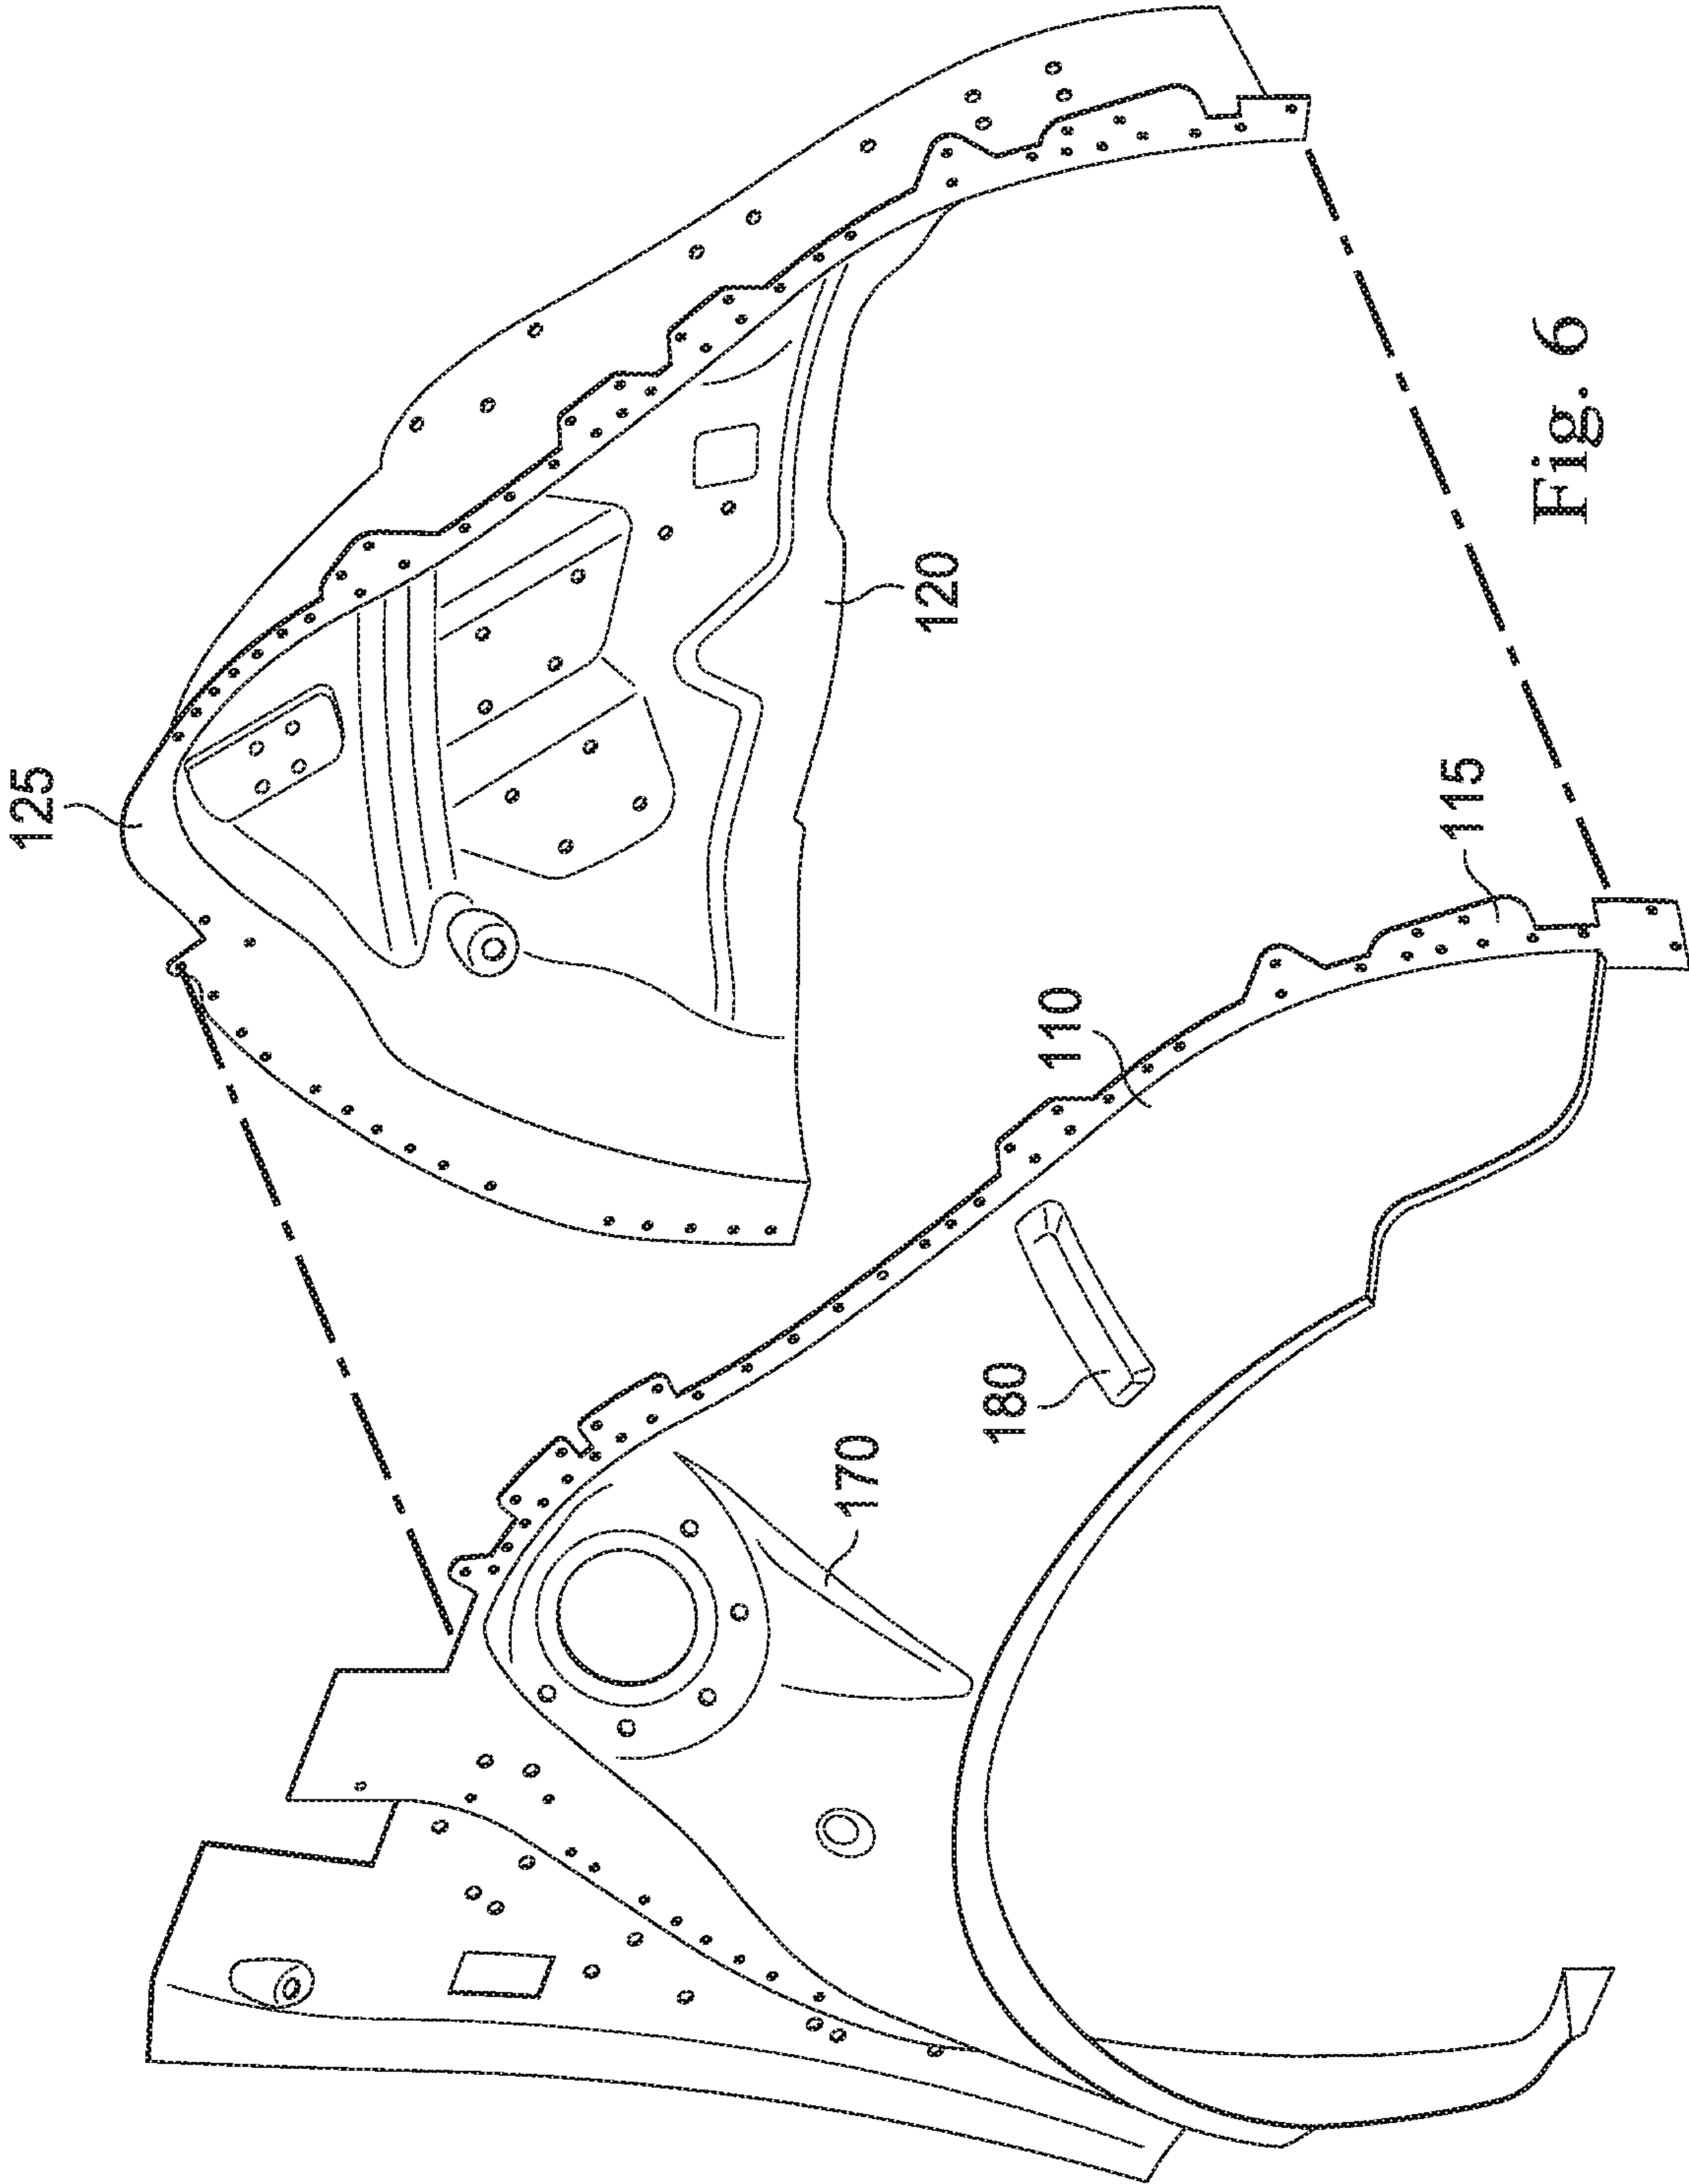
Fig. 6

FIG. 6 is a perspective, exploded view of an example deforming rear wheelhouse structure according to at least one embodiment of the present disclosure.

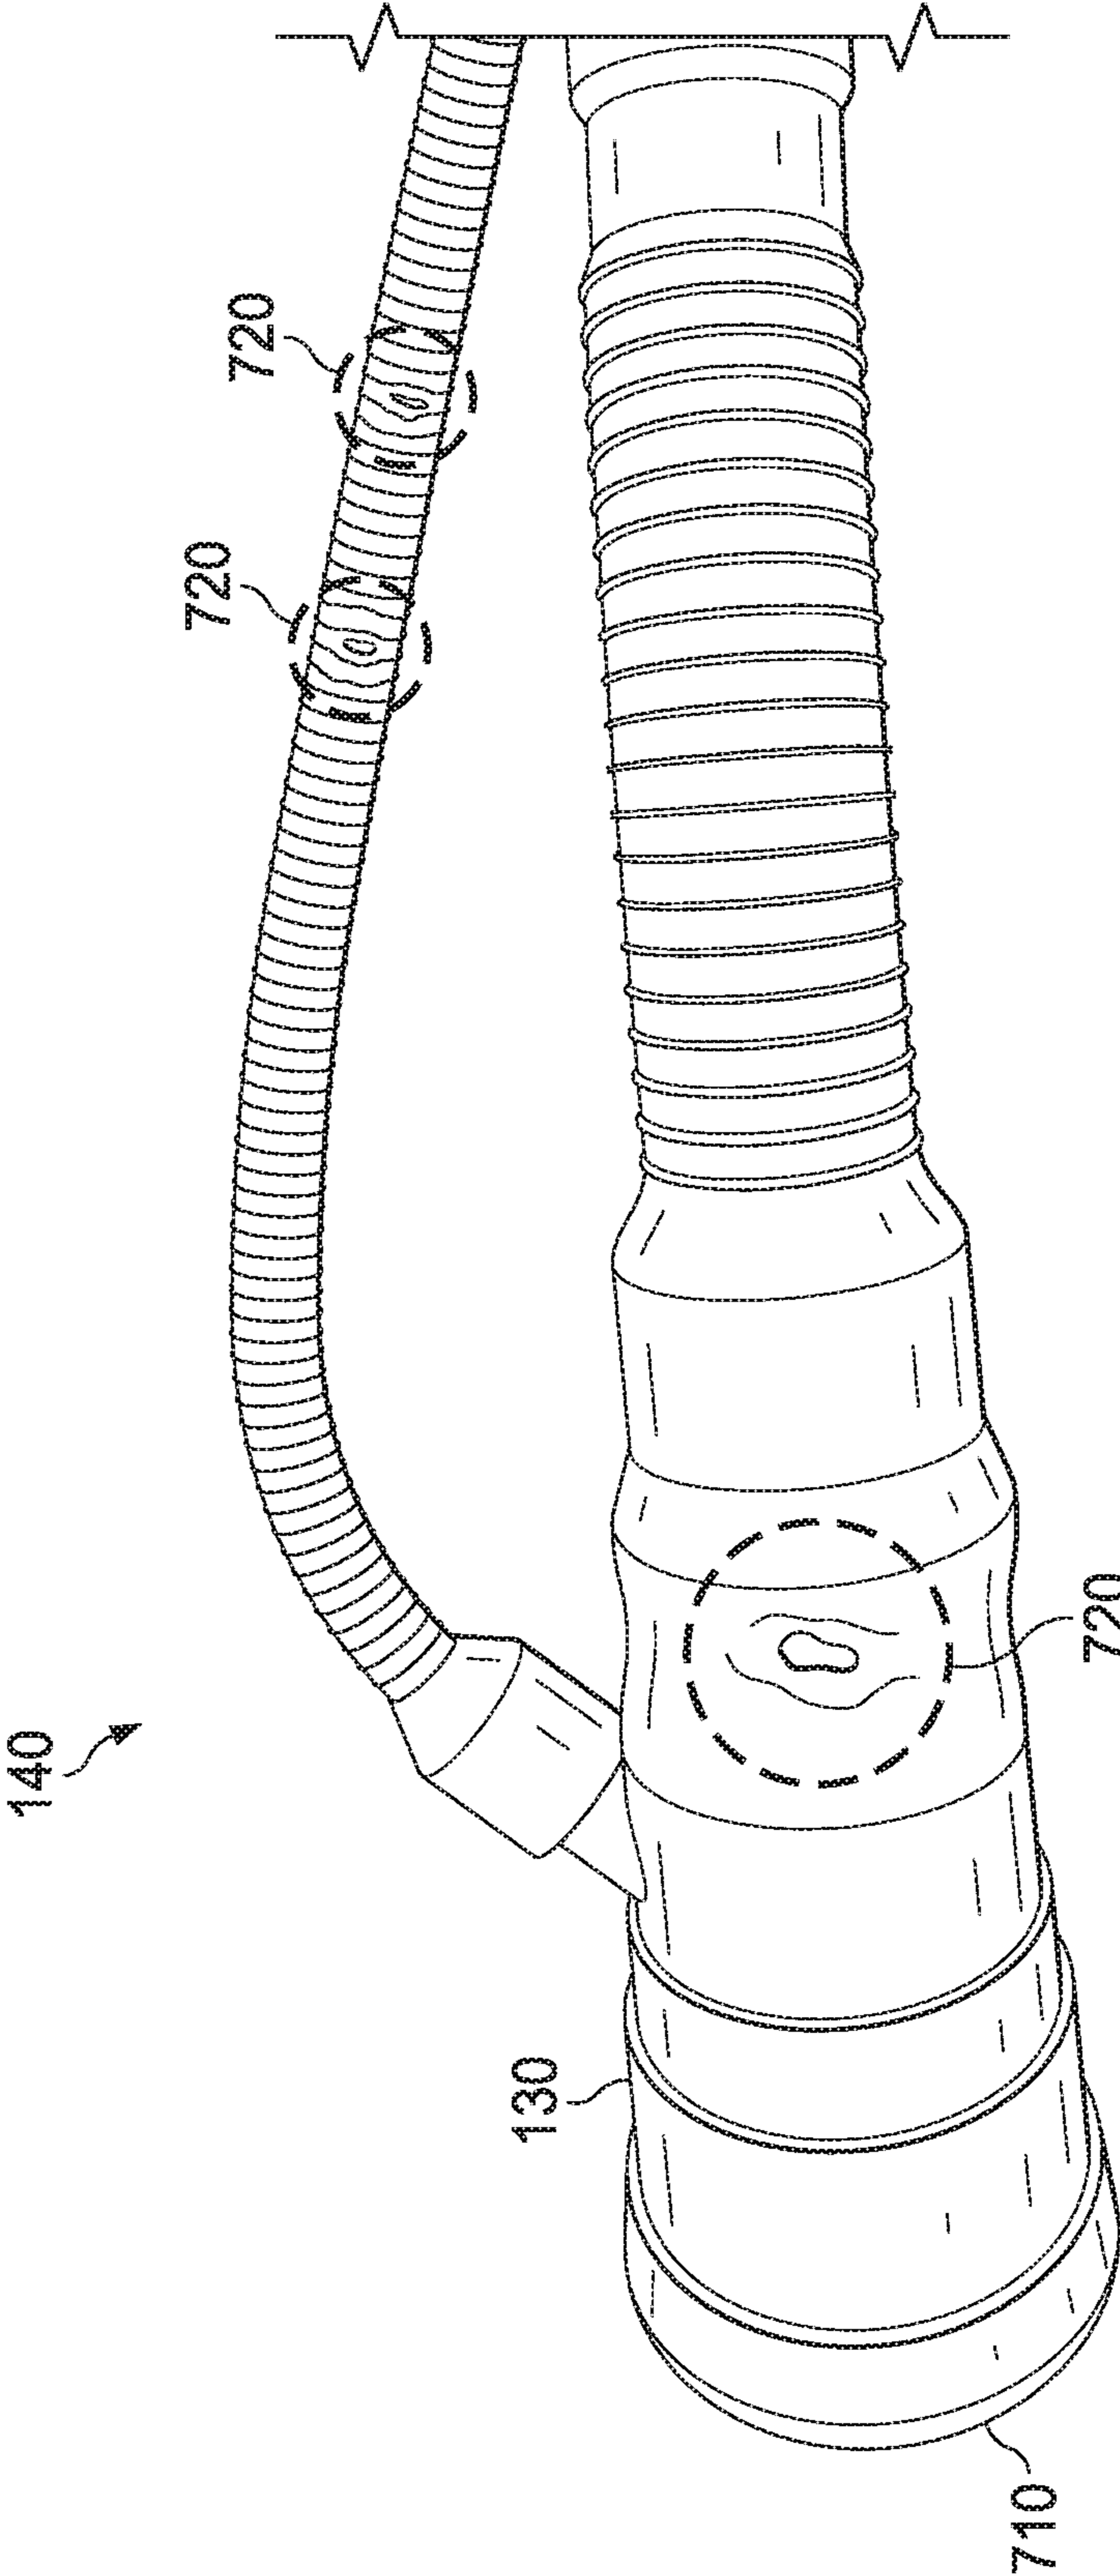
Fig. 7

FIG. 7 is a side perspective view of an example fuel pipe following a rear-impact collision in the baseline case, according to aspects of the present disclosure.
