(10) **Patent No.:** **US 11,247,733 B2**
(45) **Date of Patent:** **Feb. 15, 2022**

(54) **DEFORMING WHEELHOUSE STRUCTURE FOR A VEHICLE**

(71) Applicant: **TOYOTA MOTOR ENGINEERING & MANUFACTURING NORTH AMERICA, INC.**, Plano, TX (US)

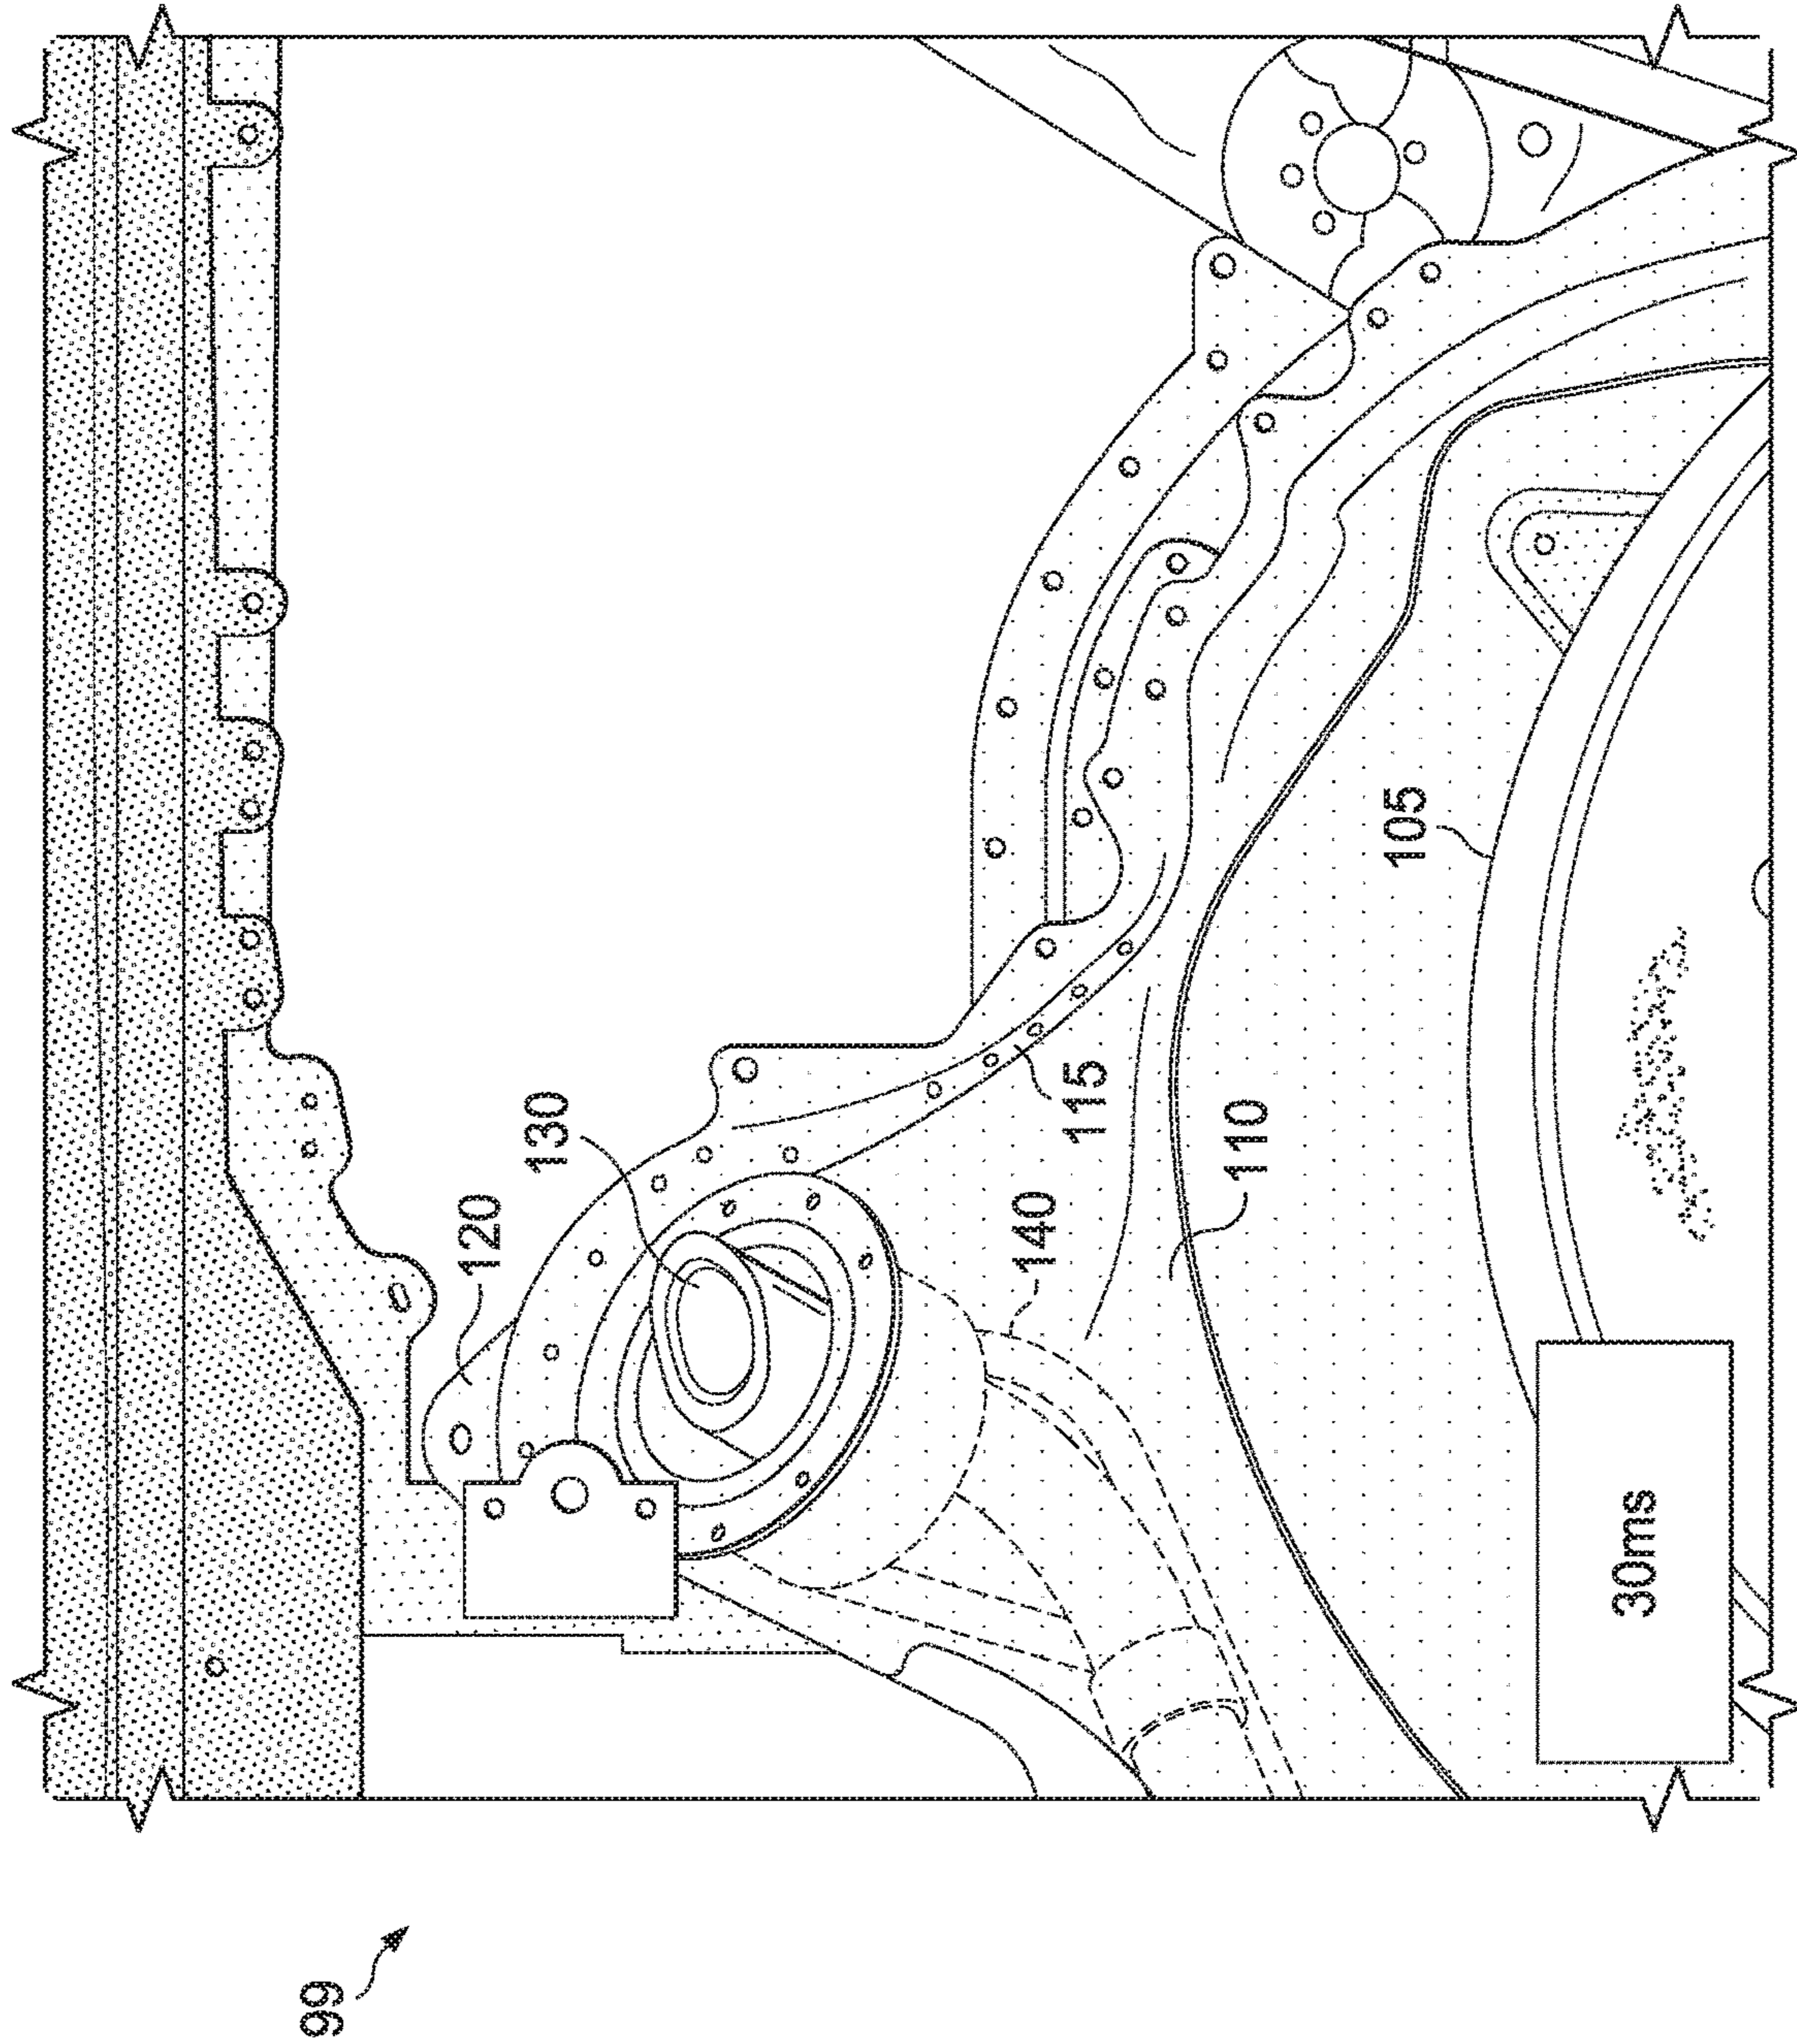
Fig. 8

FIG. 8 is a side perspective view of a baseline-case wheelhouse structure at a time point 30 milliseconds into a rear-impact collision event, according to aspects of the present disclosure.

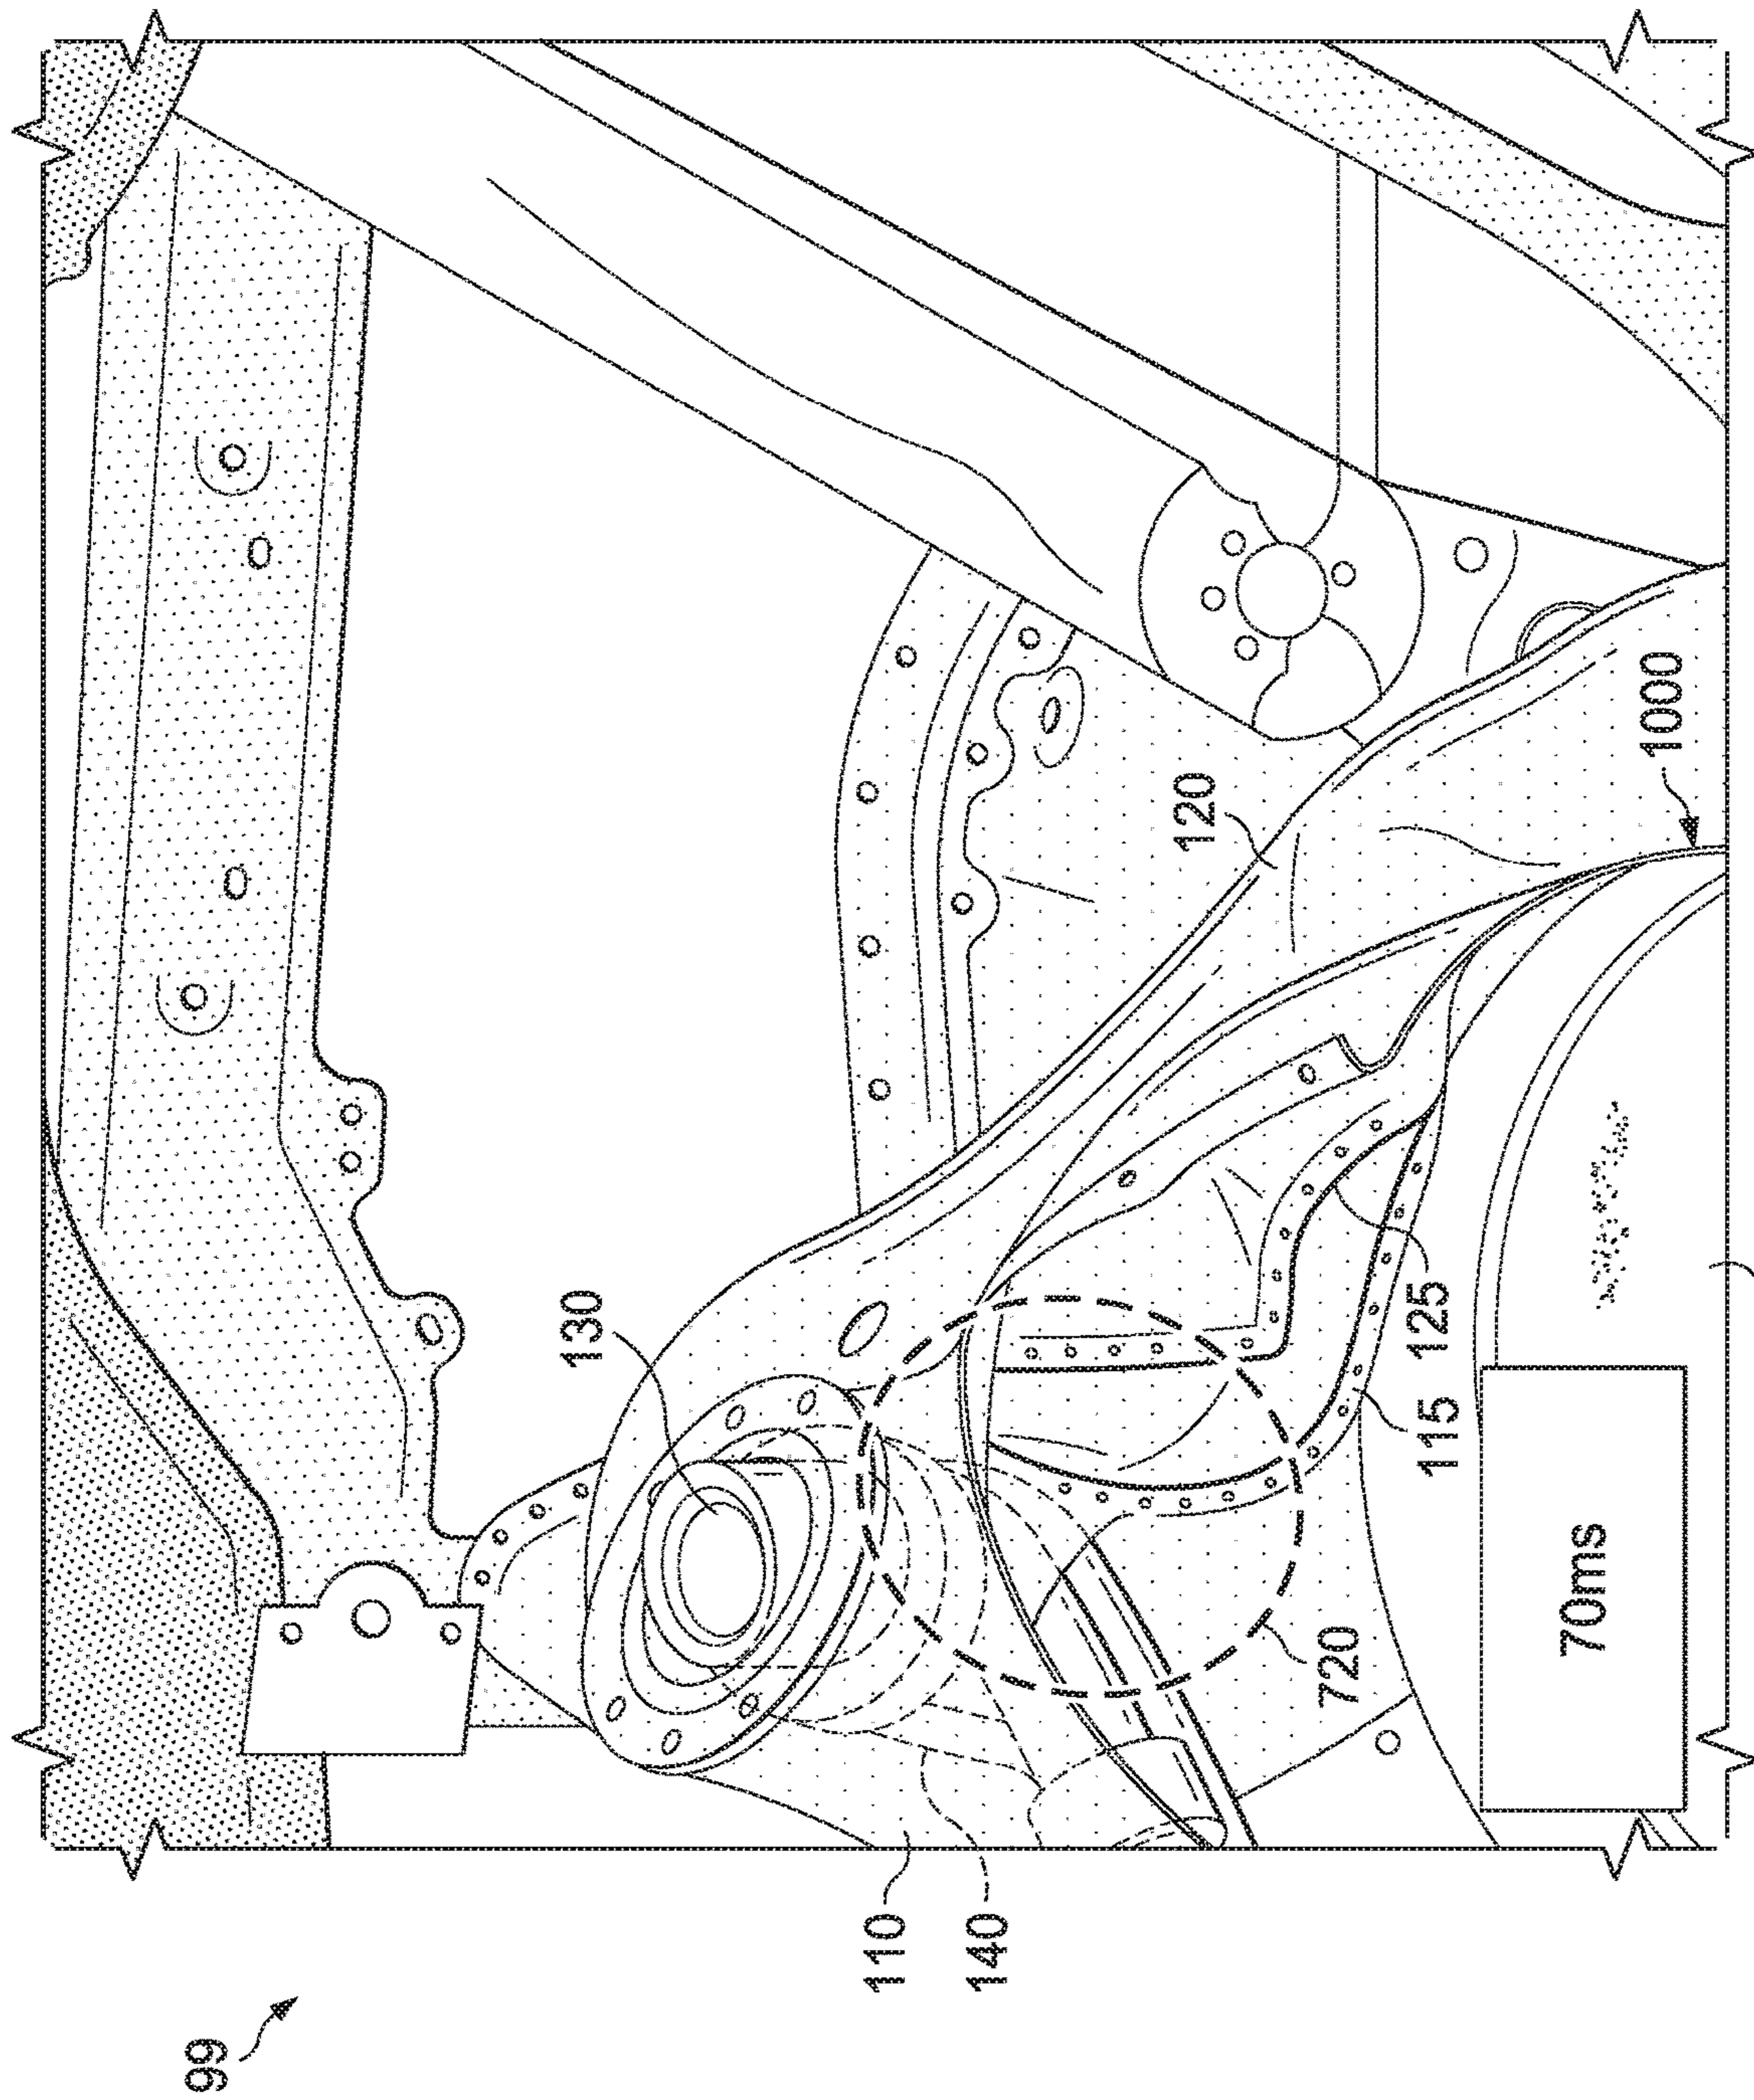
Fig. 10

FIG. 10 is a side perspective view of a baseline-case wheelhouse structure at a time point 70 milliseconds into a rear-impact collision event, according to aspects of the present disclosure.

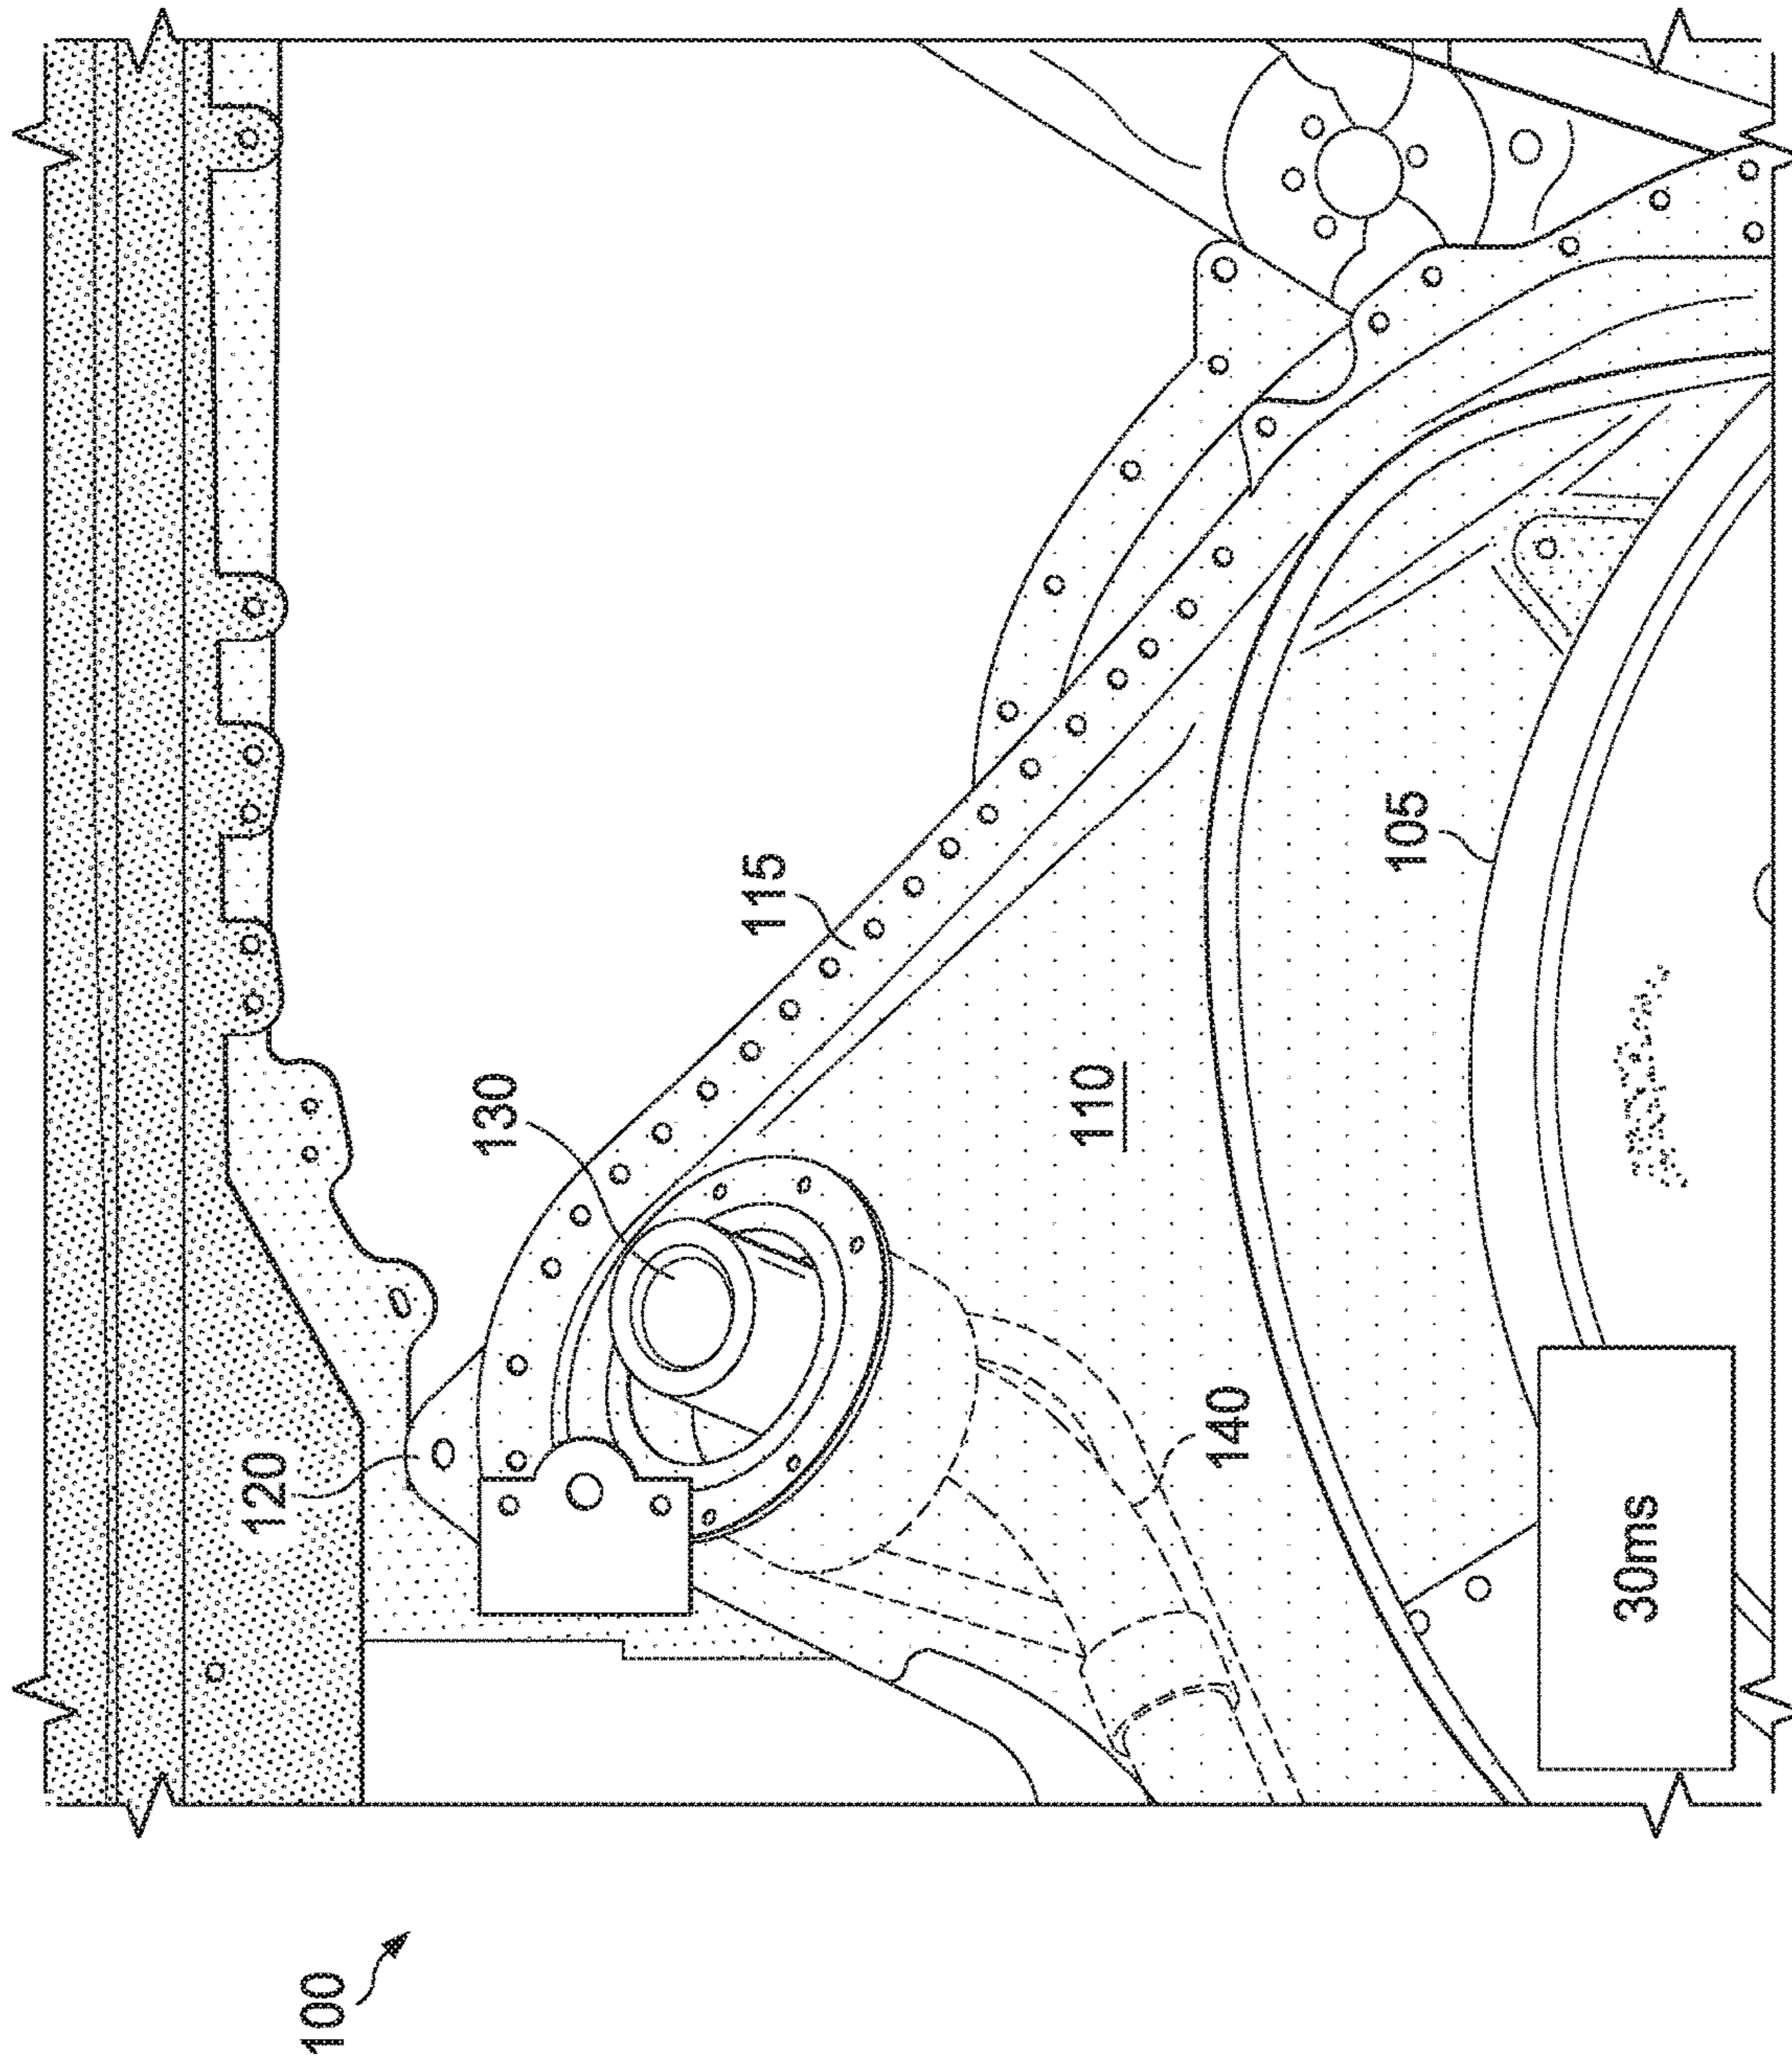
Fig. 11

FIG. 11 is a side perspective view of a countermeasure-case, deforming rear wheelhouse structure at a time point 30 milliseconds into a rear-impact collision event, according to at least one embodiment of the present disclosure.

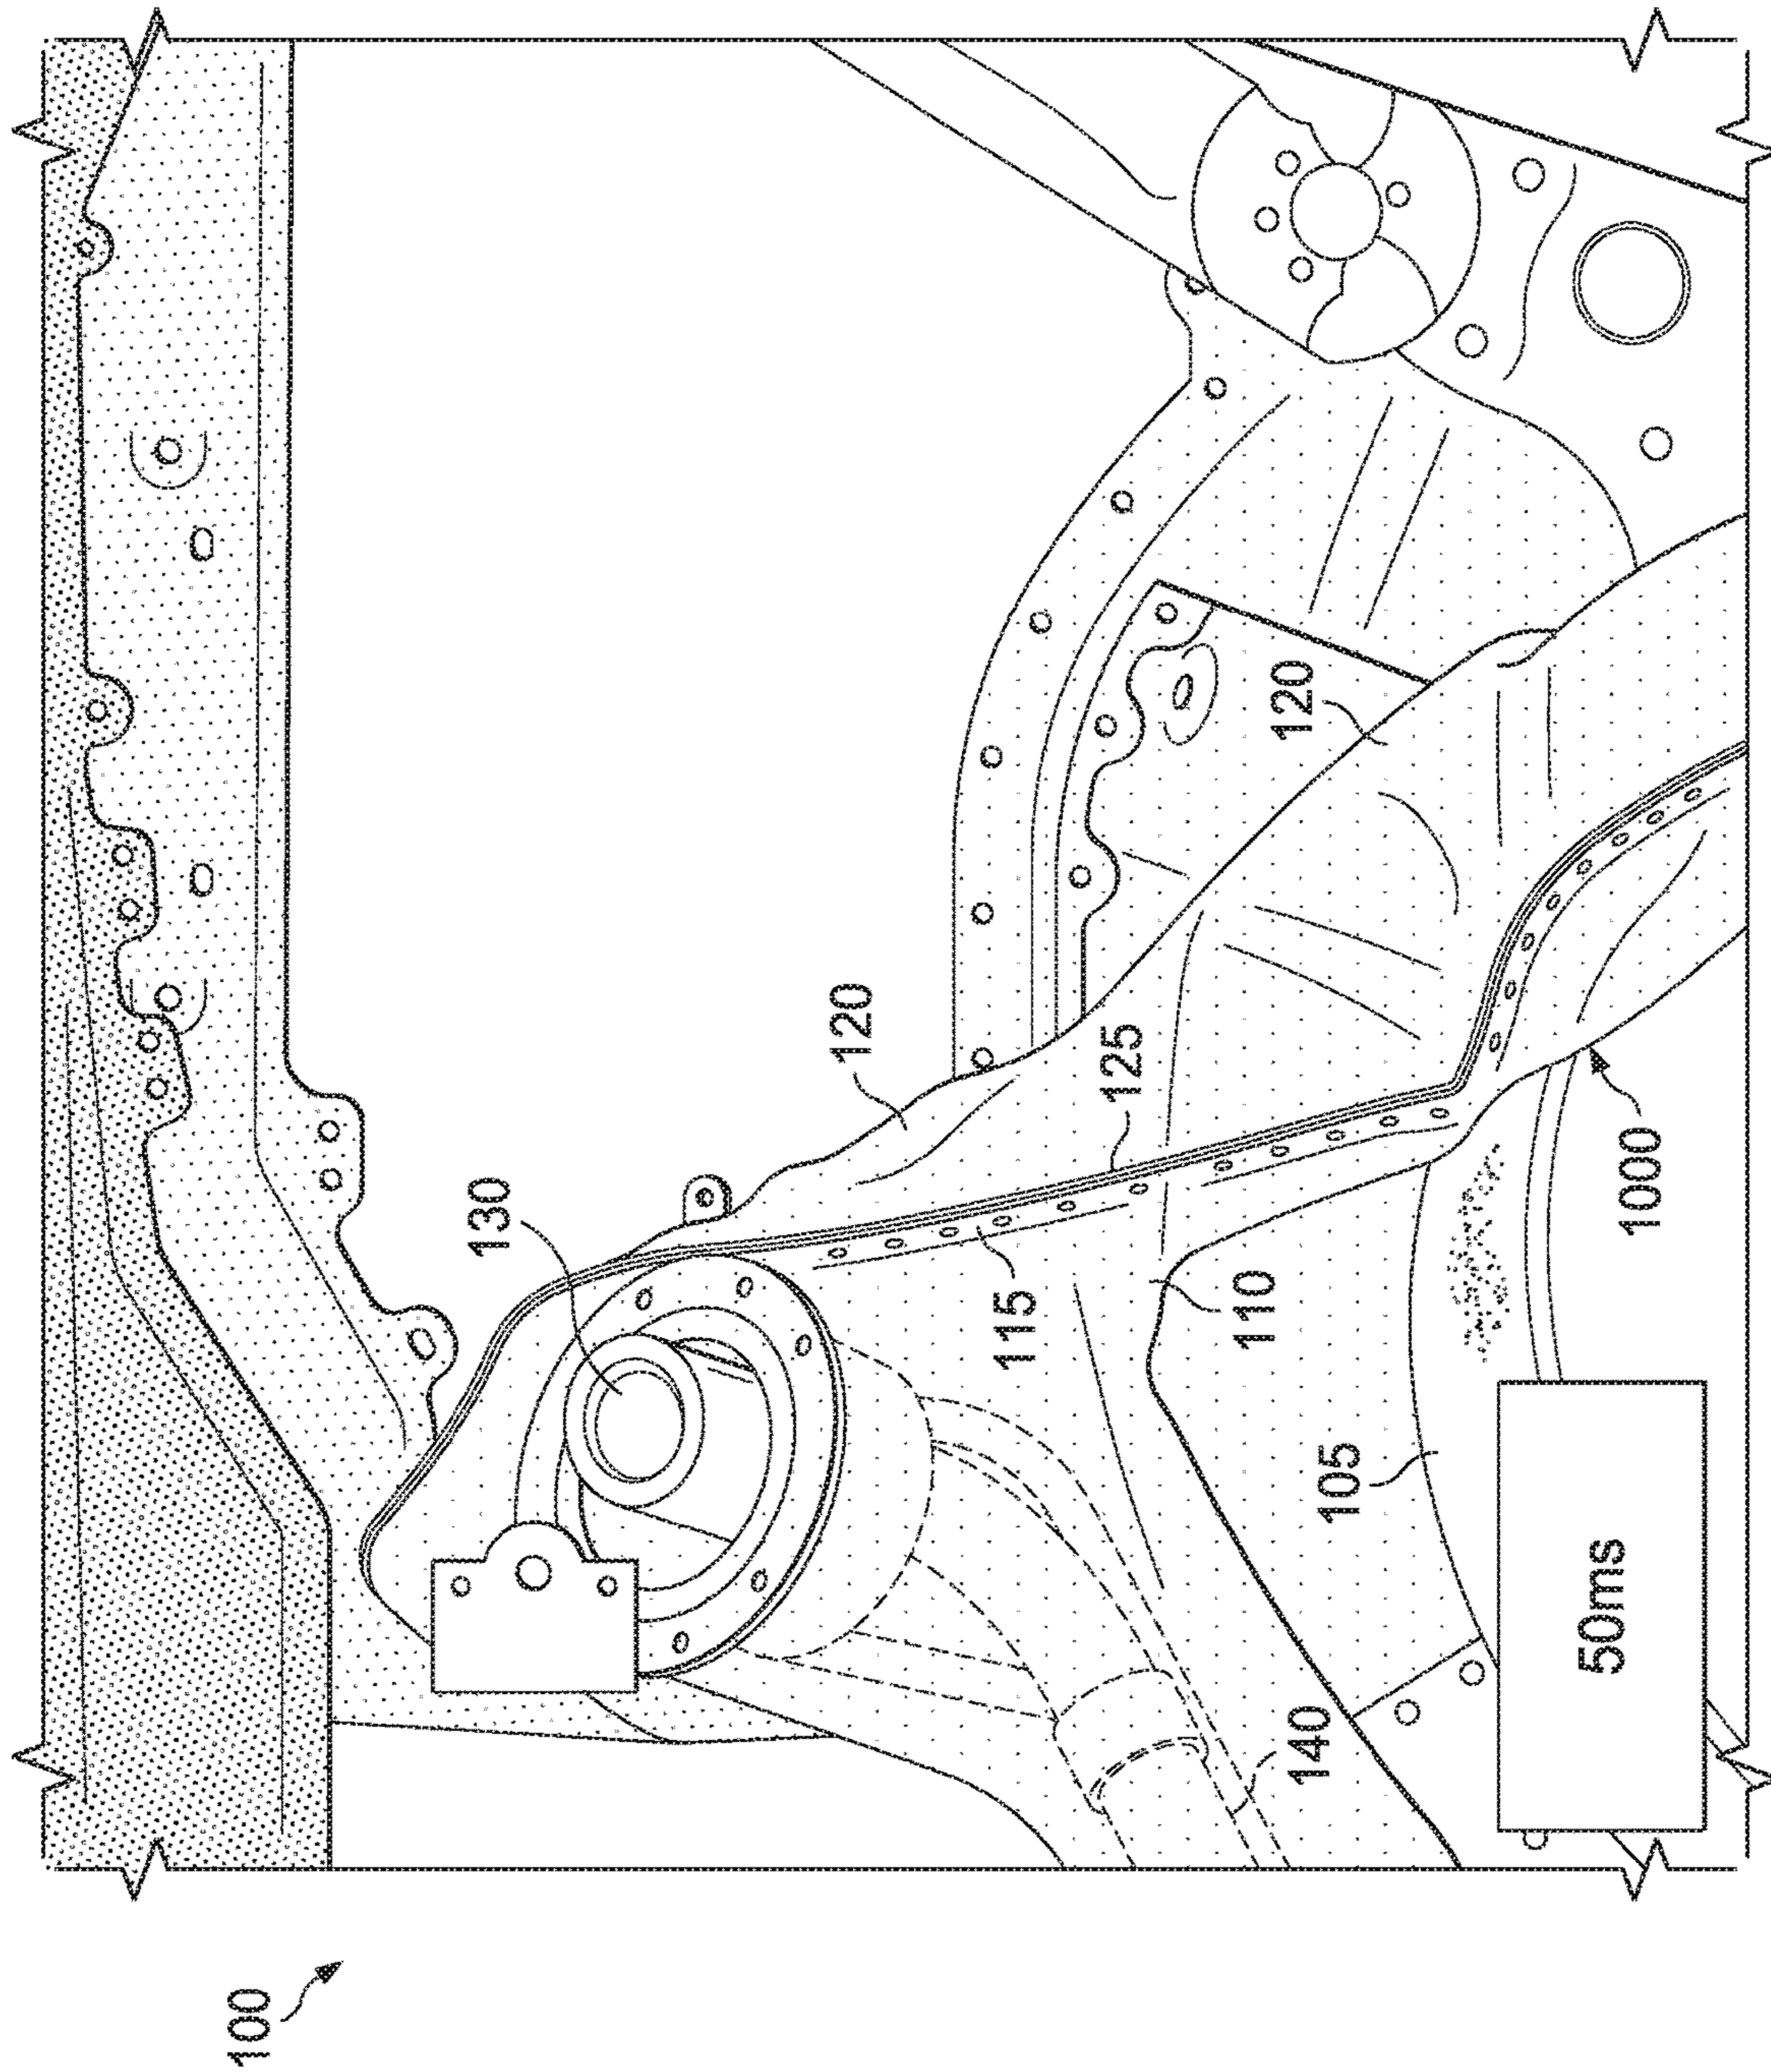
Fig. 12

FIG. 12 is a side perspective view of a countermeasure-case, deforming rear wheelhouse structure at a time point 50 milliseconds into a rear-impact collision event, according to at least one embodiment of the present disclosure.

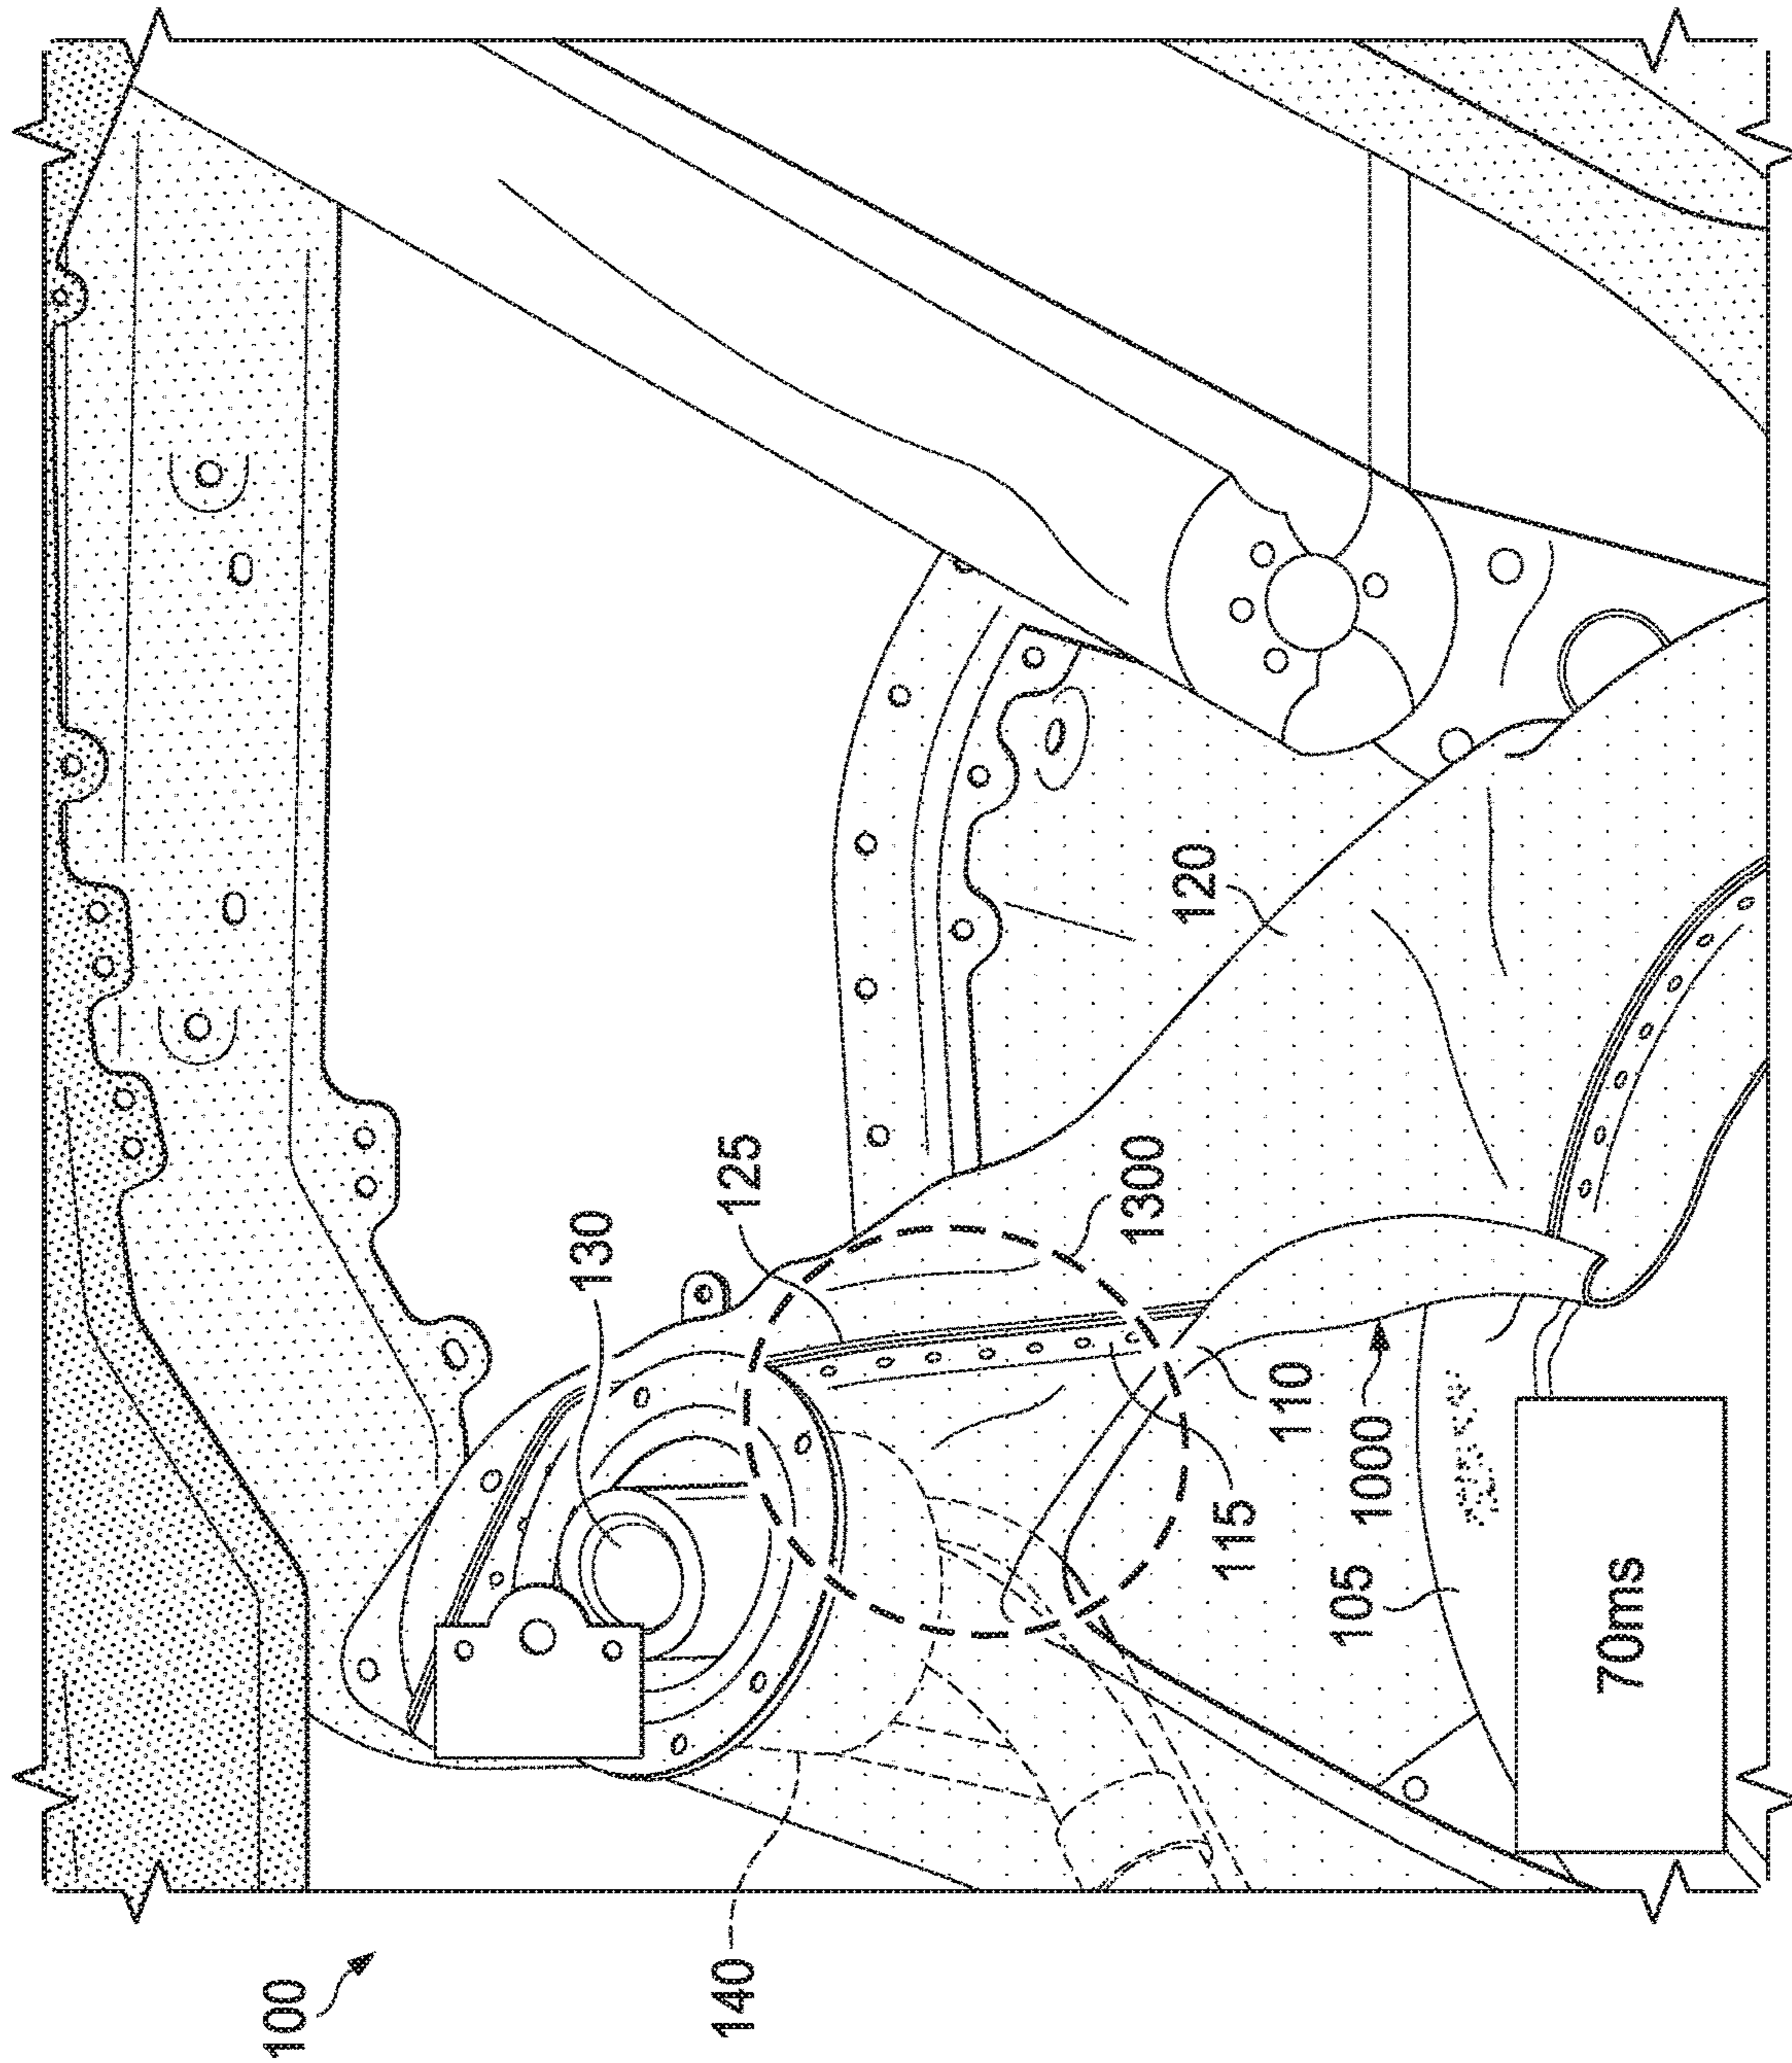
Fig. 13

FIG. 13 is a side perspective view of a countermeasure-case, deforming rear wheelhouse structure at a time point 70 milliseconds into a rear-impact collision event, according to at least one embodiment of the present disclosure.

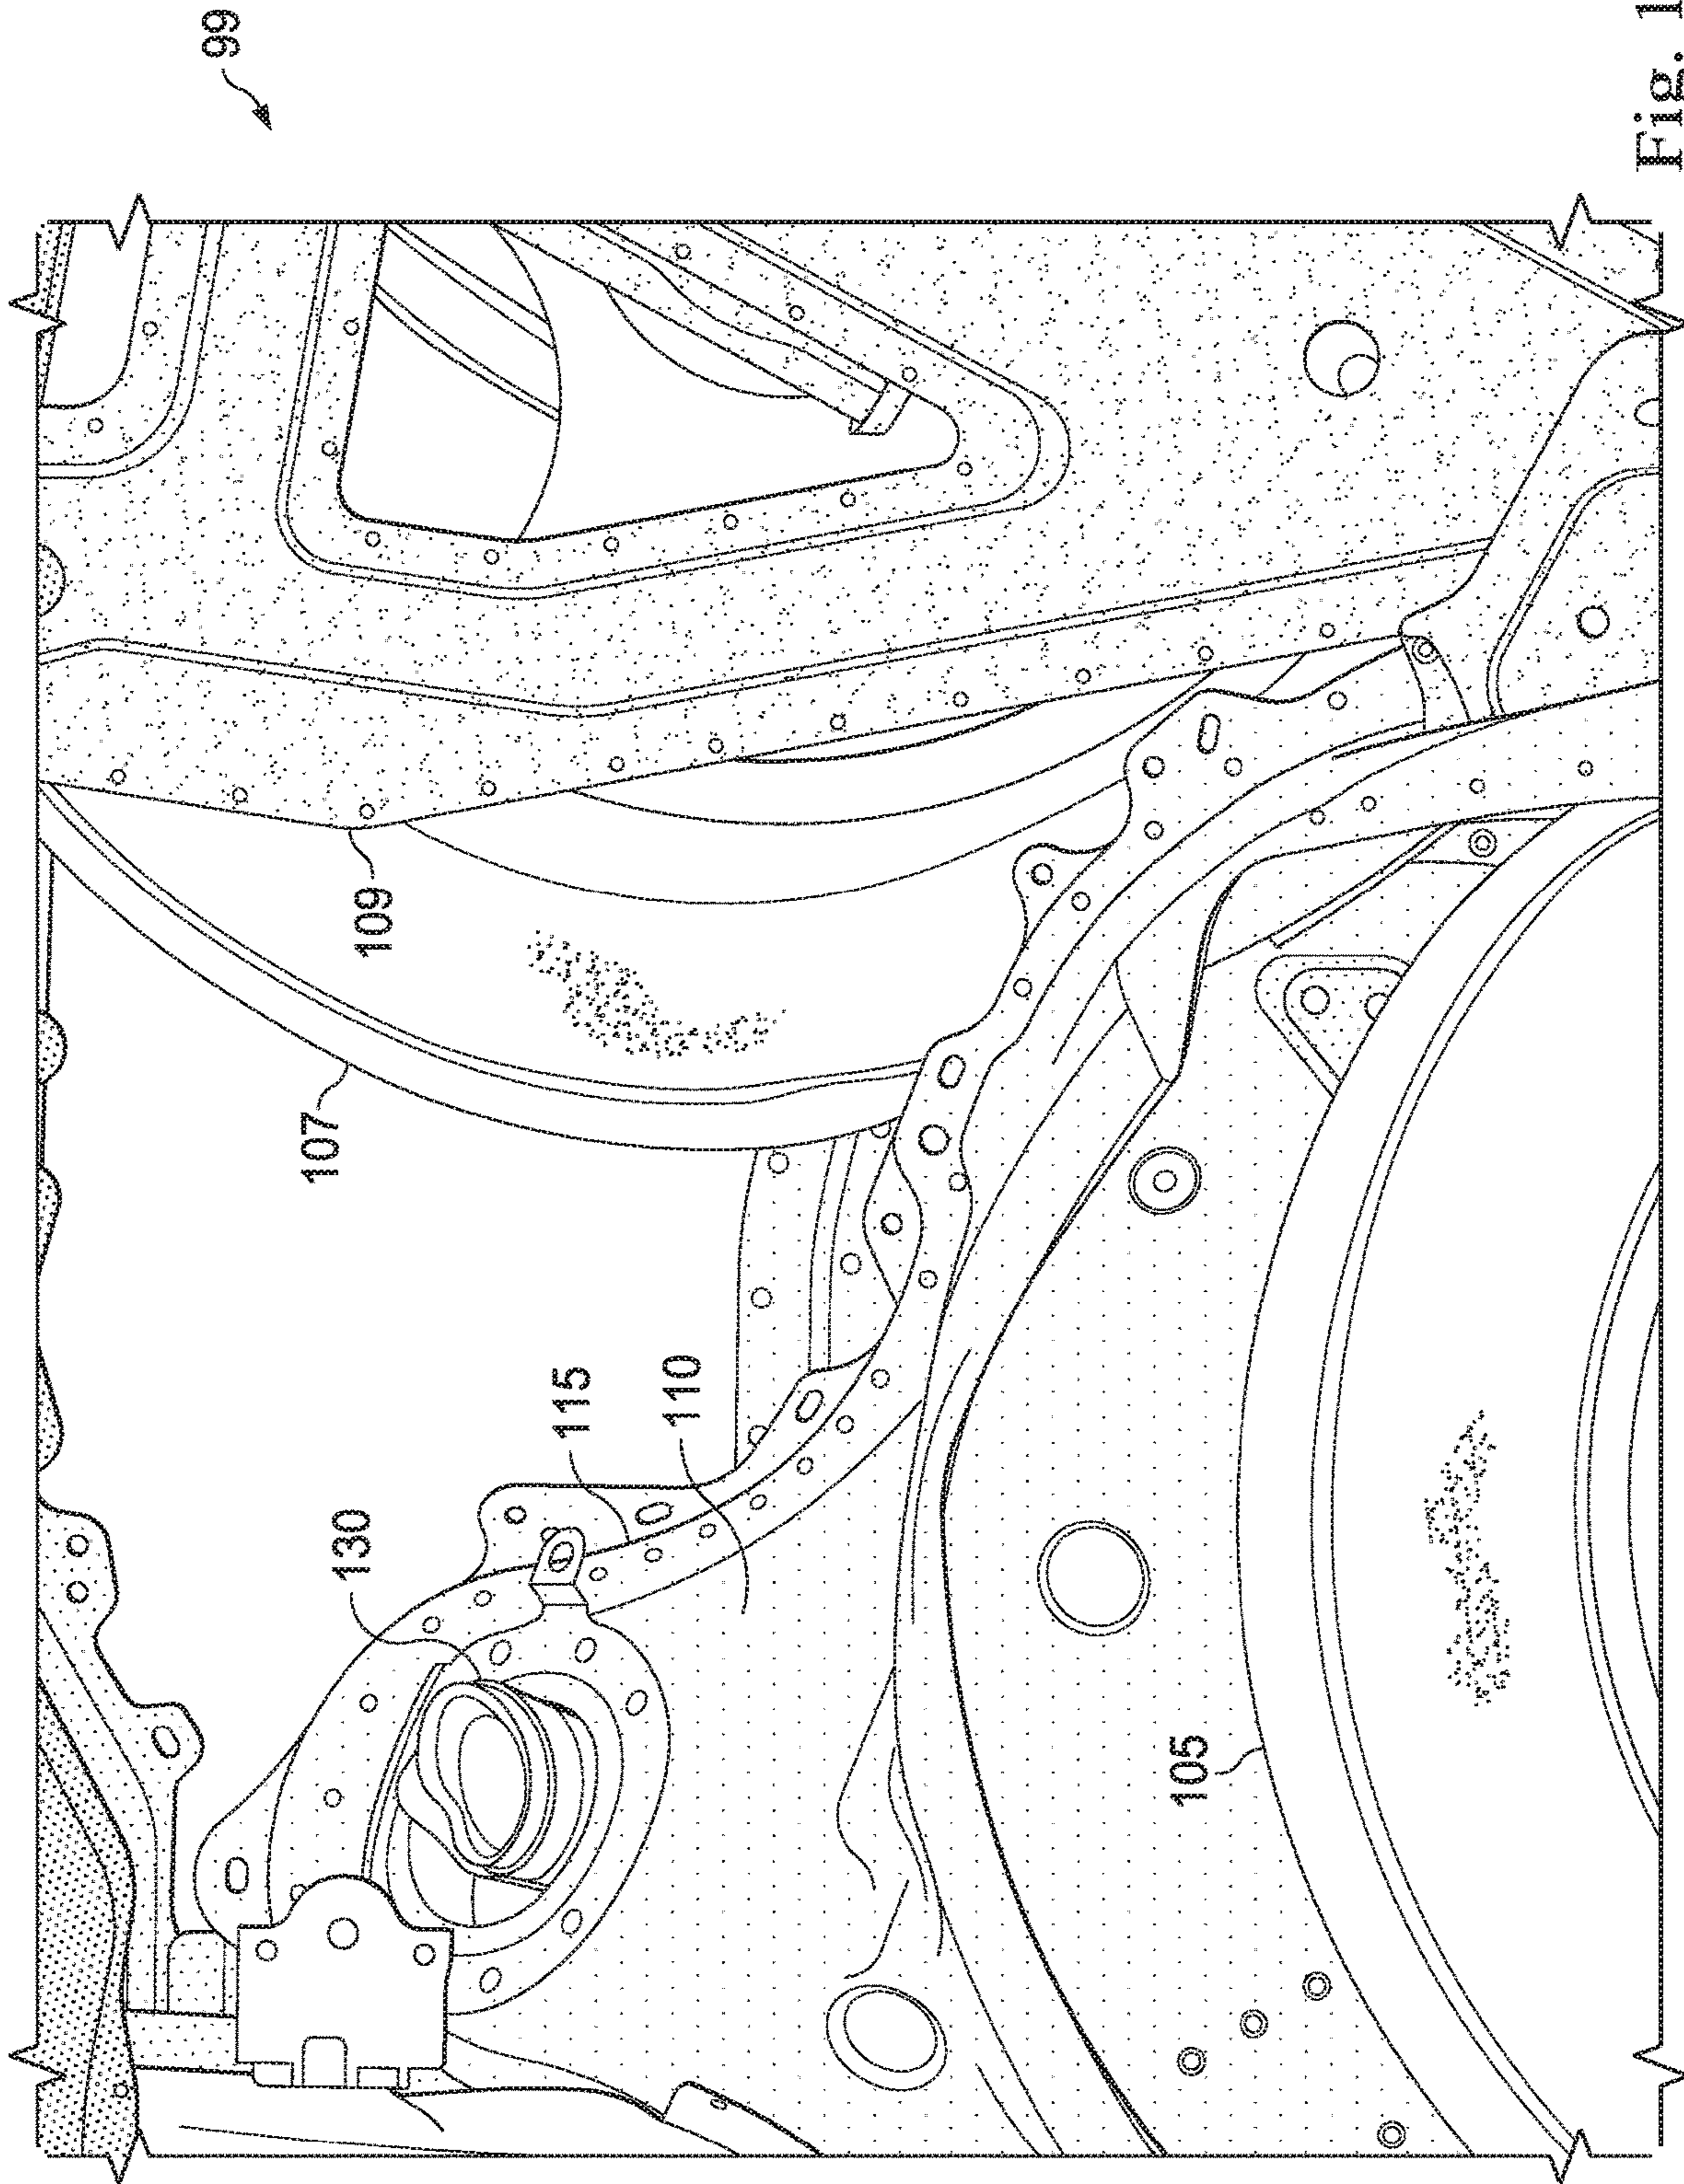
Fig. 14

FIG. 14 is a side perspective view of a baseline-case wheelhouse structure at a time point 30 milliseconds into a rear-impact collision event, according to aspects of the present disclosure.
