(10) **Patent No.:** **US 11,247,733 B2**
(45) **Date of Patent:** **Feb. 15, 2022**

(54) **DEFORMING WHEELHOUSE STRUCTURE FOR A VEHICLE**

(71) Applicant: **TOYOTA MOTOR ENGINEERING & MANUFACTURING NORTH AMERICA, INC.**, Plano, TX (US)

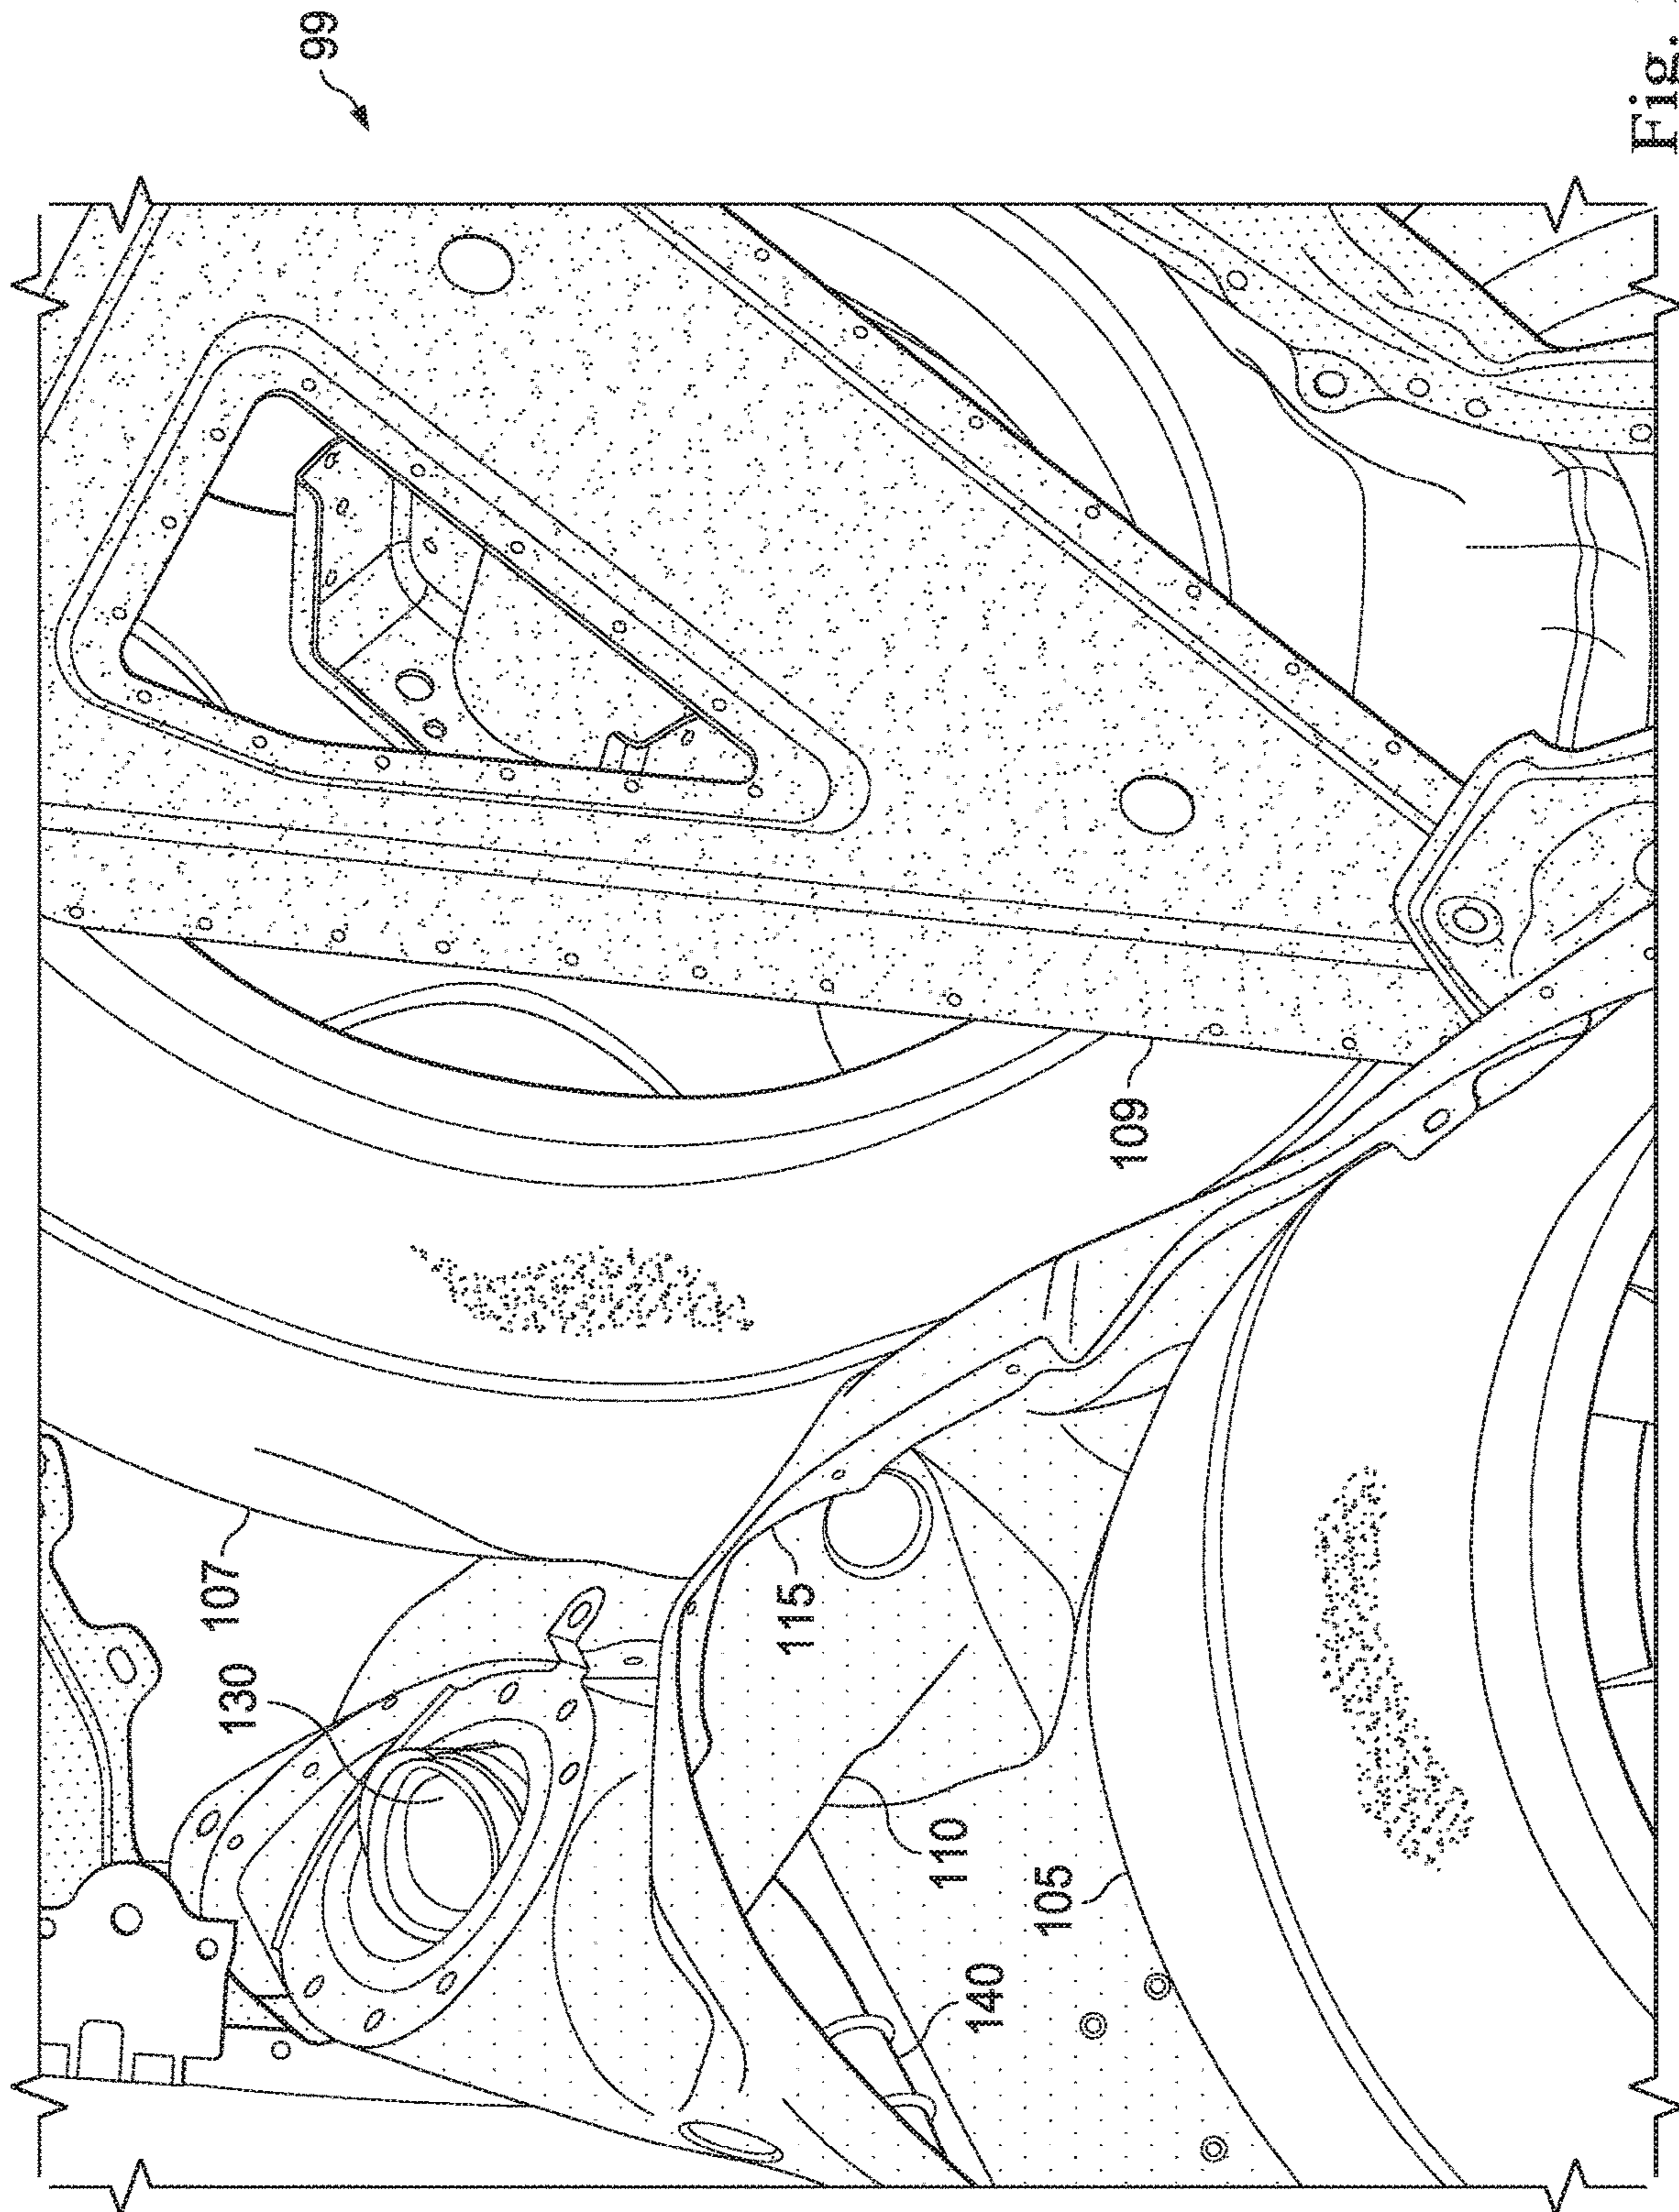
Fig. 15

FIG. 15 is a side perspective view of a baseline-case wheelhouse structure at a time point 50 milliseconds into a rear-impact collision event, according to aspects of the present disclosure.

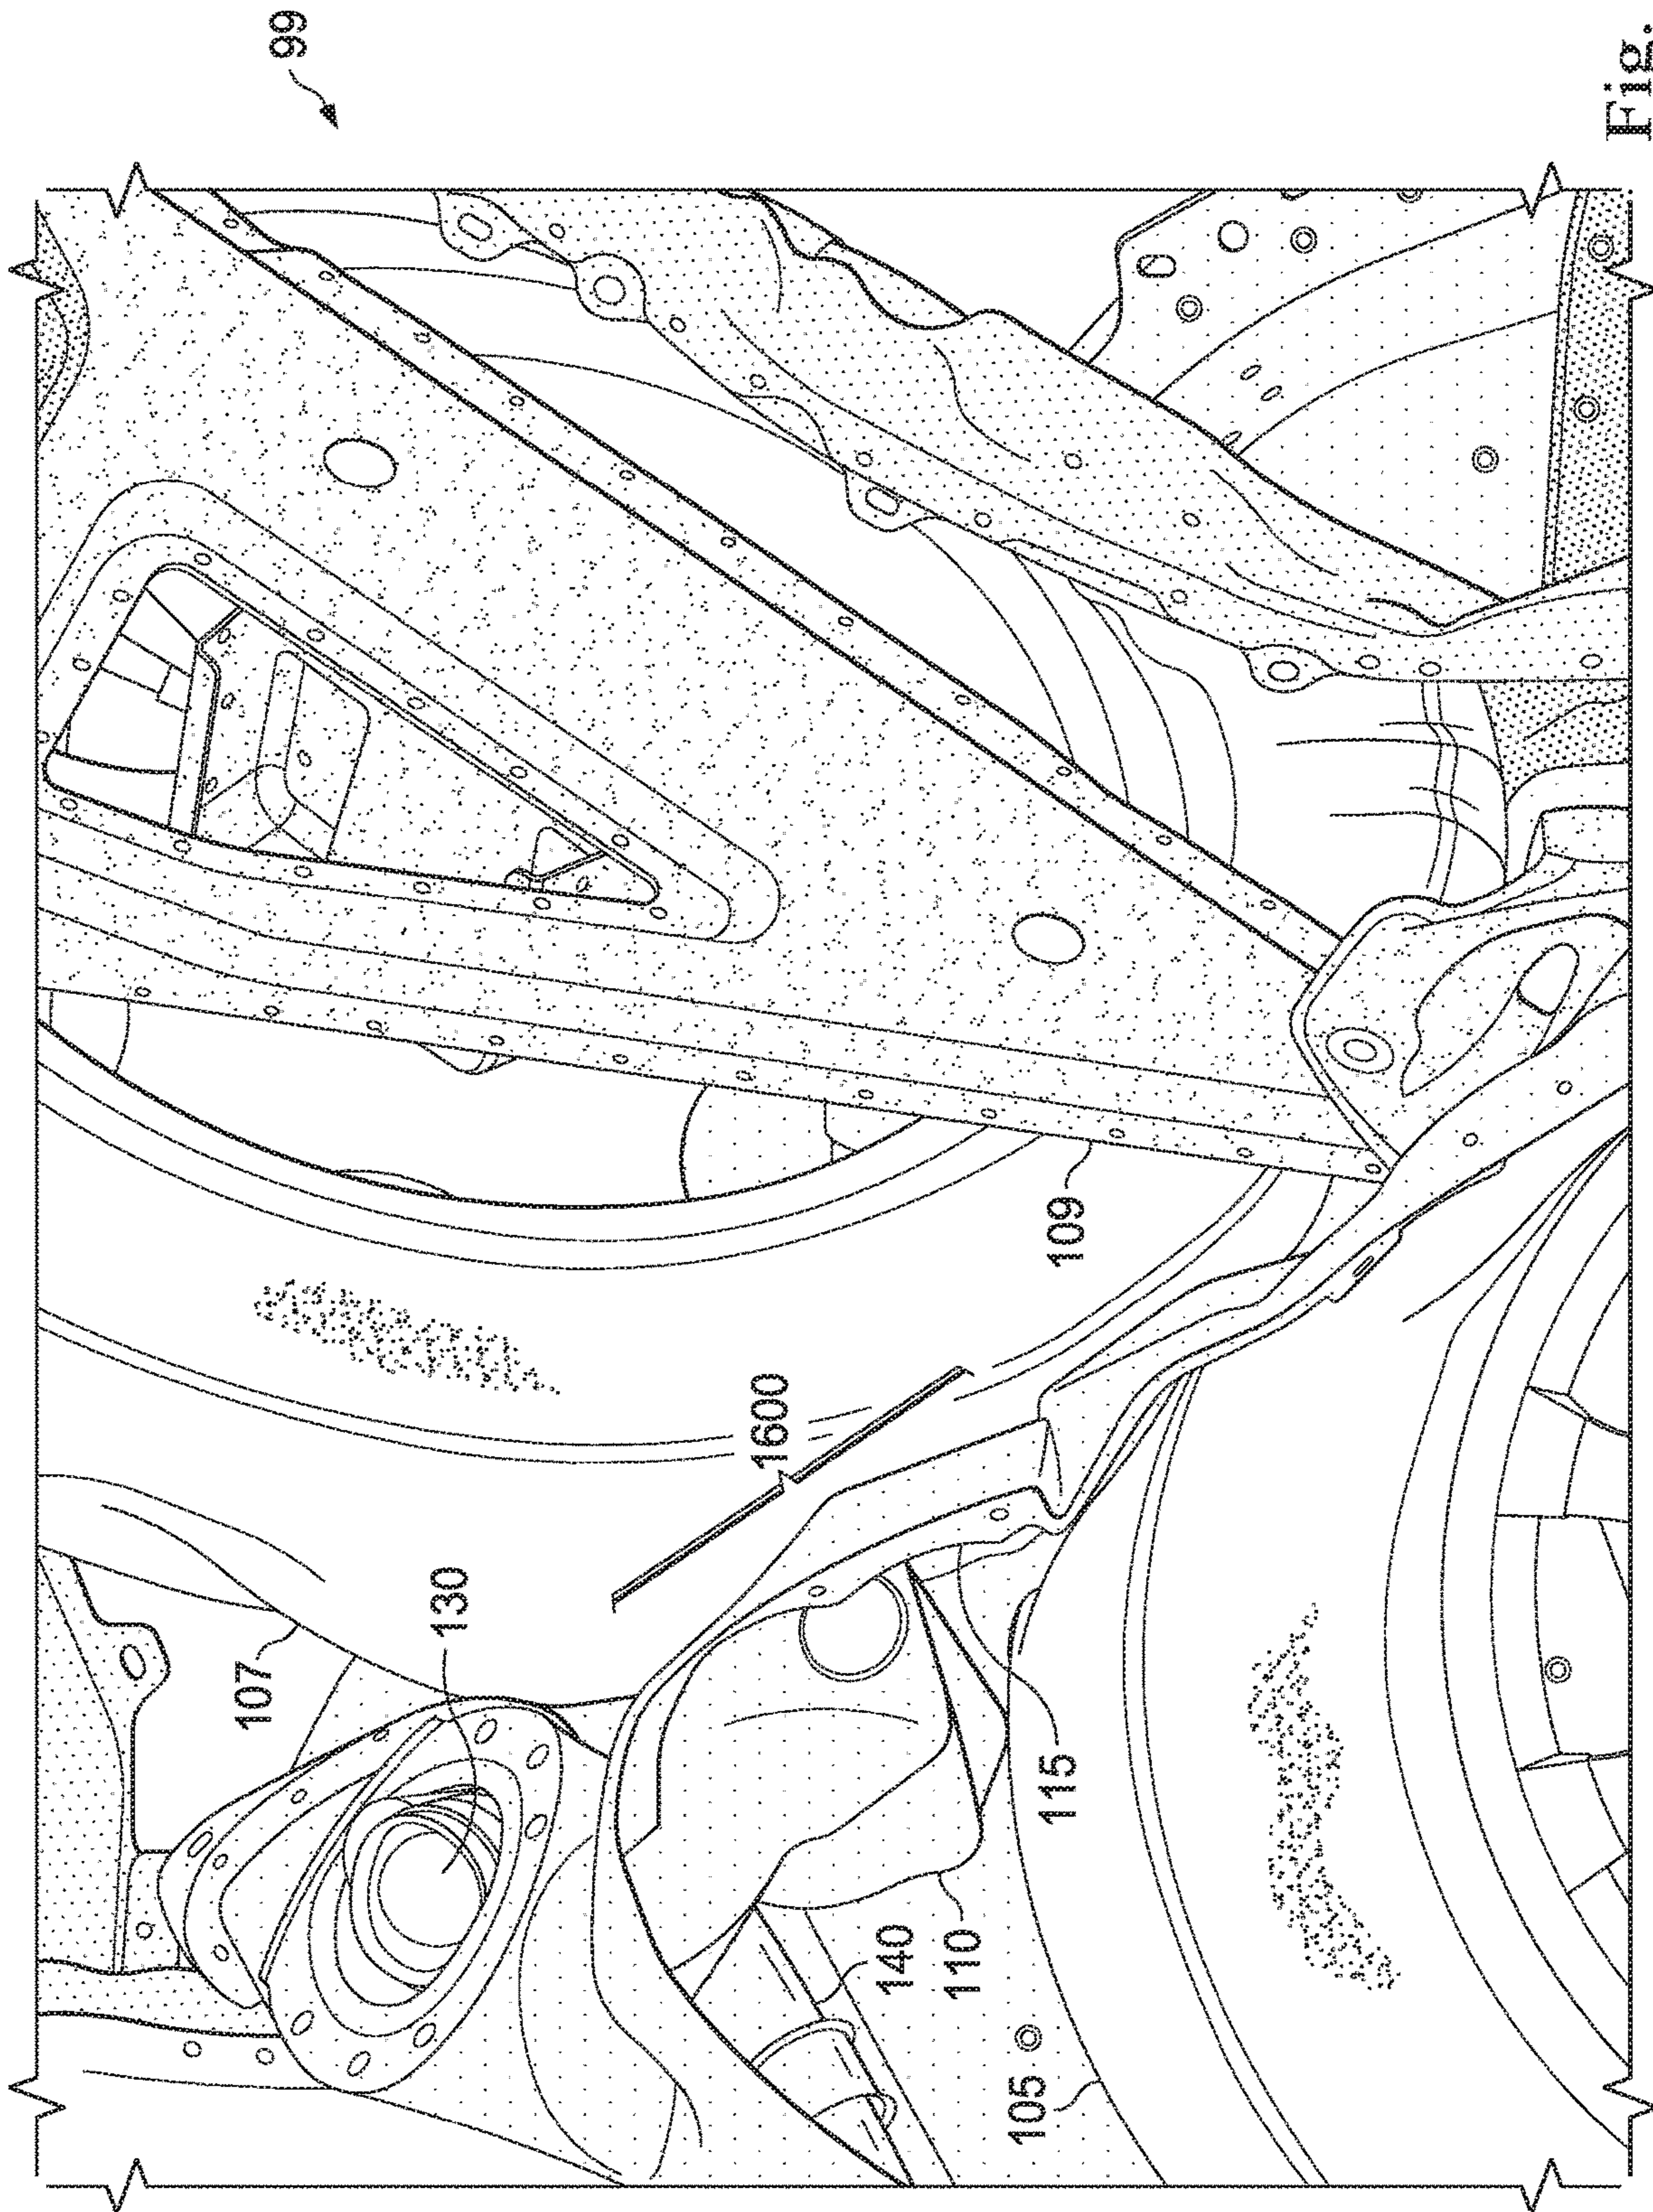
Fig. 16

FIG. 16 is a side perspective view of a baseline-case wheelhouse structure at a time point 70 milliseconds into a rear-impact collision event, according to aspects of the present disclosure.

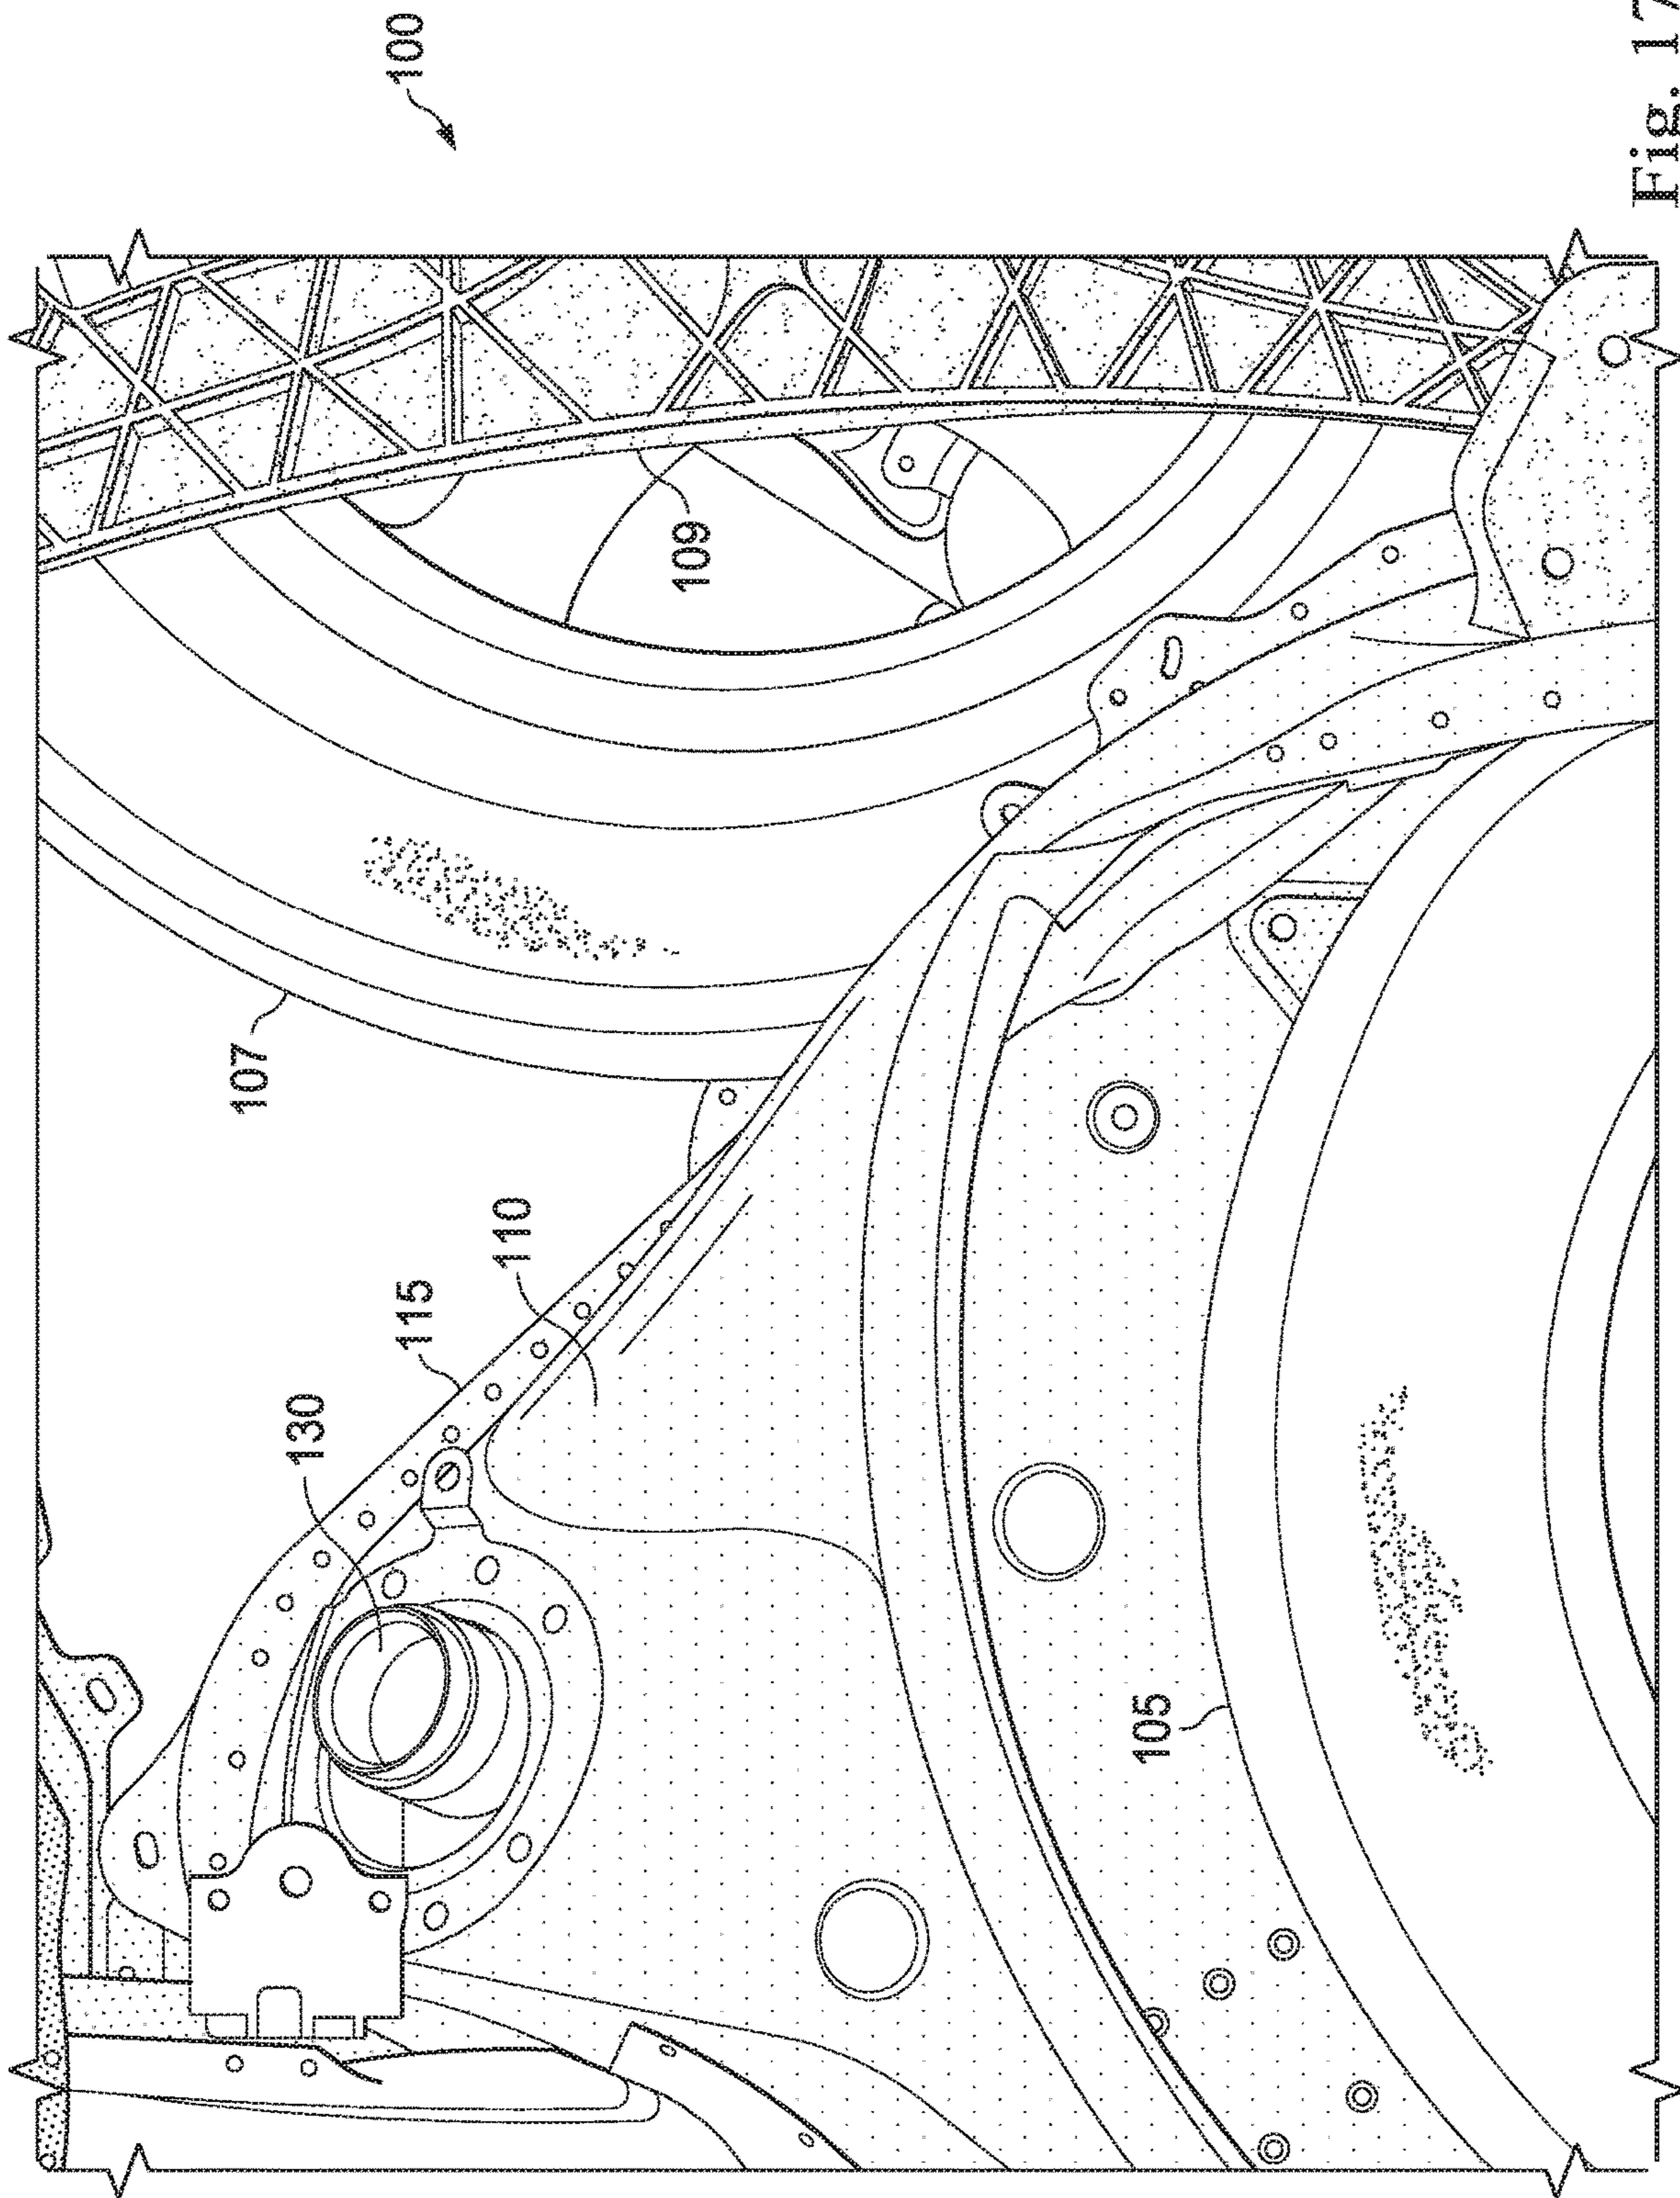
Fig. 17

FIG. 17 is a side perspective view of a countermeasure-case, deforming rear wheelhouse structure at a time point 30 milliseconds into a rear-impact collision event, according to at least one embodiment of the present disclosure.

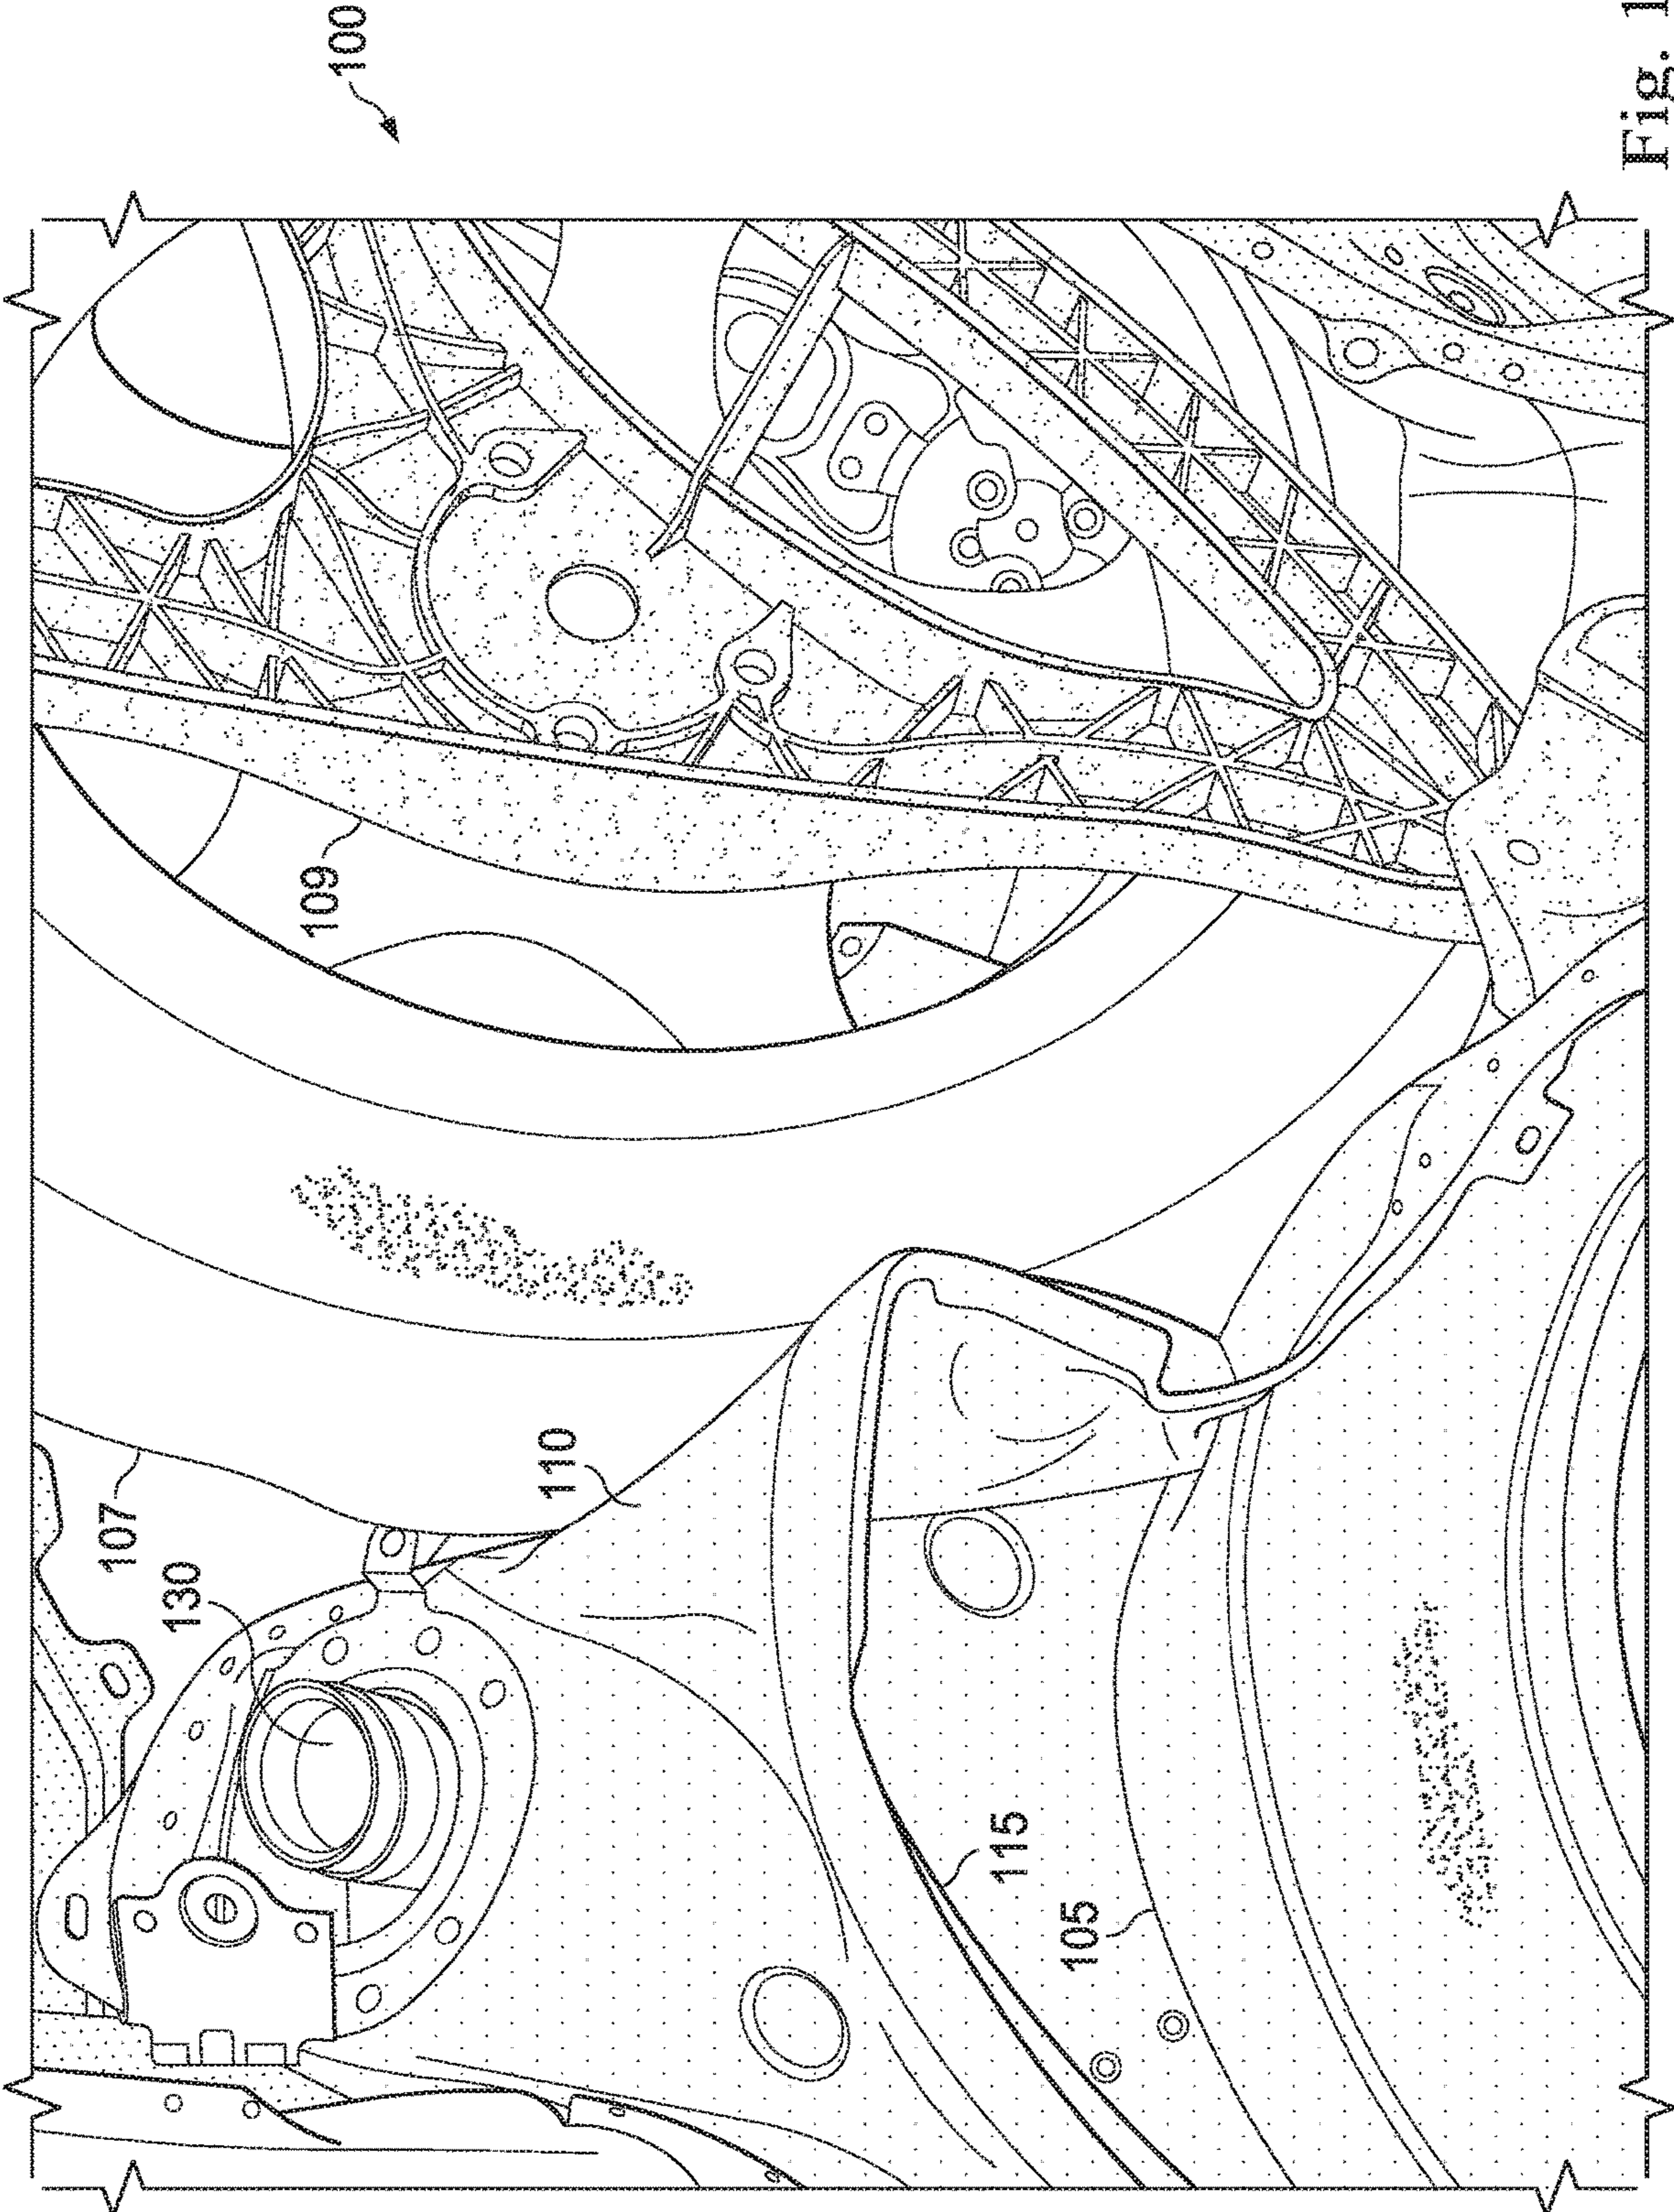
Fig. 18

FIG. 18 is a side perspective view of a countermeasure-case, deforming rear wheelhouse structure at a time point 50 milliseconds into a rear-impact collision event, according to at least one embodiment of the present disclosure.
