(12) **United States Patent**  
**Cheng et al.**

(10) **Patent No.:** **US 11,312,507 B2**  
(45) **Date of Patent:** **Apr. 26, 2022**

(54) **REPAIR ASSEMBLY TO REPAIR AN AREA ON A MEMBER OF A VEHICLE**

Methods and assemblies for repairing an identified area on a member of a vehicle. A first doubler plate is positioned over a first side of the identified area of the member. A second doubler plate is positioned over an opposing second side of the identified area of the member. A first plurality of fasteners are inserted through the identified area and each of the first and second doubler plates and secured. A second plurality of fasteners are inserted through the first and second doubler plates and the member at points away from the identified area and secured.

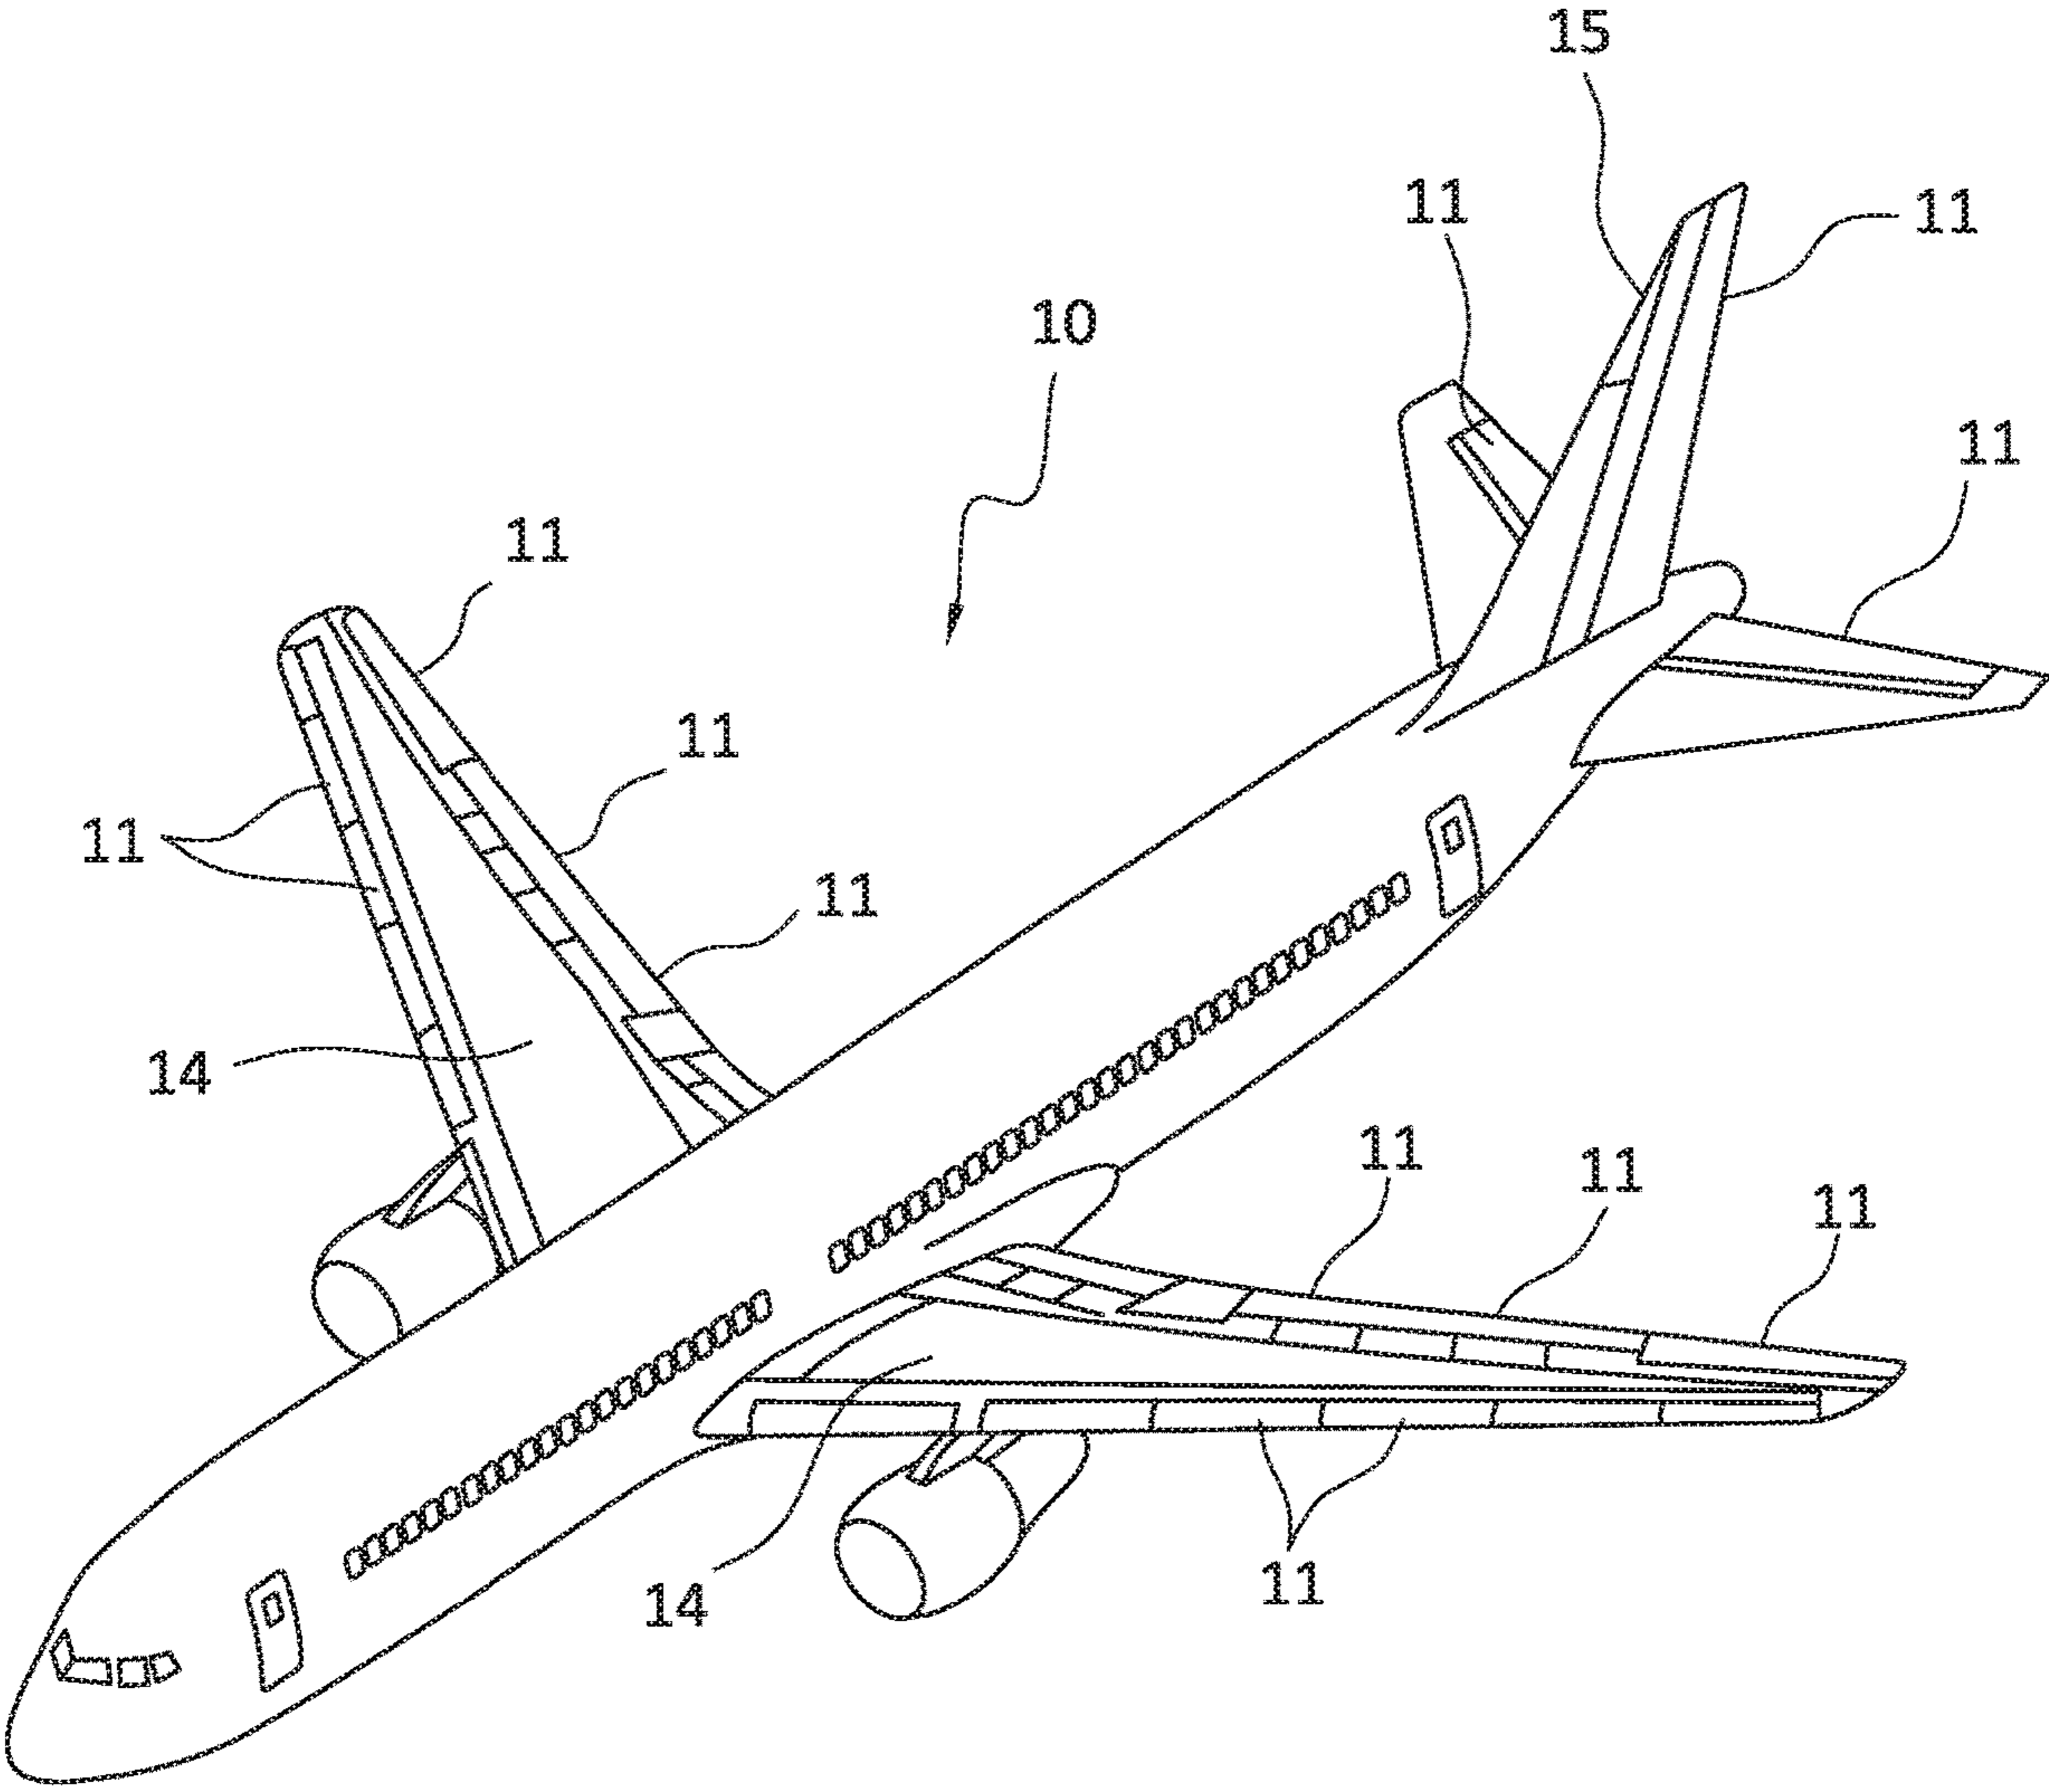
FIG. 1 is a perspective view of a vehicle.

The present application is directed to repairing a member 11 of a vehicle 10. In one example, the repairs can provide a temporary fix until more durable and longer lasting repairs can be made to the identified area. FIG. 1 illustrates one context of use in which the member 11 is a flight control member 11 on an aircraft 10. The flight control member 11 can include but is not limited to a rudder, elevator, aileron, flaperons, and flaps. The flight control members 11 are movably attached to various sections of the aircraft 10 including the wings 14 and tail 15 to change their orientation to control the flight.

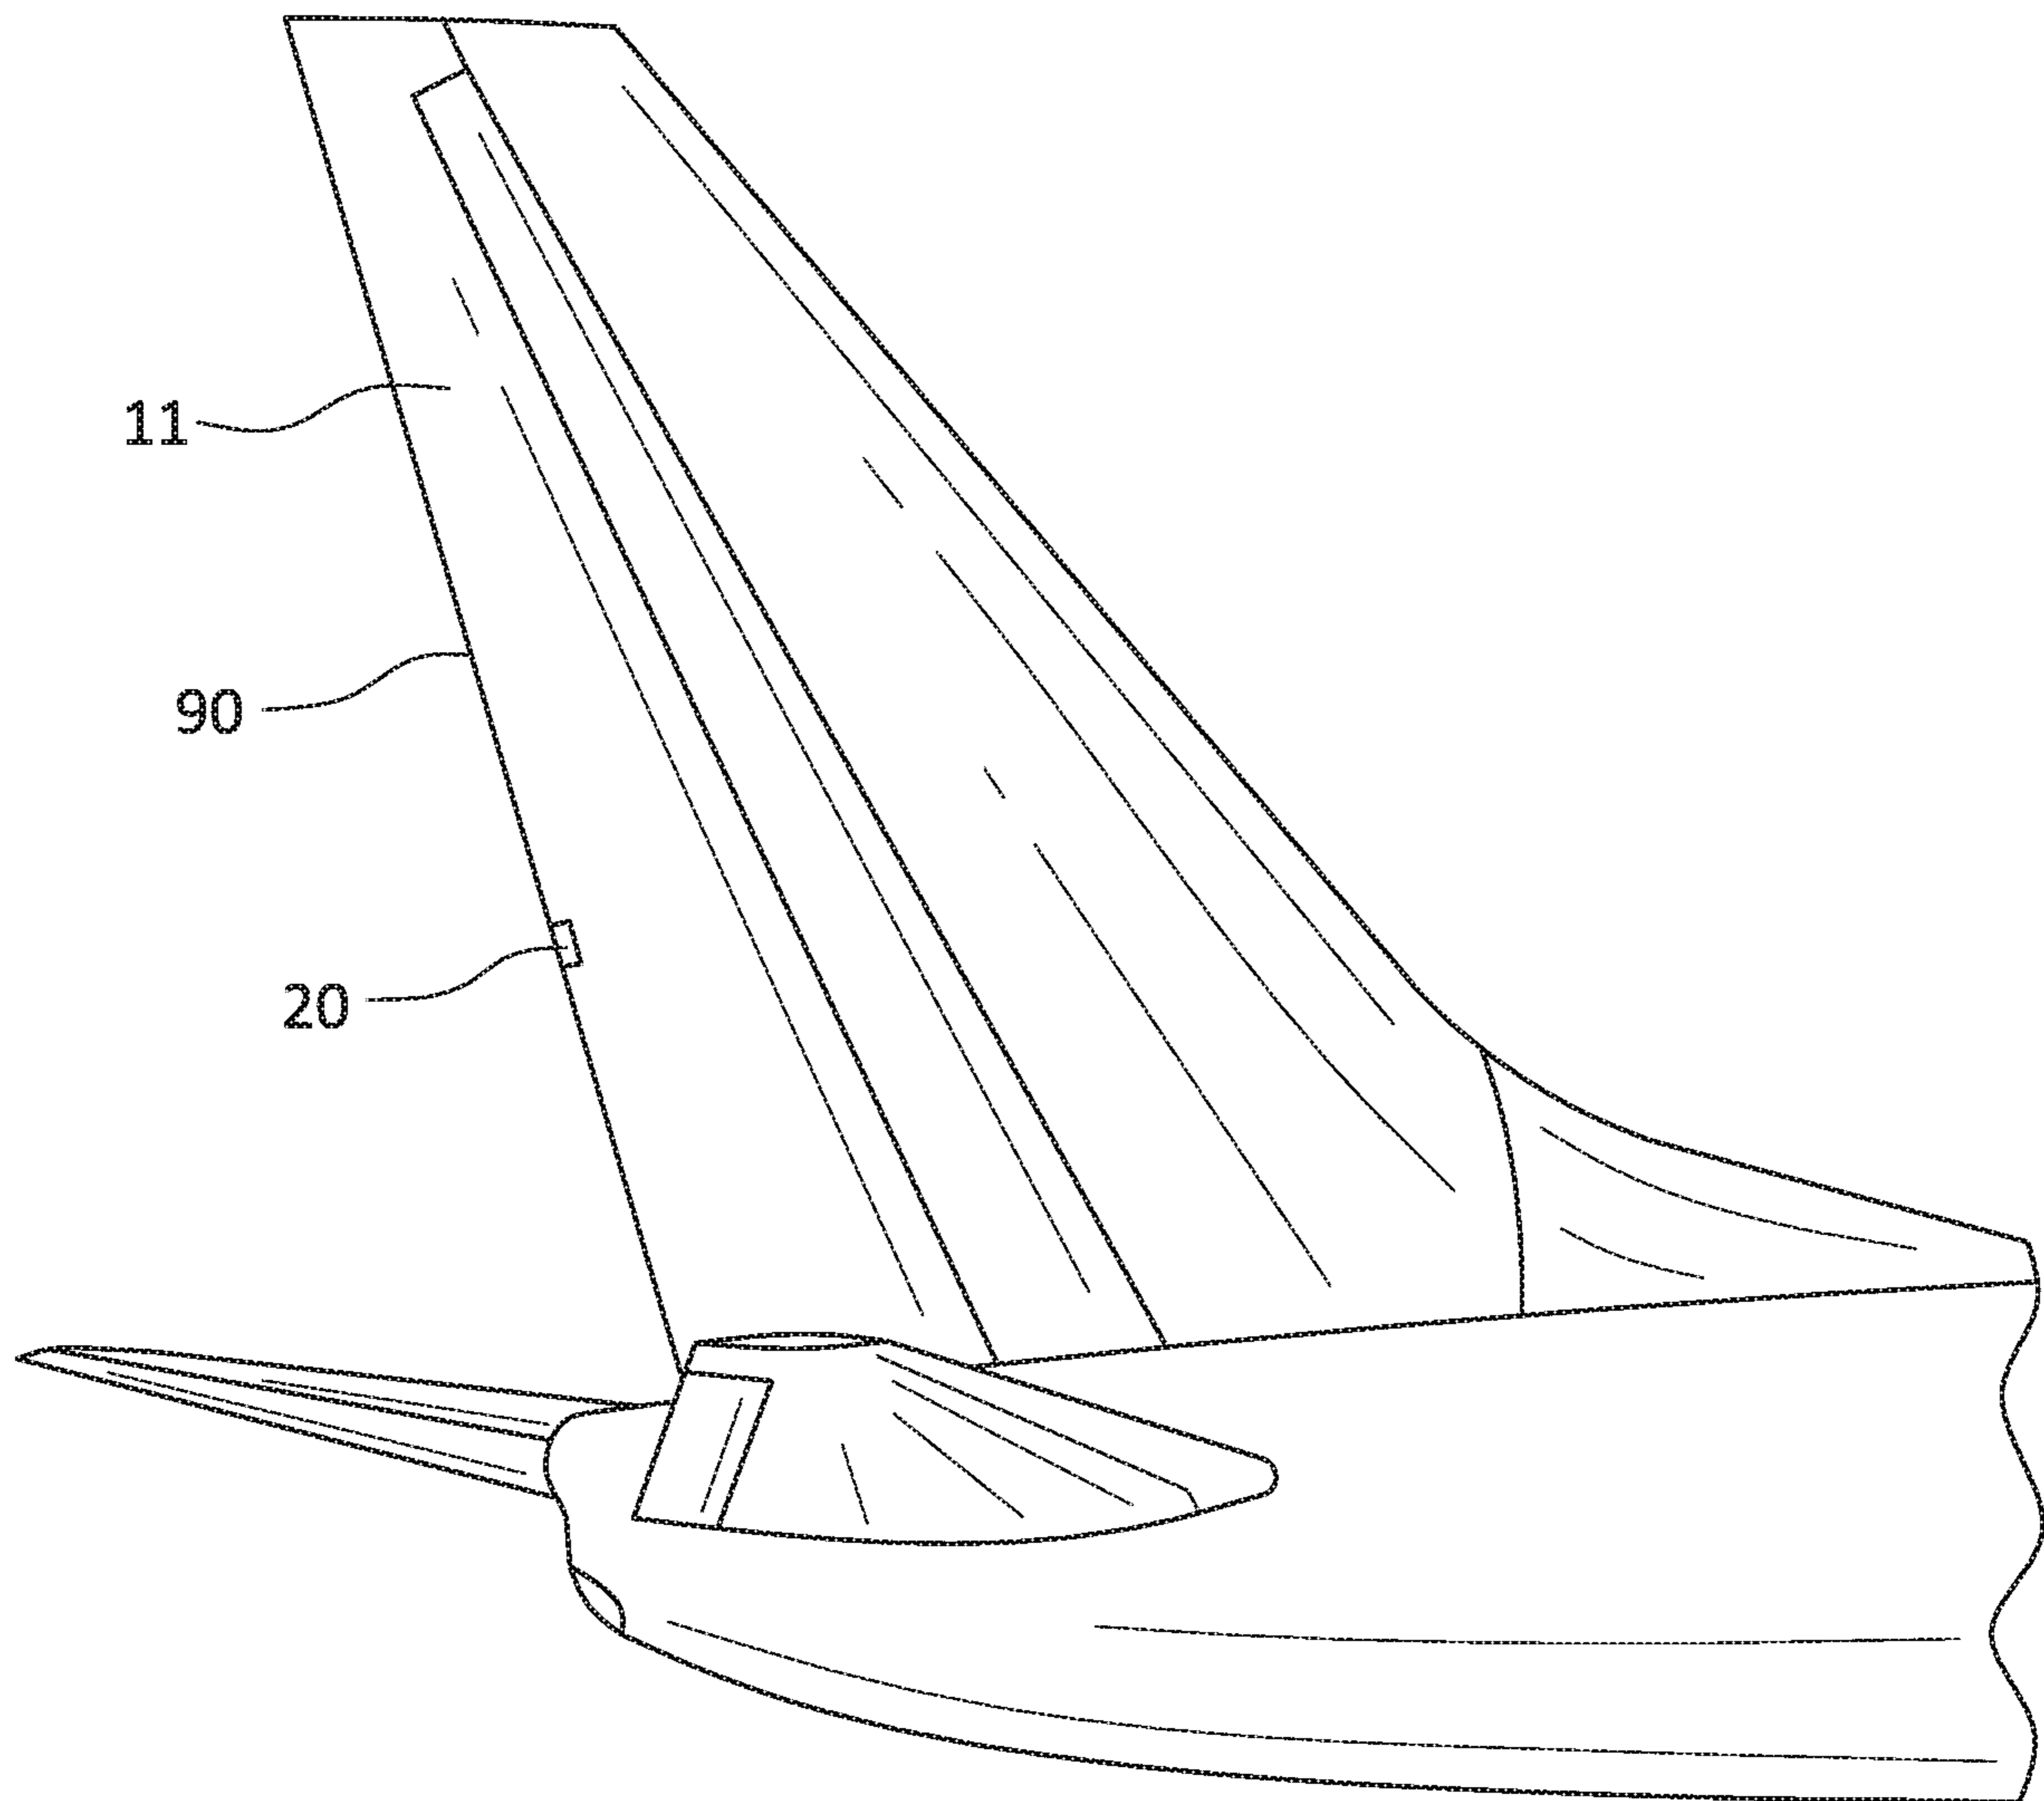
FIG. 2 is a perspective view of a repair assembly connected to a rudder of an aircraft.

FIG. 2 illustrates a repair assembly 20 mounted to a flight control member 11 of an aircraft 10. Specifically, the repair assembly 20 is mounted to a rudder 11 of the aircraft 10. The repair assembly 20 repairs the flight control member 11 to allow the aircraft 10 to remain in use for a period of time until a more permanent repair can be made to fix the identified area 19.

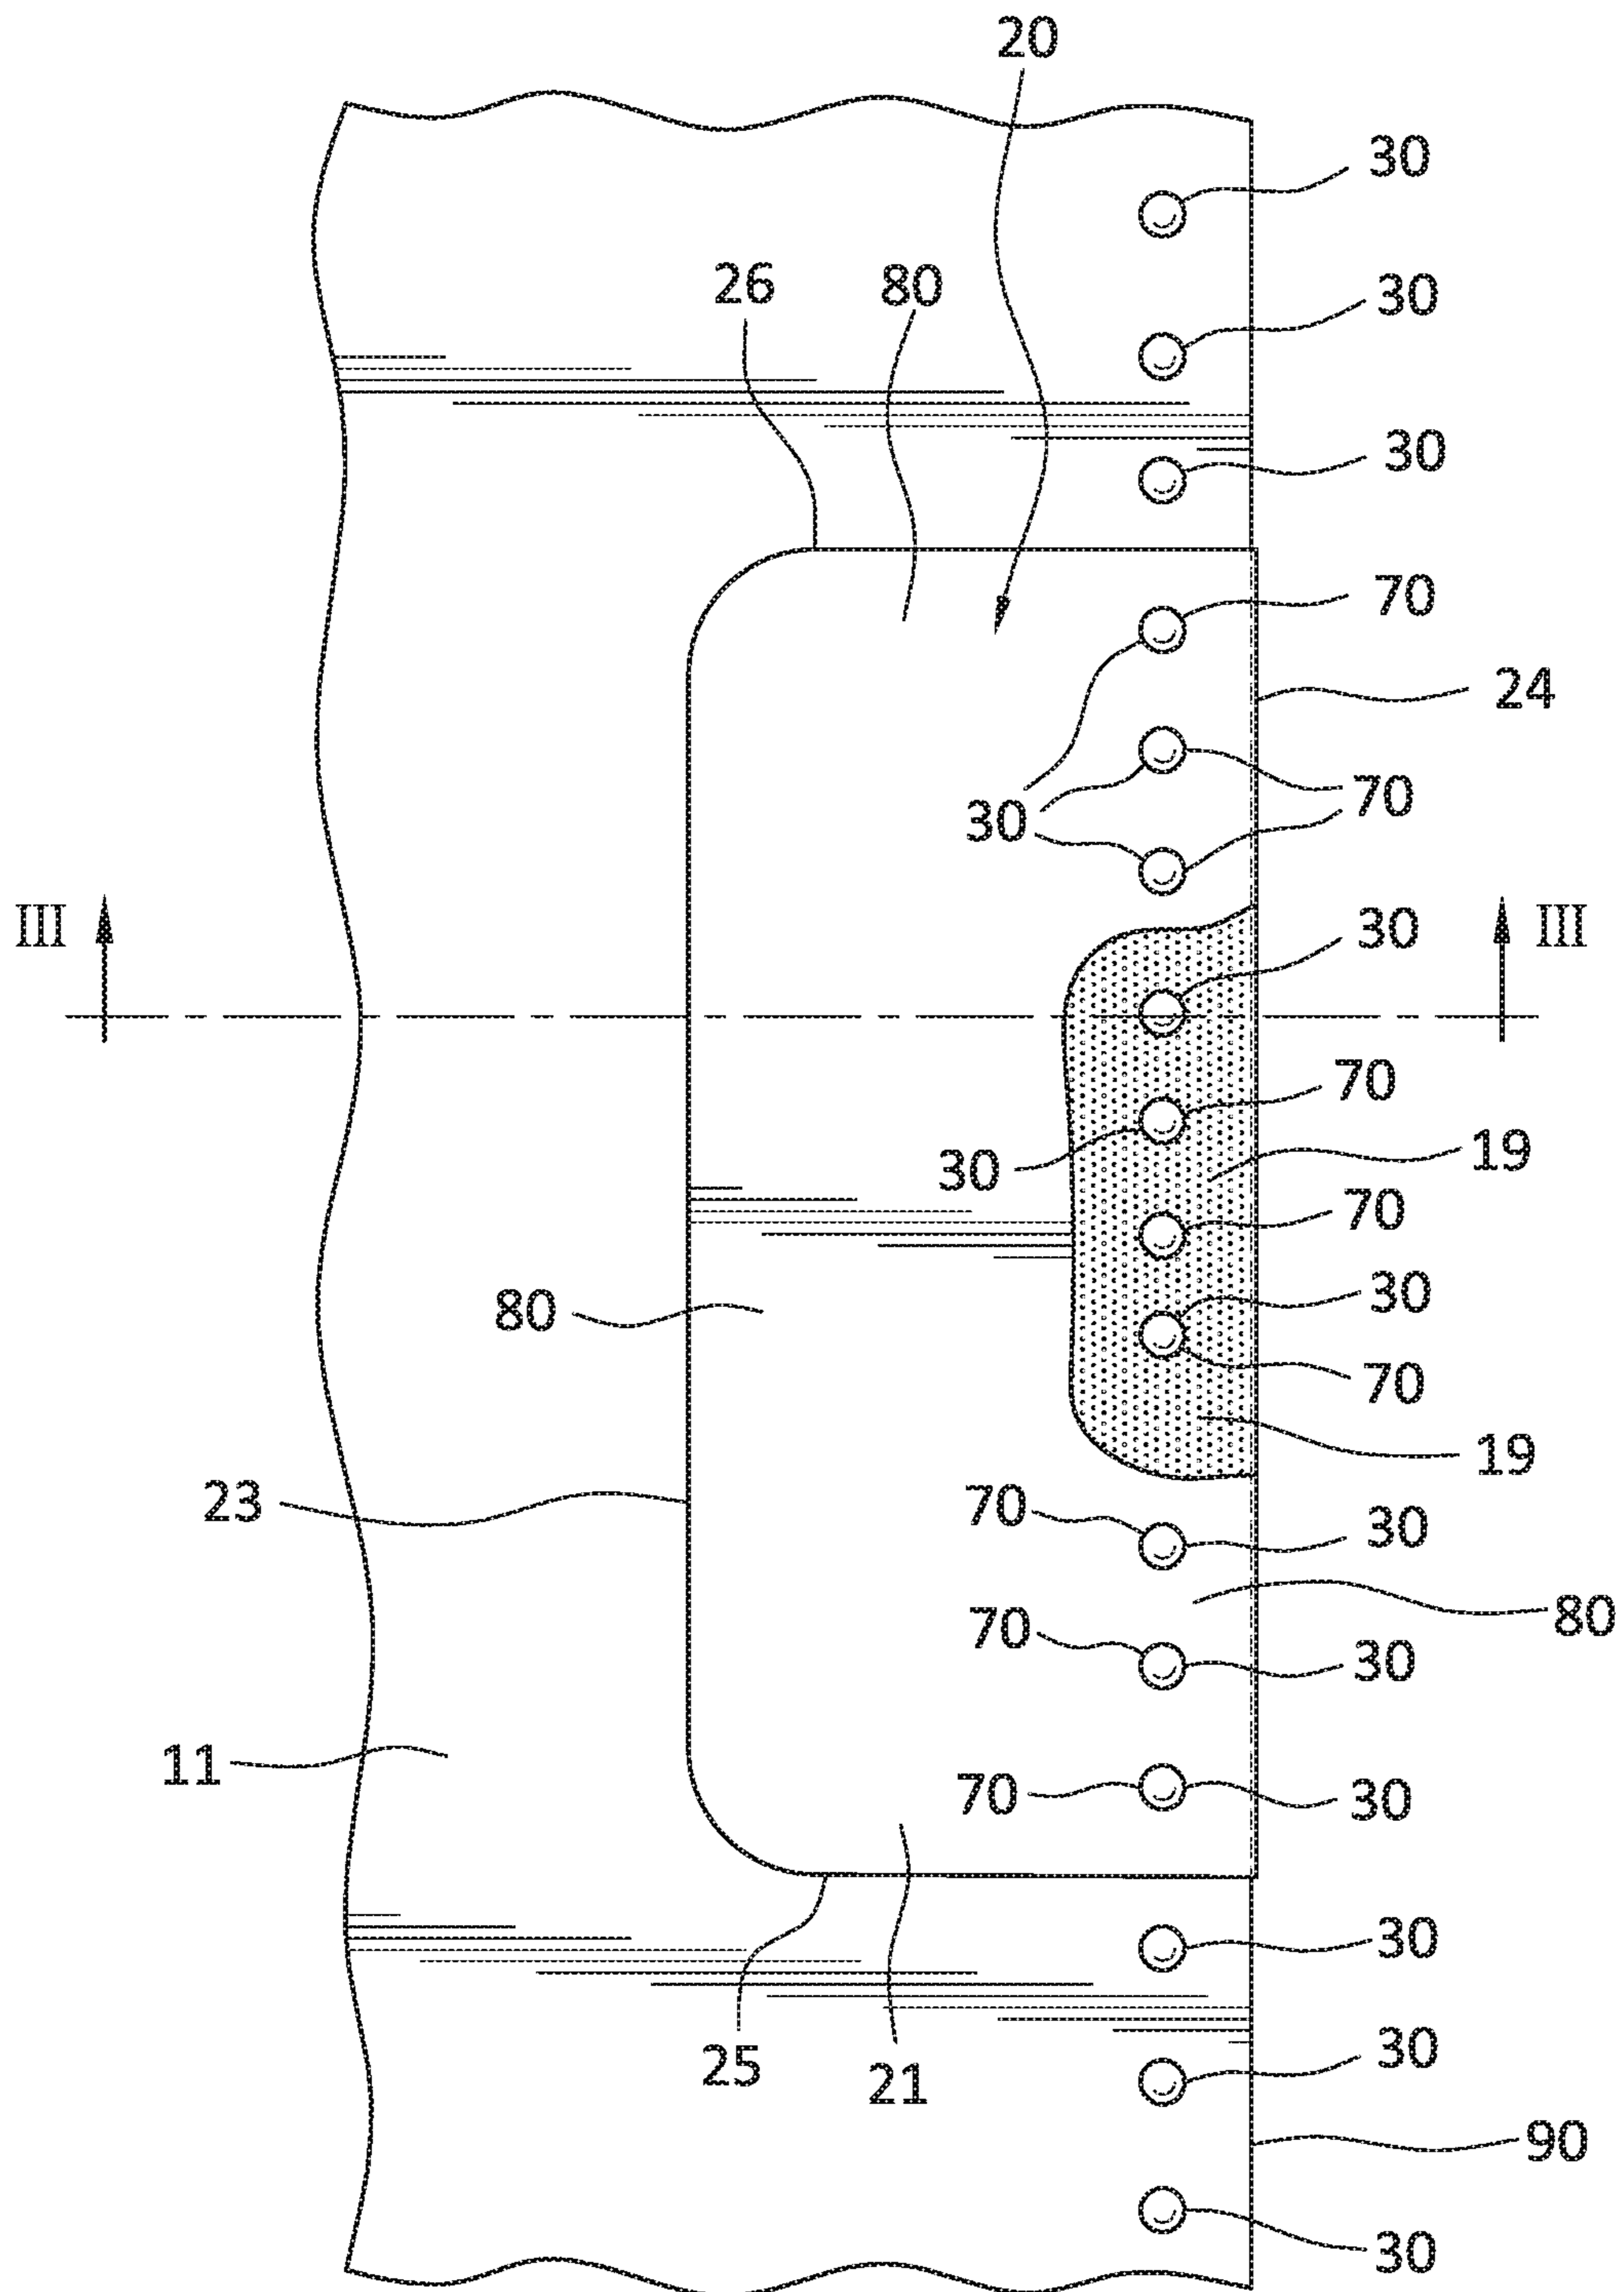
FIG. 3 is a schematic side view of a first doubler plate attached to and positioned on a member.

FIGS. 3 and 4 illustrate a repair assembly 20 positioned over an identified area 19 of a member 11. The identified area 19 is determined to be in need of repair due to a variety of different causes. This can include an area that is damaged due to various occurrences, such as but not limited to a lightning strike and wear during prolonged use. The identified area 19 can be determined in a variety of different

manners, including but not limited to during a visual inspection of the vehicle 10 (e.g., during a pre-flight inspection), and by instrument readings during use of the vehicle 10. The identified area 19 can be located at various positions along the member 11, and can include various sizes. The identified area 19 can be located along holes 70 that extend through the member 11 and receive fasteners 30 that connect together the different layers. FIG. 3 includes the identified area 19 located in proximity to a trailing edge 90 of the member 11. The identified area 19 extends through a line of fasteners 30 that extend along the trailing edge 90.

The repair assembly 20 includes a first doubler plate 21 mounted on a first side of the member 11. An opposing second doubler plate 22 is mounted on an opposing second side of the member 11. The first and second doubler plates 21, 22 include a leading edge 23, a trailing edge 24, and opposing lateral edges 25, 26. The sizes and shapes of the first and second doubler plates 21, 22 can vary. FIG. 3 includes a substantially rectangular shape with curved corners at the leading edges 23. The trailing edges 24 are straight to align with the trailing edge 90 of the member 11. The first and second doubler plates 21, 22 can include the same or different shapes and/or sizes. The first and second doubler plates 21, 22 can include a variety of thicknesses. The first and second doubler plates 21, 22 can be constructed from a variety of materials, including but not limited to aluminum, corrosion resistant steel (CRES), titanium, thermoplastics, and pre-cured composites. The first and second doubler plates 21, 22 can be constructed from the same or different materials.

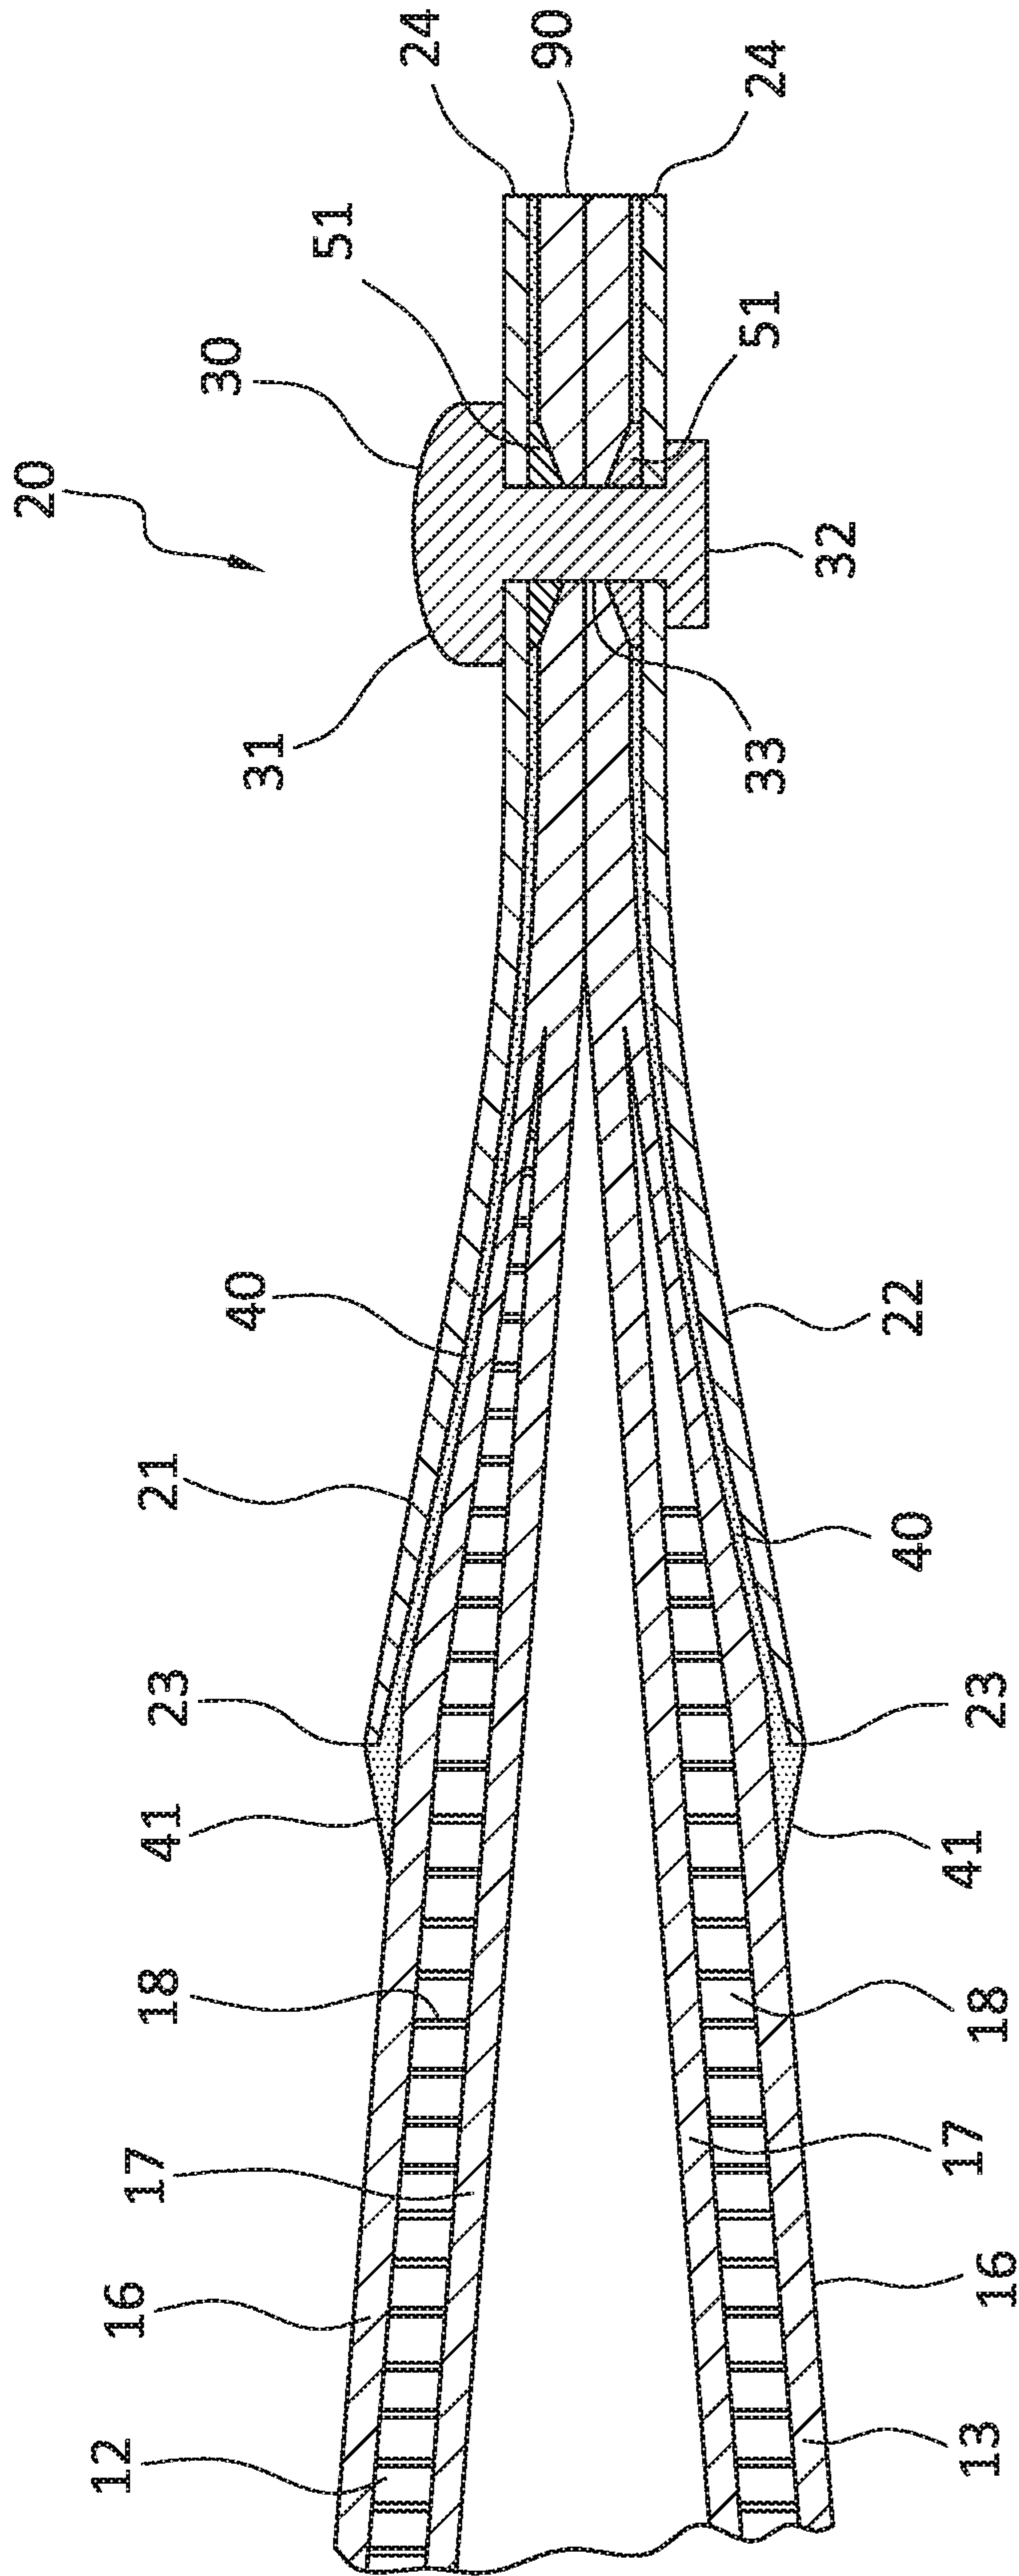
FIG. 4 is a section view cut along line of FIG. 3.

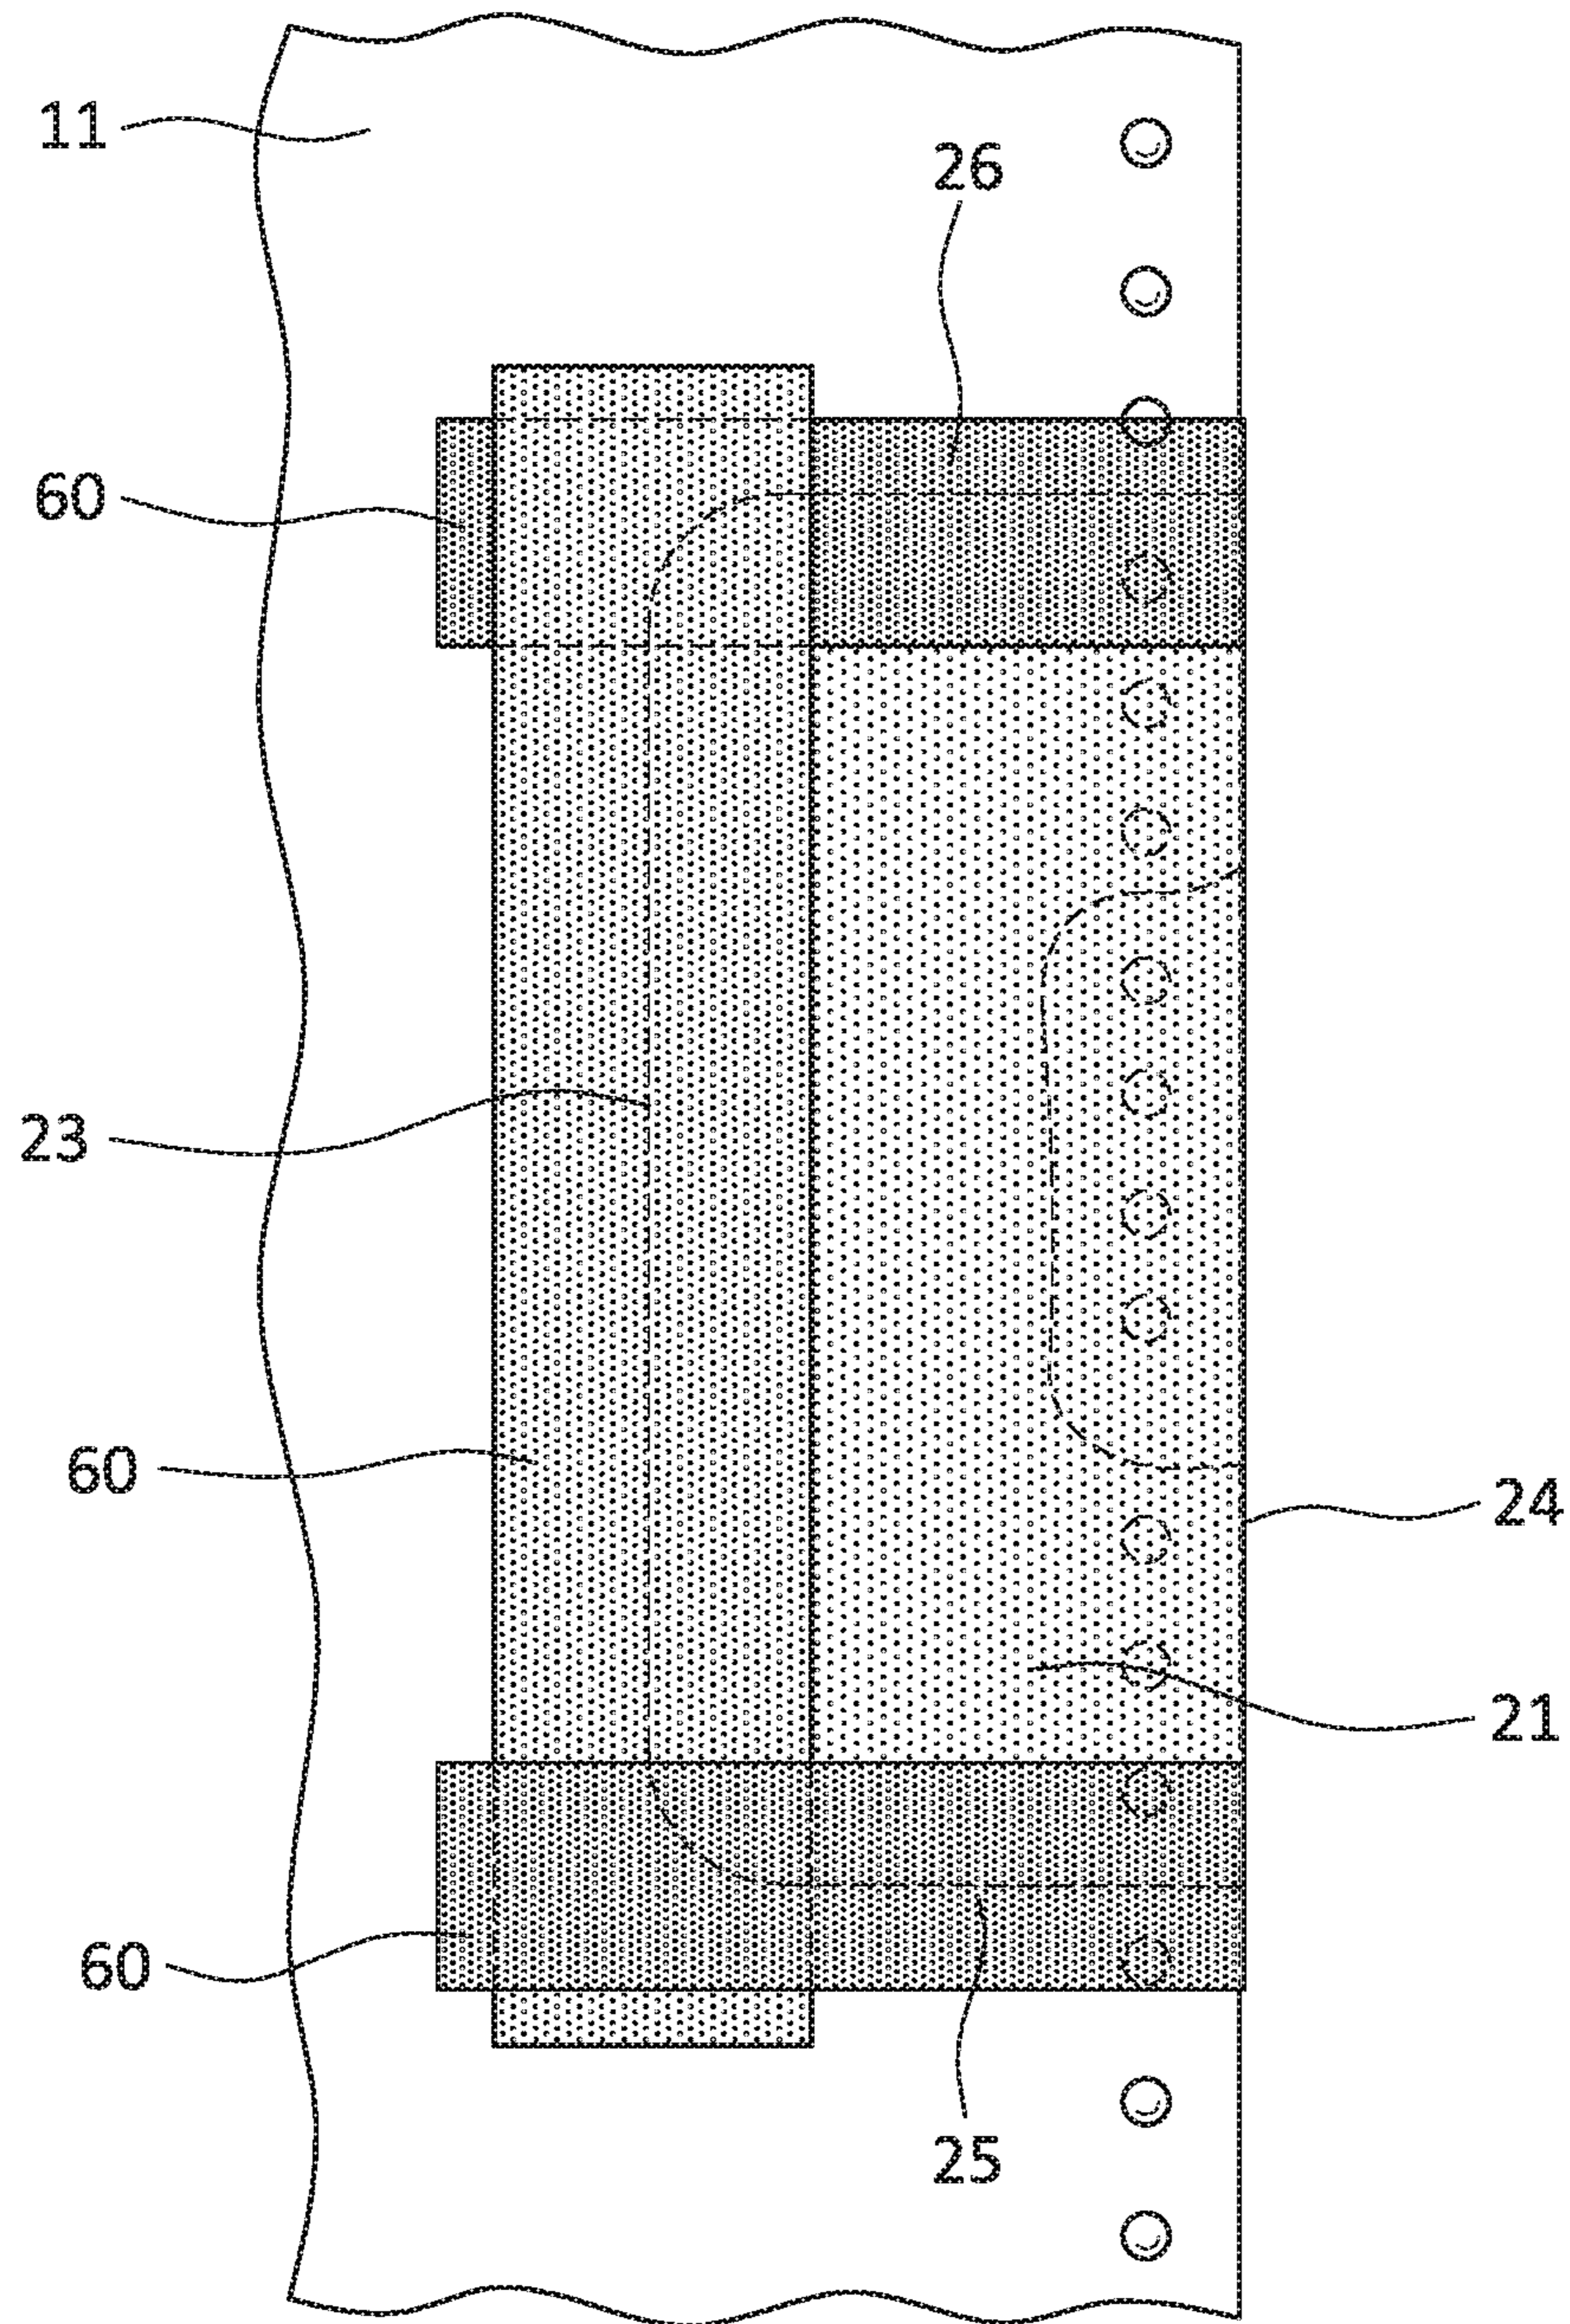
FIG. 5 is a schematic side view of a first doubler plate attached to and positioned on a member with tape attached along edges of the first doubler plate.
