US011312507B2

(54) **REPAIR ASSEMBLY TO REPAIR AN AREA ON A MEMBER OF A VEHICLE**

Methods and assemblies for repairing an identified area on a member of a vehicle. A first doubler plate is positioned over a first side of the identified area of the member. A second doubler plate is positioned over an opposing second side of the identified area of the member. A first plurality of fasteners are inserted through the identified area and each of the first and second doubler plates and secured. A second plurality of fasteners are inserted through the first and second doubler plates and the member at points away from the identified area and secured.

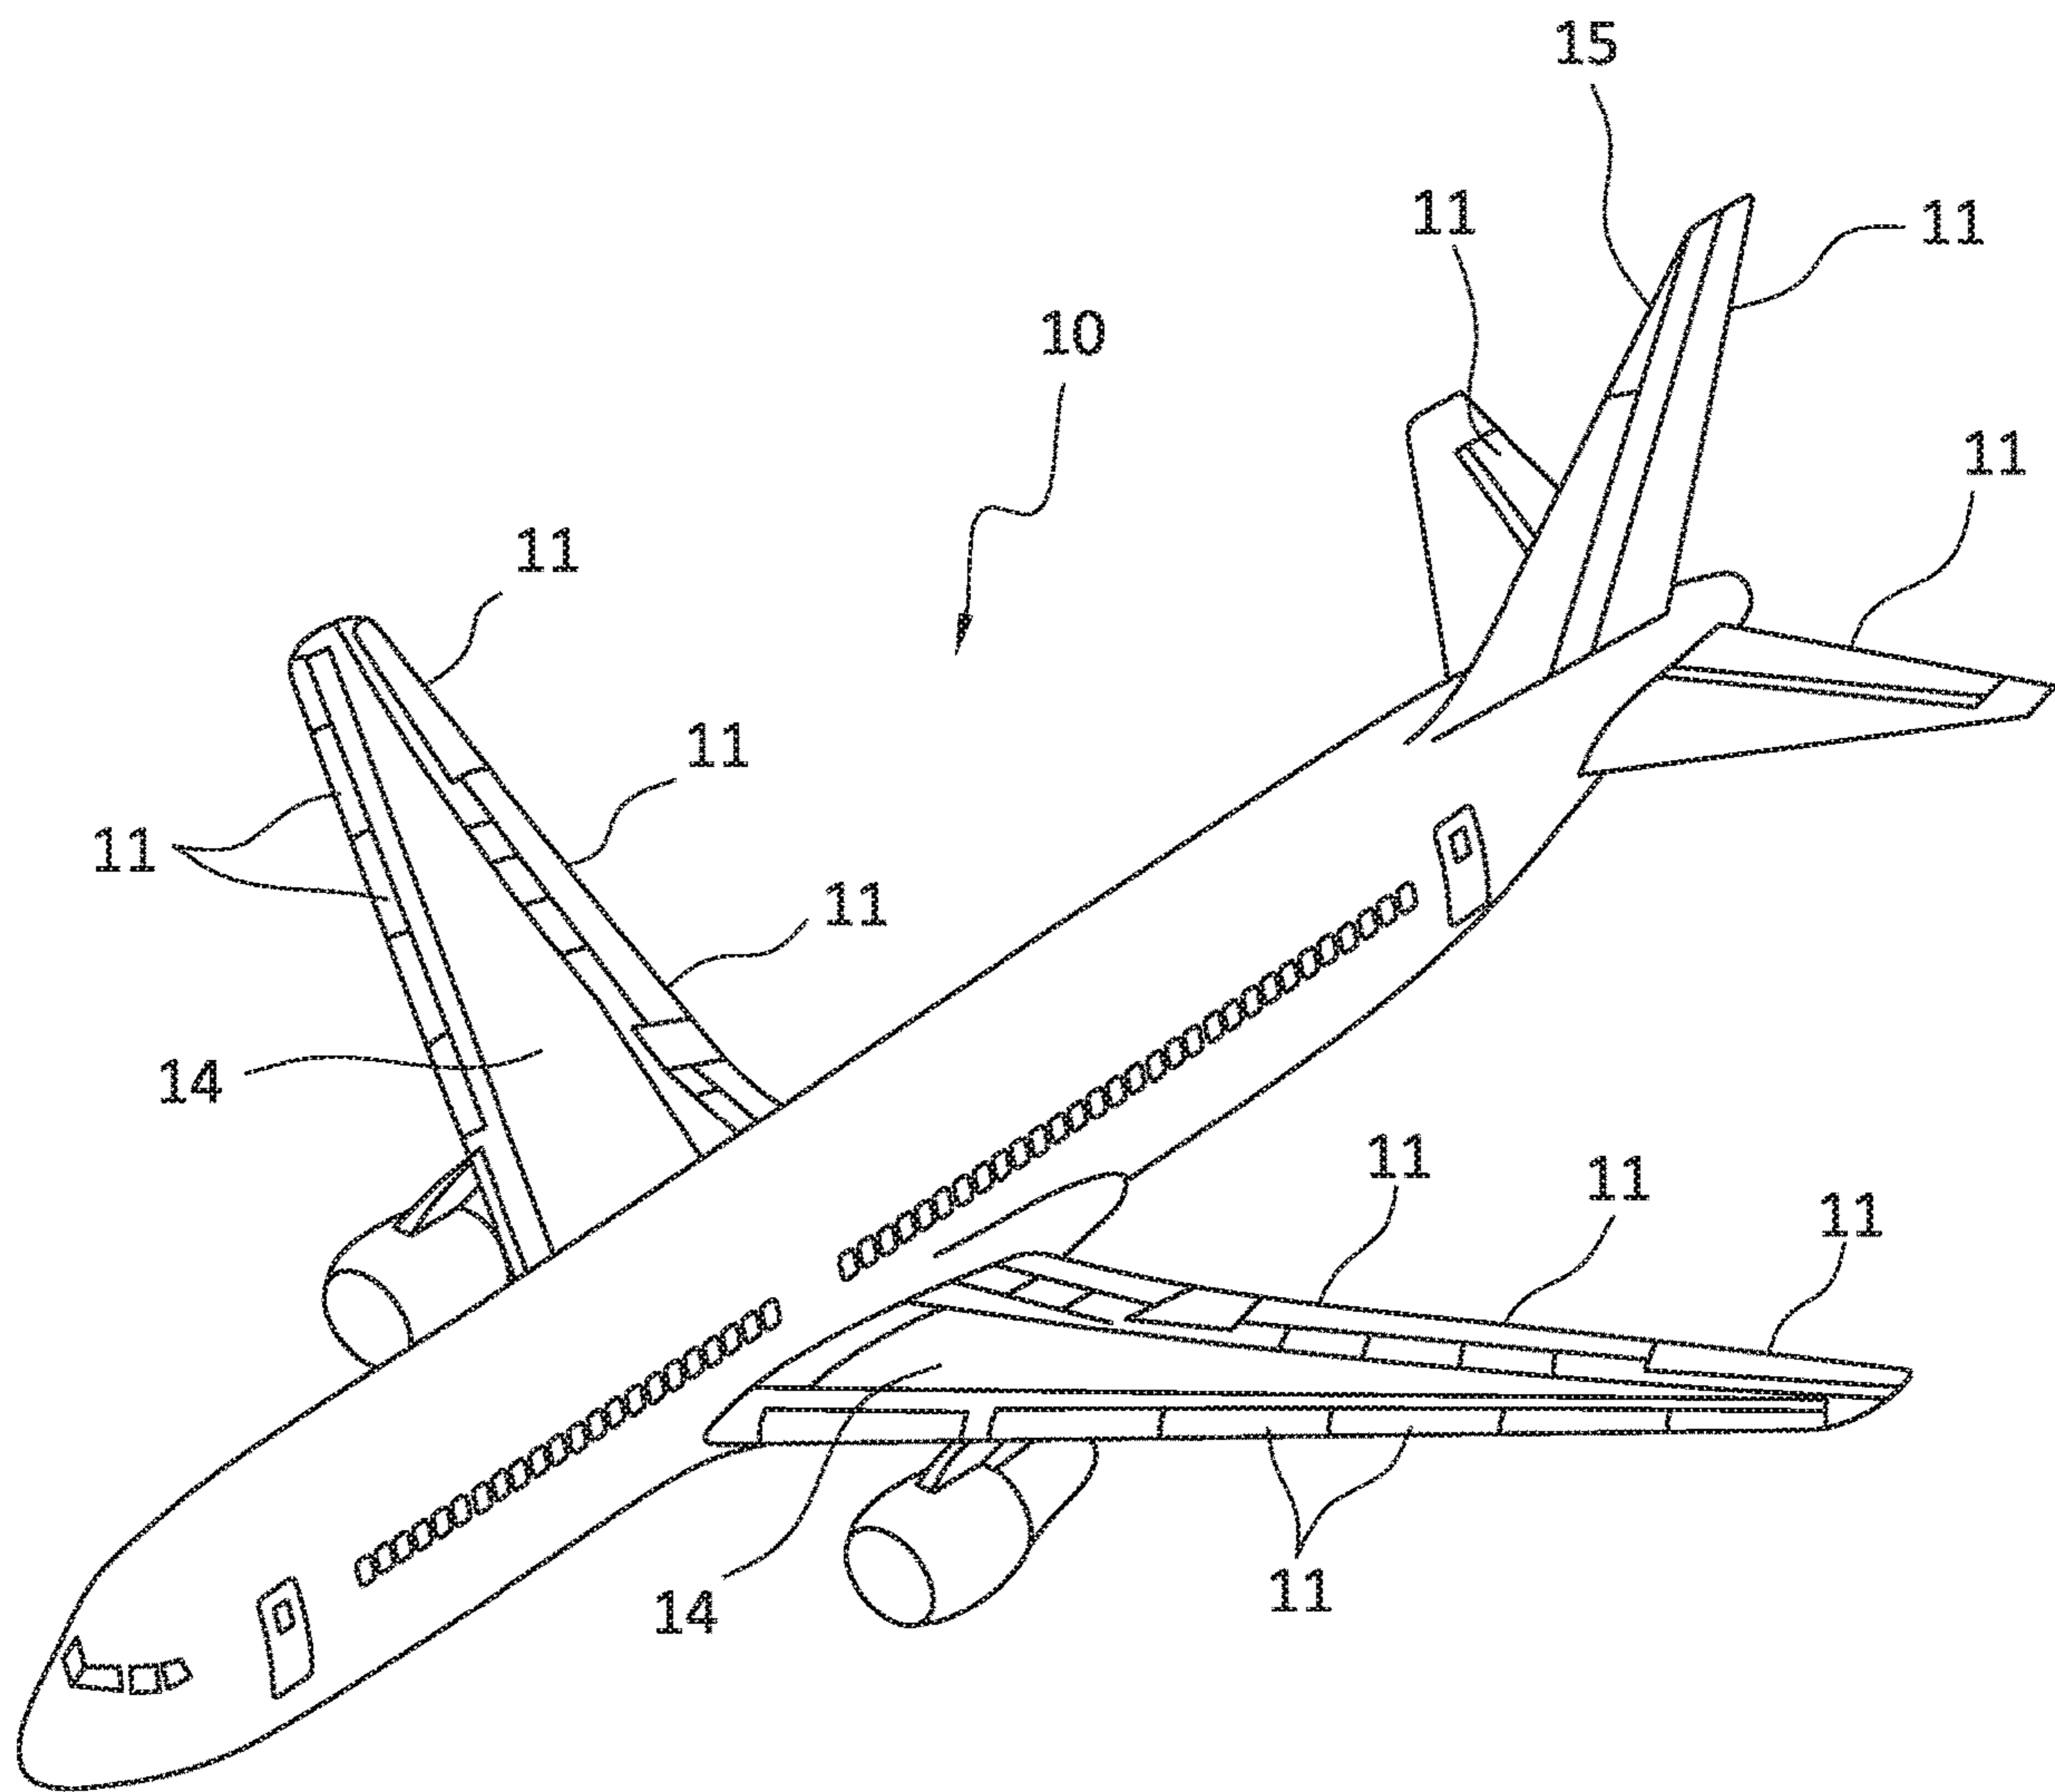
FIG. 1 is a perspective view of a vehicle.

The present application is directed to repairing a member 11 of a vehicle 10. In one example, the repairs can provide a temporary fix until more durable and longer lasting repairs can be made to the identified area. FIG. 1 illustrates one context of use in which the member 11 is a flight control member 11 on an aircraft 10. The flight control member 11 can include but is not limited to a rudder, elevator, aileron, flaperons, and flaps. The flight control members 11 are movably attached to various sections of the aircraft 10 including the wings 14 and tail 15 to change their orientation to control the flight.

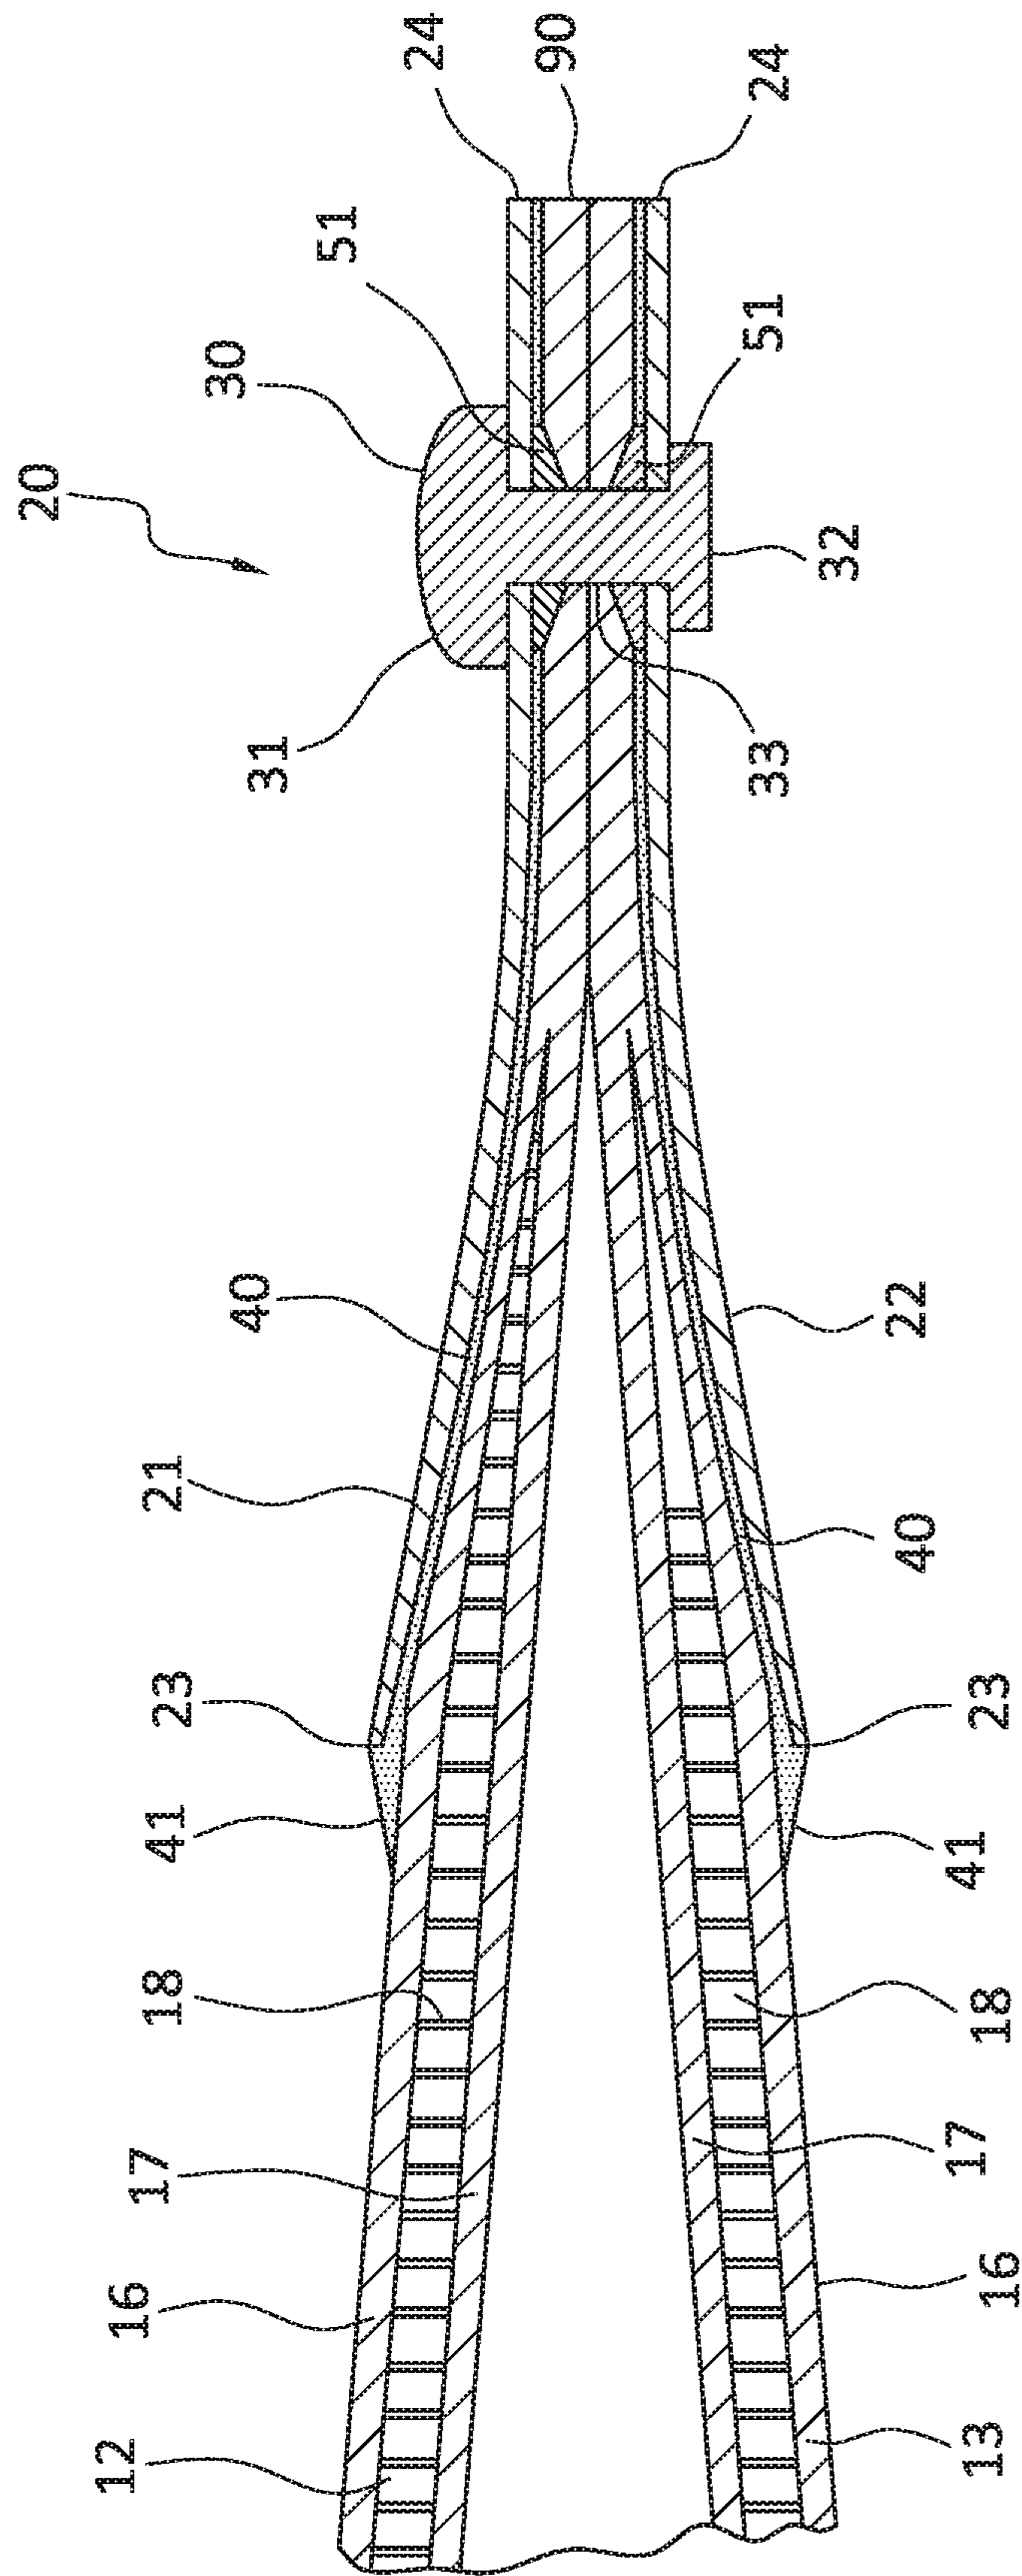
FIG. 4 is a section view cut along line of FIG. 3.

FIGS. 3 and 4 illustrate a repair assembly 20 positioned over an identified area 19 of a member 11. The identified area 19 is determined to be in need of repair due to a variety of different causes. This can include an area that is damaged due to various occurrences, such as but not limited to a lightning strike and wear during prolonged use. The iden-

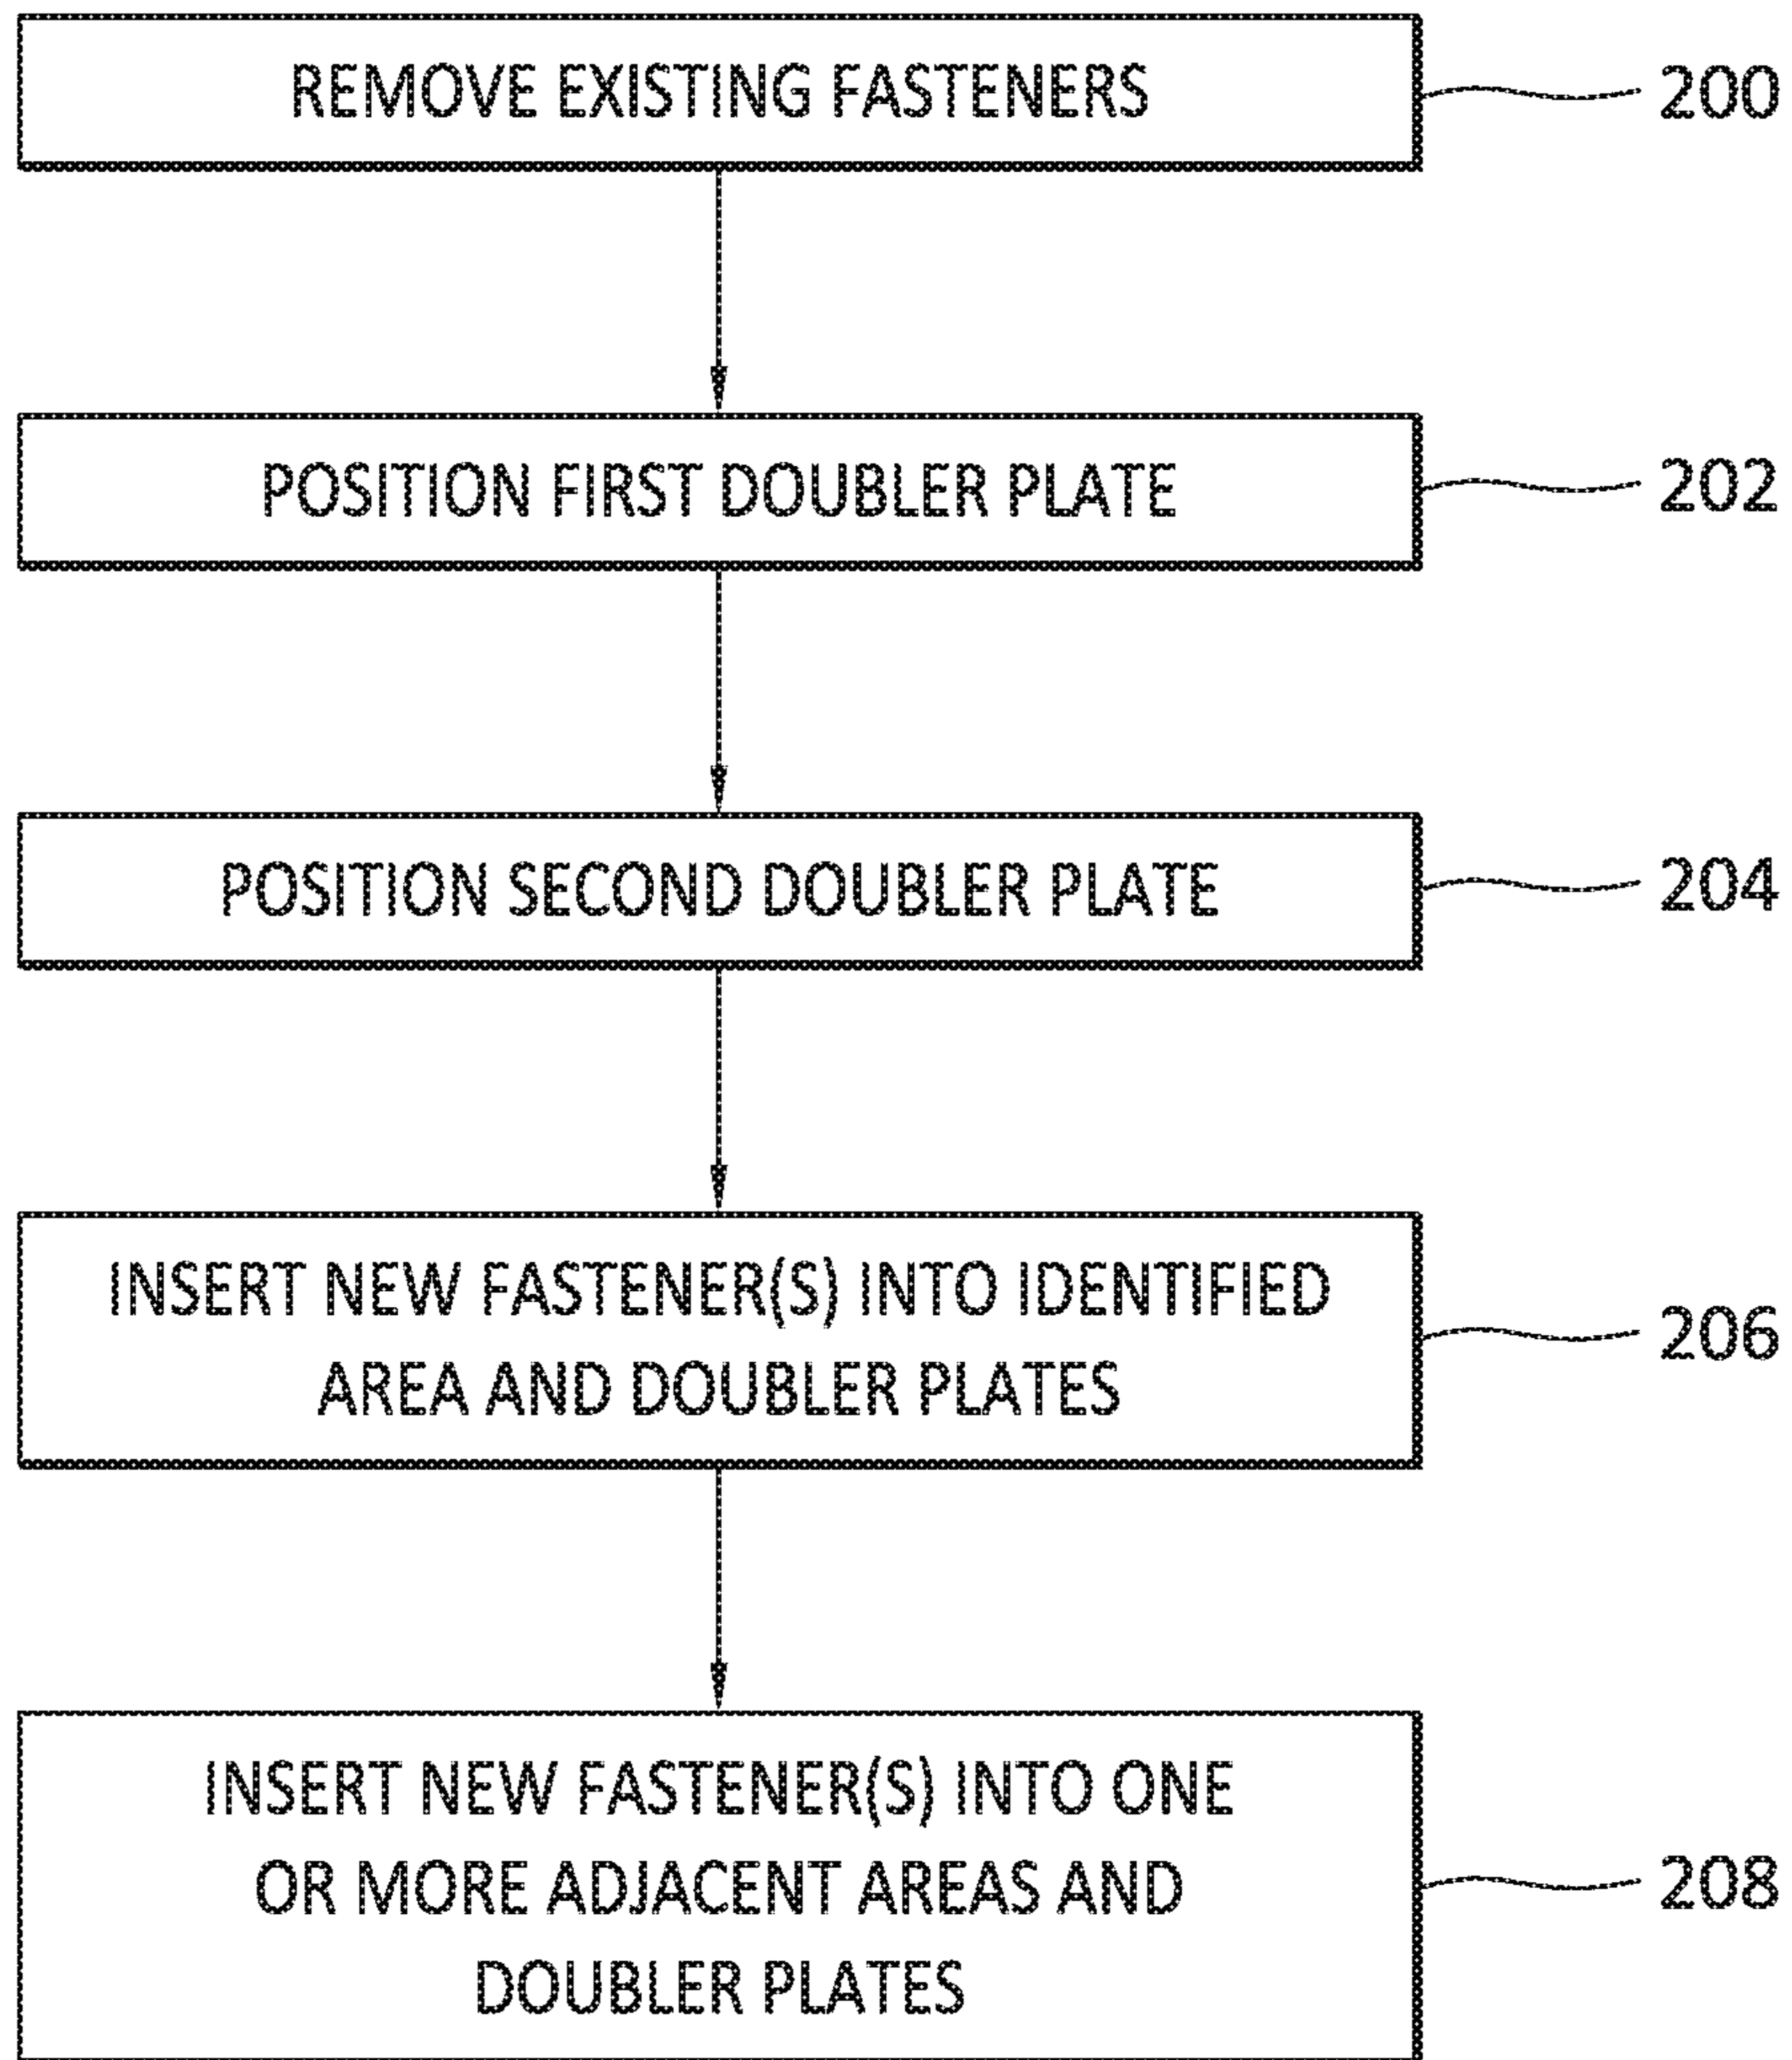
FIG. 7 is a flowchart diagram of a method of repairing an identified area on a member of a vehicle.

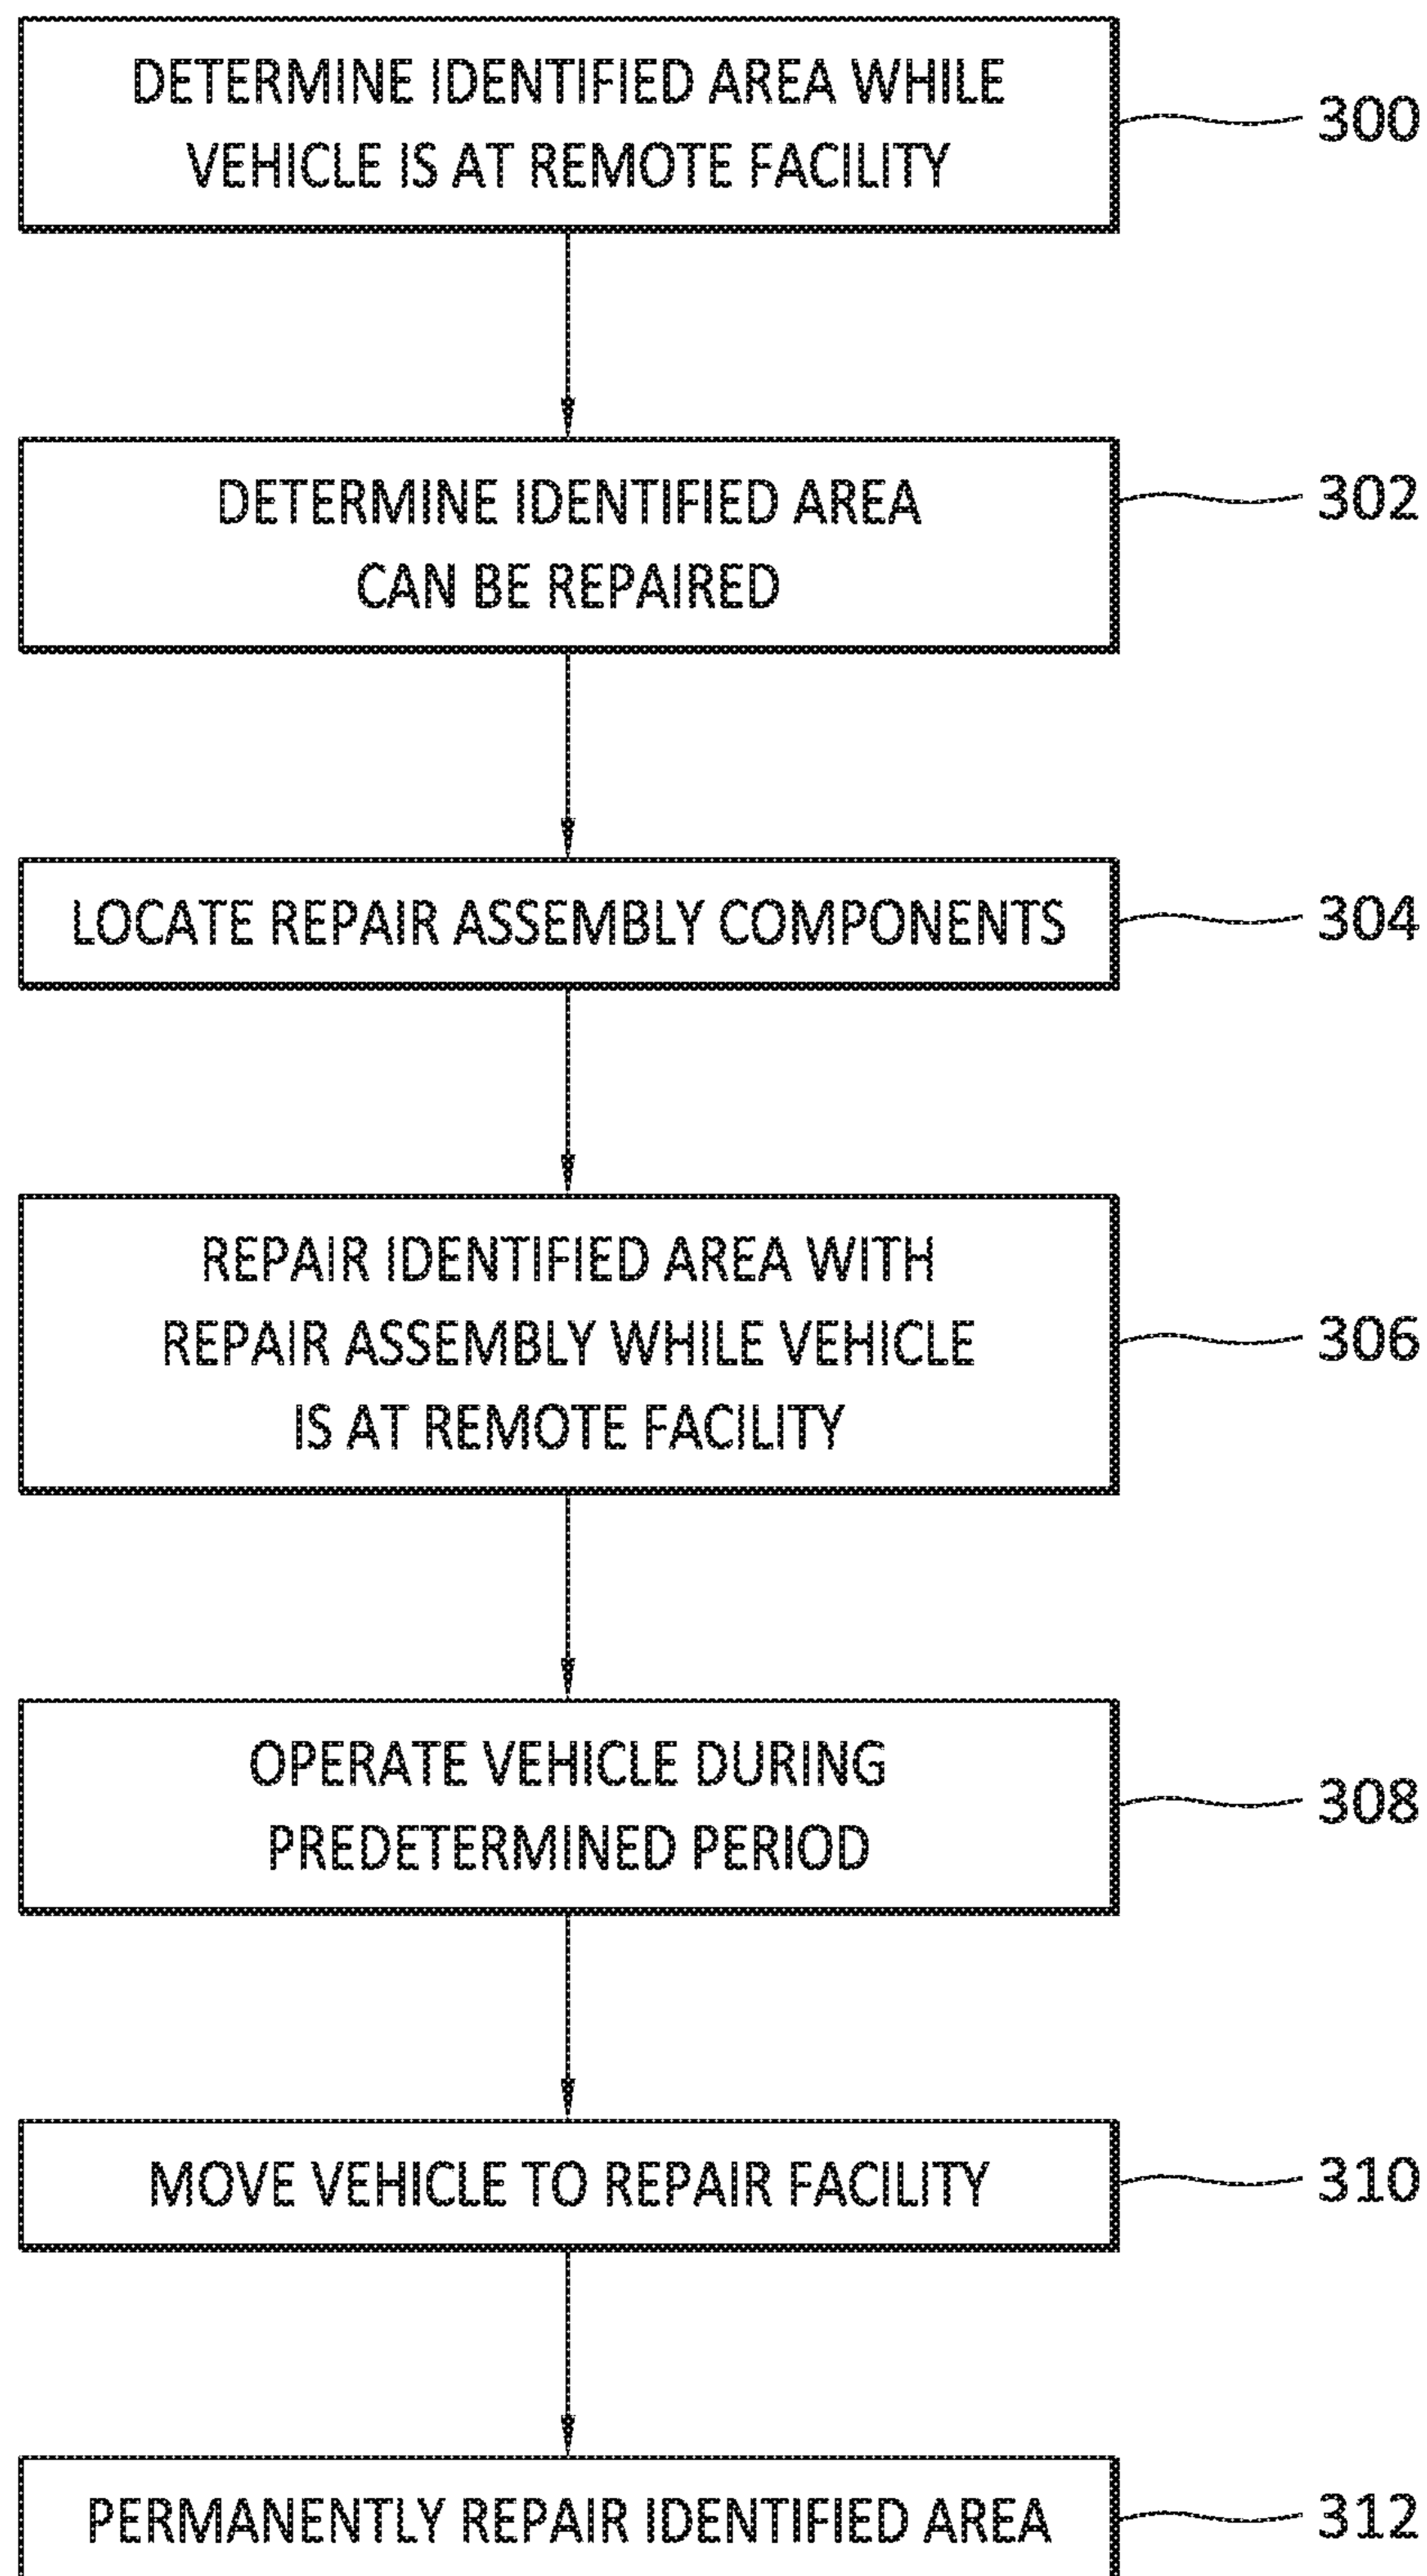
FIG. 8 is a flowchart diagram of a method of operating a vehicle.
