(54) **ABRASION INSPECTION APPARATUS, ABRASION INSPECTION METHOD, AND PROGRAM**

(71) Applicant: **MITSUBISHI HEAVY INDUSTRIES, LTD.**, Tokyo (JP)

An abrasion inspection apparatus includes: a first imaging unit that is installed on a side of a track, a vehicle traveling along the track, a guide wheel being installed on a side of the vehicle, the first imaging unit imaging an inside of the track via a telecentric lens; a second imaging unit that is installed in a vehicle traveling direction with respect to the first imaging unit on the side of the track and images the inside of the track via a telecentric lens; an image acquisition unit that acquires an image which is an image of a boundary of the guide wheel captured by the first imaging unit and is an image of a boundary on a first direction side in the vehicle traveling direction and an image which is an image of the boundary of the guide wheel captured by the second imaging unit at the same time as the capturing of the image by the

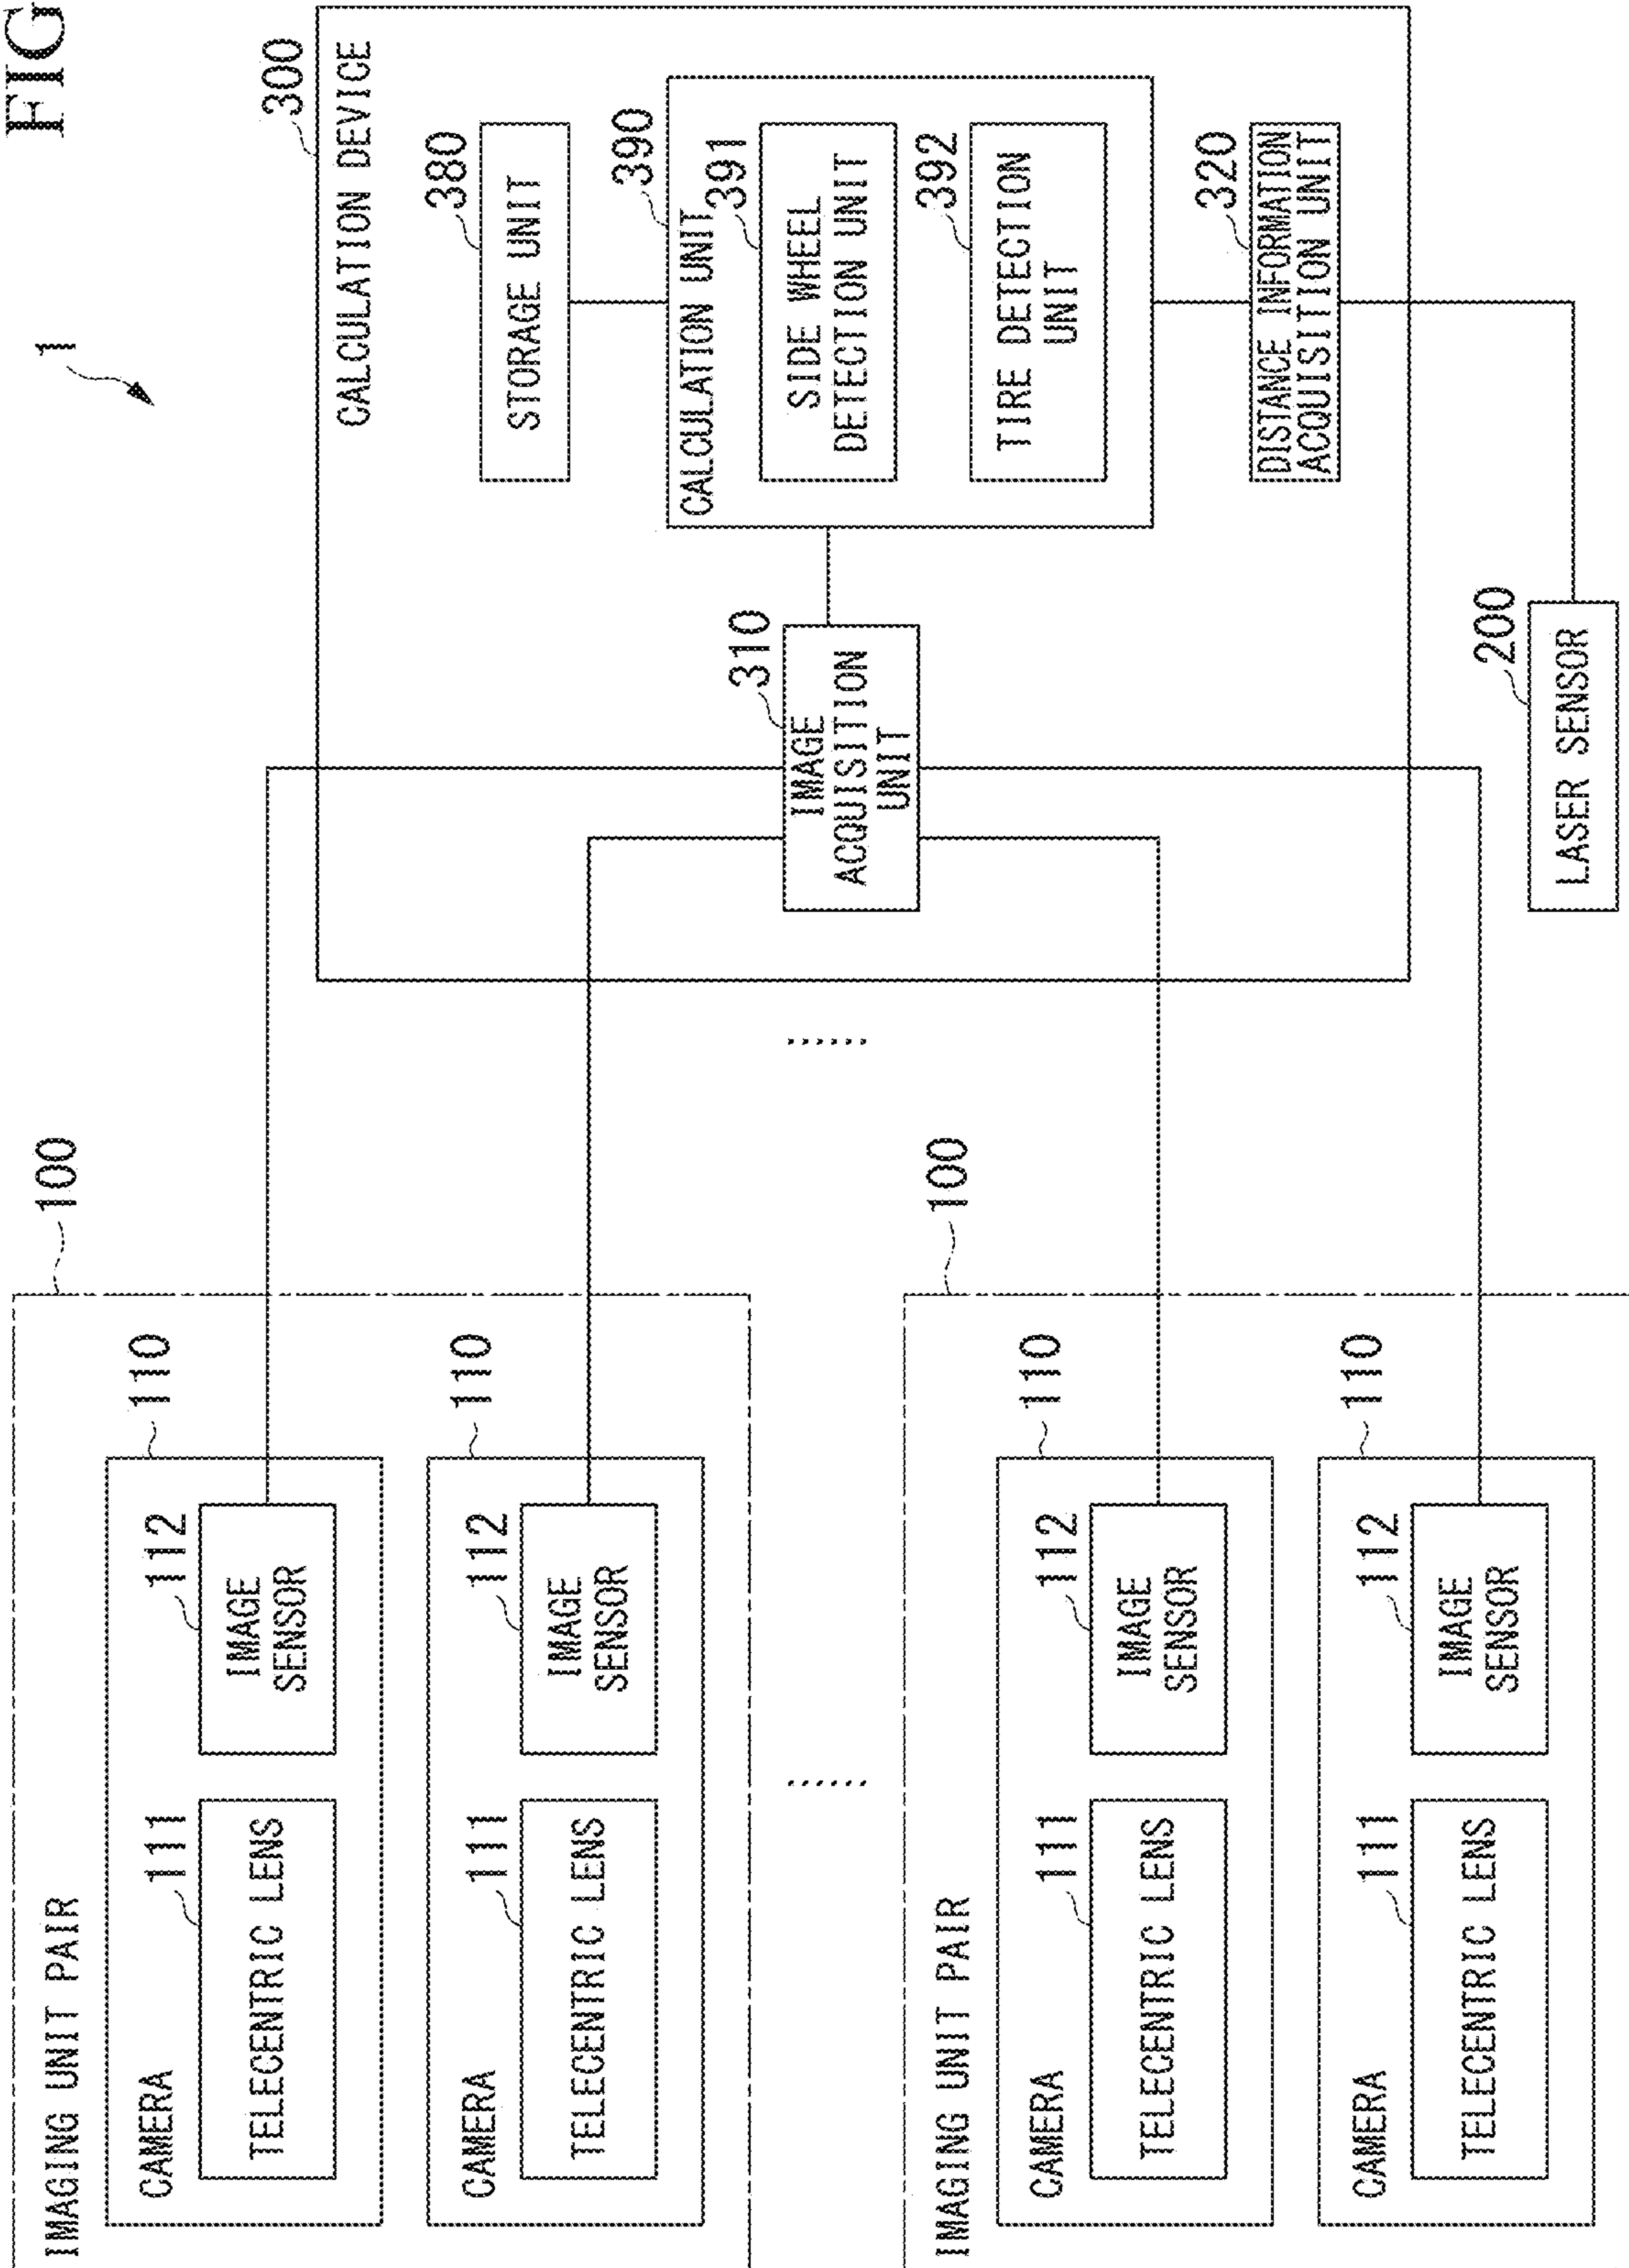
FIG. 1 is a schematic block diagram showing a functional configuration of an abrasion inspection apparatus according to an embodiment of the invention.

FIG. 1 is a schematic block diagram showing a functional configuration of an abrasion inspection apparatus according to an embodiment of the invention. In FIG. 1, an abrasion inspection apparatus 1 includes cameras 110, a laser sensor 200, and a calculation device 300. The camera 110 includes a telecentric lens 111 and an image sensor 112. The calculation device 300 includes an image acquisition unit 310, a distance information acquisition unit 320, a storage unit 380, and a calculation unit 390. The calculation unit 390 includes a guide wheel and branching wheel abrasion situation detection unit (hereinafter referred to as a side wheel detection unit) 391 and a tire abrasion situation detection unit (hereinafter referred to as a tire detection unit) 392.

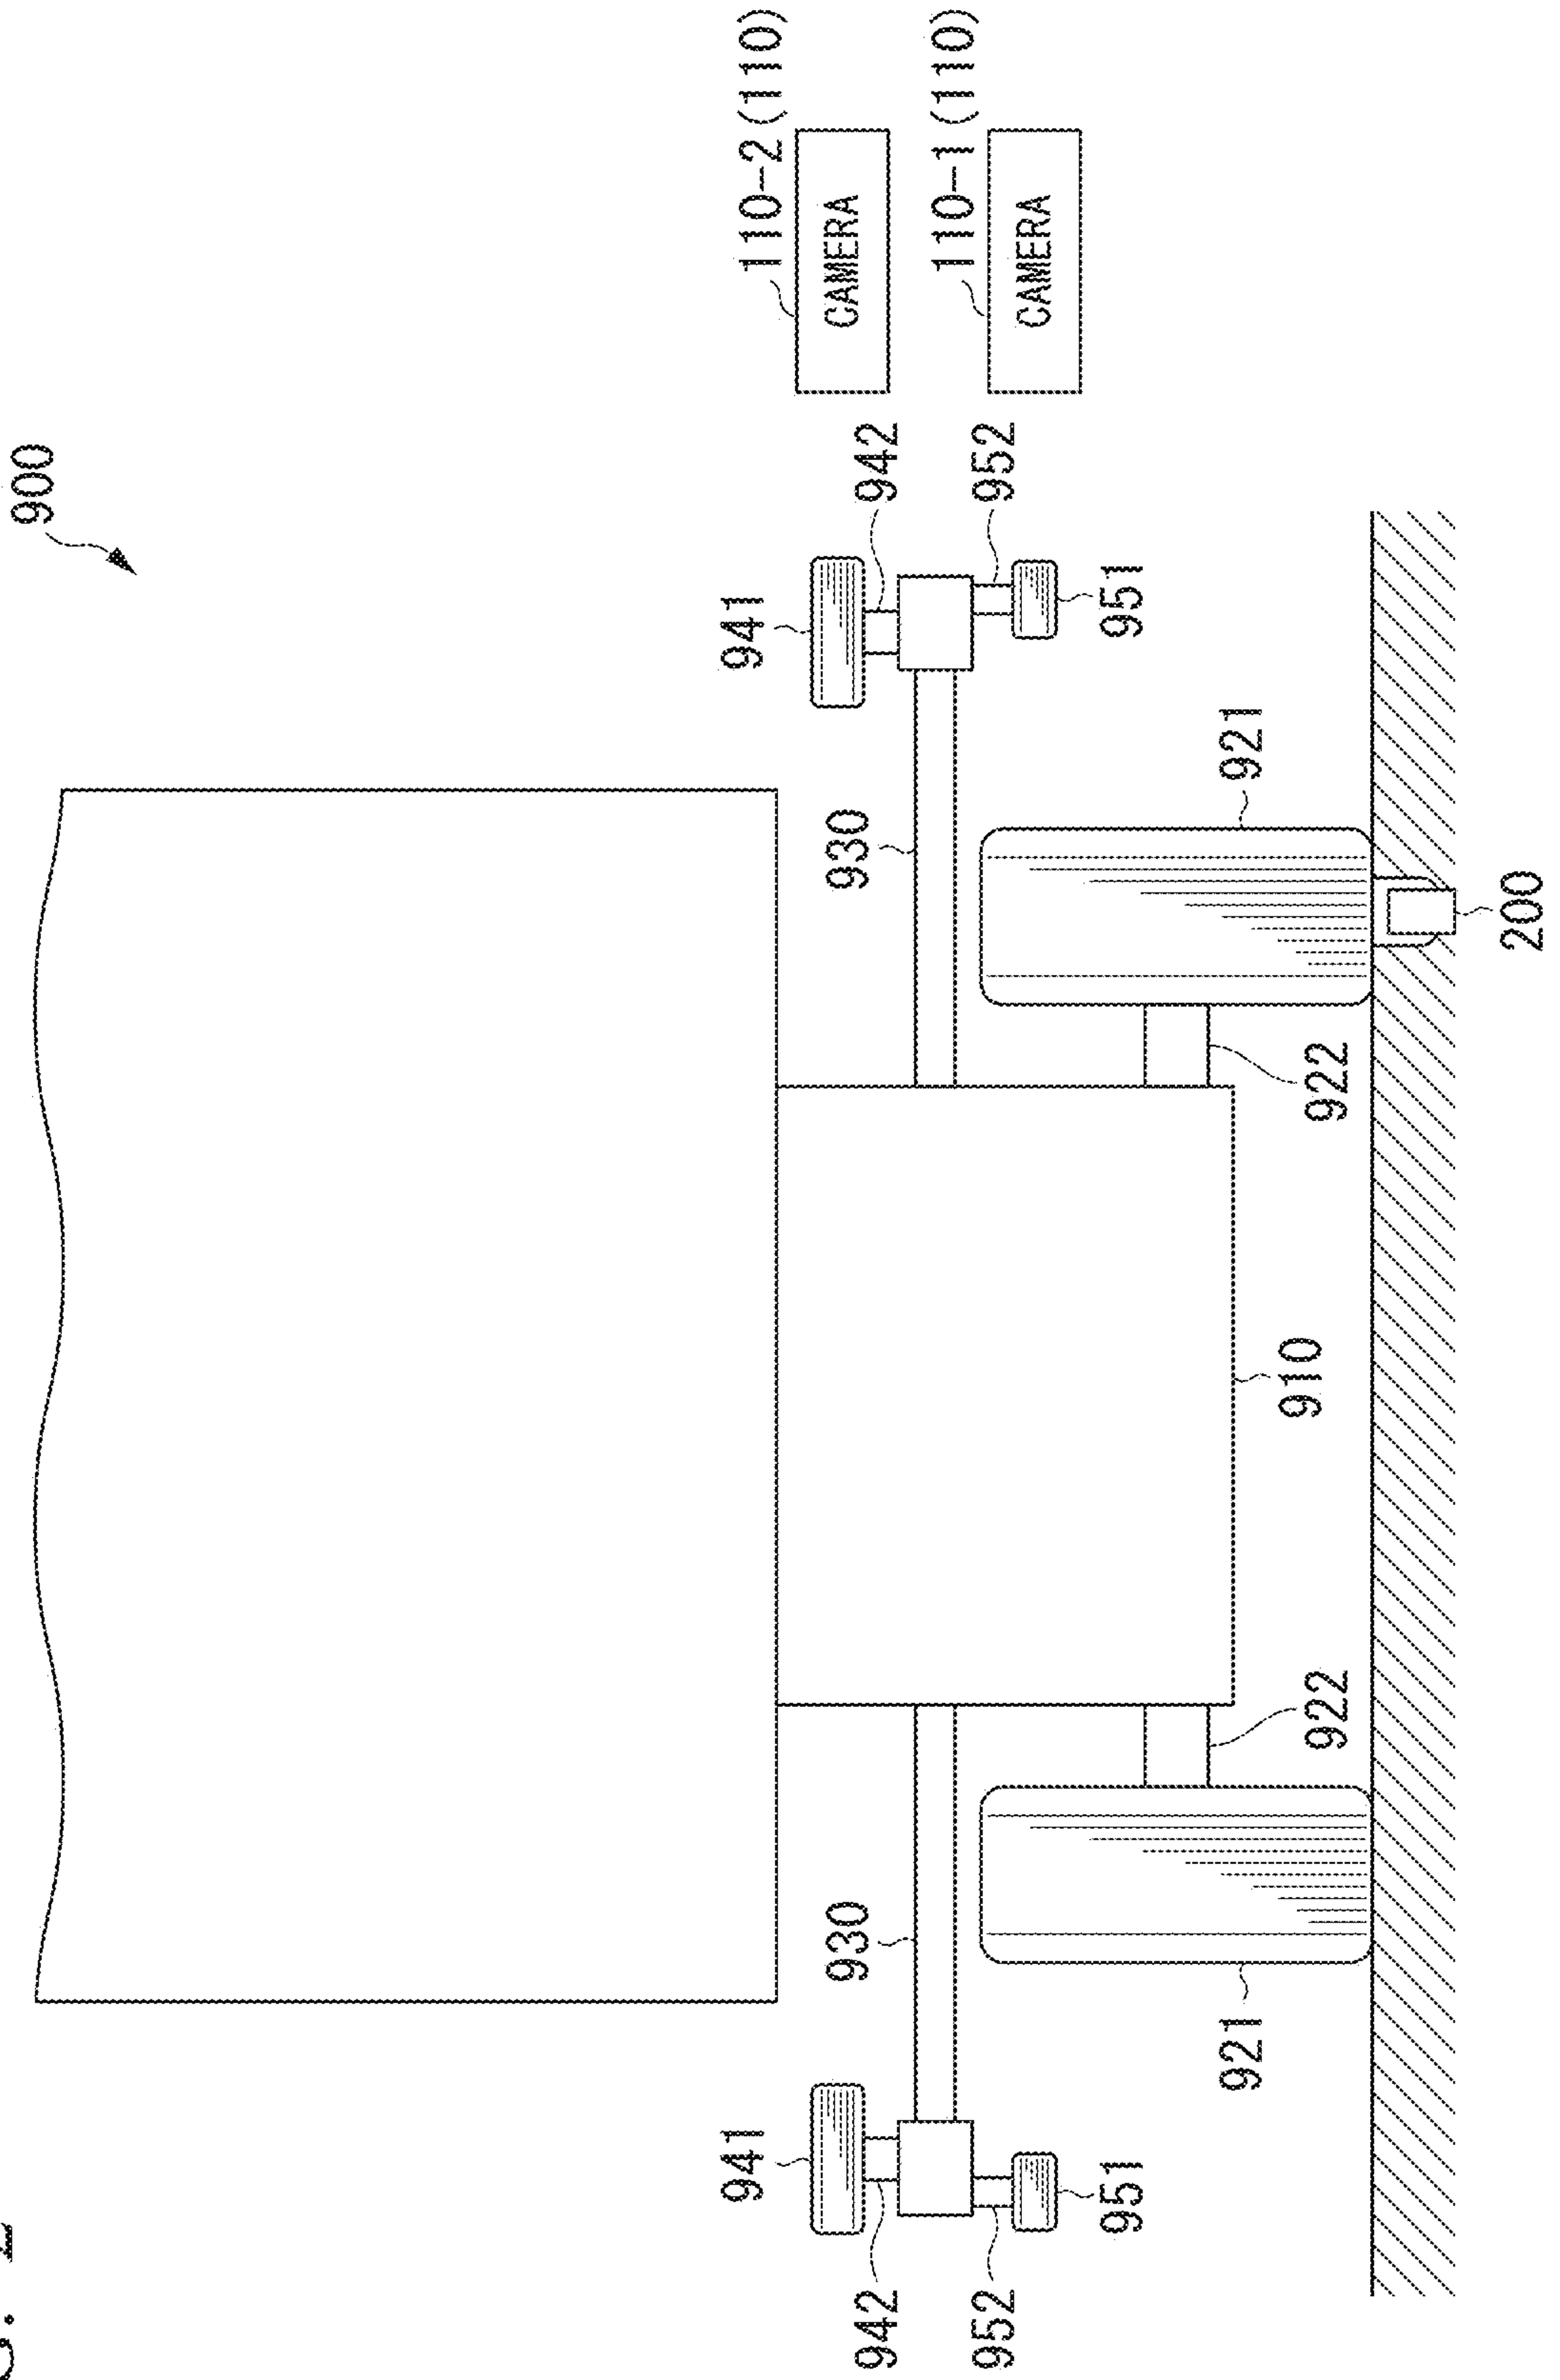
FIG. 2 is an exterior diagram showing a schematic exterior of a lower portion of a vehicle when viewed from the front side according to the embodiment.

The abrasion inspection apparatus 1 is an apparatus that inspects abrasion of a guide wheel, abrasion of a branching wheel, and abrasion of a traveling tire installed in a vehicle of a transportation system. Here, a disposition example of the guide wheel, the branching wheel, and the traveling tire will be described with reference to FIG. 2.

FIG. 2 is an exterior diagram showing a schematic exterior of a lower portion of the vehicle when viewed from the front side. In a vehicle 900 shown in FIG. 2, traveling tires 921 are installed on the right and left of a vehicle body 910 via shafts 922 and are in contact with a road surface. Supports 930 are installed on the right and left of the vehicle body 910. In the supports 930, guide wheels 941 are

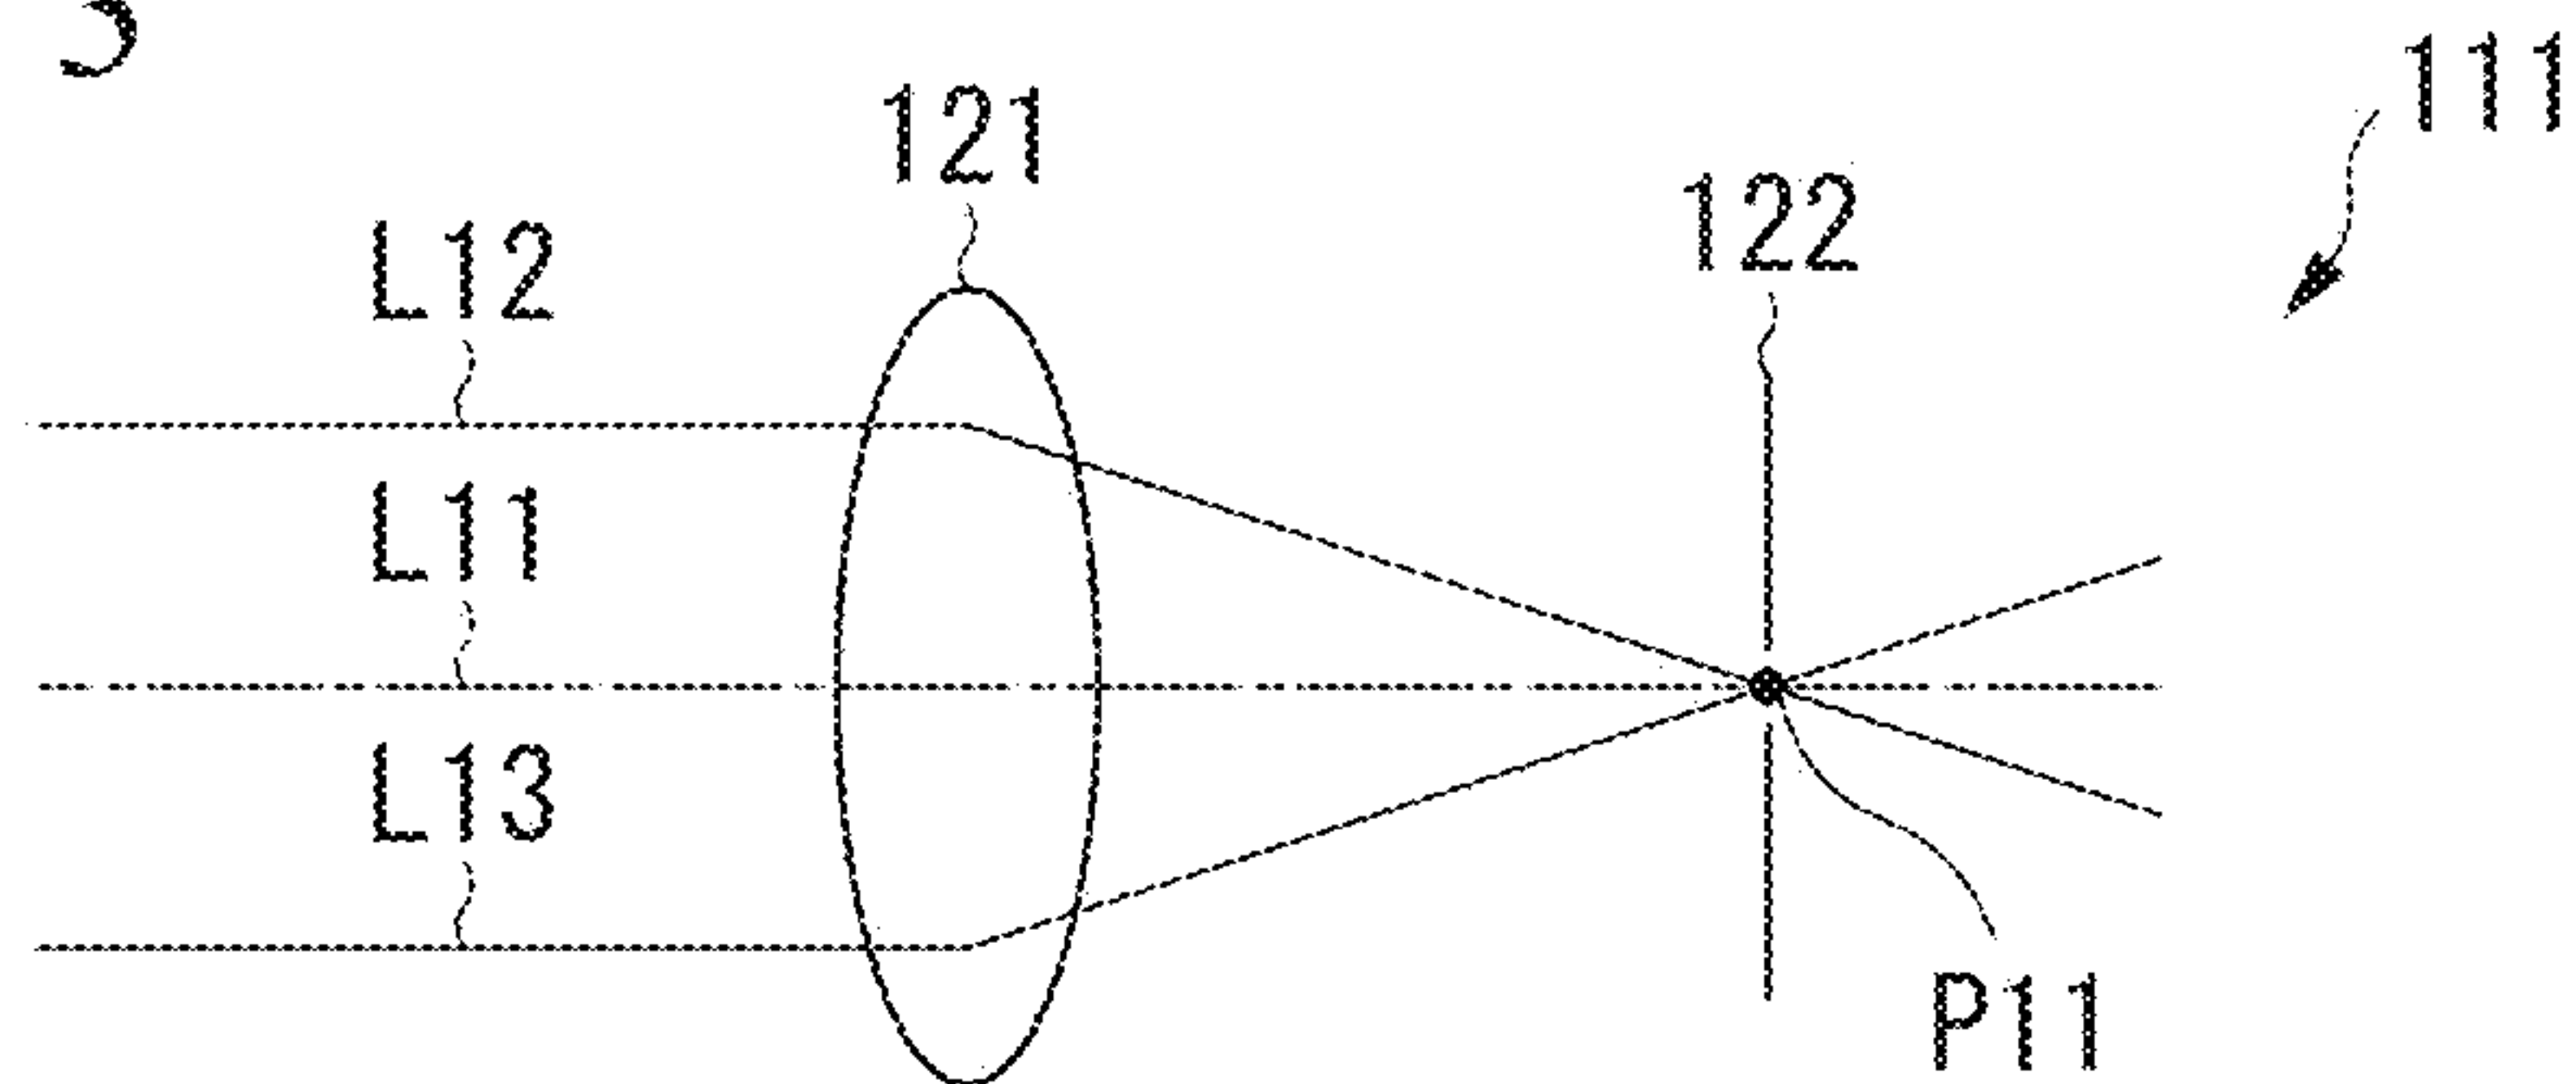
FIG. 3 is an explanatory diagram showing an example of a principal ray in a telecentric lens according to the embodiment.

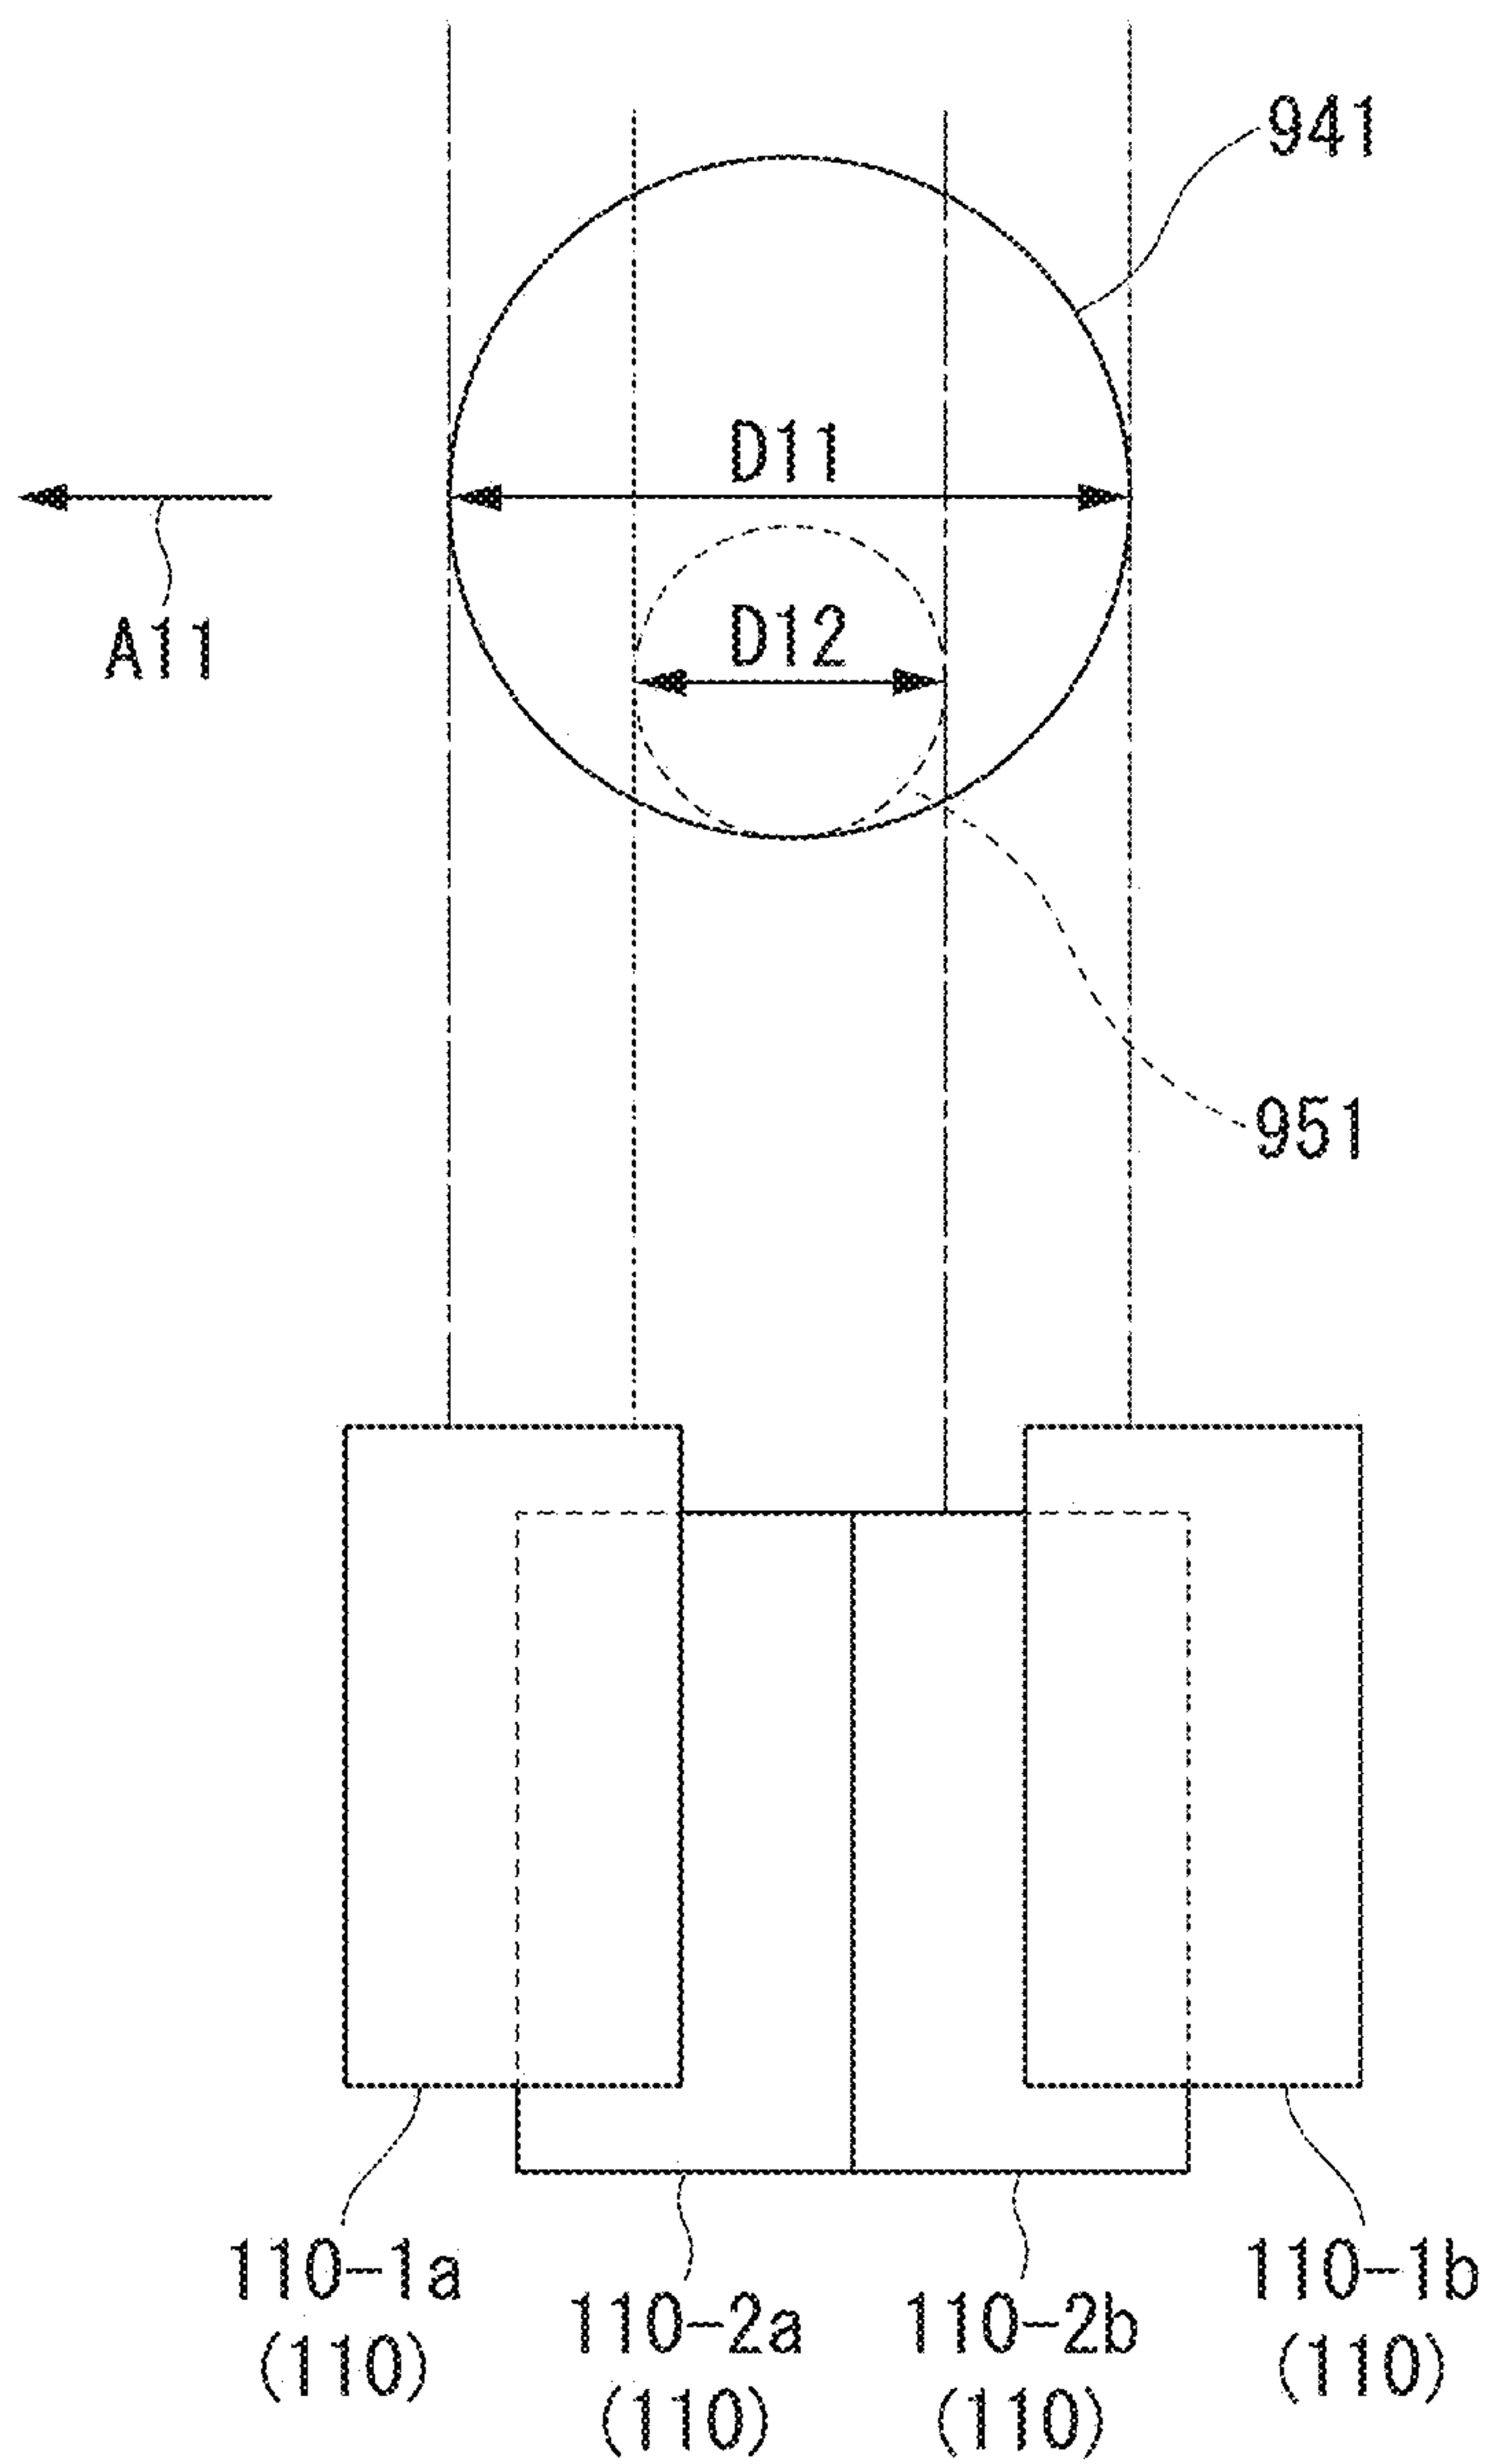
FIG. 4 is an explanatory diagram showing an example of imaged spots of a guide wheel and a branching wheel by a camera according to the embodiment.

Accordingly, in the abrasion inspection apparatus 1, the imaging unit pair 100 paired by two cameras 110 image boundaries of right and left sides of the guide wheels 941 at the same time. This point will be described with reference to FIG. 4.

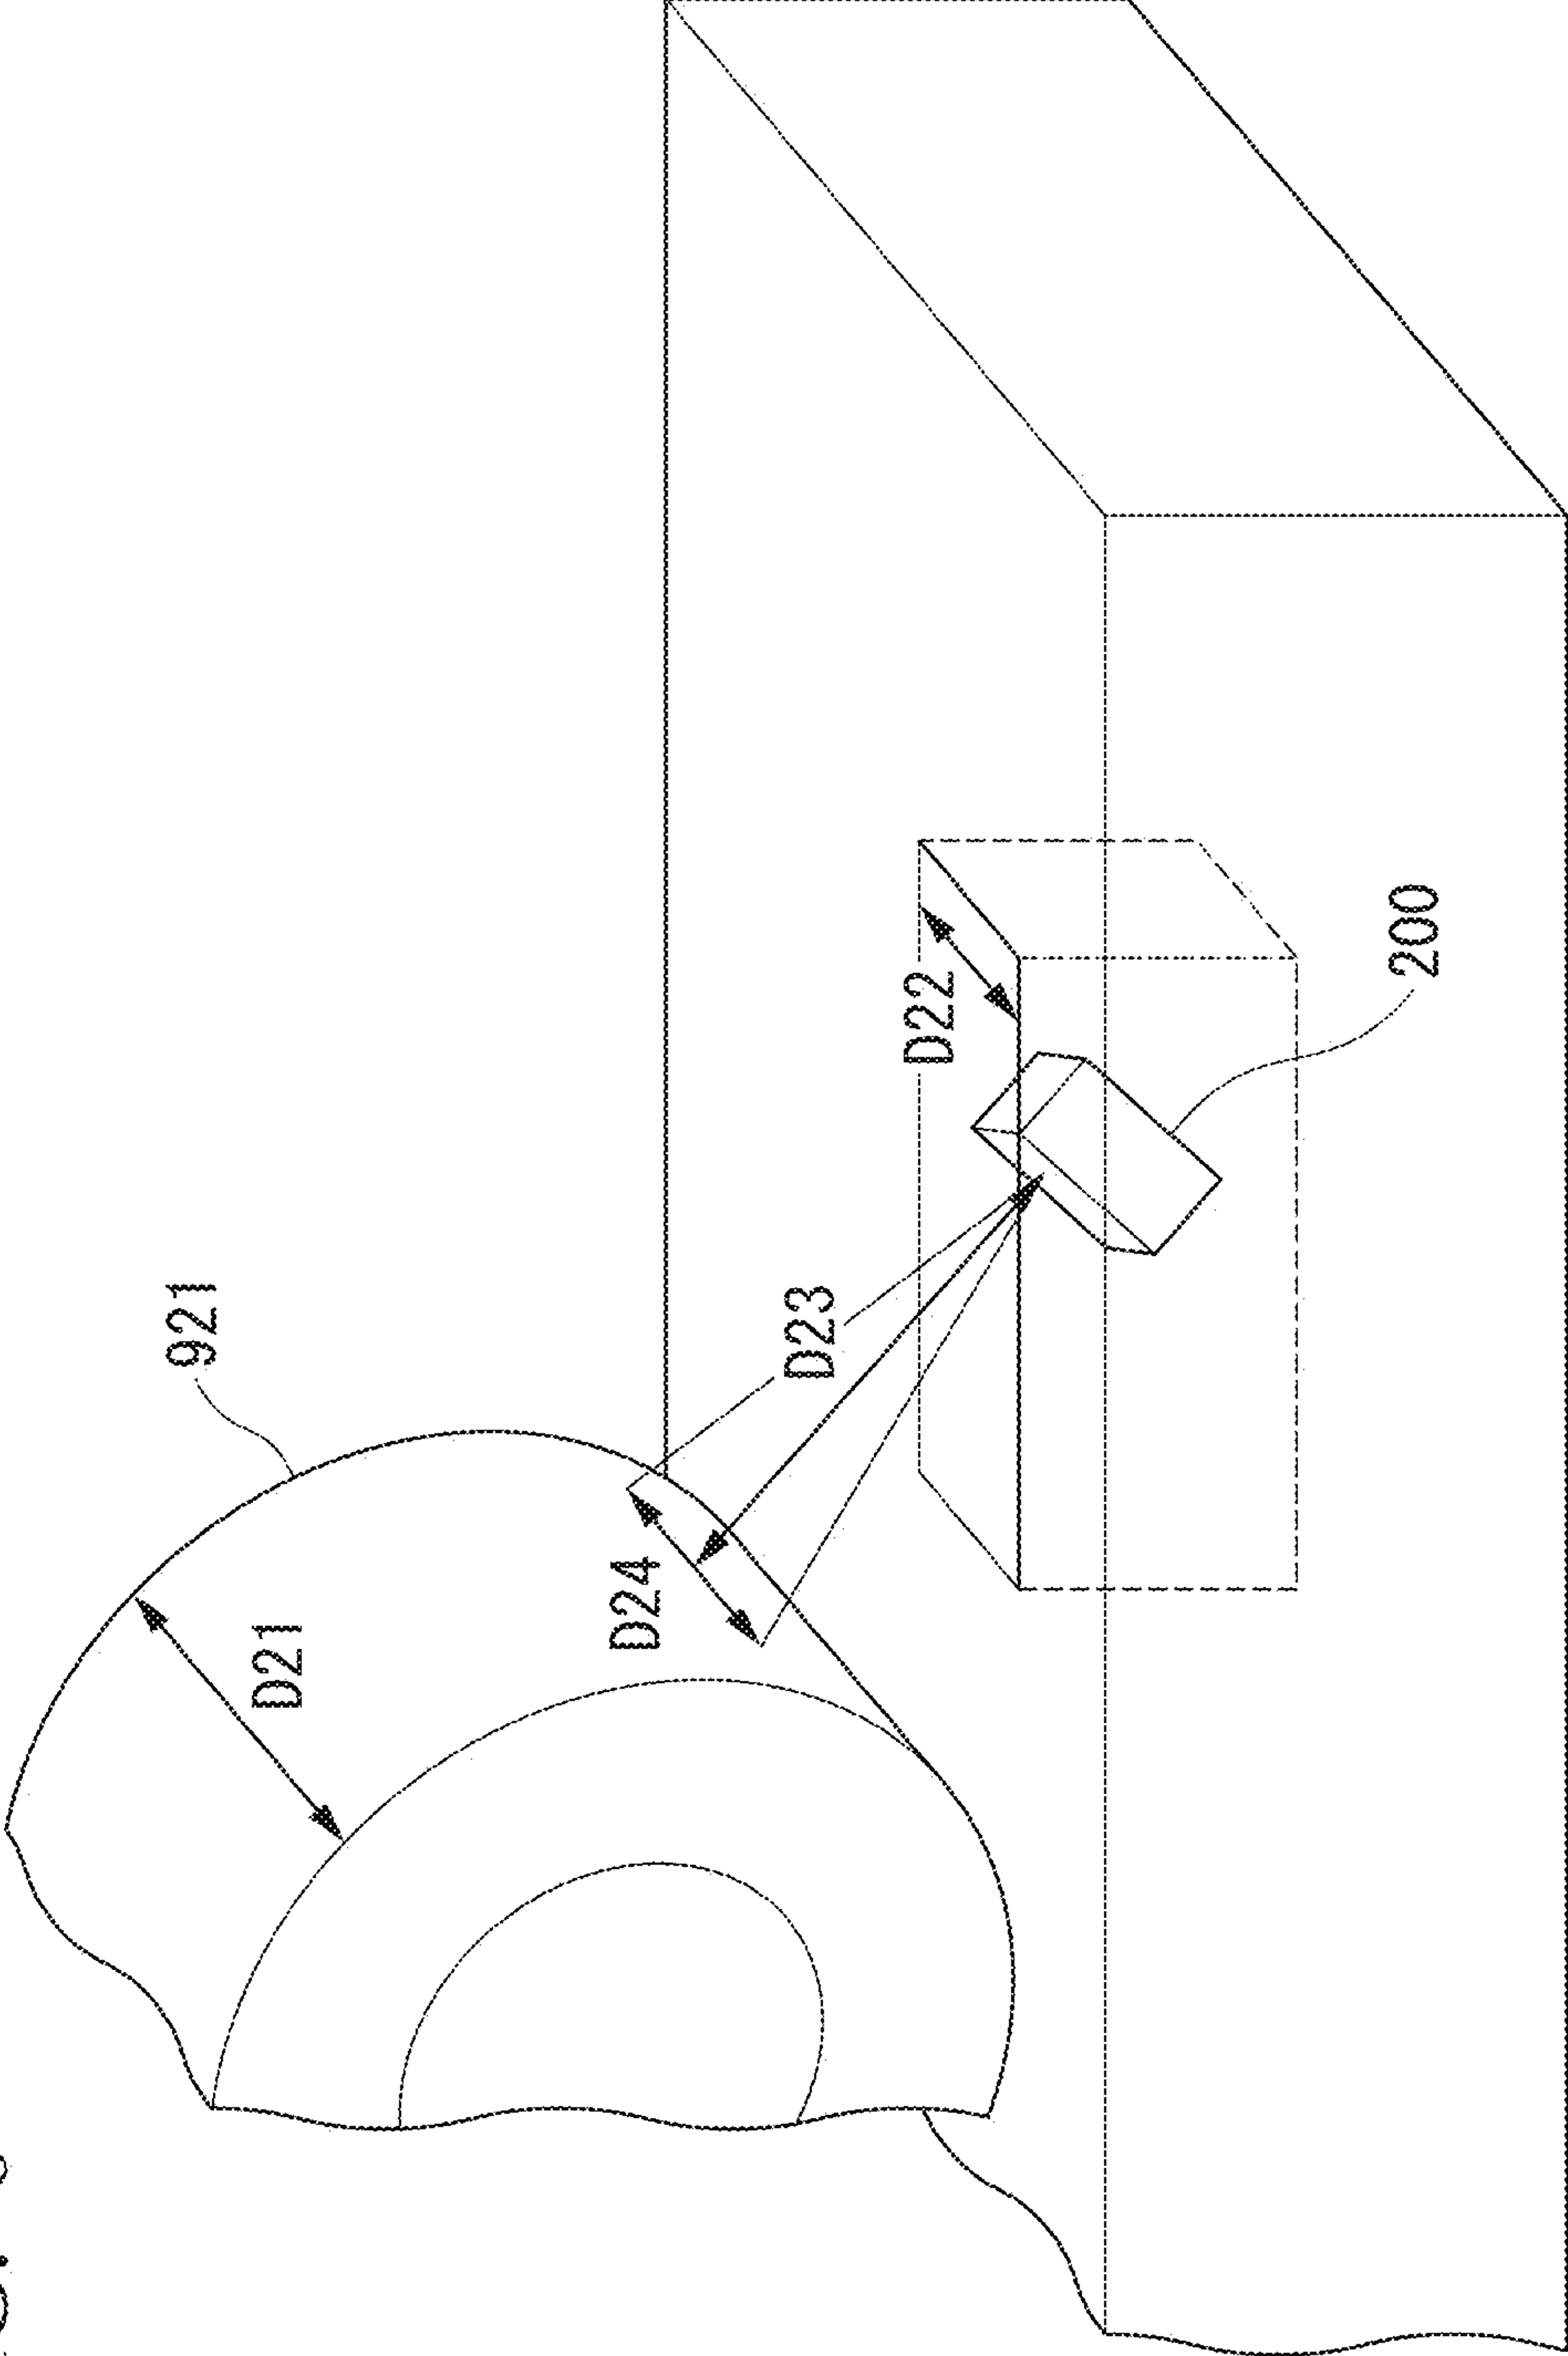
FIG. 6 is an explanatory diagram showing an installation example of a laser sensor according to the embodiment.

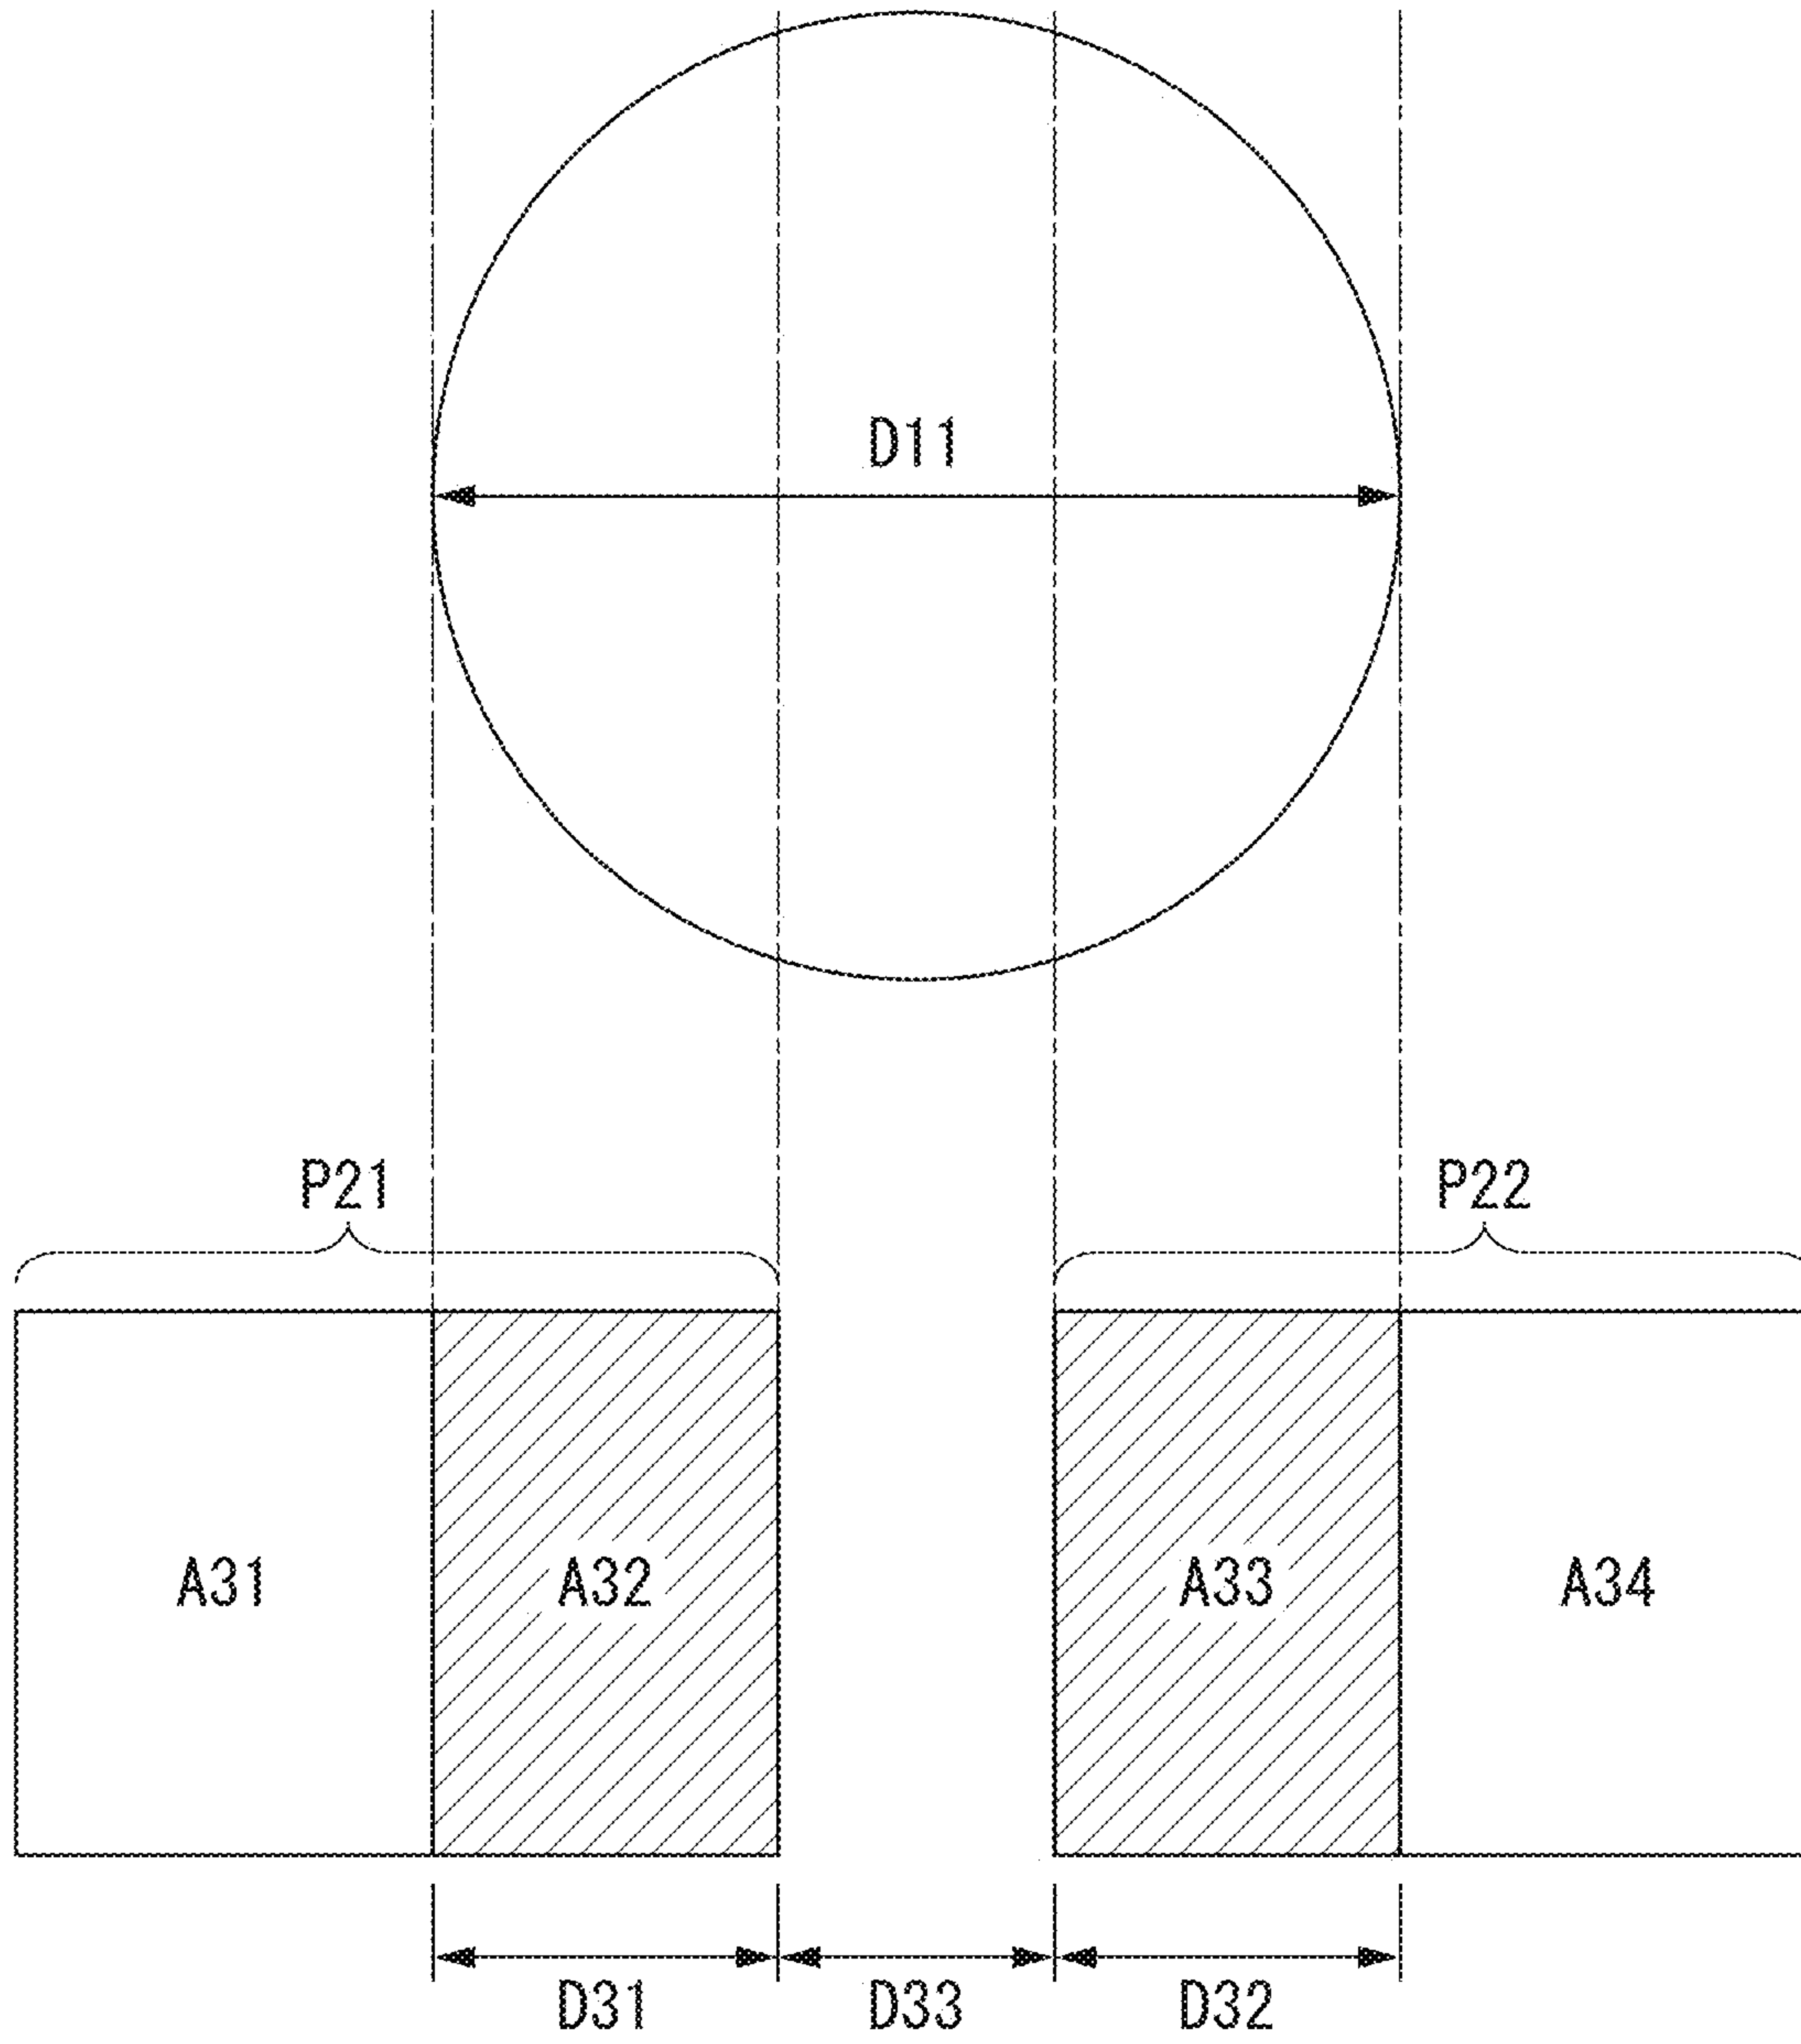
FIG. 7 is an explanatory diagram showing an example of a correspondence relation between an image captured by the camera and the guide wheel according to the embodiment.
