(54) **ABRASION INSPECTION APPARATUS, ABRASION INSPECTION METHOD, AND PROGRAM**

(71) Applicant: **MITSUBISHI HEAVY INDUSTRIES, LTD.**, Tokyo (JP)

An abrasion inspection apparatus includes: a first imaging unit that is installed on a side of a track, a vehicle traveling along the track, a guide wheel being installed on a side of the vehicle, the first imaging unit imaging an inside of the track via a telecentric lens; a second imaging unit that is installed in a vehicle traveling direction with respect to the first imaging unit on the side of the track and images the inside of the track via a telecentric lens; an image acquisition unit that acquires an image which is an image of a boundary of the guide wheel captured by the first imaging unit and is an image of a boundary on a first direction side in the vehicle traveling direction and an image which is an image of the boundary of the guide wheel captured by the second imaging unit at the same time as the capturing of the image by the

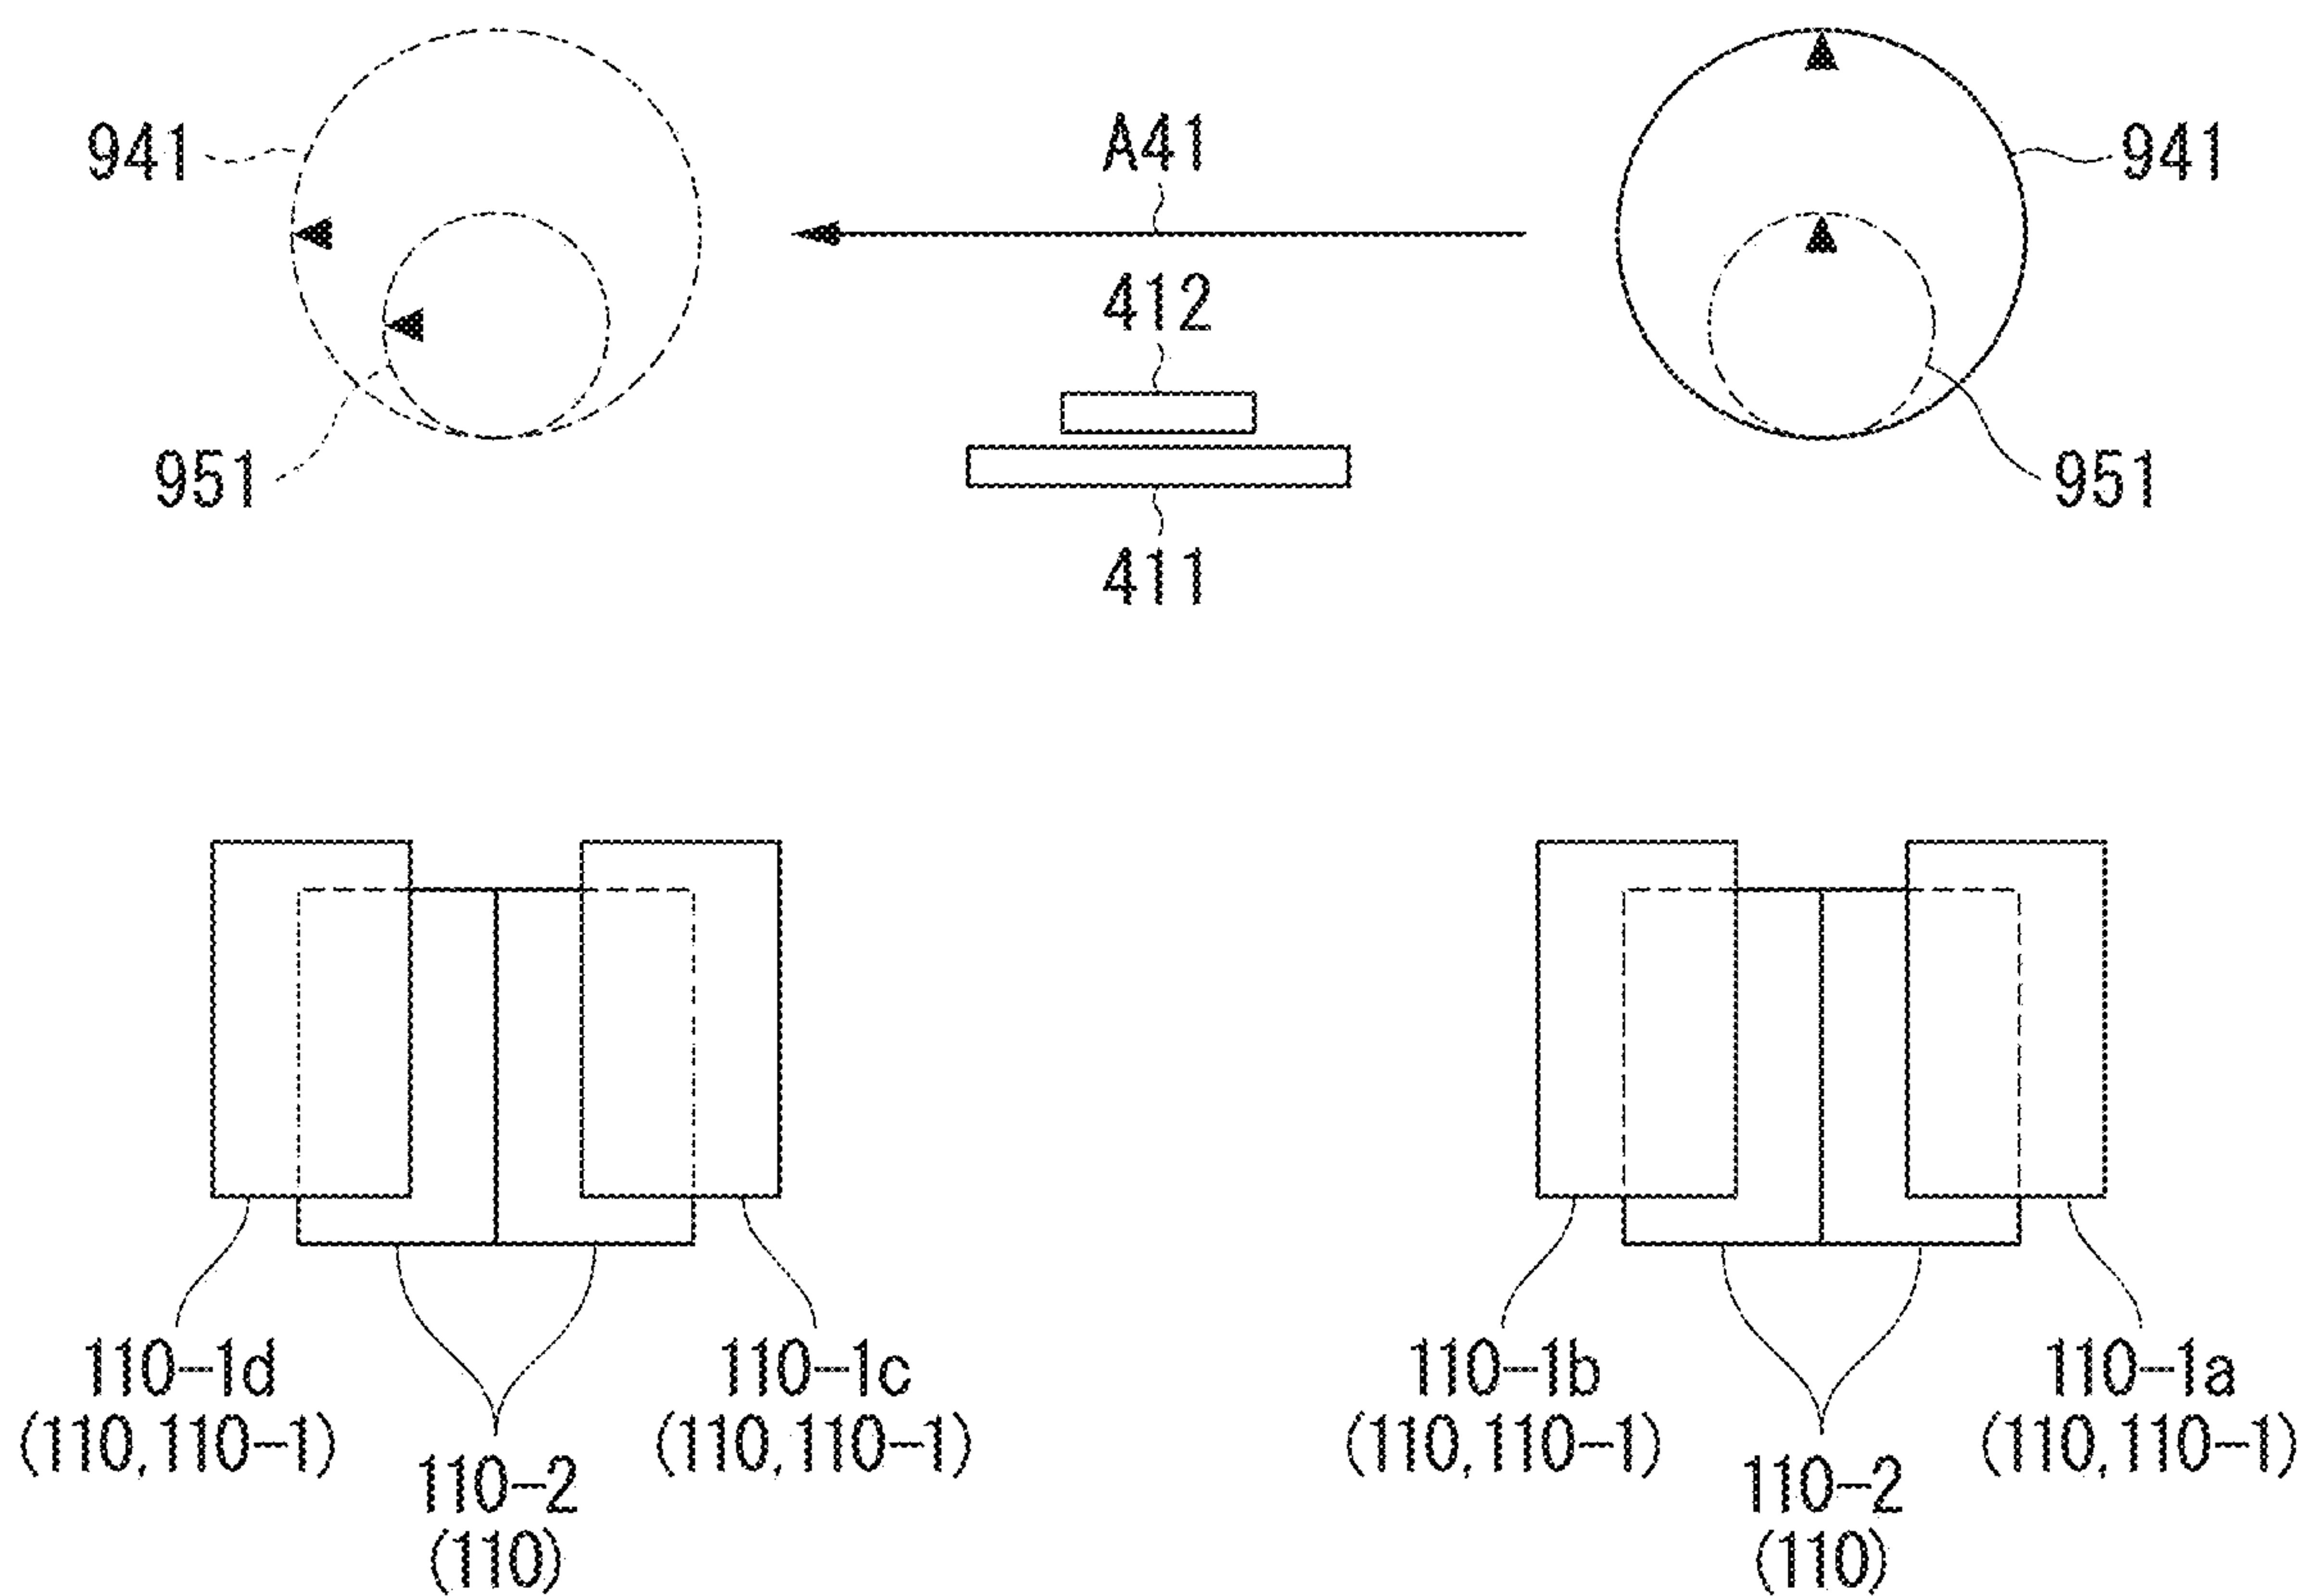
FIG. 10 is an explanatory diagram showing an example of a change in the direction of the guide wheel according to the embodiment.

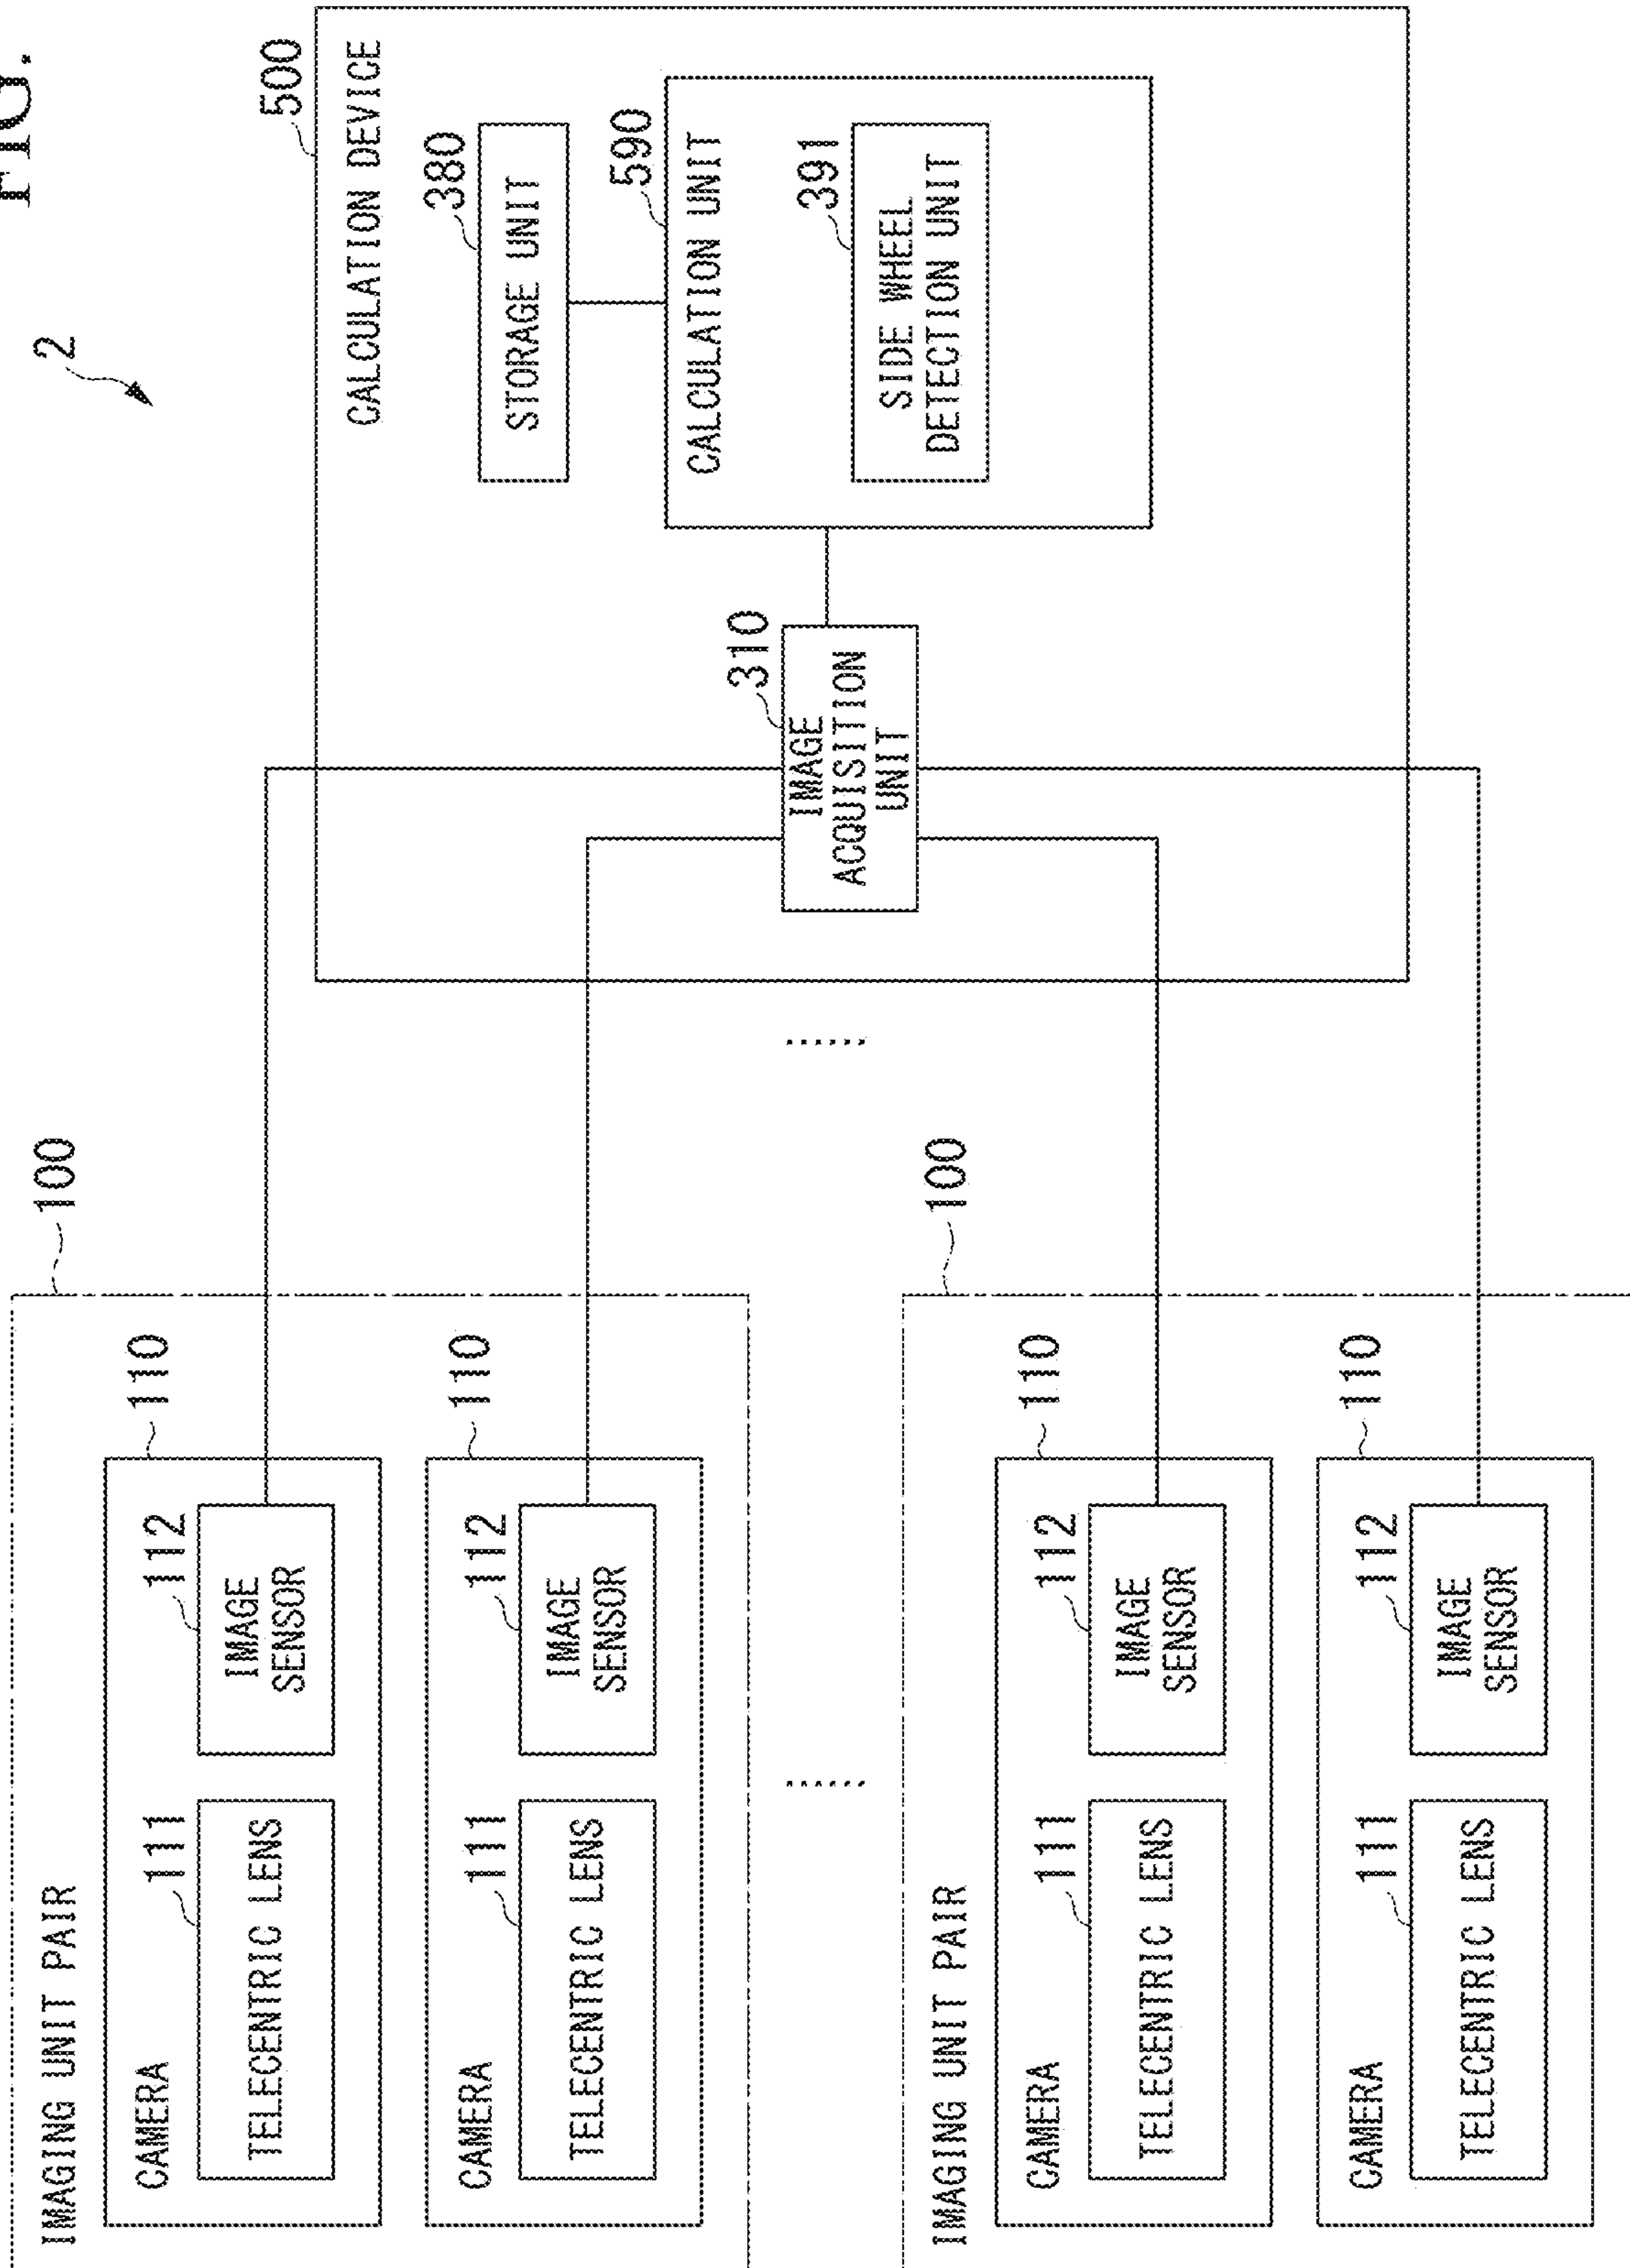
FIG. 11 is a schematic block diagram showing a functional configuration of a first modification example of an abrasion inspection apparatus according the embodiment.

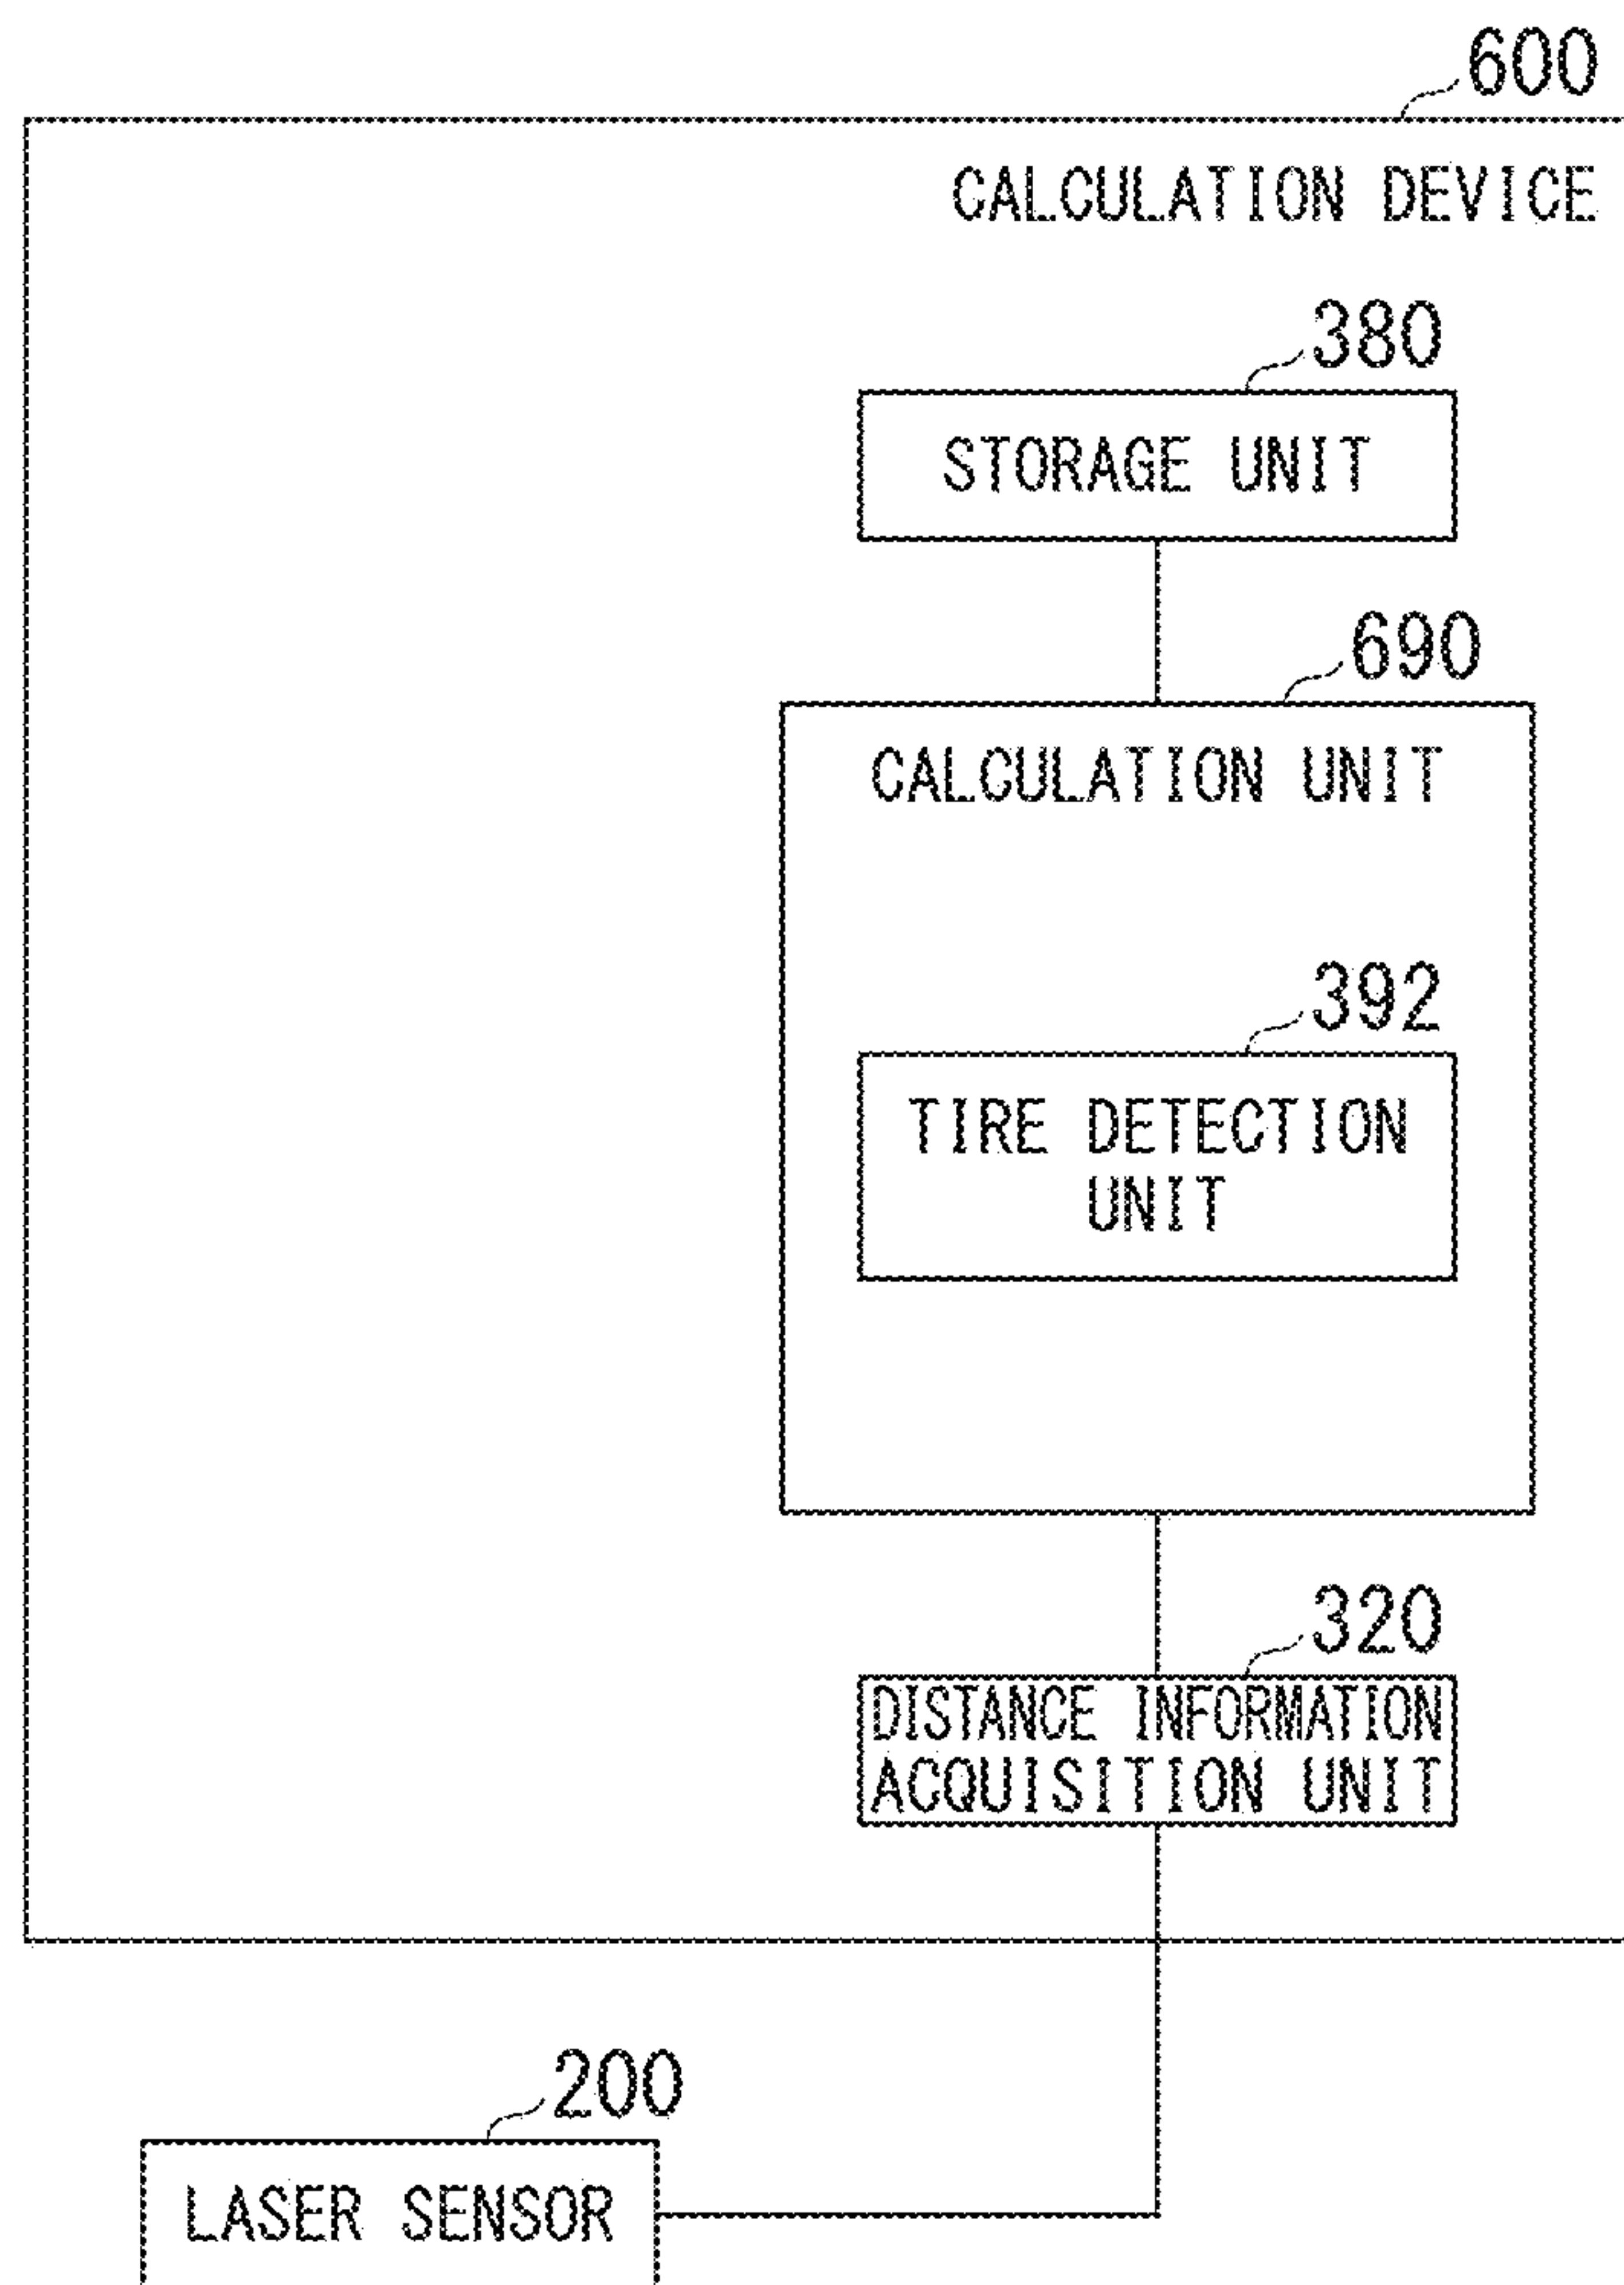
FIG. 12 is a schematic block diagram showing a functional configuration of a second modification example of an abrasion inspection apparatus according the embodiment.
