US011504813B2

(54) METHODS FOR HEALTH MONITORING OF CERAMIC MATRIX COMPOSITE COMPONENTS IN GAS TURBINE ENGINES

A method comprises inspecting a ceramic matrix composite component assembled in a gas turbine engine to determine an extent of damage to the ceramic matrix composite component, determining a repair technique to repair the damage to the ceramic matrix composite component based on the extent of damage to the ceramic matrix composite component, and repairing the ceramic matrix composite component using the repair technique.

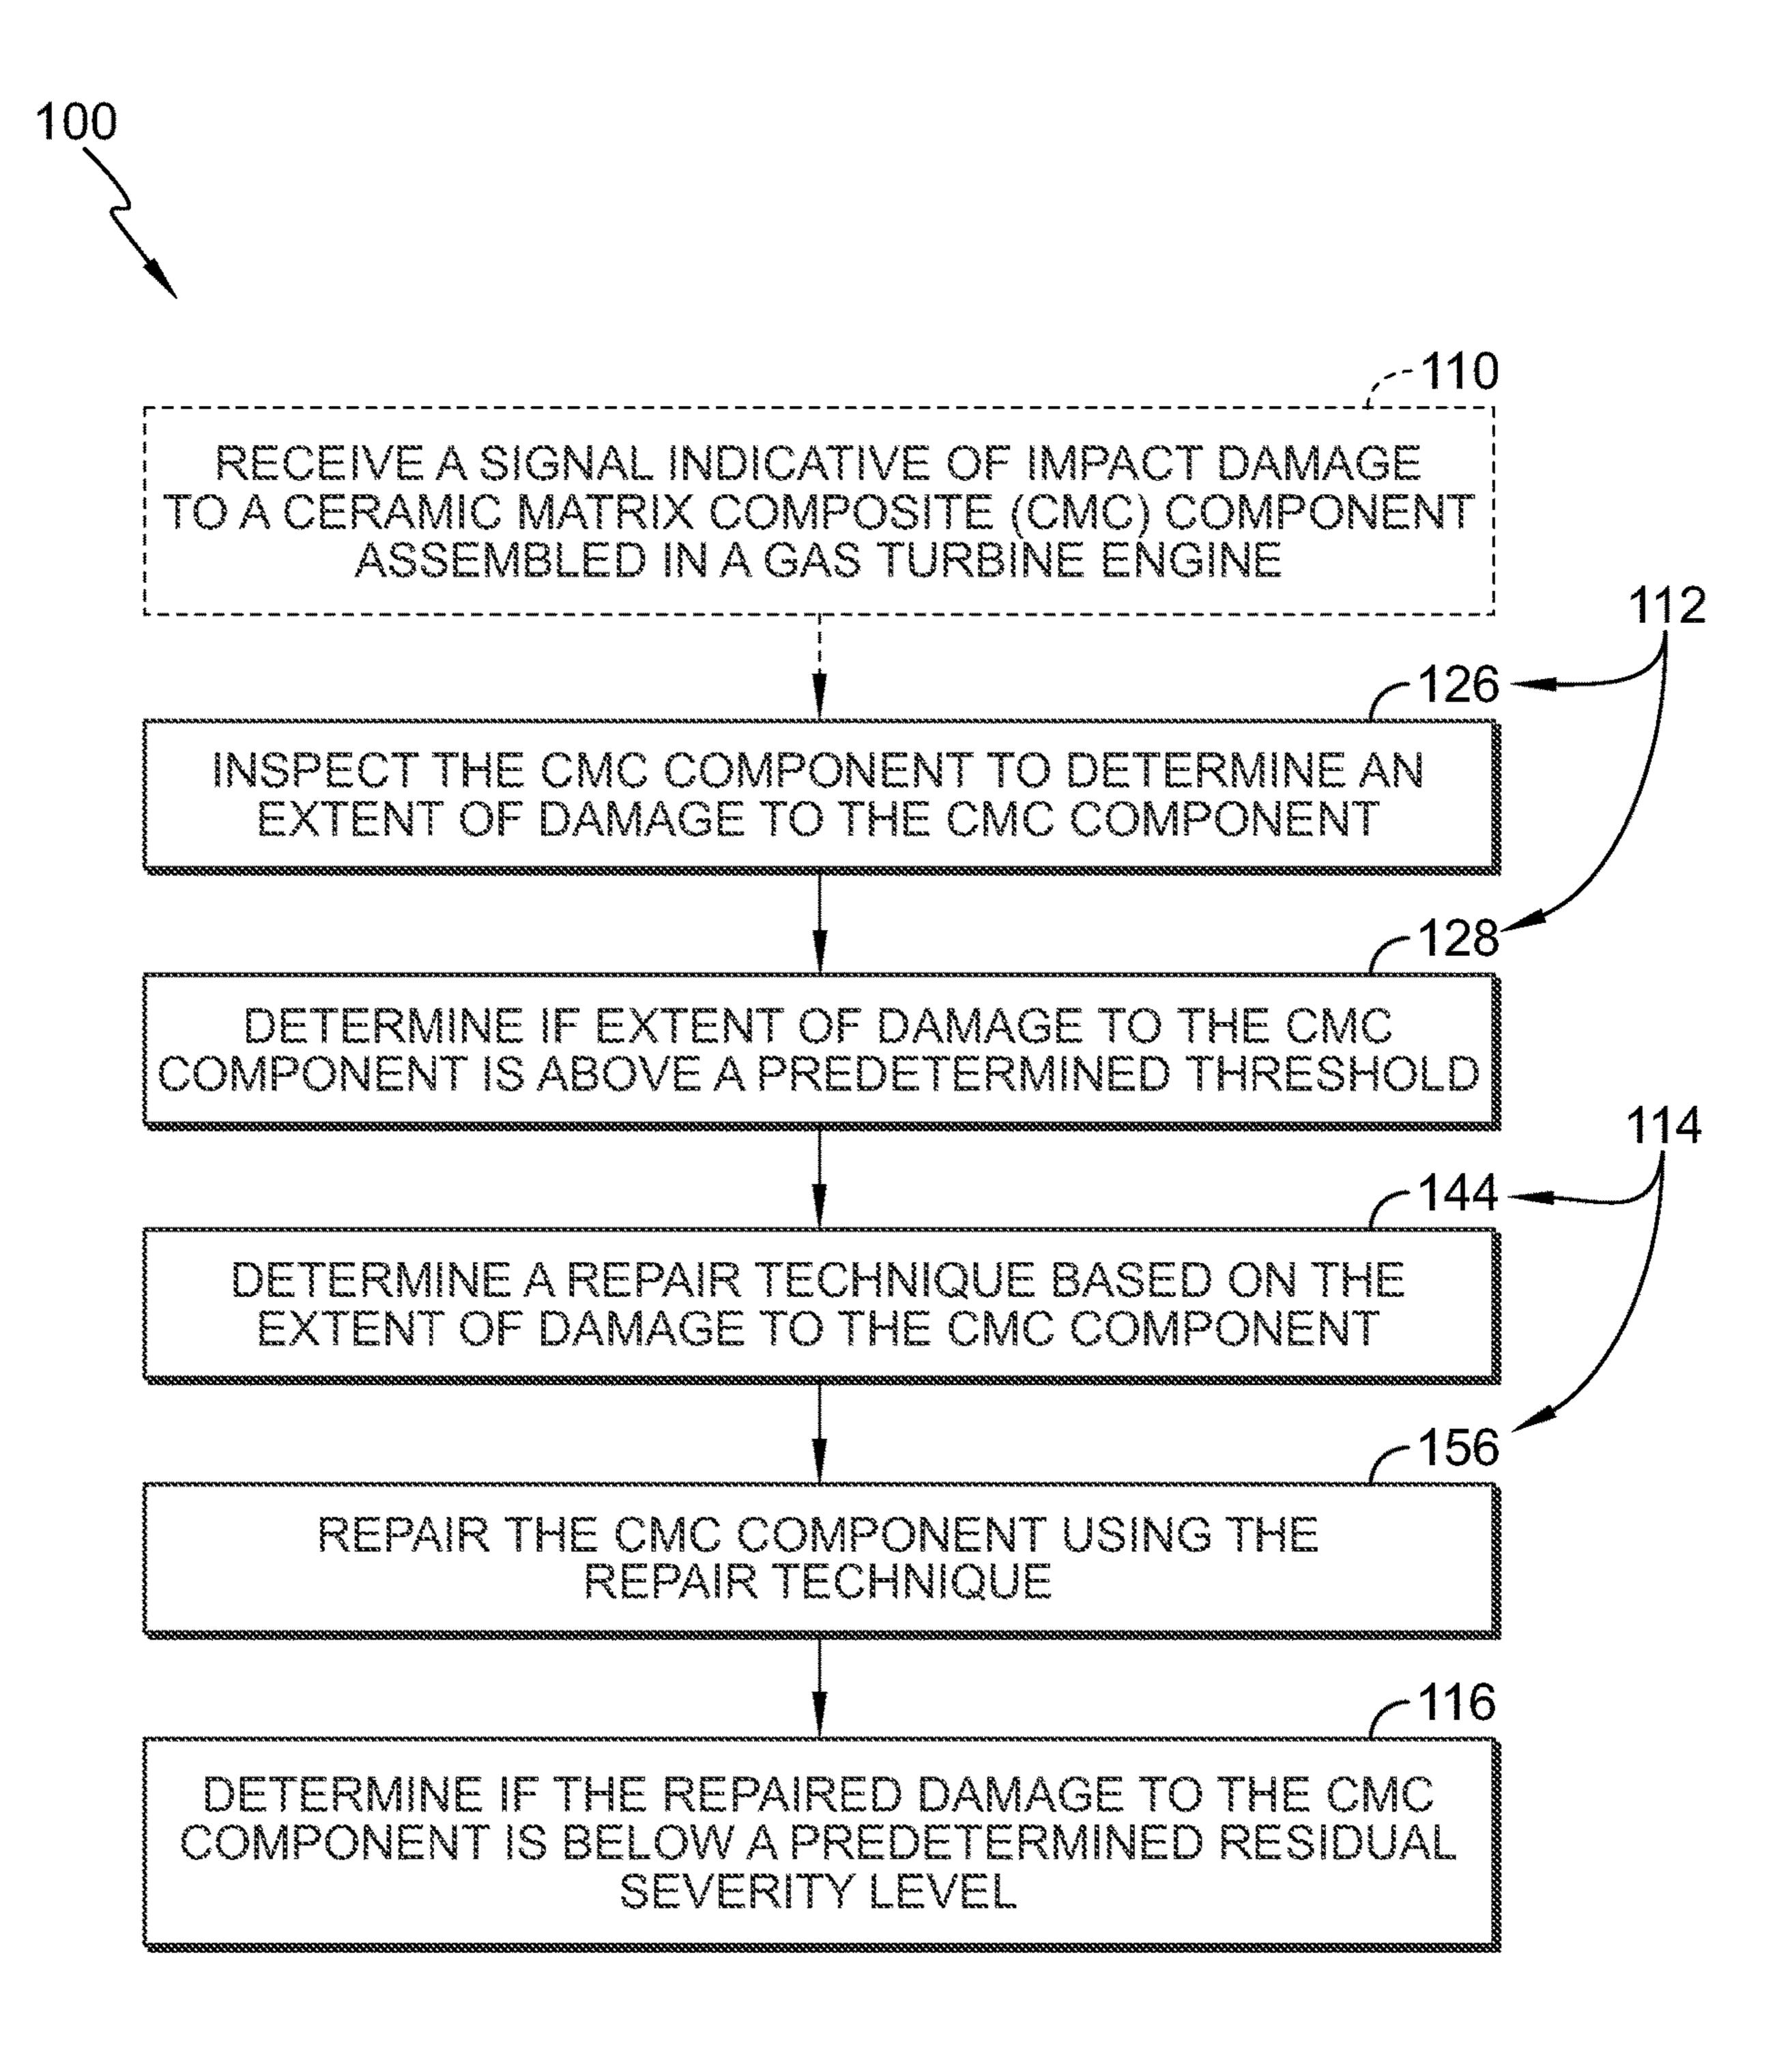
FIG. 3 is a diagrammatic view of a method of monitoring damage to a component made of ceramic matrix composite material included in one of the rotating wheel assemblies and the static turbine vane assembly of FIG. 2 showing the method includes (i) inspecting the ceramic matrix composite component to determine an extent of damage to the component, (ii) determining if the extent of damage to the ceramic matrix composite component is above a predetermined threshold, (iii) determining a repair technique to repair the damage to the ceramic matrix composite component based on the extent of damage to the component, and (iv) repairing the ceramic matrix composite component using the repair technique;

A method 100 for detecting, inspecting, and repairing impact damage to a ceramic matrix composite component 24, 26, 28 assembled in a gas turbine engine 10 is shown in FIG. 3. The gas turbine engine 10 includes a fan 12, a compressor 14, a combustor 16, and a turbine 18 as shown in FIG. 1. The fan 12 is driven by the turbine 18 and provides thrust for propelling an aircraft. The compressor 14 compresses and delivers air to the combustor 16. The combustor 16 mixes fuel with the compressed air received from the compressor 14 and ignites the fuel. The hot, high-pressure products of the combustion reaction in the combustor 16 are directed into the turbine 18 to cause the turbine 18 to rotate about an axis 11 of the gas turbine engine 10 and drive the compressor 14 and the fan 12.

The method 100 includes an inspection step 112, a repair step 114, and an assessment step 116 as shown in FIGS. 3 and 6-9. The inspection step 112 includes inspecting the ceramic matrix composite component 24, 26, 28 to determine an extent of damage 30 to the ceramic matrix composite component 24, 26, 28 and determining if the extent of damage 30 to the ceramic matrix composite component 24, 26, 28 is above a predetermined threshold. The repair step 114 includes determining a repair technique to repair the damage to the ceramic matrix composite component 24, 26, 28 based on the extent of damage 30 to the ceramic matrix composite component 24, 26, 28 and repairing the ceramic matrix composite component 24, 26, 28 using the repair technique. The assessment step 116 includes determining the repaired damage is below a predetermined residual severity limit so that the engine 10 may be cleared or permitted for flight.

In the illustrative embodiment, the method 100 may further include a detection step 110 as suggested in FIG. 3.

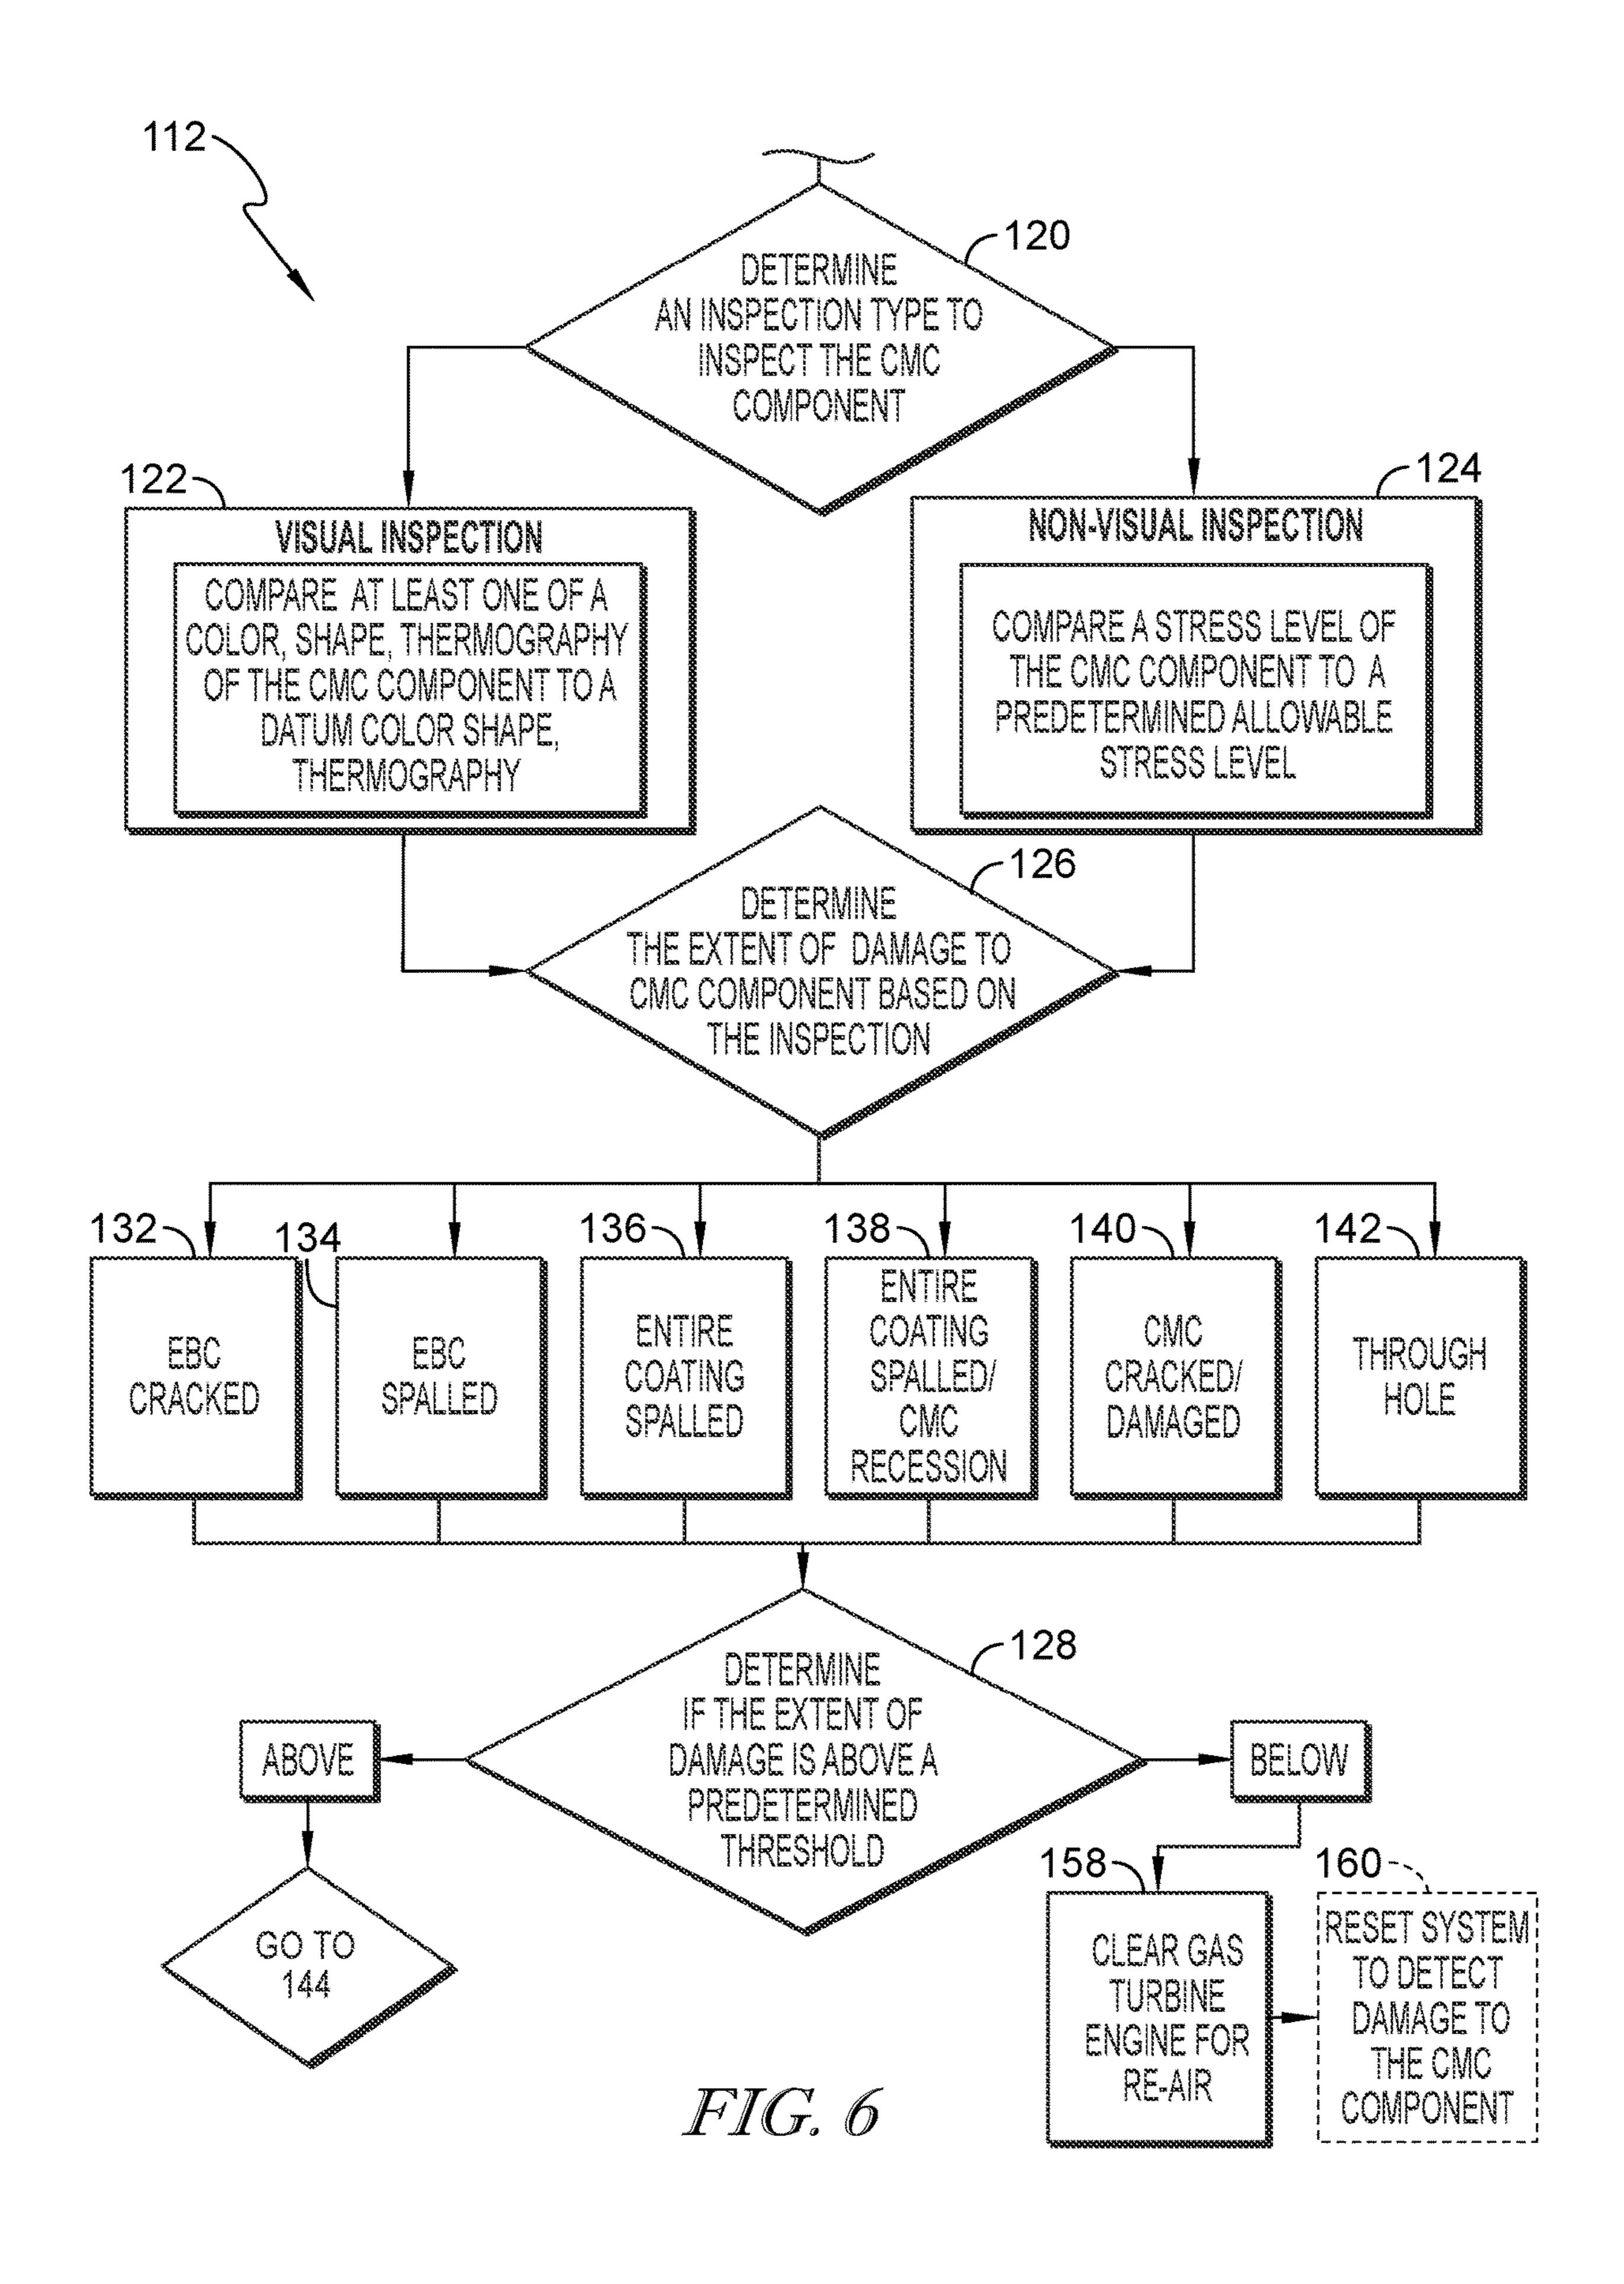
FIG. 6 is a diagrammatic view of the inspecting step of FIG. 3 showing the inspecting step includes one of a visual inspection and a non-visual inspection of the extent of damage to the ceramic matrix composite component;

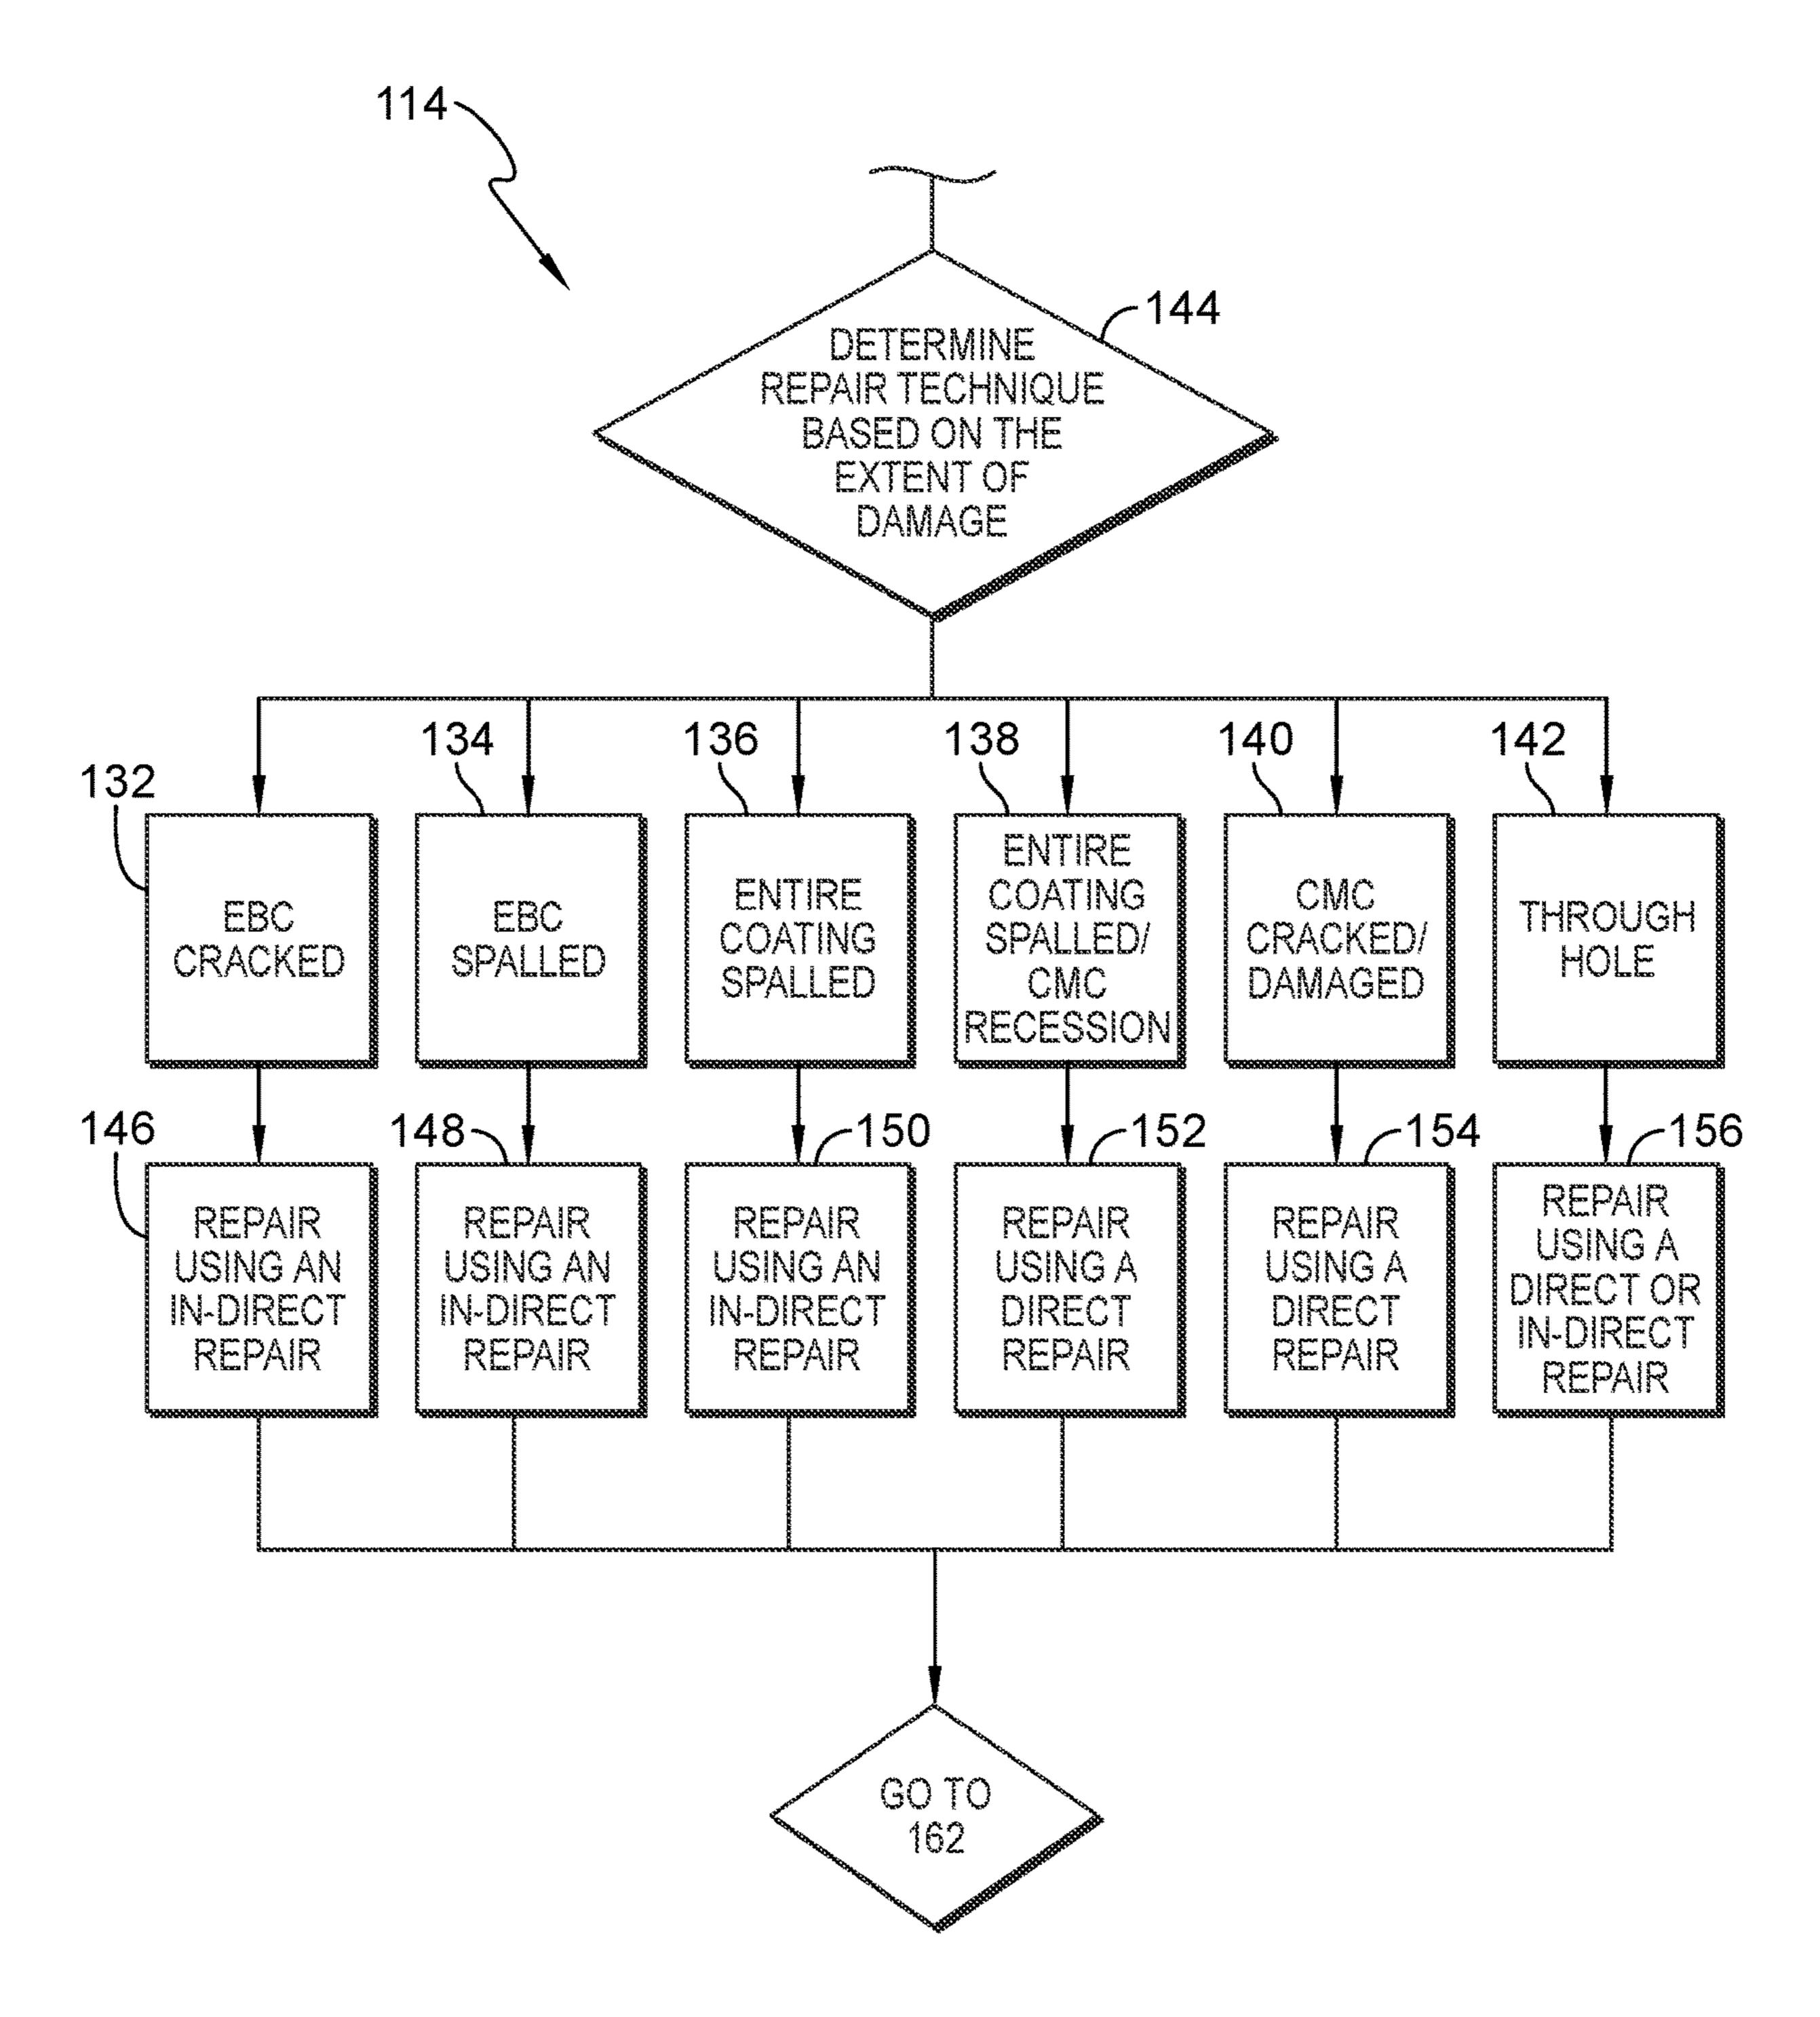
FIG. 7 is a diagrammatic view of the repair step of FIG. 3 showing the repair technique includes one of a direct repair of the ceramic matrix composite material of the ceramic matrix composite component and an in-direct repair of the ceramic matrix composite composite material of the ceramic matrix composite component based on the extent of damage to the component;

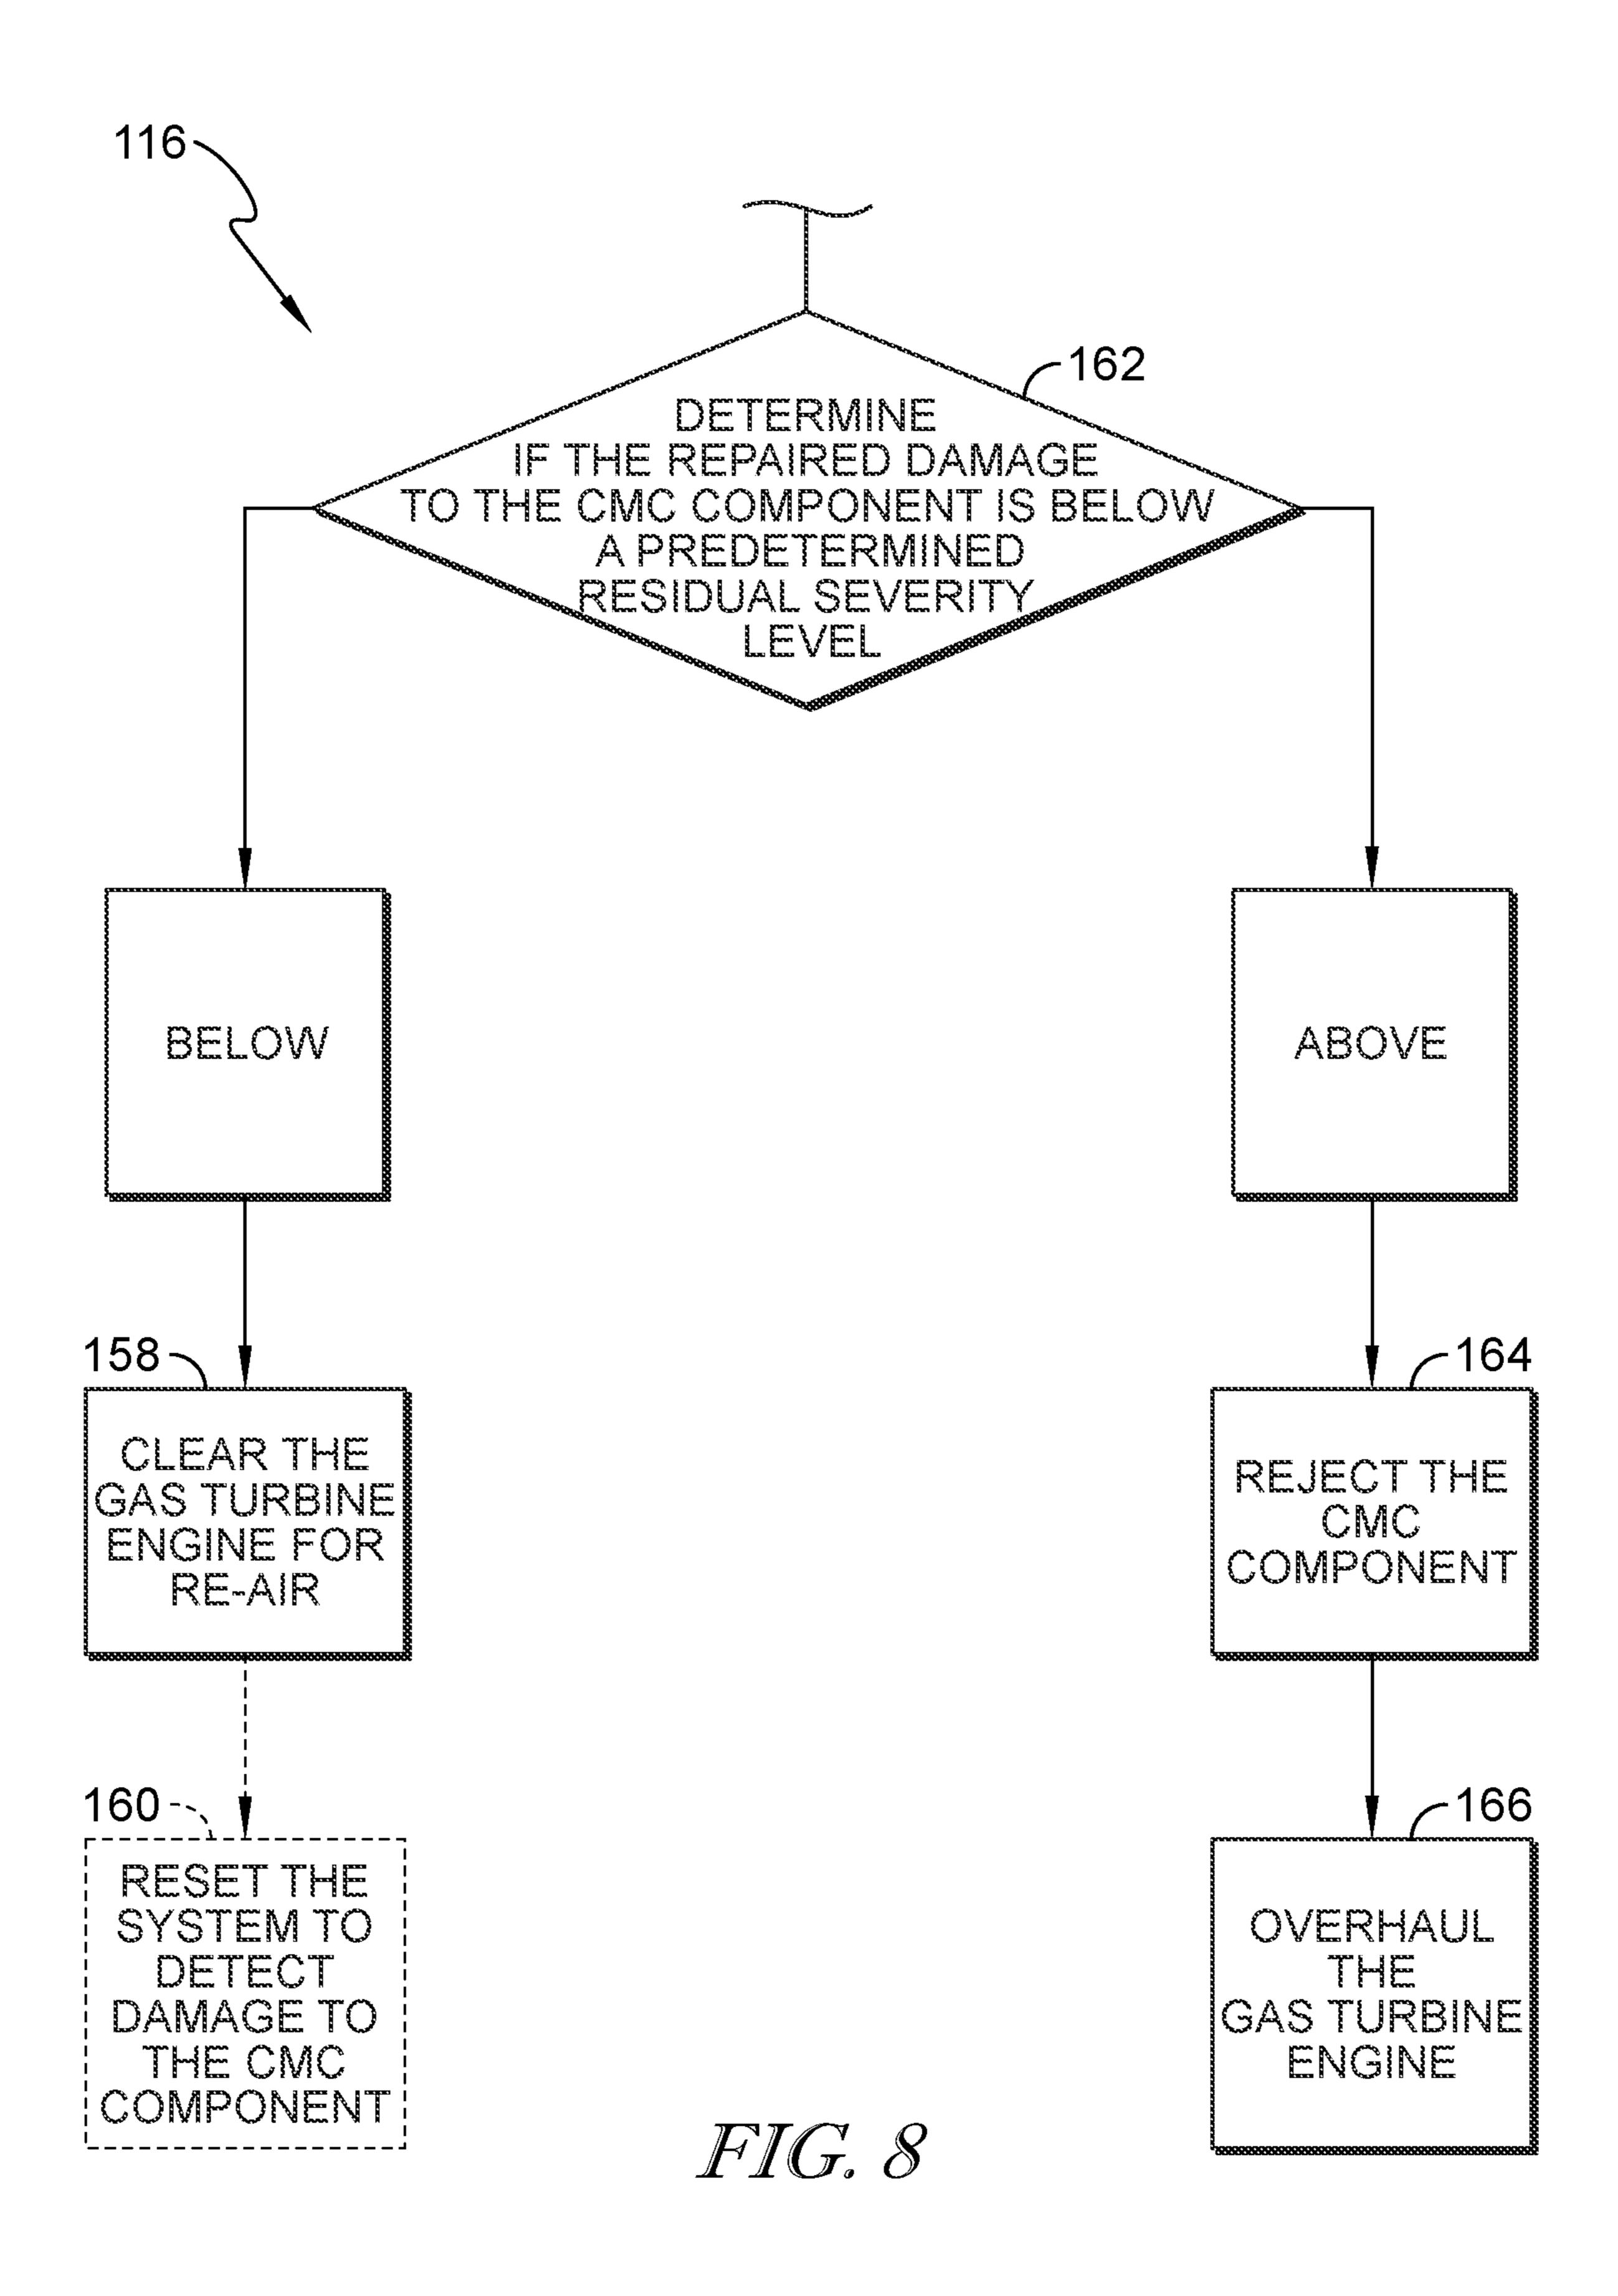
FIG. 8 is a diagrammatic view of the assessment step of 55 FIG. 3 showing the assessment step includes determining if the repaired damaged to the ceramic matrix composite component is below a predetermined residual severity limit; and

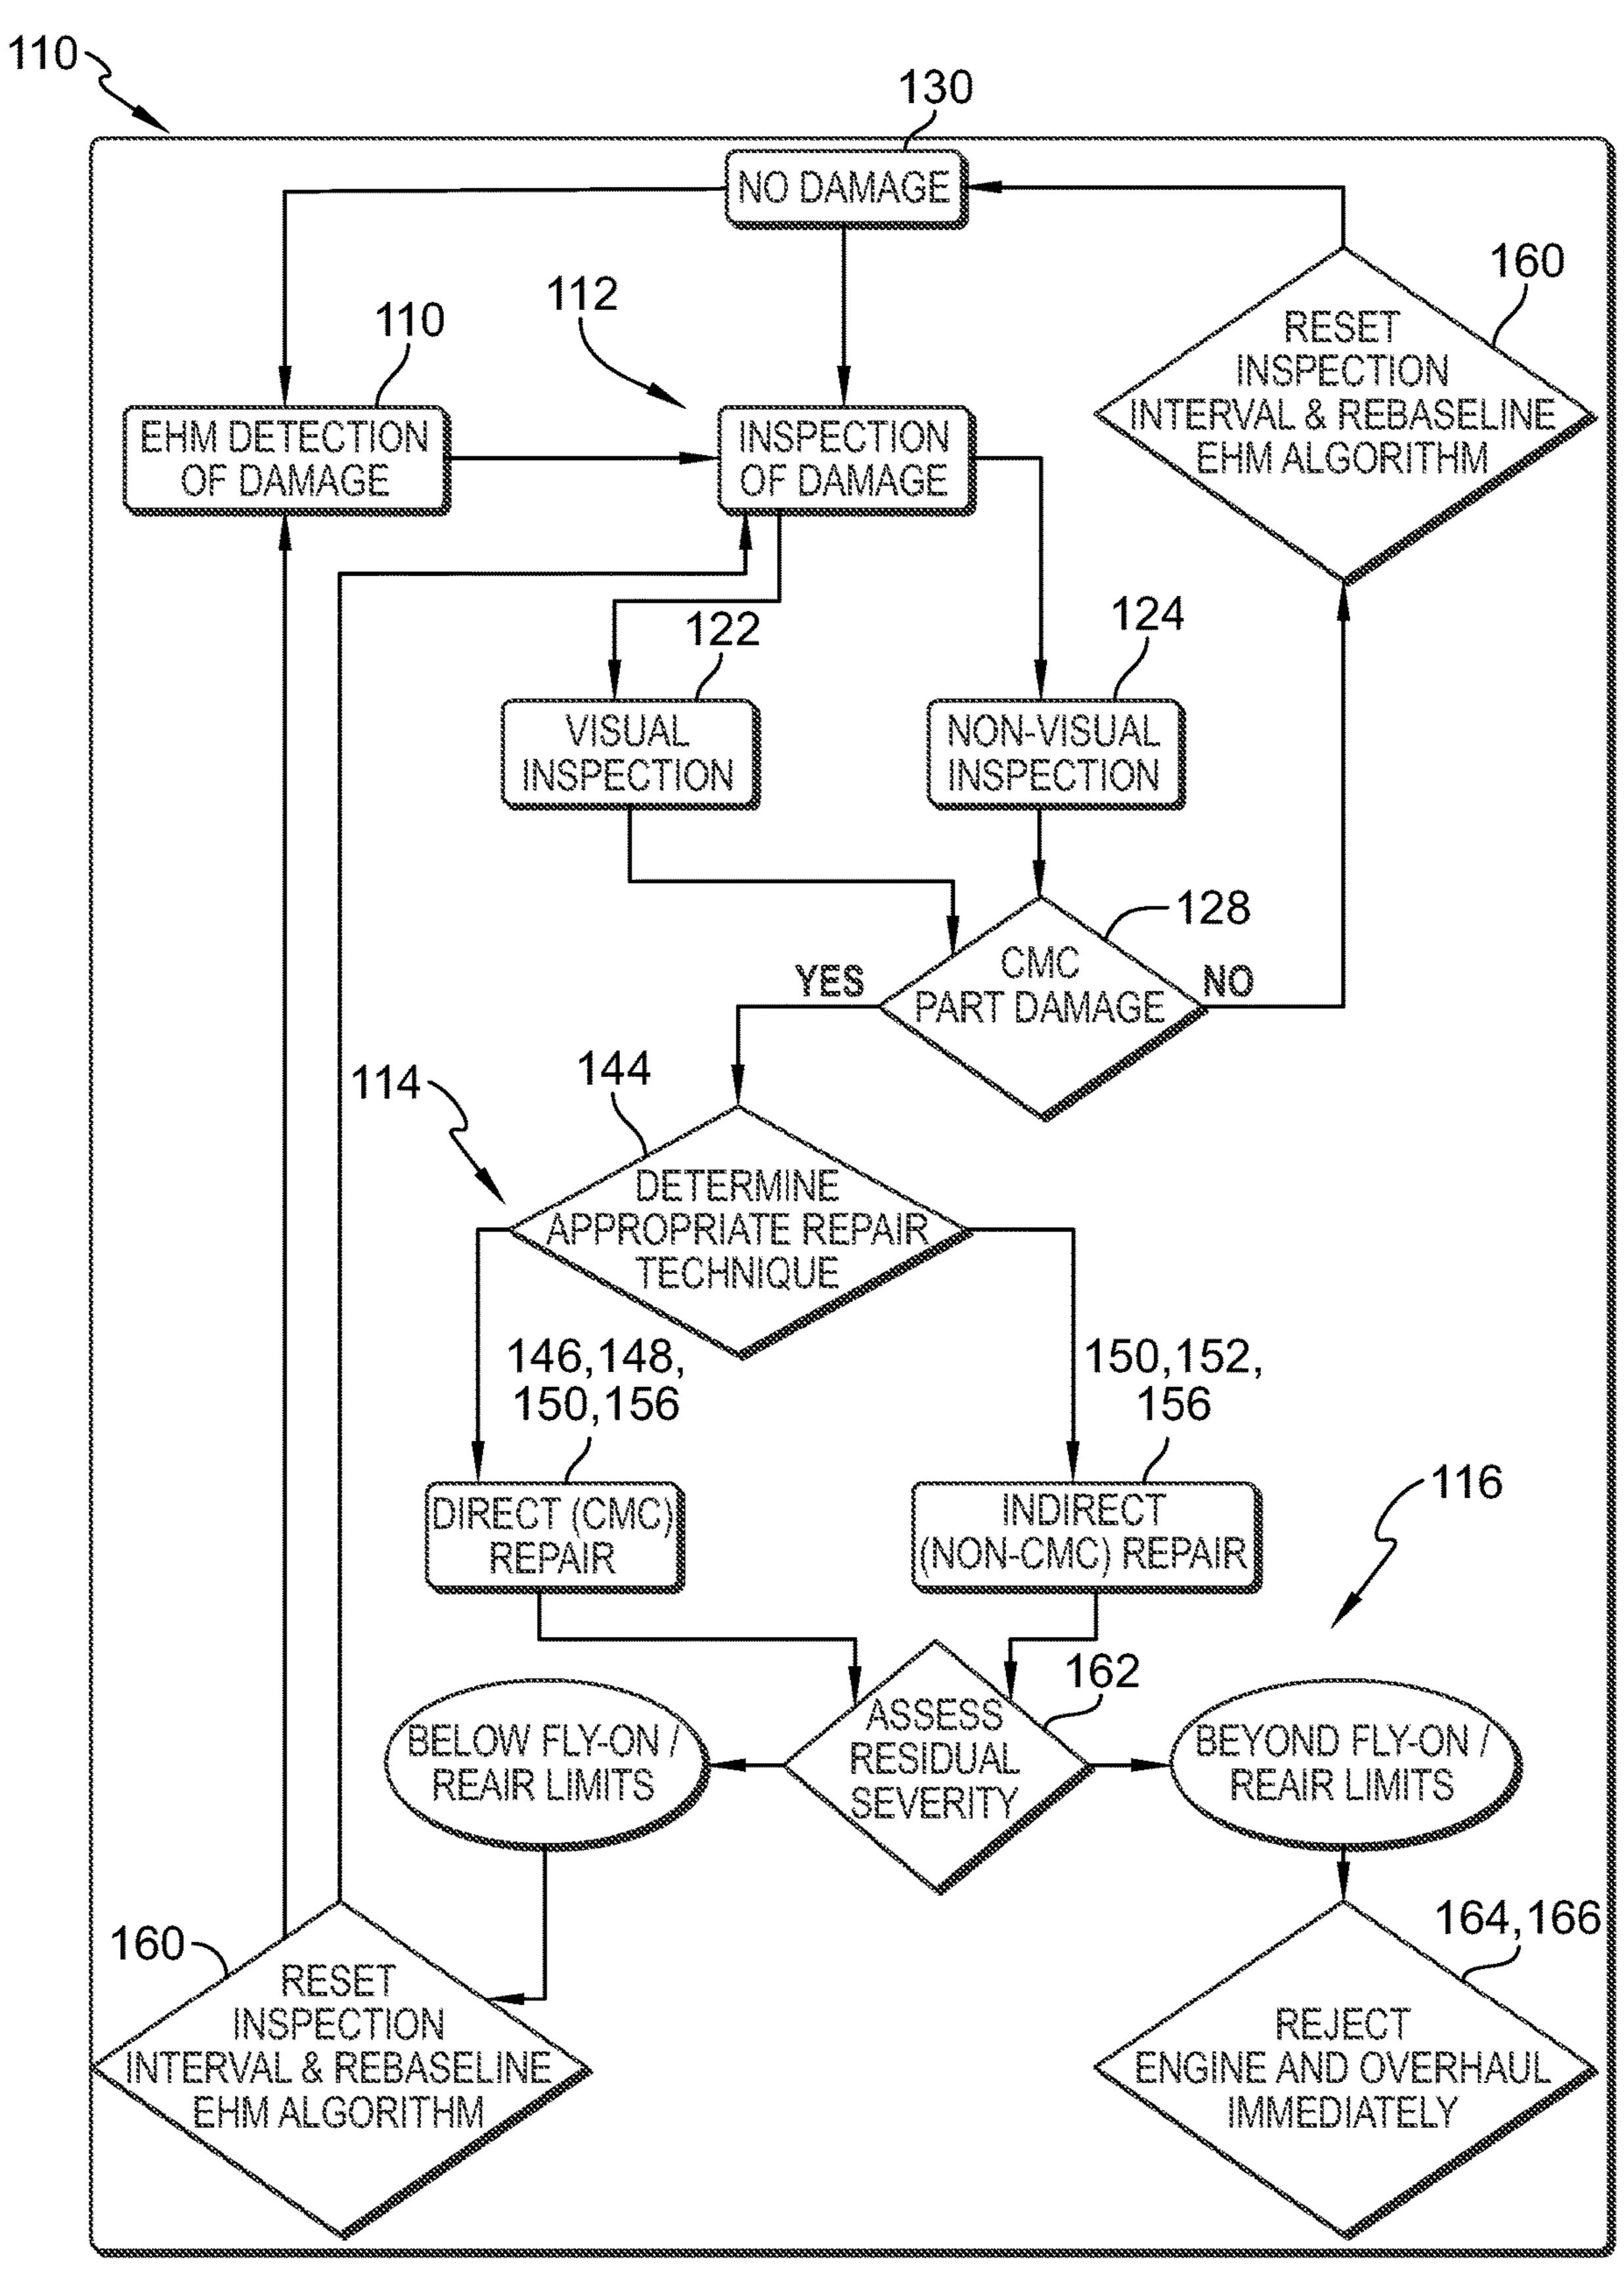
FIG. 9 is a diagrammatic view of the method of FIG. 3 60 showing the method includes a detection step along with the inspection, repair, and assessment steps.
