(54) **INTERCHANGEABLE BASE STEEL  
STRUCTURE STORAGE ASSEMBLY**

A storage rack assembly includes a base steel structure which is interchangeably connected to the storage rack above. The base steel structure assembly is comprised of structural material with bolted connections which allow for the replacement or changing of damaged material due to accidental forklift contact all while the above storage system stays in place.

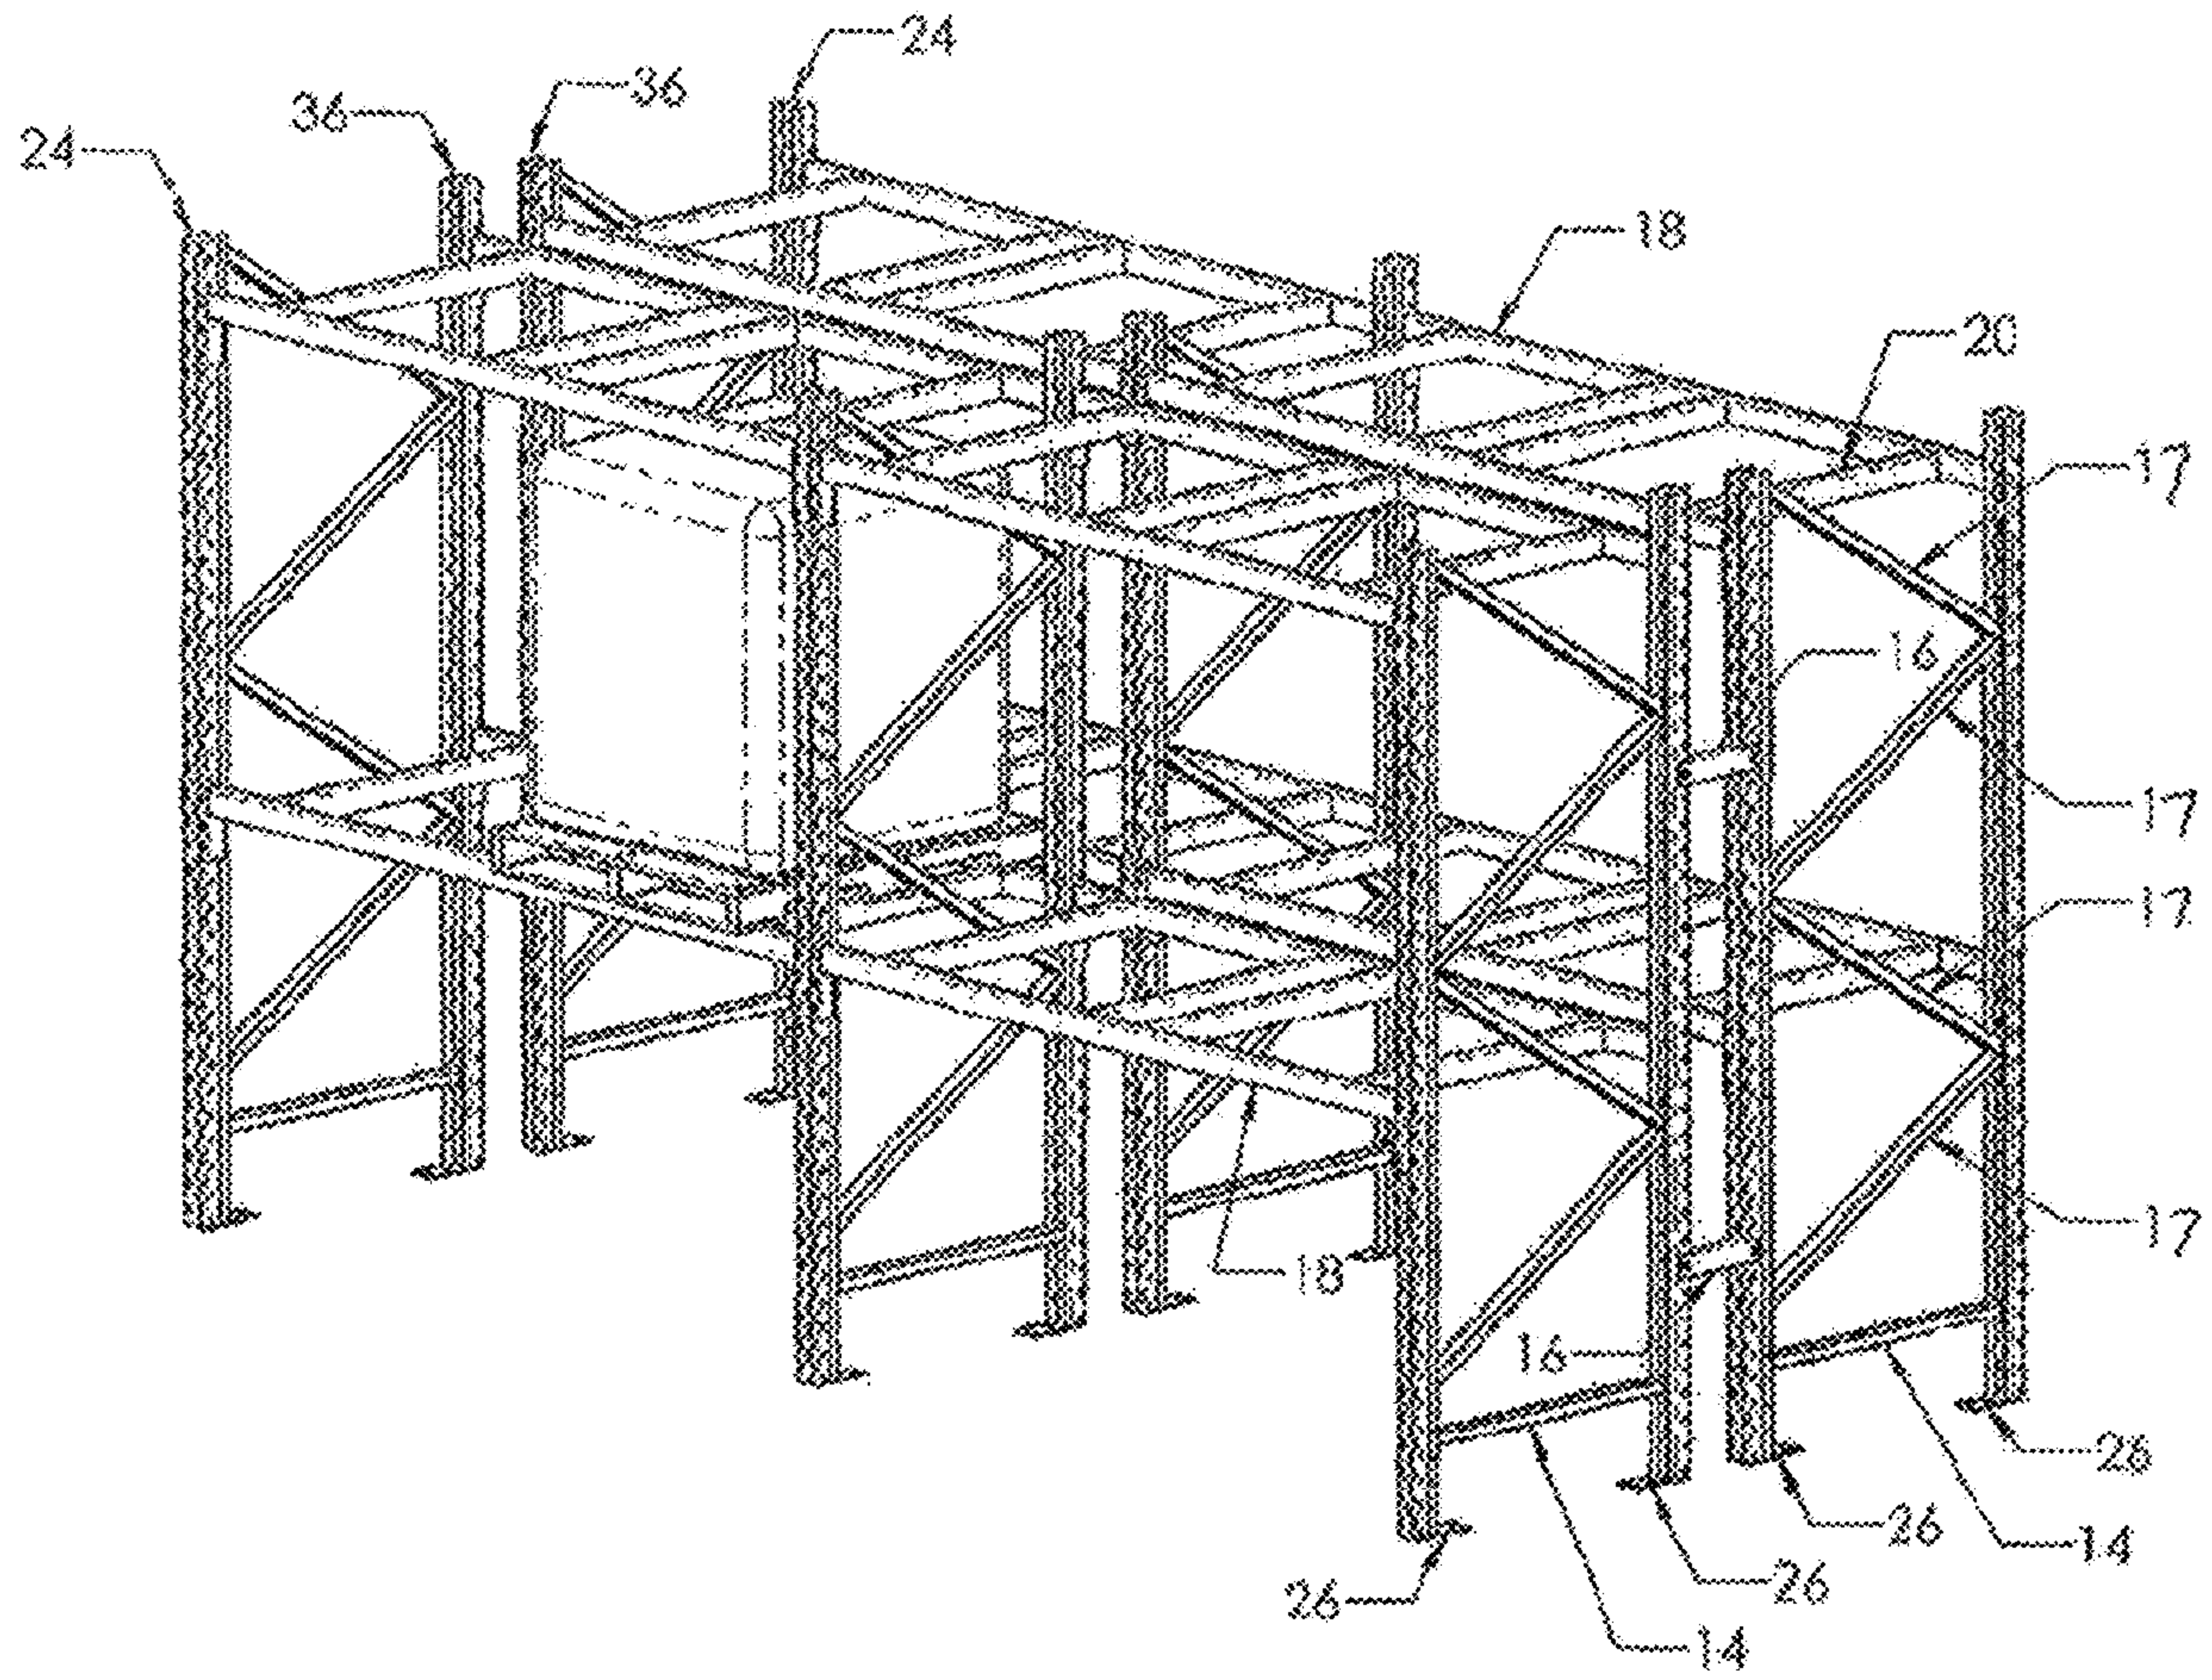
PRIOR ART  
*FIG. 1*

FIG. 1 is a side perspective view of a prior art storage rack;

FIG. 1 shows an example of a prior art storage rack that may be retrofitted to make a rack in accordance with the present invention. A preferred embodiment of the present invention is shown in FIGS. 2-11.

The rack of FIG. 1 has a multitude of forward columns 24, and a multitude of rear columns 36, and horizontal load

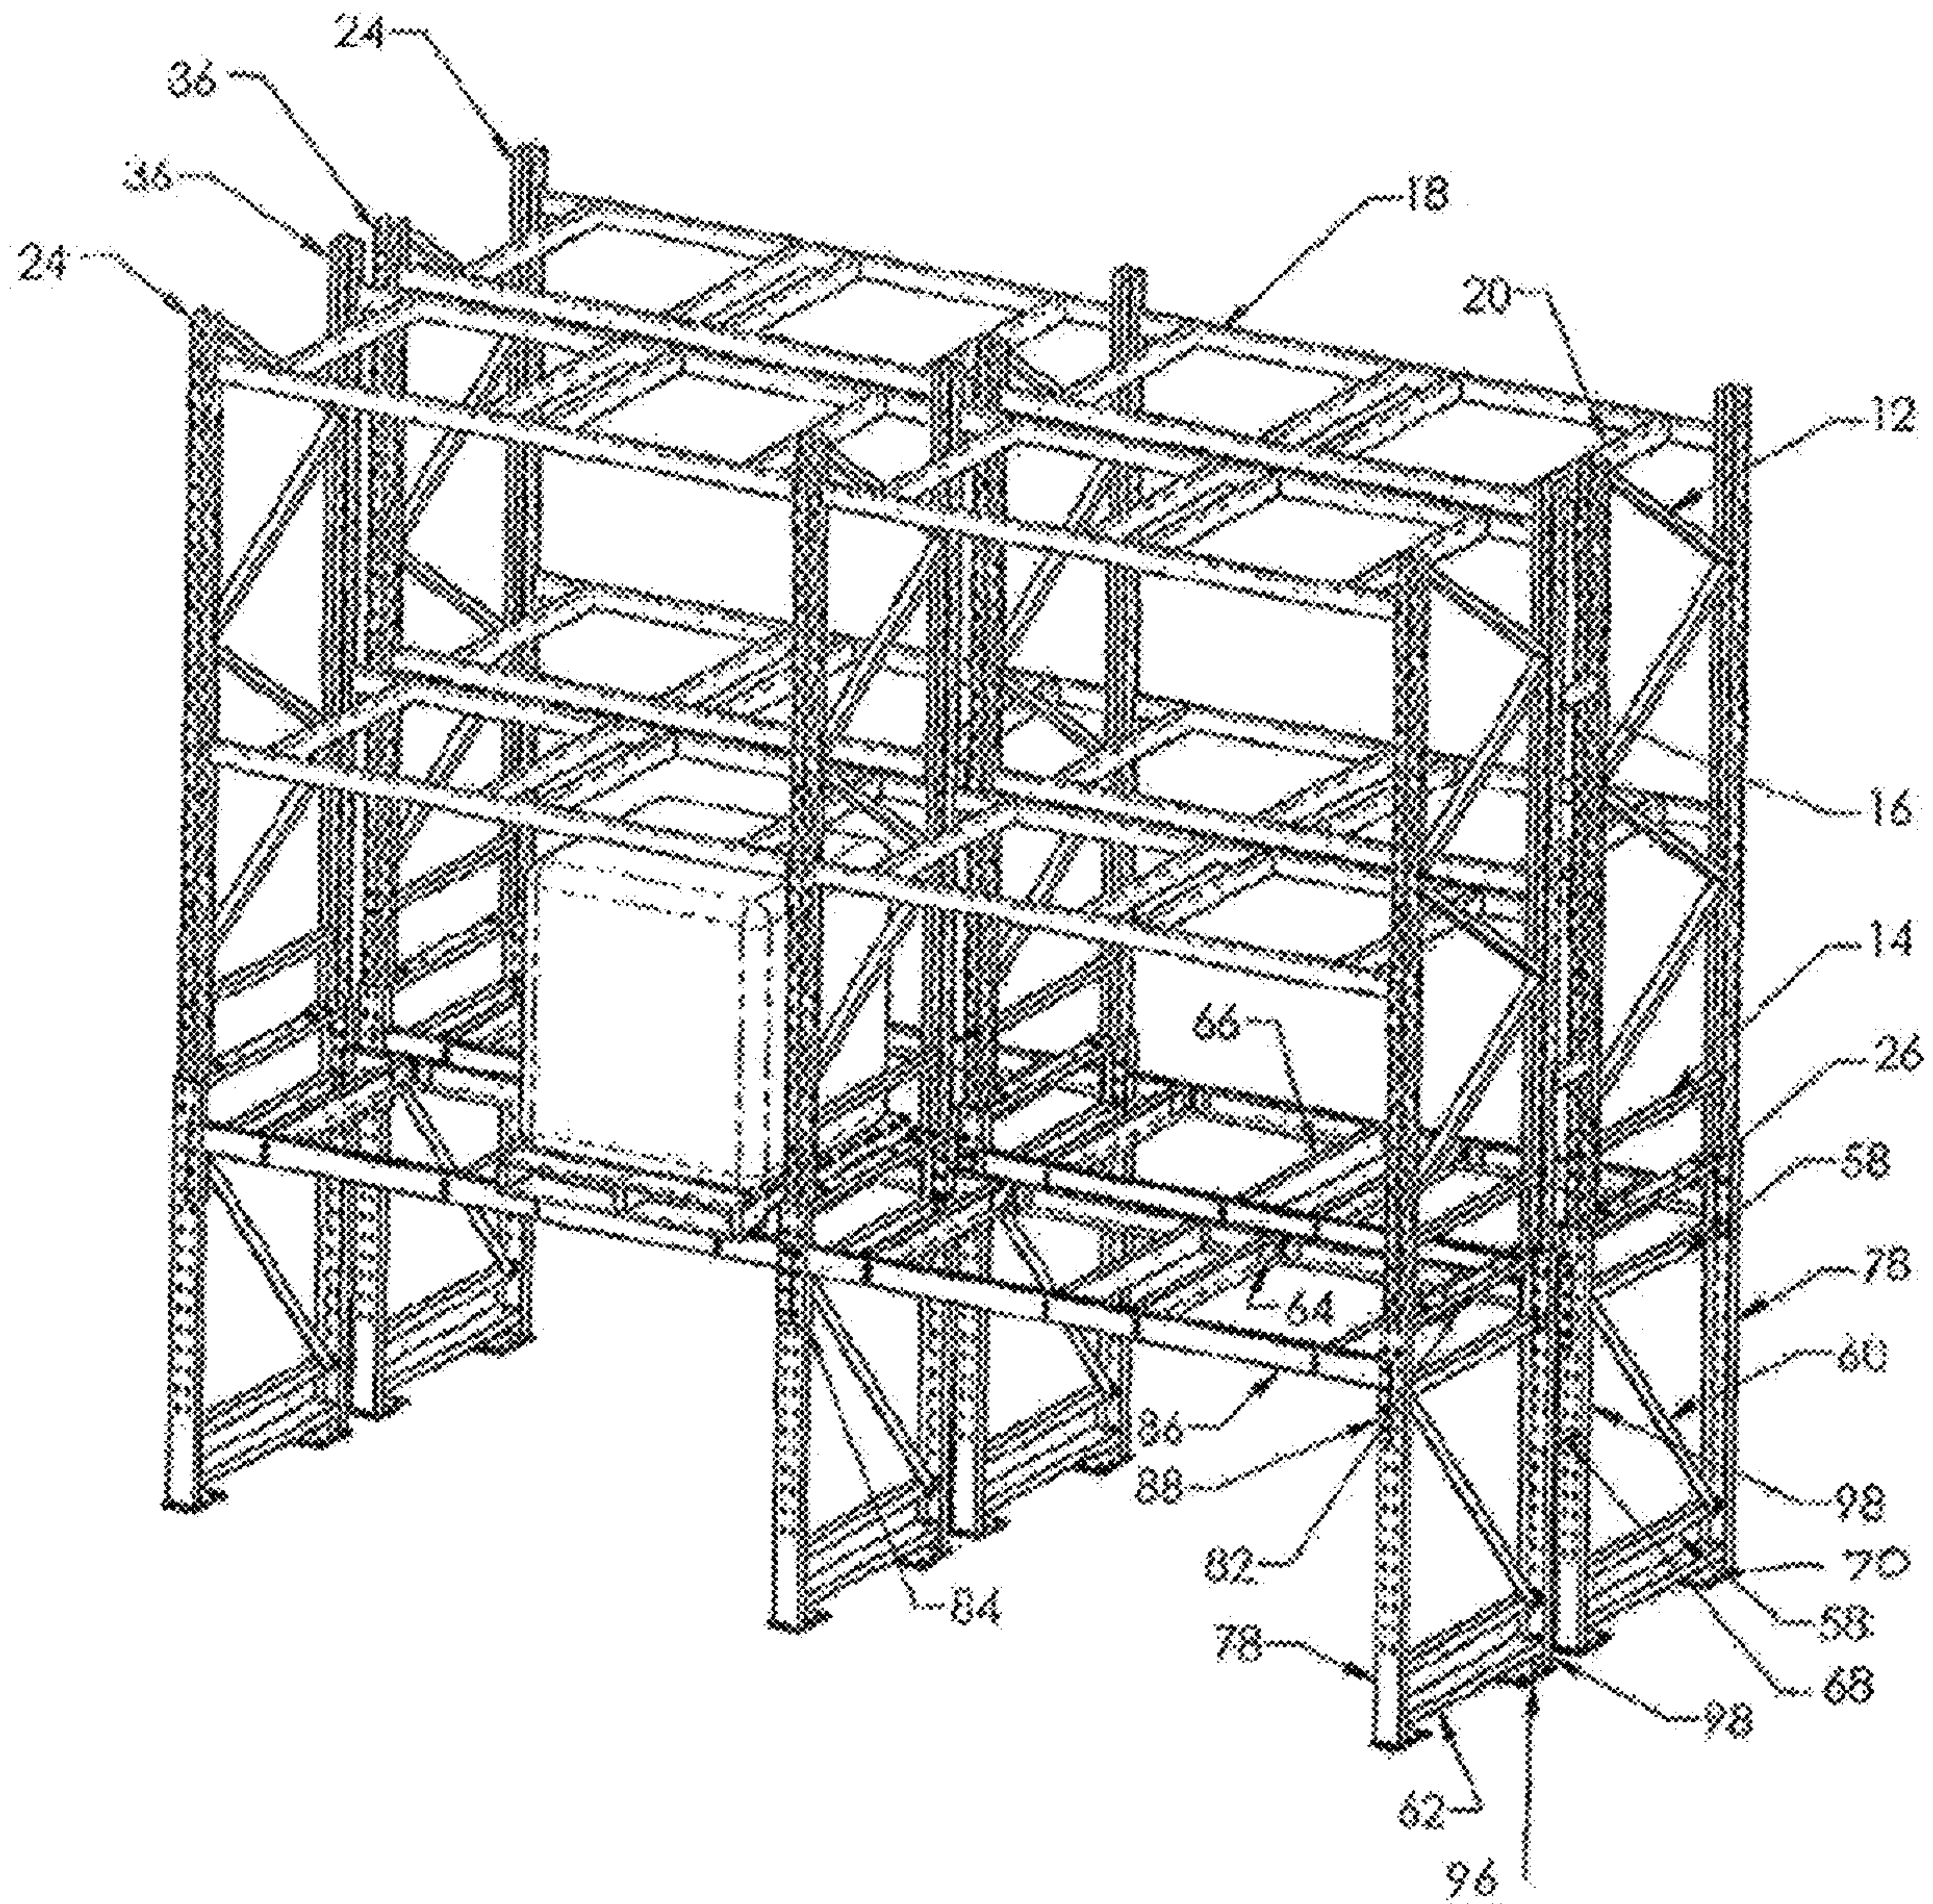
FIG. 2 is a side perspective view of a first embodiment of a storage system made in accordance with the present invention;

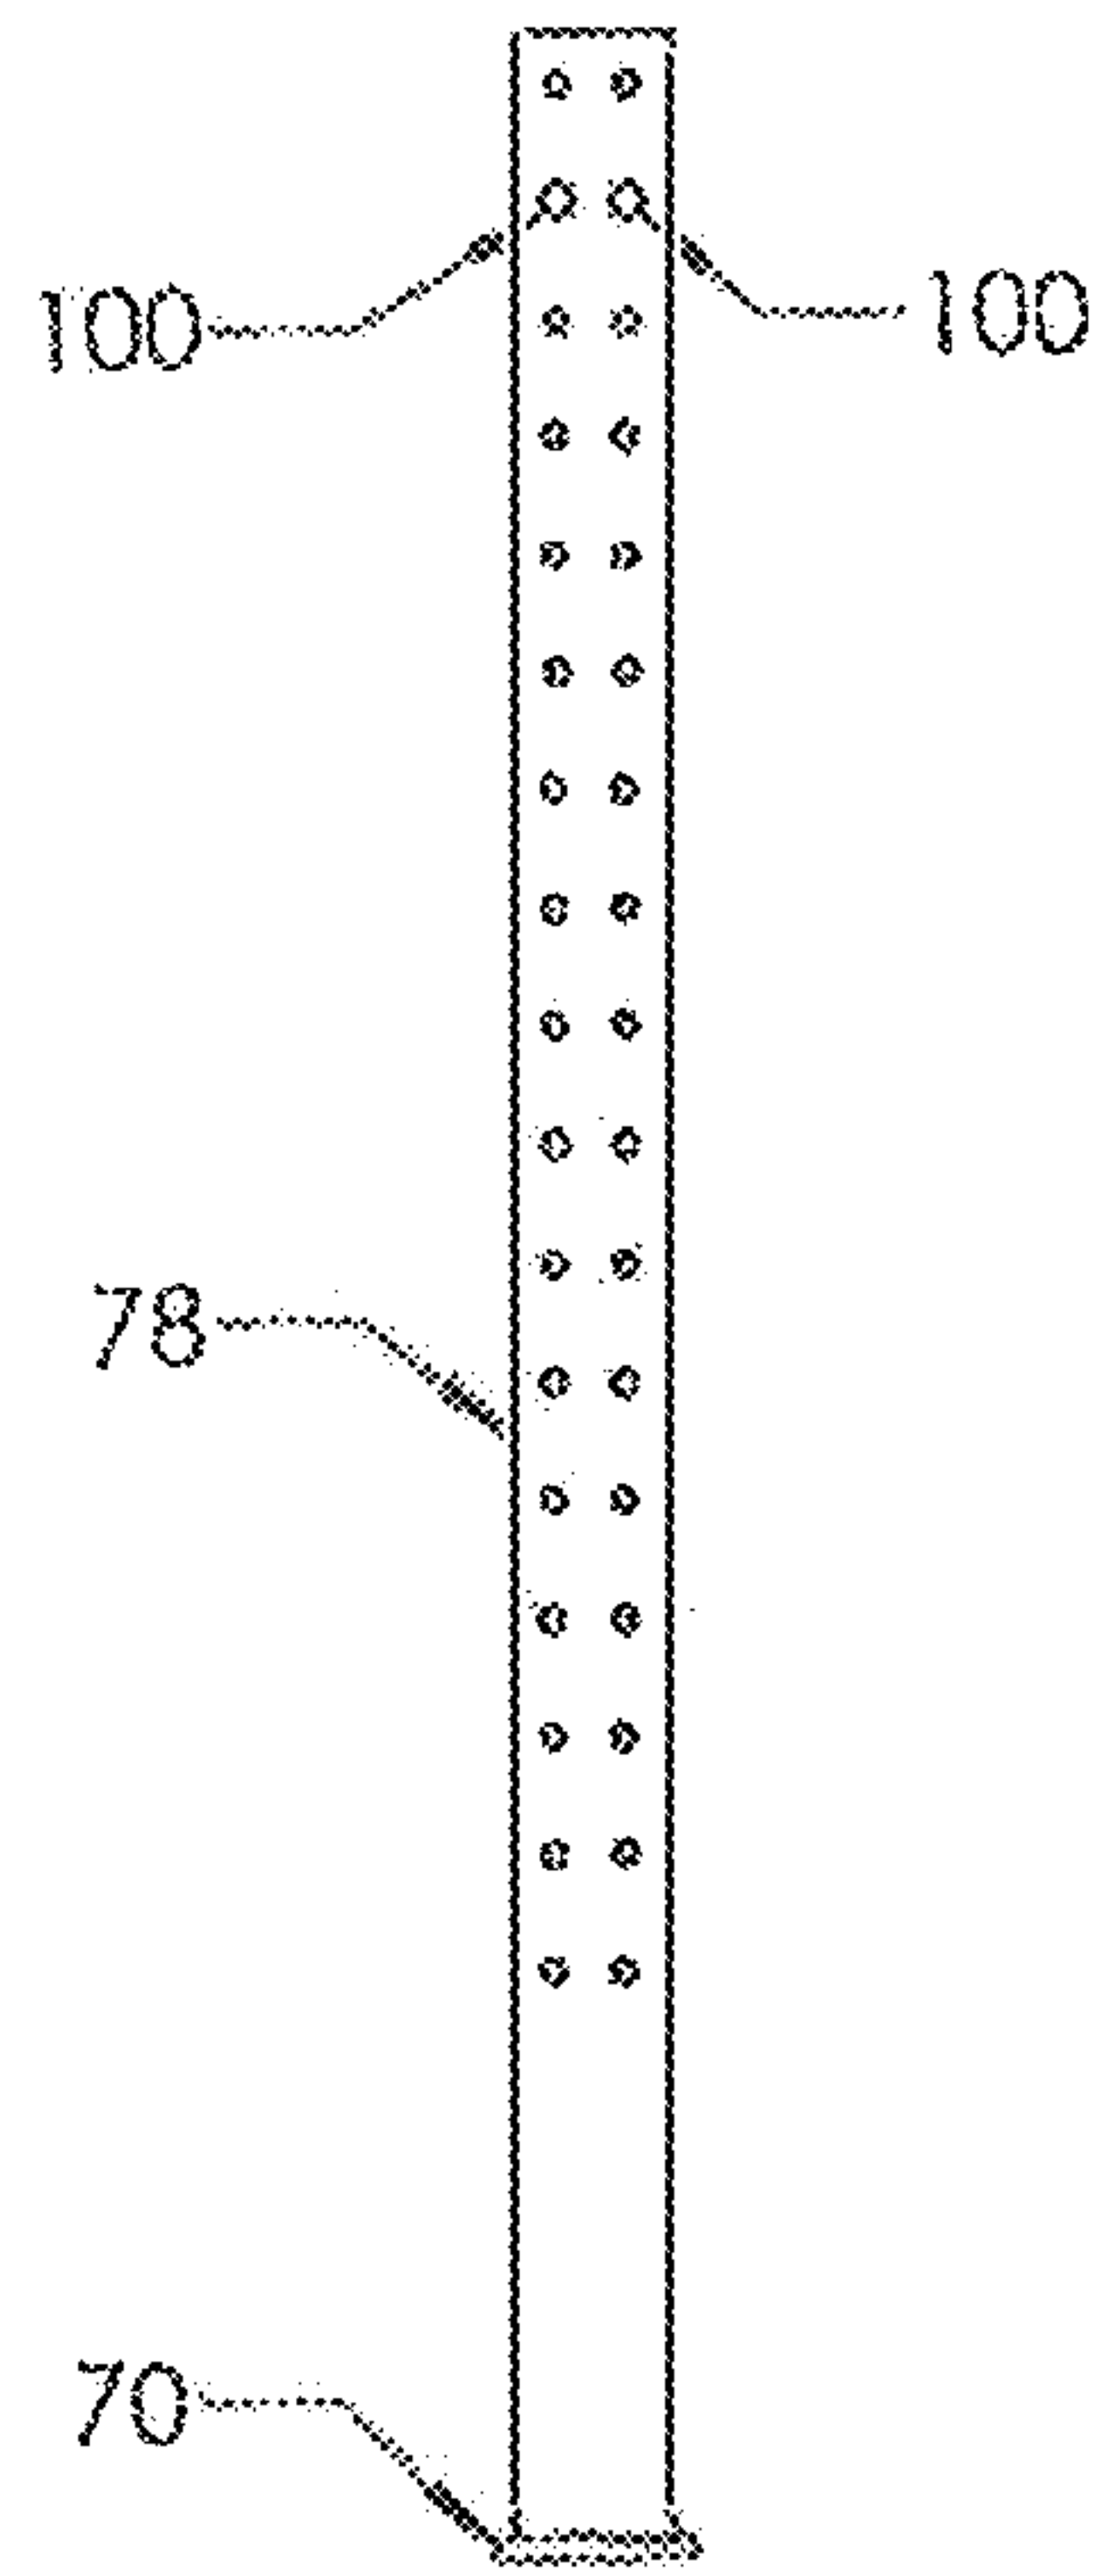
FIG. 3 is a front view of a base portion of the storage system of FIG. 2;

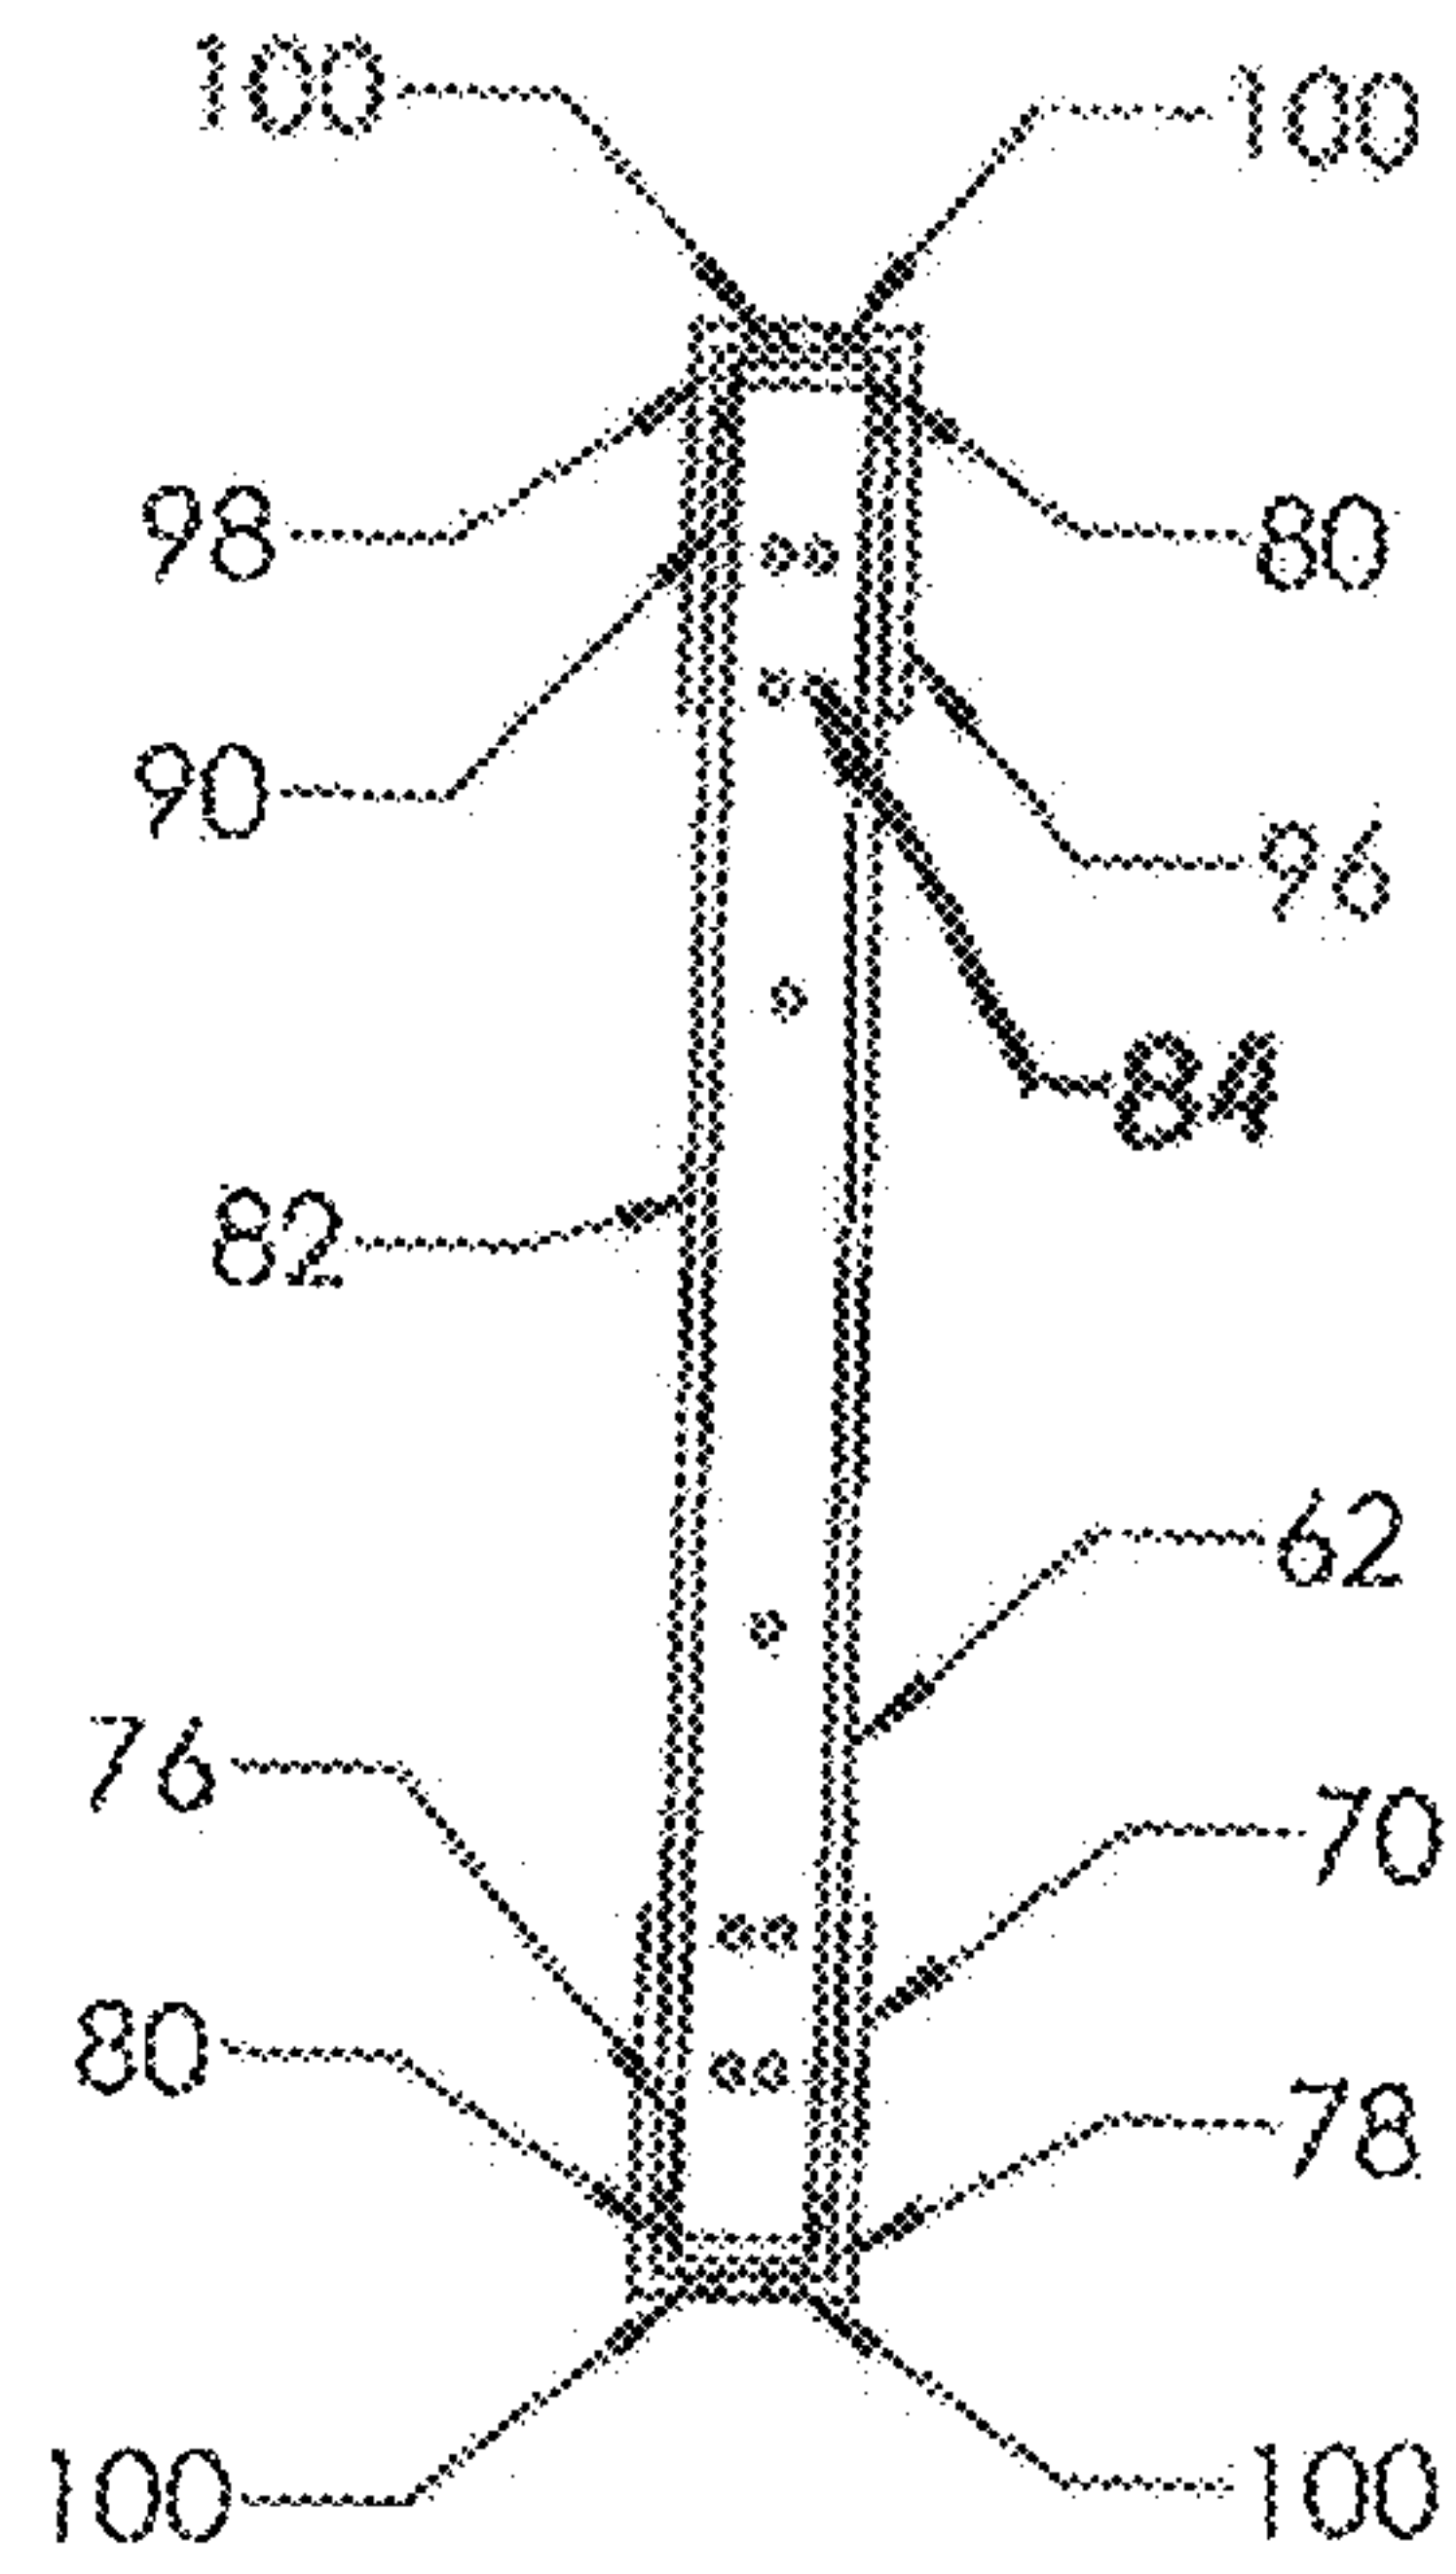
FIG. 4 is a top view of the base portion of the storage system in FIG. 2;

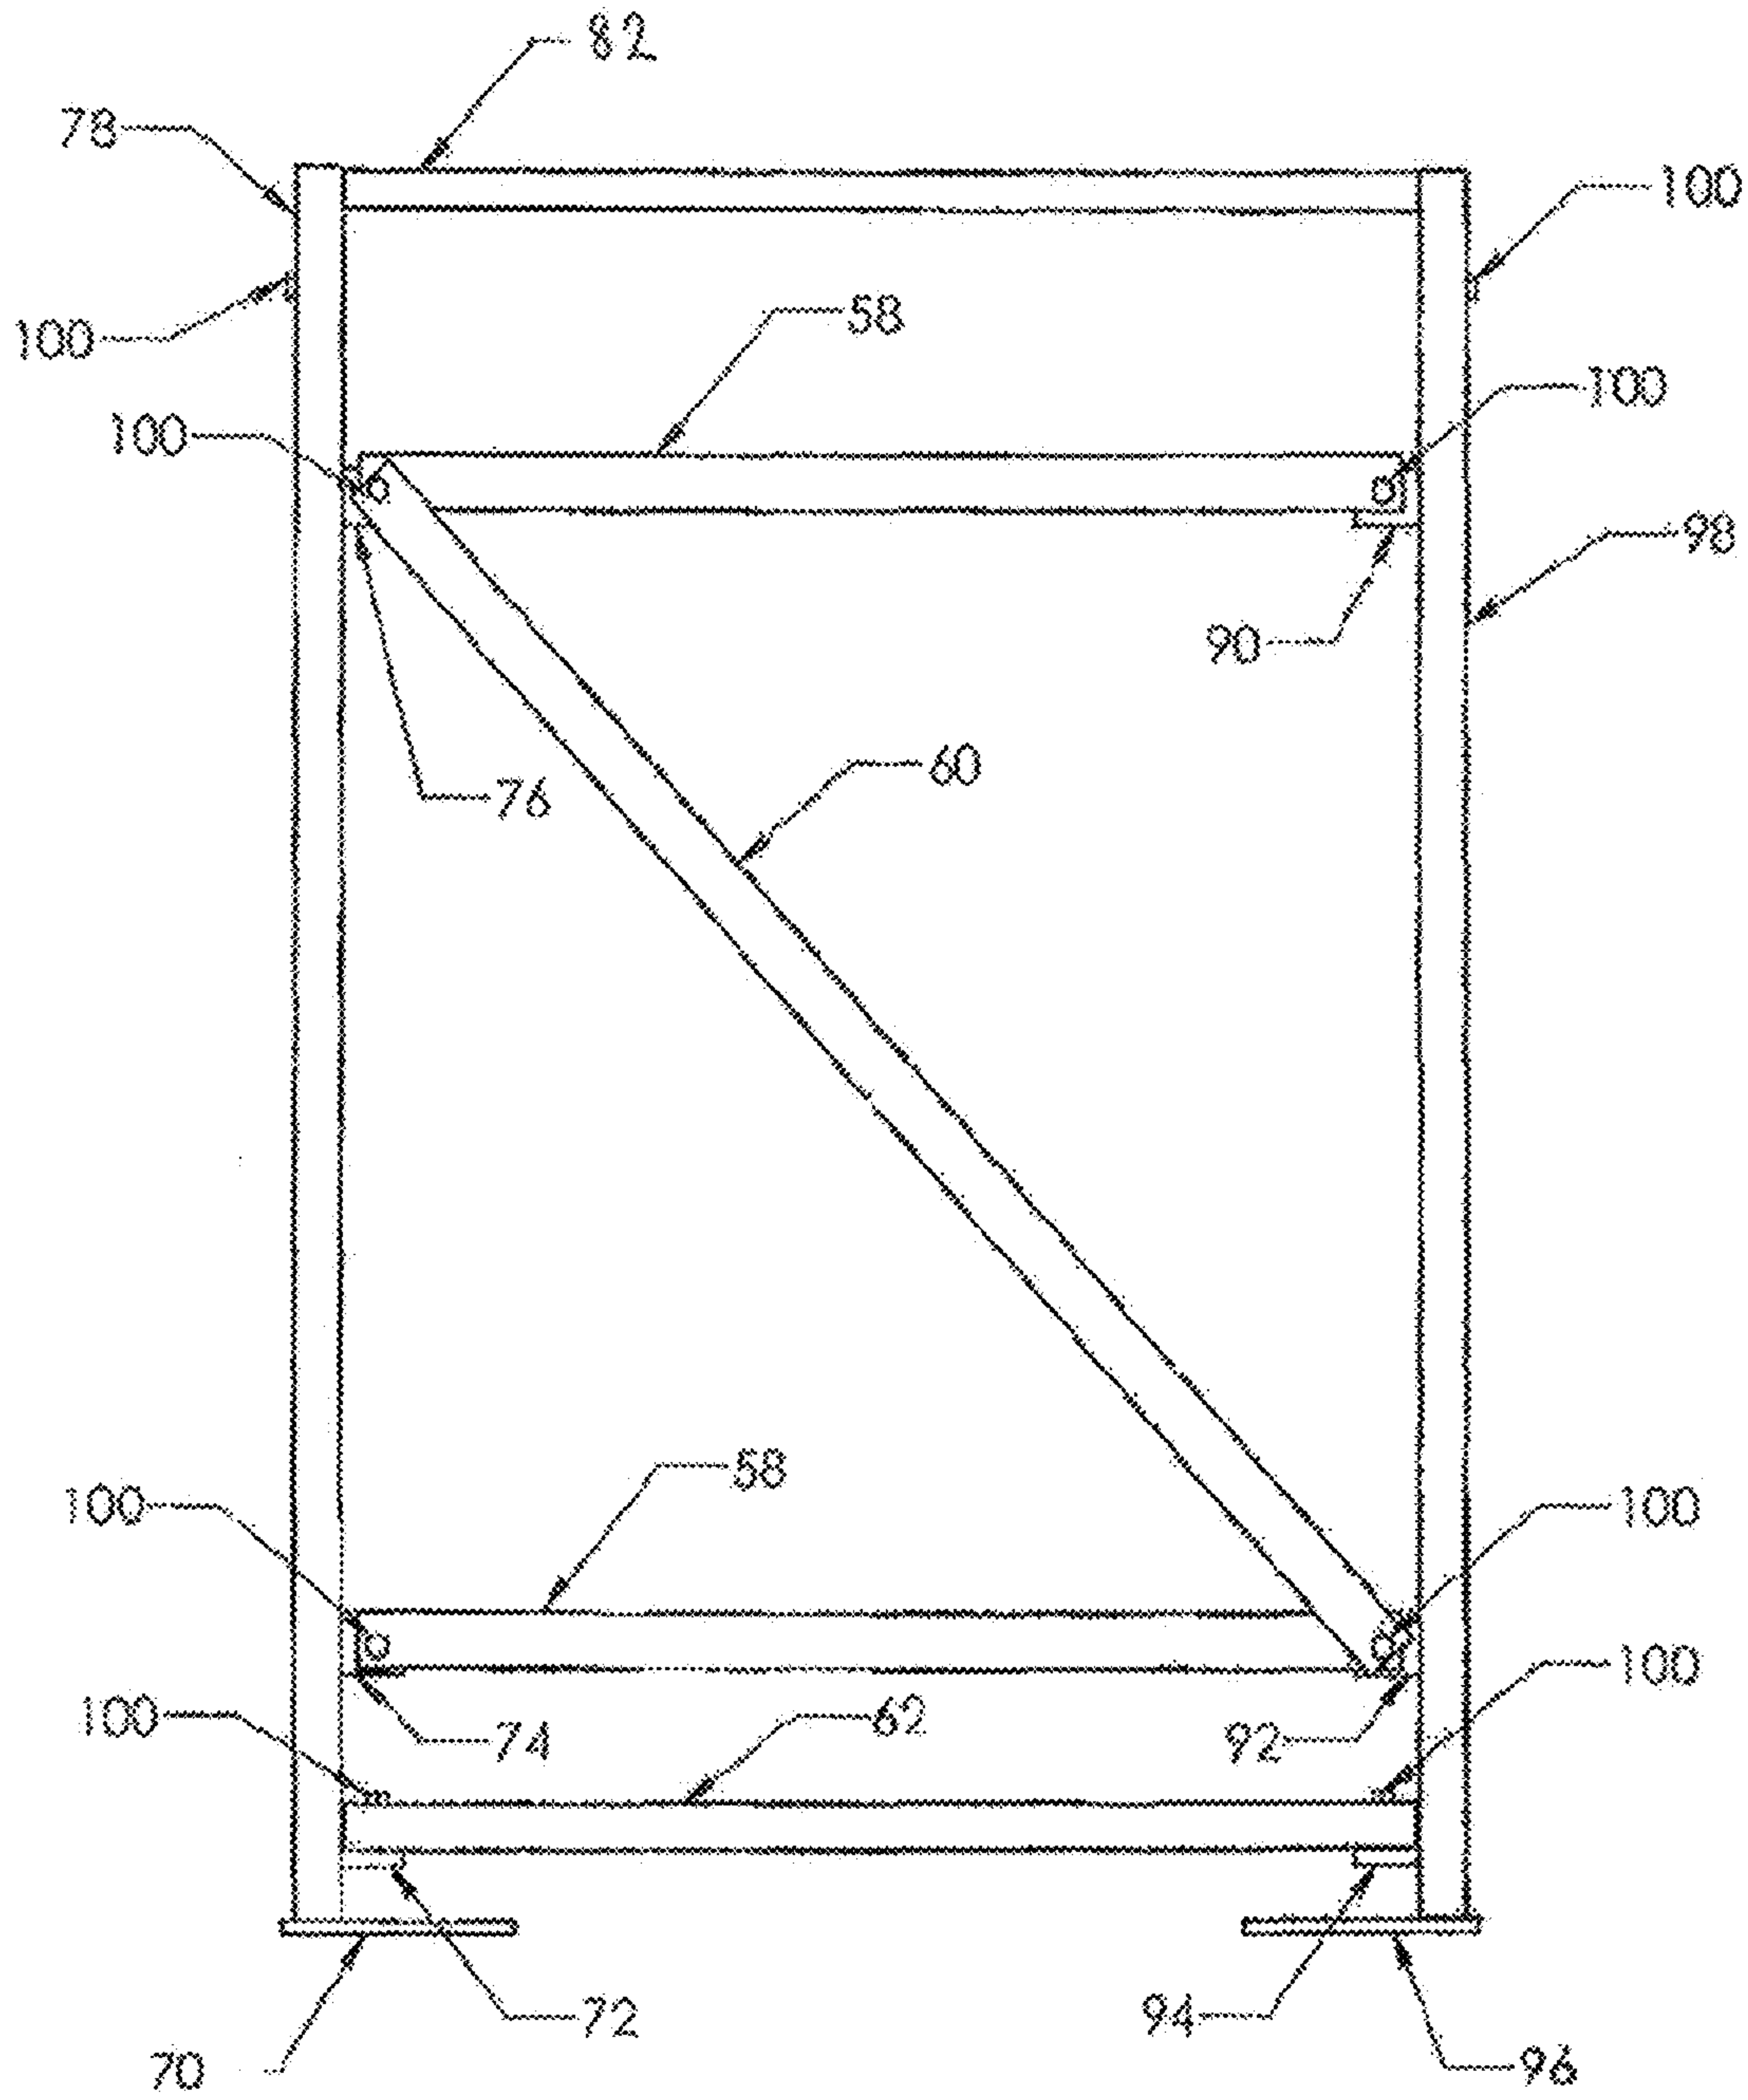
FIG. 5 is a side view of the base portion of the storage system in FIG. 2;

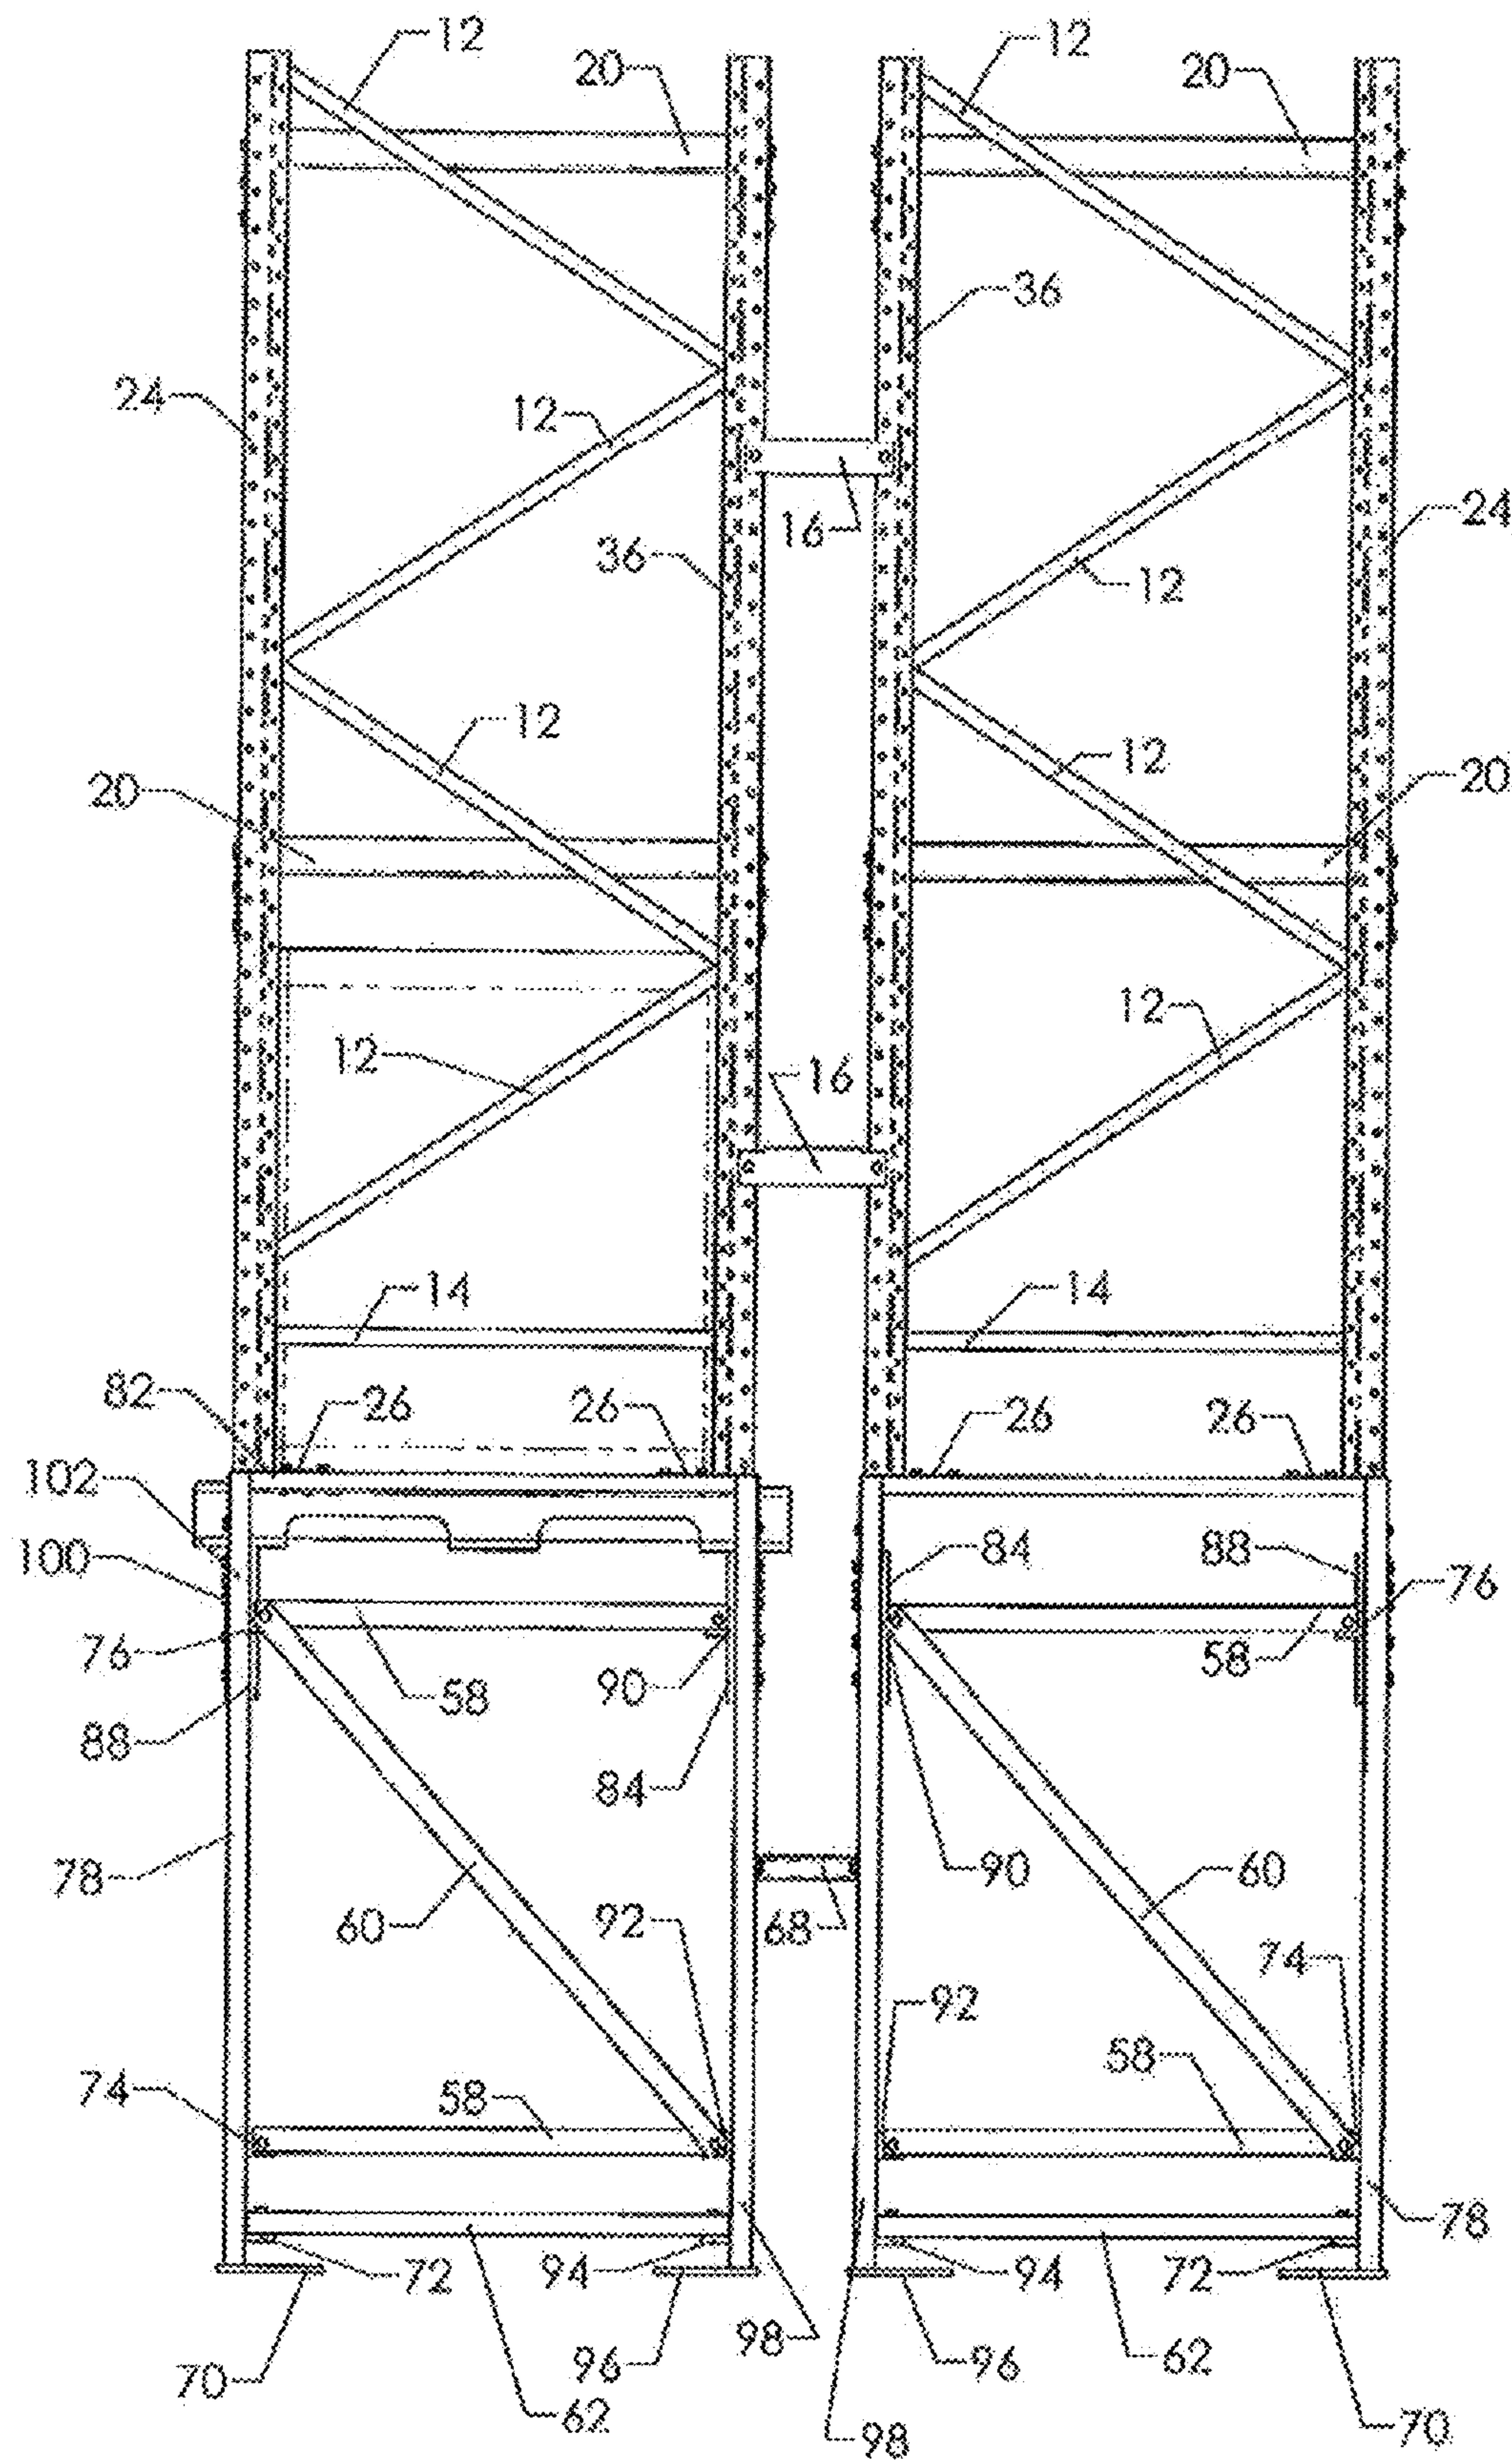
FIG. 6 is a side view of the storage system of FIG. 2;
