(54) **INTERCHANGEABLE BASE STEEL  
STRUCTURE STORAGE ASSEMBLY**

A storage rack assembly includes a base steel structure which is interchangeably connected to the storage rack above. The base steel structure assembly is comprised of structural material with bolted connections which allow for the replacement or changing of damaged material due to accidental forklift contact all while the above storage system stays in place.

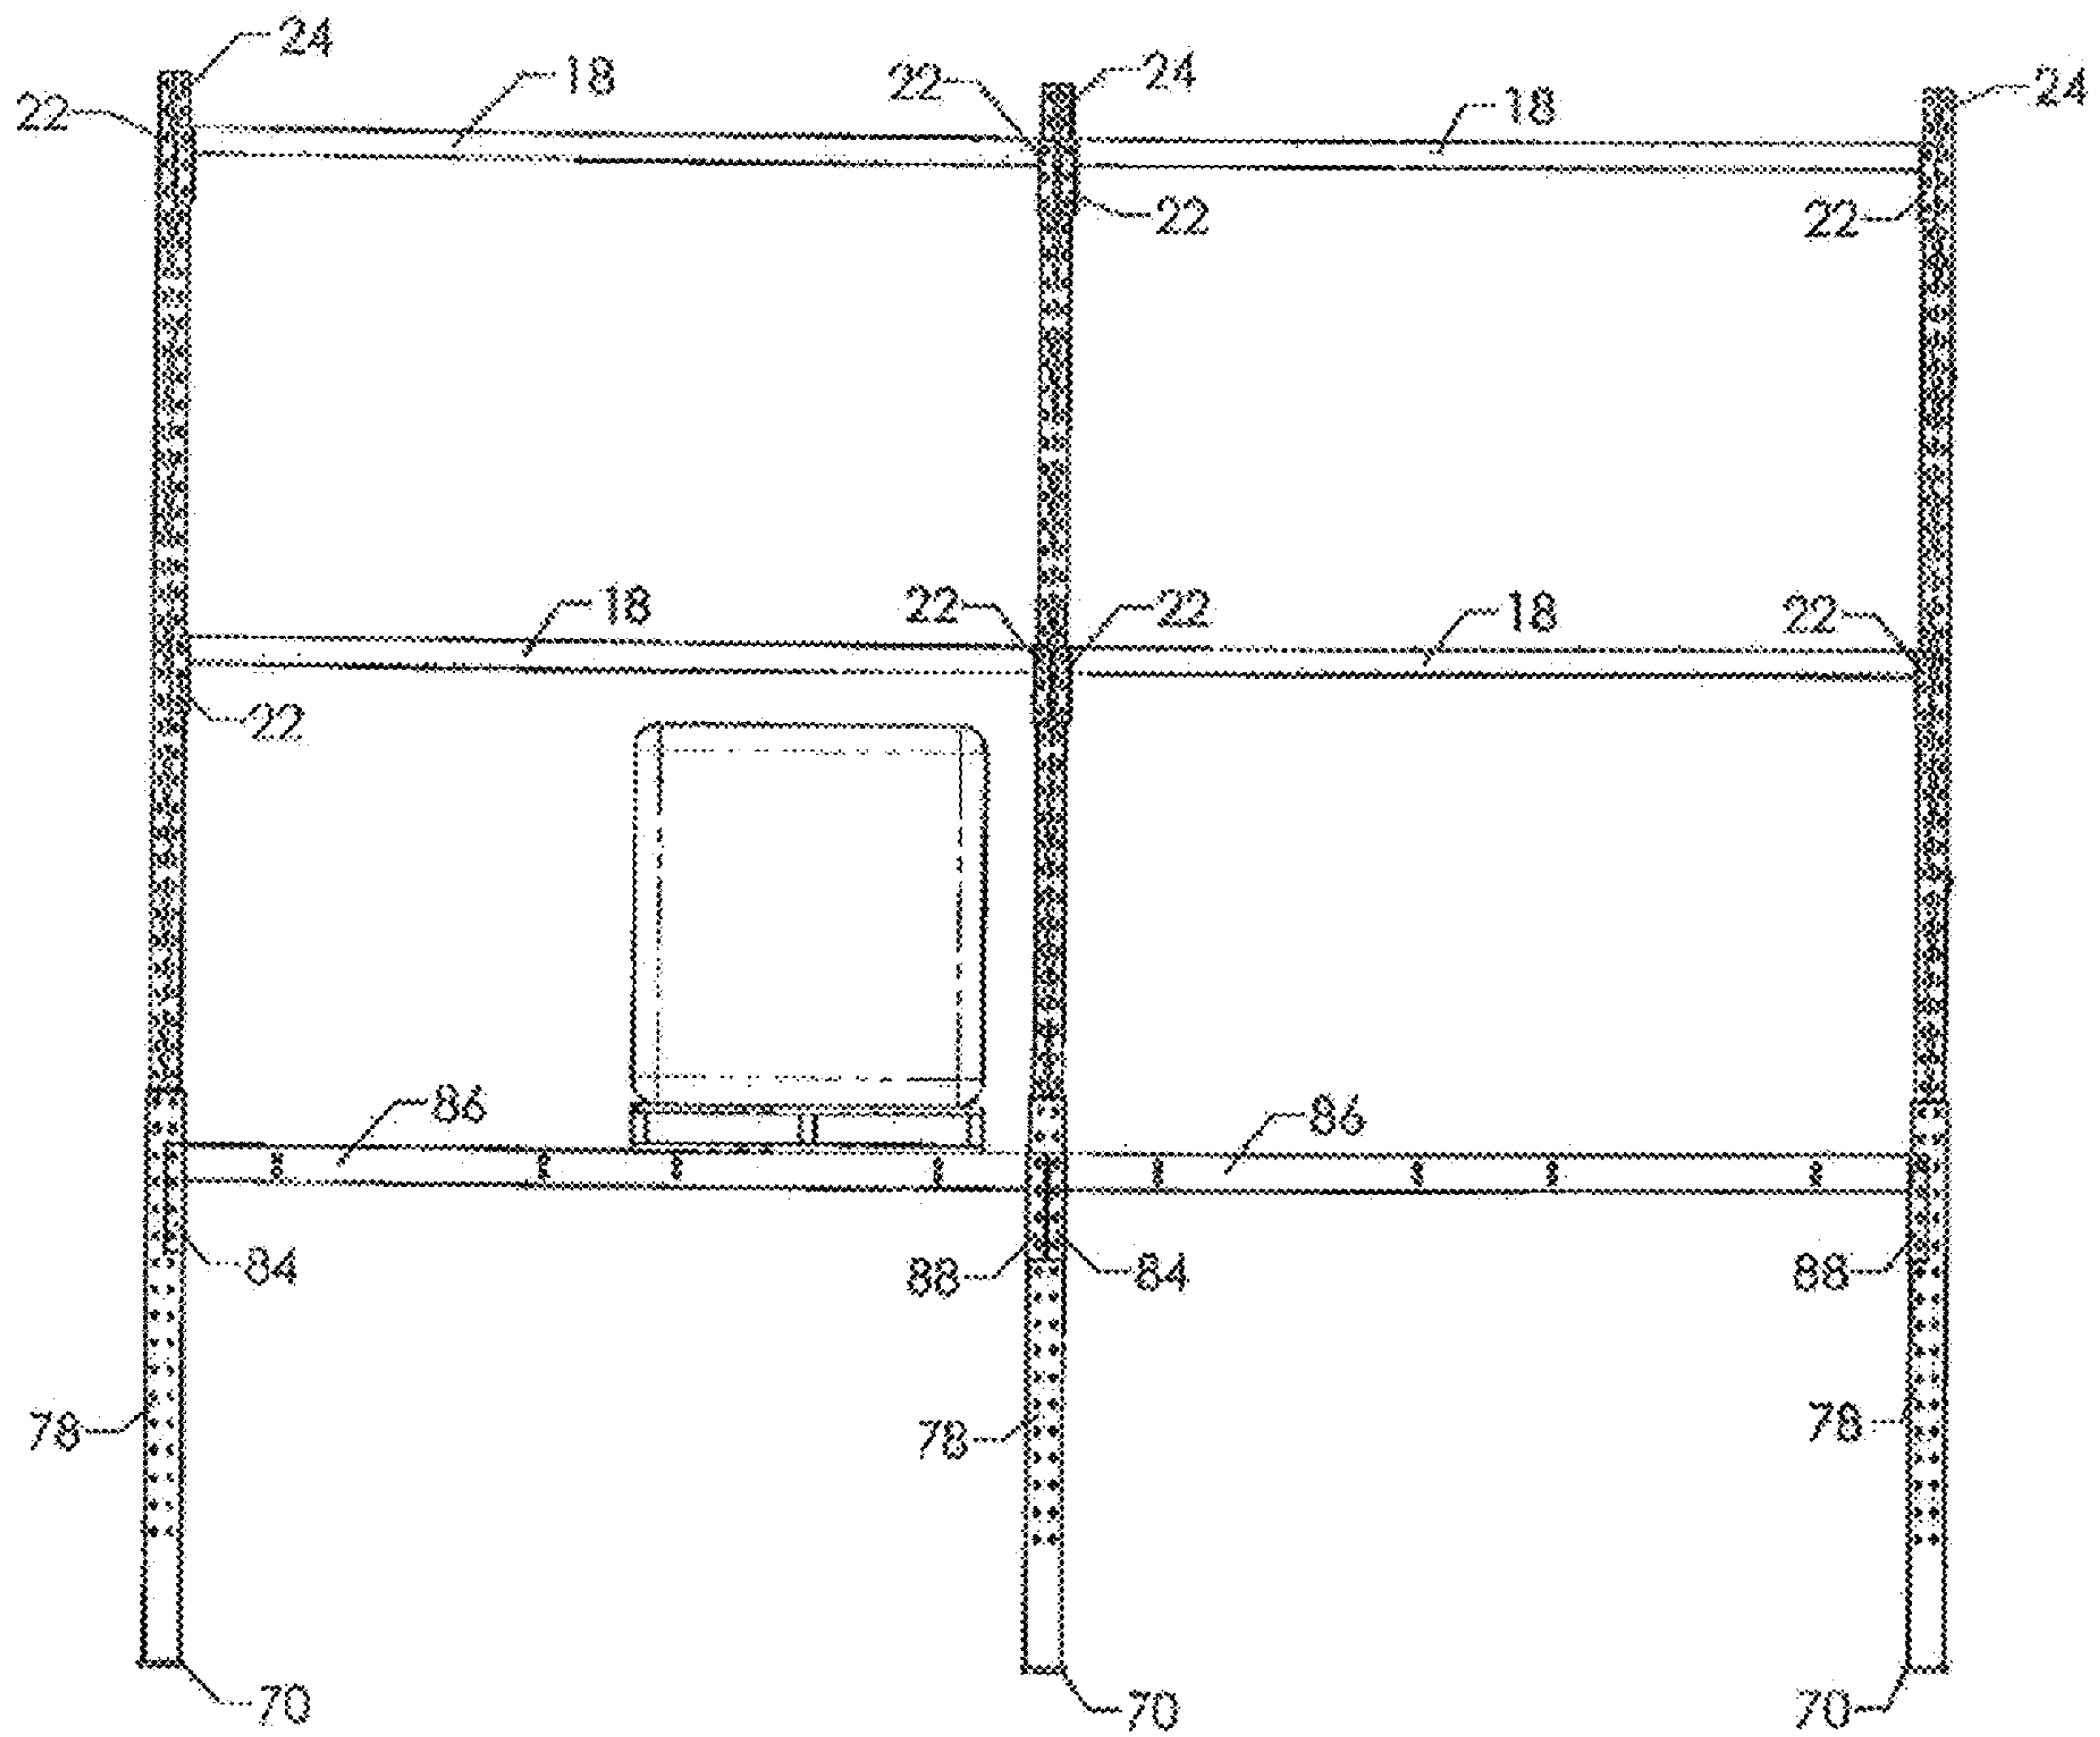
FIG. 7 is a front view of the storage system of FIG. 2;

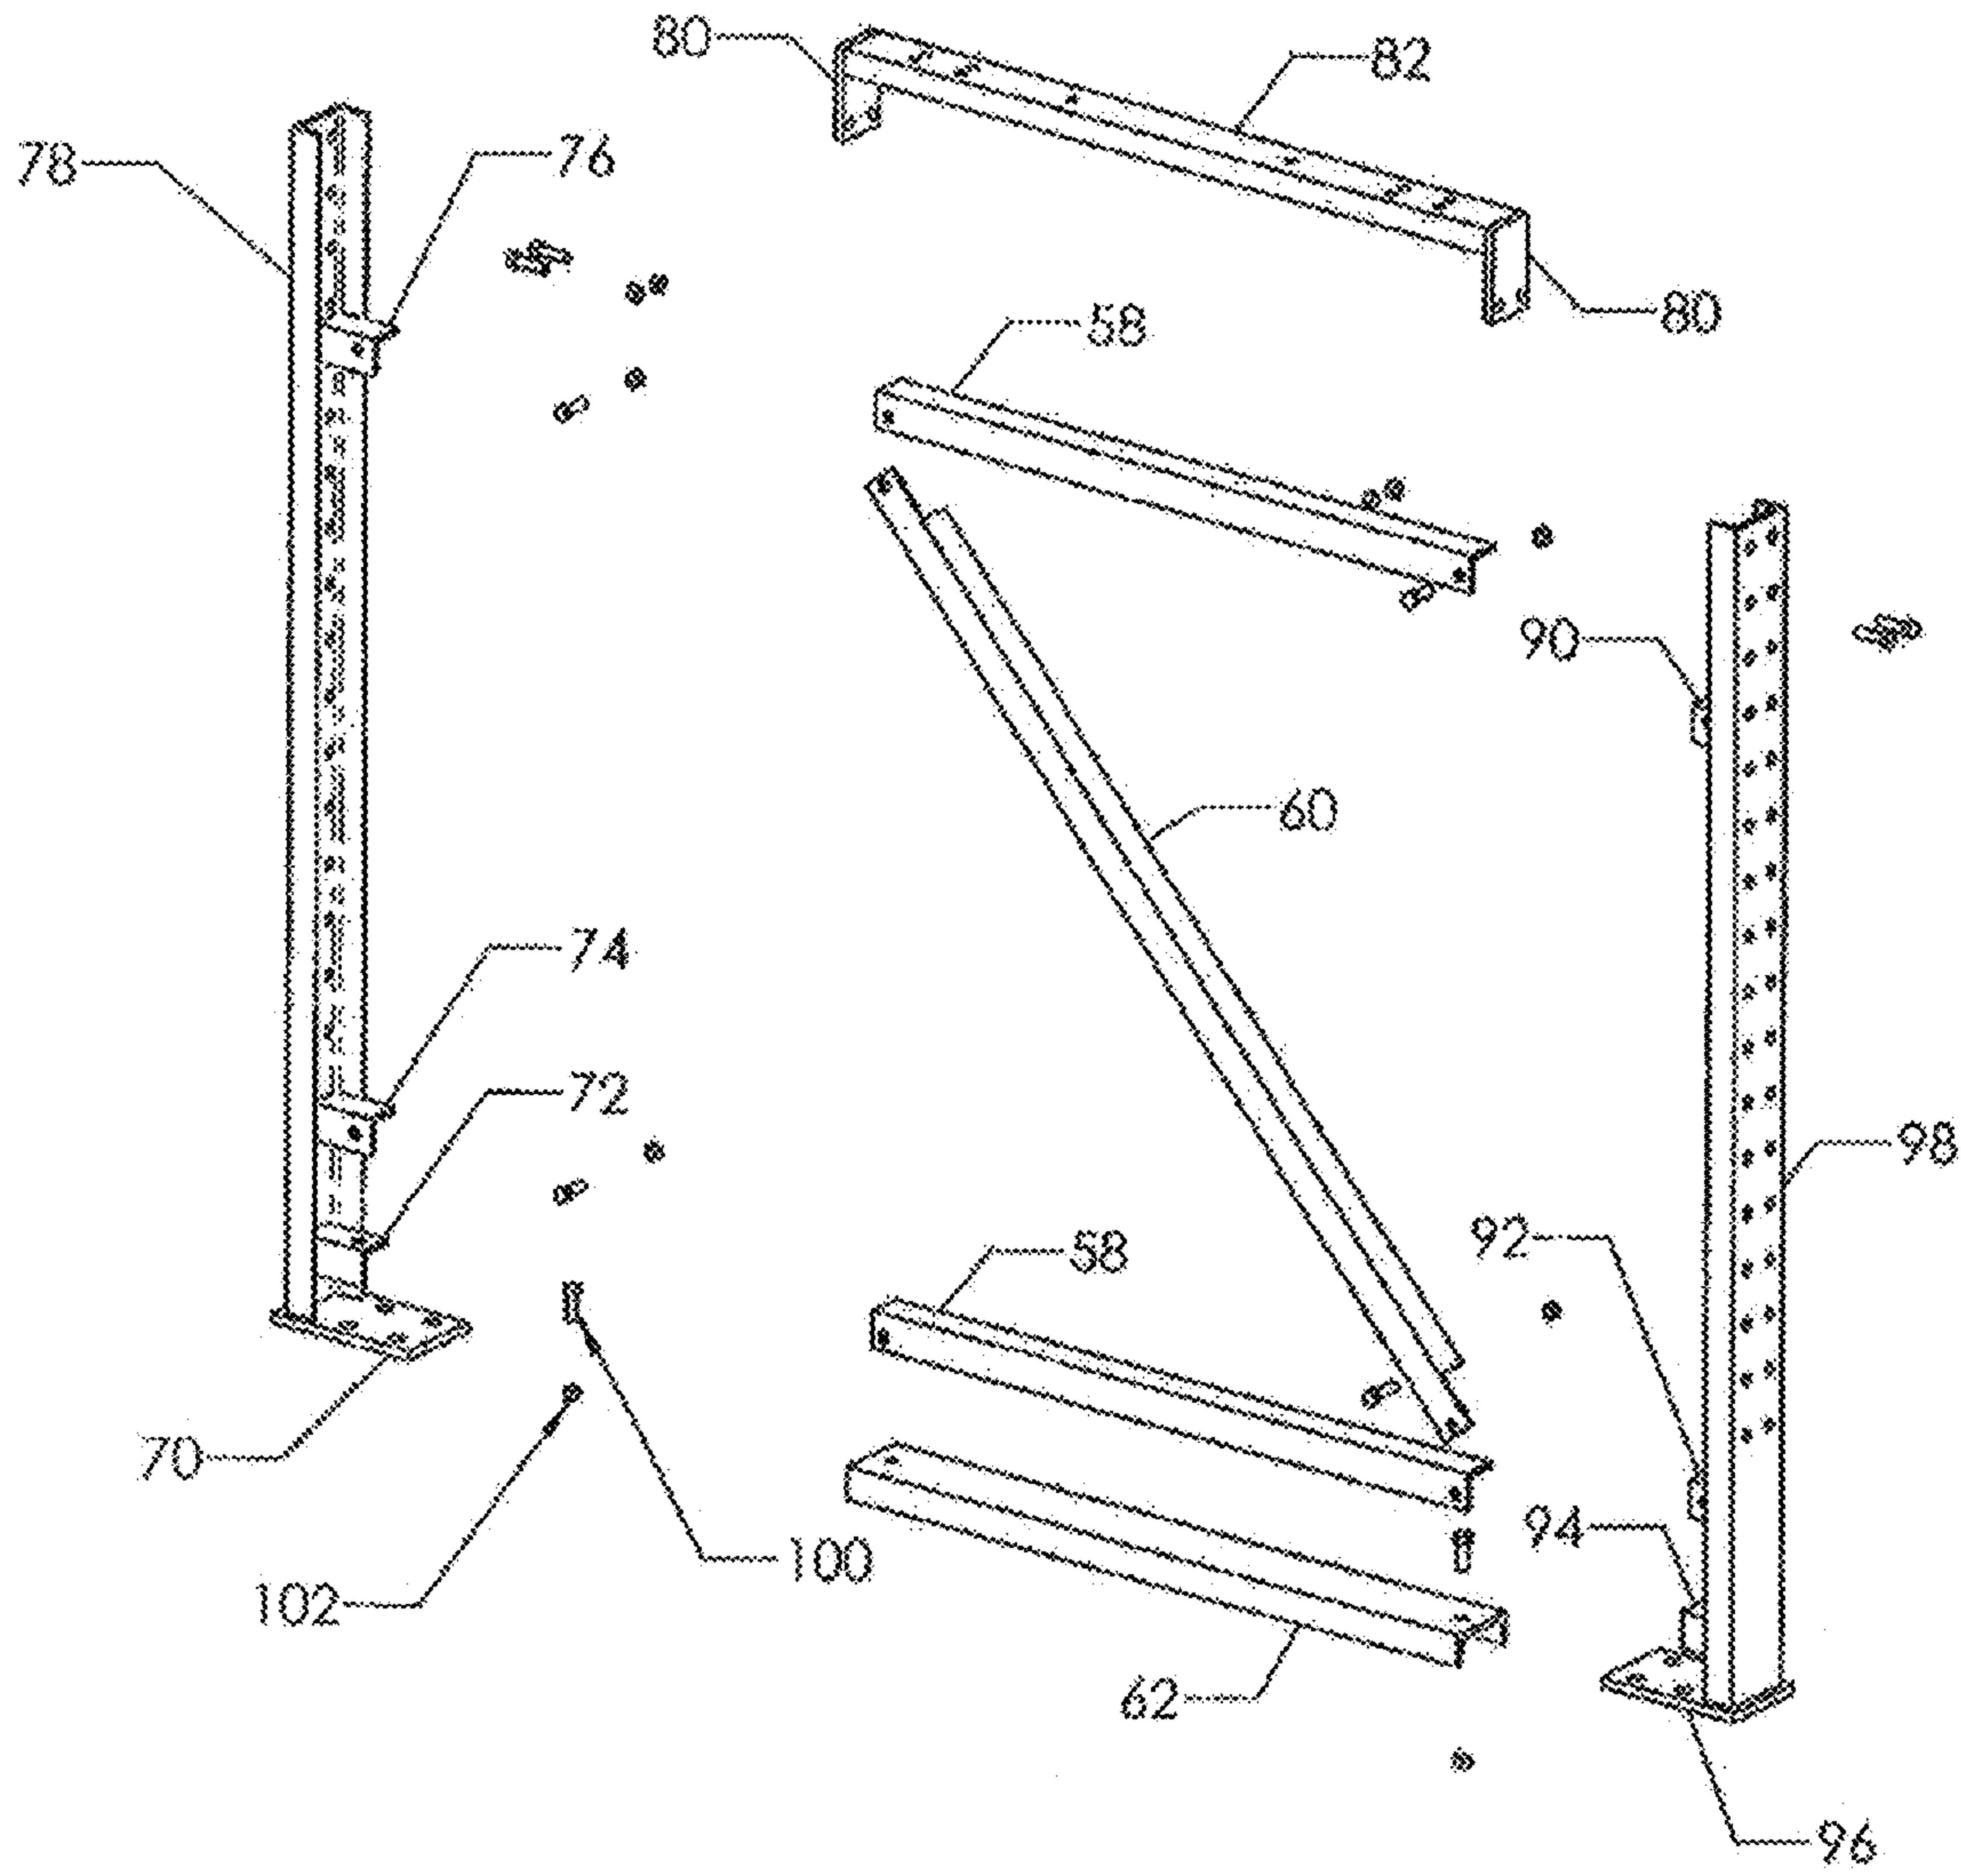
FIG. 8 is a side perspective view of a dismantled base;

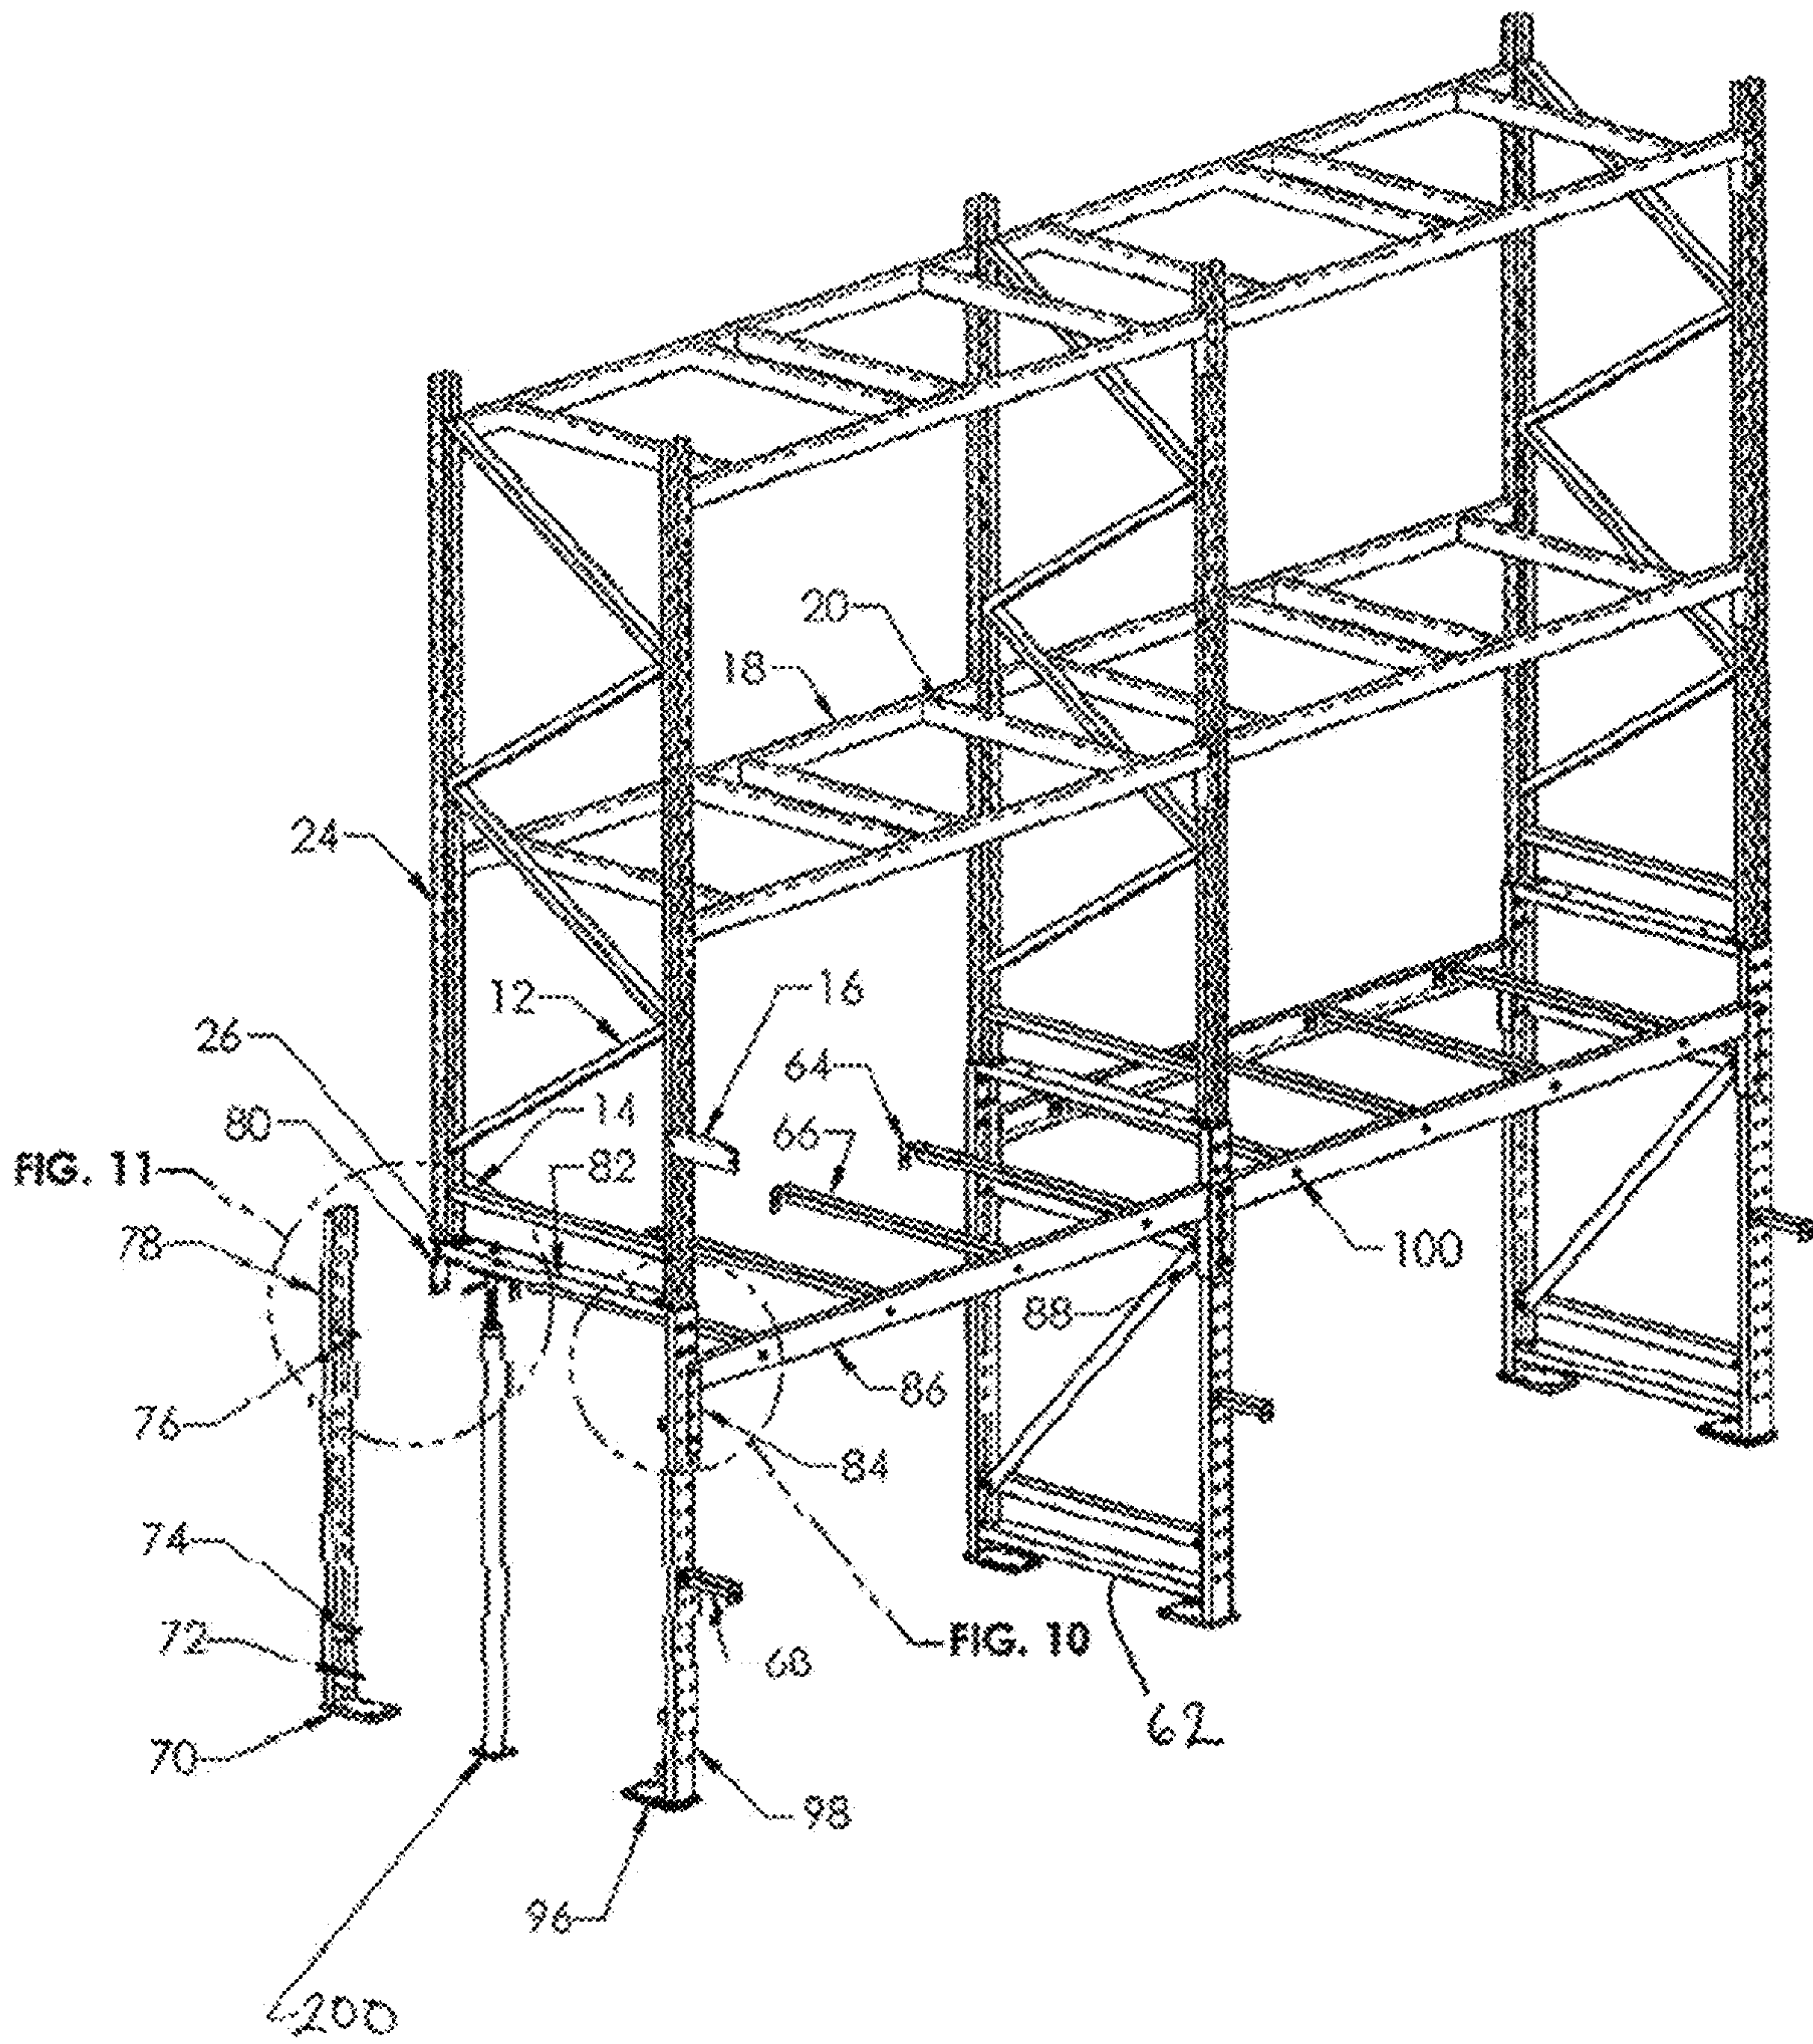
FIG. 9 is a side perspective view of the base being repaired while being supported by the load jack;

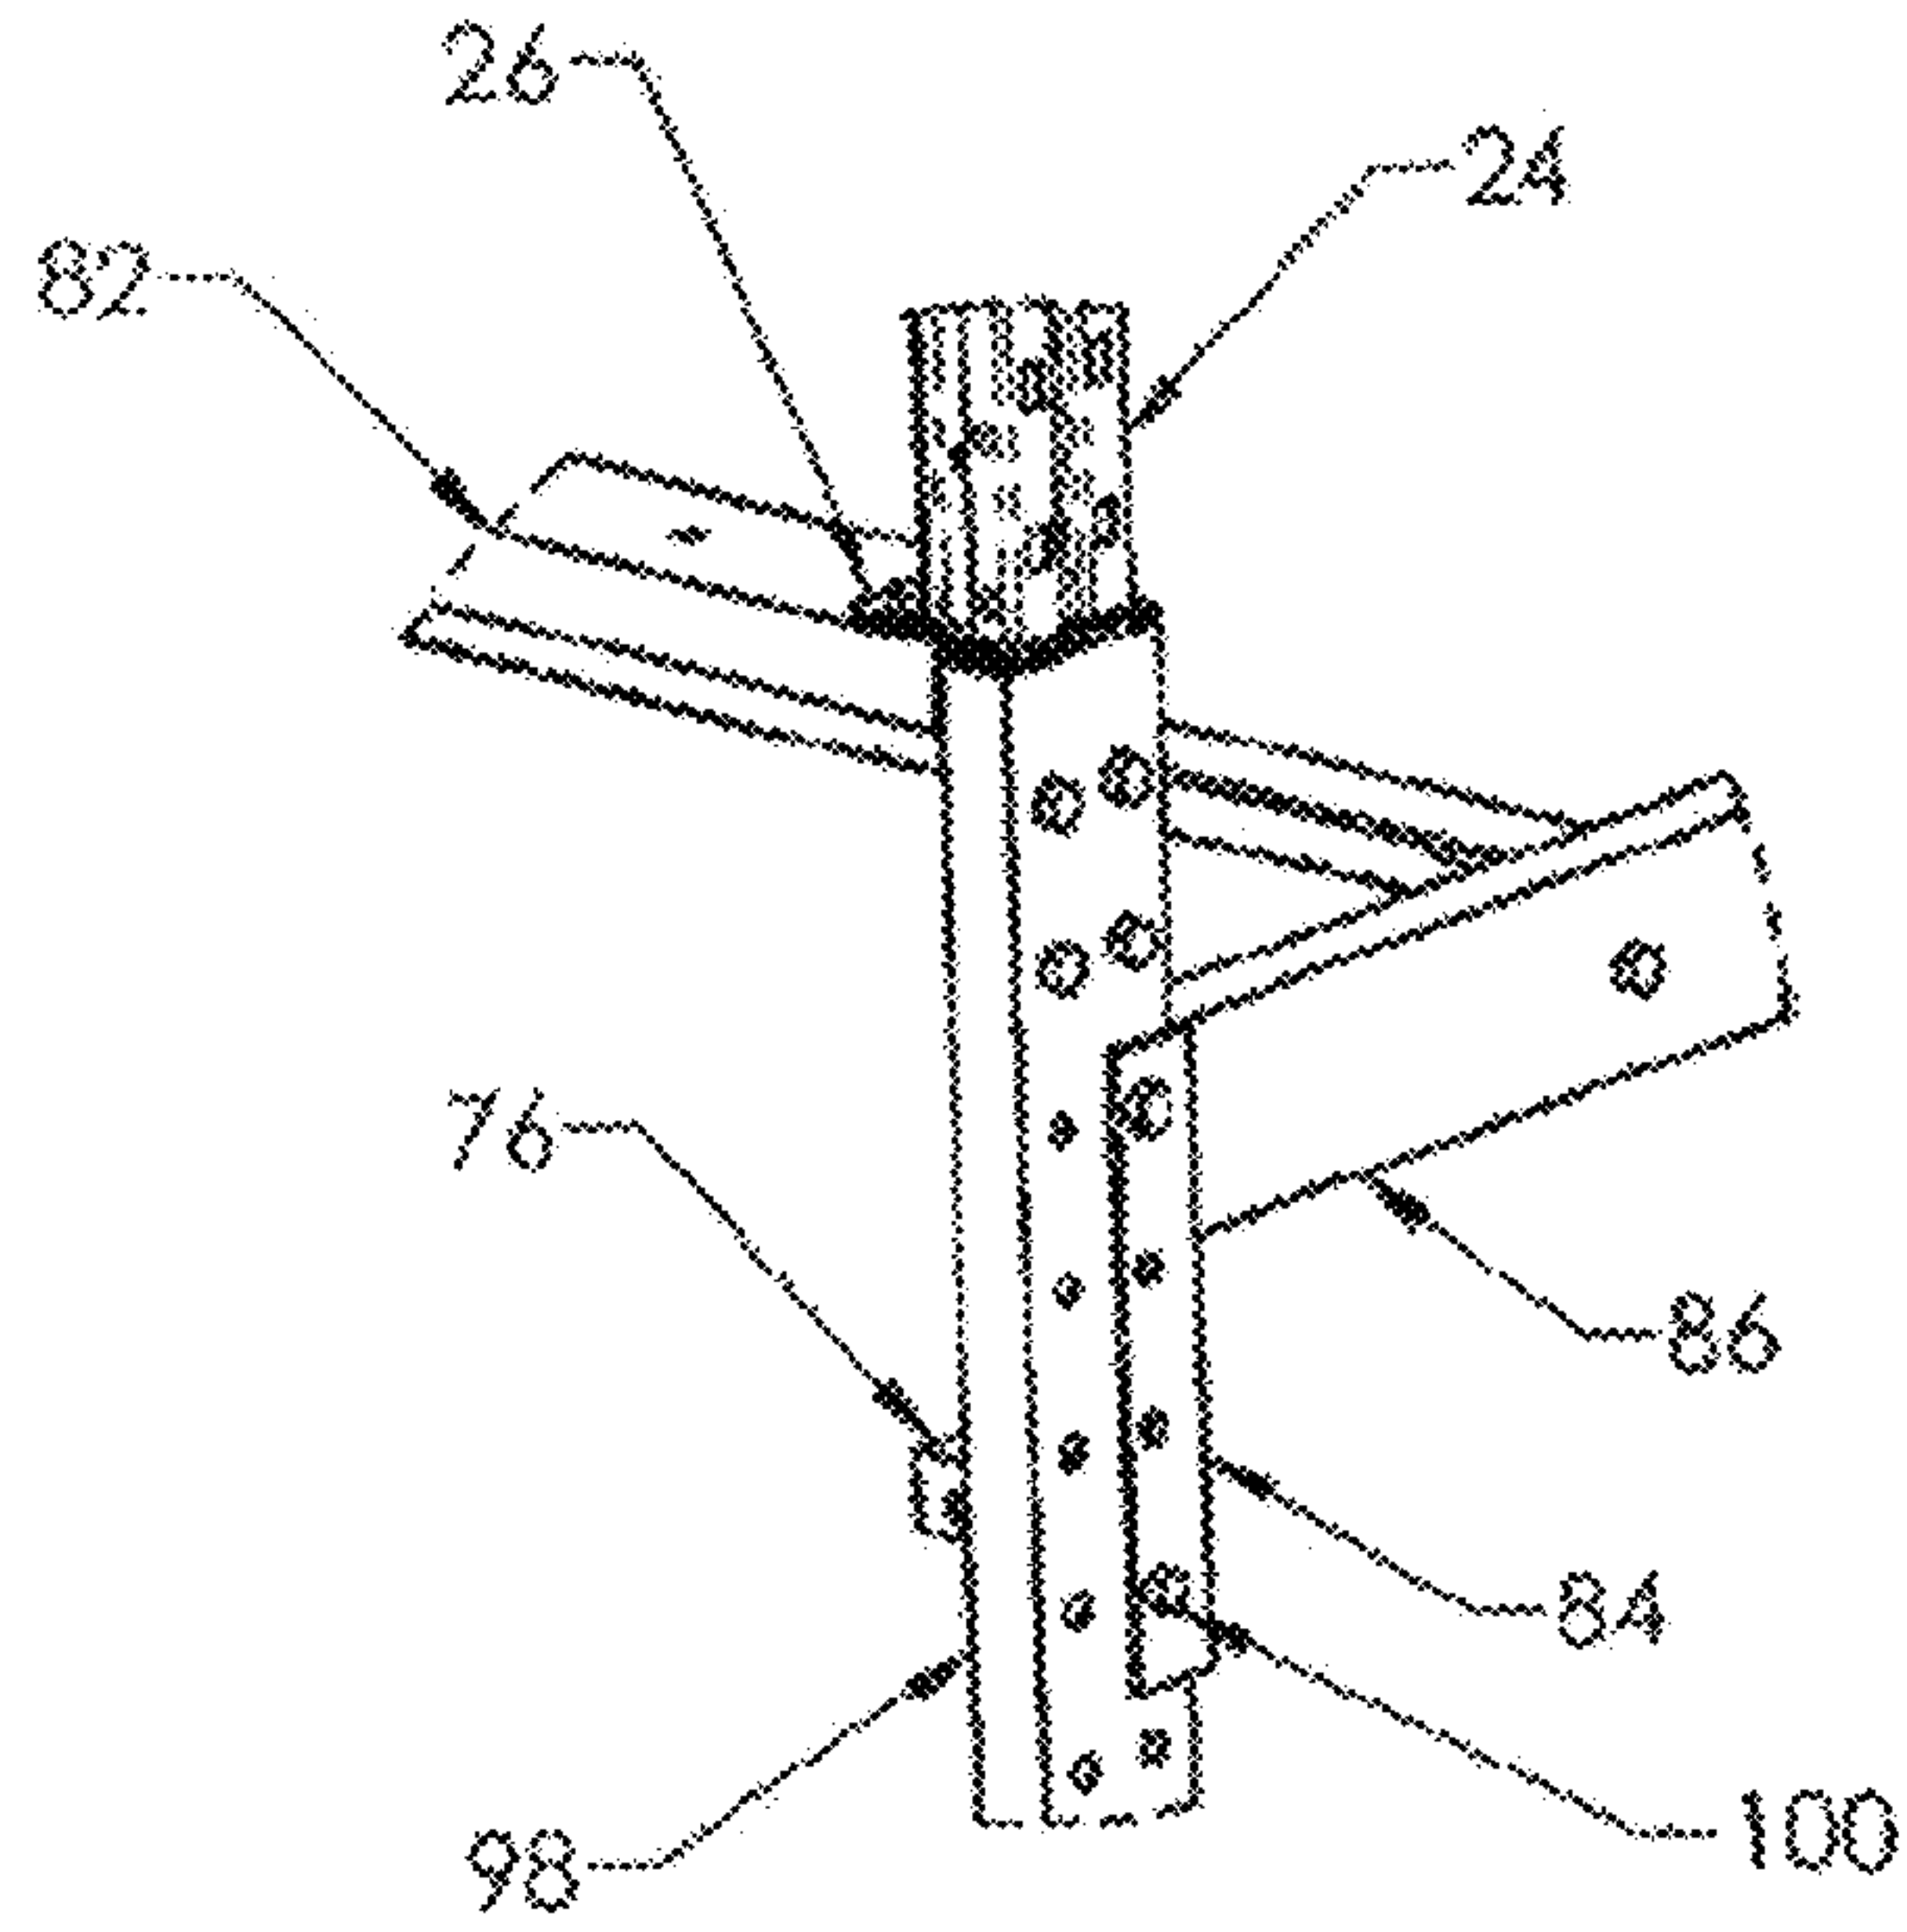
FIG. 10 is an enlarged perspective view of the encircled area 10 in FIG. 9 of the base and above upright connection;

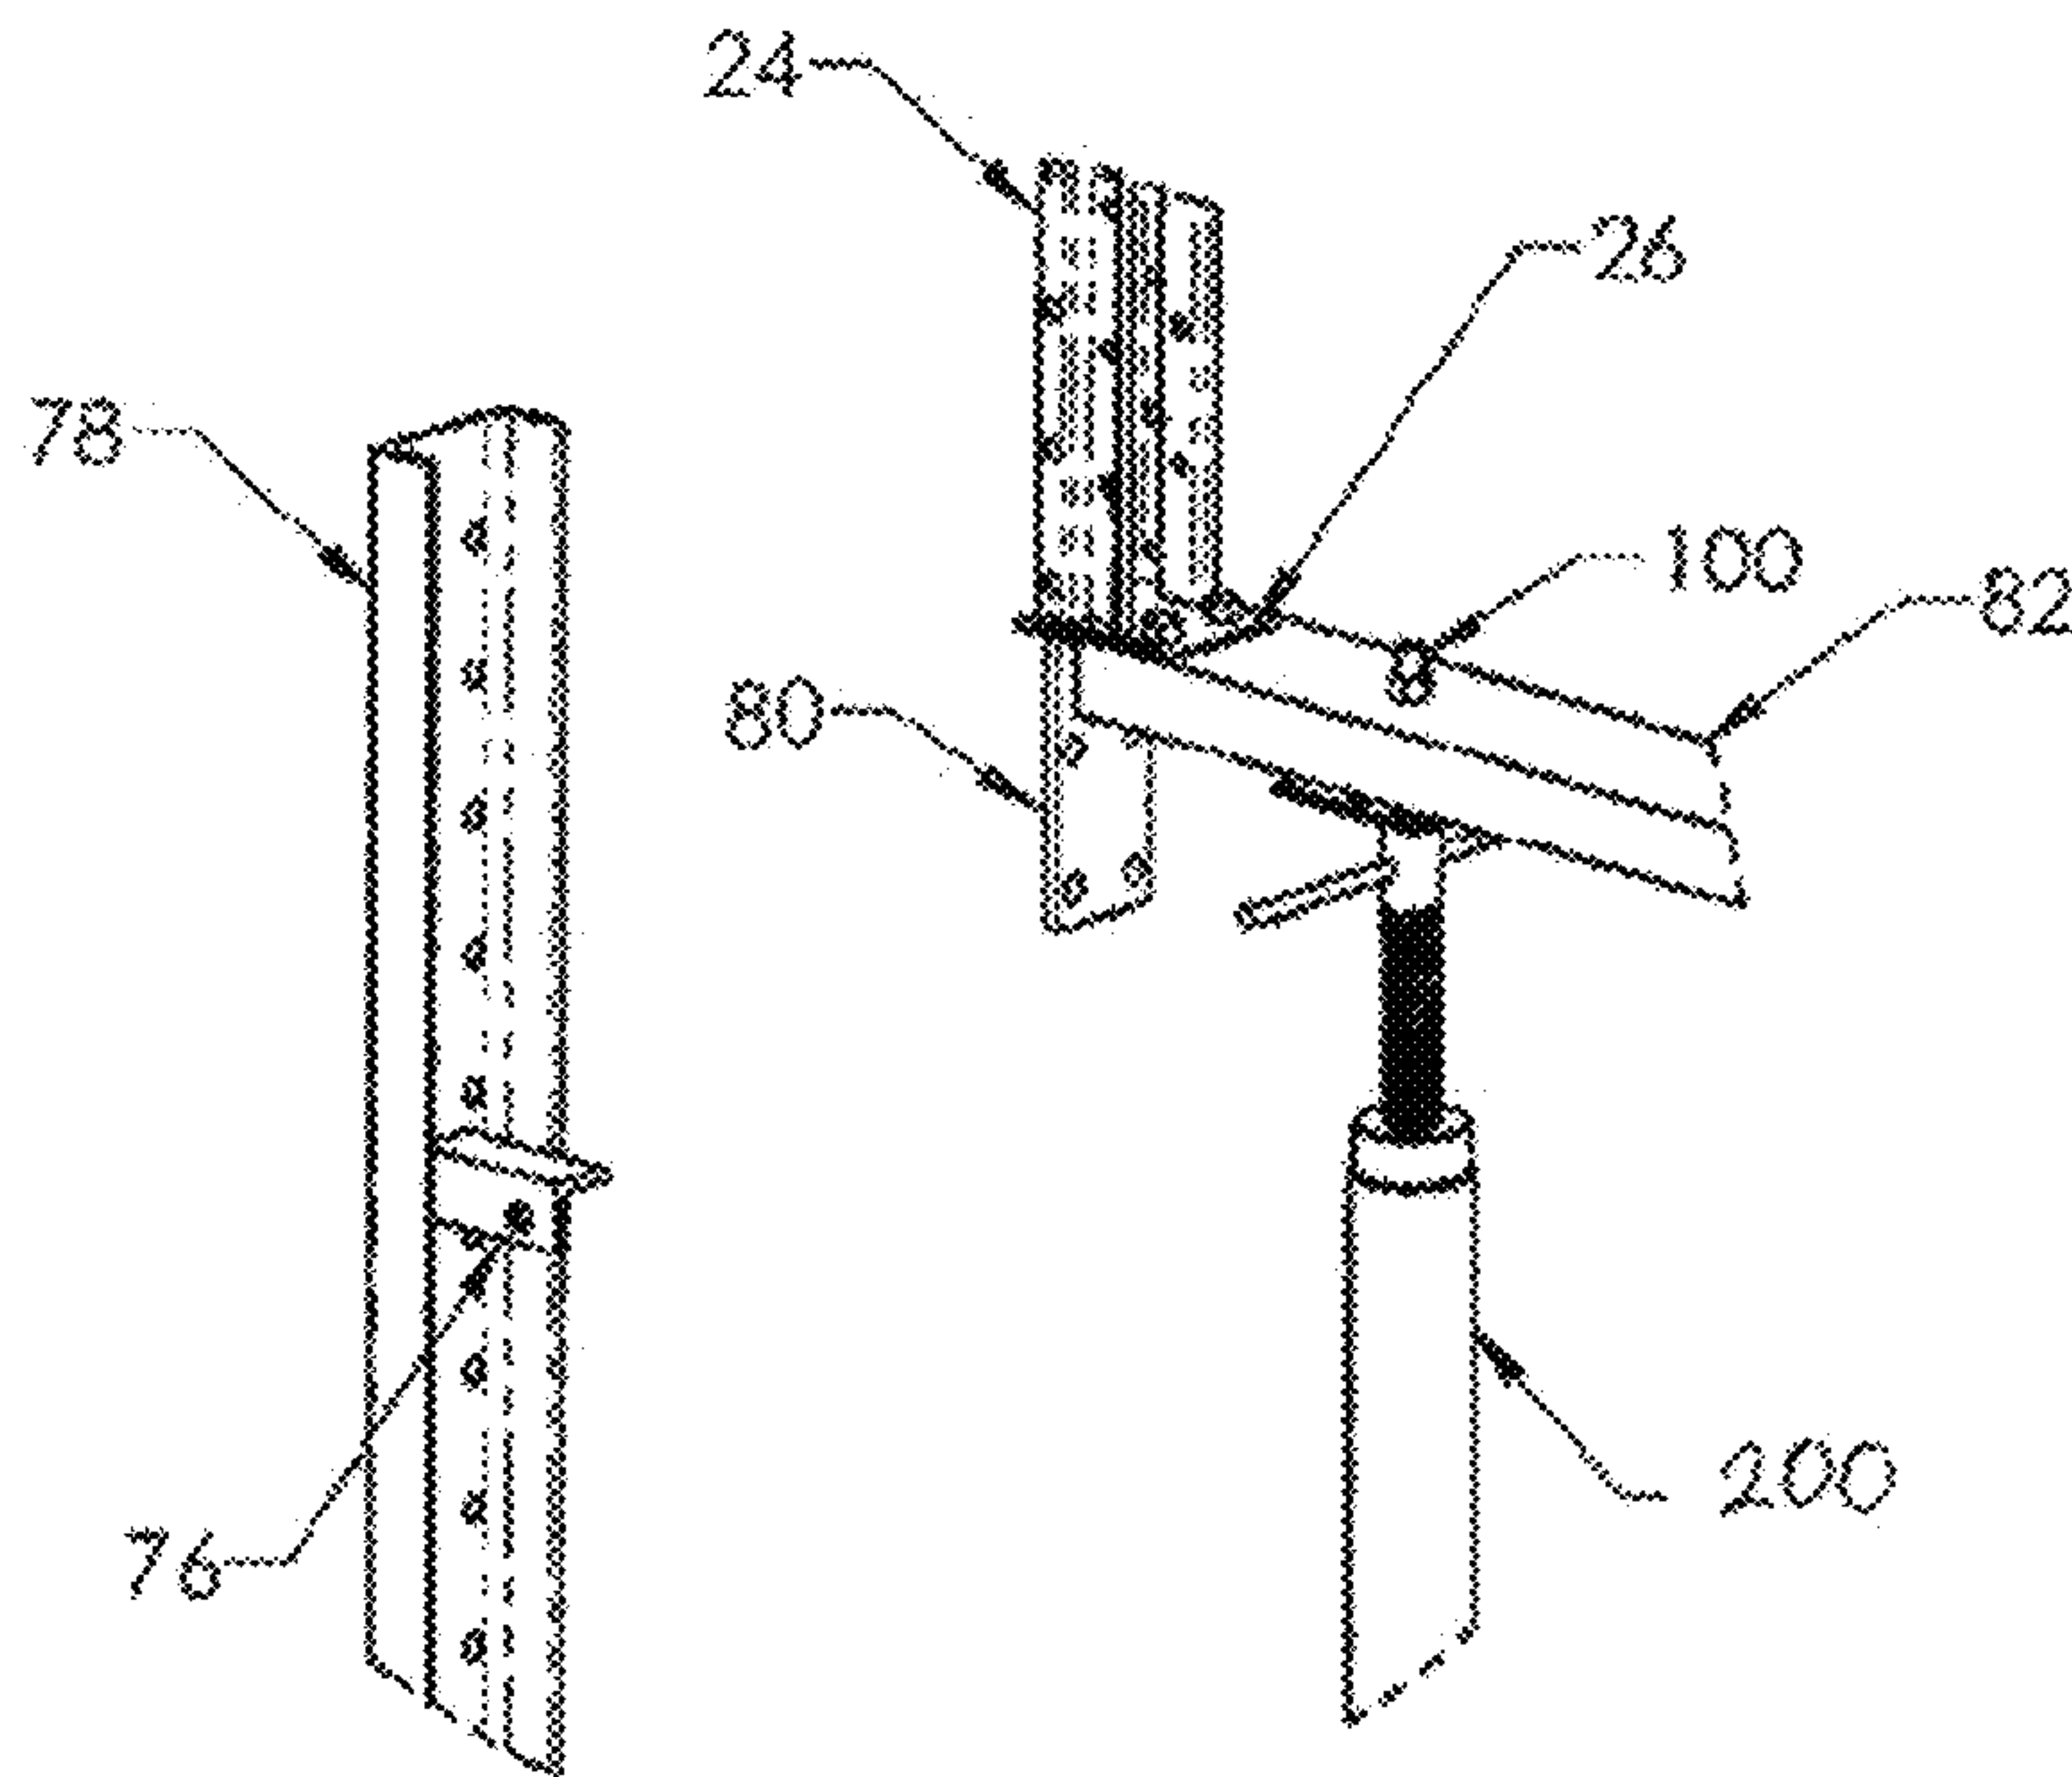
FIG. 11 is an enlarged perspective view of the encircled area 11 in FIG. 9 showing the base and above upright connections as well as a portion of the sub assemblies while under repair;

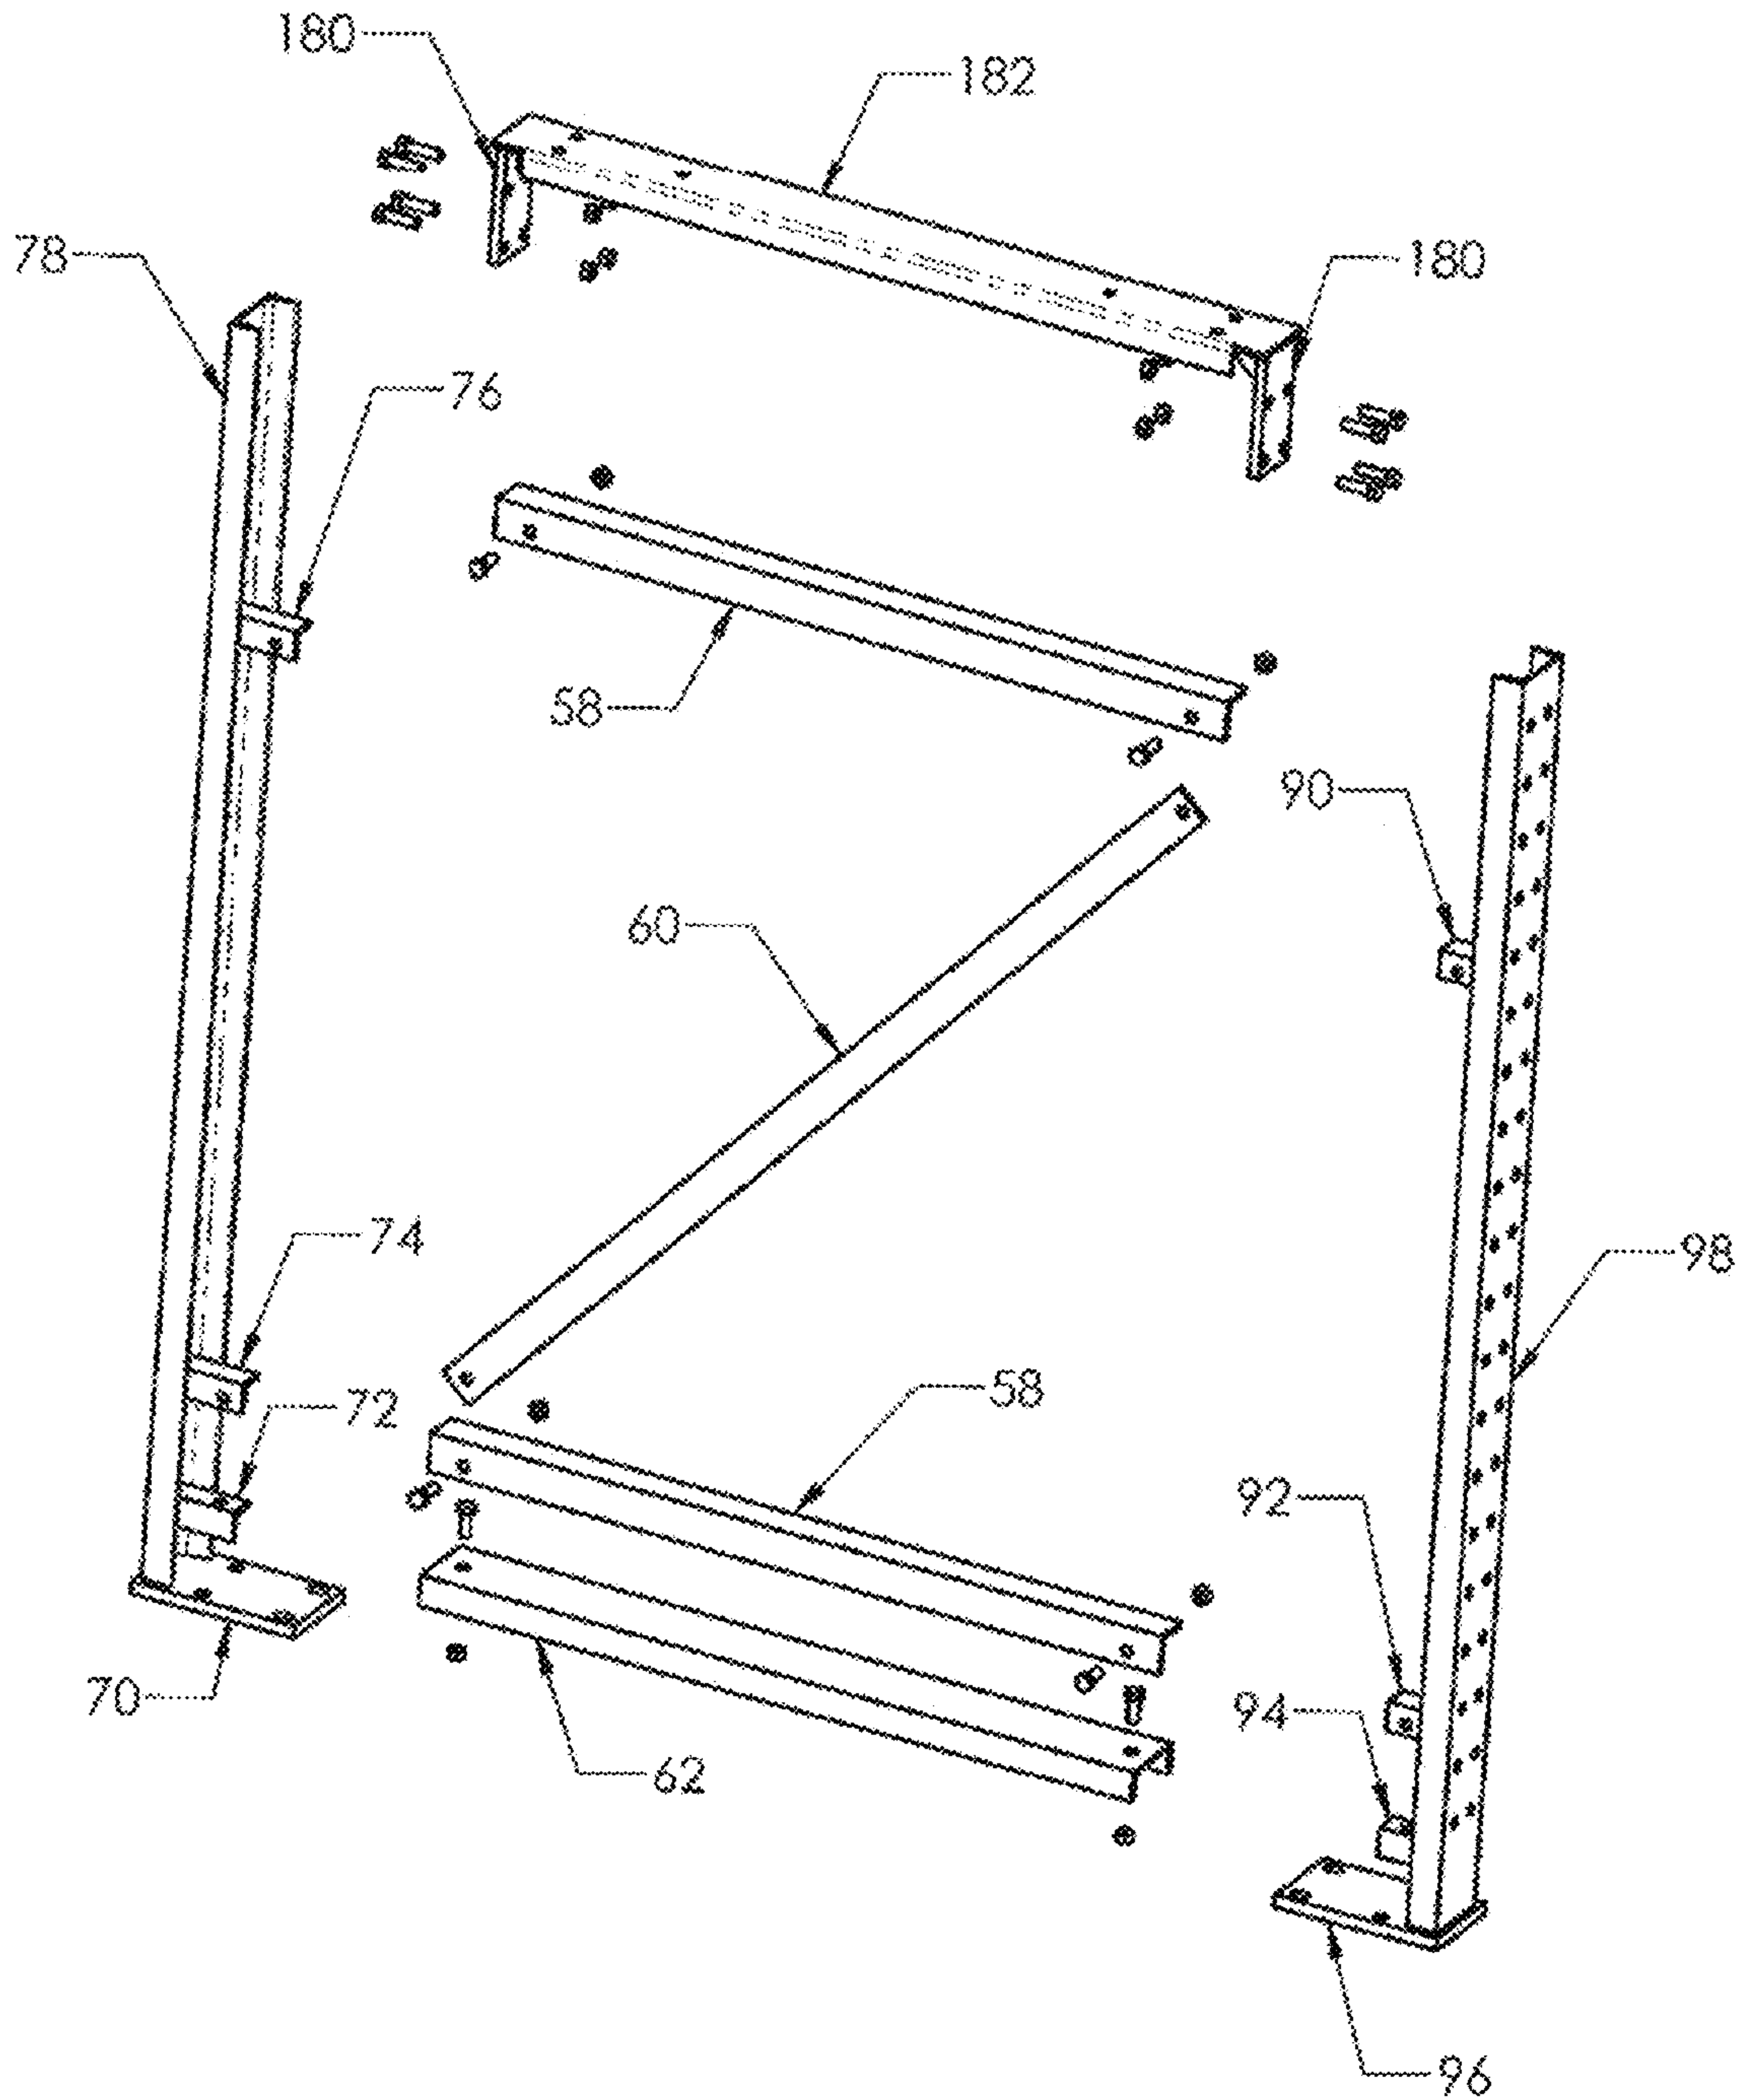
FIG. 12 is a side perspective view of the dismantled base of an alternate embodiment of the storage system; and
