(54) **INTERCHANGEABLE BASE STEEL  
STRUCTURE STORAGE ASSEMBLY**

A storage rack assembly includes a base steel structure which is interchangeably connected to the storage rack above. The base steel structure assembly is comprised of structural material with bolted connections which allow for the replacement or changing of damaged material due to accidental forklift contact all while the above storage system stays in place.

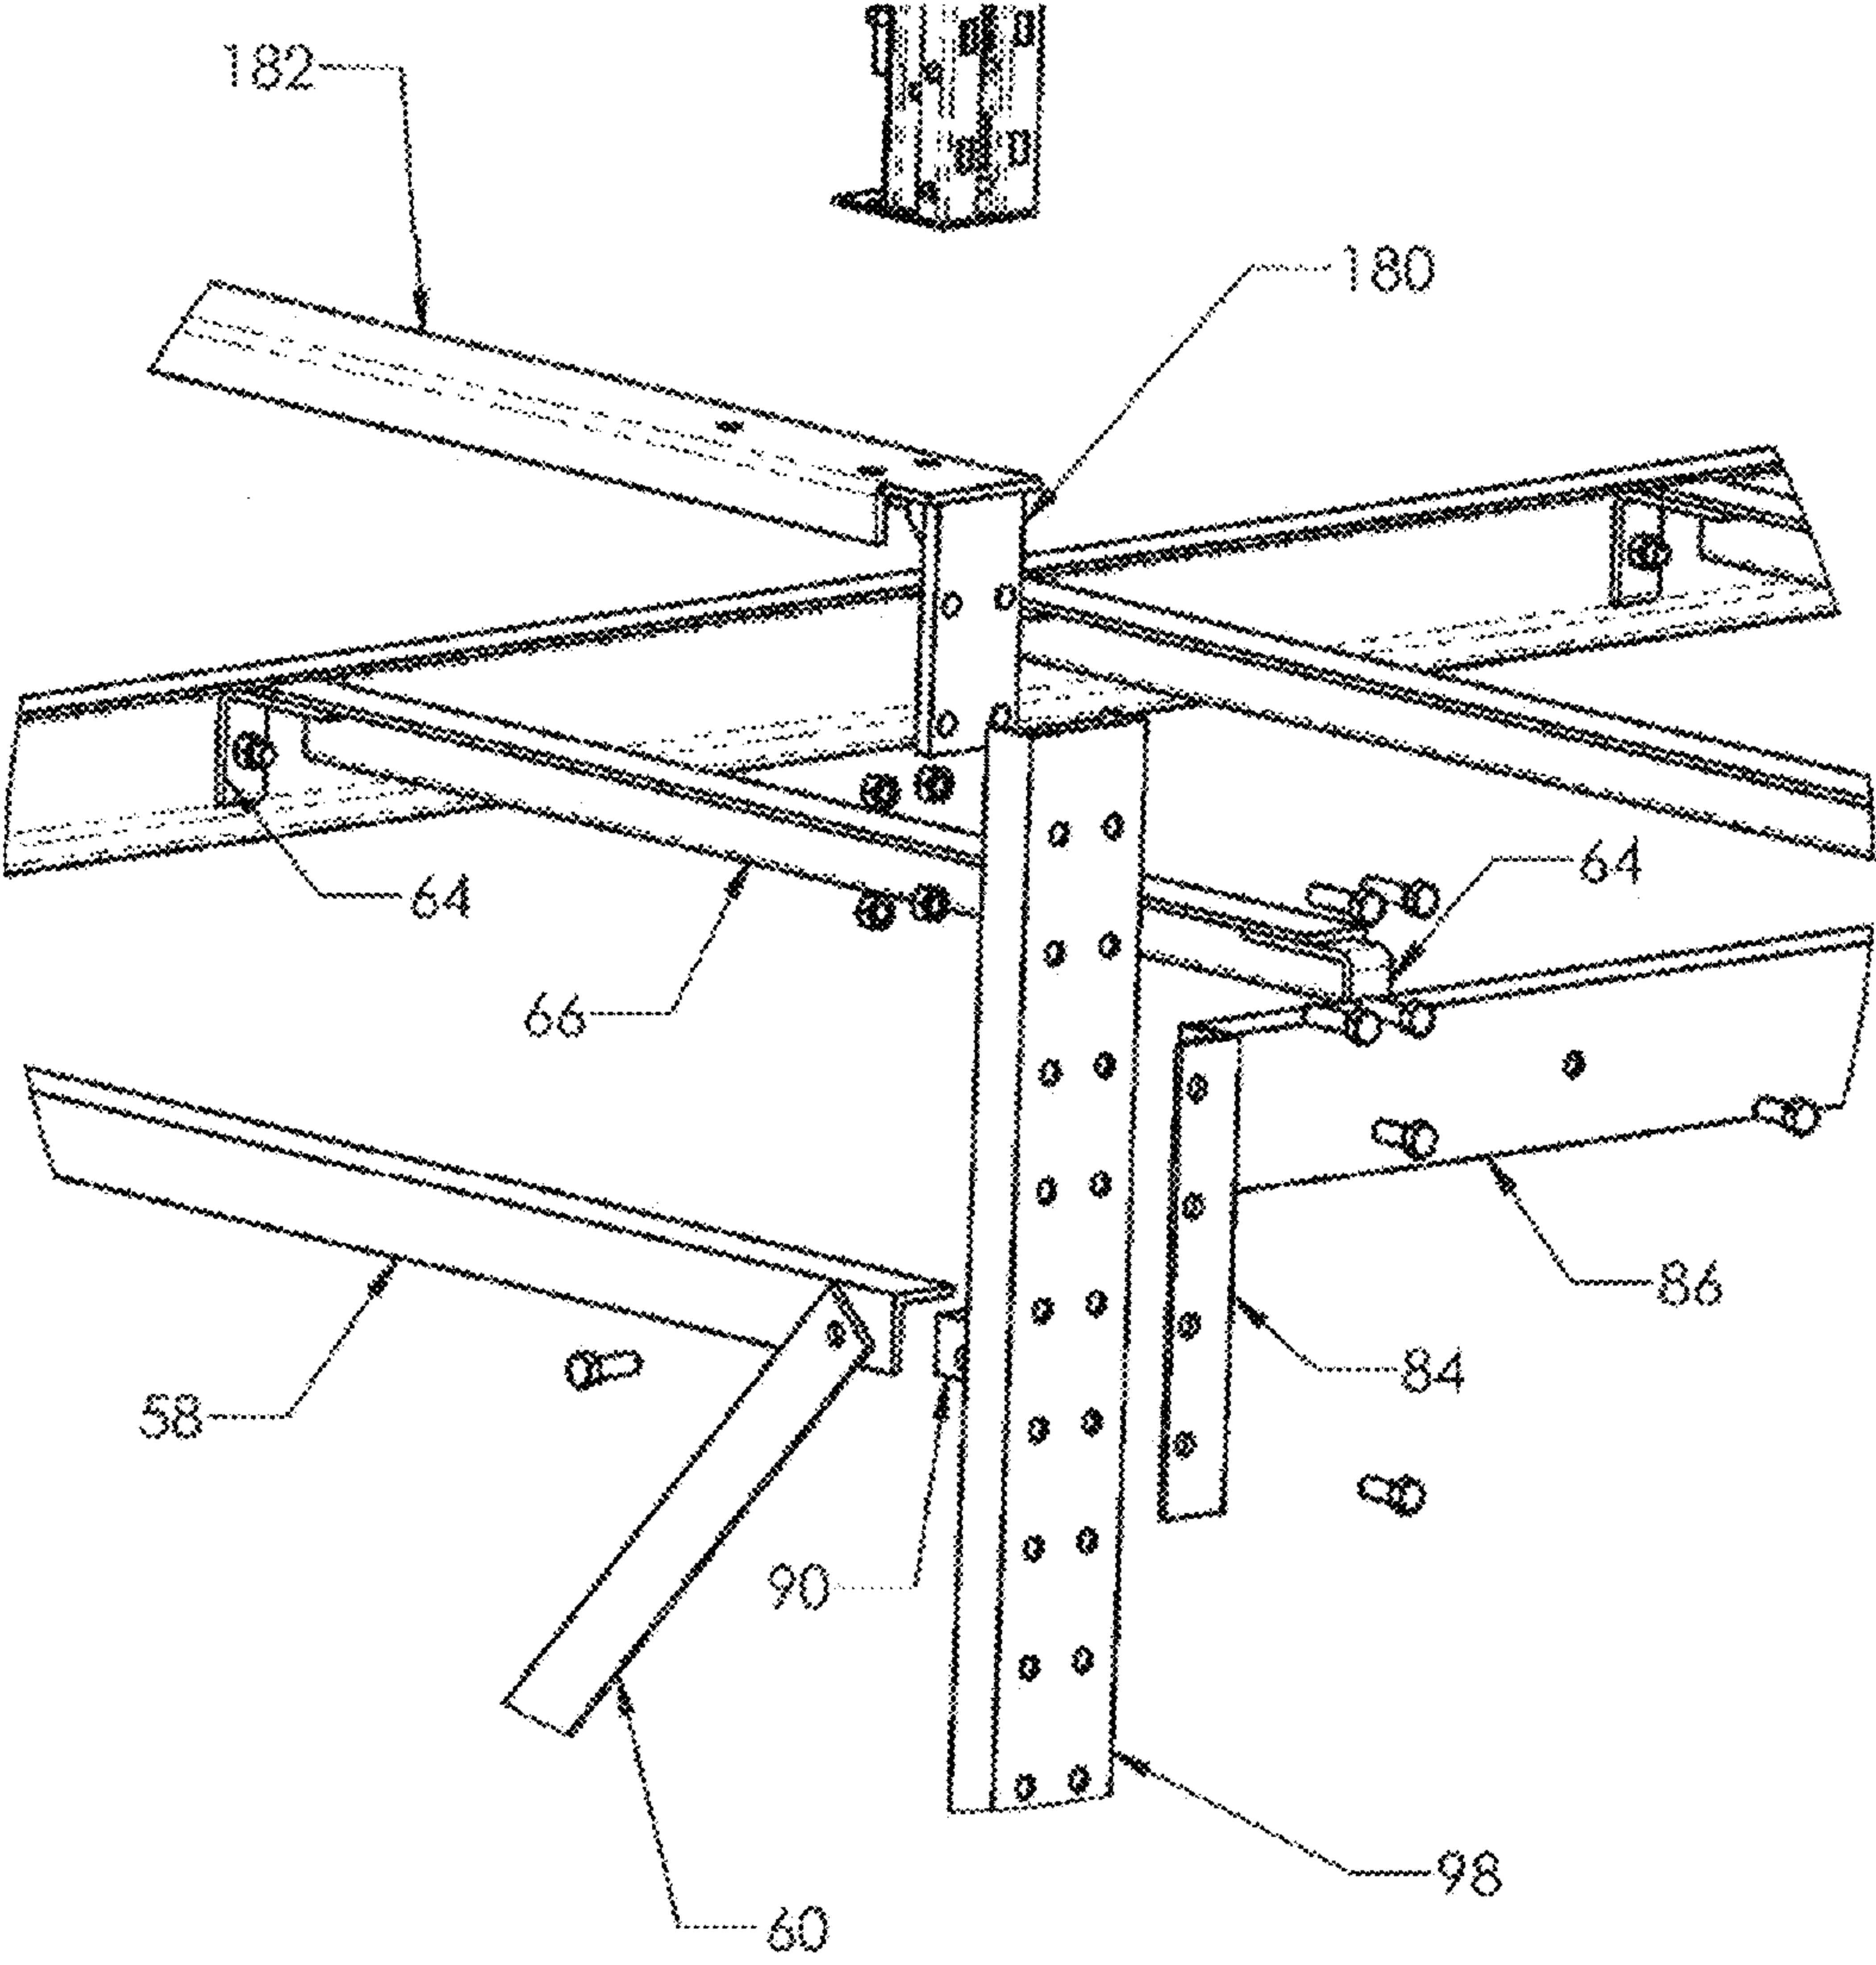
FIG. 13 is an exploded side perspective view of the upper right portion of the base showing an enhanced connection detail.
