(54) **INTERCHANGEABLE BASE STEEL
STRUCTURE STORAGE ASSEMBLY**

A storage rack assembly includes a base steel structure which is interchangeably connected to the storage rack above. The base steel structure assembly is comprised of structural material with bolted connections which allow for the replacement or changing of damaged material due to accidental forklift contact all while the above storage system stays in place.

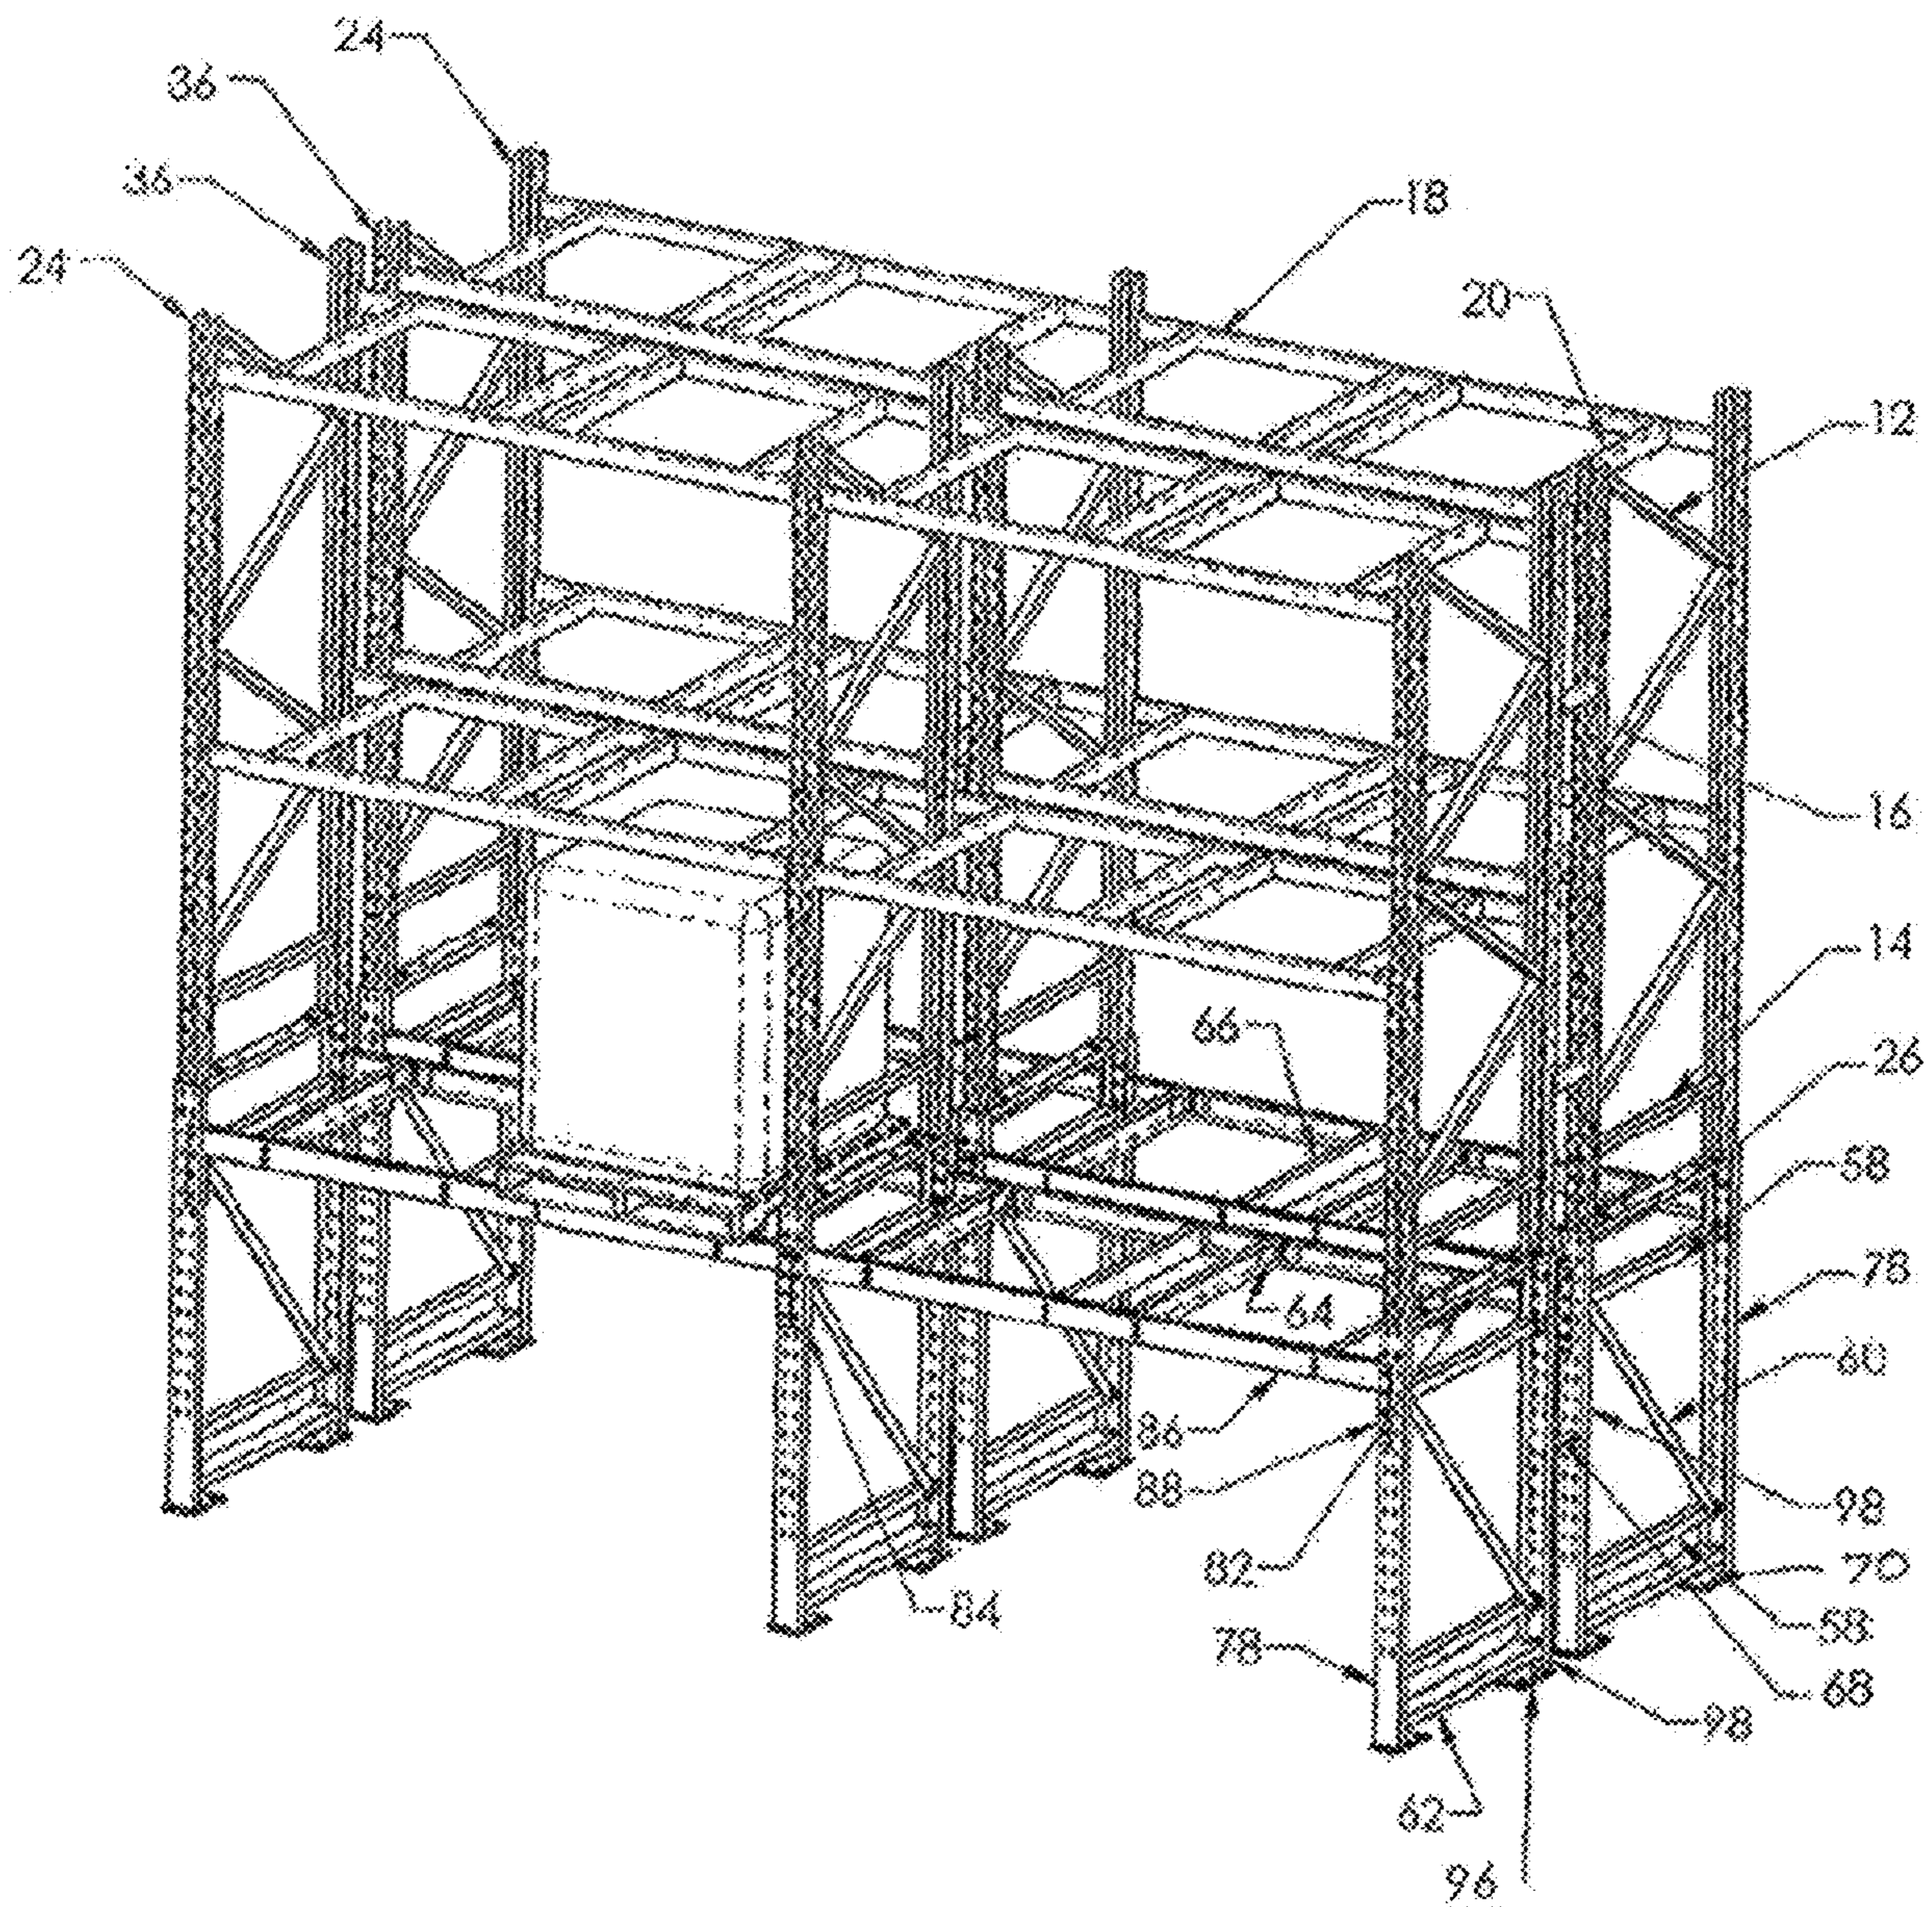
FIG. 2 is a side perspective view of a first embodiment of a storage system made in accordance with the present invention;

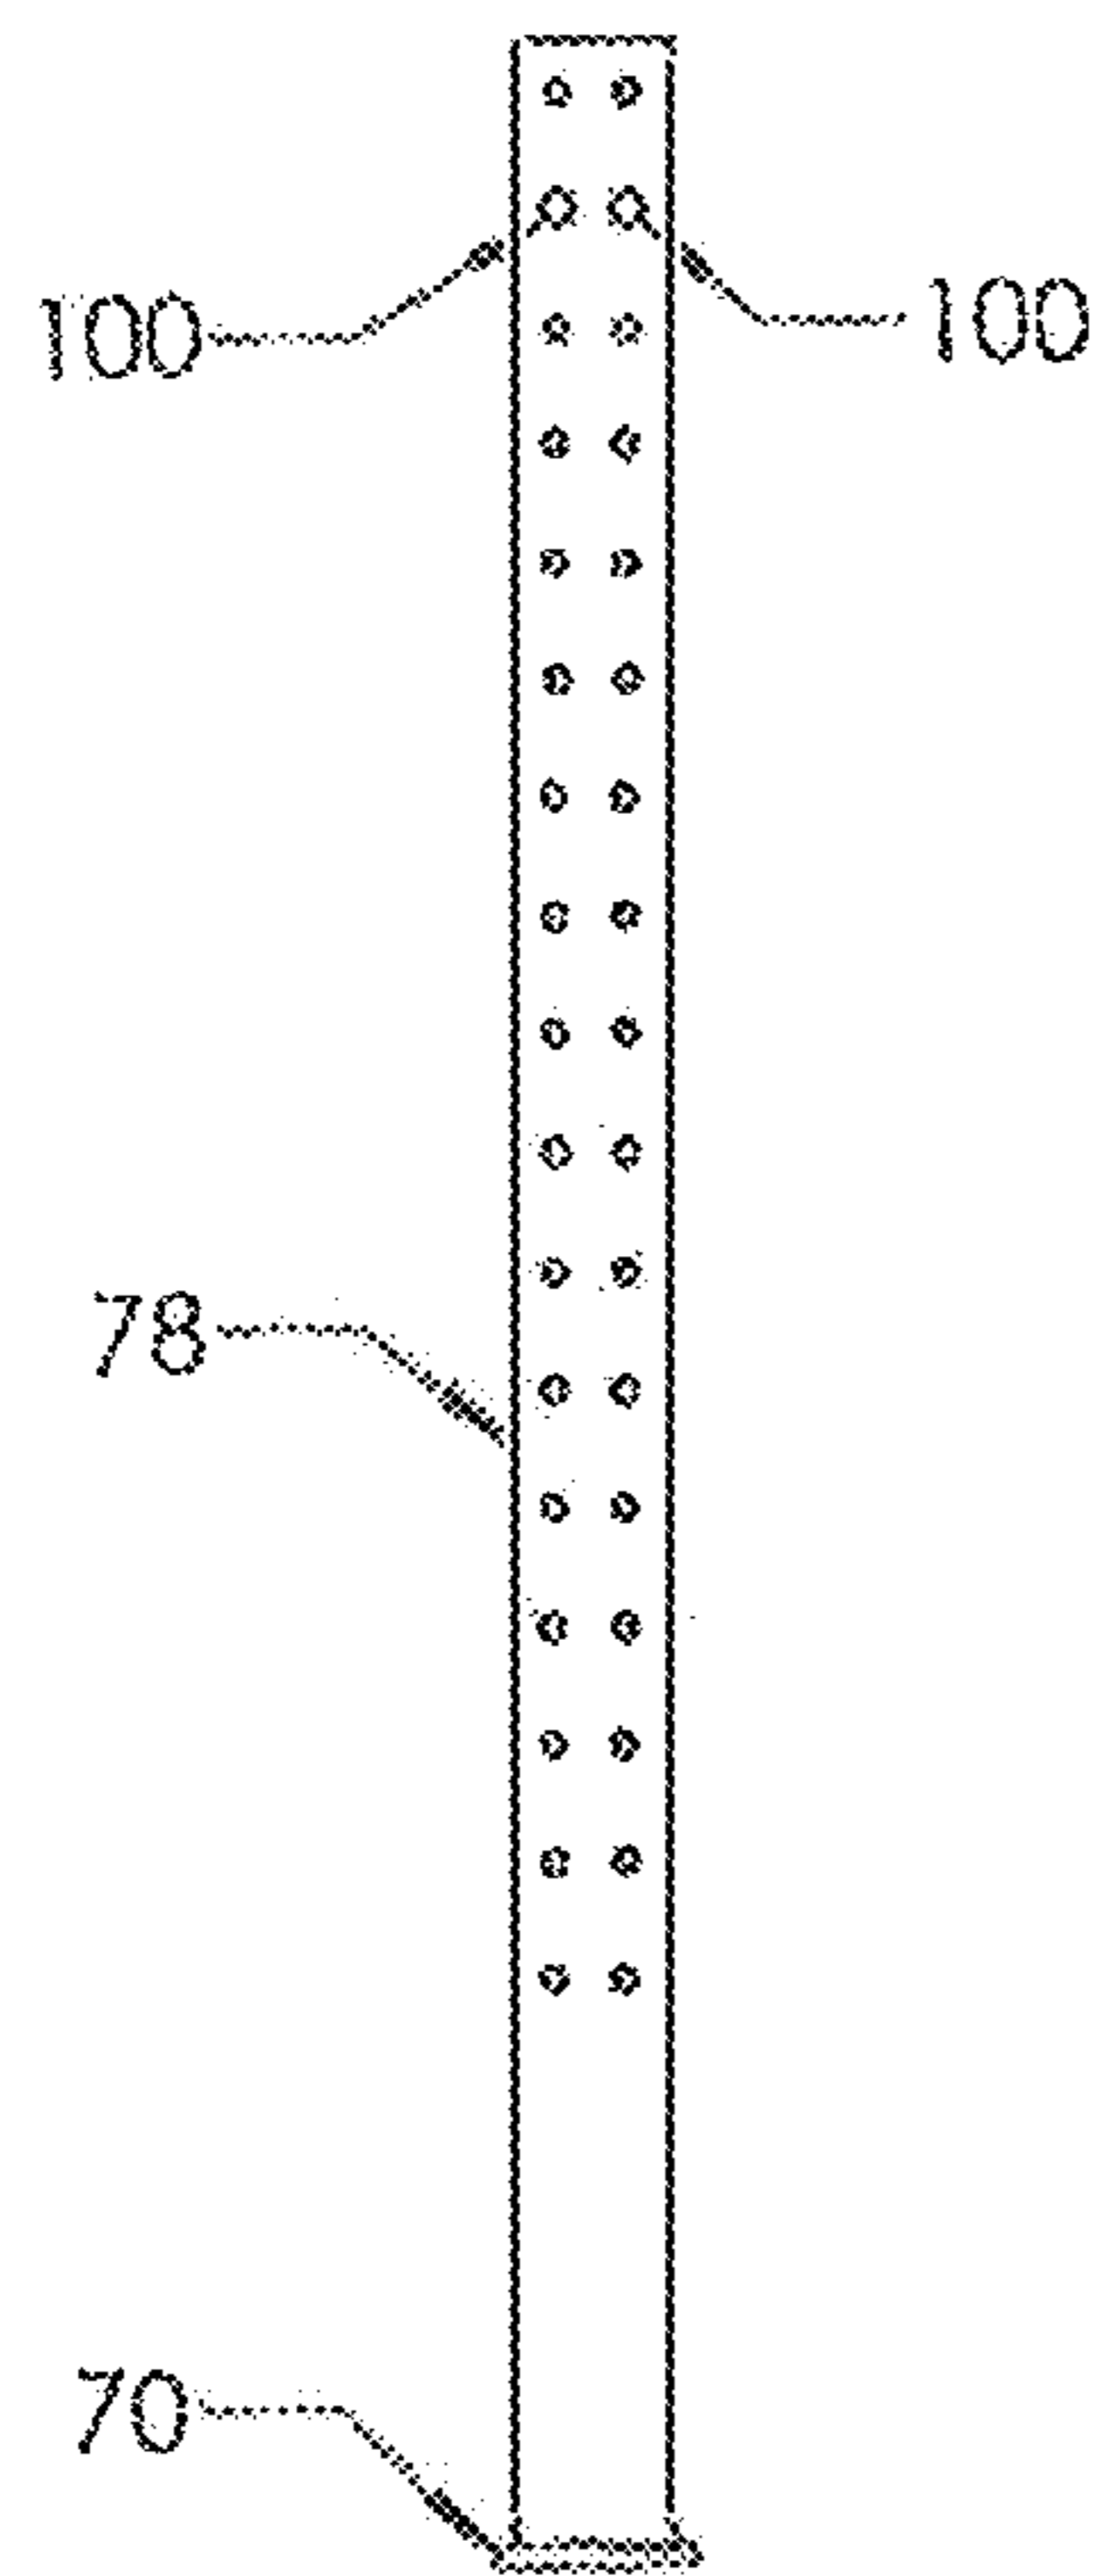
FIG. 3 is a front view of a base portion of the storage system of FIG. 2;

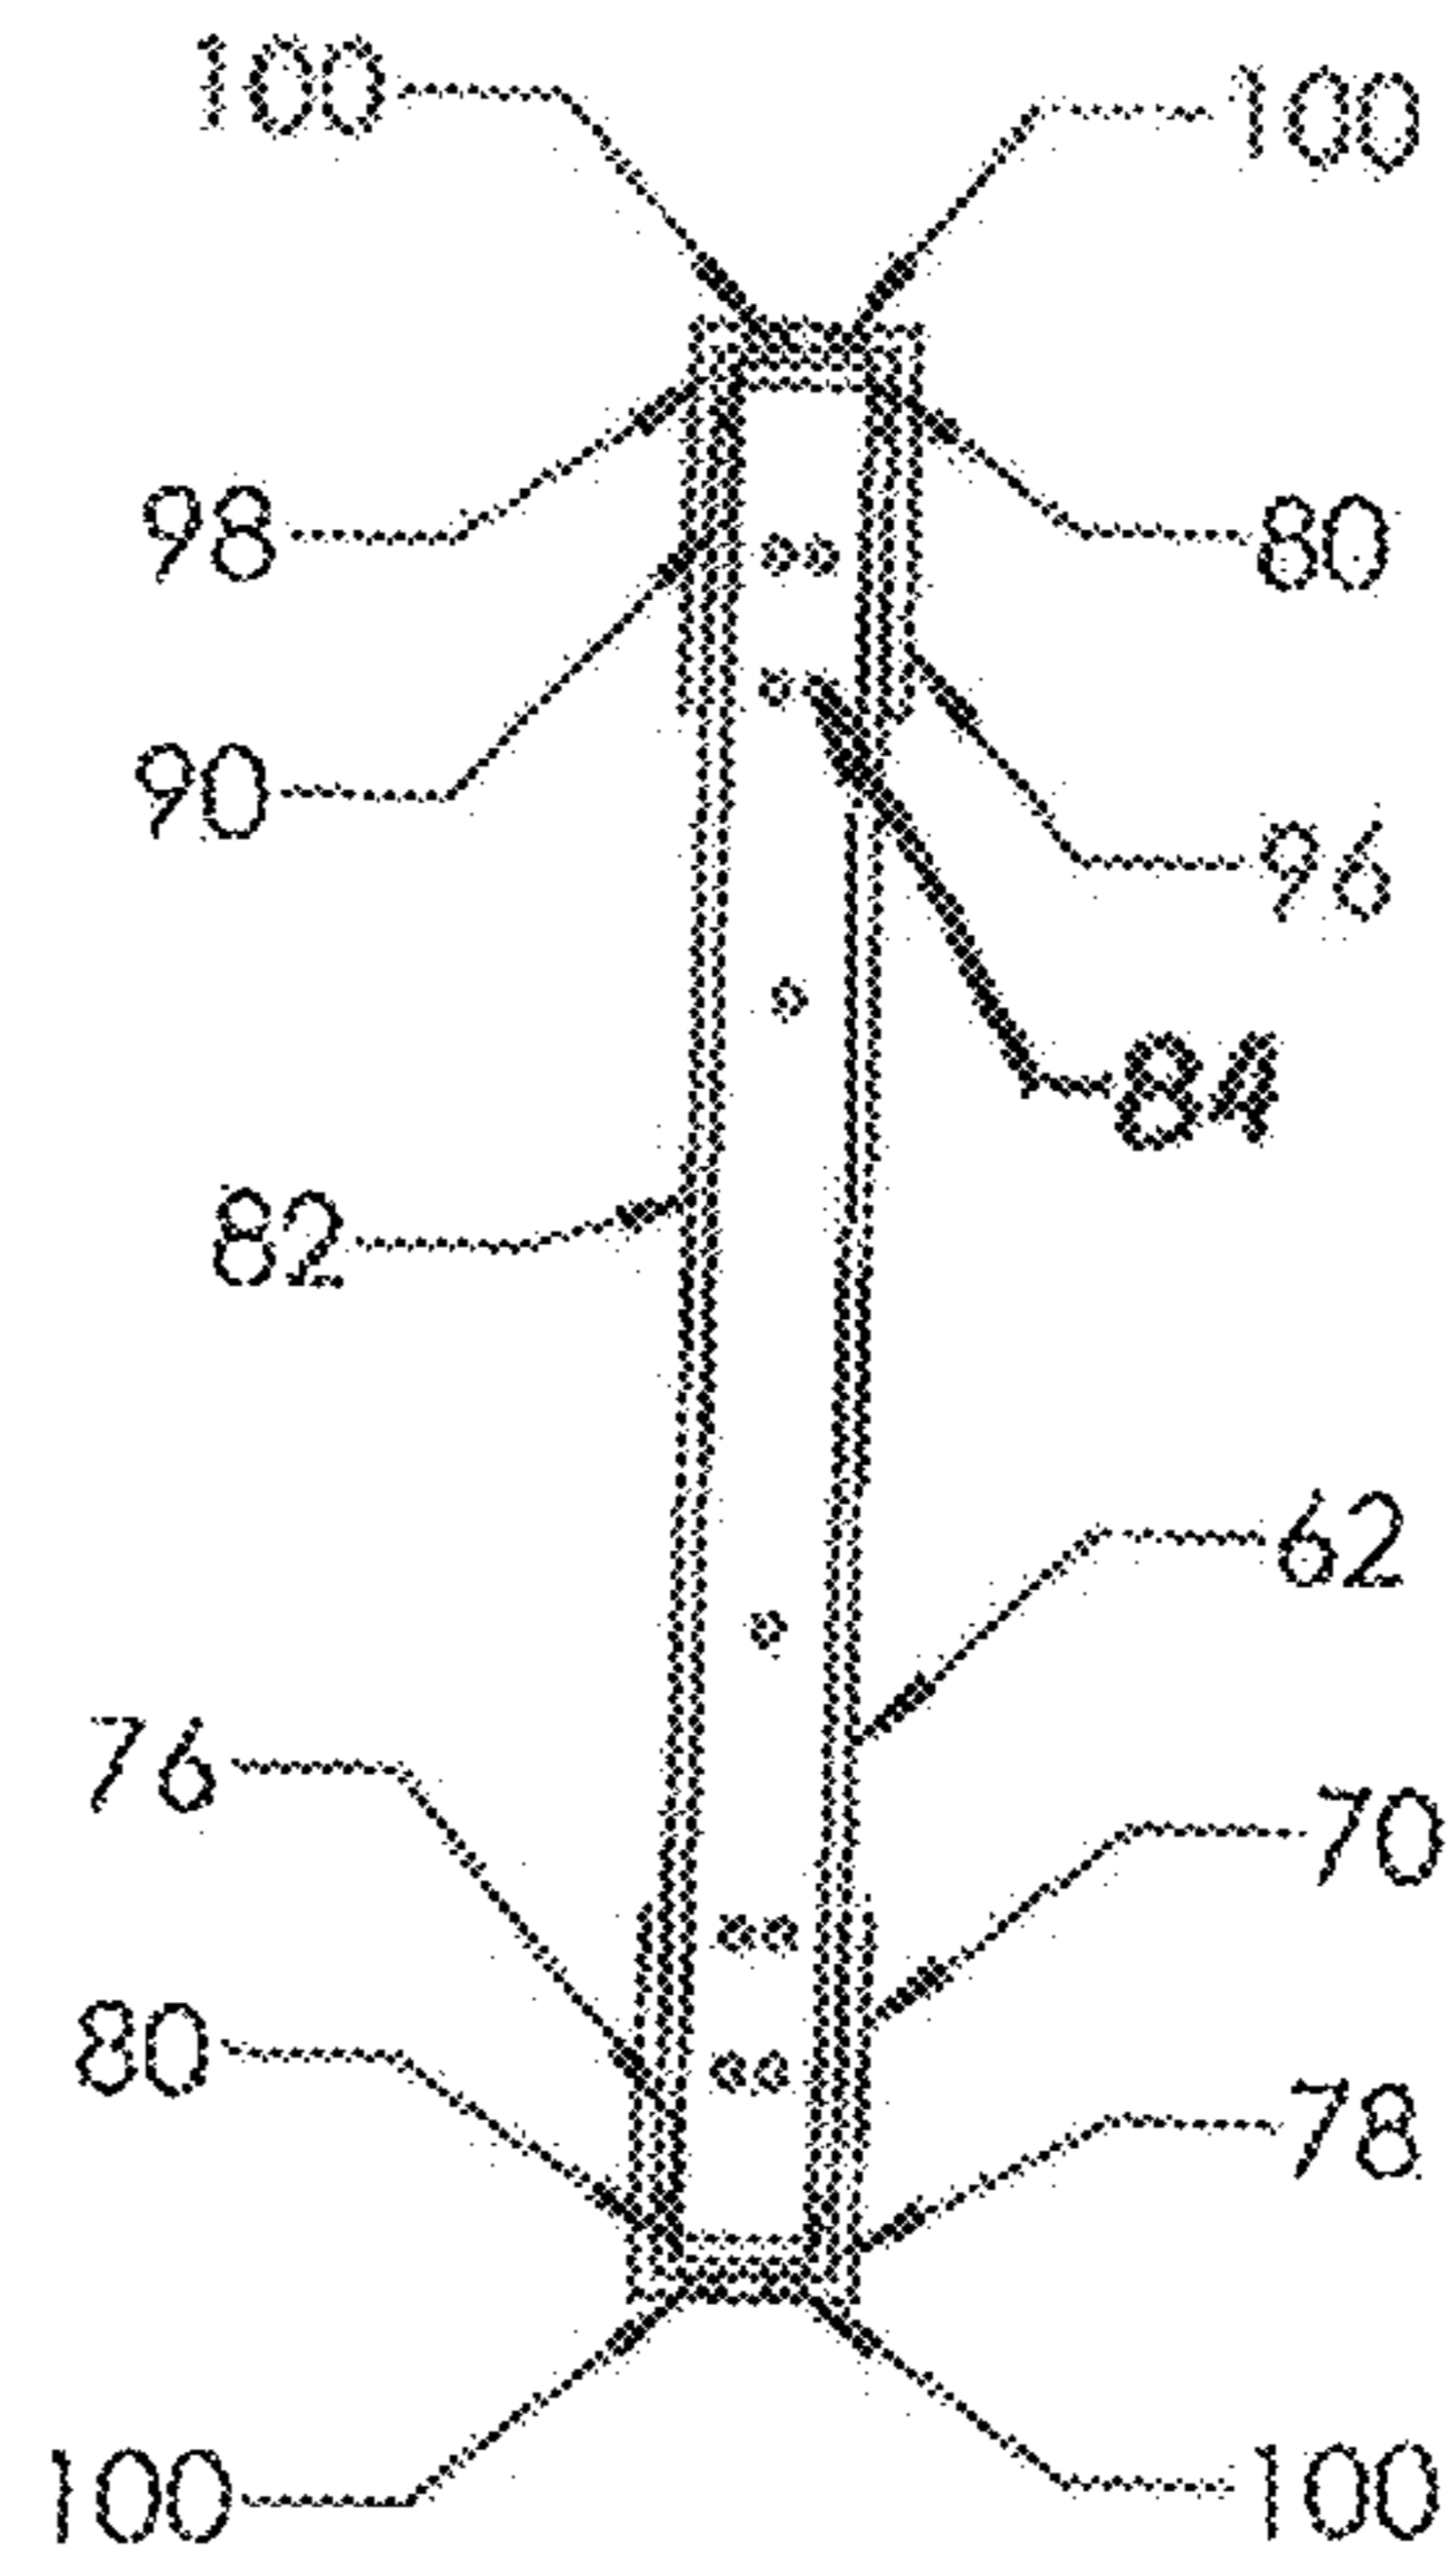
FIG. 4 is a top view of the base portion of the storage system in FIG. 2;

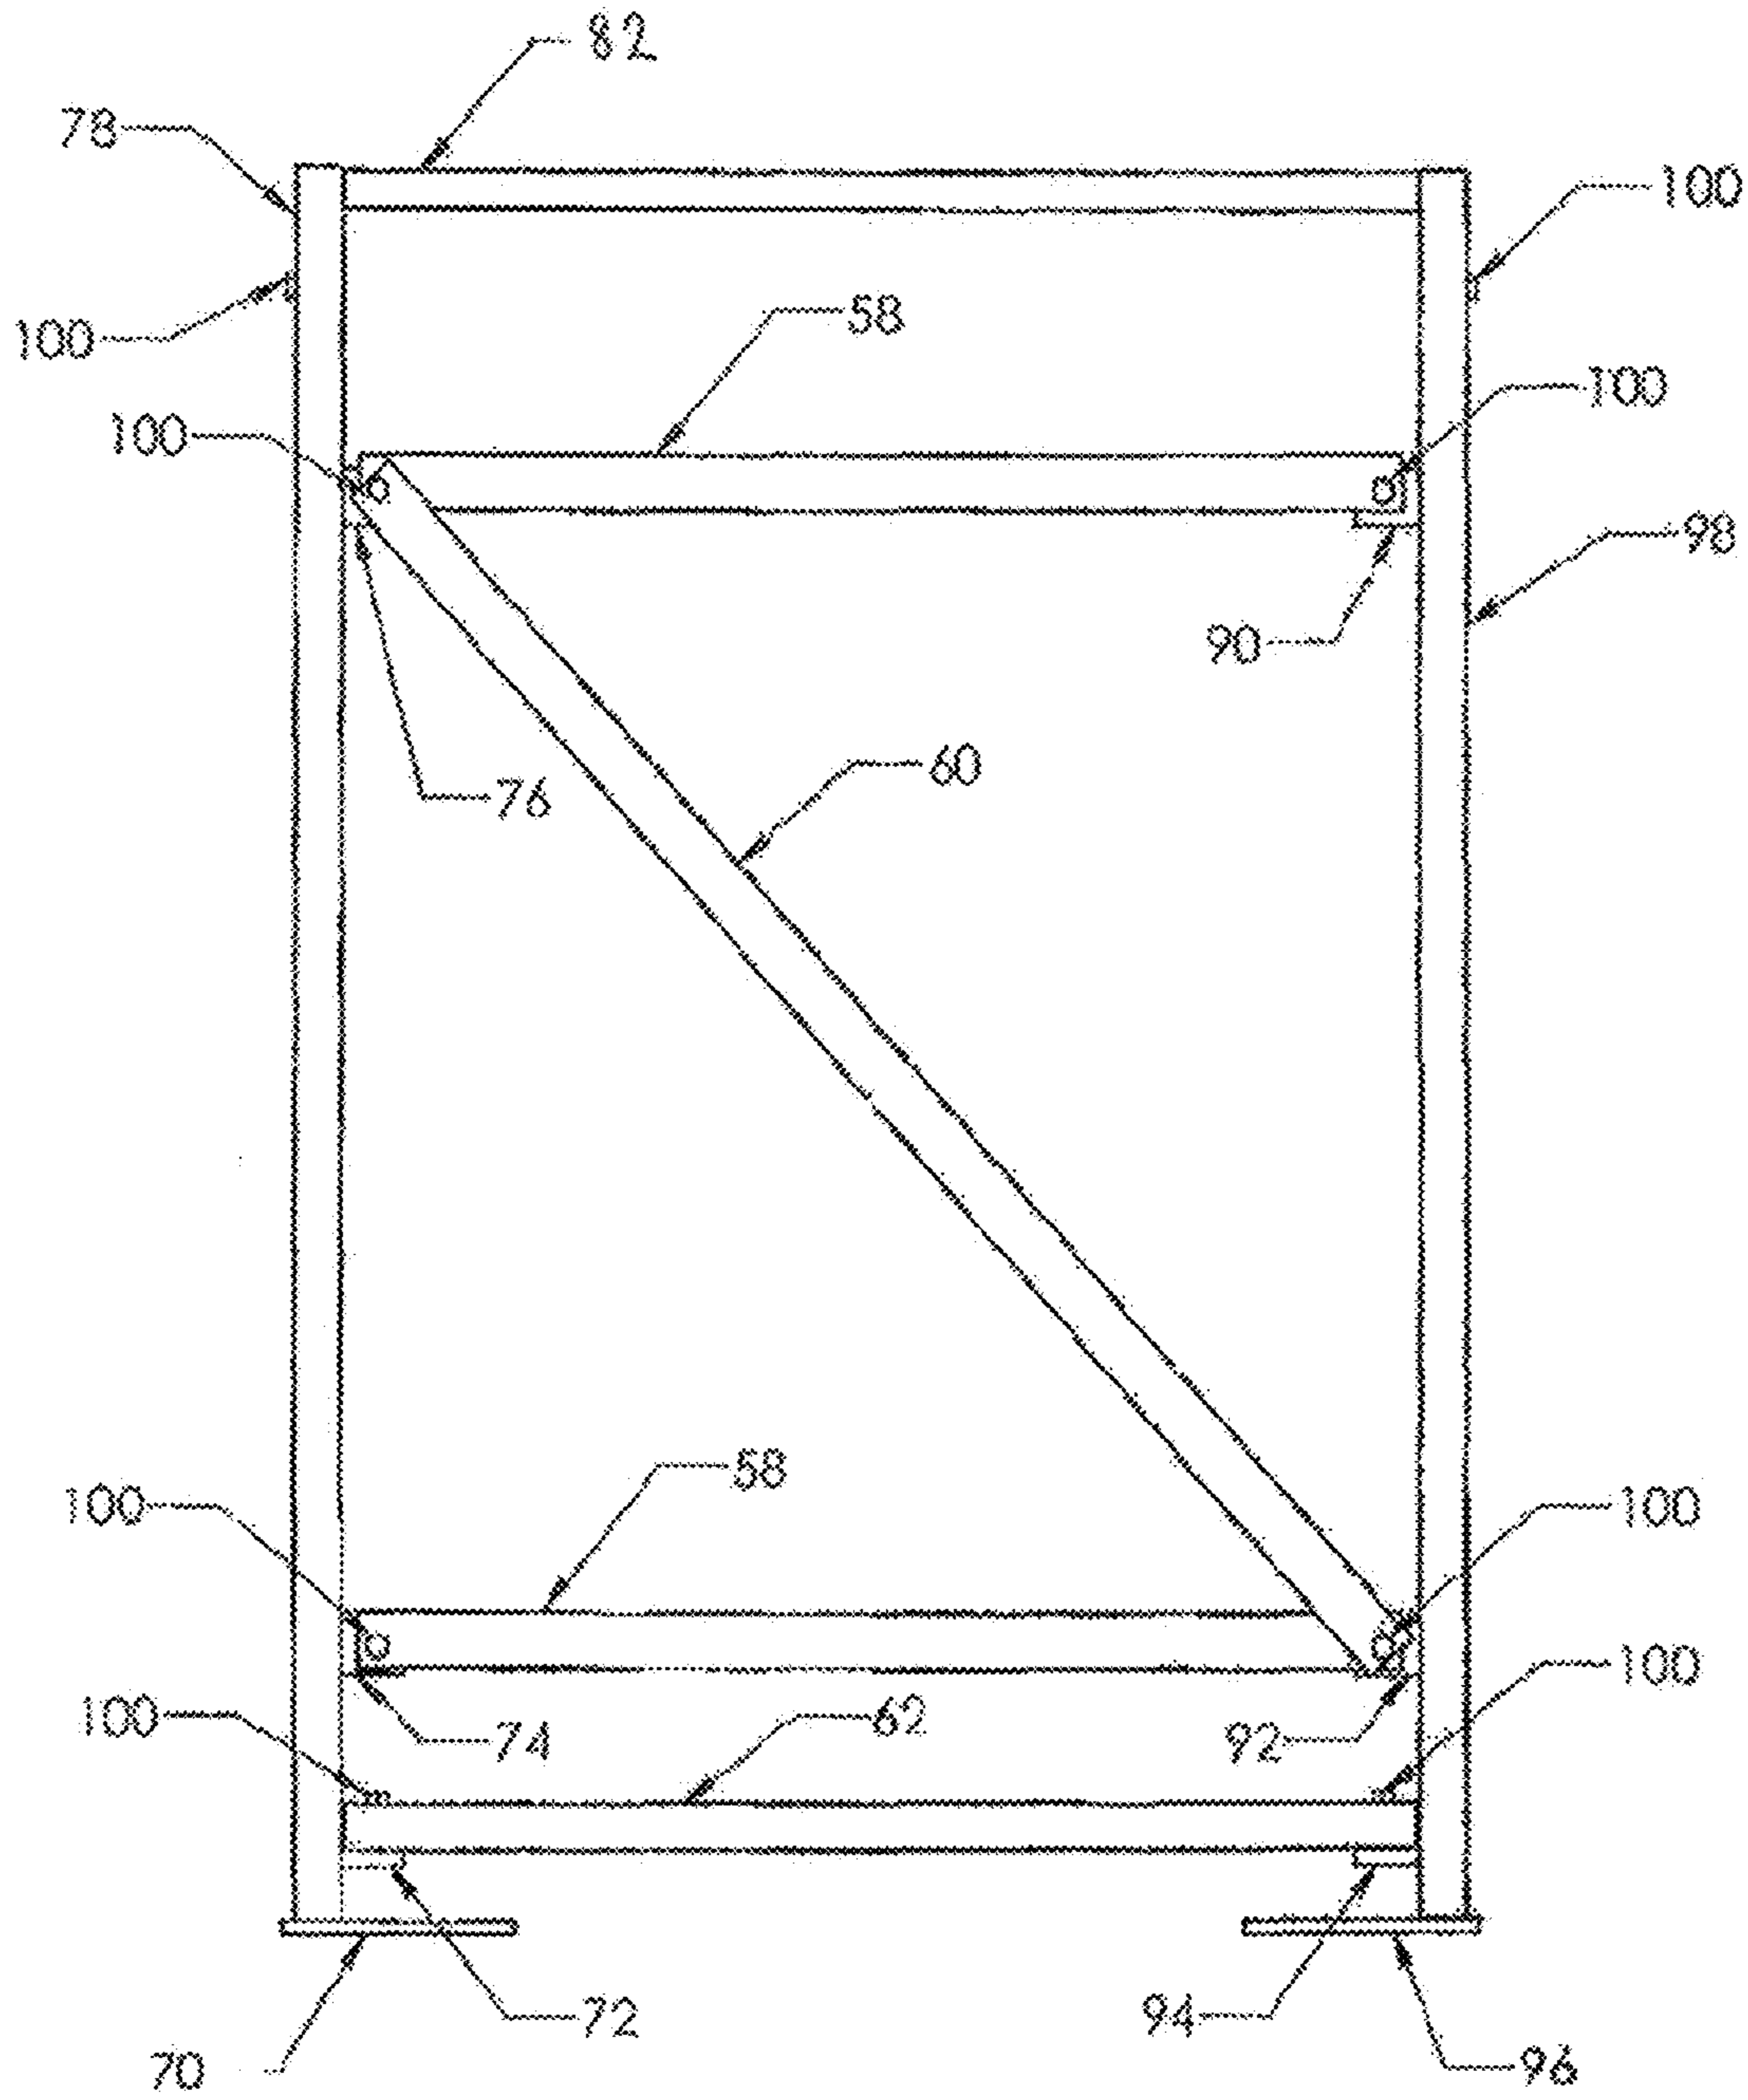
FIG. 5 is a side view of the base portion of the storage system in FIG. 2;

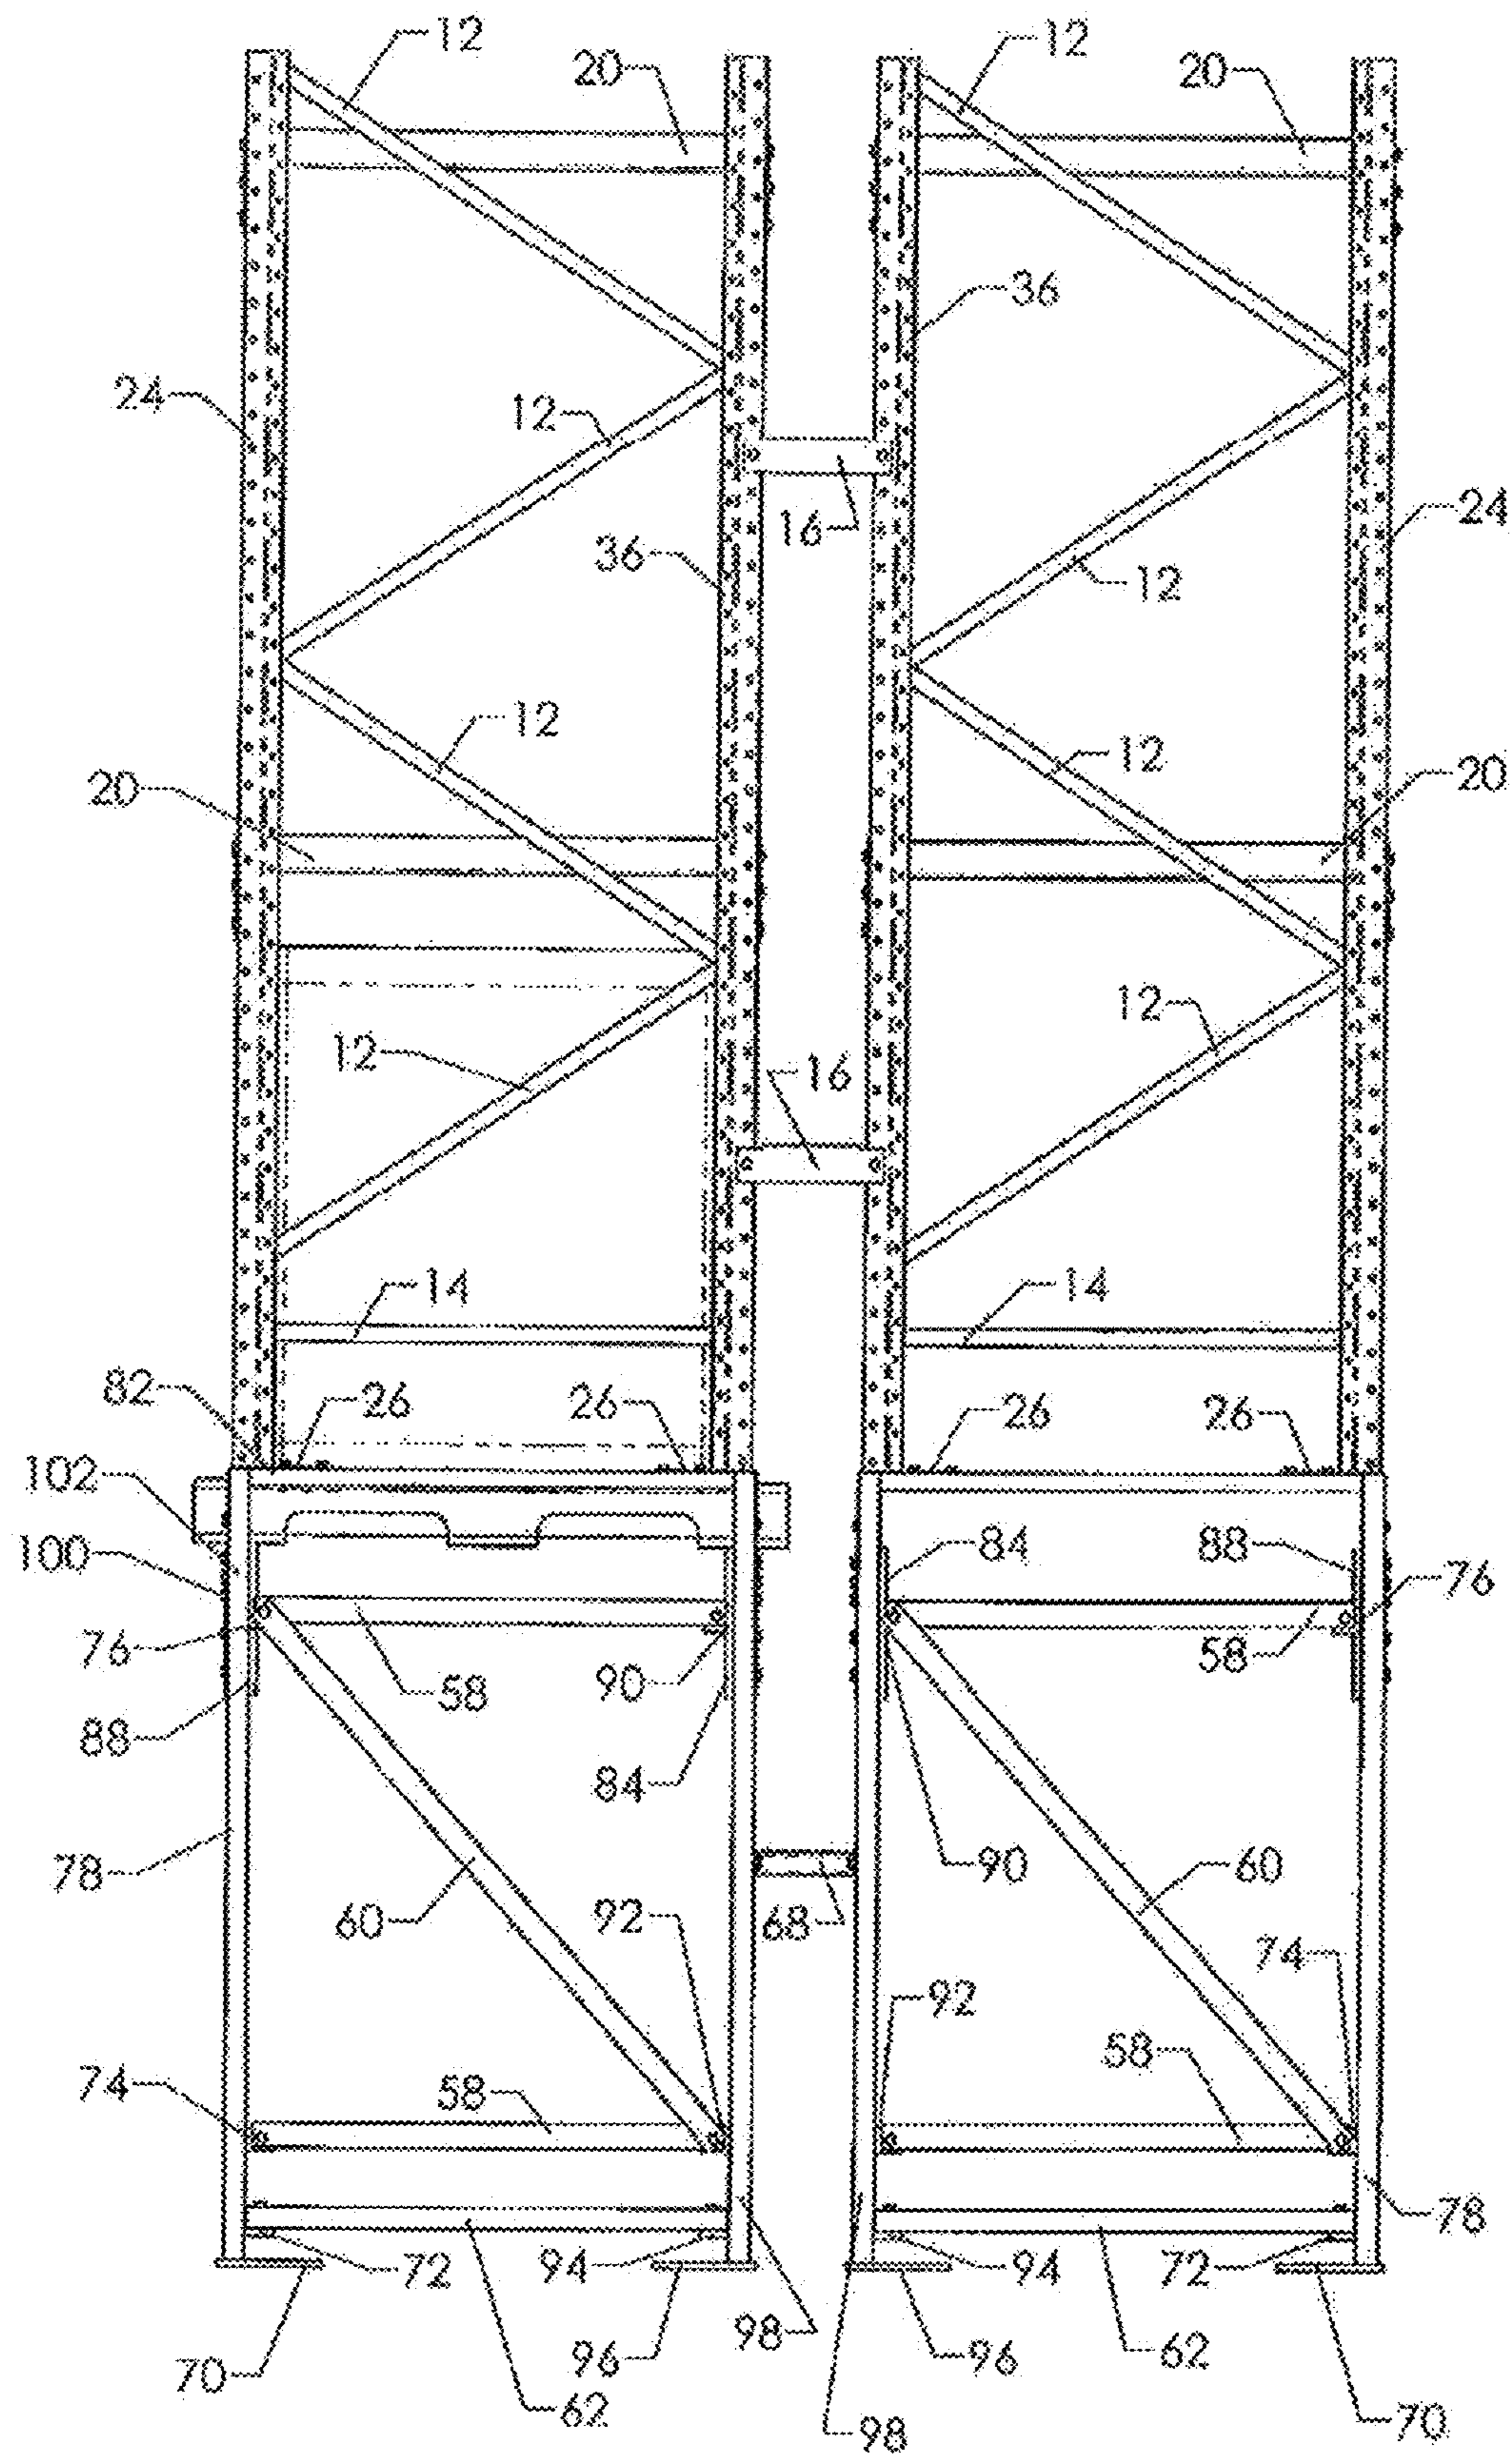
FIG. 6 is a side view of the storage system of FIG. 2;

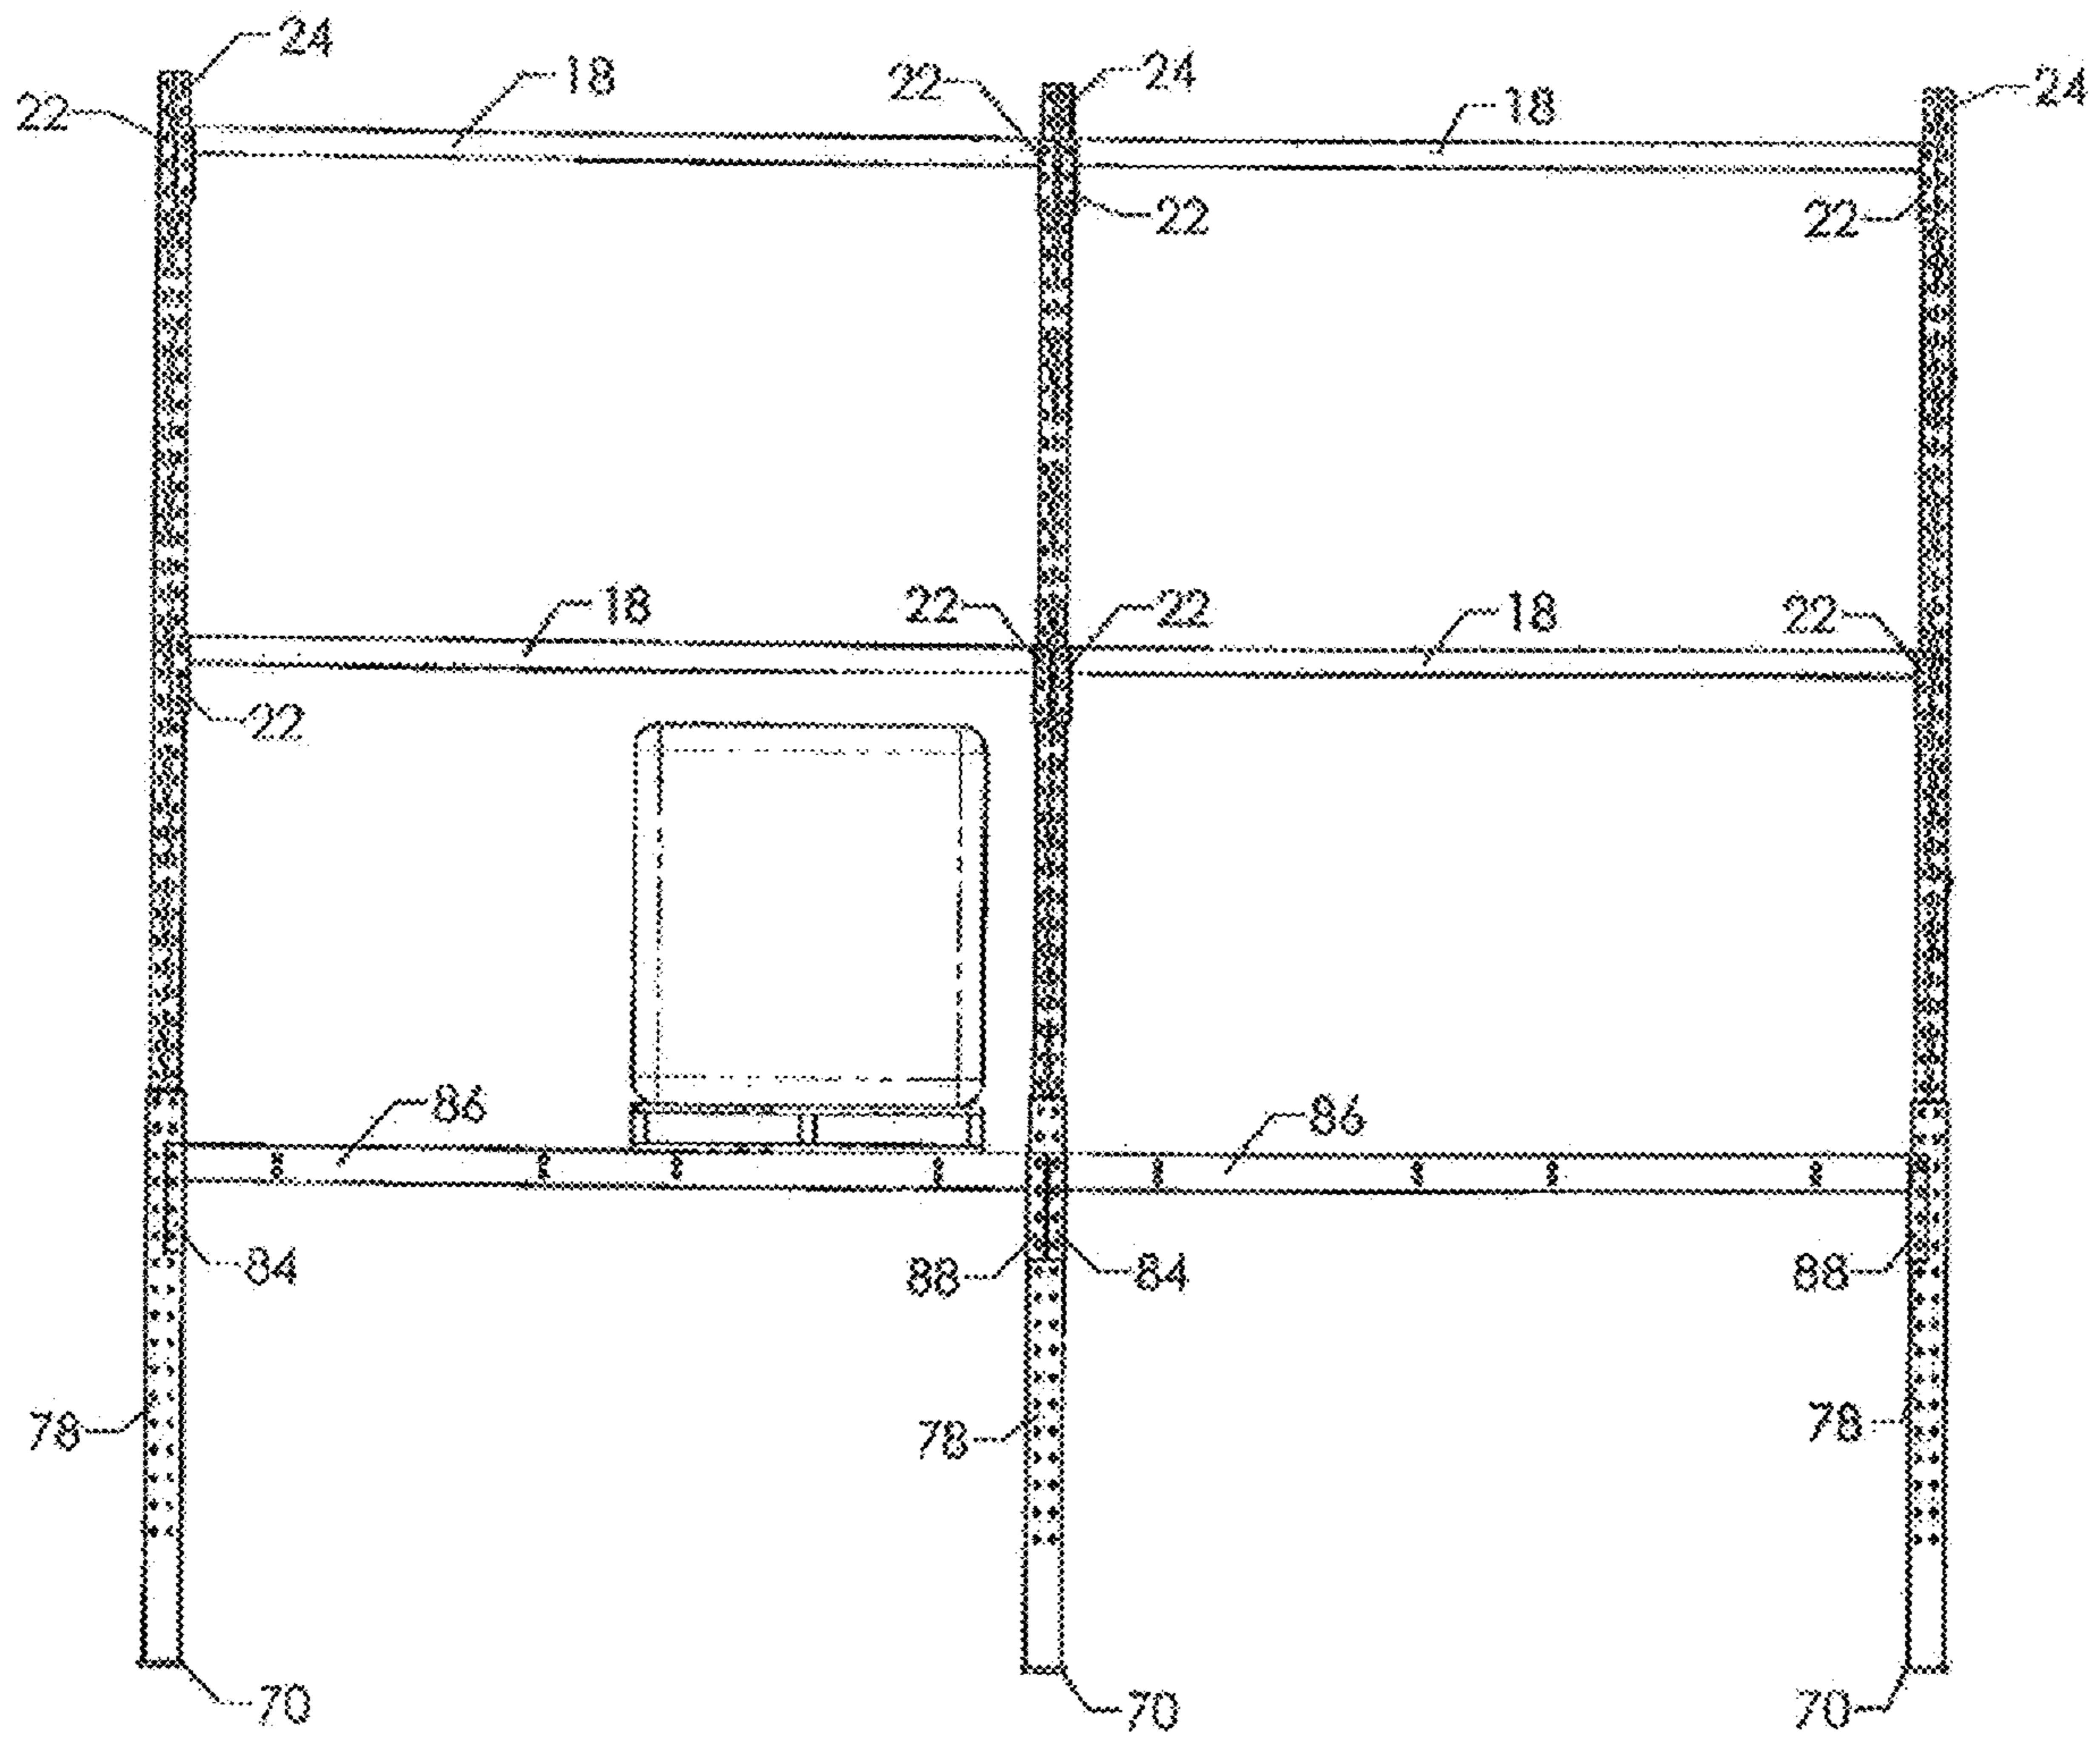
FIG. 7 is a front view of the storage system of FIG. 2;
