(54) **INTERCHANGEABLE BASE STEEL
STRUCTURE STORAGE ASSEMBLY**

A storage rack assembly includes a base steel structure which is interchangeably connected to the storage rack above. The base steel structure assembly is comprised of structural material with bolted connections which allow for the replacement or changing of damaged material due to accidental forklift contact all while the above storage system stays in place.

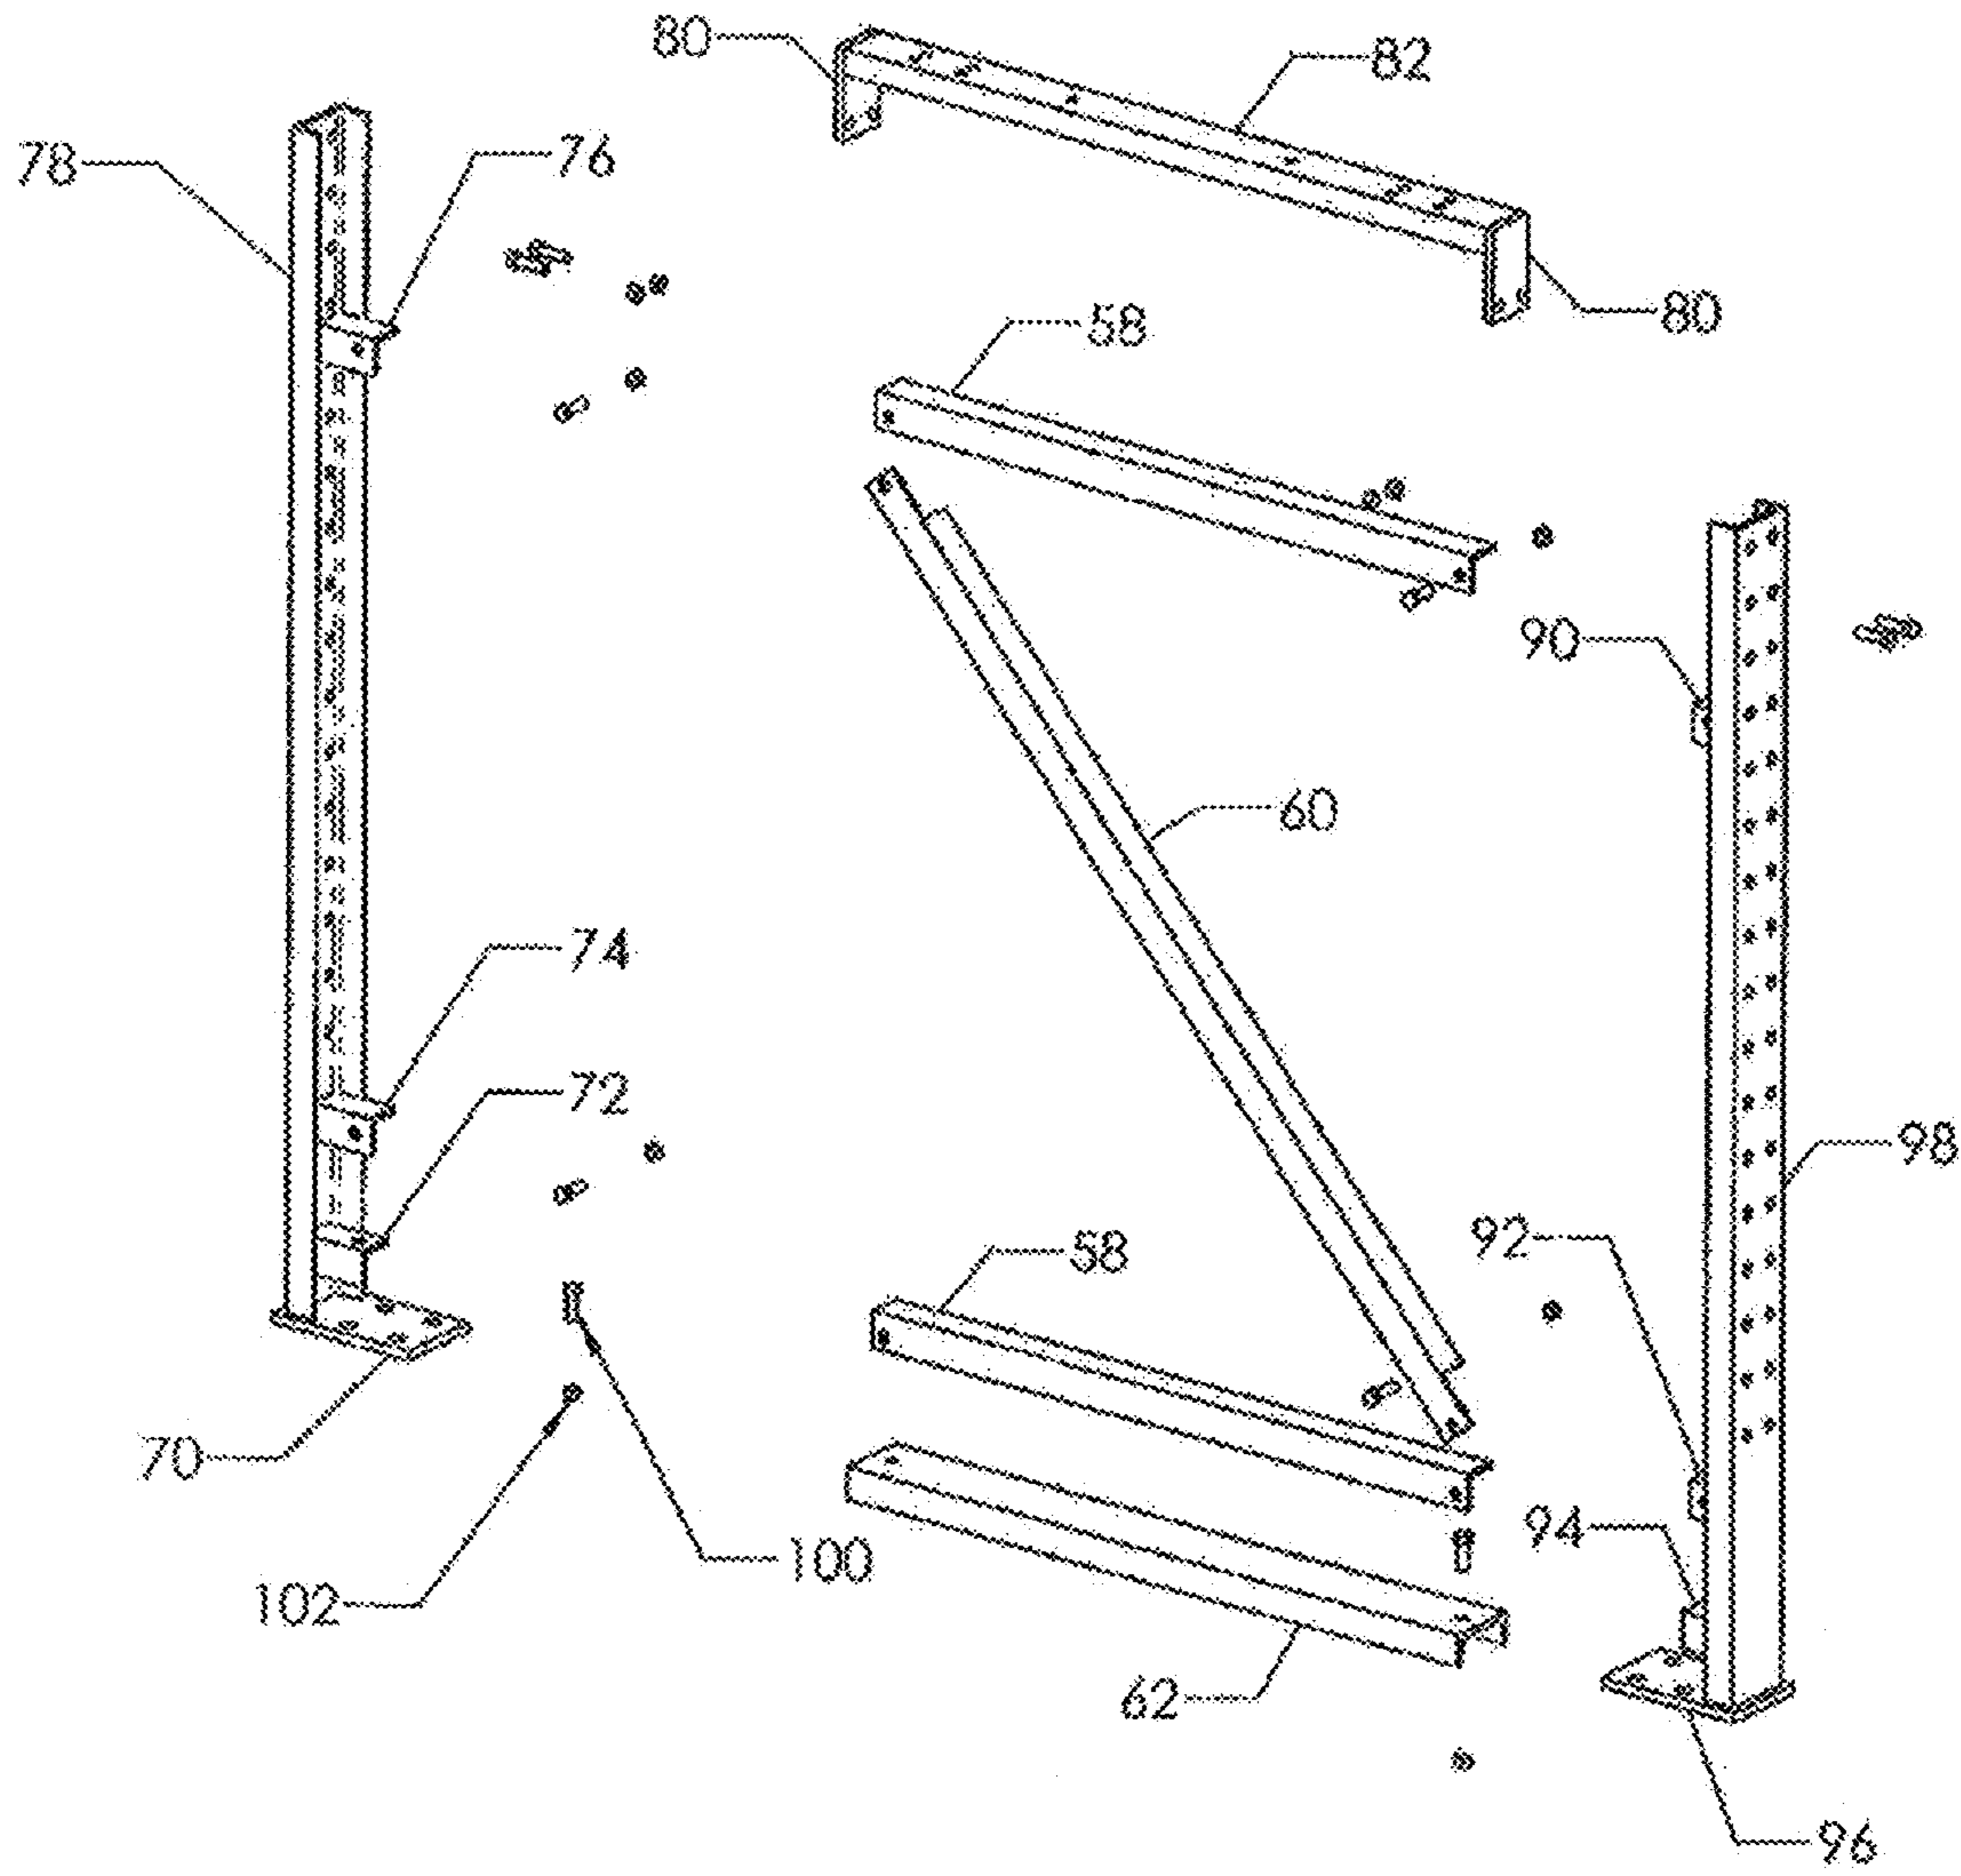
FIG. 8 is a side perspective view of a dismantled base;

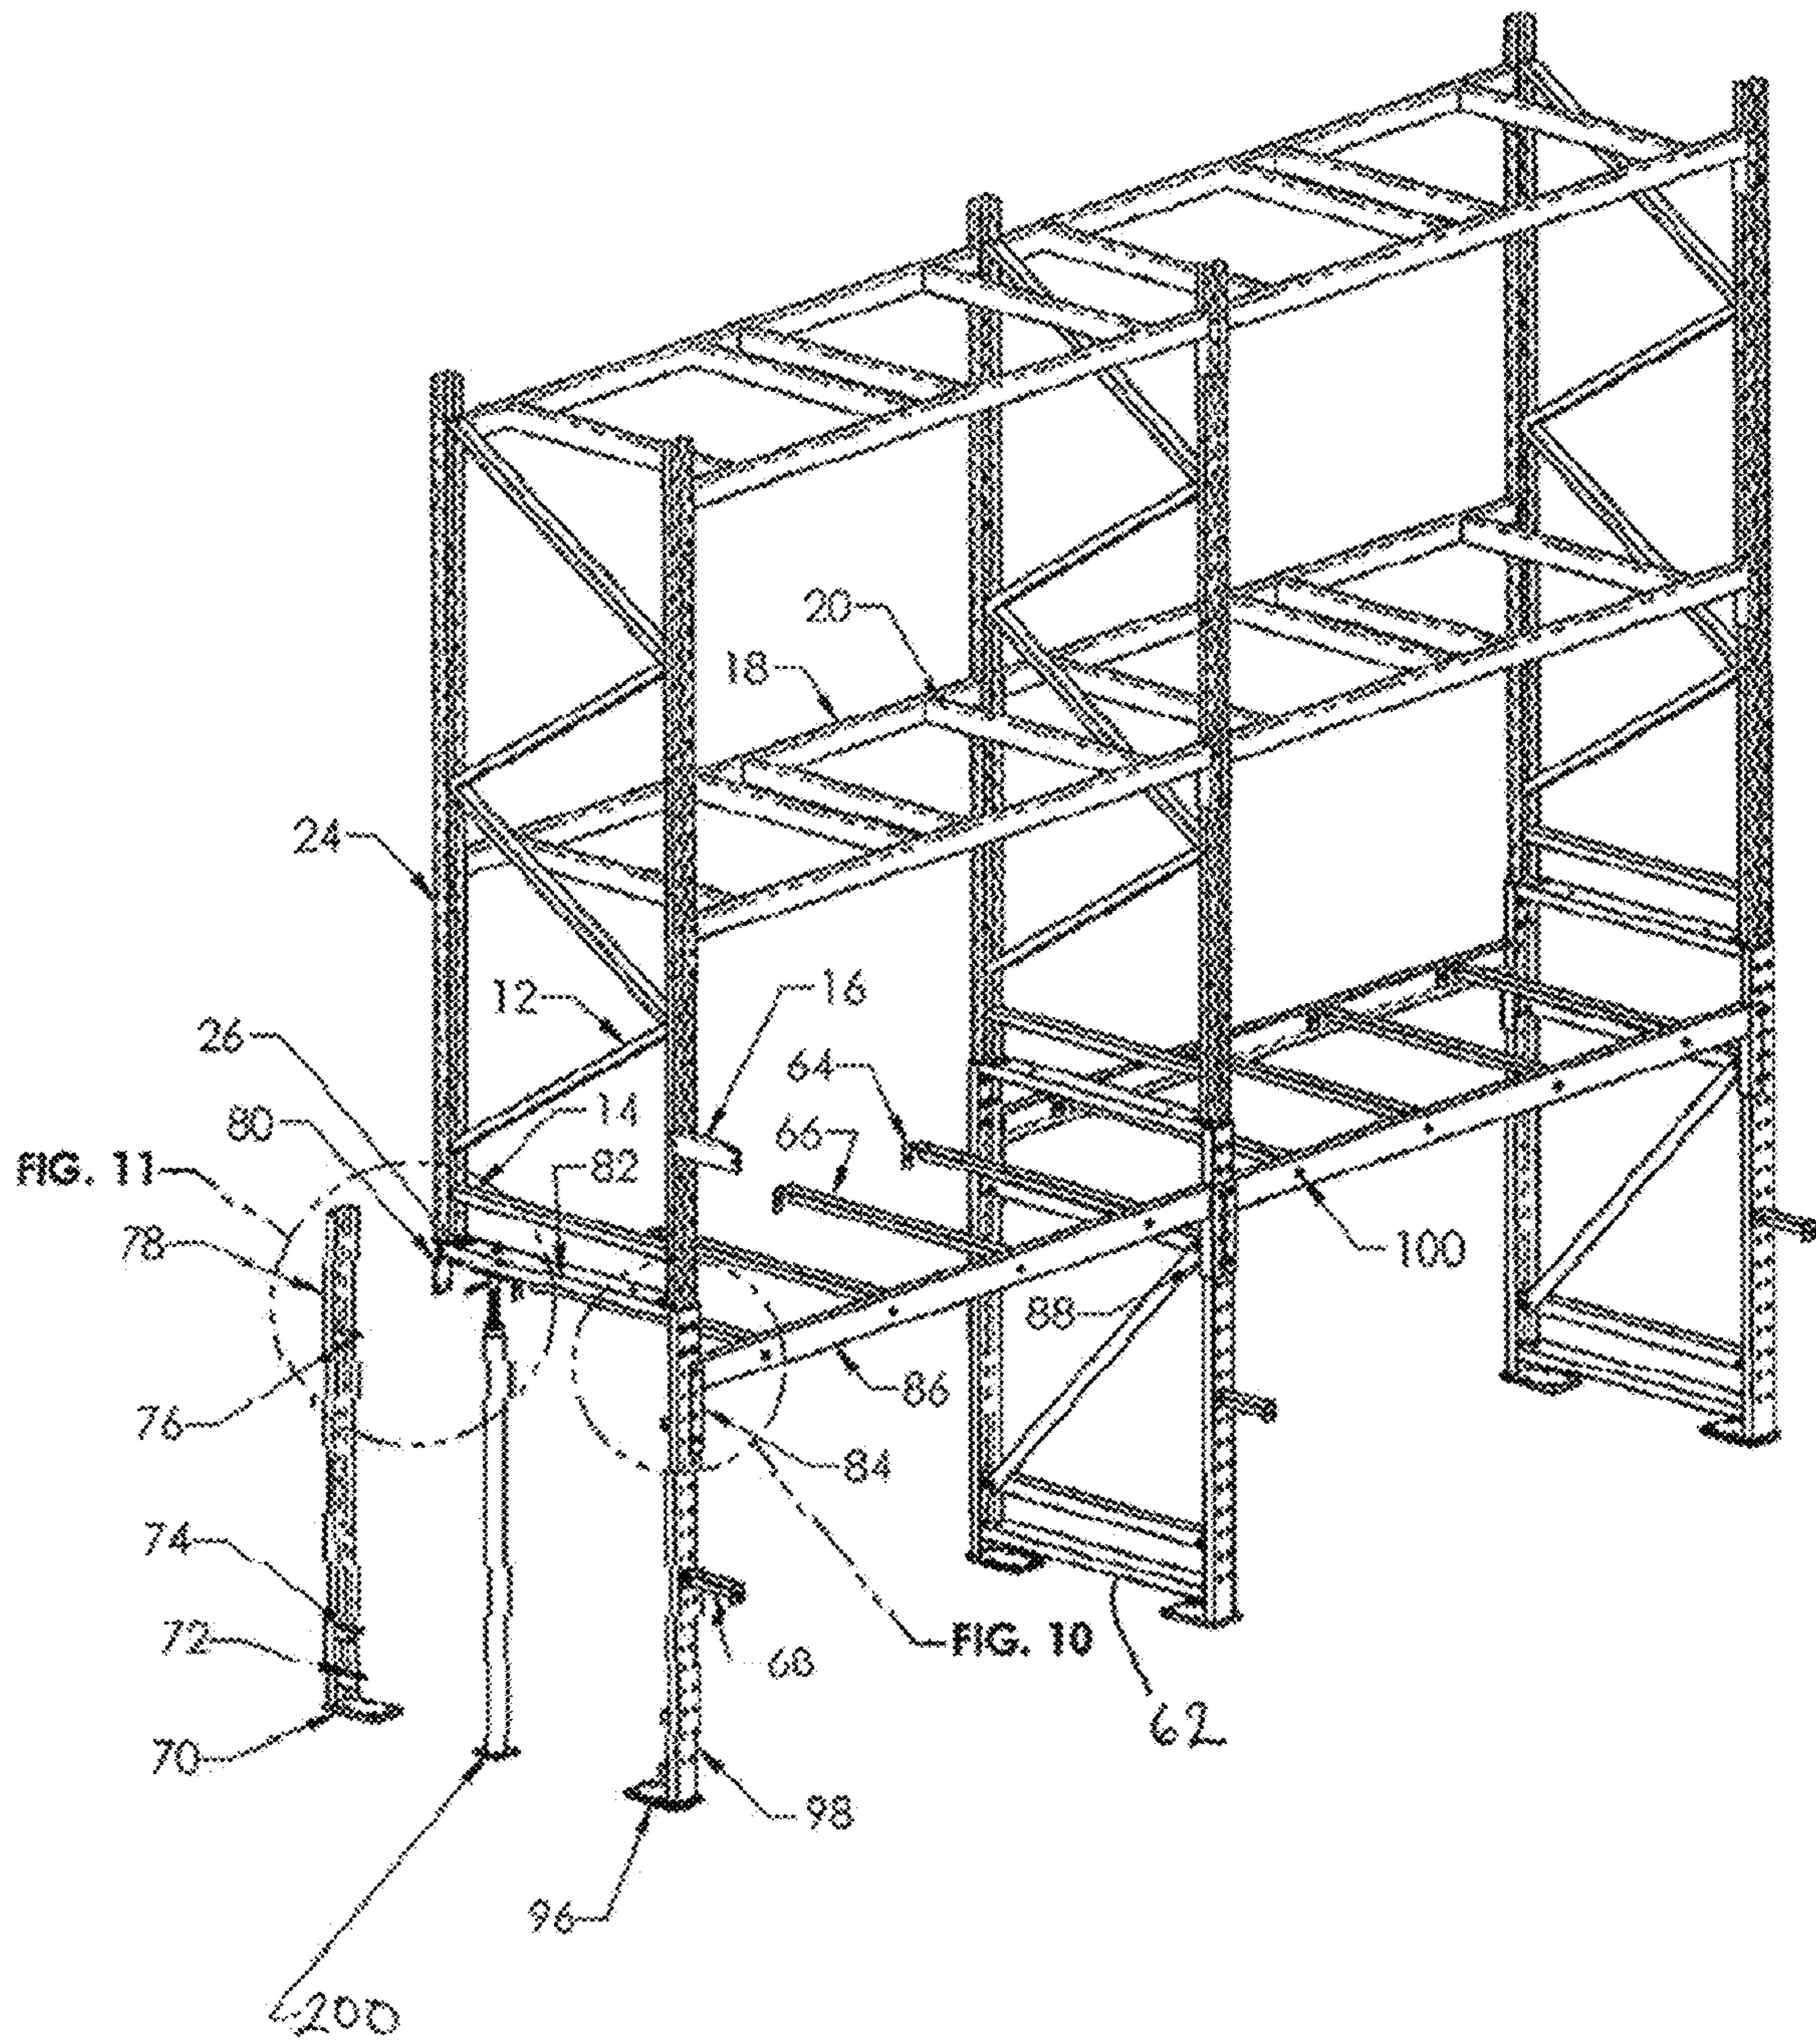
FIG. 9 is a side perspective view of the base being repaired while being supported by the load jack;

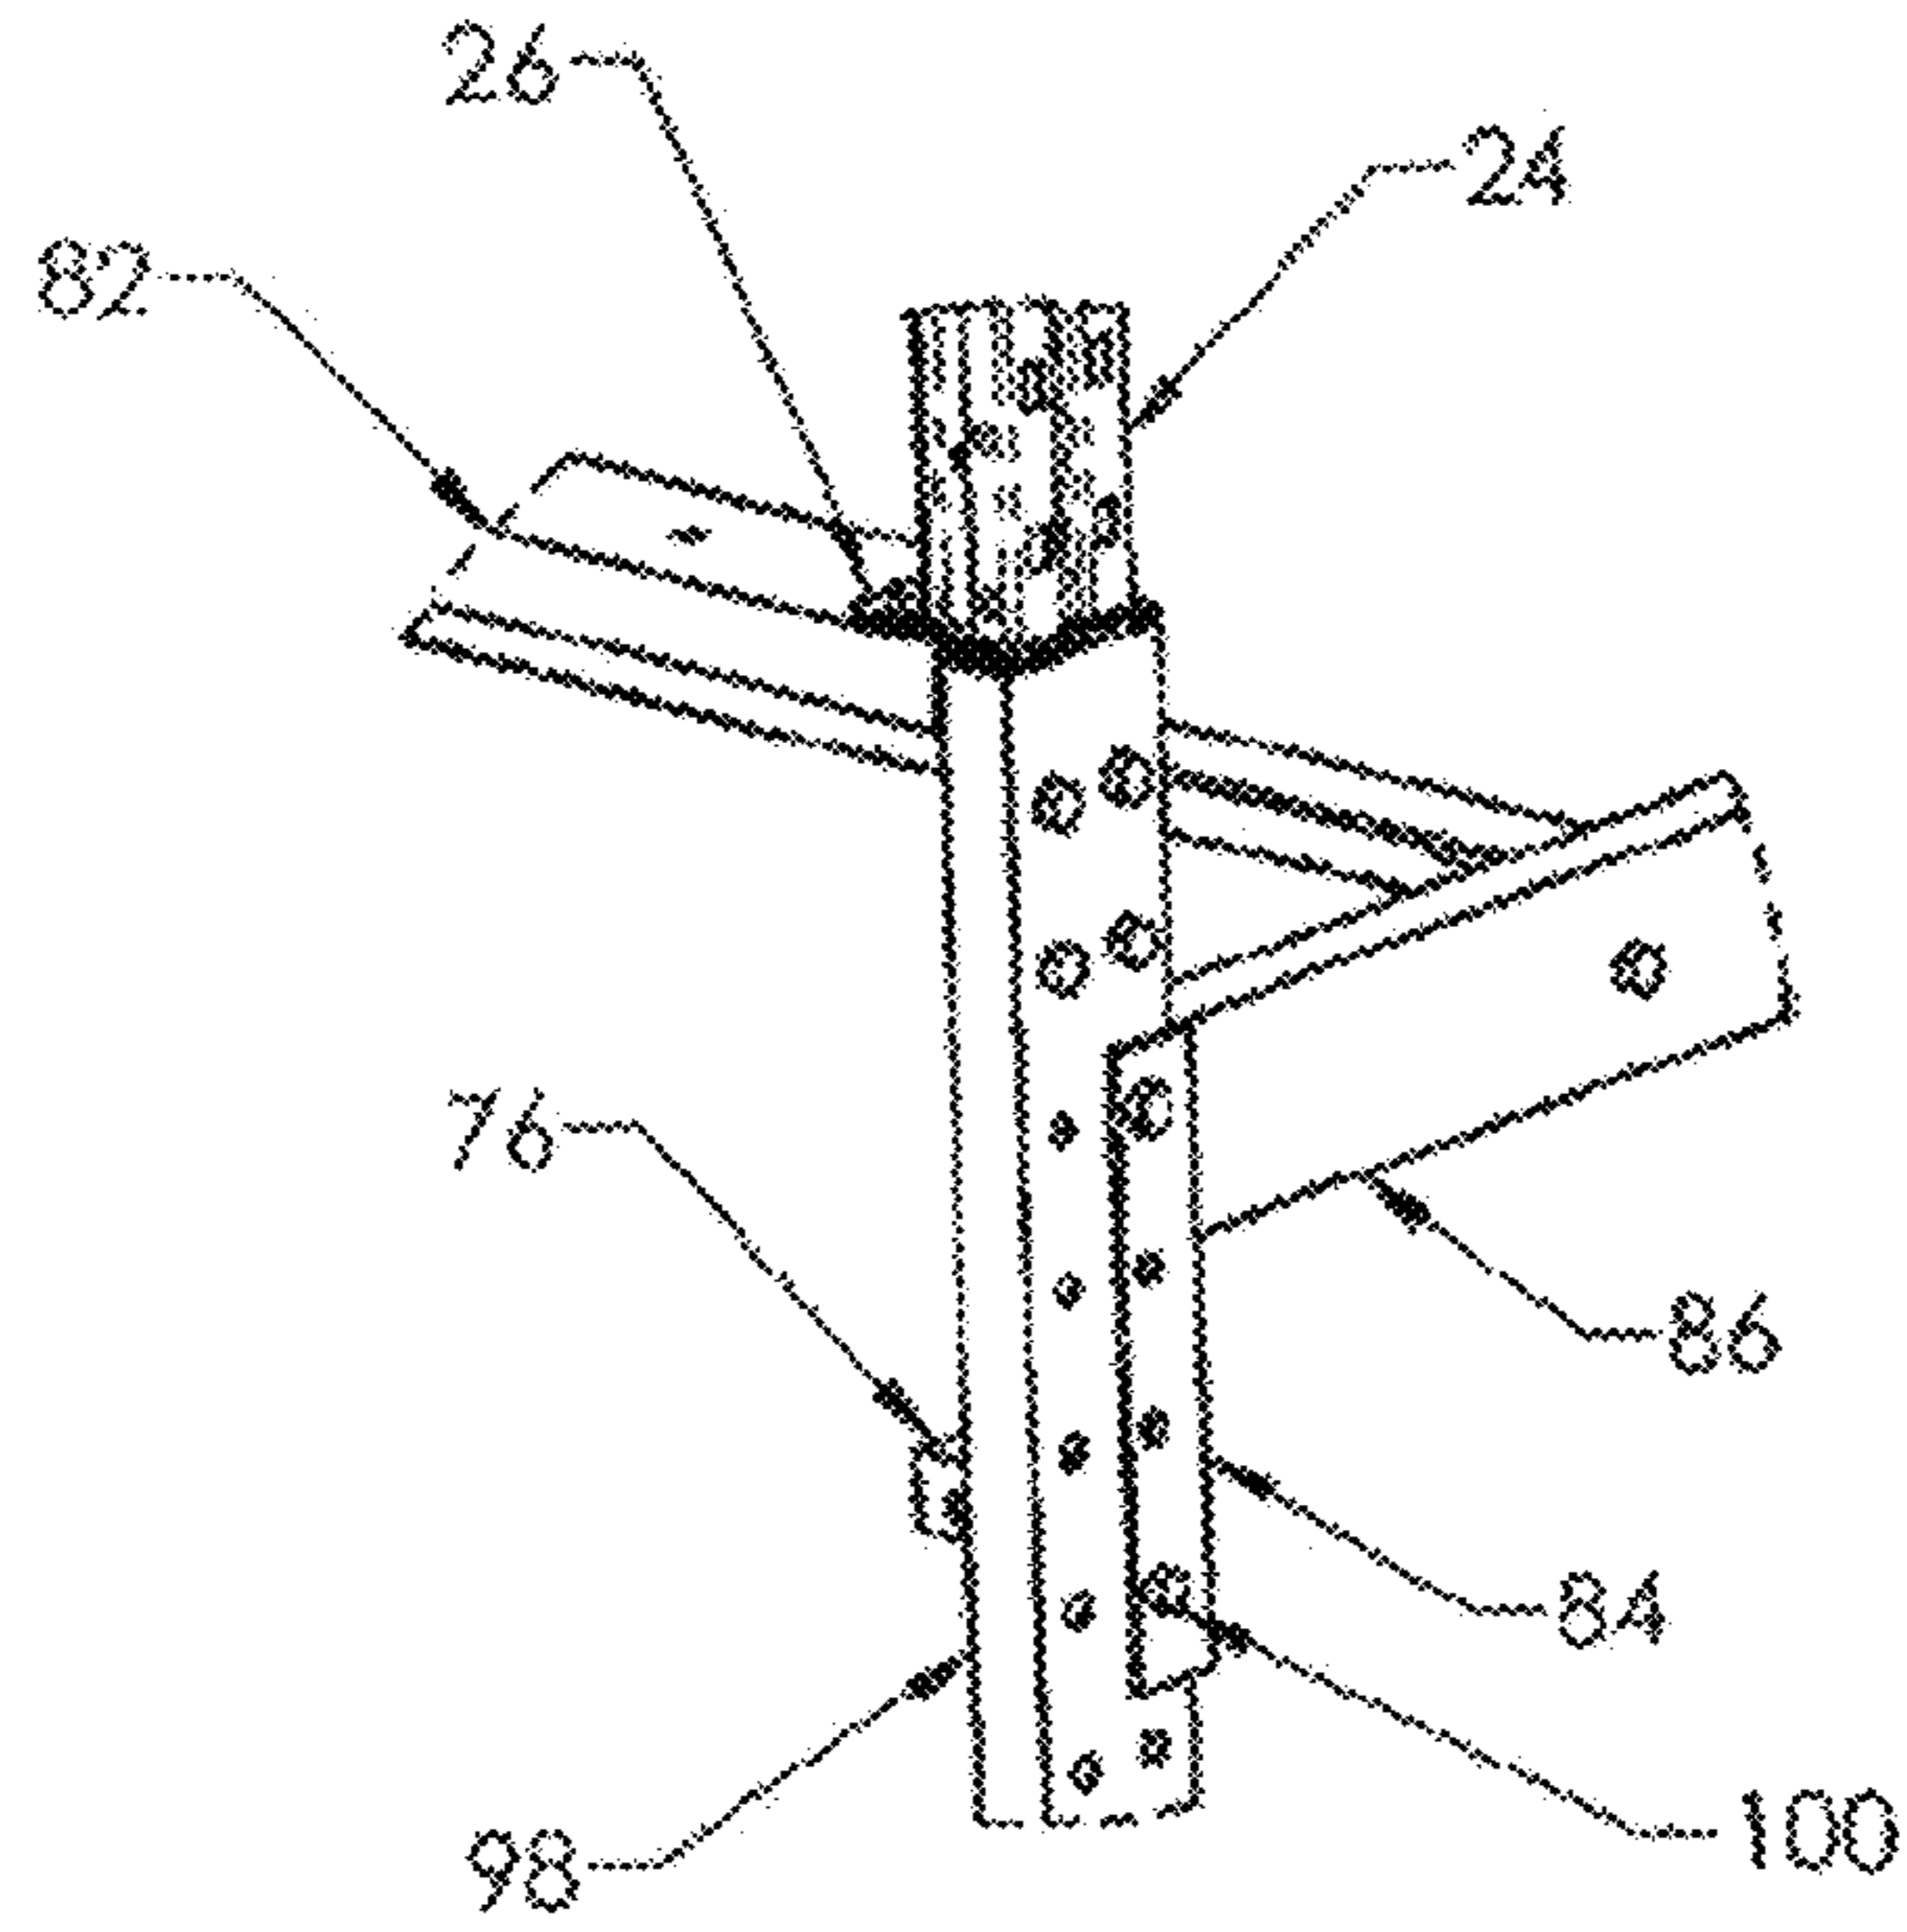
FIG. 10 is an enlarged perspective view of the encircled area 10 in FIG. 9 of the base and above upright connection;

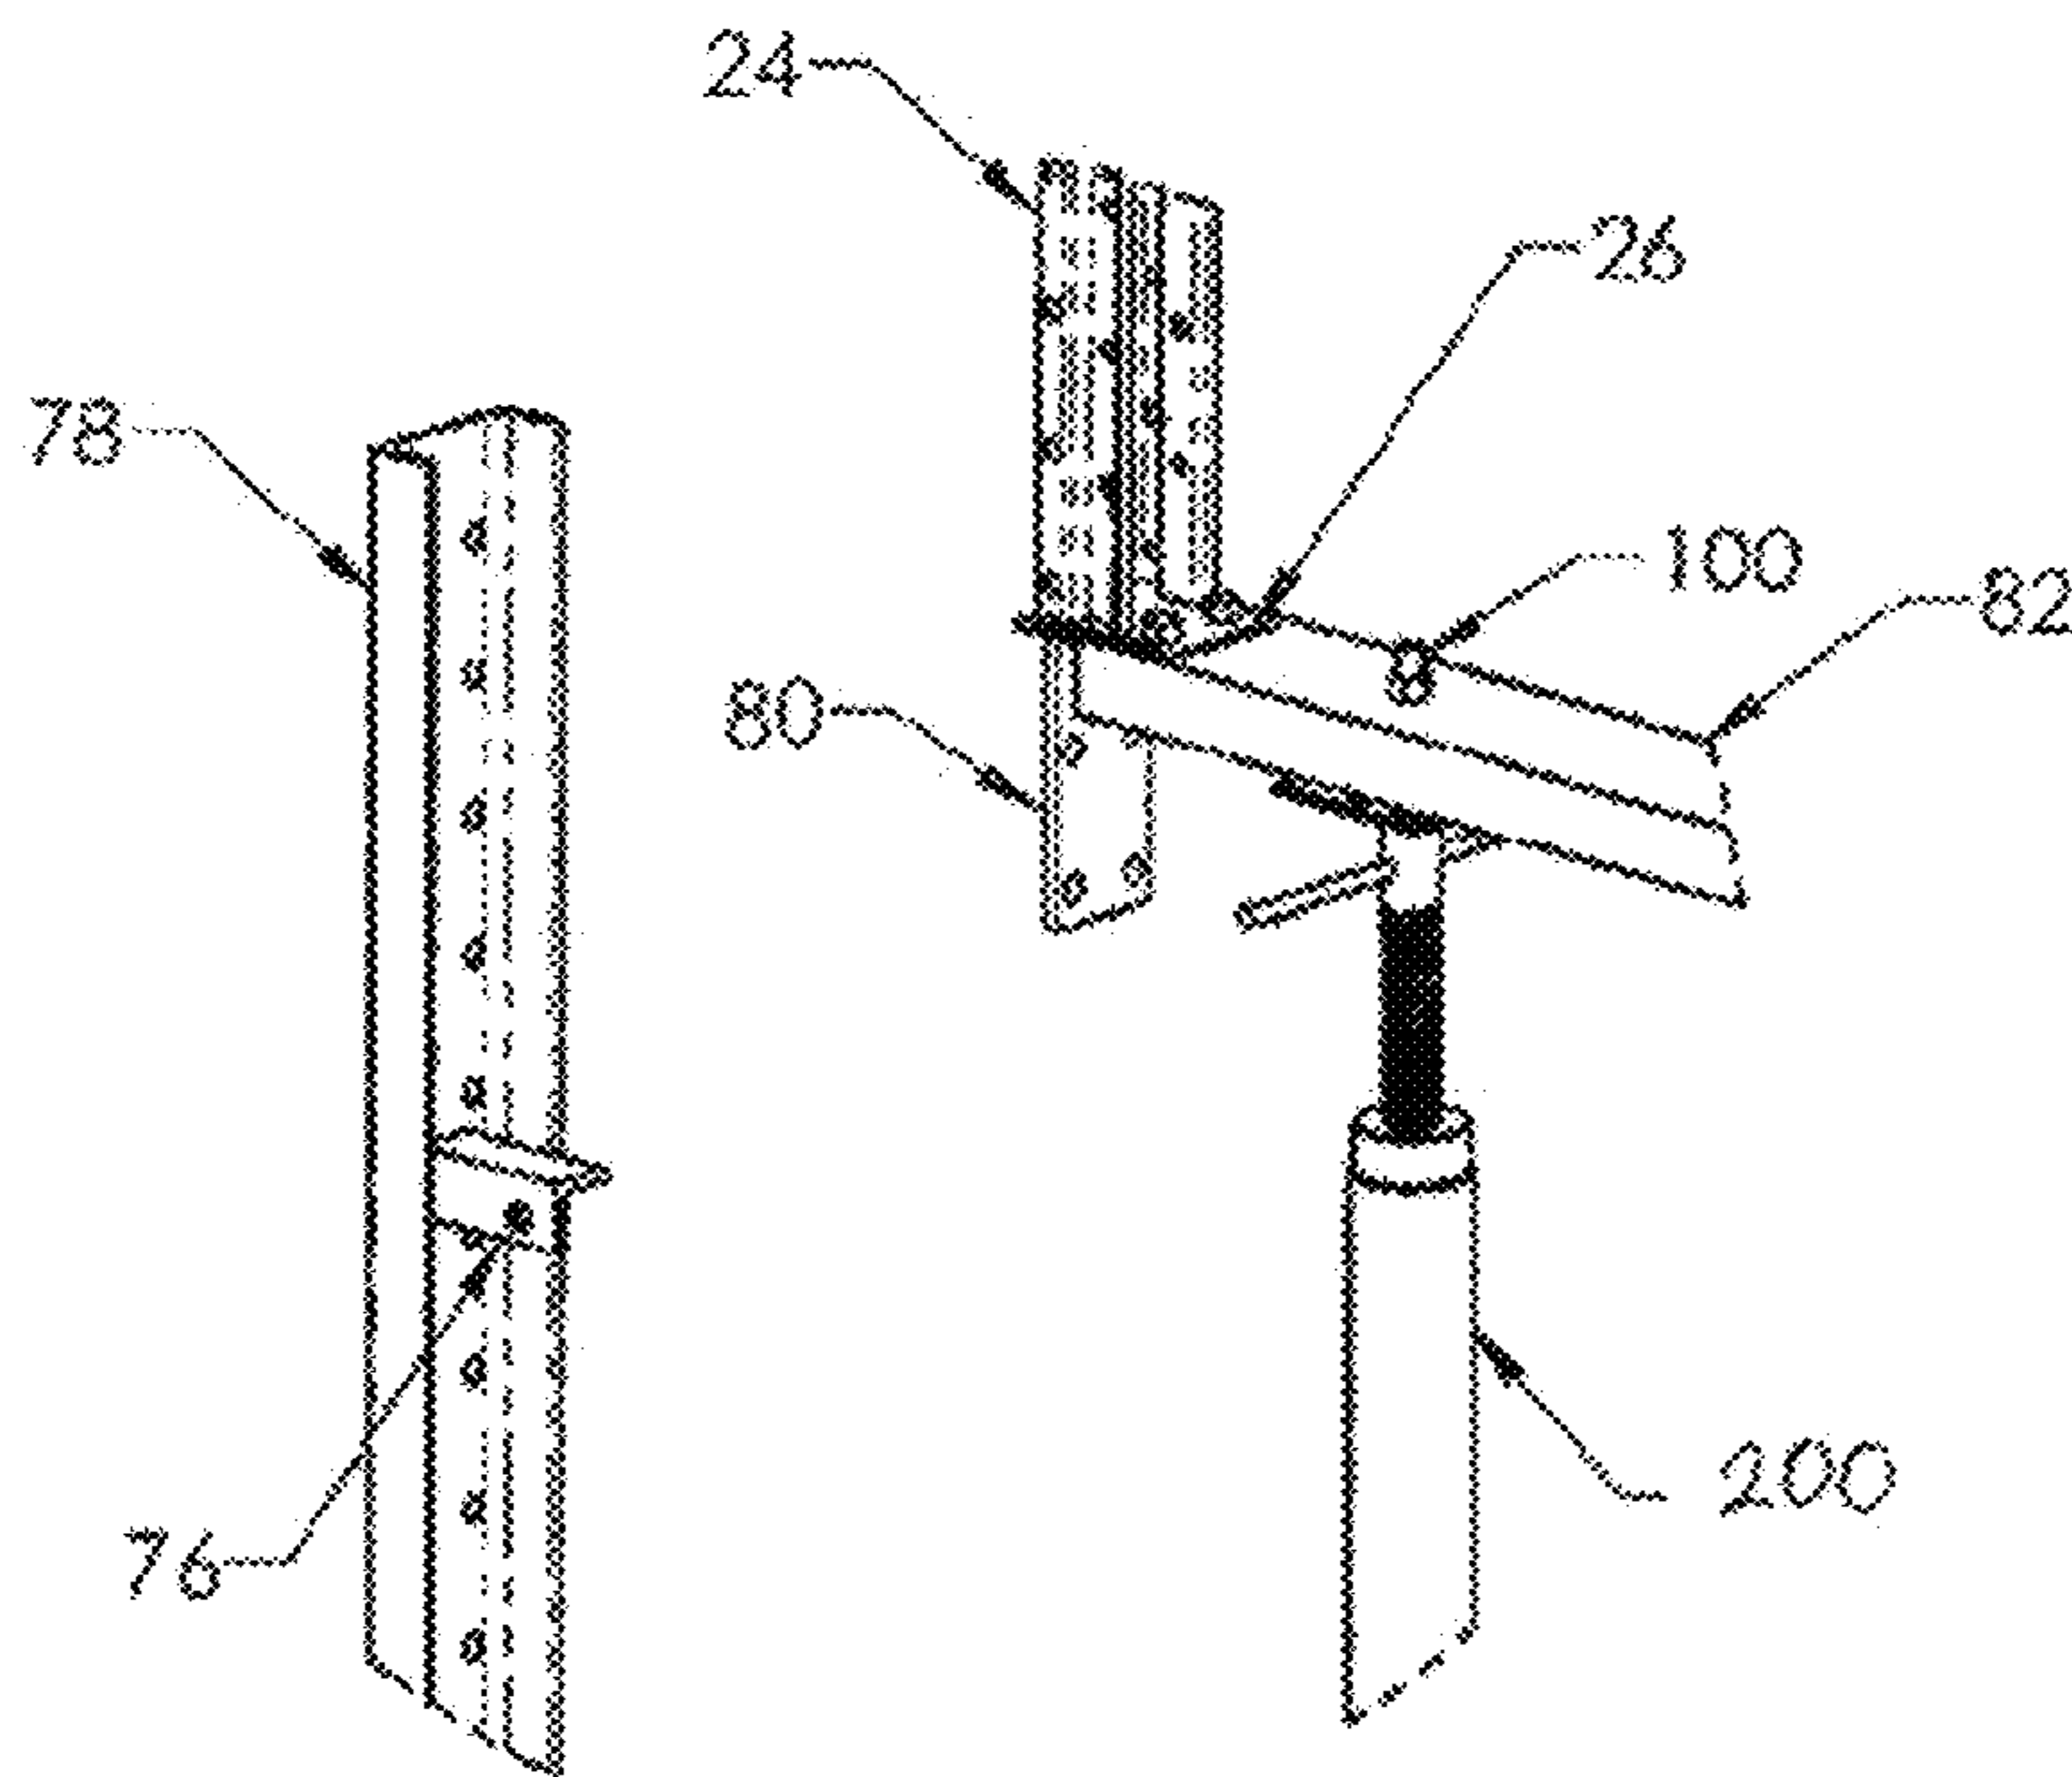
FIG. 11 is an enlarged perspective view of the encircled area 11 in FIG. 9 showing the base and above upright connections as well as a portion of the sub assemblies while under repair;

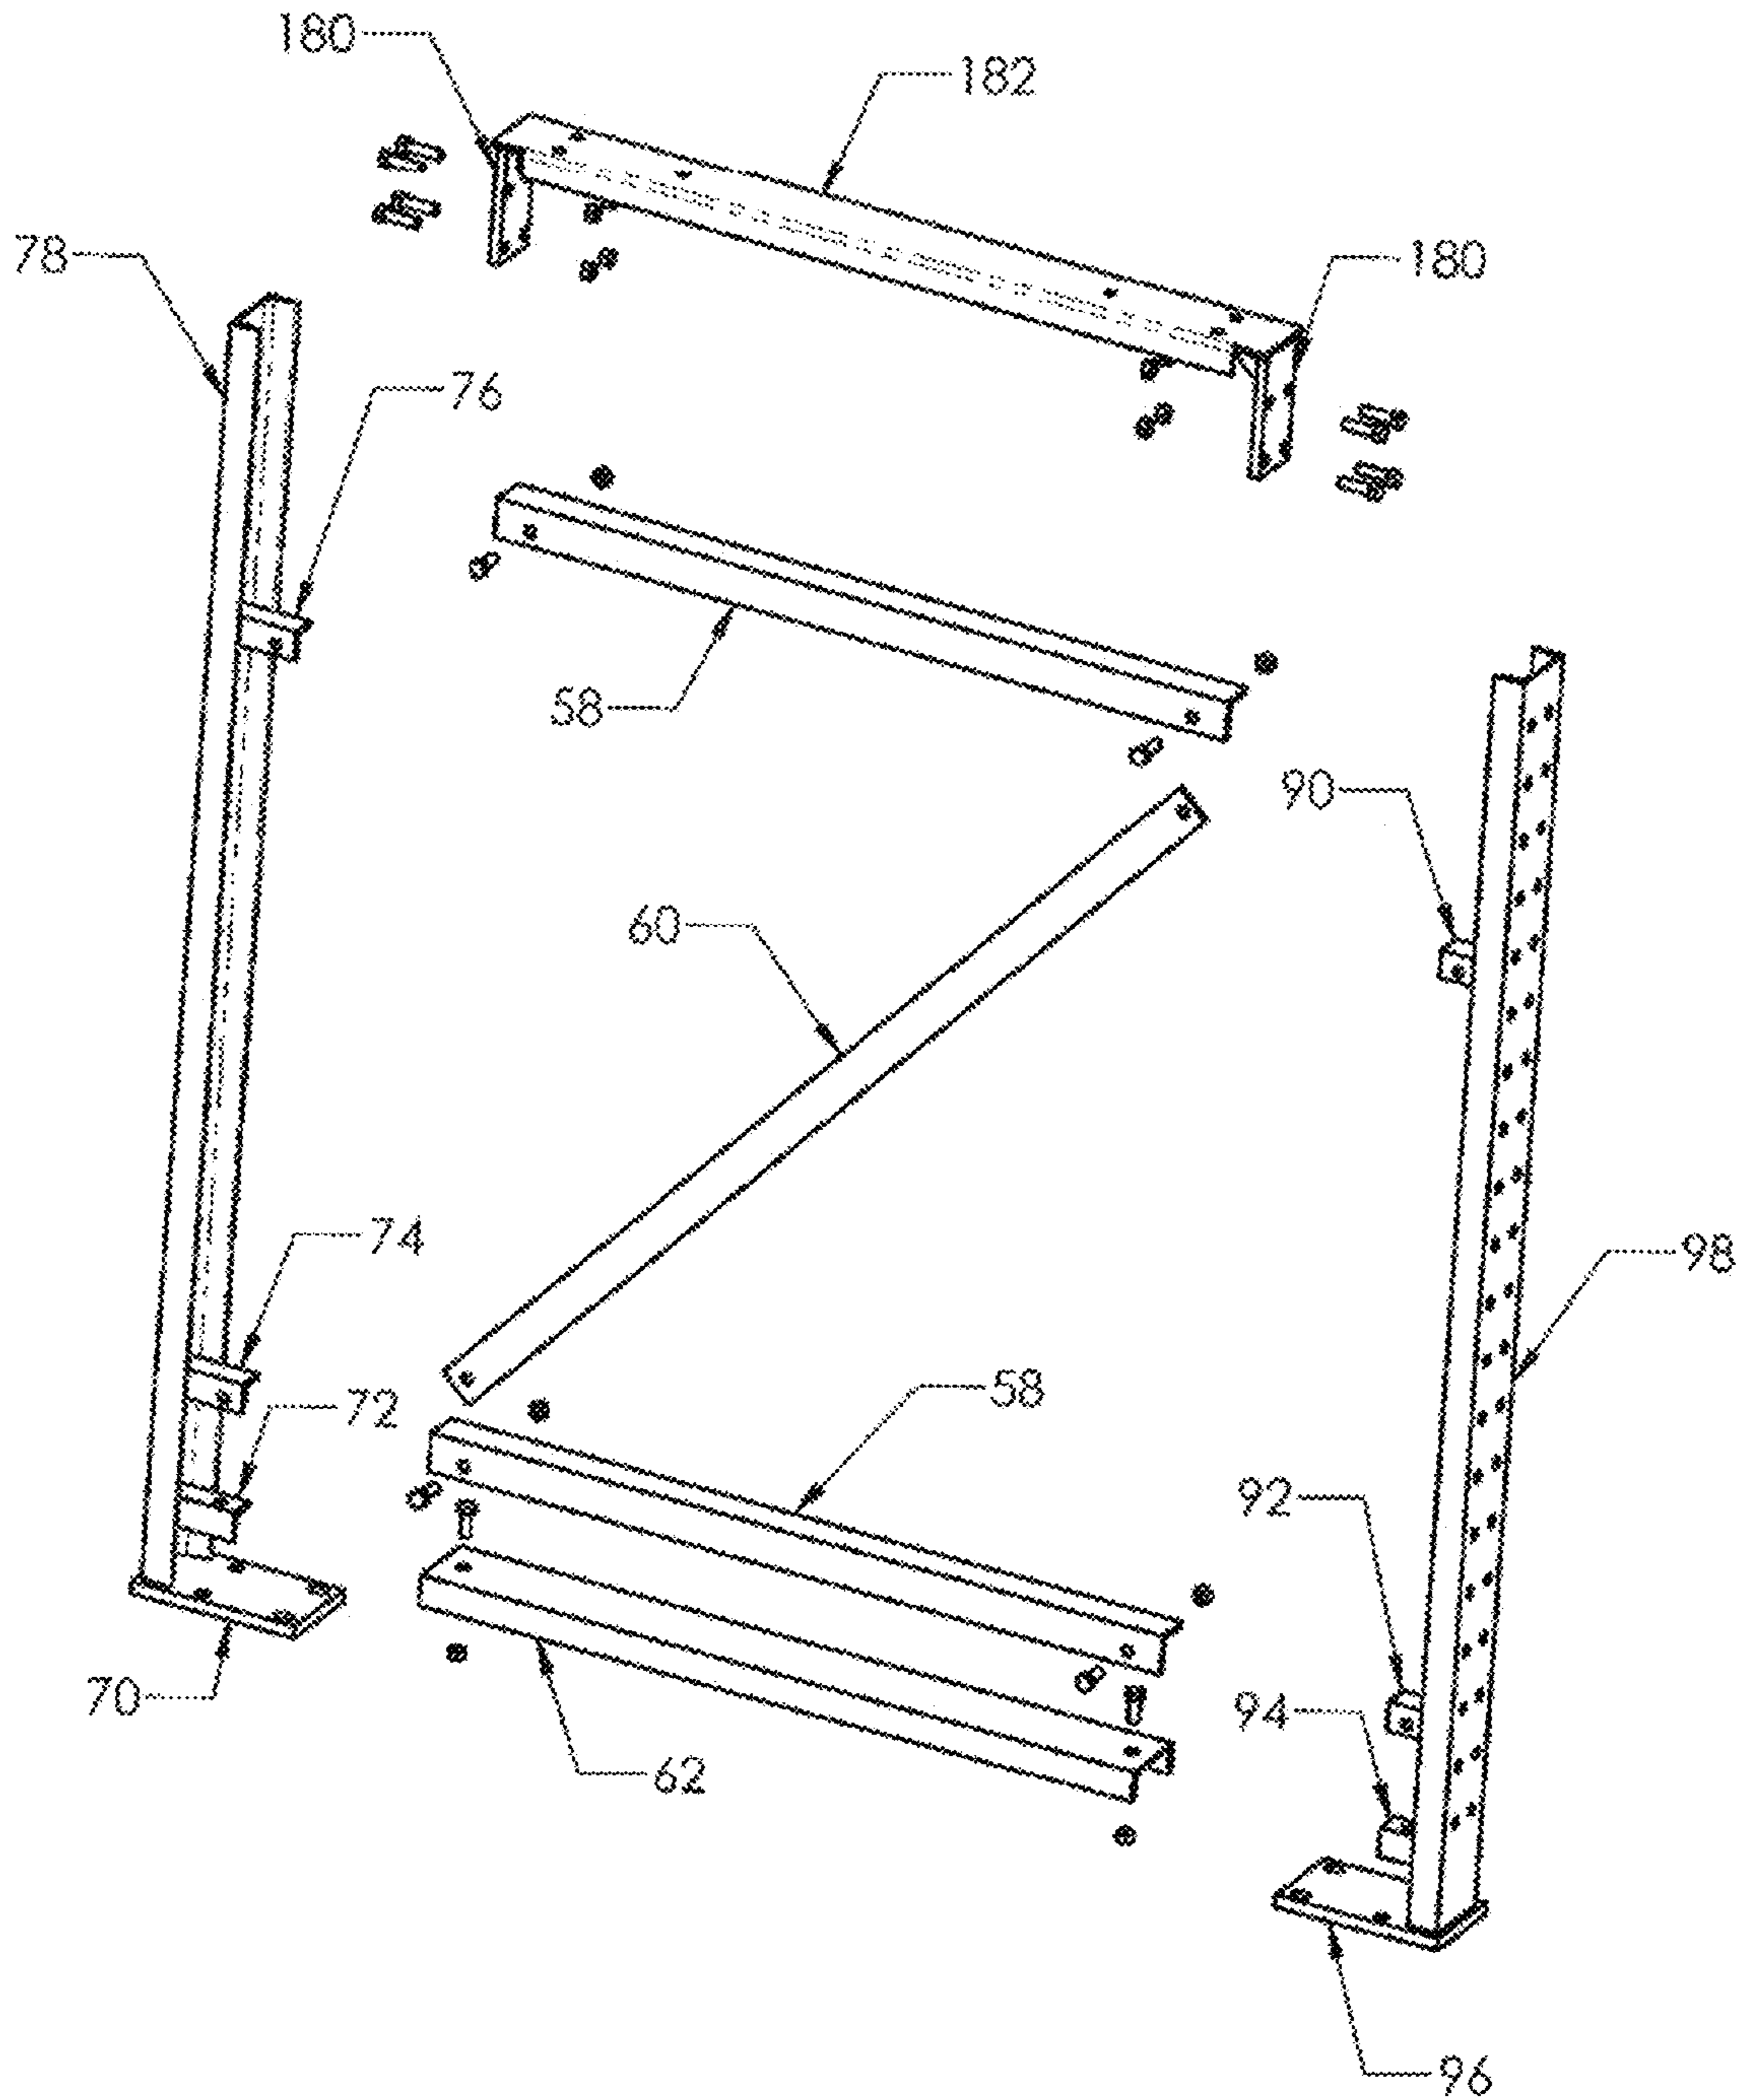
FIG. 12 is a side perspective view of the dismantled base of an alternate embodiment of the storage system; and

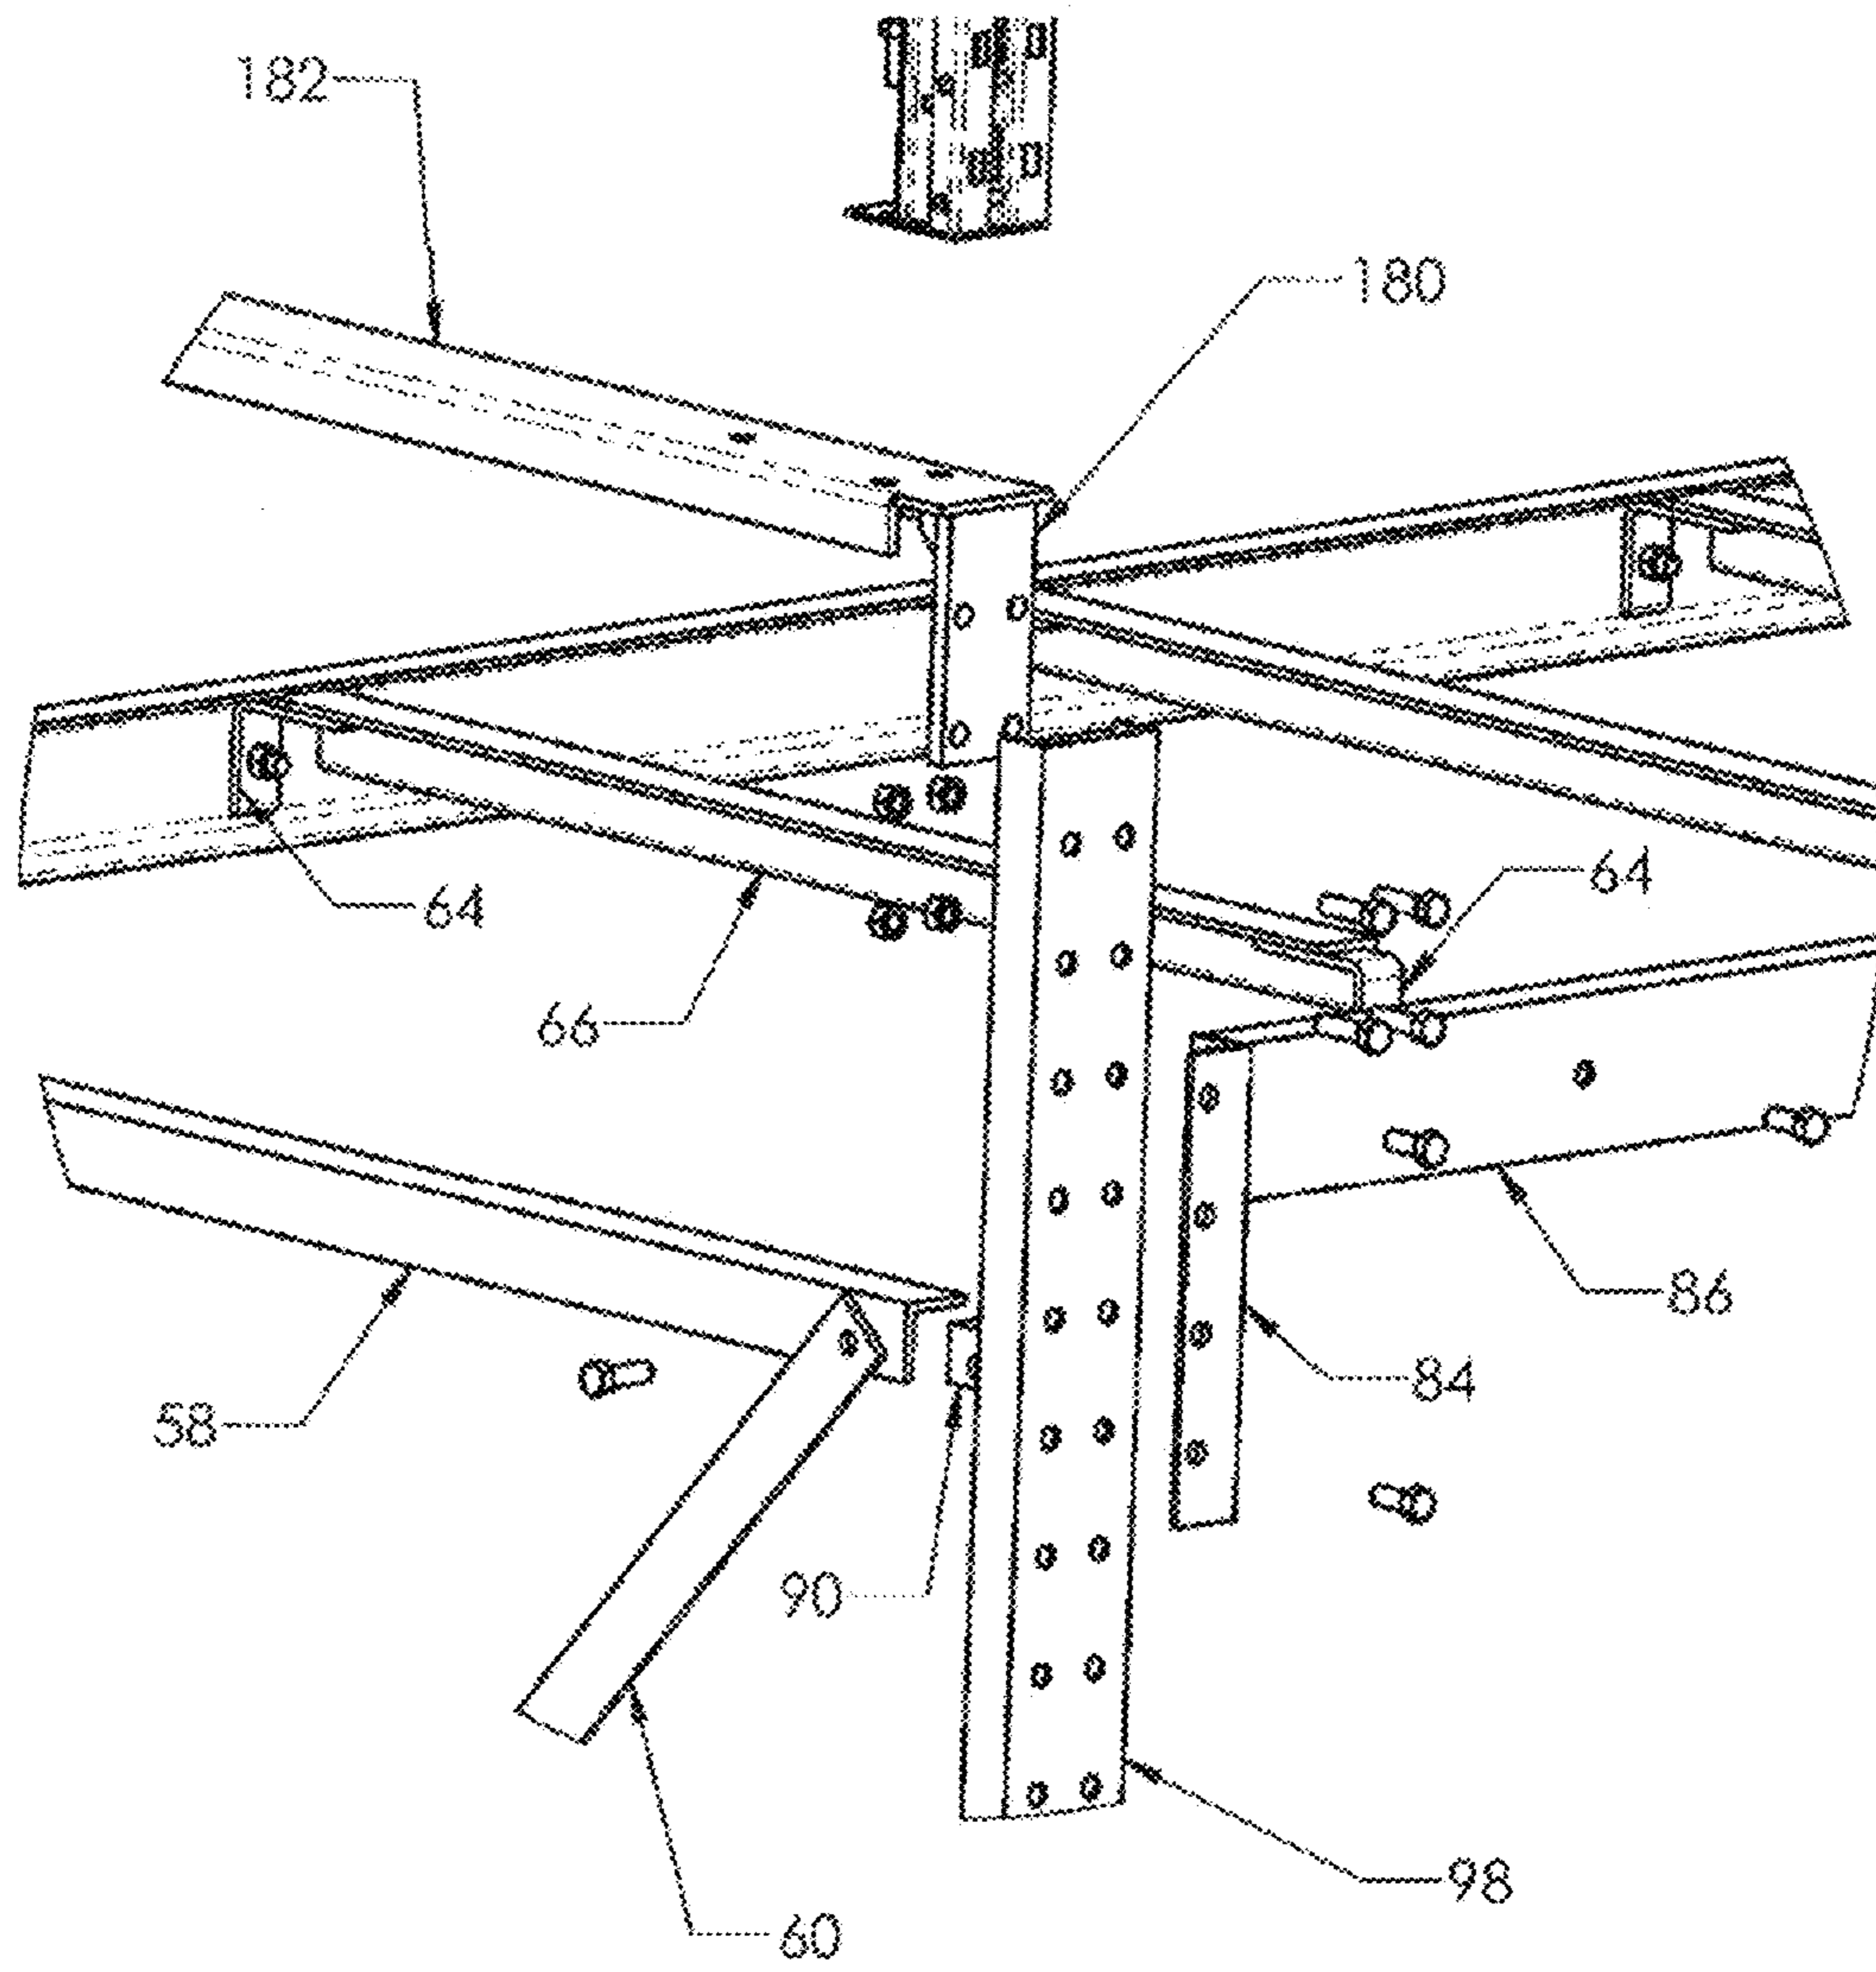
FIG. 13 is an exploded side perspective view of the upper right portion of the base showing an enhanced connection detail.
