(54) **METHOD FOR REPAIRING IN-SITU INSTALLATIONS INSIDE A COMPRESSOR REAR FRAME CASE OF A GAS TURBINE**

A method for repairing in-situ an oil manifold of the aft end bearing assembly of a gas turbine is provided that is cost-efficient, effective and dramatically reduces the costs for repair of a leaking oil manifold.

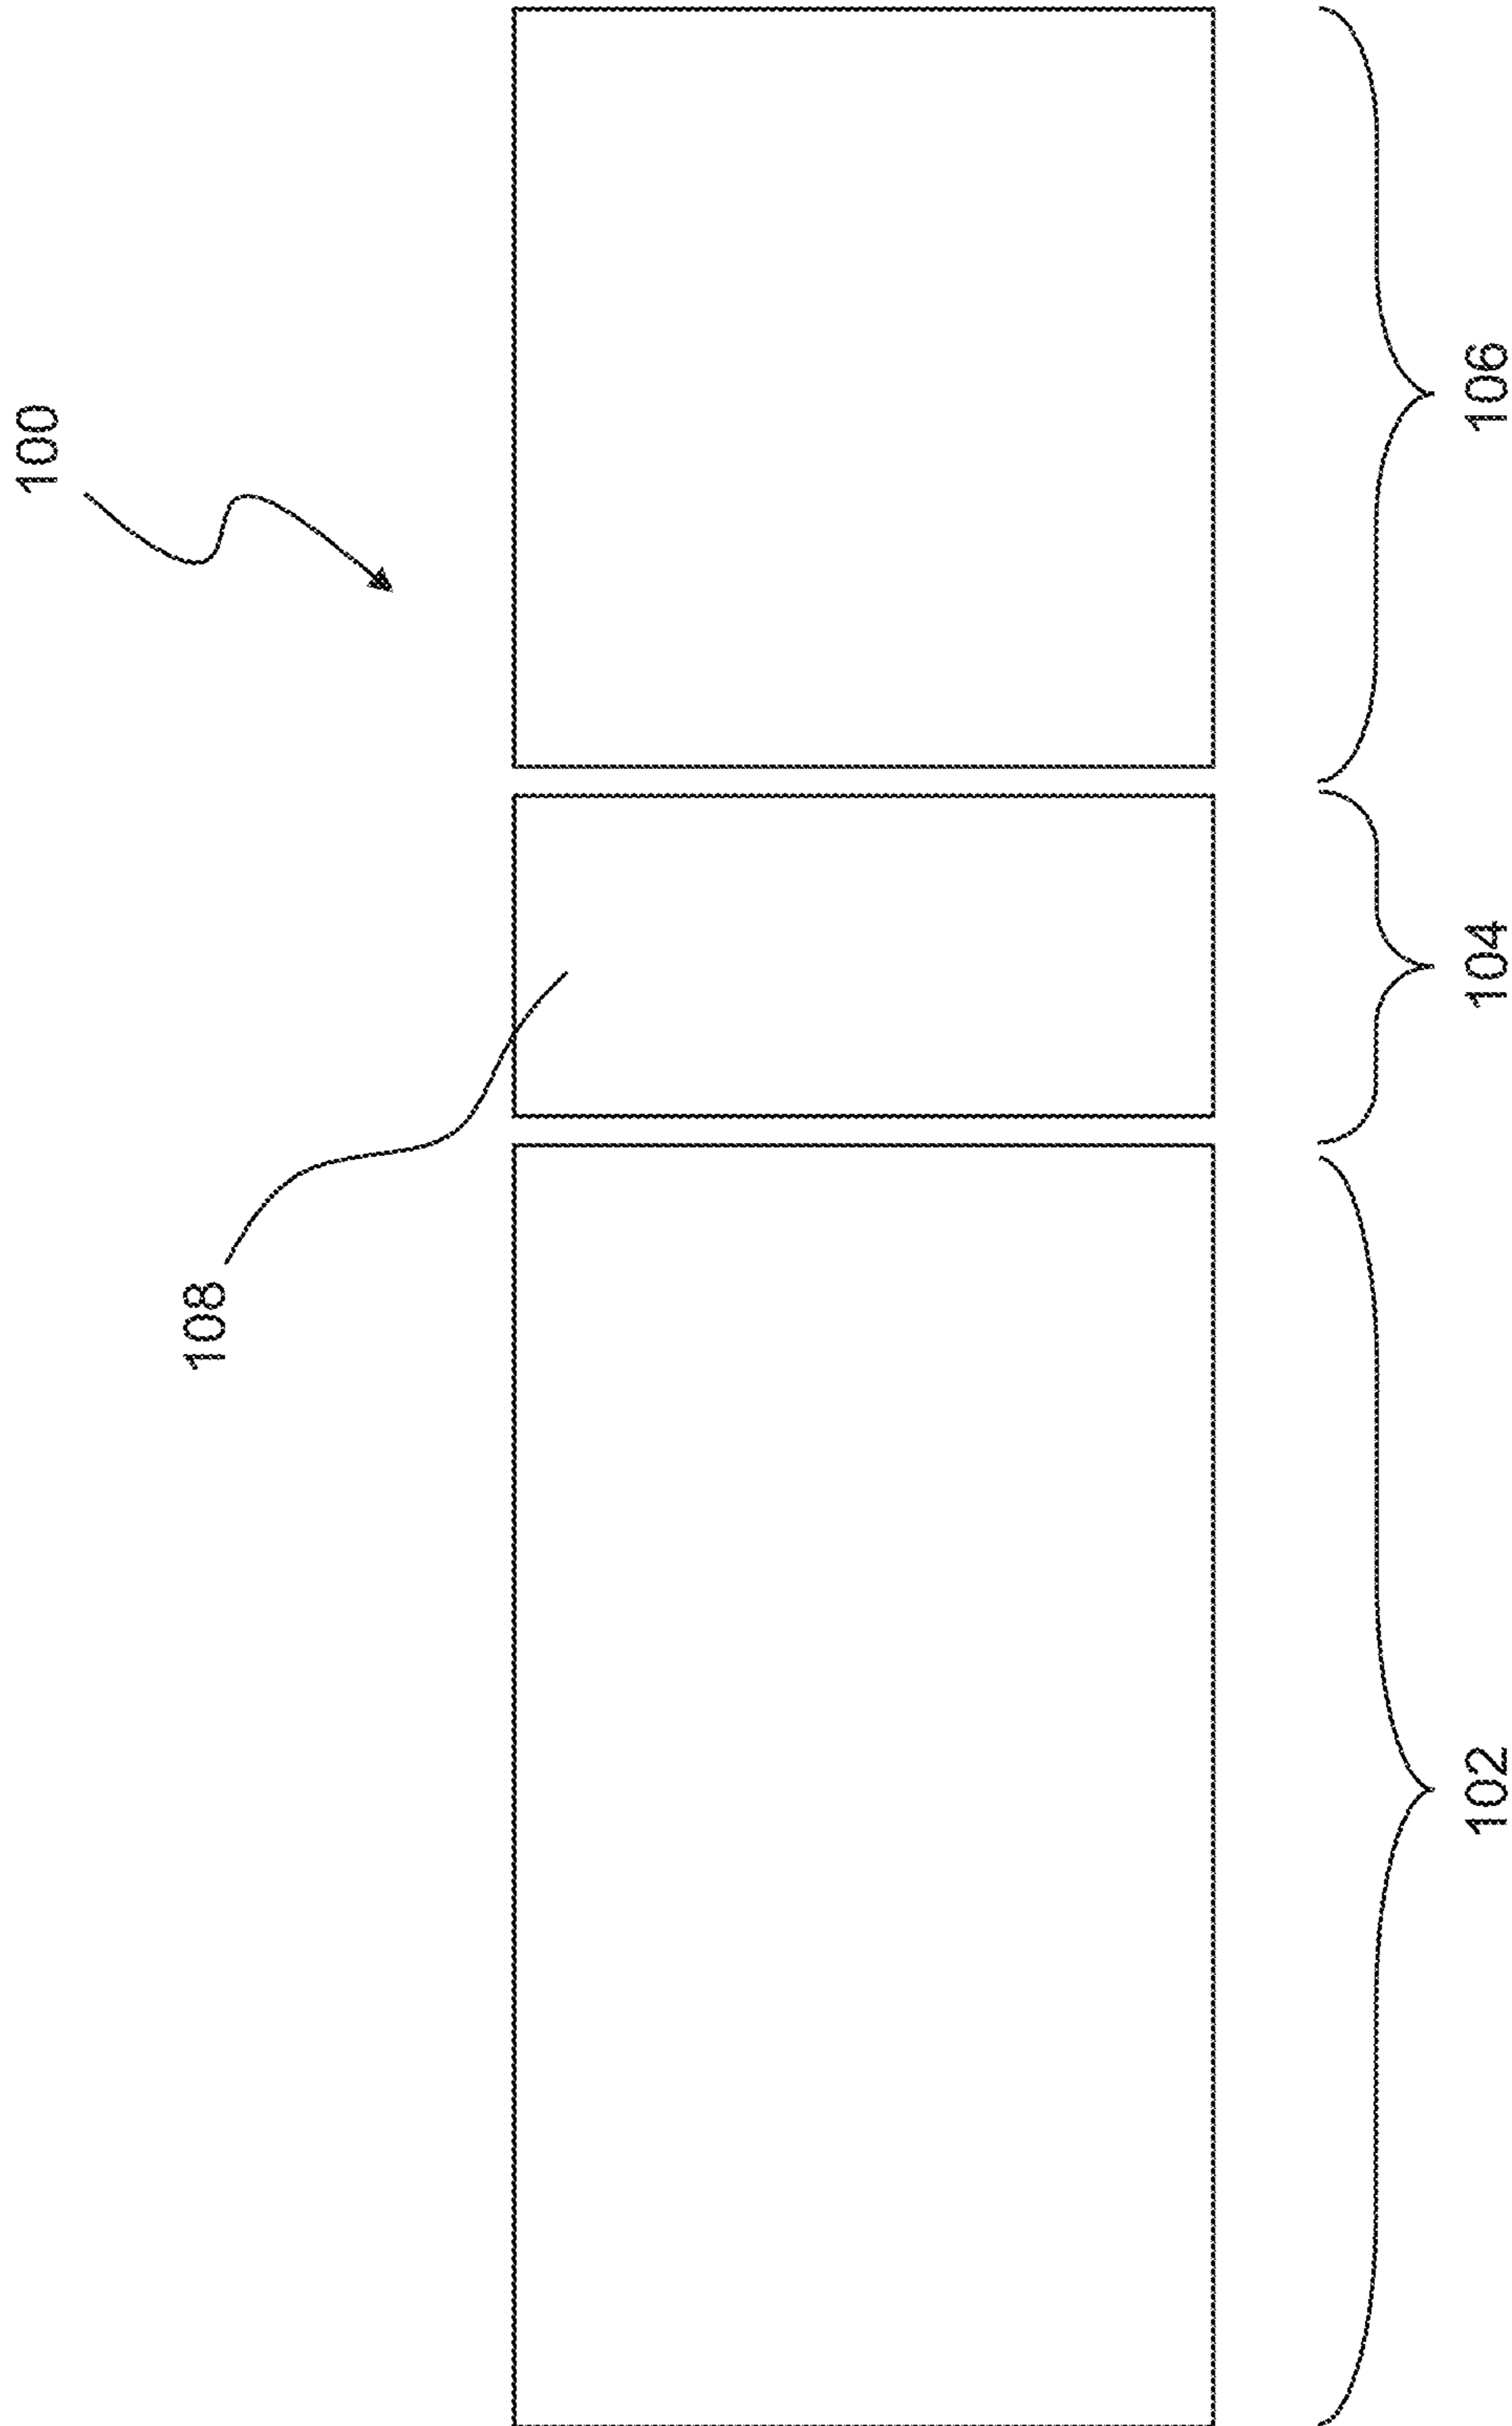
Fig. 1

FIG. 1 is a schematic illustration of a gas turbine,

FIG. 1 shows in a schematic way the arrangement of the main components of a gas turbine 100. The major sub-assemblies of the gas turbine 100 are a compressor 102, a combustor 104 and a turbine 106. The compressor 102 may comprise a low pressure compressor LPC and a high pressure compressor HPC. For example, the low pressure compressor LPC may comprise 5 (five) stages and the high pressure compressor LPC may comprise 14 stages. The combustor 104 is located inside a compressor rear frame case 108 and between the compressor 102 and the turbine 106.

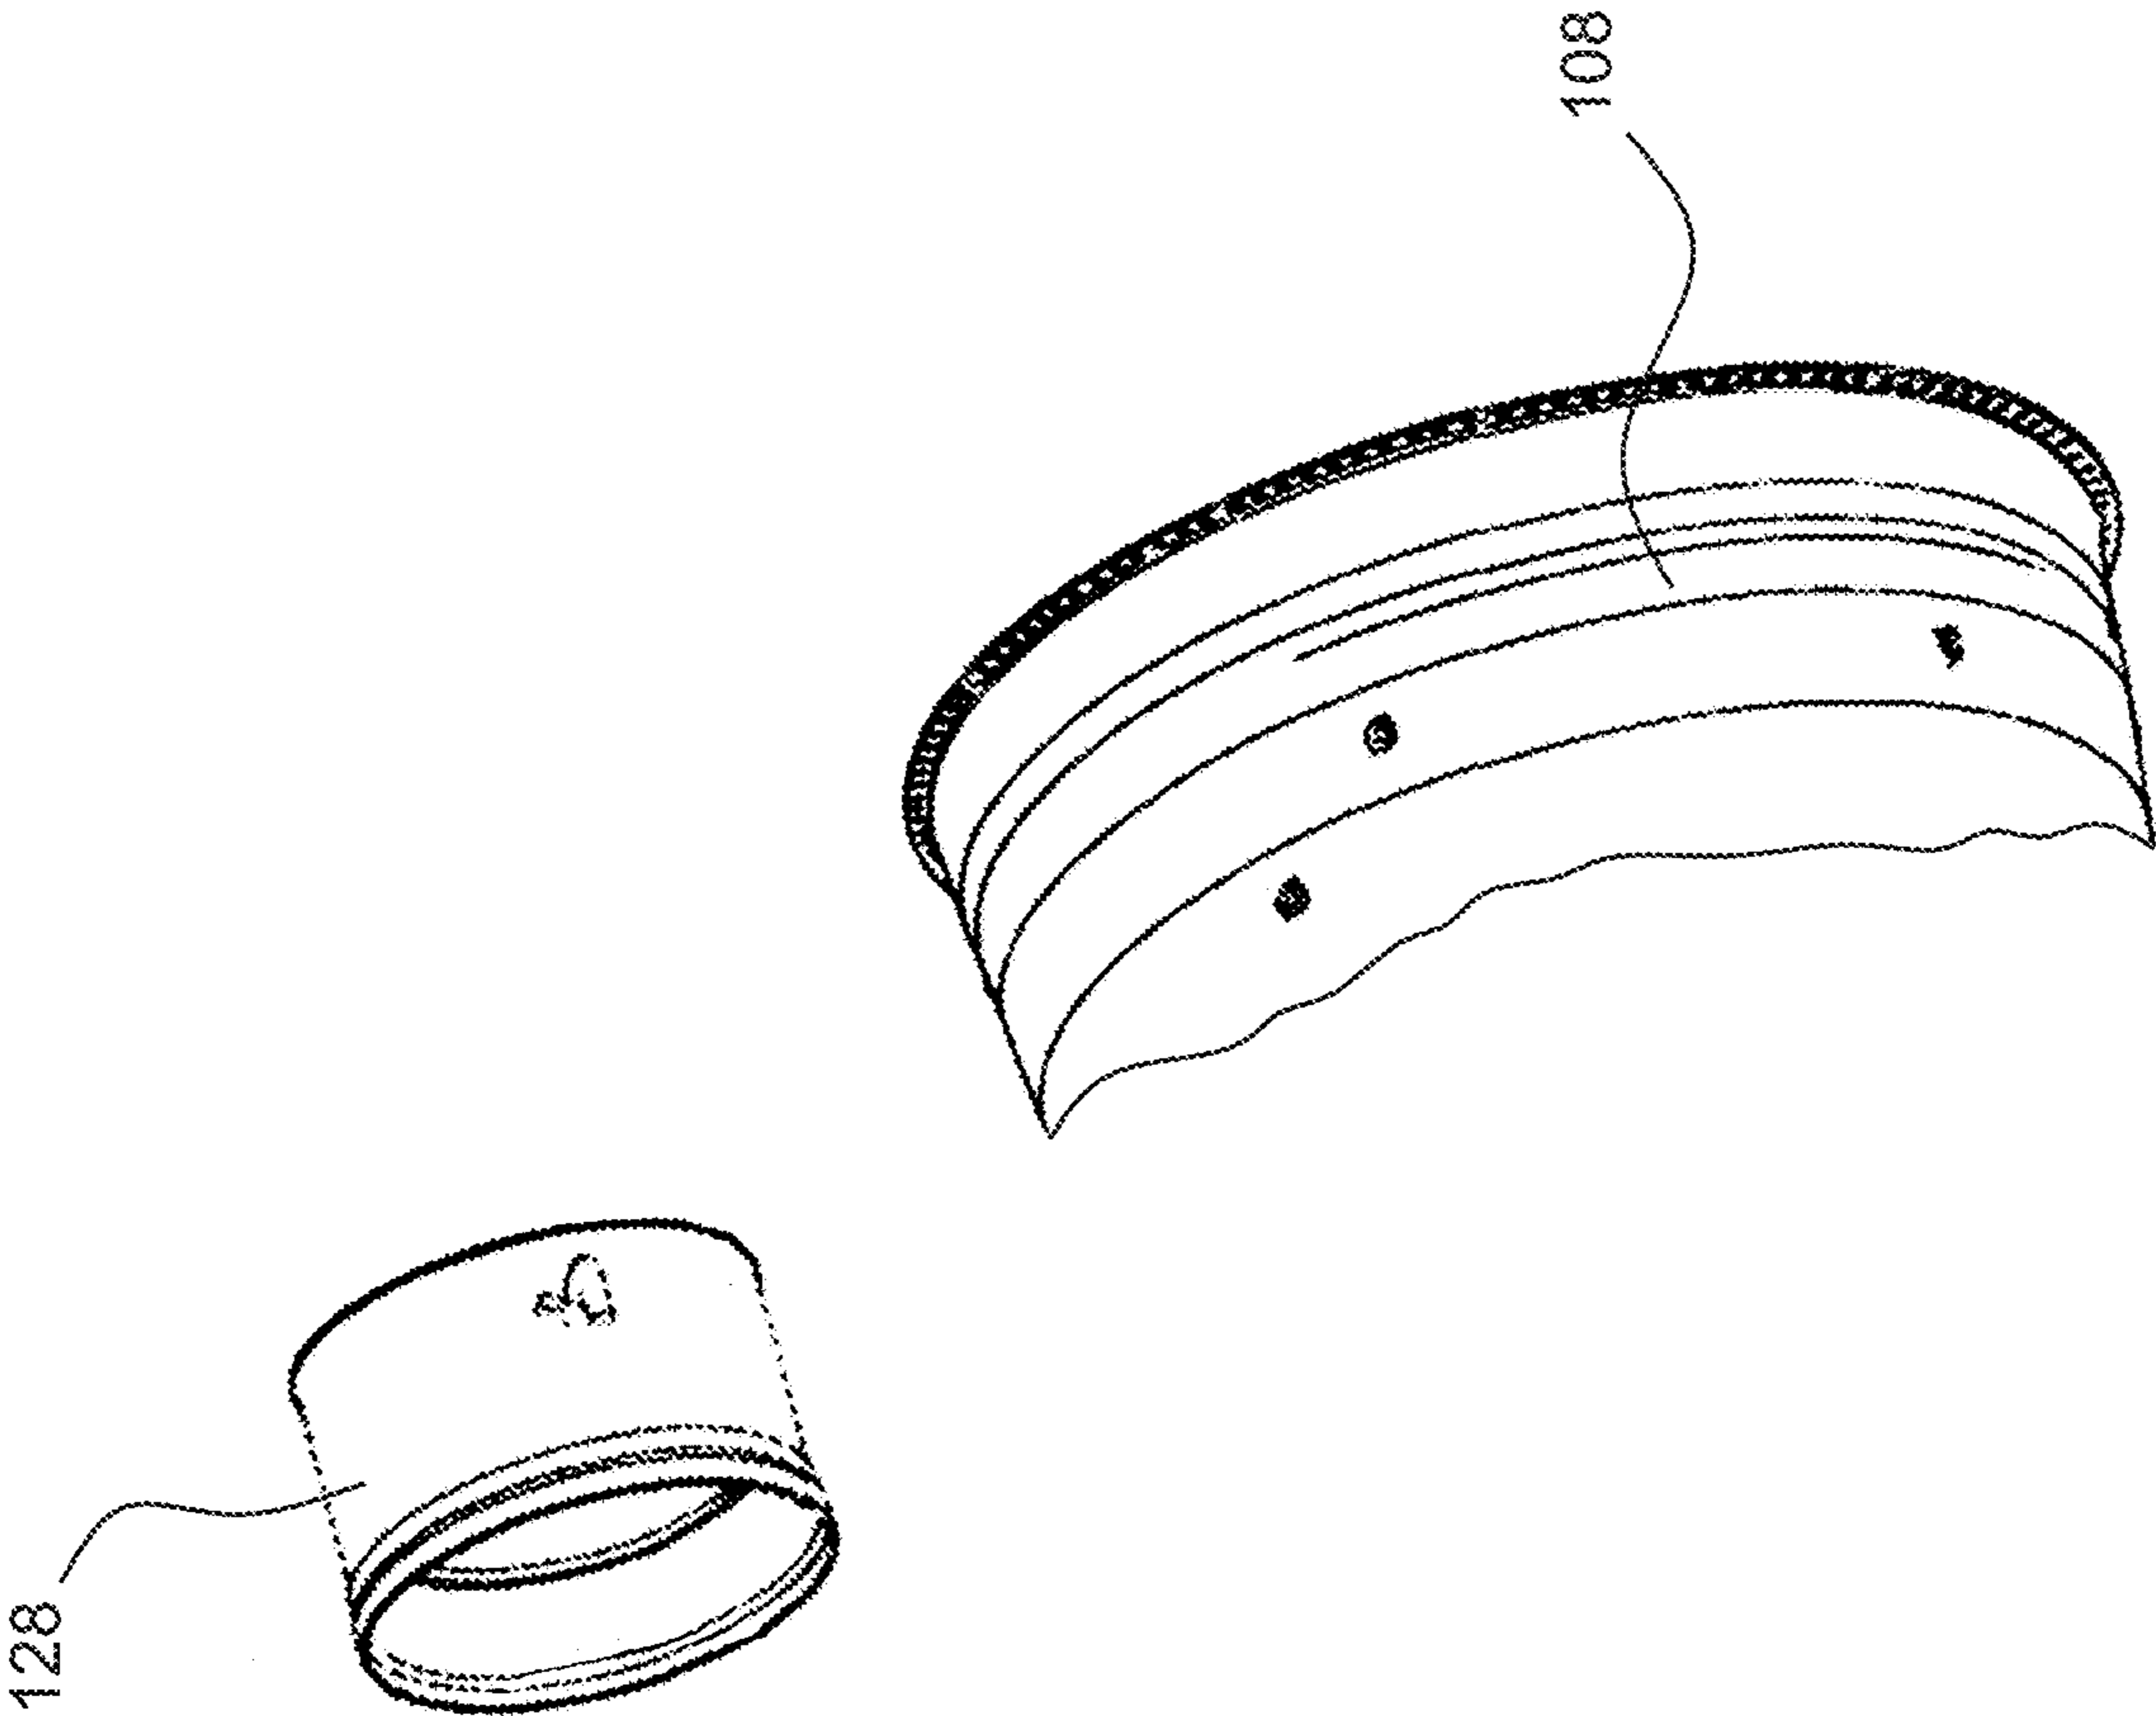
Fig. 2

FIG. 2 illustrates a simplified exploded view of the compressor rear frame case,

FIG. 2 illustrates in an exploded view the CRF case 108 and an aft sump assembly 128.

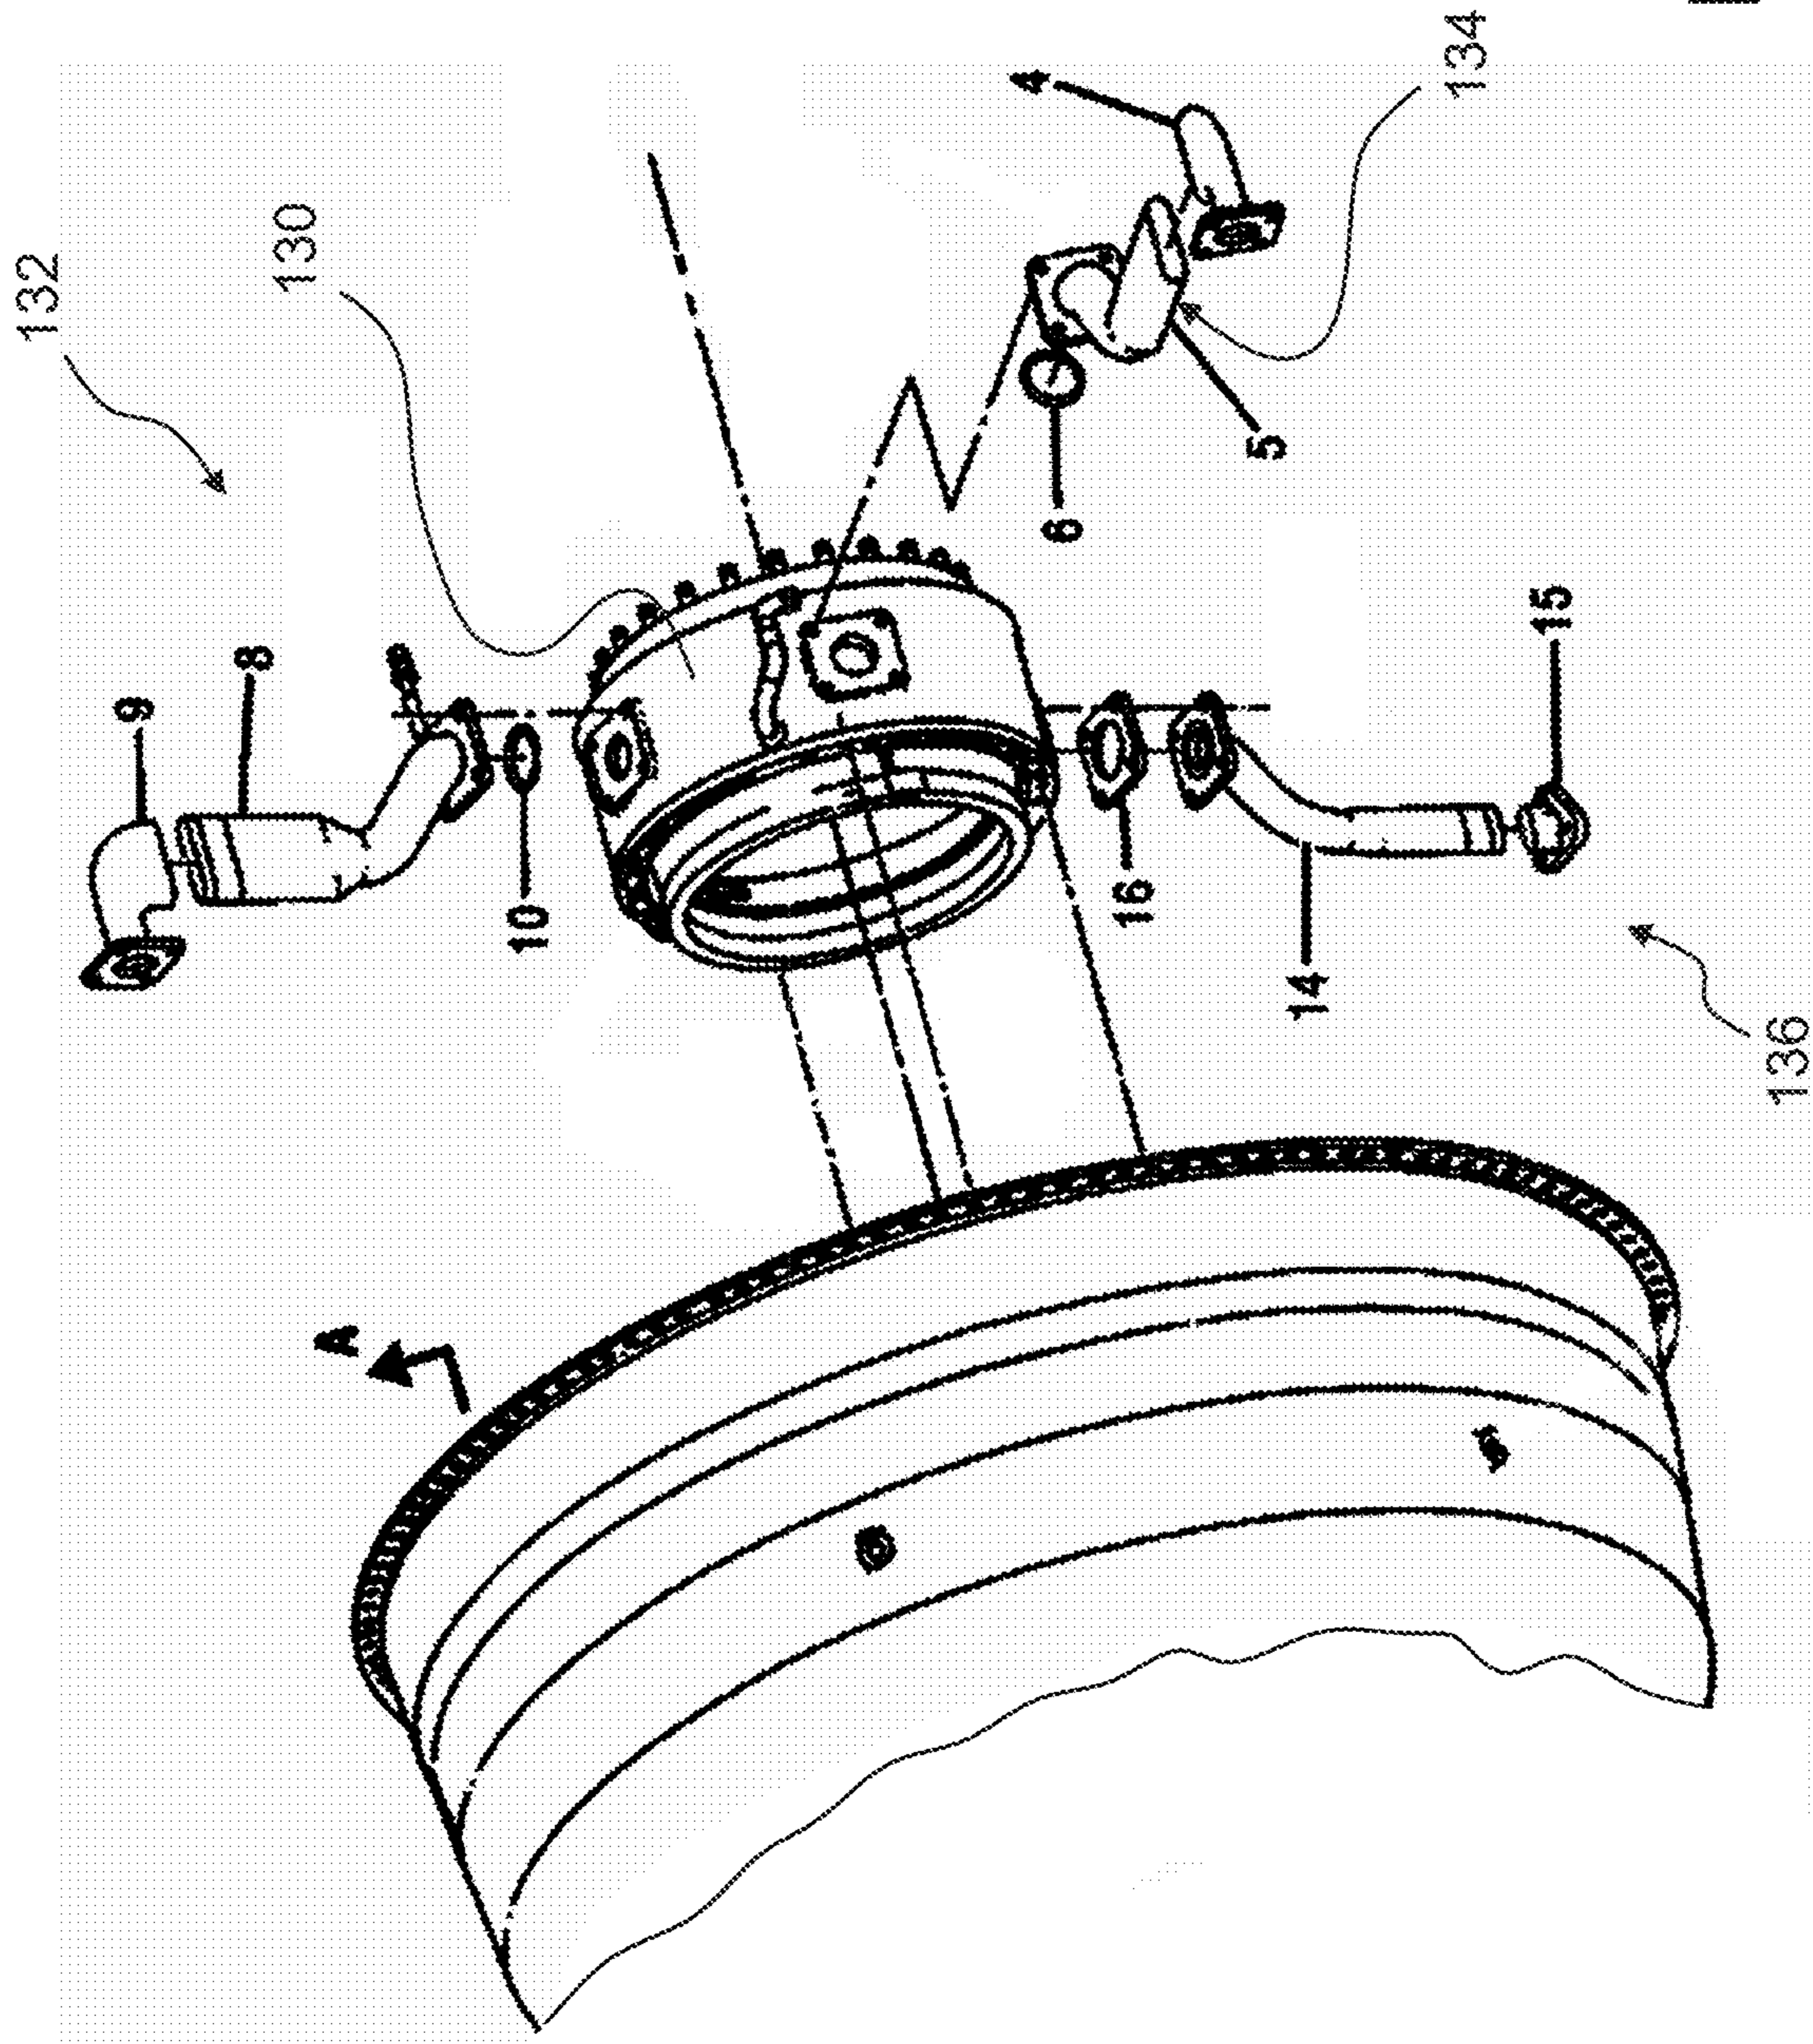
Fig. 3

FIG. 3 illustrates a simplified exploded view showing the forward sump housing that is installed in the aft end of the compressor rear frame case,

FIG. 3 illustrates a part of the aft end bearing assembly that is located on the right end side of the CRF case 108. For clarity only those components of the aft end bearing assembly are shown that are important for the understanding of the method. One of the important components of the aft end bearing assembly is the forward sump housing 130. As can be seen from FIG. 3 there are several lines connected to the forward sump housing 130 in an exploded view. The line comprised of the parts 8 and 9 is a vent line 132. The line comprised of the components 4 and 5 is an air supply that pressurizes several parts inside the forward sump housing 130 to avoid leakage of oil inside the forward sump housing 130.

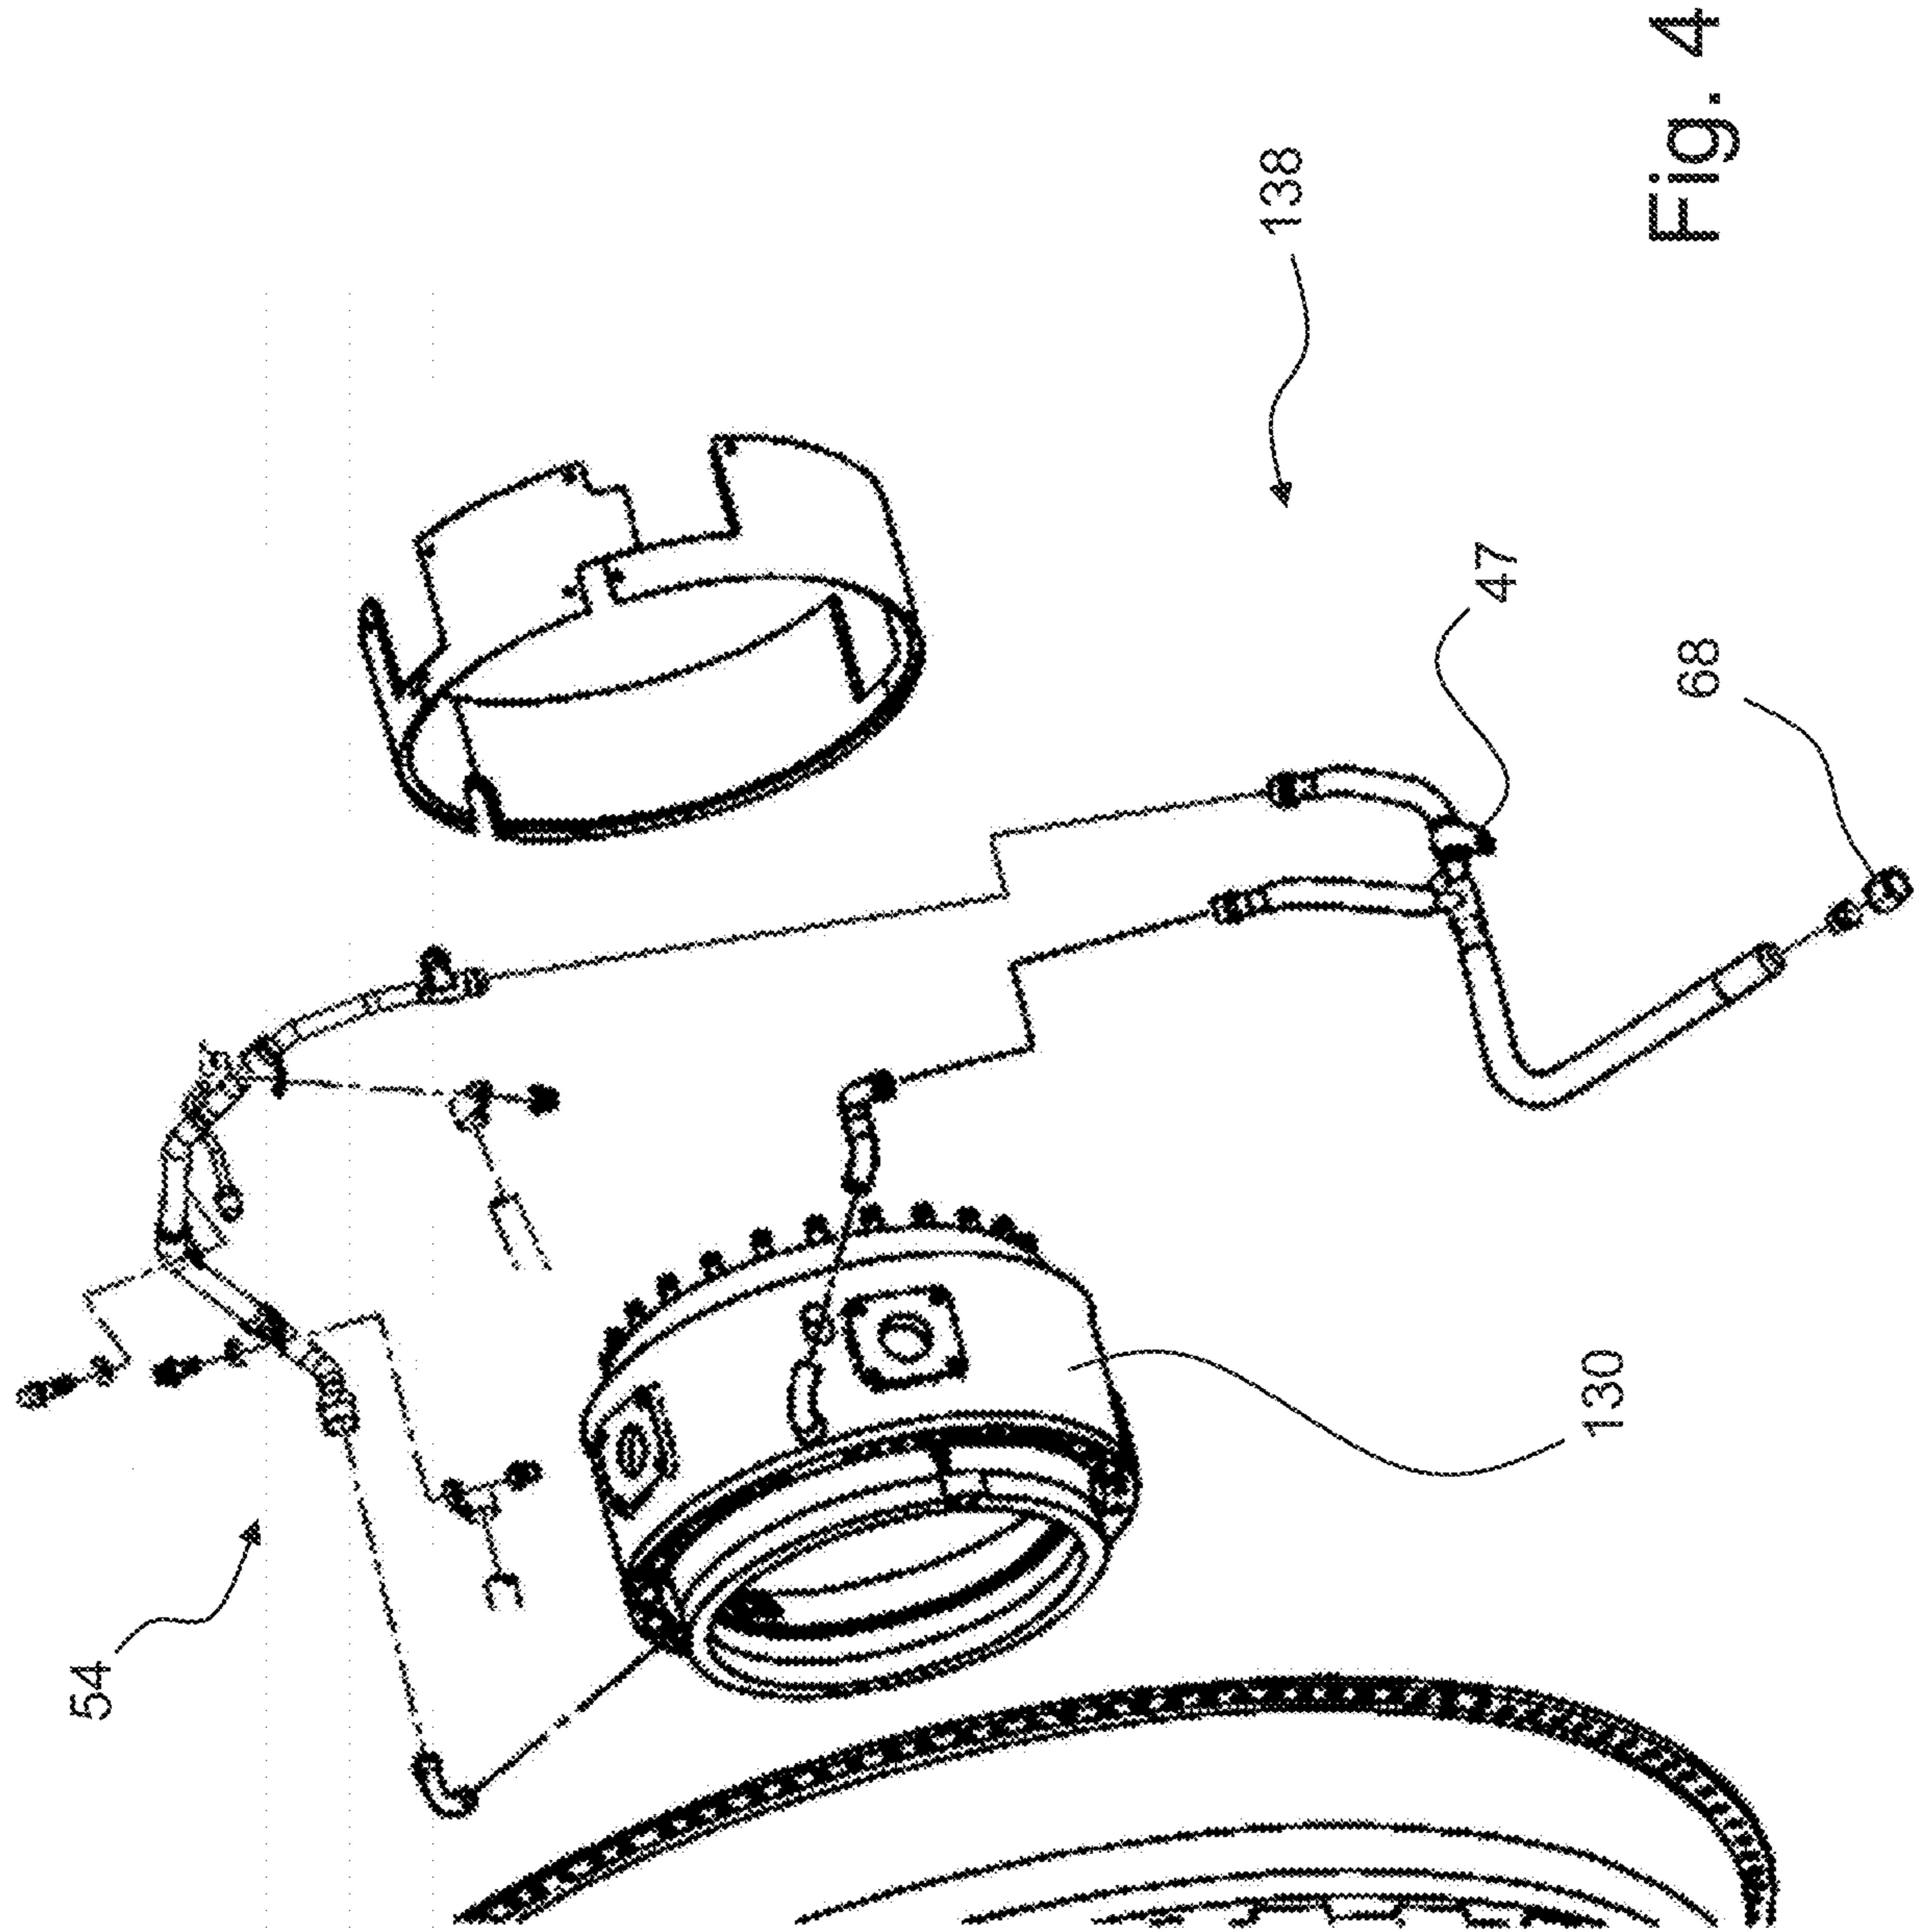
Fig. 4

FIG. 4 illustrates an exploded view of the oil manifold fitted to the forward sump housing,

FIG. 4 illustrates some further components of the forward sump assembly, namely an oil manifold 138 that is attached and fluidly connected with the forward sump housing 130. In FIG. 4 the parts that are installed inside the forward sump

The oil manifold in its entirety bears the reference numeral 54. As can be seen from the exploded view in FIG. 4 the oil manifold 54 is comprised of several tubes (straight and bent), some brackets as well as fittings, sealing rings and other components.

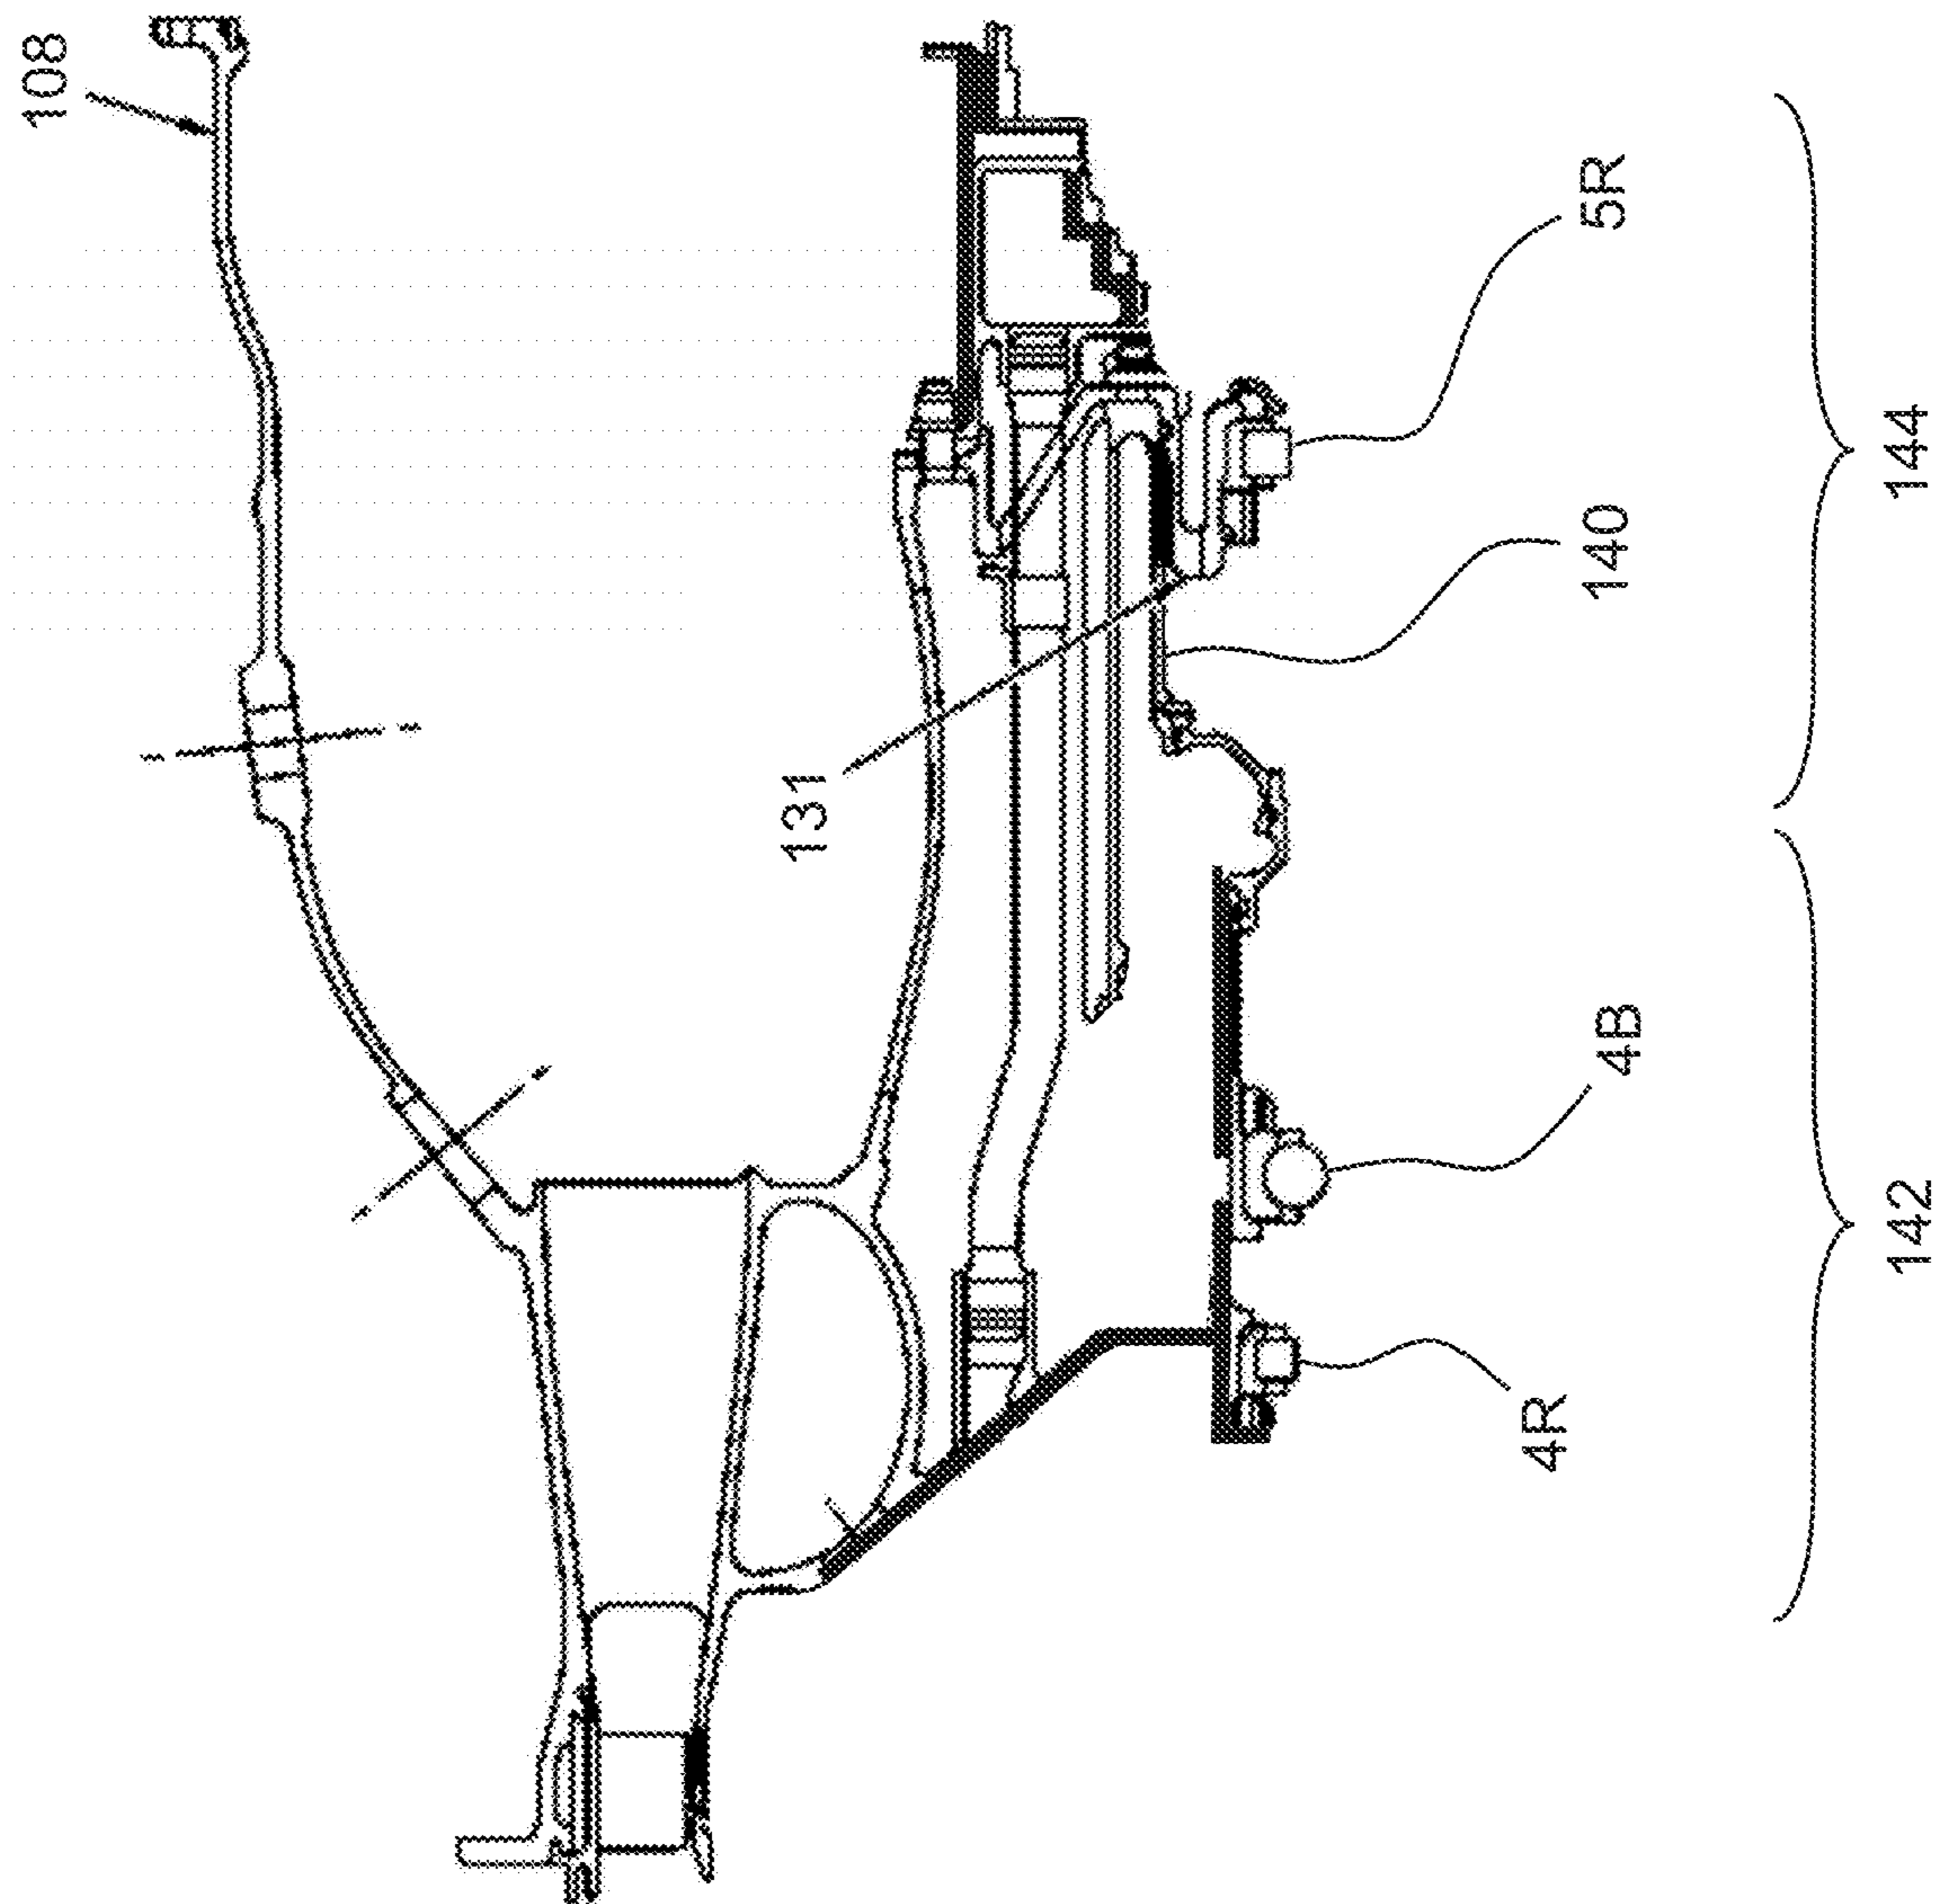
Fig. 5

FIG. 5 illustrates a detailed cross-section of a part of the compressor rear frame case and the front bearing housing, a forward sub assembly, the aft end bearing housing, the aft sump assembly and some further components without the rotors of the compressor and the gas turbine,

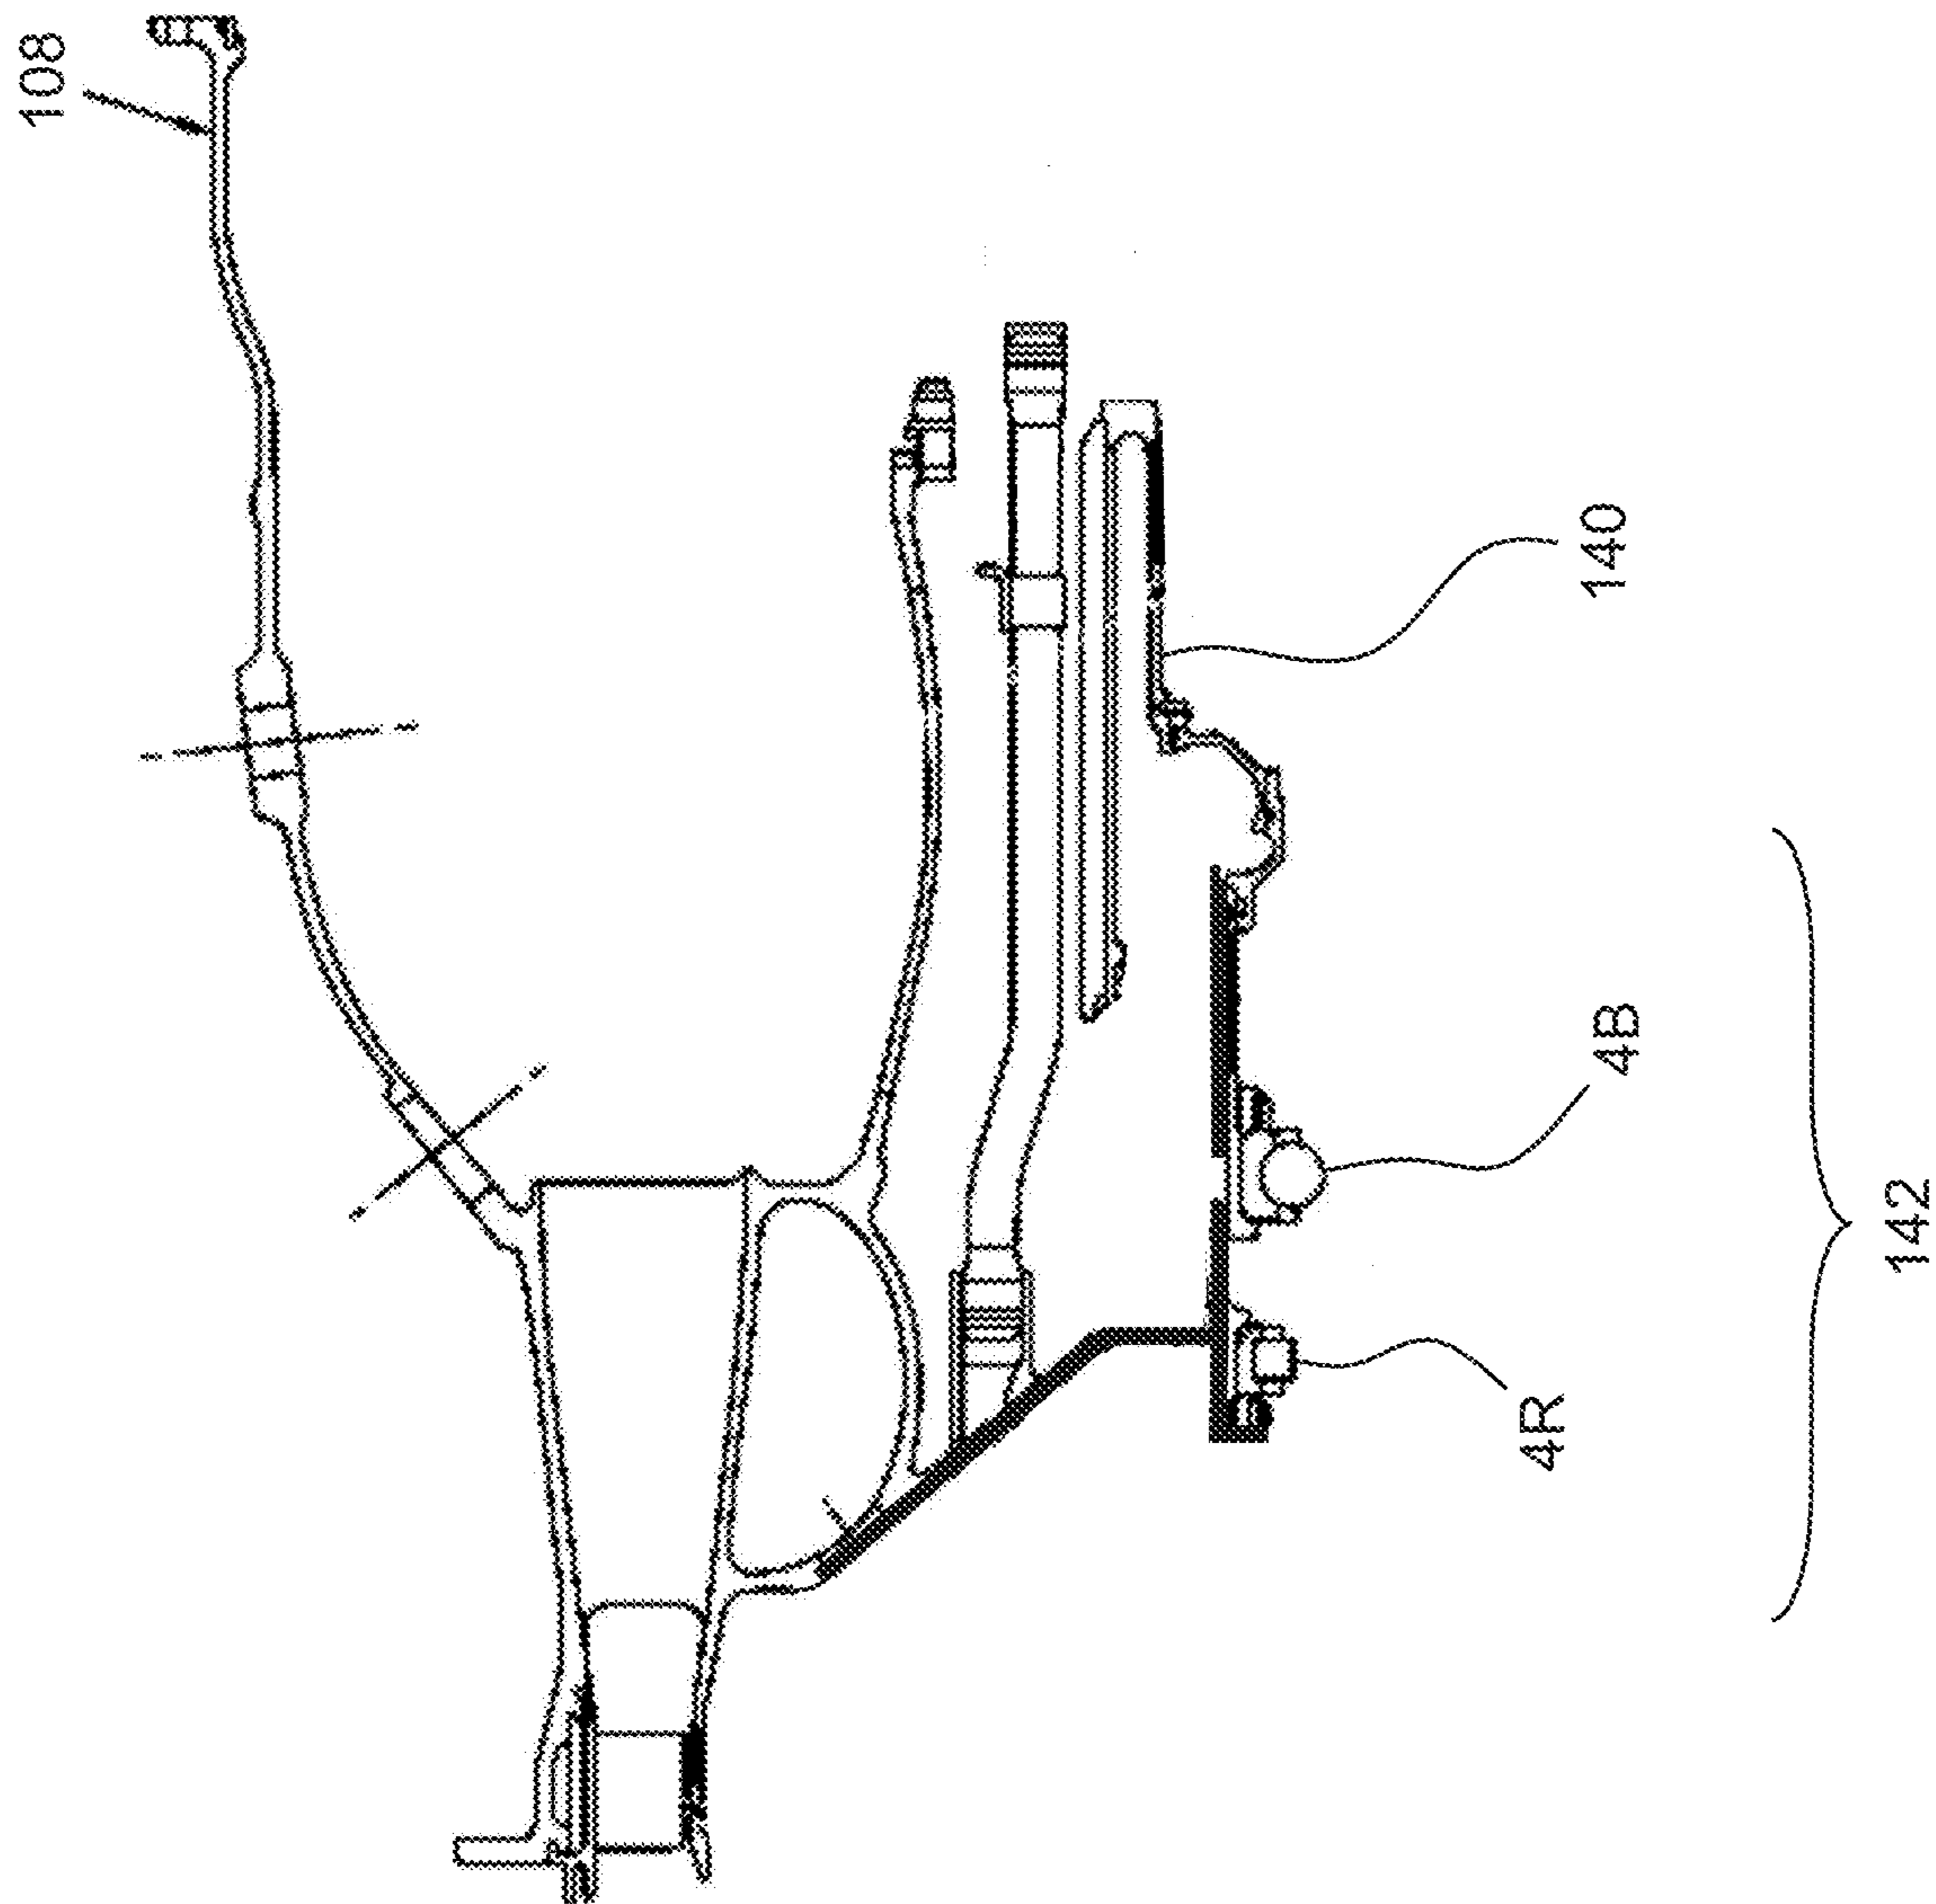
Fig. 6

FIGS. 6 and 7 illustrate different statuses of disassembling parts from the aft end of the CRF case shown in FIG. 5, and FIG. 8 is a flowchart of the method described herein.

In FIGS. 6 and 7 two different stages of dismantling the aft end bearing assembly 144 are illustrated.
