(54) **METHOD FOR REPAIRING IN-SITU INSTALLATIONS INSIDE A COMPRESSOR REAR FRAME CASE OF A GAS TURBINE**

A method for repairing in-situ an oil manifold of the aft end bearing assembly of a gas turbine is provided that is cost-efficient, effective and dramatically reduces the costs for repair of a leaking oil manifold.

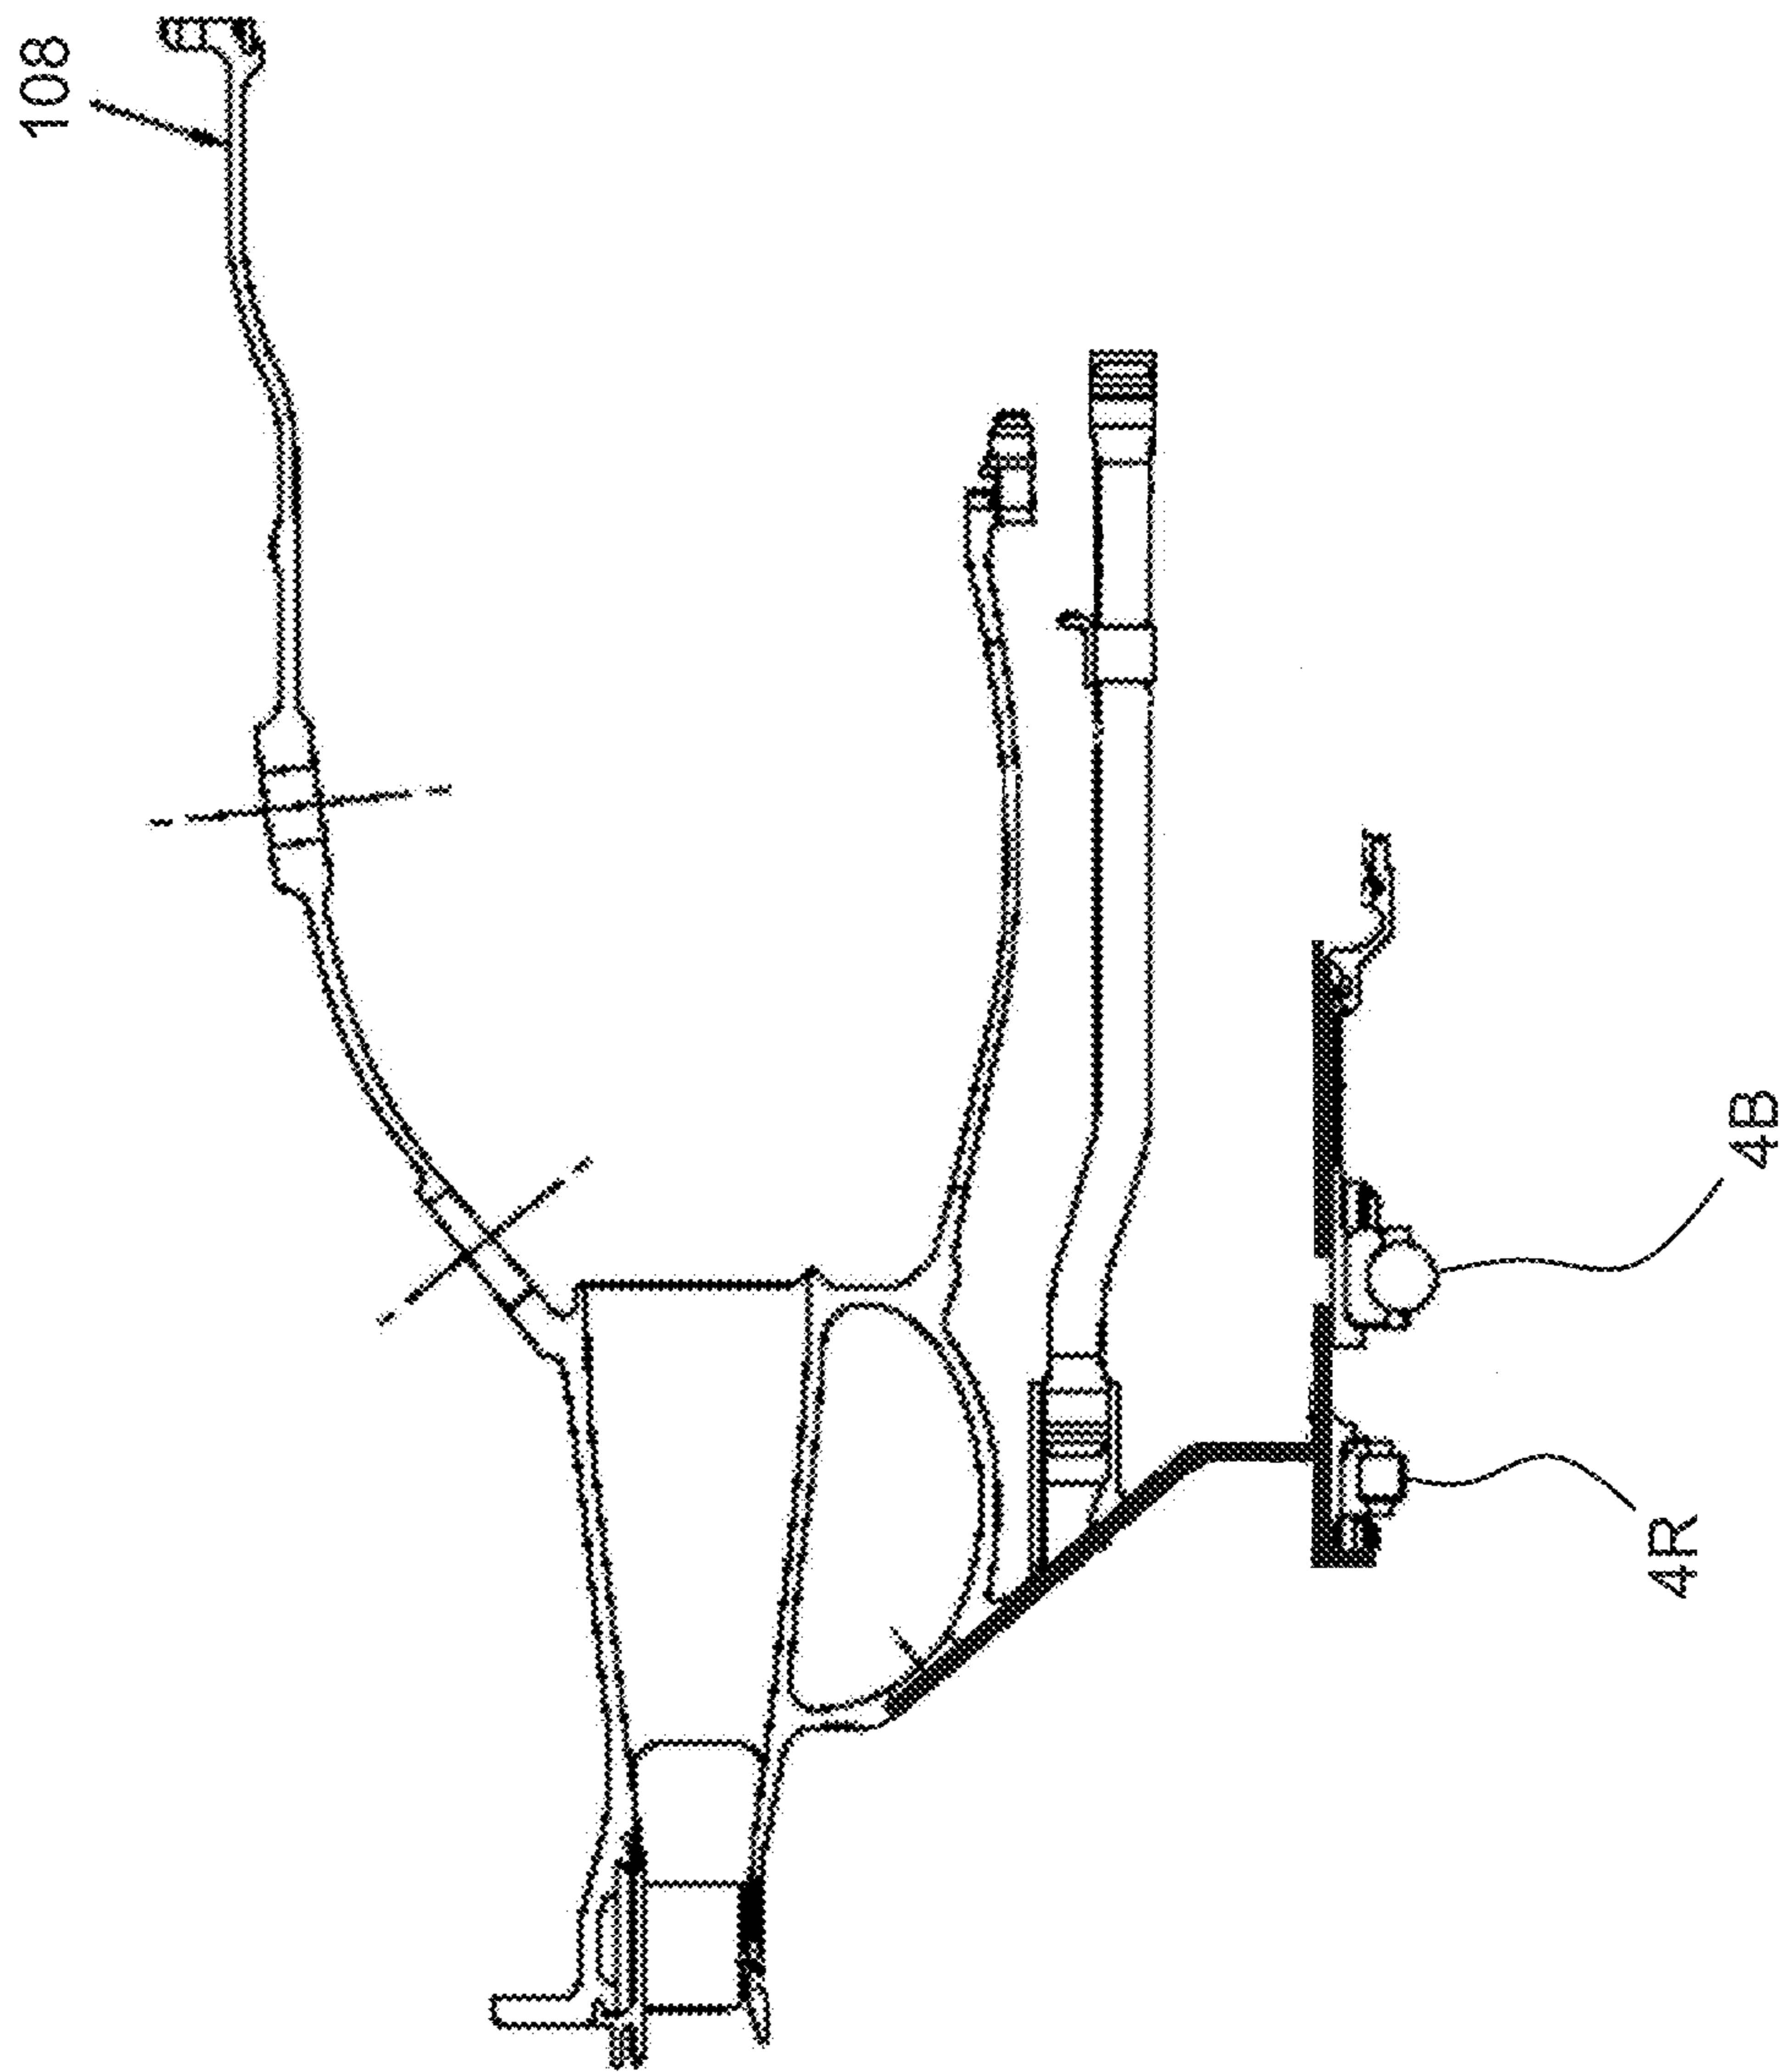
Fig. 7

FIGS. 6 and 7 illustrate different statuses of disassembling parts from the aft end of the CRF case shown in FIG. 5, and FIG. 8 is a flowchart of the method described herein.

In FIGS. 6 and 7 two different stages of dismantling the aft end bearing assembly 144 are illustrated.
