(54) **INTERCHANGEABLE BASE STEEL  
STRUCTURE STORAGE ASSEMBLY**

A storage rack assembly includes a base steel structure which is interchangeably connected to the storage rack above. The base steel structure assembly is comprised of structural material with bolted connections which allow for the replacement or changing of damaged material due to accidental forklift contact all while the above storage system stays in place.

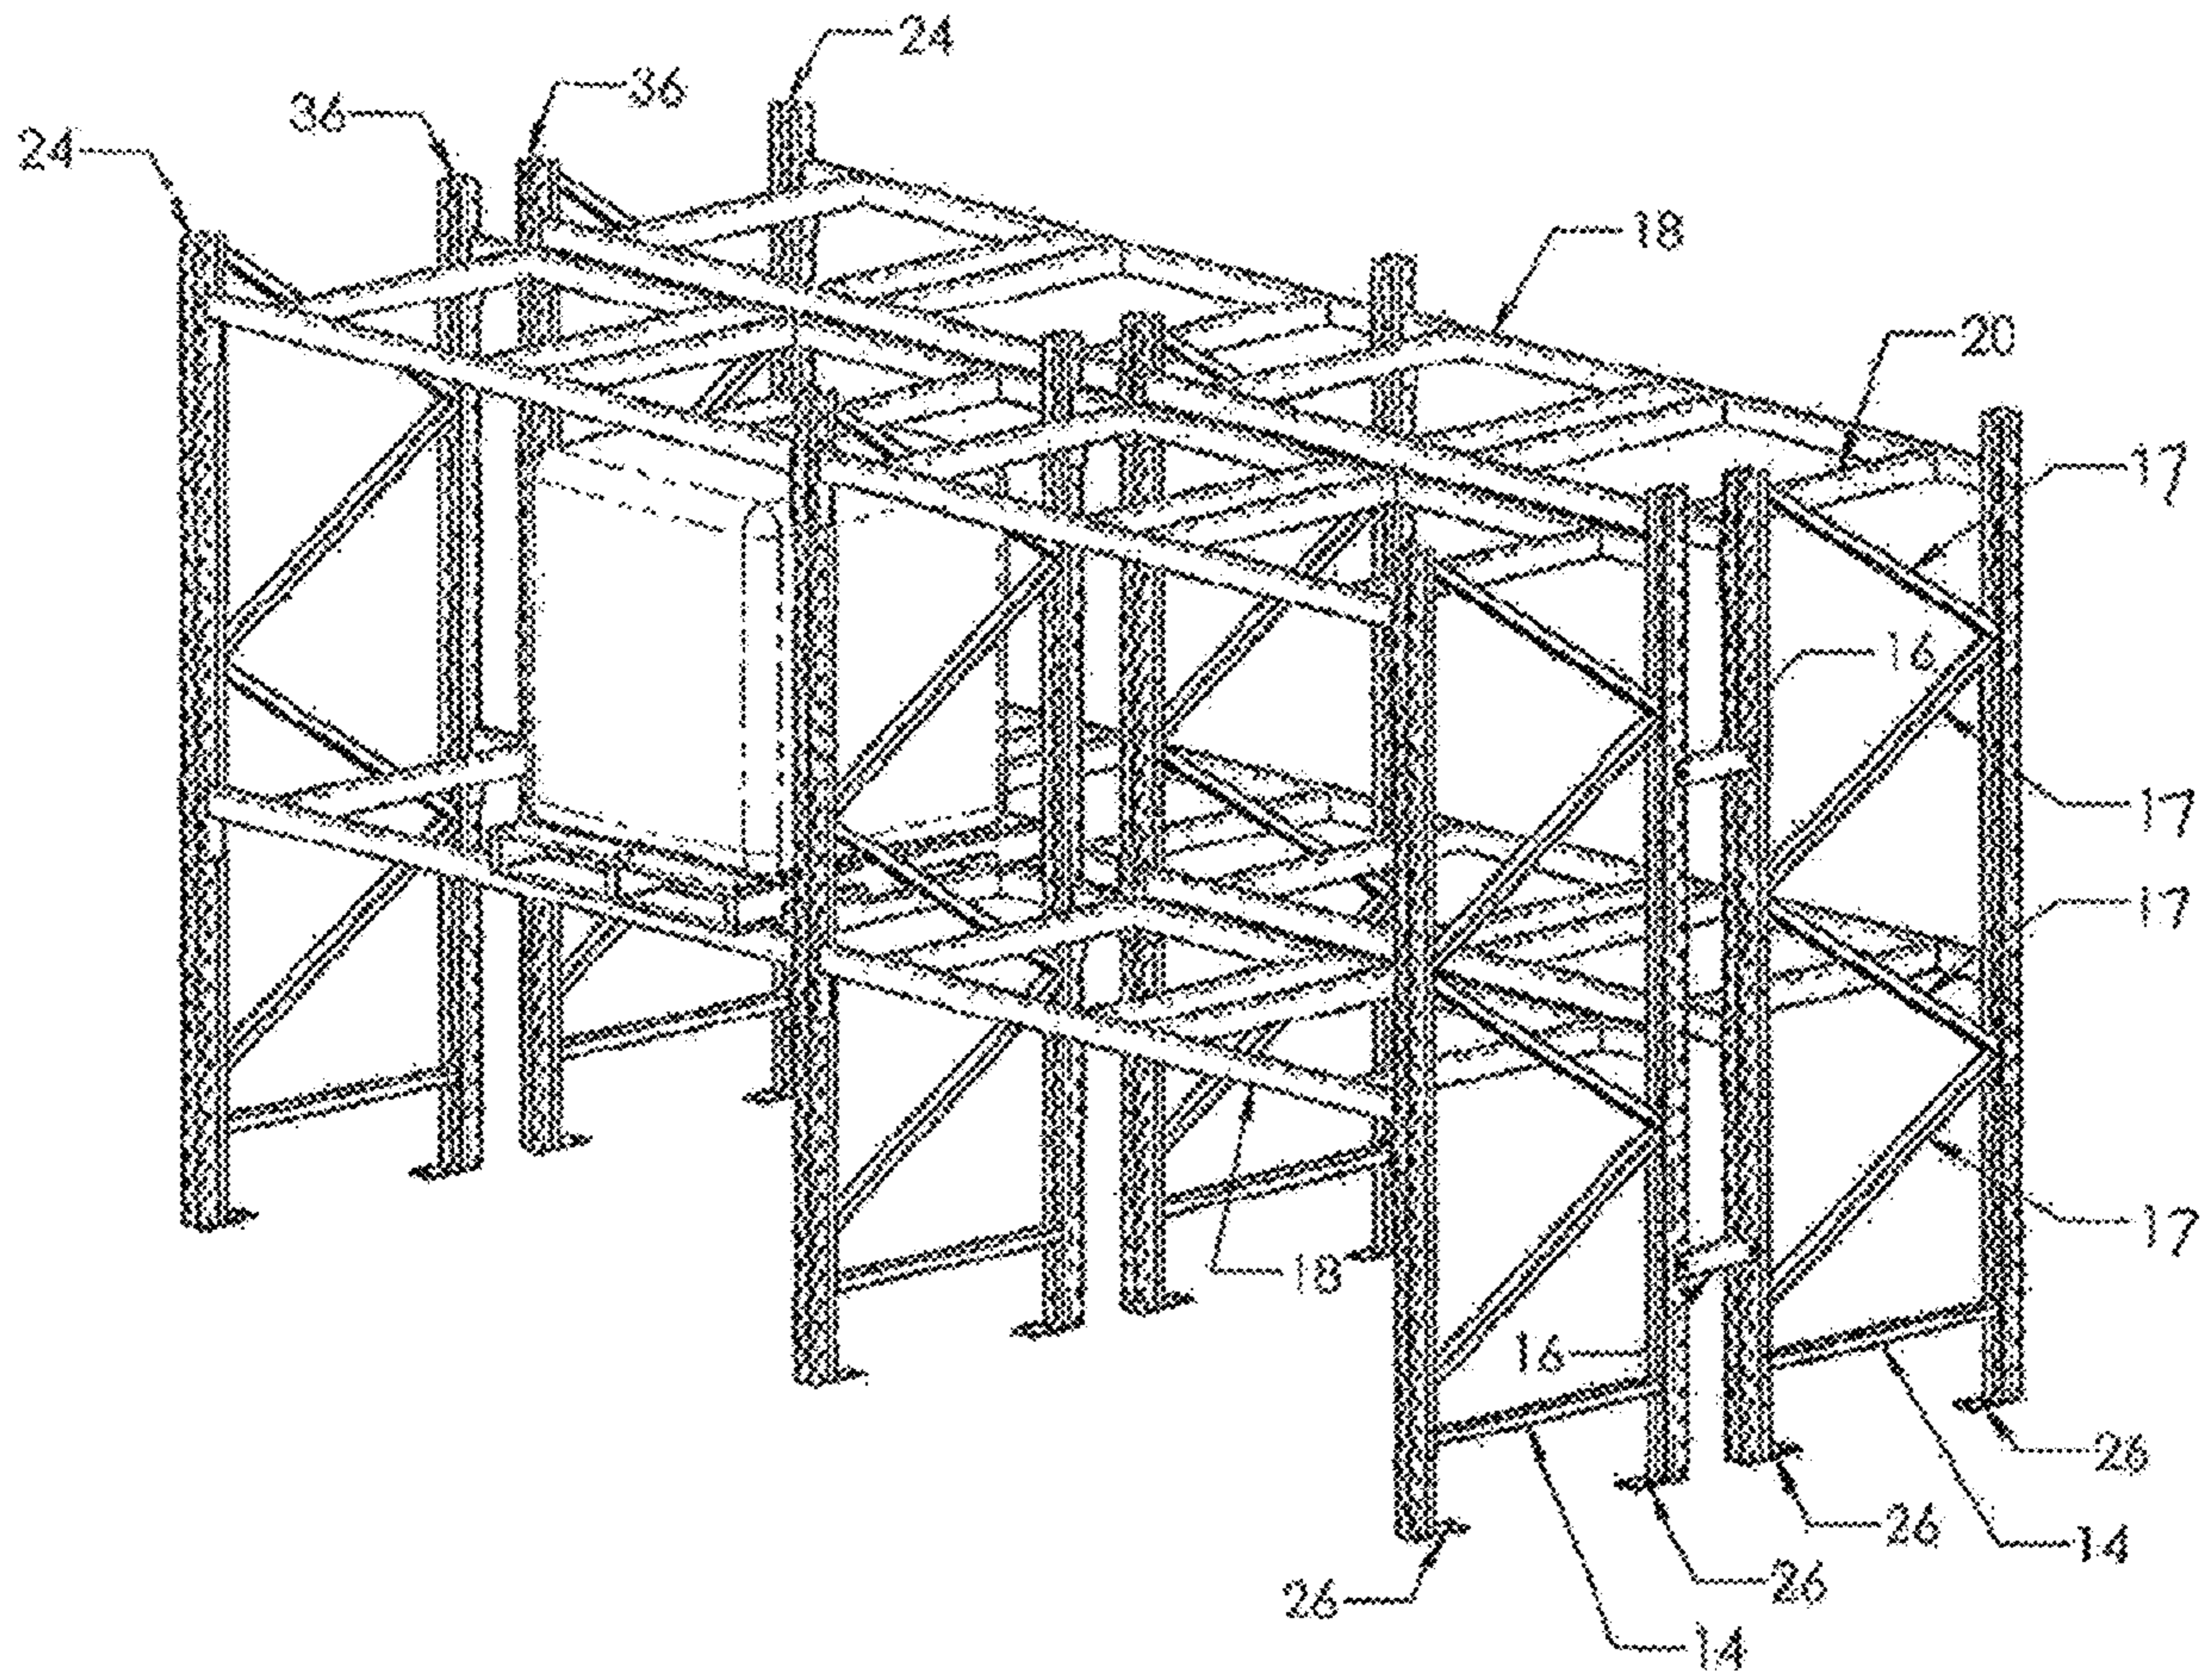
PRIOR ART  
*FIG. 1*

FIG. 1 is a side perspective view of a prior art storage rack;

FIG. 1 shows an example of a prior art storage rack that may be retrofitted to make a rack in accordance with the

The rack of FIG. 1 has a multitude of forward columns 24, and a multitude of rear columns 36, and horizontal load beams 18 interconnecting the forward and rear columns 24, 36 to form levels to support palletized material. Each pair of forward and rear columns 24, 36 extends from a baseplate 26 and also includes horizontal forward-to-rear braces 14 and diagonal forward-to-rear braces 17. In this configuration, the back to back columns 36 have row spacers 16 that control the flue dimension. This rack is prone to damage from material handling equipment (MHE) when the operator is interfacing with the racking system. It is then very problematic and costly to repair the damage uprights as discussed above.

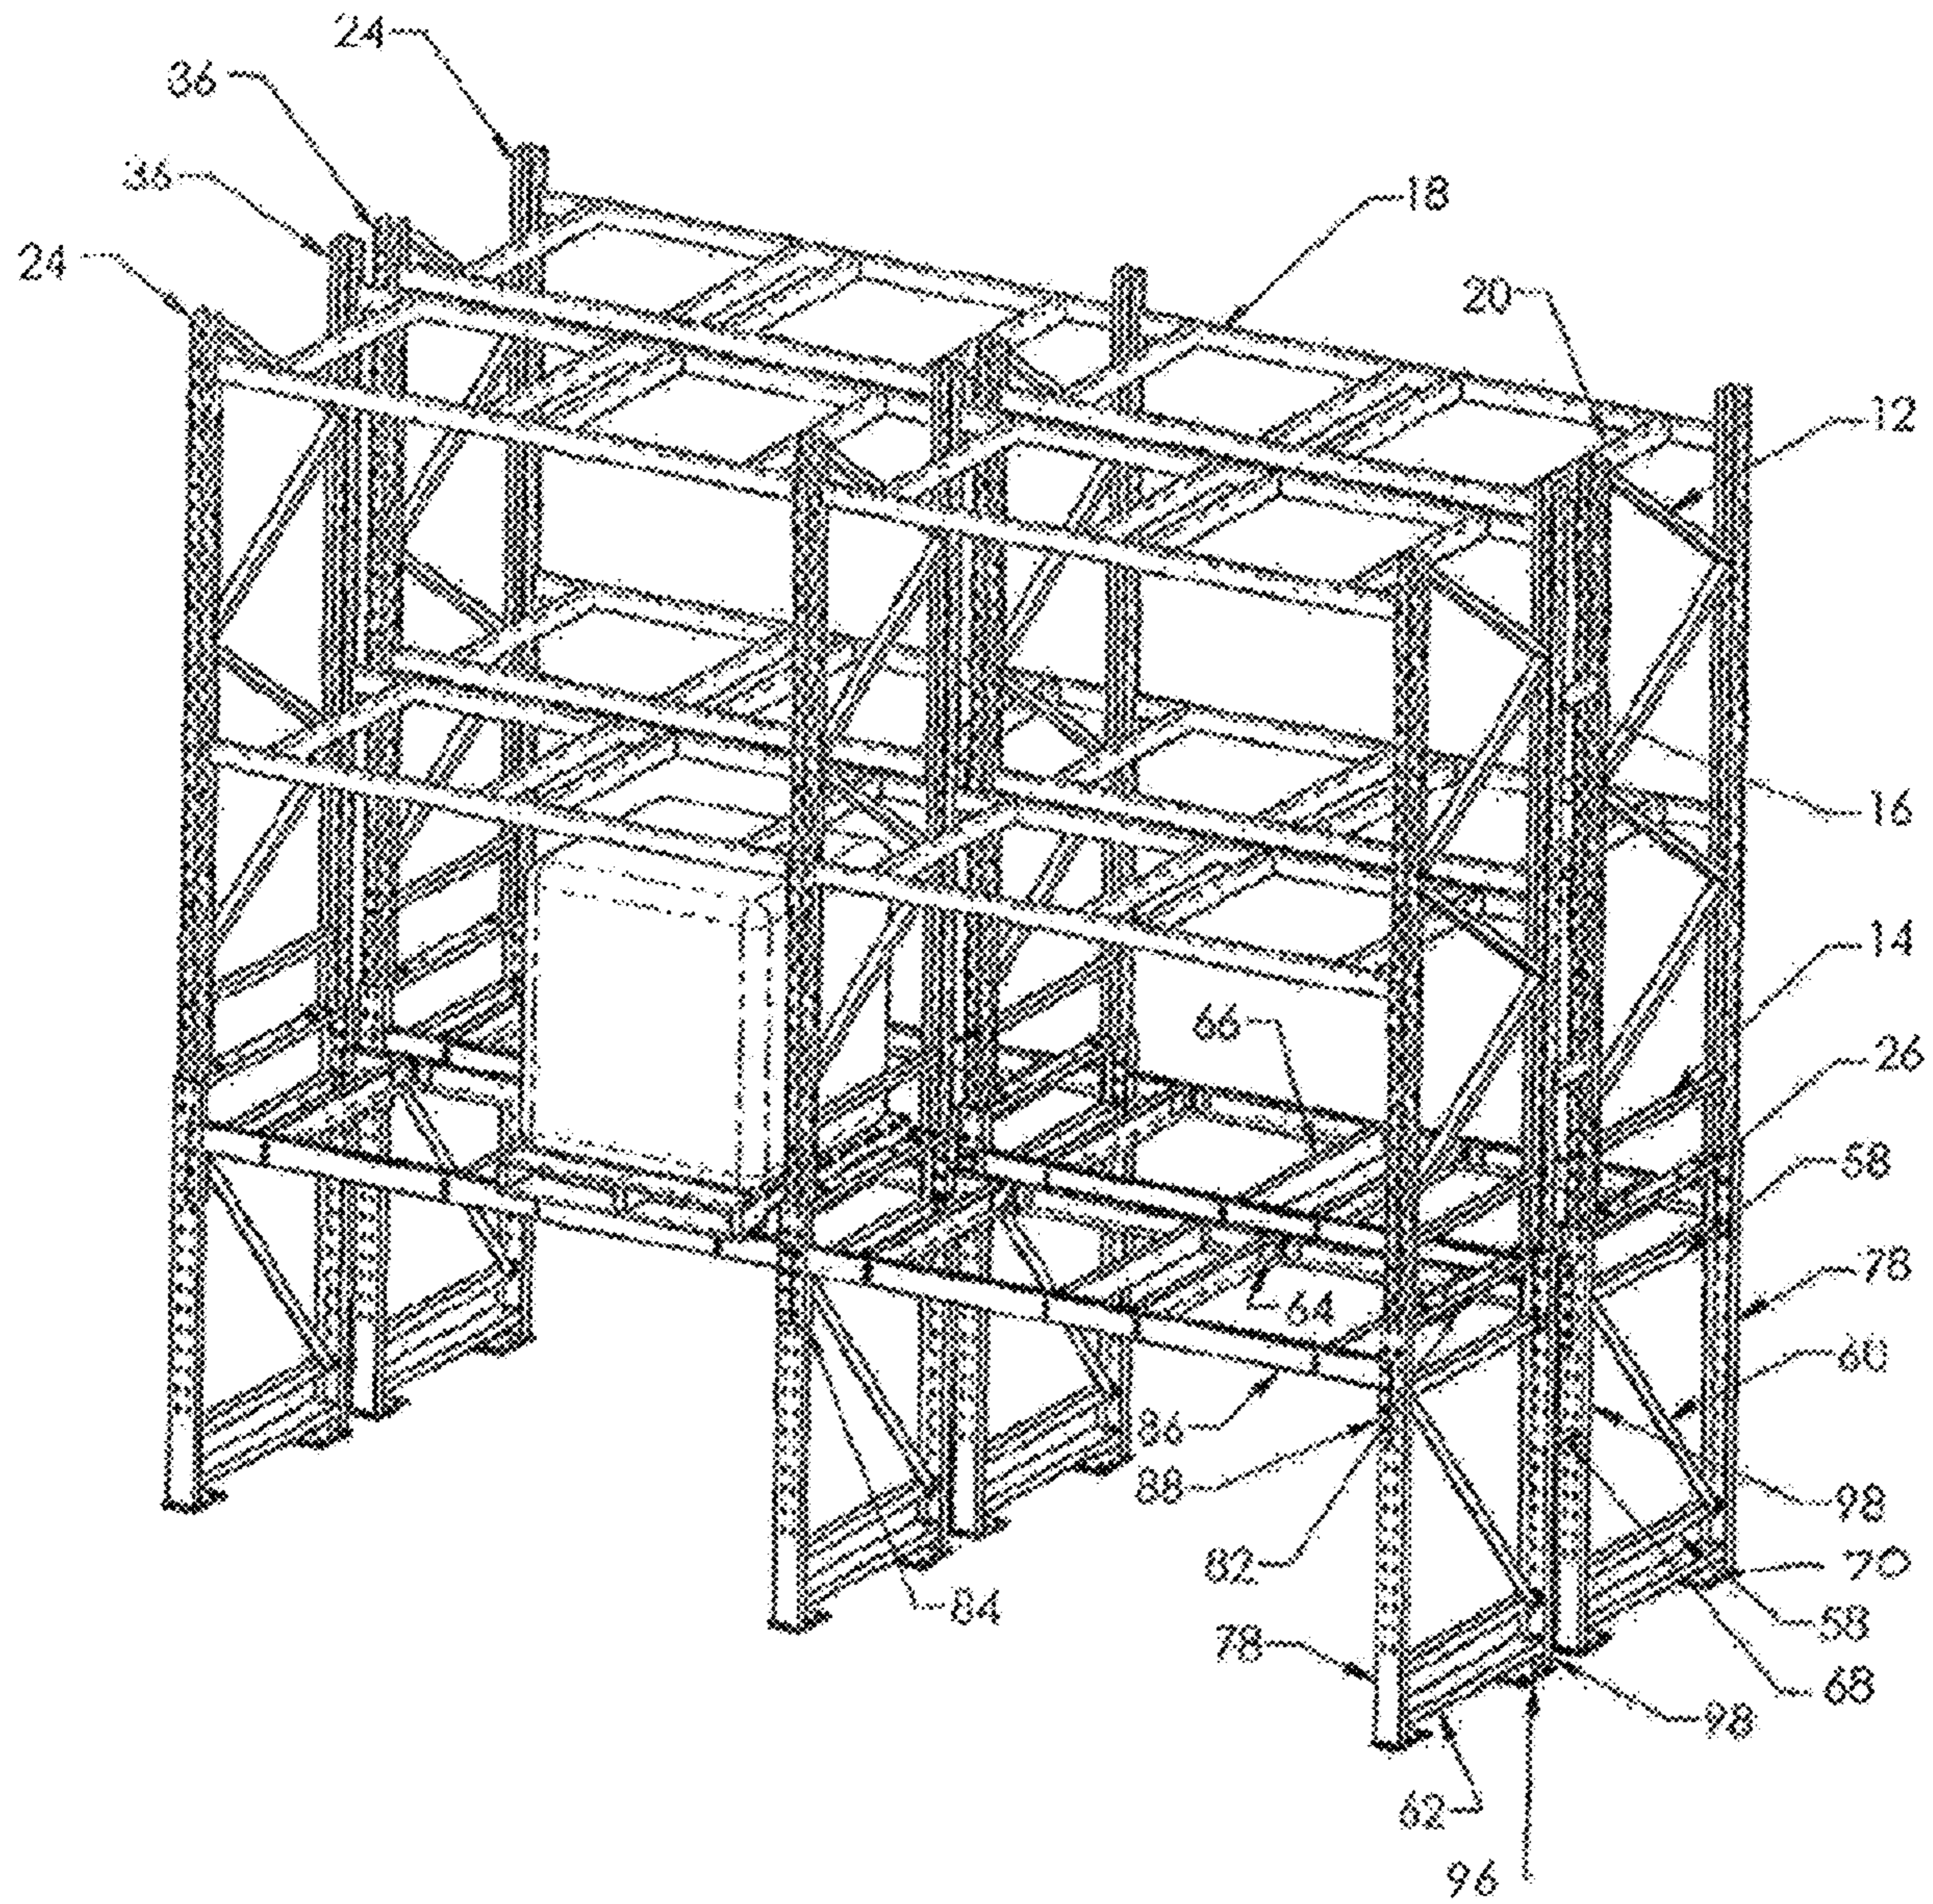
FIG. 2 is a side perspective view of a first embodiment of a storage system made in accordance with the present invention;

FIG. 2 shows a storage rack with a base steel structure assembly made up of structural components to greatly reduce the damage due to impact by the MHE. The upper portion of the front columns terminate above the first load beam level as the load beam connection adds additional durability and rigidity to the base steel structure assembly. This rack may be made in this form initially, or it may be made by retrofitting the prior art rack of FIG. 1. This rack also has a front column 78, rear column 98, horizontal load beams 86 and horizontal pallet supports 66. The columns are supported by bolted horizontal forward-to-rear braces 58 and bolted diagonal forward-to-rear braces 60. The pallet supports interconnect via an angle bracket 64 to the front and rear horizontal load beams 86. A horizontal member 82 is bolted connected to the top of the front column 78 and the rear column 98. This horizontal member has an identical hole punch pattern on the front face of the material which corresponds to the baseplates' 26 hole pattern, this allows for a bolted connection between the upper and lower columns. Once fully assembled, the entire assembly is then anchored to an underlying floor via holes extending through baseplates 70 attached to the front columns 78 and baseplates 96 attached to the rear columns 98.

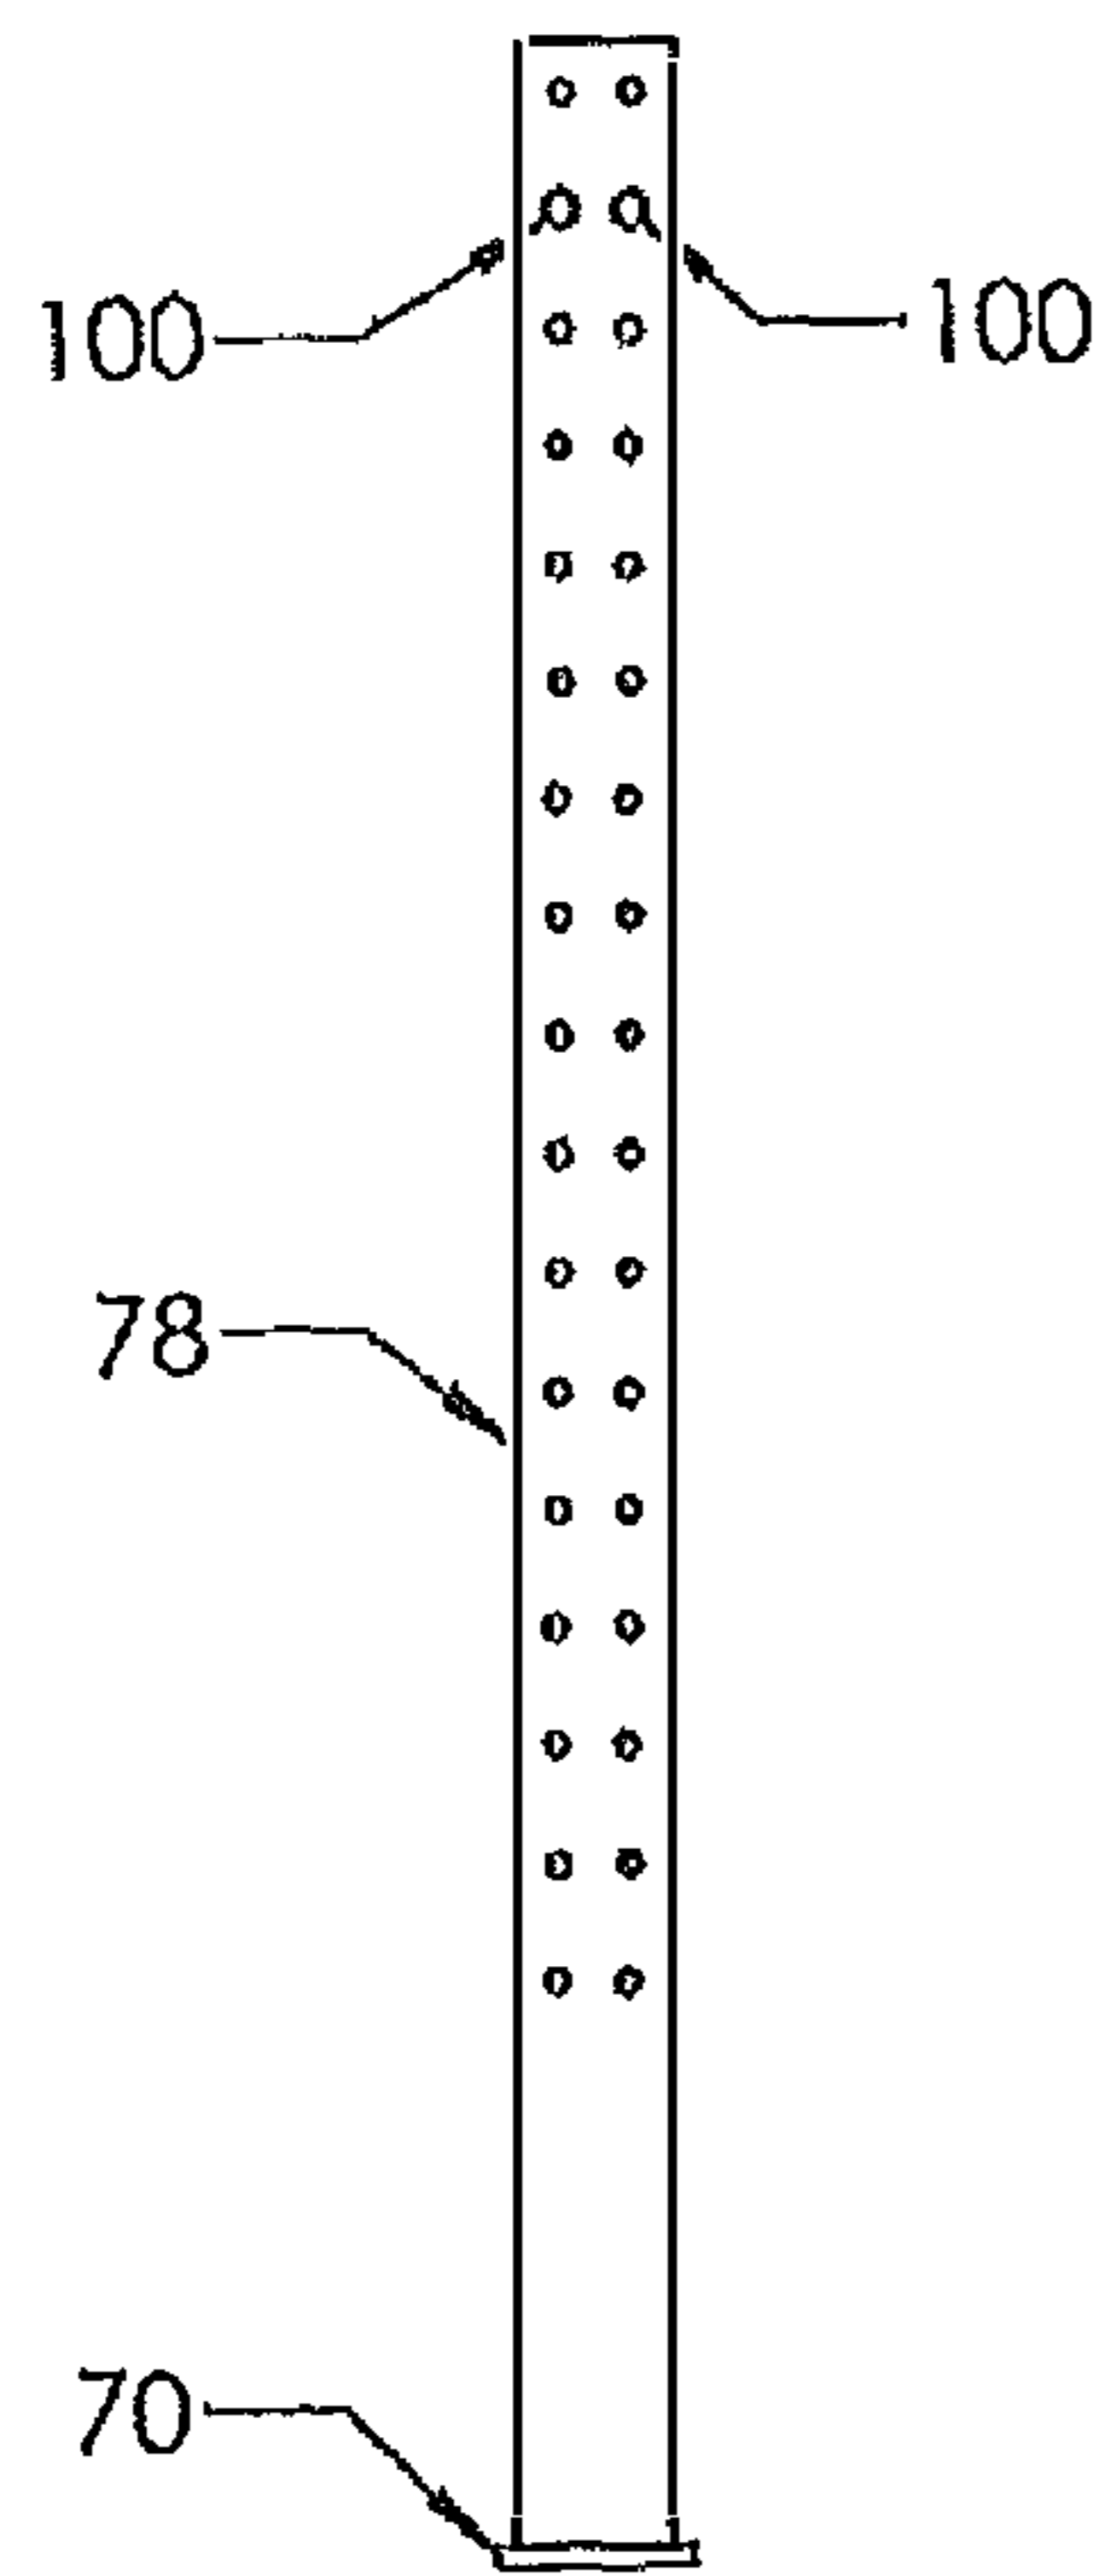
FIG. 3 is a front view of a base portion of the storage system of FIG. 2;

FIG. 3 shows front column 78 with corresponding baseplate 70. The front column is punched with round holes to accept bolted connections as required.

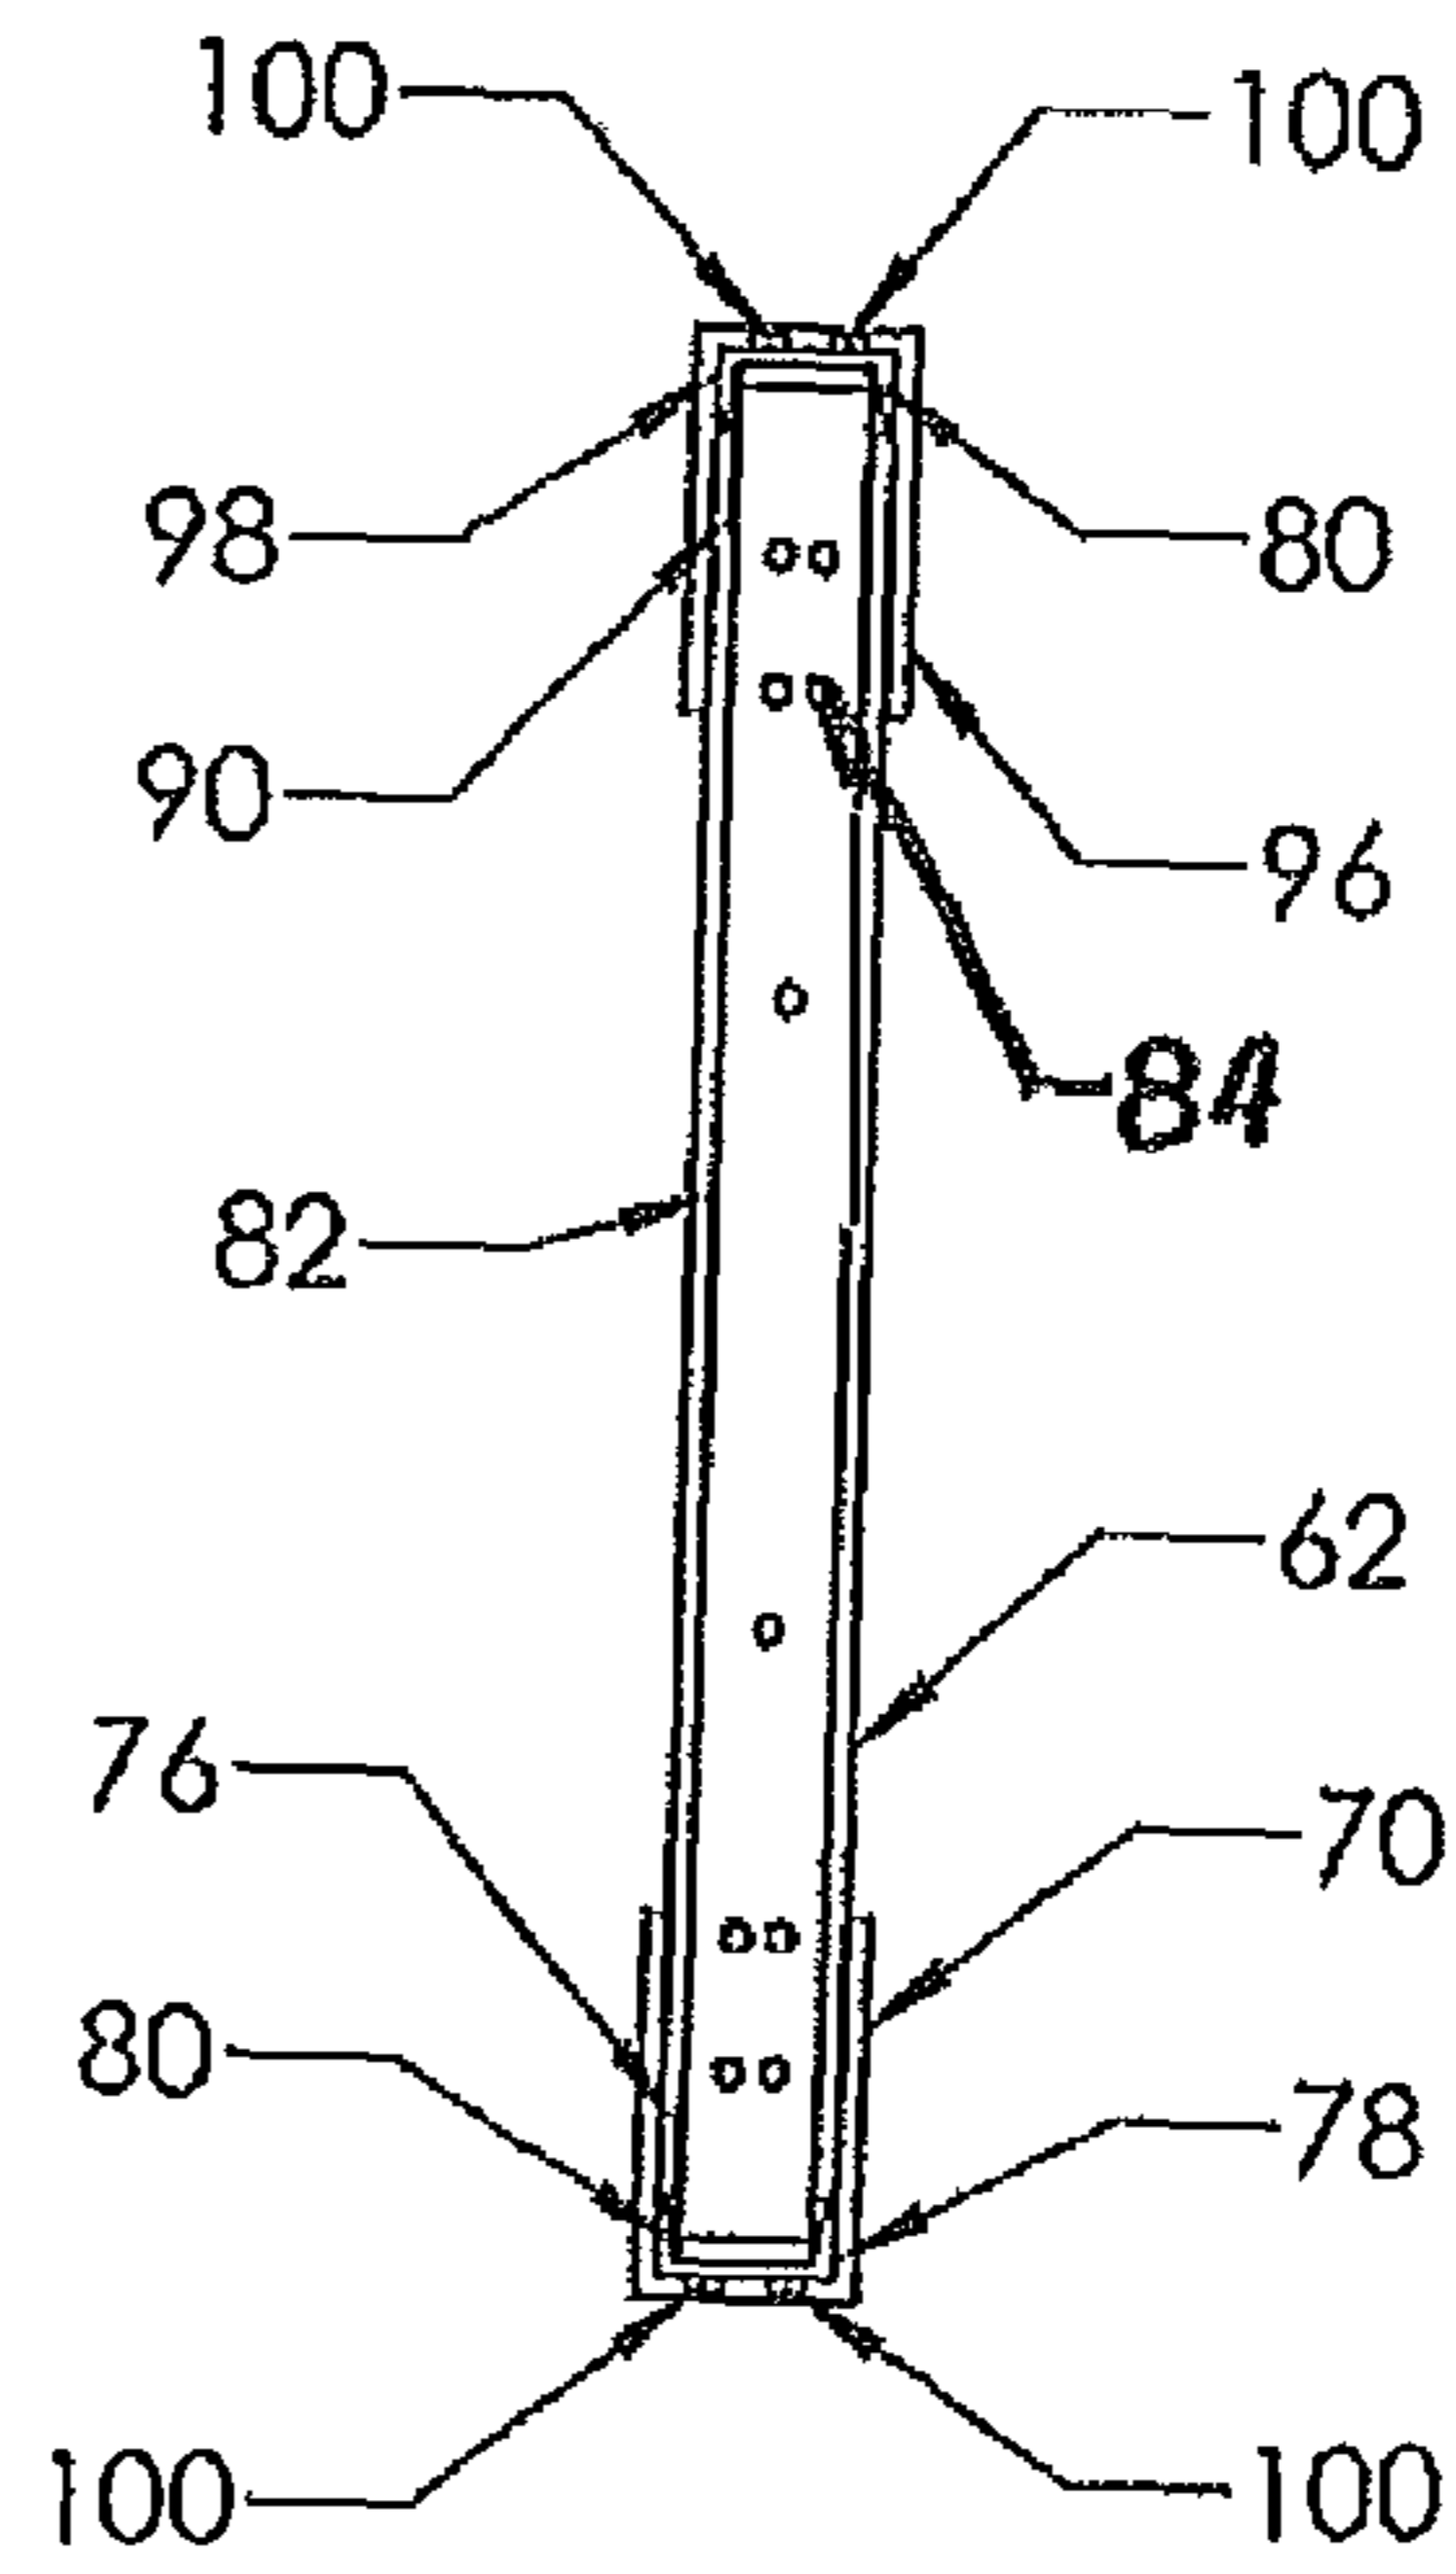
FIG. 4 is a top view of the base portion of the storage system in FIG. 2;

FIG. 4 shows a top view of the horizontal member 82 with corresponding front column 78 and rear column 98. The horizontal member would have holes 84, punched or otherwise formed on the front face of the material which correspond to the holes in the baseplate 26 in FIG. 2 to allow for a bolted connection. The front baseplate 70 and rear baseplate 96 which allow for the assembly to be anchored to the floor are also illustrated. A plate 80 is welded to each end of the horizontal structural member 82 which allows for a bolted connection between the front column 78 and the rear column 98.

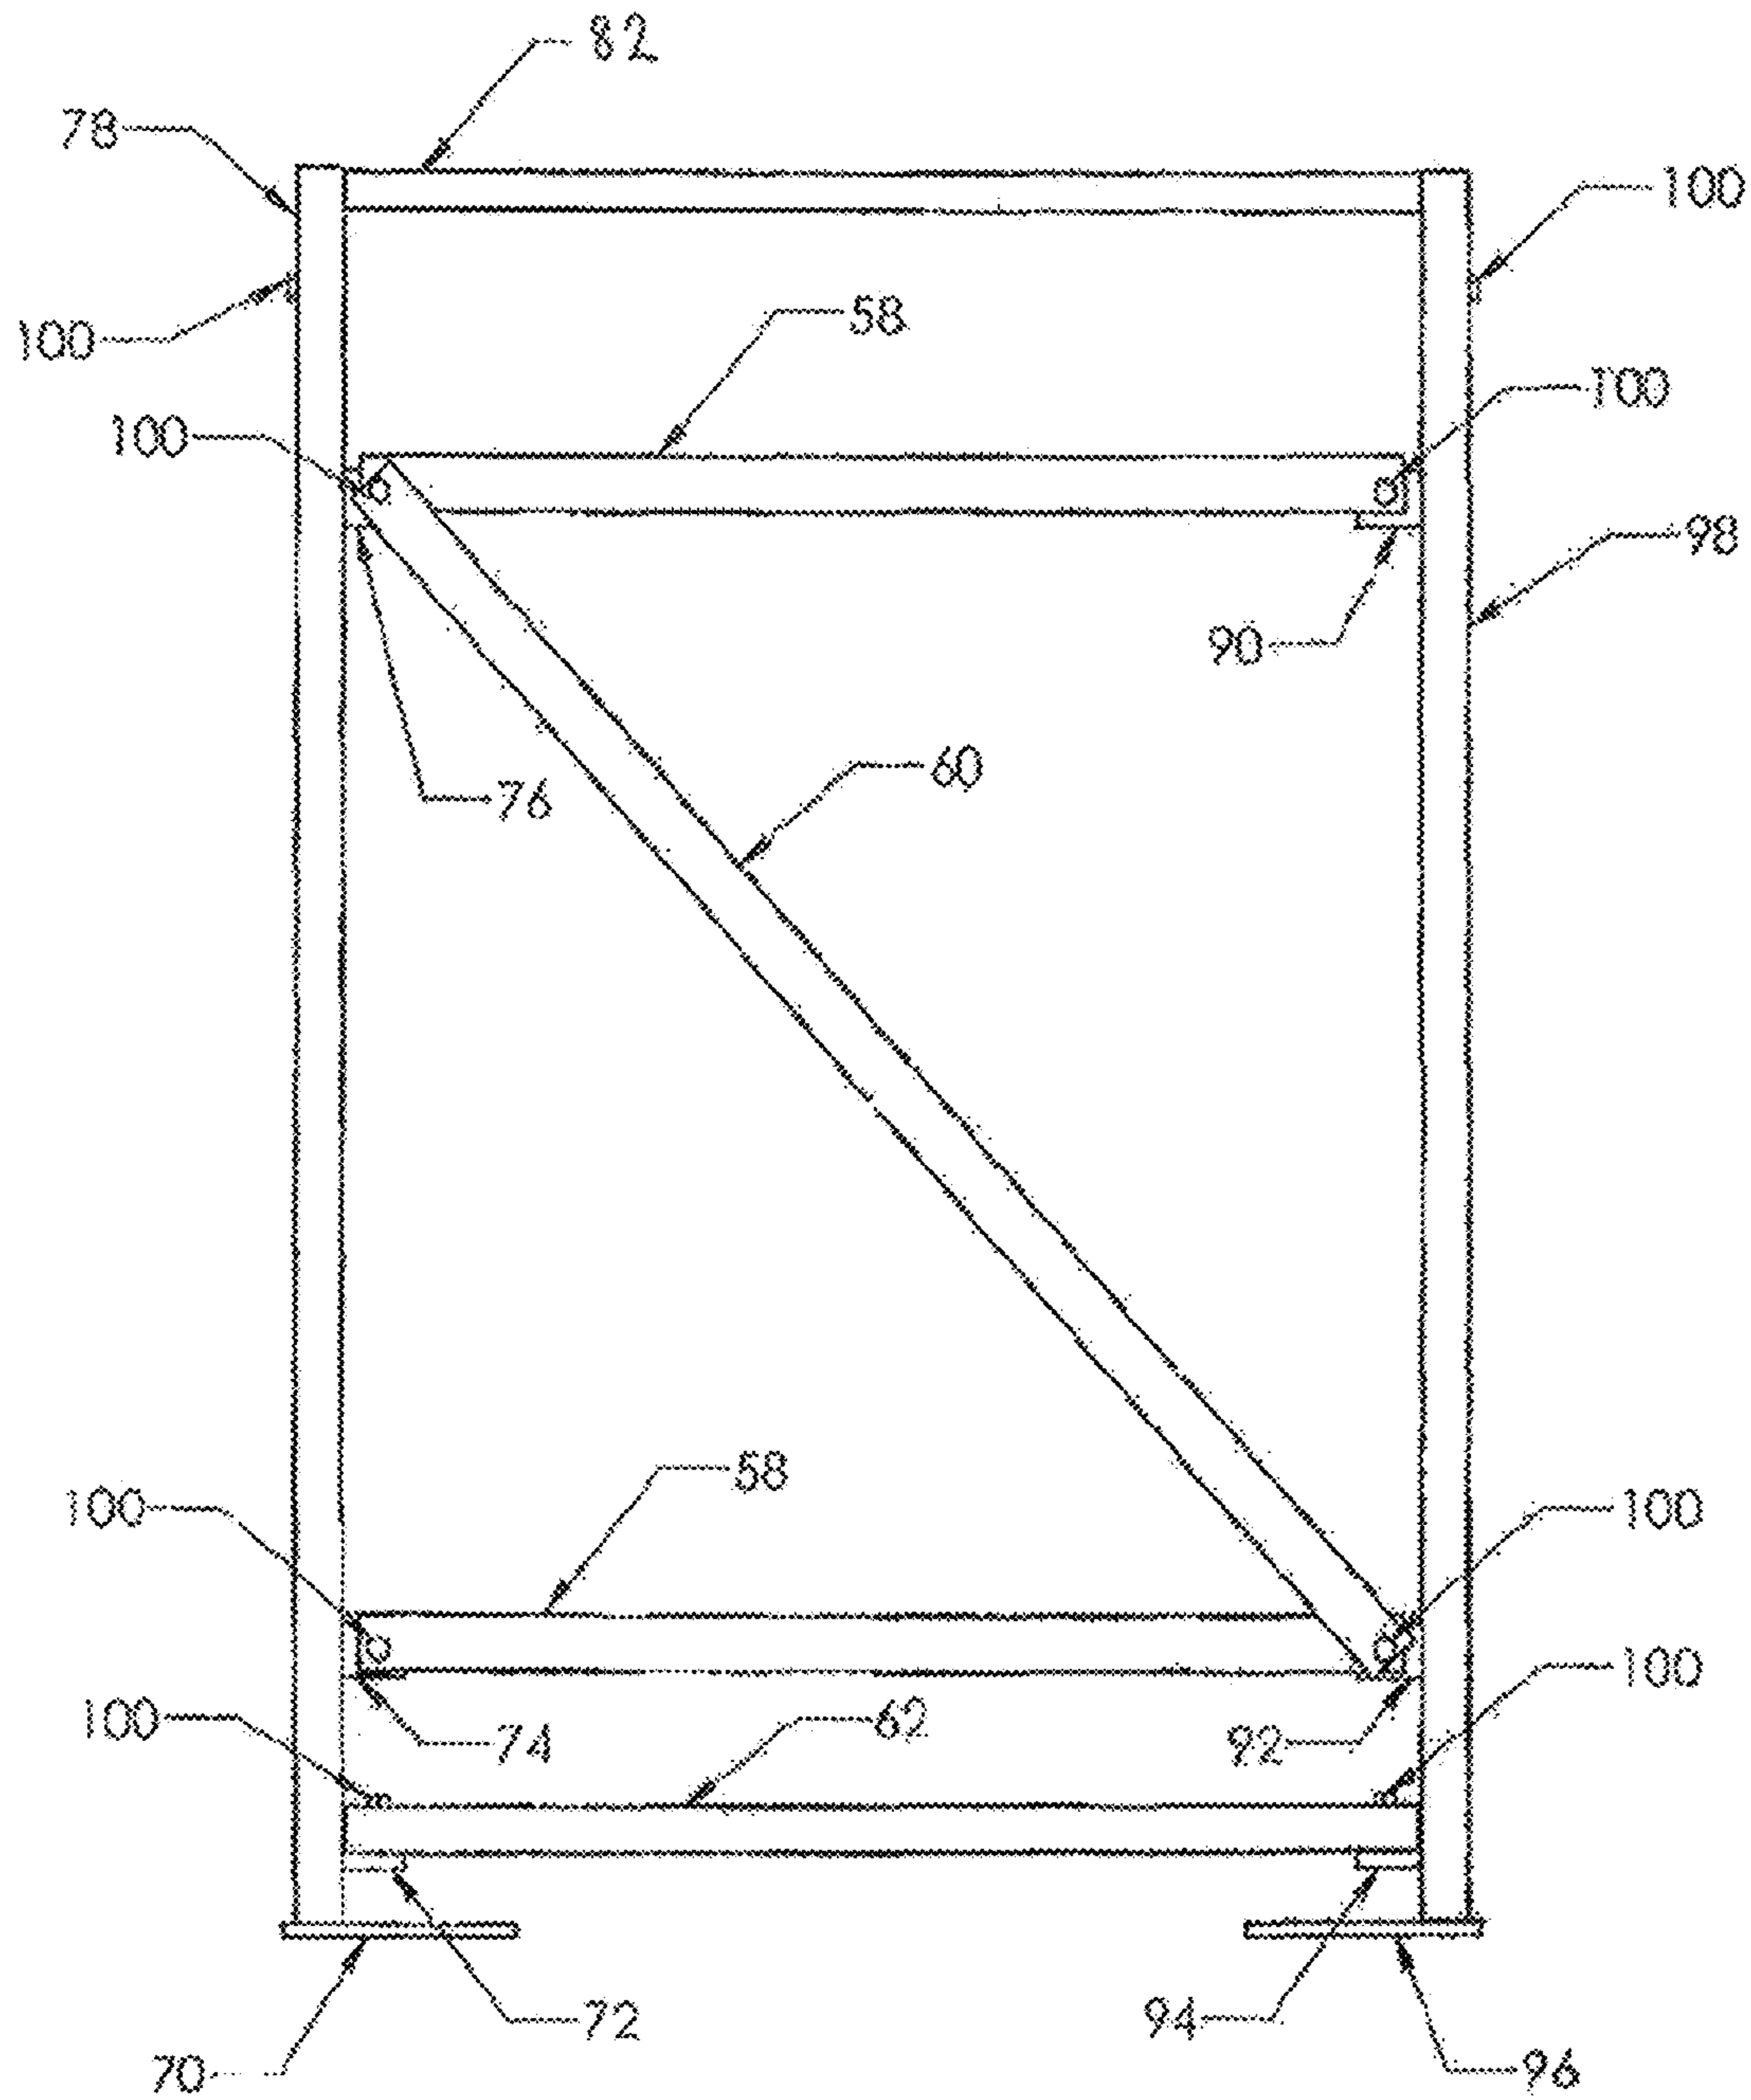
FIG. 5 is a side view of the base portion of the storage system in FIG. 2;

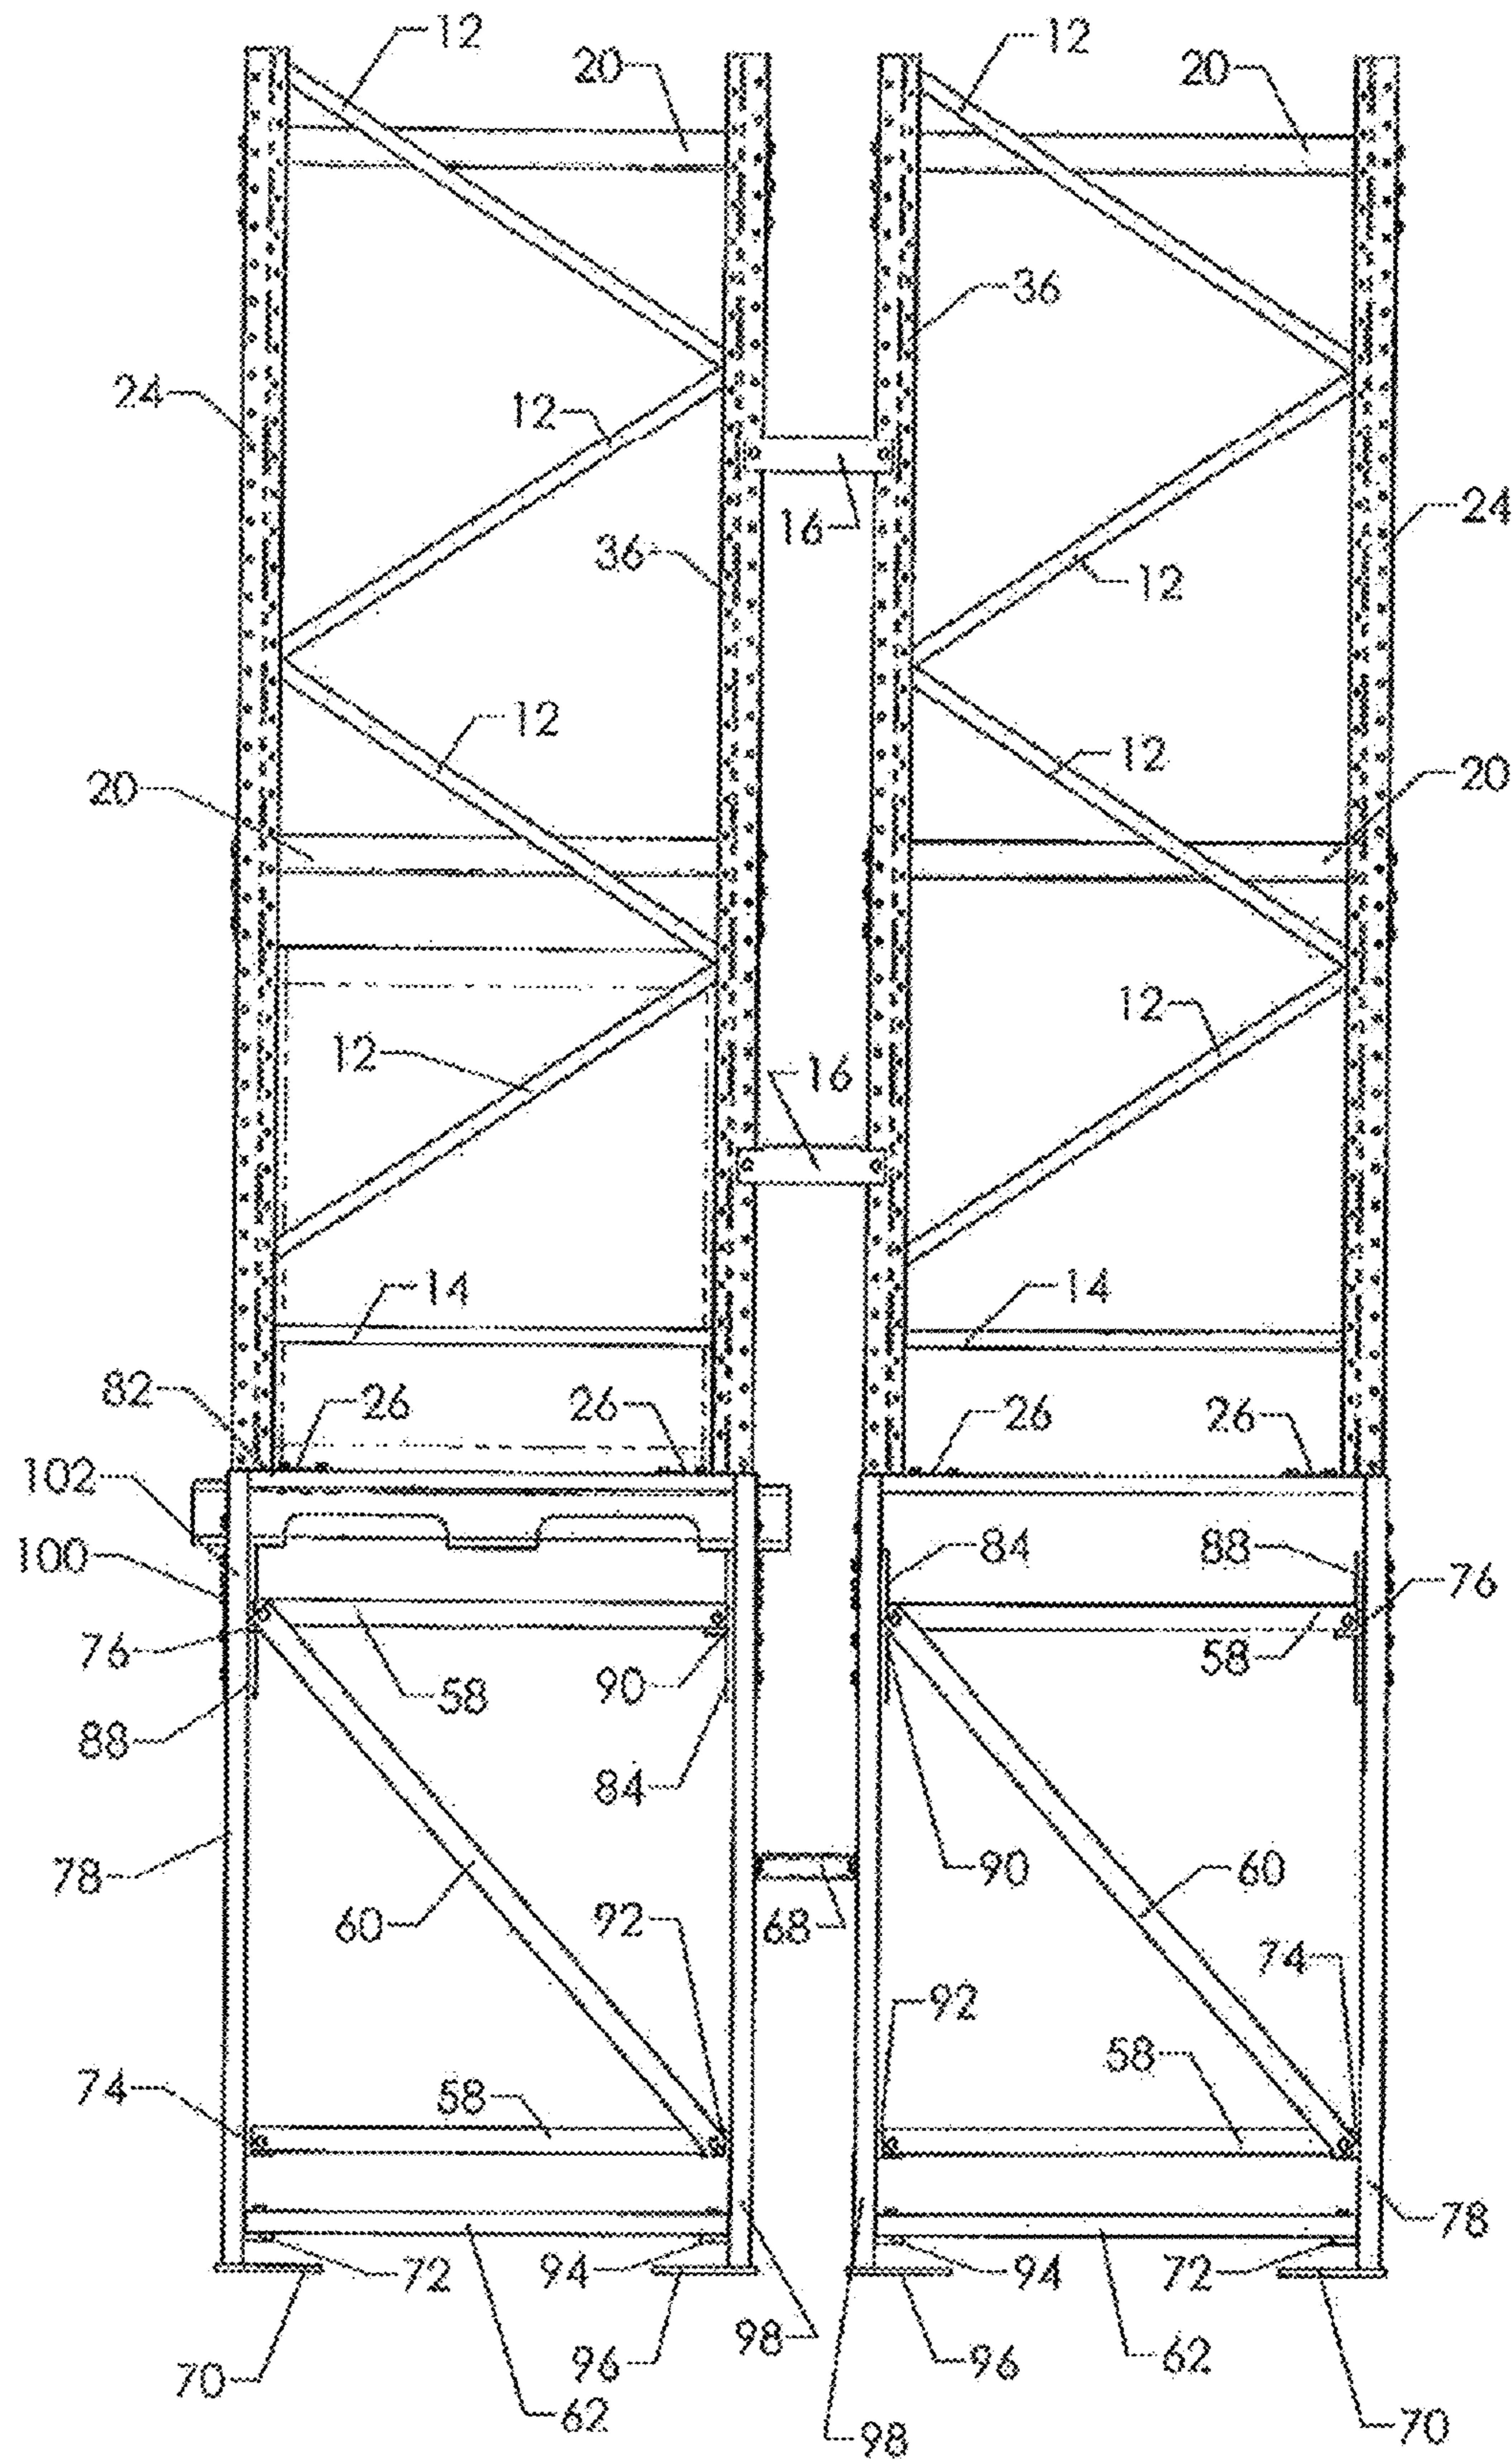
FIG. 6 is a side view of the storage system of FIG. 2;
