(54) **INTERCHANGEABLE BASE STEEL  
STRUCTURE STORAGE ASSEMBLY**

A storage rack assembly includes a base steel structure which is interchangeably connected to the storage rack above. The base steel structure assembly is comprised of structural material with bolted connections which allow for the replacement or changing of damaged material due to accidental forklift contact all while the above storage system stays in place.

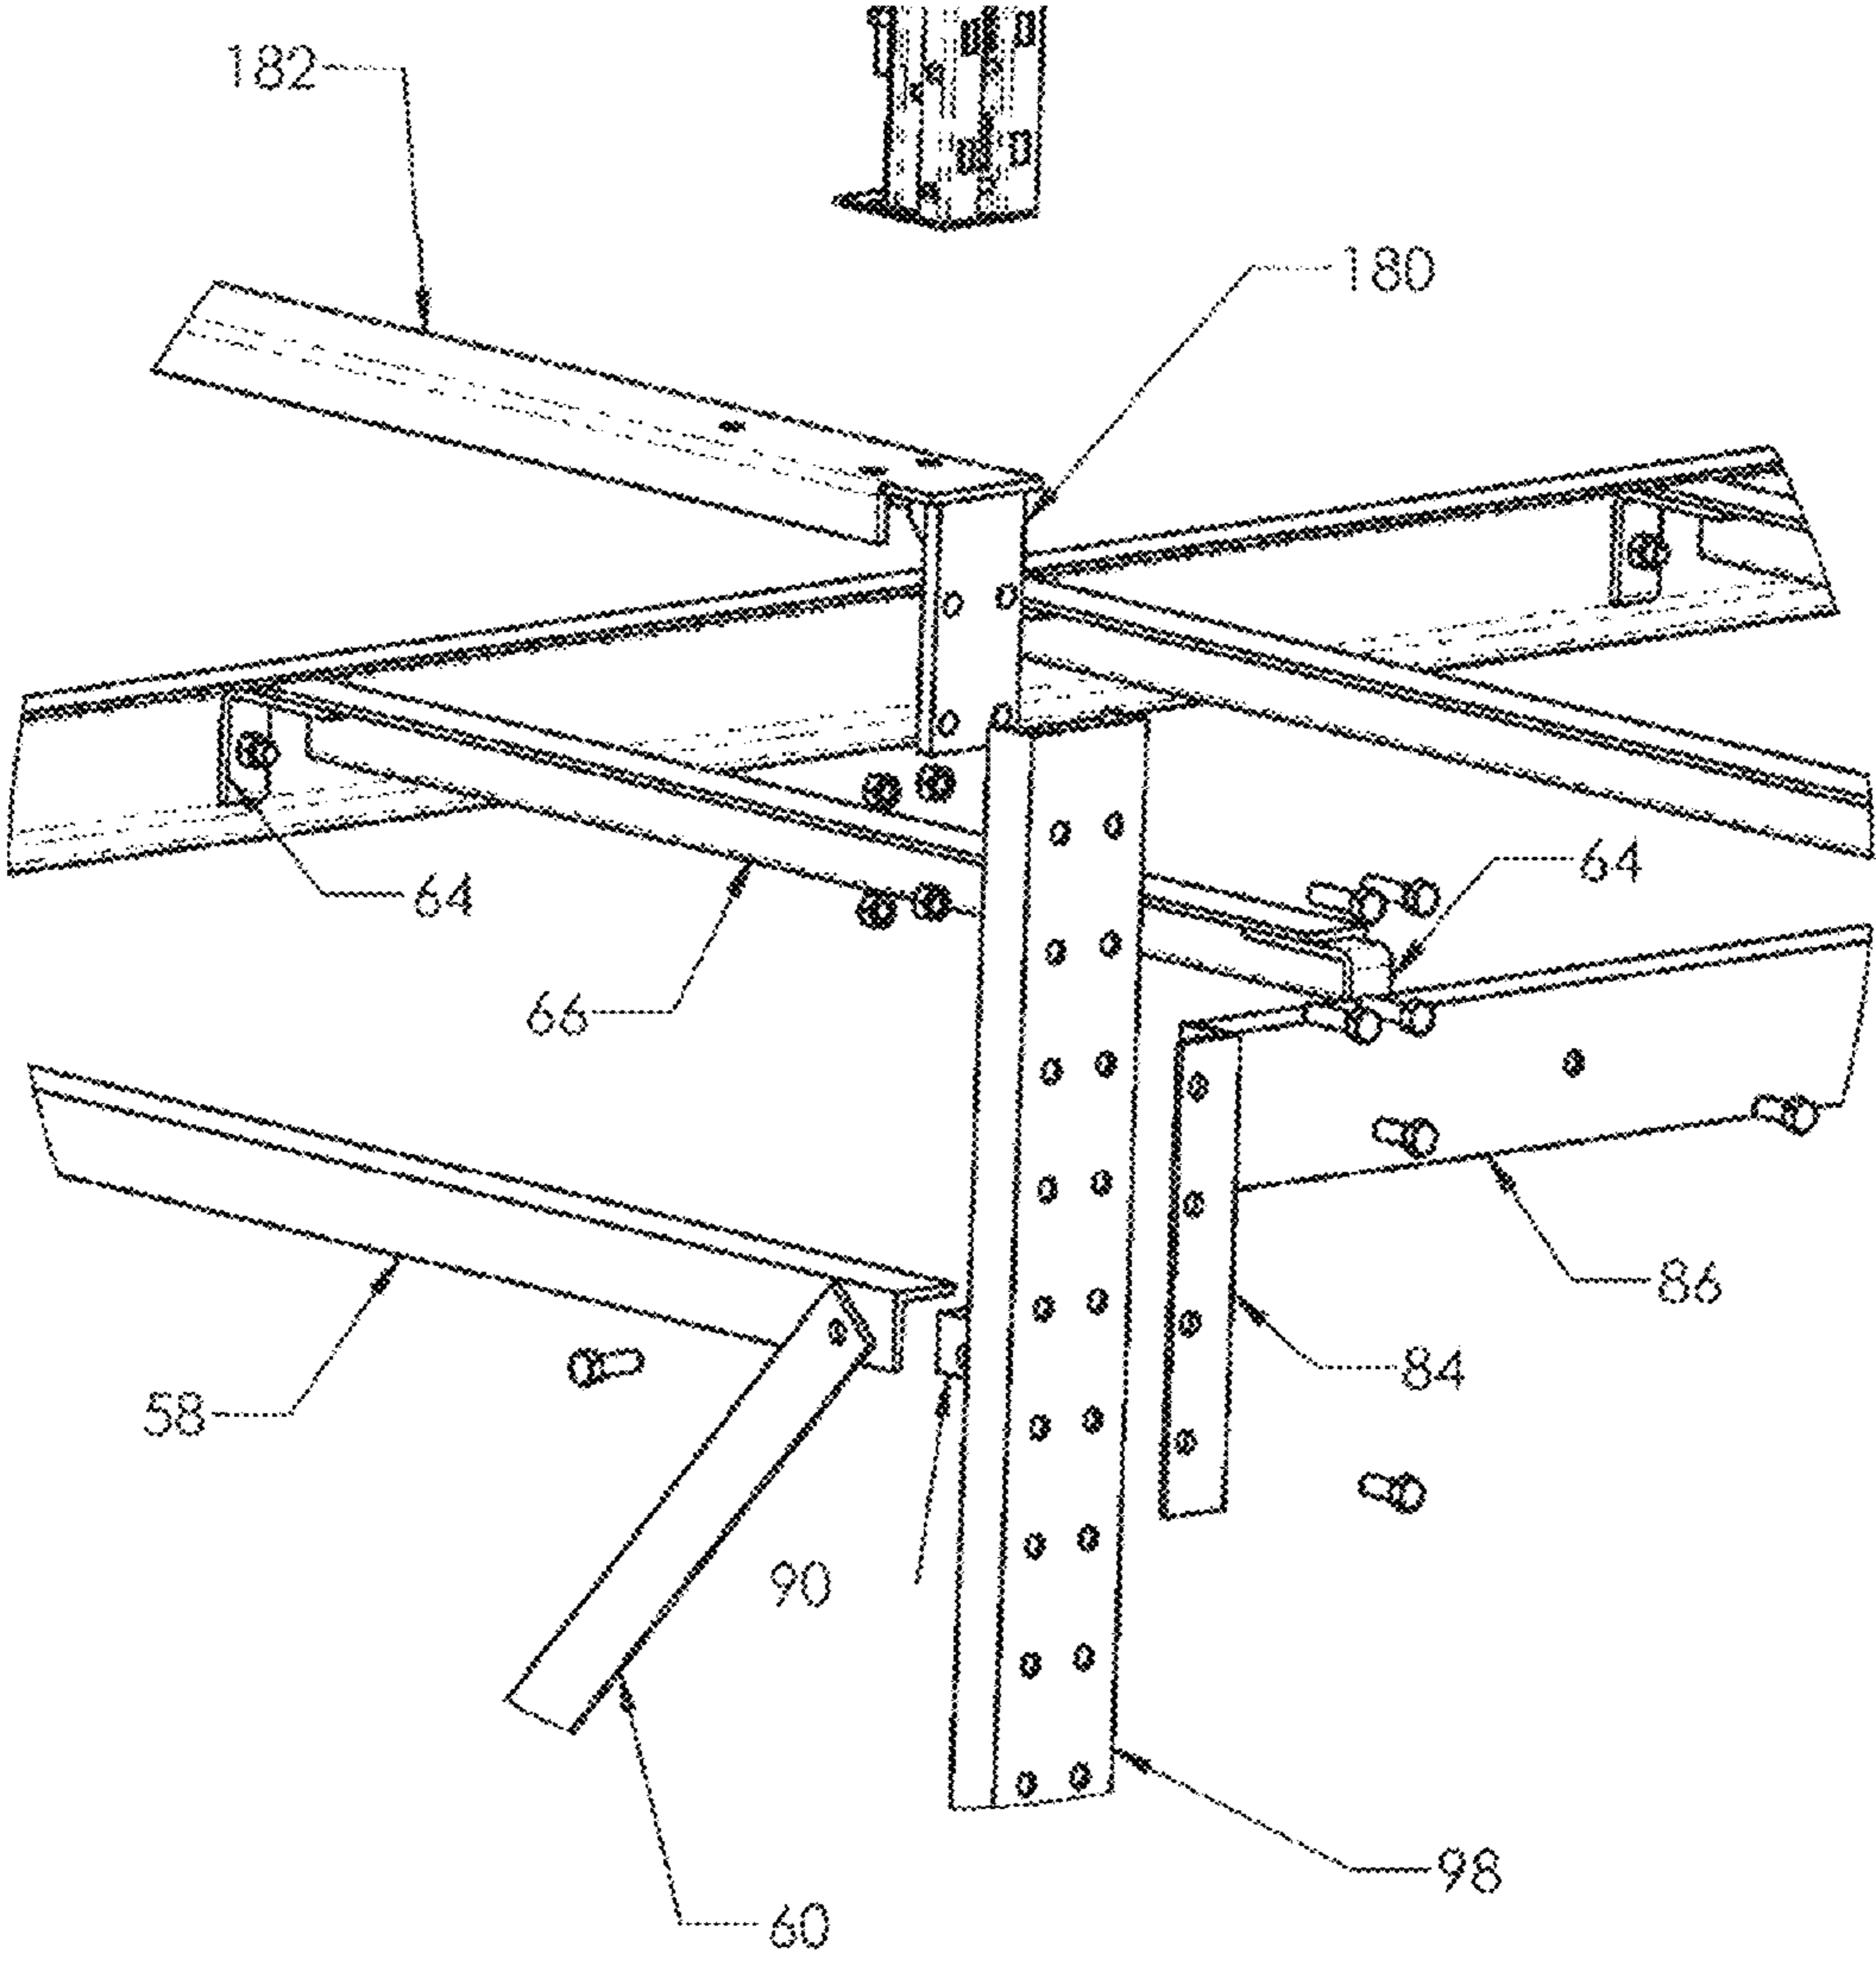
FIG. 13 is an exploded side perspective view of the upper right portion of the base showing an enhanced connection detail.

FIG. 13 shows the base assemblies in an exploded view for the rear column **98**, the enhanced top horizontal member **182**, the repositioned plate **180** as well as the horizontal brace **58** and diagonal brace **60**. The explanation for enhancements to both **180** and **180** are explained in FIG. 12.
