US011958150B2

(54) **METHOD FOR REPAIRING A DAMAGED LEADING OR TRAILING EDGE REGION OF A METALLIC TURBINE BLADE**

(71) Applicant: **Siemens Energy Global GmbH & Co. KG, Bayern (DE)**

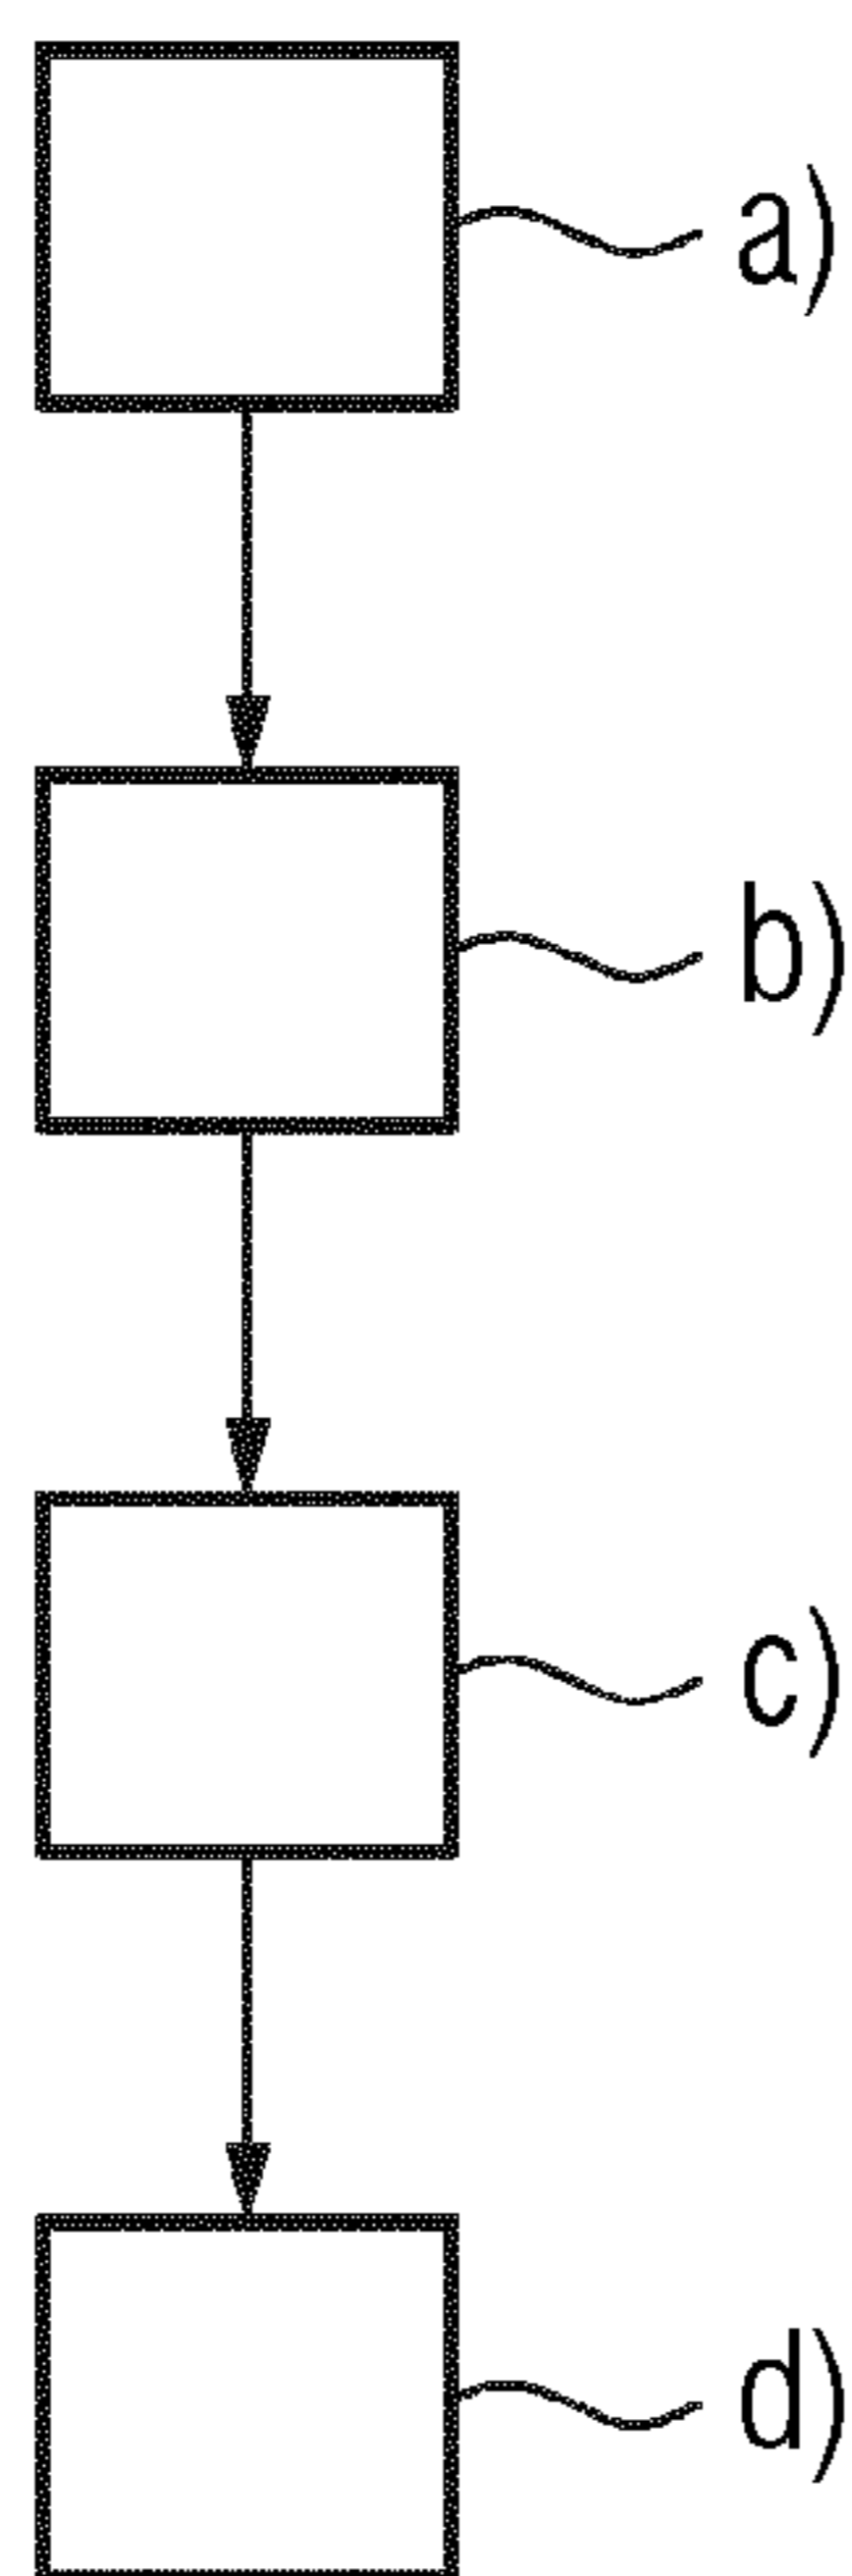
FIG 1

FIG. 1 shows a schematic illustration of the method steps of a method according to one embodiment of the present invention;

FIG. 1 shows schematically a method according to one embodiment of the present invention which is used to repair a damaged metallic turbine blade 1. In the present example, a damaged trailing edge region 2 of a turbine blade 1, comprising a suction-side blade wall 3, a pressure-side blade wall 4, a leading edge 5 and a trailing edge 6, is repaired using the method according to the invention as shown in FIG. 2. However, it should be clear that other damaged regions of the turbine blade 1 may be repaired using the method according to the invention, in particular damaged regions of the leading edge 5.

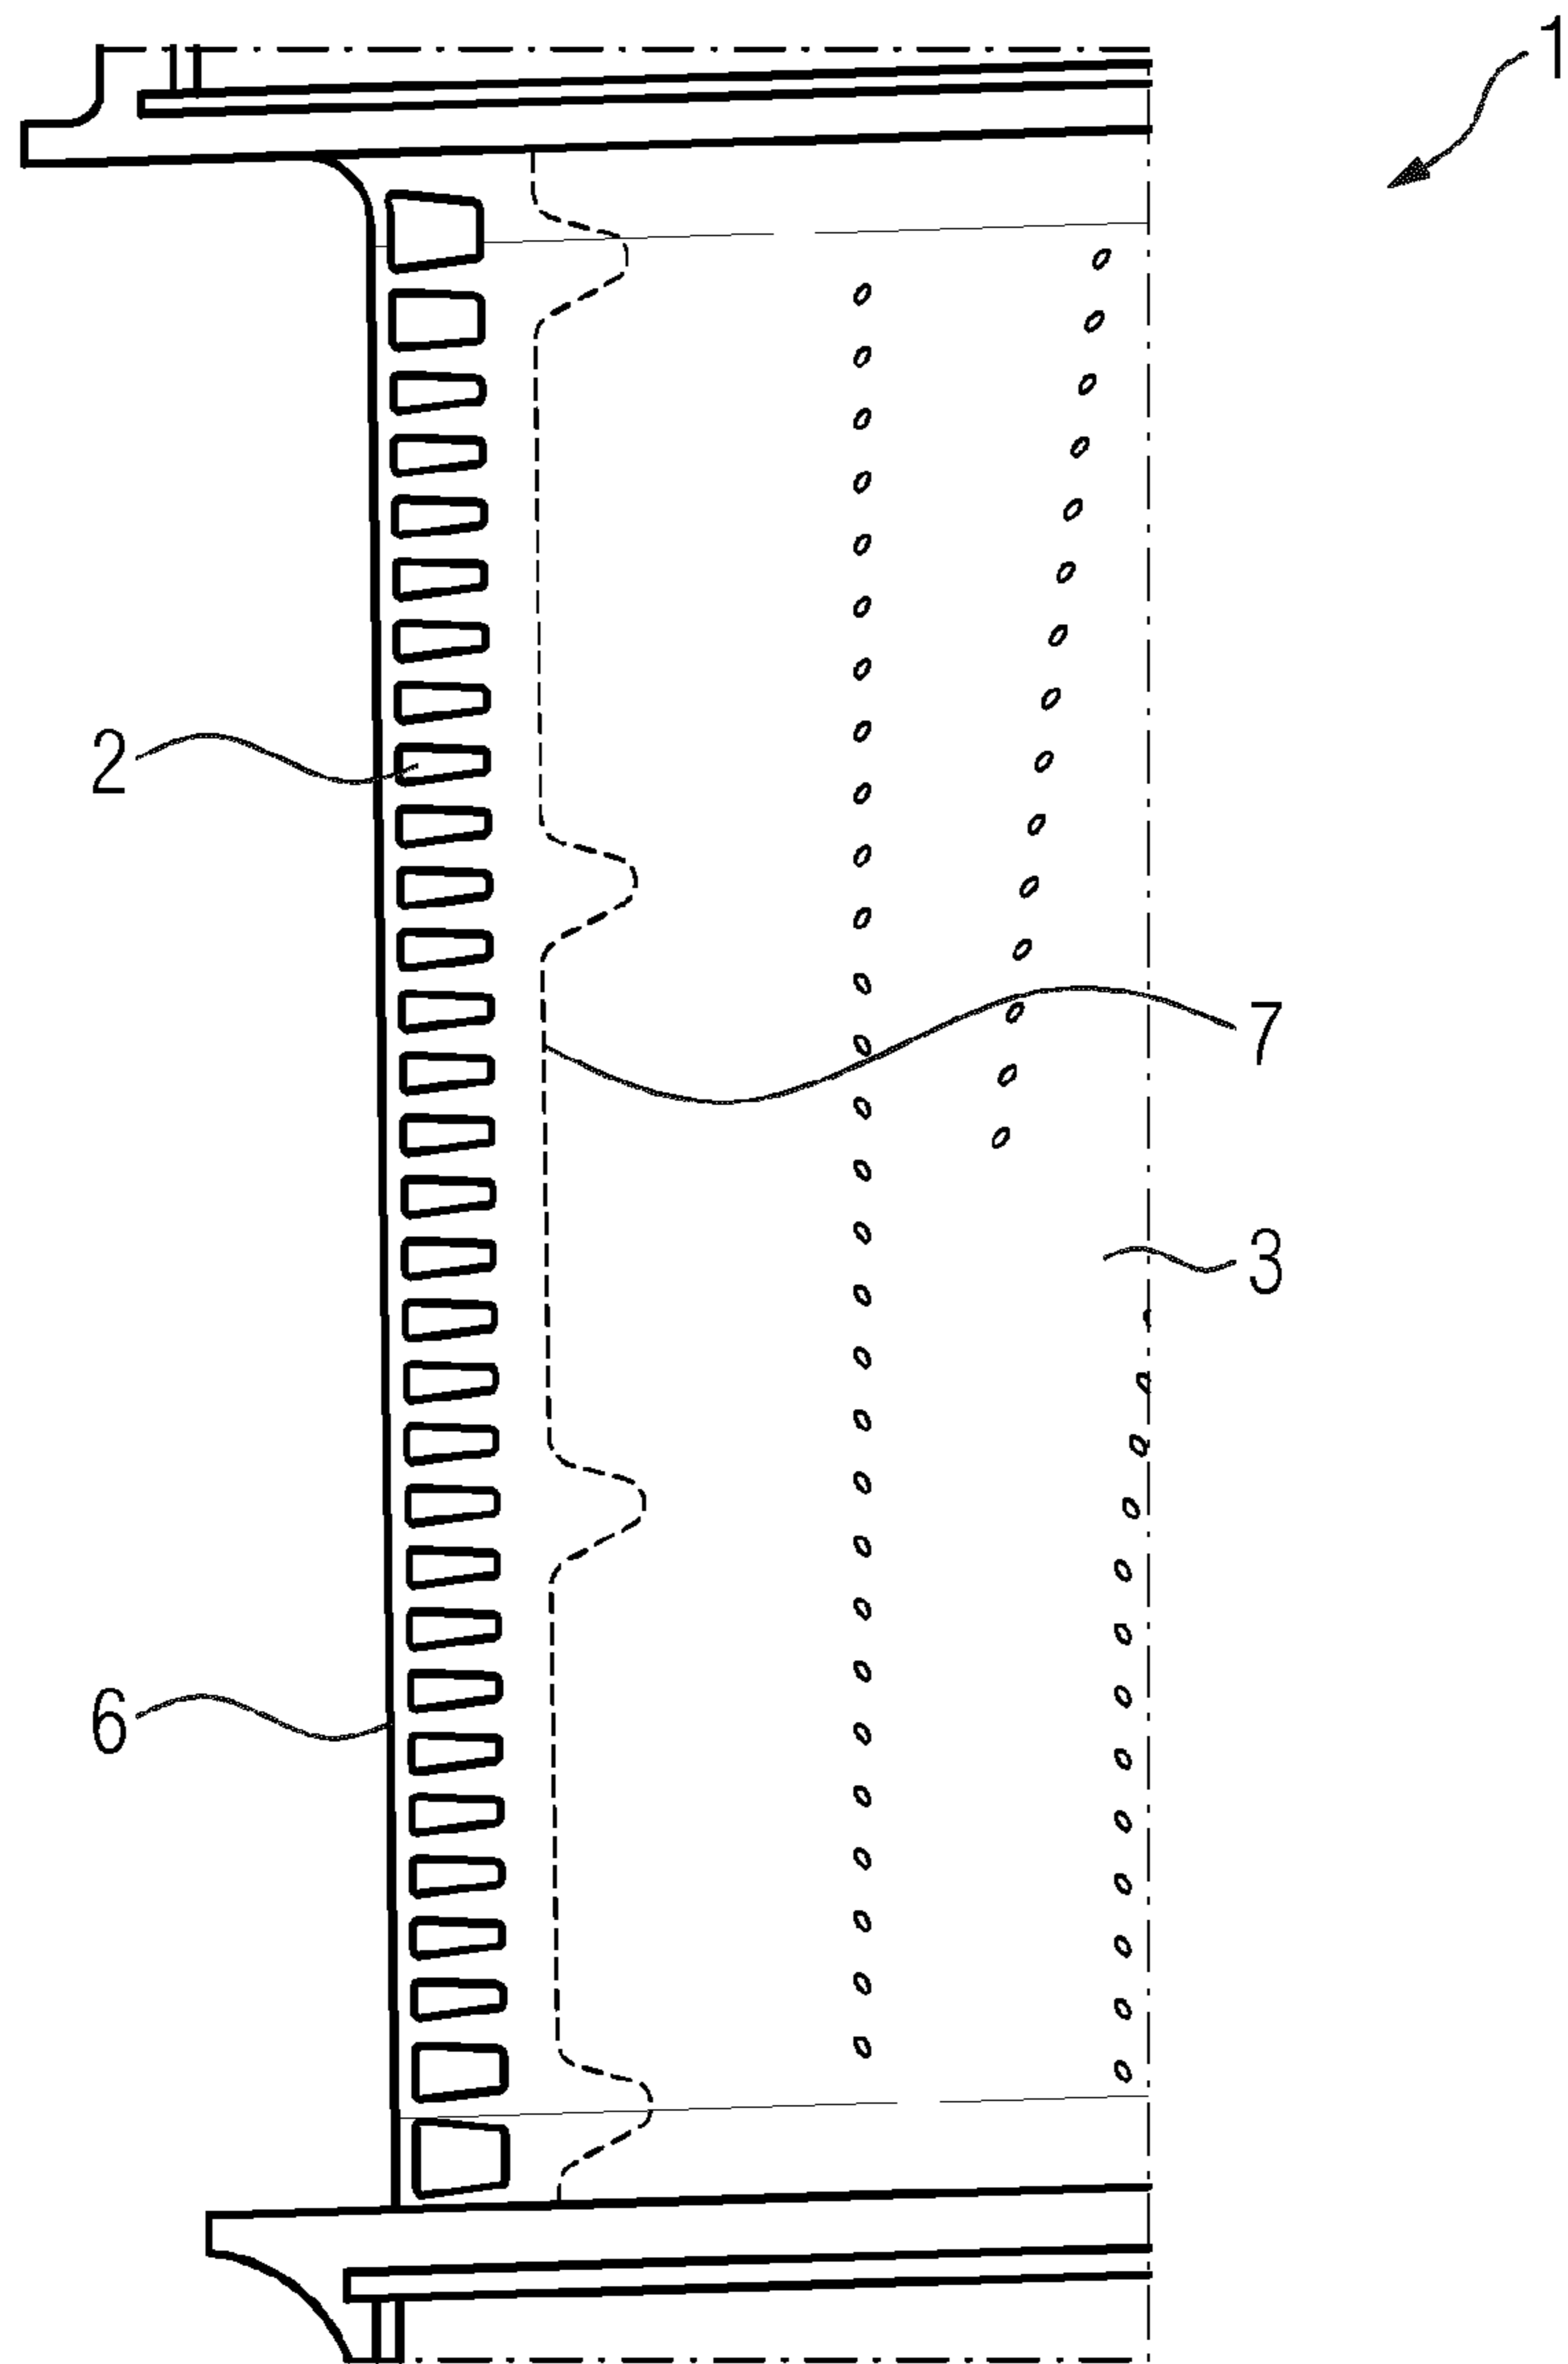
FIG 2

FIG. 2 shows a side view of a part region of a turbine blade with damaged trailing edge which is to be repaired using the method illustrated in FIG. 1;

In a first step a), the damaged trailing edge region 2 is removed by forming a cutout 7, illustrated in FIG. 2 as a dotted line. The cutout 7 should be selected sufficiently large to cover, as far as possible, all damage present in the region of the trailing edge 6. In the present case, the cutout 7 is created using a vertical spark erosion process, wherein in principle naturally other material-removal processes are conceivable such as e.g. milling or grinding. During creation of the cutout 7, recesses 9 without undercut relative to the insertion direction 8 are formed on the blade walls 3 and 4, wherein the recesses 9 of the suction-side blade wall 3 are positioned offset to the recesses 9 of the pressure-side blade wall 4 when the turbine blade 1 is viewed from the side according to FIG. 3.

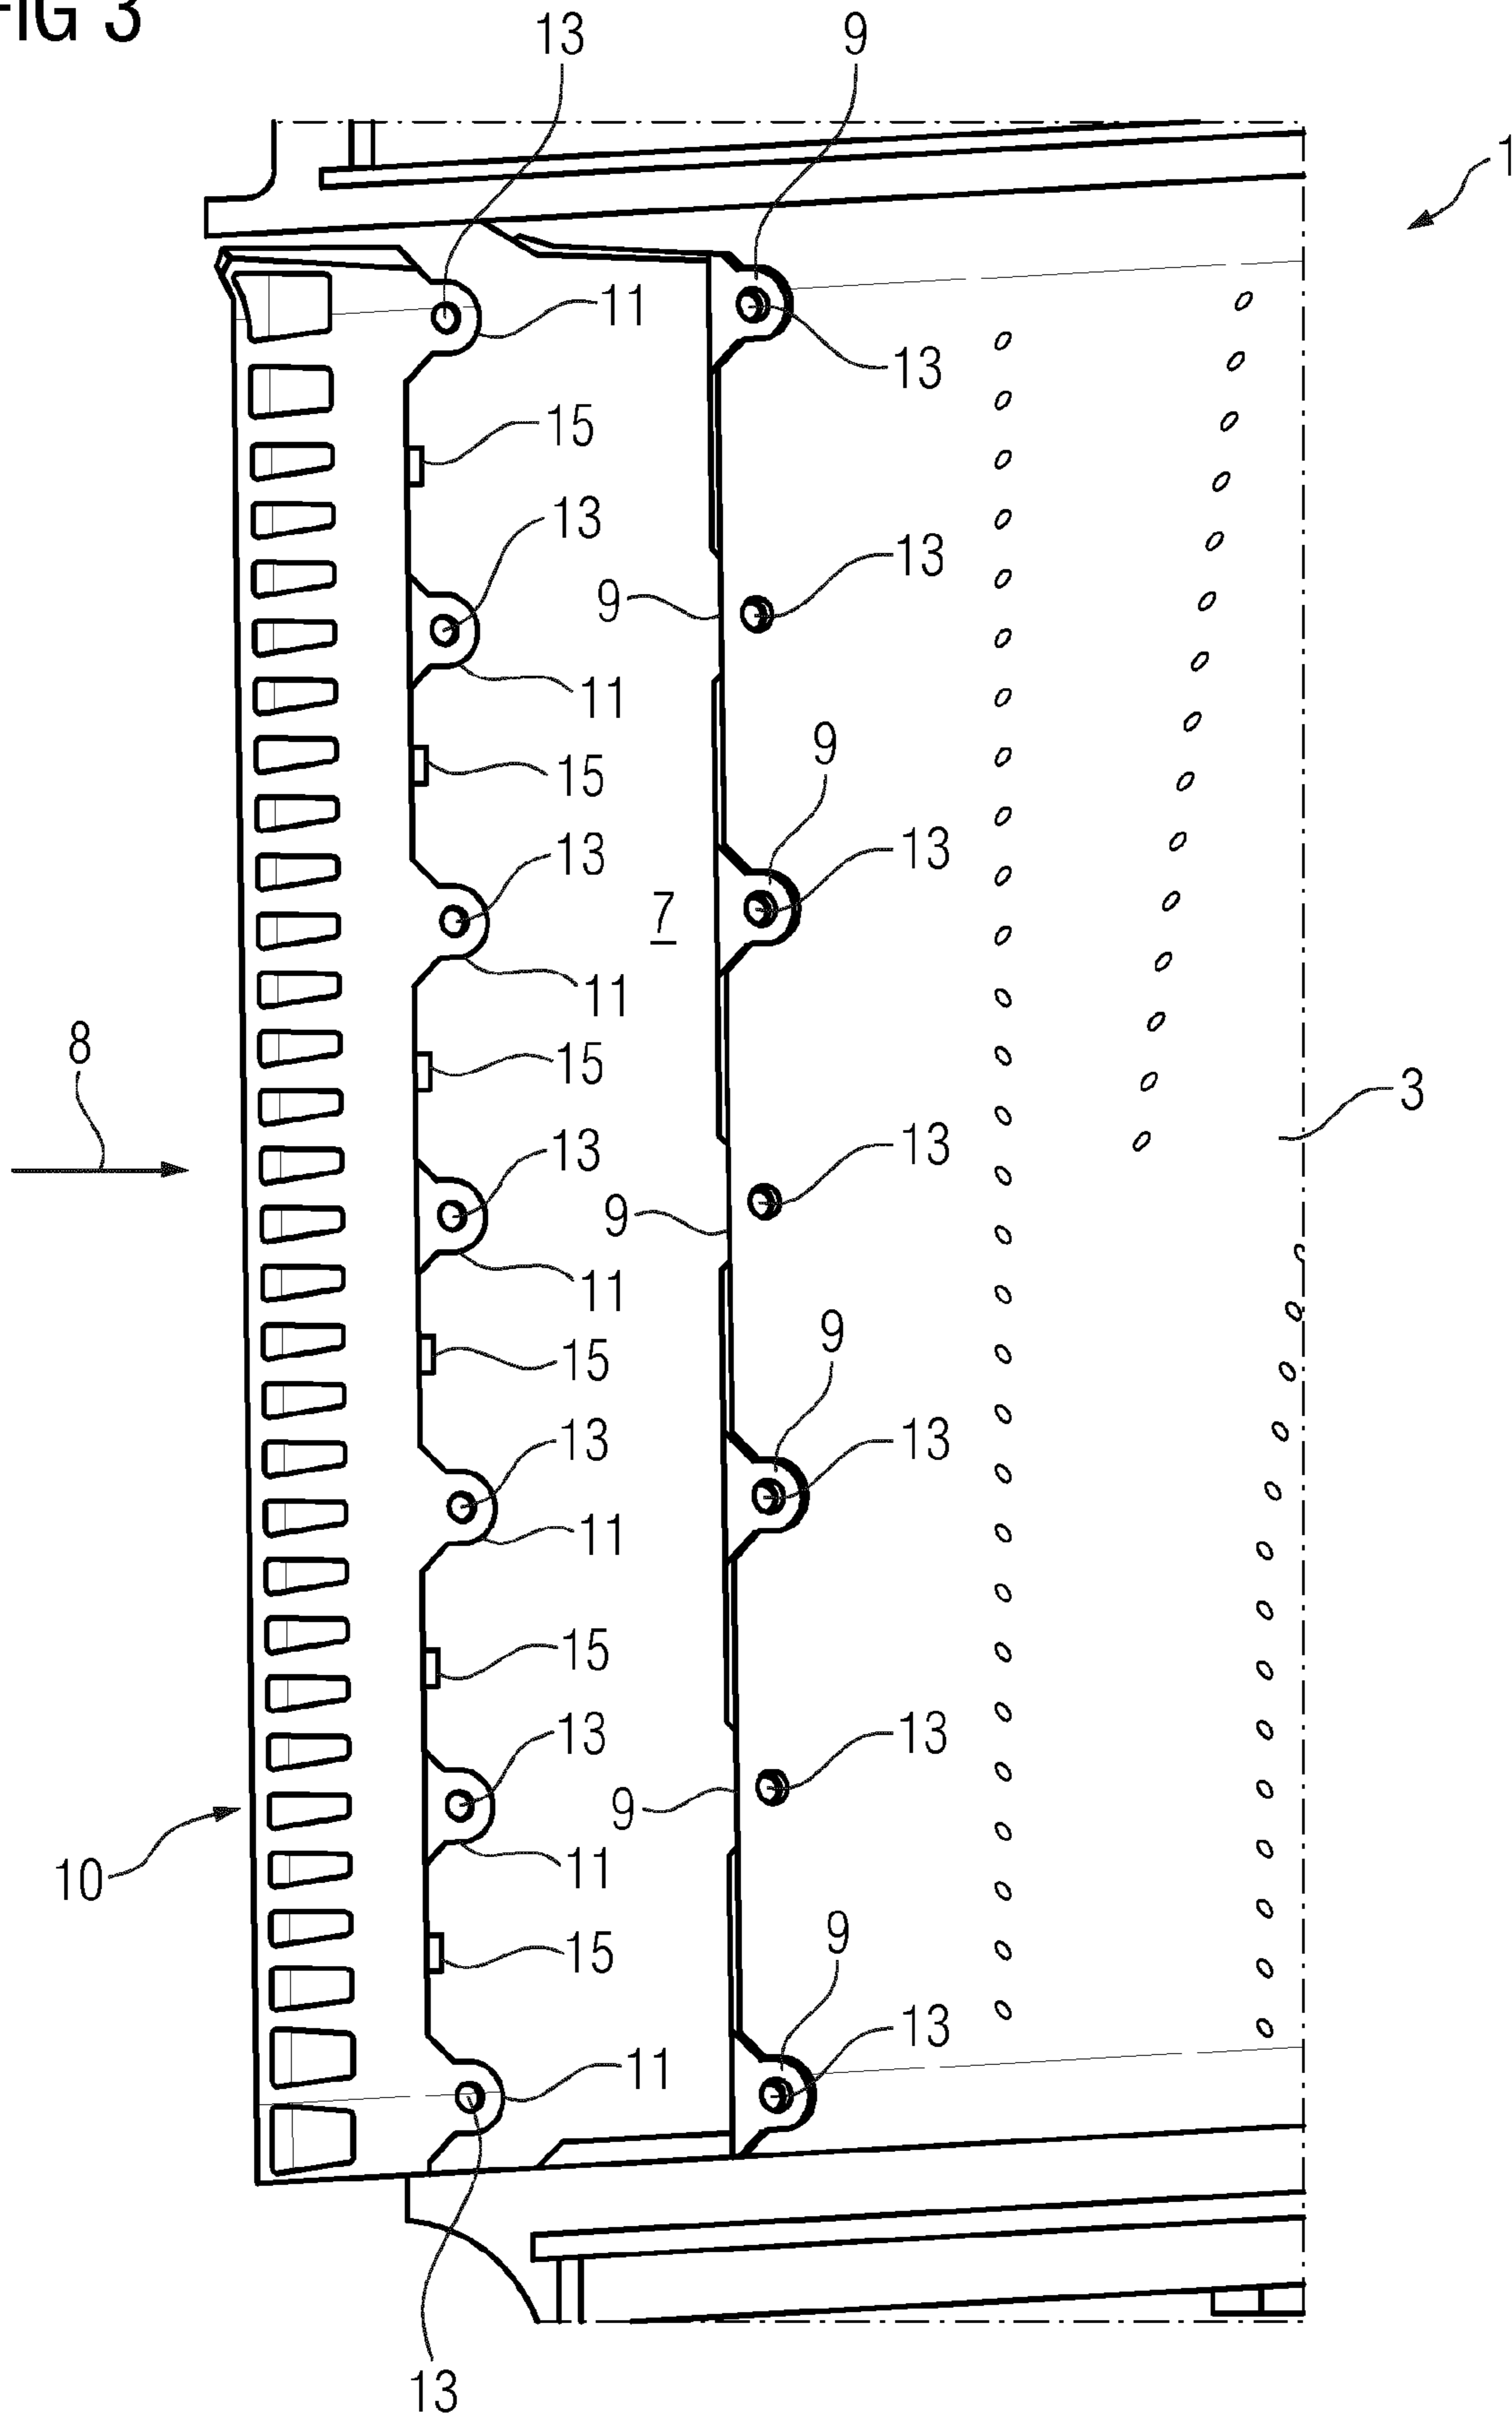
FIG 3

FIG. 3 shows a side view of the turbine blade illustrated in FIG. 2, in which the damaged trailing edge region has been removed by forming a cutout, and a replacement part which can be inserted by form fit in the cutout and restores the intended geometry of the damaged trailing edge;

To optimize the substance-bonded connection, the abutting edges of the replacement part 10 may be provided with spacer protrusions 15, as indicated in FIG. 3, so as to set a predetermined joint width for the substance-bonded connection.

In a further step c), the replacement part 10 is inserted by form fit in the cutout 7 in the insertion direction 8. The protrusions 11 of the replacement part 10 are here inserted in recesses 9 formed in the blade walls 3 and 4, creating regions in which the replacement part 10 and the turbine blade 1 overlap one another when the turbine blade 1 is viewed from the side, see again the view in FIG. 3. Before performance of step c), the standard replacement part may be machined in order where necessary to minimize any deviations of the geometry of the standard replacement part from the geometry of the cutout 7, for example deviations which have resulted from a distortion of the turbine blade 1 during use in a gas turbine. After insertion in the cutout 7, in step c) the replacement part 10 is furthermore mechanically fixed to the turbine blade 1 using fixing elements 12 extending through the mutually overlapping regions, such that this mechanical fixing blocks any removal of the replacement part 10 from the cutout 7 against the predetermined insertion direction 8. In the present case, the fixing elements 12 are pin-like fixing elements which extend through passage openings 13 formed firstly in the blade walls 3 and 4 and secondly in the protrusions 11 of the replacement part 10. The passage openings 13 of the turbine blade 1 may for example be produced, in particular by boring, during step a) after production of the cutout 7.

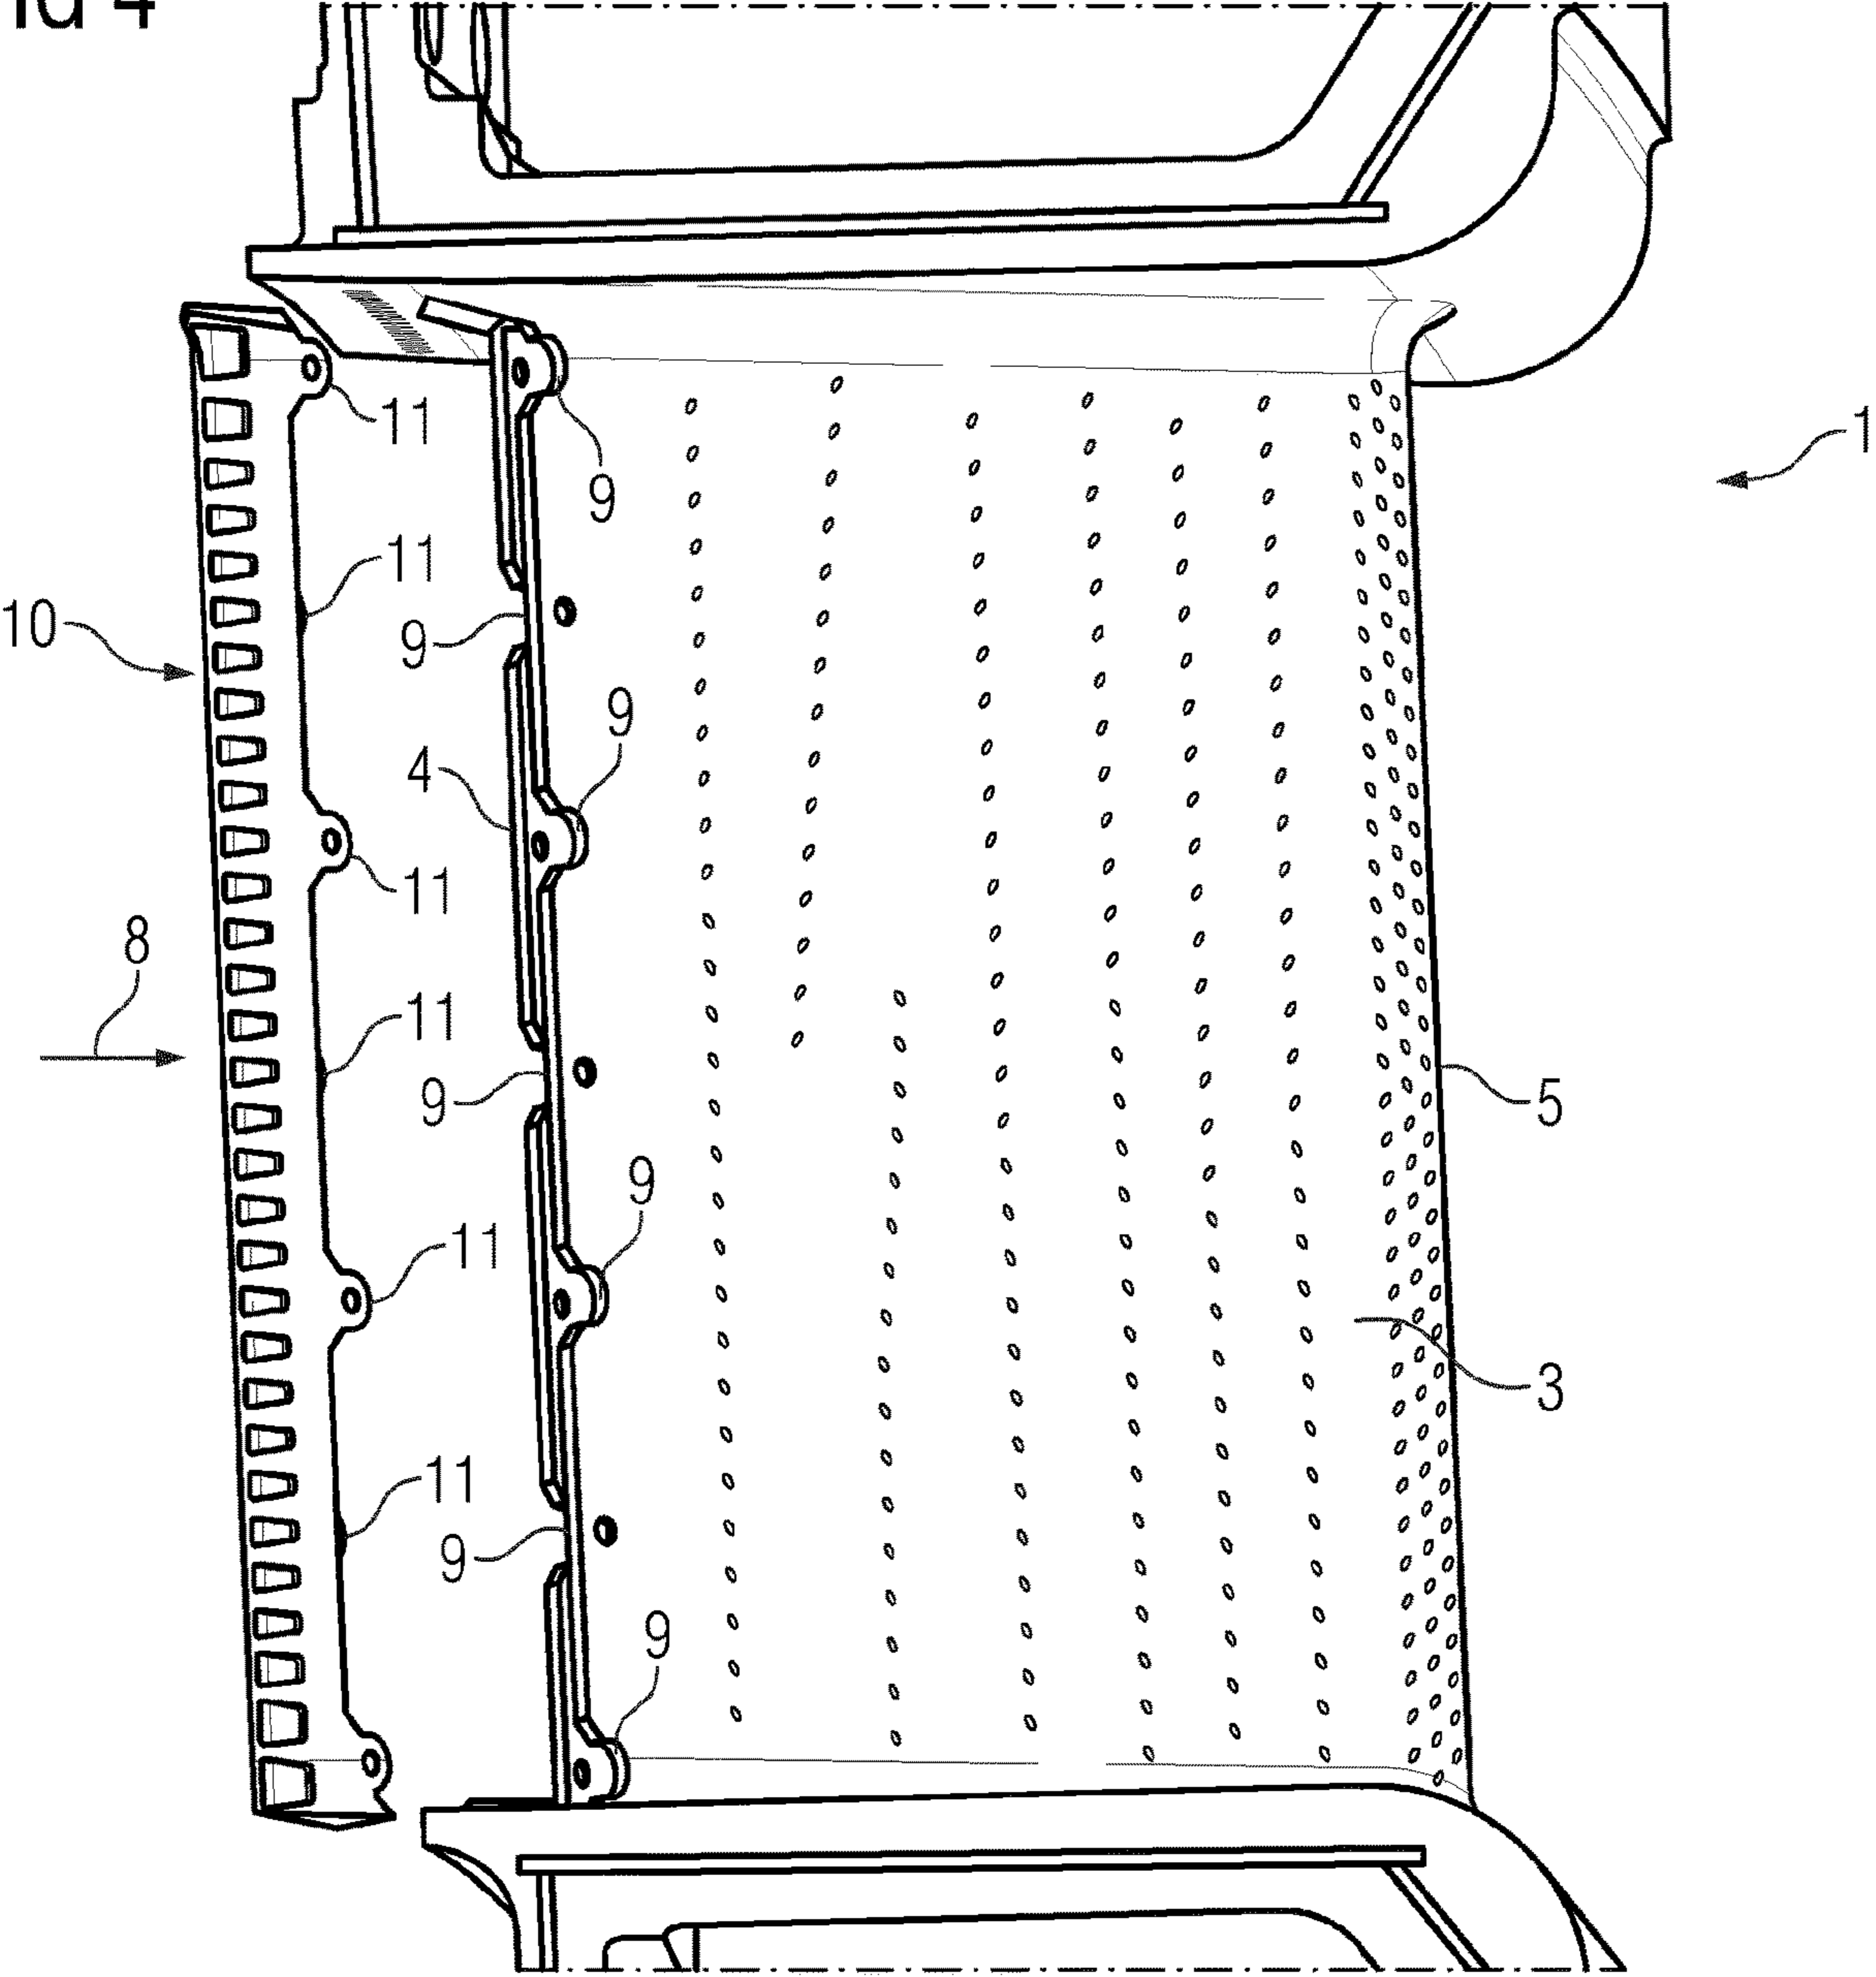
FIG 4

FIG. 4 shows a perspective view of the arrangement shown in FIG. 3; and

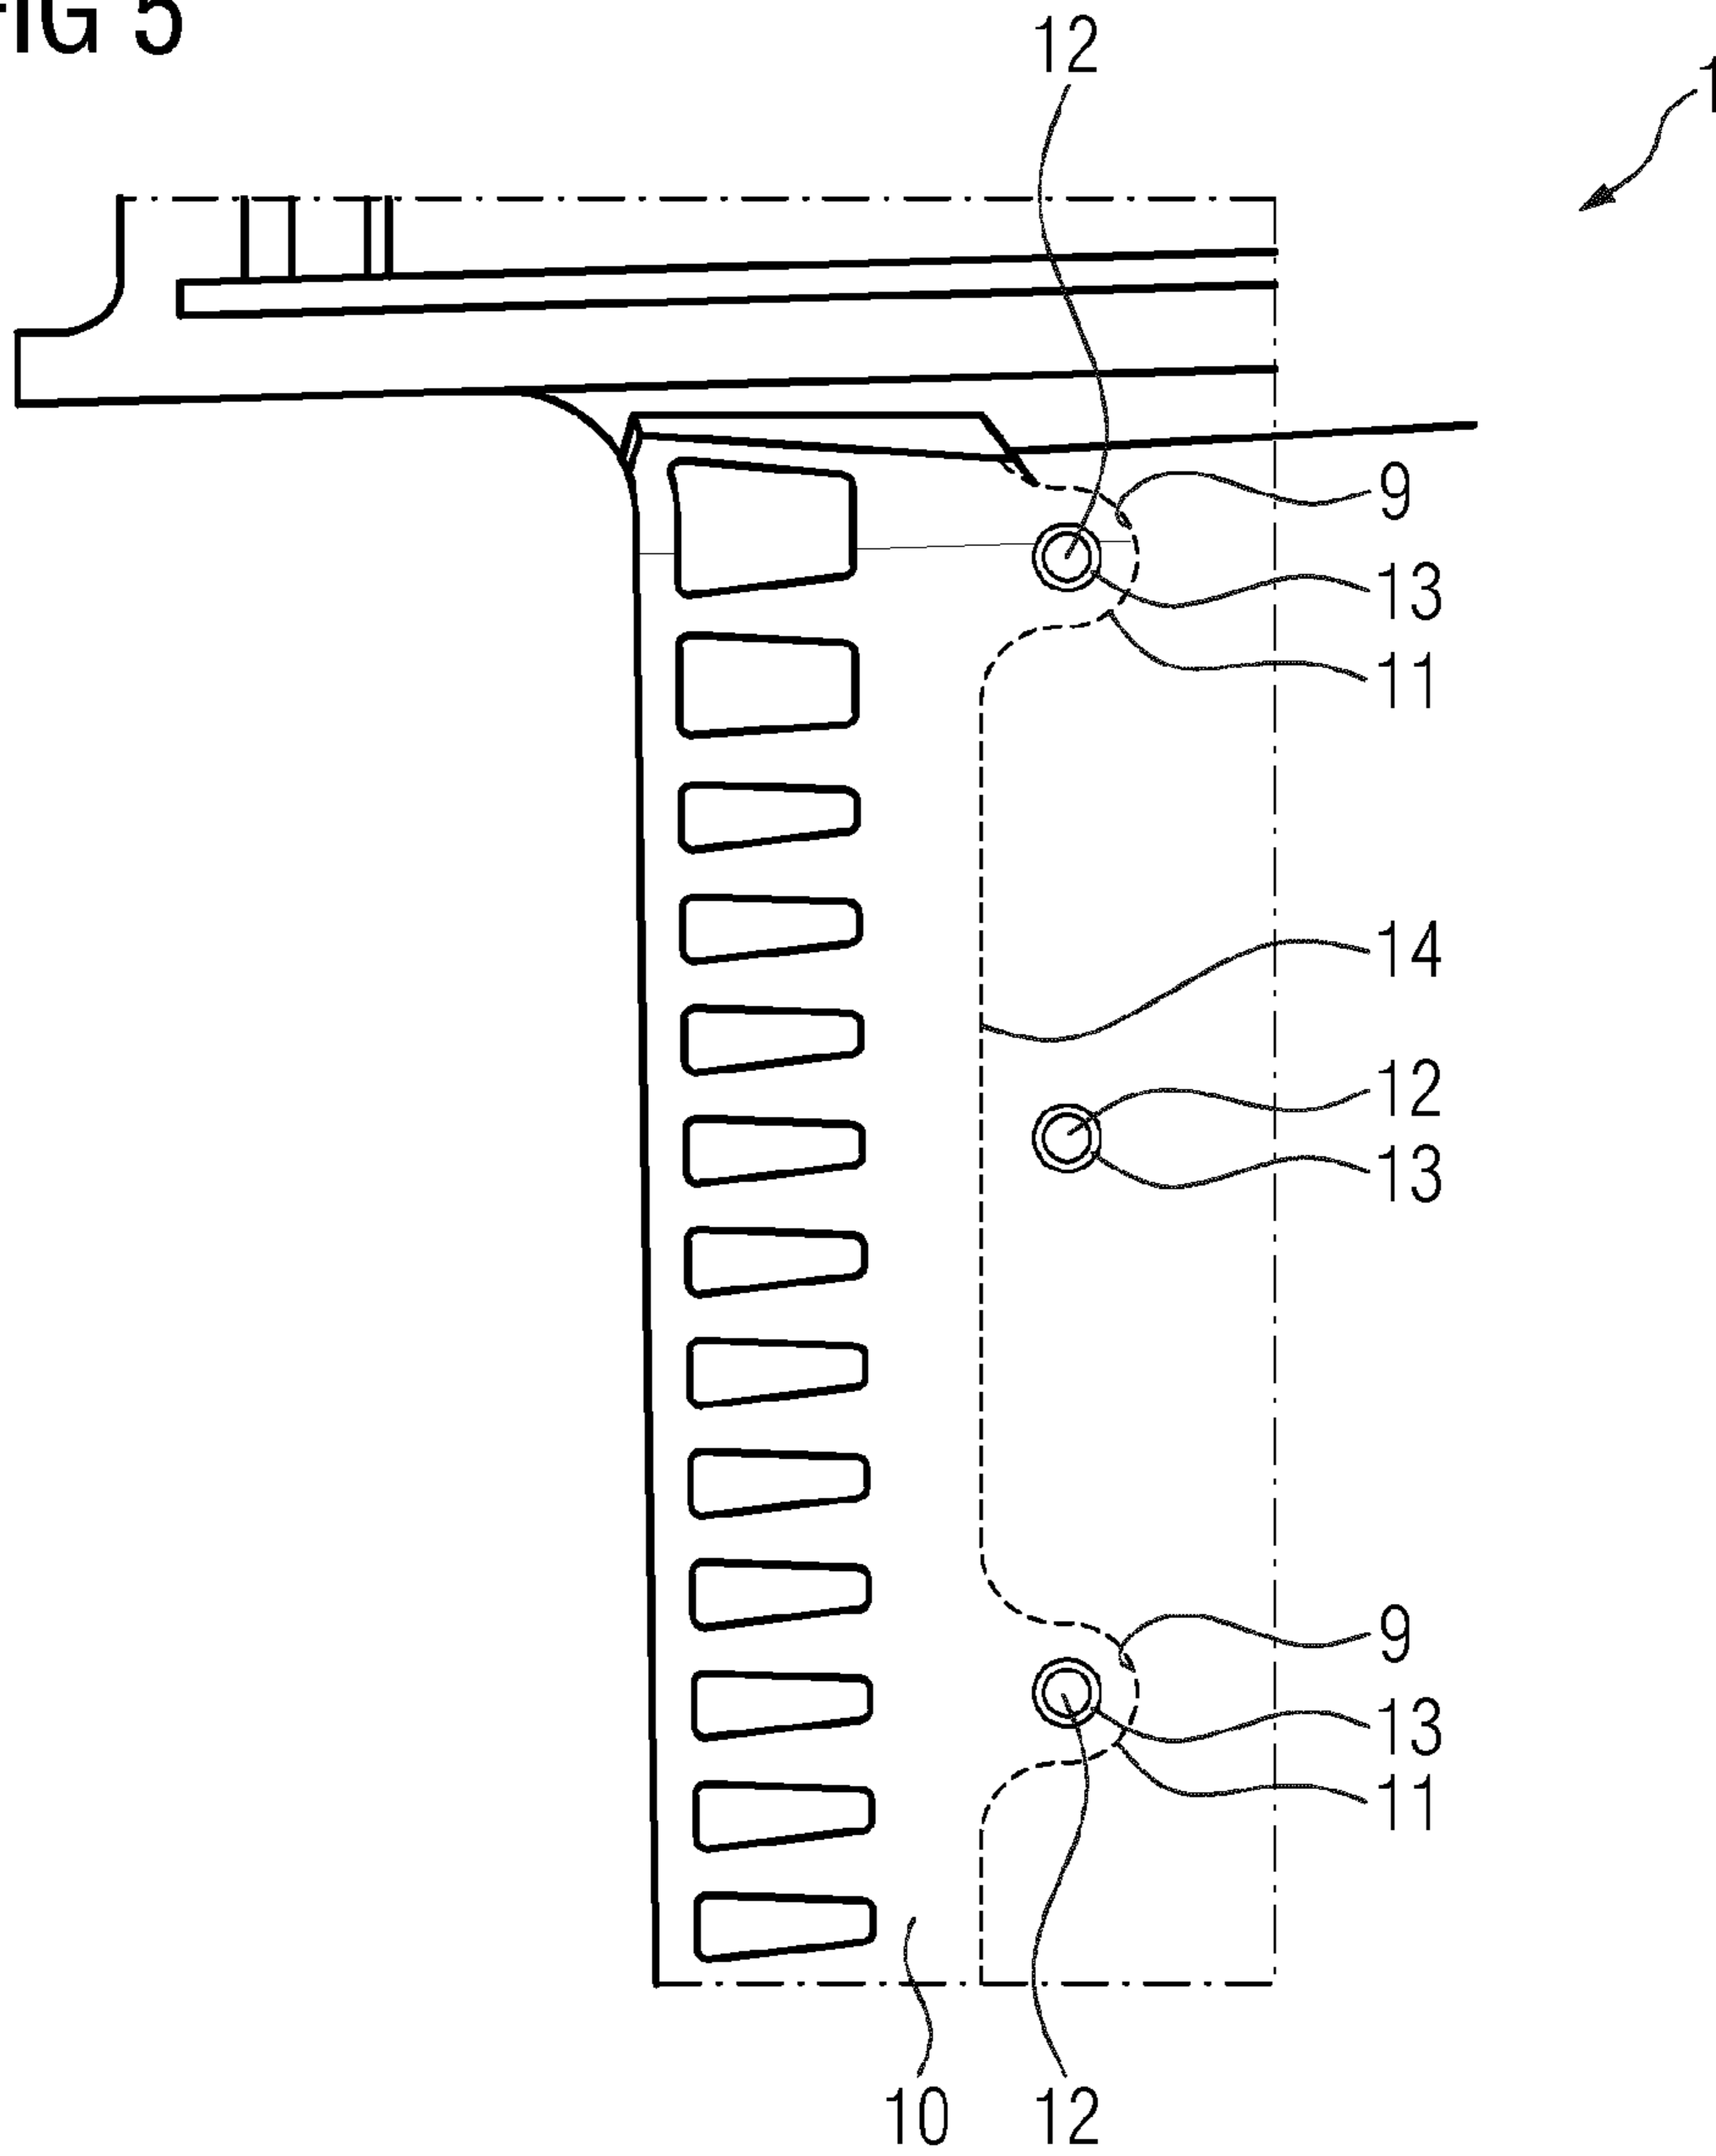
FIG 5

FIG. 5 shows a side view of the arrangement illustrated in FIGS. 3 and 4, in a state in which the replacement part is fixed to the turbine blade.

In a subsequent step d), the replacement part 10 and the turbine blade 1 are connected together along their abutting edges by substance bonding, in the present case using a brazing process. FIG. 5 shows the corresponding connecting seams 14.
