US011982207B2

(54) **TIP REPAIR OF A TURBINE COMPONENT USING A COMPOSITE TIP BORON BASE PRE-SINTERED PREFORM**

(71) Applicant: **Siemens Energy, Inc.**, Orlando, FL (US)

The present disclosure relates generally to the field of metallurgy, and more particularly, to processes for the repair of structural defects in a metallic substrate, and even more particularly, to a tip repair of a turbine component using a composite boron base pre-sintered preform.

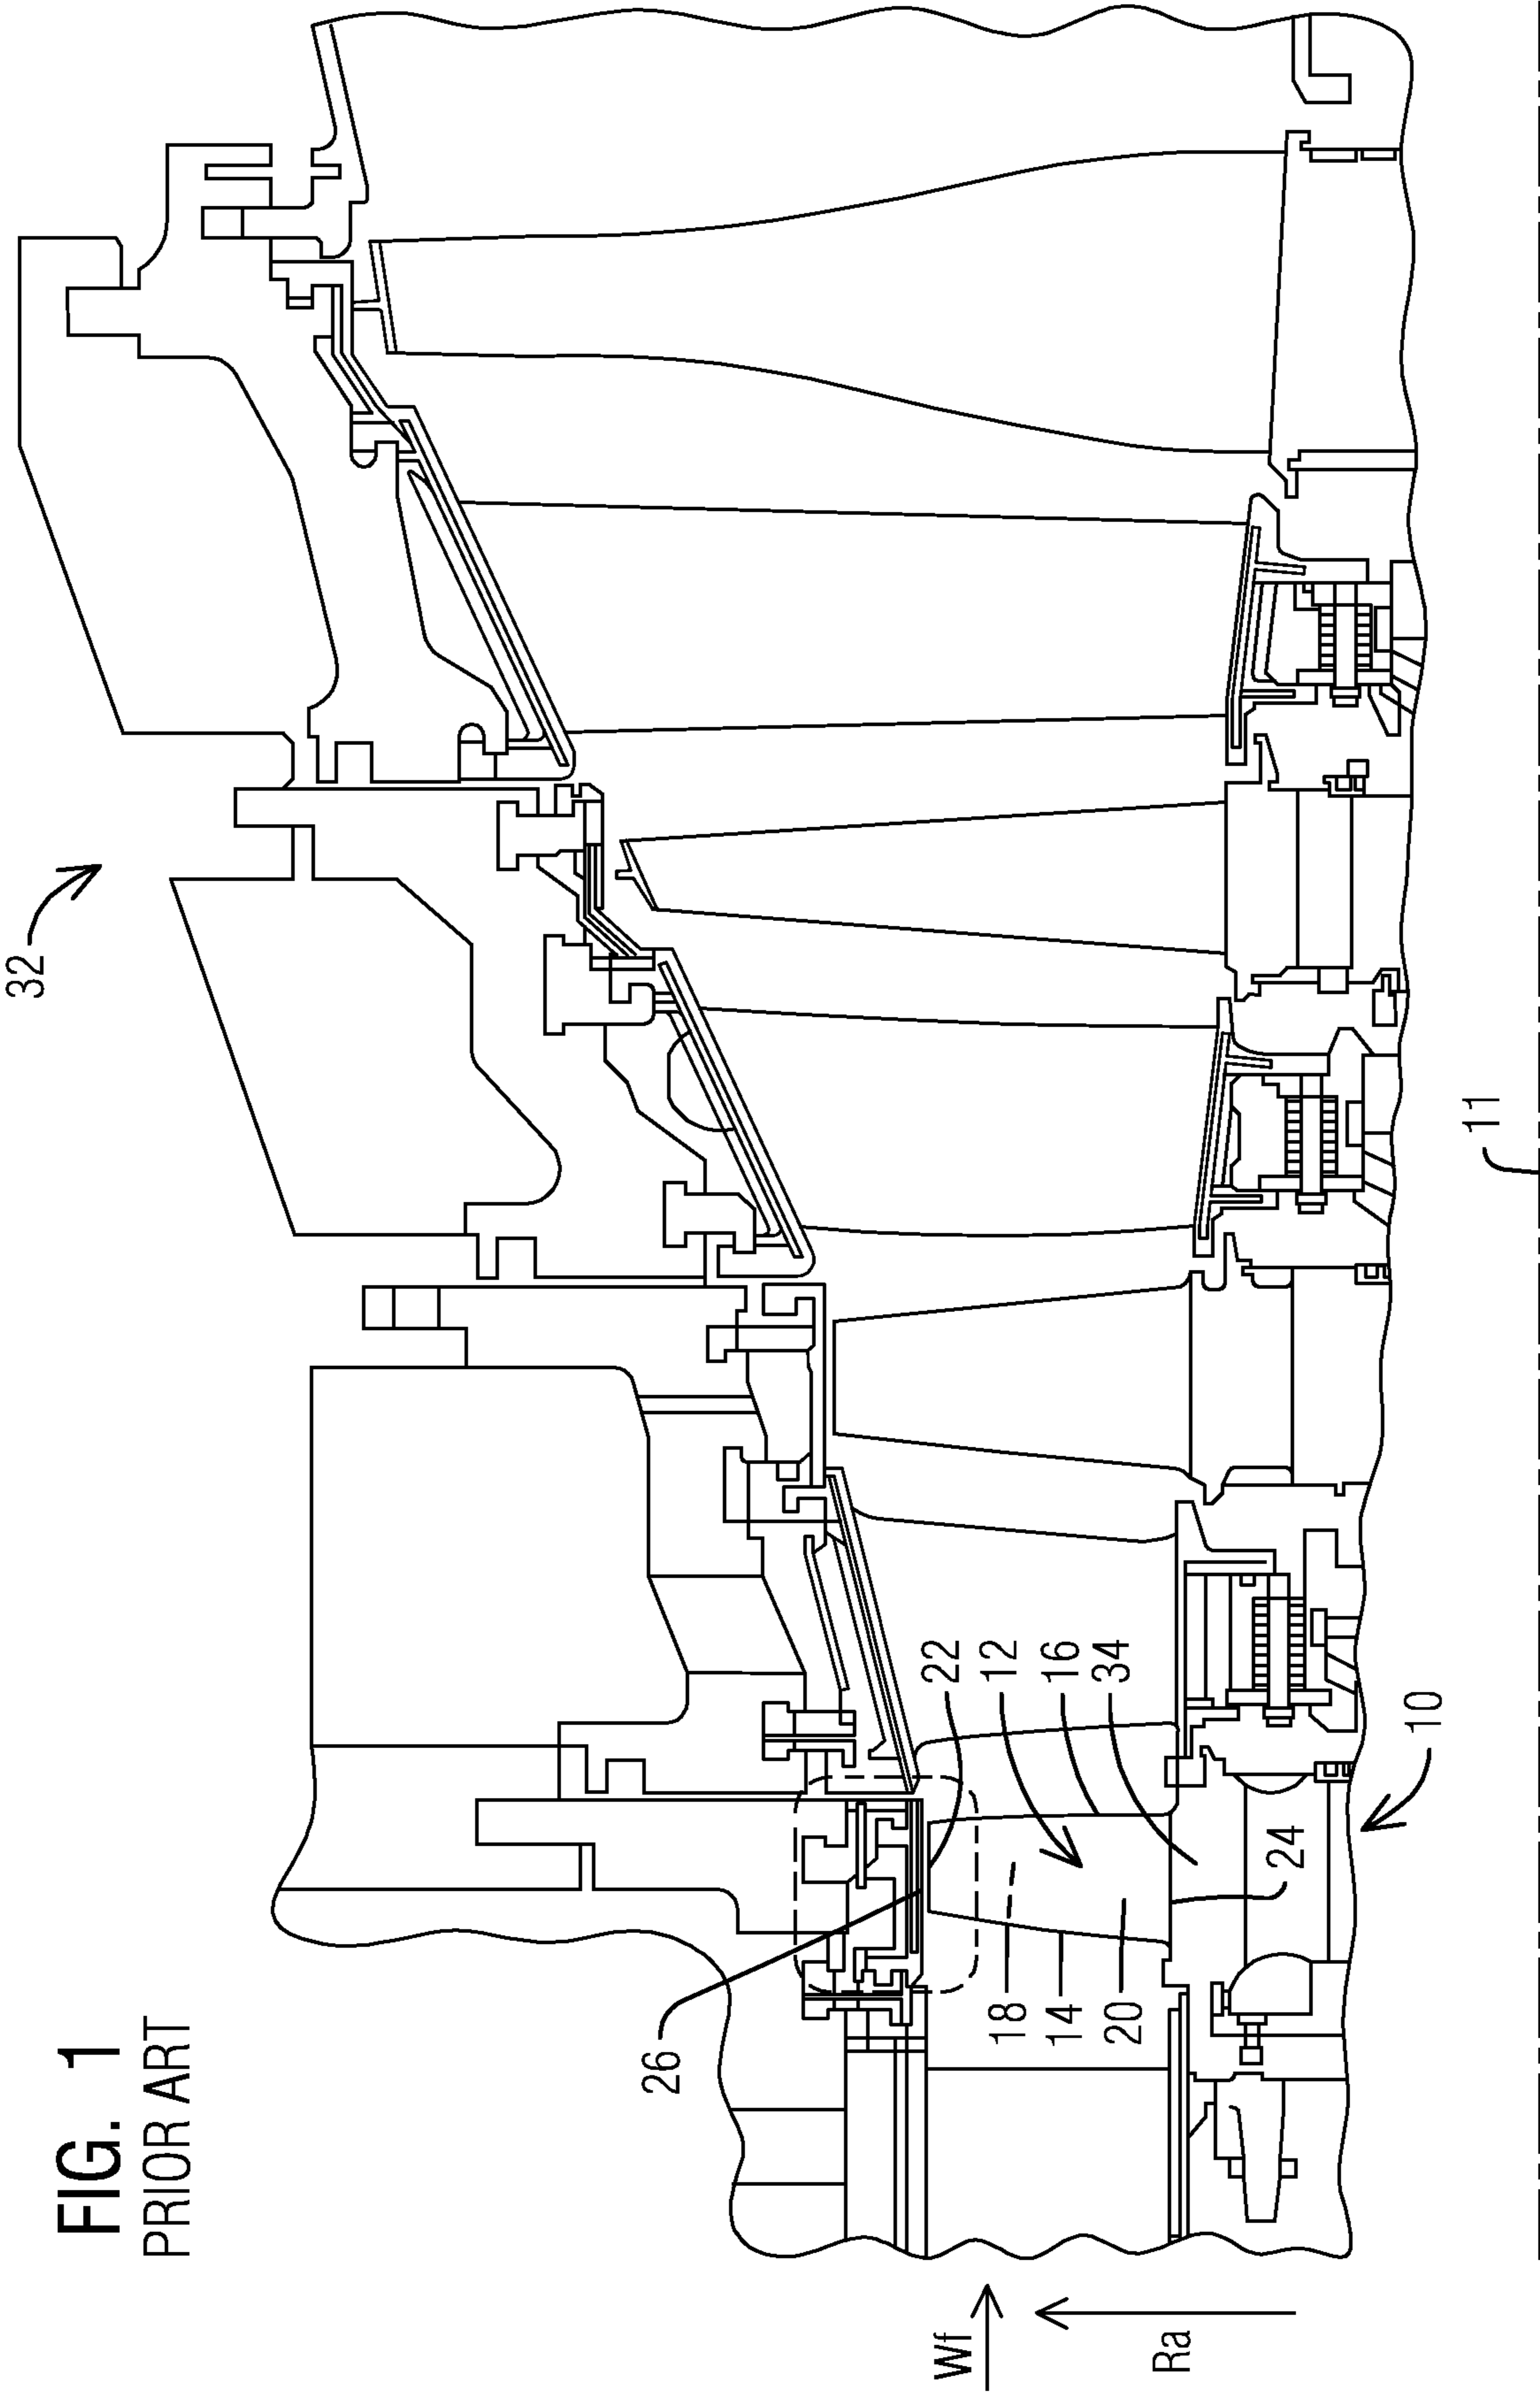
FIG. 1  
PRIOR ART

FIG. 1 is an axial cross-sectional view of a gas turbine engine with a row of turbine blades wherein embodiments of the present invention may be incorporated,

FIG. 2 is a partial cross-sectional view of a configuration of a tip portion of a turbine component,

Referring to FIG. 1, a portion of a turbine engine 32 is shown. A centerline 11 is shown to represent an axial center of the turbine engine 32. A radial direction Ra is shown in a direction that is radially outward. Further, a working fluid Wf direction is shown. A turbine blade 10 is formed from a root portion 34 coupled to a rotor disc (not shown) and an elongated portion forming an airfoil 12 that extends outwardly from a platform 24 coupled to the root portion 34. At an opposite end of the turbine blade 10, the blade 10 is composed of a tip 22 opposite the root section 34, a leading edge 14, and a trailing edge 16. Connecting the leading edge 14 and the trailing edge 16 is radially extending a pressure side 18 and a suction side 20 of the airfoil 12. Along the tip end 22 of the turbine blade 10 is a tip feature in position to reduce the size of the gap between ring segments 26 and blades 10 in a gas path of a turbine to prevent tip flow leakage, which reduces the amount of torque generated by the turbine blades 10. The tip feature is referred to as a squealer or squealer tip and is incorporated onto the tips of blades to help reduce aerodynamic losses between turbine stages. These features are designed to minimize the leakage between the blade tip 22 and the ring segment 26.

FIG. 2 represents a conventional squealer tip 36 location where spaced apart tip walls extend directly up from and extending the length of the pressure side 18 and suction side 20 of the blade 10. At the tip end 22 lying in between the squealer tip walls 36 lies a tip shelf 40 having a tip shelf surface 50.
