(54) METHOD OF REPAIR TO COMPRESSOR HOUSING AND REPAIRED HOUSING

A replacement compressor outlet housing includes a compressor outlet housing, having a volute and a radially inwardly extending finger extending from a radially inner end of the volute. The radially inwardly extending finger is welded to an insert. The insert has a bearing support defining a bore. The insert has a web connecting a ledge to the bearing support. The radially inwardly extending finger welded to the ledge.

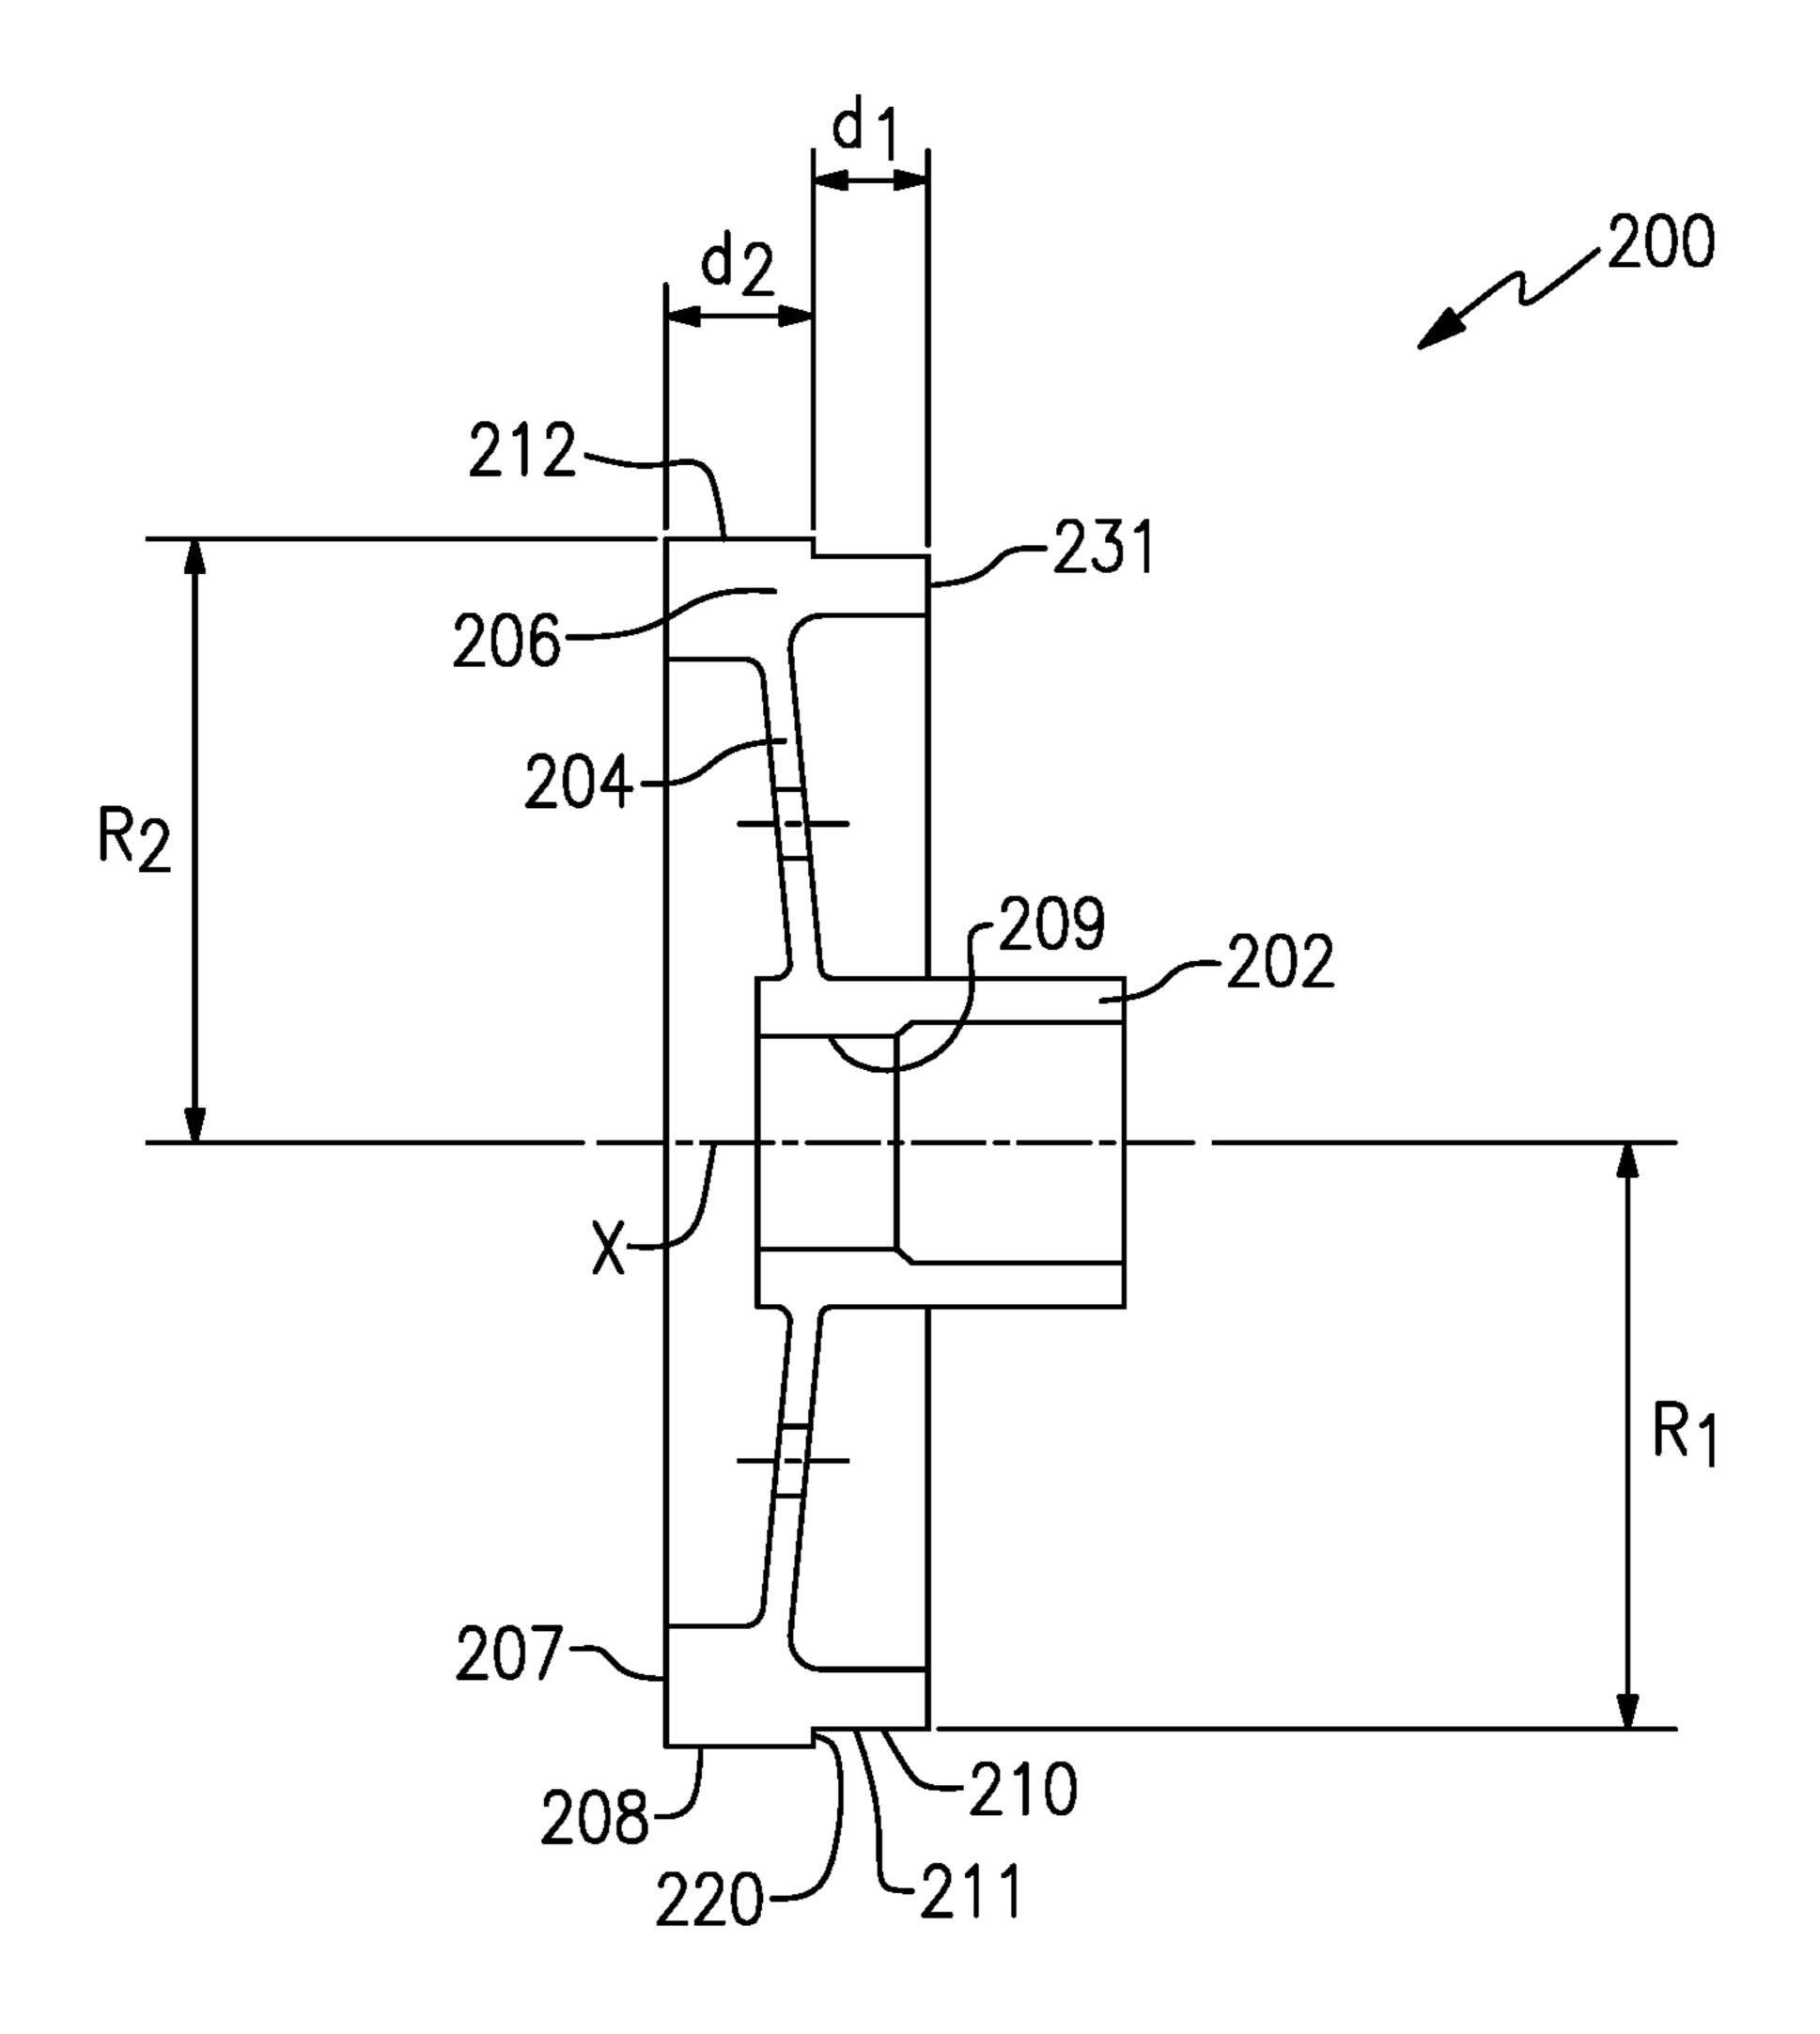
FIG.5

FIG. 5 shows an insert to replace a removed portion of a compressor outlet housing.

An insert 200 is illustrated in FIG. 5. Insert 200 has a replacement bearing support 202, which roughly matches the bearing support 32 in size, material, etc. A replacement web 204 (also matching the web 38) extends from the bearing support 202 to a replacement ledge 206. Replacement ledge 206 has an axially rear enlarged portion 208 and a forward extending portion 210. A first radius R₁ is defined from a central axis X of a bore 209 in the bearing support 202 to an outer surface 211 of the forward extending portion 210. A second radius R₂ is defined from axis X to the outer surface 212 of the rear portion 208. An axial distance d₁ is defined from a rear point 220 of the forward portion 210 to

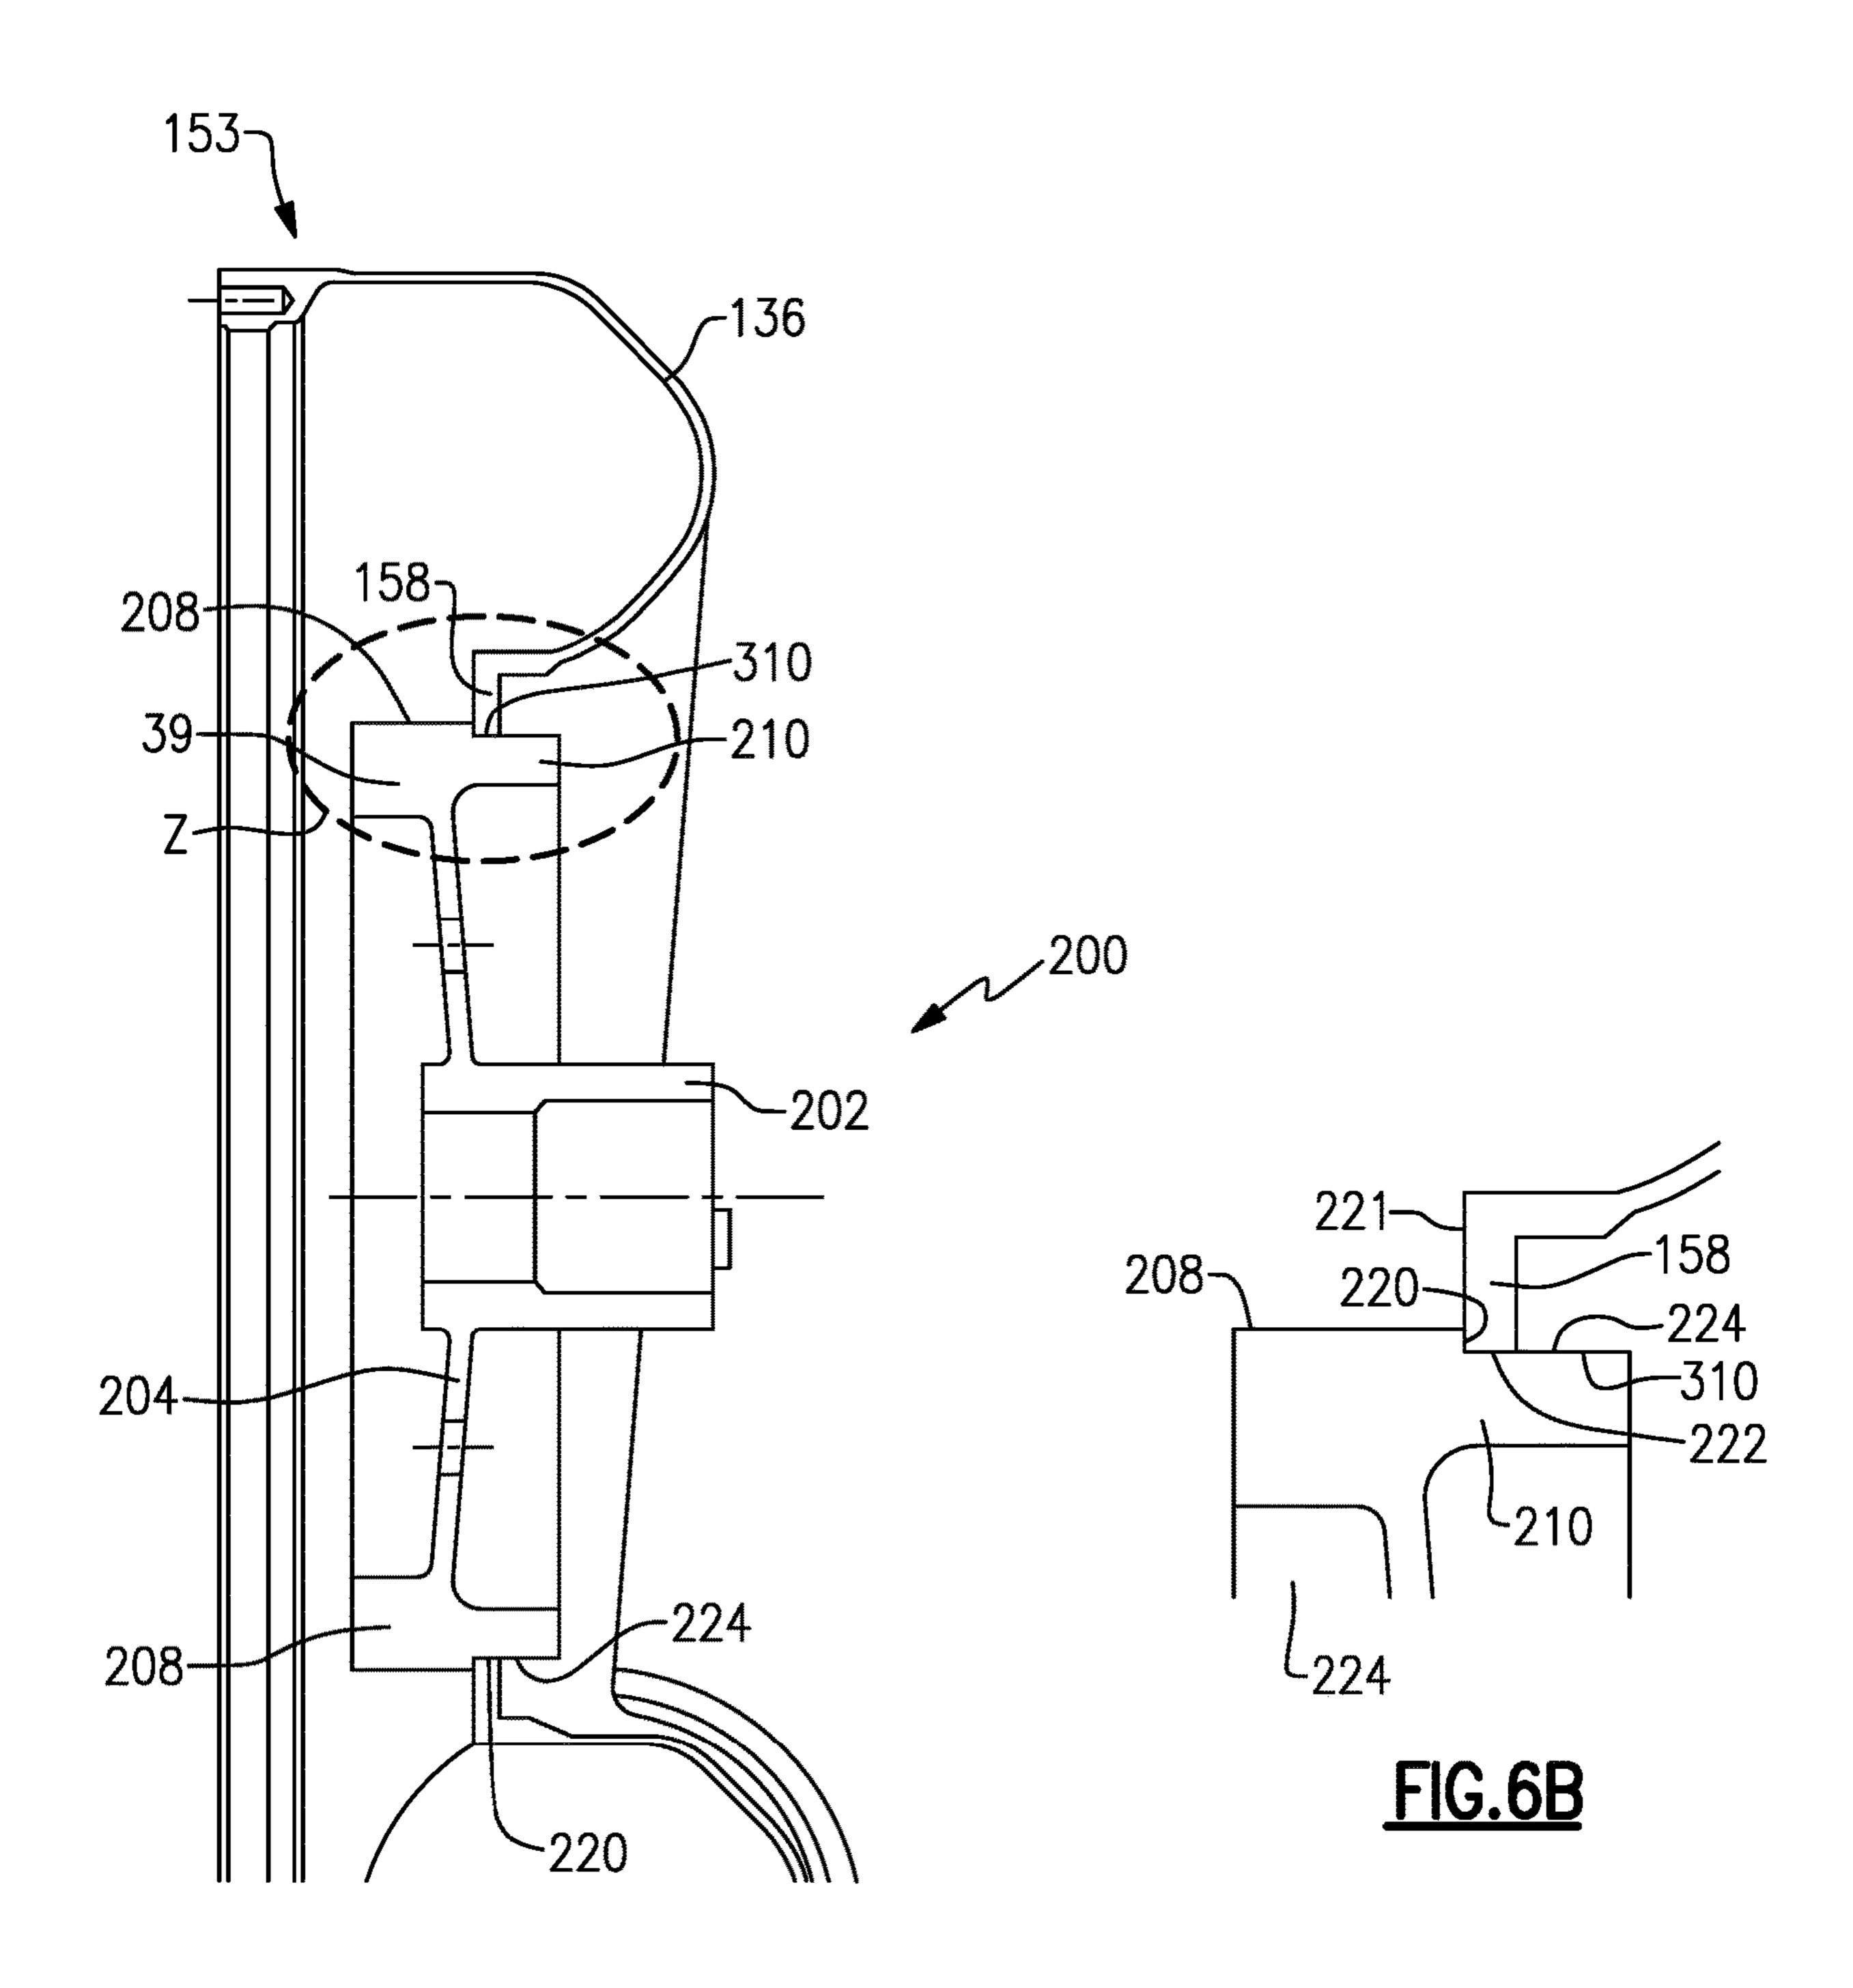
FIG.6A

FIG. 6A shows a method step.

As shown in FIG. 6A, insert 200 is now inserted within the remaining finger 158 of the intermediate part 153. A weld joint 310 is formed to connect the two. Electron beam welding is preferably utilized. The forward end 220 of the 15 rear portion 208 of insert 200 abuts a rear surface 221 of the finger 158. An outer surface 224 of the forward portion 210 supports the inner surface 222 of finger 158. As can be appreciated, the location of the axially forward surface 220 of the rear portion 208 and the outer surface 224 of the 20 housing. forward portion 210 are carefully formed to a desired size and mate with finger 158 to properly position the remaining 153 in both radial and axial directions.

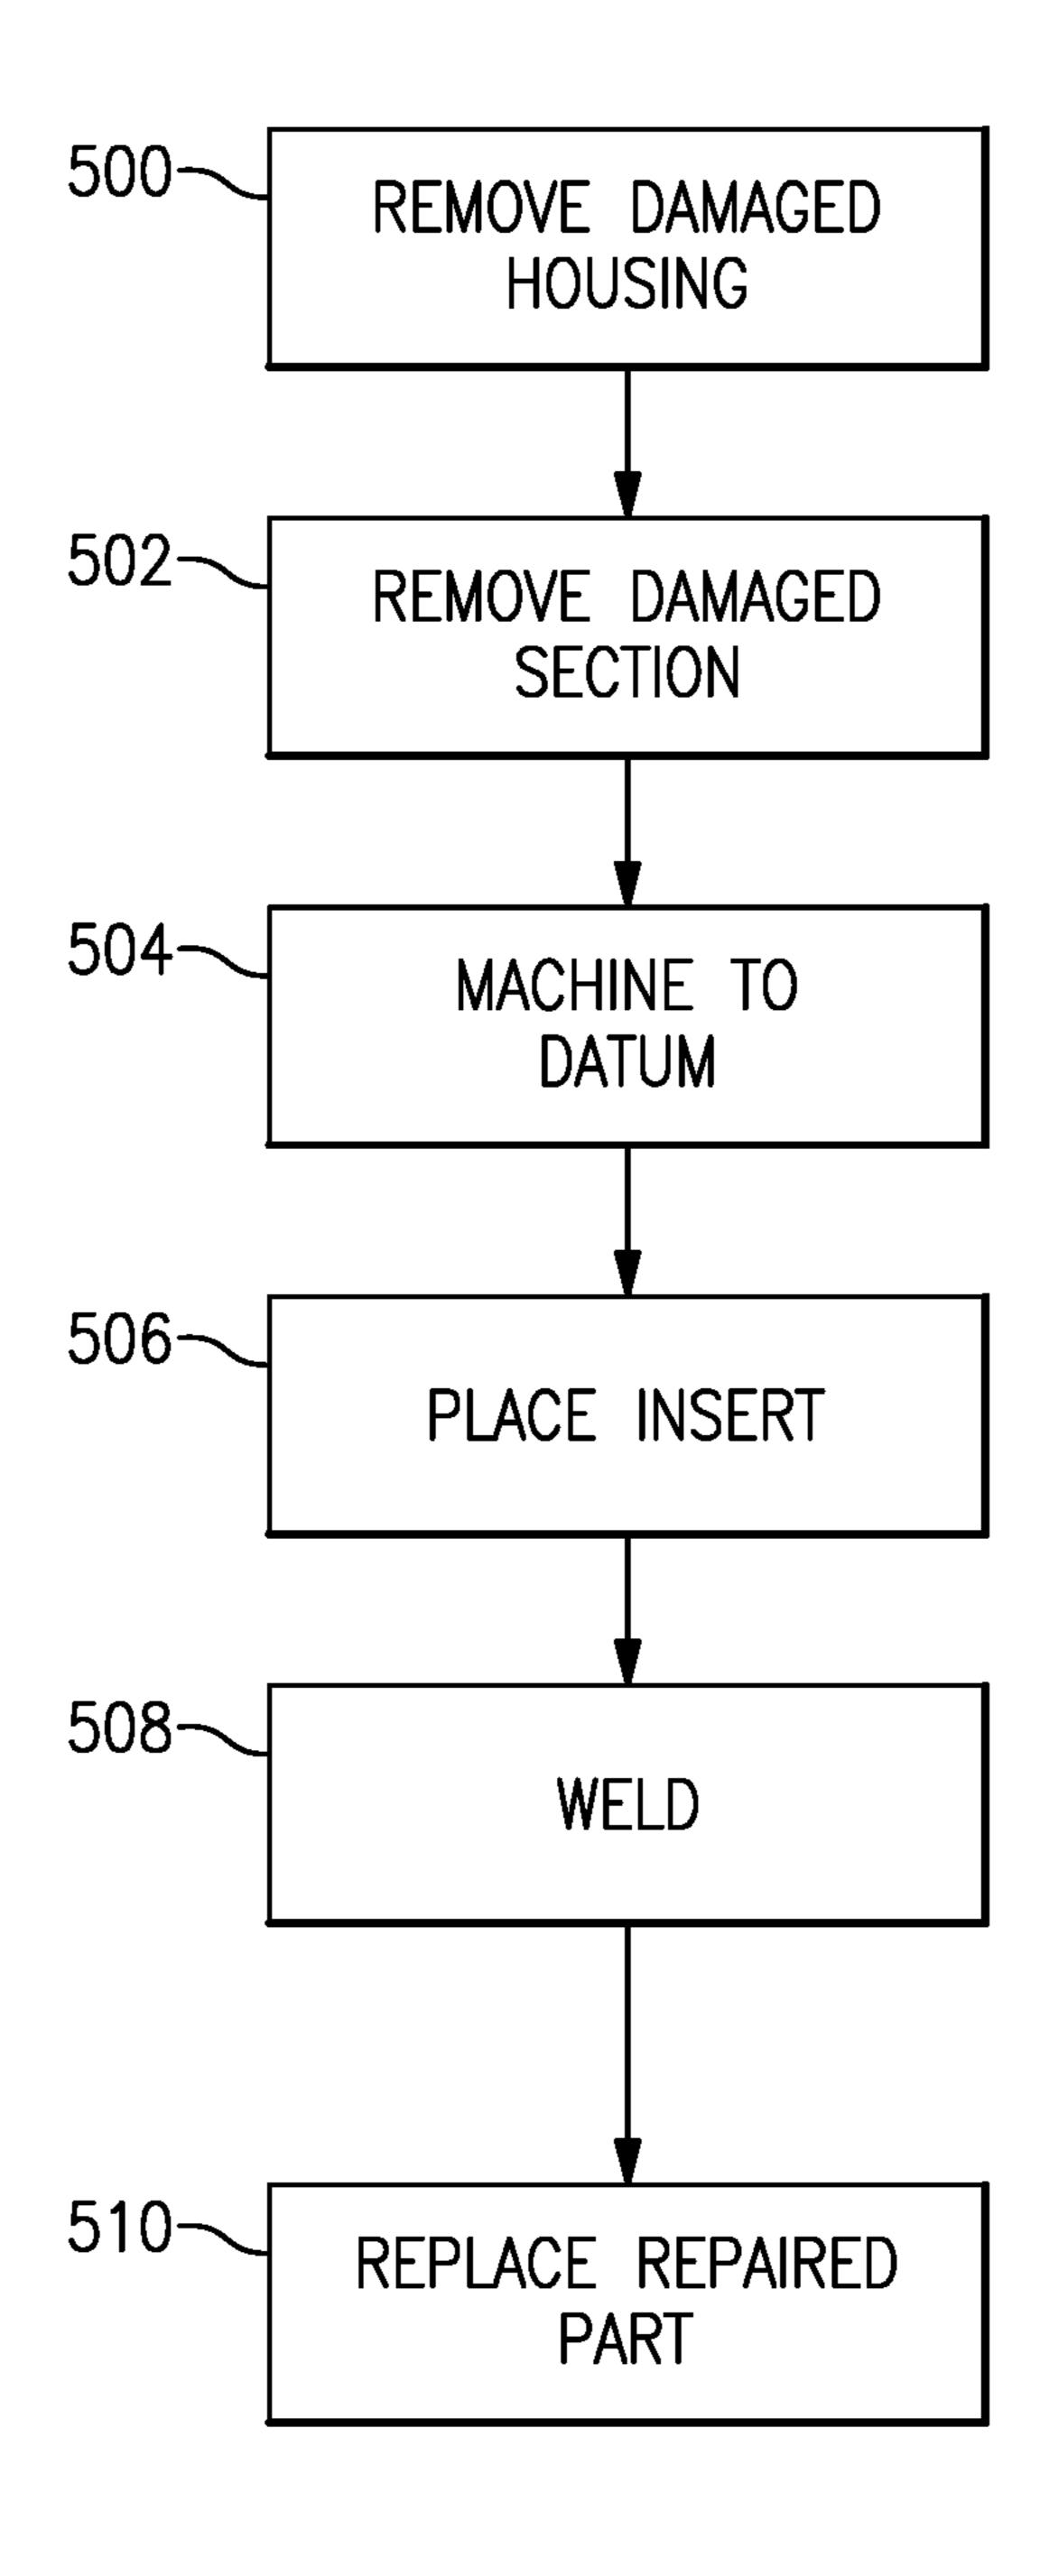
FIG. 7A is a flowchart.

As shown in FIG. 7A, a flowchart of the method accord- 35 content of this disclosure. ing to this disclosure could be said to include a step 500 of removing the damaged housing from the compressor. Next, a damaged section is removed from the damaged housing at step 502. Next, the remaining portion of the damaged housing is machined to a datum at step **504**. In step **506**, an 40 insert is placed within the remaining portion. At step 508, the insert is welded to the remaining portion. At step 510, the repaired compressor housing is replaced in a compressor.

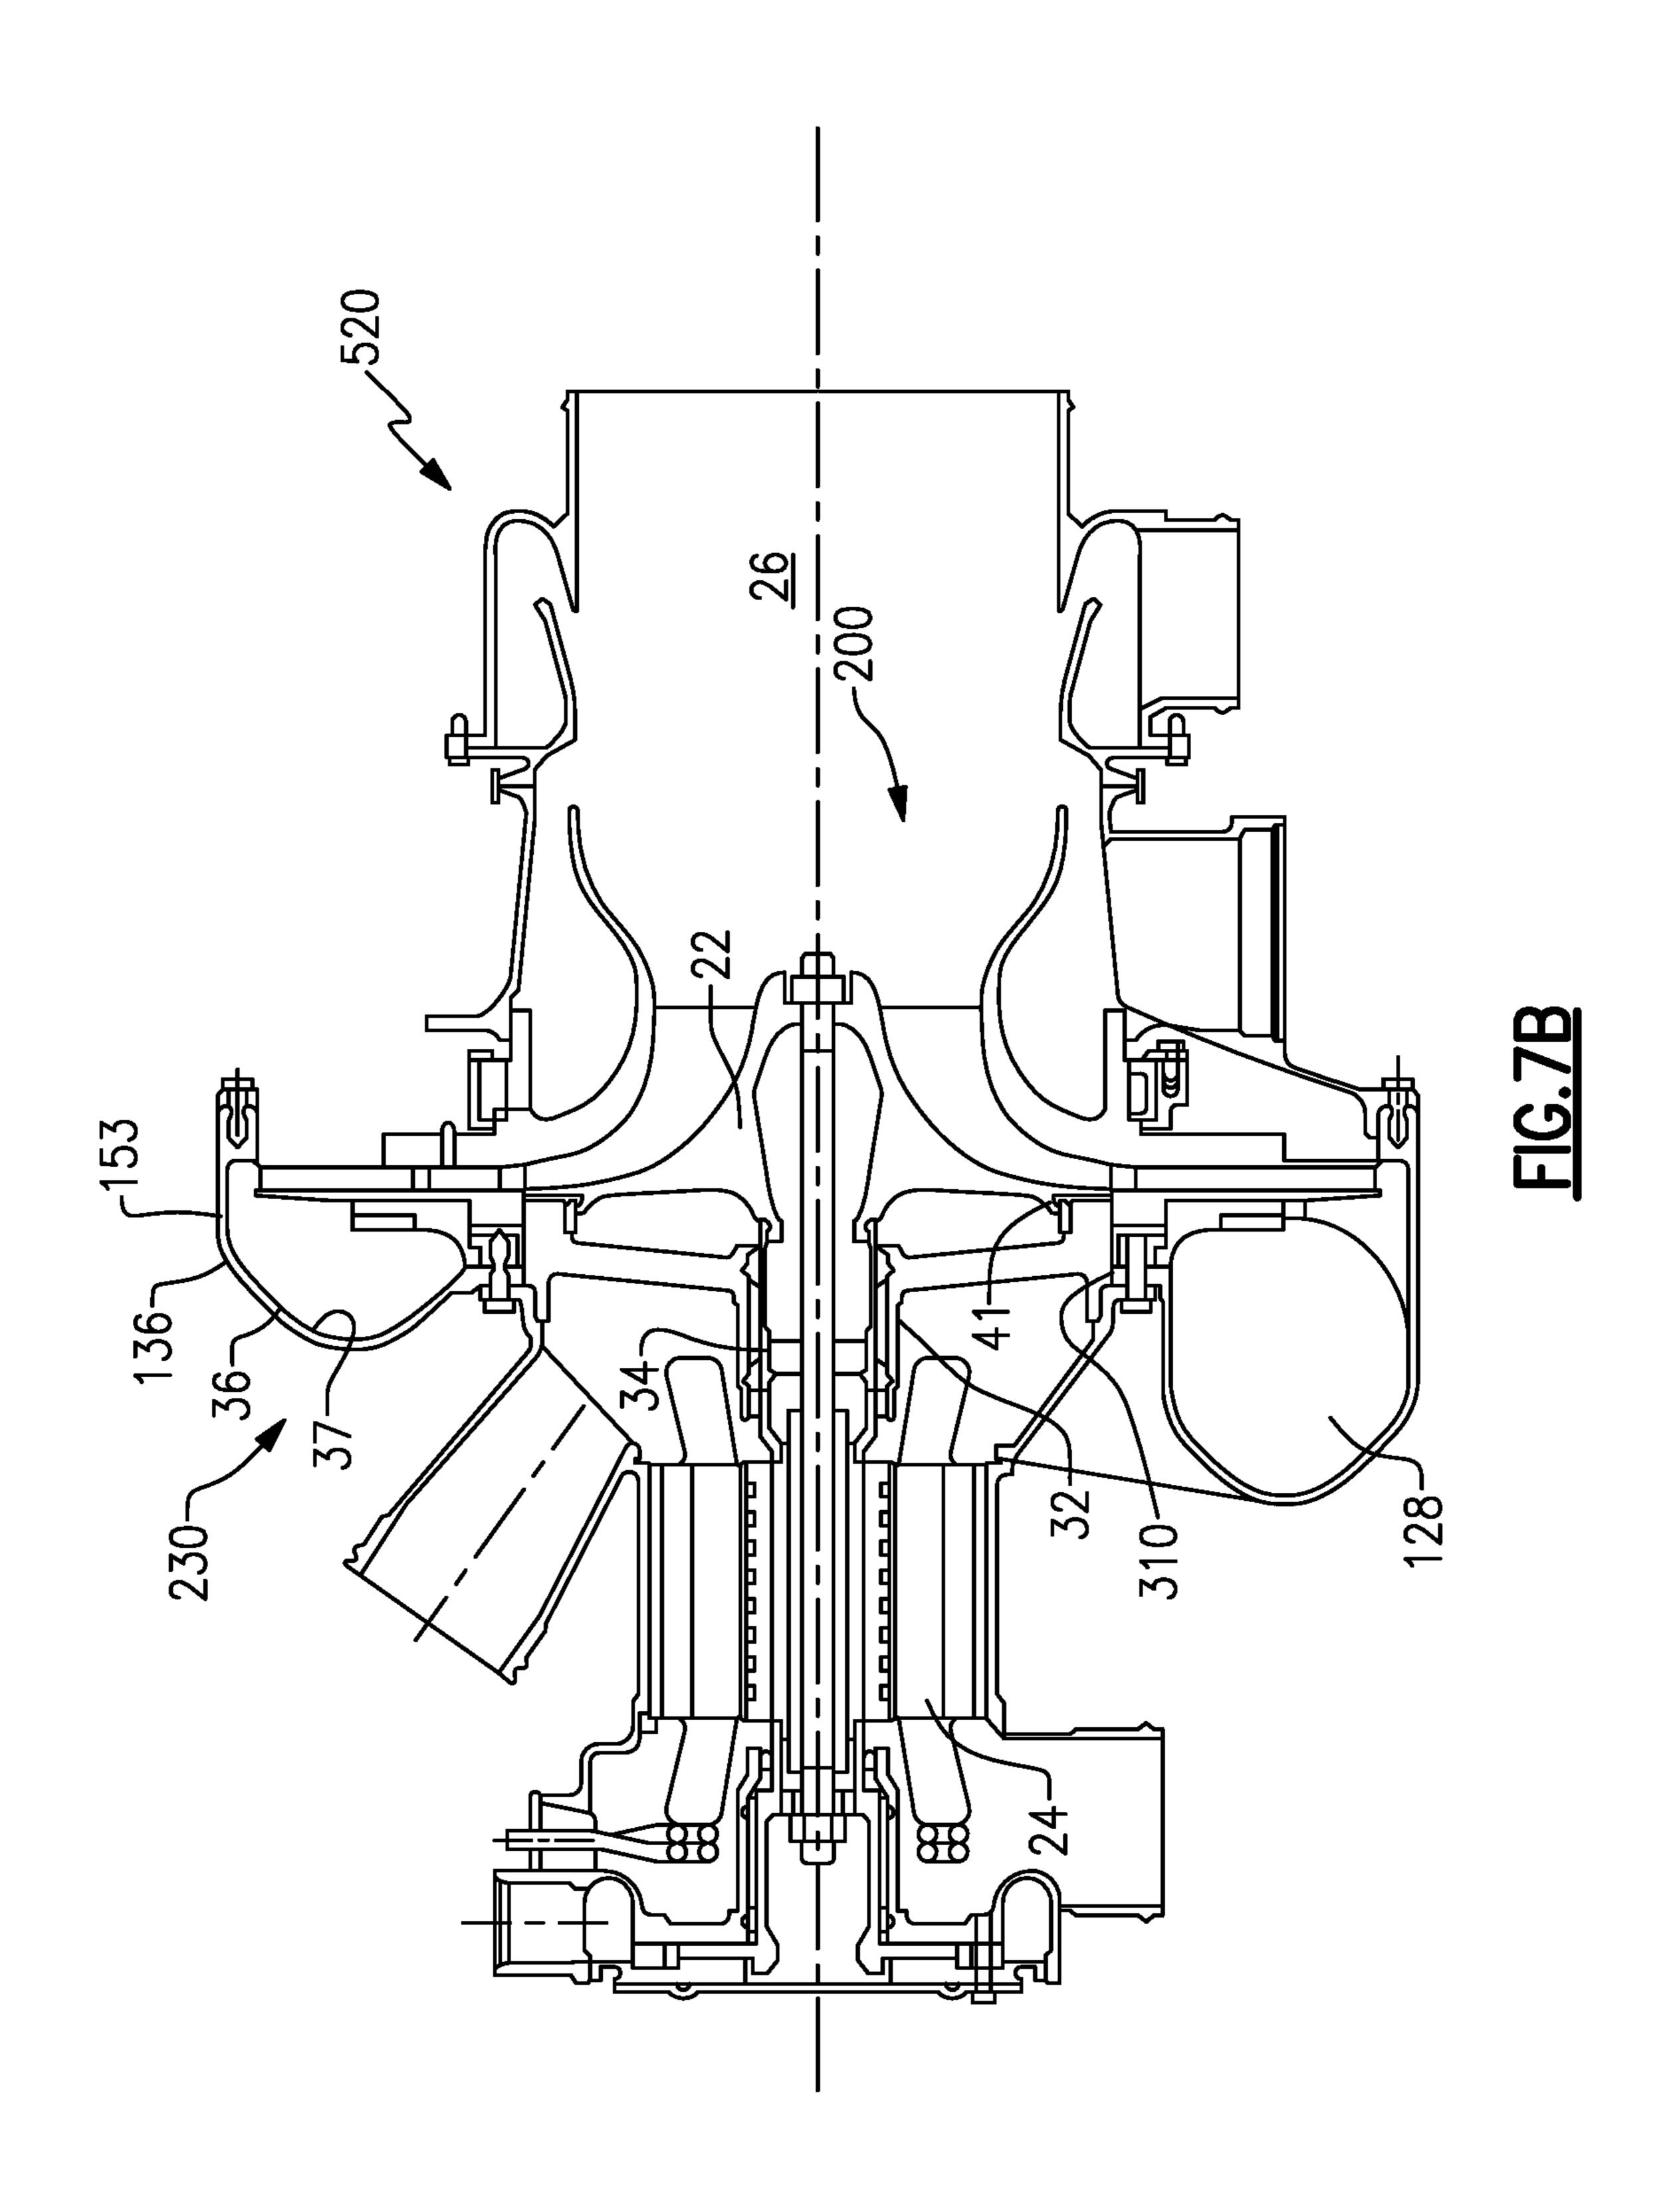
FIG. 7B shows a repaired compressor.

FIG. 7B shows a repaired compressor **520** now having a compressor outlet housing 230, which includes the insert 45 200 and the remaining part 153.
