STATOR FOR WIND TURBINE **GENERATORS**

Applicant: The Timken Company, North Canton, OH (US)

(57)**ABSTRACT**

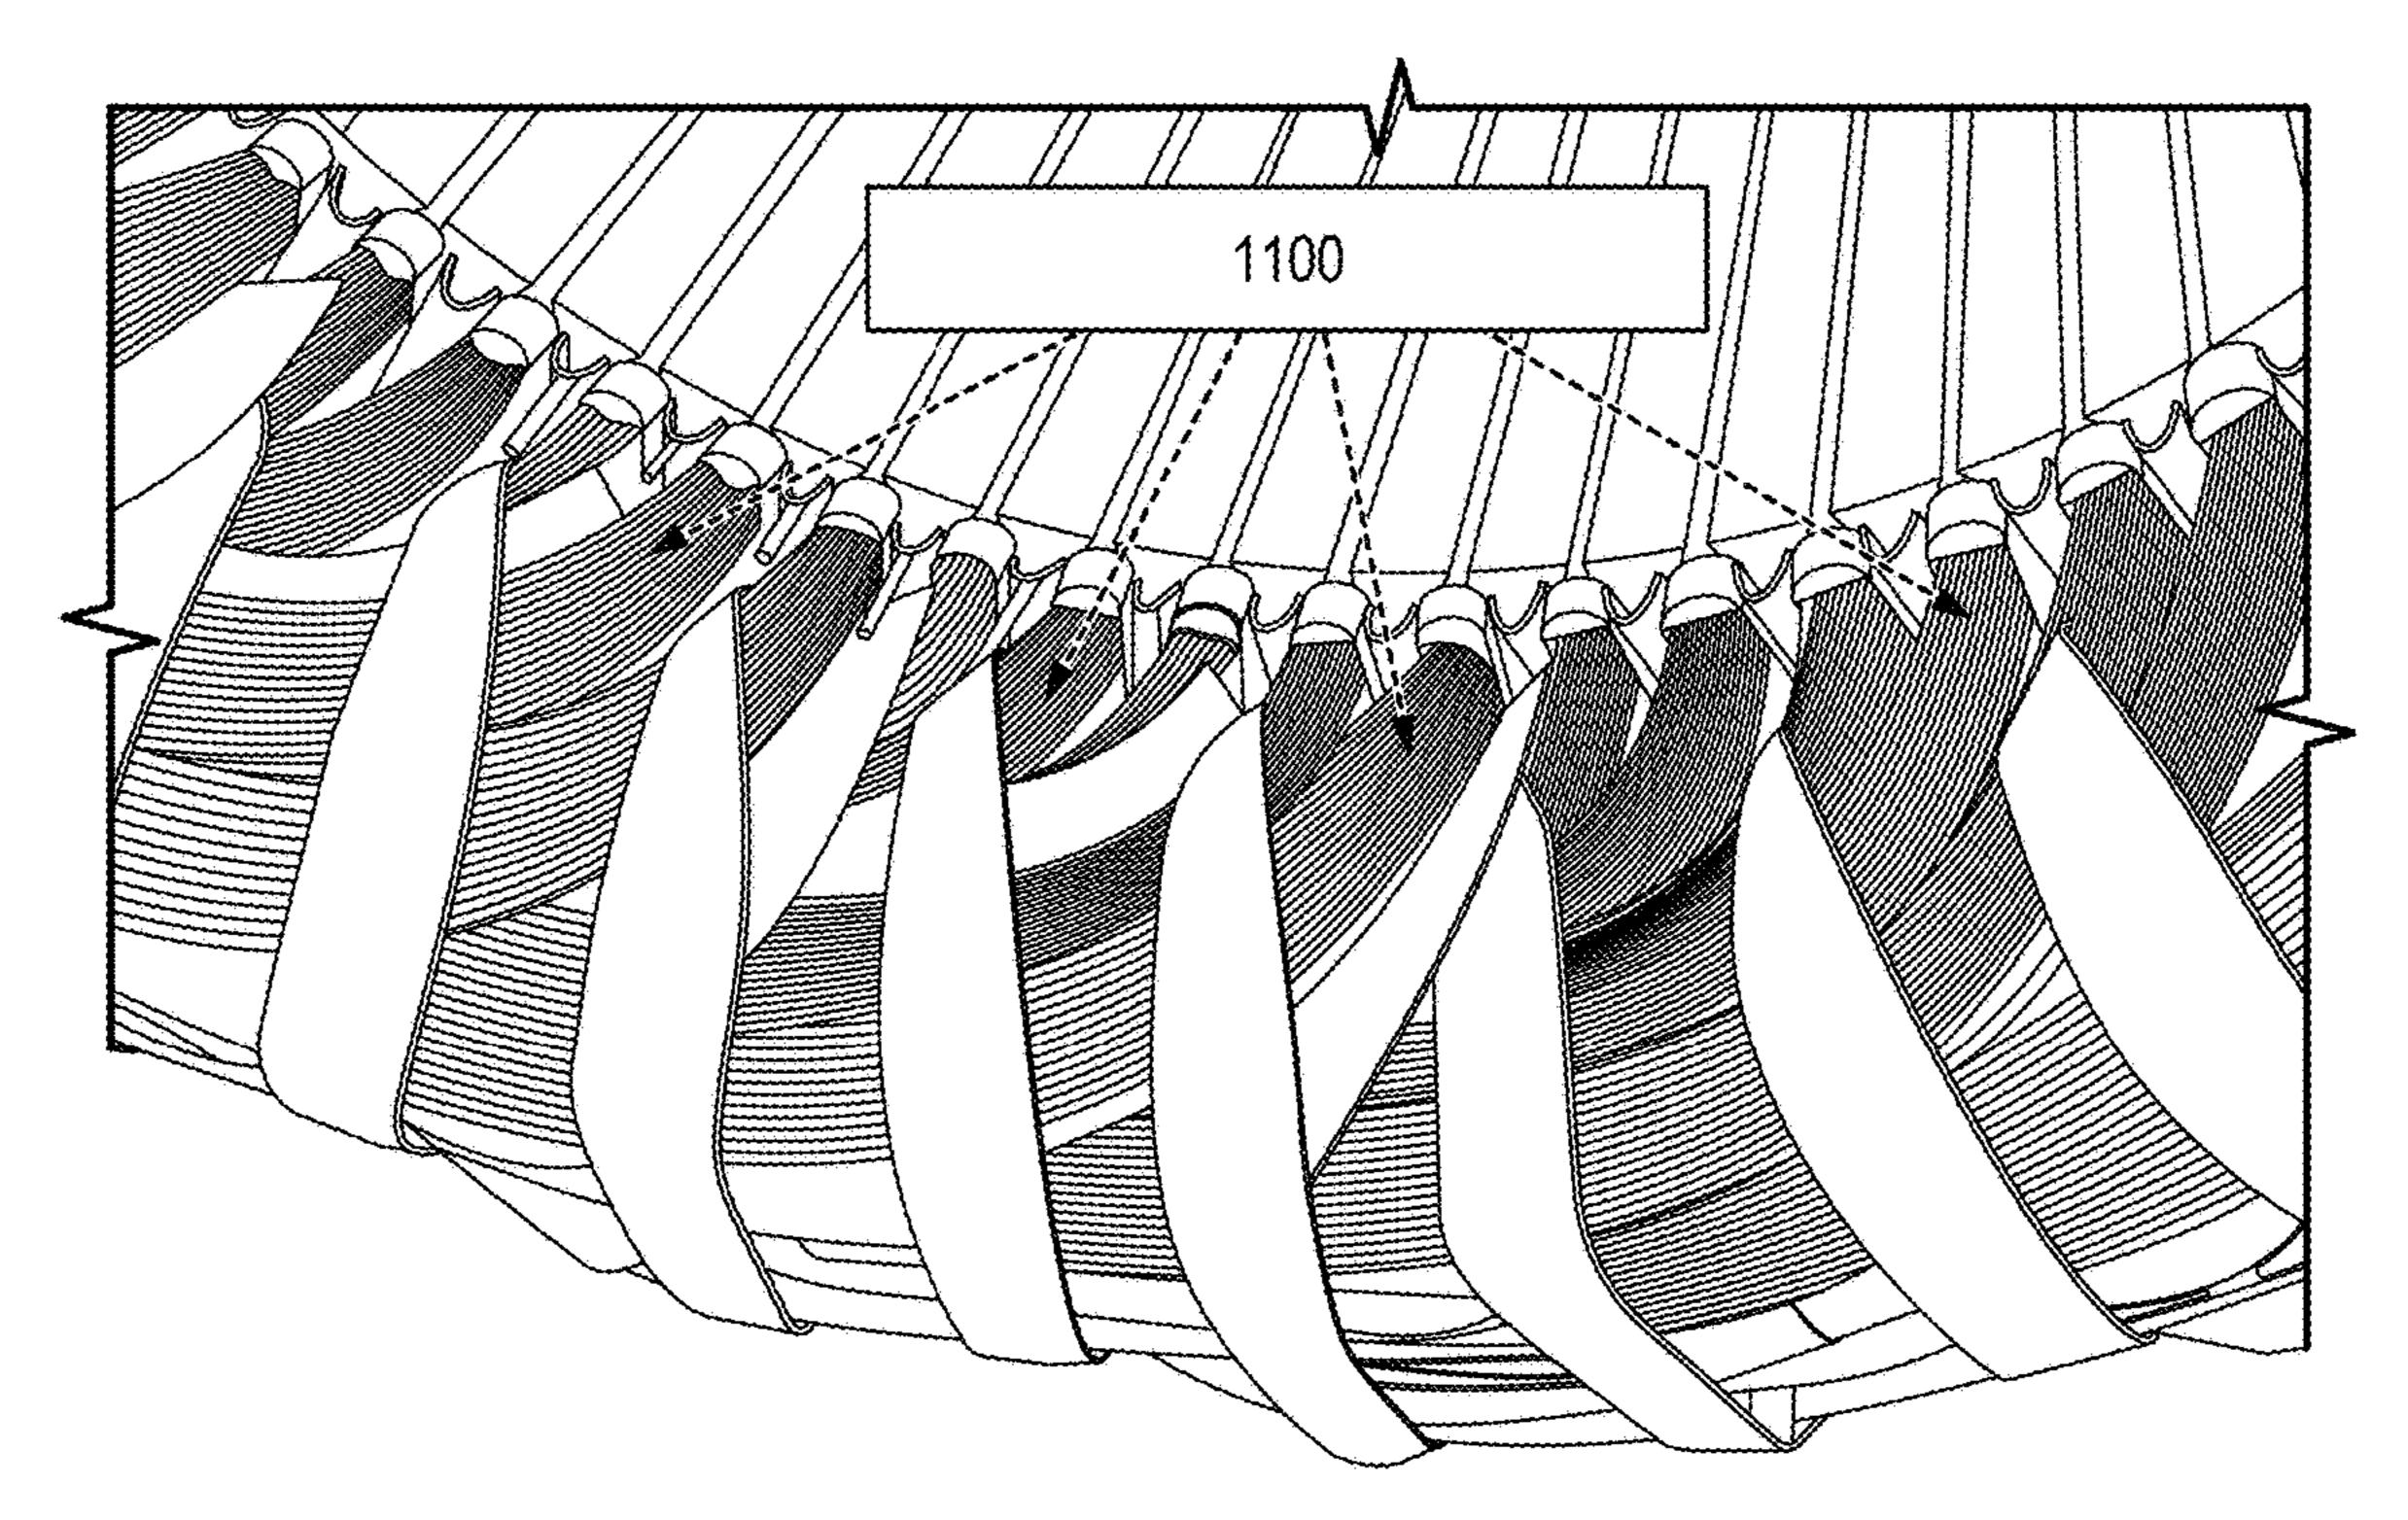
[0029] FIG. 11 illustrates an example stator without coilto-coil insulation.

[0056] The stator coil to coil insulation in original stators, shown in FIG. 11, is non-existent (see 1100 showing no coil insulation). As the original winding design has a coil-to-coil voltage of approximately 152.2V, the lack of coil-to-coil insulation creates a risk of inter-coil failure on the overhang portion. To provide electrical insulation, each coil end 1200 on the overhang portion is taped with porous glass cloth or

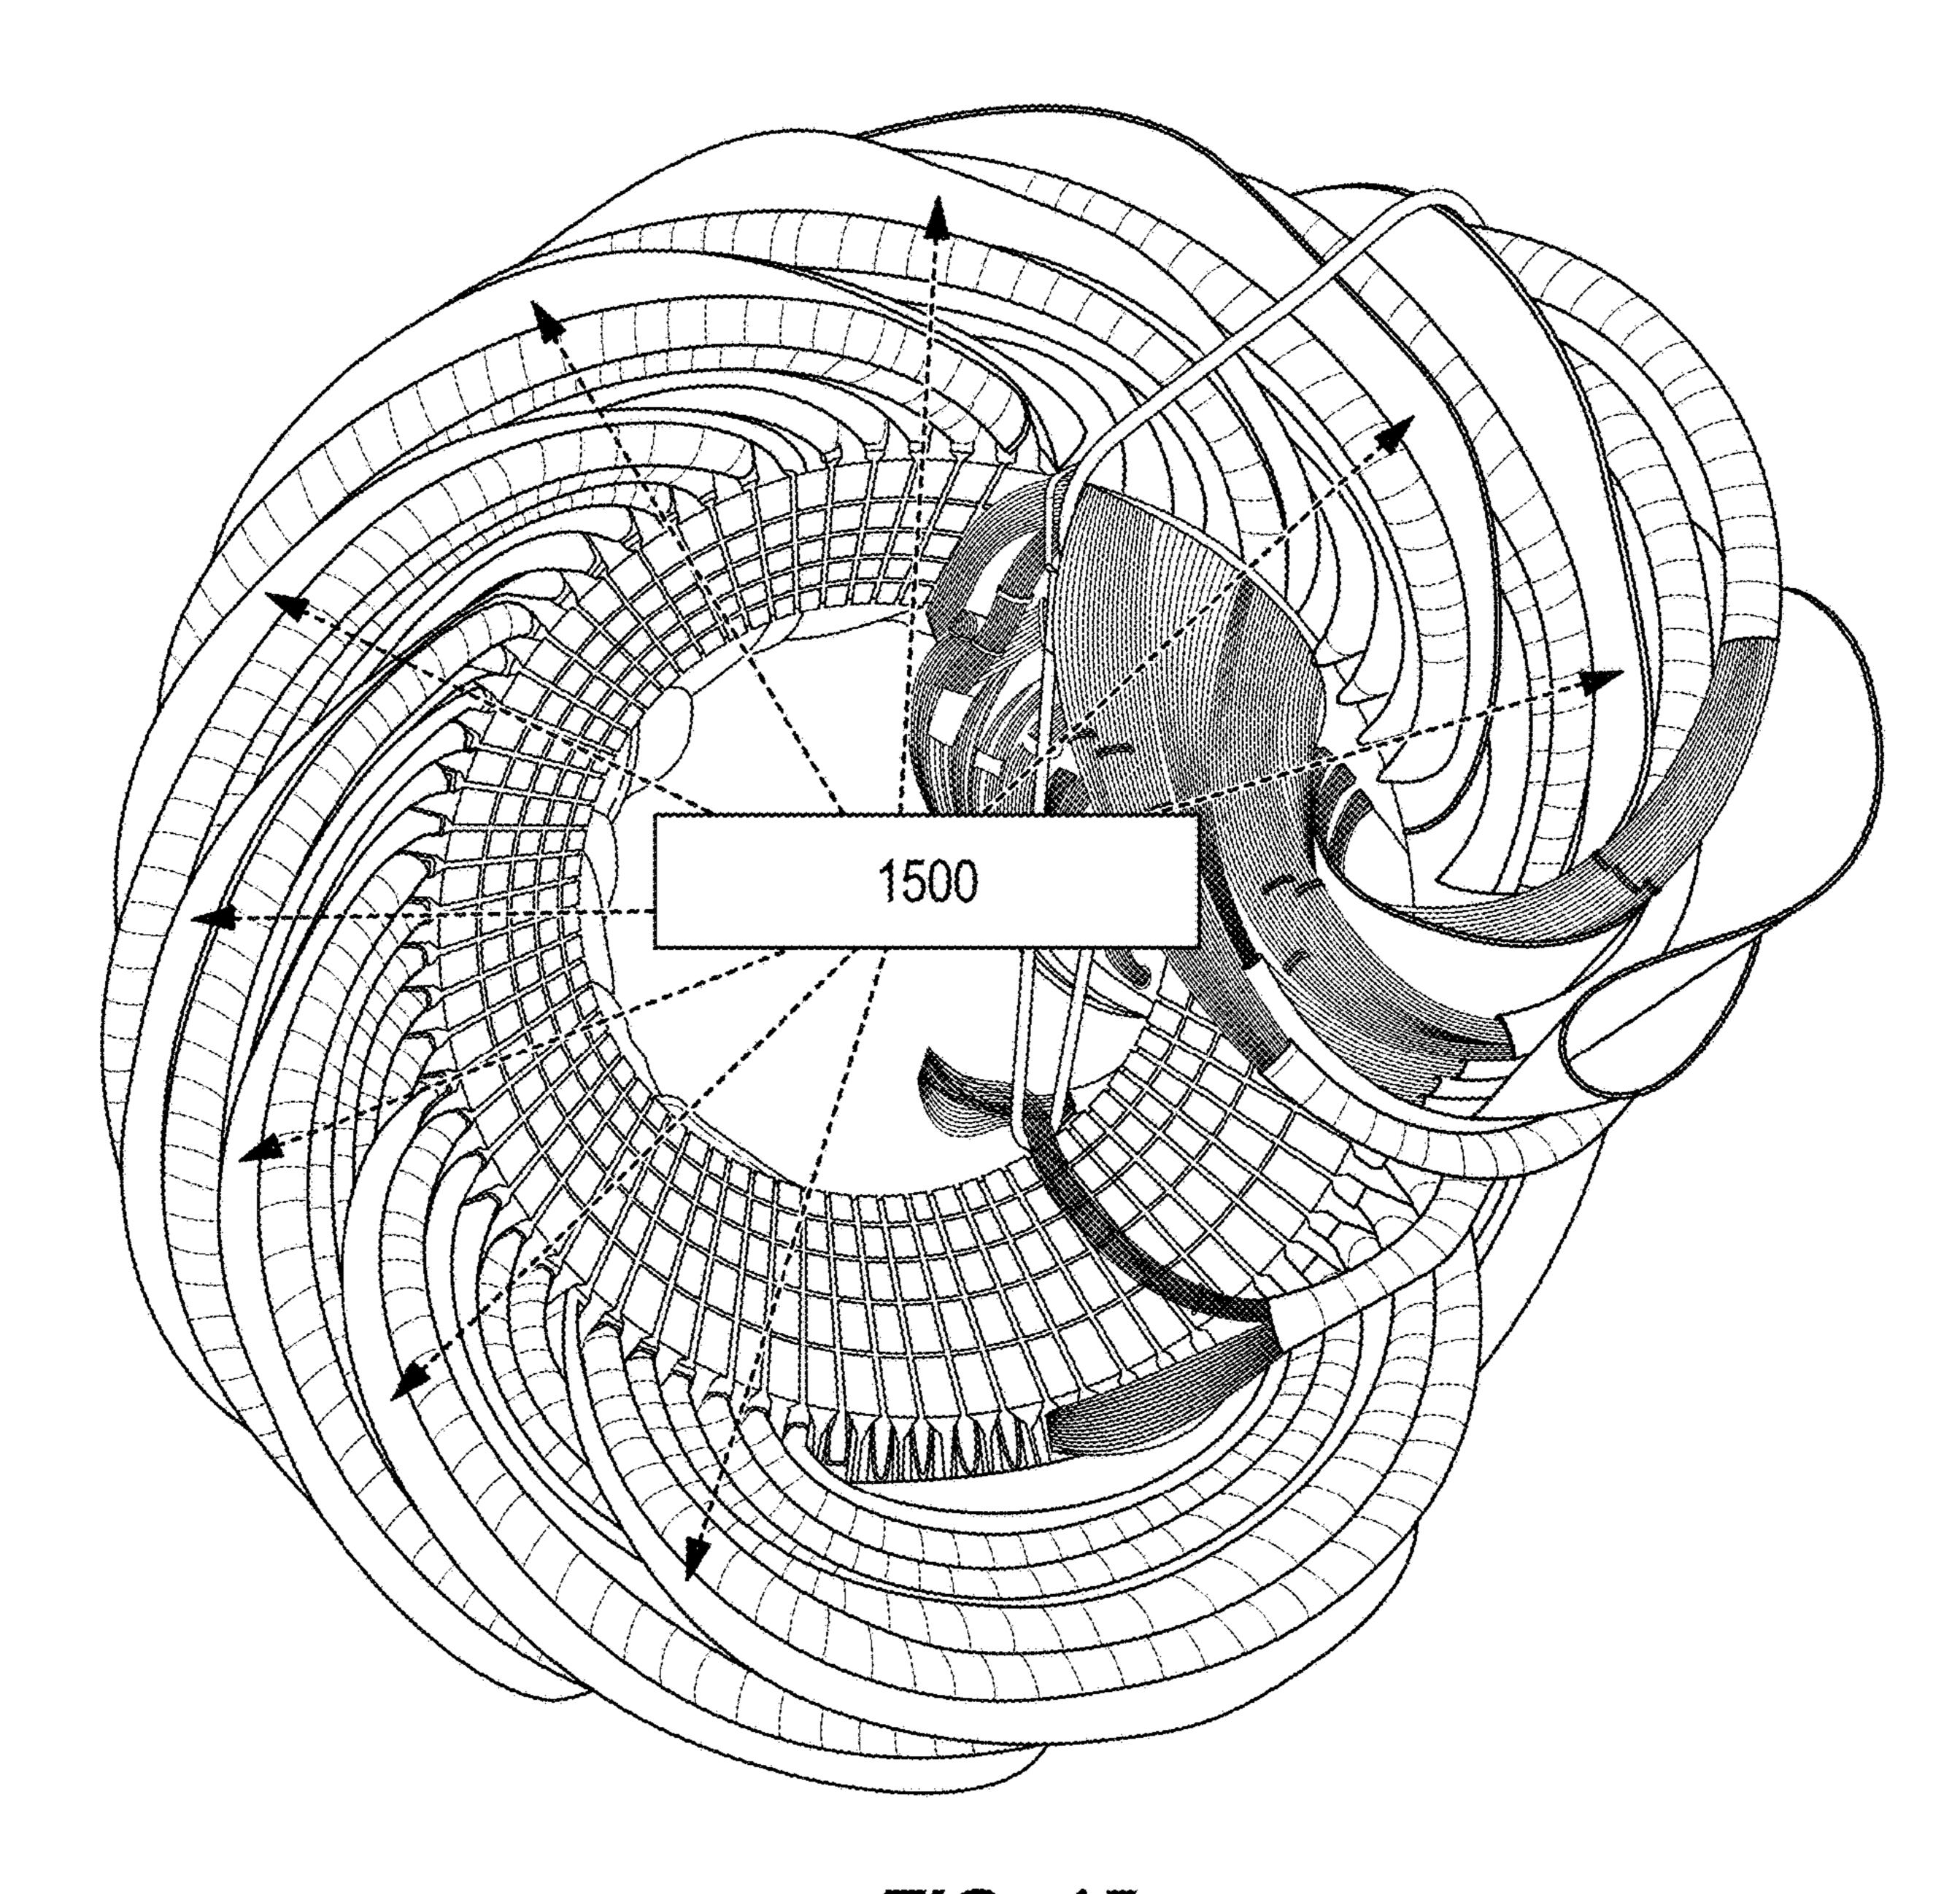
[0032] FIG. 15 illustrates an example stator having phase separators between the phases.

[0058] When the stator is replaced with a lap wound, single span winding configuration, as previously described, the coil to coil and phase to phase voltages are uniform throughout the winding. This uniformity allows for the installation of phase separators 1500, shown in FIG. 15.
