[54] PROCESS FOR REFURBISHING METAL BUOYS

A procedure for refurbishing hollow metal buoys that have been surveyed out of service. The buoy repair method involves removing a metal section, filling the buoy interior with polyurethane foam, welding back the removed metal section and coating the metal exterior with fiber glass-resin composition. Buoys repaired in this manner are essentially maintenance free.

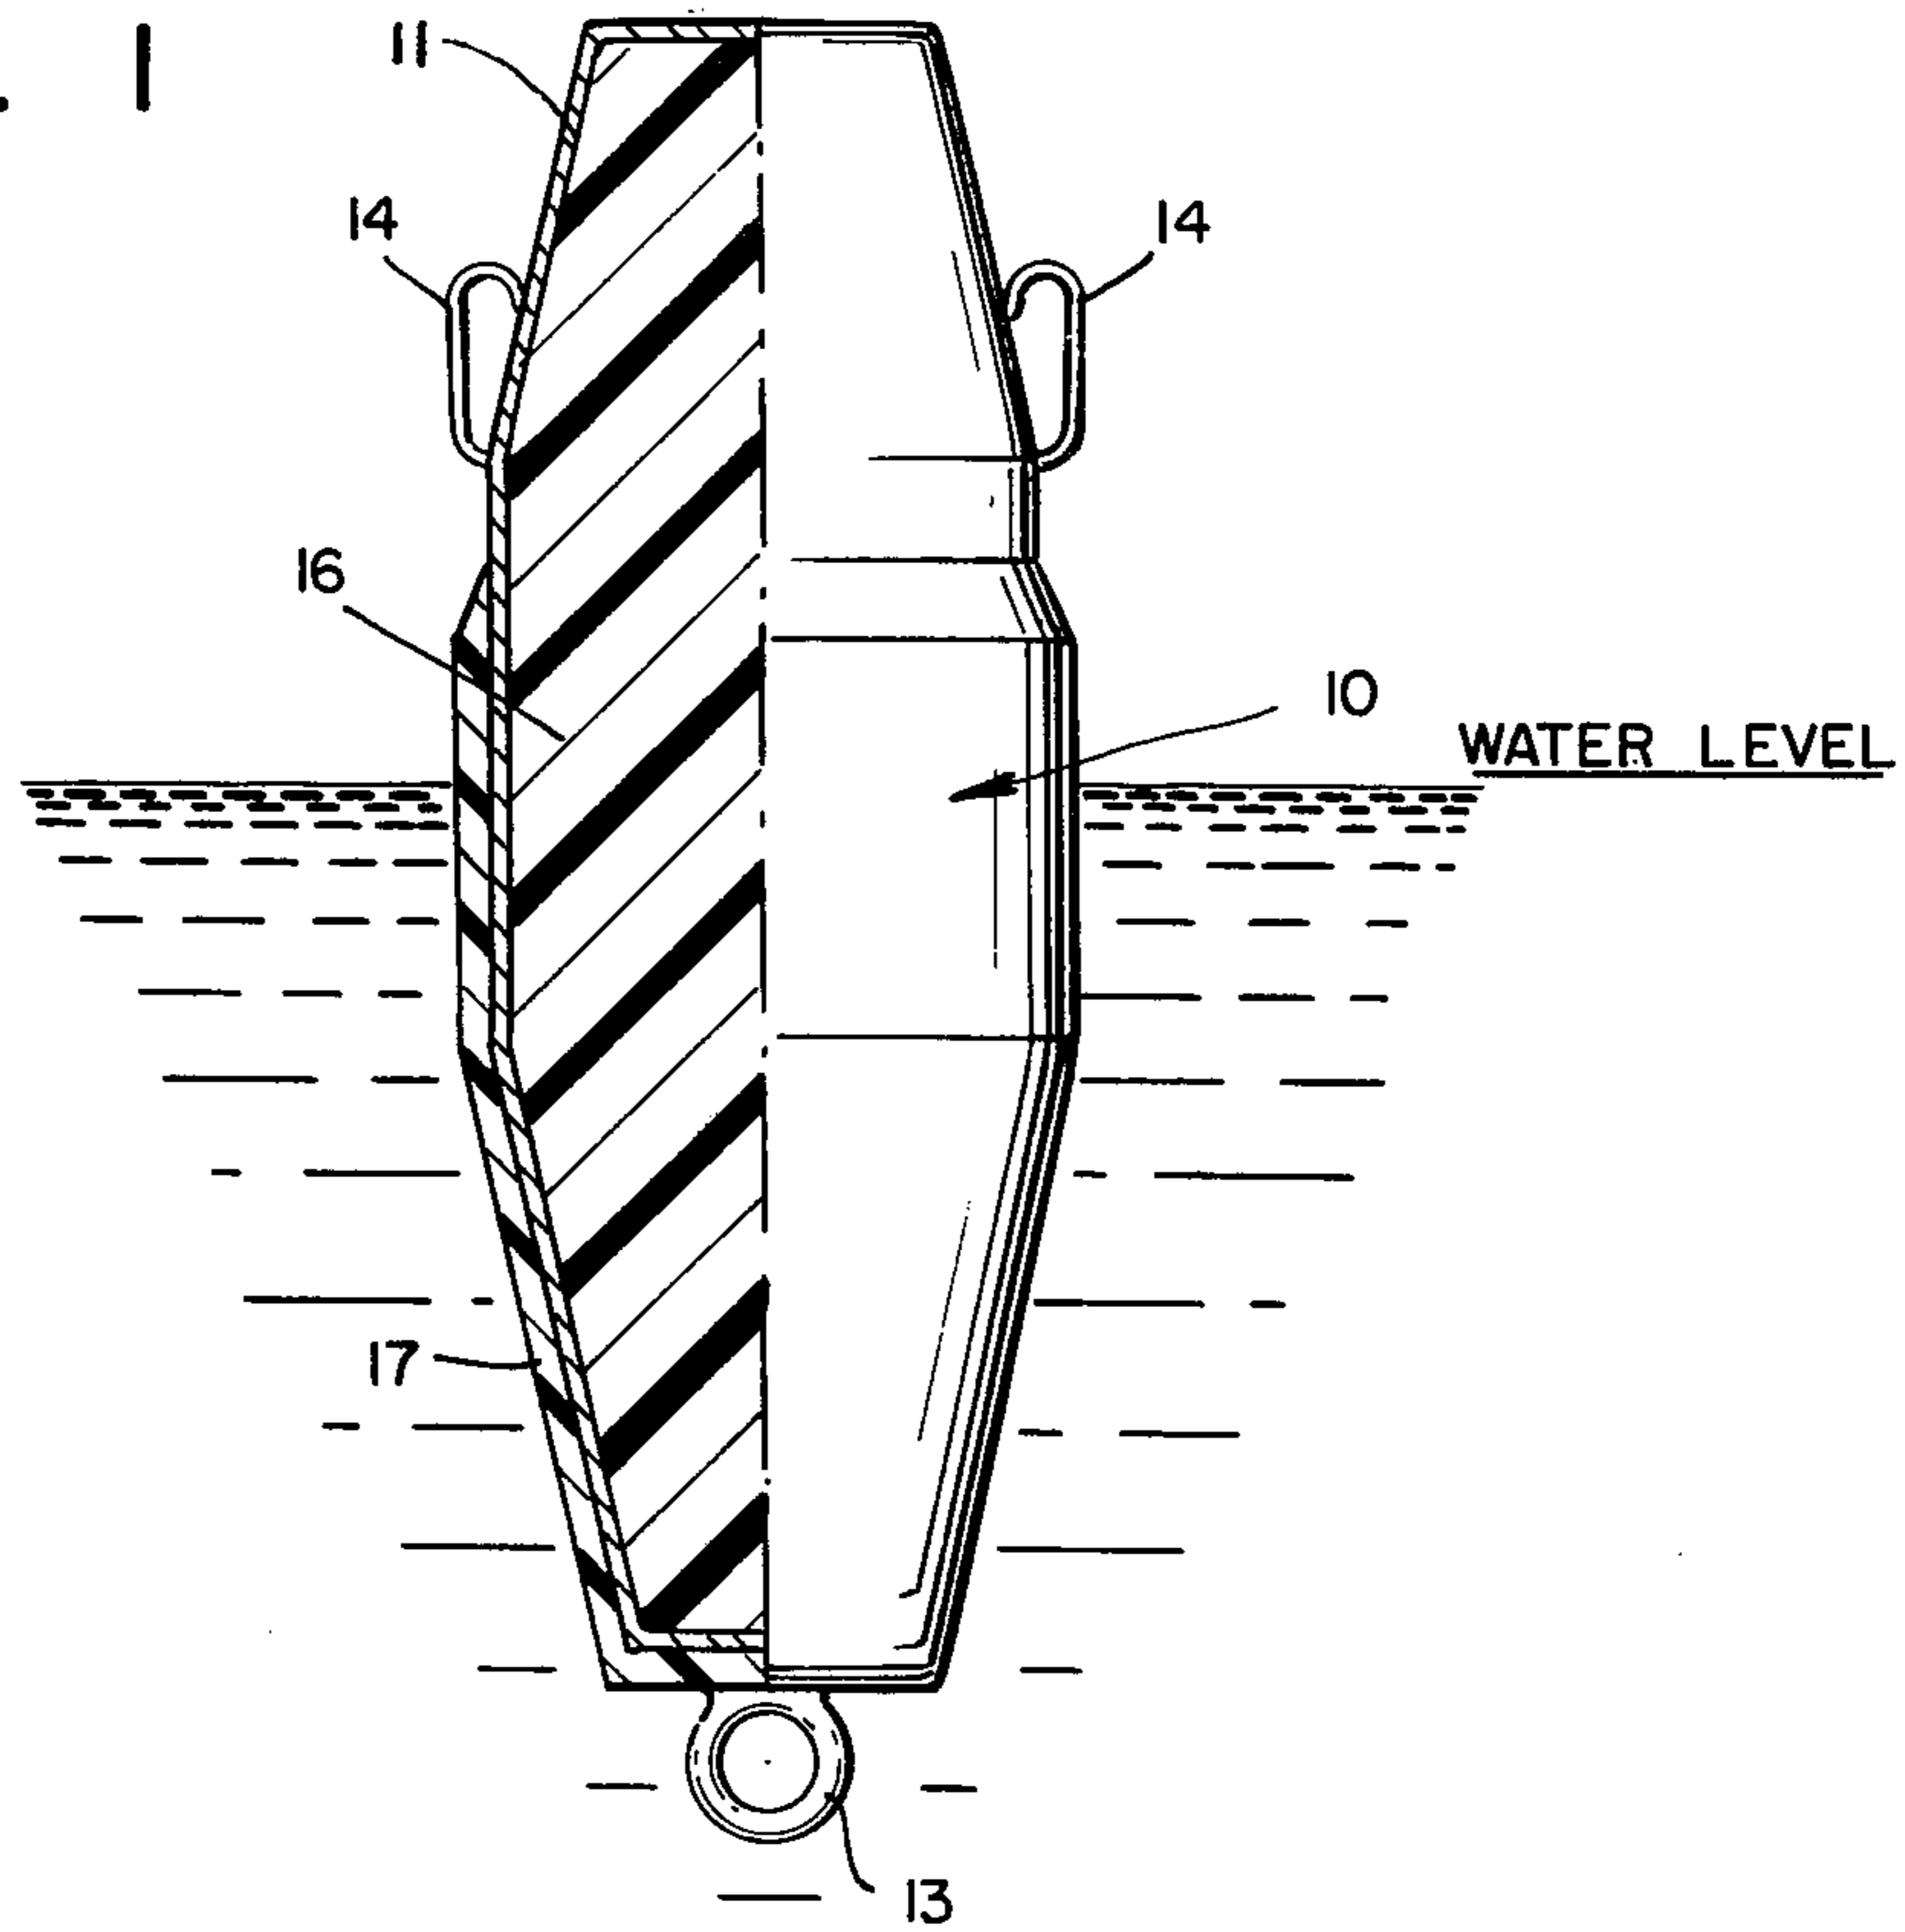
FIG. 1 is an elevation view of a buoy of the type contemplated, shown in partial cross section and subsequent to being repaired.

As shown in FIG. 1 the repaired buoy inner or flotation chamber 12 is completely filled with a mass of expanded polyurethane foam 16. An outer coating 17 formed of multiple plies of a resin impregnated fiberglass provides a water tight skin to shell 11.

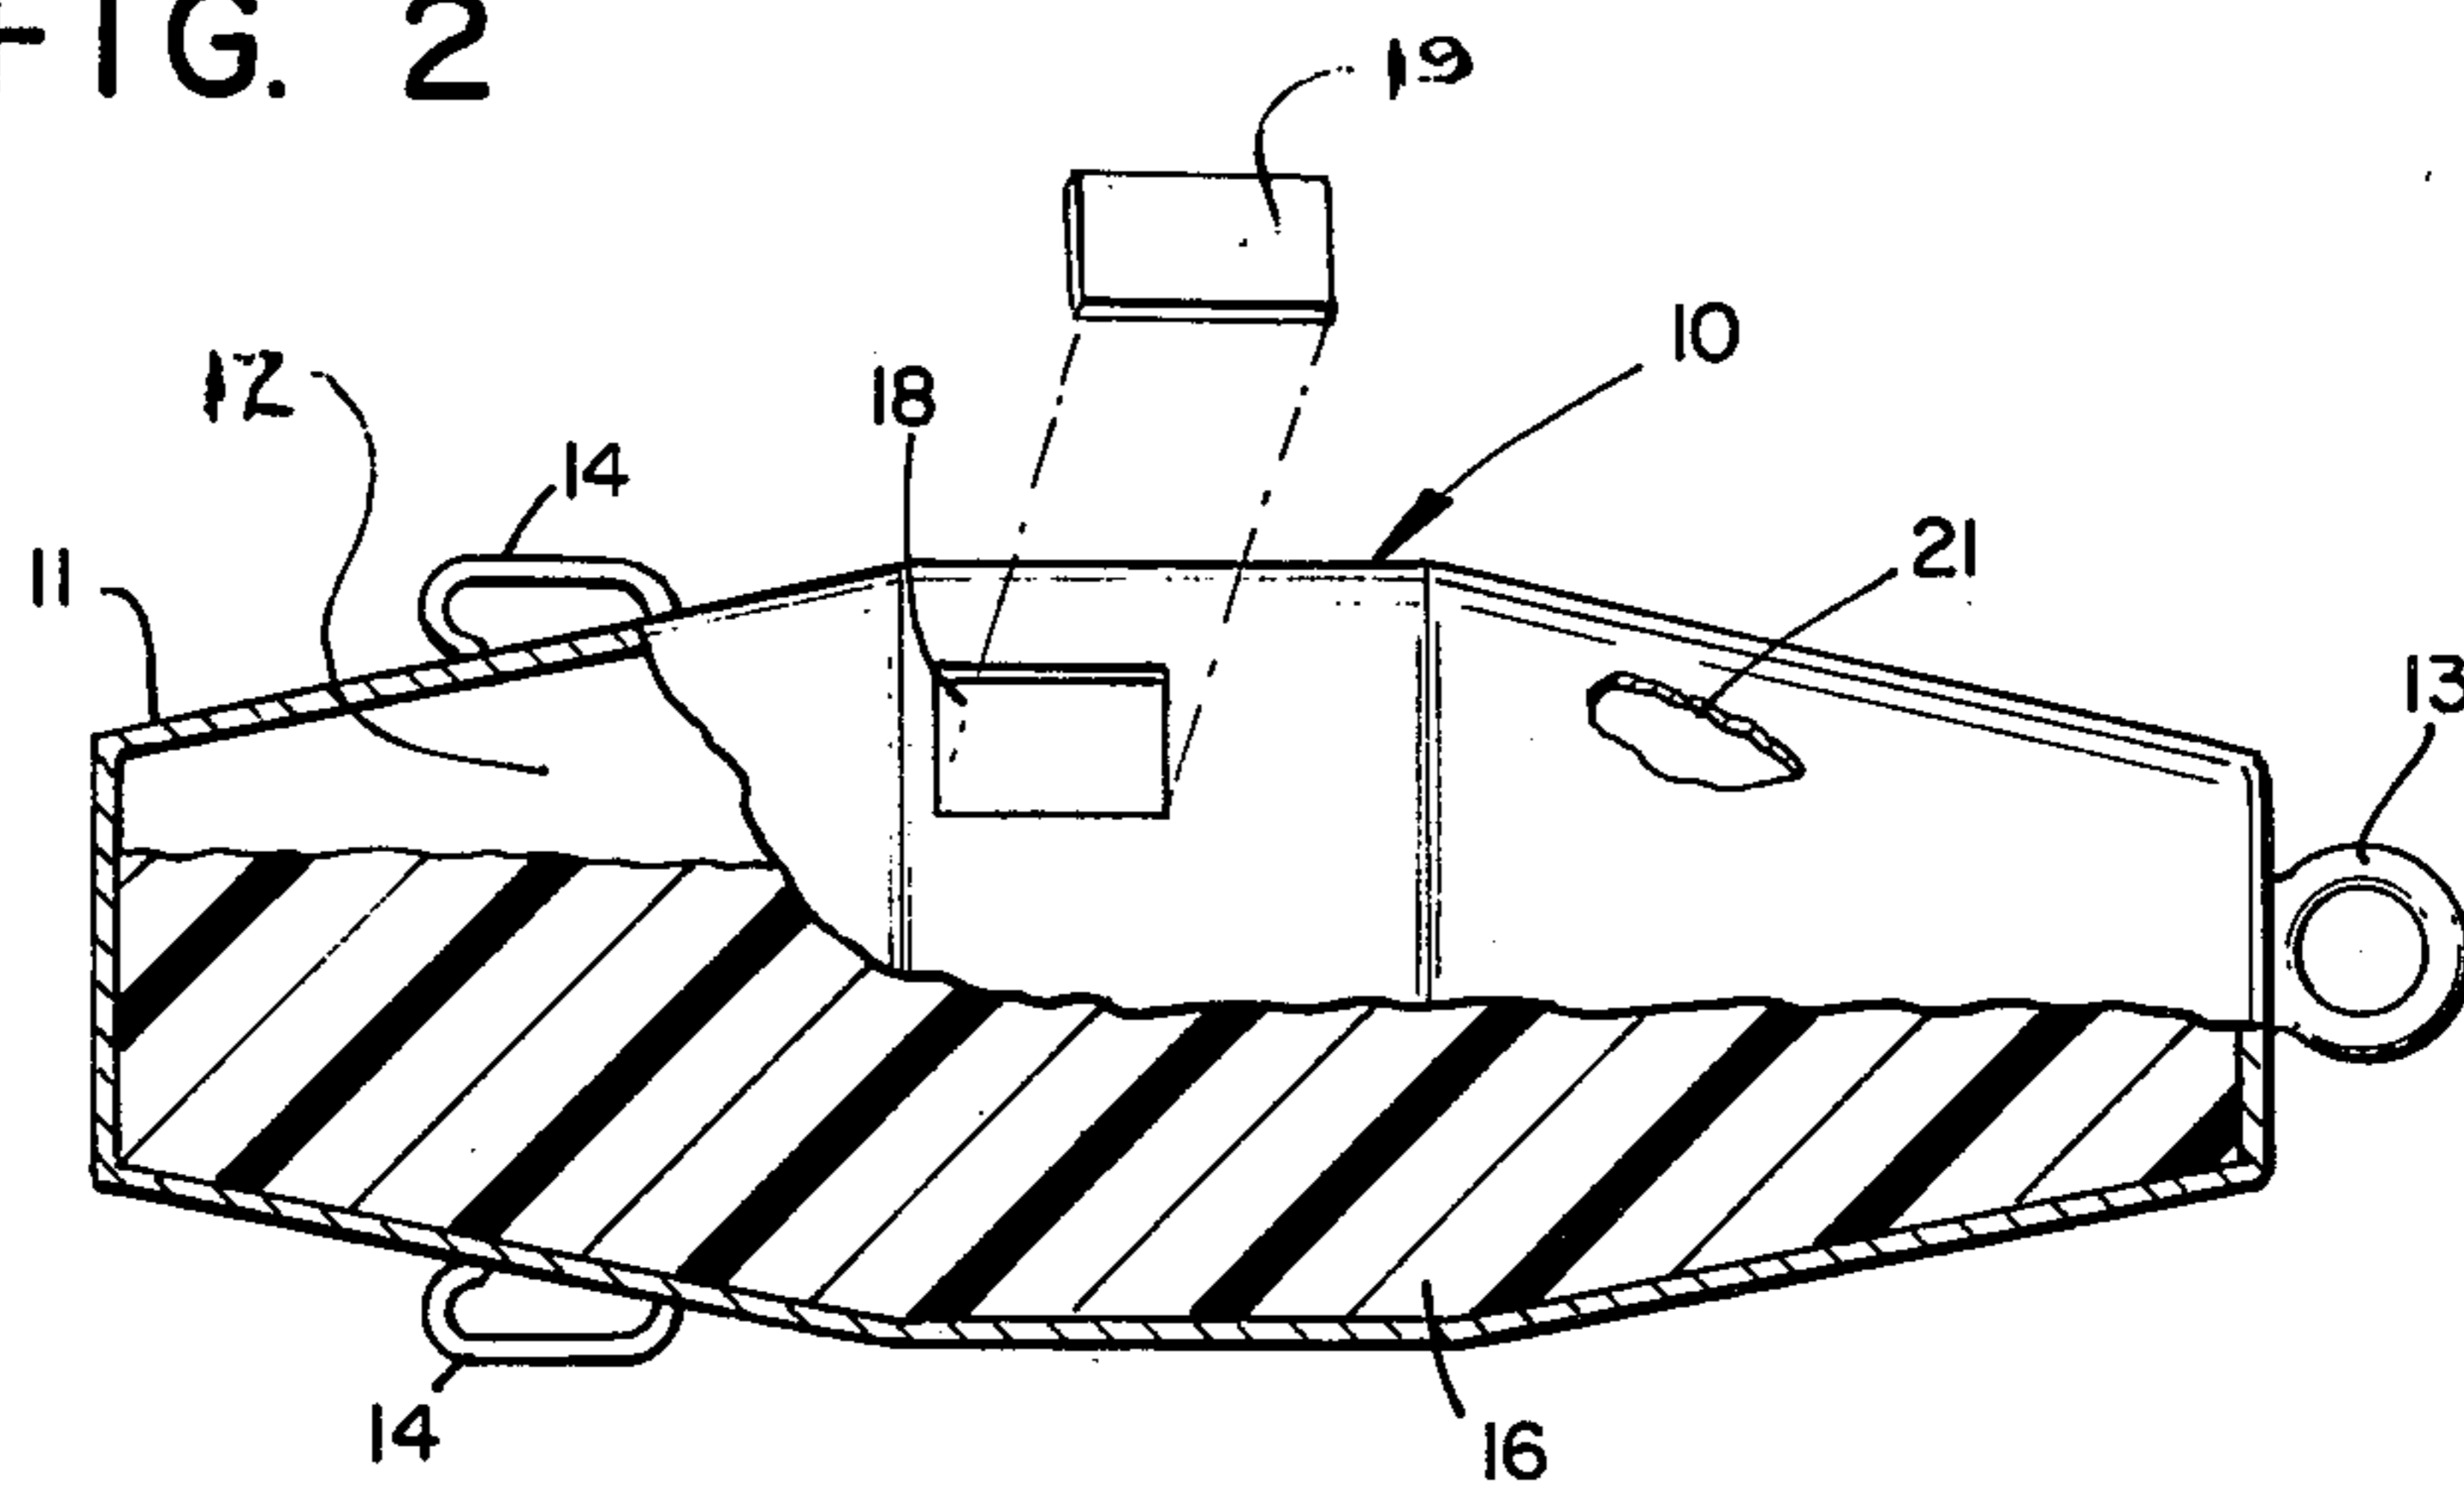
FIG. 2 illustrates in partial cross section, the buoy of FIG. 1 prior to being repaired but with an aperture formed in the metal shell for insertion of the urethane foam filler material.

Referring to FIG. 2, the buoy 10 is shown having an aperture 18 formed by removal of a closure section 19. A break or fracture of shell 11 is shown as item 21. Said break, whether a fracture, or a corroded area of the shell, ordinarily necessitates the presently described repair procedure.
