[54] **PROCESS FOR REFURBISHING METAL BUOYS**

A procedure for refurbishing hollow metal buoys that have been surveyed out of service. The buoy repair method involves removing a metal section, filling the buoy interior with polyurethane foam, welding back the removed metal section and coating the metal exterior with fiber glass-resin composition. Buoys repaired in this manner are essentially maintenance free.

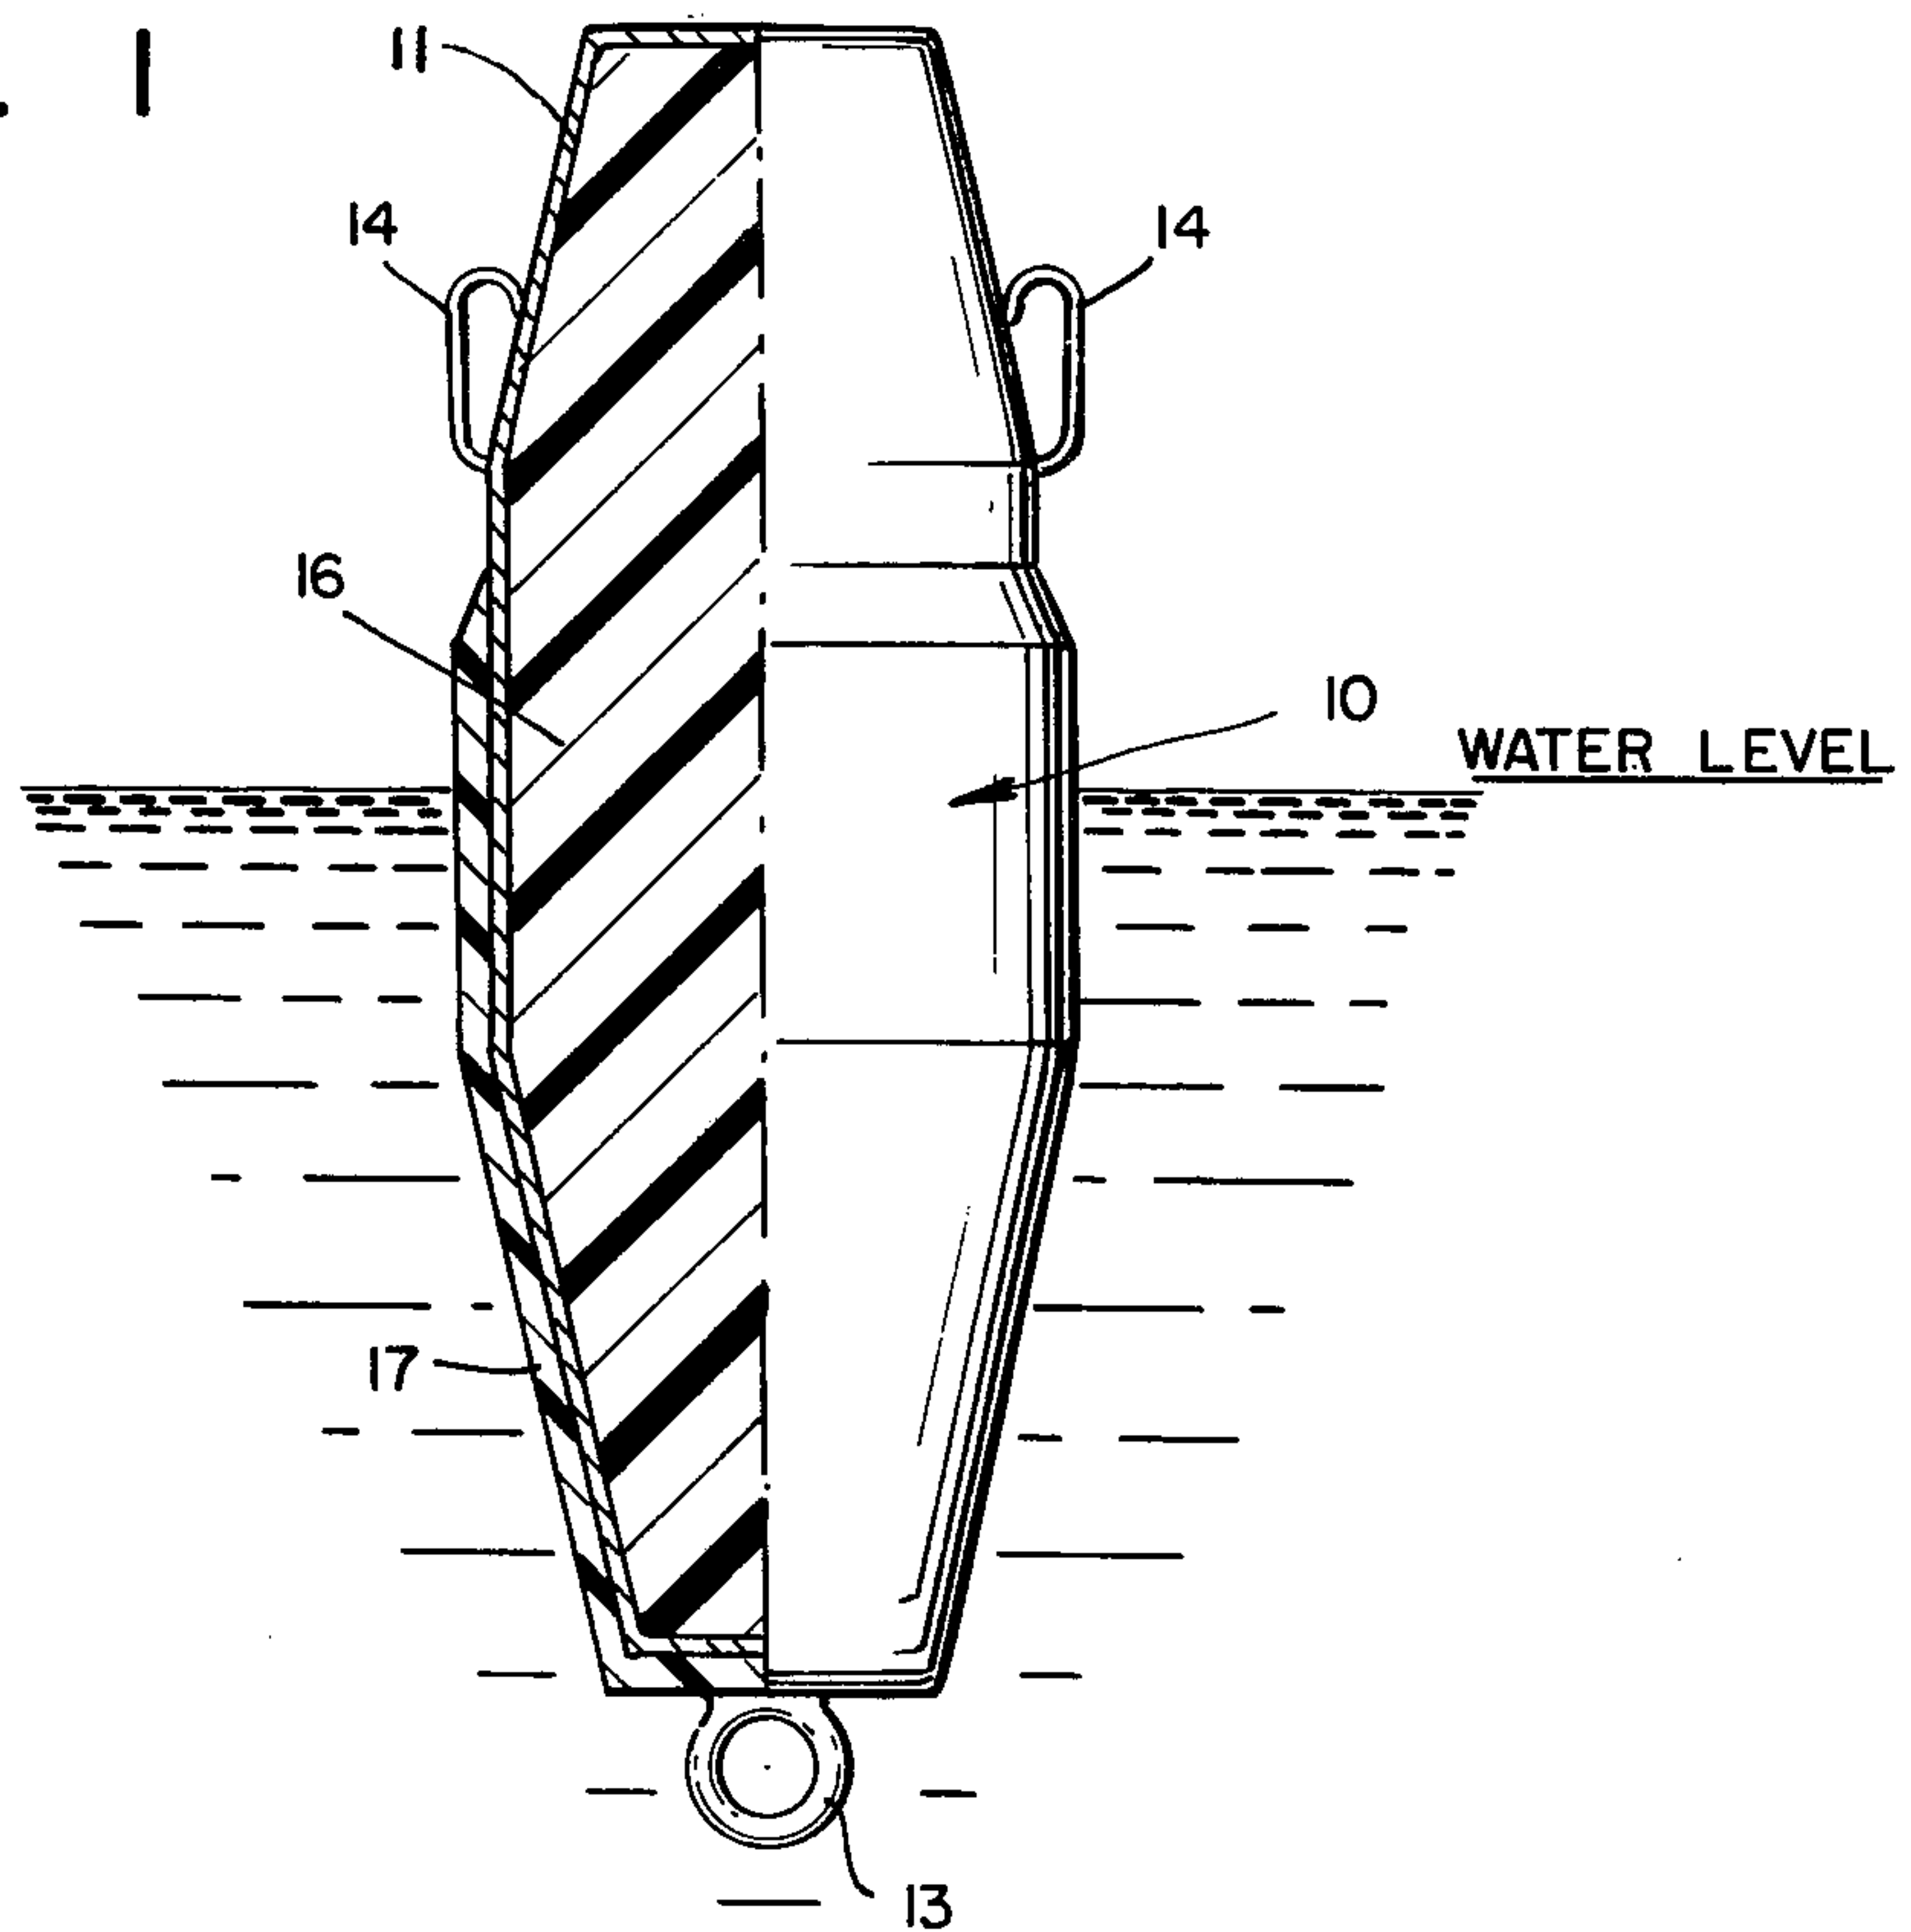
FIG. 1 is an elevation view of a buoy of the type contemplated, shown in partial cross section and subsequent to being repaired.

As shown in FIG. 1 the repaired buoy inner or flotation chamber 12 is completely filled with a mass of expanded polyurethane foam 16. An outer coating 17 formed of multiple plies of a resin impregnated fiberglass provides a water tight skin to shell 11.

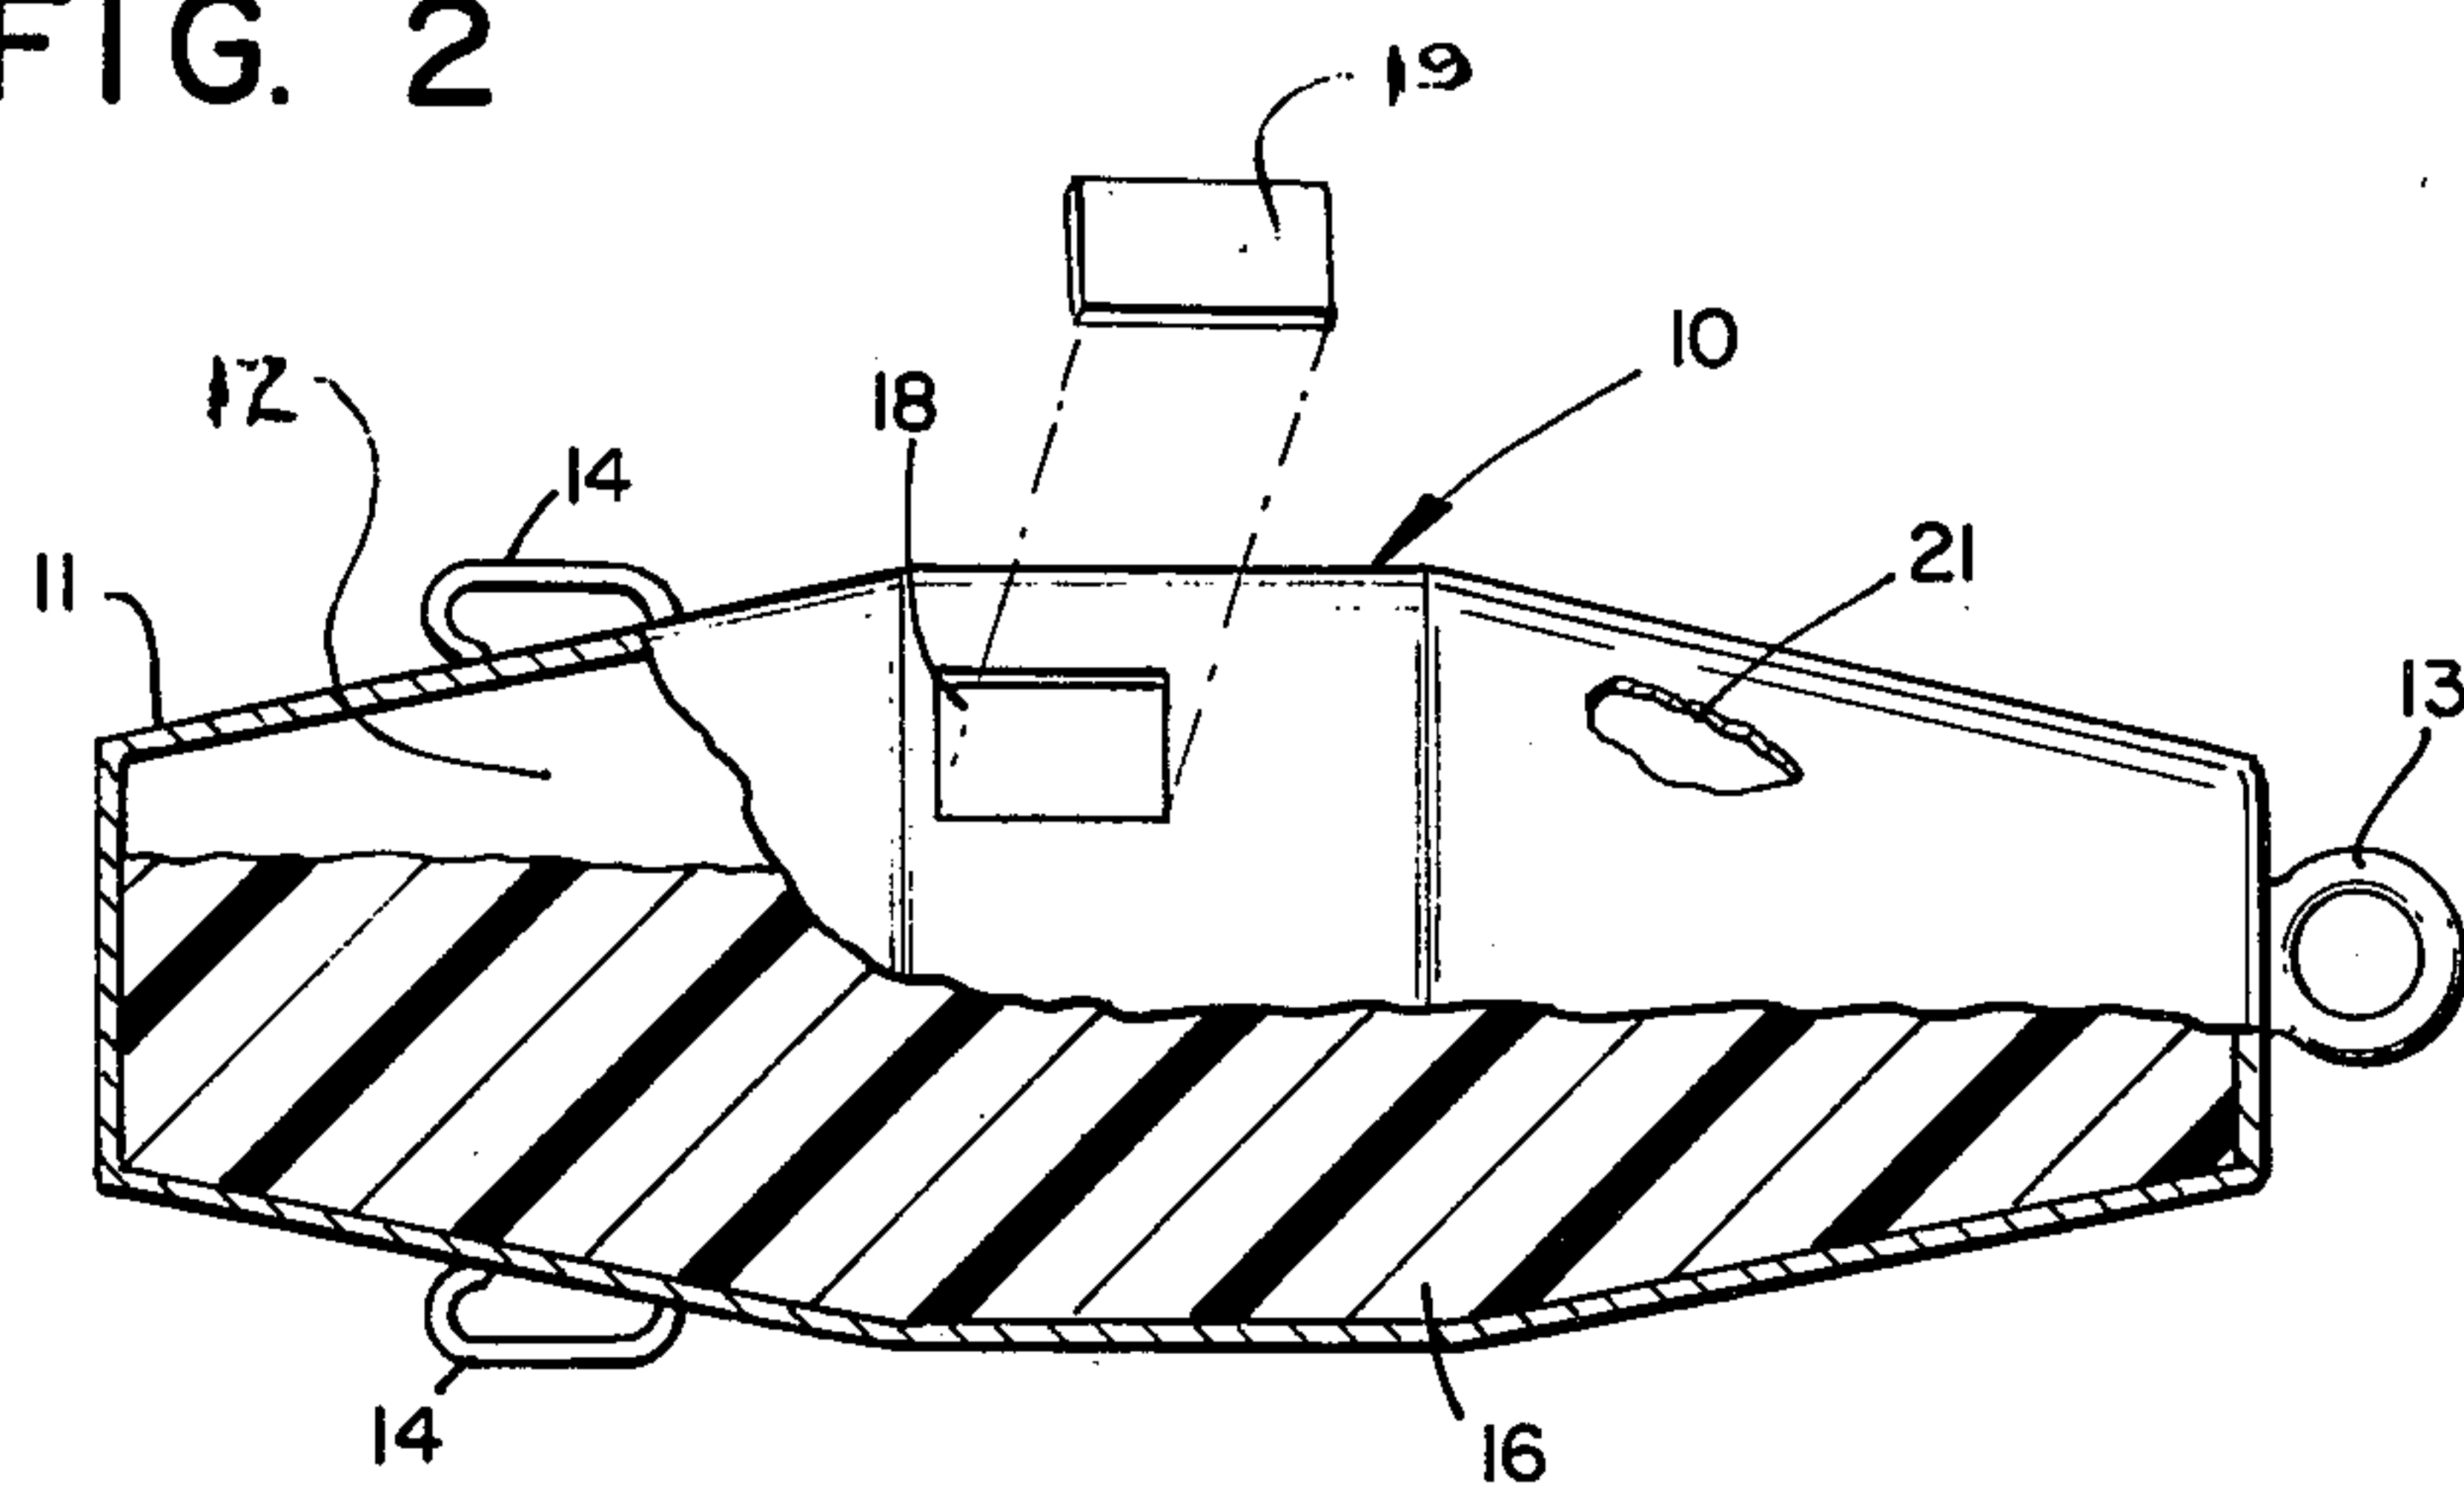
FIG. 2 illustrates in partial cross section, the buoy of FIG. 1 prior to being repaired but with an aperture formed in the metal shell for insertion of the urethane foam filler material.

Referring to FIG. 2, the buoy 10 is shown having an aperture 18 formed by removal of a closure section 19. A break or fracture of shell 11 is shown as item 21. Said break, whether a fracture, or a corroded area of the shell, ordinarily necessitates the presently described repair procedure.
