[54] **REFURBISHED TURBINE COMPONENTS, SUCH AS VANES OR BLADES**

[57] **ABSTRACT**

A refurbished turbine vane or blade. Used turbine vanes and blades are cleaned, annealed and in some cases slotted adjacent their ends, after which any cooling passages are welded closed and all cracks welded over, on both leading and trailing edges. The trailing edge, for a vane or blade having a short chord, is built up by welding along its full length with an alloy wire, after which any slots that were cut adjacent the ends are closed, also by welding. Then the worn surfaces of the vane or blade are built-up by a plasma spray process, using a metal powder with added silica, to a thickness as great as 30 to 40 thousandths of an inch. The built-up vane or blade is then sintered and thereafter surface finished to conform to the original contour of the component when new. Any cooling holes are finally recut, and the vane or blade polished as required and inspected.

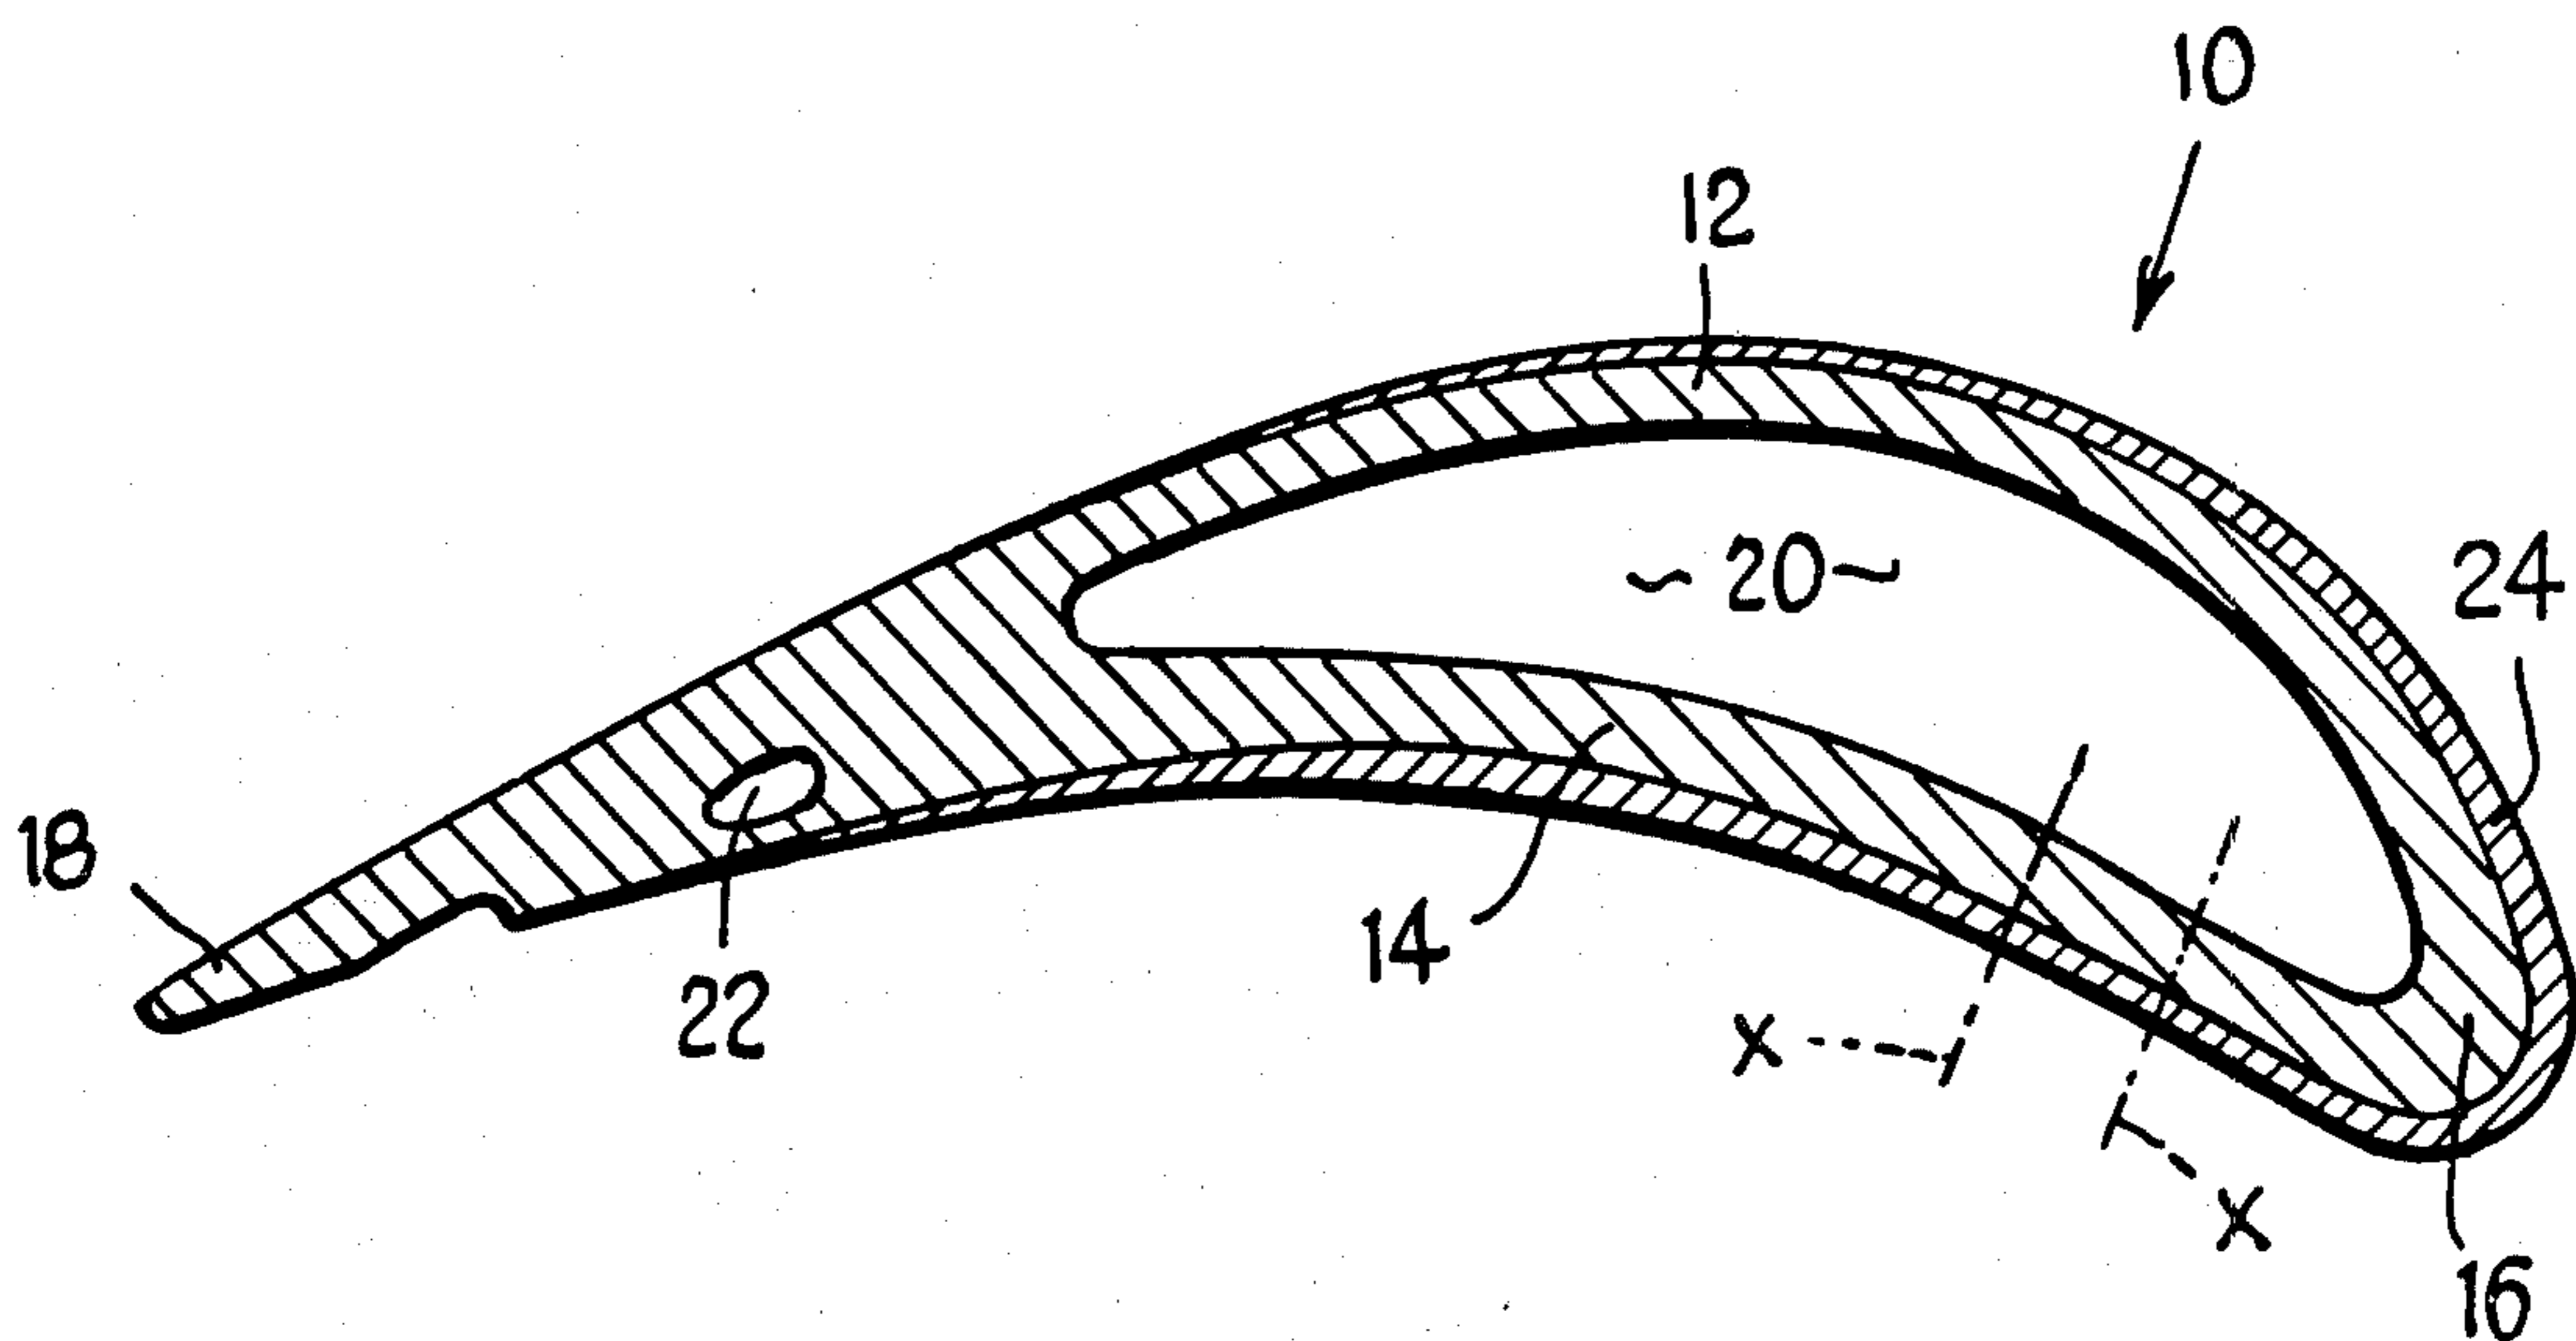
Fig. 1

FIG. 1 is an elevational view of the convex side of a vane of the type refurbished by a process involved with the invention.

Considering first FIGS. 1-4, a finished or refurbished component in the form of a vane designated 10 is shown, said vane comprising convex and concave airfoil portions 12, 14 joined at a broad leading edge 16 and also at a narrow trailing edge 18. The vane 10 is hollow, having an airfoil-shaped inner space 20 between the airfoil portions. Adjacent the trailing edge 18, the vane 10 has cooling passages 22 which communicate with the interior space 20. Such passages are clearly seen particularly in FIG. 2.

The vane 10 of FIGS. 1-4 has been refurbished according to the process by which the invention is carried out, and in FIGS. 3 and 4 the cross-sectional areas 24 designate overlay metal which has been added to the vane surfaces by a plasma spray process and thereafter refinished to conform to the original contours as specified for new vanes. The overlay metal of the areas 24 can be applied to build up a thickness of as much as 30 to 40 thousandths of an inch, and can be feathered as shown, as the overlay approaches the trailing edge 18 of the vane.

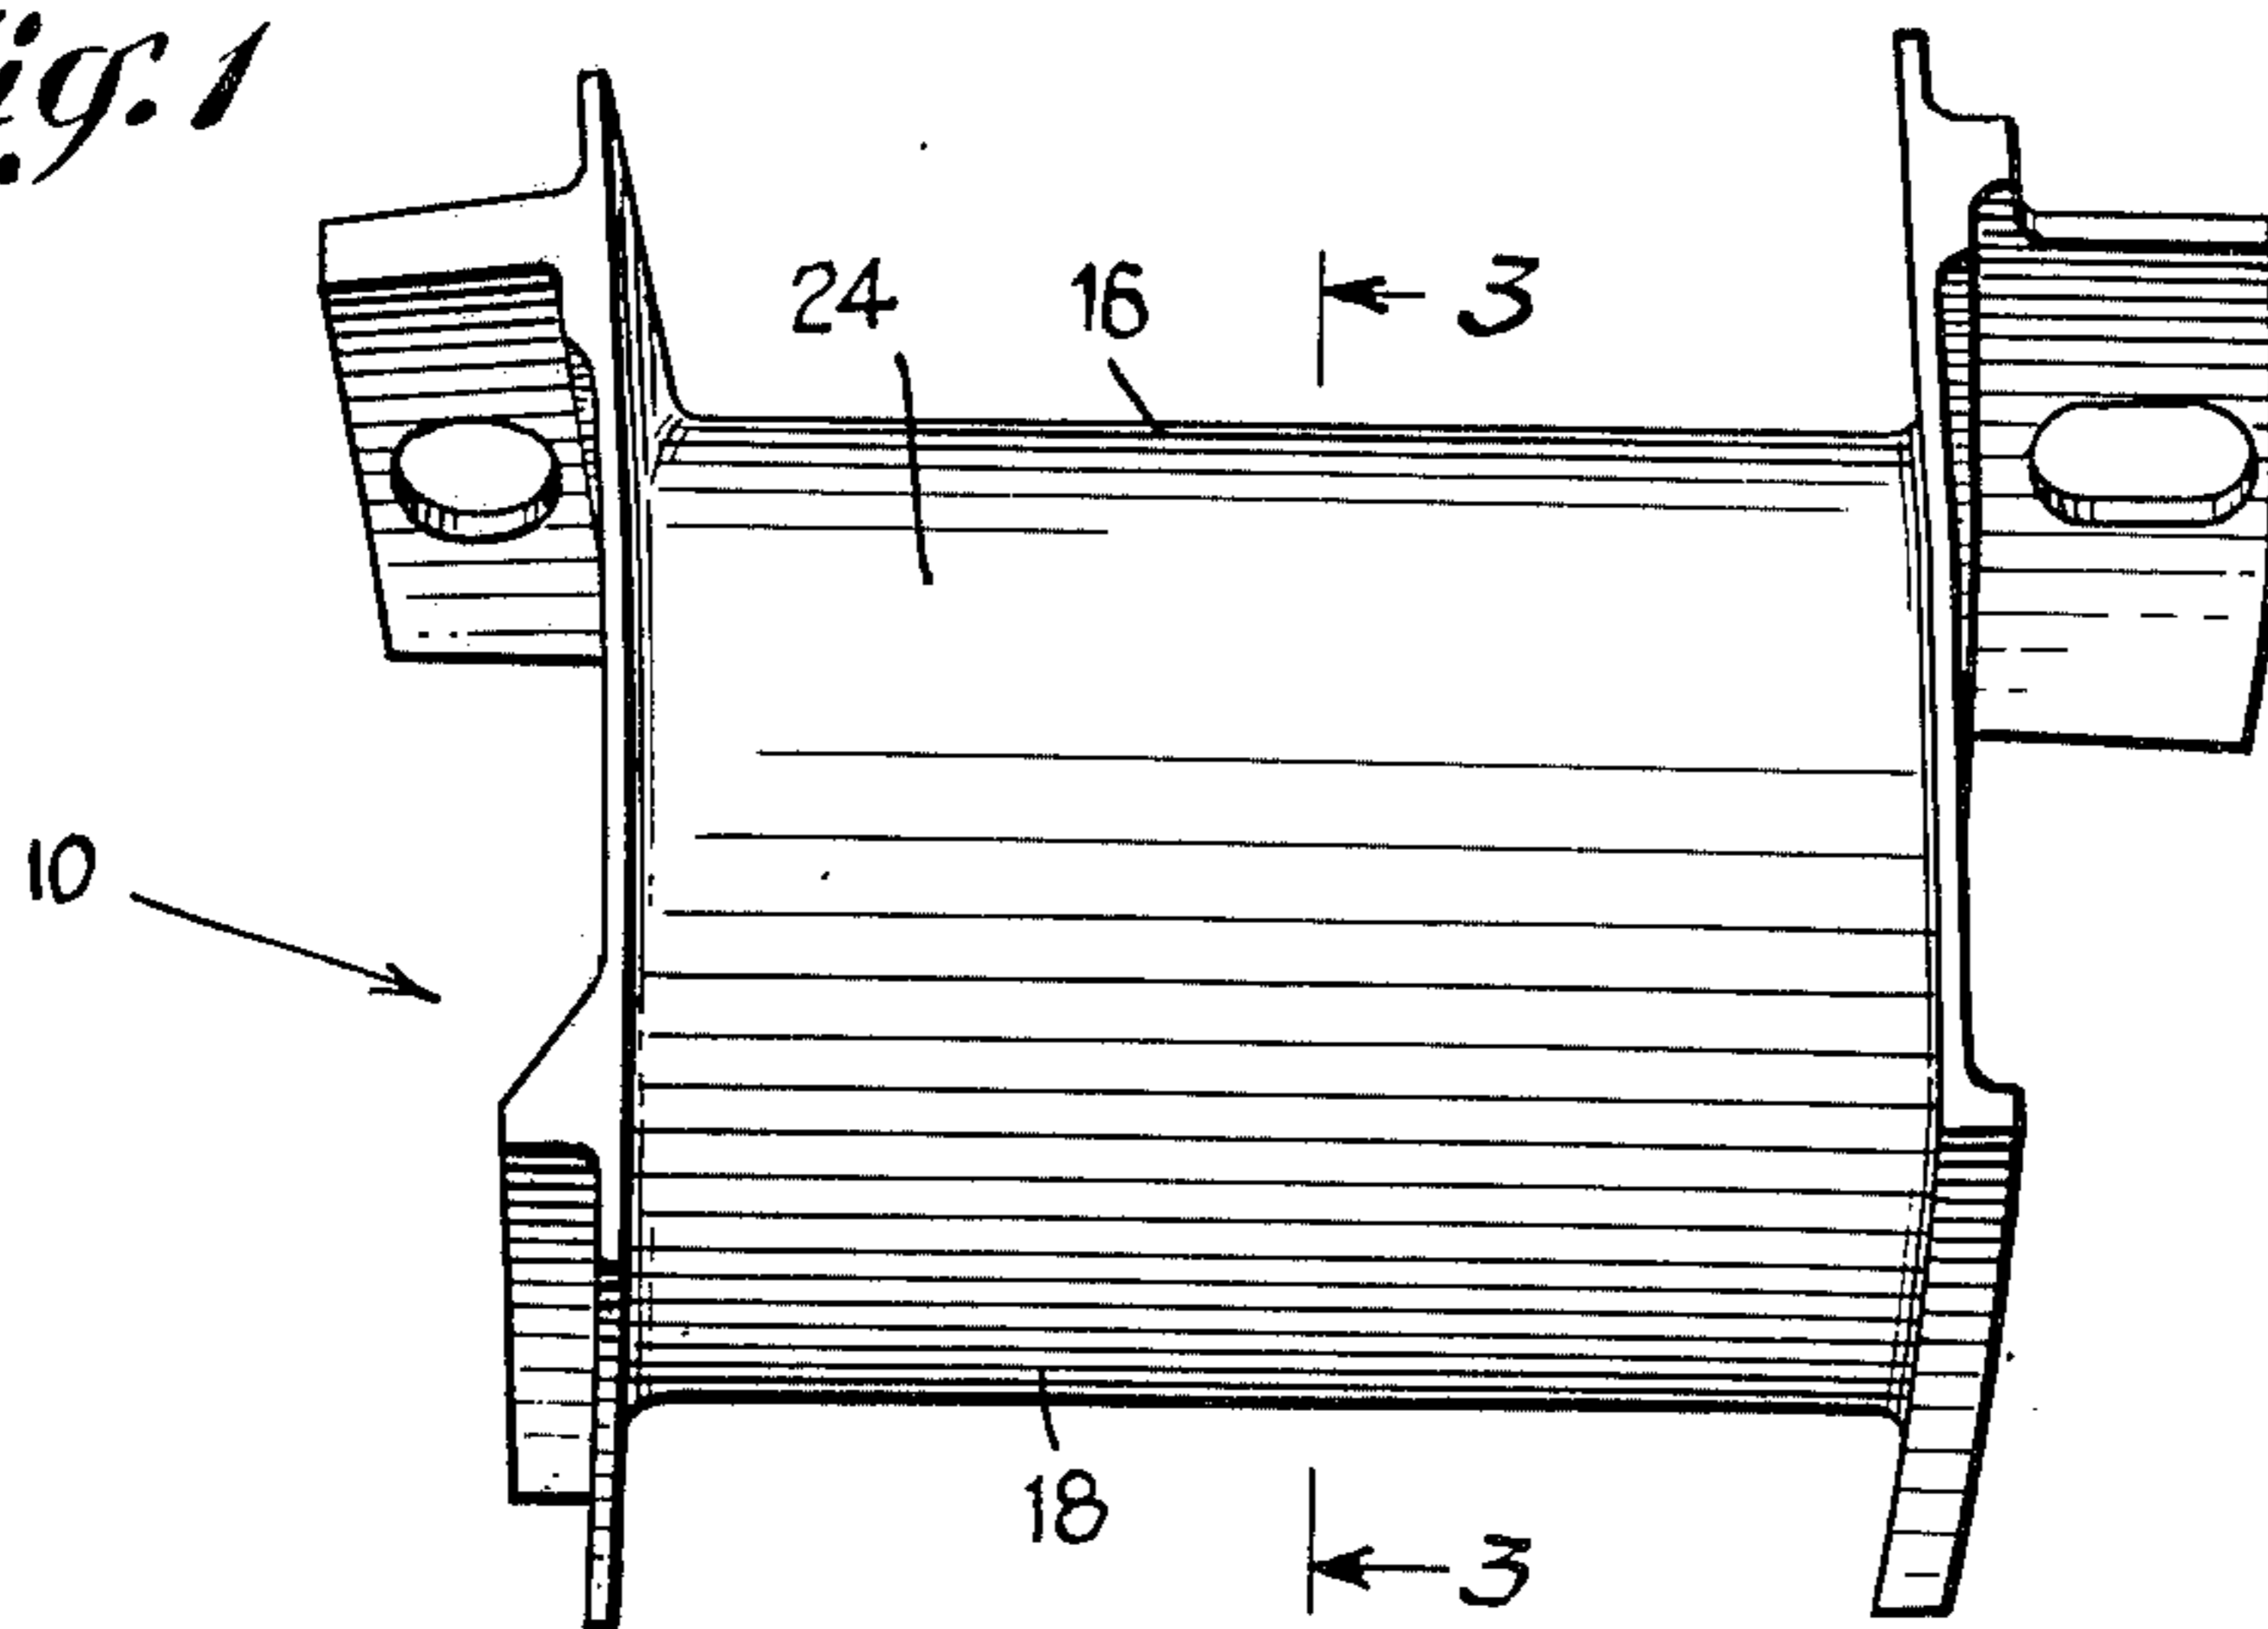
Fig. 2

FIG. 2 is an elevational view of the concave side of the vane.

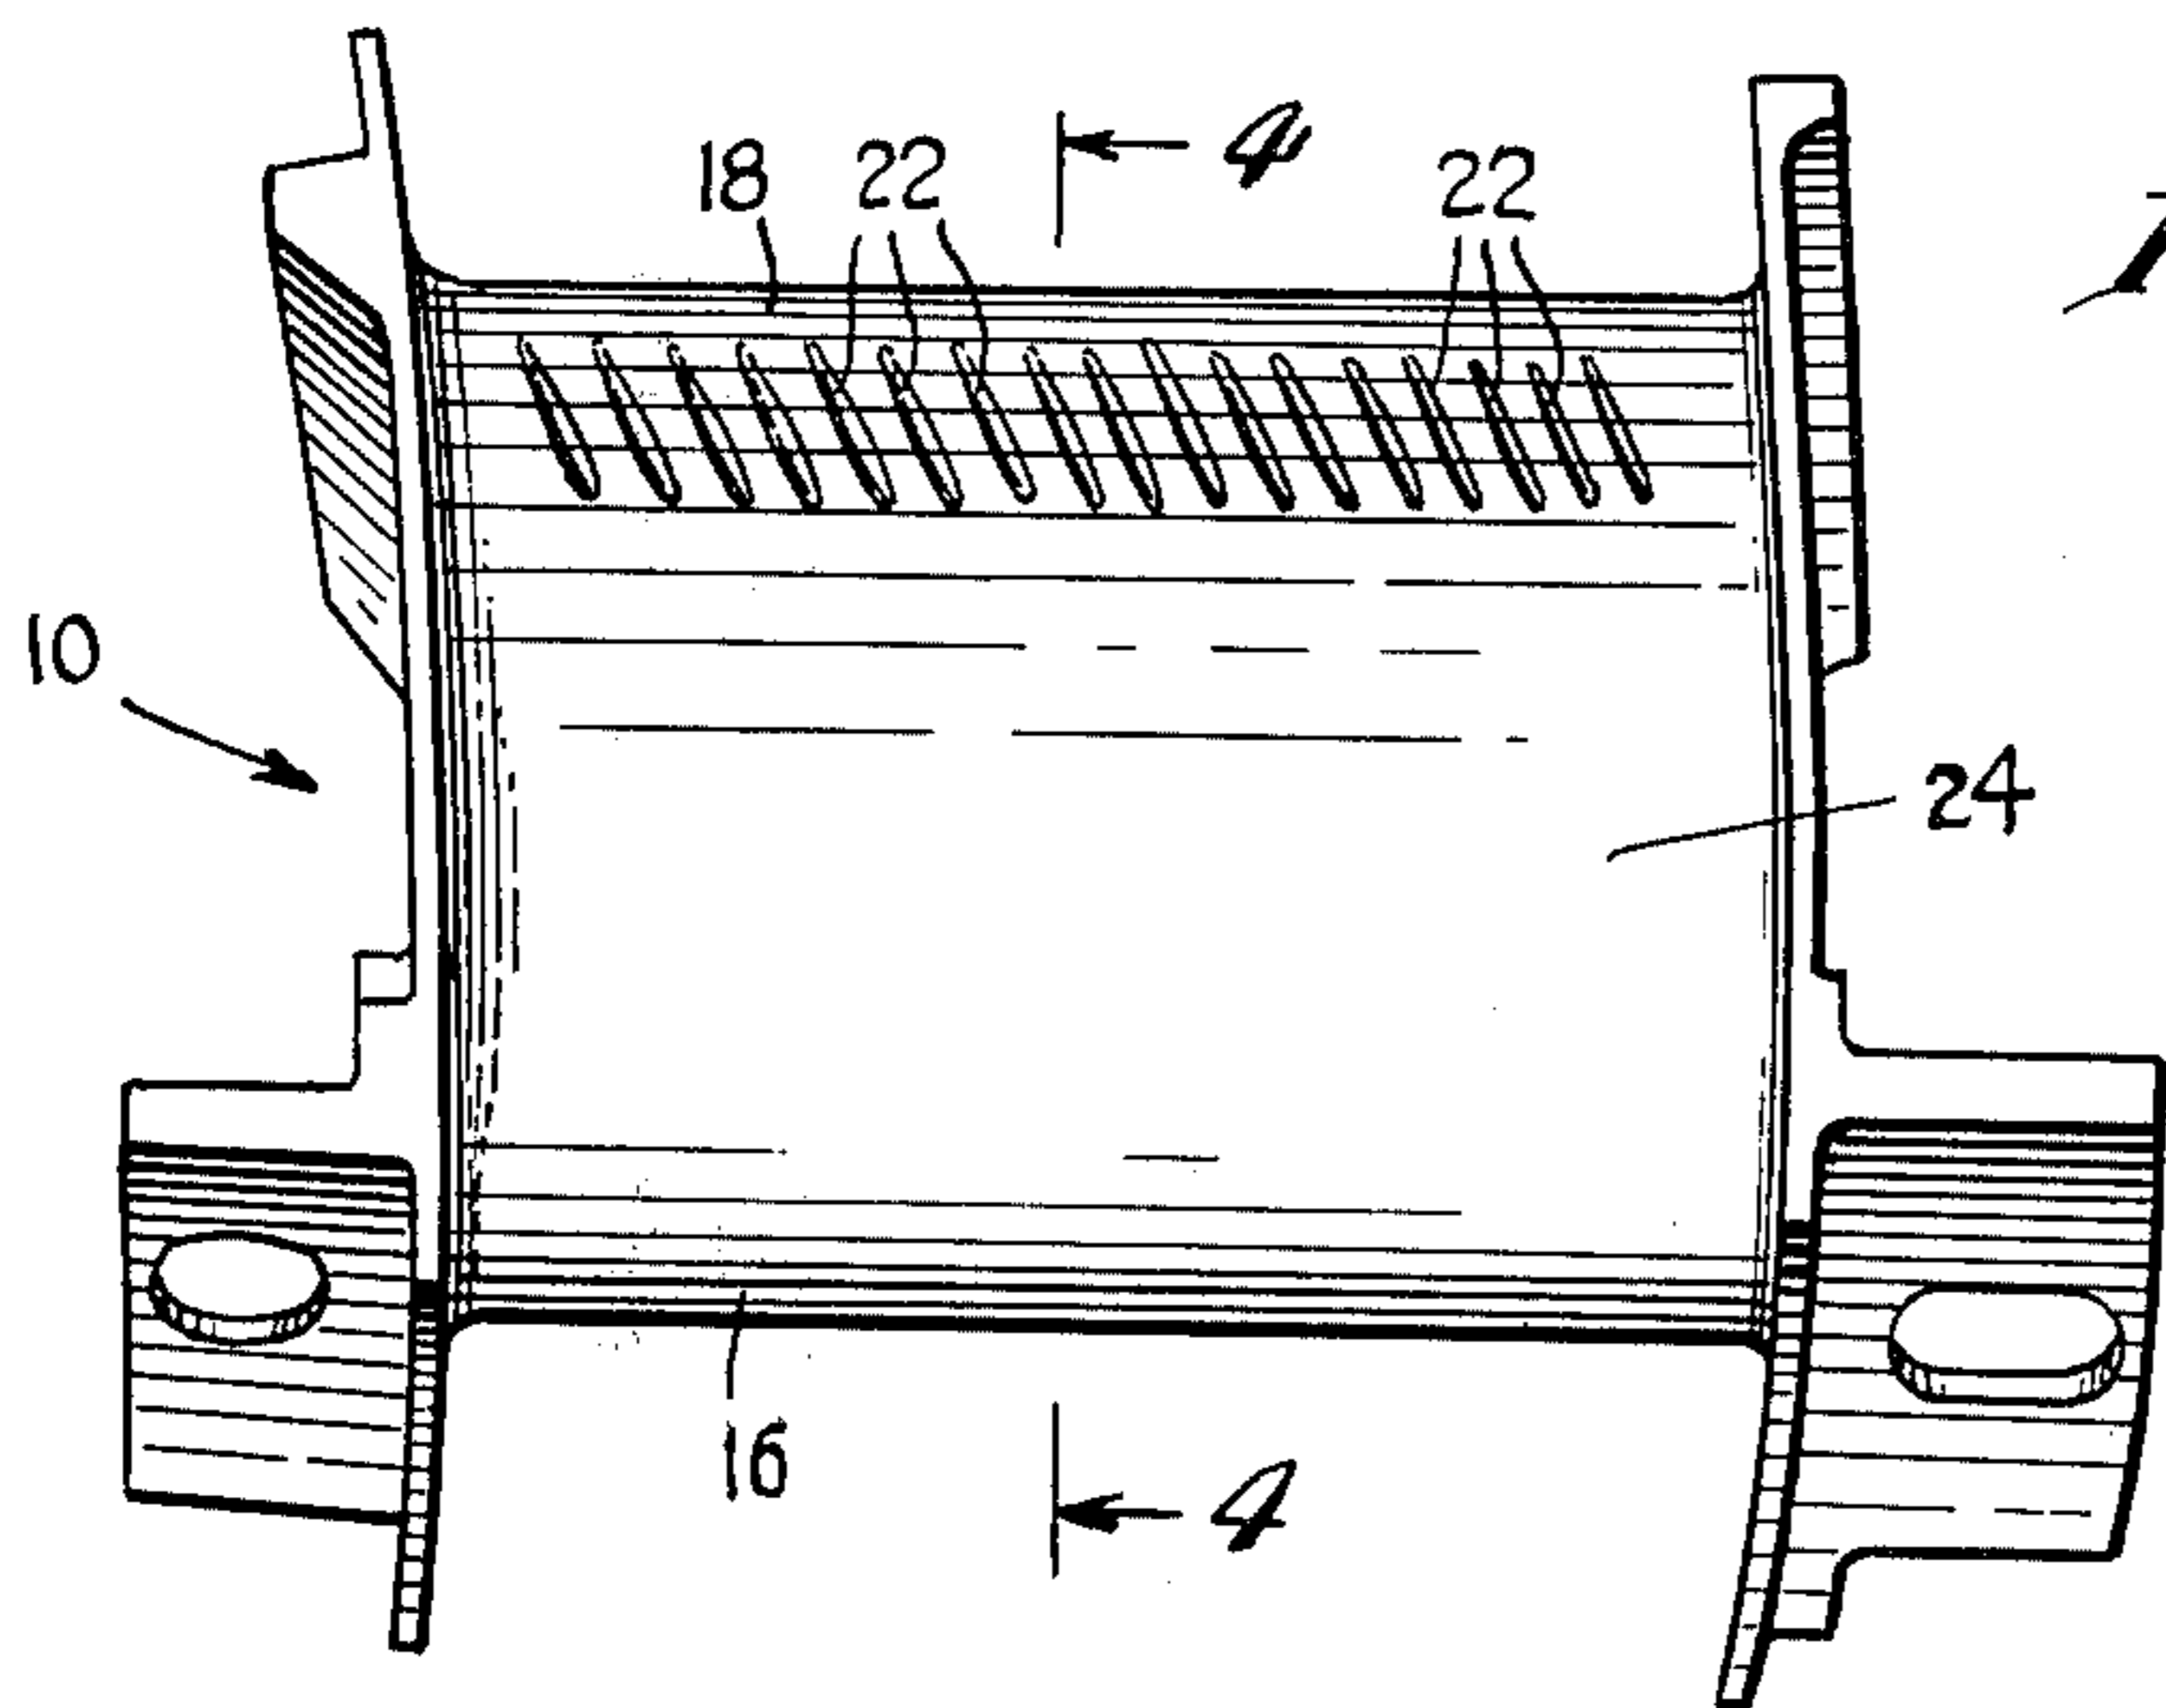
Fig. 3

FIG. 3 is a cross-section through the vane, taken on the line 3—3 of FIG. 1.

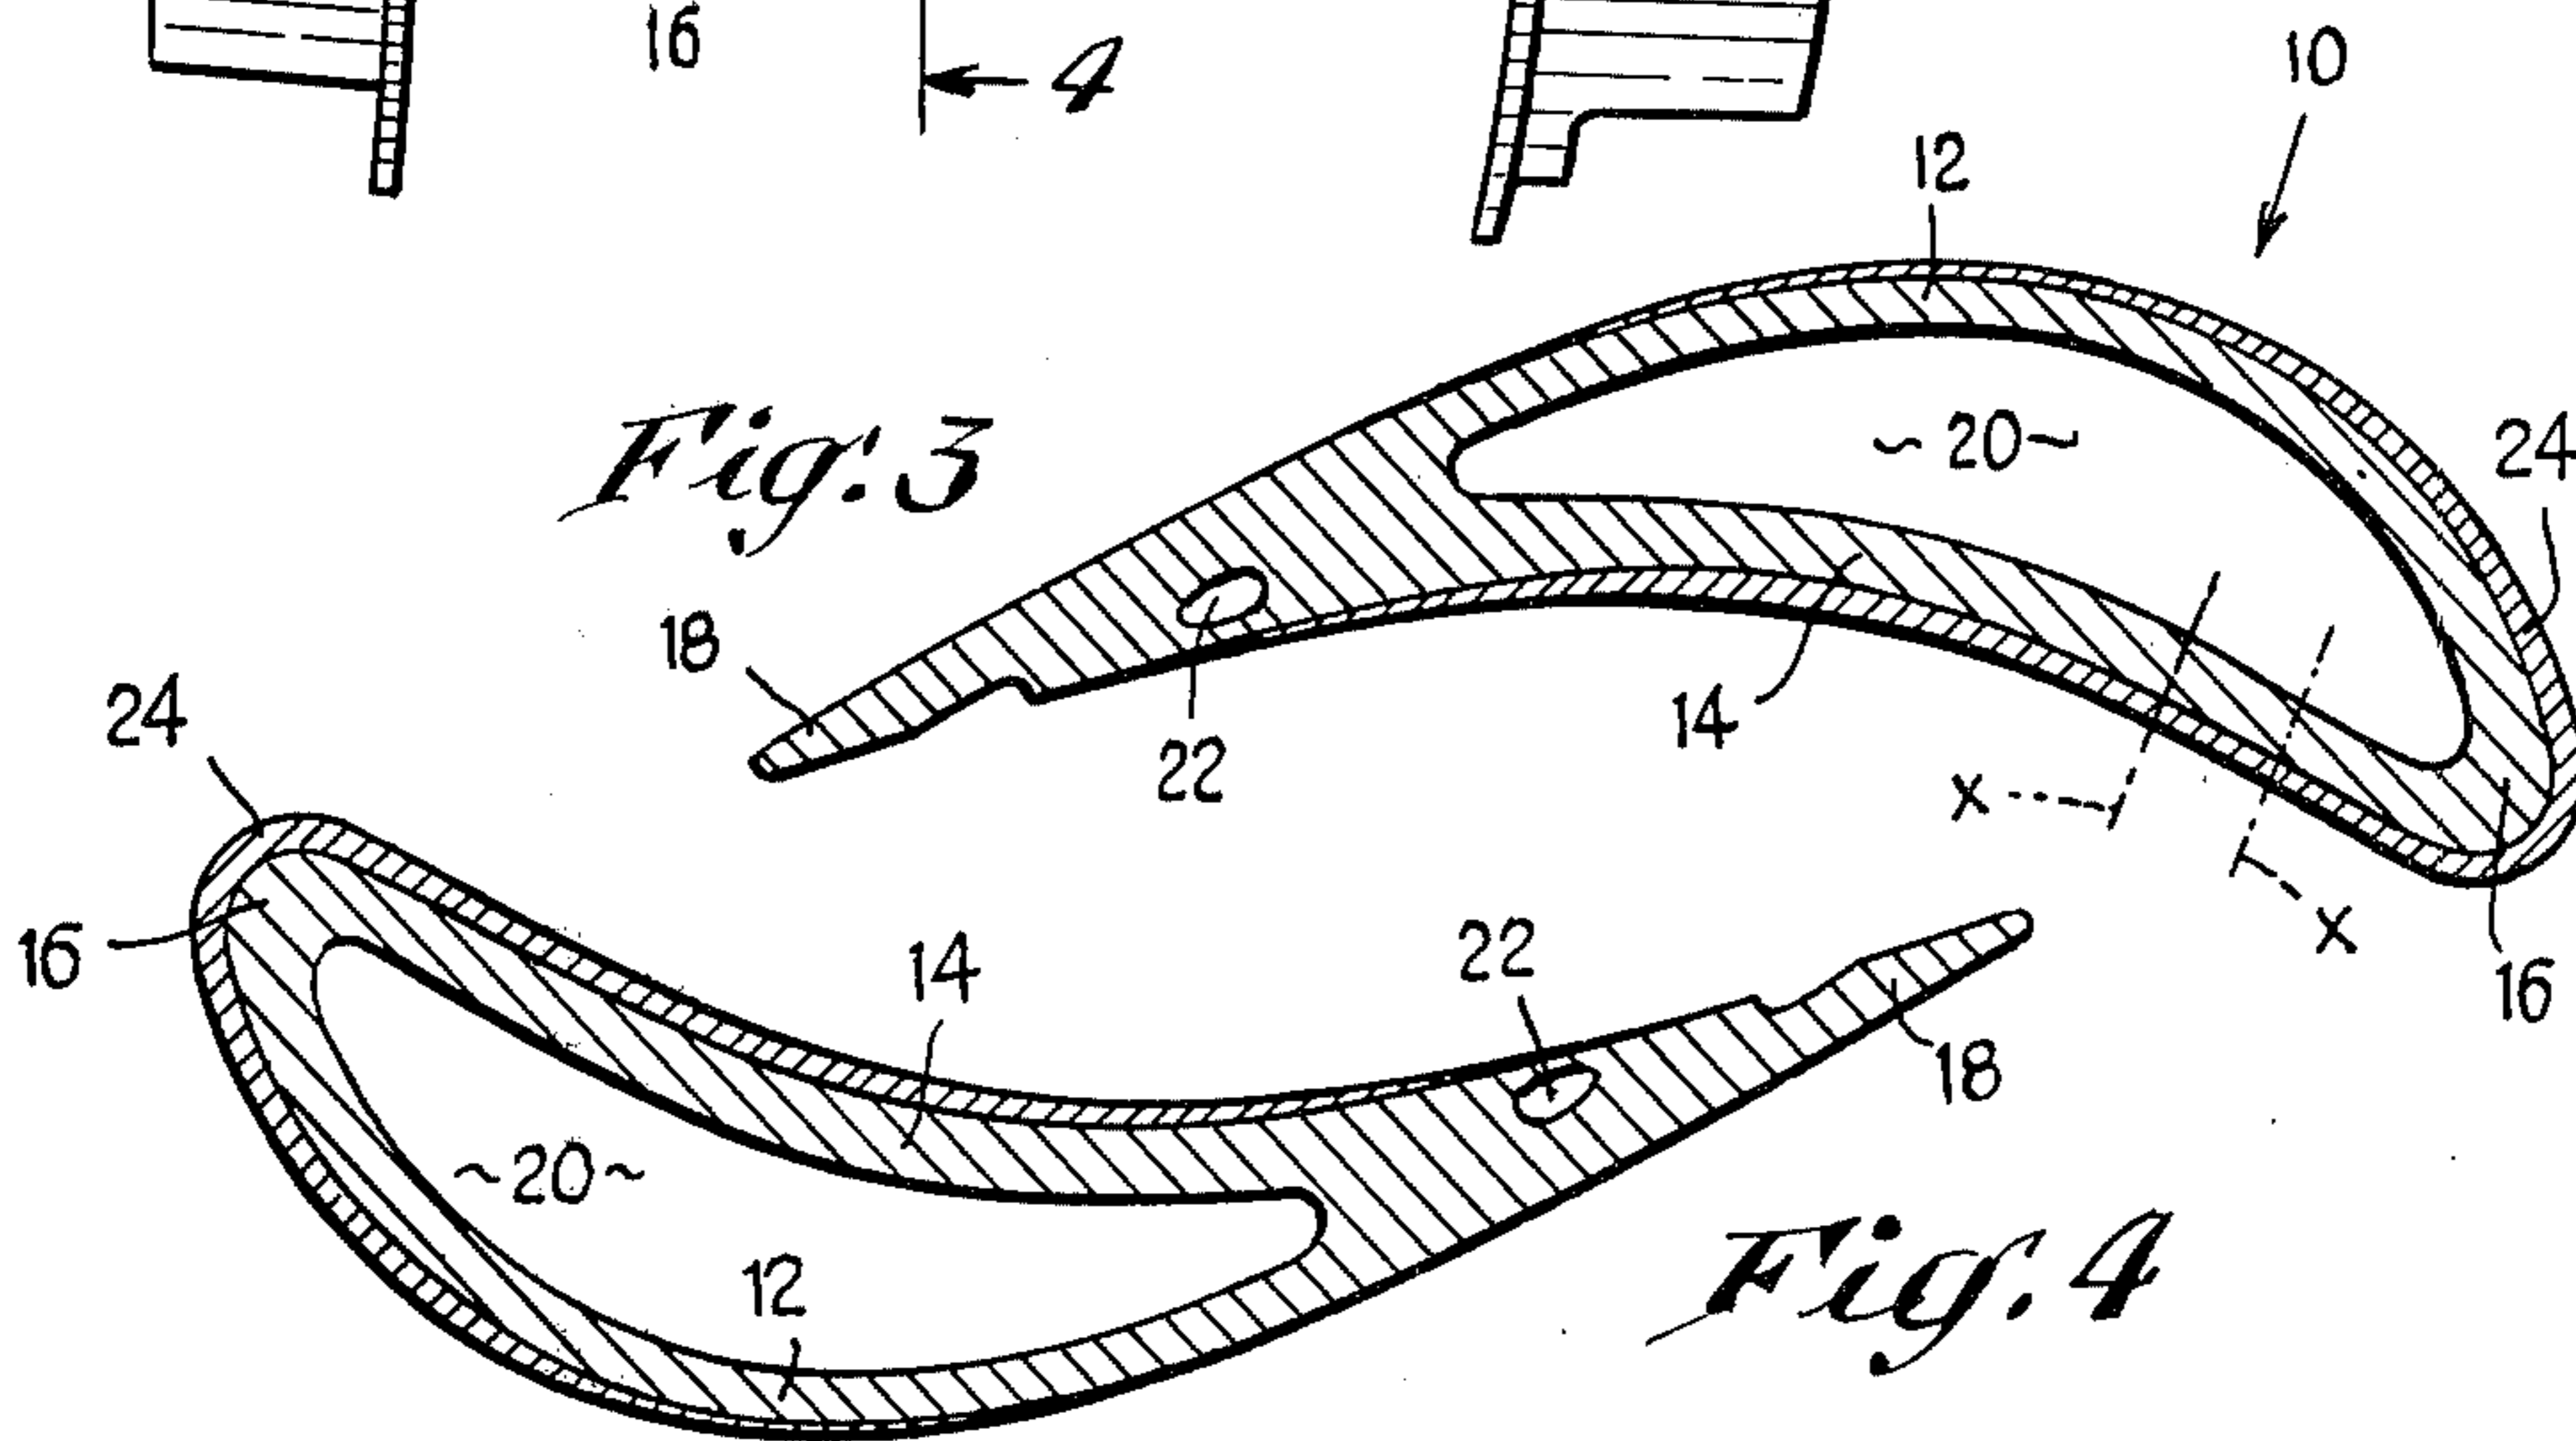
Fig. 4

FIG. 4 is a section taken on the line 4—4 of FIG. 2.

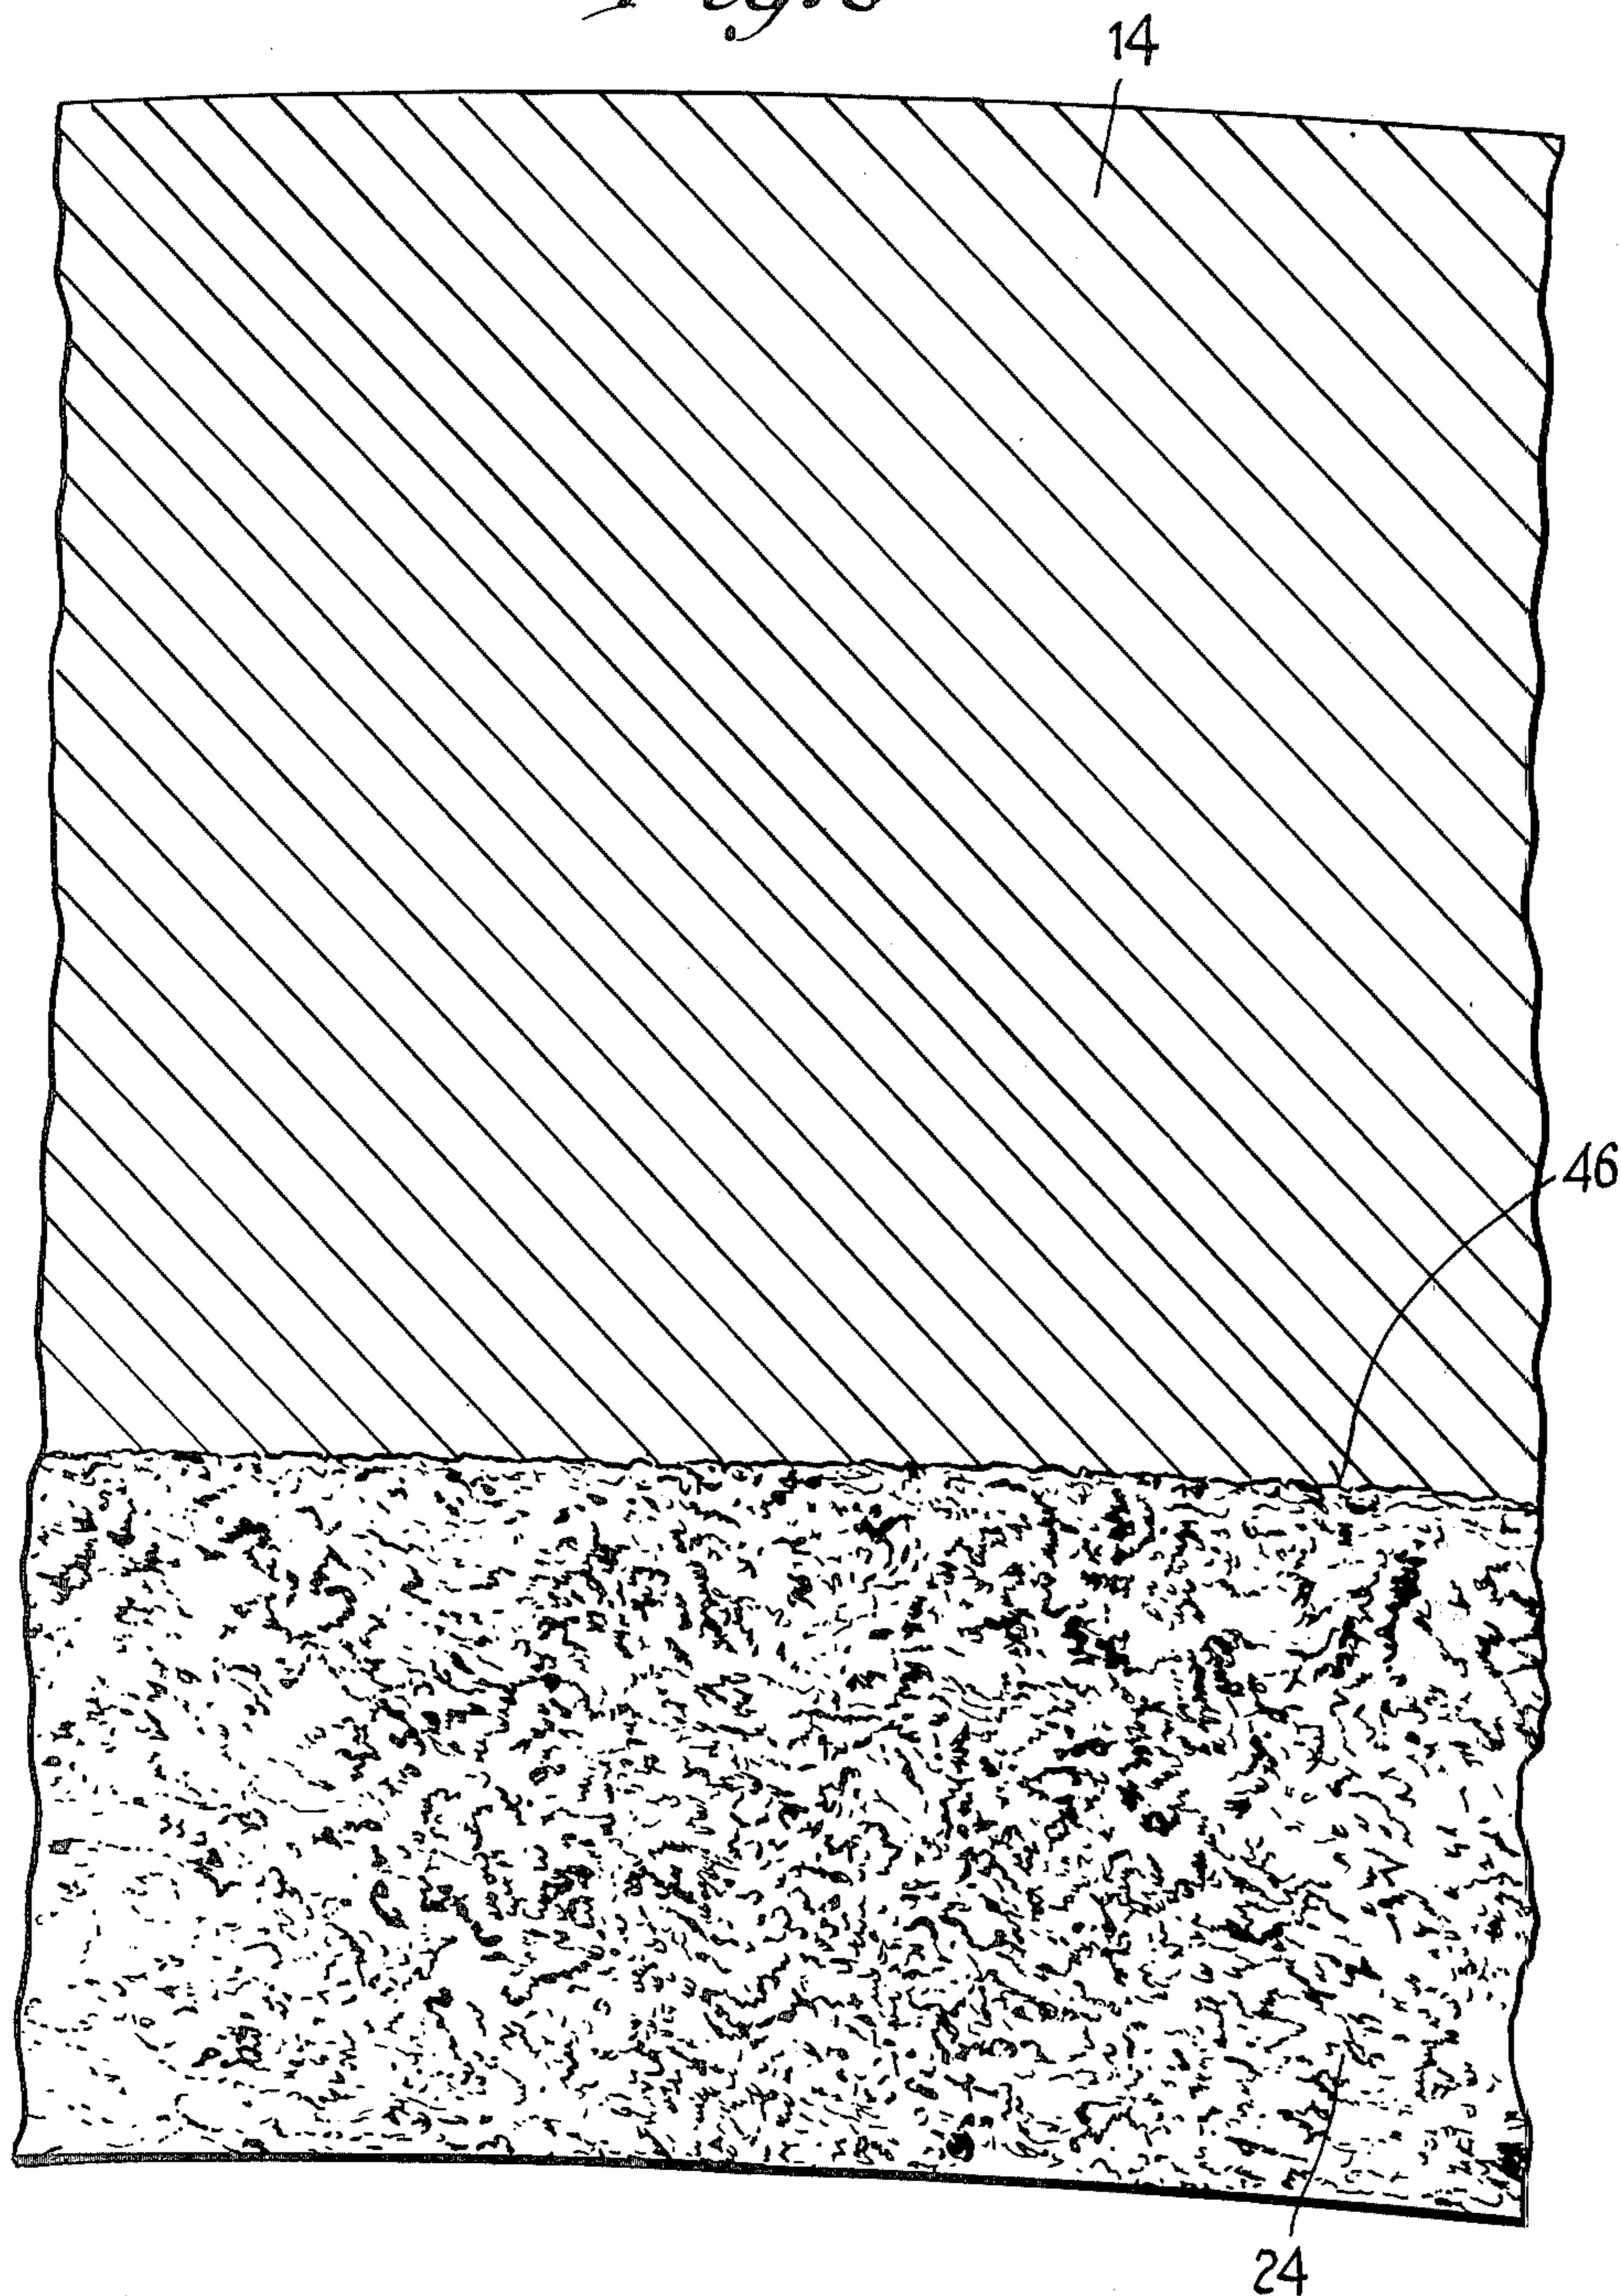
Fig. 8

FIG. 8 is a cross-section through the vane, taken on the line 8—8 of FIG. 6.

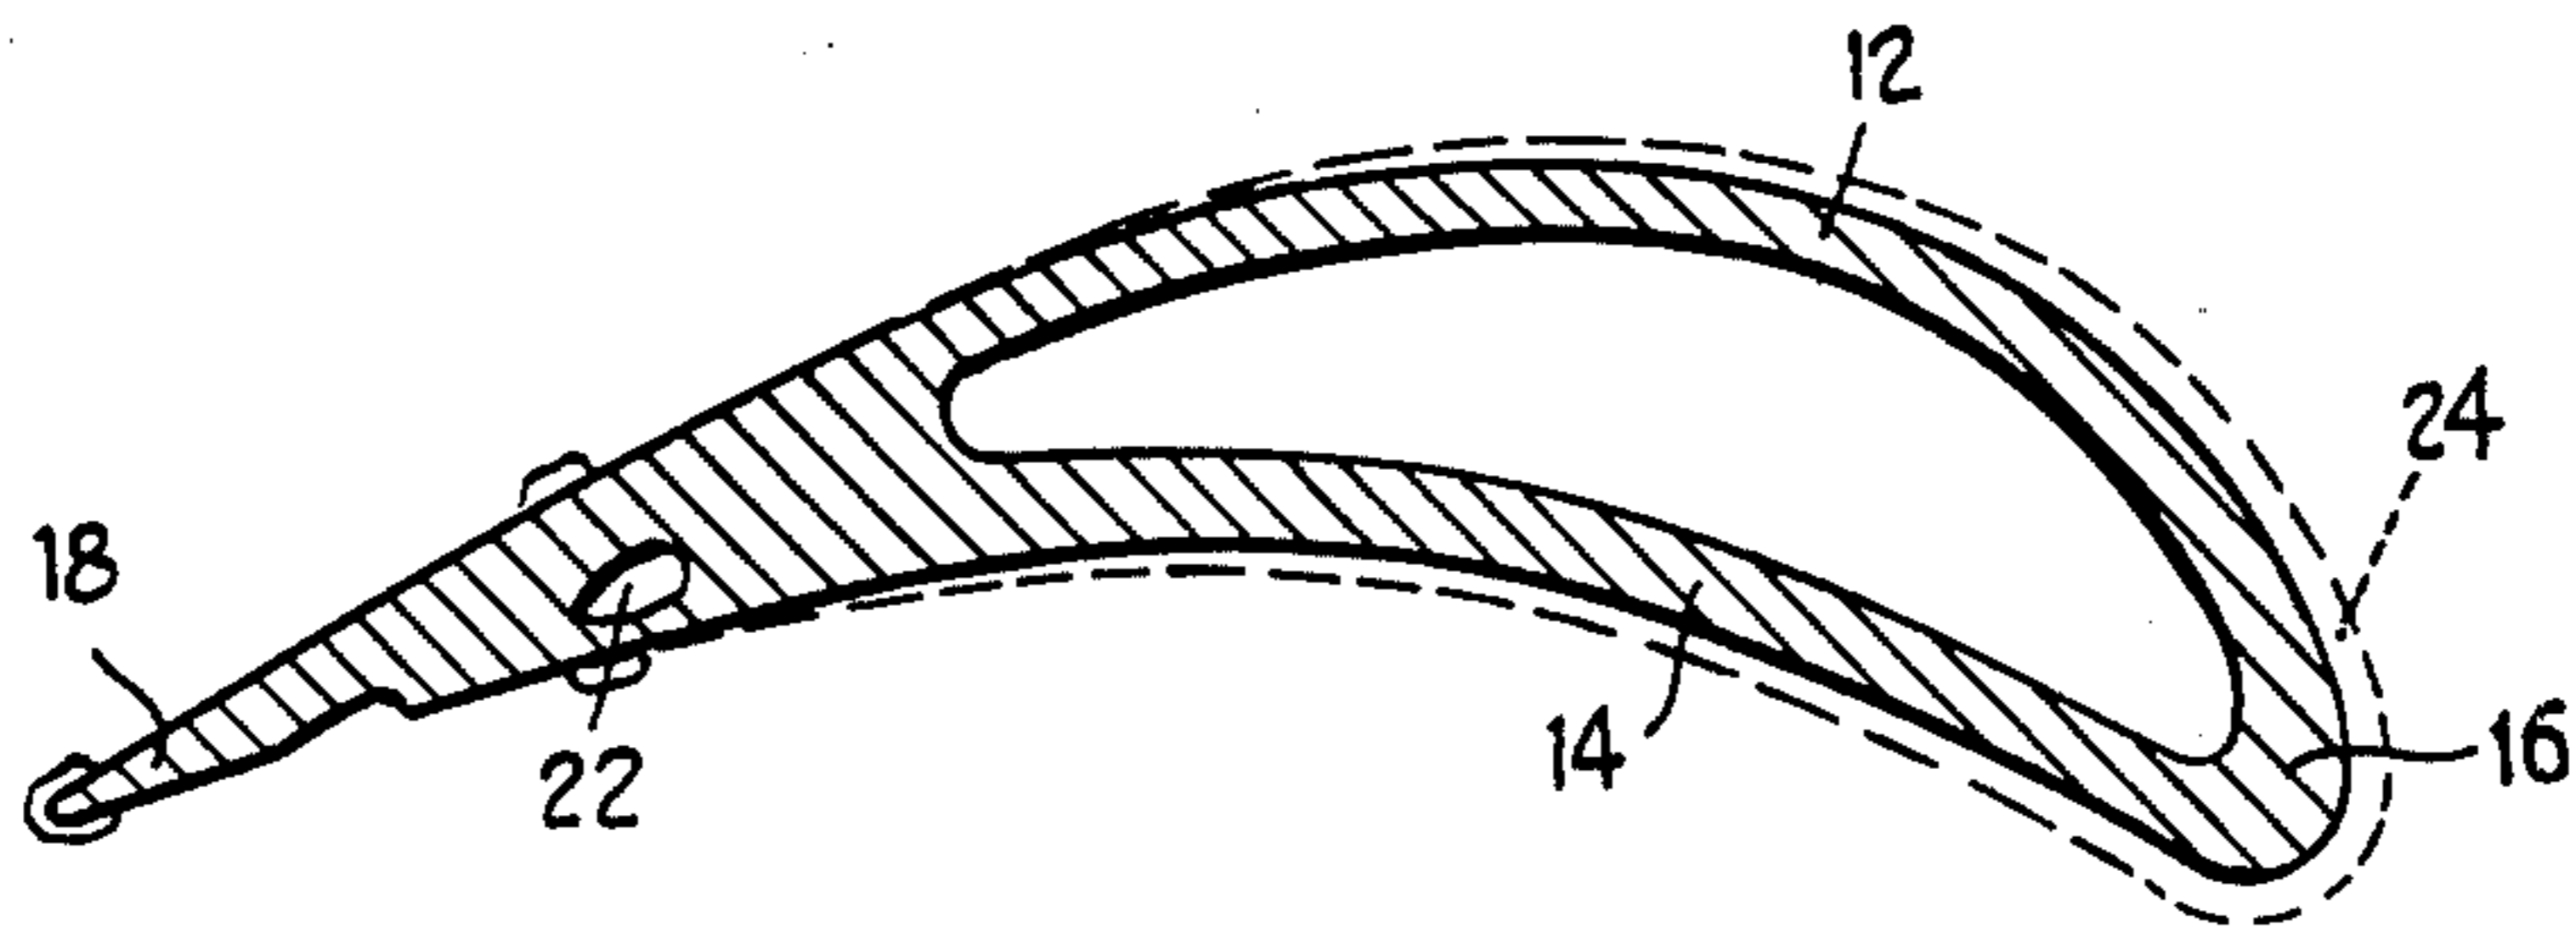
Fig. 6

FIG. 6 is an elevational view of the convex side of a worn vane. This view is similar to the showing of FIG. 1 but illustrates certain steps in the processing of the component.

Referring to FIG. 6, a vane to be refurbished according to the invention, as exemplified by one embodiment thereof, is cut to provide a pair of slits 26 adjacent the end flanges 28, said slits being made from the trailing edge 18 substantially parallel with the end flanges and for a distance roughly as shown in the figure. The slits 26 are made, where required, to relieve stresses caused by any unequal heating of the vane during the processing. After formation of any slits 26, a welded bead 30 can be applied to the trailing edge, in cases where the chordal distance (from the leading edge) has become shortened by wear. Also, welded repairs indicated as short beads 32 are made to the leading and trailing edges to fuse over any hairline cracks. A pair of beads 34, 36 (formed by welding worn areas of the convex and concave surfaces respectively) are provided in those instances where the vanes are badly worn, to reinforce the vane airfoil structure, such beads extending in
