[54] METHOD OF REFURBISHING TURBINE VANE OR BLADE COMPONENTS

A method of refurbishing vane or blade components. Used turbine vanes or blades are cleaned, annealed and in some cases slotted adjacent their ends, after which any cooling passages (in the case of vanes) are welded closed and all cracks welded over, on both leading and trailing edges. The trailing edge, for a vane or blade component having a short chord, is built up by welding along its full length with an alloy wire, after which any slots that were cut adjacent the ends are closed, also by welding. Then the worn surfaces of the vane or blade are built-up by a plasma spray process, using a metal powder with added silica, to a thickness which can be as great as 30 to 40 thousandths of an inch. The built-up vane or blade is then sintered and thereafter surface finished to conform to the original contour of the component when new. Any cooling holes are finally recut, and the vane or blade polished as required and inspected.

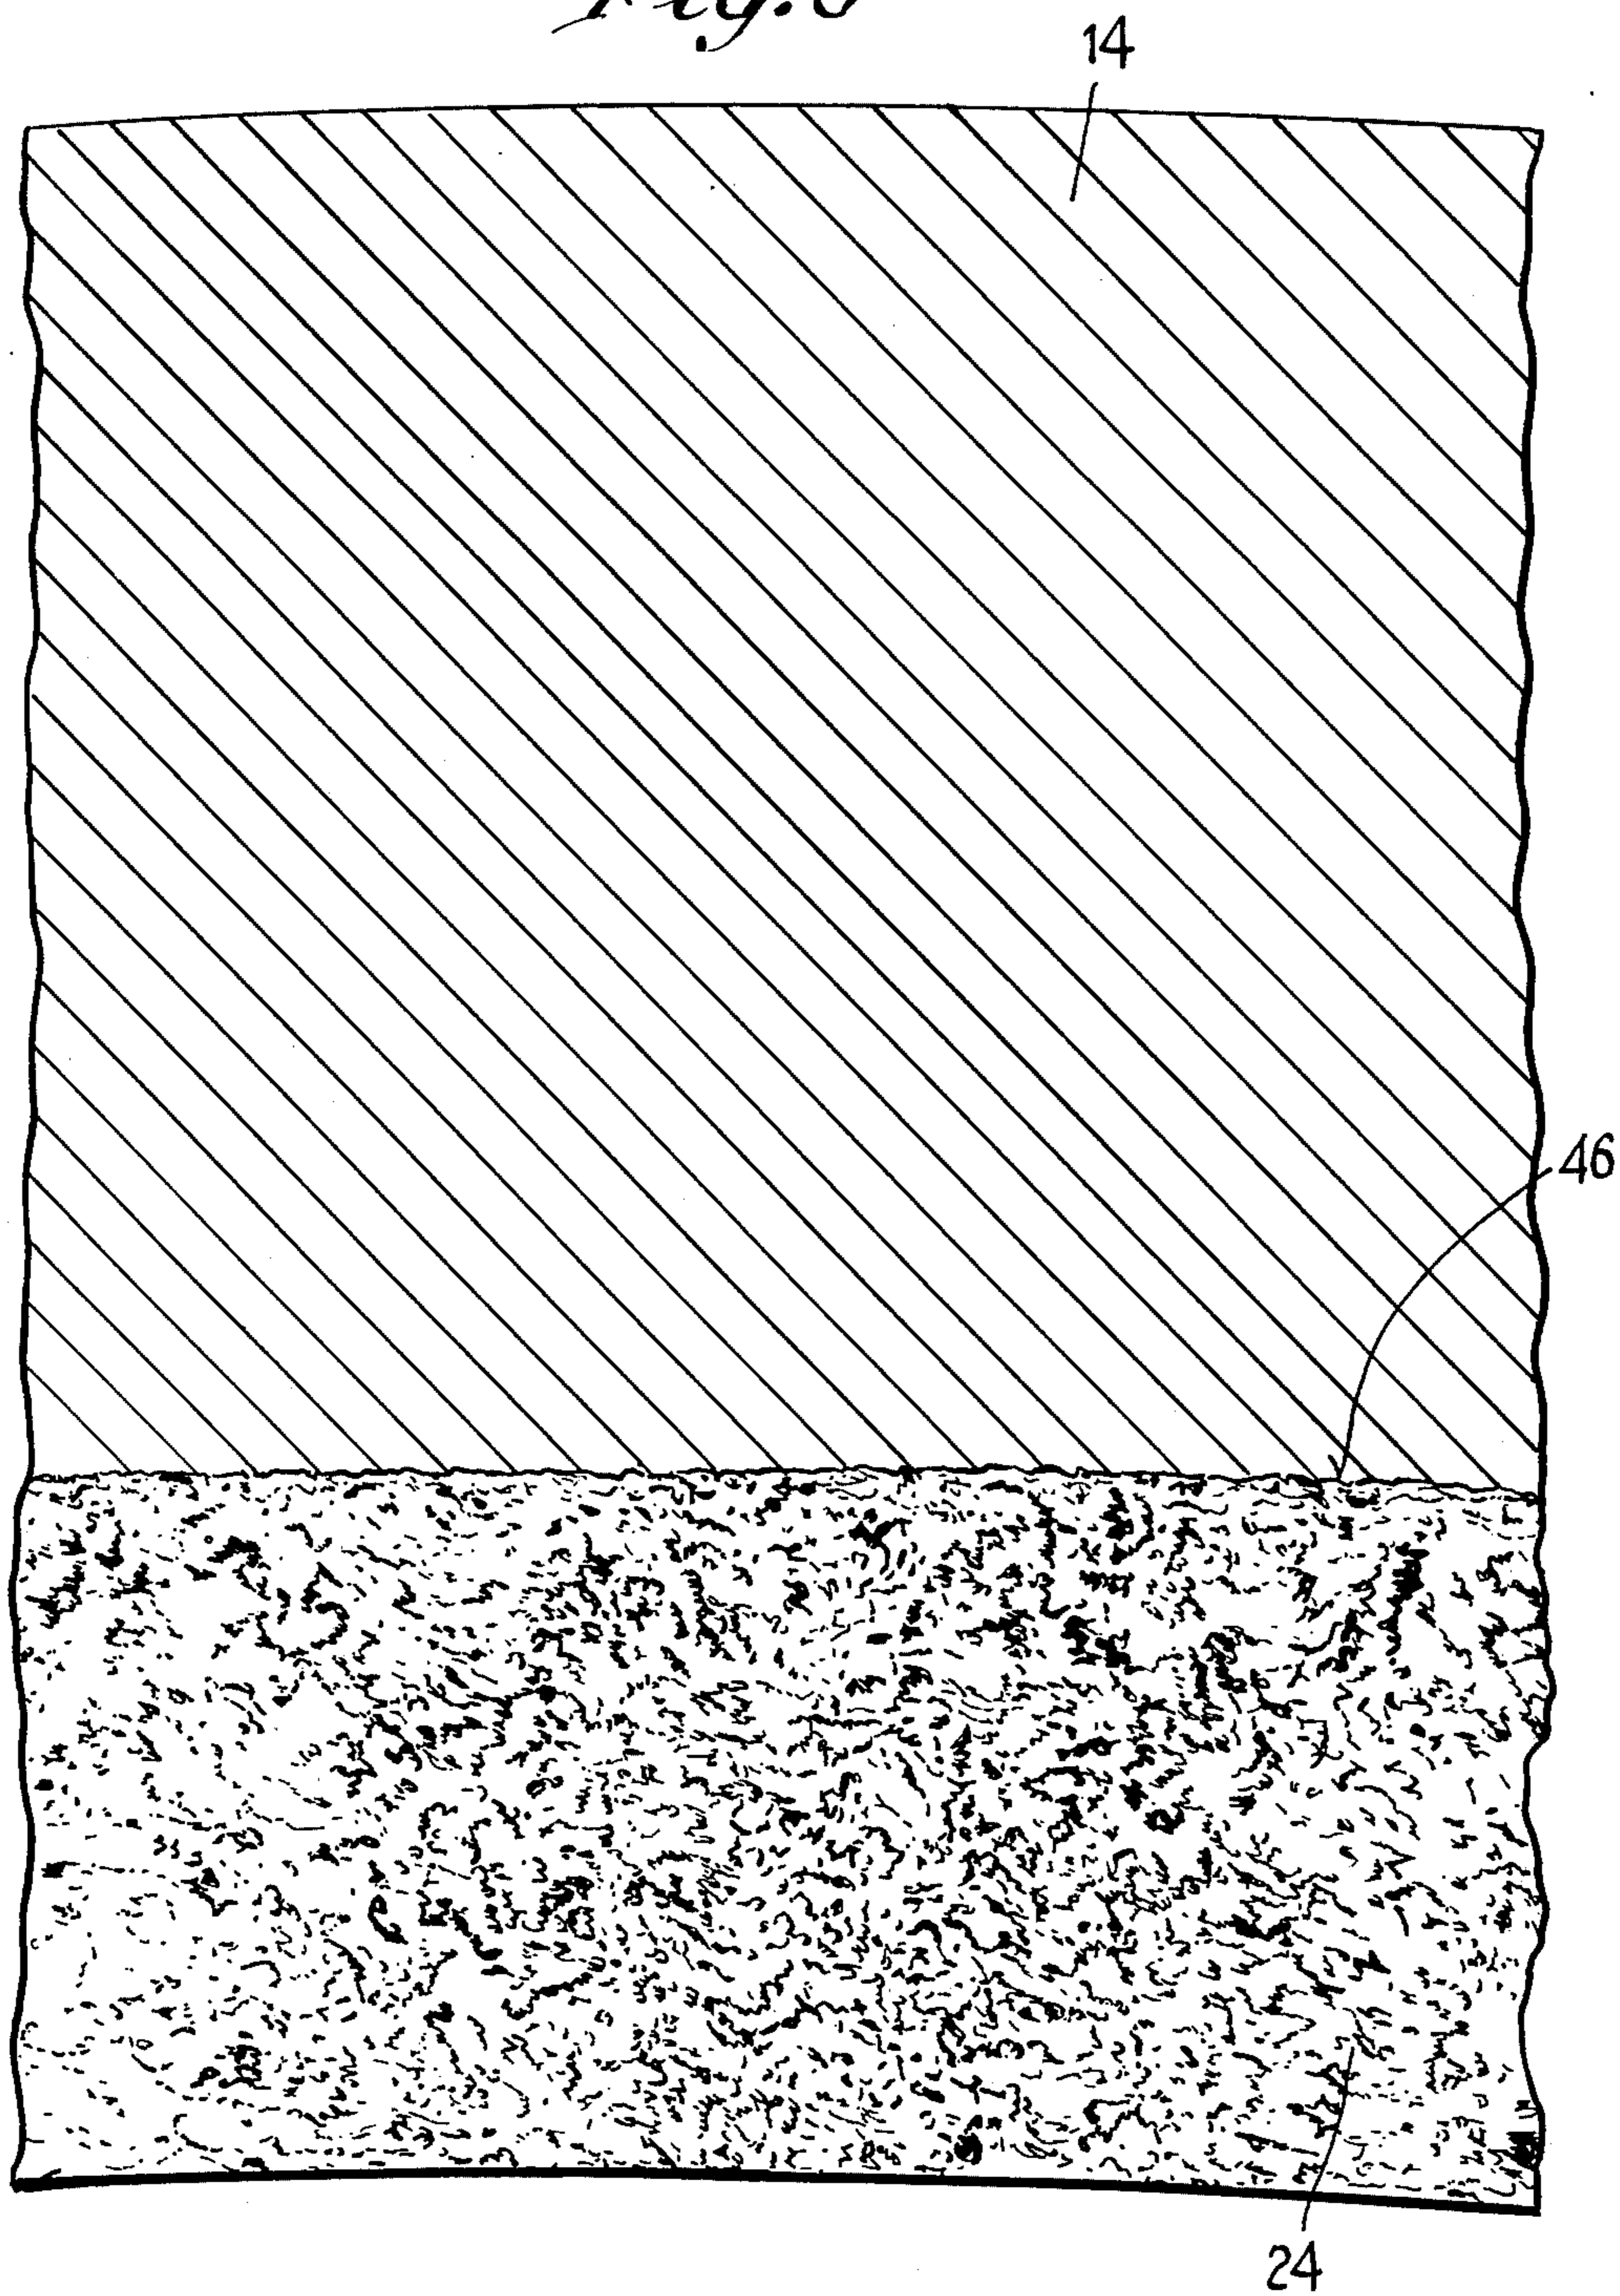
*Fig. 5*

FIG. 5 is a fragmentary cross-section showing a portion (designated by the lines X—X) of FIG. 3 greatly enlarged.

FIG. 5 pictures a photomicrograph of a section through a refurbished vane, taken at the location generally designated in FIG. 3 between the broken lines X—X. The designation of FIG. 5 represents an enlargement or magnification approximately of 100 times. The section of overcast metal 24, having been etched, reveals a dense grain structure which is joined to the roughened surface of the vane airfoil portion 14 at an interface 46. Such roughened surface is the result of sand blasting or ball-peening the vane in preparation for the plasma spray overcast. The vane airfoil portion 14 is shown conventionally by the usual crosshatching lines. The use of a cross-hatching representation in the overlay 24 is considered not desirable since the cross-section surface has been etched to reveal grain structure, and the grain lines are of more importance. It will be seen that the grain structure of the overlay 24 is characterized by a desirable uniformity, as the section is traversed from the outer surface to the interface 46. The uniformity and the density of the plasma spray coating is important in providing for uniform wear or attrition when the vane is in use, with an absence of porous or soft spots which could break down quickly.

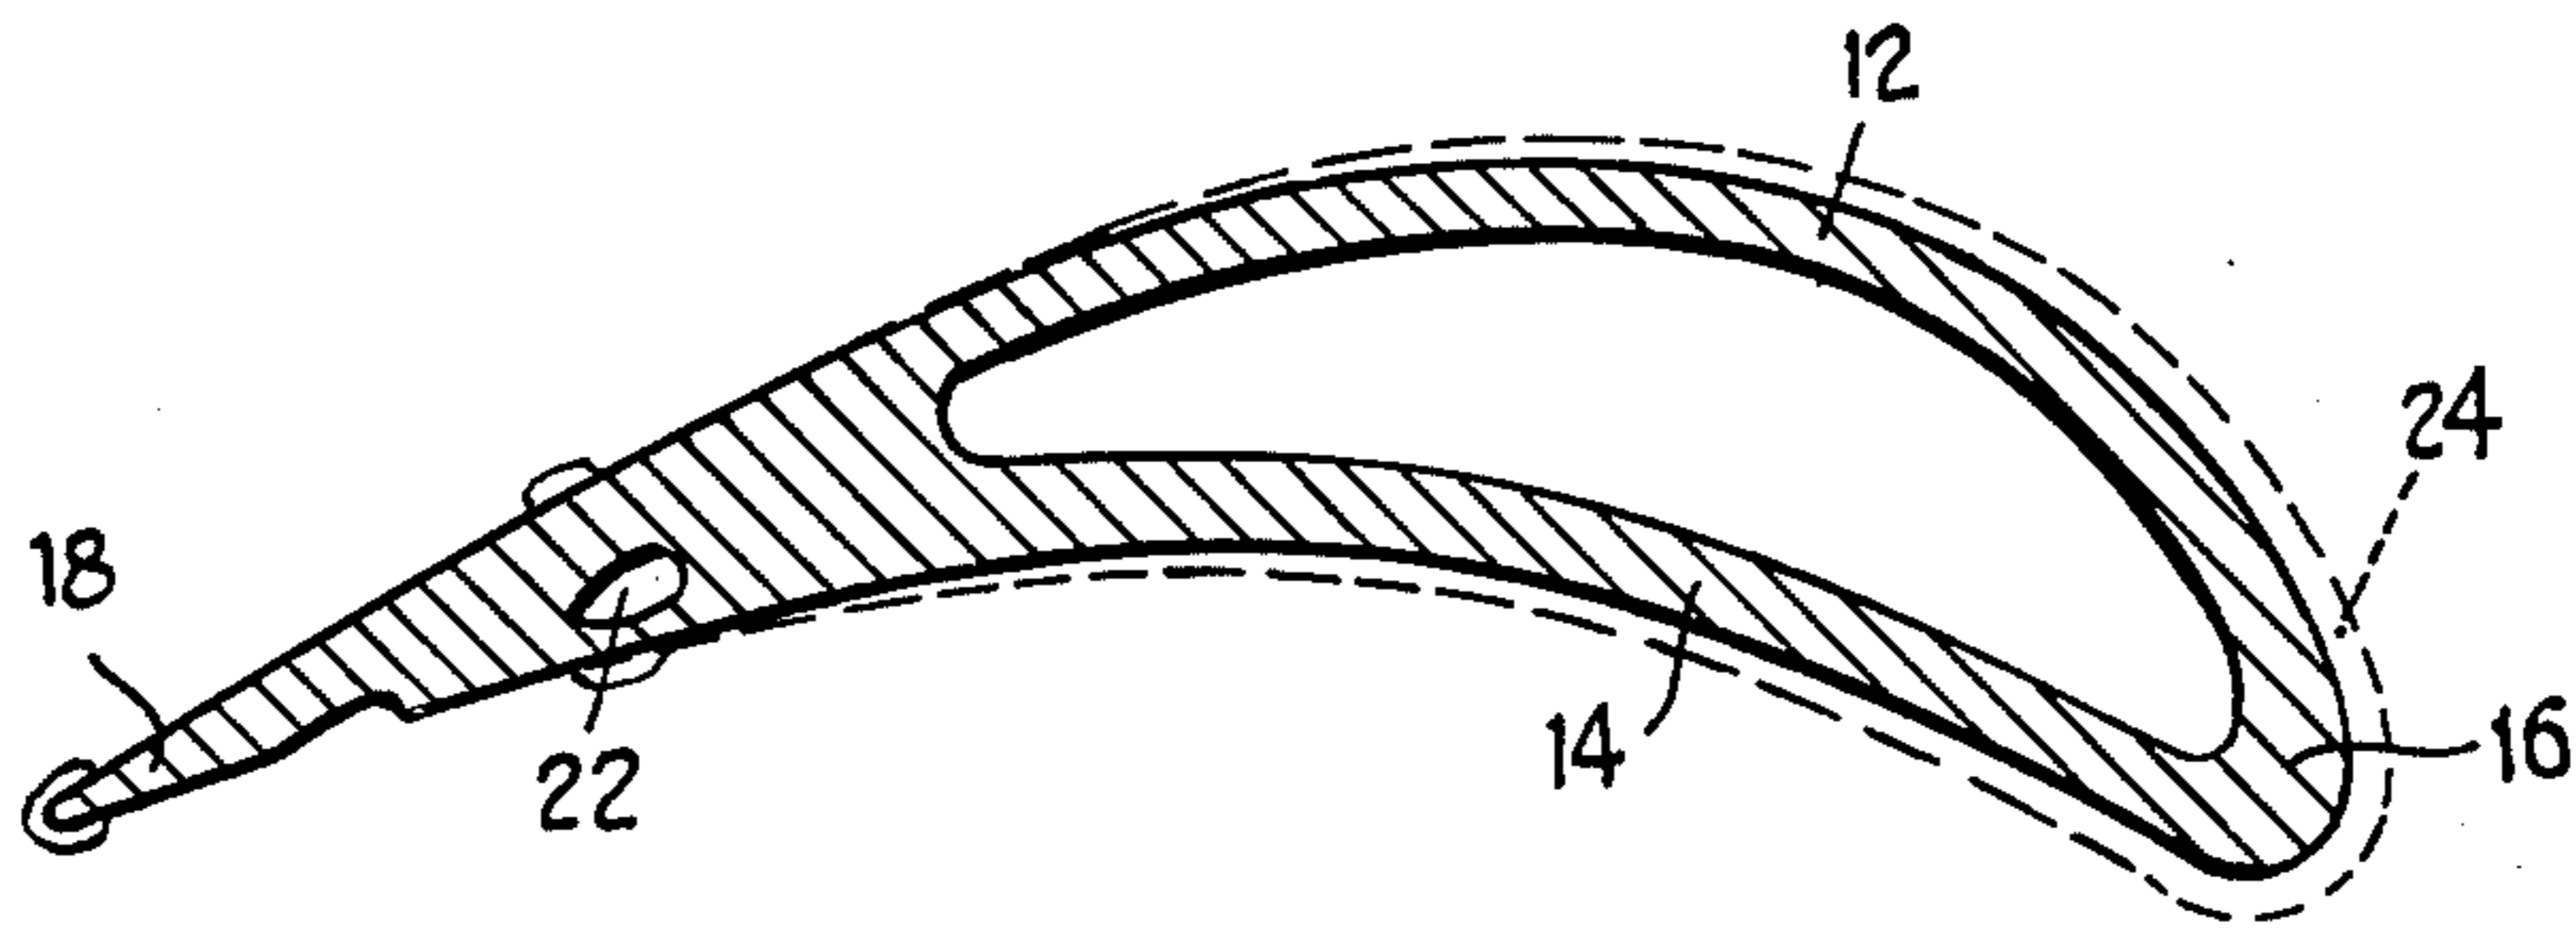
*Fig. 8*

FIG. 8 is a cross-section through the vane, taken on the line 8—8 of FIG. 6.

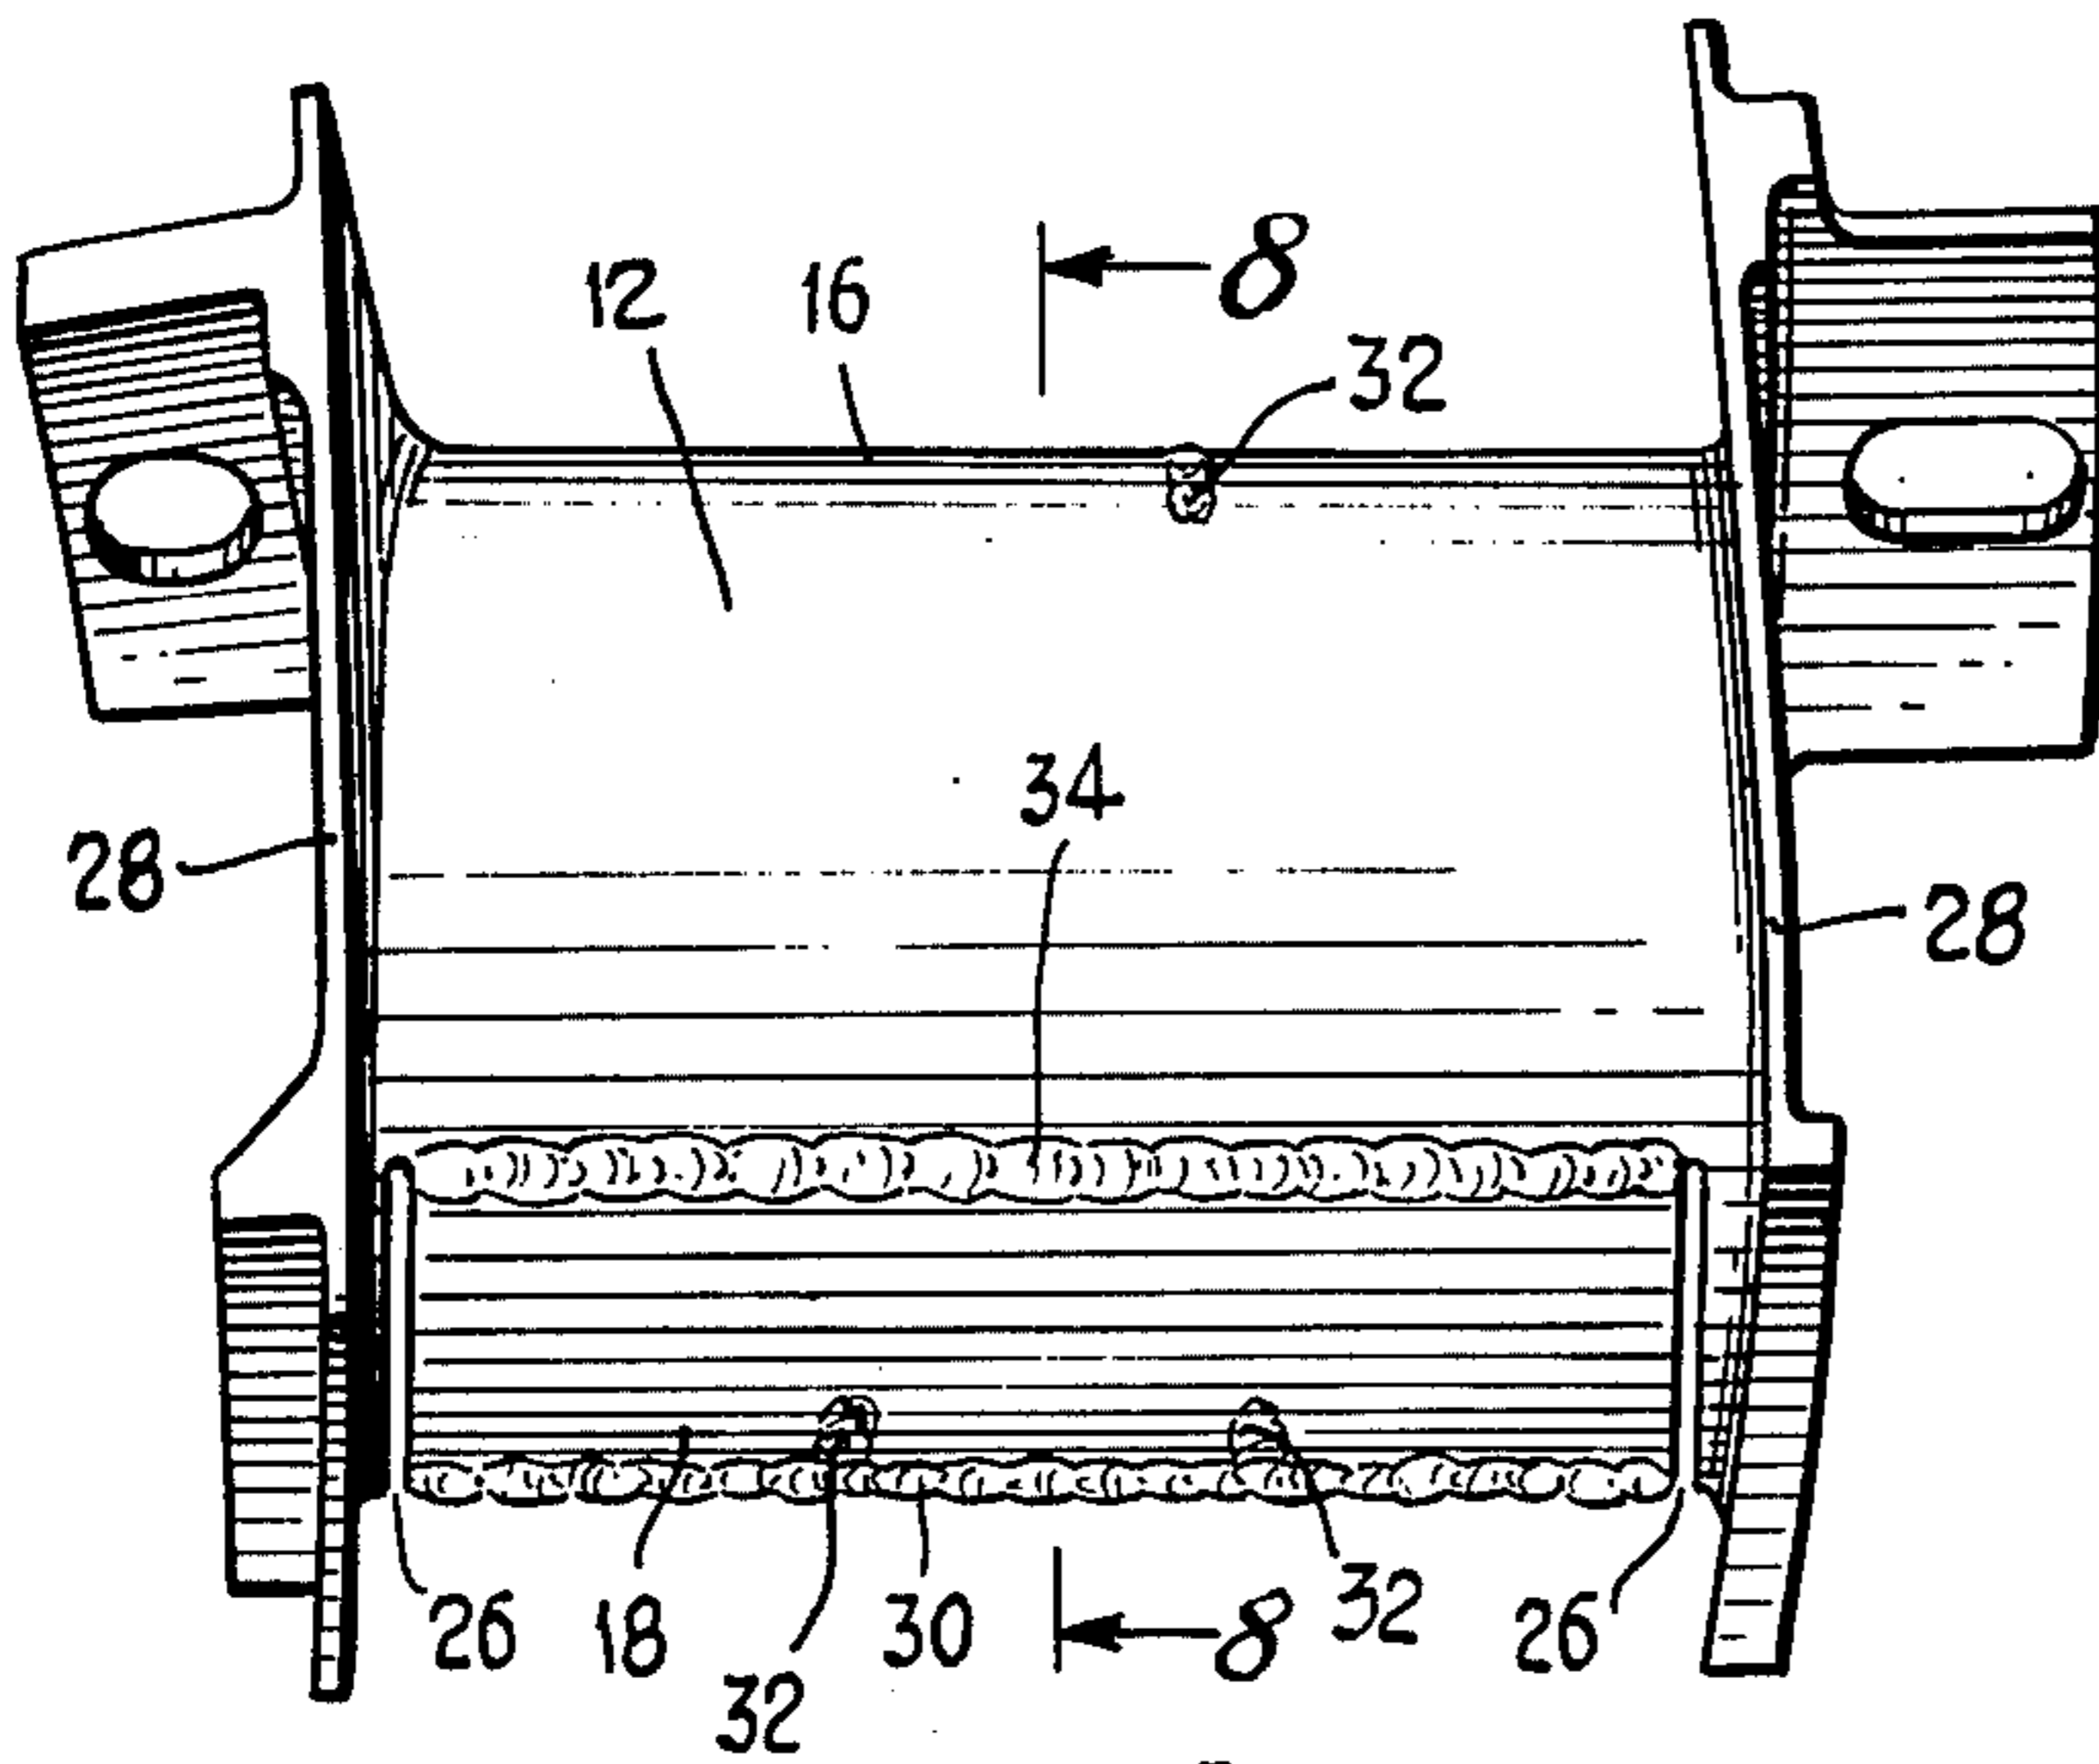
*Fig. 6*

FIG. 6 is an elevational view of the convex side of a worn vane. This view is similar to the showing of FIG. 1 but illustrates certain steps in the processing of the component.

Referring to FIG. 6, a vane to be refurbished according to the invention as exemplified in one embodiment thereof is cut to provide a pair of slits 26 adjacent the end flanges 28, said slits being made from the trailing edge 18 substantially parallel with the end flanges and for a distance roughly as shown in the figure. The slits 27 relieve stresses caused by any unequal heating of the vane during the processing, notably when welding portions of the vane is done. After formation of the slits 26, a welded bead 30 can be applied to the trailing edge, in cases where the chordal distance (from the leading edge) has become shortened by wear. Also, welded

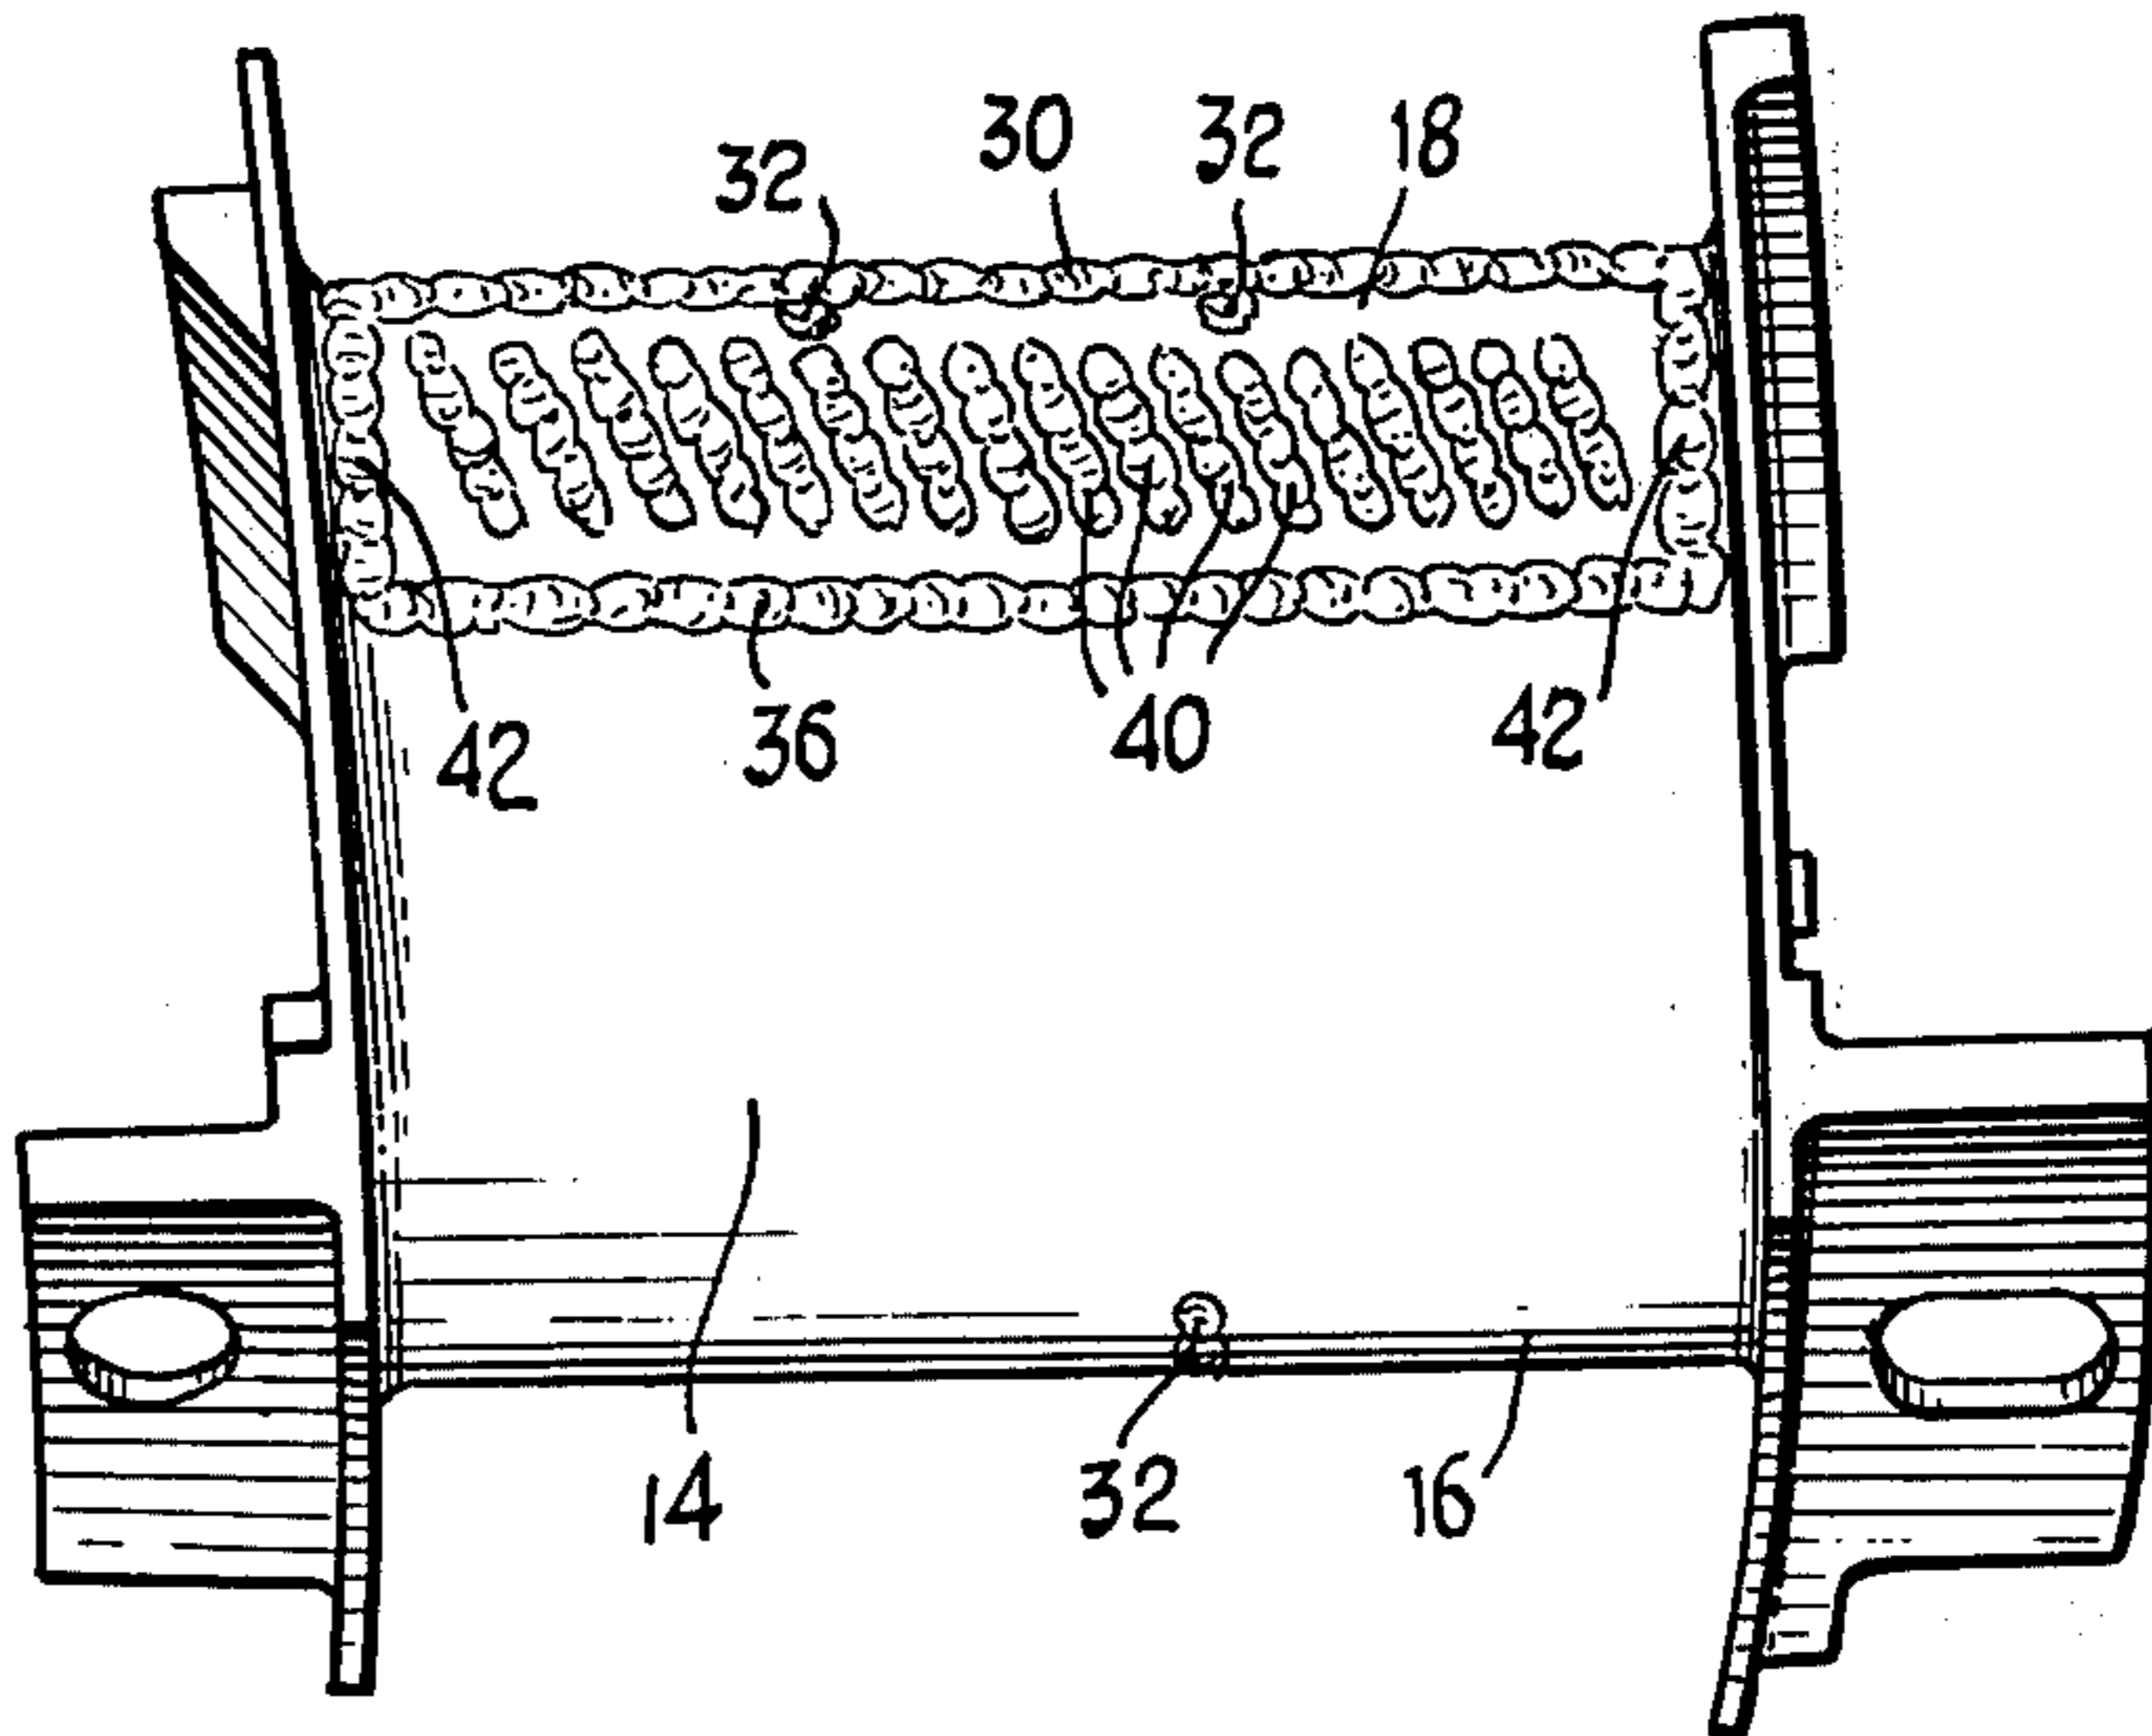
*Fig. 7*

FIG. 7 is an elevational view of the concave side of the vane of FIG. 6, showing other steps and welded beadments as incorporated on the vane prior to the plasma spraying.

Also, as seen in FIG. 7, any air cooling passages 22 of the vane are welded closed by beads 40. Finally, the slots 26 are welded closed by beads 42. Thereafter, following any surface processing that is employed as indicated below, the airfoil surfaces are plasma sprayed to deposit a layer of alloy metal 24 indicated by the broken outline of FIG. 8. This is accomplished in an apparatus shown in FIG. 9, comprising a plasma spray gun 48 including a nozzle 50 from which there emanates a fine spray 52 of particles of molten having generally the same composition as that of the vane material, except with added silica as specified above. The gun liquifies the metal powder which is fed into it in an atmosphere of hydrogen, argon, or helium at a temperature of 7000° F. Excellent results are thus obtained, from the standpoint of surface density and bonding to the base metal. The layer 24 which is the built-up surfacing done by plasma spraying, can be as thick as from 30 to 40 thousandths of an inch, tapering to feathered edges as the trailing edge 18 of the vane is approached. Prior to the plasma spraying build-up, a surface processing of the vanes is carried out, in the form of a sand blast, or shot peen.

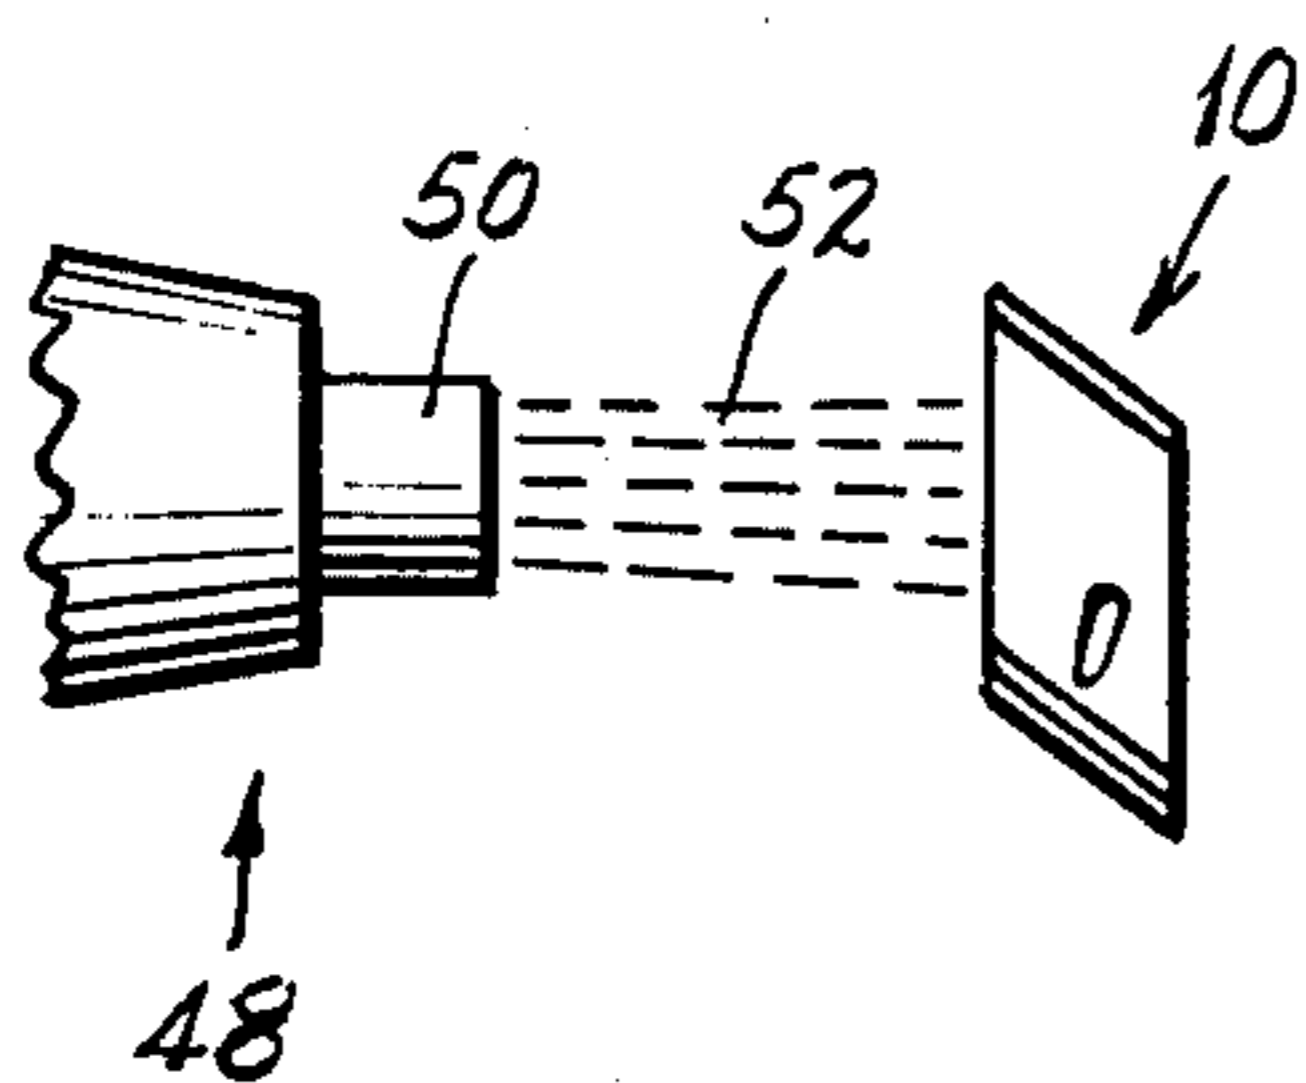
*Fig. 9*

FIG. 9 is a side elevational view of a plasma spray gun, shown applying a coat of molten metal to one surface of a turbine vane.

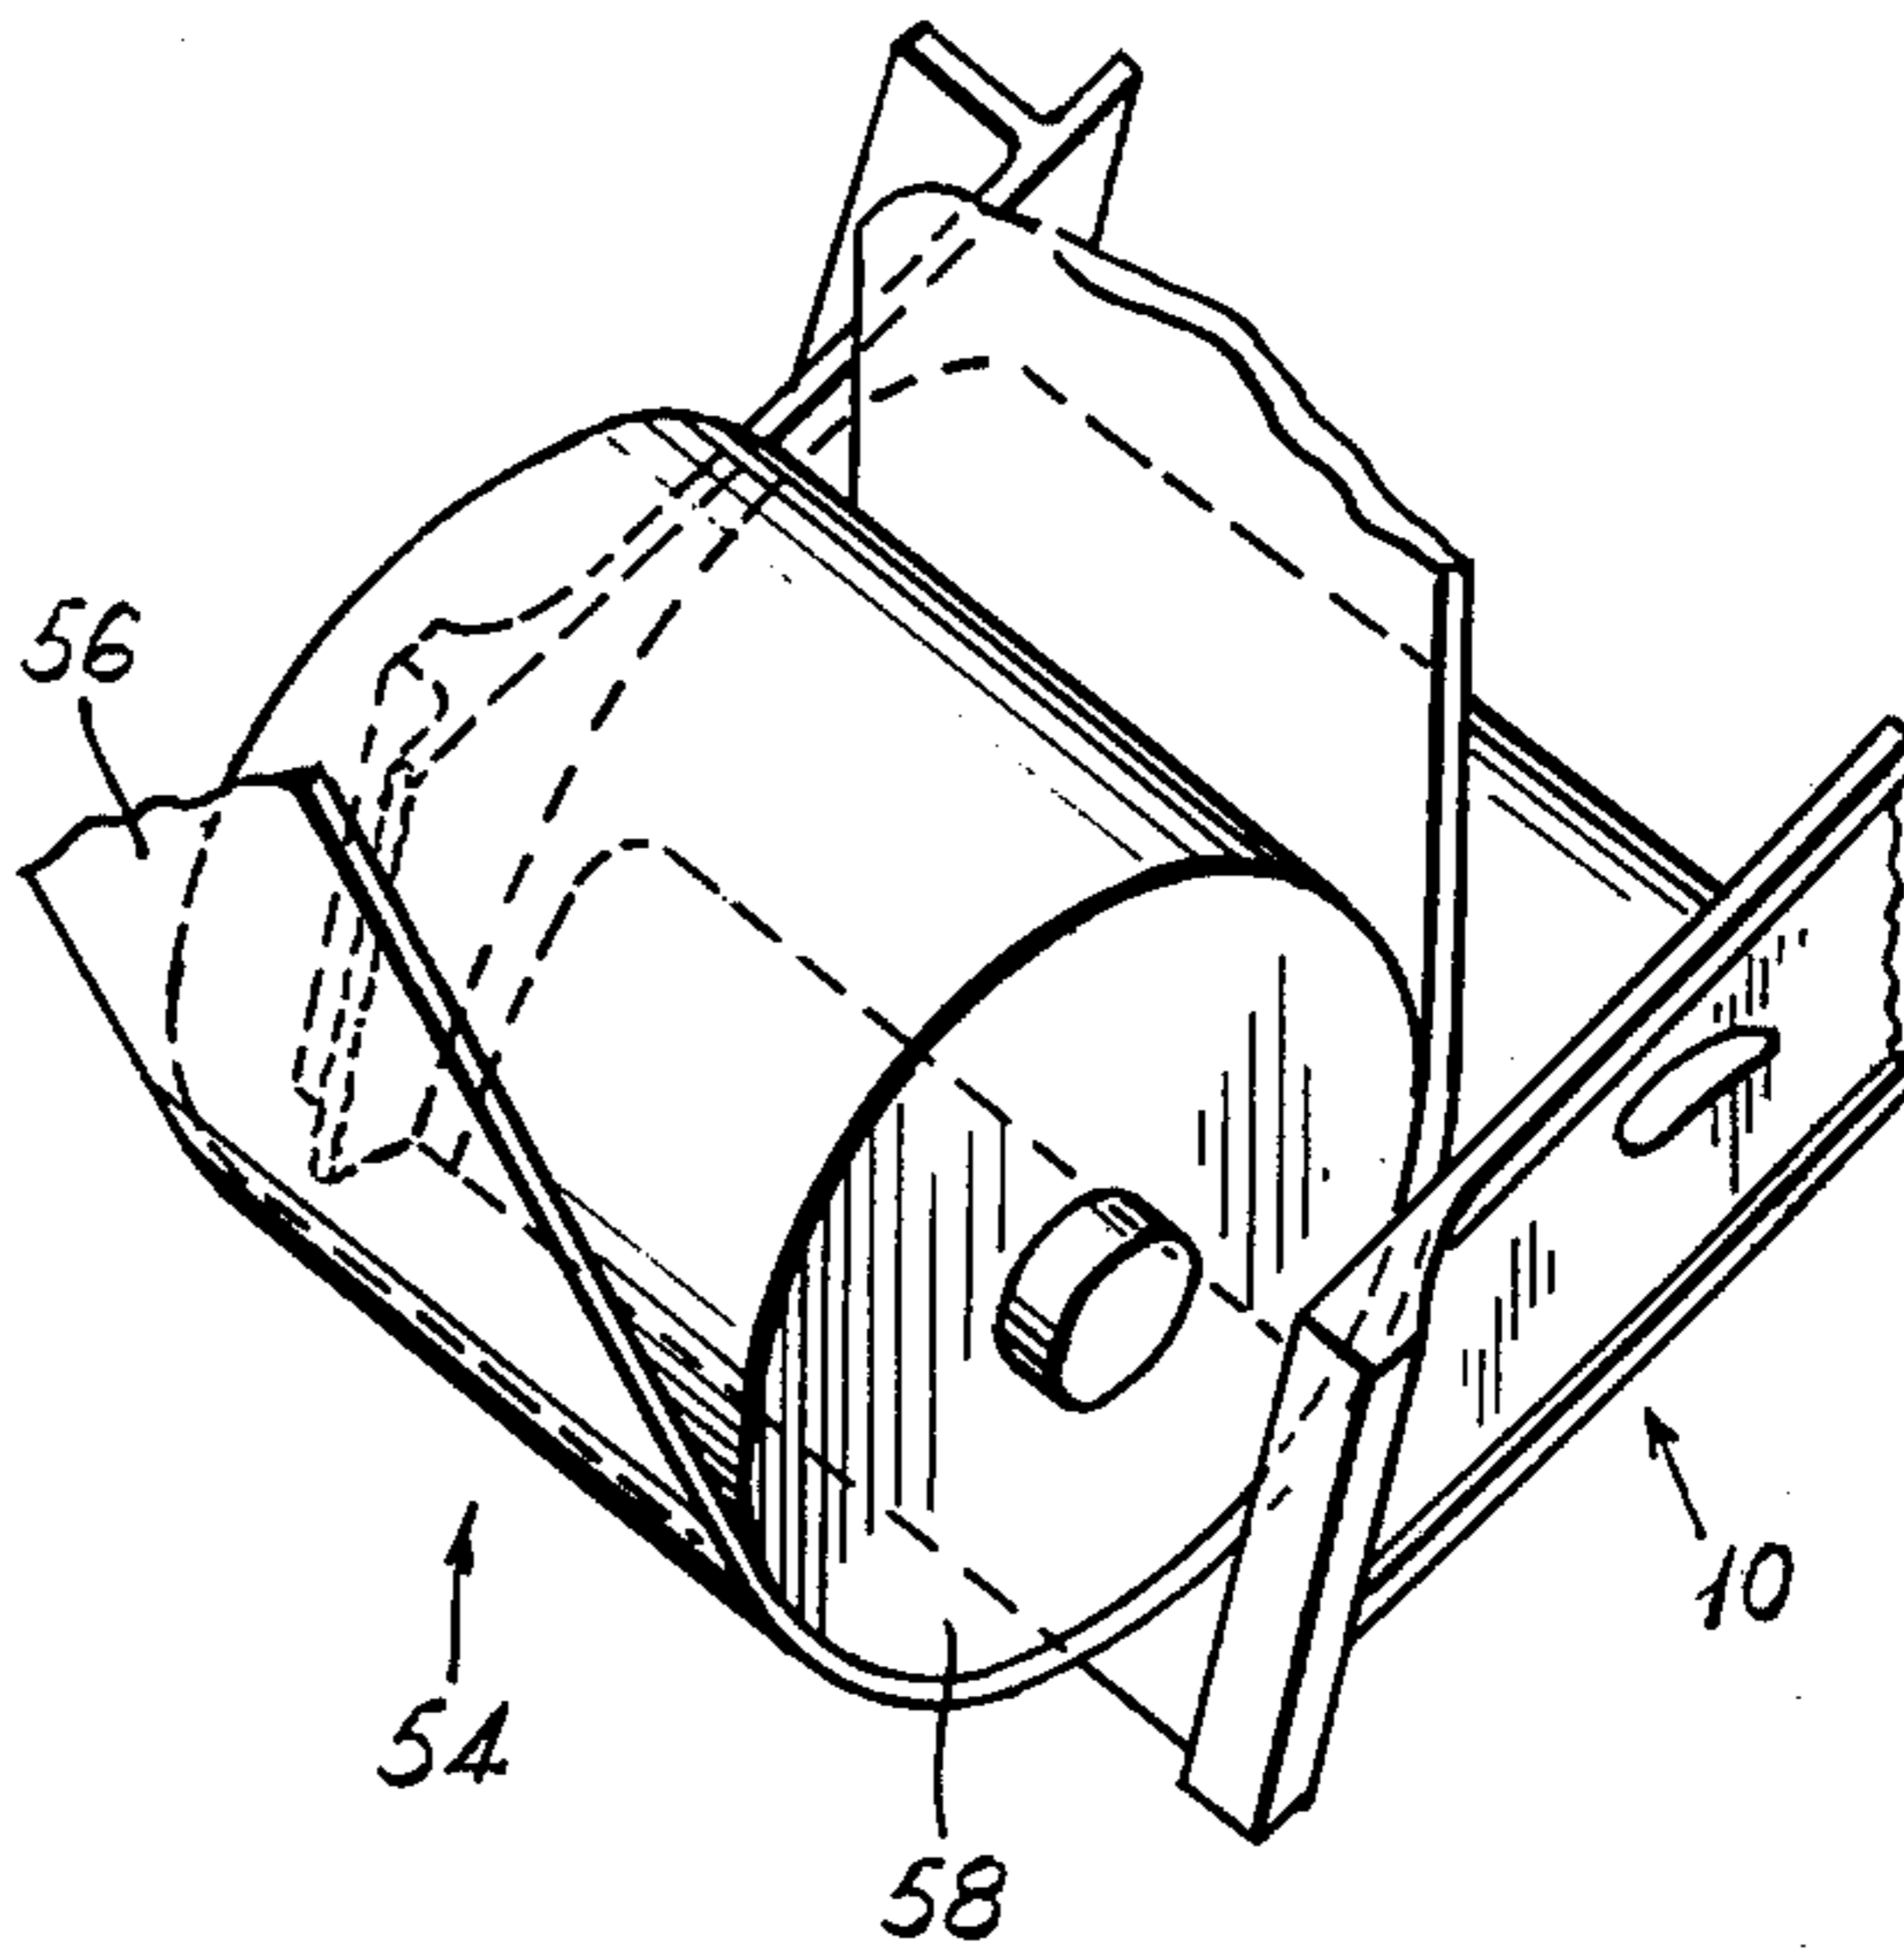
*Fig. 10*

FIG. 10 is a perspective fragmentary view of a grinding apparatus for removing controlled quantities of the built-up surface of the vane, to thereby restore the airfoil surface of the vane to its original dimensions.

13. The built-up airfoil surfaces are now recut by an abrading process, such as one using an abrasive belt, to produce the original surface measurements. The refinishing is preferably accomplished by an automatic machine illustrated diagrammatically in FIG. 10 and designated 54, employing an endless abrasive belt 56 which passes over a drum 58, and which is powered by a suitable motor (not shown). Such a machine employing an endless abrasive belt is described and claimed in the copending application of Ralph T. DeMuis identified above.
