- [54] **METHOD OF REPAIRING A BOX BEAM**
- [76] **Inventor:** Alan W. Wentworth, 41 Mayfair Rd., Warwick, R.I. 02888
- [21] **Appl. No.:** 154,811
- [22] **Filed:** May 30, 1980
- [51] **Int. Cl.³** B22D 19/10; B23K 31/00
- [52] **U.S. Cl.** 29/402.16; 52/514; 52/731; 52/728; 29/155 R; 29/155 C; 228/119; 403/311; 403/11; 403/271; 285/286; 219/106; 219/107; 219/59.1; 138/99
- [58] **Field of Search** 29/402.16, 402.01, 402.02, 29/402.09, 402.11, 402.12, 402.13, 402.14, 402.15, 402.17, 155 R, 155 C, 402.08, 402.18, 157.3 R, 157.3 A, 157.3 B, 157.3 C, 157.3 V, 157.3 D, 157.4, 463, 527.2; 138/98, 97, 99; 113/118 R, 118 A, 118 B, 118 C, 118 D, 1 C, 116 C, 116 W, 1 M; 72/369, 453.15, 367; 219/104, 106, 107, 59.1; 52/170, 514, 740, 733, 728, 735, 726, 731; 285/286; 403/23, 271, 272, 11, 12, 310, 311; 228/119, 183, 184
- [56] **References Cited**

A method of repairing a box beam is disclosed in which a cracked or broken portion of a box beam may be repaired and the strength returned to normal by forming a pair of plates that fit snugly about at least one half of the box beam, the plates being welded to the box beam and to each other, each edge of the plates being either welded to its jux

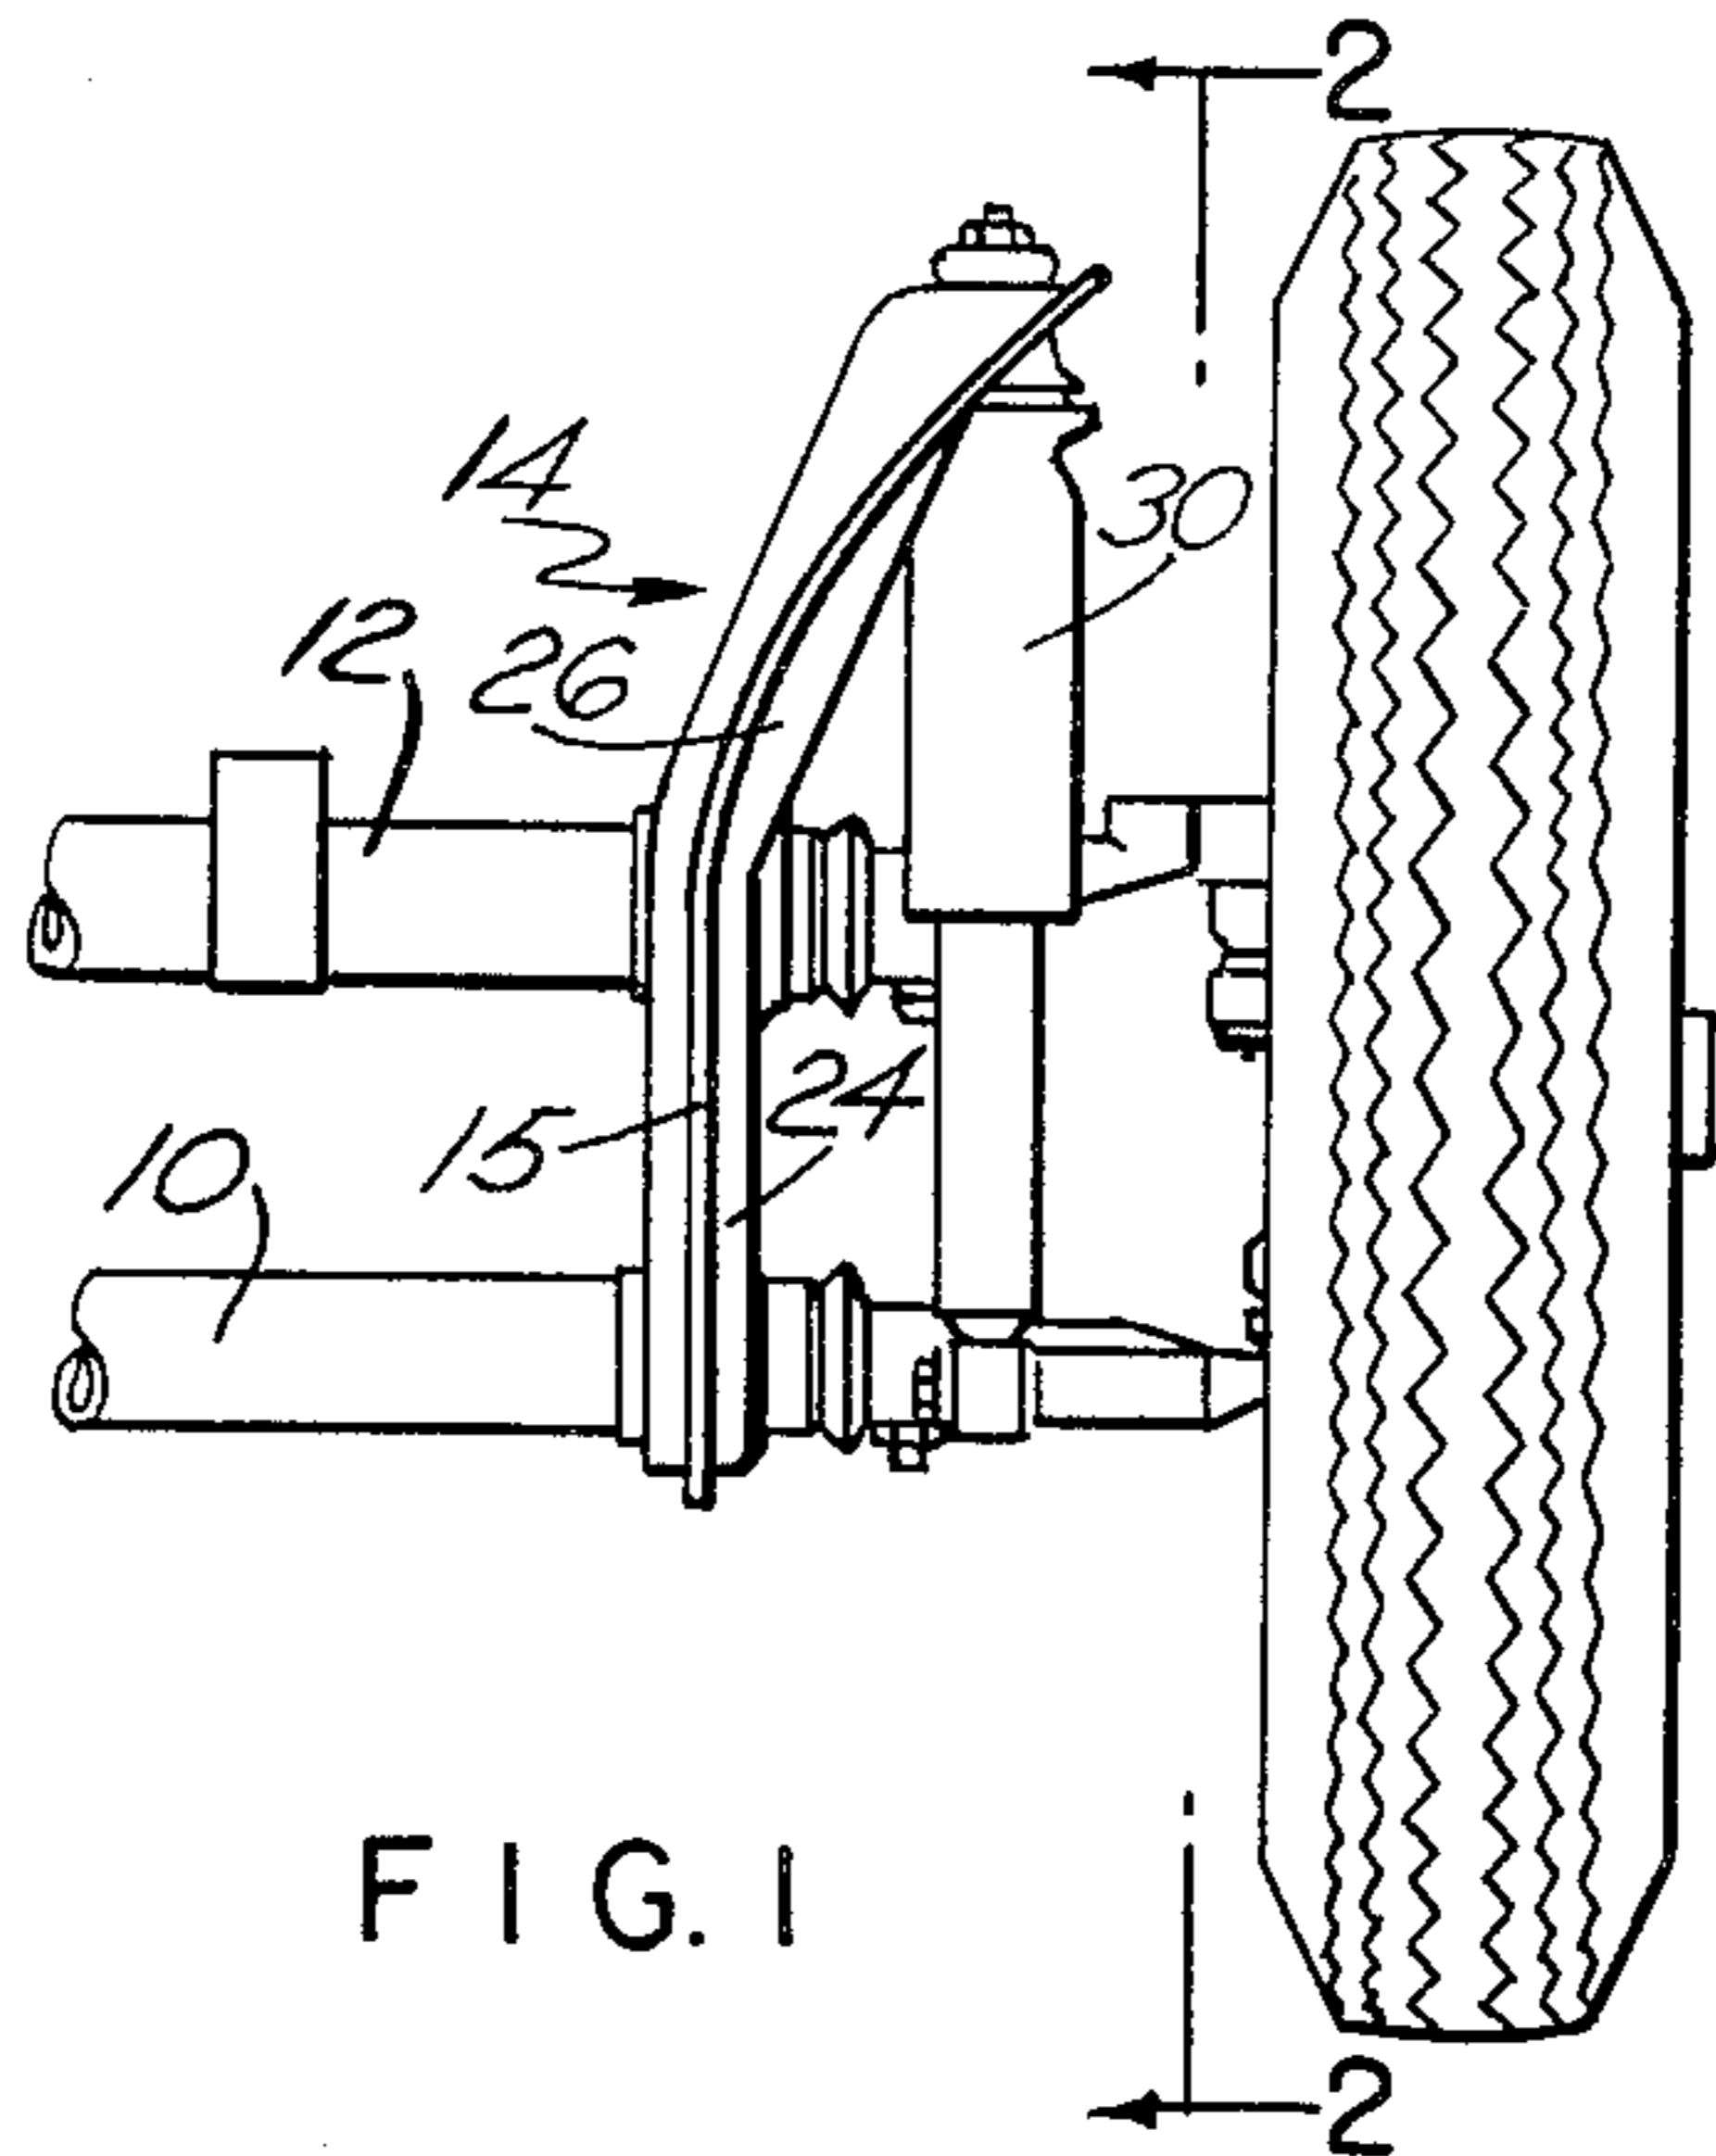
FIG. 1 is a front elevational view showing a box beam construction in the context of a front axle for an automotive vehicle;

Referring to FIG. 1, a portion of the front axle beam in an automotive vehicle is shown, which comprises a first tubular member 10 that encloses a torsion bar and

a second tubular member 12 in which is also received the second torsion bar, these two members being connected together at either end by a box beam structure generally designated 14, only one such structure being shown. The box beam structure has apertures with suitable bearings through which the torsion bar 16 (See FIG. 2) extends and through which the torsion bar 18 extends, each of these bars being respectively connected to torsion arms 20 and 22. The box beam is defined by a lower portion 24 which extends between the portions 10 and 12 and continues upwardly with a portion 26 that has an aperture therein as at 28 into which the upper end of a shock absorber 30 is received.

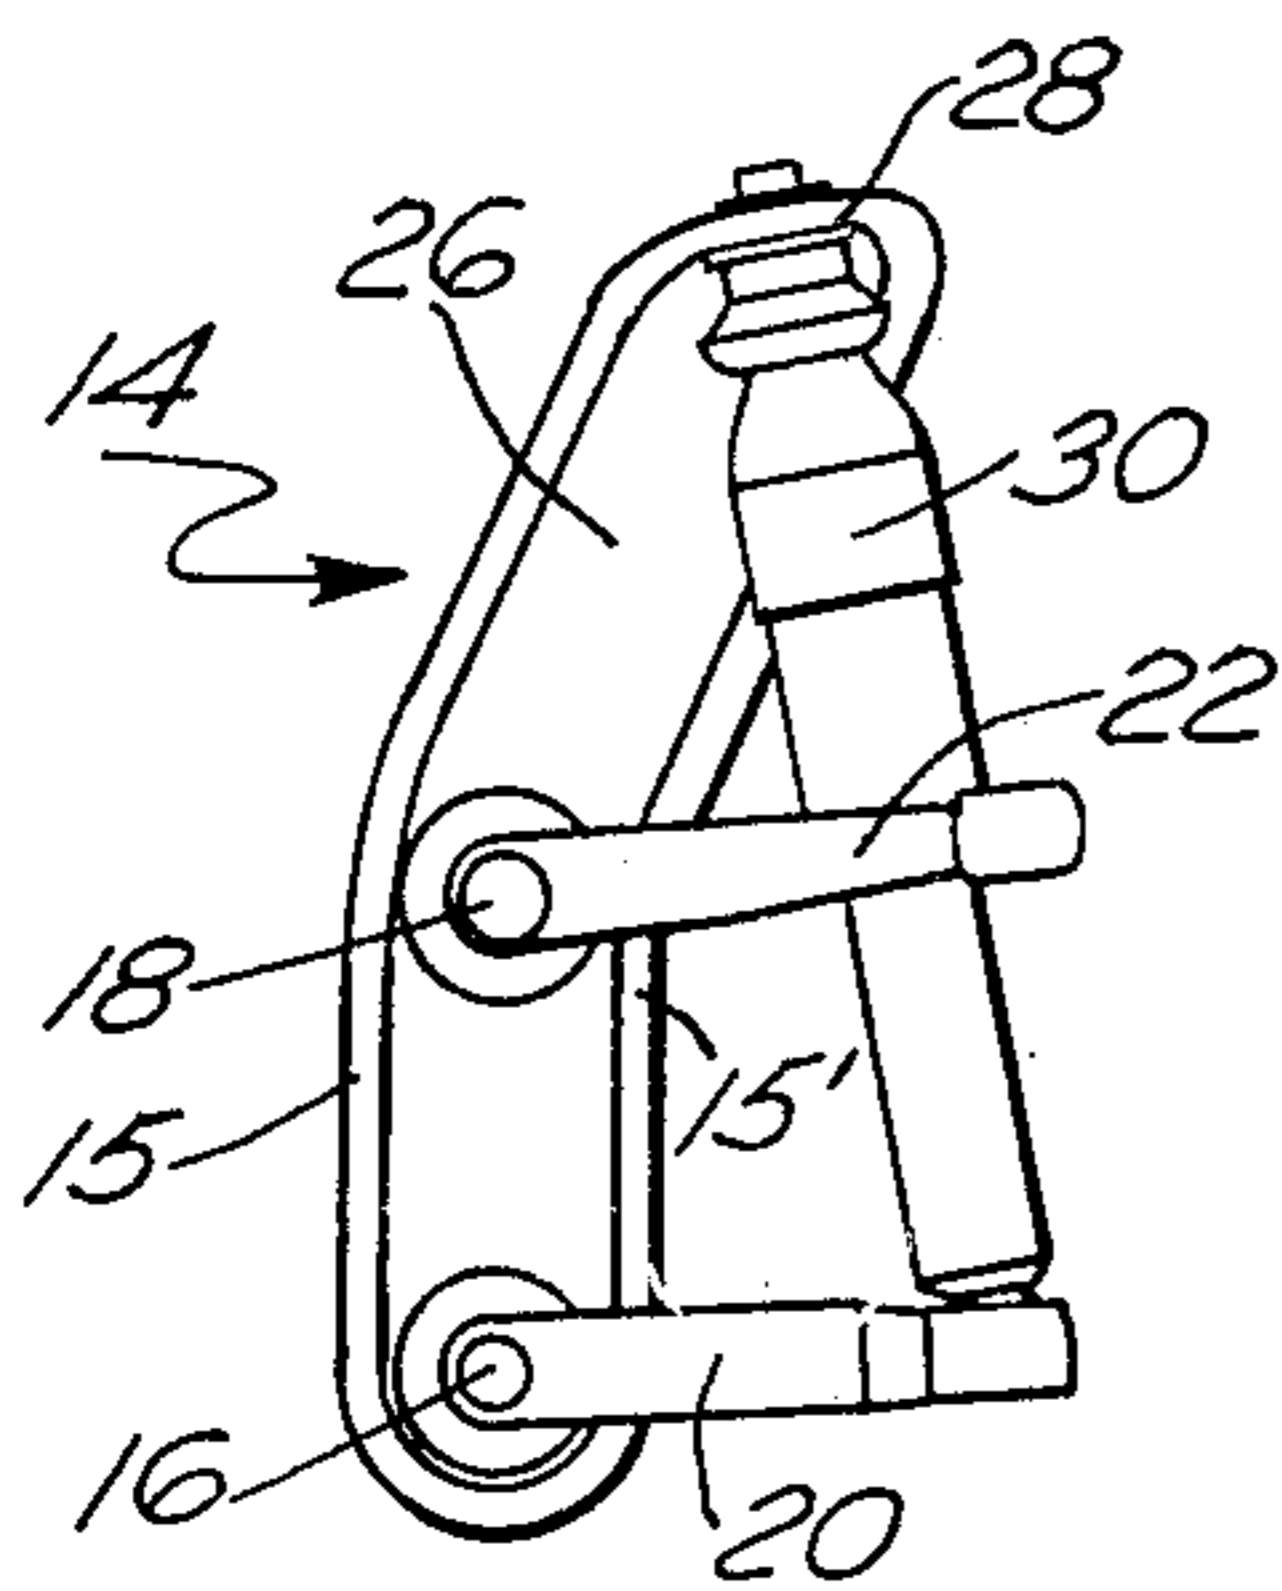
FIG. 2 is a sectional view taken on lines 2—2 of FIG. 1;

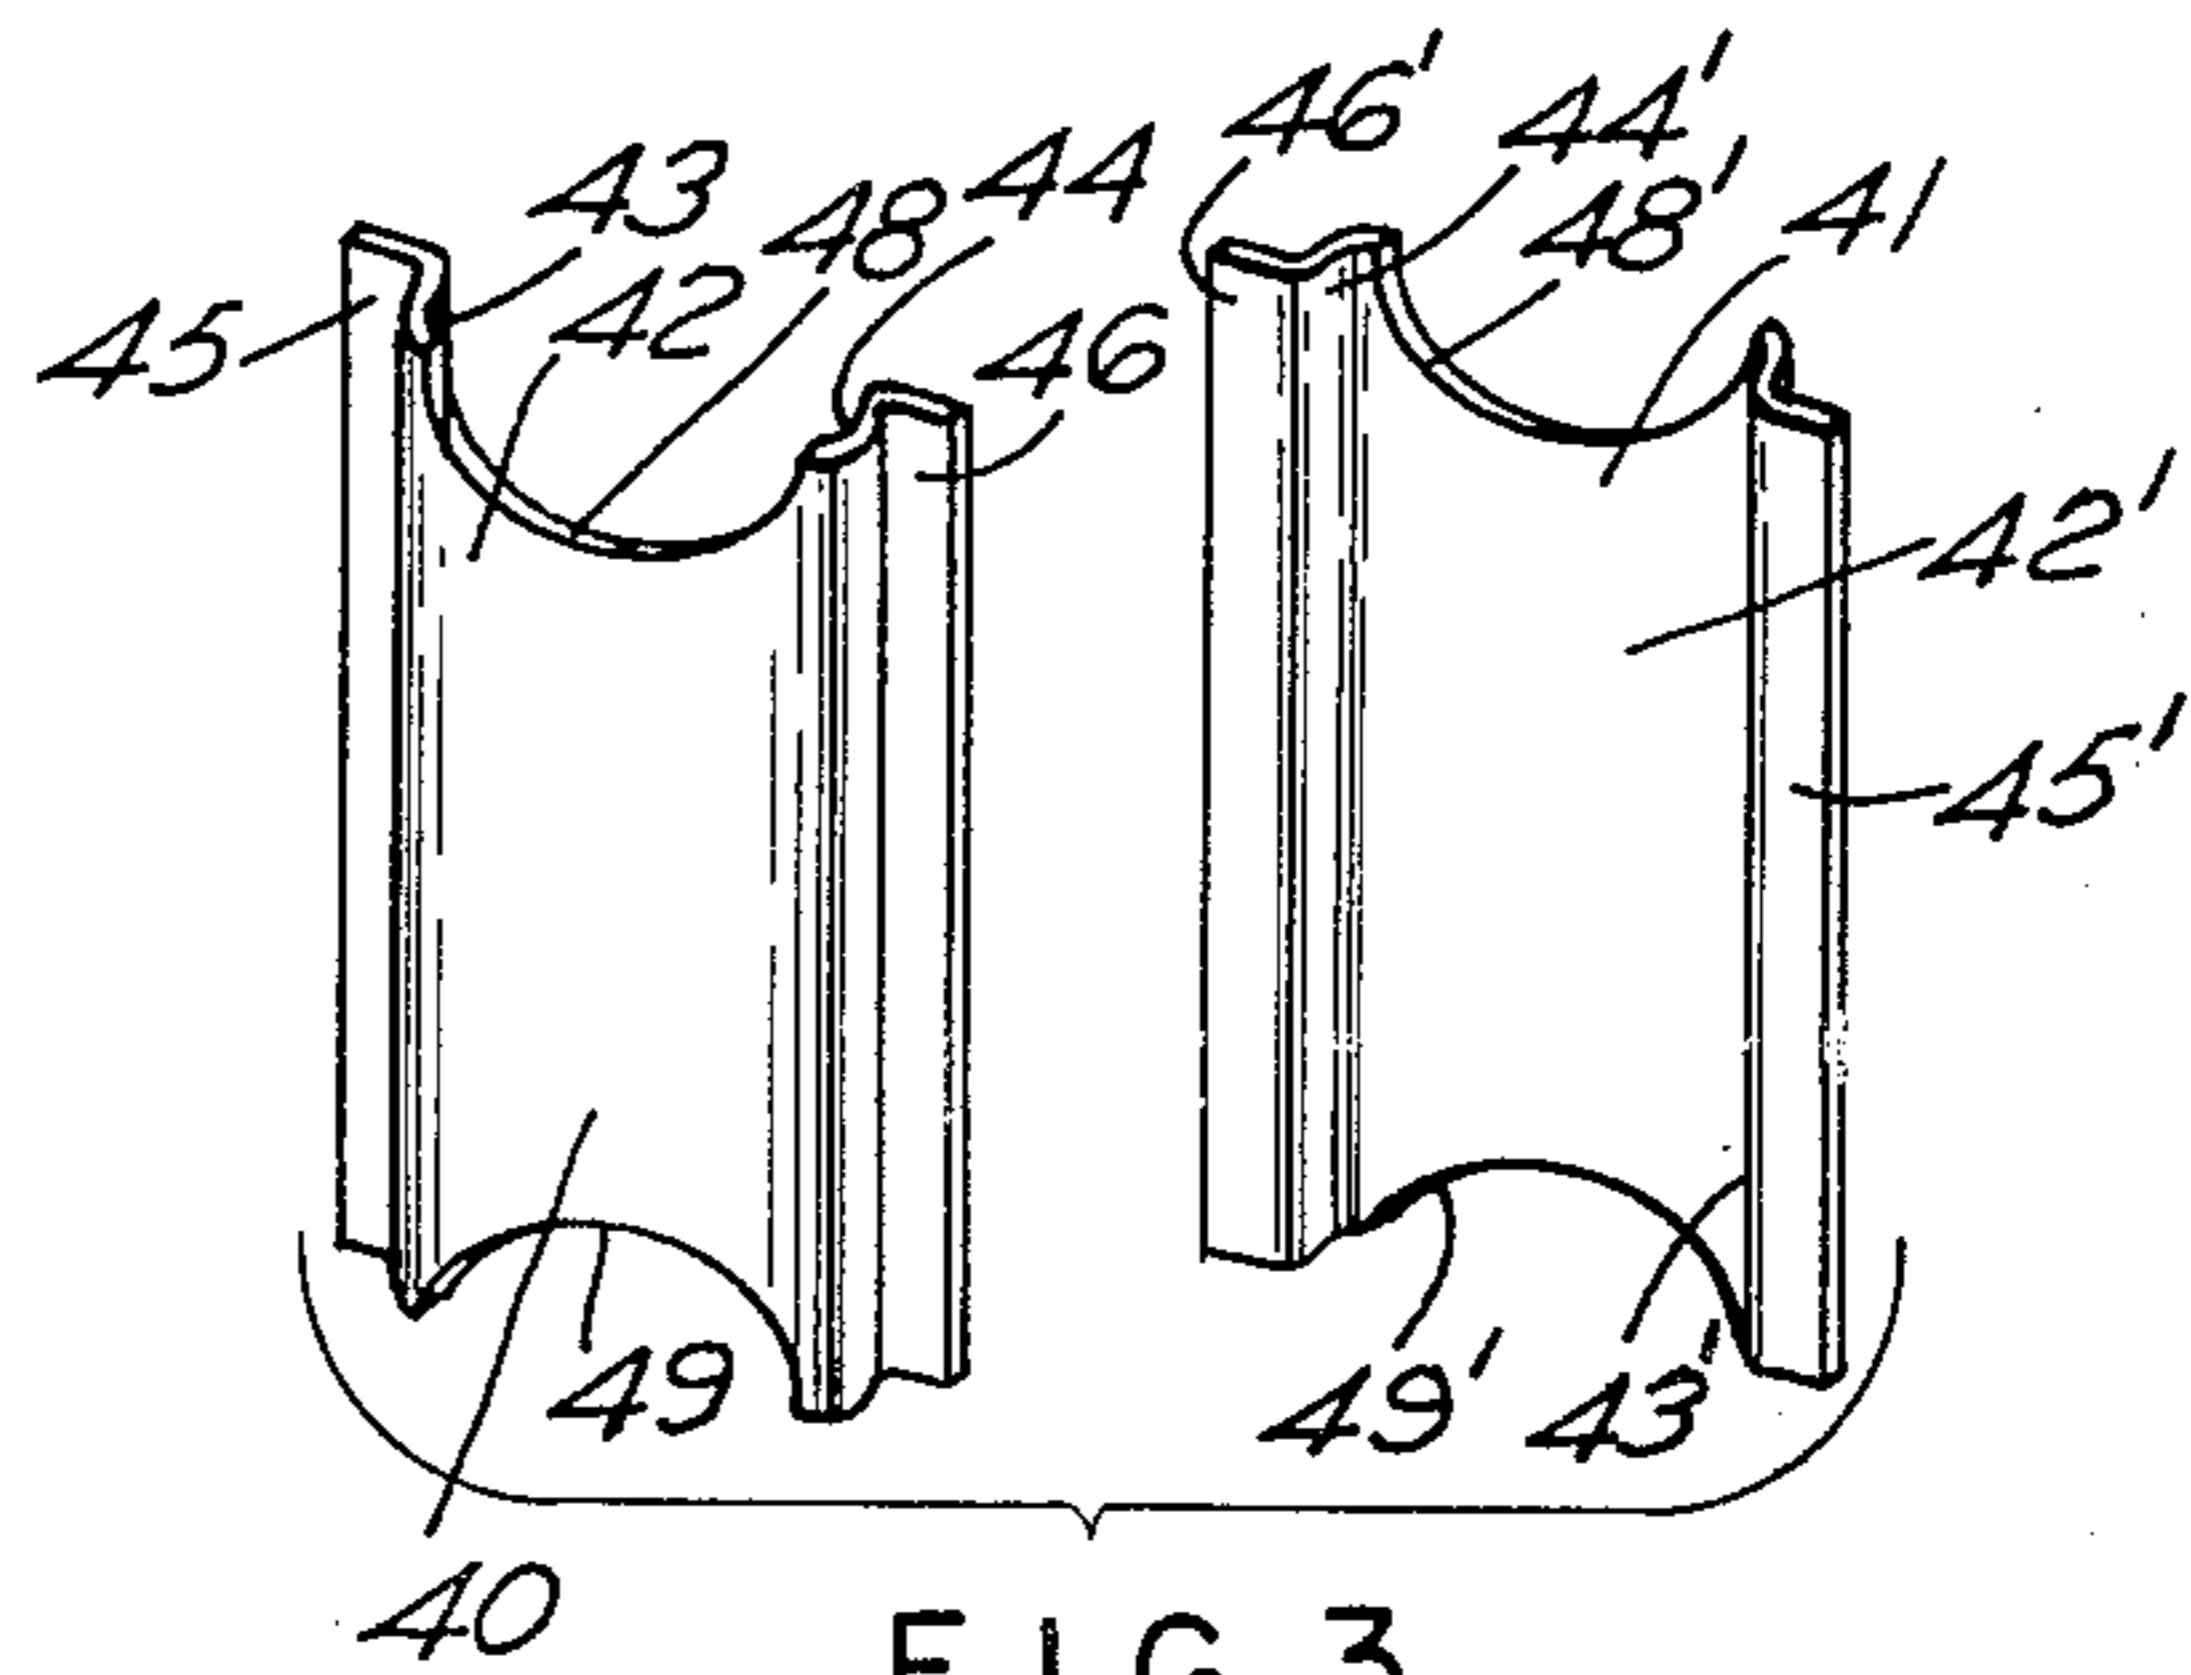
FIG. 3 is a detached perspective view of the repair plate;

In order to obviate a complete replacement there is formed from sheet material a pair of plates, designated 40 and 41, (see FIG. 3) which are identical plates and which as shown have in effect a face 42, 42' with an intumed edge such as 43, 44, 43', 44', and then outwardly turned lips 45, 45', 46, 46'. These plates 40, 41 are placed on either side of the box beam as seen in FIG. 5. The cut-outs as at 48 and 49 for example being adapted in this particular instance to fit about the bosses that are formed by the cylindrical members 10 and 11 passing through the box beam. In some instances the area about the cut-outs may be further formed to provide a proper fit, as for example, by flaring from the planar extent of face. It will of course be apparent that before the plates are positioned on the box beam and assuming that the box beam is rusted and has a coating of grease and other materials thereon it is first necessary to clean the box beam by the use of suitable degreasing compounds and then as necessary clean out any additional rust that may be present. At this point, if desired, the box beam may be painted in the central portion thereof leaving the ends where the upper and lower edges of the plates 40 and 41 will contact absolutely clean. The plates are then clamped in position and welding material is used to make joints as seen at 50, 51, 52, 53, 54, and 55 so that all of the edges of the plates 40 and 41 have been welded together and to the box beam structure. After the welding has been completed the repair may now be suitably painted with primer paint and then with undercoating material such as a tar-based compound or the like. The box beam has now been returned to its original strength and situation.

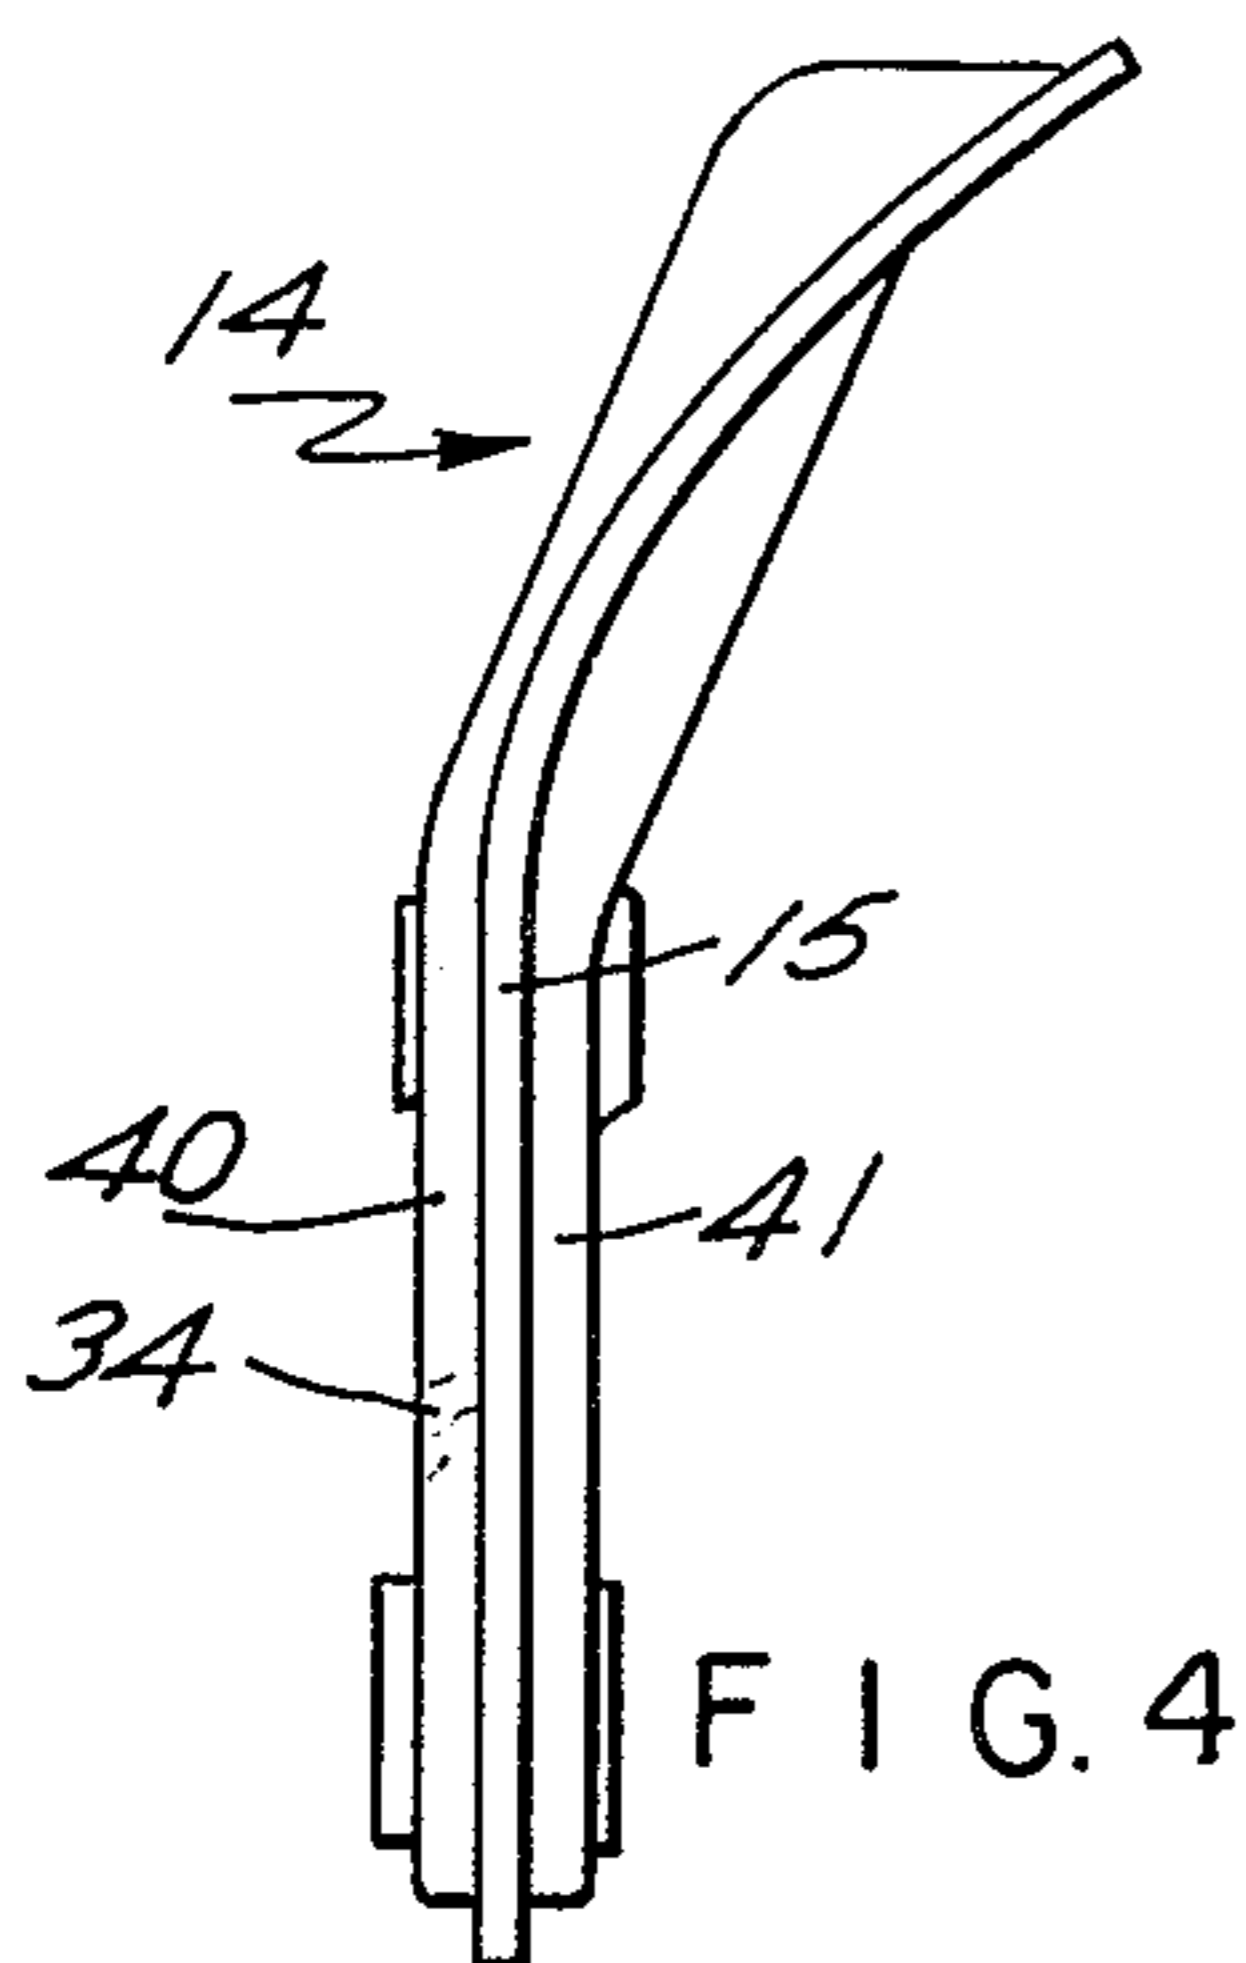
FIG. 4 is an elevational view of the box beam showing failures therein.

In structures of this nature and as a result of considerable stress as well as the effects of road salt, water and other elements, the box beam at the section 24 will develop cracks and other fatigue points as seen by the cracks shown at 34 in FIG. 4. It is to be appreciated that this considerably weakens the entire structure and support for the front end of the automotive vehicle, and under normal circumstances as the box beam and the tubular portions 10 and 12 are integral formed-up units, it may become necessary to replace the entire unit in order to make the automotive vehicle safe to drive.

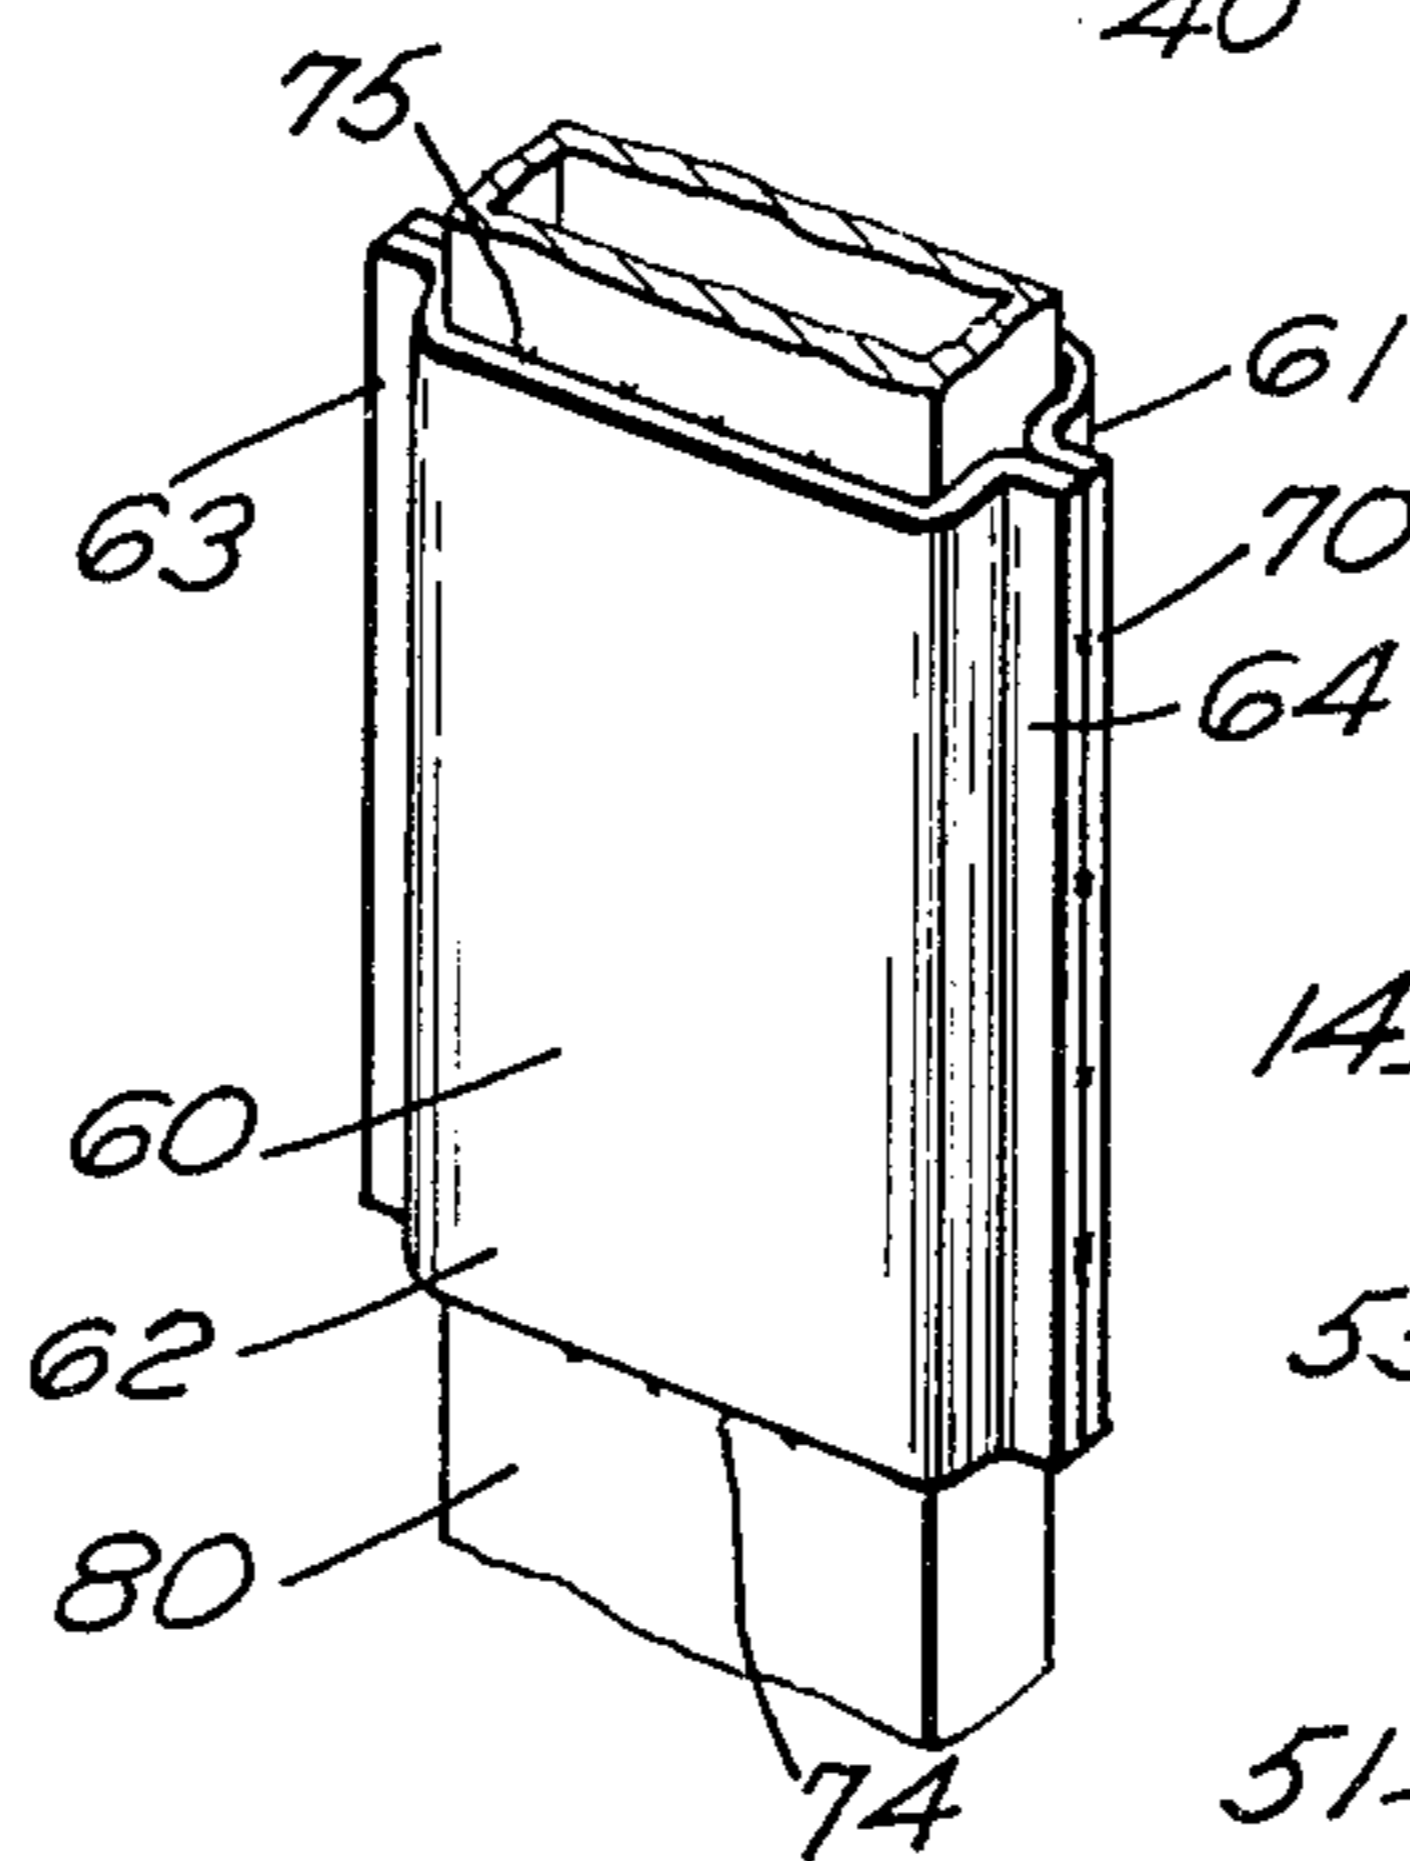
FIG. 6 is a perspective view showing the utilization of the repair device on any box beam structure.

It will be noted in the particular illustration made herein that the box beam to which reference has been had includes a particular structure with a web such as 15, 15' which web has been utilized merely for convenience in structural assembly, and to this end the plates that are utilized for repair purposes have been provided with mating outwardly turned flanges 45, 46. It will be apparent, however, that the method of repair will apply to any box beam and with reference to FIG. 6 a typical rectangular box beam 60 has been illustrated with repair plates 60 and 61 which have been formed with face

portions such as 62 and downwardly turned side edges such as 63, 64. This type of structure can indeed be utilized for any type of box beam repair, and in the illustration of FIG. 6 the repair plate 40a is welded as at 74, 75 and the edges as at 70 are also welded to the box beam and also to a mating repair plate such as a repair plate 61 which would be identical to the illustrated plate 60 and utilized in precisely the same fashion as that described in connection with repair plates 40 and 41.

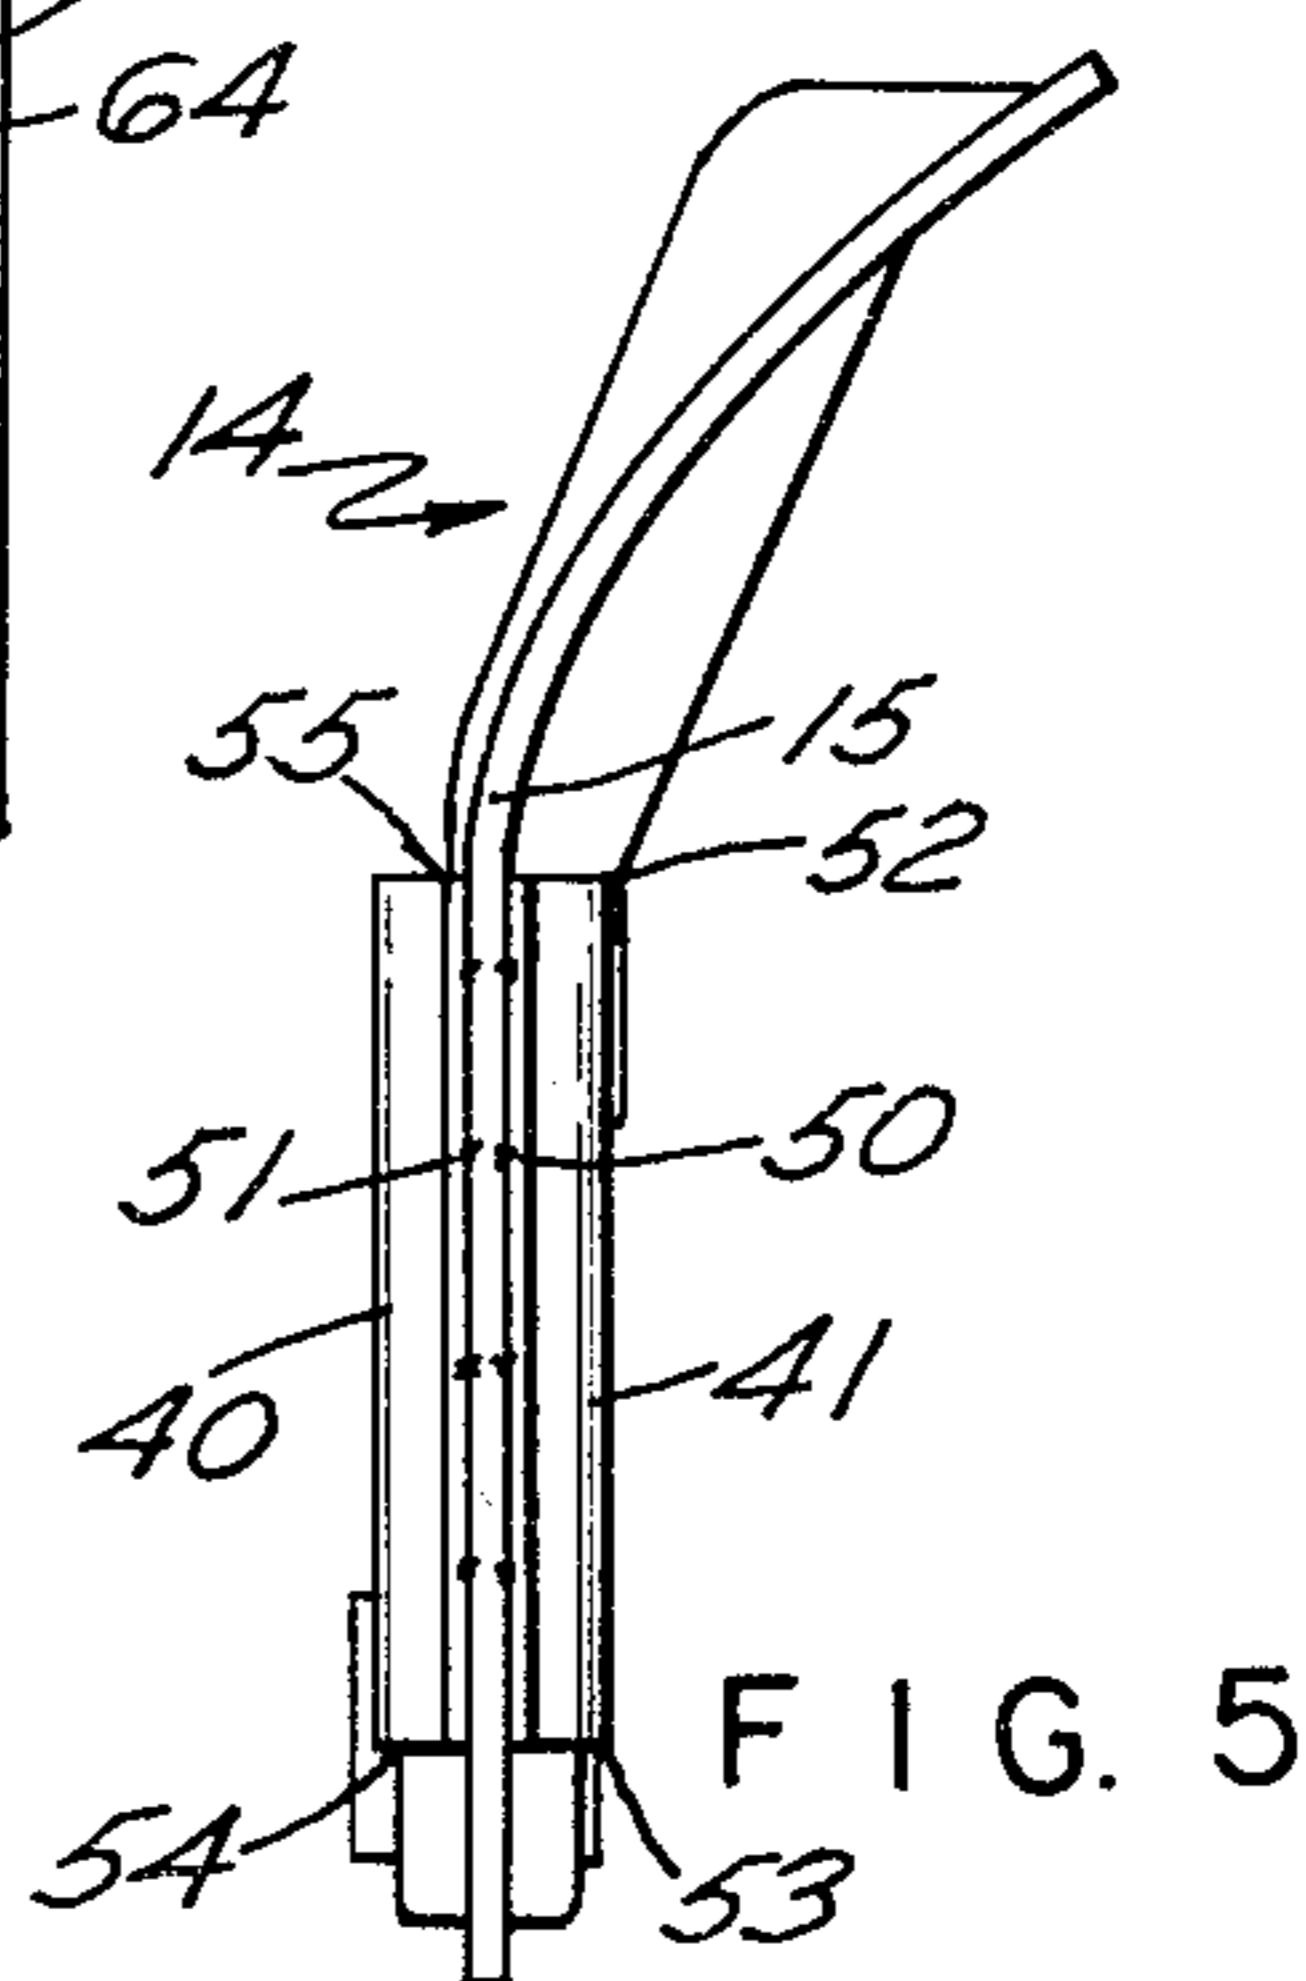
FIG. 5 is a view of the box beam completely repaired; and
