[54] METHOD OF REPAIRING A BOX BEAM

A method of repairing a box beam is disclosed in which a cracked or broken portion of a box beam may be repaired and the strength returned to normal by forming a pair of plates that fit snugly about at least one half of the box beam, the plates being welded to the box beam and to each other, each edge of the plates being either welded to its juxtaposed plate or to the box beam to provide full strength to the structure.

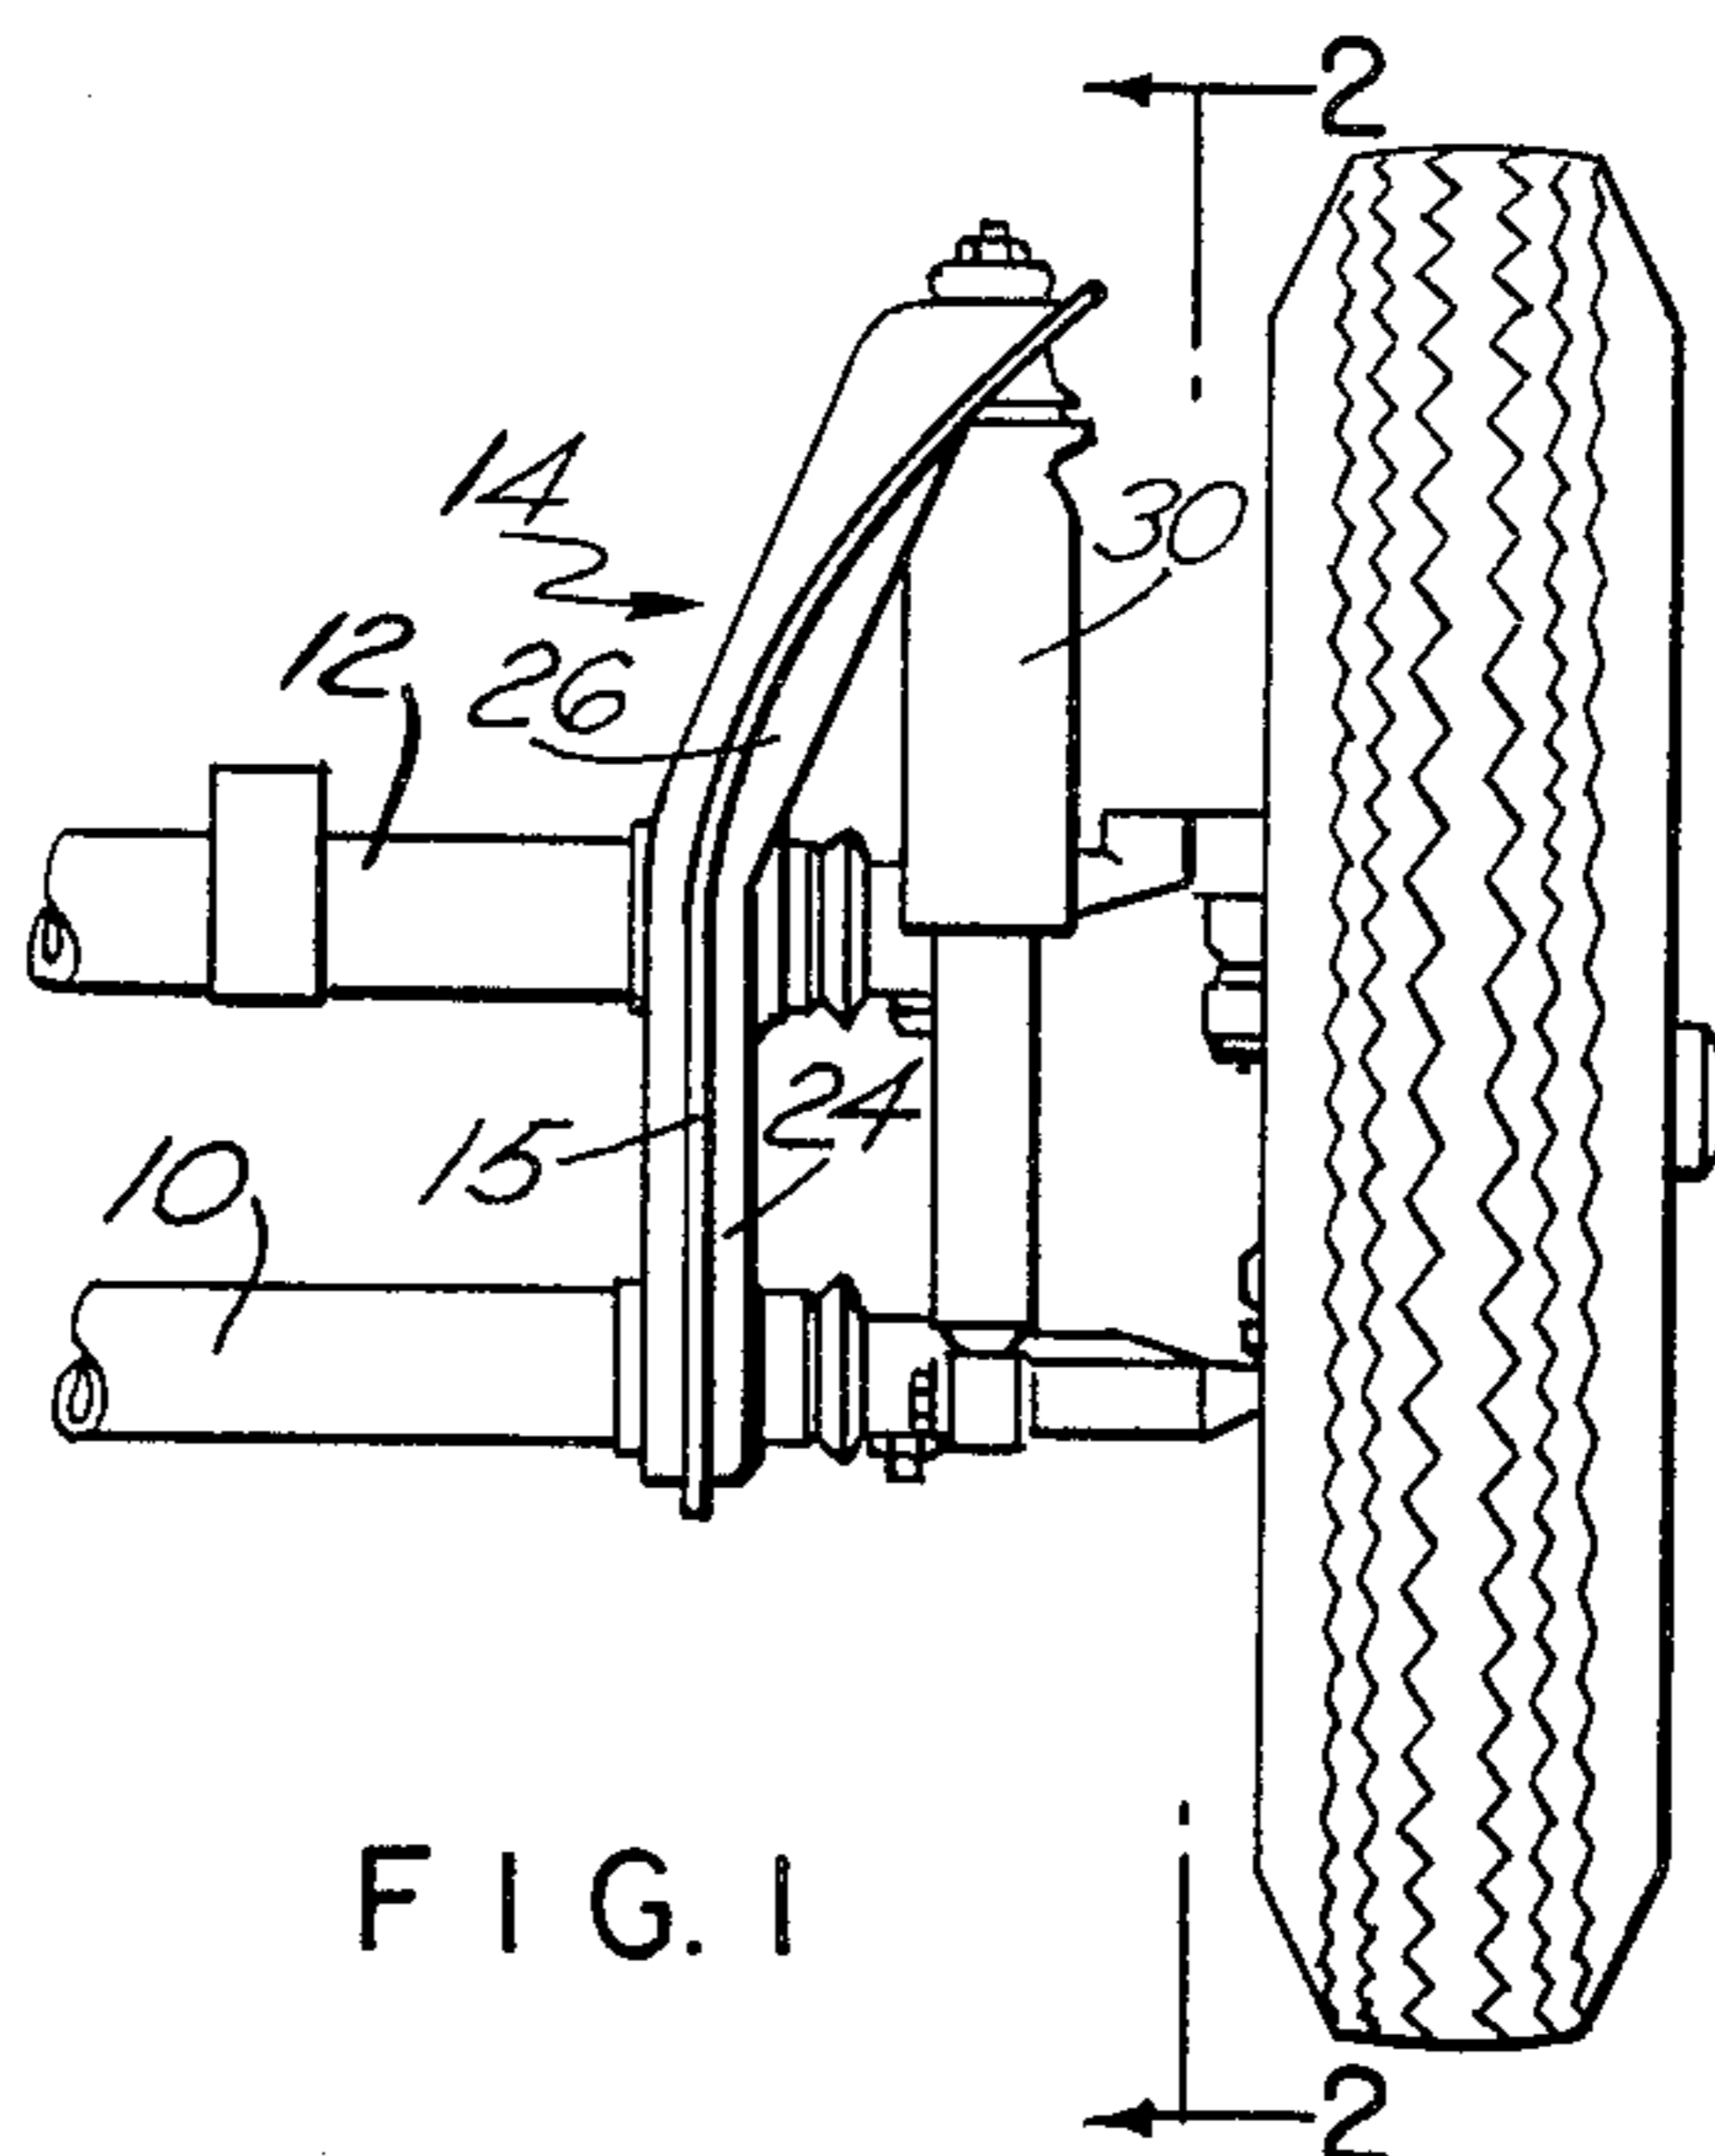
FIG. 1 is a front elevational view showing a box beam construction in the context of a front axle for an automotive vehicle;

Referring to FIG. 1, a portion of the front axle beam in an automotive vehicle is shown, which comprises a first tubular member 10 that encloses a torsion bar and

a second tubular member 12 in which is also received the second torsion bar, these two members being connected together at either end by a box beam structure generally designated 14, only one such structure being shown. The box beam structure has apertures with suitable bearings through which the torsion bar 16 (See FIG. 2) extends and through which the torsion bar 18 extends, each of these bars being respectively connected to torsion arms 20 and 22. The box beam is defined by a lower portion 24 which extends between the portions 10 and 12 and continues upwardly with a portion 26 that has an aperture therein as at 28 into which the upper end of a shock absorber 30 is received.

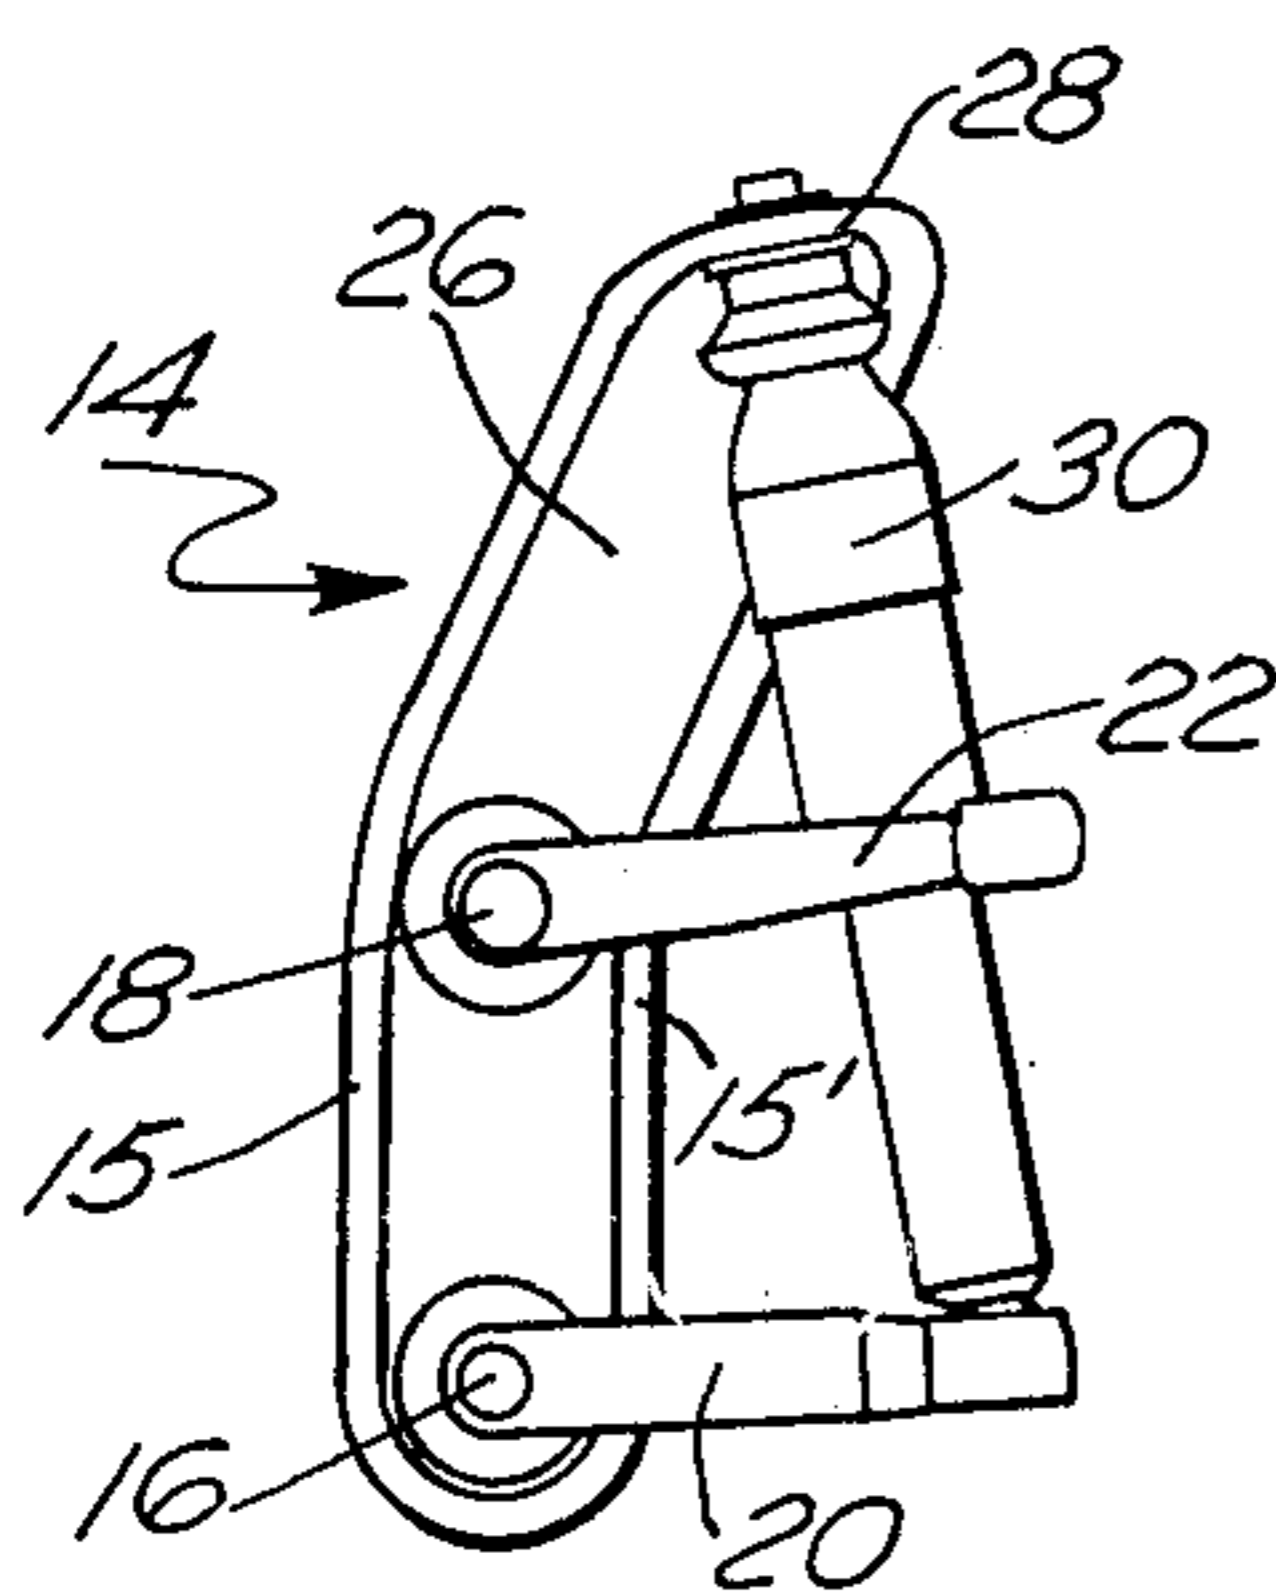
FIG. 2 is a sectional view taken on lines 2—2 of FIG. 1;

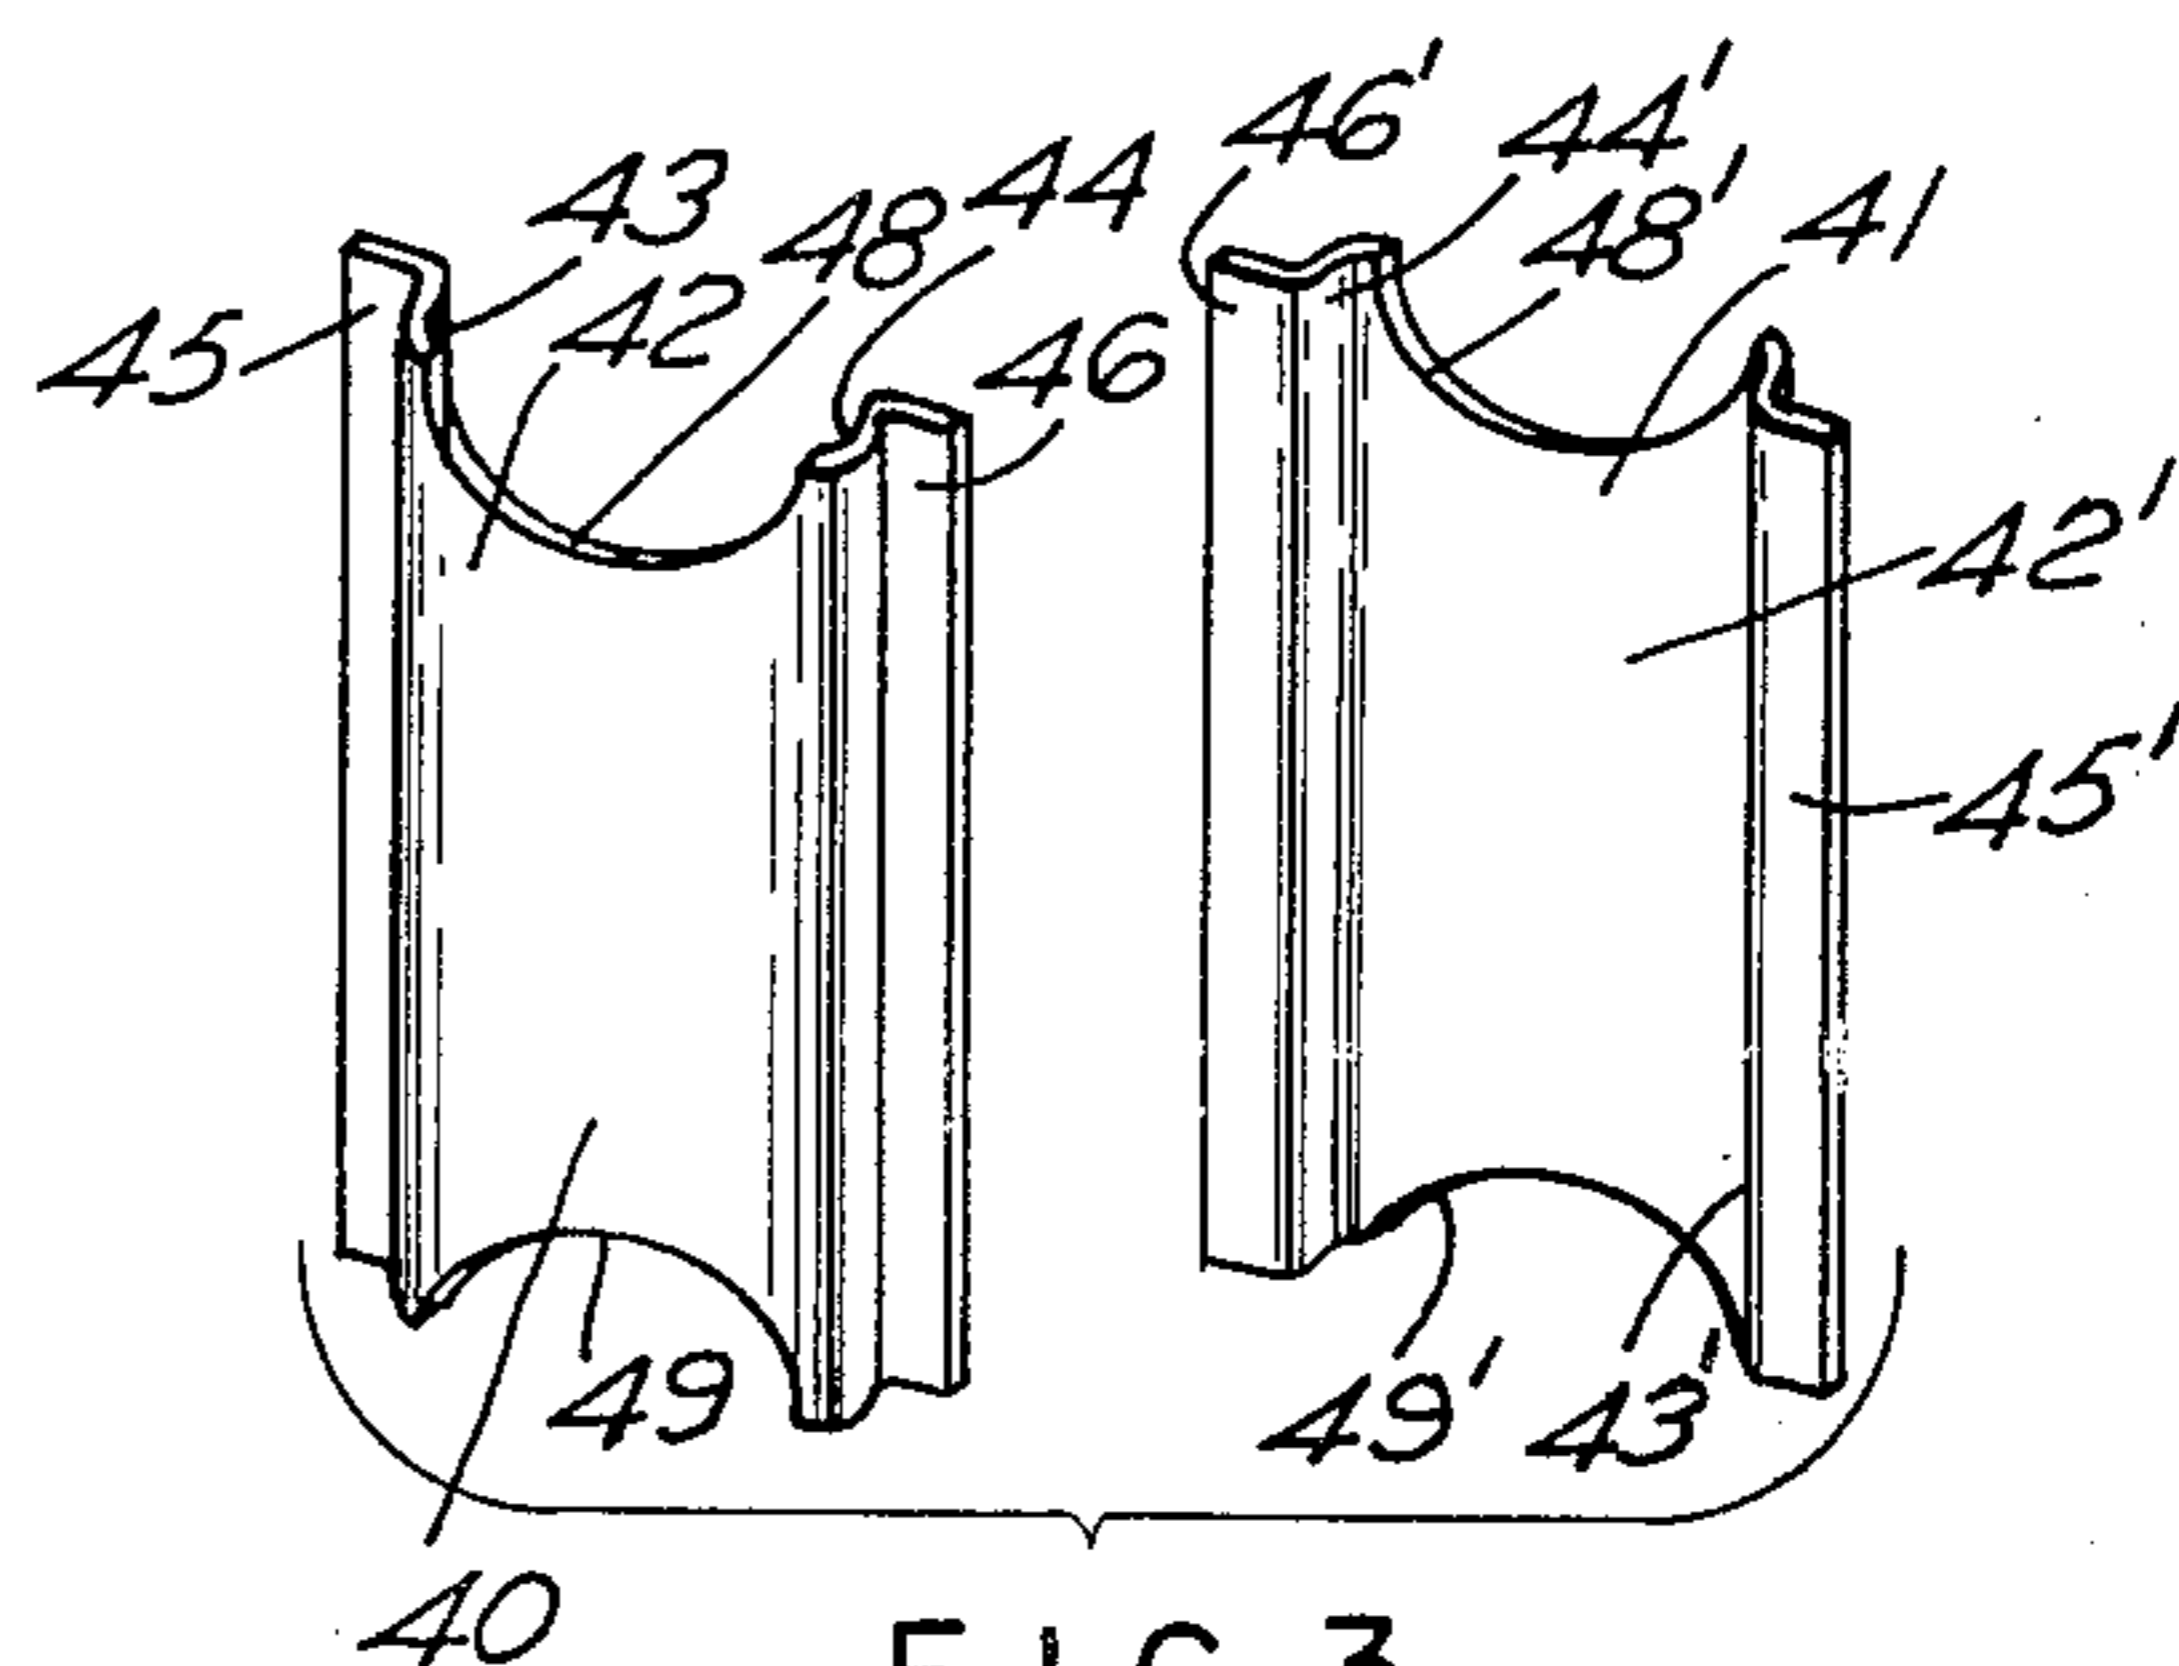
FIG. 3 is a detached perspective view of the repair plate;

In order to obviate a complete replacement there is formed from sheet material a pair of plates, designated 40 and 41, (see FIG. 3) which are identical plates and which as shown have in effect a face 42, 42' with an intumed edge such as 43, 44, 43', 44', and then outwardly turned lips 45, 45', 46, 46'. These plates 40, 41 are placed on either side of the box beam as seen in FIG. 5. The cut-outs as at 48 and 49 for example being adapted in this particular instance to fit about the bosses that are formed by the cylindrical members 10 and 11 passing through the box beam. In some instances the area about the cut-outs may be further formed to provide a proper fit, as for example, by flaring from the planar extent of face. It will of course be apparent that before the plates are positioned on the box beam and assuming that the box beam is rusted and has a coating of grease and other materials thereon it is first necessary to clean the box beam by the use of suitable degreasing compounds and then as necessary clean out any additional rust that may be present. At this point, if desired, the box beam may be painted in the central portion thereof leaving the ends where the upper and lower edges of the plates 40 and 41 will contact absolutely clean. The plates are then clamped in position and welding material is used to make joints as seen at 50, 51, 52, 53, 54, and 55 so that all of the edges of the plates 40 and 41 have been welded together and to the box beam structure. After the welding has been completed the repair may now be suitably painted with primer paint and then with undercoating material such as a tar-based compound or the like. The box beam has now been returned to its original strength and situation.

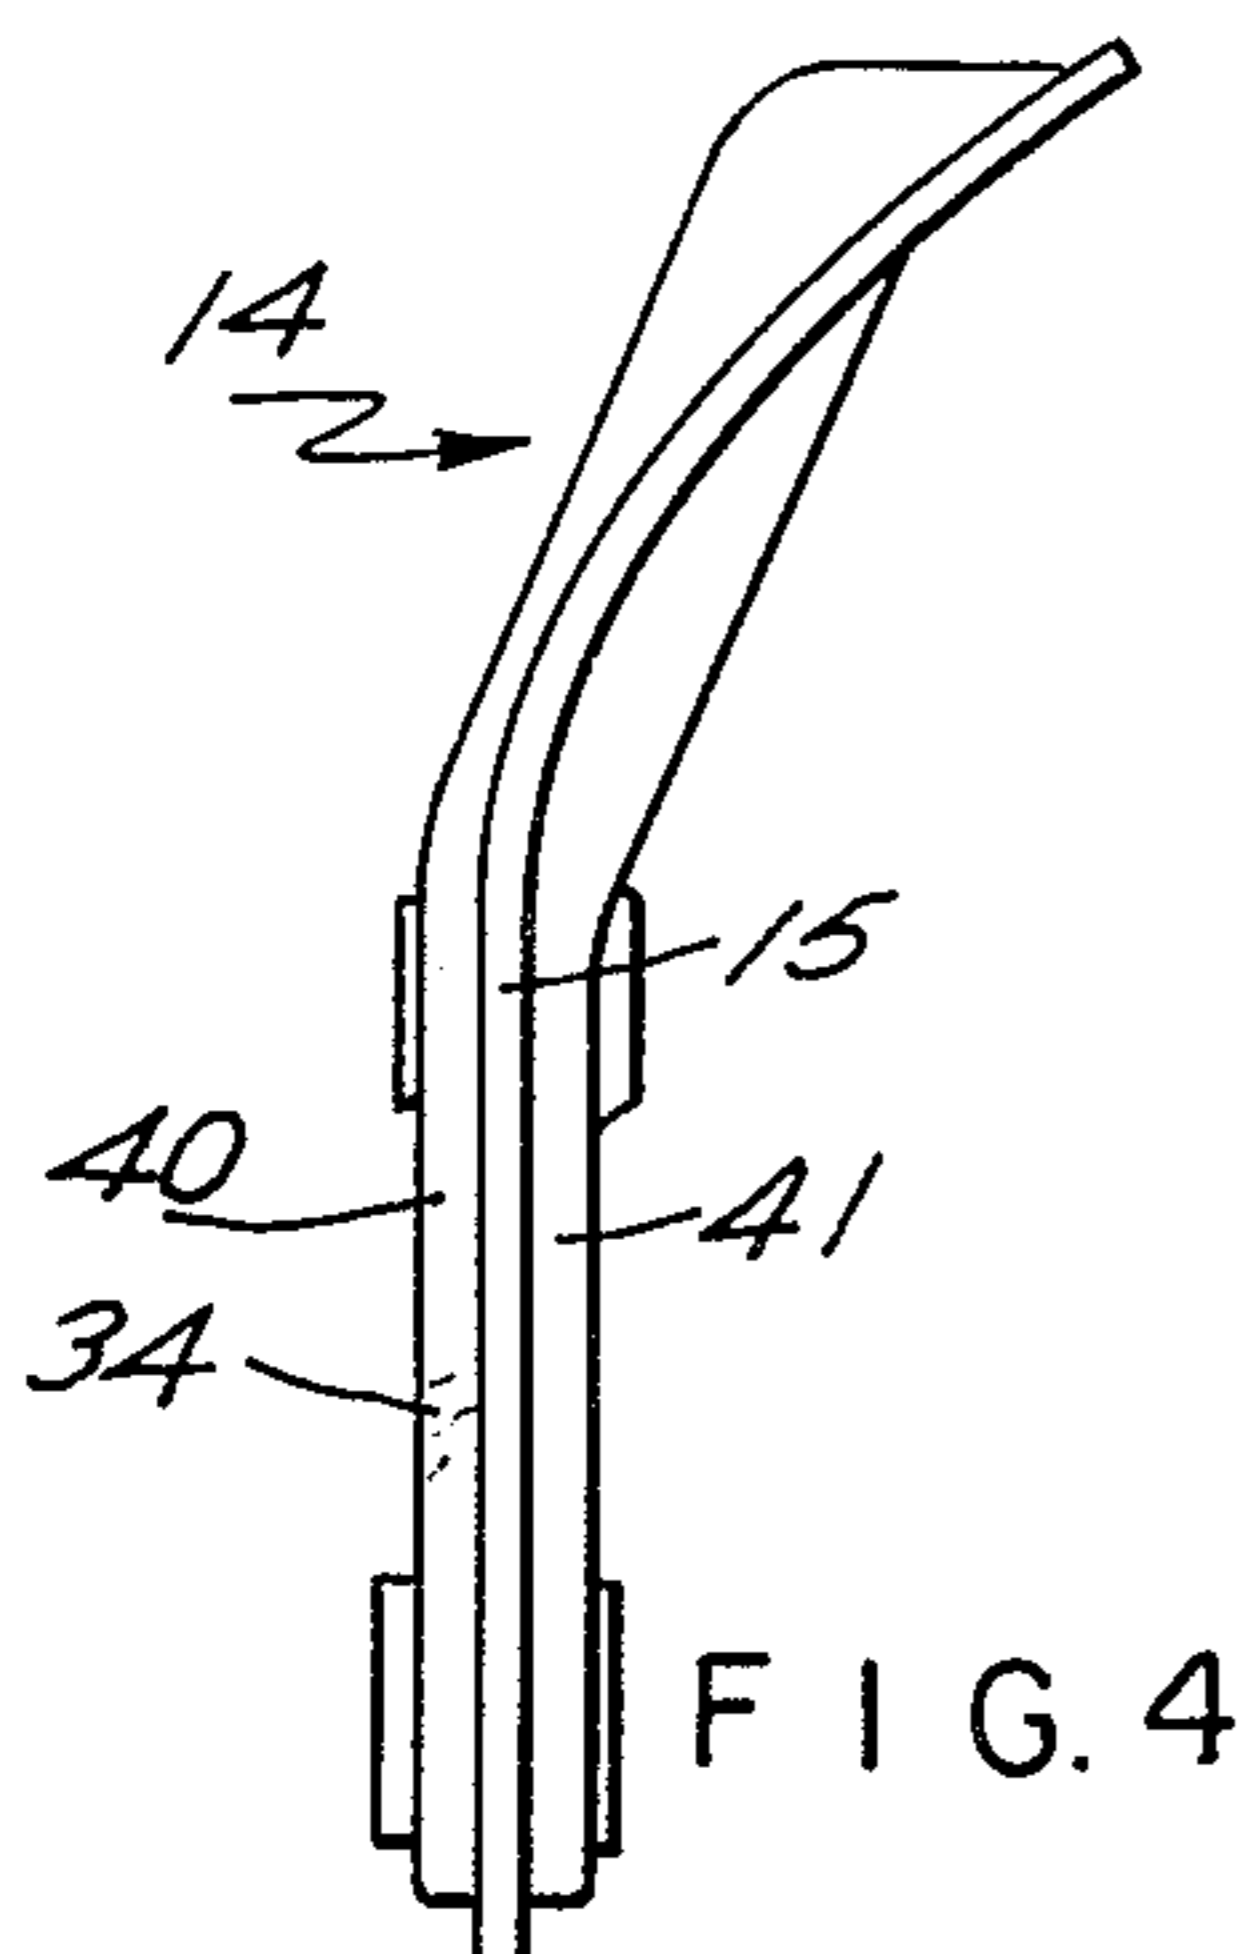
FIG. 4 is an elevational view of the box beam showing failures therein.

In structures of this nature and as a result of considerable stress as well as the effects of road salt, water and other elements, the box beam at the section 24 will develop cracks and other fatigue points as seen by the cracks shown at 34 in FIG. 4. It is to be appreciated that this considerably weakens the entire structure and support for the front end of the automotive vehicle, and under normal circumstances as the box beam and the tubular portions 10 and 12 are integral formed-up units, it may become necessary to replace the entire unit in order to make the automotive vehicle safe to drive.
