- [54] ROTOR BLADE SHAFT INTEGRITY MONITORING SYSTEM
- [75] Inventors: Donald L. Ferris, Newtown; Peter C. Ogle, Woodbridge, both of Conn.
- [73] Assignee: United Technologies Corporation, Hartford, Conn.
- [21] Appl. No.: 315,125
- [22] Filed: Oct. 26, 1981
- [51] Int. Cl.³ B64C 11/16; B64C 27/48
- [52] U.S. Cl. 416/61; 416/134 A; 416/226; 73/40.7; 116/264
- [58] Field of Search 416/61, 134 R, 134 A, 416/226, 138 A; 73/40.7; 116/264

ROTOR BLADE SHAFT INTEGRITY MONITORING SYSTEM

This invention relates to helicopter rotors and more particularly to an improved blade retention apparatus including a redundant tension member and an indicator system to monitor the reliability of the primary member.

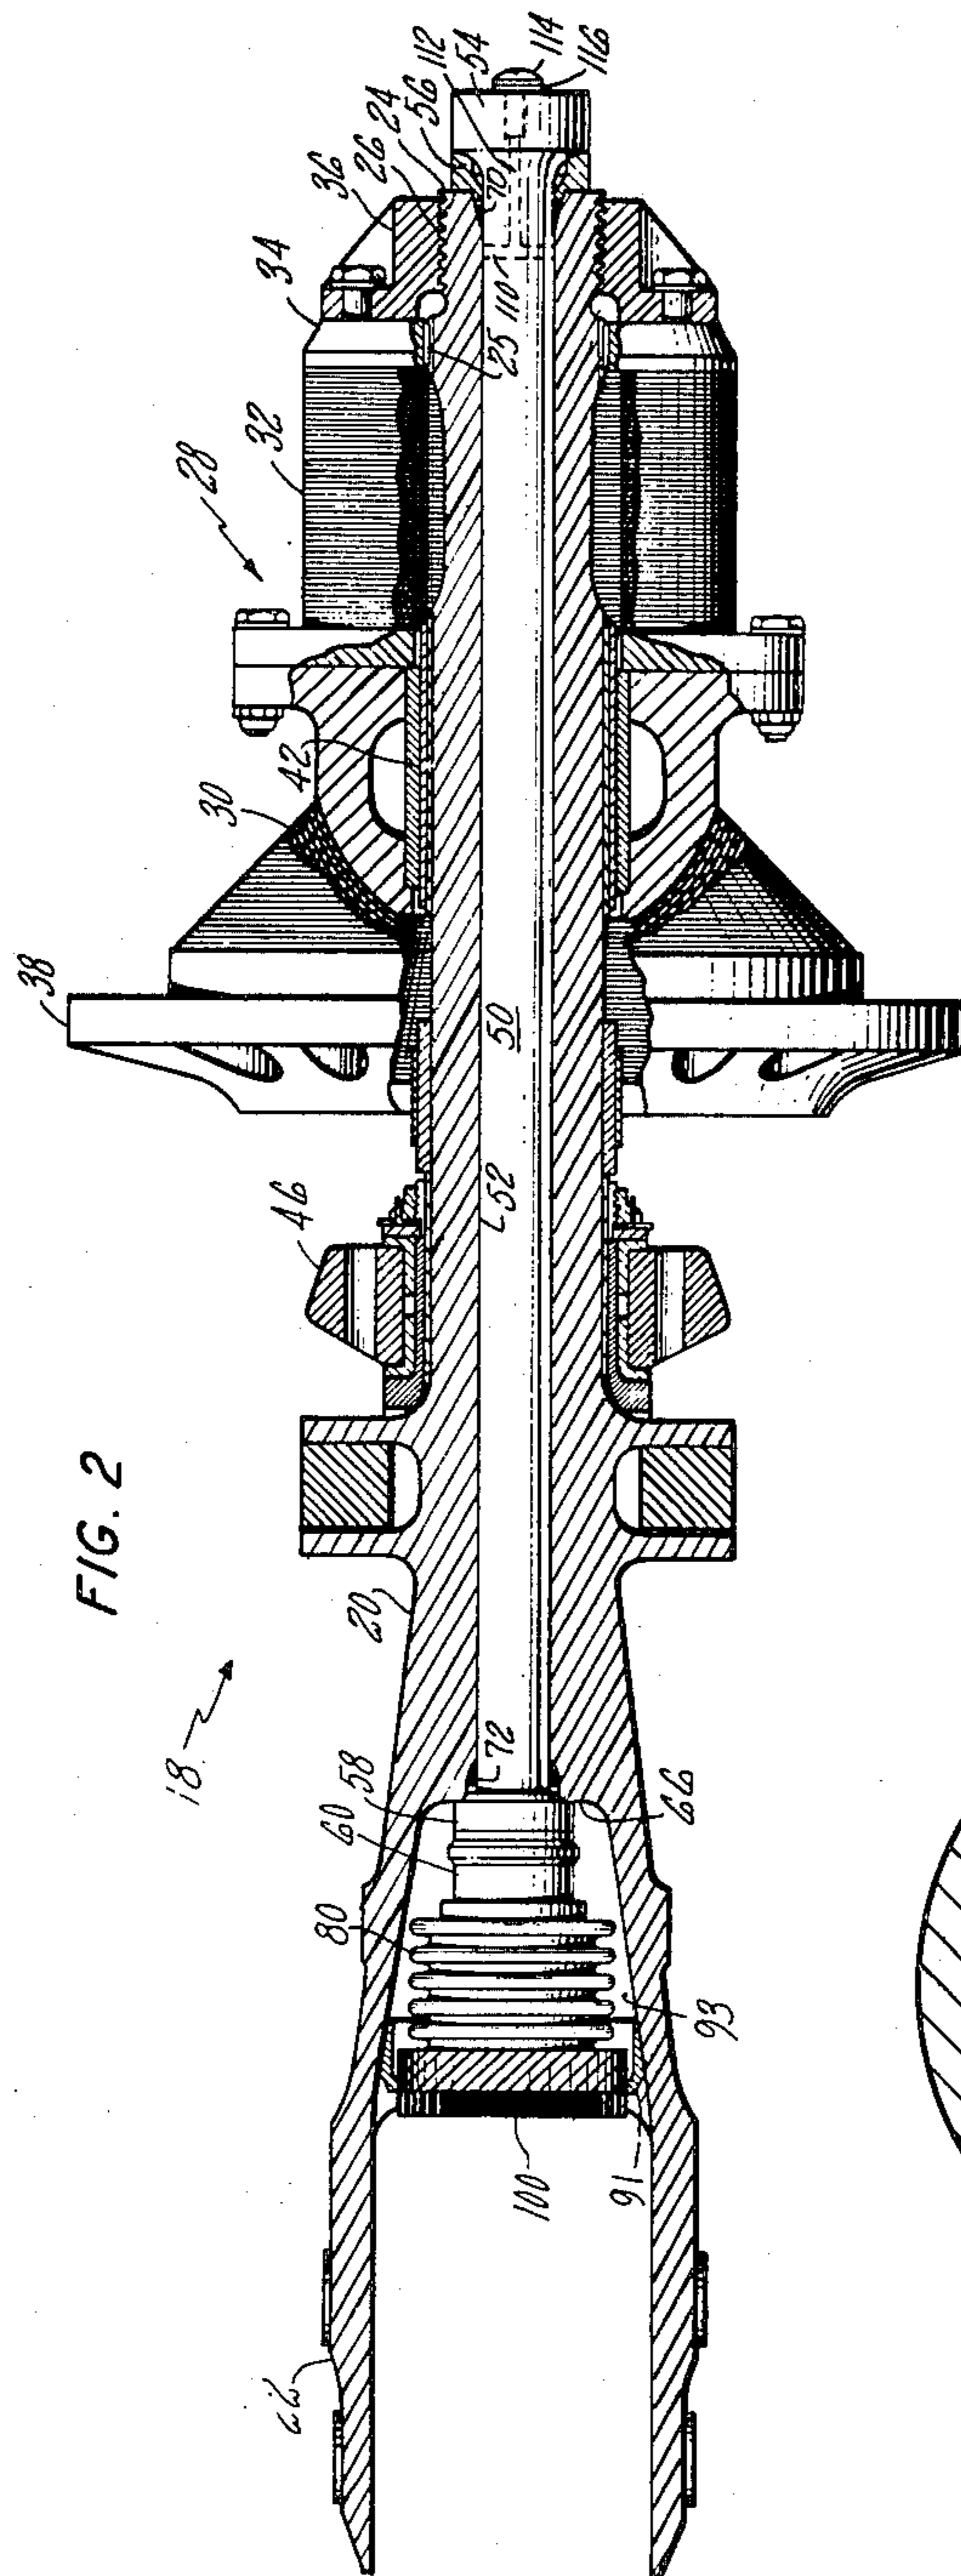
FIG. 2 is a larger scale cross-sectional showing of a typical spindle assembly installed in a rotor hub arm and depicting the preferred embodiment of this invention.

FIG. 2 illustrates both the redundant means added to the spindle assembly as an improvement to the configuration illustrated in the '708 patent together with the integrity monitoring means associated therewith that provides knowledge to the operator or service personnel that damage has occurred to the spindle assembly, and the normal load path has been diverted to a backup path. Spindle replacement can then be scheduled. Still referring to FIG. 2, we can realize that the primary load

path of the reaction to blade centrifugal force travels inboard the length of spindle 20 to its innermost end 24 at thread 26. Tension loading in spindle 20 translates to compression loading in the bearing array 28 as the load reverses through jam nut 36. Such was the sole load path until the addition herewith of bolt 50, located in the bore 52 of spindle 20, with generous clearance between bolt and bore providing an annulus 53 of several thousandths of an inch that is illustrated in FIG. 4. Bolt head 54 and spherical washer 56 are provided at the inner end 24 of spindle 20, while spacer 58, nut 60, nut lock 62, and nut lock ring 64 are provided at the opposite end. A pre-load may be provided to bolt 50 prior to installation of the spindle assembly into the hub arm 12. Under centrifugal operating loads imposed on the spindle 20, shoulder 66 will bear against spacer 58 and impose a tension load into bolt 50. This tension load will be reversed at the bolt head 54 so as to create a compression load path through bushing 56, spindle end 24, and nut 36 into the bearing array 28. The spherical shape of the washer 56 aids in centering the bolt 50 so as to provide tensile loading only across its cross section. Thus, the bolt 50 creates a secondary load path that may either share the total load or be held in reserve until failure of a member in the primary load path. When a pre-load is applied to the bolt, the degree of load sharing between the two load paths will be a function of the amount of pre-load. A failure of the spindle in its cross section, such as a crack which would open to an enlarged condition under centrifugal force, would render the spindle incapable of continued tensile loading. Upon such failure, the bolt 50 will become the primary load path. The spindle will be relieved of loading for its length inboard of the shoulder 66.

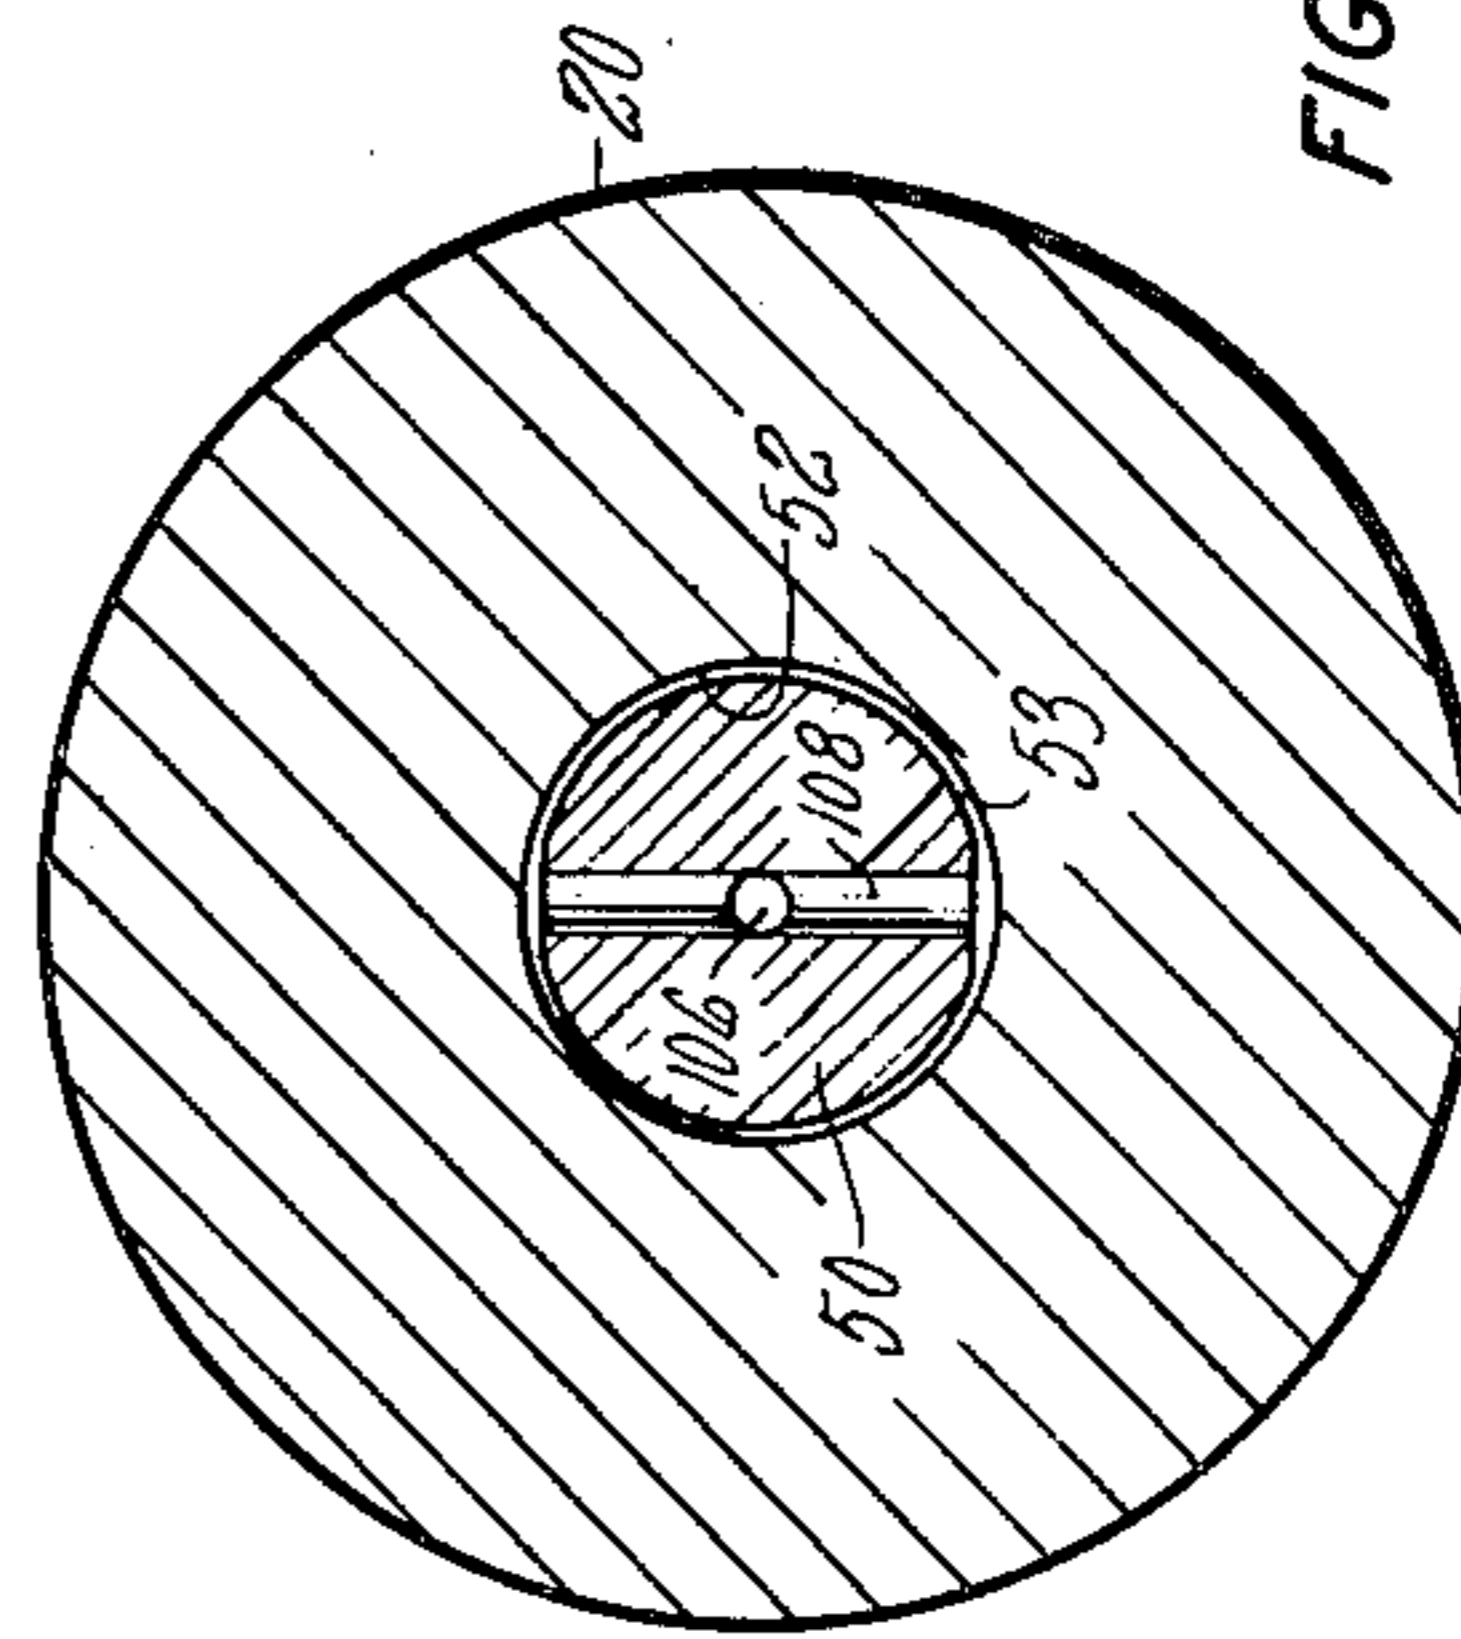
FIG. 4 is a cross-sectional view taken along line 4—4 of FIG. 3.

occupies a large proportion of the volume of the spindle bore 52, the total amount of dye present in the bore and bellows is limited to a few ounces. Flats may be machined on the outer diameter of the bolt 50 to further increase the space between bolt 50 and bore 52 as shown in FIG. 4. To compensate for the small amount of fluid available to extend over the long spindle bore, it is desirable that the pressure imposed by the expanded bellows 80 be great enough to compensate for small changes in volume due to temperature variations and also to pump dye against centrifugal force from the bellows 80 to the inboard end of the spindle bore. Centrifugal force can then carry the escaped dye externally back from the crack in spindle wall 20 past spline 25, mating surfaces of spindle 20 and shear bearing 42, to droop stop ring 46, past the opening of hub arm 12 so as to be visible by ground support personnel after aircraft flight. We recognize that a crack in the spindle 20 will be open to the fullest for passage of dye when the spindle is under centrifugal force and may close when the blade is stationary. Therefore, it is important that the bellows be adequately pressurized to drive the dye through the crack while overcoming centrifugal force. The bellows 80 is attached as follows to the outboard end 82 of the bolt 50 and is shown in FIG. 2 in its collapsed or negligible pressure condition. Stud 84 is threadably attached to the end 82 of bolt 50 by rotating nut portion 86 and stud 84 supports a first bellows flange 88 to which the inner end of bellows 80 is attached. A sealing washer 89 prevents leakage between bellows flange 88 and end 82 of bolt 50. The outer end of bellows 80 is attached to a second bellows flange 90 which threadably engages filler plug 92. An O-ring 94 seals this threaded connection. To allow axial freedom for the bellows 80 to expand and contract, the plug 92 is piloted loosely on a cylindrical extension 96 of stud 84 but of sufficient closeness as to support outer flange 90 against any out-of-plane motions of spindle 20 and bellows 80. Indicator shield 100 is attached to filler plug 92. The shield 100 is preferably of molded plastic in a bright fluorescent green color. Molded lip seal 91 is bonded within spindle cavity 93 and protects bellows 80 from environmental or other damage. When the bellows 80 is at its minimum pressure condition with a large portion of the shield 100 hidden from sight behind seal 91, the exposed shield portion will be painted a dull color, such as black. Thus, whenever the bellows 80 is extended, as in its normal condition and as shown in FIG. 3, the bright green portion will be visible outboard of the lip seal 91. This appearance of the green portion of shield 100 will indicate a fully pressurized system and comprises the second visual indication of a fully capable spindle to ground support personnel. The axial location of the black paint on the outer portion of the shield 100 must be carefully coordinated with the pressure drop expected due to a leak while under the opposing influence of centrifugal force. This takes into account the possibility that when the helicopter lands, the spindle crack may close before the bellows fully loses pressure. Since it has been determined that the bellows requires a minimum of 20 psi to overcome centrifugal force, there should be no green portion of shield 100 showing when the bellows 80 pressure is below 20 psi.

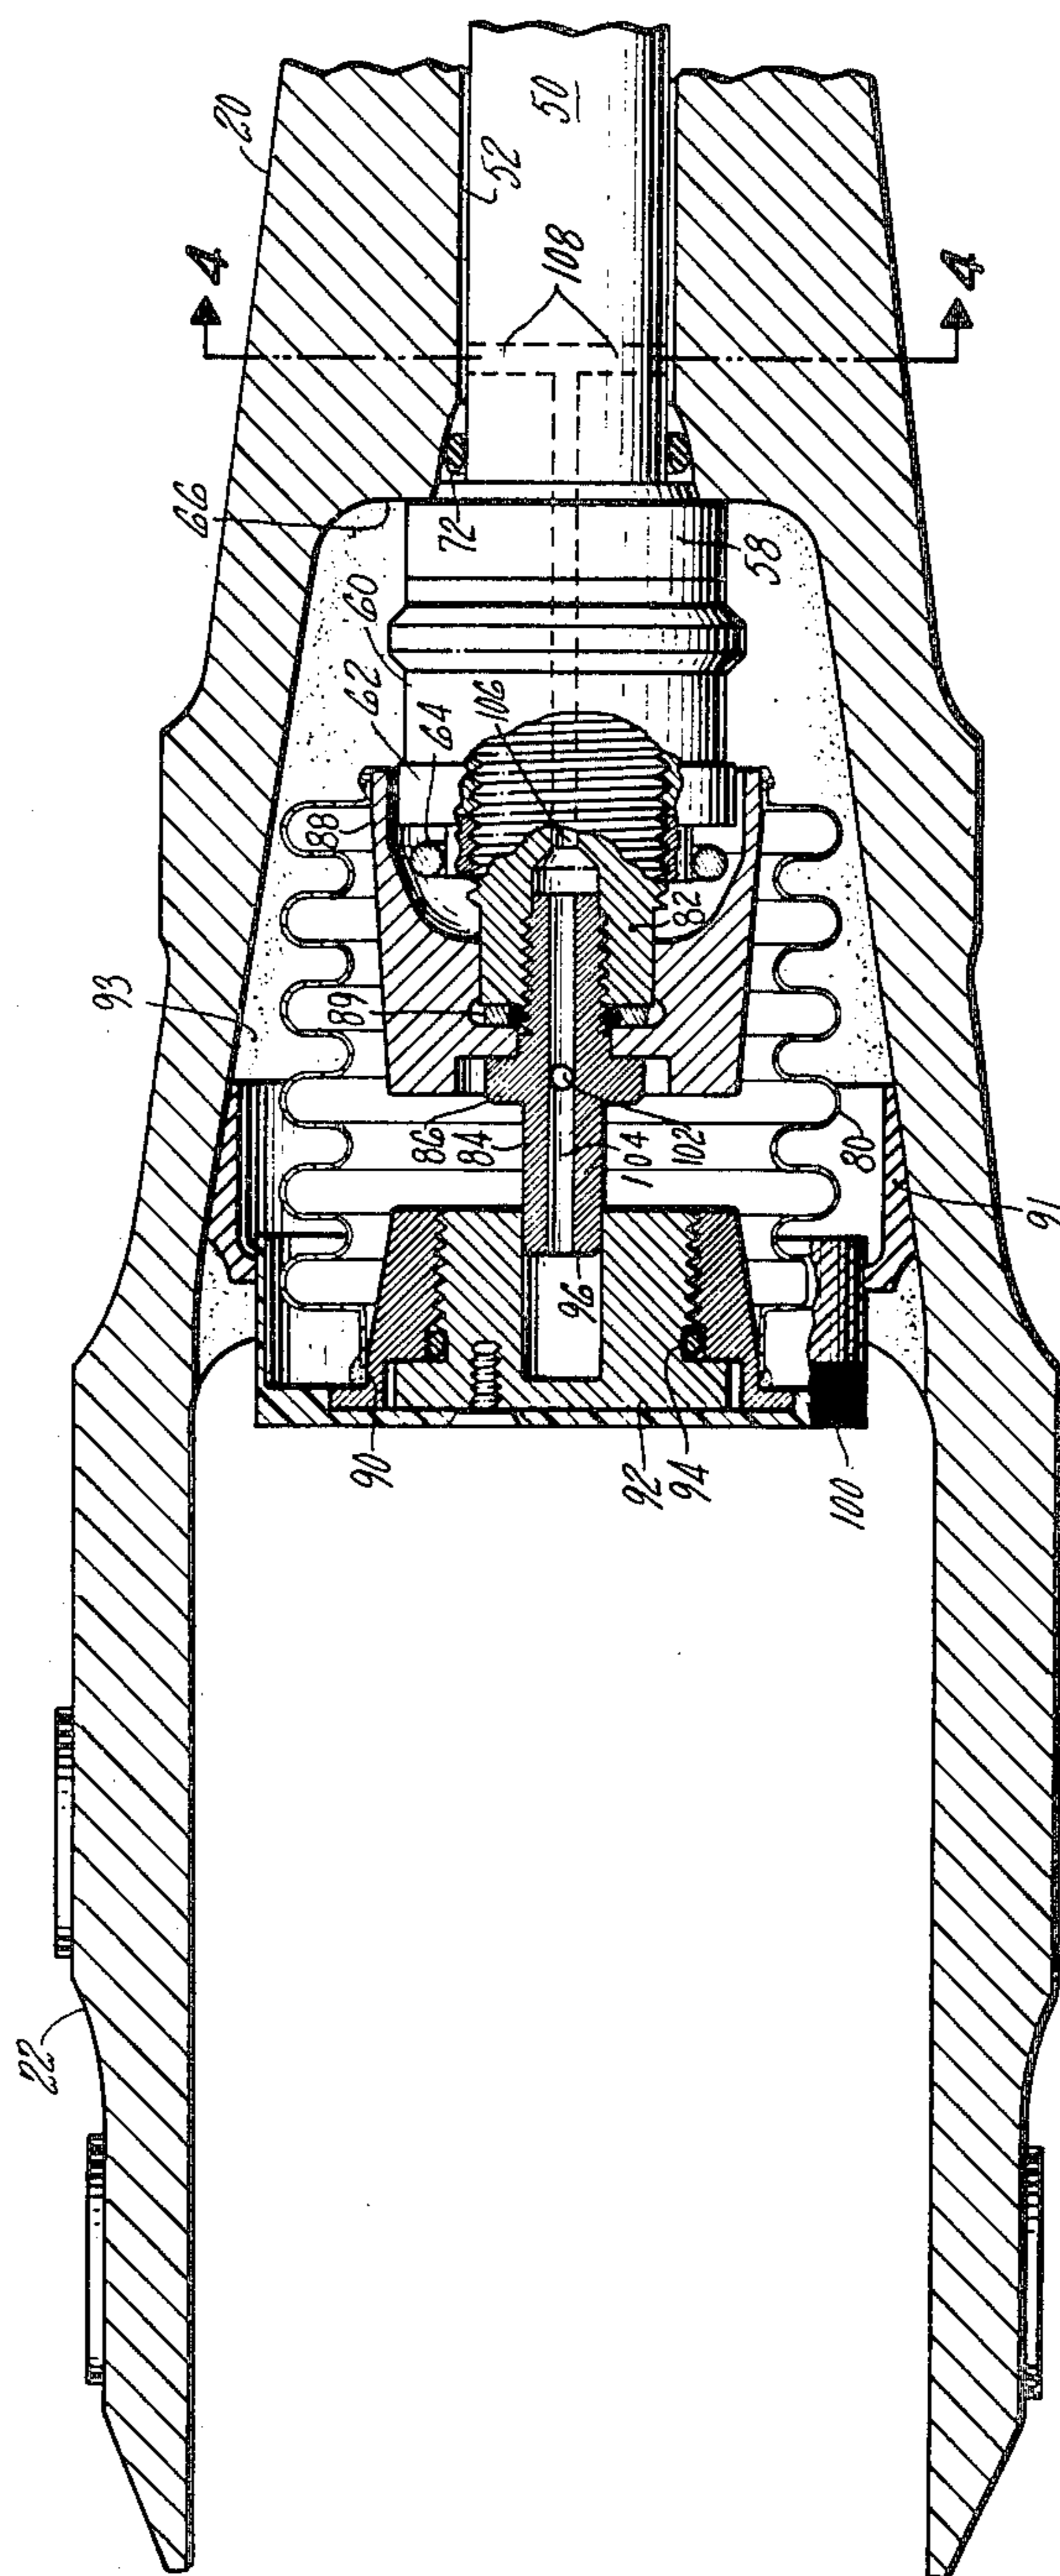
FIG. 3 is a still larger showing of the outboard end of the spindle to illustrate the bellows.

With the bellows 80 filled, as shown in FIG. 3, and the bolt 50 pre-loaded, the bearing array 28 is slid into place co-axial to the spindle 20, and the spindle spline 25 is engaged with a mating spline of the race 34 of the thrust bearing 32. End nut 36 is installed on the thread 26 of spindle 20, and the nut and face 34 are connected by suitable bolts or pins locking the nut. Flange 38 of the outer bearing 30 is then bolted to hub arm 12.
