- [54] ROTOR BLADE SHAFT INTEGRITY MONITORING SYSTEM
- [75] Inventors: Donald L. Ferris, Newtown; Peter C. Ogle, Woodbridge, both of Conn.
- [73] Assignee: United Technologies Corporation, Hartford, Conn.
- [21] Appl. No.: 315,125
- [22] Filed: Oct. 26, 1981
- [51] Int. Cl.<sup>3</sup> ..... B64C 11/16; B64C 27/48
- [52] U.S. Cl. .... 416/61; 416/134 A; 416/226; 73/40.7; 116/264
- [58] Field of Search ..... 416/61, 134 R, 134 A, 416/226, 138 A; 73/40.7; 116/264

## ROTOR BLADE SHAFT INTEGRITY MONITORING SYSTEM

This invention relates to helicopter rotors and more particularly to an improved blade retention apparatus including a redundant tension member and an indicator system to monitor the reliability of the primary member.

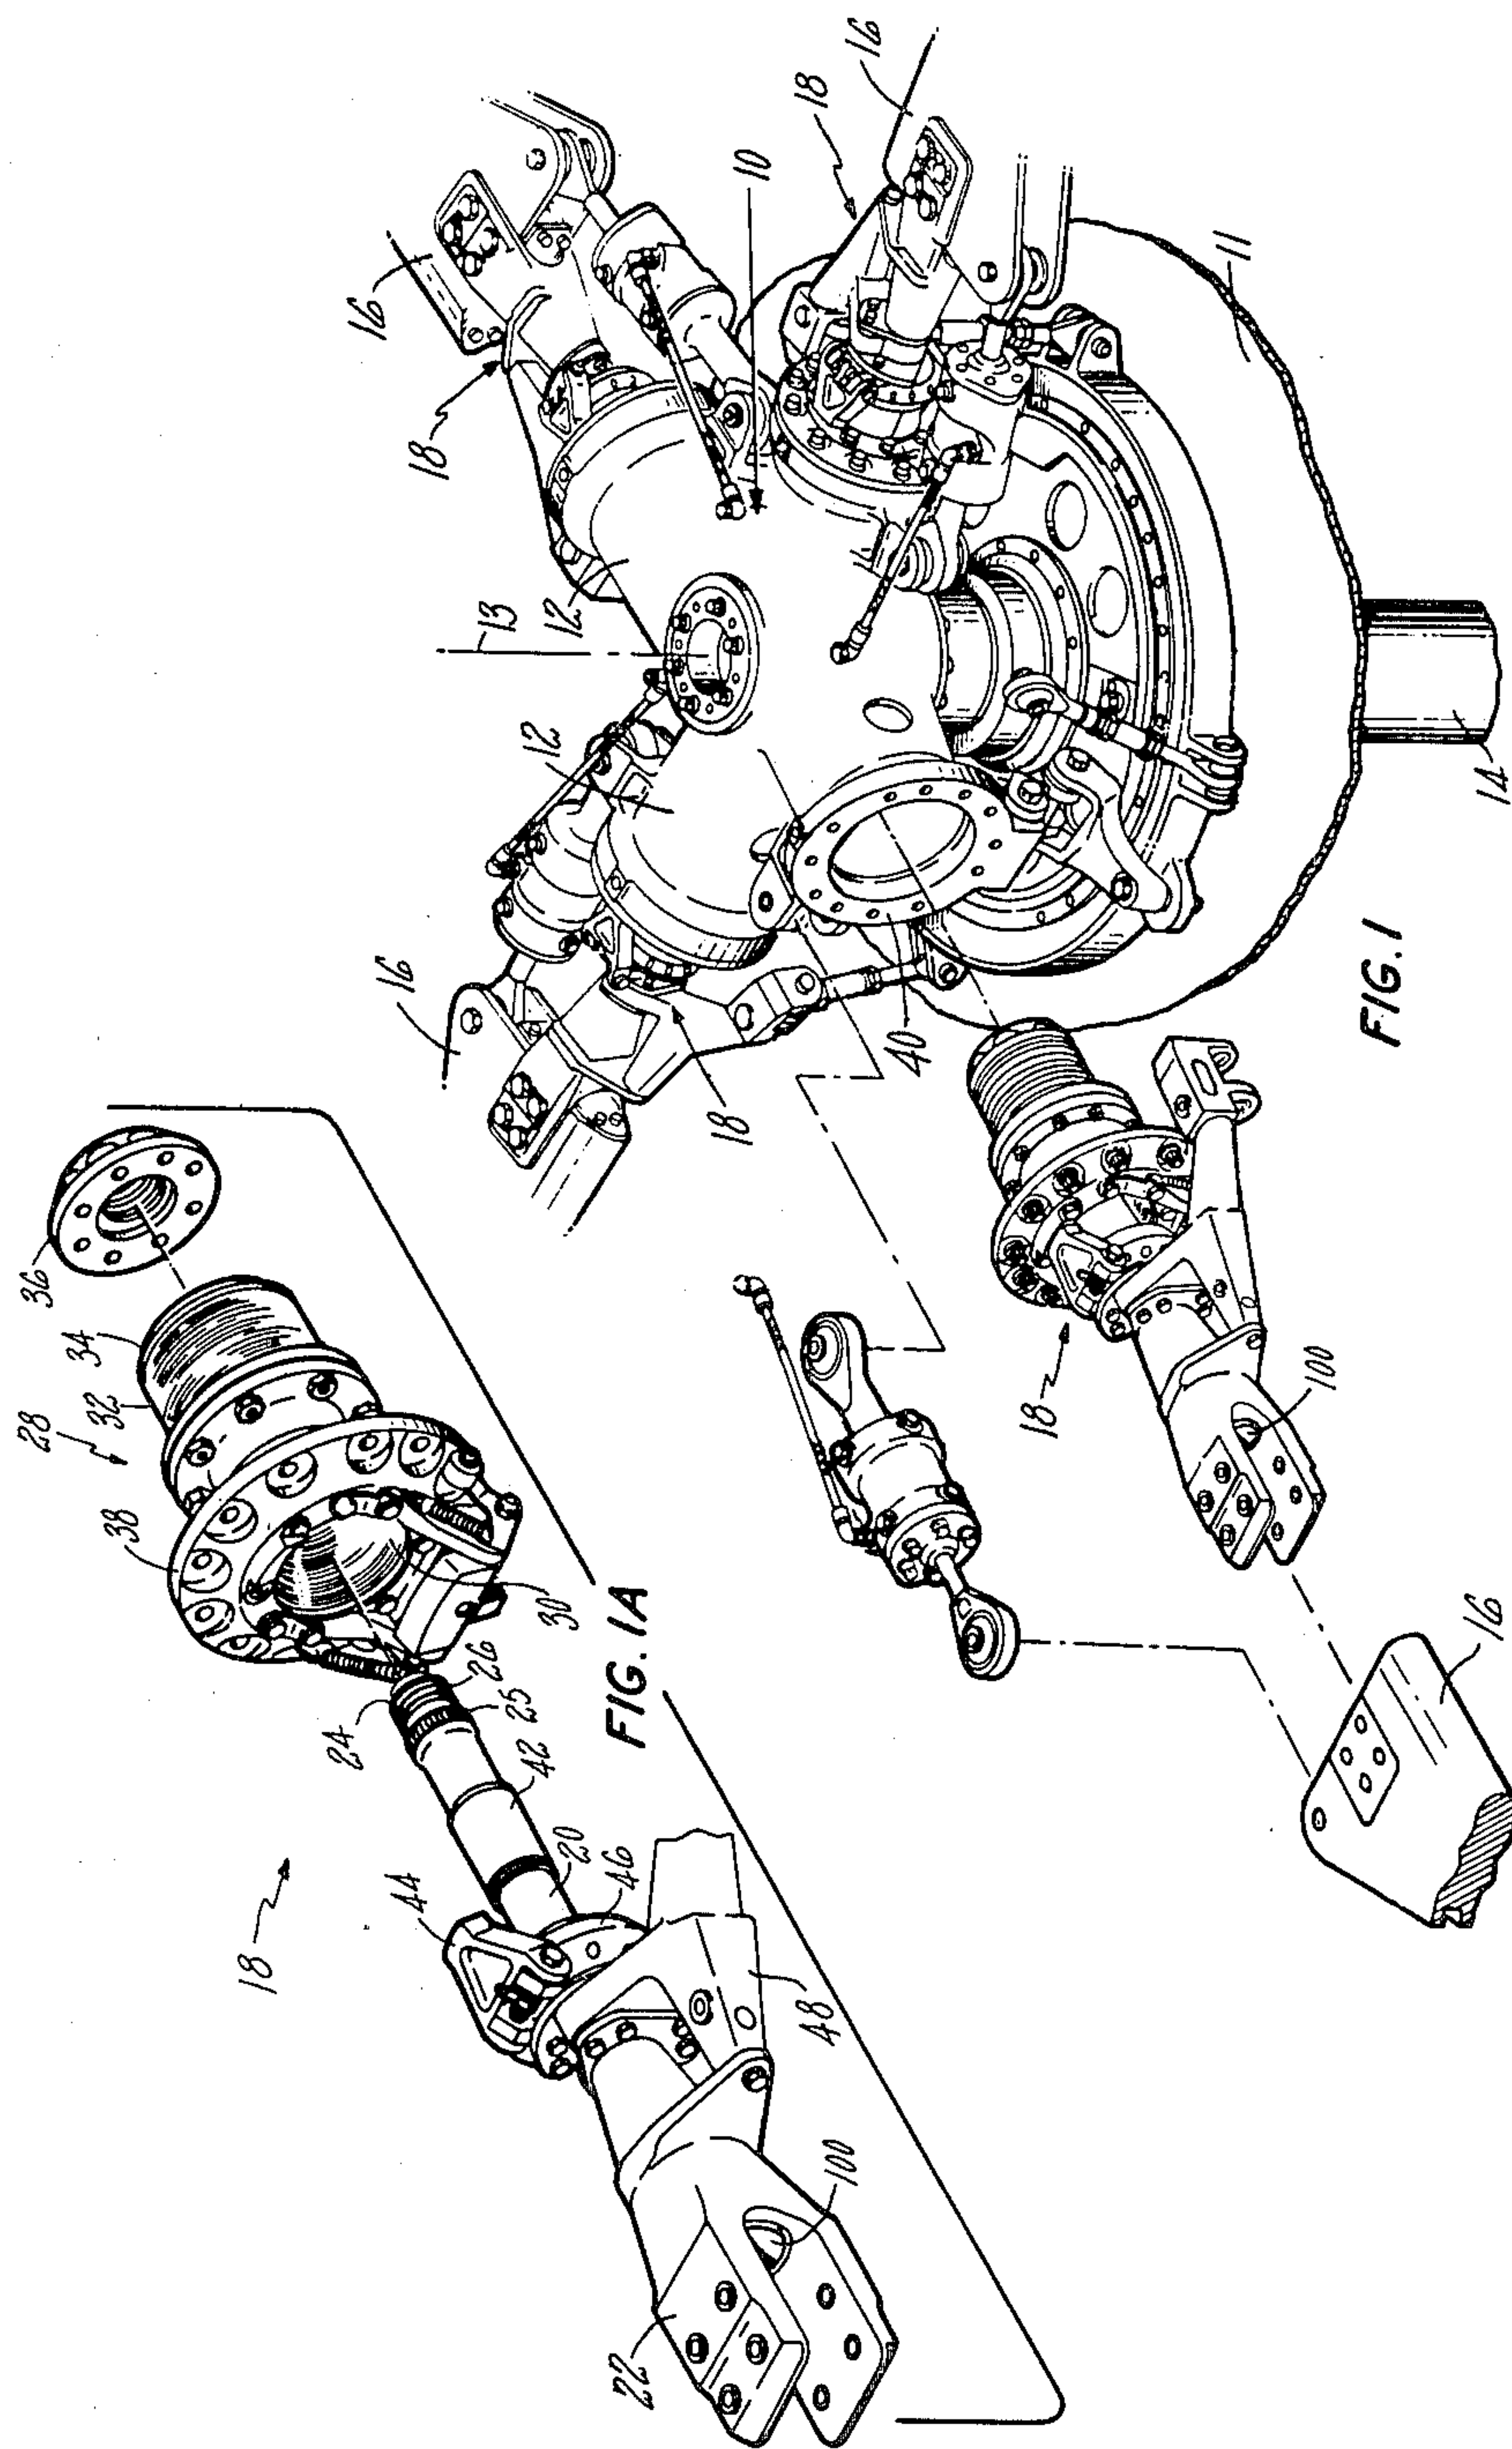
FIG. 2 illustrates both the redundant means added to the spindle assembly as an improvement to the configuration illustrated in the '708 patent together with the integrity monitoring means associated therewith that provides knowledge to the operator or service personnel that damage has occurred to the spindle assembly, and the normal load path has been diverted to a backup path. Spindle replacement can then be scheduled. Still referring to FIG. 2, we can realize that the primary load

path of the reaction to blade centrifugal force travels inboard the length of spindle 20 to its innermost end 24 at thread 26. Tension loading in spindle 20 translates to compression loading in the bearing array 28 as the load reverses through jam nut 36. Such was the sole load path until the addition herewith of bolt 50, located in the bore 52 of spindle 20, with generous clearance between bolt and bore providing an annulus 53 of several thousandths of an inch that is illustrated in FIG. 4. Bolt head 54 and spherical washer 56 are provided at the inner end 24 of spindle 20, while spacer 58, nut 60, nut lock 62, and nut lock ring 64 are provided at the opposite end. A pre-load may be provided to bolt 50 prior to installation of the spindle assembly into the hub arm 12. Under centrifugal operating loads imposed on the spindle 20, shoulder 66 will bear against spacer 58 and impose a tension load into bolt 50. This tension load will be reversed at the bolt head 54 so as to create a compression load path through bushing 56, spindle end 24, and nut 36 into the bearing array 28. The spherical shape of the washer 56 aids in centering the bolt 50 so as to provide tensile loading only across its cross section. Thus, the bolt 50 creates a secondary load path that may either share the total load or be held in reserve until failure of a member in the primary load path. When a pre-load is applied to the bolt, the degree of load sharing between the two load paths will be a function of the amount of pre-load. A failure of the spindle in its cross section, such as a crack which would open to an enlarged condition under centrifugal force, would render the spindle incapable of continued tensile loading. Upon such failure, the bolt 50 will become the primary load path. The spindle will be relieved of loading for its length inboard of the shoulder 66.

The difficulty of periodically inspecting the entire length of the spindle 20 to learn of its possible failed condition is tedious because over half of the spindle is hidden from external view by the bearing array 28 and hub arm 12. Thus, we have devised a dual spindle inspection system to monitor the integrity of the component and provide a readily detectable and visual indication of either partial or full spindle malfunction. The bore 52 of the spindle 20 is sealed to form a closed vessel by means of stationary O-ring type seals 70 and 72 at its opposite ends acting in conjunction with the outer diameter of the bolt 50. A suitable low viscosity dye is introduced into the annular space 53 defined by the internal bore 52 of the spindle 20, bolt 50, and seals 70 and 72. The dye will flow through any small crack of the spindle to the outer surface and when colored or fluorescent will appear as a prominent stain on the external surface. The use of dye for detection of cracks and potential failure in components is known, and one reference to aircraft usage is the development of the "bleeding bolt" at British Aerospace Dynamics for structural applications.

To provide positive assurance that the dye or penetrant fluid used will flow through any crack in the spindle 20 and to further provide a second means for indication redundancy, the chamber containing the dye is pressurized. Pressurization will preempt the need for temperature compensation and allow system reliability while using a small amount of dye or small chamber for dye storage. A mechanical spring container in the form of a bellows 80 acts in conjunction with the spindle bore 52 to both contain dye and to provide pressurization to urge the dye through any small crack extending through the wall of the spindle 20. Since the bolt 50
