[54] **TIRE REPAIR CONSTRUCTION AND METHOD**

A repair construction and method are disclosed for repairing a damaged portion in the wall of a tire. A patch is installed over the damaged portion on the inside of the tire, and the inside of the tire is pressurized to force the patch into the damaged portion, preferably in a concave shape. The remainder of the plug area then is filled on the outside of the patch with a suitable plug material, and the plug material and patch are then cured while the patch is maintained in position at least partially within the damaged portion. This construction and repair method eliminates bulging on the exterior of the tire after the repair is completed.

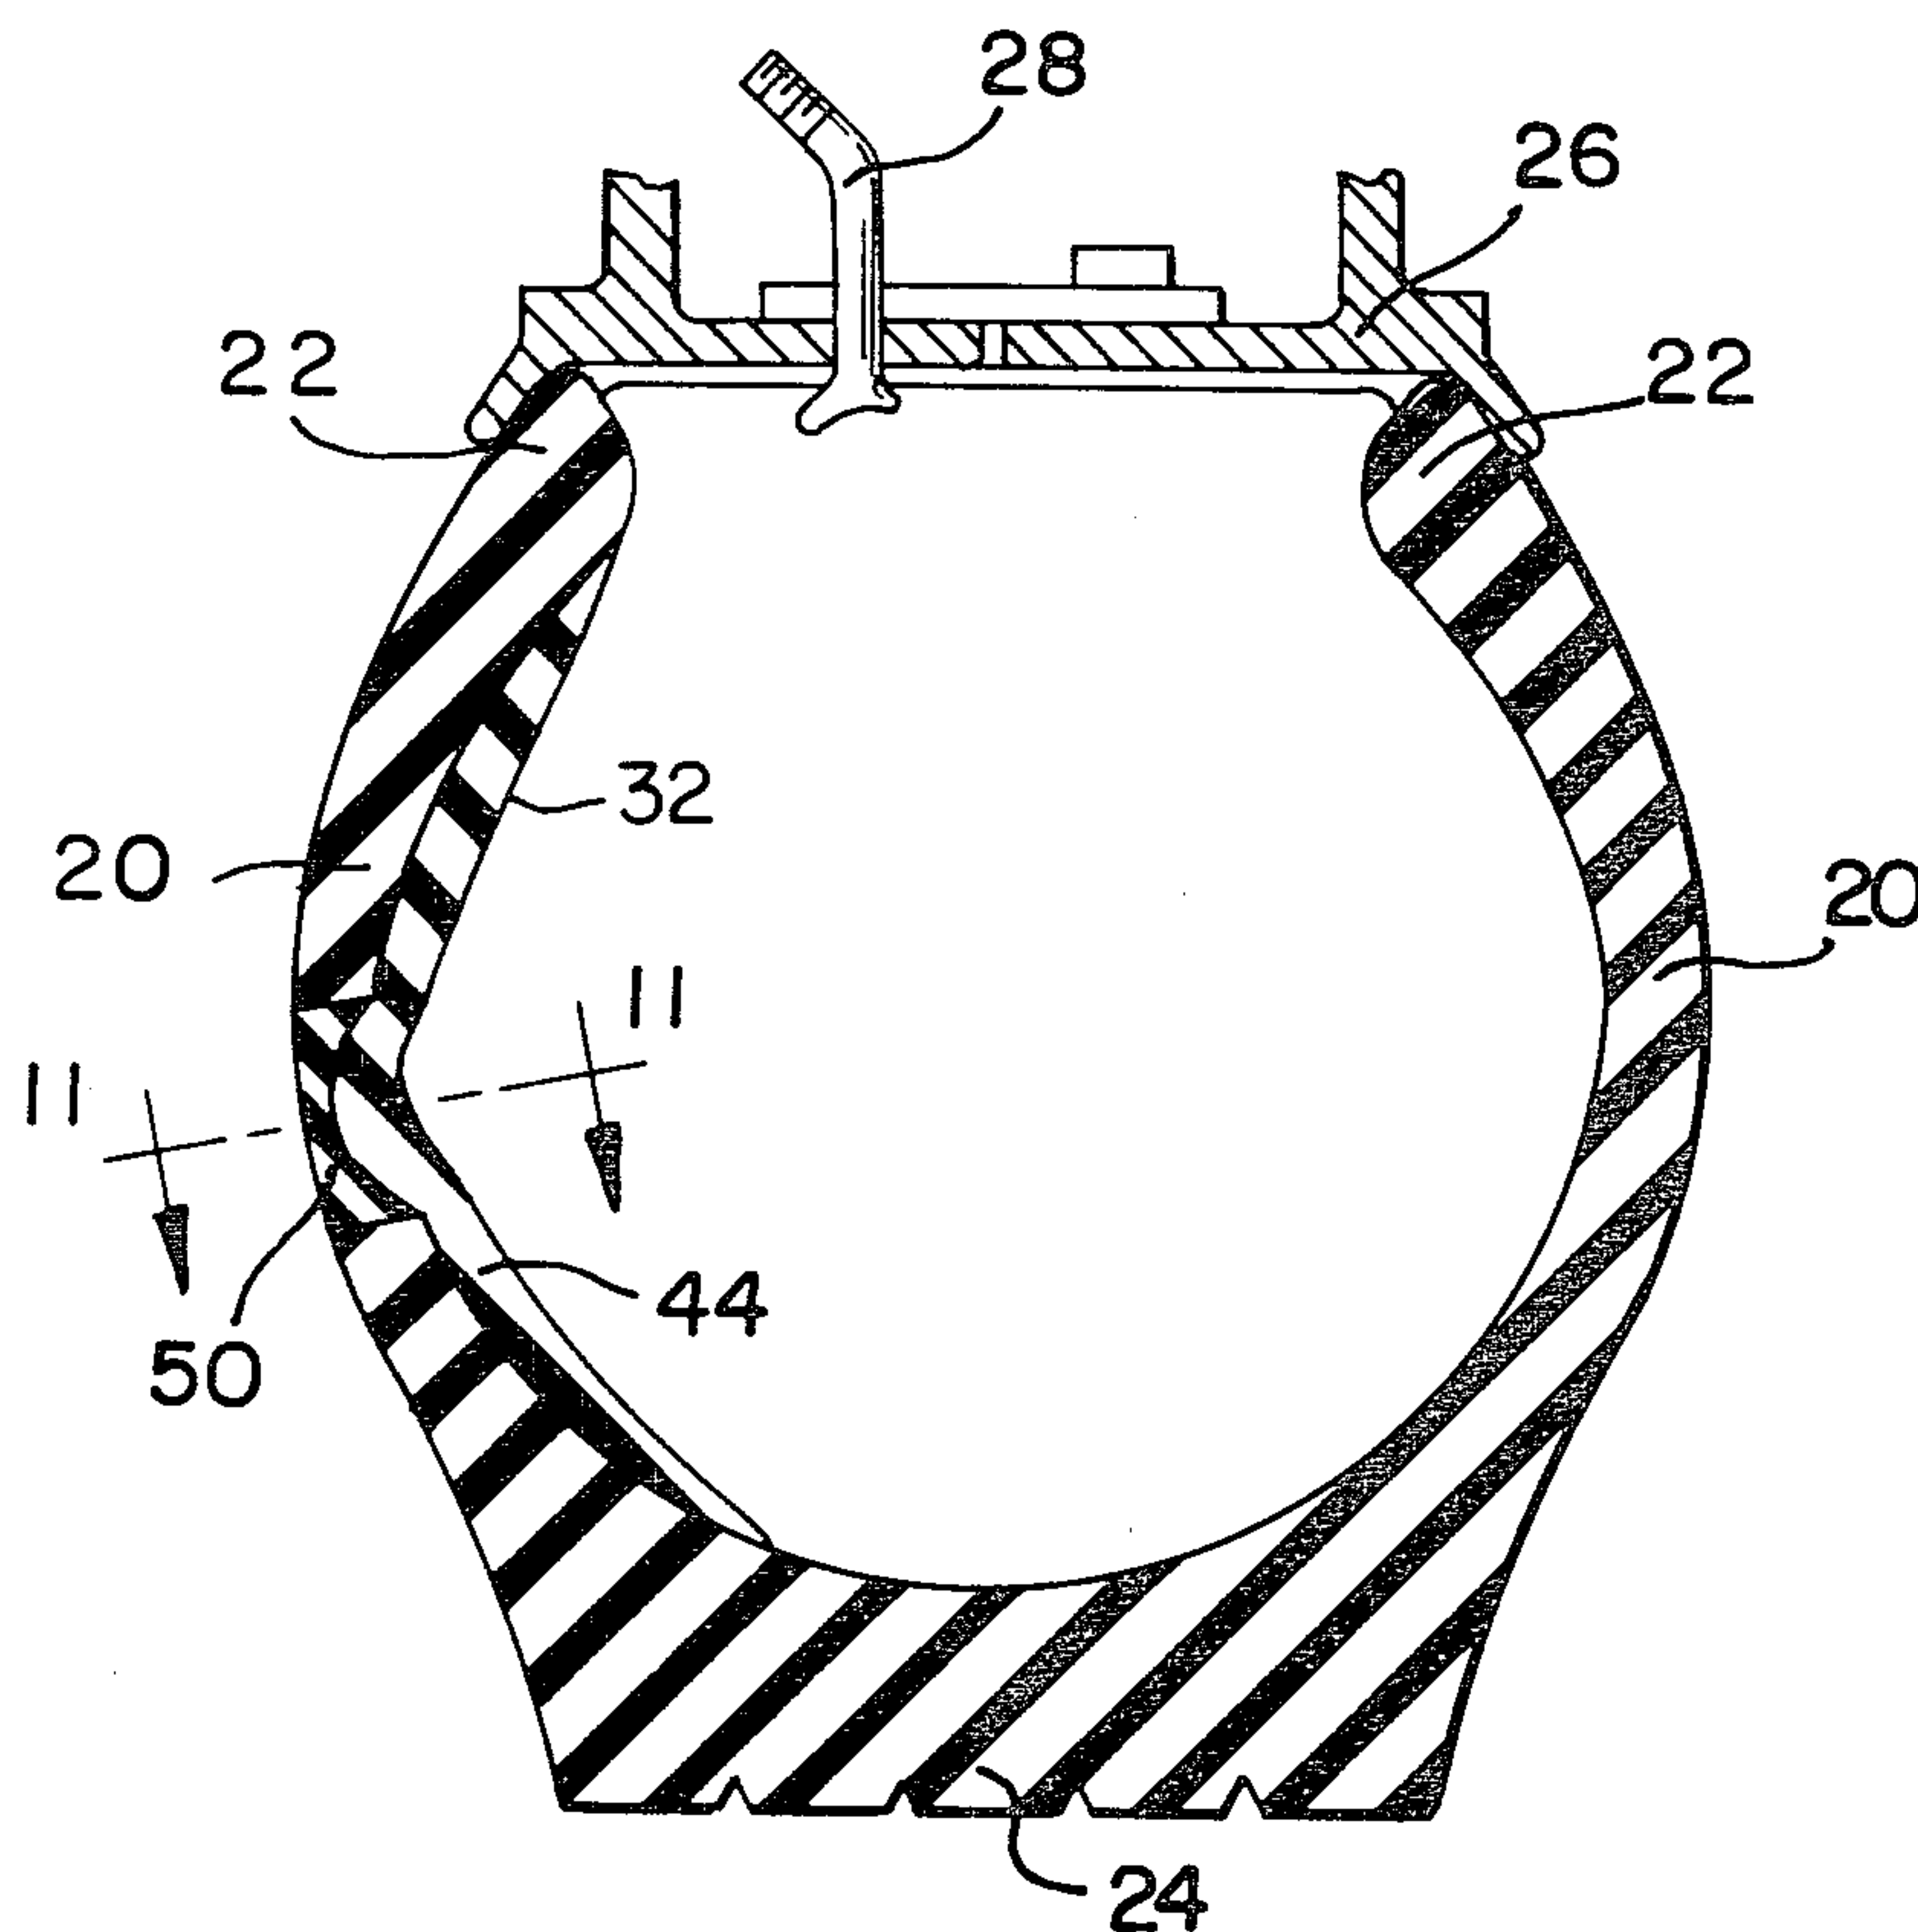
FIG. 1
PRIOR ART

FIG. 1 is a sectional view radially through a tire having a sidewall repair construction in accordance with the prior art;

By way of comparison, FIGS. 1 and 2 show respective tires repaired in accordance with the prior art (FIG. 1) and the present invention (FIG. 2). Each tire includes sidewalls 20 extending between beads 22 and a tread portion 24 of the tire. Through beads 22, the tire is mounted on a rim 26, and an air valve stem 28 extends through the rim for inflating the tire. Referring particularly to FIGS. 1 and 3, a conventional prior art method of repairing damaged areas in the walls of tires first will be described. FIG. 3 shows tire wall 20 with a section of the wall, including the damaged portion, cut out to form a plug area 30. This is a common procedure normally referred to as "skiving" the tire injury. A patch 32 is placed over the plug area on the inside of the tire, and the remainder of the plug area is filled with a plug material 34. The patch cord 32' runs generally parallel to the tire cord 20'. The plug material and patch are then cured to complete the repair construction except for final dressing. To better understand this conventional construction and repair method, it should be noted that the patch is installed on the inside of the tire over the plug area and the plug material is applied to the plug area with the tire in an uninflated condition. As a consequence the patch is positioned either flat across the plug area or possibly with an inward or convex bulge as shown by full lines in FIG. 3. Under the influence of internal tire pressure P, patch 32 assumes a bulge condition generally as shown by the dotted lines 40. The bulge condition is also shown in FIG. 1. By comparison, a typical patch construction in accordance with the present invention is shown at the same location on a tire sidewall in FIG. 2, with no resulting outward bulge even when the internal tire pressure reaches approximately 100 p.s.i., i.e. similar to road running conditions.
