[54] TIRE REPAIR CONSTRUCTION AND METHOD

[57] ABSTRACT

This invention relates to a repair construction and a method of repairing a damaged portion in the wall of a tire, particularly the sidewall of a radial tire.

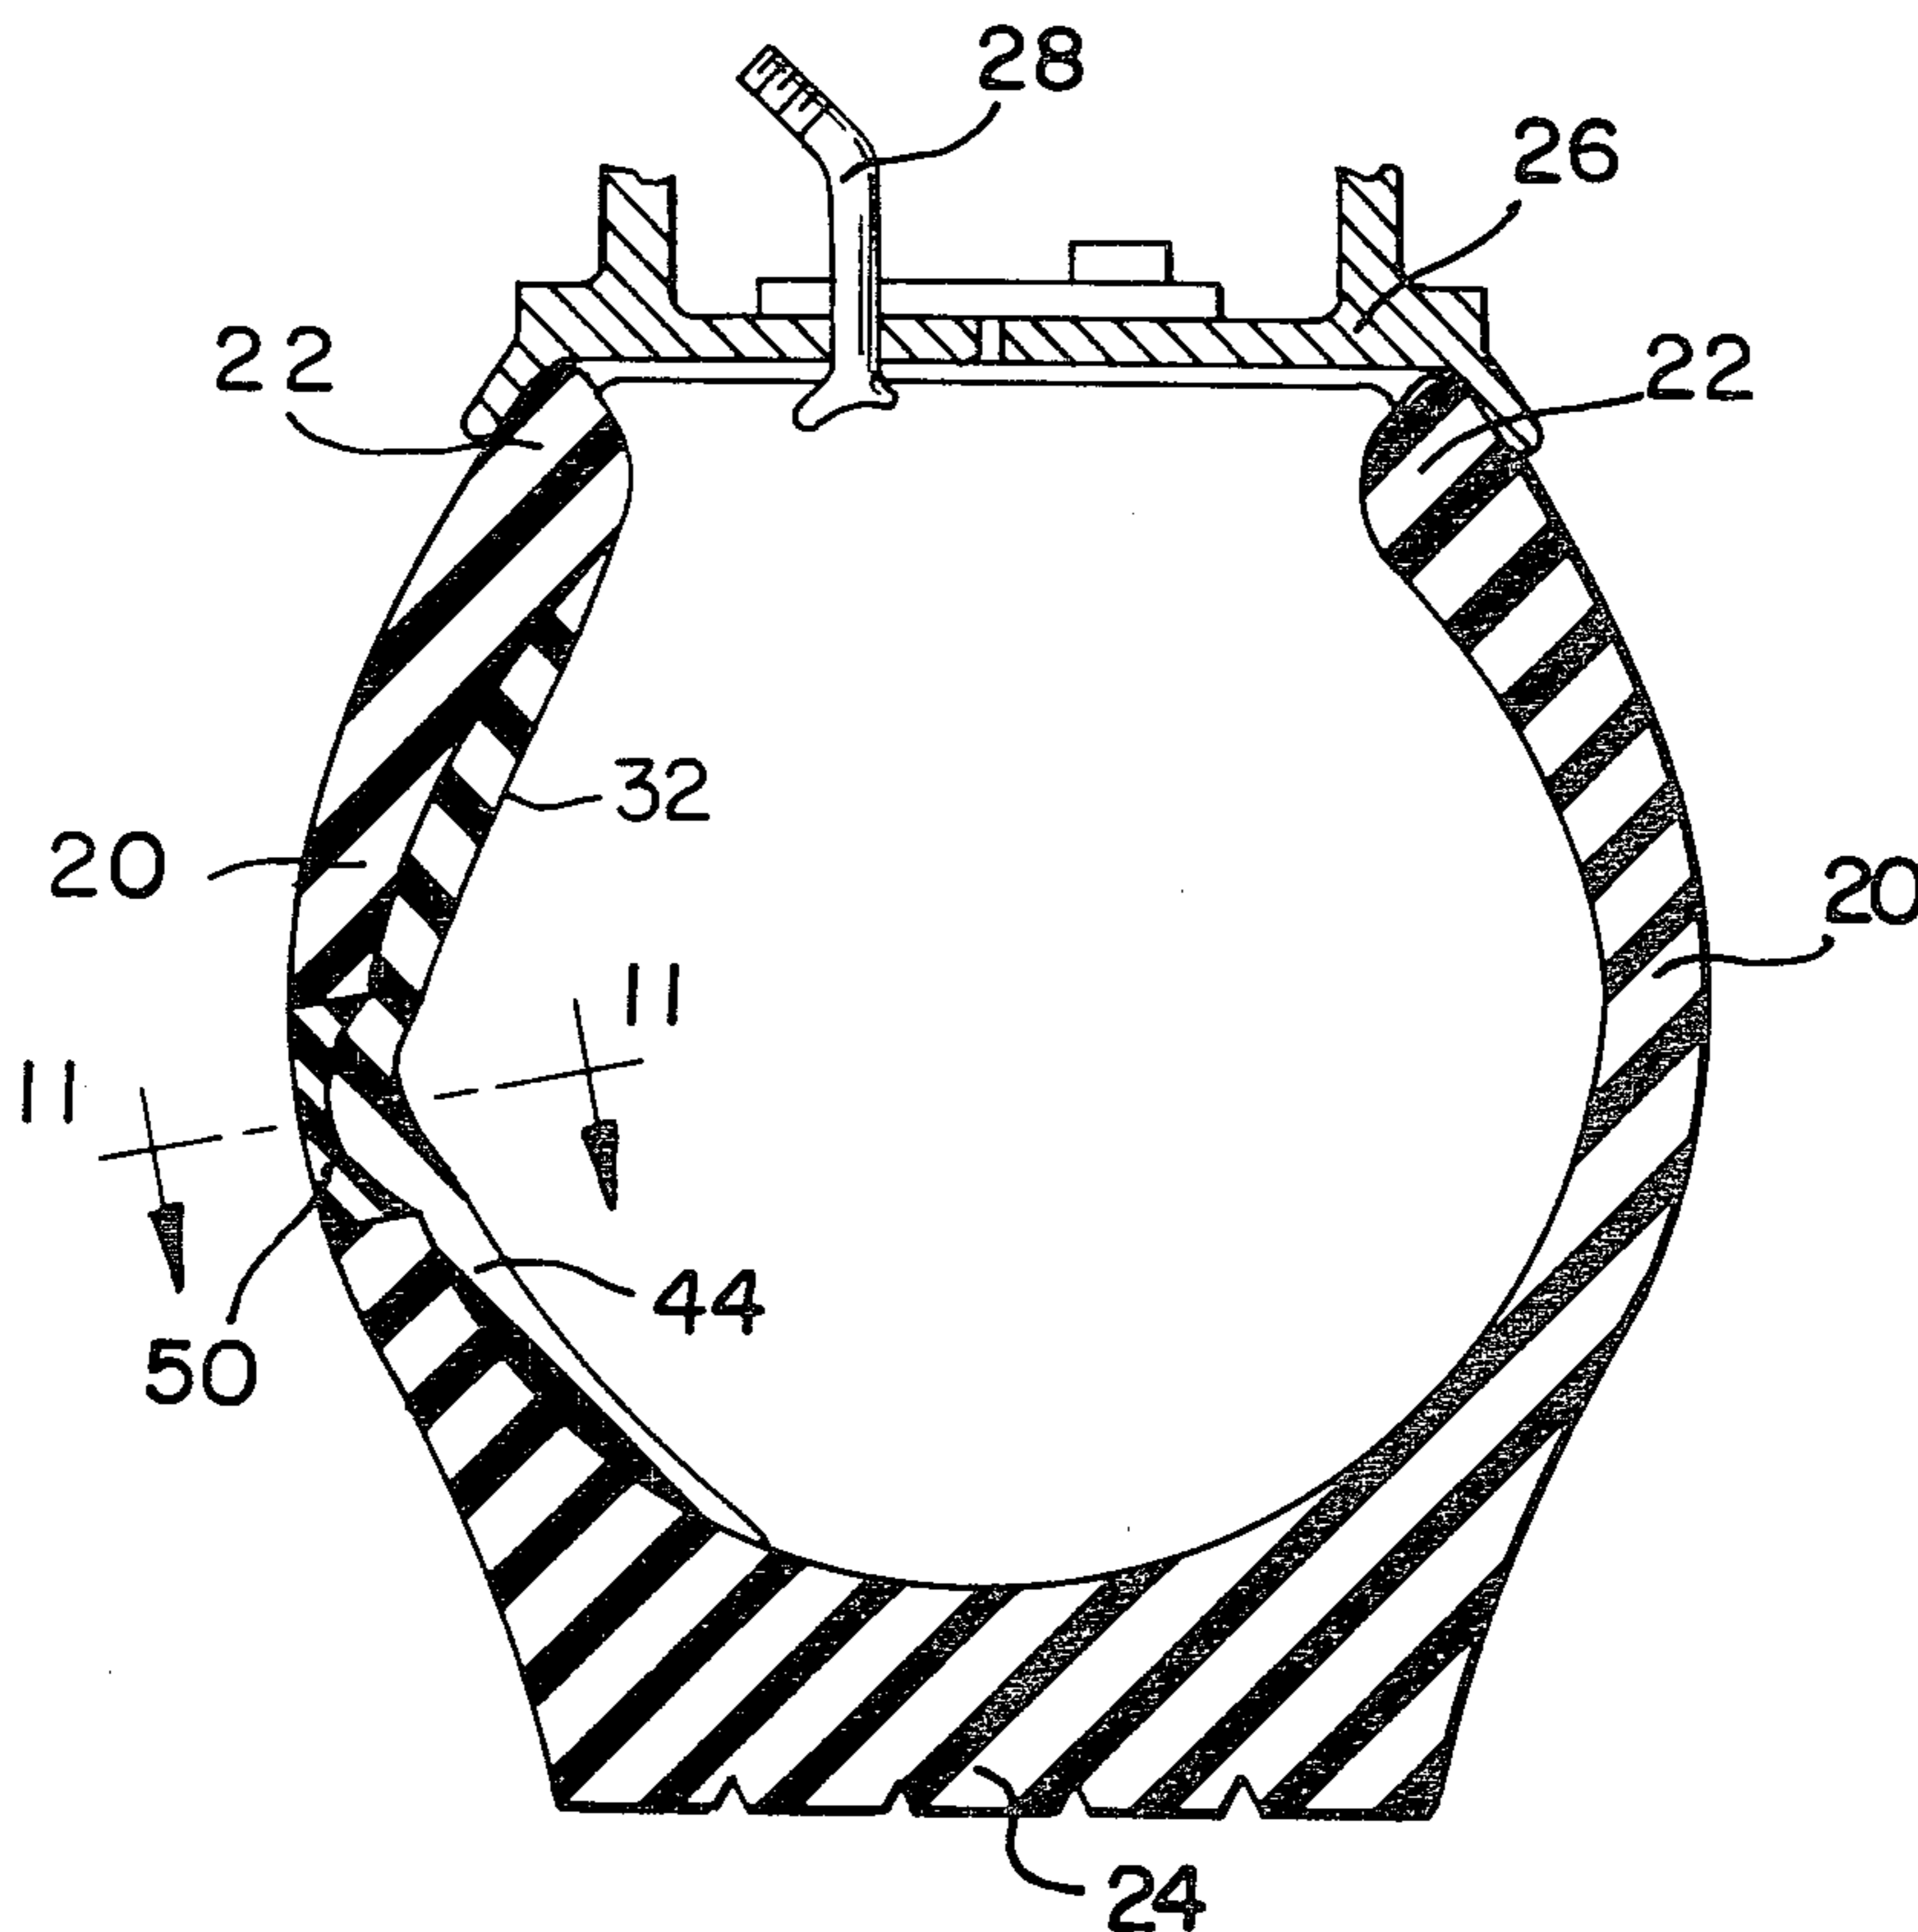
FIG. 1
PRIOR ART

FIG. 1 is a sectional view radially through a tire having a sidewall repair construction in accordance with the prior art;

By way of comparison, FIGS. 1 and 2 show respective tires repaired in accordance with the prior art (FIG. 1) and the present invention (FIG. 2). Each tire includes sidewalls 20 extending between beads 22 and a tread portion 24 of the tire. Through beads 22, the tire is mounted on a rim 26, and an air valve stem 28 extends through the rim for inflating the tire. Referring particularly to FIGS. 1 and 3, a conventional prior art method of repairing damaged areas in the walls of tires first will be described. FIG. 3 shows tire wall 20 with a section of the wall, including the damaged portion, cut out to form a plug area 30. This is a common procedure normally referred to as "skiving" the tire injury. A patch 32 is placed over the plug area on the inside of the tire, and the remainder of the plug area is filled with a plug material 34. The patch cord 32' runs generally parallel to the tire cord 20'. The plug material and patch are then cured to complete the repair construction except for final dressing. To better understand this conventional construction and repair method, it should be noted that the patch is installed on the inside of the tire over the plug area and the plug material is applied to the plug area with the tire in an uninflated condition. As a consequence the patch is positioned either flat across the plug area or possibly with an inward or convex bulge as shown by full lines in FIG. 3. Under the influence of internal tire pressure P, patch 32 assumes a bulge condition generally as shown by the dotted lines 40. The bulge condition is also shown in FIG. 1. By comparison, a typical patch construction in accordance with the present invention is shown at the same location on a tire sidewall in FIG. 2, with no resulting outward bulge even when the internal tire pressure reaches approximately 100 p.s.i., i.e. similar to road running conditions.

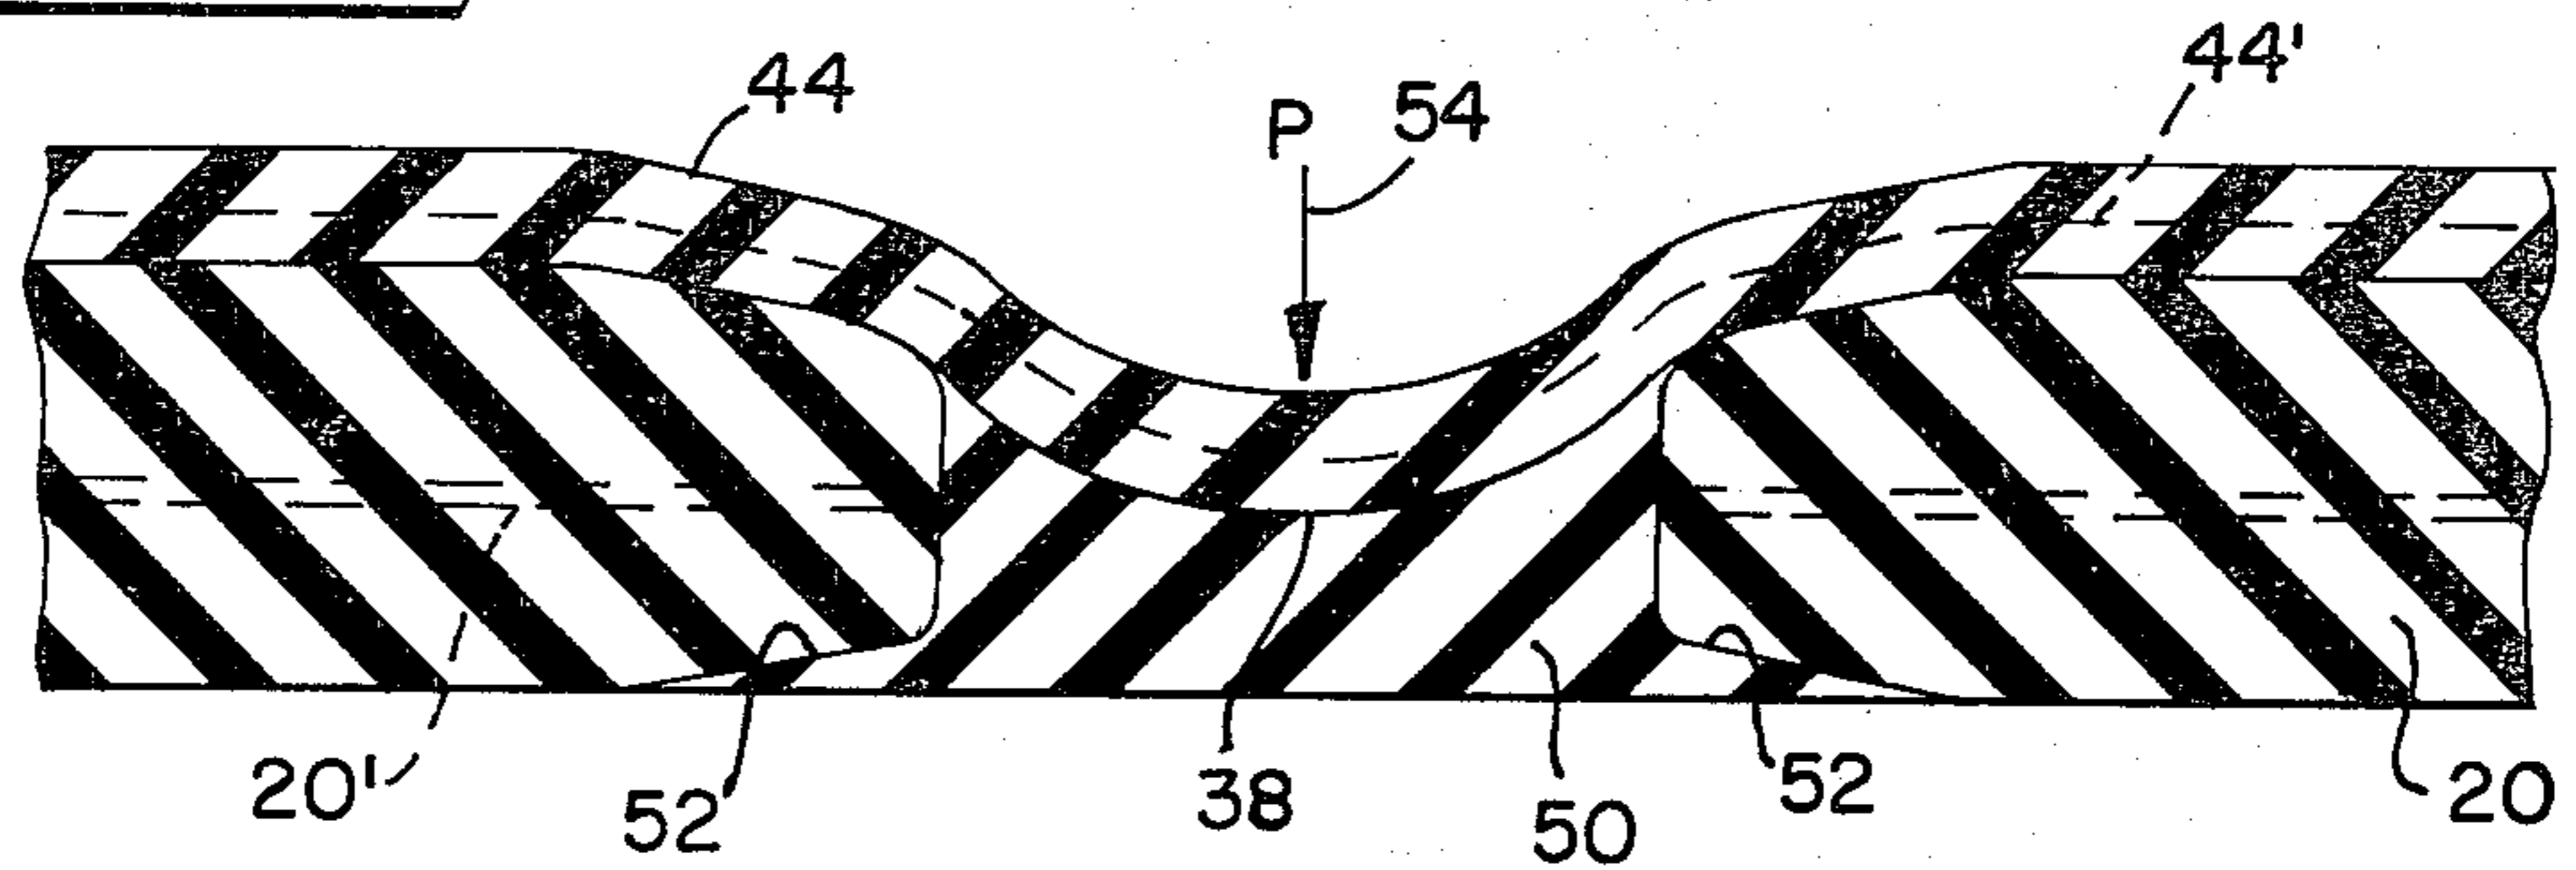
FIG. 7 is an enlarged circumferential sectional view illustrating a completed repair construction after the patch and filler material have been cured in accordance with the present invention, and illustrating the completed repair construction having used an uncured patch material;

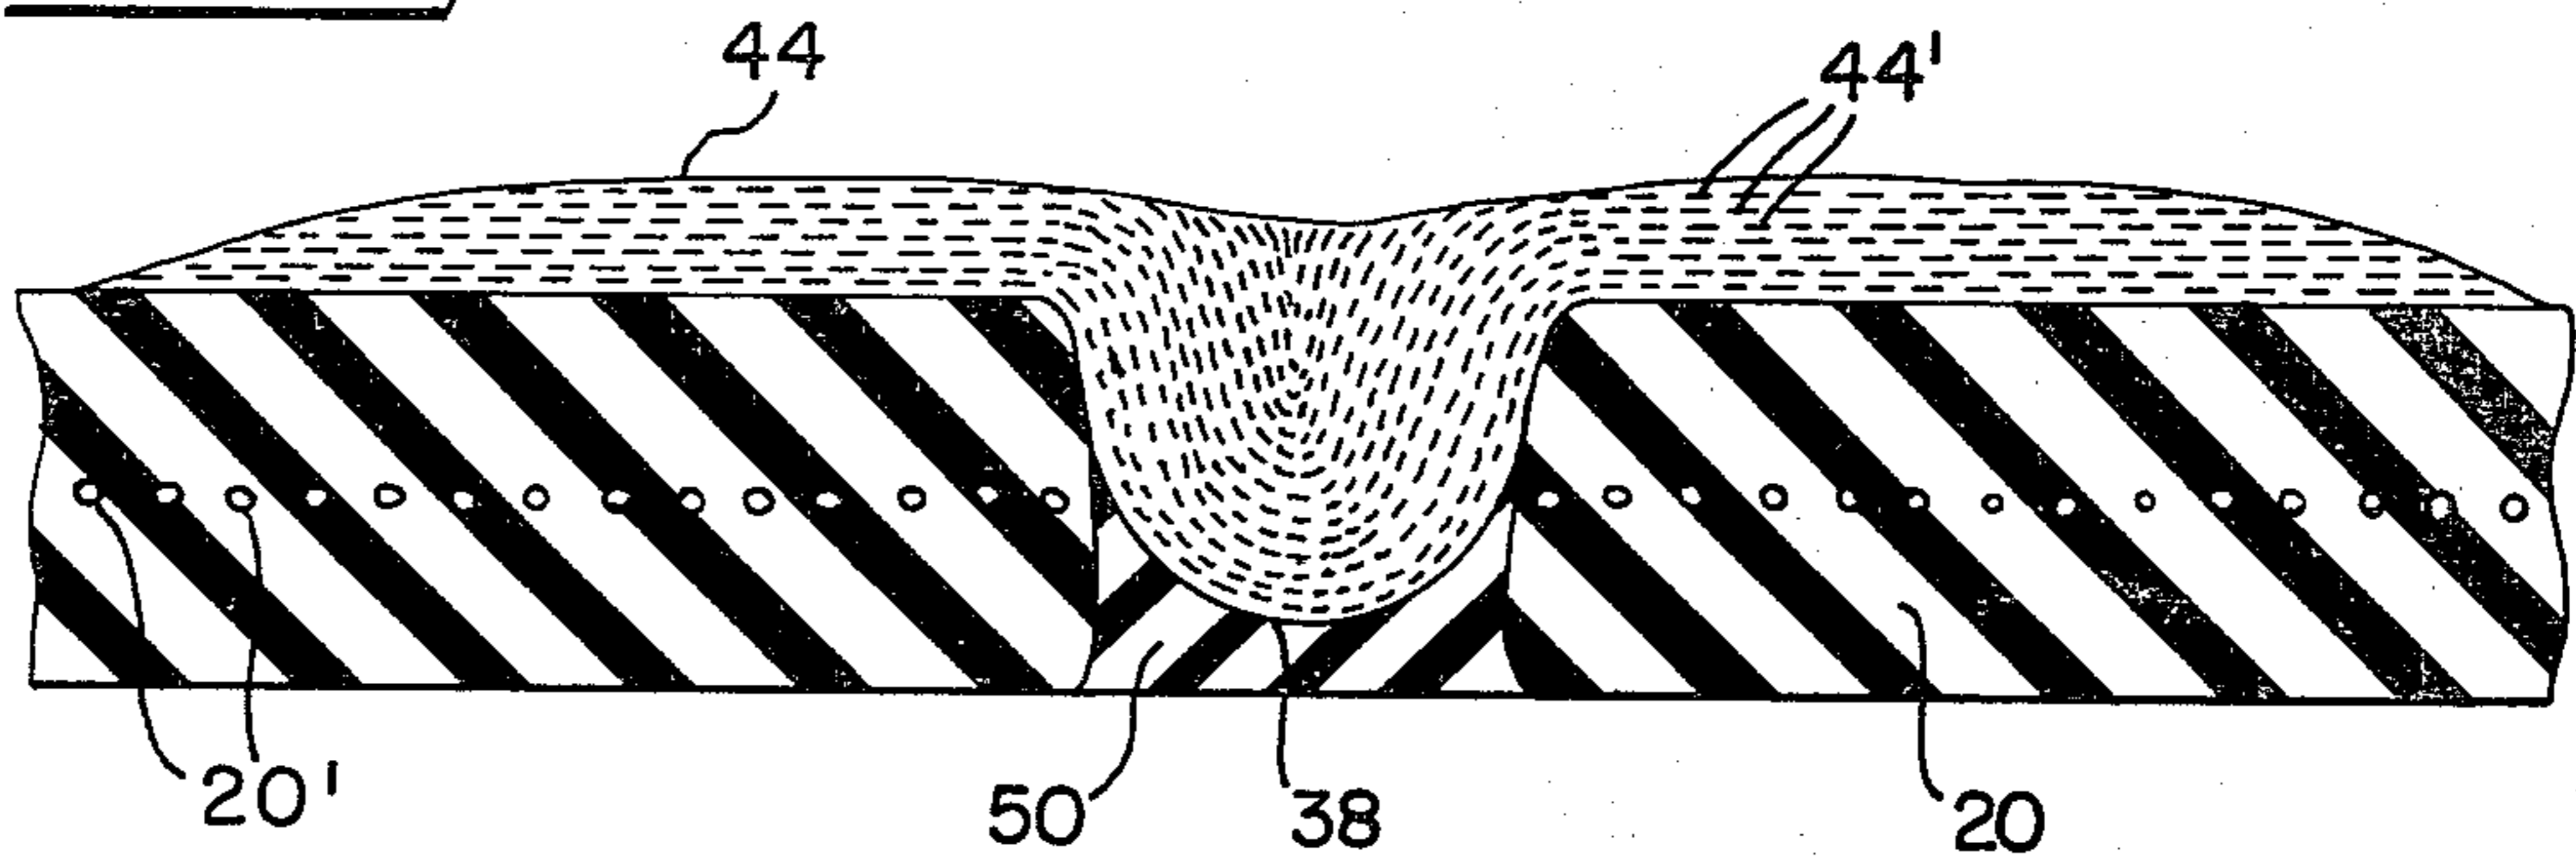
FIG. 8 is a view similar to that of FIG. 7 illustrating the completed repair construction of the present invention having used a cured patch material;
