[54] **RISER REPAIR ASSEMBLY FOR UNDERGROUND IRRIGATION SYSTEMS**

A repair assembly for broken or leaking risers in underground irrigation systems is provided. The repair assembly is adapted to be inserted into a hole through the wall of a buried water distribution line and is held in place by locking tangs engaging the interior surface of the distribution line and by a locking ring flange disposed about the exterior of the assembly and bearing on the exterior wall of the distribution line.

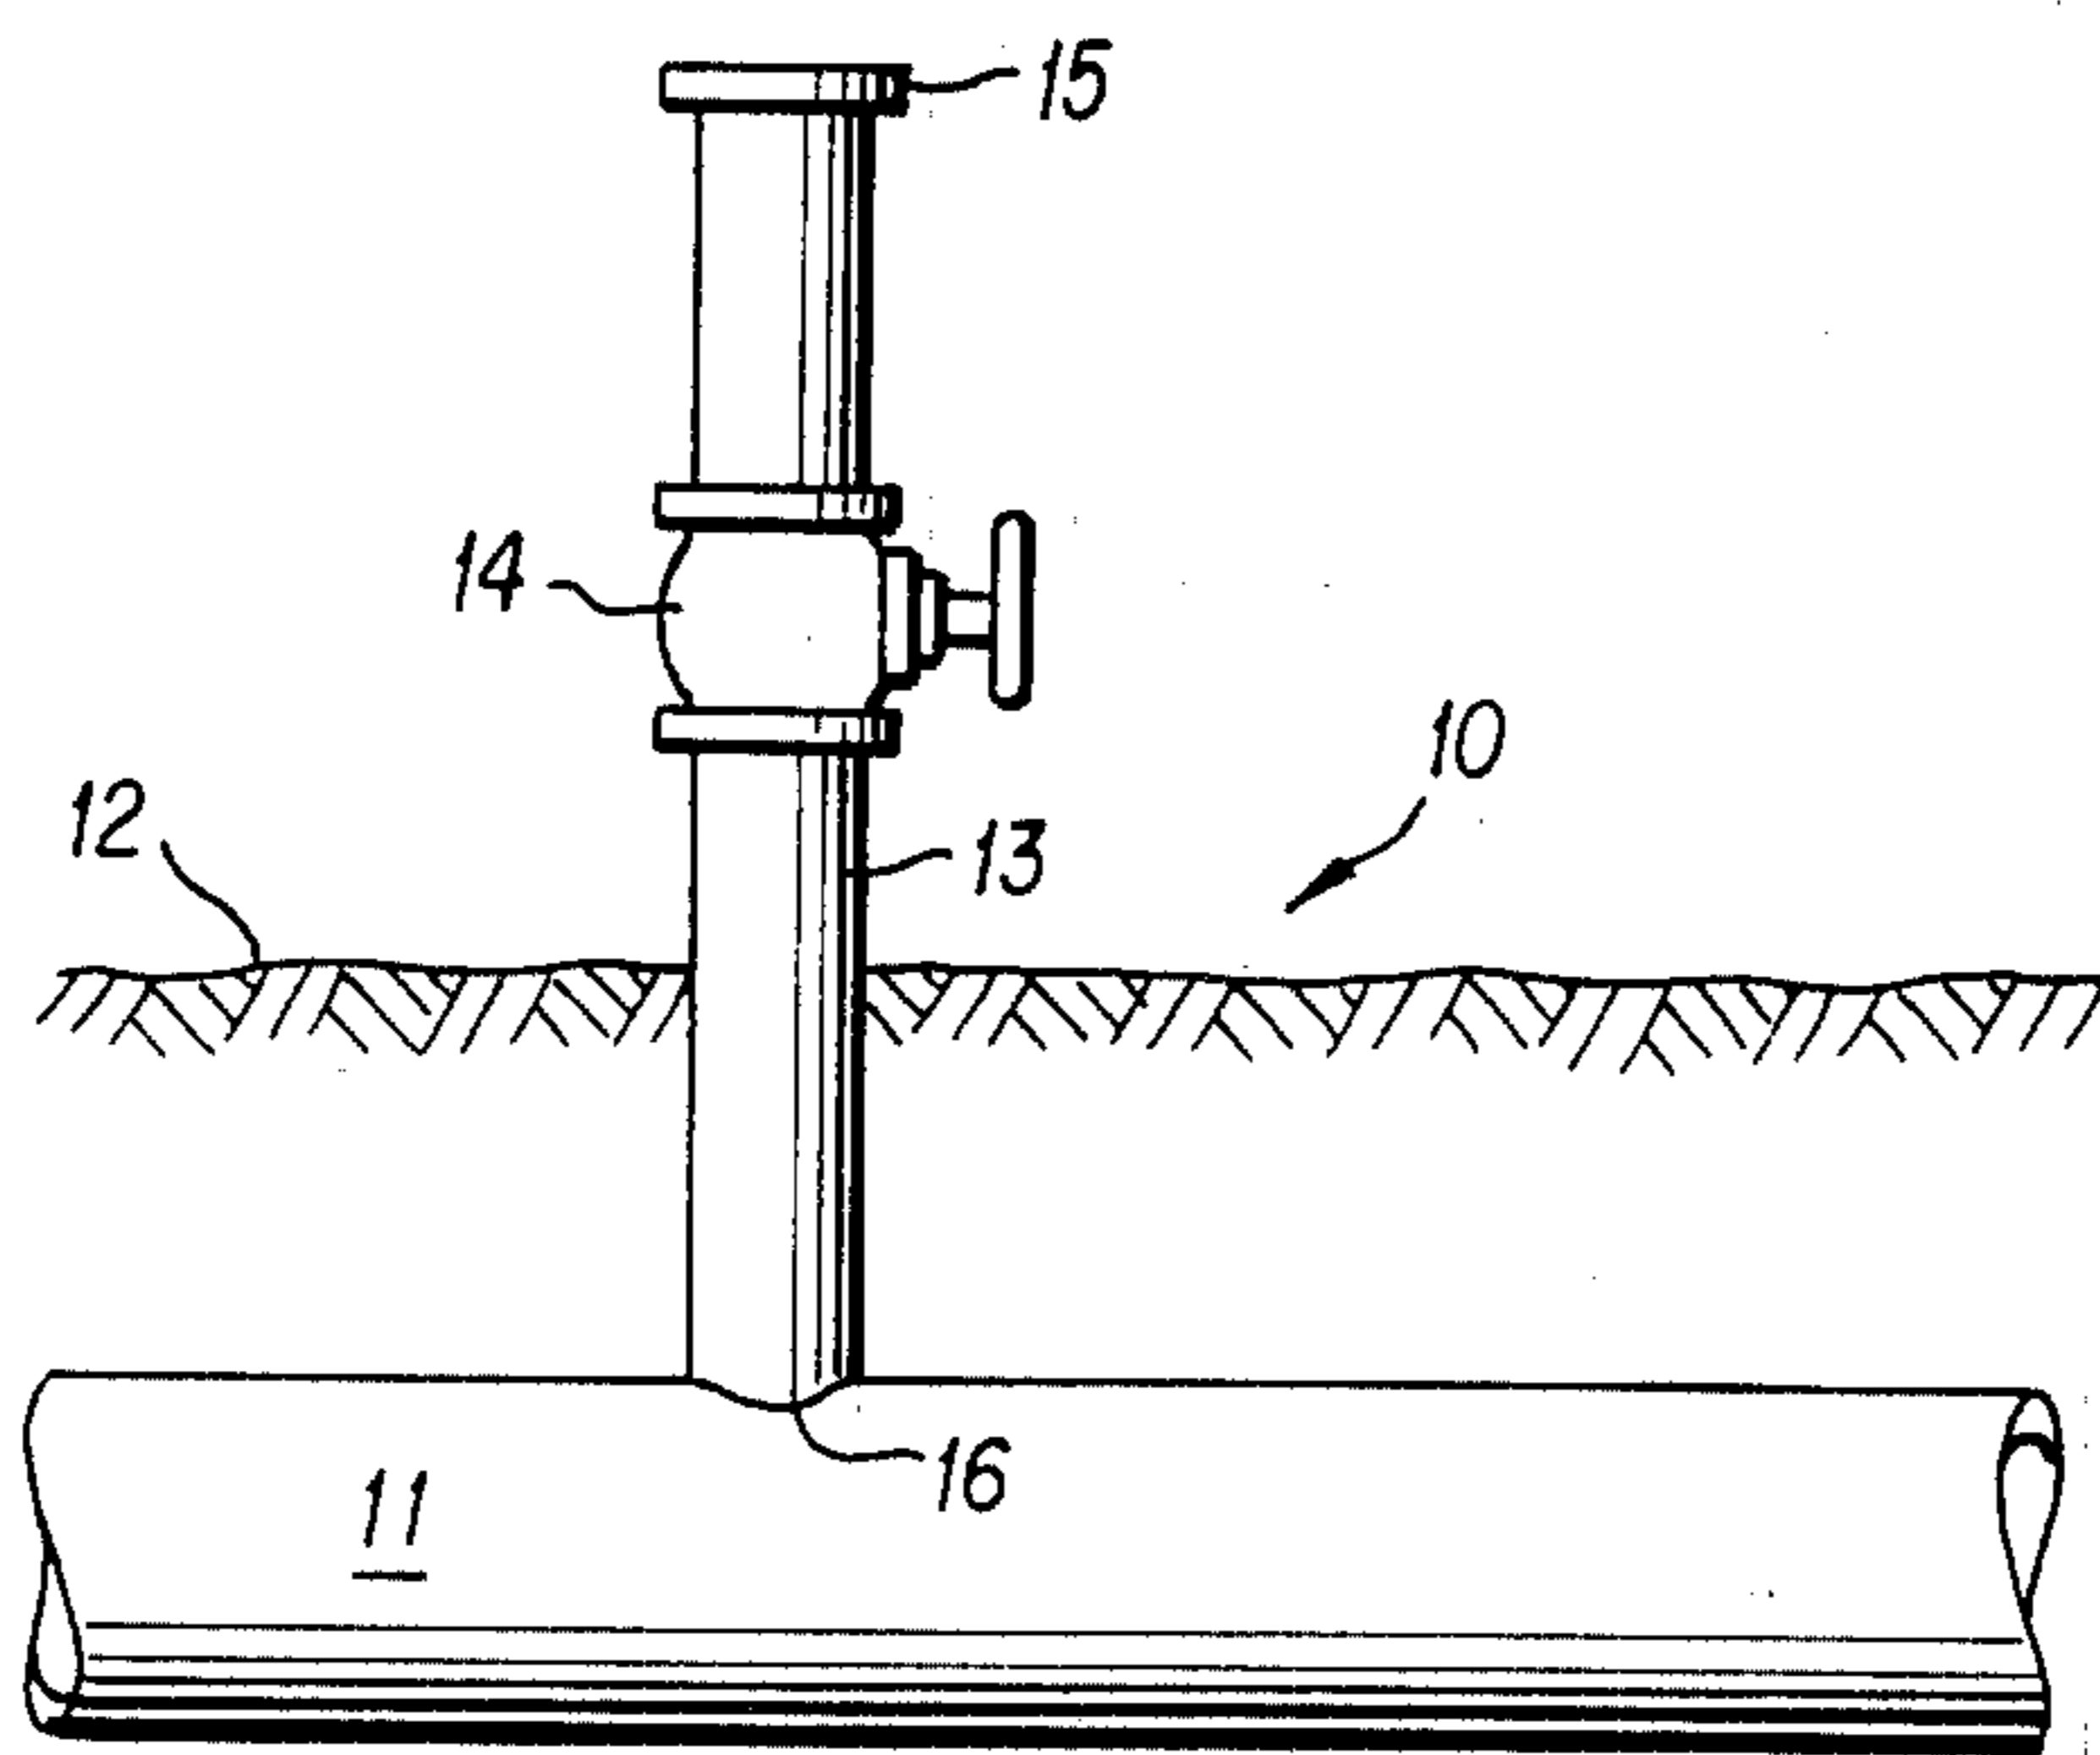
FIG. 1 is a schematic view illustrating a conventional arrangement of a buried irrigation water distribution line and riser;

Referring now to FIG. 1, there is shown at 10 the customary arrangement of an underground irrigation system. A water distribution line 11 is buried below the ground surface 12 at a depth which does not interfere with normal cultivation. Spaced along the distribution line 11 are risers 13 which communicate with the interior of the water mains or laterals. An above-ground valve 14 controls the flow of water through the riser. Riser 13 may terminate in a connection flange or similar means 15 for attachment to a sprinkler system or other conventional water distribution system.

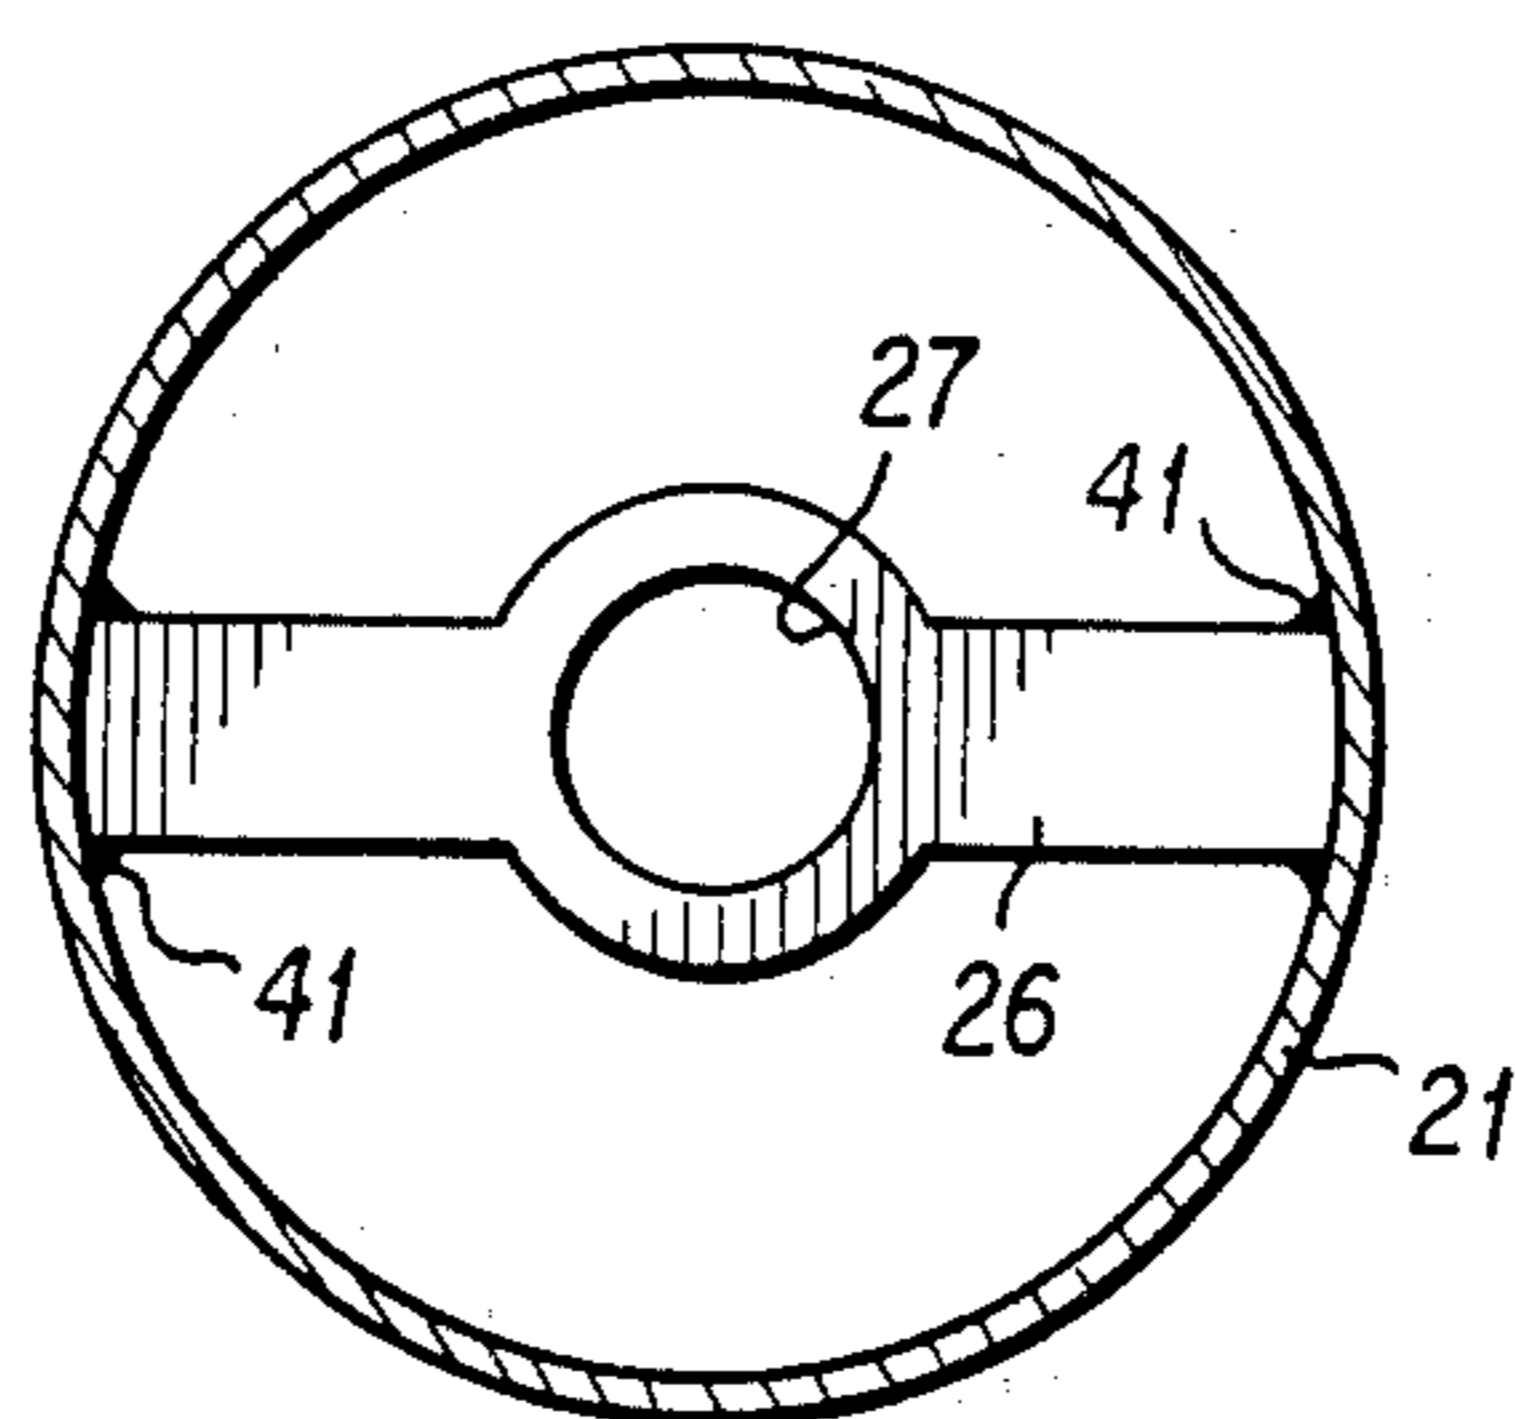
FIG. 4 is a detail view of the cross bar assembly;

Disposed within housing 21 at an upper portion thereof is cross bar 26 shown in a more detailed view in FIG. 4. Cross bar 26 is fixedly attached within housing 21 as by welds 41 securing its ends to the housing interior. A threaded hole 27 is provided in the center of cross bar 26 to accept an upper, matingly threaded, portion of wedge activating rod 28. The lower end of rod 28 rotatably engages wedge bar 29 which is fixedly disposed across the open interior of cylindrical wedge member 30. Wedge member 30 by means of welds 42 comprises a relatively thick walled metal cylinder having an inwardly tapered lower end 31. The external diameter of wedge member 30 is sized just slightly smaller than the internal diameter of housing 21 so as to allow free movement of the wedge relative to the hous-

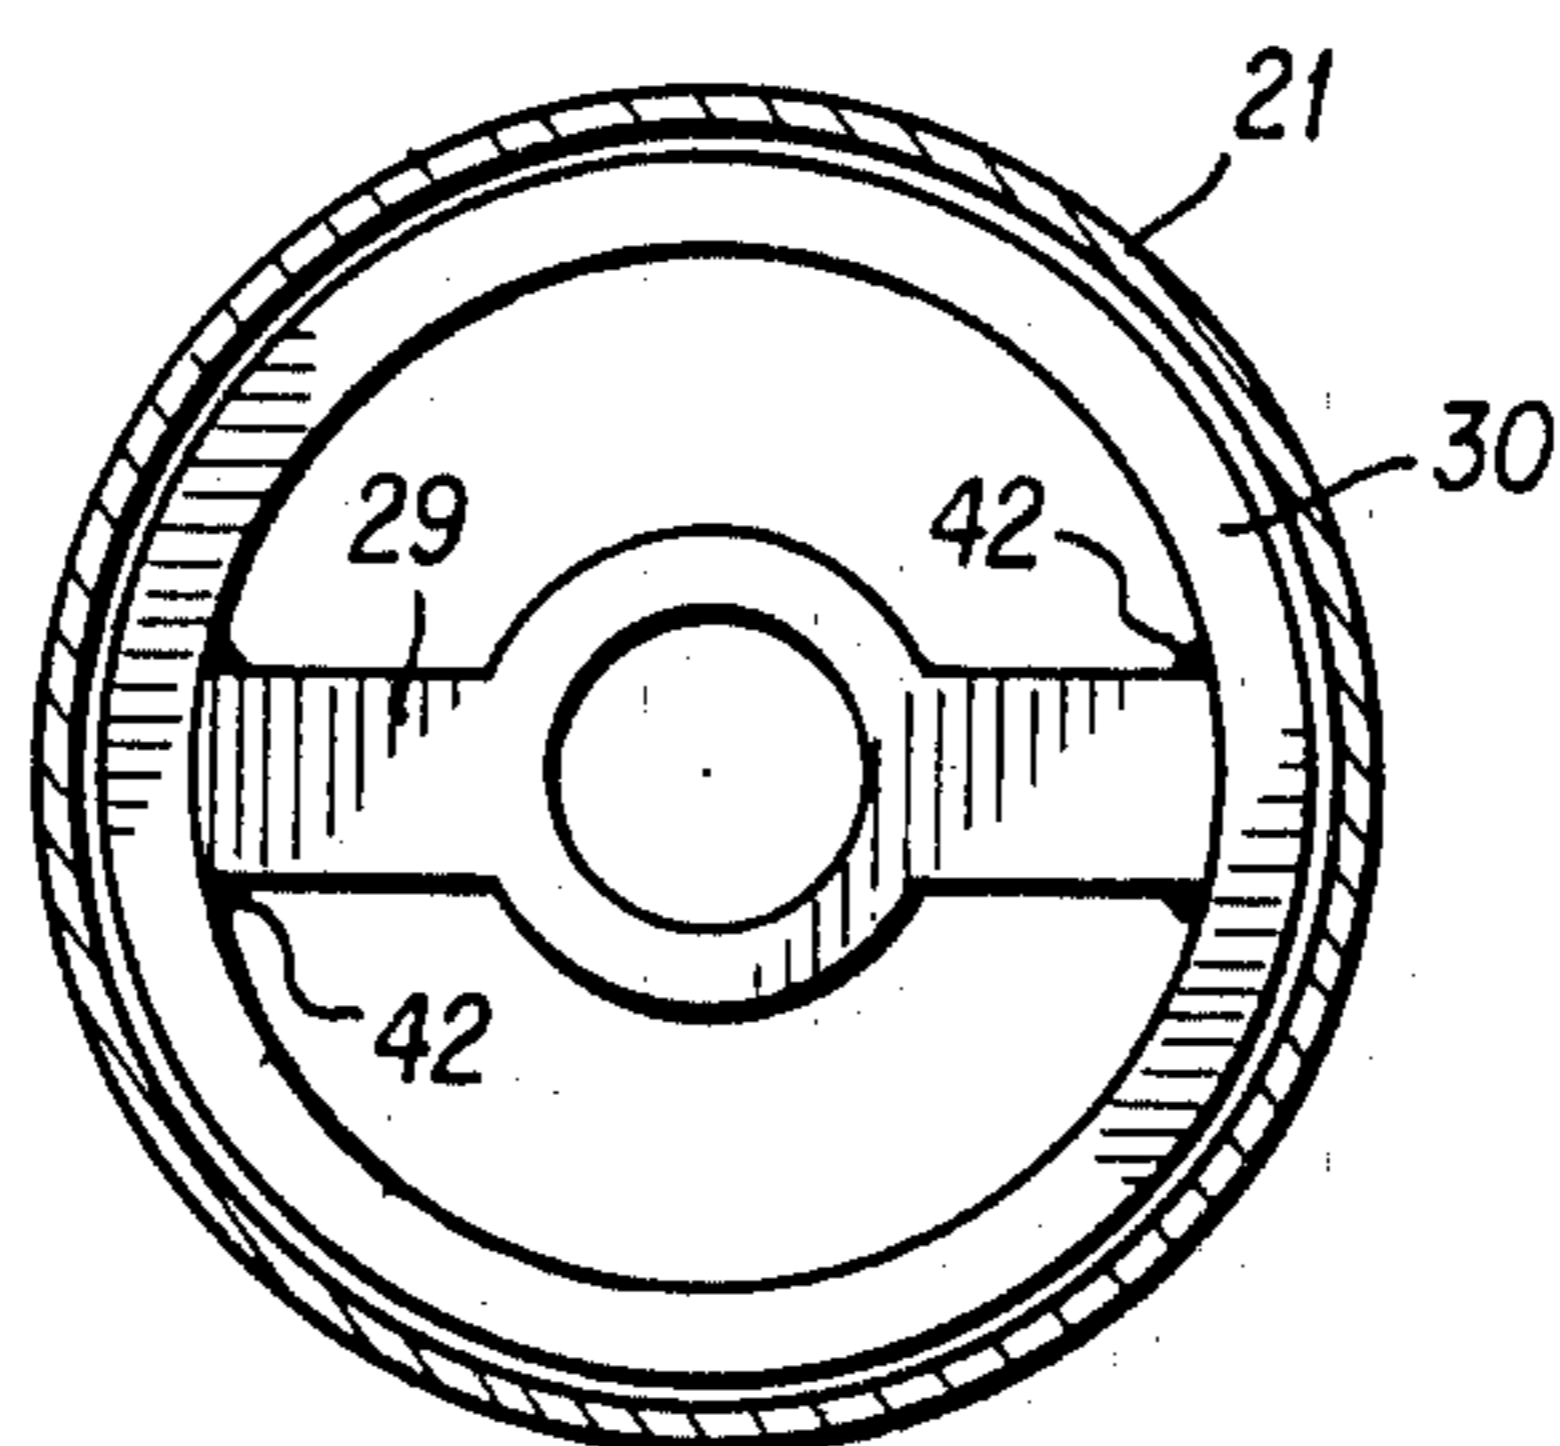
FIG. 5 details the arrangement of the wedge member, wedge bar and housing; and

ing. Rod 28 is fixed to, but free to rotate within, wedge bar 29 by means of thrust washer 32 and retaining means 33. FIG. 5 shows in plan view the arrangement of the wedge member, wedge bar and housing.

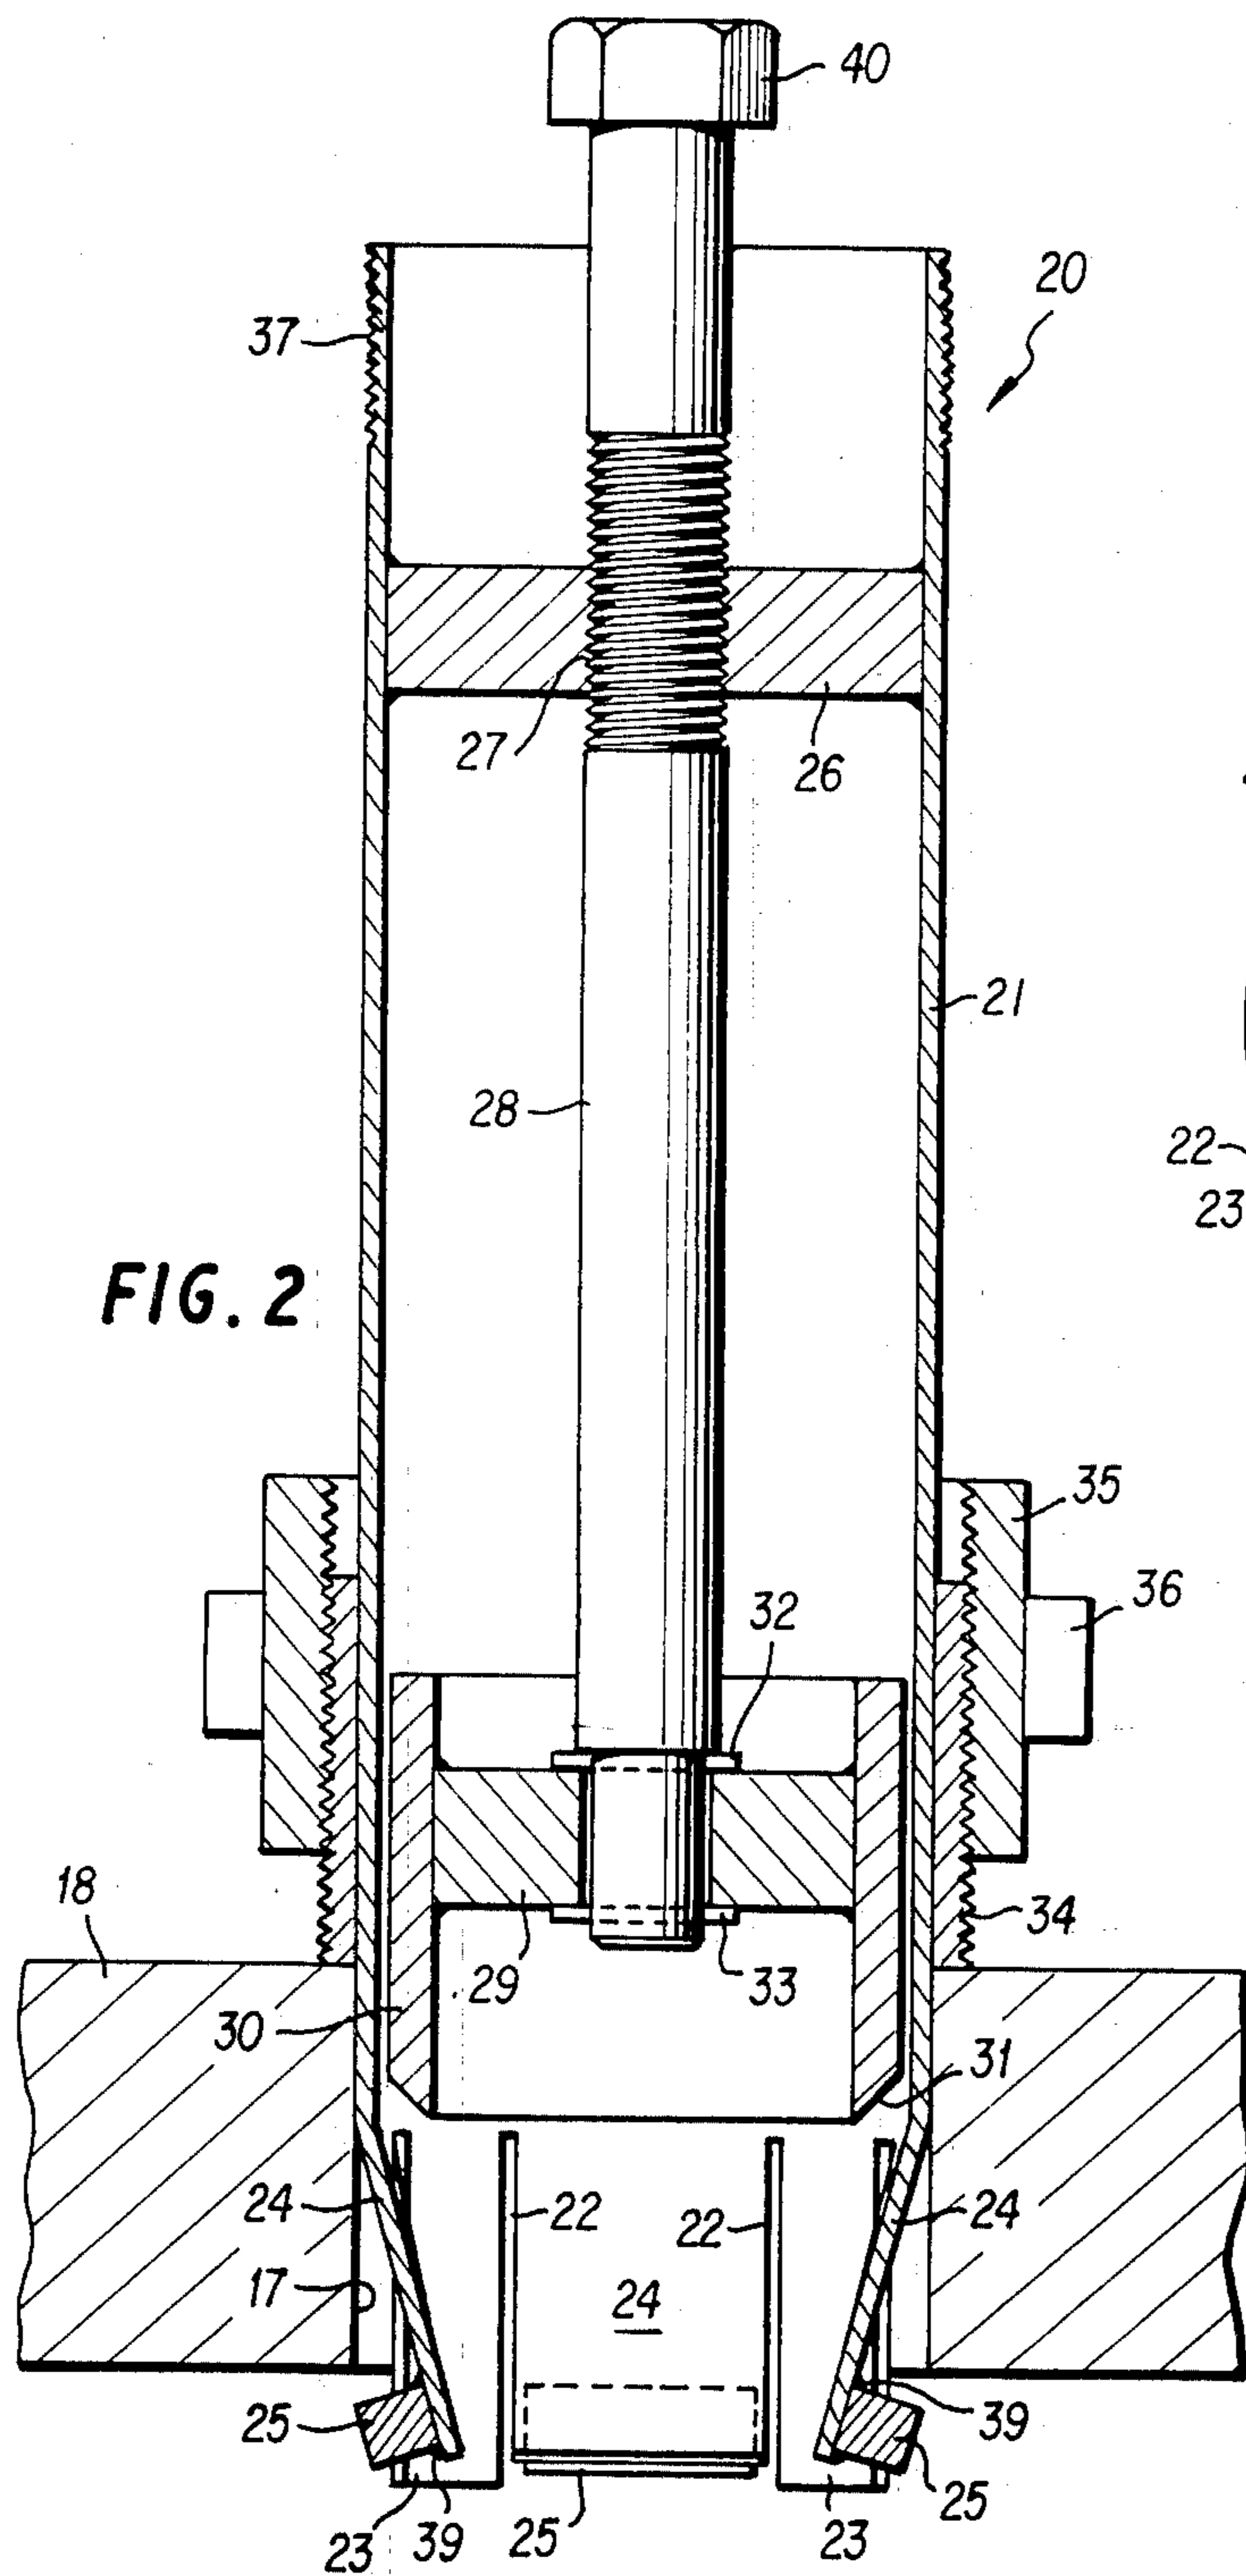
FIG. 2 is a partial sectional view in elevation of the repair assembly of this invention;

After removal of the riser and reaming of the hole through the pipe wall, the repair assembly of this invention, illustrated in FIG. 2, is inserted into the pipe wall. Turning now to FIG. 2, repair assembly 20 comprises a cylindrical housing 21 having a lower end adapted for insertion into the reamed hole 17 in the pipe wall 18. Housing 21 is preferably formed from a section of relatively thin-walled steel pipe having a diameter equal to that of the original riser. A series of eight slots 22 are cut into the lower end of housing 21 for a distance somewhat shorter than the wall thickness of pipe 11. Slots 22 are all of equal depth and extend parallel to the housing axis to form eight tang members. These eight tang members comprise four guide tangs 23 alternating with four locking tangs 24. Each locking tang 24 is provided with an outwardly extending lug 25 attached, suitably by weld 39, adjacent its free end and perpendicular to the axis of housing 21. The top side of each lug 25 preferably forms a right angle with its companion tang 24 so as to provide a secure lock with the interior surface of the pipe wall in a manner which will be later described.

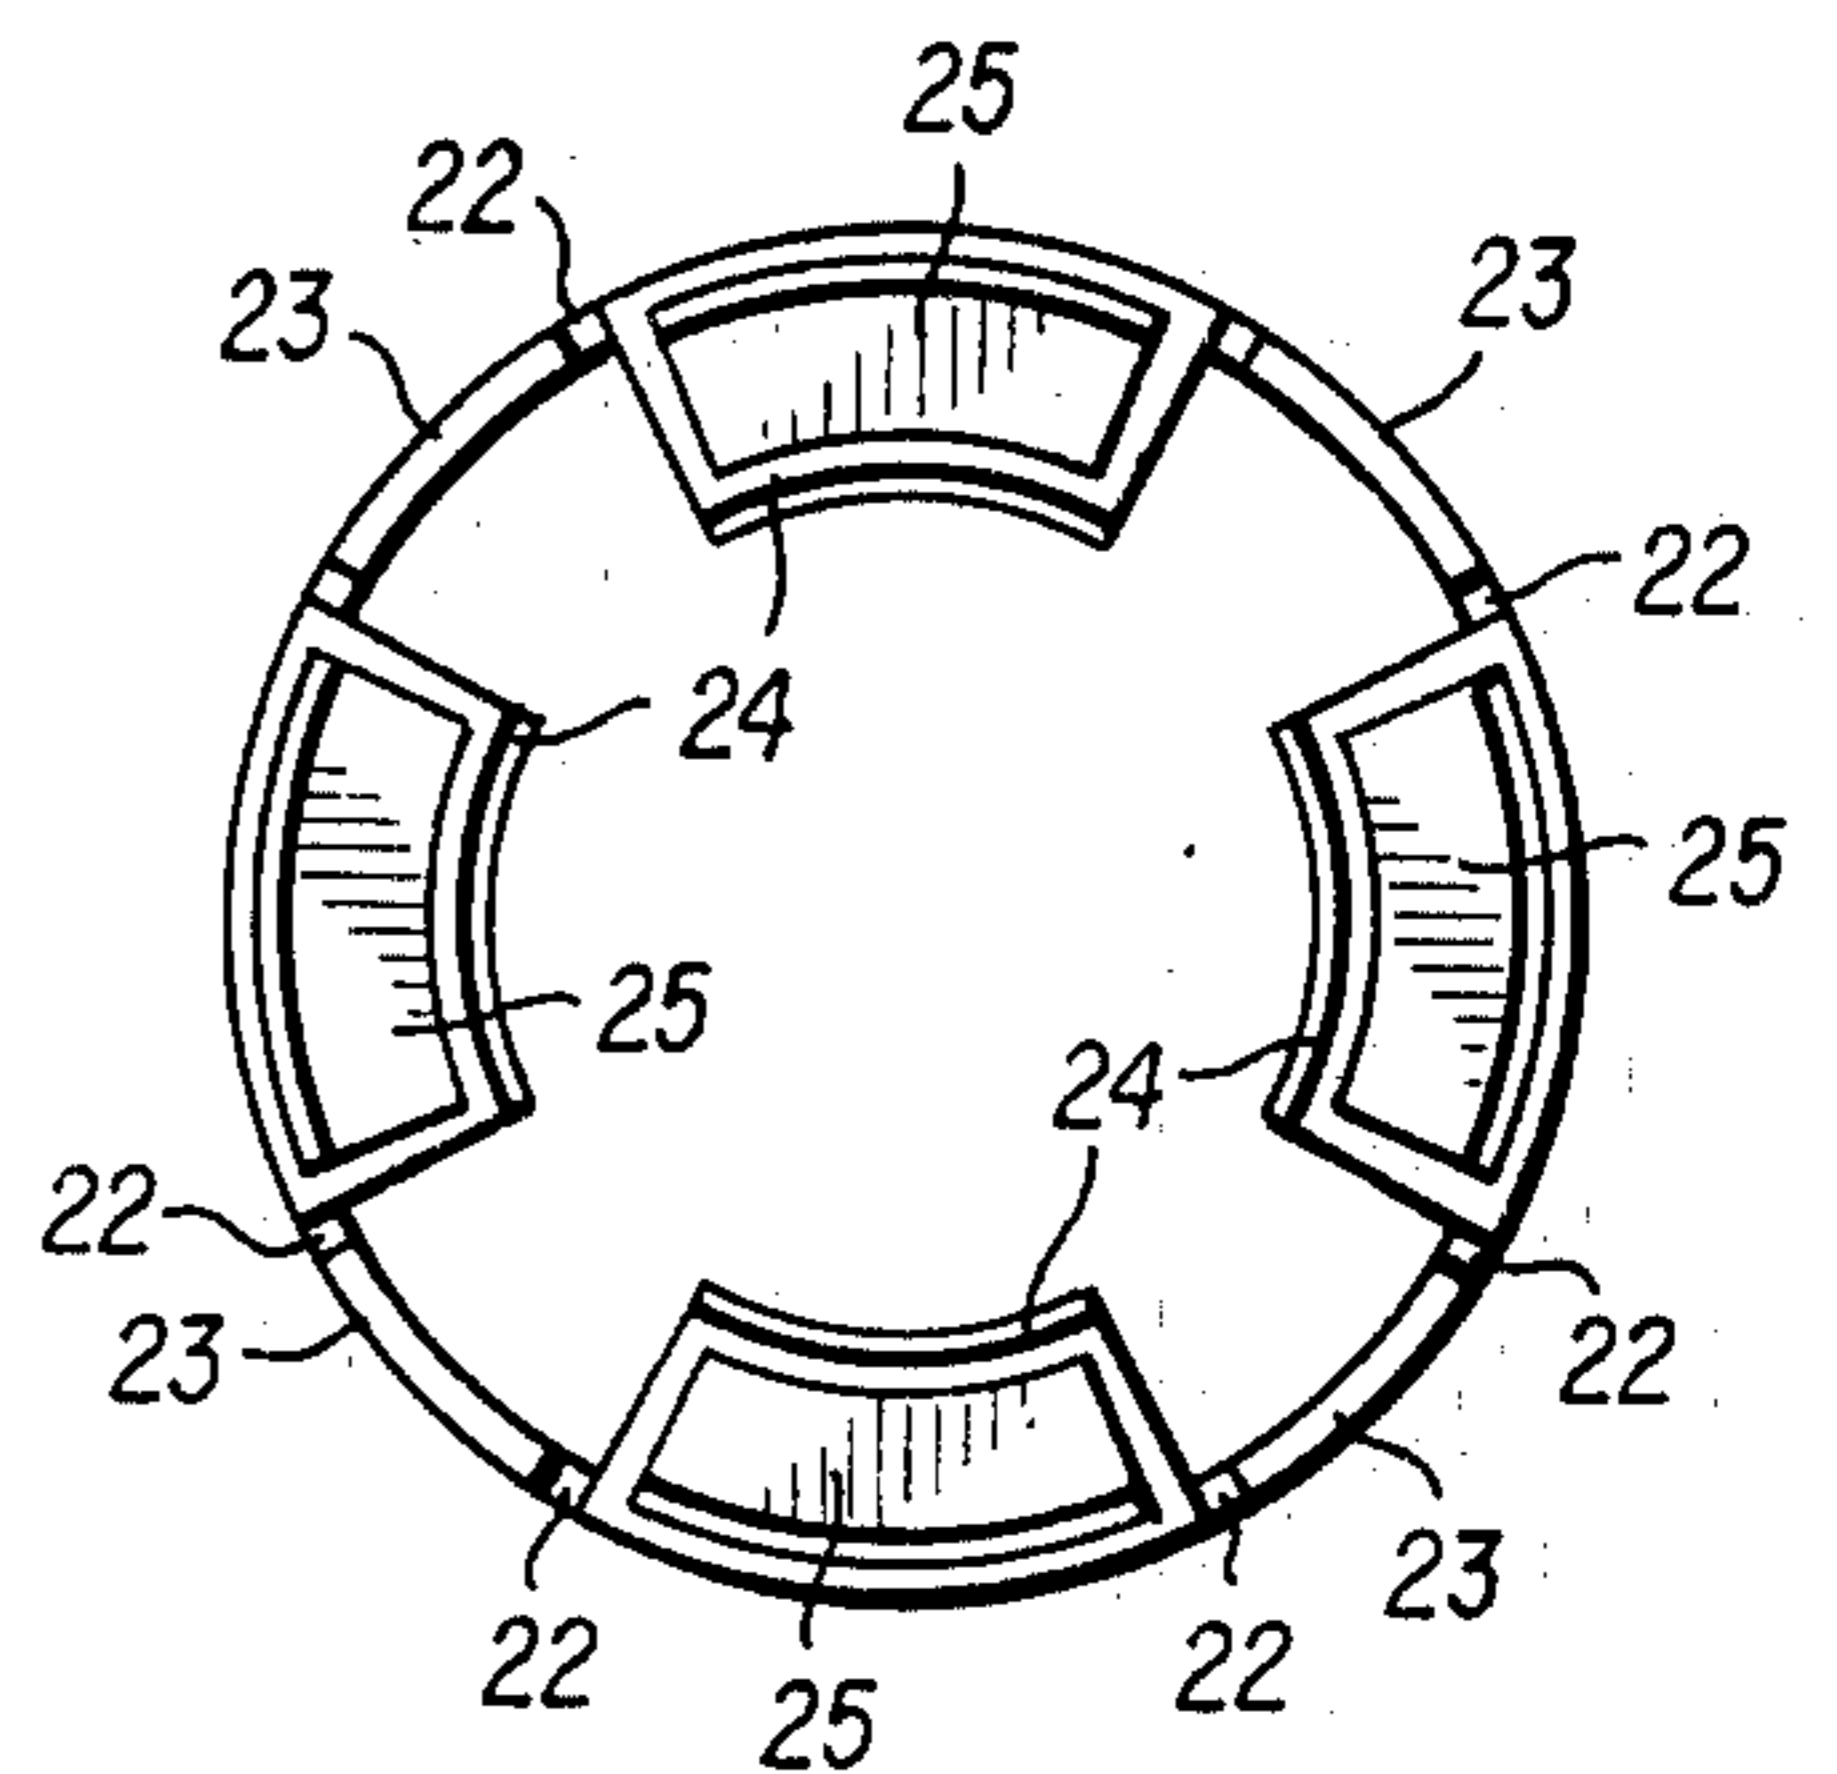
FIG. 3 is a bottom view of the repair assembly showing the attitude of guide and locking tangs;

All four locking tangs 24 are then bent inwardly a sufficient amount so that the projection of lugs 25 does not extend beyond the diameter of housing 21. Guide lugs 23 remain unbent as extensions of the housing wall. The resulting attitude of the guide tangs and locking tangs, each with its companion lug, is shown in FIG. 3. As is shown in FIG. 3, it is preferred but not required, that each locking tang include about twice the arc length of each guide tang. It is necessary for proper functioning of the repair assembly that opposing pairs of locking tangs be of equal arc length and that the midpoint of opposing lug pairs be disposed at essentially 180° one from the other. In a preferred embodiment, each guide tang and adjacent locking tang encompasses 90° of arc with the arc length of the locking tang being about twice that of the guide tang.

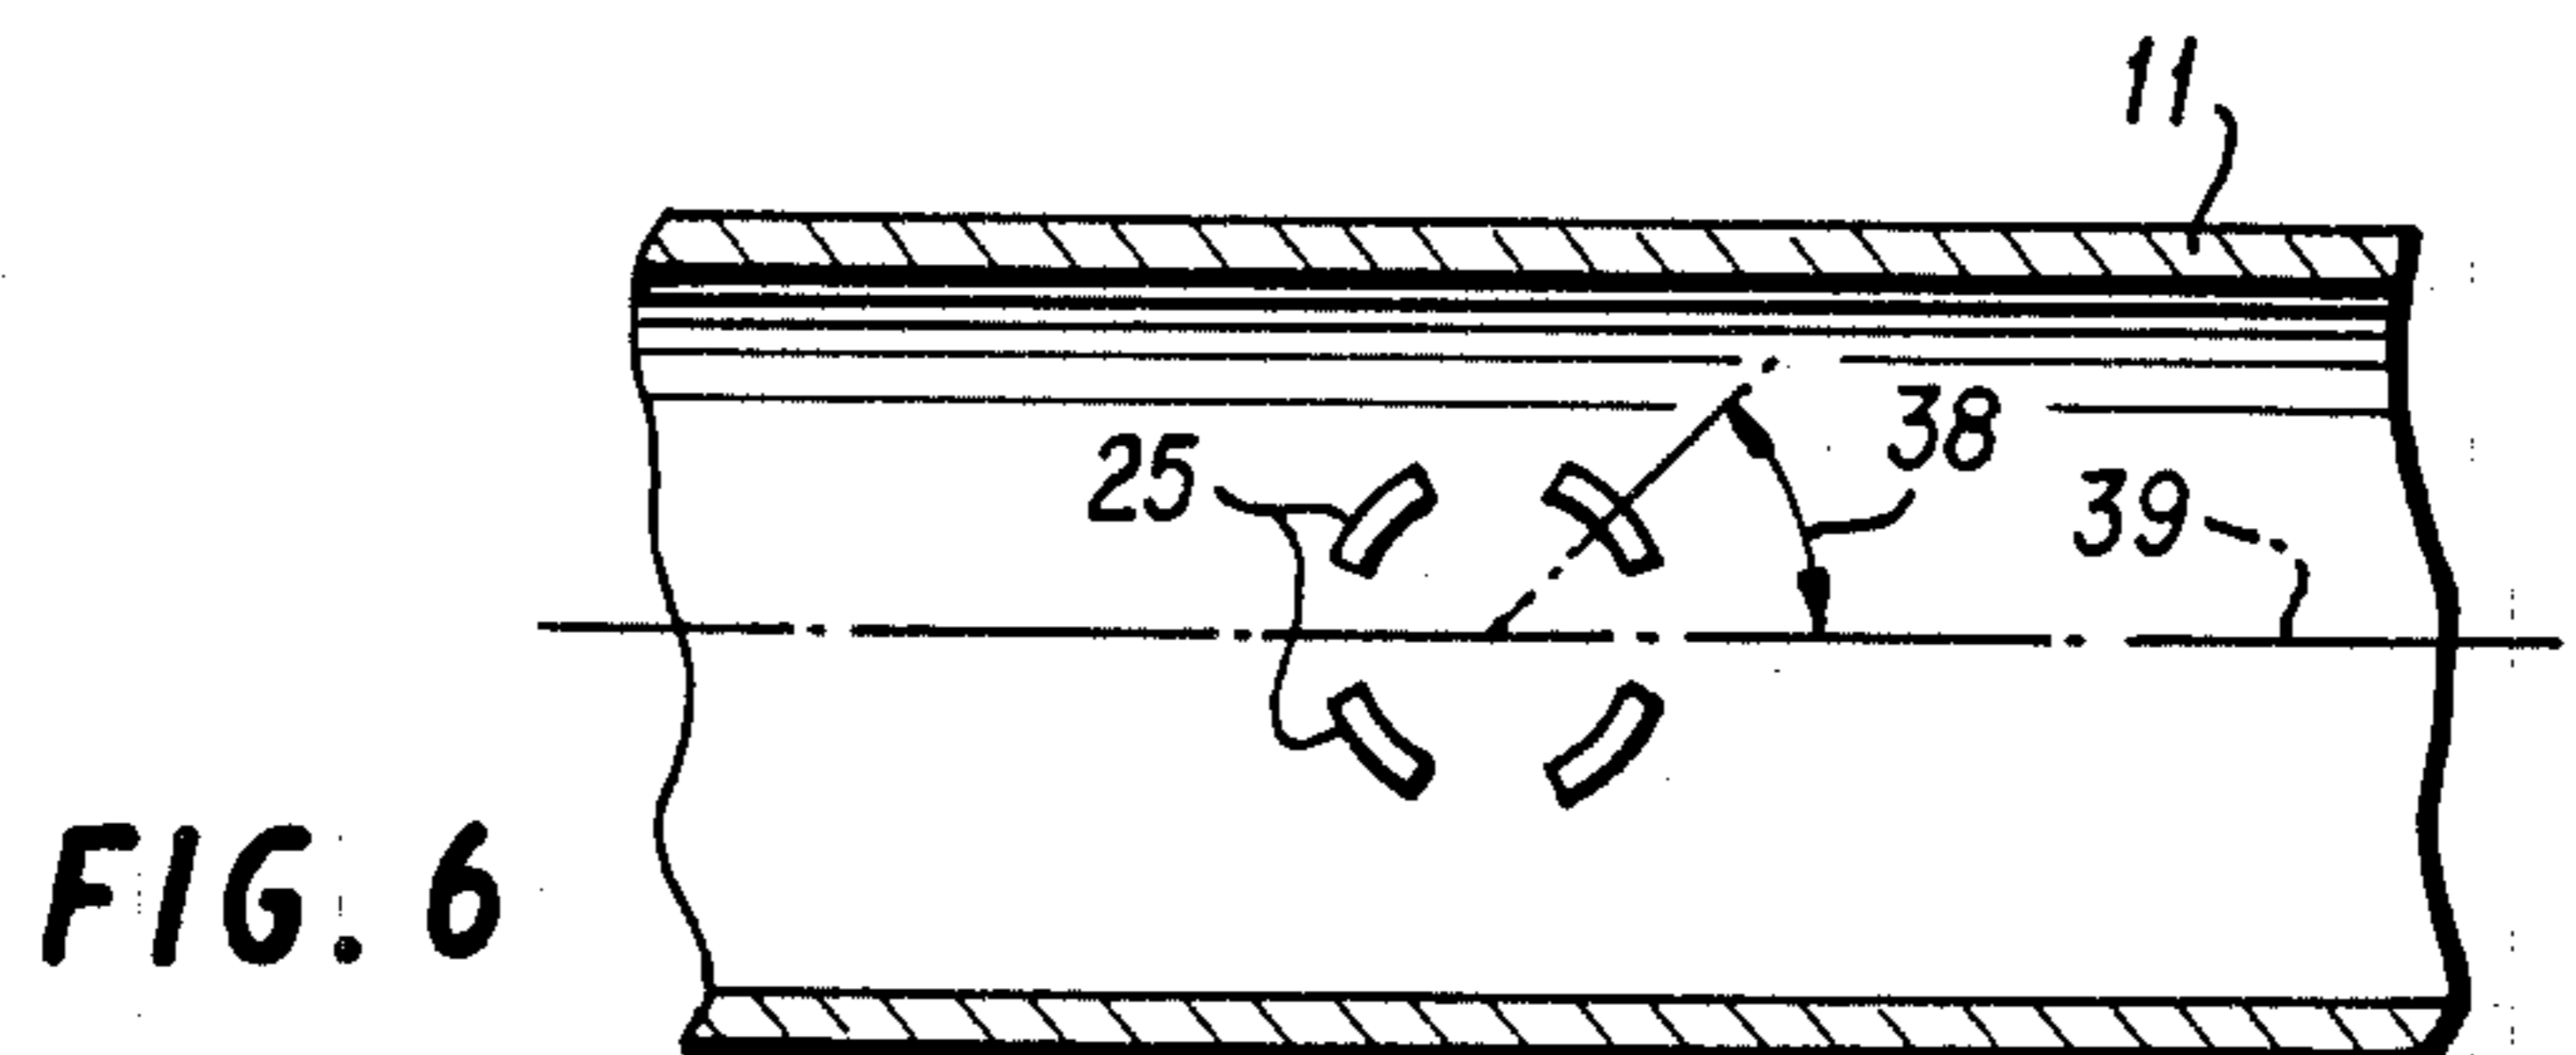
FIG. 6 shows the arrangement of the repair assembly on a water distribution line.

The sealant-coated tang end of the repair assembly is then inserted into the hole in the pipe wall. The assembly is then rotated so as to position the centers of each of locking tangs 24 and lugs 25 at an equal angle 38 (FIG. 6) from the axis 39 of line 11. In the case of equally spaced tang members, angle 38 will be 45°. This rotational positioning of the repair assembly relative to the pipe axis is critical to successful use of the repair assembly. As may be appreciated, the interior surface of pipe 11 is curved. Positioning opposite lugs 25 at an equal angle relative to the pipe axis ensures that all of the lugs will grippingly contact the internal surface of the pipe wall.
