[54] PAIR CUT APPARATUS AND METHOD OF USE

[73] Assignee: Southwestern Bell Telephone Company, St. Louis, Mo.

[57] ABSTRACT

A method and device for reducing the cost and out of service time in repairing defective wire pairs in telephone networks. The device comprises a cable having metal prongs on each end which correspond to the receptacles on the protector block which is located on the vertical component of the central office distributing frame. The device is used to connect the receptacles on the protector block that are connected to a new functioning pair of field wires to the receptacles on the protector block of the office wires of the nonfunctioning old pair of wires. Thus, restoring service to a customer through a new wire pair until permanent wiring can be installed on the horizontal component of the central office distributing frame.

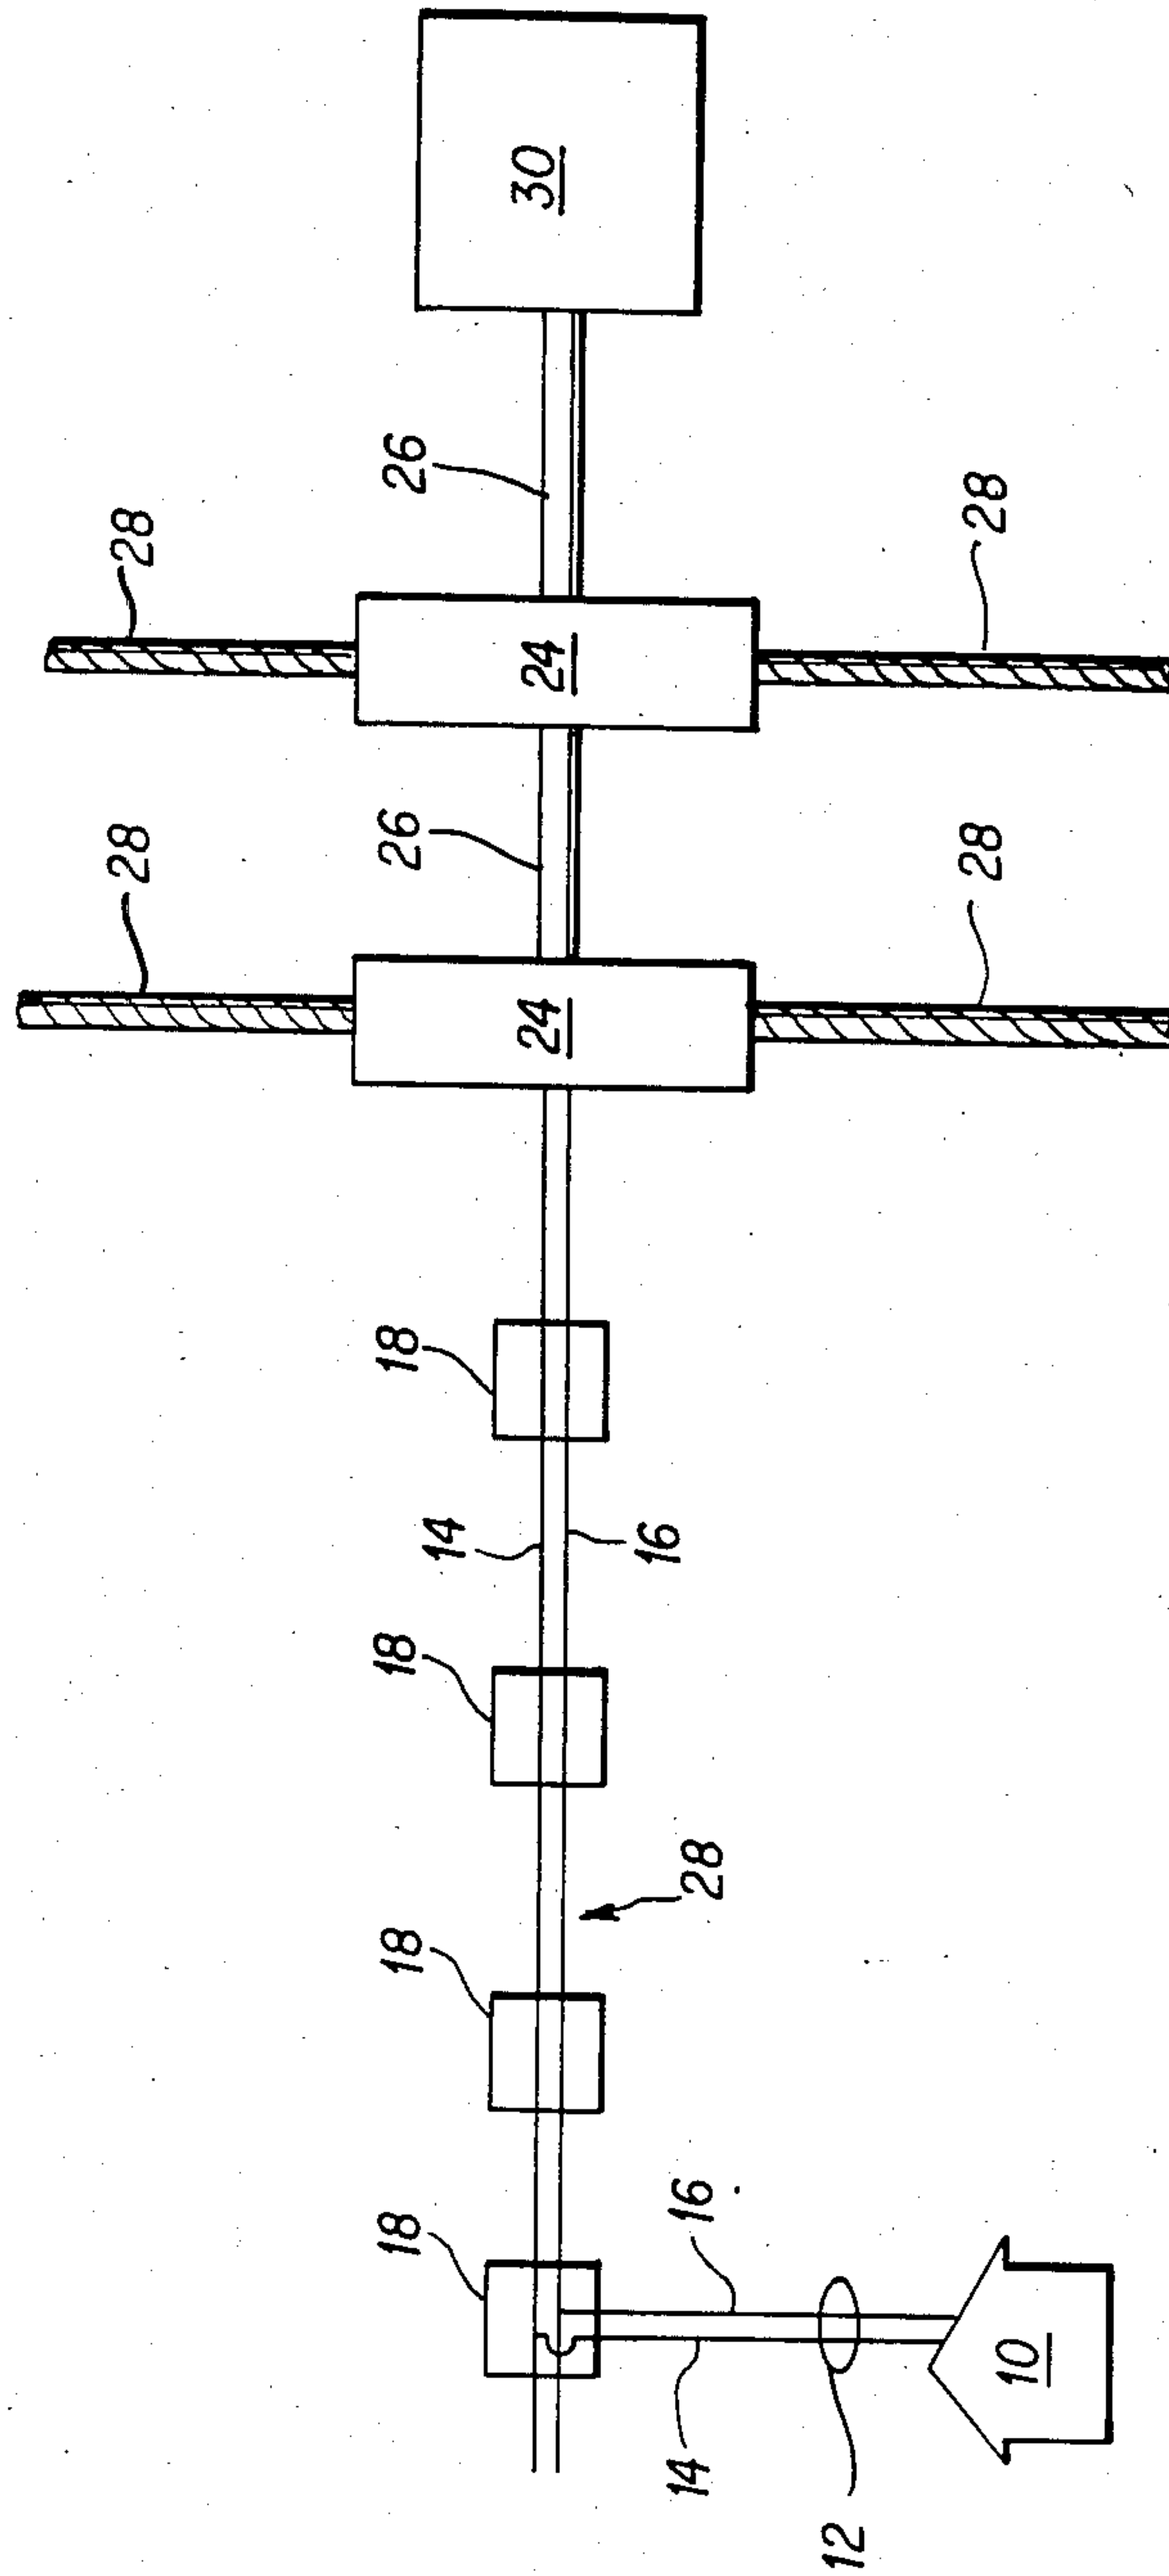
FIG. 1 is a general block diagram showing the path of a wire pair from a customer's premises to a central switching station.

The telephone network basically comprises pairs of wires which connect the premises of individual customers to a central office. FIG. 1 traces the path of a pair of wires from a customer's premises in the field to a central telephone switching office.

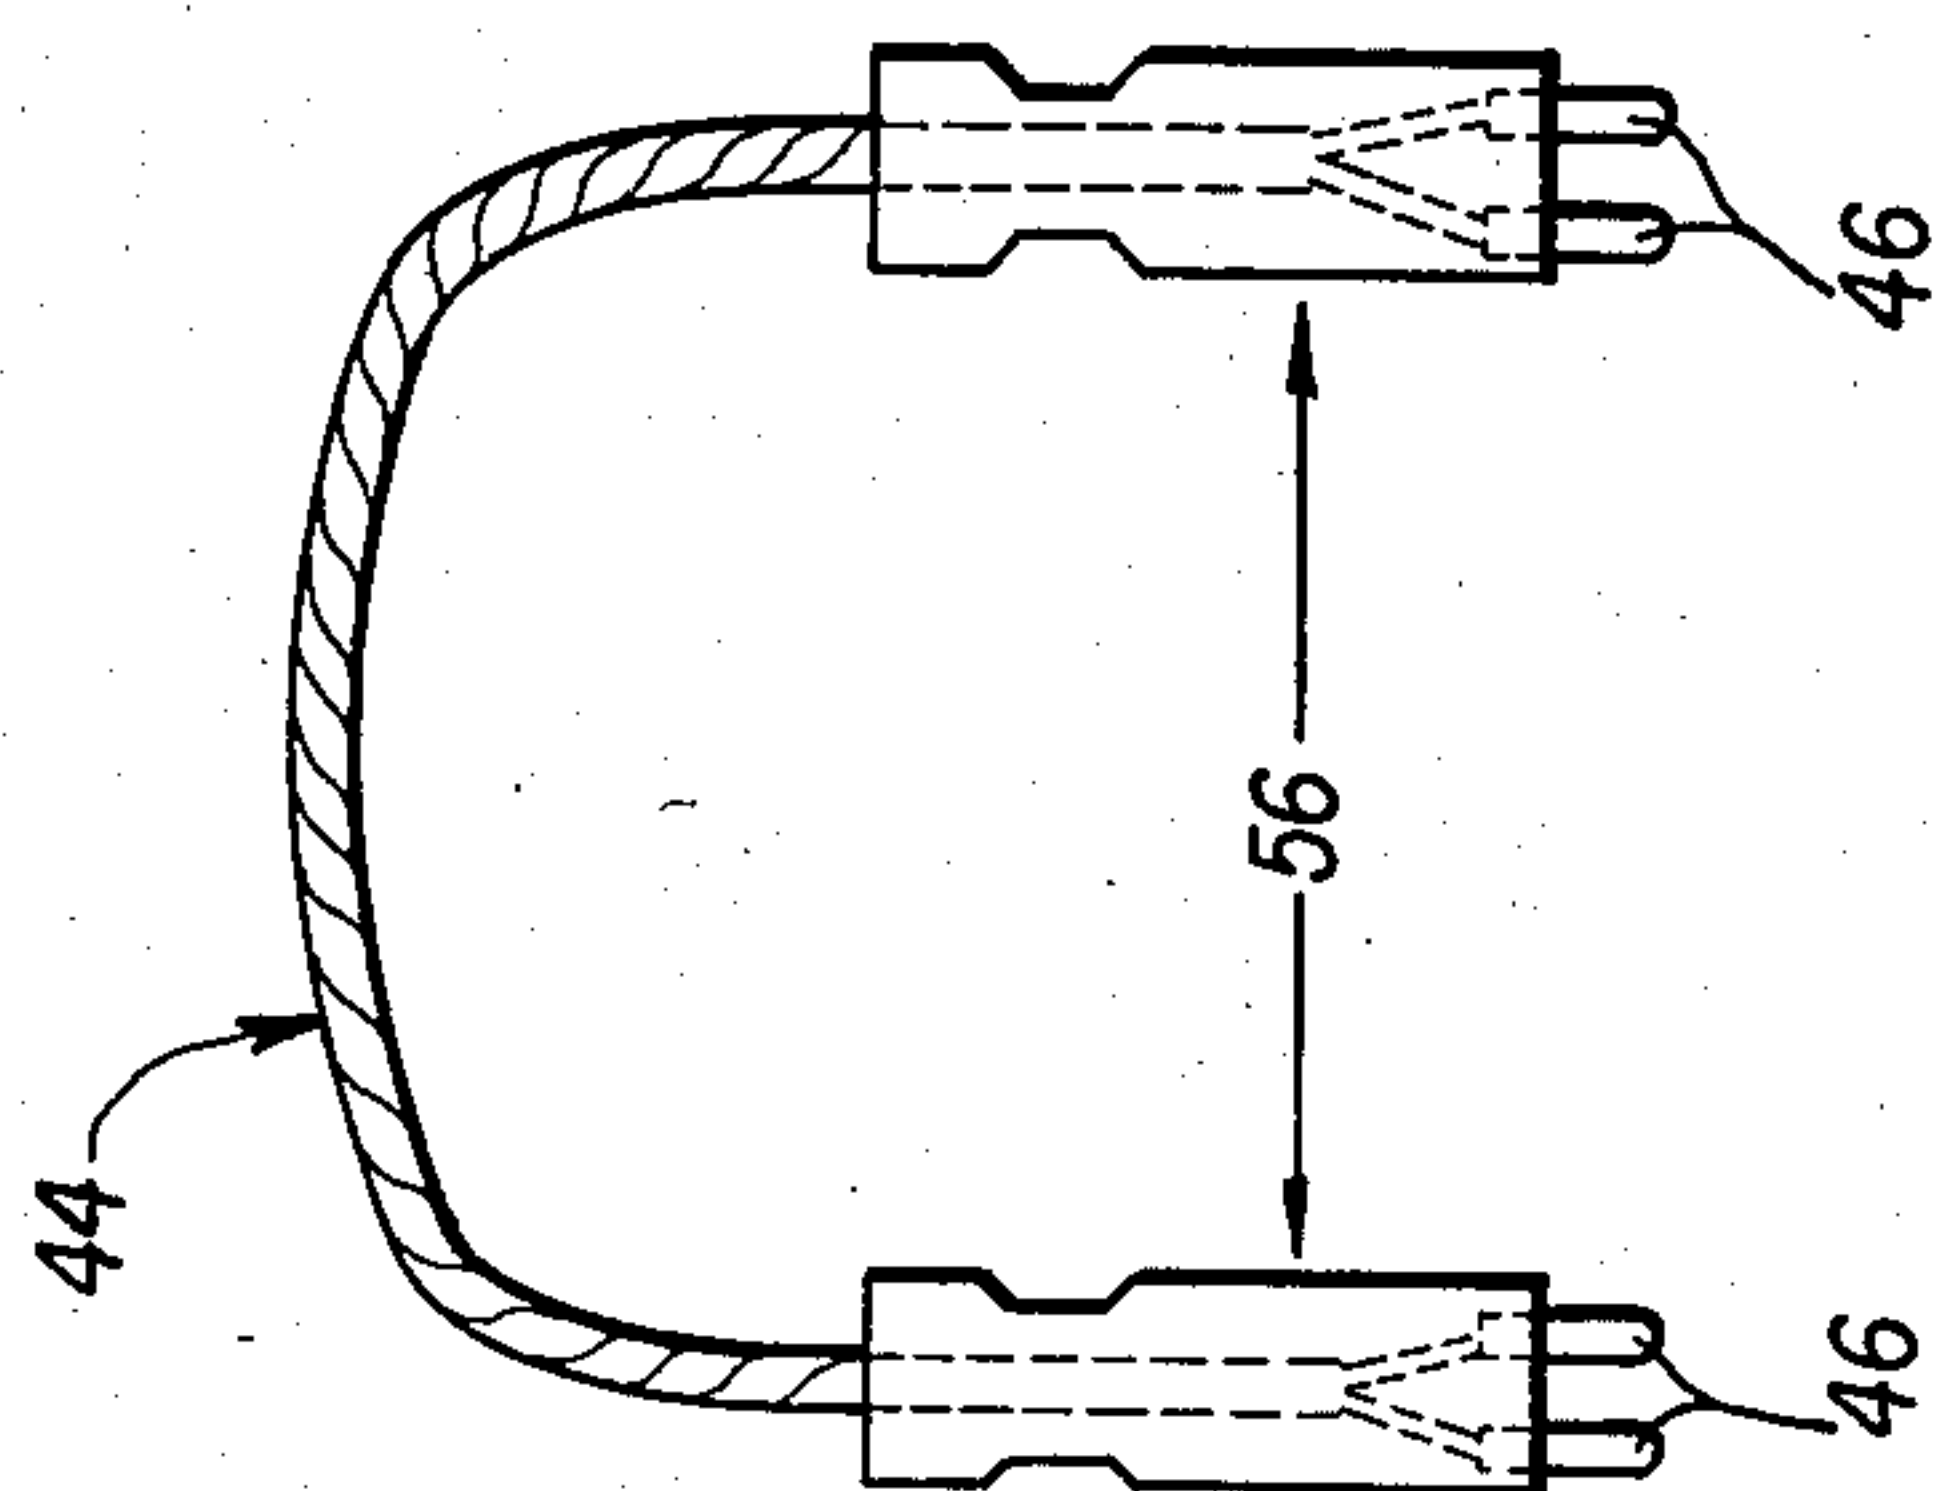
FIG. 4 shows the device of the invention.

The preferred device 56, as illustrated in FIG. 4, is comprised of 0.15 inch diameter conductor cord 44 having two wires. Its length is either 3 feet, 6 feet, 9 feet or 12 feet. At both ends of the conductor cord are two metal prongs 46 each 0.093 inches diameter and having brass gold flashing. The distance between the prongs is 0.437 inches. They are designed to mate with the recepticals 48 of the protector block 40 as shown in FIG. 5. The prongs should be marked to insure that they are inserted to obtain the correct polarity.

blocks, protectors, etc. will vary depending on the circumstances. All methods and devices which are equivalent to that which is disclosed herein are intended to be included within the following claims. Including the use of conventional protectors connected by a wire pair in place of the molded pronged device shown in FIG. 4.

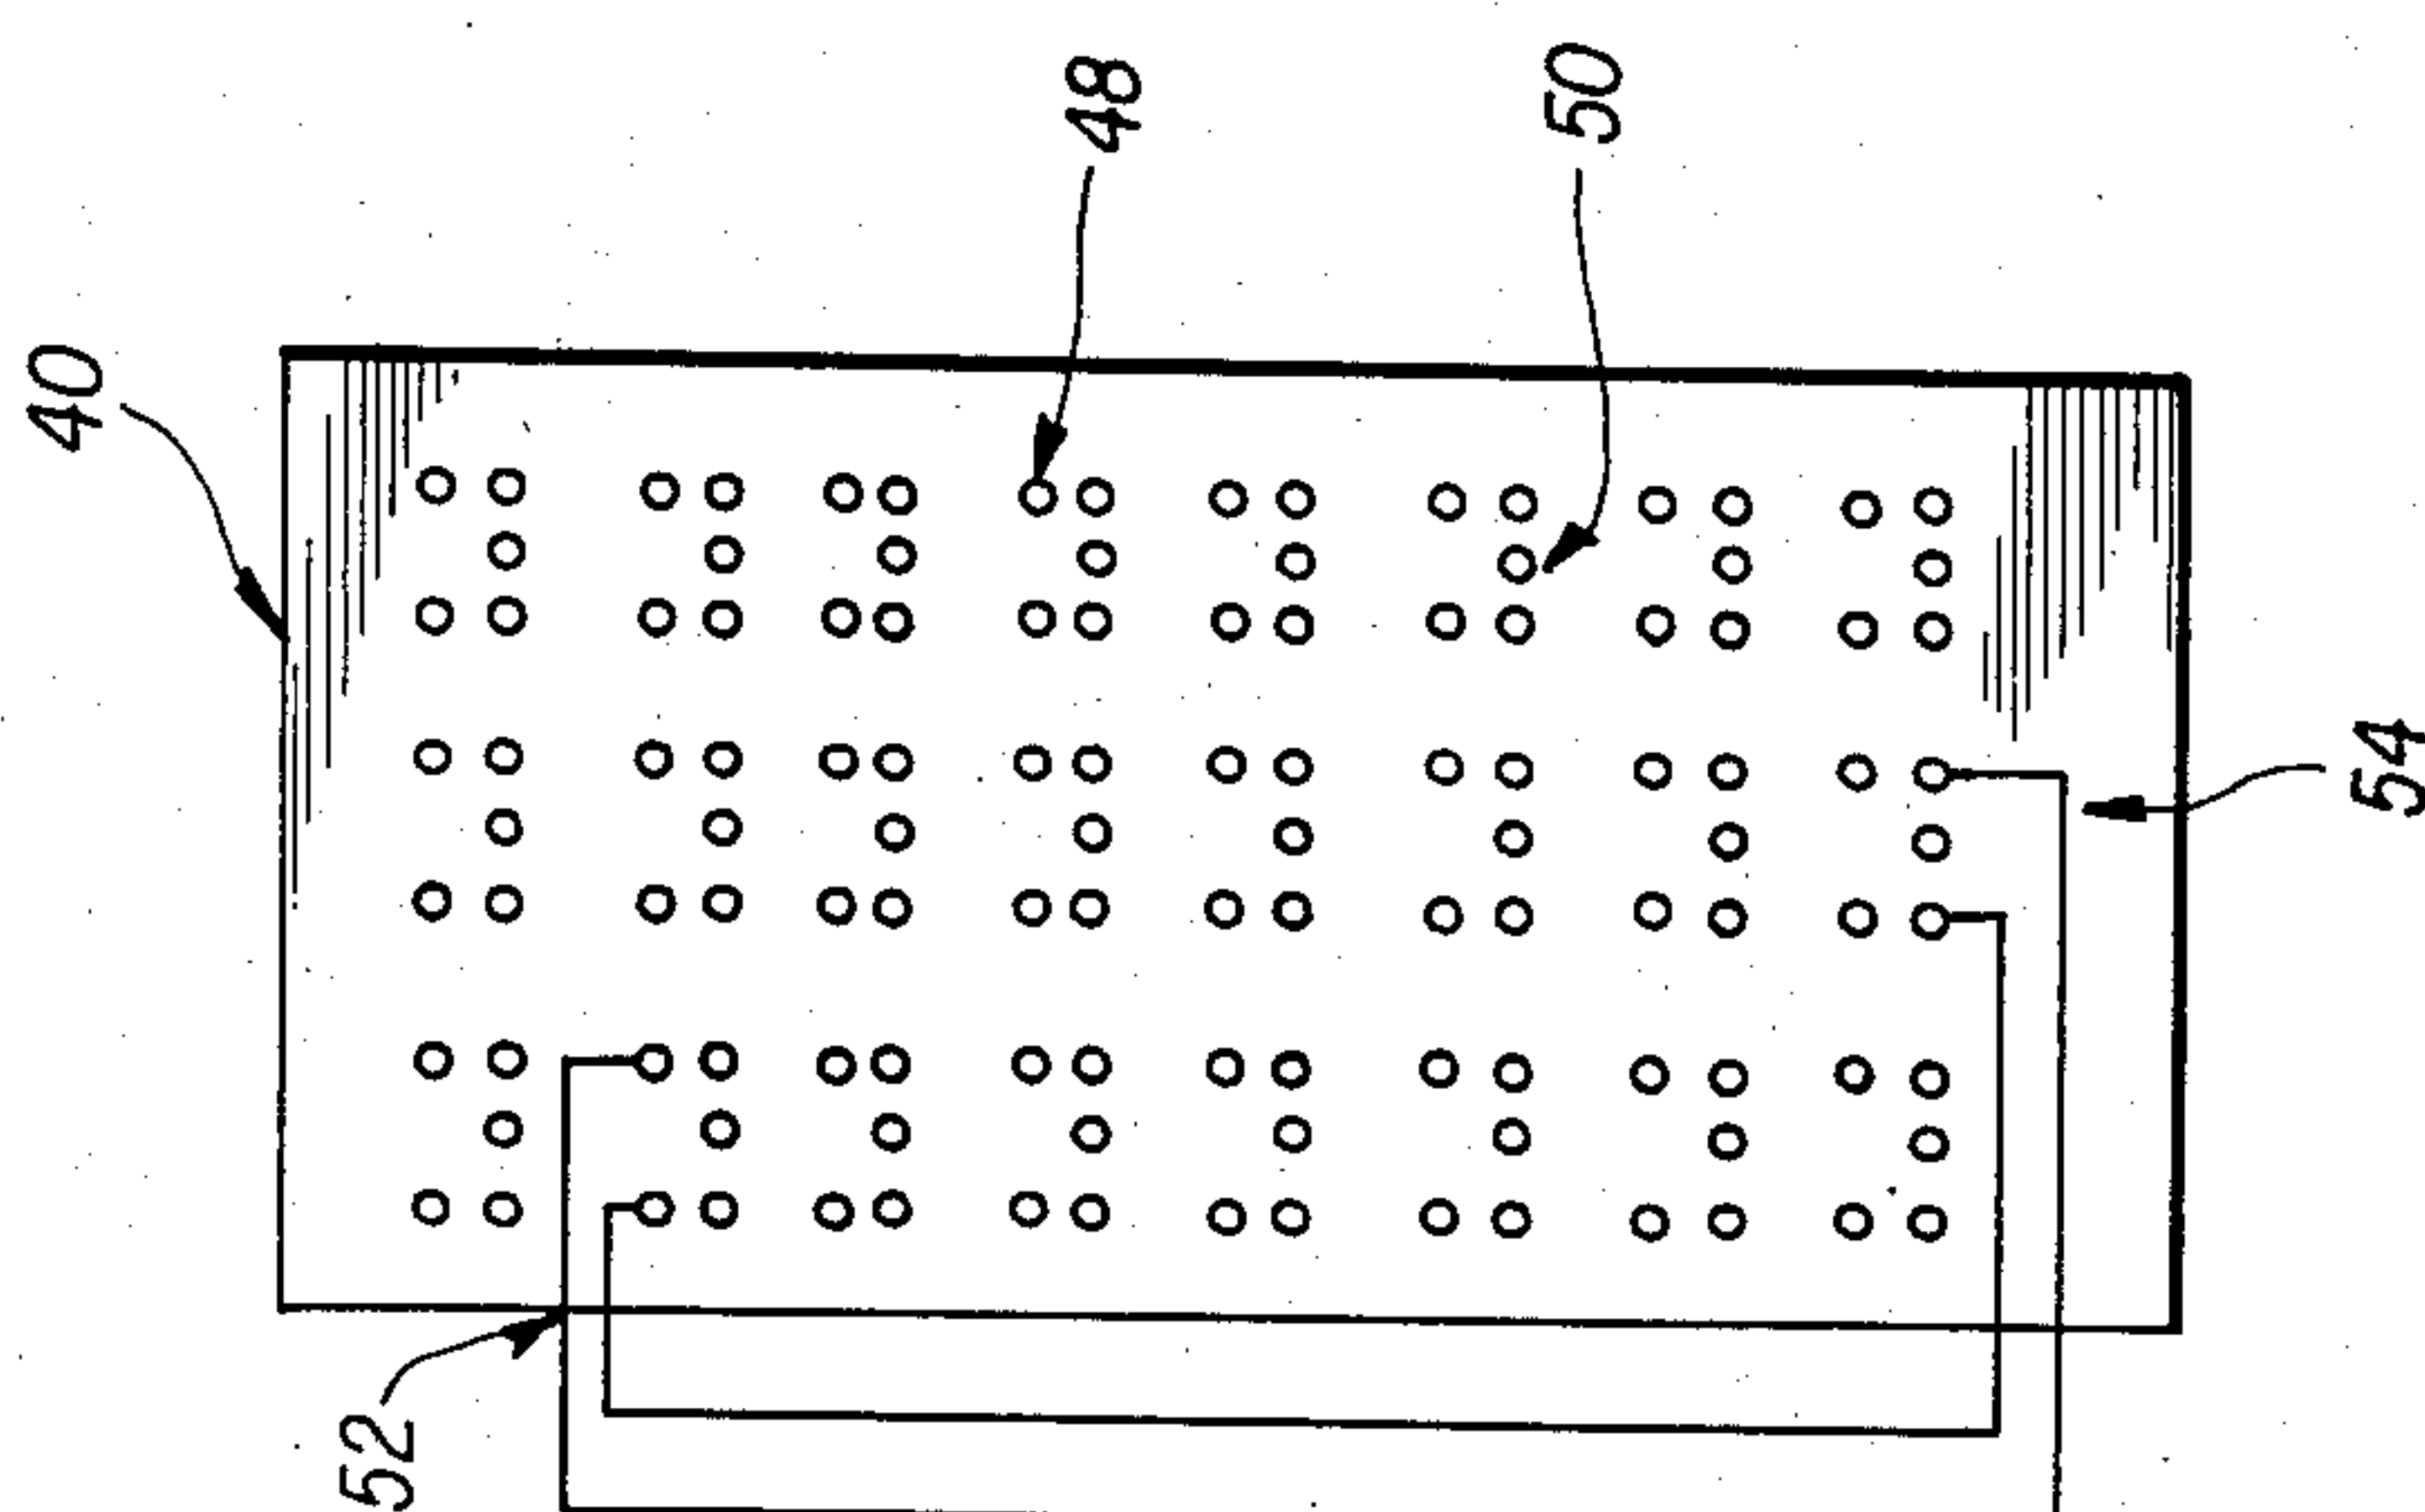
FIG. 5 illustrates a general form of a protector block.

As illustrated in FIG. 5, one end of the device is plugged into the protector block position 52 of the field wires for a new pair and the other end is plugged into the position 54 of the office wires for the old pair; thus, providing service on the new pair without first having to change the switching computer. At a convenient time the telephone company can change records and the office wires thus switching to the new pair. Under the method of the prior art all of the changes had to be made prior to the restoration of service.

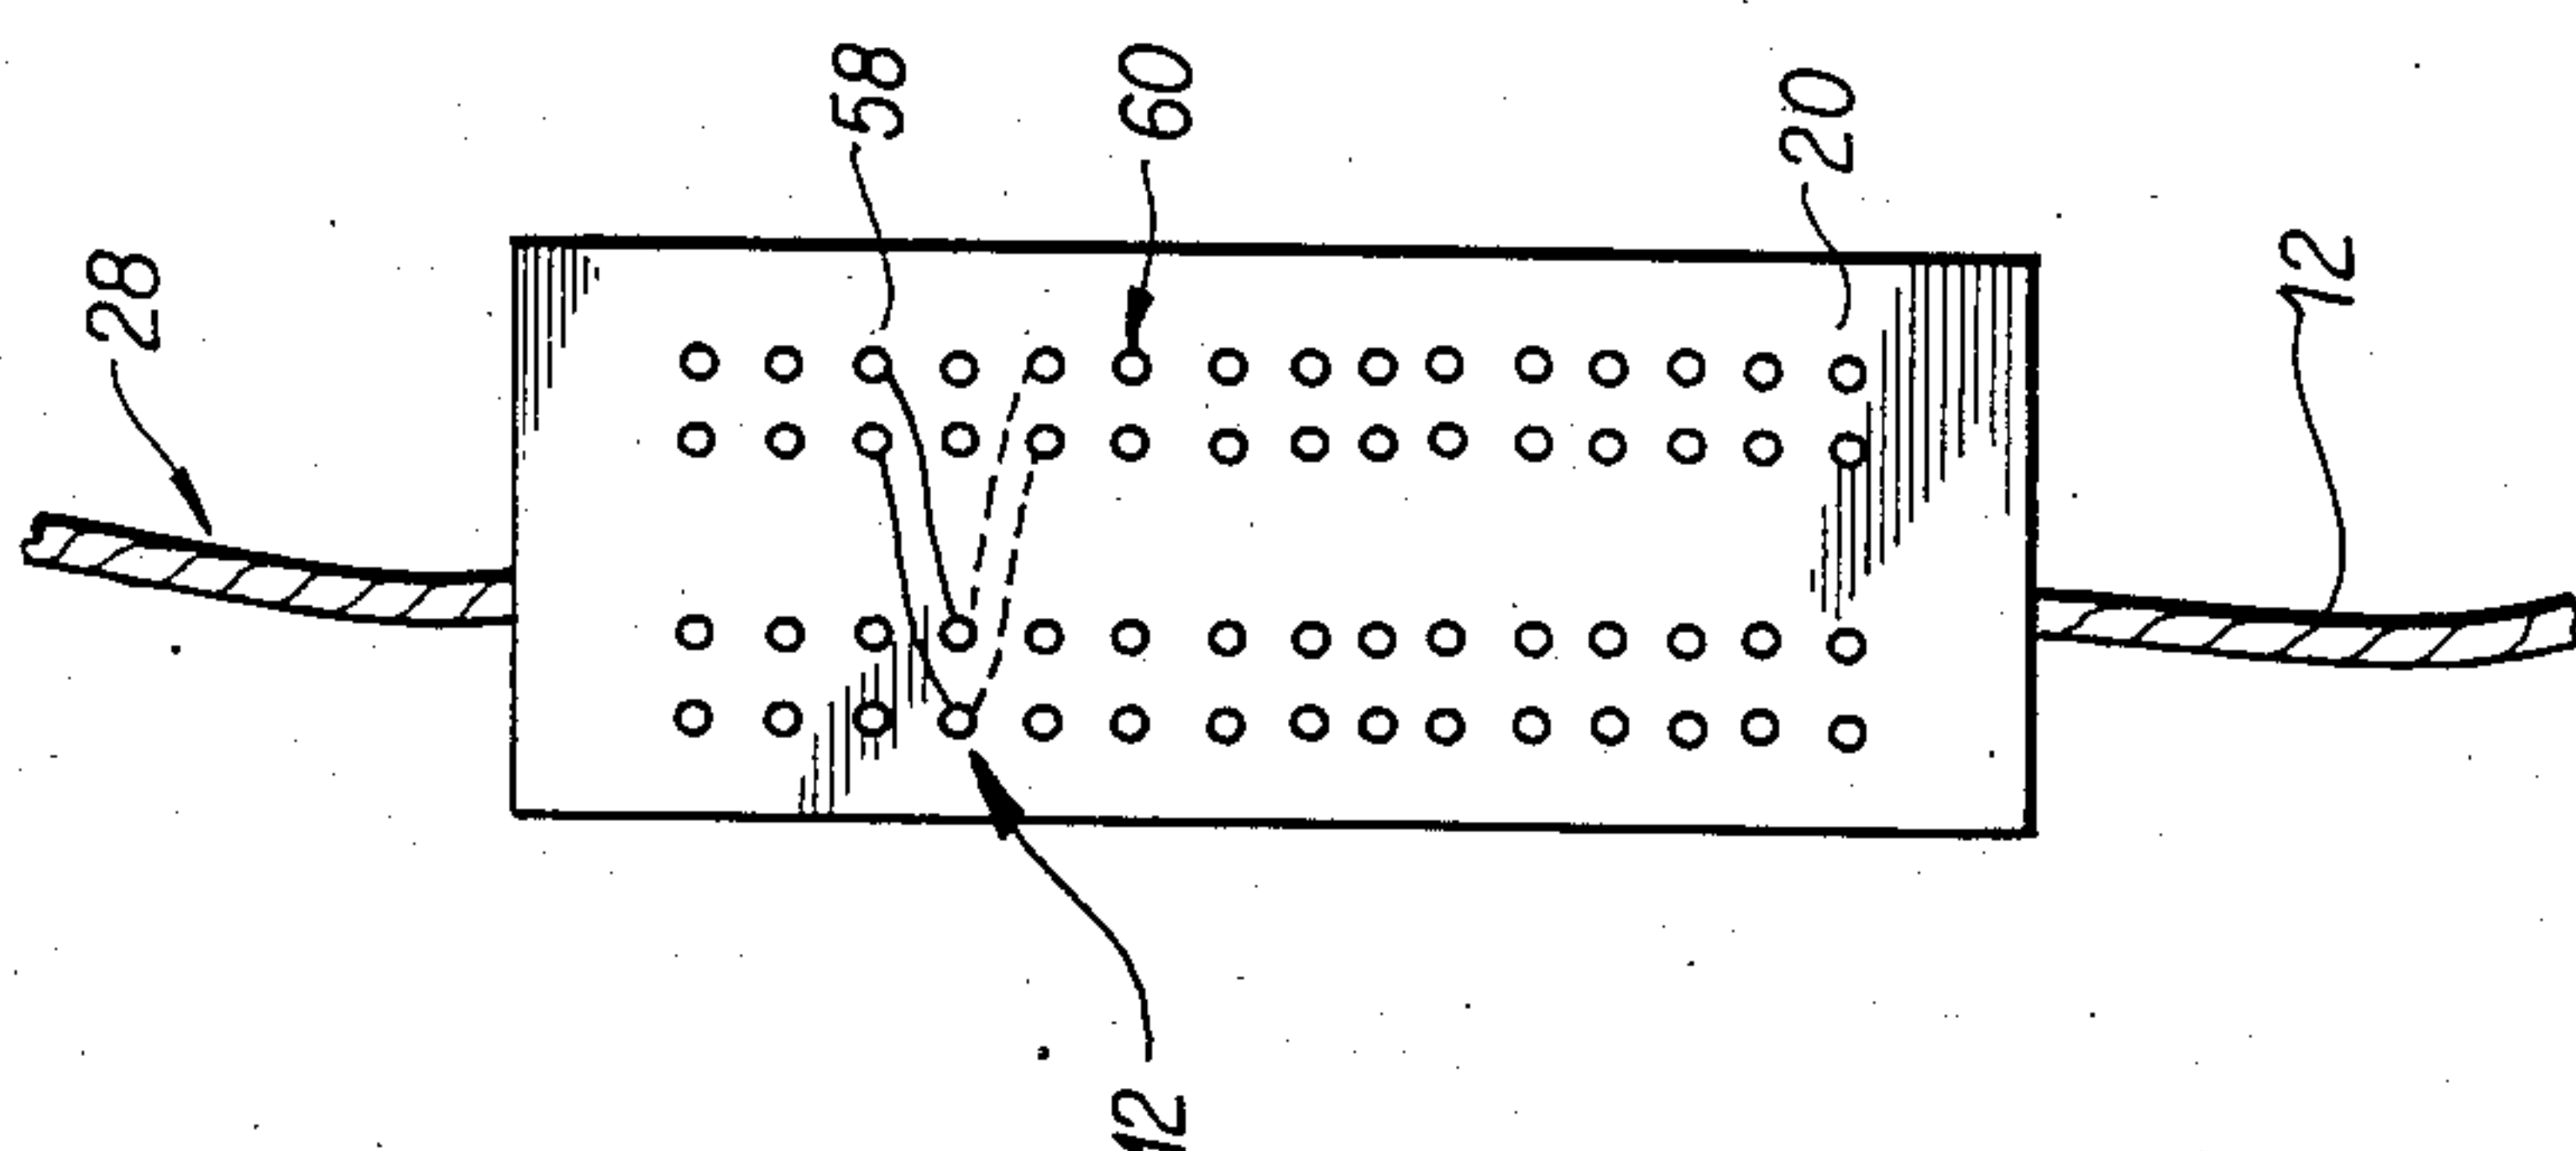
FIG. 2 illustrates a general form of a field connection box.

A terminal or cable closure 18 as shown in FIG. 2 has a number of sets of posts 20. Each set of posts 20 is attached to a pair of wires that together form the cable 28. The service wire 12 from the customer premises is connected to a particular pair of posts as per the assignment of the telephone company. More than one customer may use the same terminal or cable closure 18.

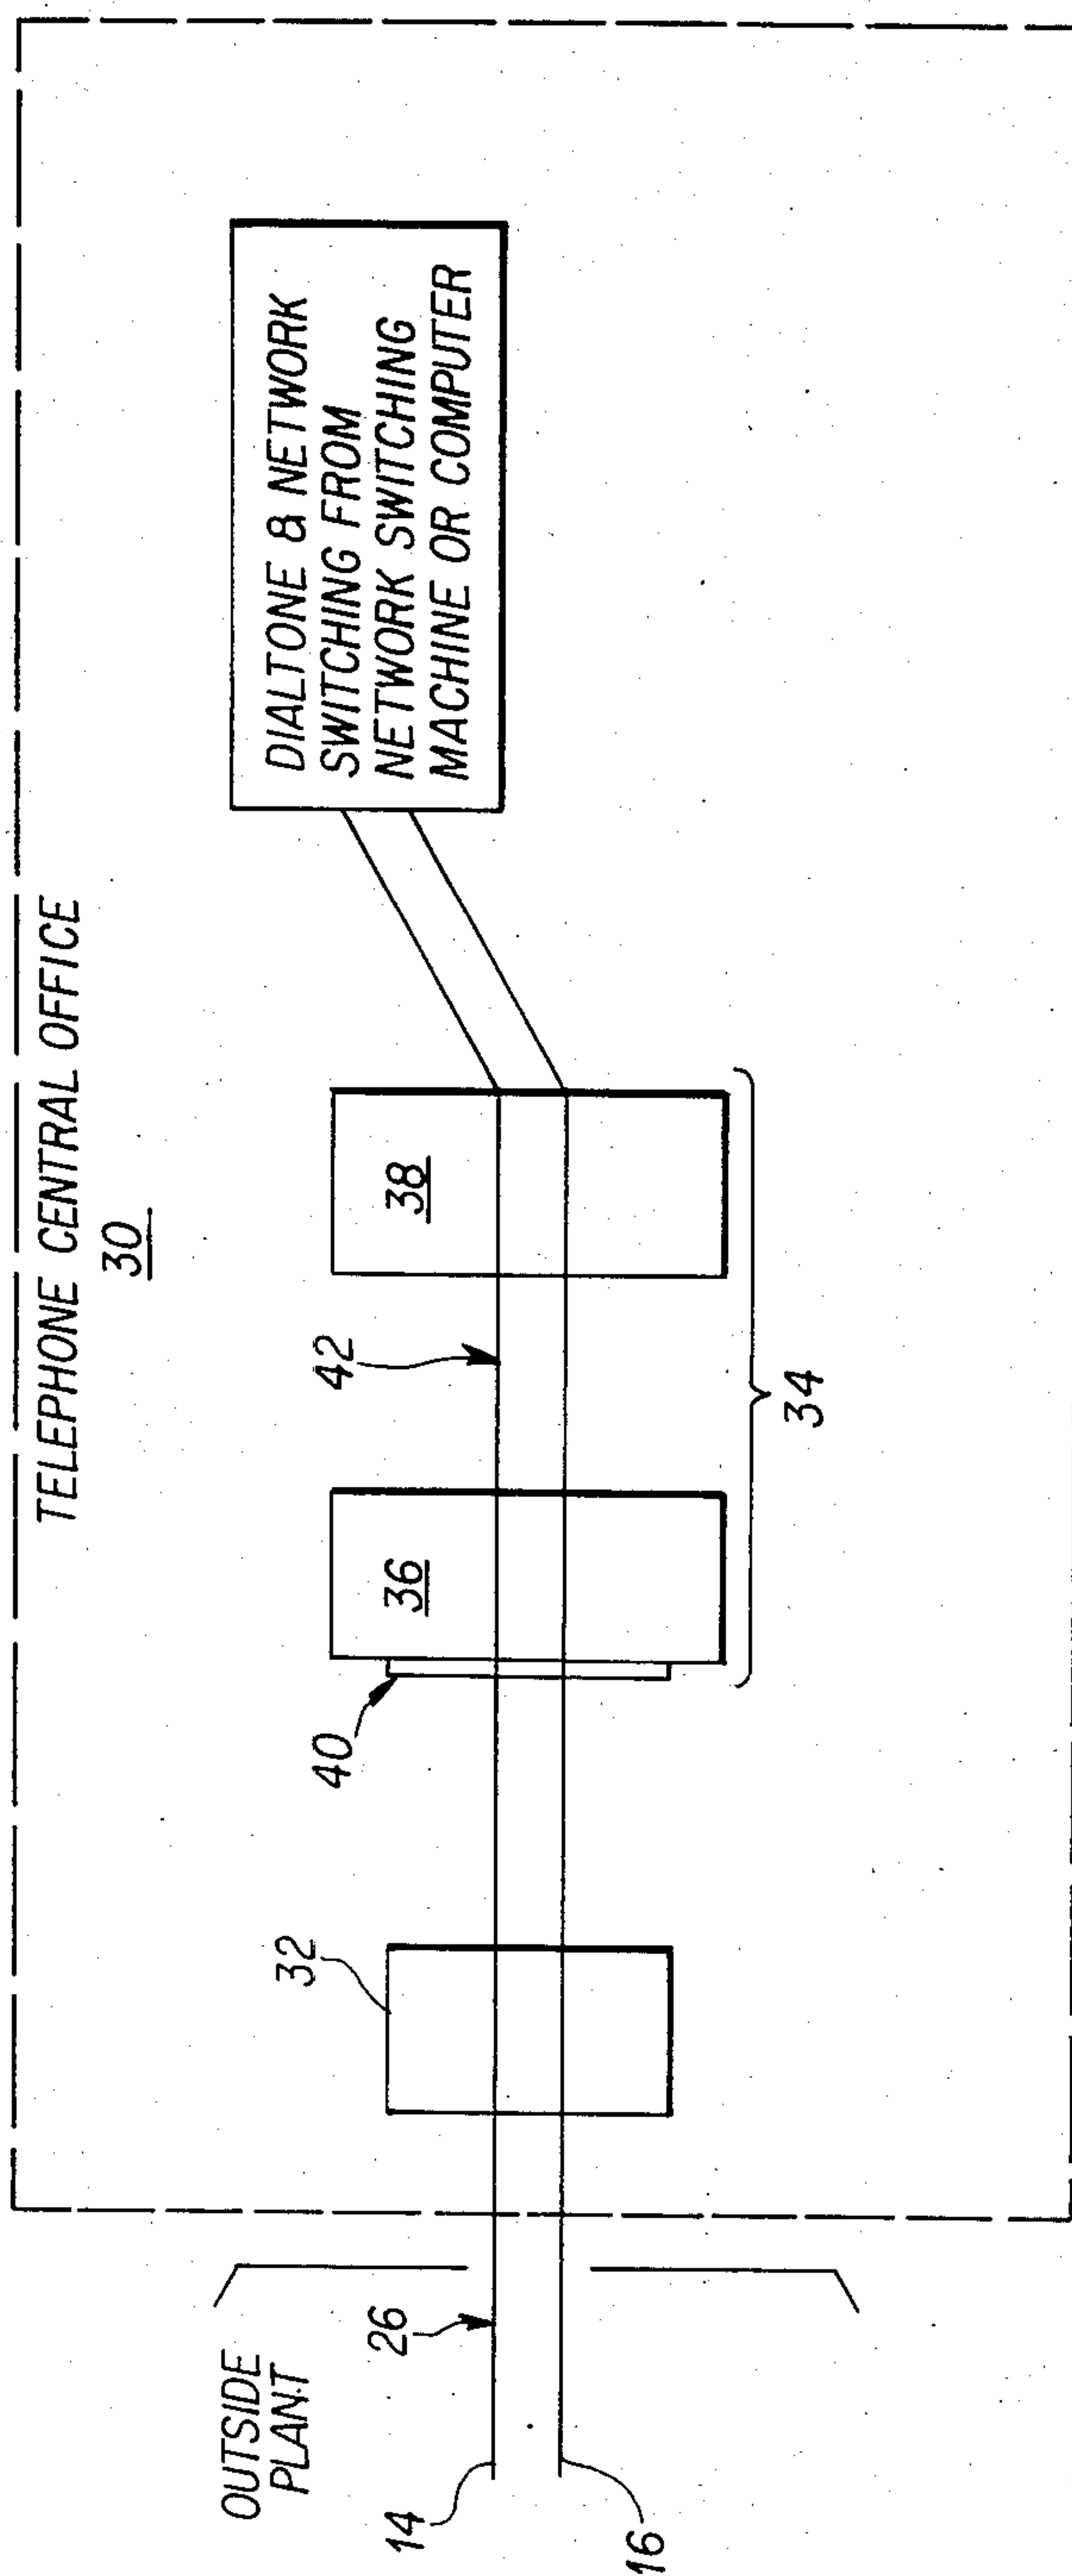
FIG. 3 is a general block diagram showing the path of a wire pair from the field through the distributing frame.

As shown in FIG. 3 the wire pairs are strung from the basement 32 to a distributing frame 34 which is on an upper floor of the central office. This frame has a vertical 36 and horizontal 38 component. Located on the vertical component of the frame are protector blocks 40 containing a protector for each wire pair. The purpose of the protector blocks 40 is to protect the central office equipment from excessive voltage or current surges. The frame is a metal support structure having protector blocks 40 mounted on its front face. The protectors have metal prongs which plug into the front of the blocks and connect the wire pairs from the field that have entered the central office to jumper wires 42 that connect the incoming field wires to the horizontal component 38 of the distributing frame 34. The vertical component 36 of the frame 34 is the terminating point of the outside or field wire pairs from cable 26.
