[54] **ELECTRIC MOTOR REPAIR**

[57] **ABSTRACT**

An electric motor armature is repaired, to correct a loose armature or separated armature laminations, by drilling holes through the armature at various locations around the armature and along its length. The holes extend to the armature shaft. Adhesive is injected into the holes, under pressure, and fills any voids between the laminations and between the armature and the shaft.

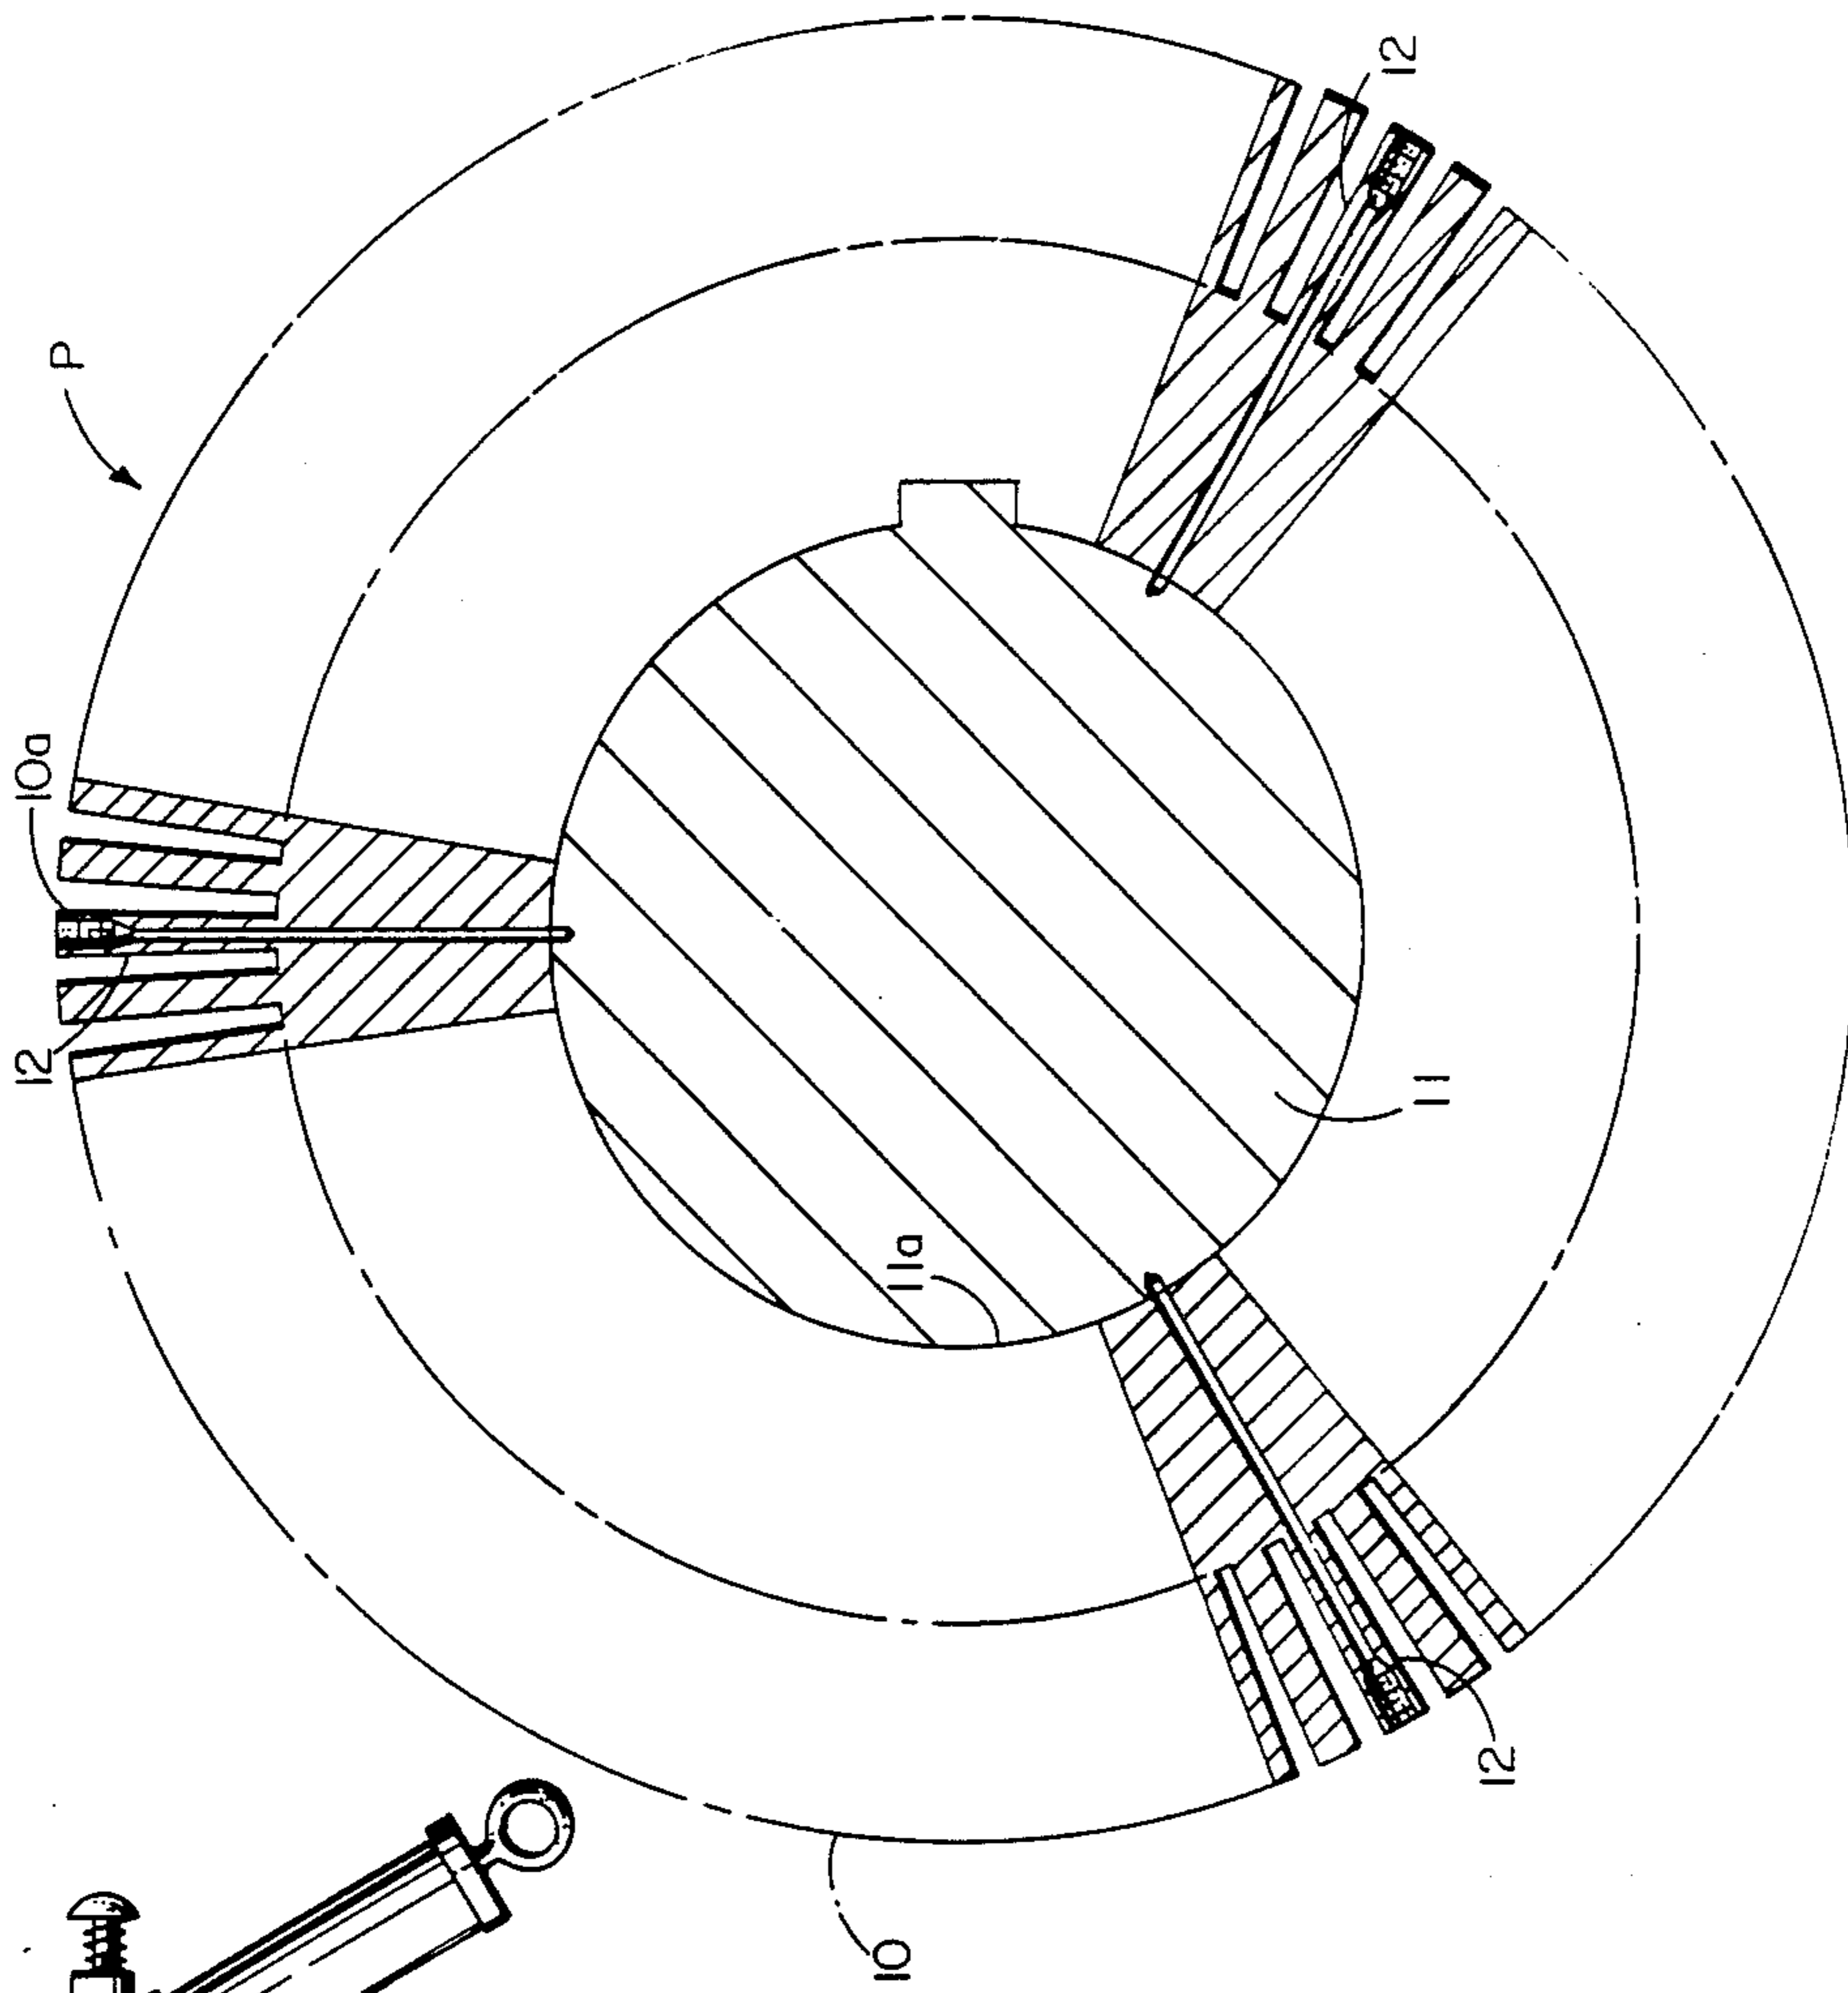
FIG. 1 is a cross-sectional view of a motor armature, exclusive of the armature windings; and

FIG. 1 shows a motor armature 10, on a shaft 11, as seen if looking down axially along the motor shaft. The armature is made up of a number of laminations forming a cylindrical stack. The armature 10 has slots between portions 10a, along its entire perimeter (360° around). In FIG. 1, however, only a portion of the slots, around the armature, are shown for convenience. The slots normally contain the armature windings, but these are not shown, also for convenience. The windings, if shown, would fit within the slots and they would be wound in a configuration that depends upon the desired motor winding parameters. This is well known, of course.

According to the present invention, a bore hole 12 is drilled through the armature, all the way to the shaft. In FIG. 1, three of these holes are shown, separated approximately 120° apart on a common circumferential plane P. The spacing is largely arbitrary. The criteria is adequate access to the shaft and the laminations. Similar holes may be placed axially along the armature, e.g., 1 inch apart, to provide access to the shaft along the entire armature. The holes provide access to the space 11a between the shaft and the armature, and this space, though small, also provides access to the laminations around it.

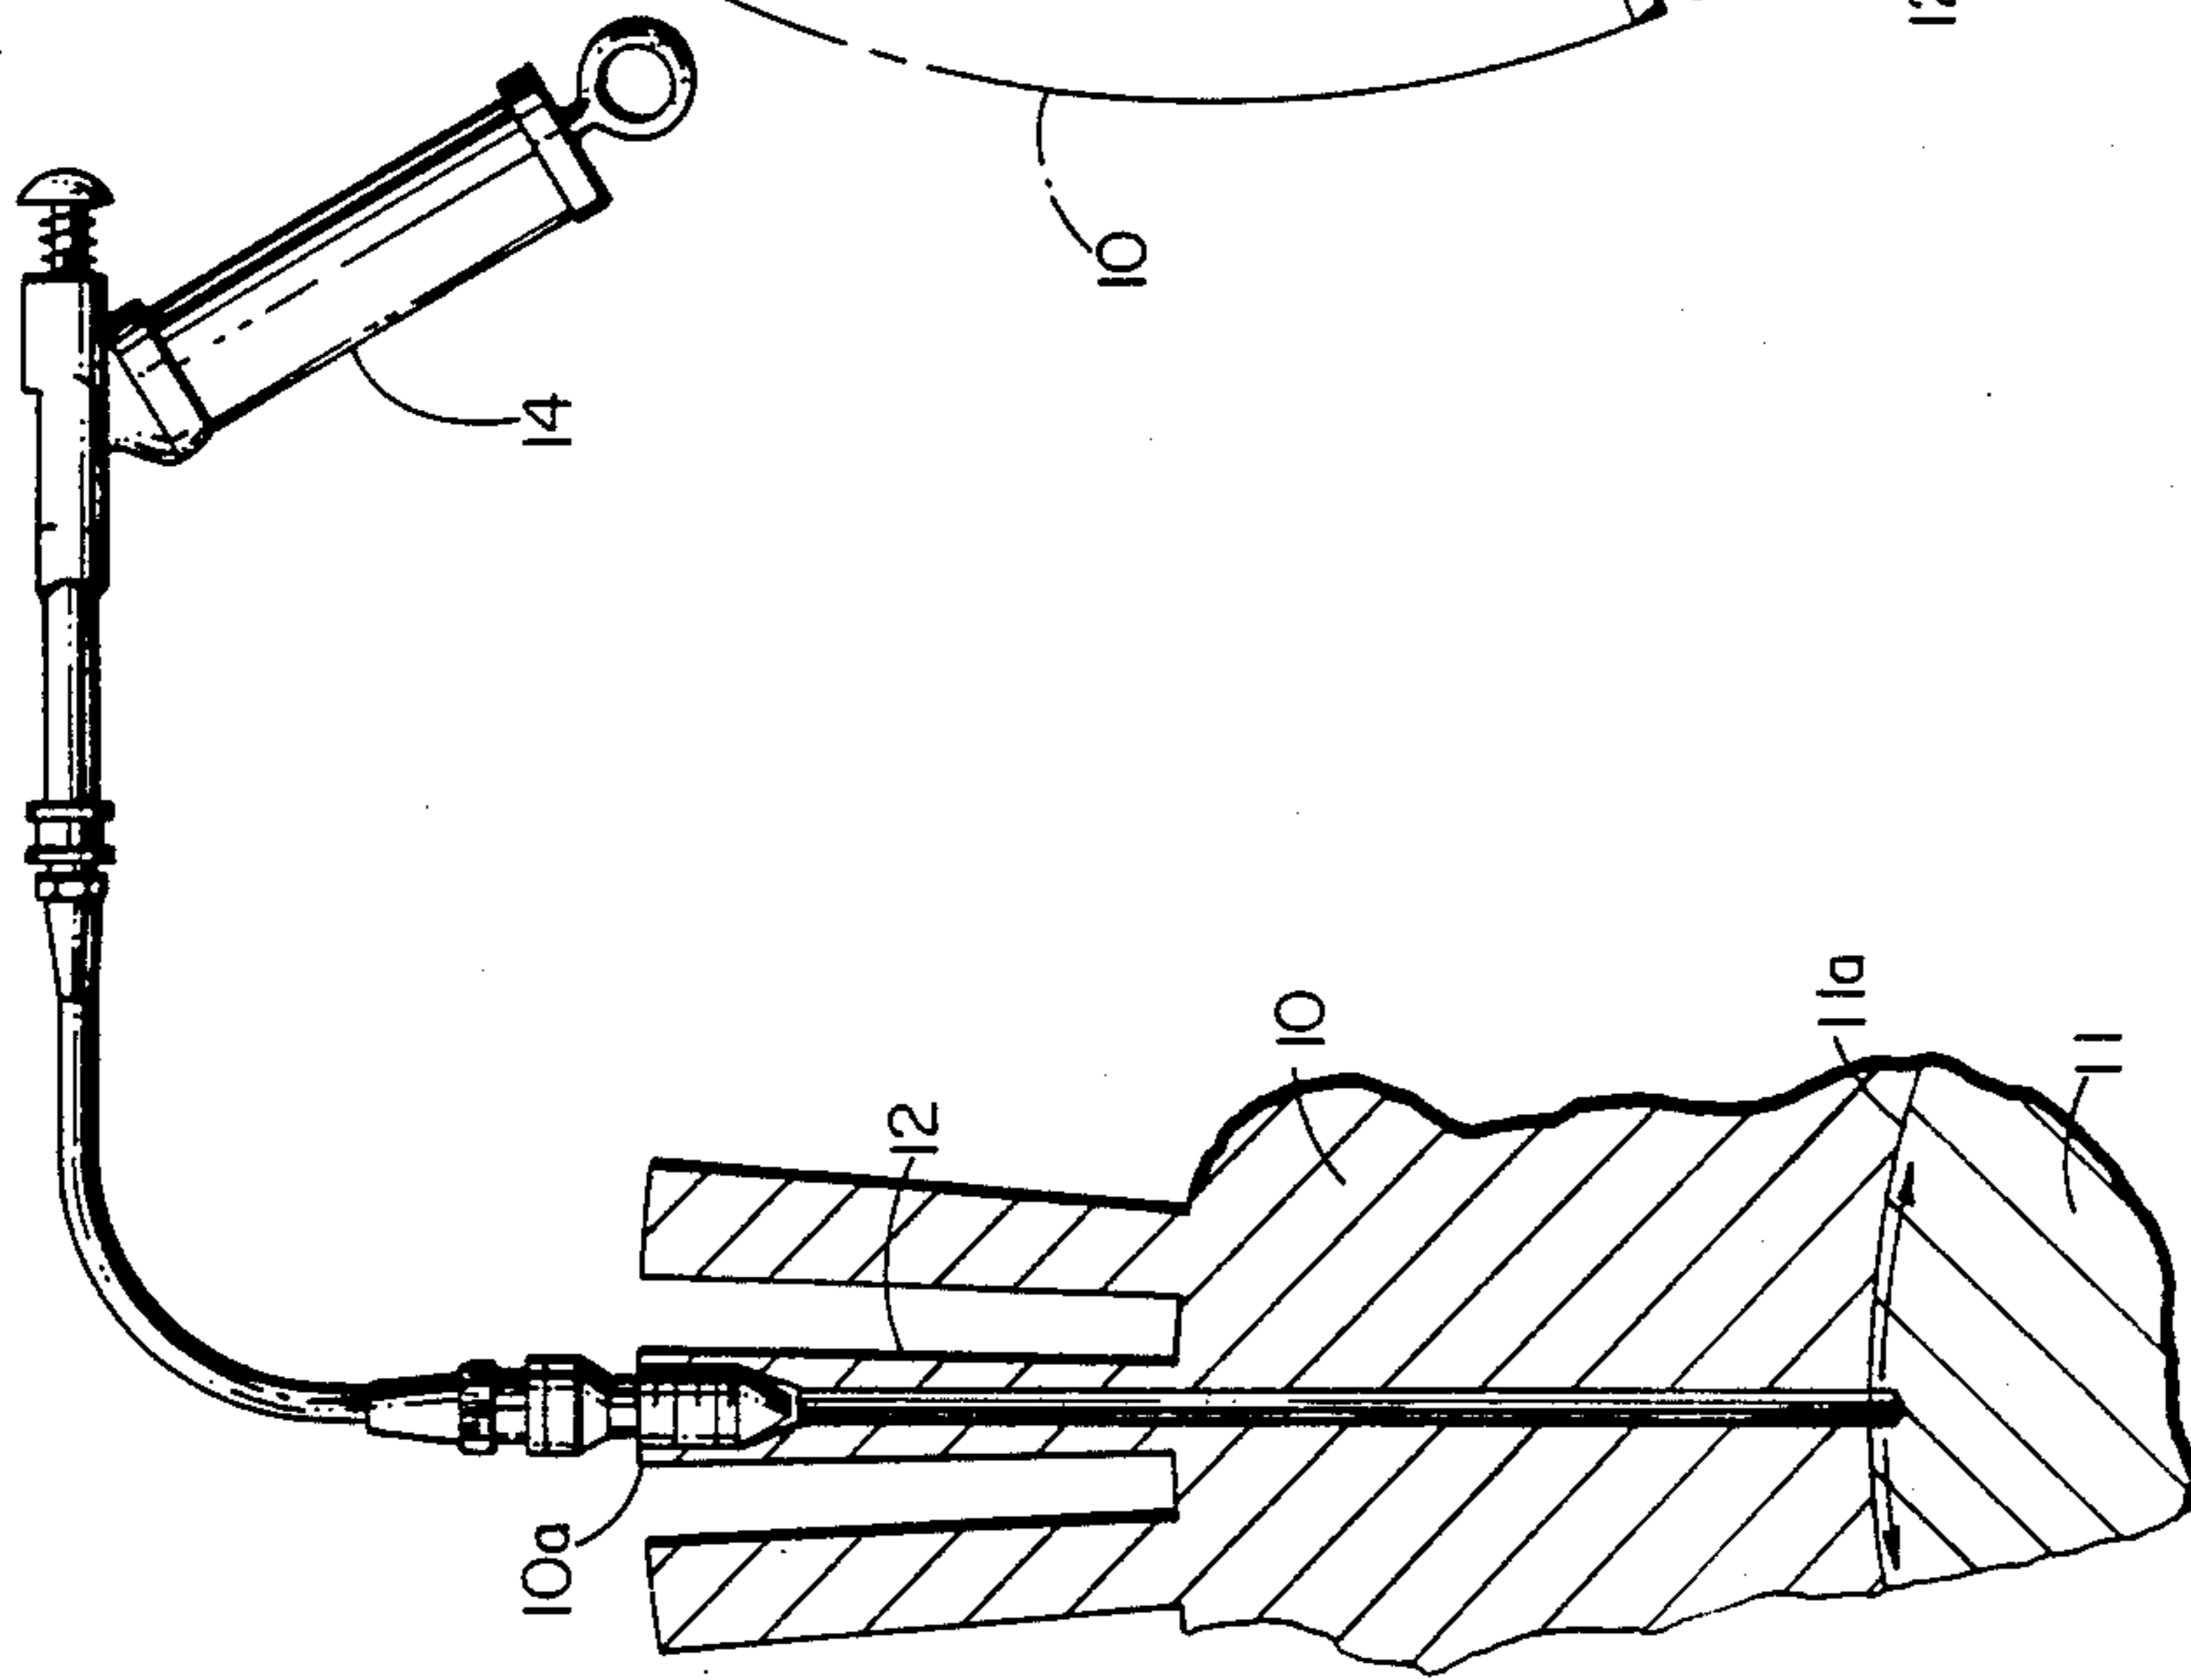
FIG. 2, also an elevational view, but of a portion of the armature, shows a pneumatic tool which is connected to a hole armature.

FIG. 2 shows a small portion of the armature 10. One hole 12 is shown there, and, like the others in FIG. 1, it extends through the armature to the shaft 11. According to the invention, adhesive is inserted under pressure through the hole, preferably using pressure gun 14. The gun is screwed into the outermost portion of the bore hole 12, which is suitably threaded for this purpose. The adhesive is forced into the hole 12, flowing within space area 11a and any void within any immediate laminations. The adhesive is similarly applied through each bore hole 12, and the entire space between the shaft and the armature is filled with adhesive, as a result of the process. Once the adhesive cures, the armature is tightly bonded to the shaft and the laminations are tightly bonded to each other.
