[54] FASTENED LIGHTNING PROTECTION REPAIR SYSTEM AND METHOD FOR ITS USE

[73] Assignee: The Boeing Company, Seattle, Wash.

A lightning protection repair system for graphite epoxy structures. An aircraft graphite epoxy structure is repaired by fastening a repair plate over the hole to be covered, followed by a dielectric sheet covering the outer surface of the metal repair plate. An electrically conducting lightning diversion sheet, conforming to the outer surface of the repair plate, is fastened to the repair plate through the dielectric sheet. The edges of the lightning diversion sheet are bent toward the outer surface of the aircraft graphite epoxy structure to be adjacent or touching its outer surface. Sealing compounds can be used around the repair plate to prevent moisture intrusion, and the repair can be faired into the aircraft graphite epoxy structure by means of a fairing compound.

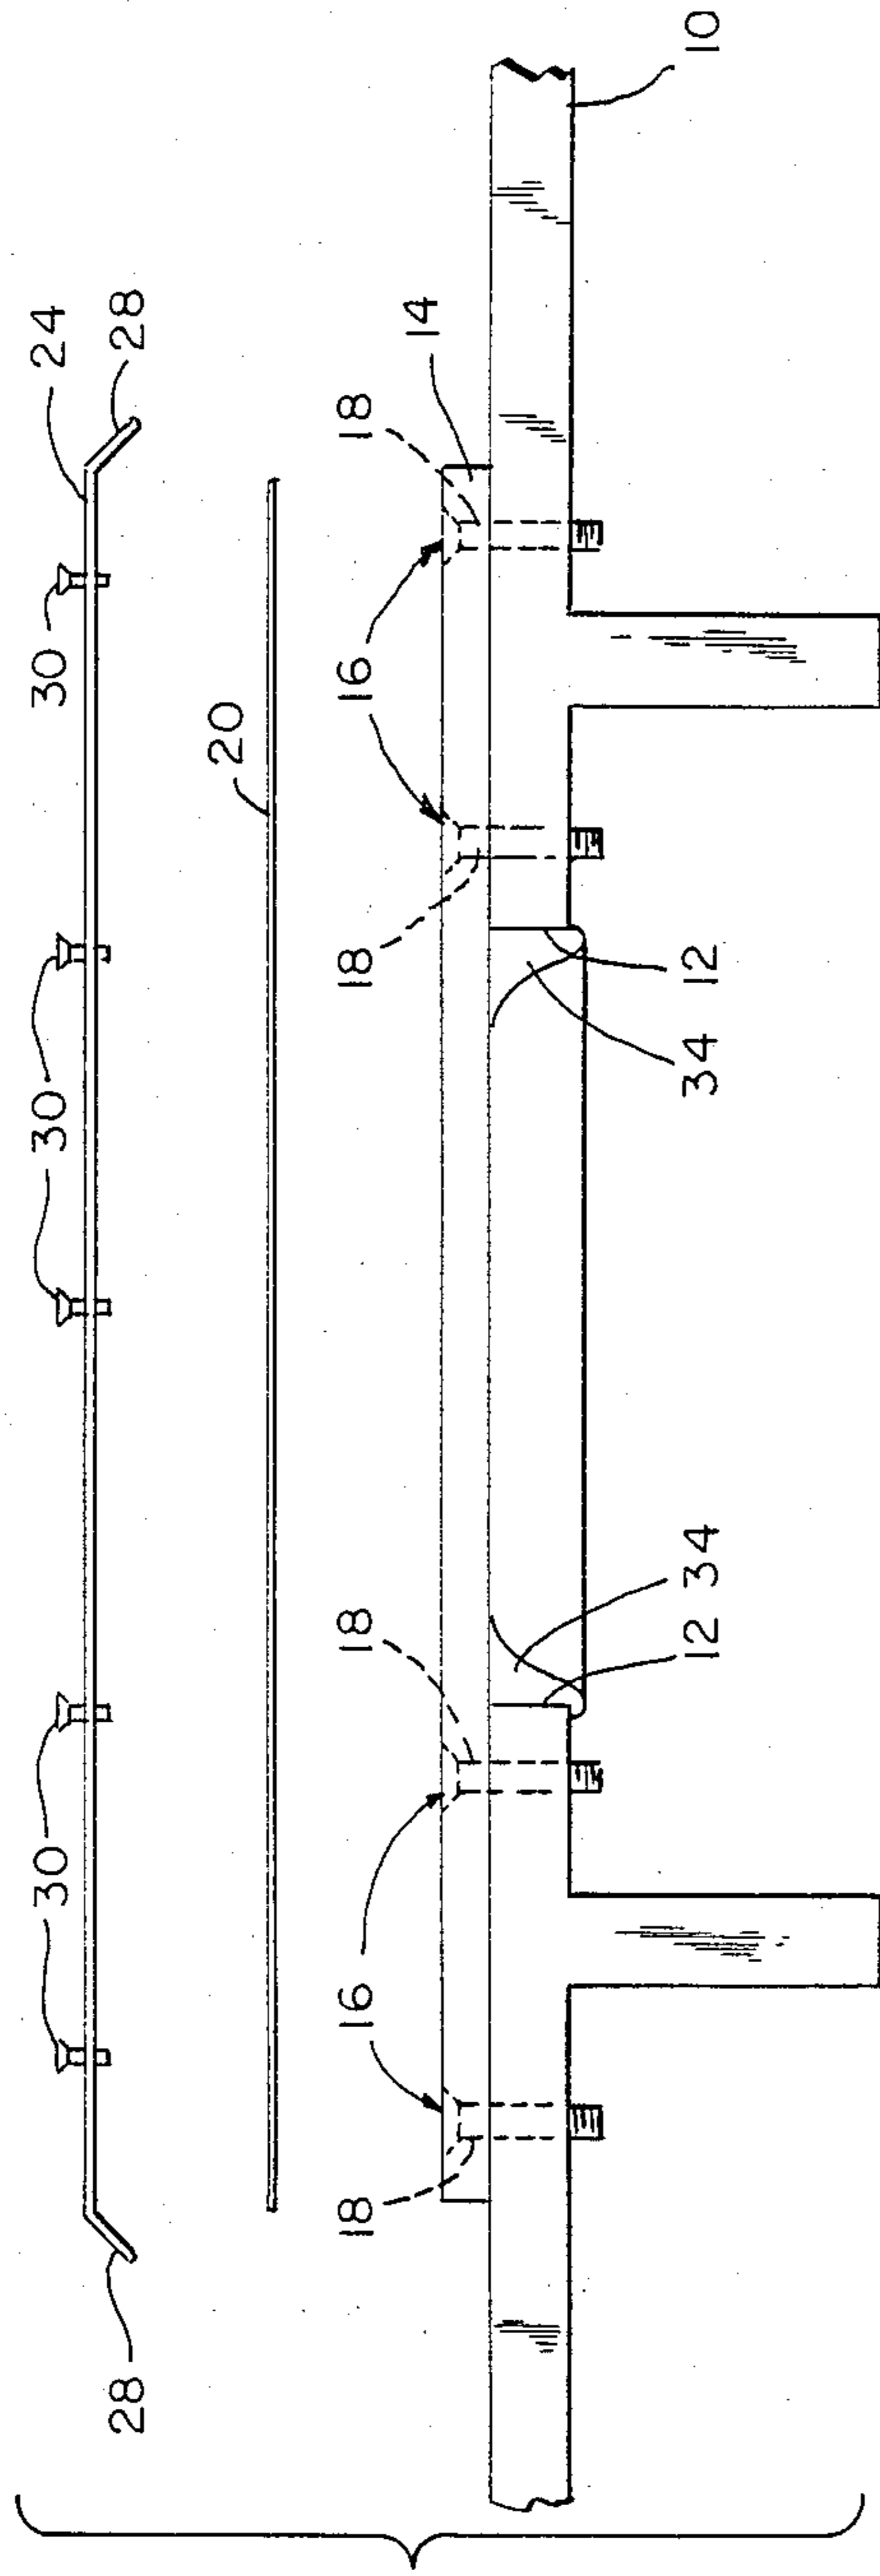
FIG. 1 is a cross-sectional view of a fastened lightning protection repair system showing the repair plate, the dielectric layer, and the diversion sheet; and

Referring to FIG. 1, an aircraft graphite epoxy structure 10 having a hole 12 has been repaired by the fastened lightning protection system of the present invention. Hole 12 has been covered over by a repair plate 14, which can, for example, be made from aluminum. Repair plate 14 completely covers hole 12 from the outside of aircraft graphite epoxy structure 10. Plate 14 can be attached to graphite epoxy structure 10 by means of fasteners 16, which can, for example, be titanium bolts 18. The fasteners are countersunk into the outer surface of metal repair plate 14. A suitable form of fastener 16 is the Hi-Lok™ fastener.

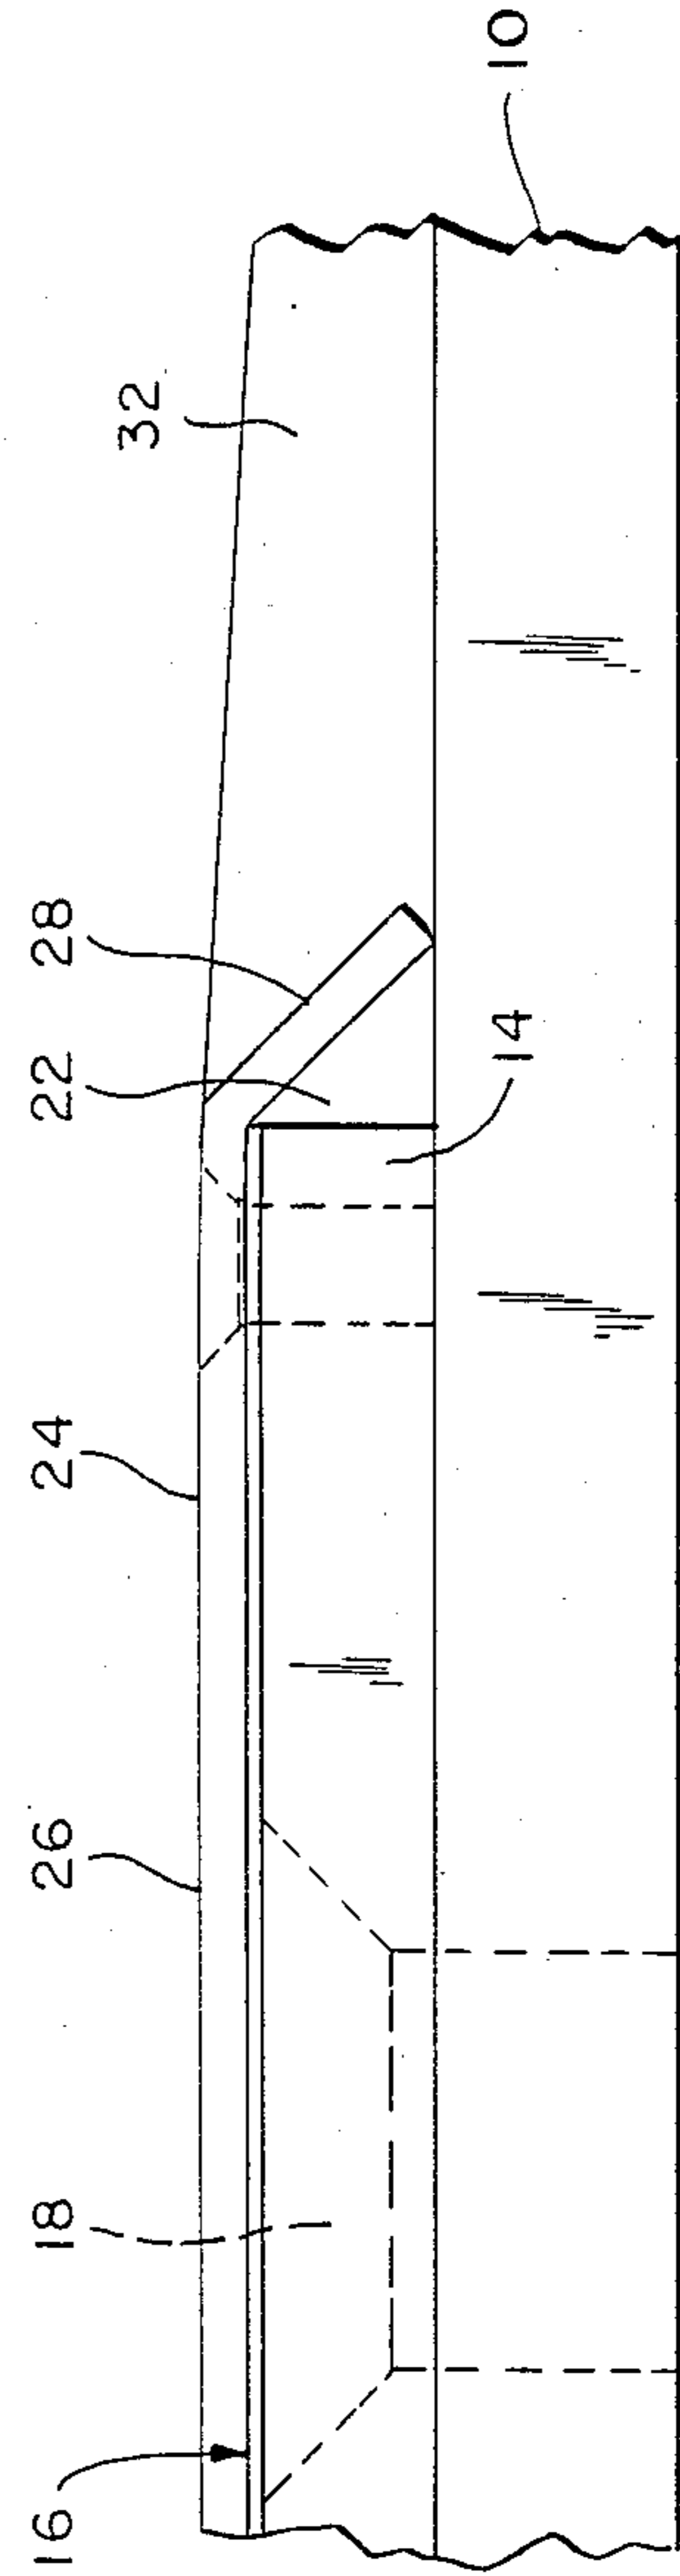
FIG. 2 is a closeup cross-sectional view of the fastened lightning protection repair system showing the relationship of the diversion sheet and the aircraft graphite epoxy structure.

As shown in the closeup view of FIG. 2, the edge of plate 14 can be sealed by means of a polysulfide sealant 22 to prevent moisture intrusion and subsequent freeze-thaw cycle damage. An electrically conducting lightning diversion plate 24 conforms surface of repair plate 14. The edges 28 of the diversion plate 24 are bent downwardly around the whole periphery of lightning diversion plate 24. Lightning diversion plate 24, which may be made from 32 mil aluminum sheet, is then attached to repair plate 14 by means of fasteners, such as countersunk screws 30. Edge 28 is bent downwardly so as to be adjacent the outer surface of aircraft graphite epoxy structure 10 (see FIG. 2). This creates an electrical path between the diversion plate 24 and the aircraft graphite epoxy structure. Finally, diversion plate 24 is faired into the surface of the aircraft graphite epoxy structure 10 by means of a ramp of fairing compound 32.
