[54] DETERIORATED EAVEPOST REPAIR APPARATUS FOR HOUSES HAVING SAME

Apparatus and method for repair of deteriorated eaveposts on houses having eaveposts. The apparatus consists of an elongated, tubular body with an end cap and a mounting flange. The apparatus slips over the deteriorated eavepost and attaches to the house with conventional fasteners. The body and end cap of the apparatus are textured to resemble the texture of an intact wooden eavepost and the mounting flange is textured to resemble the texture of the exterior wall of the house.

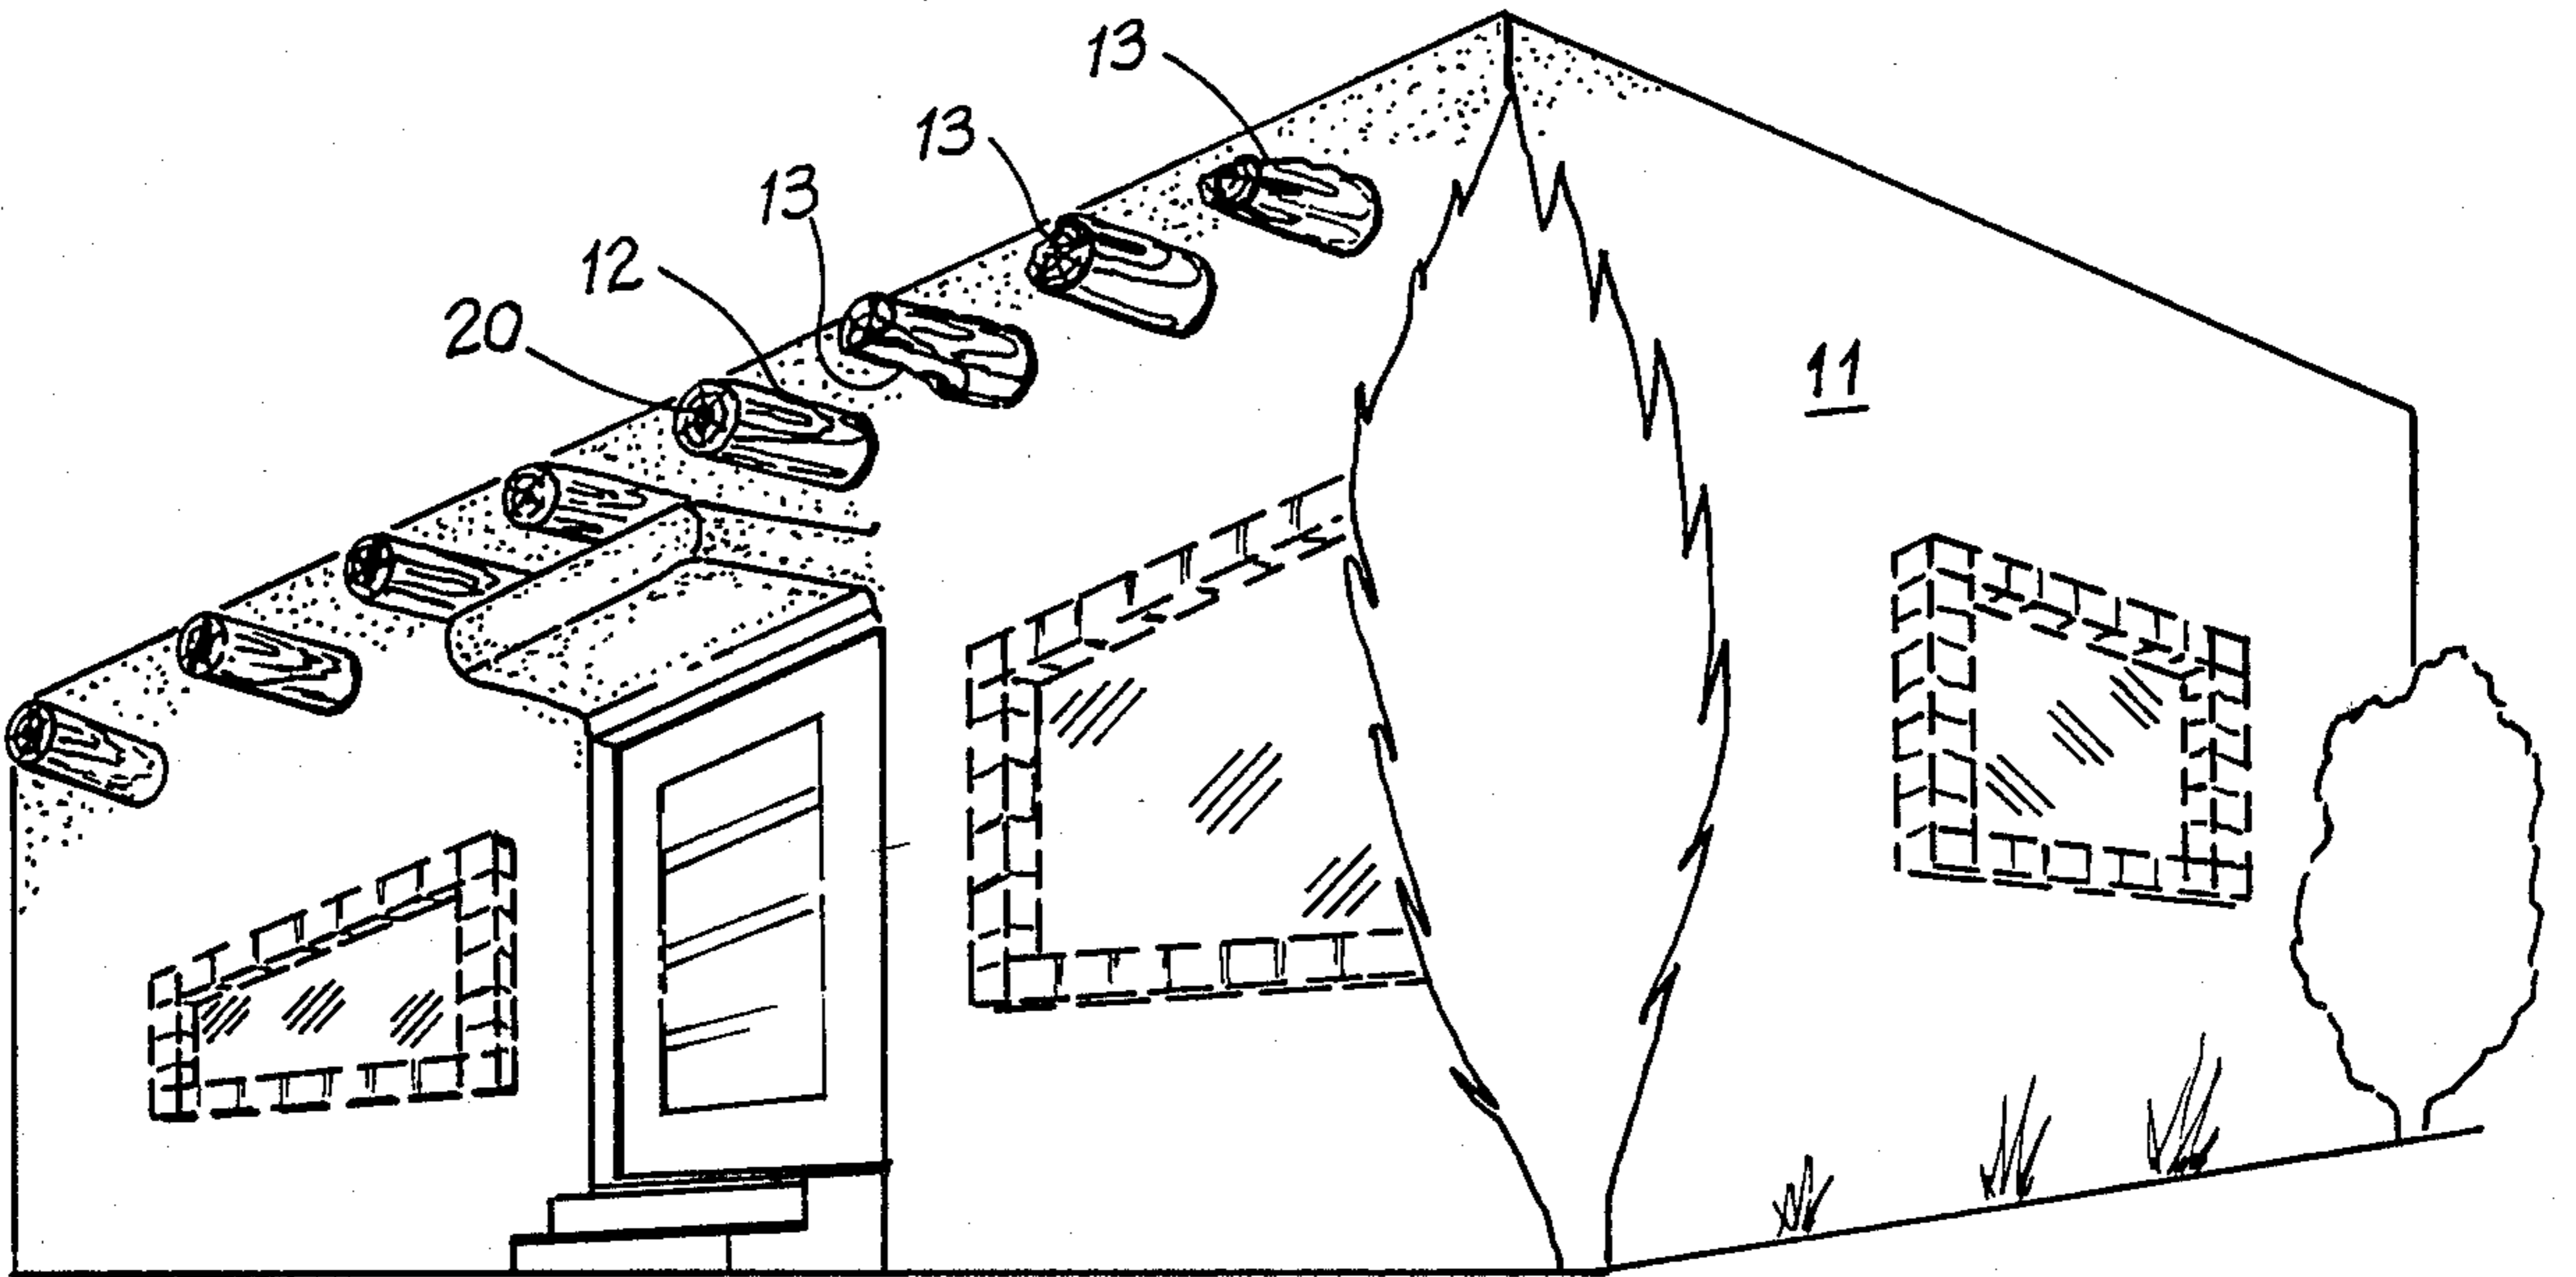
Fig. 1

FIG. 1 is a side elevational view of a home in the southwest style having exposed eaveposts which have deteriorated.

As seen in FIG. 1, houses in the southwest style 11, have exposed, wooden eaveposts 12, called vigas, which have intact, round, wood ends 20. Exposure to the elements results in cracked, broken, and chipped eaveposts 13.

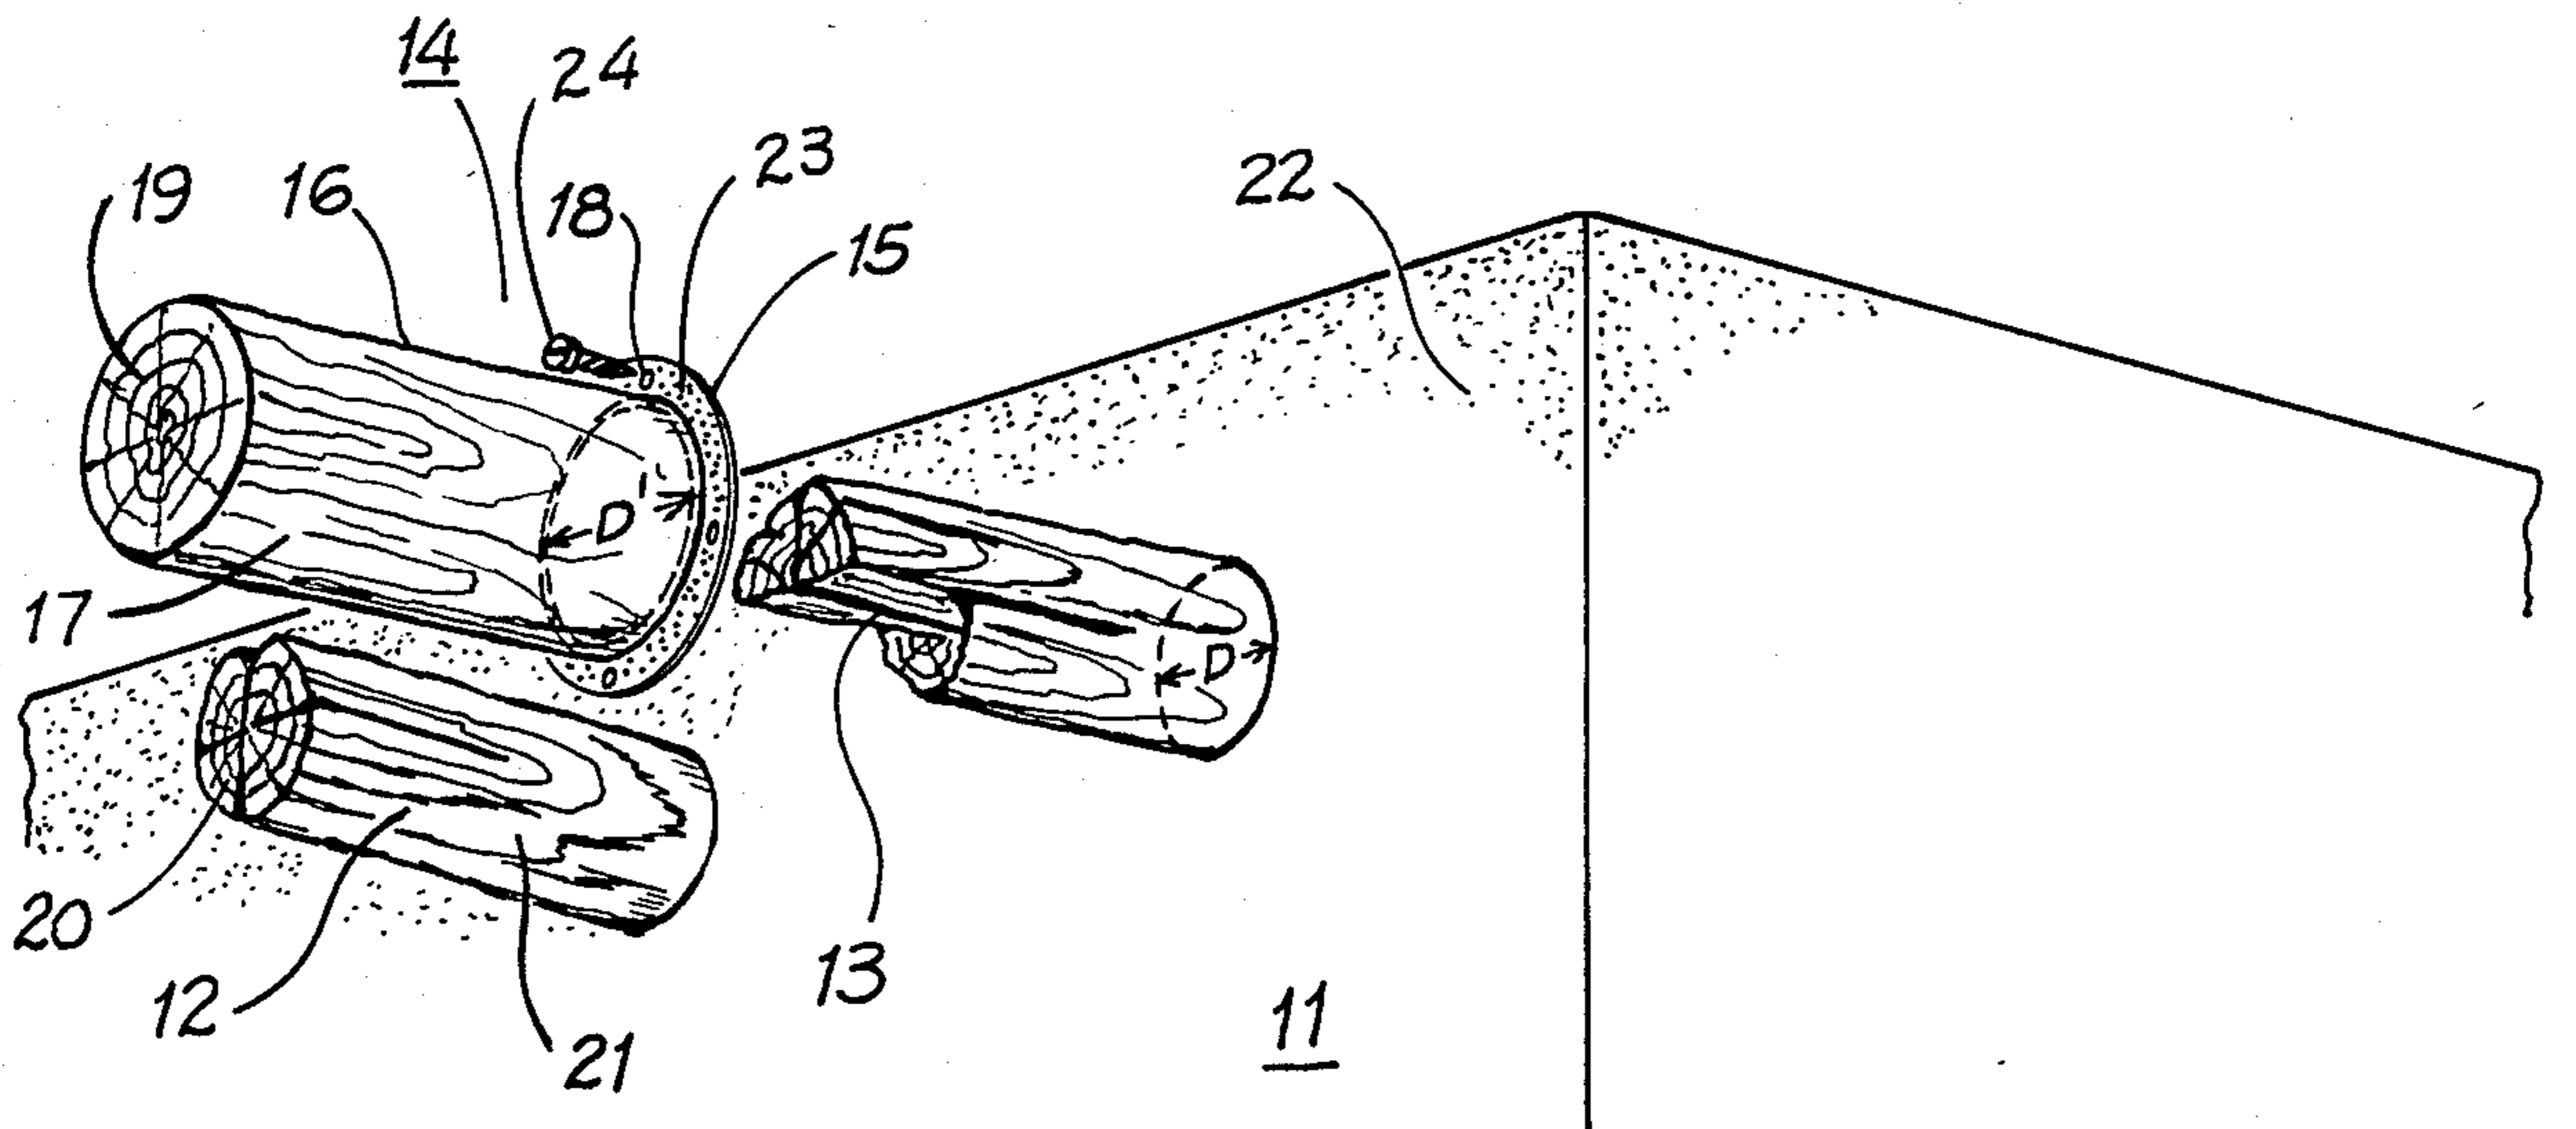
Fig. 2

FIG. 2 is an enlarged perspective view of a deteriorated eavepost and of the repair apparatus of the present invention.

Referring now to the drawings, and more particularly to FIG. 2, there is shown a repair apparatus, generally designated 14, which comprises the preferred embodiment of the invention. The apparatus includes an elongated body 16, and end cap 19, and a mounting flange 15.

FIG. 2 shows the preferred embodiment of the invention which provides a method for slipping a repair apparatus 14 over a deteriorated eavepost 13. The repair apparatus 14 consists of an elongated tubular body 16, which has a wood grain appearance 17 resembling that of an intact eavepost 21 and which has a length only nominally longer than that of an intact eavepost 12. The interior diameter D' of the tubular body 16 is minimally larger than the exterior diameter D of the eavepost being repaired 13. An end cap 19 is attached to the tubular body 16 and has a wood grain appearance 19 which resembles the appearance of the end of an intact eavepost 20.

The repair apparatus 14 has a round mounting flange 15 having holes 18 through which the apparatus 14 is attached to the house 11 by conventional means 24. The mounting flange 15 has a texture 23 which resembles the texture of the exterior wall of the house 22.
