- [54] ENVELOPE FOR PROTECTING DISASSEMBLED STATOR COIL
- [75] Inventor: Daniel Klawitter, Fond du Lac, Wis.
- [73] Assignee: Brunswick Corporation, Skokie, Ill.
- [21] Appl. No.: 297,990
- [22] Filed: Jan. 17, 1989
- [51] Int. Cl.<sup>5</sup> ..... B23P 19/04; B65D 33/16
- [52] U.S. Cl. .... 29/722; 29/700; 206/349; 383/86
- [58] Field of Search ..... 29/156.4 R, 700, 722, 29/729, 760; 206/349; 383/84, 86, 86.1, 86.2, 99

## ENVELOPE FOR PROTECTING DISASSEMBLED STATOR COIL

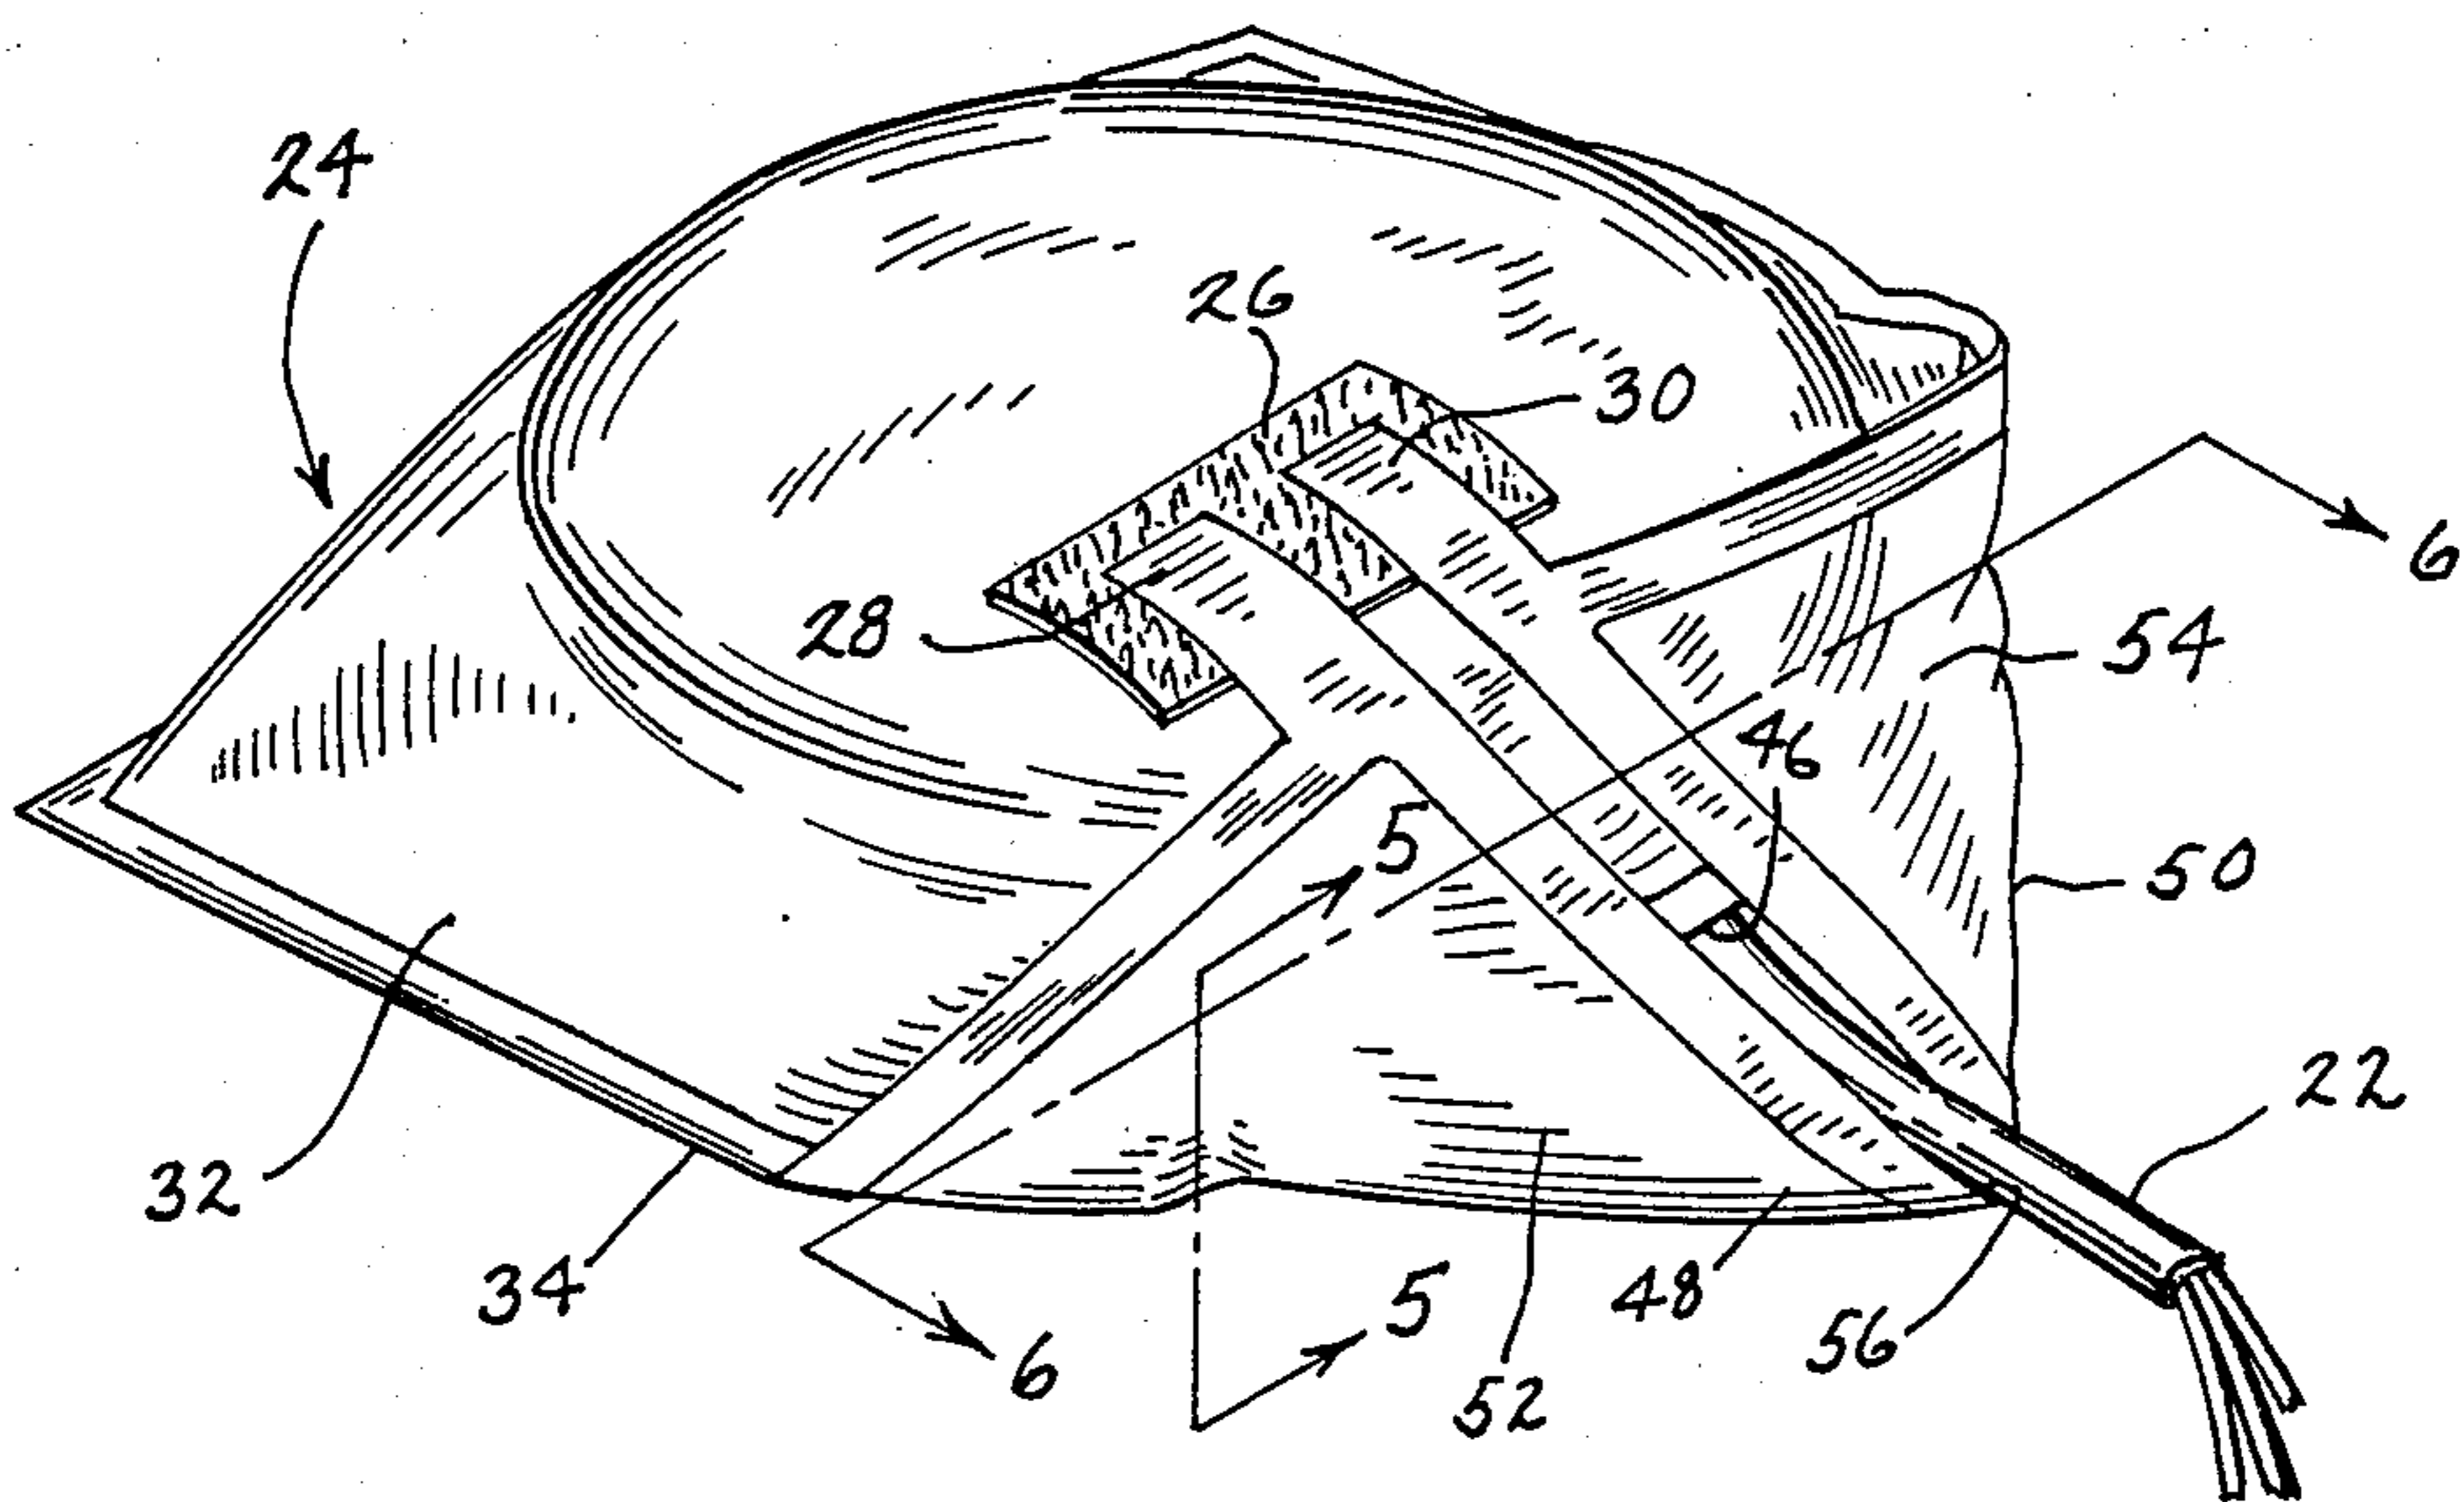
FIG. 2 shows a stator envelope in accordance with the invention, with a stator coil therein.

In the present invention, stator coil 16 is placed in a protective envelope 24, FIGS. 2 and 3, to protect the stator coil from damage and abrasion during movement of the engine during repair while stator coil 16 dangles from the engine by wires 22, as shown at 22a, FIG. 1, and is subject to striking miscellaneous objects in the immediate vicinity, as noted above. The envelope also protects the stator coil when on a workbench or stored on a shelf, etc. The envelope is closed, with wires 22 extending outwardly therefrom and remaining attached to the engine such that the envelope is retained on the stator coil to provide protection during repair. The envelope is closed at fasteners 26, 28, 30 to enclose the stator coil, and to retain the envelope on the stator coil. The fasteners are hook and loop type fasteners, for example as known under the trademark VELCRO, snaps, or other suitable attachment or closure structure. The envelope is opened following the engine repair, and the stator coil is removed from the envelope and replaced on the crankshaft.

Envelope 24 is a canvas or the like material and has a frontwall 32 and a backwall 34 forming an open-topped pocket 36 therebetween, FIG. 3, receiving stator coil 16. Frontwall 32 has an upper flap folded over stator coil 16 along fold lines 38 and 40 forming first and second folded flap portions 42 and 44 defining a slit 46 therebetween through which wires 22 extend outwardly, FIG. 4. Backwall 34 has an upper flap folded over the folded flap of the frontwall and over stator coil 16 along fold lines 48 and 50 forming folded flap portions 52 and 54 defining a slit or opening 56 therebetween, FIG. 2, through which wires 22 extend outwardly.
