[54] METHOD OF INSPECTING TIRES FOR DEFECTS

[57] ABSTRACT

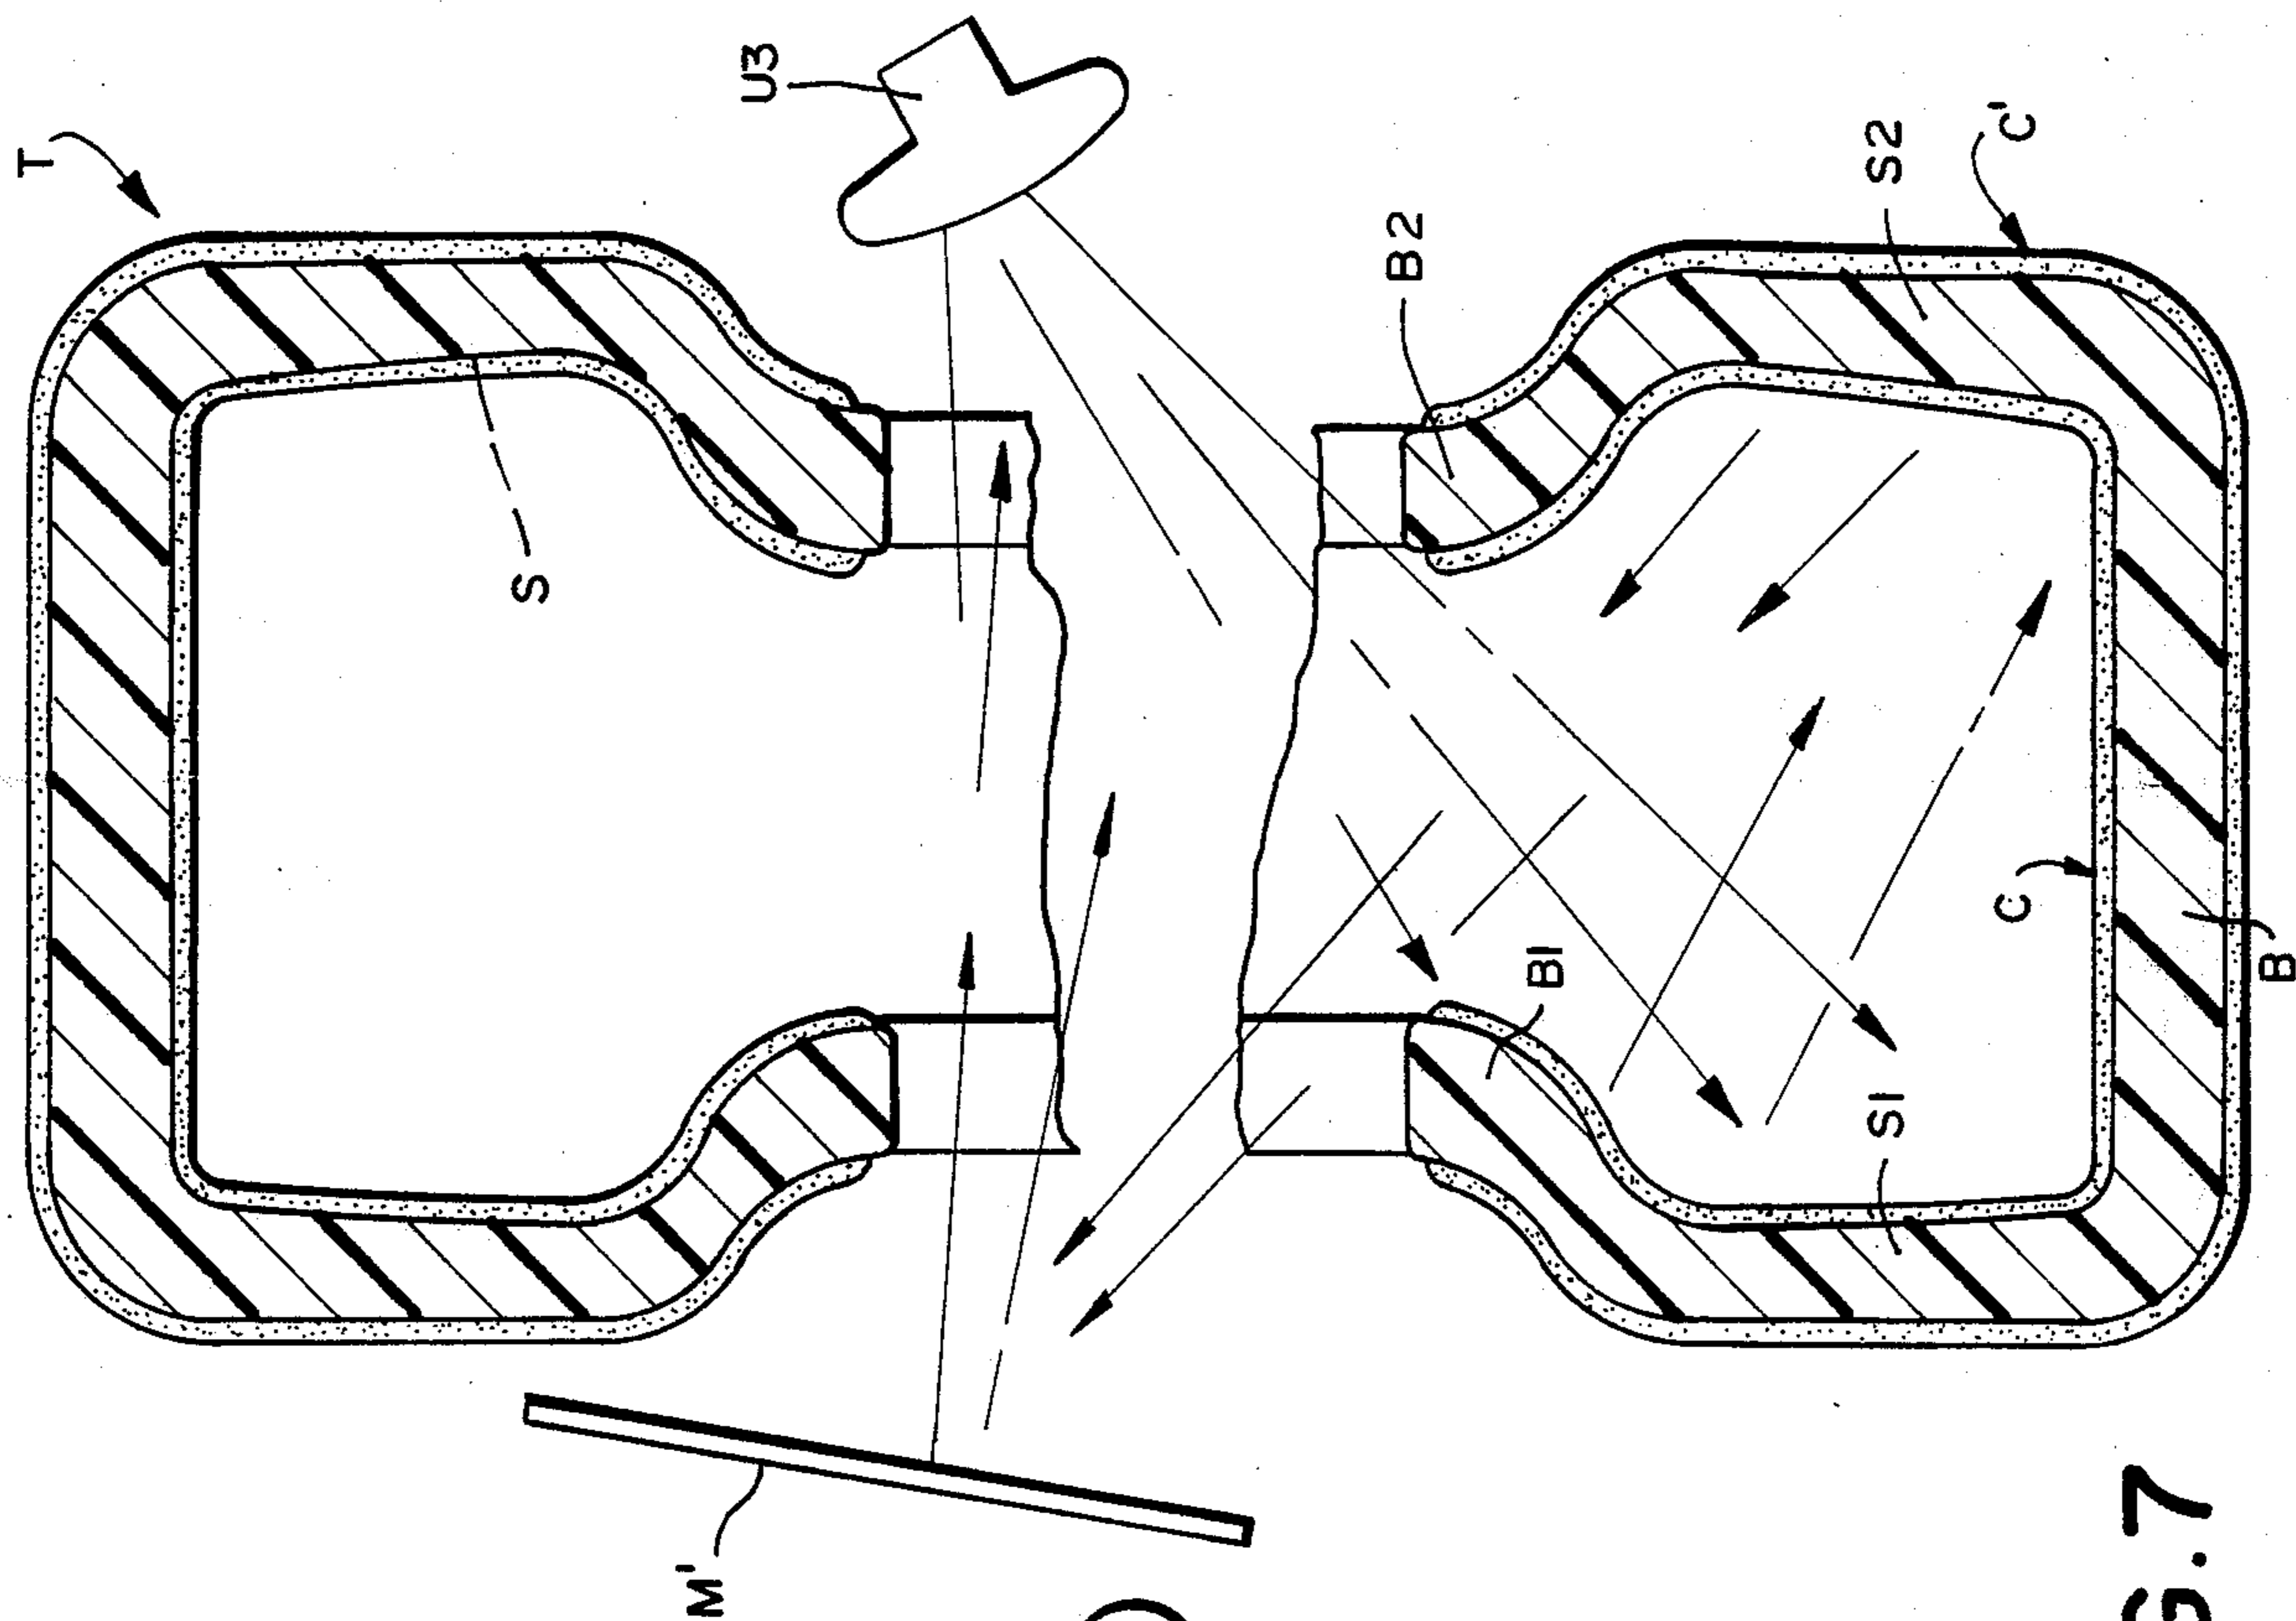
FIG. 7 is a fragmentary sectional view similar to FIG. 6 after the excess coating material has been removed from the tire interior, the tire has been removed from the expandable hub, and the tire exterior and interior can be spot-checked for relative large defects.

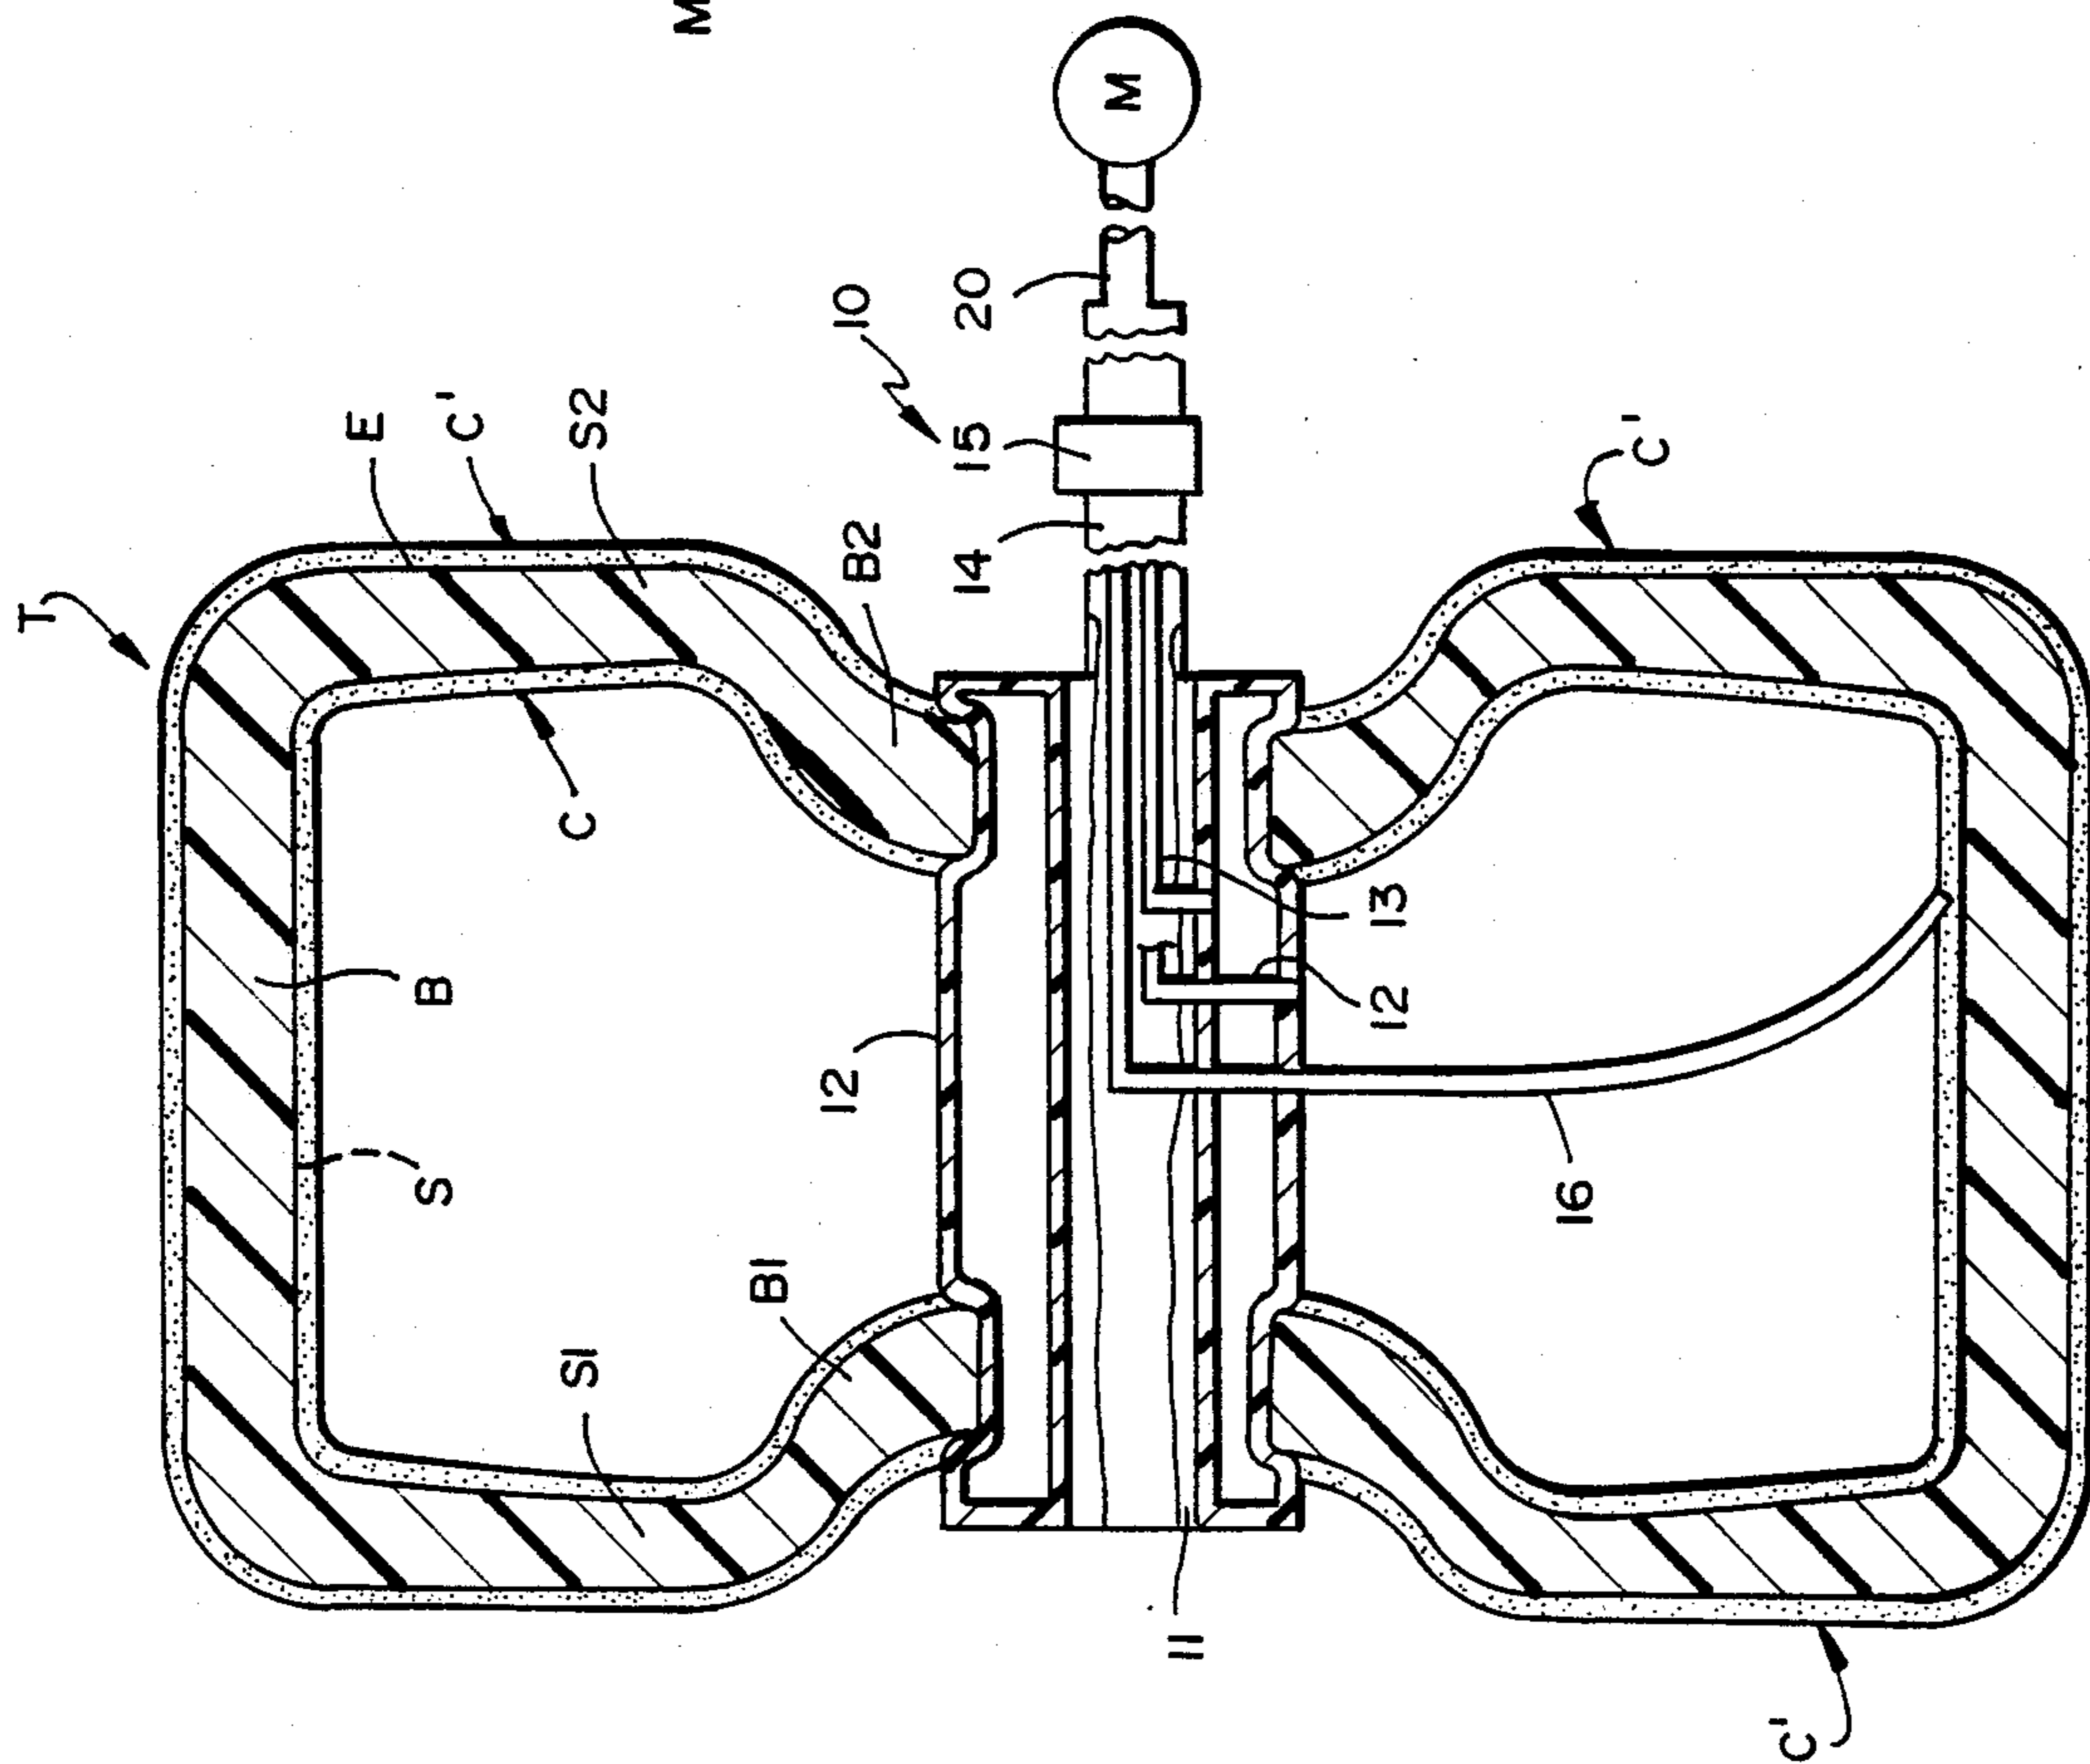
FIG. 6 is a fragmentary schematic view illustrating the tire after having been removed from the tank of FIG. 5 with the exterior coated with the coating material.

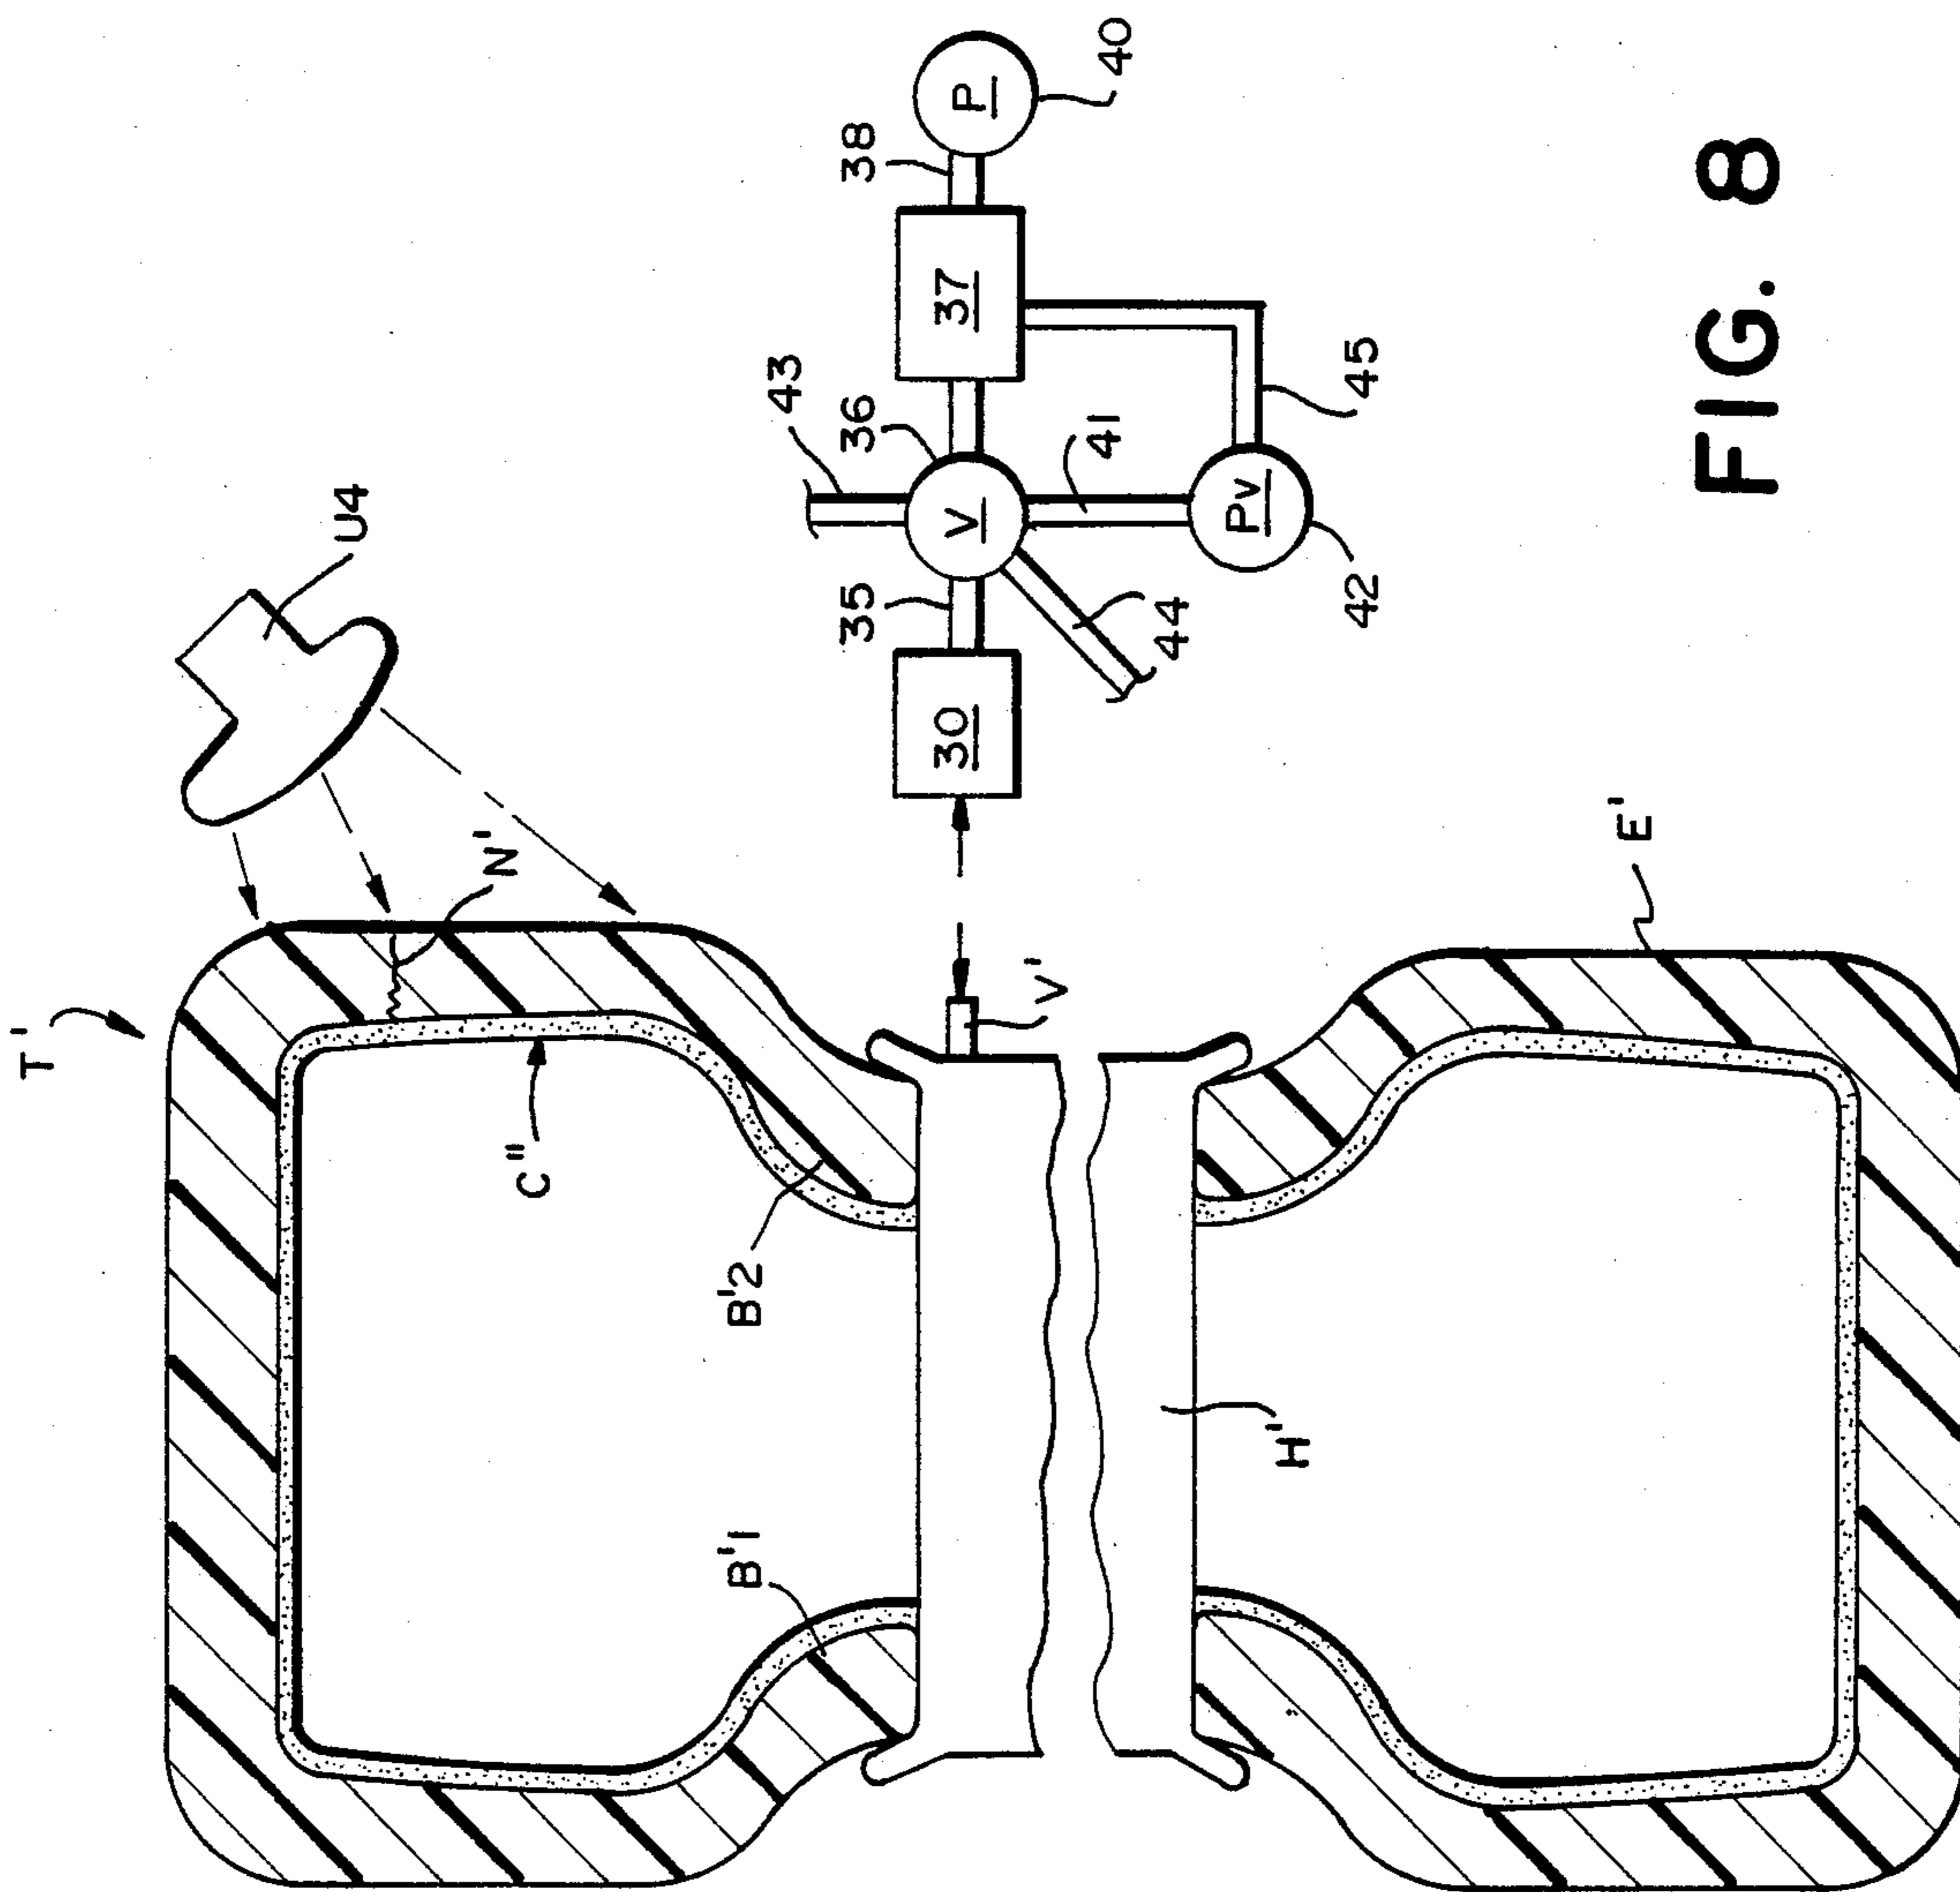
FIG. 8 is a fragmentary schematic view of a conventional tire mounted on a conventional rim having a conventional valve connected to a system for pumping coating material into the tire and removing the coating material out of the tire through the valve stem and externally inspecting the tire for coating material migration so that defects can be found and repaired without removing the tire from the rim.
