[54] METHOD OF INSPECTING TIRES FOR DEFECTS

A method of inspecting a tire for defects by applying to an interior surface of a tire a coating of material which accentuates defects when influenced by predetermined electromagnetic wavelengths, road-running the tire to thereby create tread wear, buffing the exterior tread surface of the tire, and applying predetermined electromagnetic wavelengths to the exterior of the buffed tread surface whereby coating material which has migrated through a defect in the tire to the exterior is accentuated and thereby readily detected. Preferably the coating material fluoresces or brightens when subjected to ultraviolet light. The coating material is preferably part of an admixture composed of the ultraviolet light accentuating coating material and a tire sealant which seals punctures, nail holes and the like when the same migrates through the tire.

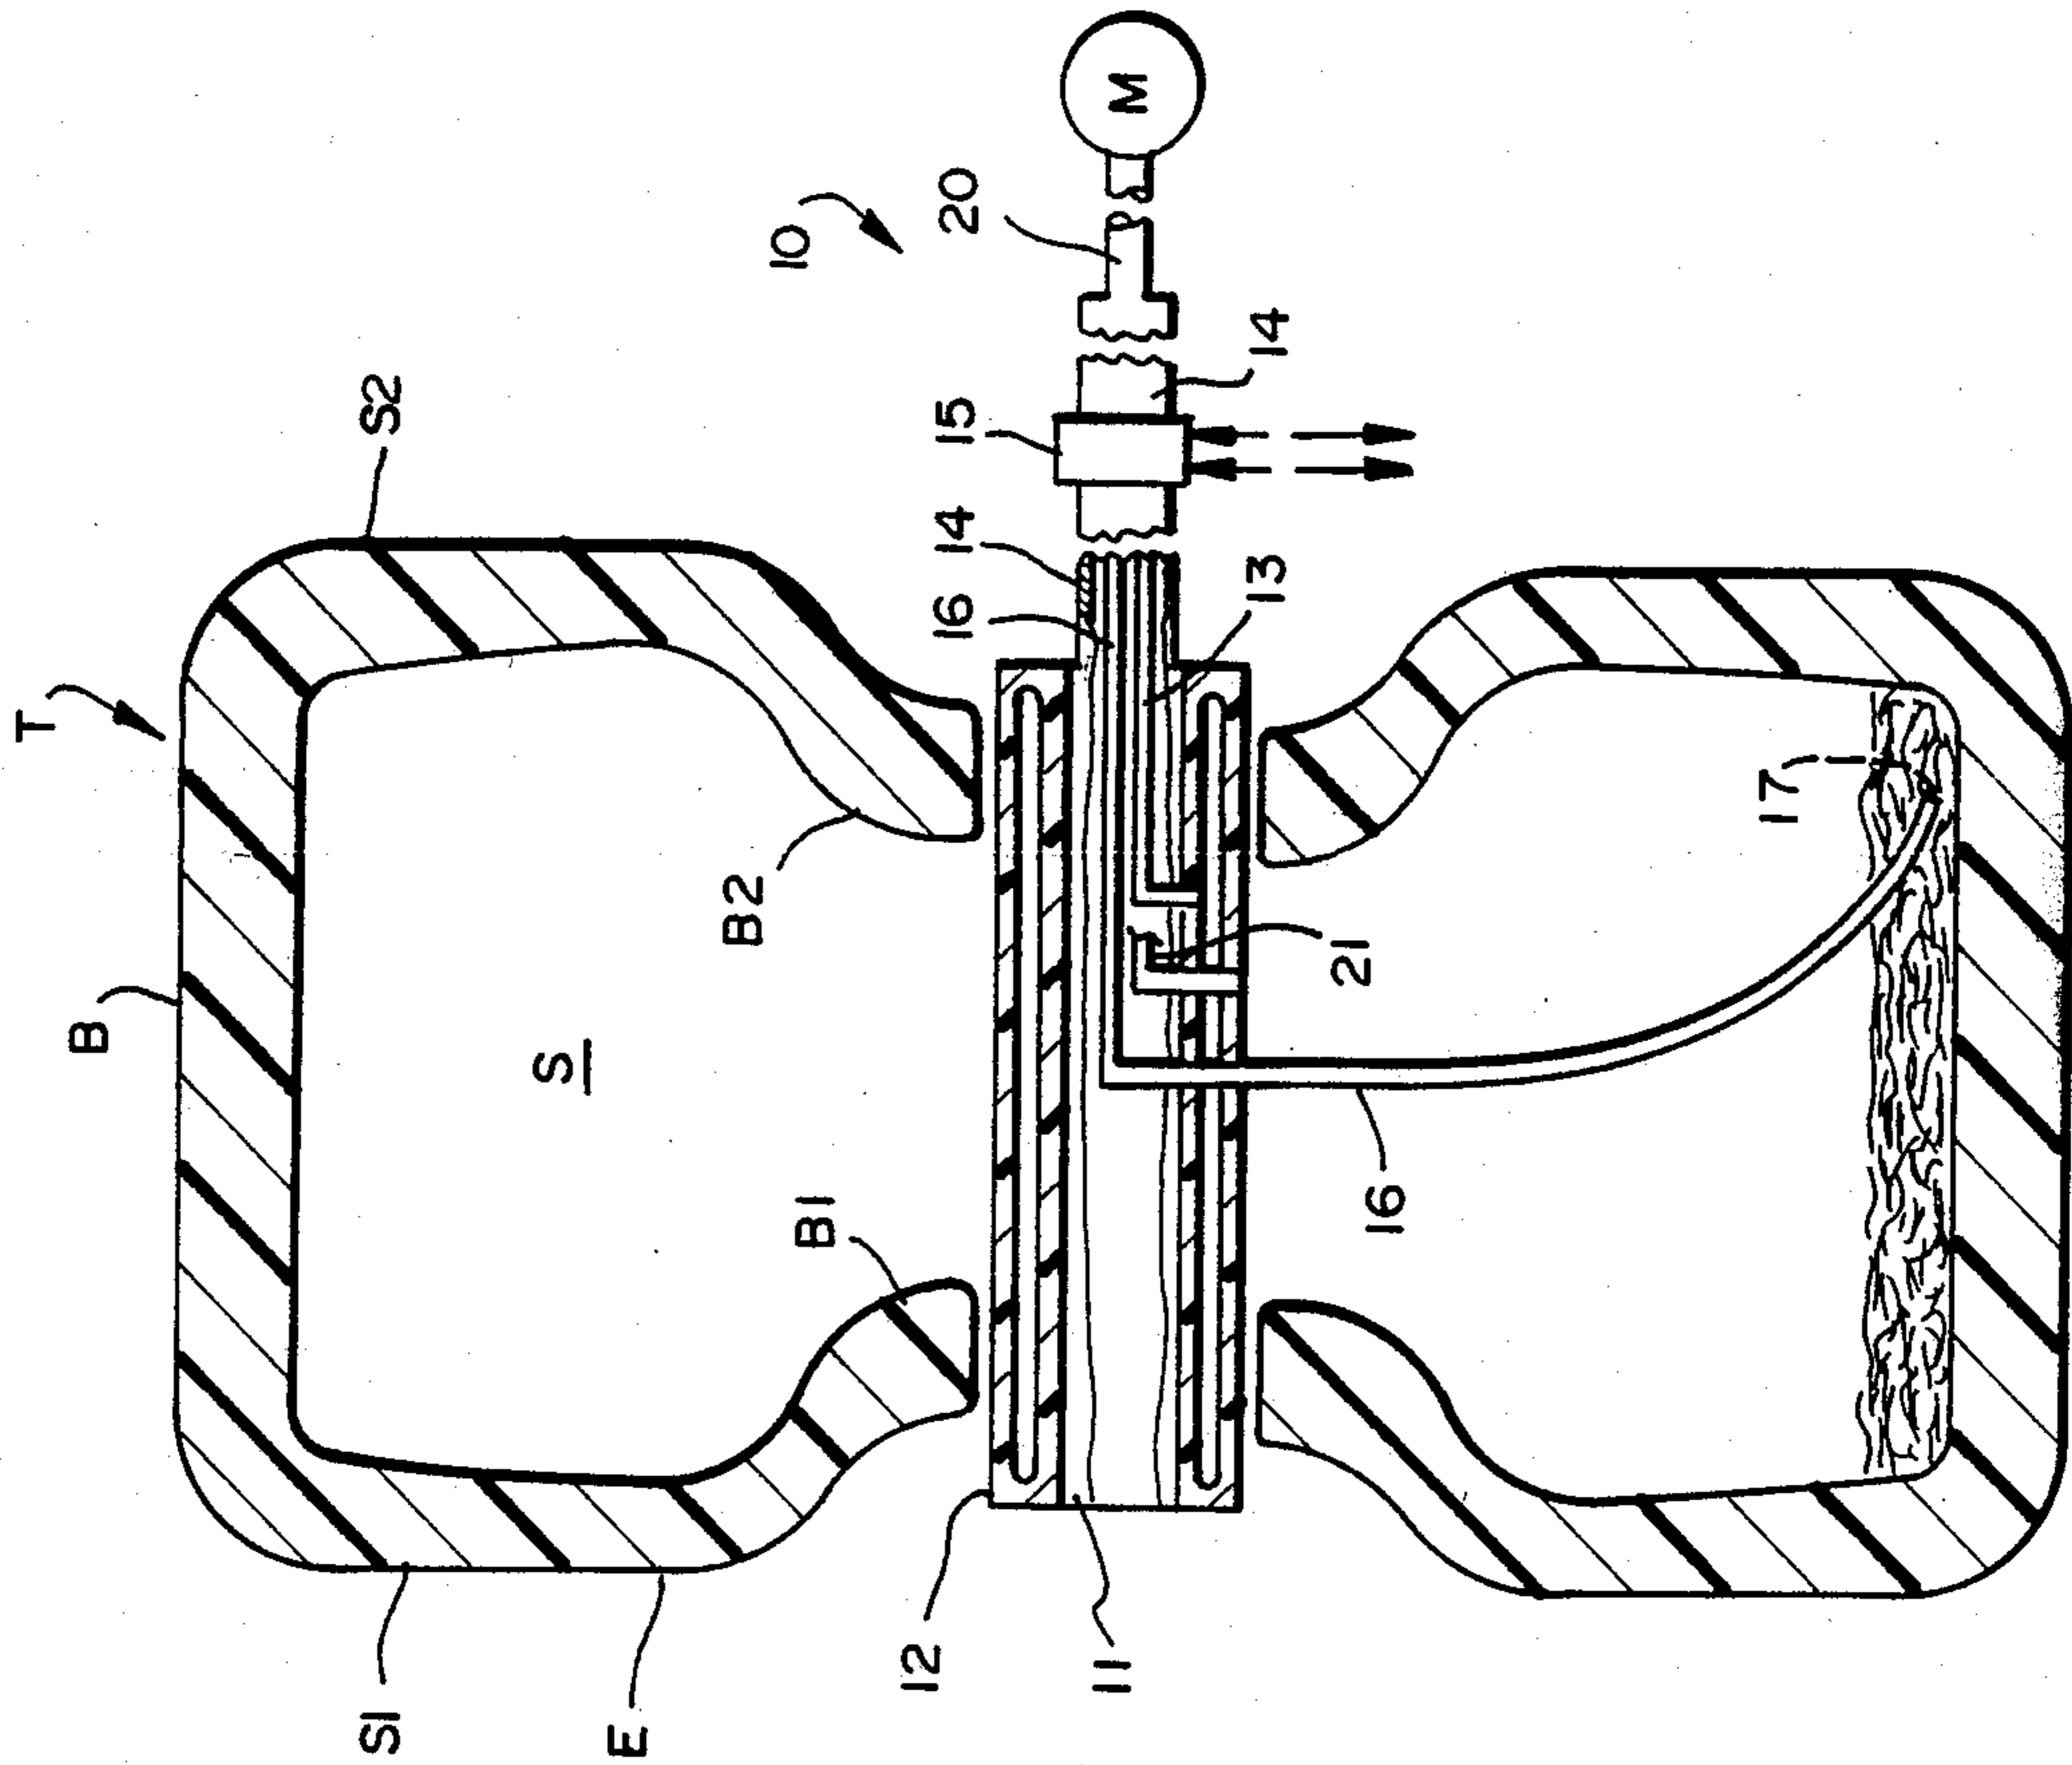
FIG. 1 is fragmentary schematic view taken through the axis of a tire and an expandable mandrel carried by a rotatable shaft and illustrates the initial step of the process.

The interior surface S of the tire T is thoroughly vacuumed clean before the tire is positioned generally in coaxial relationship to the expandable hub 12, as shown in FIG. 1.

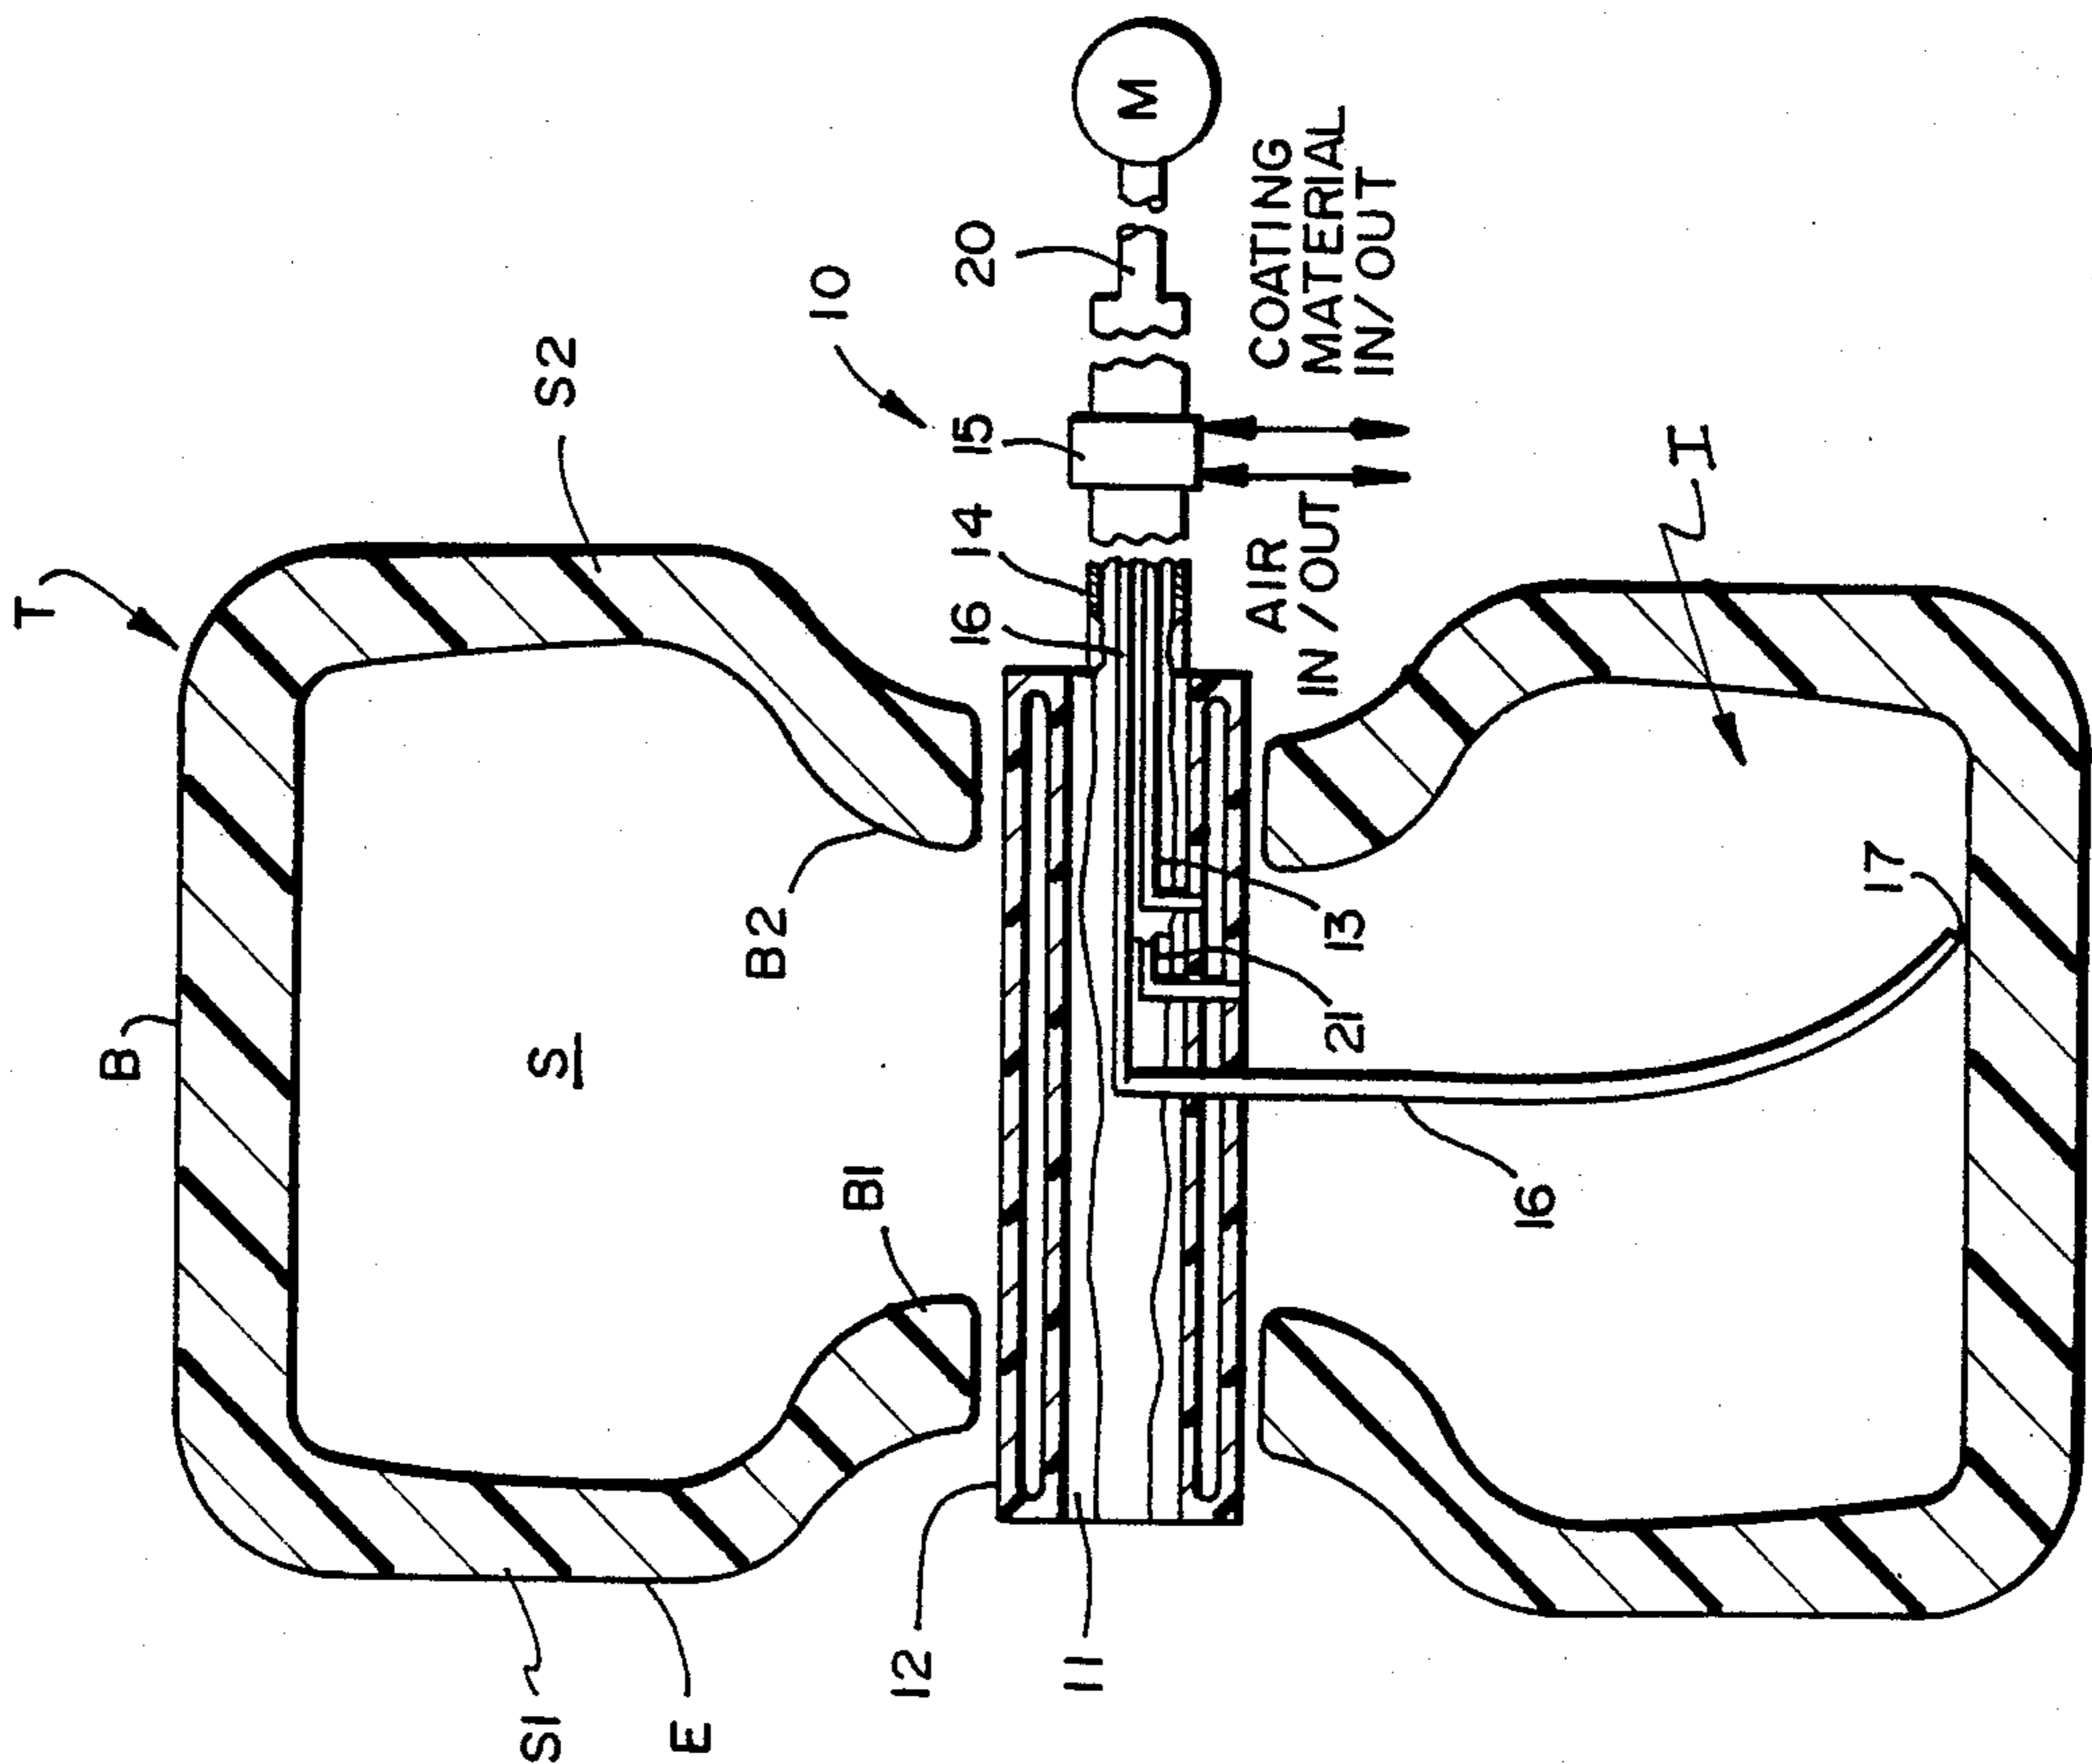
FIG. 2 is a fragmentary schematic view similar to FIG. 1 and illustrates coating material being injected into the tire interior just prior to or simultaneously with the expansion of the expandable hub.

After the tire T has been positioned upon the expandable hub 12 the pump P (FIG. 5) is energized and the liquid admixture or coating material L is pumped by the pump P through the flexible pipe 18 into the coupling 15 and through the flexible pipe 16 into the interior I of the tire T through the opening 17, as is diagrammatically illustrated in FIG. 2. The liquid L preferably is heated by a heater H in tank V to a temperature of approximately 160° F. before it is pumped into the tire T. Approximately three gallons of the liquid admixture or coating material L is pumped into the tire T which, if the tire T is not rotating, will accumulate along the bottom portion of the tire T, as shown in FIG. 2. However, in keeping with the present invention, the expandable hub 12 can be inflated to its expanded position (FIG. 3) by air being introduced through the coupling 15 and the flexible pipe 13 into the expandable hub 12 prior to or simultaneously with the introduction of the coating material L into the tire interior I through the opening 17. Furthermore, as soon as the expandable hub 12 has expanded by the air introduced therein, as shown in FIG. 3, the motor M is energized to rotate the drive shaft 20, the shaft 14, the metallic mandrel 11, the now-expanded expandable hub 12 and the tire T, as indicated by the unnumbered headed arrow in FIG. 3 associated with the drive shaft 20. Obviously if the motor M is energized simultaneously with the introduction of the coating material L into the interior I of the tire T through the opening 17, the material L will not accumulate in the bottom portion of the tire T, as shown in FIGS. 2 and 3, but will be progressively applied over the entire interior surface S by the rotation of the tire, the liquid nature of the coating material L and the relatively low centrifugal force (three revolutions per minute). The interior I of the tire is also pressurized preferably between 7 psi-10 psi, but anywhere between 2 psi to 120 psi has been found appropriate. This internal pressurization of the interior I is achieved by another flexible air pipe 21 which runs from the external air pressure source (pump, not shown) through the coupling 15, the tubular shaft 14, and through the annular expandable hub 12, as is best illustrated in FIG. 4. Thus, the same air source can be used to inflate the expandable hub 12 via the flexible pipe 13 and, through a suitable check valve, the flexible pipe 21 can pressurize the interior of the tire T.

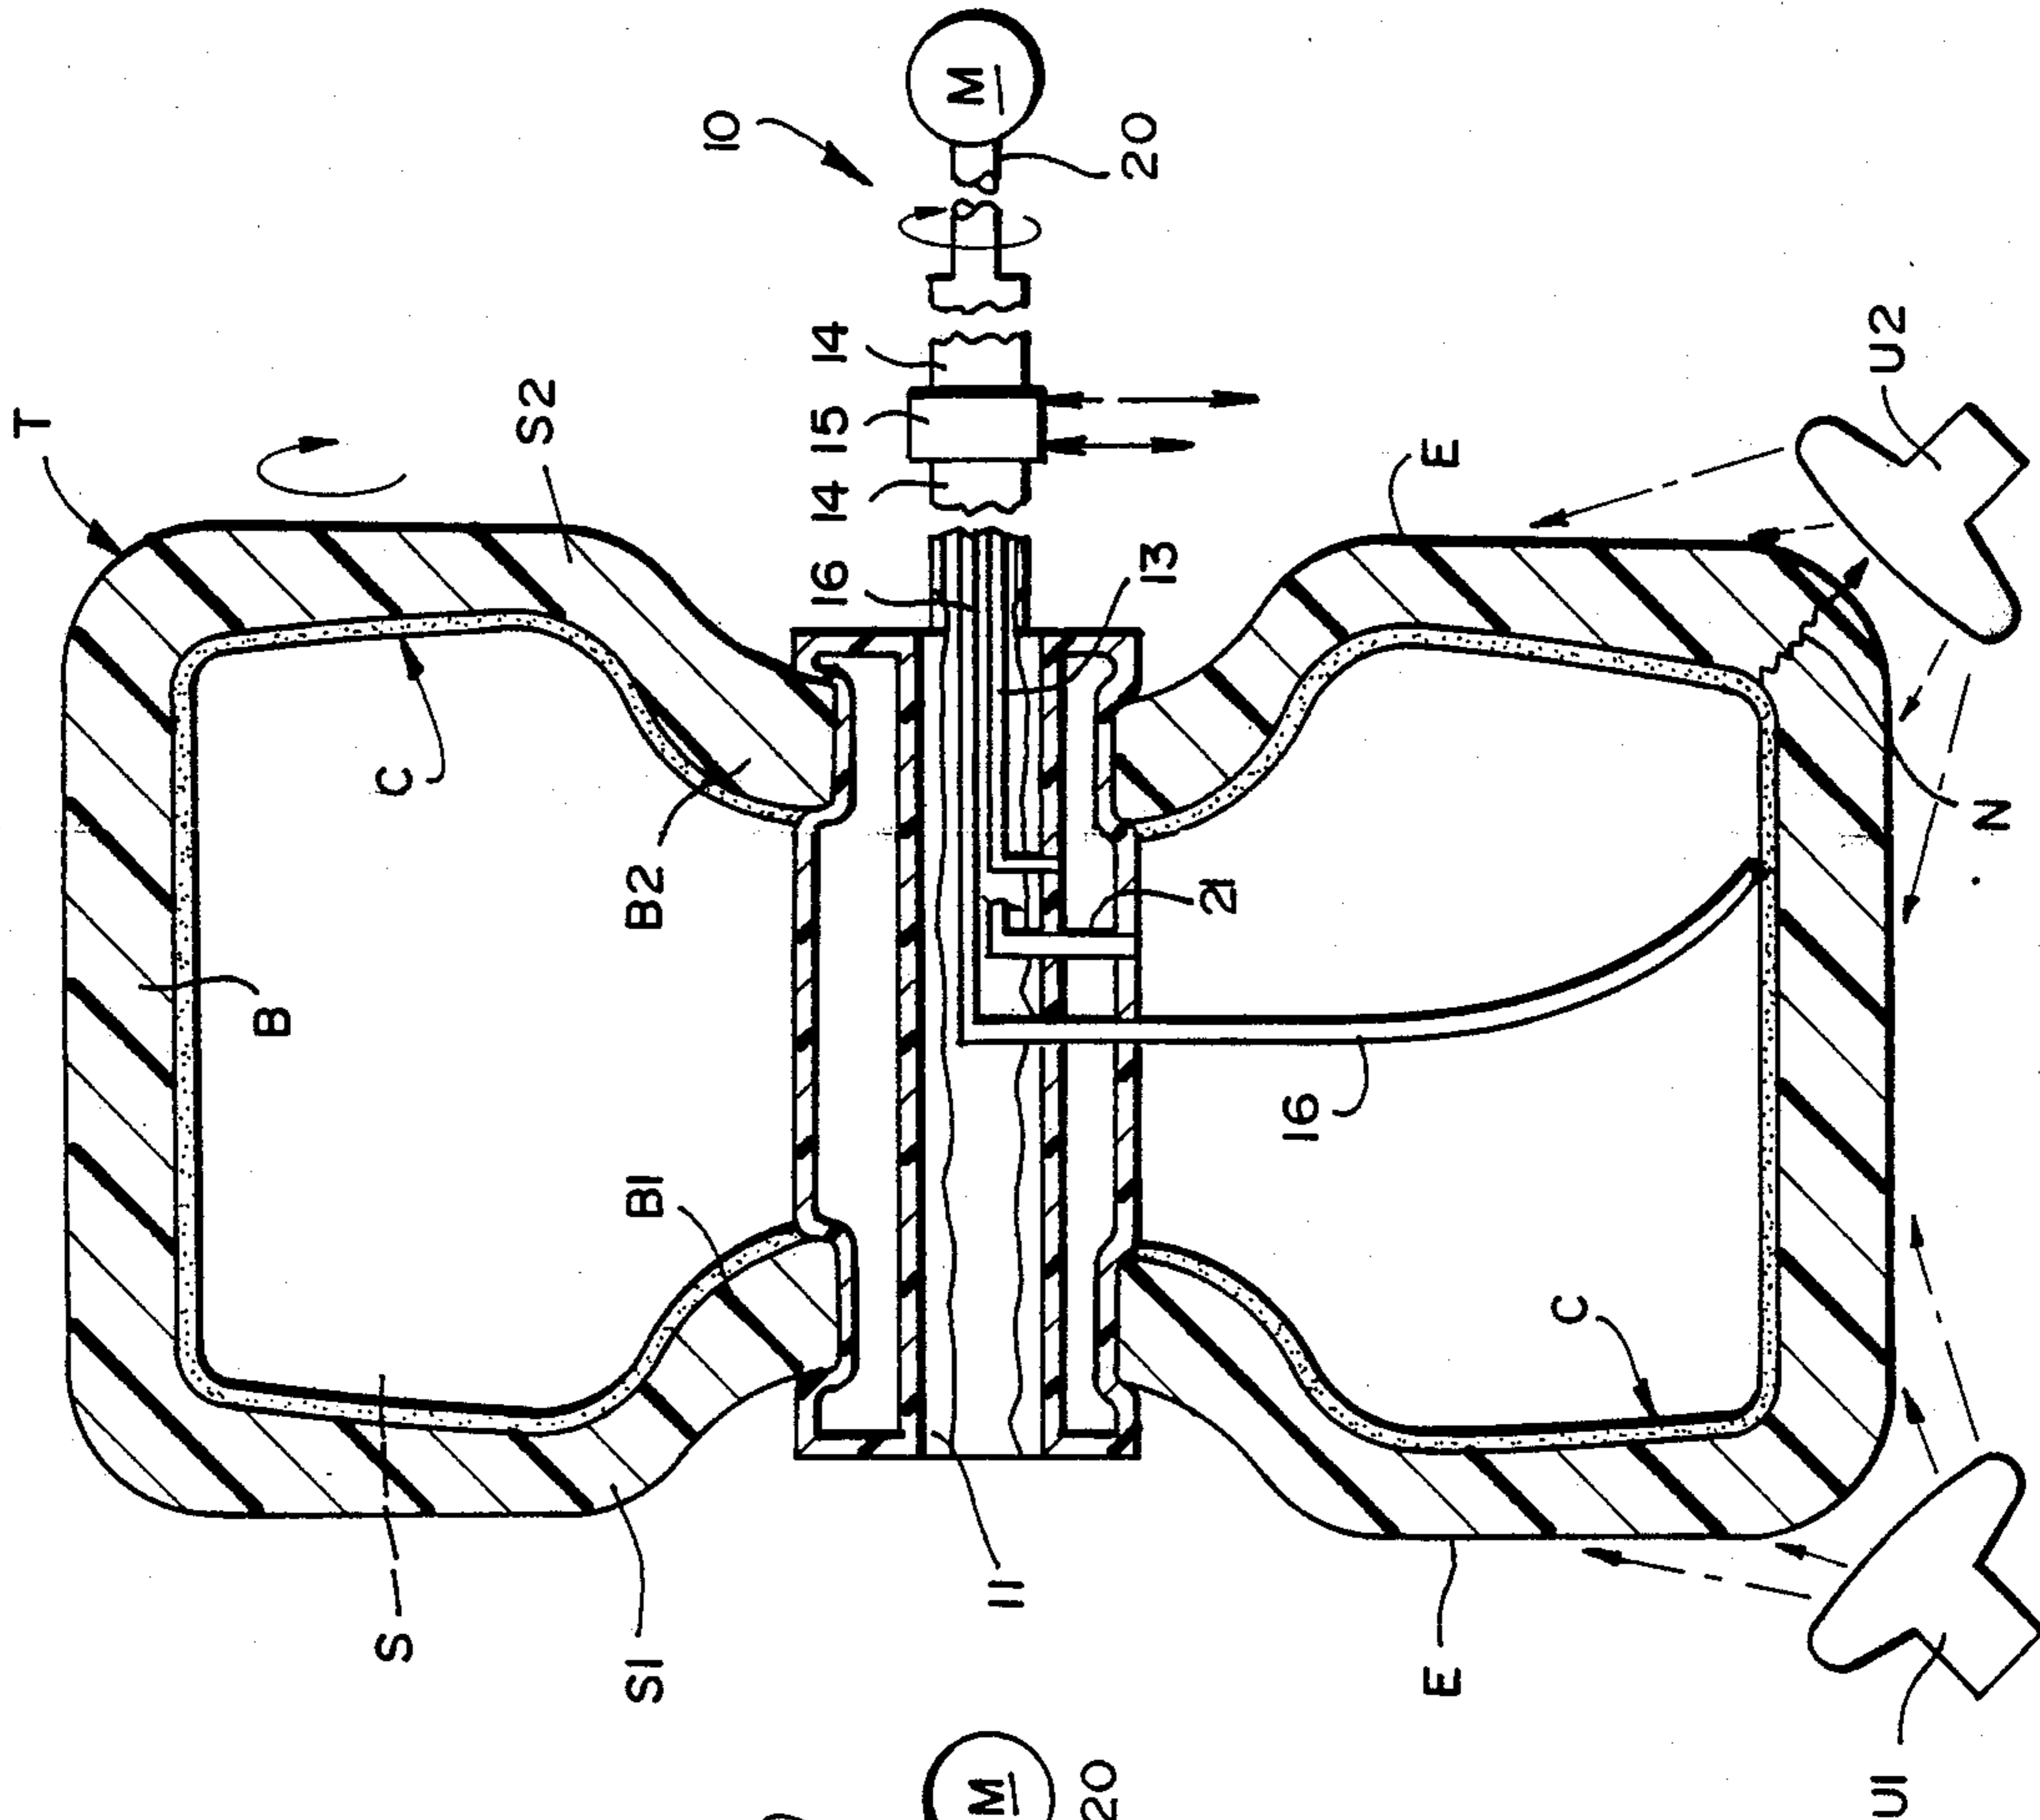
FIG. 3 is a fragmentary schematic view similar to FIG. 2, and illustrates the expandable hub in its ex-

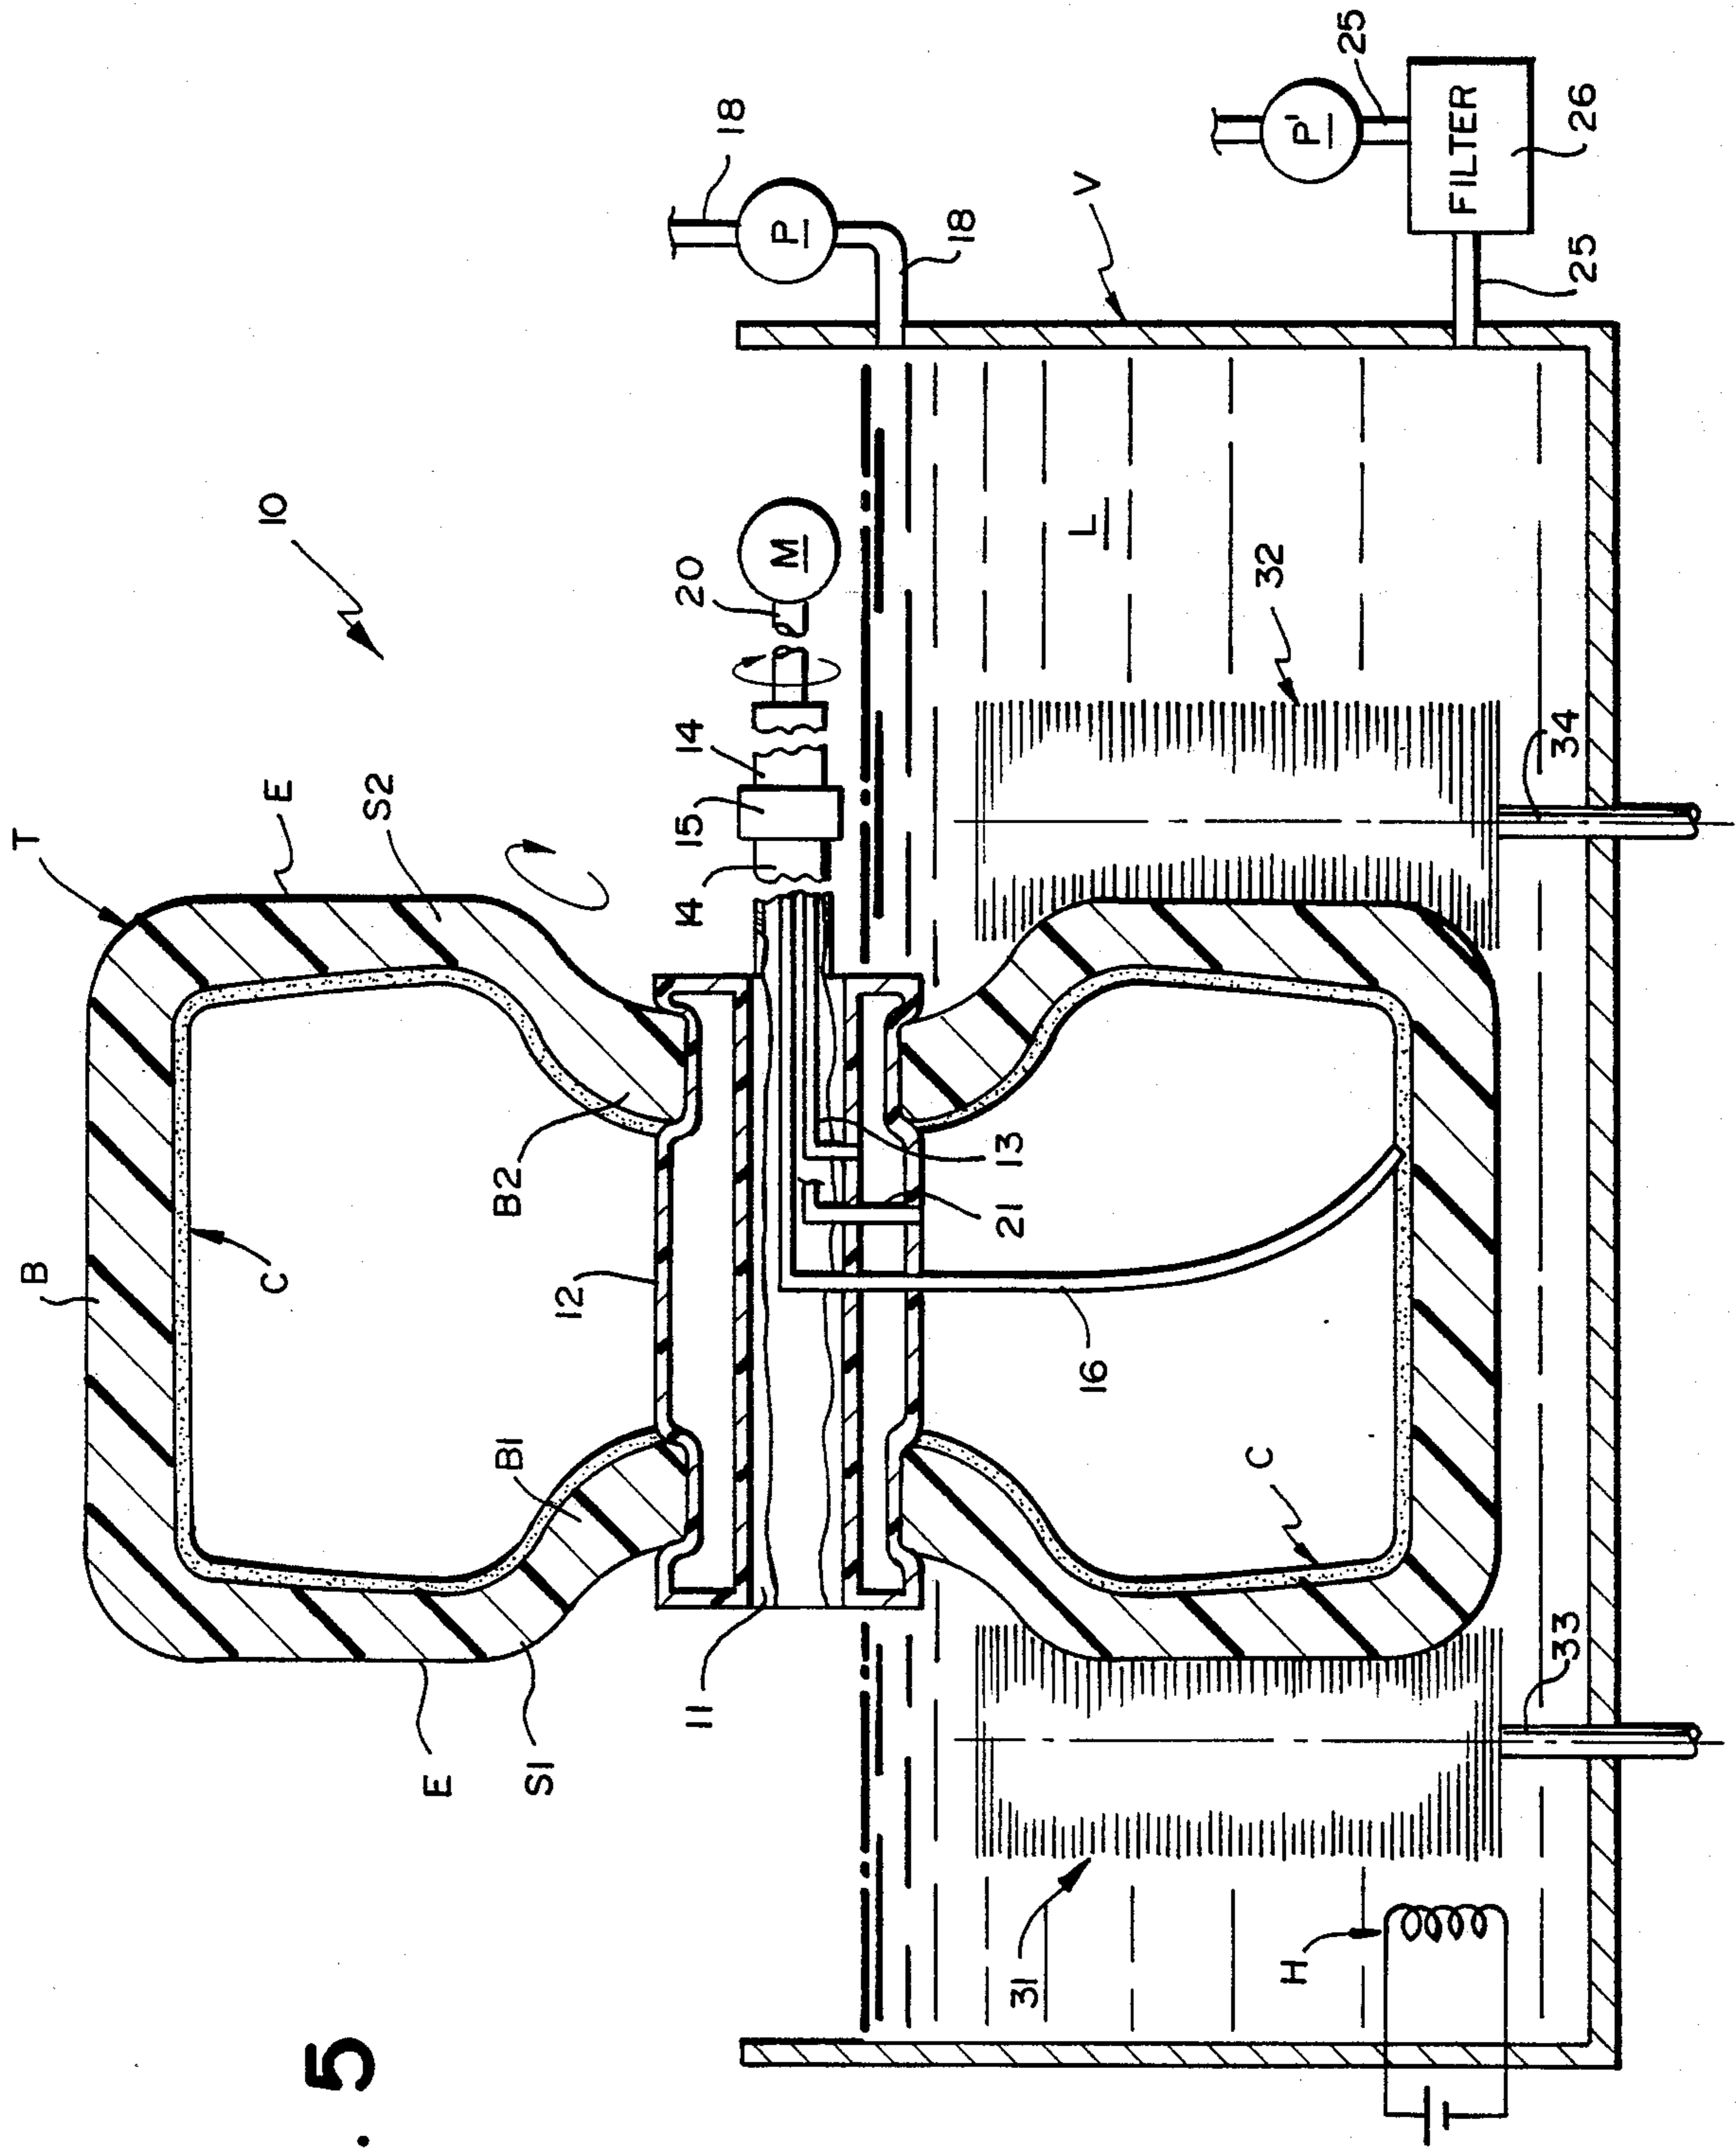
FIG. 5 is a fragmentary schematic view similar to FIG. 4, and illustrates the tire partially immersed in the coating material which also includes a detergent in an associated tank and associated brushes for cleaning the exterior sidewalls of the tire.

Before the tire T is removed from the expanded hub 12 (FIG. 4), the tire T is immersed, also during its 20 rpm rotation, in the tank V, as shown in FIG. 5. A pair of brushes 31, 32 have shafts 33, 34 arranged generally parallel to each other and are journaled for rotation in the tank V. As the brushes 31, 32 are rotated, preferably in opposition to the direction of rotation of the tire T, the exterior surface E of both sidewalls S1, S2 are thoroughly cleansed because of the detergent in and the temperature of the liquid admixture L. After approximately two or three rotations the tire T is removed from the tank V, and as illustrated in FIG. 6, the entire exterior surface E is coated with a coating C' of the liquid L. Thereafter, the motor M is deenergized, a pump P' connected to the flexible pipe 16 through the coupling 15 is energized, and the pump P' draws the excess liquid L from the tire interior I through the flexible pipe 16 and delivers the same through a flexible pipe 25 and a filter 26 into the tank V adjacent the bottom thereof. The liquid L is preferably drawn from adjacent a top of the tank V and returned adjacent the bottom of the tank V because debris removed from the exterior E of the tire T by the brushes 31, 32 tends to accumulate near the bottom of the tank V, and therefore cleaner liquid L is adjacent the top of the tank V.

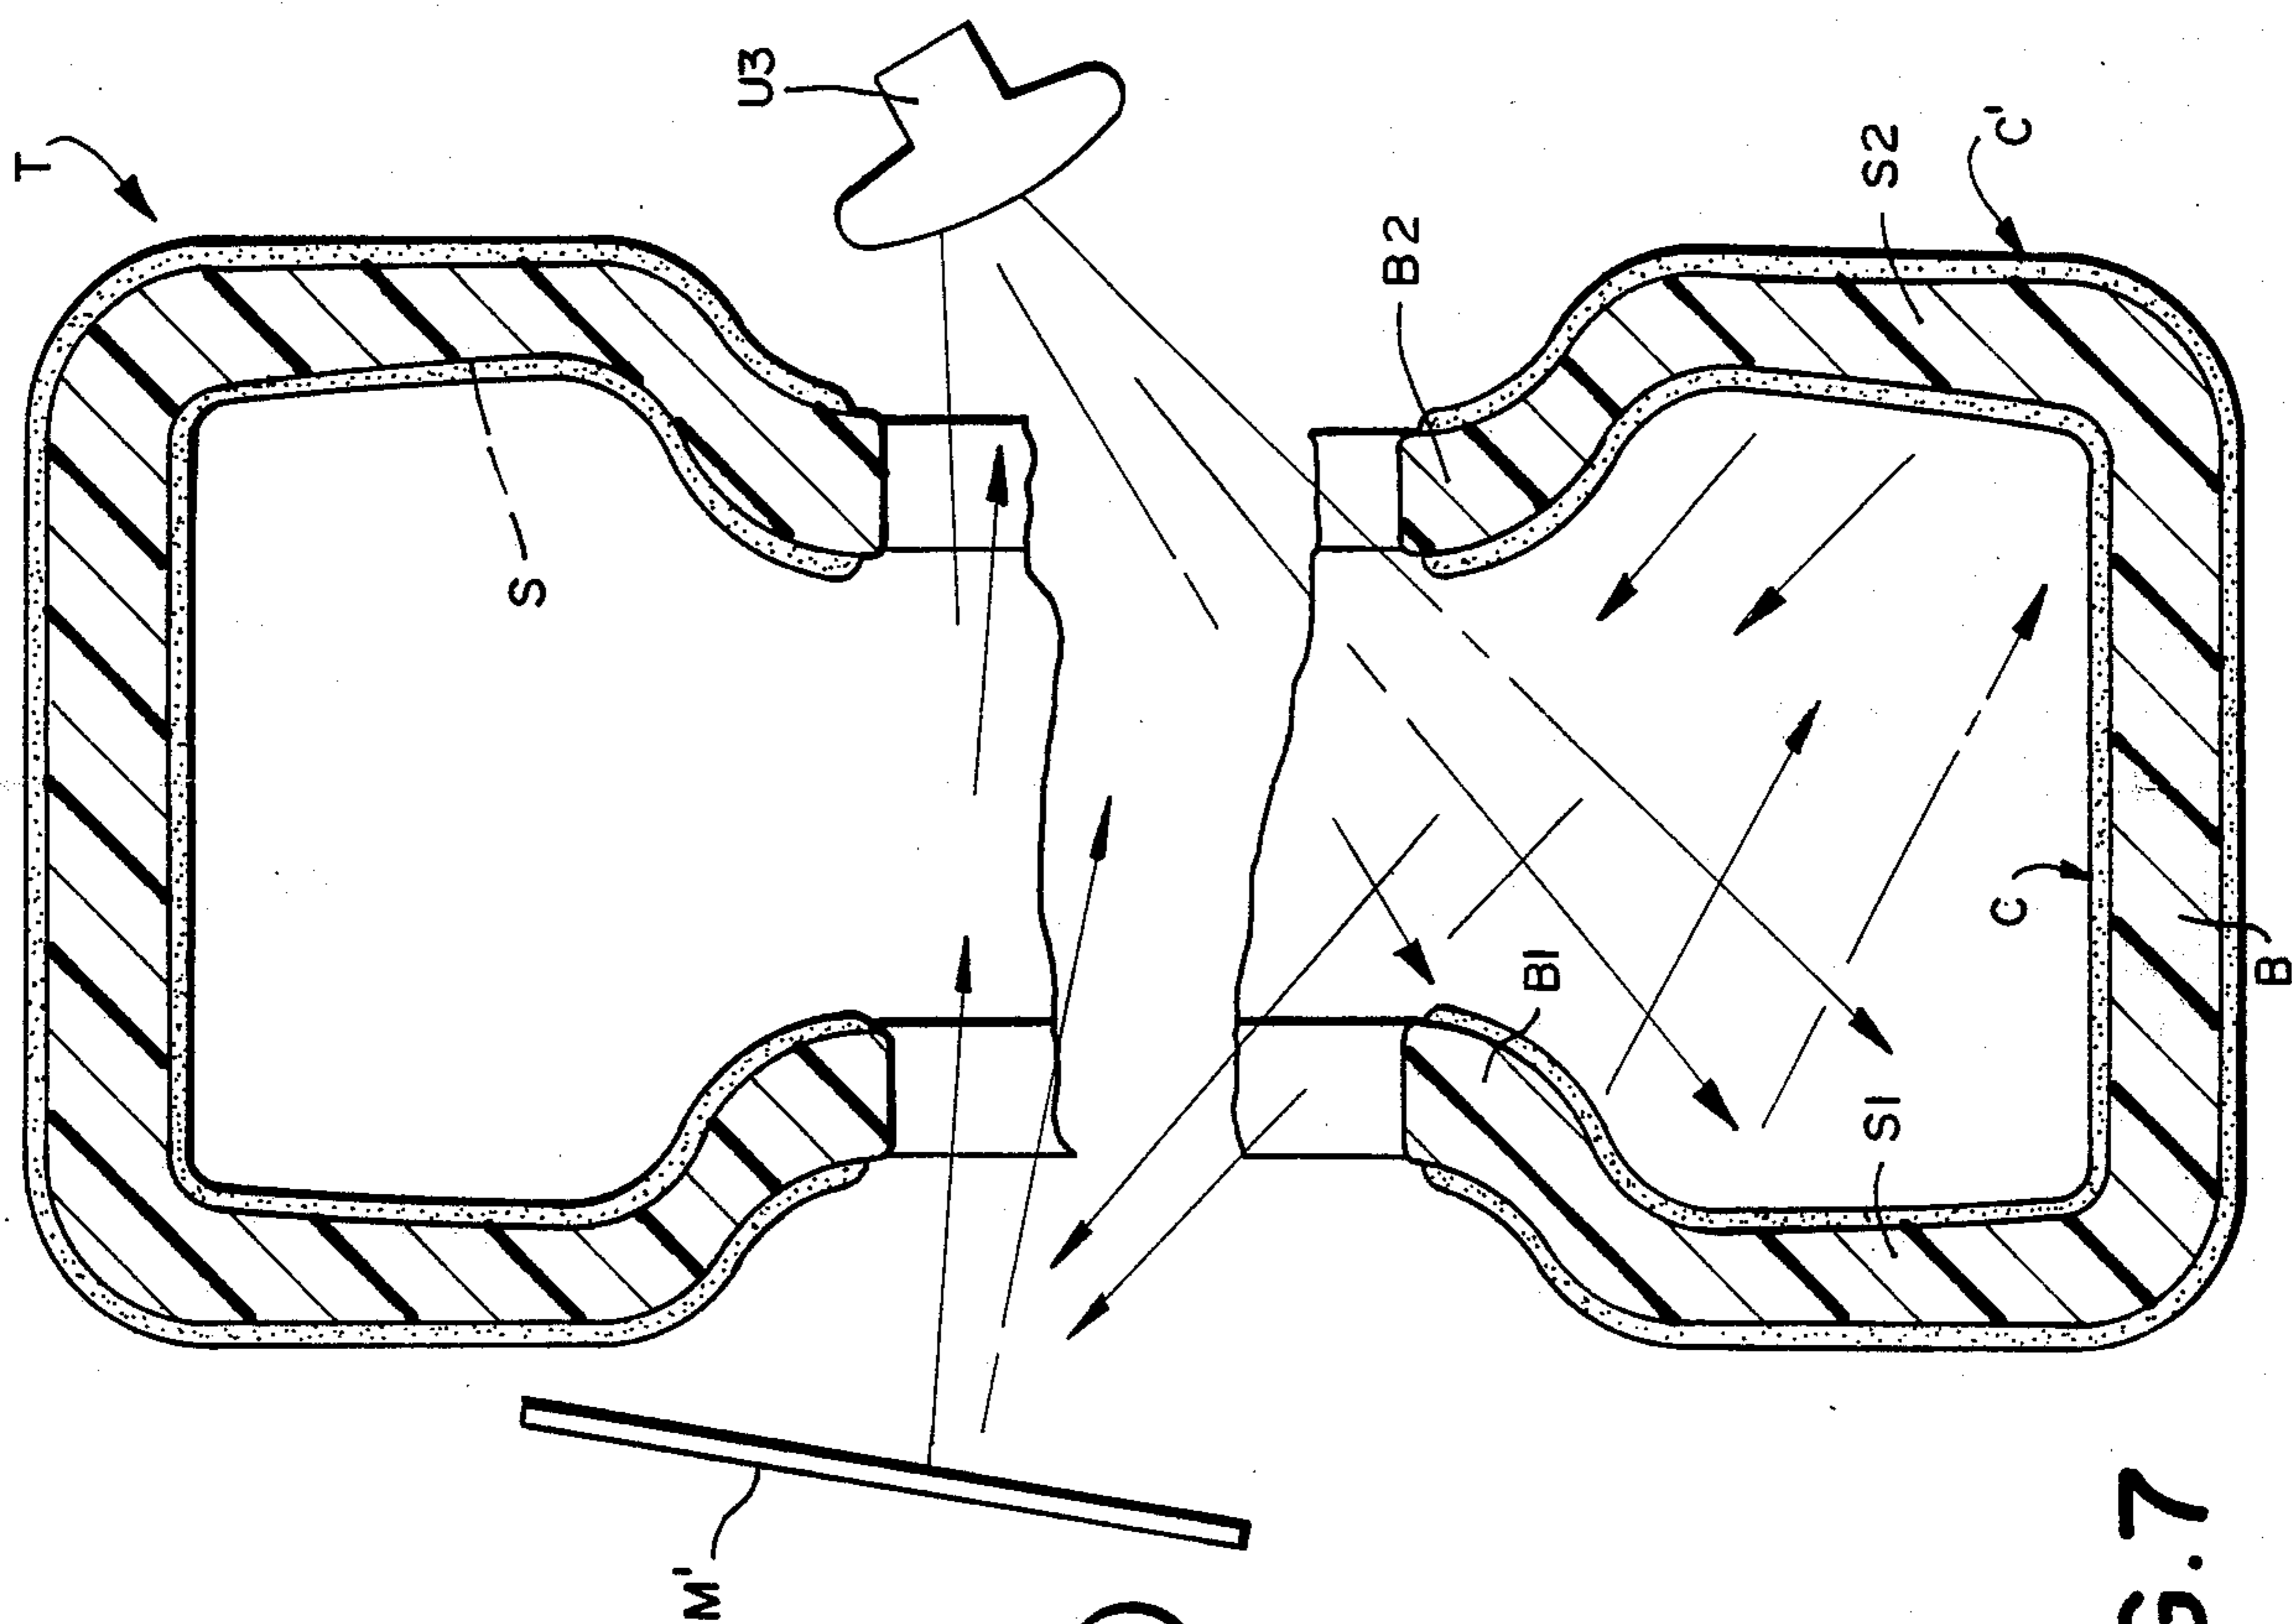
FIG. 7 is a fragmentary sectional view similar to FIG. 6 after the excess coating material has been removed from the tire interior, the tire has been removed from the expandable hub, and the tire exterior and interior can be spot-checked for relative large defects.
