[54] METHOD OF INSPECTING TIRES FOR DEFECTS

A method of inspecting a tire for defects by applying to an interior surface of a tire a coating of material which accentuates defects when influenced by predetermined electromagnetic wavelengths, road-running the tire to thereby create tread wear, buffing the exterior tread surface of the tire, and applying predetermined electromagnetic wavelengths to the exterior of the buffed tread surface whereby coating material which has migrated through a defect in the tire to the exterior is accentuated and thereby readily detected. Preferably the coating material fluoresces or brightens when subjected to ultraviolet light. The coating material is preferably part of an admixture composed of the ultraviolet light accentuating coating material and a tire sealant which seals punctures, nail holes and the like when the same migrates through the tire.

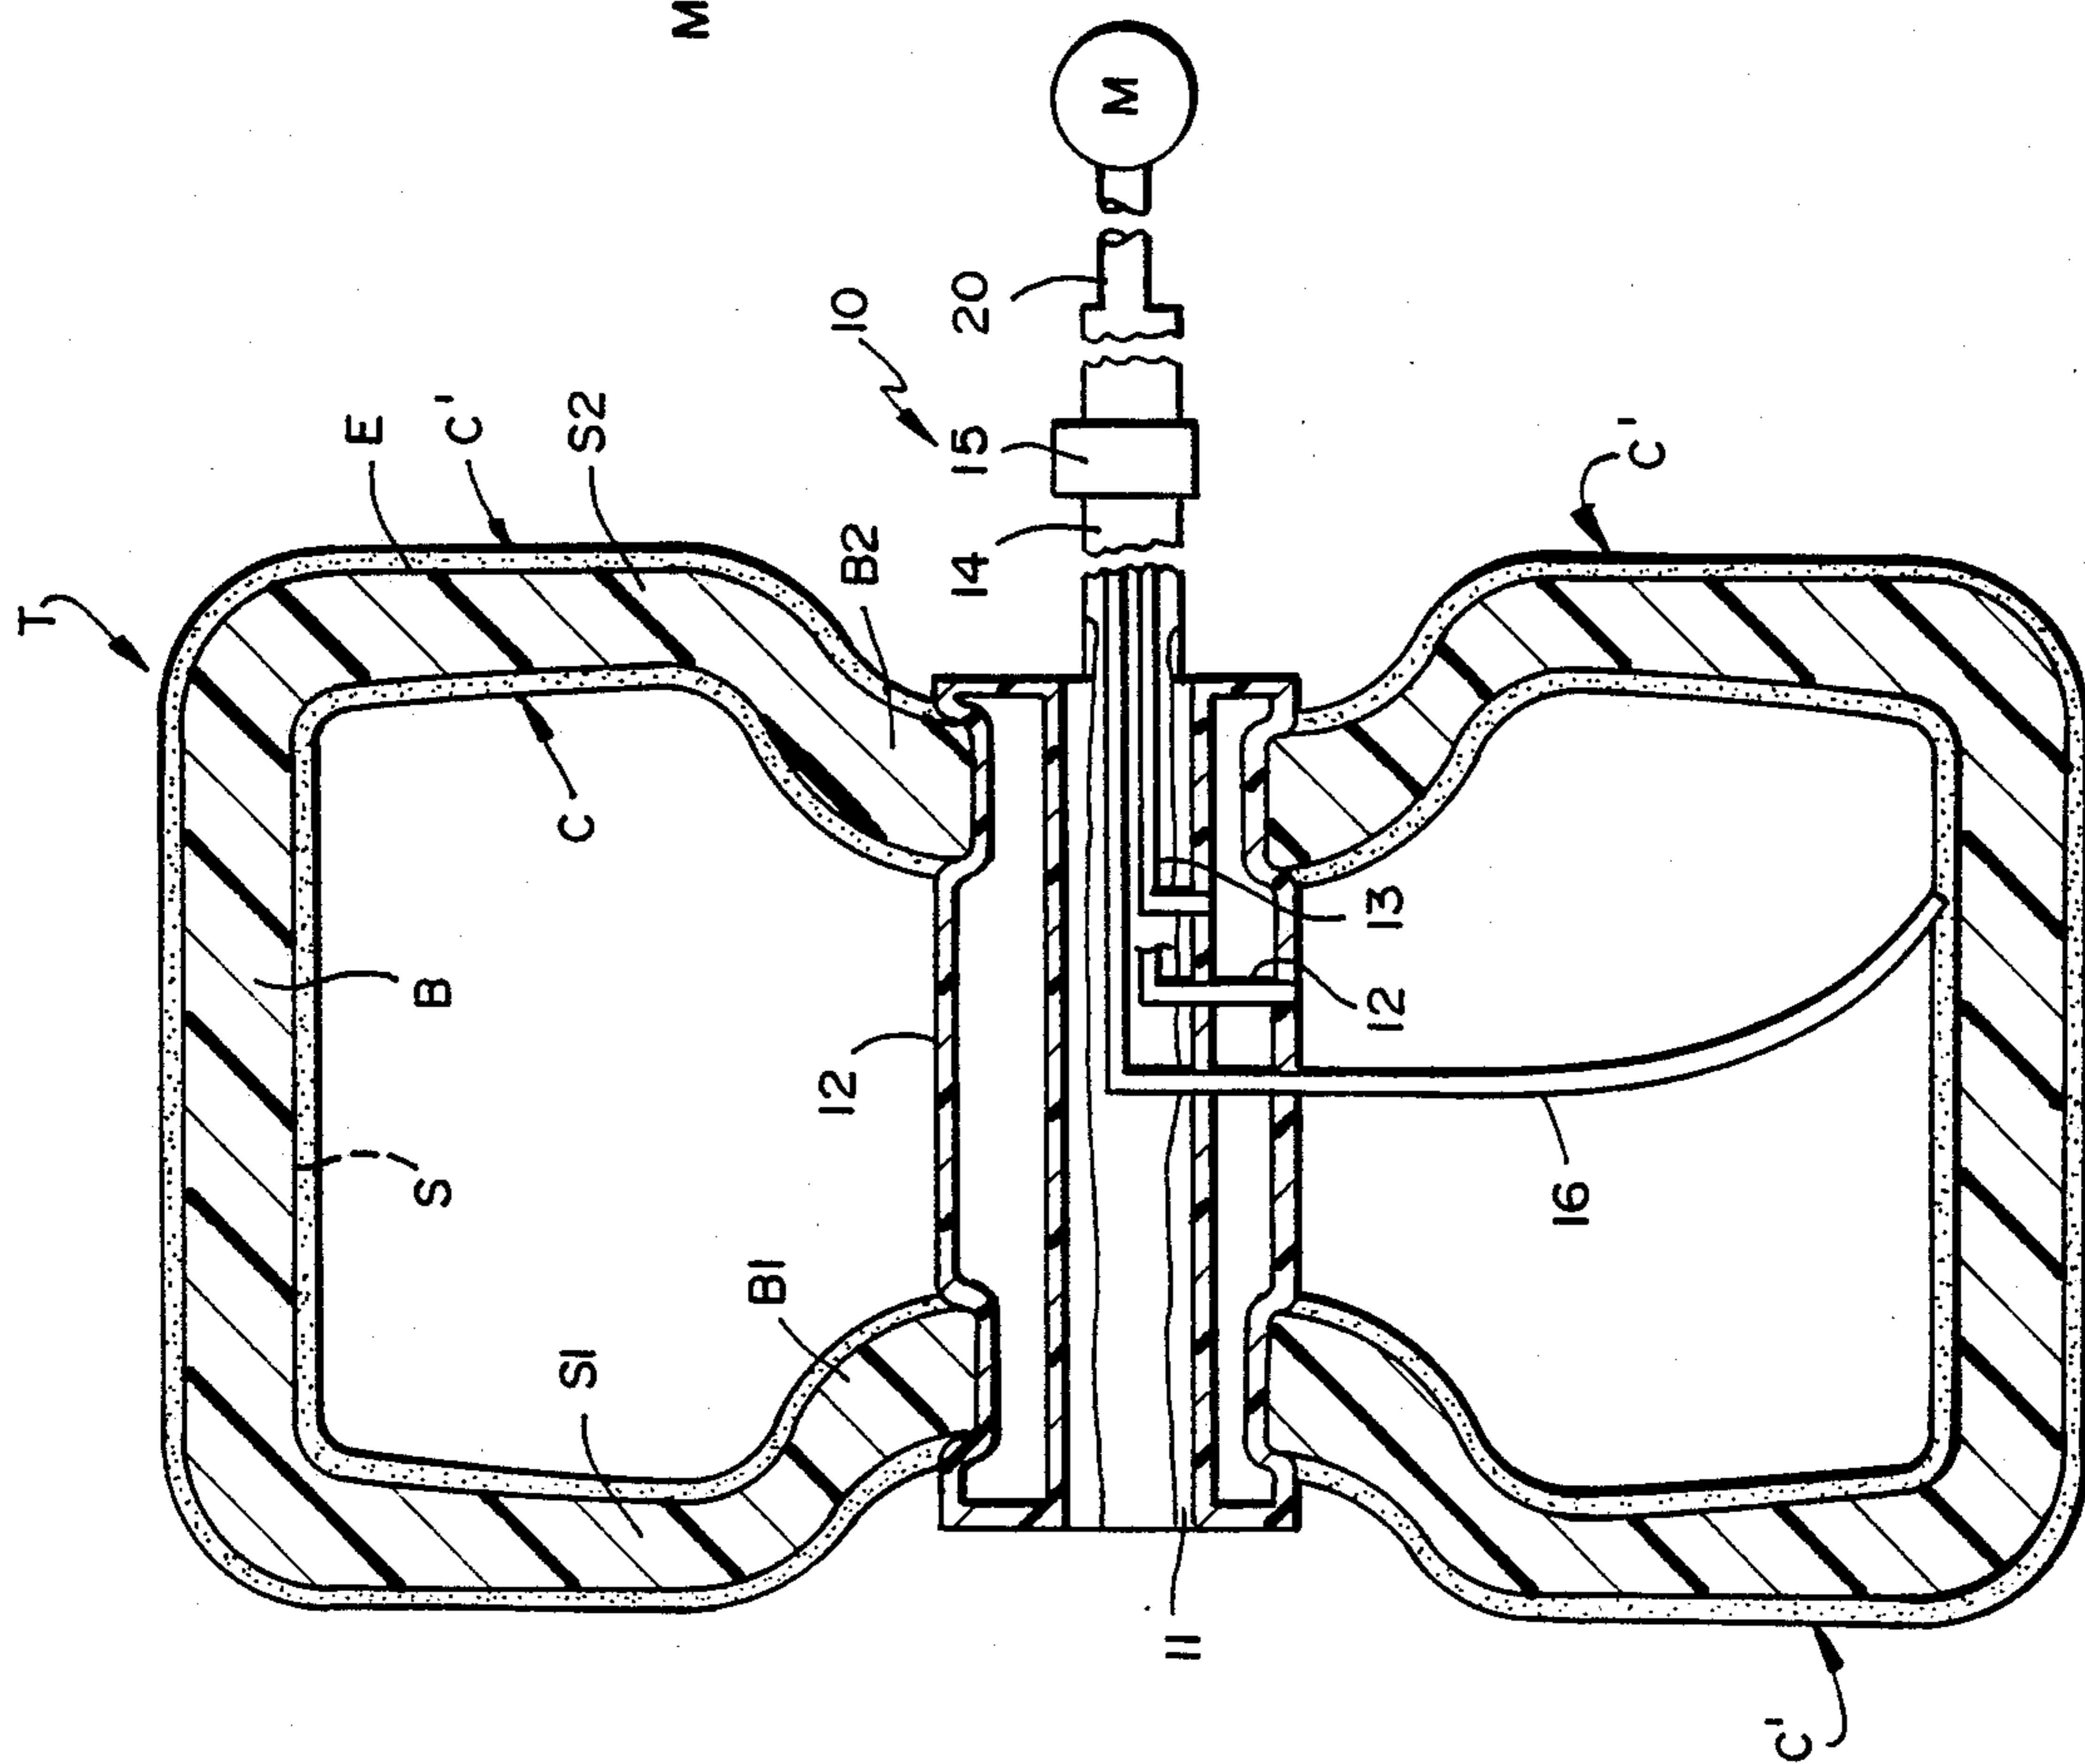
FIG. 6 is a fragmentary schematic view illustrating the tire after having been removed from the tank of FIG. 5 with the exterior coated with the coating material.

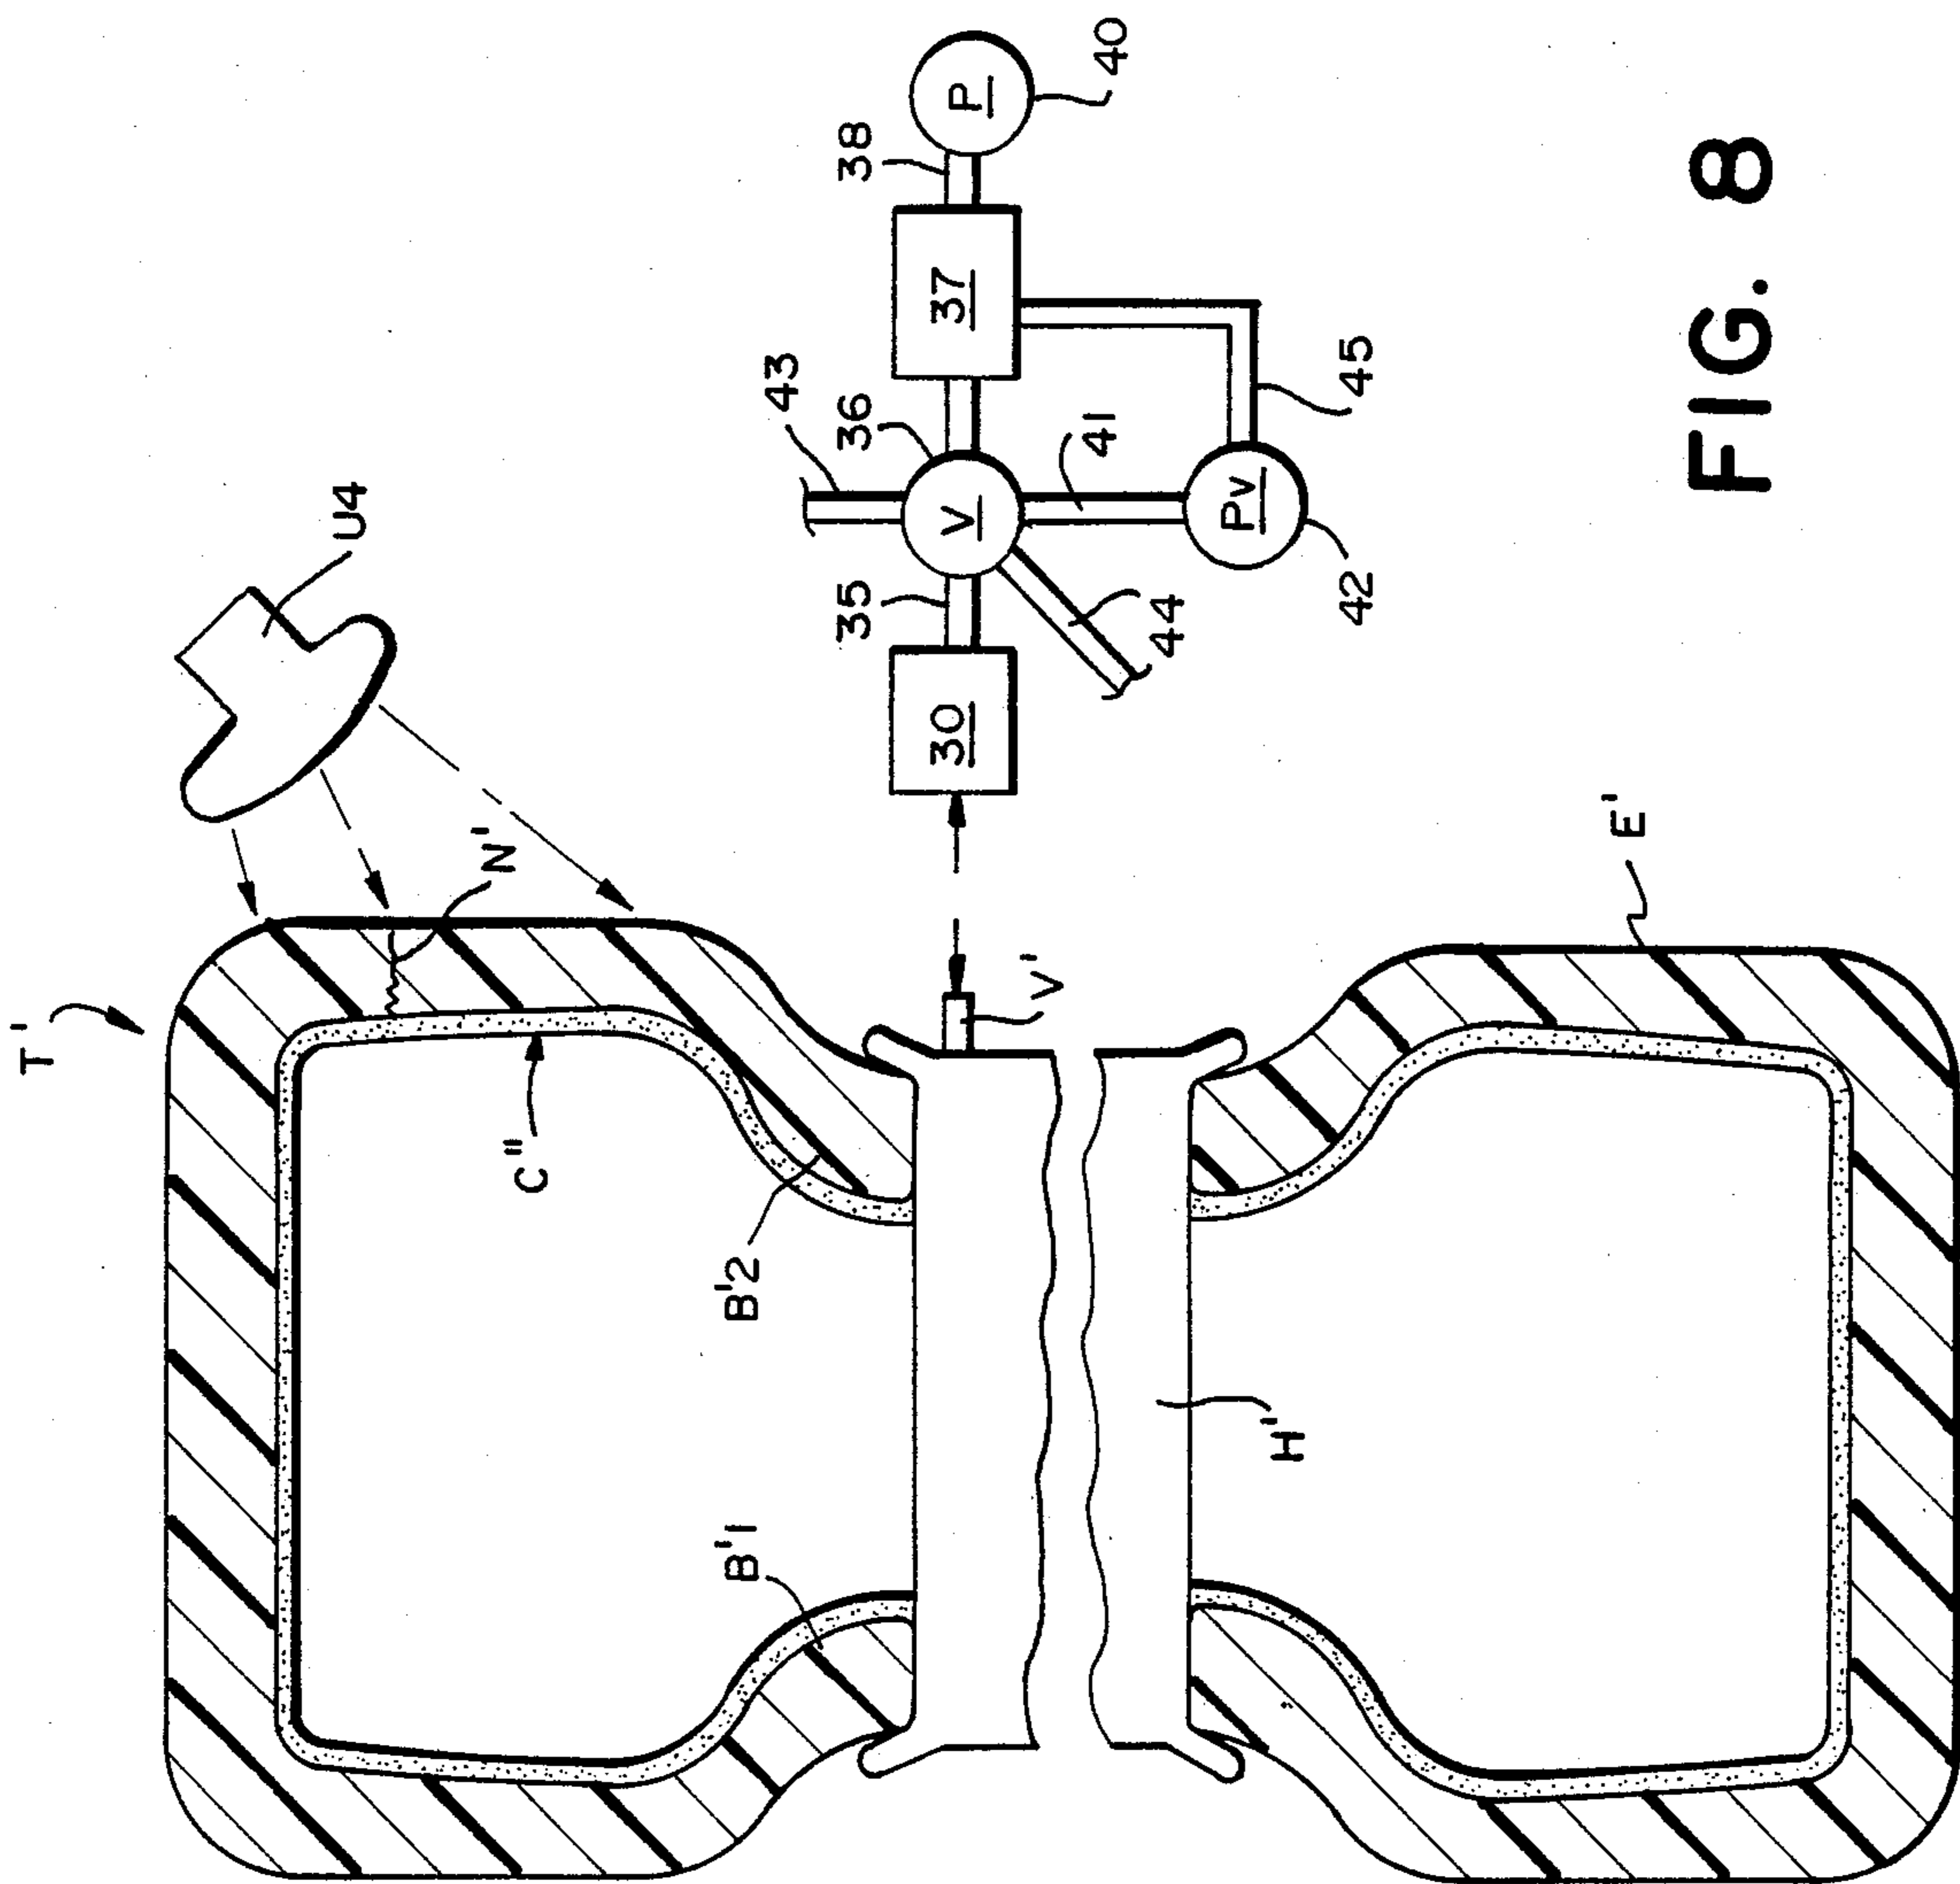
FIG. 8 is a fragmentary schematic view of a conventional tire mounted on a conventional rim having a conventional valve connected to a system for pumping coating material into the tire and removing the coating material out of the tire through the valve stem and externally inspecting the tire for coating material migration so that defects can be found and repaired without removing the tire from the rim.
